NC DEPARTMENT OF TRANSPORTATION
 DIVISION OF HIGHWAYS
 STRUCTURE MANAGEMENT UNIT

ATTENTION: **PAR SUBMITTED**
NEW REPAIRS ON RAILS
TEMPORARY REPAIRS ON BEAMS

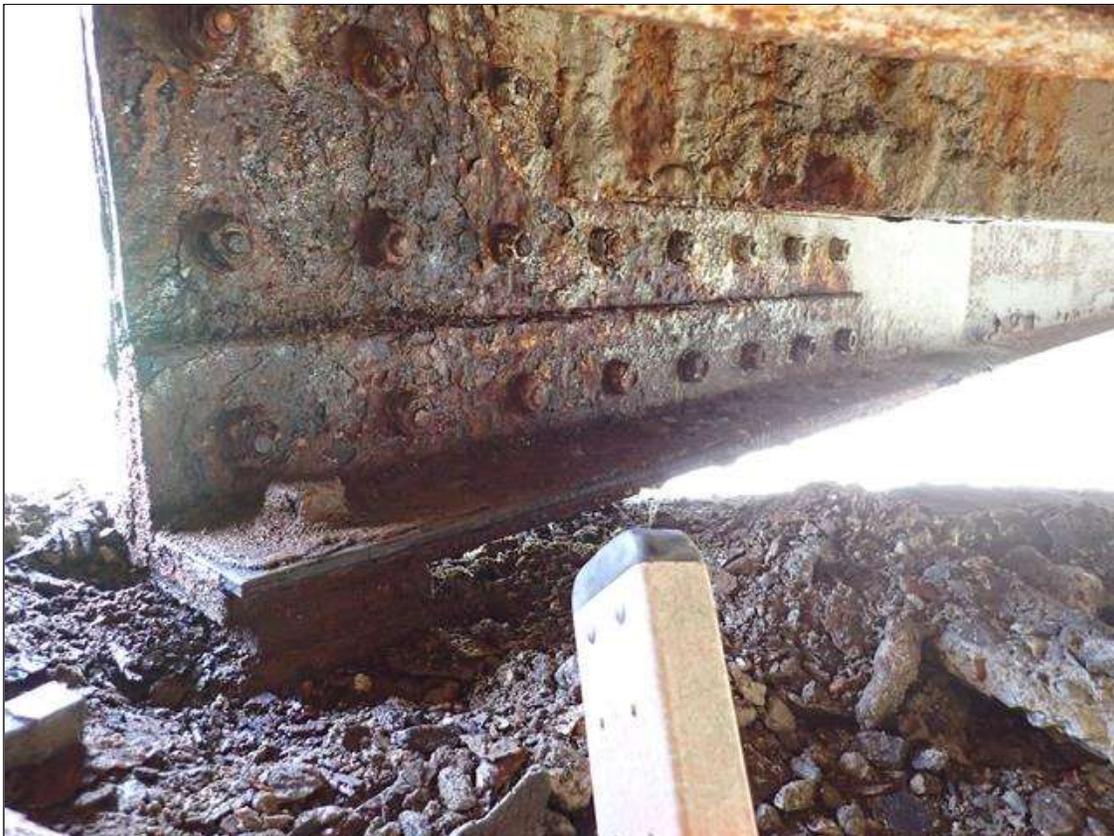
Span 2 Beam 1: AT BENT 1, ANGLES BOLTED TO BOTTOM FLANGE WITH 4FT LIGHT SCALING BOTTOM FLANGE AND UP TO 24IN IN THE WEB

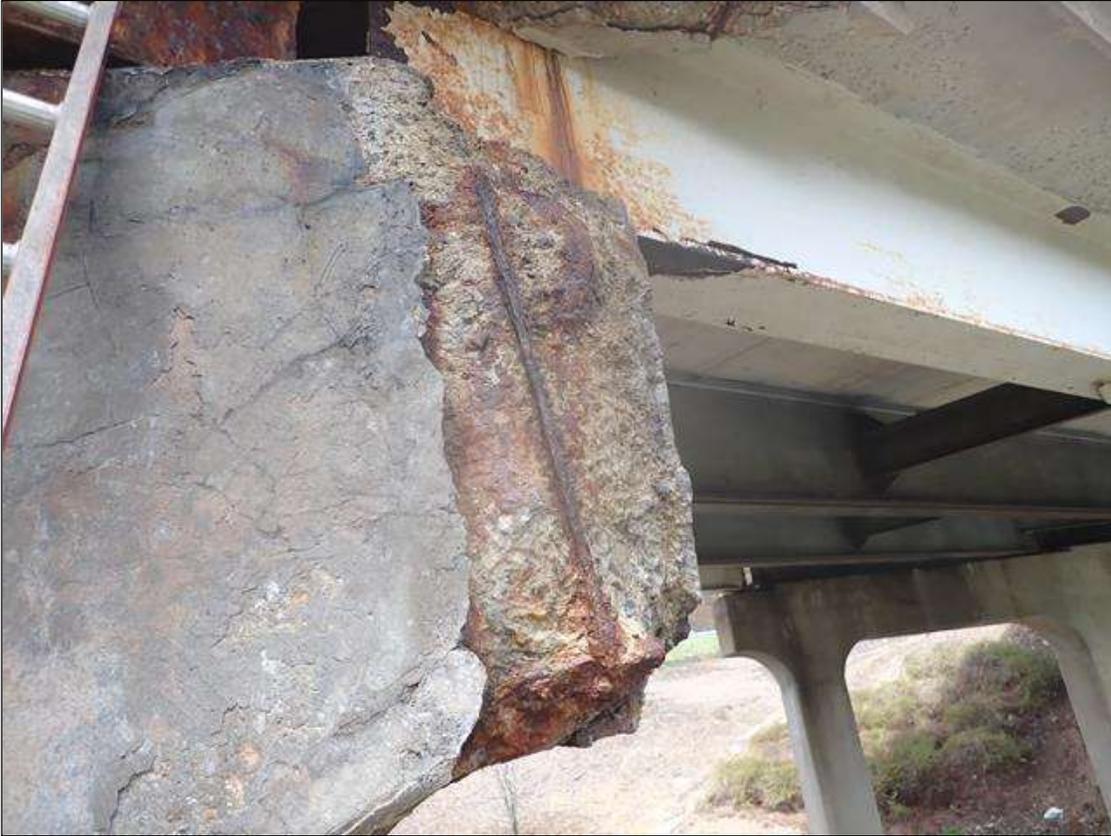
Bent 1 Cap 1: (PAR) SOUTHEAST CORNER EXTENDING ONTO BOTTOM FACE, 16IN X UP TO 40IN X 33IN SPALL WITH EXPOSED REINFORCING WITH 20% SECTION LOSS

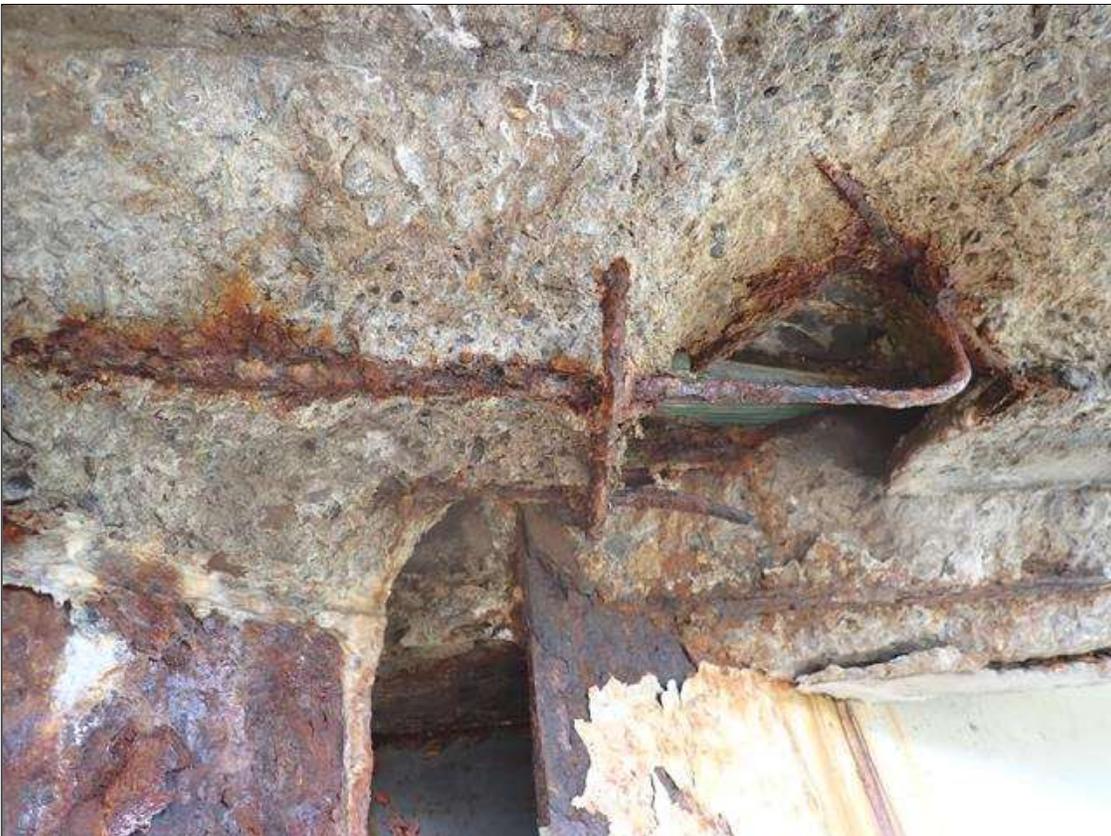
Span 1 Deck: (PAR) EAST OVERHANG DIAPHRAGM AT BENT 1, 5FT WIDE X UP TO FULL WIDTH X FULL DEPTH SPALLING WITH EXPOSED REBAR WITH 30% SECTION LOSS AND (1) BROKEN REBAR

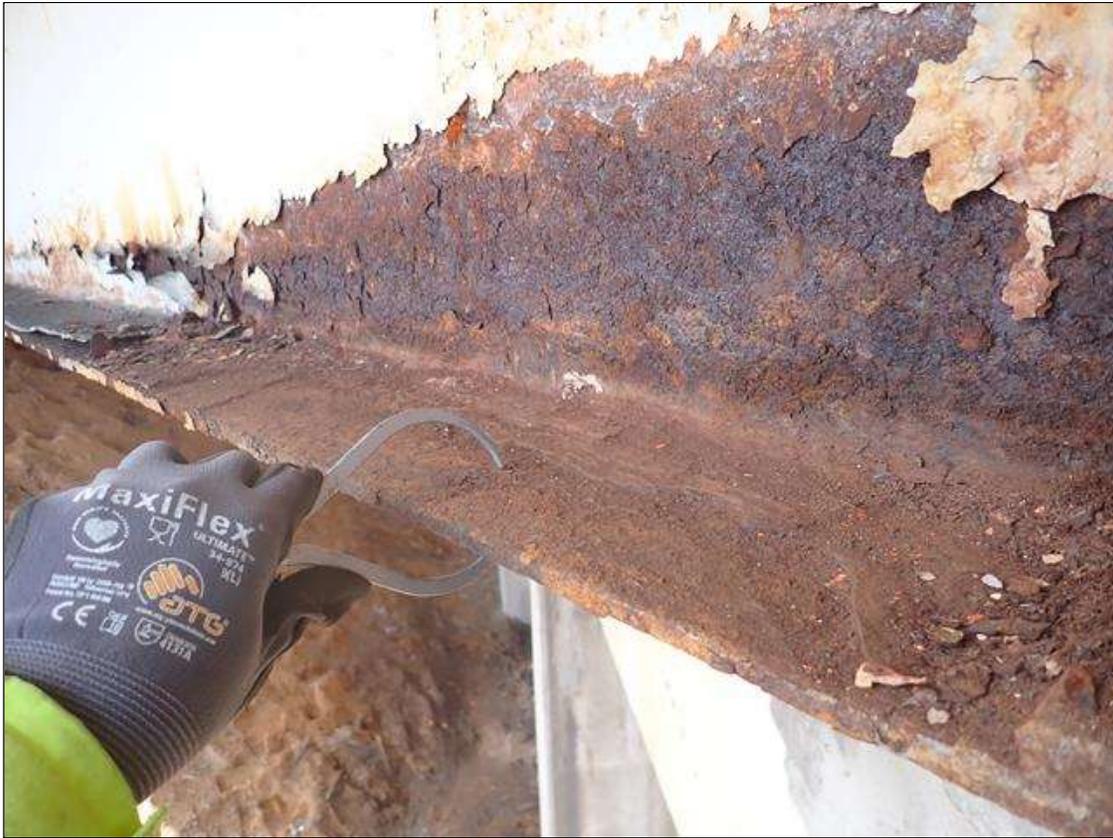
Span 1 Beam 4: (PAR) AT BENT 1, 17FT CORROSION WITH SECTION LOSS IN BOTTOM FLANGE DOWN TO 0.4IN REMAINING. 1/4IN REMAINING IN THE WEB; A 36IN X 22IN TEMPORARY REPAIR PLATE IS PRESENT ON THE WEB AND A 36IN X 5IN TEMPORARY REPAIR PLATE IS PRESENT ON THE LOWER FLANGE

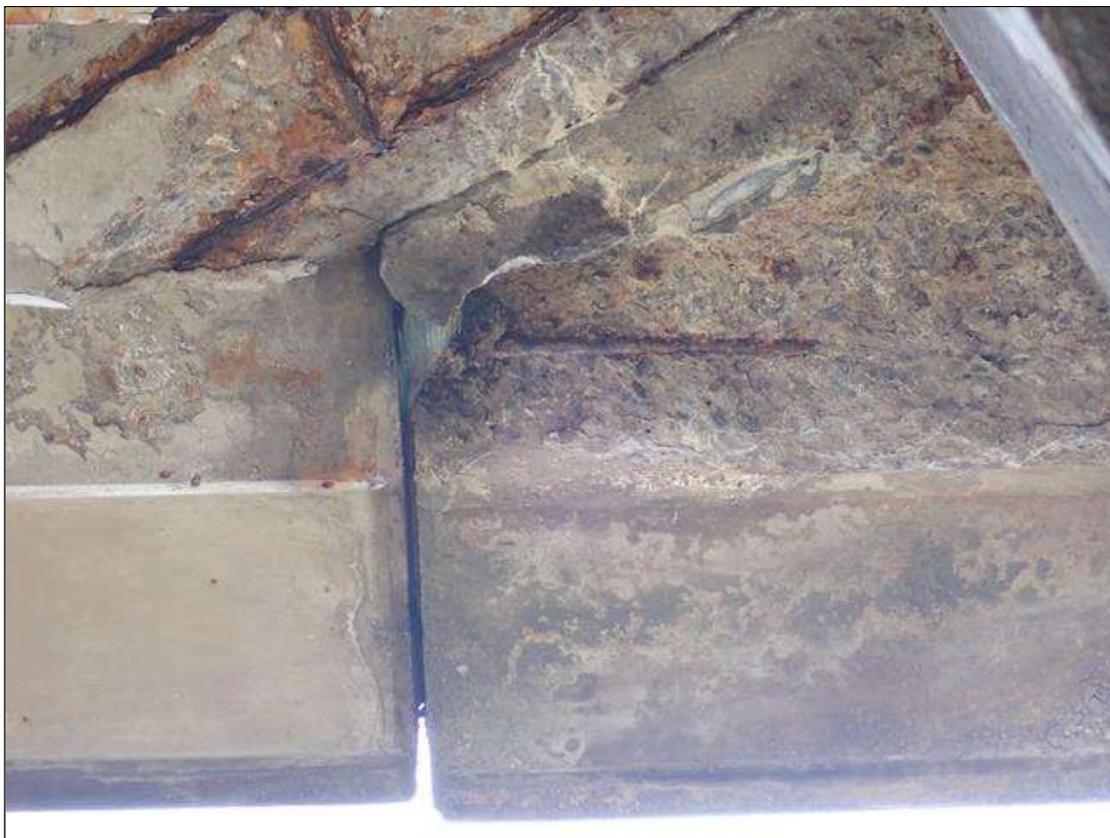
Span 1 Deck: EAST OVERHANG AT BENT 1, 3FT X UP TO 18IN X 7IN DEEP SPALL WITH EXPOSED REBAR WITH 10% SECTION LOSS

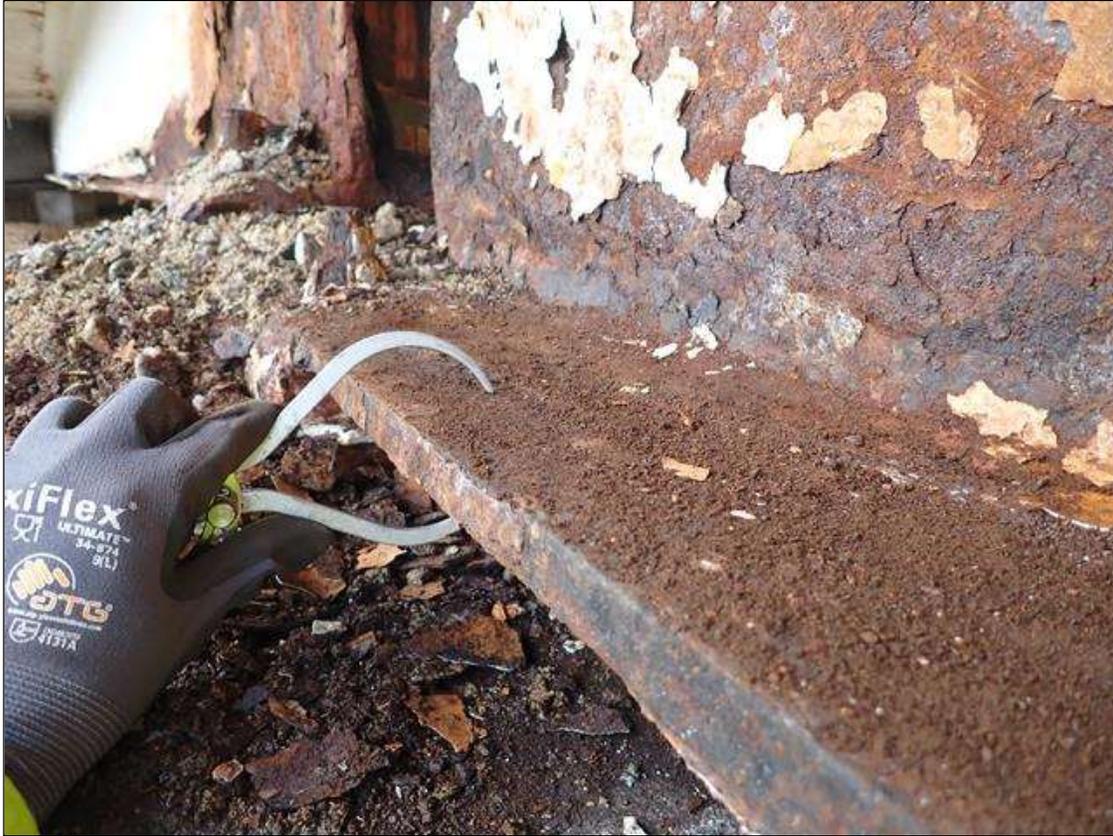
Span 2 Beam 4: (PAR) AT BENT 1, 4FT OF CORROSION WITH SECTION LOSS BOTTOM FLANGE AND UP TO FULL HEIGHT IN THE WEB. 1/2IN AVERAGE REMAINING IN BOTTOM FLANGE AND 0.22IN AVERAGE REMAINING IN THE WEB

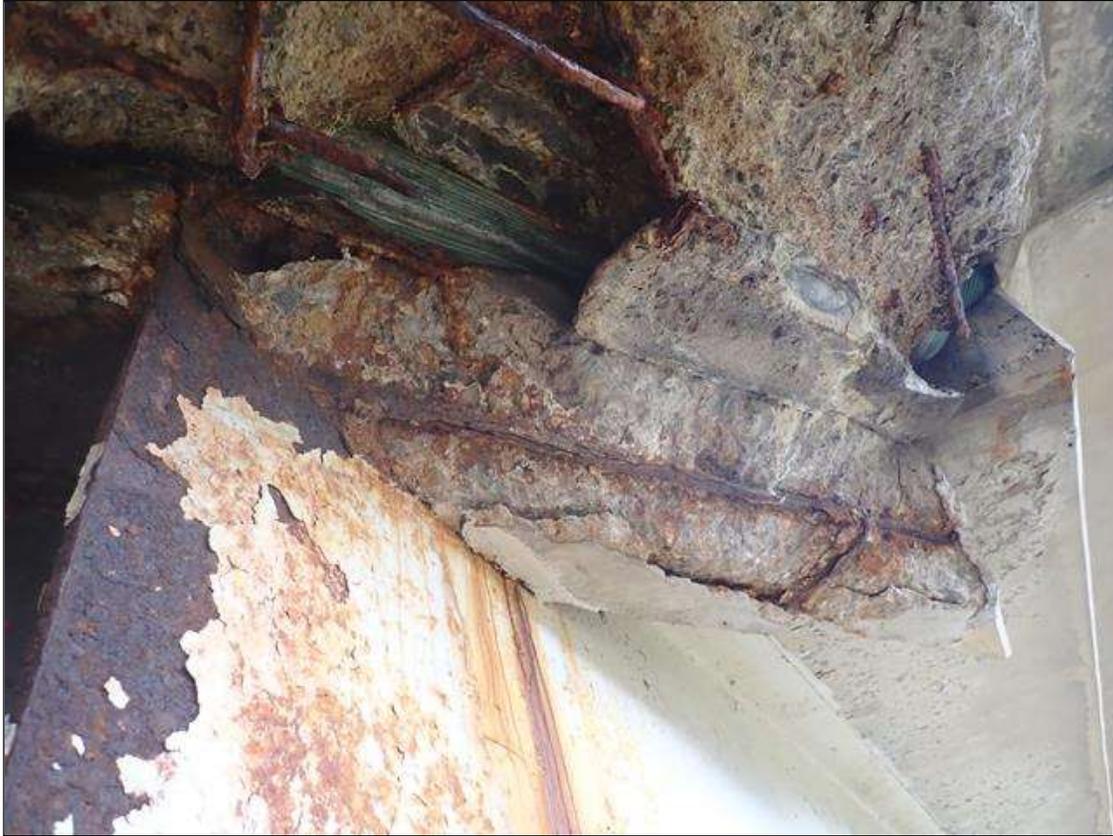
Span 2 Deck: (PAR) EAST OVERHANG DIAPHRAGM AT BENT 1, 4FT X UP TO 1FT X FULL DEPTH SPALL WITH EXPOSED REBAR WITH 10% SECTION LOSS

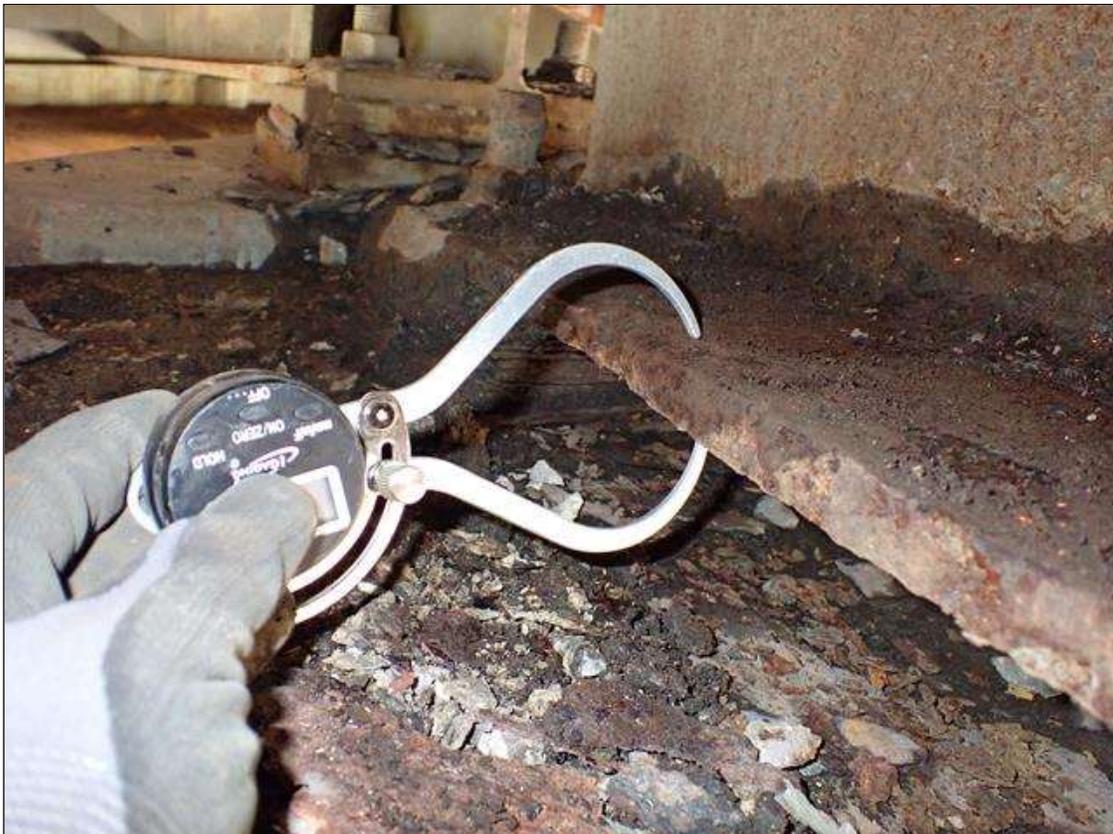
Span 2 Beam 3: (PAR) AT BENT 1, 3FT OF RUST SCALE BOTTOM FLANGE AND UP TO 33IN IN THE WEB WITH 0.52IN AVERAGE REMAINING IN BOTTOM FLANGE

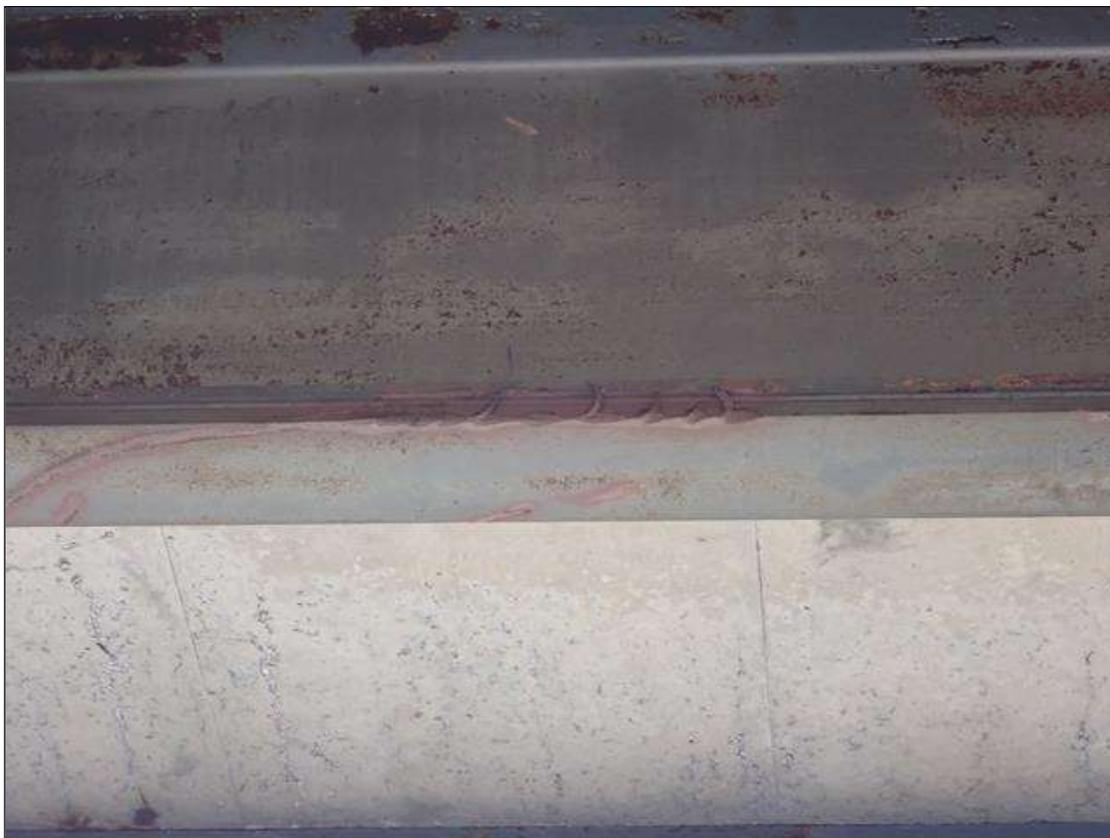
Span 2 Beam 3: NEAR MIDSPAN, 2FT OF SCRAPING FROM IMPACT DAMAGE ON BOTTOM FLANGE

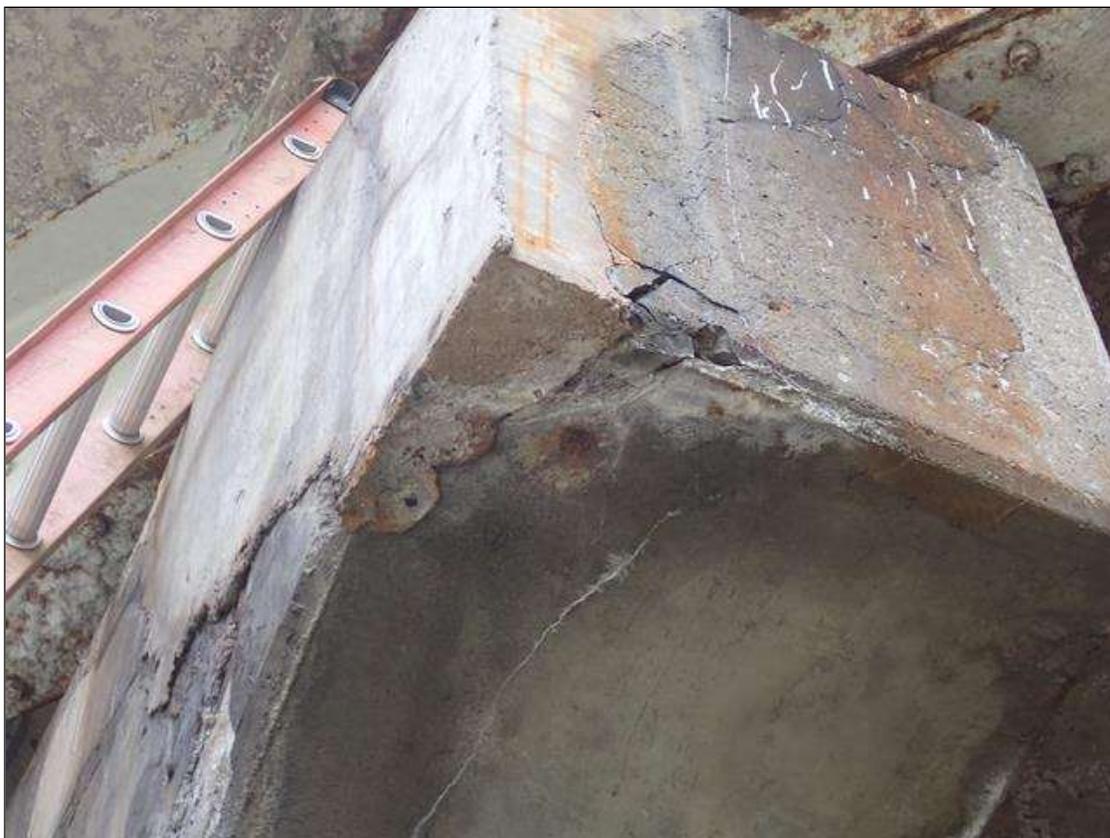
Bent 1 Cap 1: WEST FACE EXTENDING 2FT ON BOTTOM FACE, 3FT X 3FT AREA OF MAP CRACKING UP TO 1/16IN WIDE WITH EFFLORESCENCE.

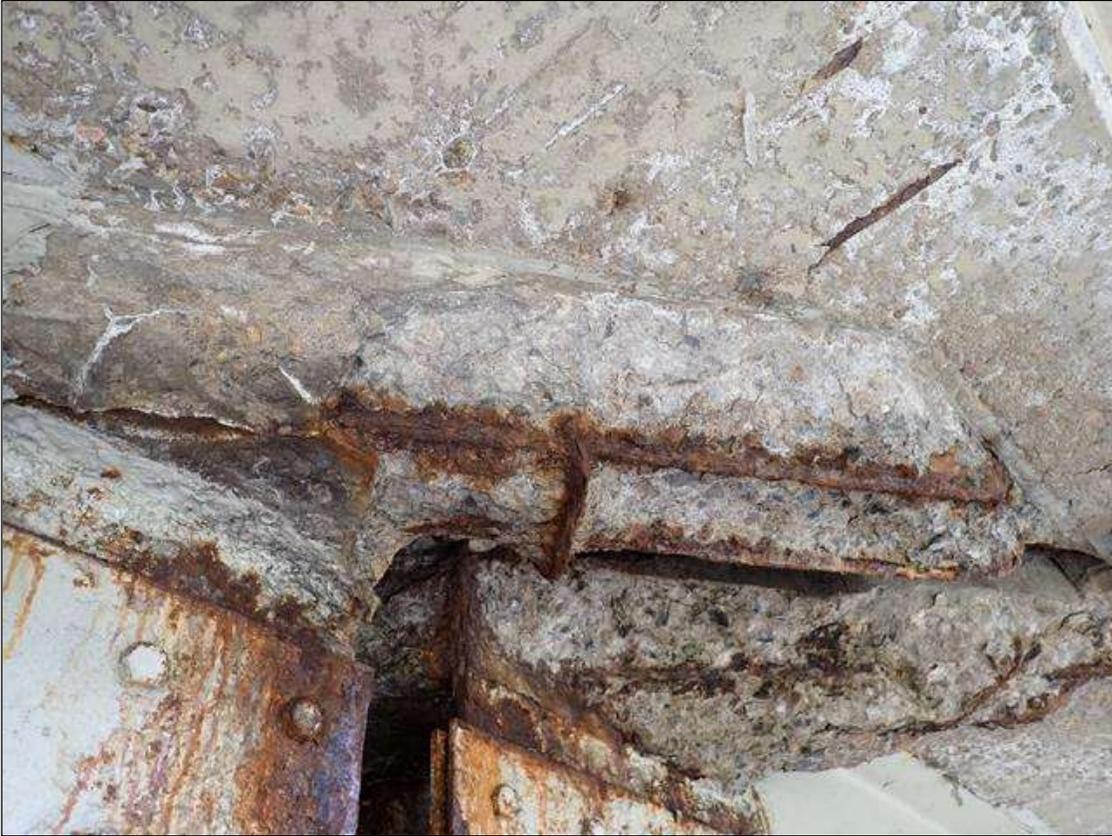
Span 2 Deck: (PAR) WEST OVERHANG EXTERIOR DIAPHRAGM AT BENT 1, 3FT WIDE X 1FT LONG X UP TO FULL DEPTH SPALL WITH EXPOSED REBAR WITH 10% SECTION LOSS

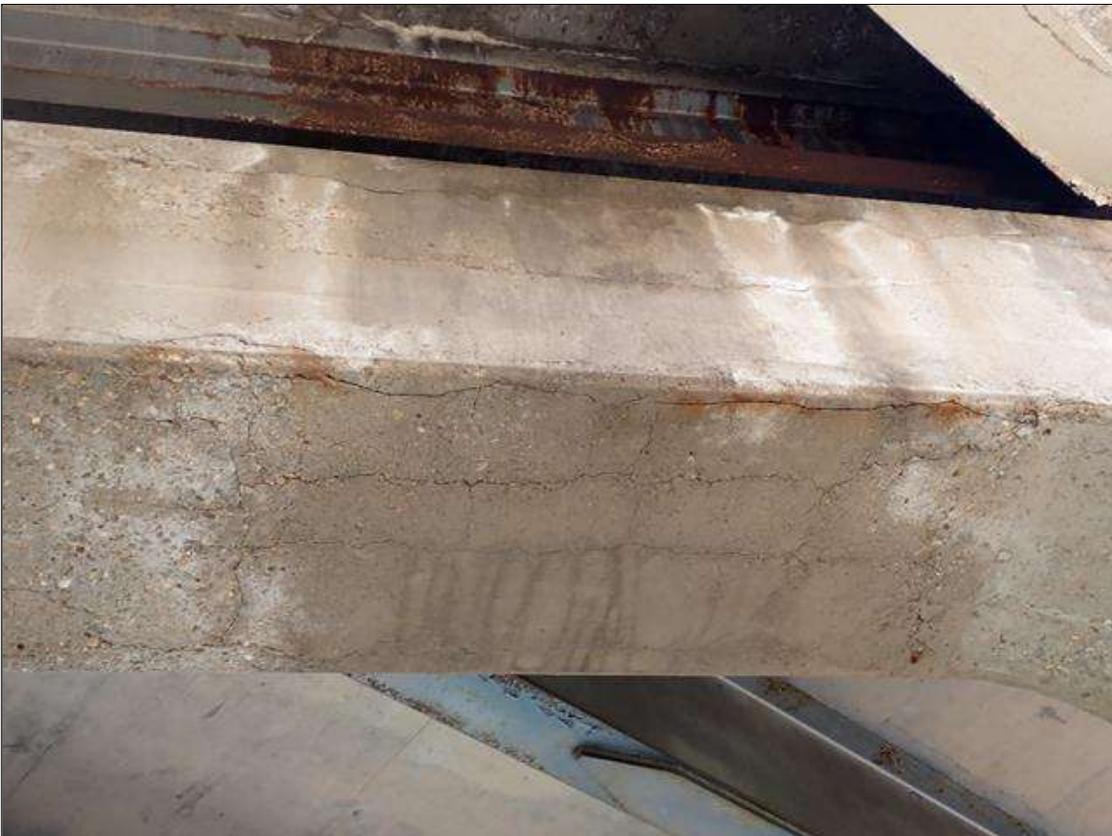
Bent 2 Cap 1: NORTH FACE AND BOTTOM SIDE BETWEEN BEAMS 1 AND 2, 18SF MAP CRACKING UP TO 1/16IN WIDE

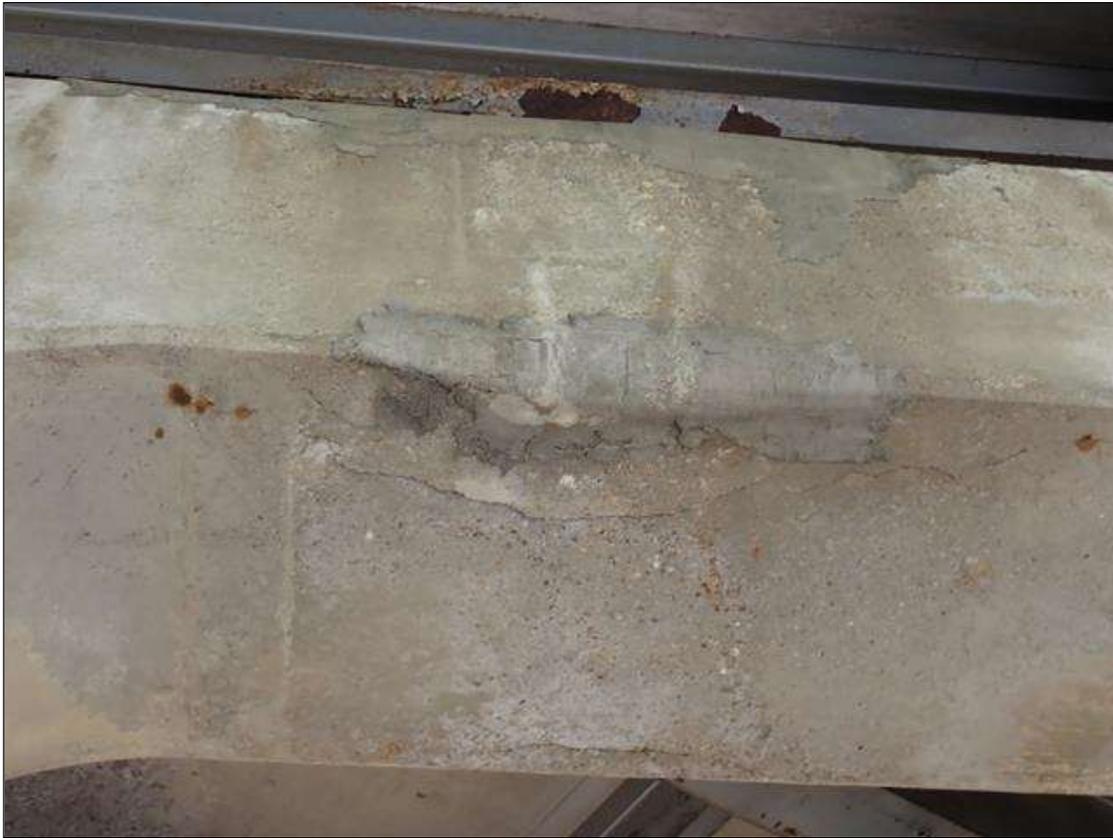
Bent 2 Cap 1: SOUTH AND BOTTOM FACES 4FT EAST OF PILE 2, 33IN X UP TO 7IN X 7IN CRACKED PATCHED AREA WITH EFFLORESCENCE

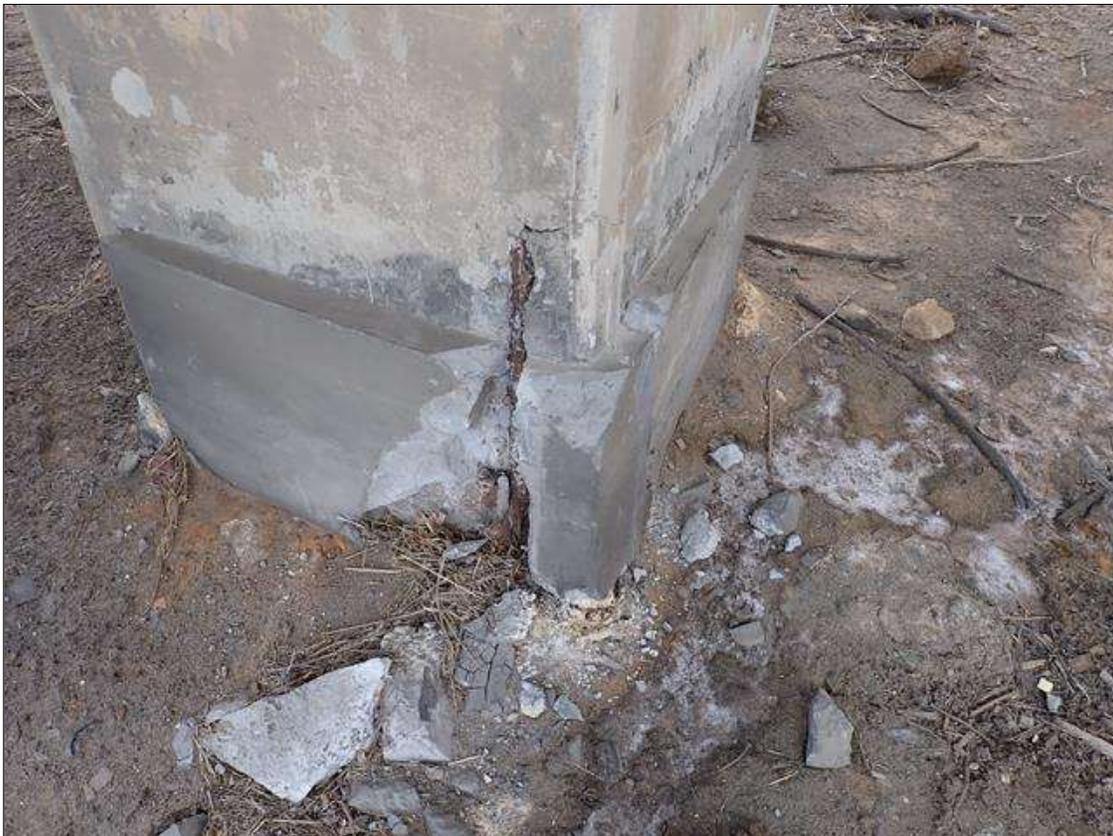
Bent 2 Pile 2: (PAR) EAST AND SOUTH FACES AT BOTTOM OF PILE, 18IN X 29IN CRACKED PATCHED AREA. SOUTH FACE PATCH HAS FAILED WITH EXPOSED REBAR, NO SECTION LOSS

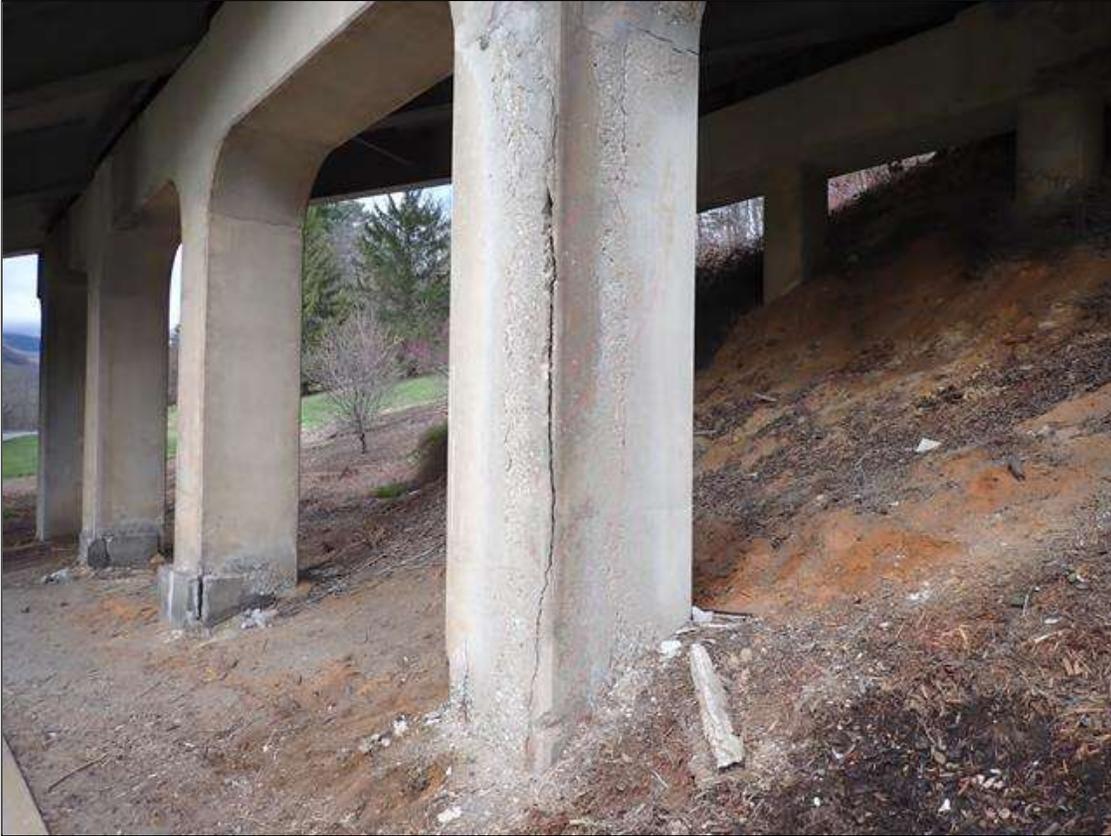
Bent 2 Pile 4: SOUTHEAST CORNER, DELAMINATION (FULL HEIGHT X UP TO 2FT) AND SPALL AT BASE (3IN DIAMETER X 1.5IN DEEP)

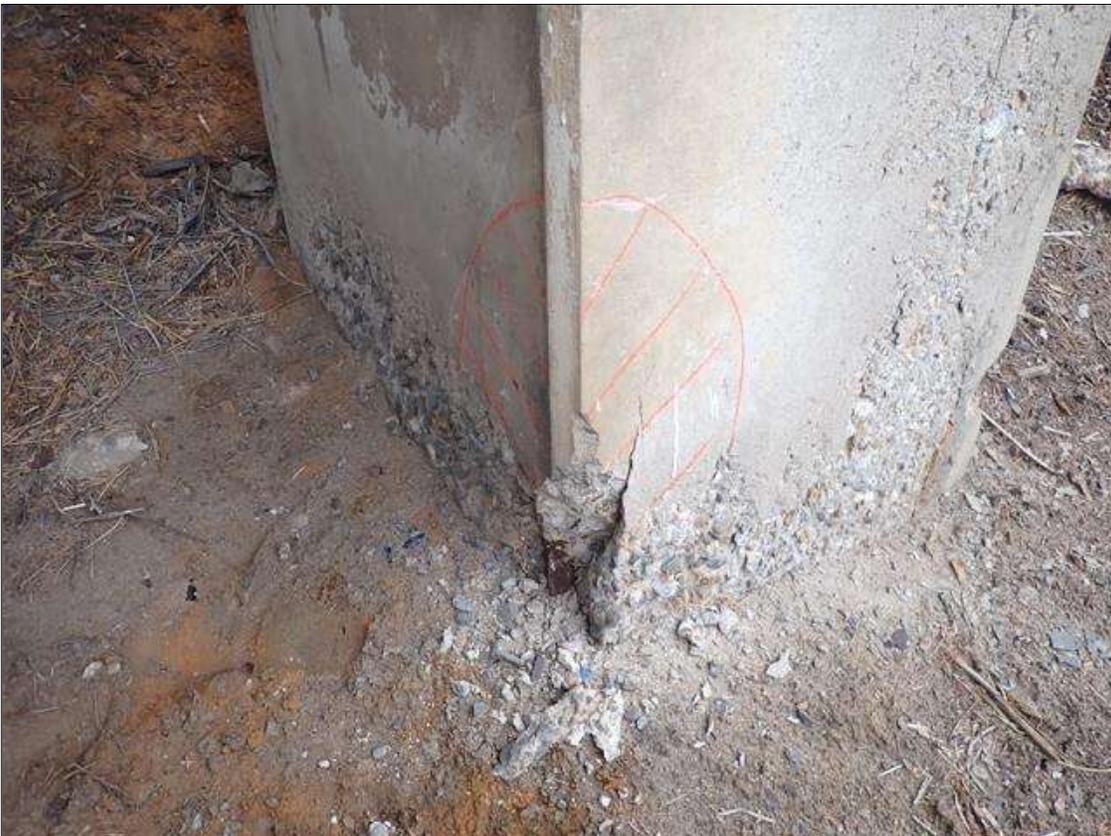
Bent 2 Pile 4: (PAR) SOUTHWEST CORNER AT BOTTOM, SPALL (20IN X 16IN X 3IN DEEP) WITH EXPOSED RUSTED REBAR (NO MEASURABLE LOSS)

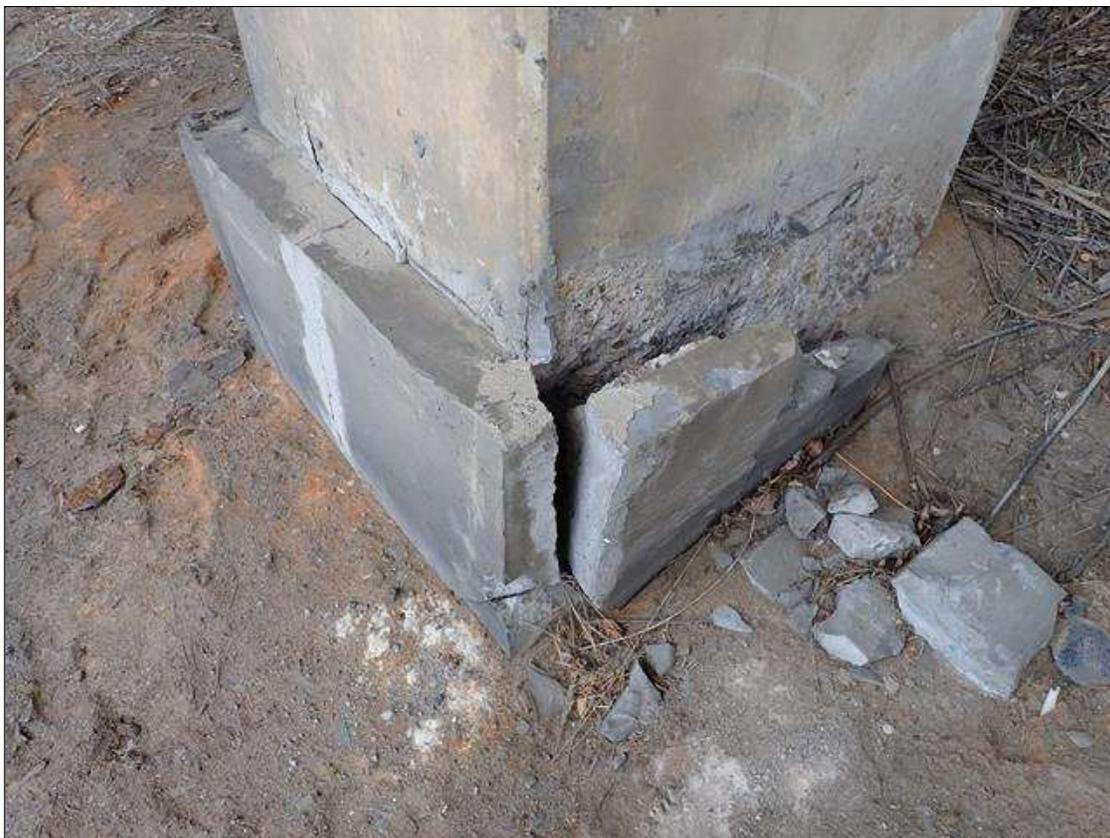
Bent 2 Pile 3: (PAR) SOUTH FACE, 18IN X 25IN CRACKED PATCH. EAST FACE OF PATCH HAS FAILED WITH EXPOSED REBAR, NO SECTION LOSS

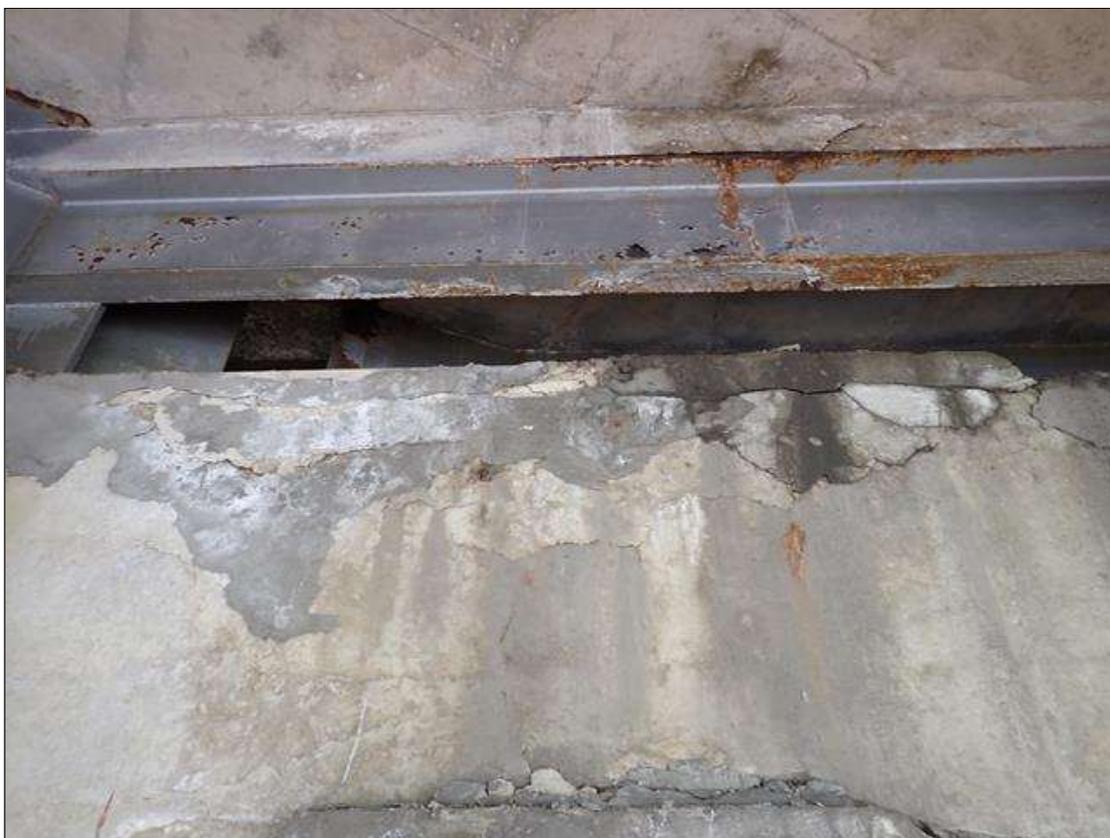
Bent 3 Cap 1: (5) UP TO 6FT X 2FT CRACKED PATCHED AREAS AT RANDOM THROUGHOUT.

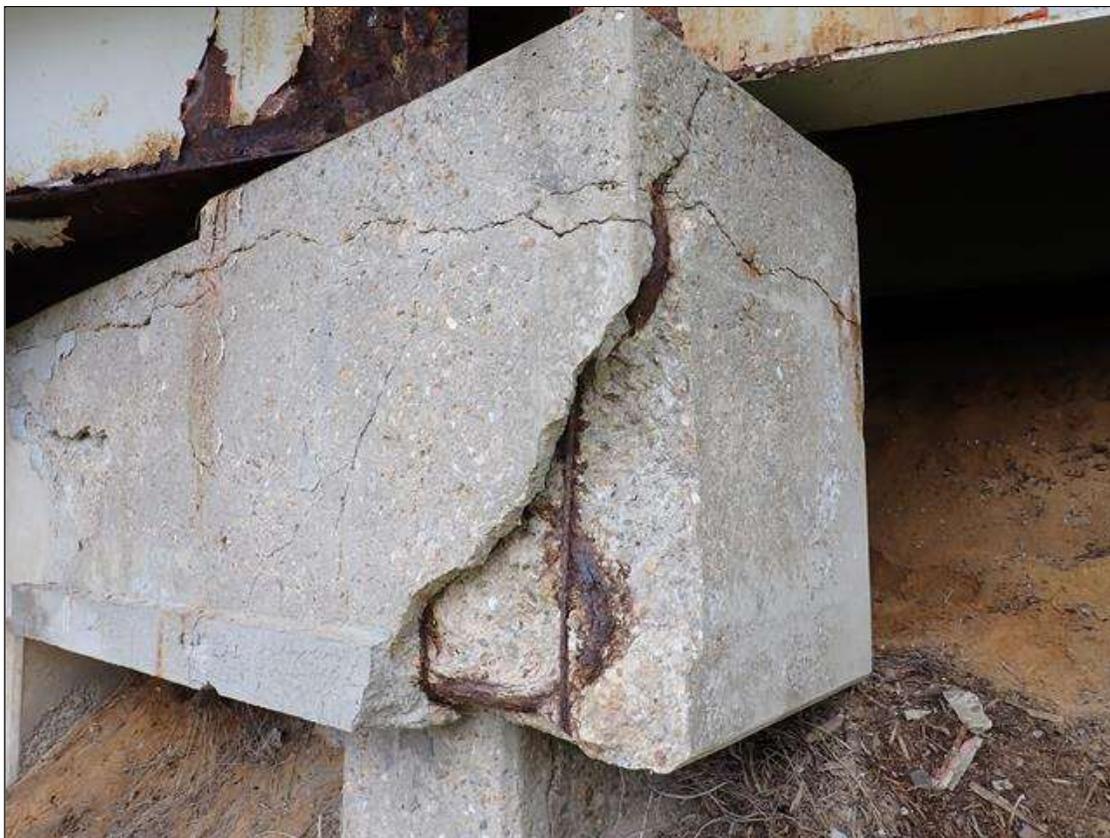
Bent 3 Cap 1: (PAR) NORTH, SOUTH AND EAST FACES ABOVE PILE 7, ADVANCED SPALLING UP TO 22IN LONG X 3FT TALL X UP TO 7IN DEEP WITH EXPOSED REBAR (UP TO 20% SECTION LOSS)

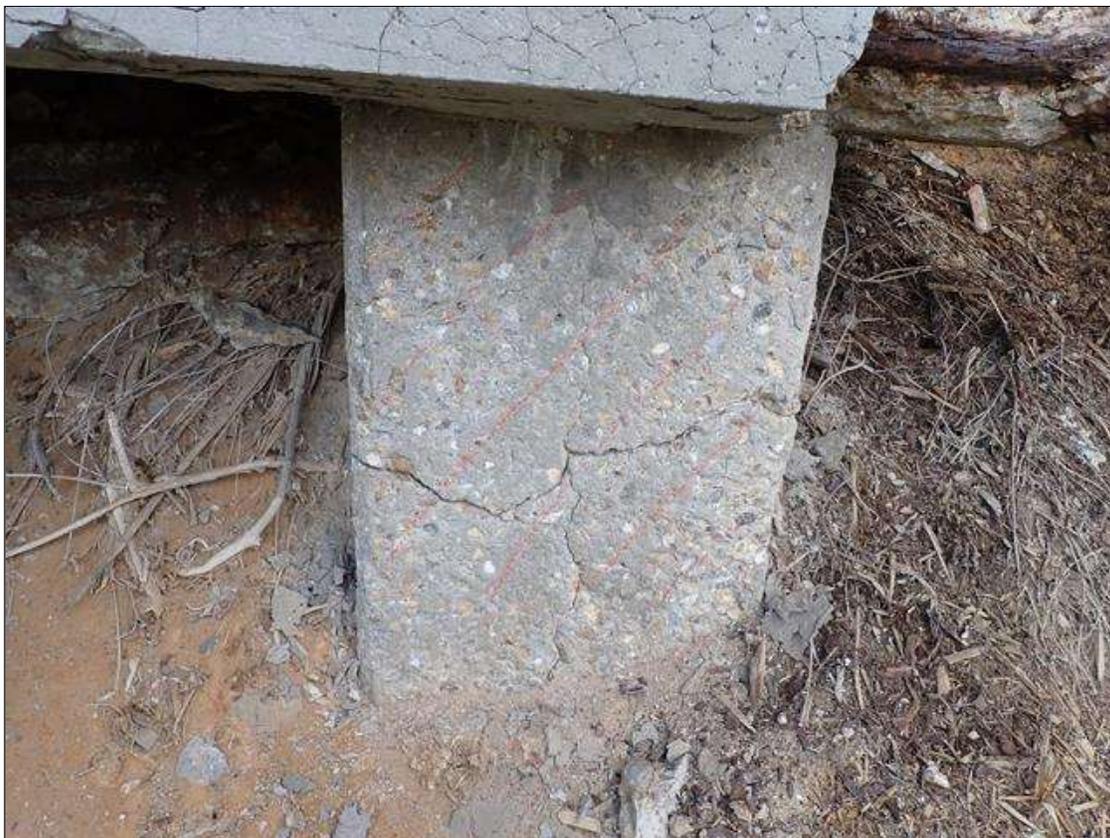
Bent 3 Pile 7: SOUTH FACE AT BOTTOM OF CAP, DELAMINATION (28IN X 20IN)

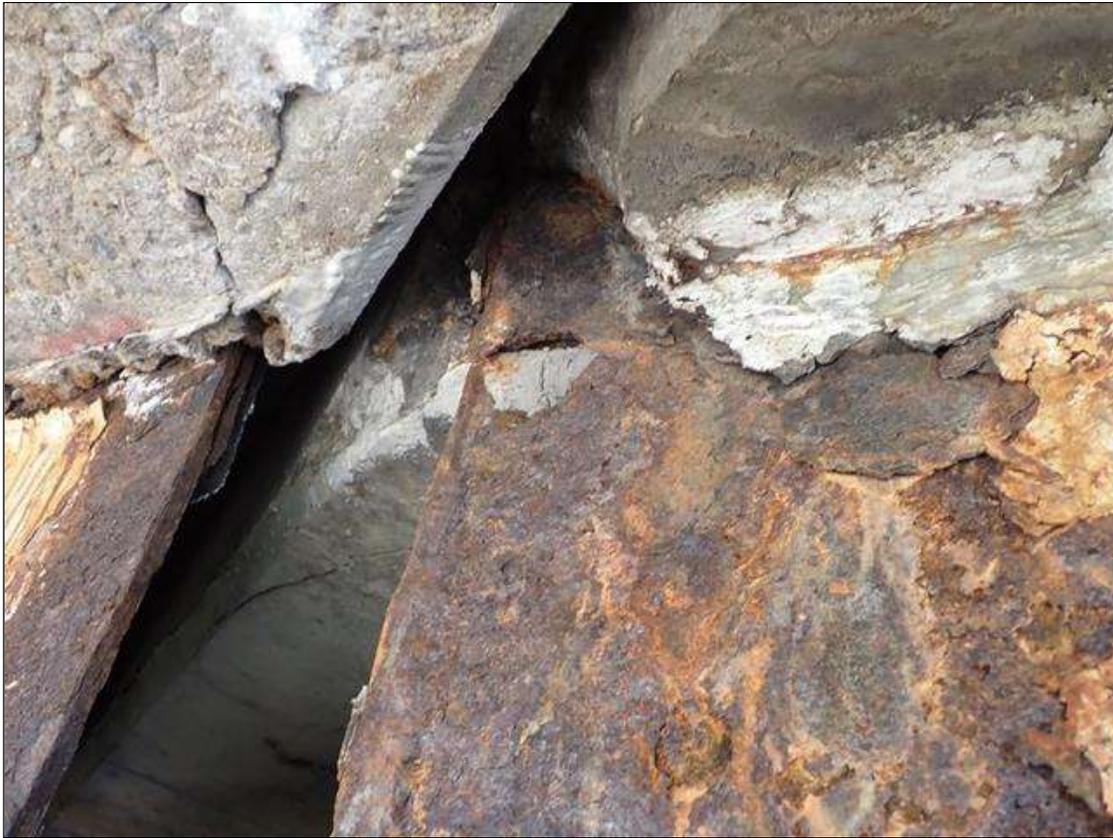
Span 2 Beam 1: (PAR) AT BENT 2, 4FT OF CORROSION WITH SECTION LOSS IN BOTTOM FLANGE AND UP TO 28IN IN THE WEB. 0.29IN AVERAGE REMAINING IN BOTTOM FLANGE. 2-1/2IN LONG X 2IN HIGH HOLE IN WEB AT TOP (PHOTO 1 OF 2)

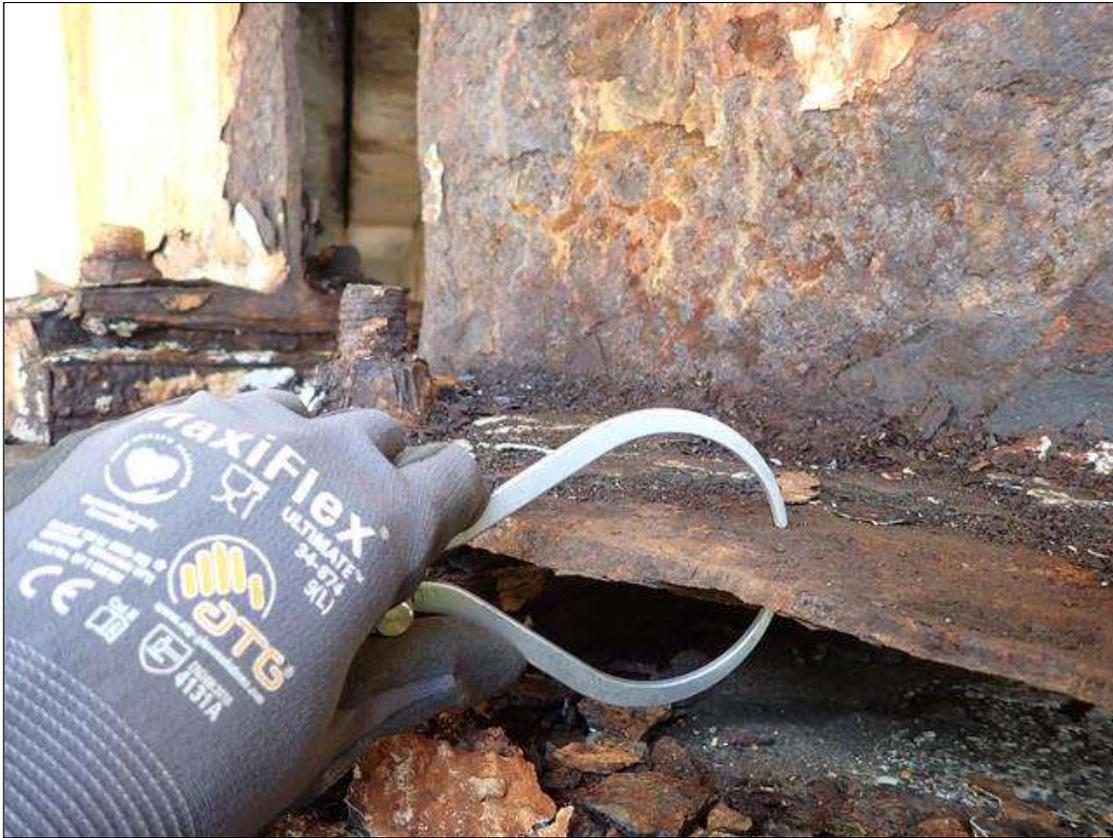
Span 2 Beam 1: (PAR) AT BENT 2, 4FT OF CORROSION WITH SECTION LOSS IN BOTTOM FLANGE AND UP TO 28IN IN THE WEB. 0.29IN AVERAGE REMAINING IN BOTTOM FLANGE. 2-1/2IN LONG X 2IN HIGH HOLE IN WEB AT TOP (PHOTO 2 OF 2)

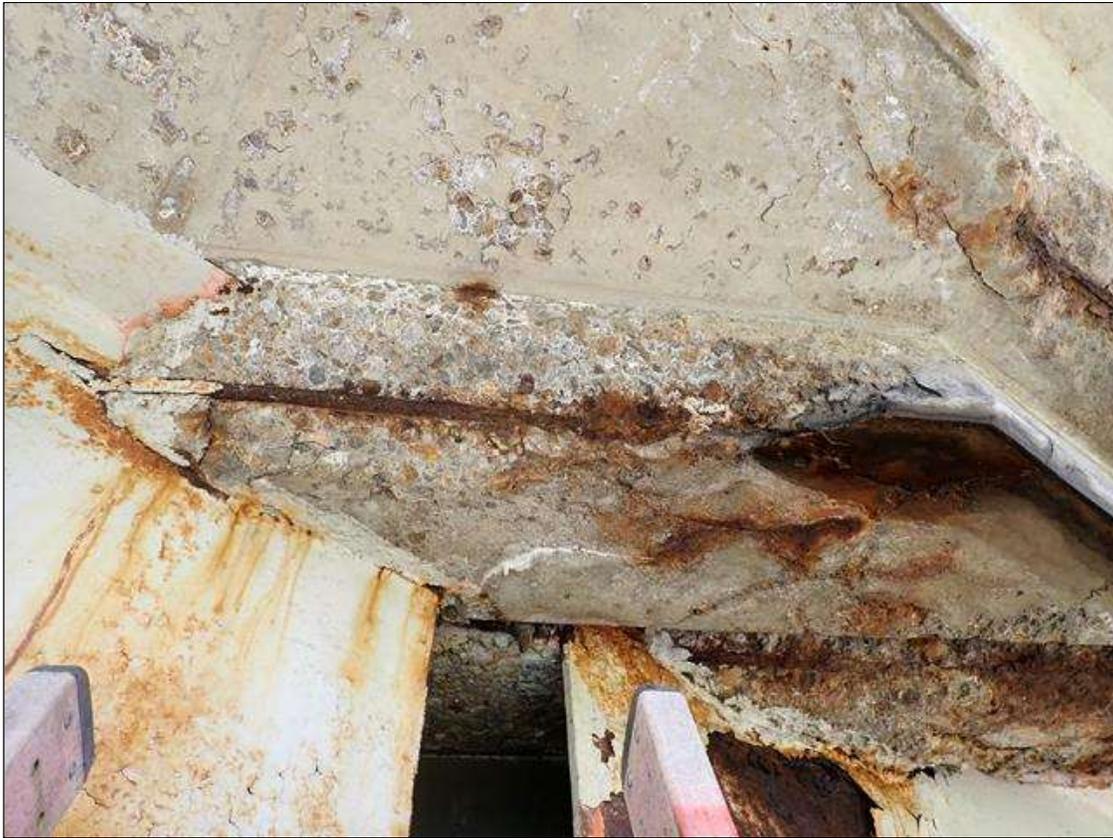
Span 2 Deck: (PAR) EAST OVERHANG DIAPHRAGM AT BENT 2, 3FT X UP TO 8IN X 8IN SPALL WITH EXPOSED REBAR (UP TO 10% SECTION LOSS)

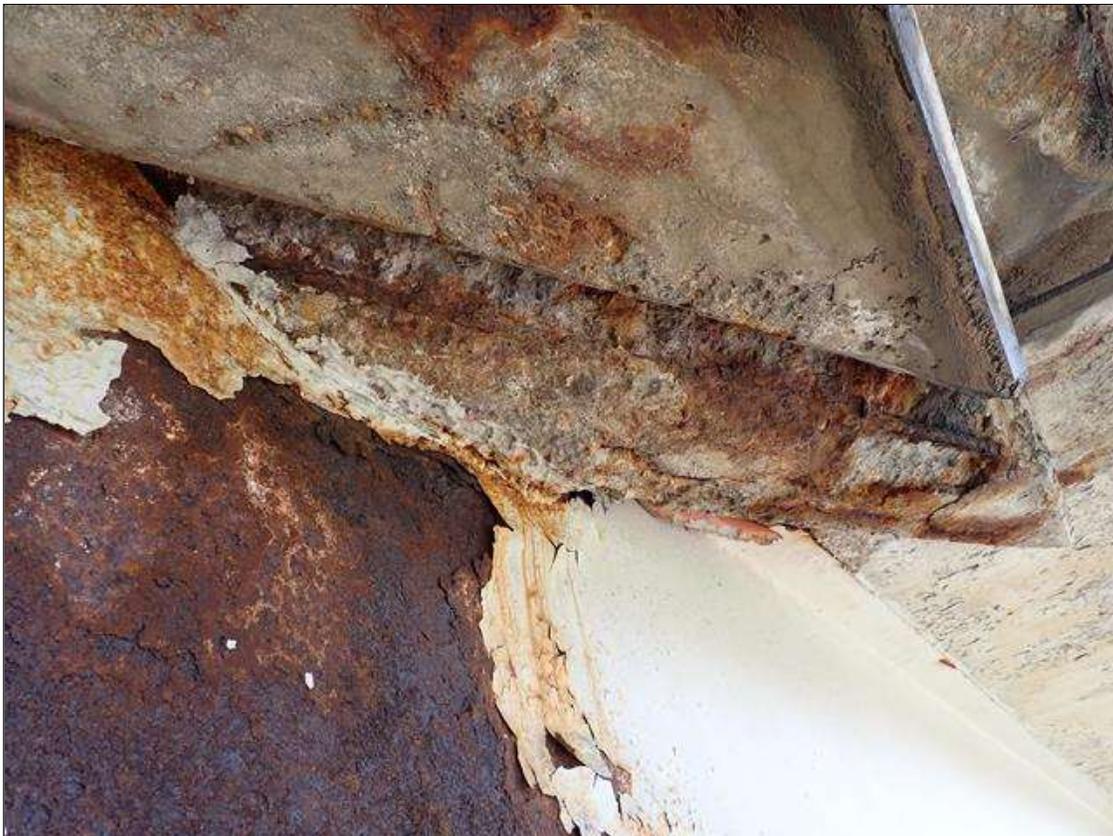
Span 3 Deck: (PAR) EAST OVERHANG DIAPHRAGM AT BENT 2, 3FT X UP TO 8IN X 10IN SPALL WITH EXPOSED REBAR (NO MEASUREABLE LOSS)
