NC DEPARTMENT OF TRANSPORTATION
 DIVISION OF HIGHWAYS
 STRUCTURE MANAGEMENT UNIT

ATTENTION: **PAR SUBMITTED**
NEW REPAIRS ON RAILS
TEMPORARY REPAIRS ON BEAMS

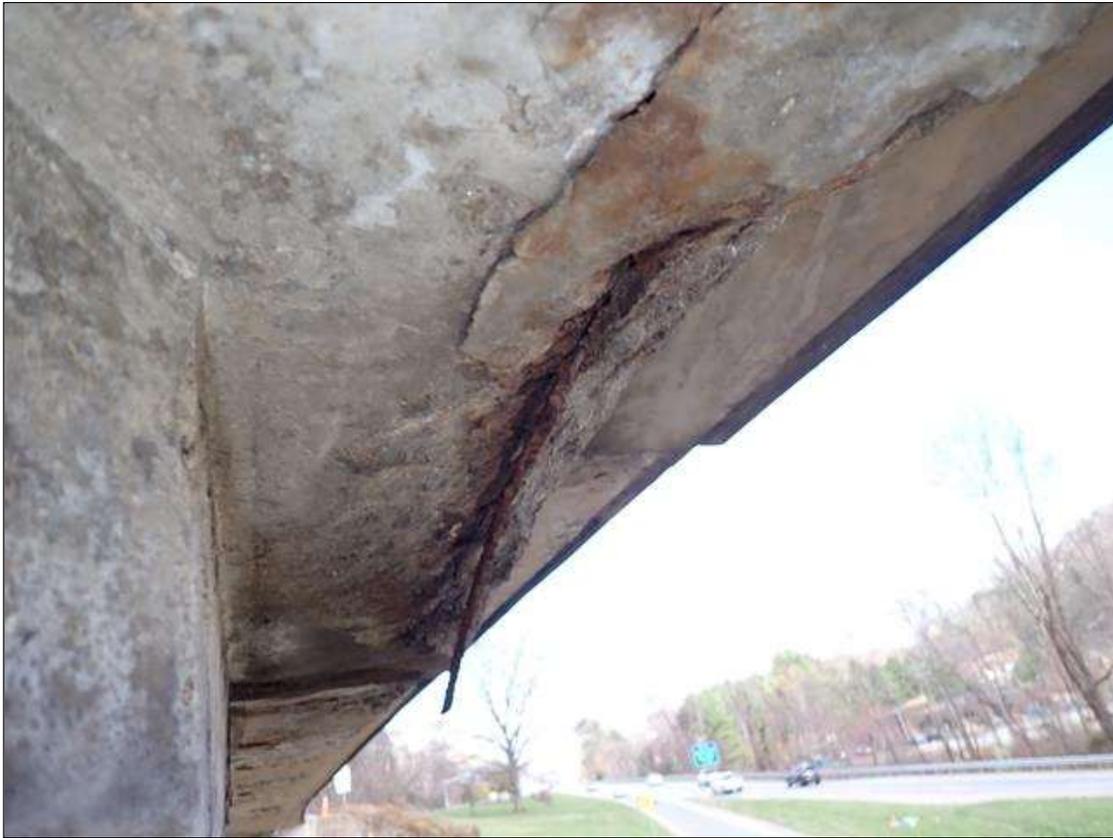
Span 2 Deck: (PAR) EAST OVERHANG AT BENT 2, 3FT X UP TO 4IN X 8IN DEEP SPALL WITH (1) EXPOSED BROKEN REBAR

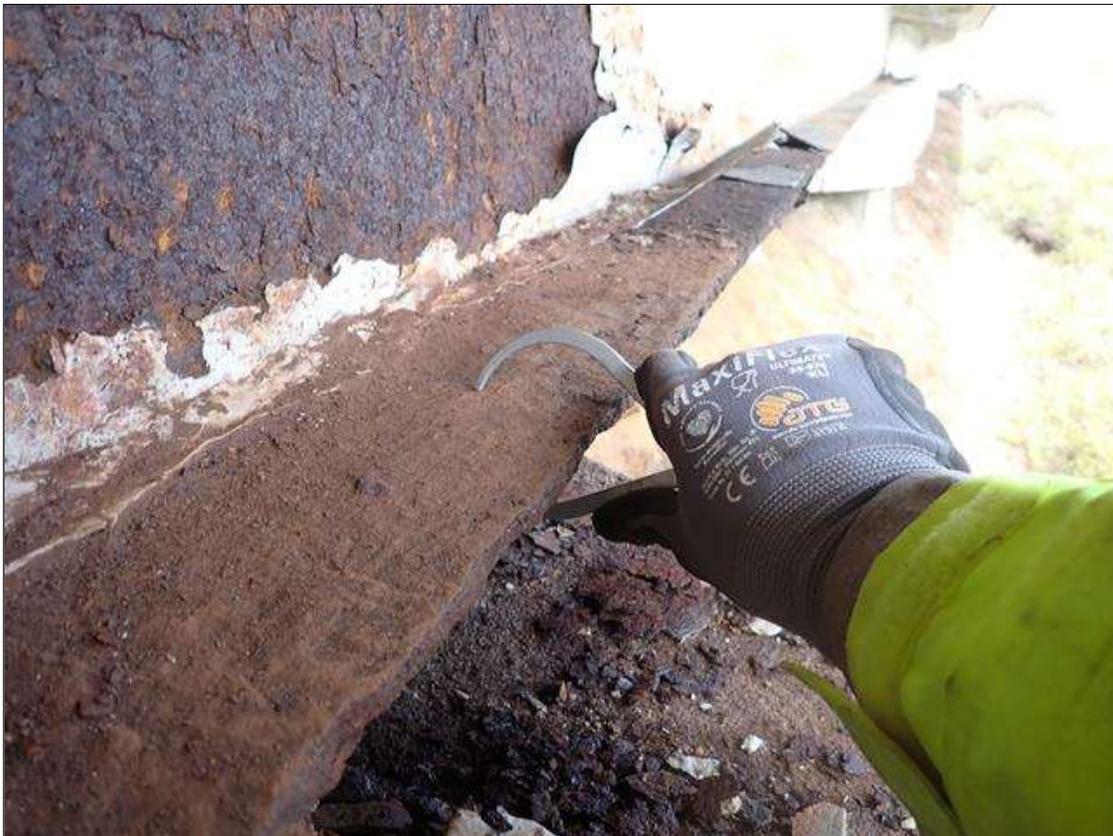
Span 3 Beam 4: (PAR) AT BENT 2, 5FT CORROSION WITH SECTION LOSS ON BOTTOM FLANGE AND UP TO 24IN IN THE WEB WITH 1/4IN AVERAGE REMAINING IN BOTTOM FLANGE

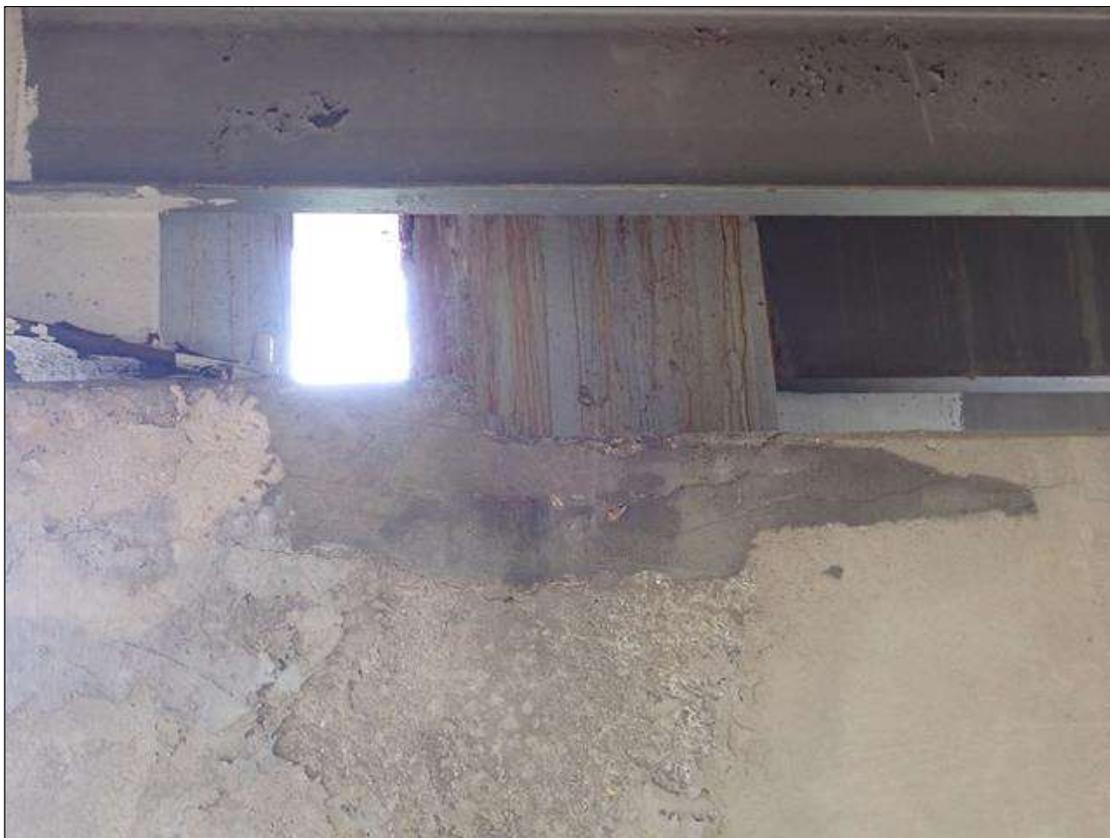
Bent 2 Cap 1: SOUTH AND TOP FACES AT BEAM 4, 22IN X UP TO 10IN X 22IN CRACKED PATCHED AREA

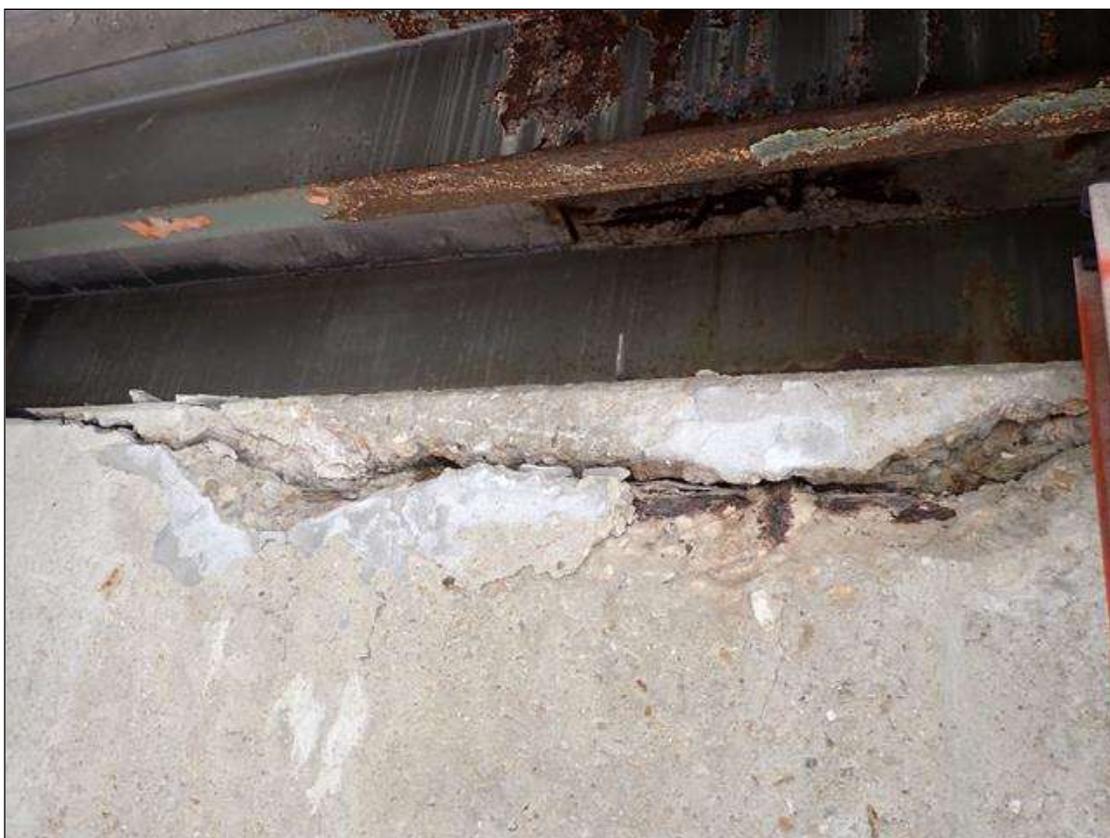
Bent 2 Cap 1: (PAR) NORTH FACE AT TOP OF CAP BETWEEN BEAMS 2 AND 3, DELAMINATION/SPALL (4FT X UP TO 33IN WIDE X 4IN DEEP) WITH EXPOSED RUSTED REBAR (NO MEASUREABLE LOSS)

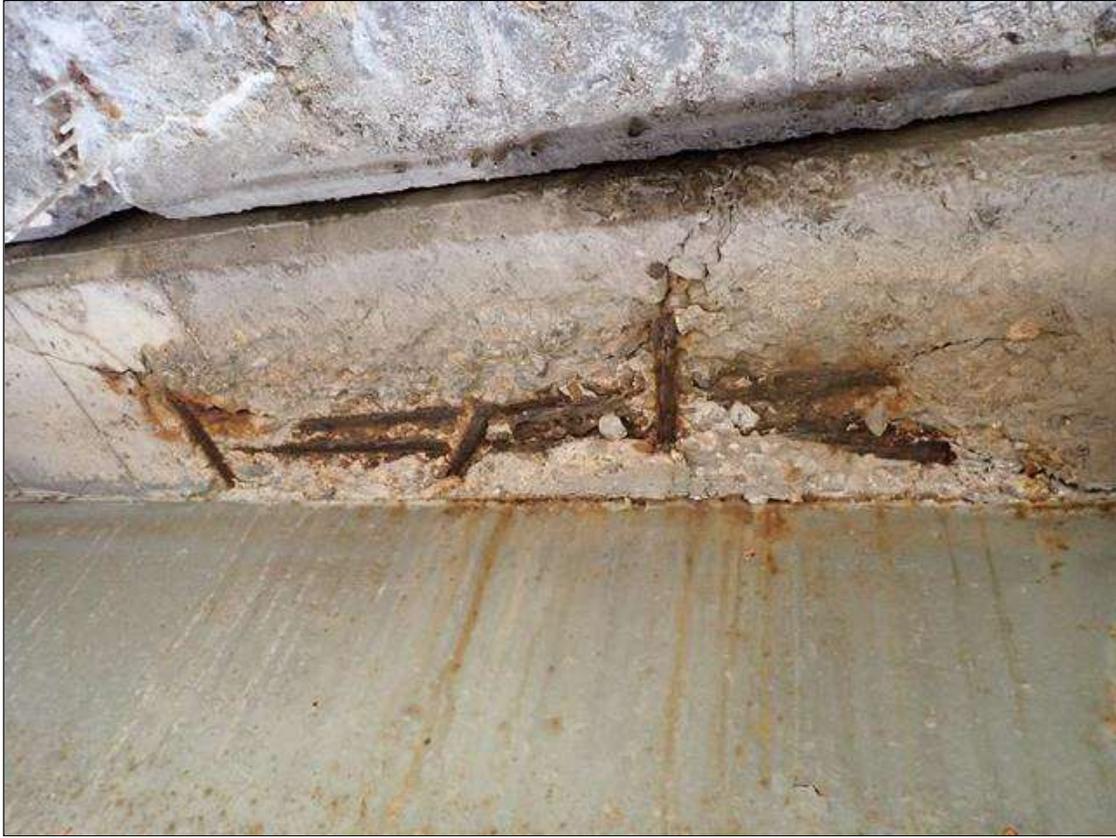
Span 2 Deck: (PAR) underside at bent 2 bay 2 north of end diaphragm, spall (3ft x 18in x 1in deep) with exposed rusted rebar (no measurable loss)

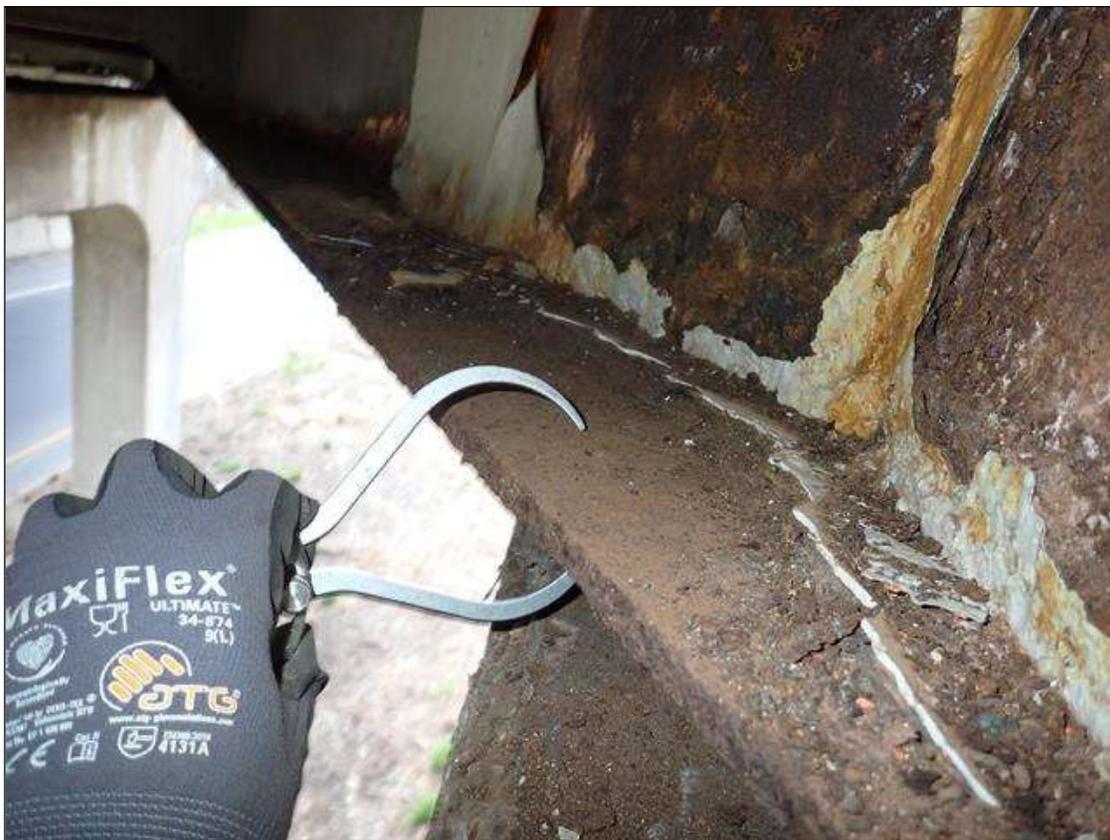
Span 3 Beam 1: (PAR) AT BENT 3, 5FT OF CORROSION WITH PACK RUST BOTTOM FLANGE AND UP TO 24IN IN THE WEB. SECTION LOSS DOWN TO 0.4IN AVERAGE REMAINING IN BOTTOM FLANGE AND DOWN TO 0.4IN AVERAGE REMAINING IN WEB

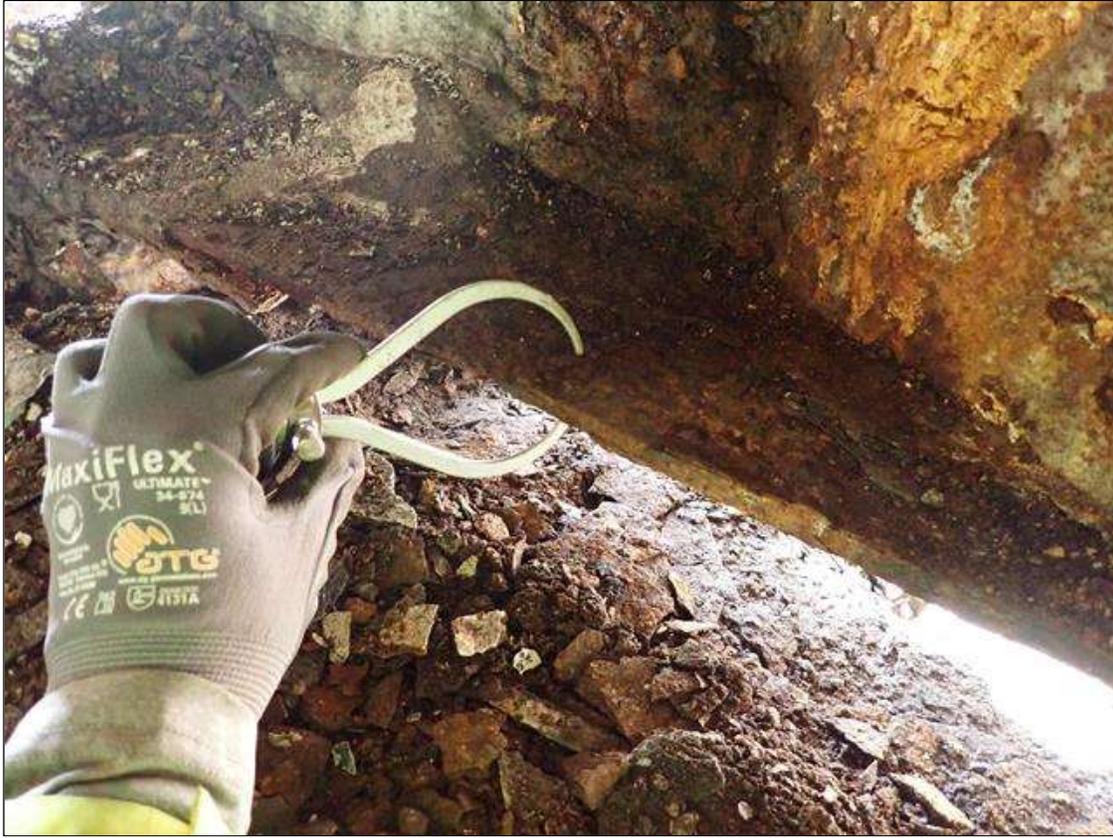
Span 4 Beam 1: (PAR) AT BENT 3, 5FT RUST SCALING BOTTOM FLANGE AND UP TO 24IN IN THE WEB WITH SECTION LOSS 0.38IN AVERAGE REMAINING IN THE BOTTOM FLANGE AND 0.37IN AVERAGE REMAINING IN THE WEB

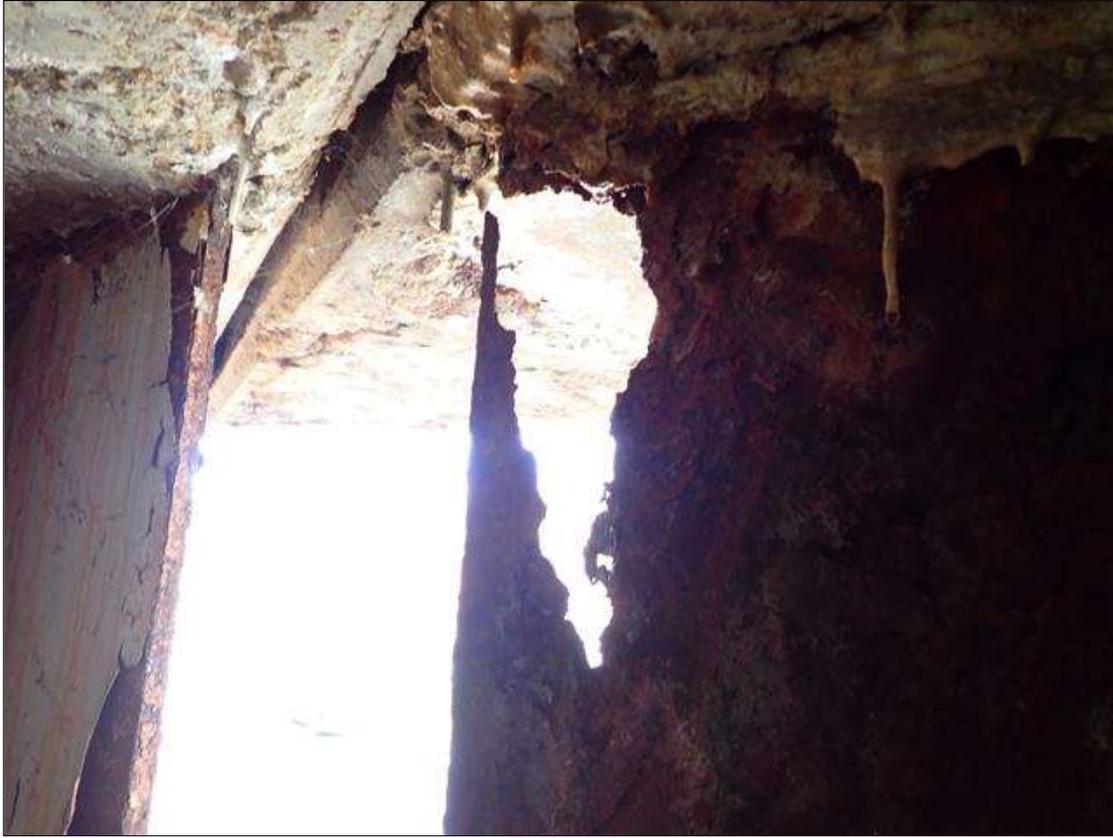
Span 3 Beam 4: (PAR) AT BENT 3, 6FT OF CORROSION WITH SECTION LOSS ON BOTTOM FLANGE, AT 18IN FROM END OF BEAM ON WEST SIDE OF BOTTOM FLANGE (KNIFE'S EDGE REMAINING FOR 8IN LONG) WITH (2) 1IN DIAMETER HOLES. CORROSION IN THE WEB WITH SECTION LOSS AND A CORROSION HOLE AT BEAM END (4IN X UP TO 8IN) (PHOTO 1 OF 2)

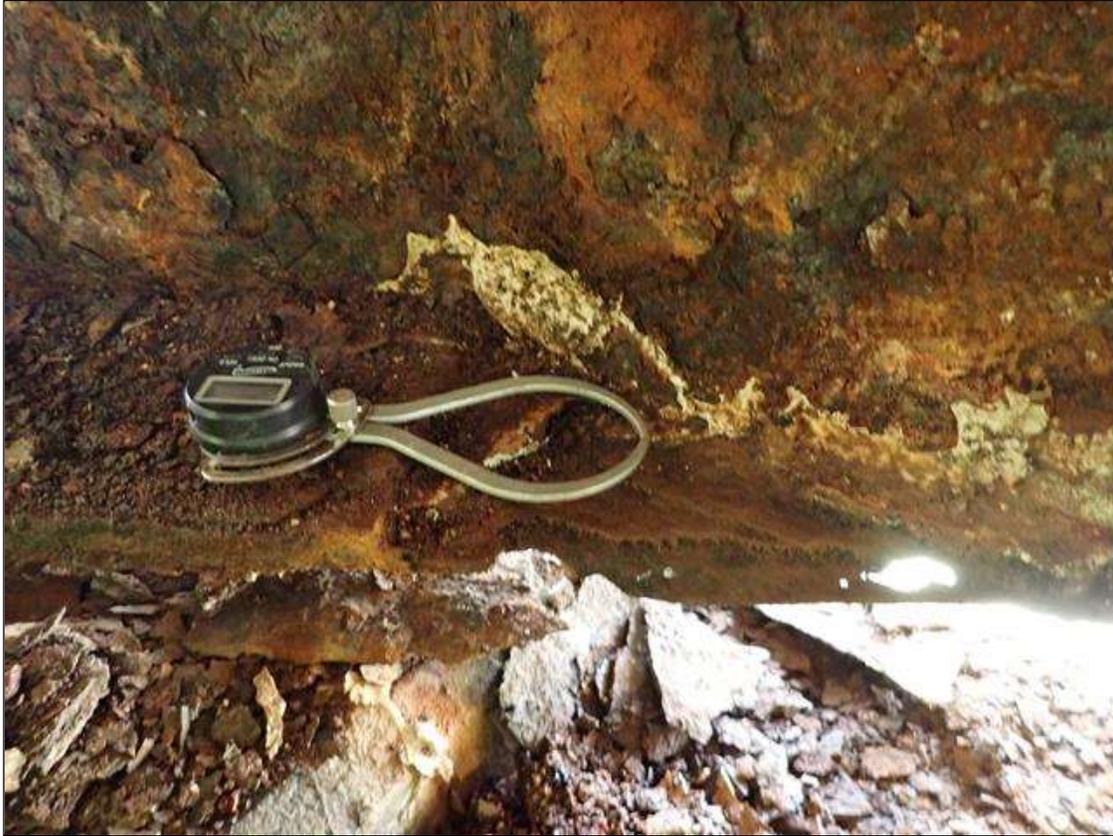
Span 3 Beam 4: (PAR) AT BENT 3, 6FT OF CORROSION WITH SECTION LOSS ON BOTTOM FLANGE, AT 18IN FROM END OF BEAM ON WEST SIDE OF BOTTOM FLANGE (KNIFE'S EDGE REMAINING FOR 8IN LONG) WITH (2) 1IN DIAMETER HOLES. CORROSION IN THE WEB WITH SECTION LOSS AND A CORROSION HOLE AT BEAM END (4IN X UP TO 8IN) (PHOTO 2 OF 2)

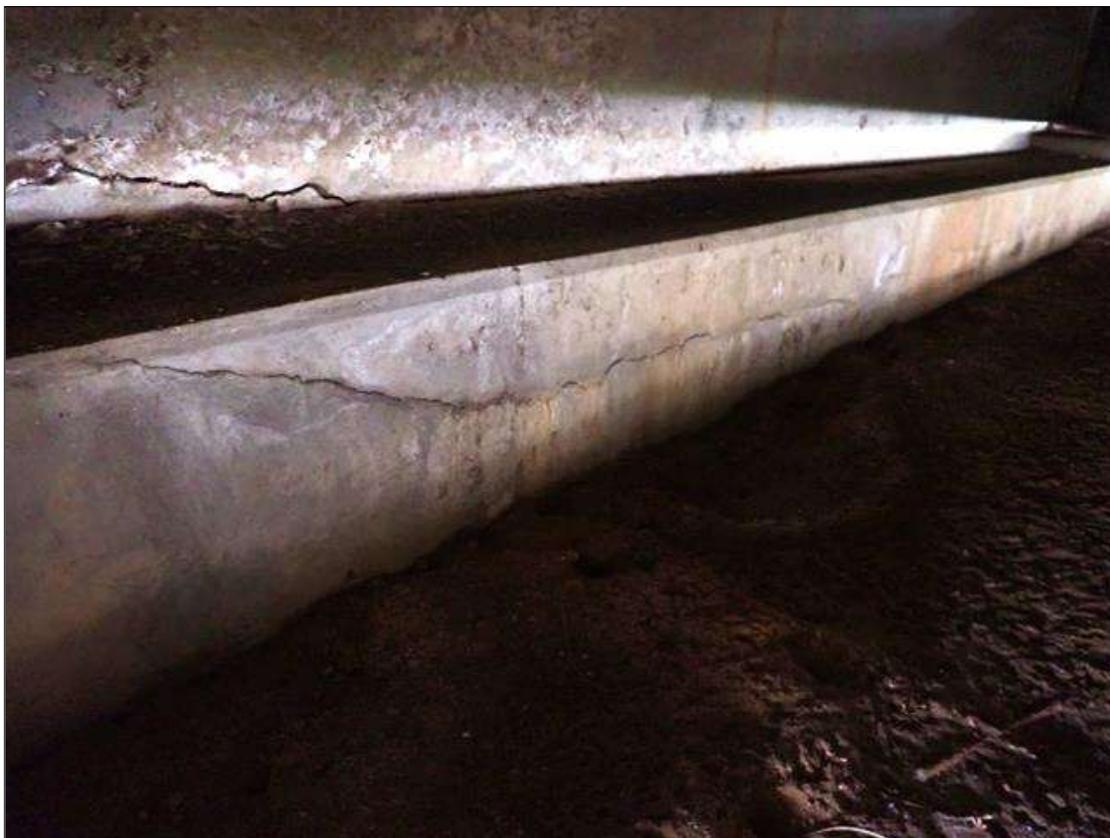
End Bent 2 Cap 1: BETWEEN BEAMS 1 AND 2, 8FT X UP TO 1/16IN WIDE HORIZONTAL CRACKS

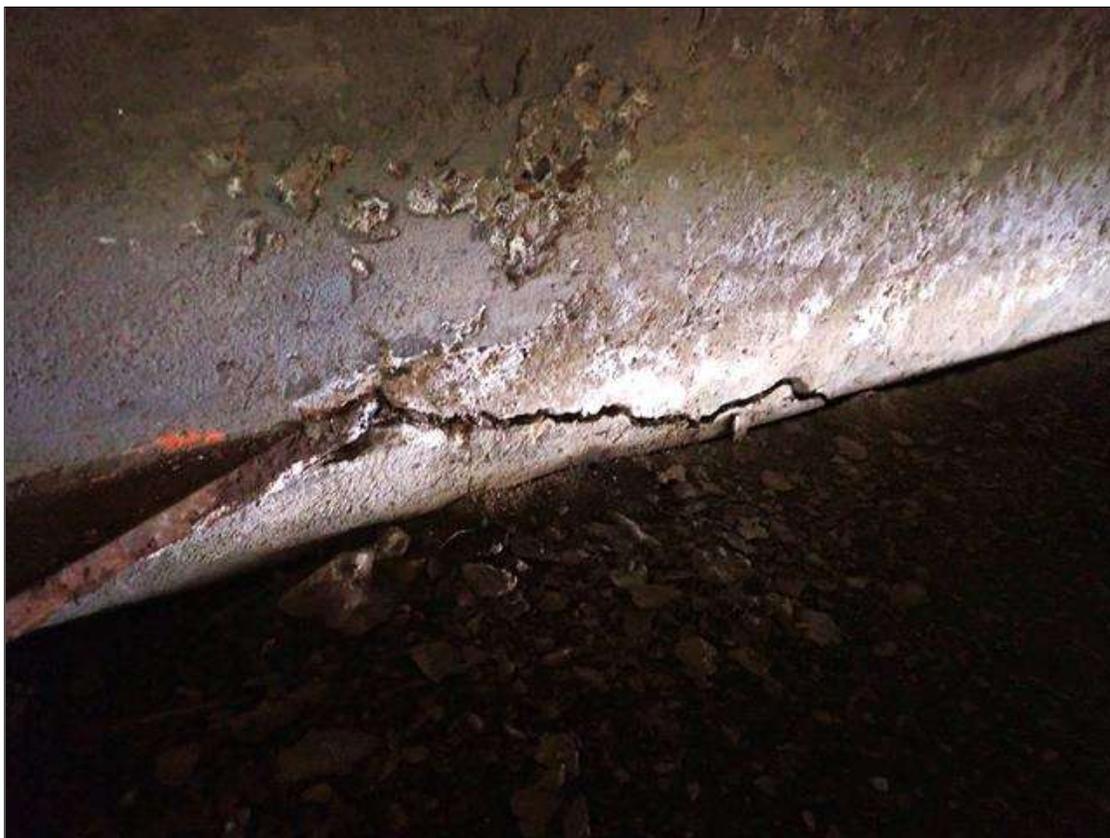
End Bent 2 Abutment: BAY 1, 15IN LONG X 1/4IN WIDE HORIZONTAL CRACK

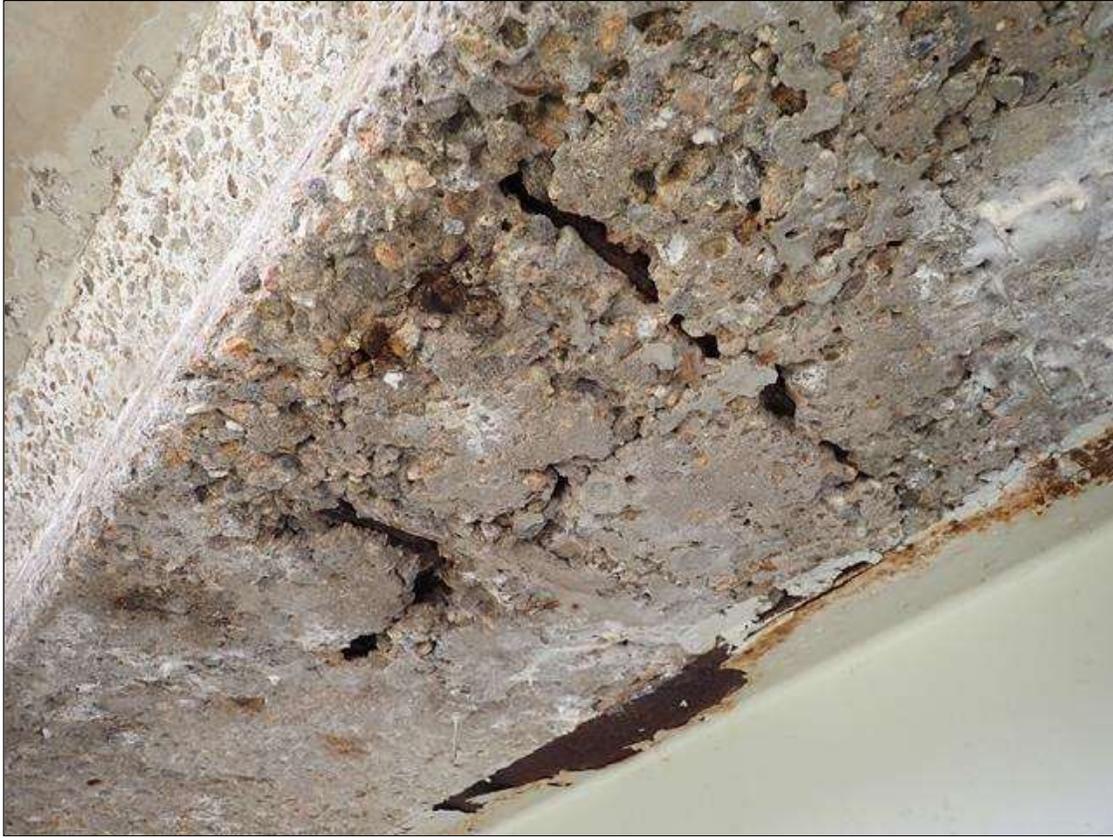
Span 4 Deck: RIGHT OVERHANG NEAR MIDSPAN, AREAS OF SPALLING WITH HEAVY ABRASION (UP TO 18IN LONG X 12IN WIDE X UP TO 3IN DEEP) WITH EXPOSED REBAR (UP TO 10% SECTION LOSS)

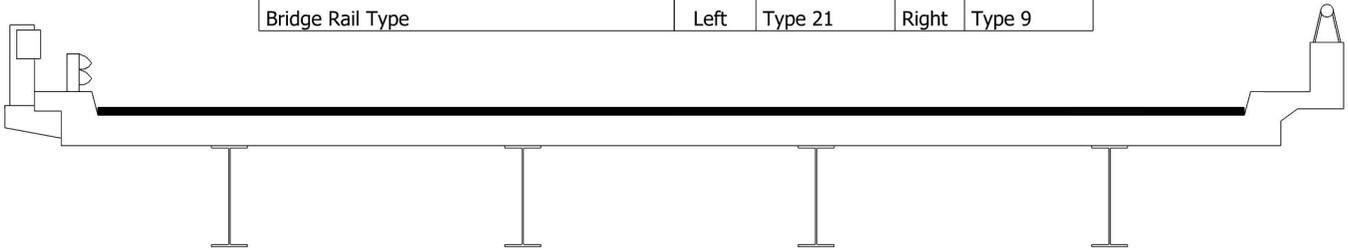
Measurements for Span #	1	All Spans Similar	
Deck Thickness	10in	Left Overhang	4.583ft
Top of Rail to Bottom of Beam (Avg)	7.01ft	Right Overhang	4.583ft

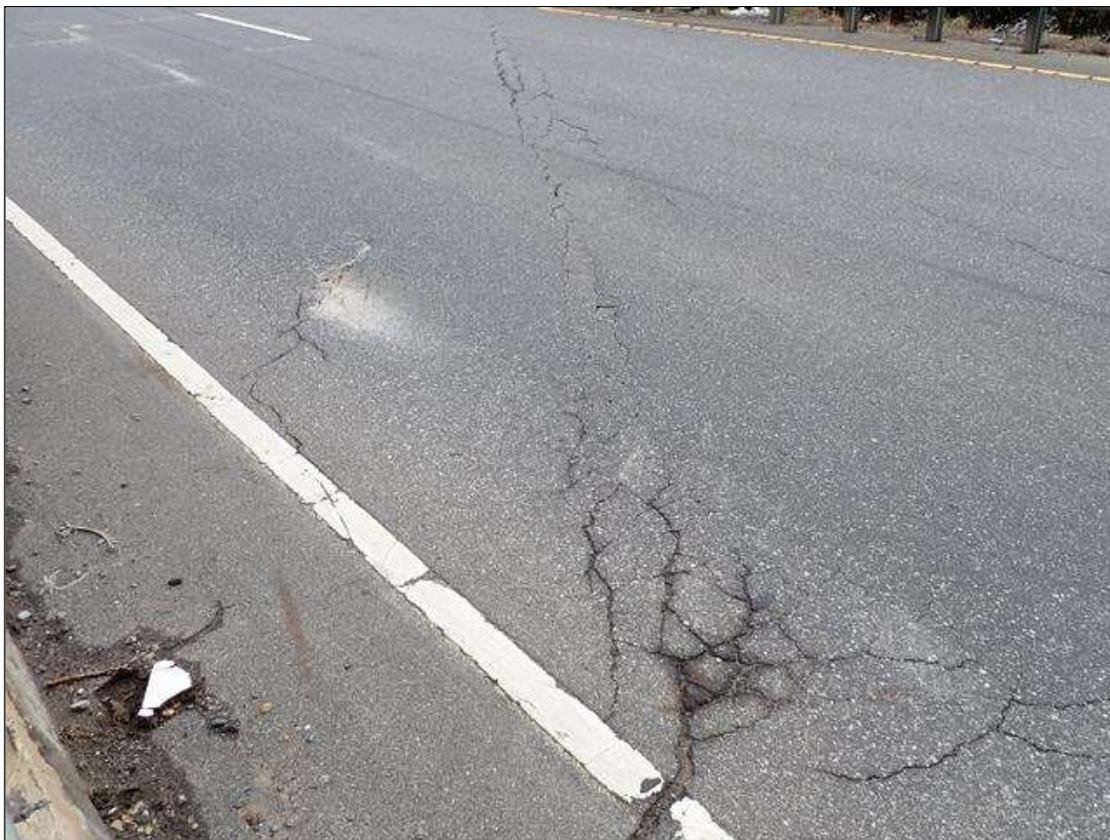
asphalt wearing surface over end bent 1

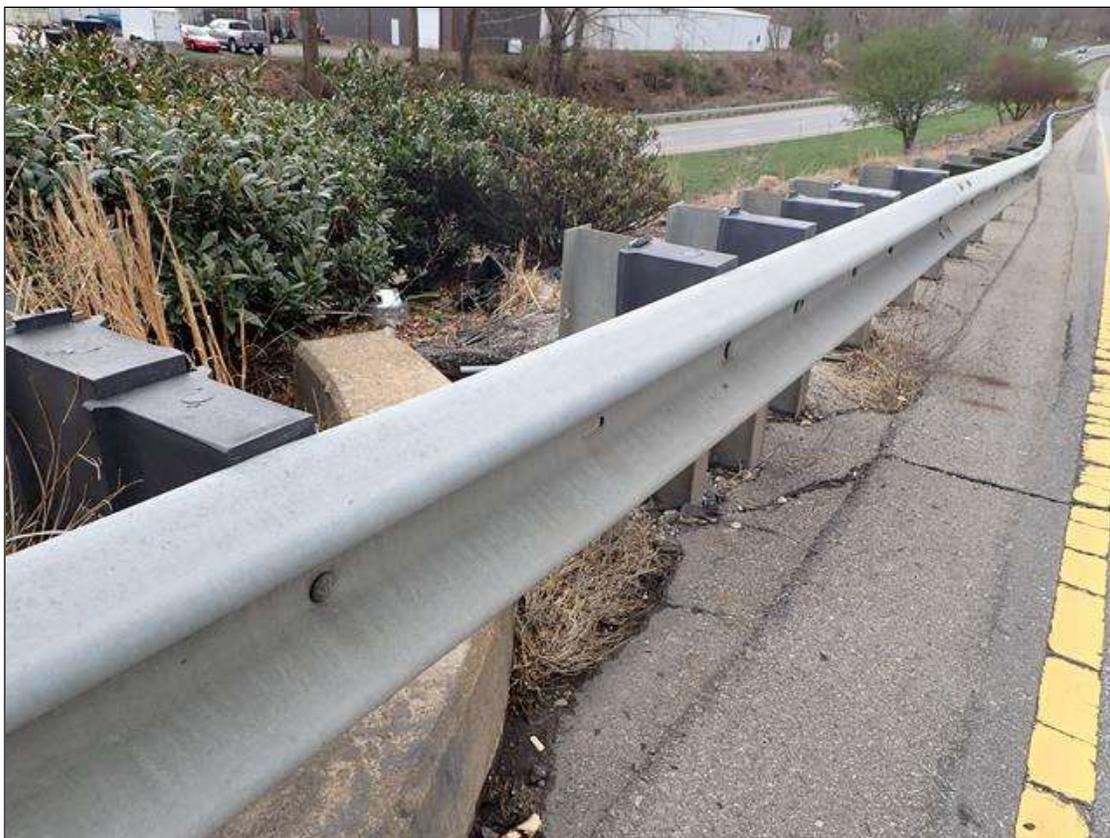
southeast guardrail and post spacing

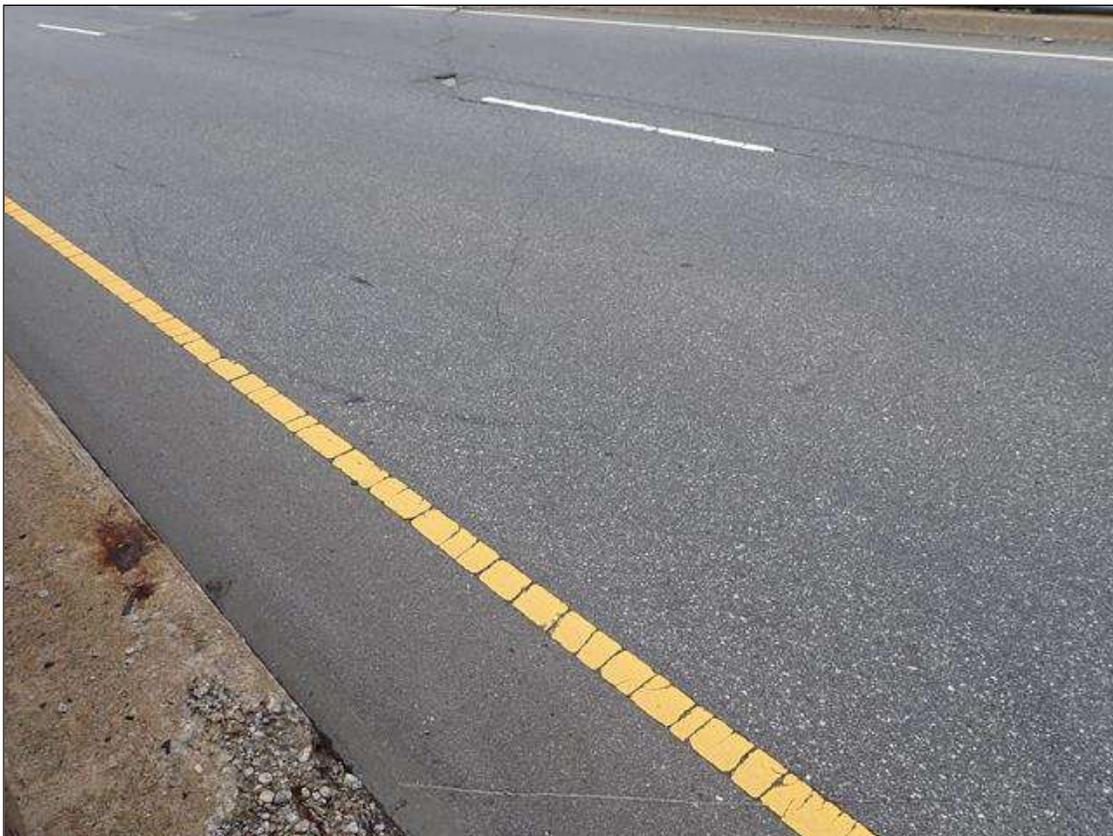
asphalt wearing surface over bent 1

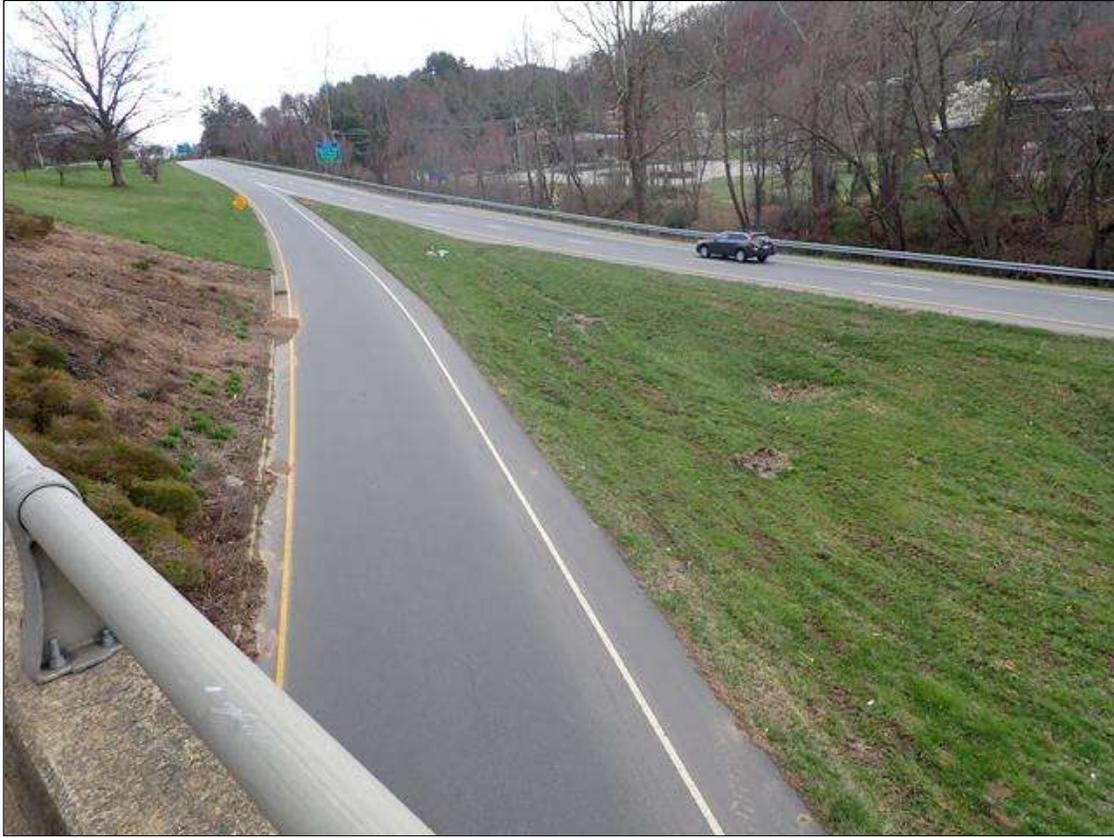
looking east from deck

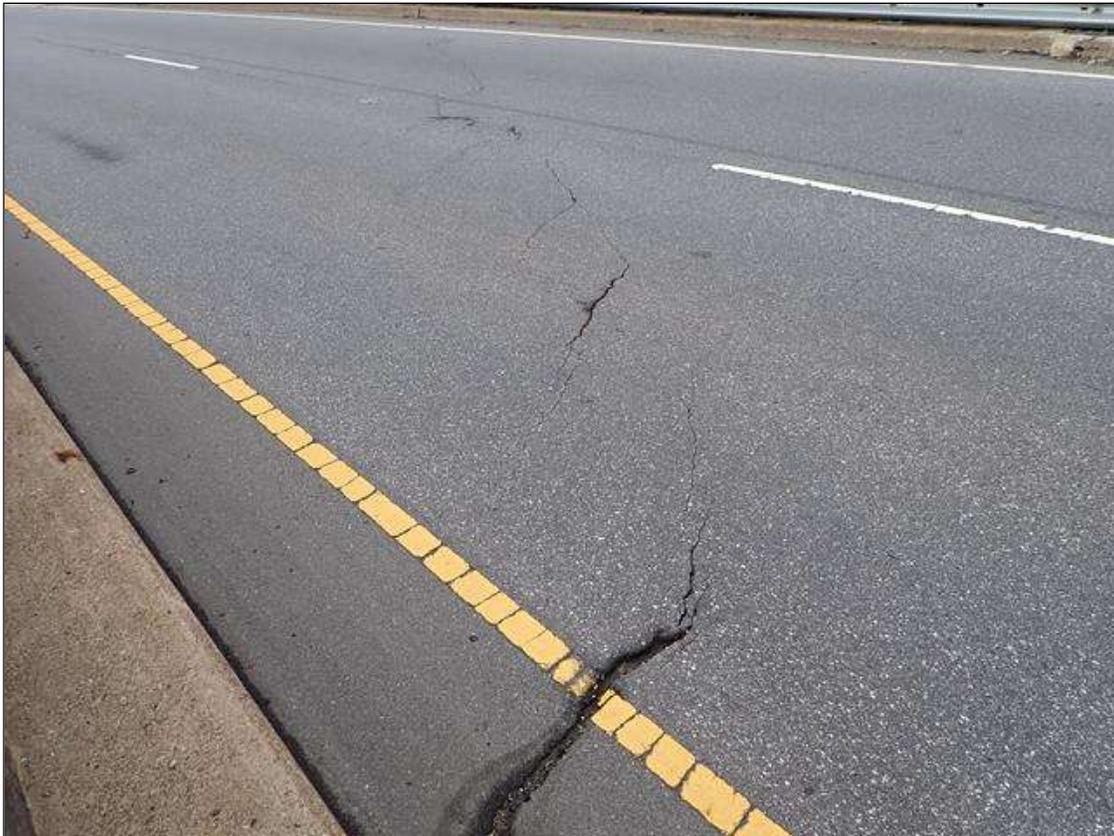
asphalt wearing surface over bent 2

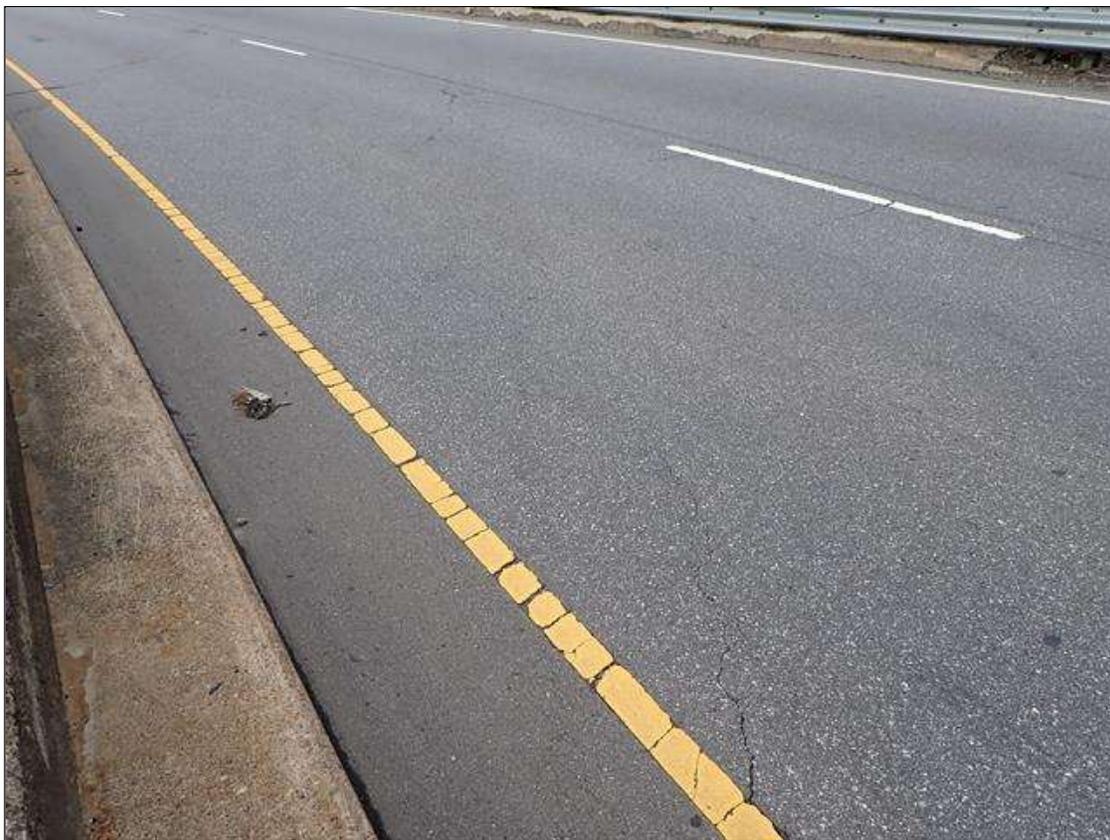
asphalt wearing surface over bent 3

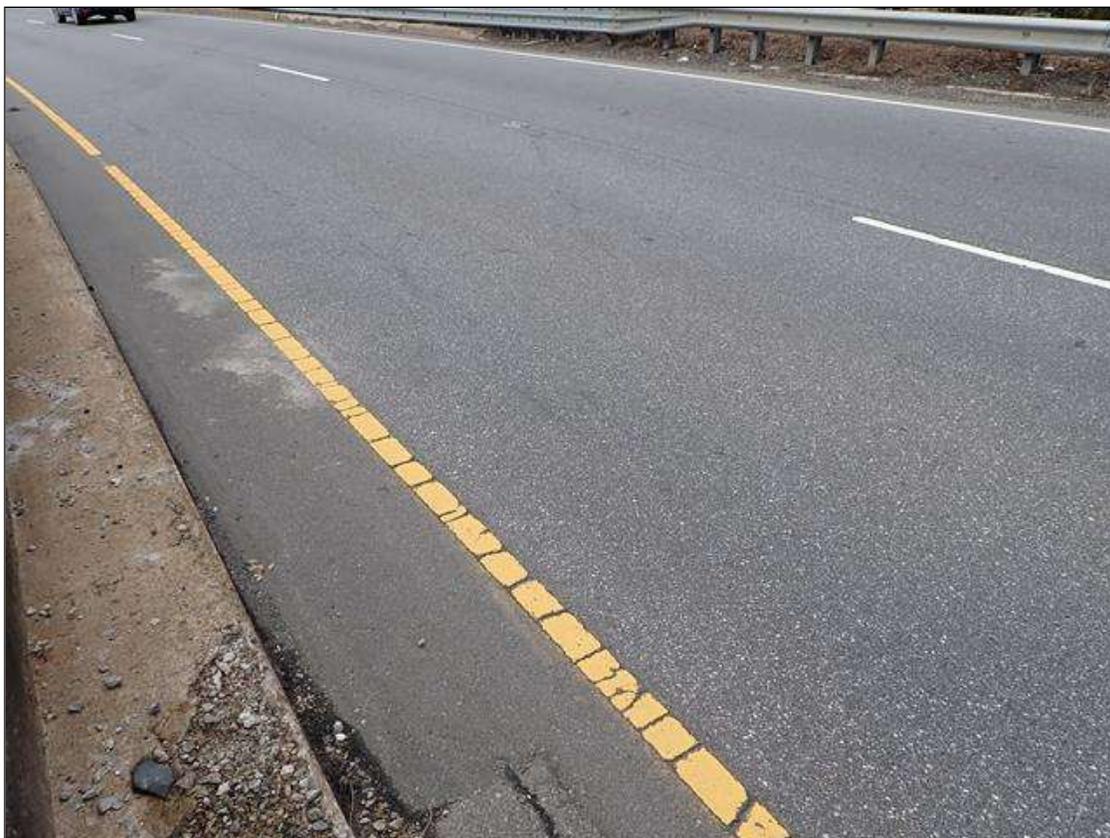
asphalt wearing surface over end bent 2

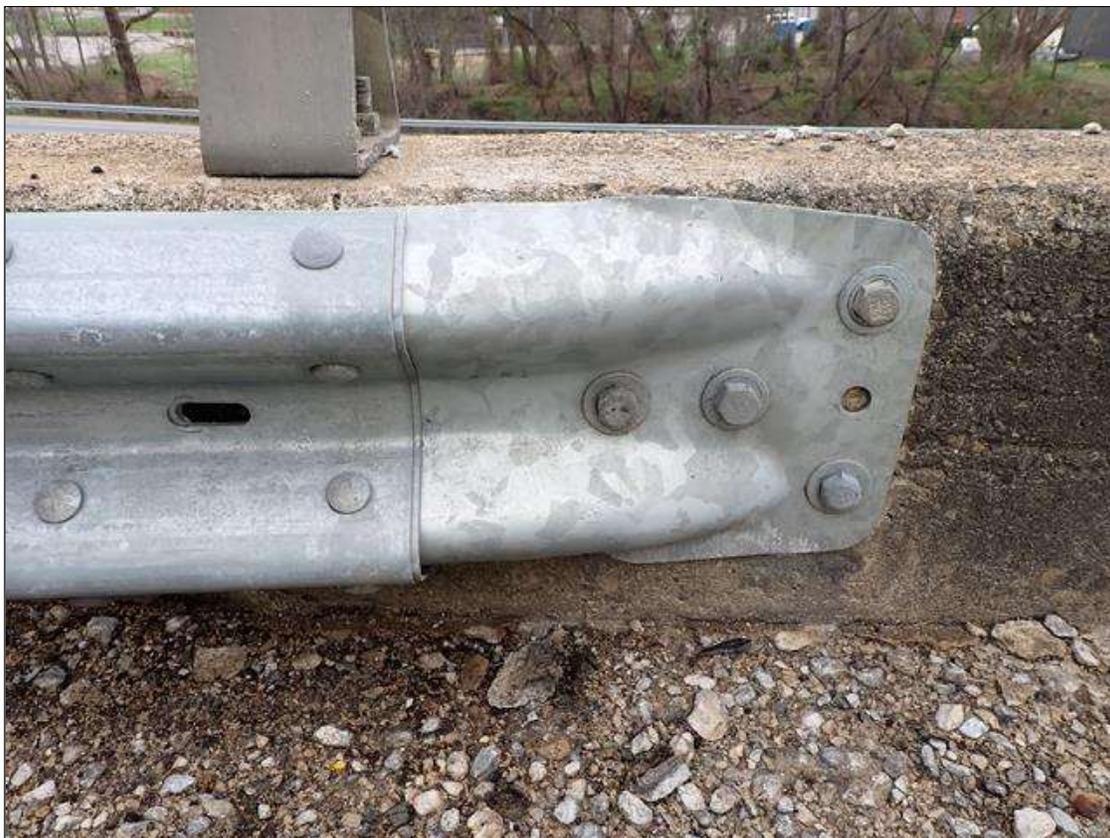
northeast guardrail attachment

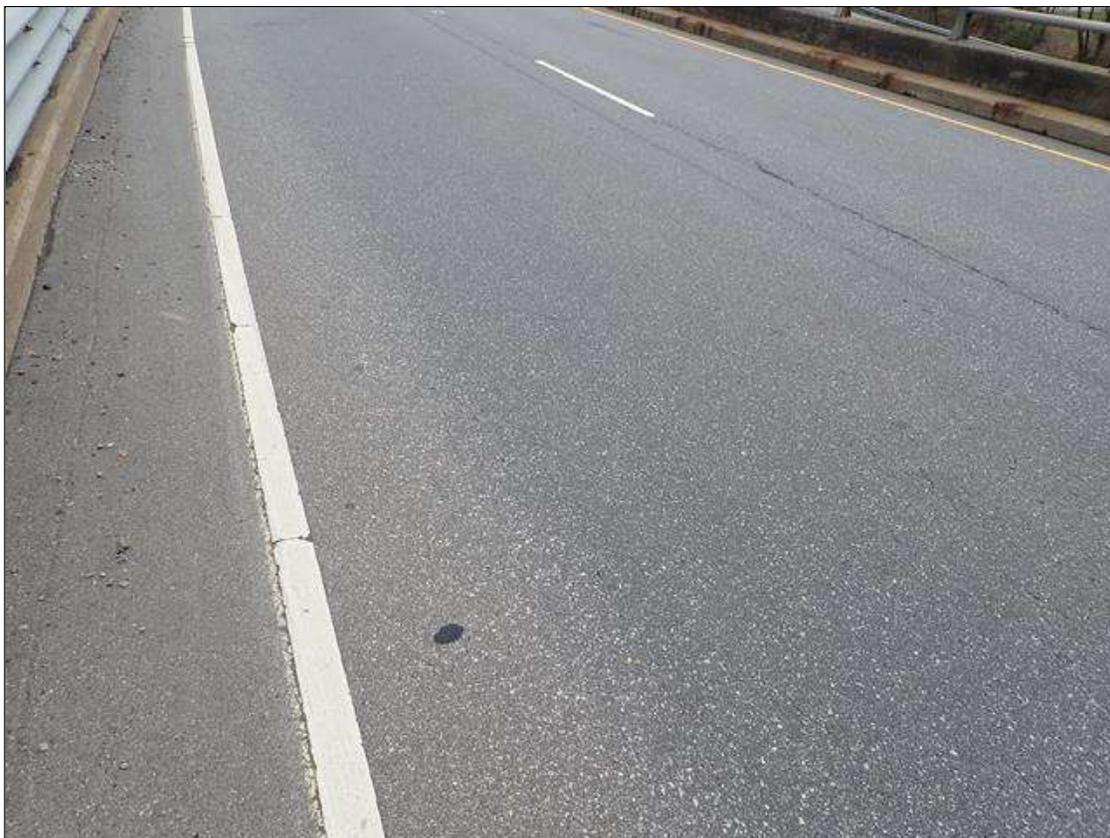
asphalt wearing surface

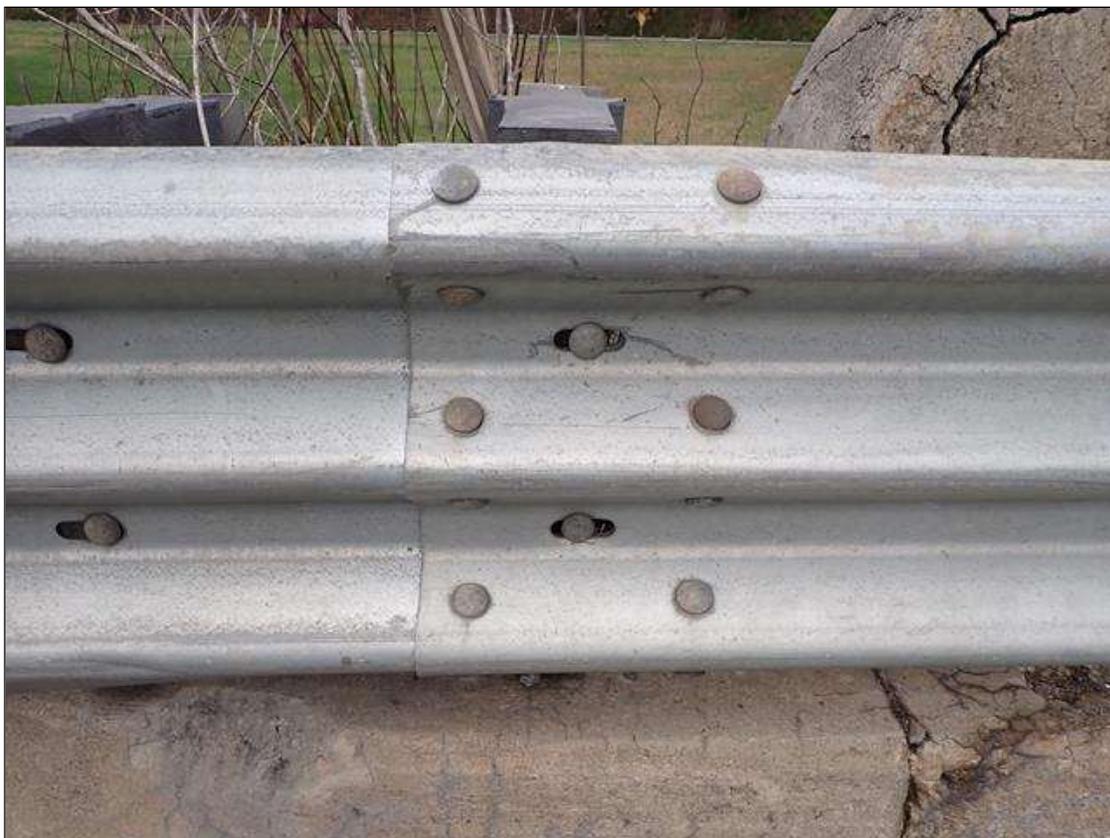
southwest guardrail attachment
