December 9, 2020

Mr. Christopher Tripp
On-Scene Coordinator
U.S. Environmental Protection Agency, Region 4
61 Forsyth Street, SW
Atlanta, Georgia 30303

**Subject: Removal Site Evaluation Report
Davidson Community Asbestos
Davidson, Mecklenburg County, North Carolina
EPA Contract No.: 68HE0519D0006
Task Order / Task Order Line Item No.: 68HE0419F0097 / 97-005**

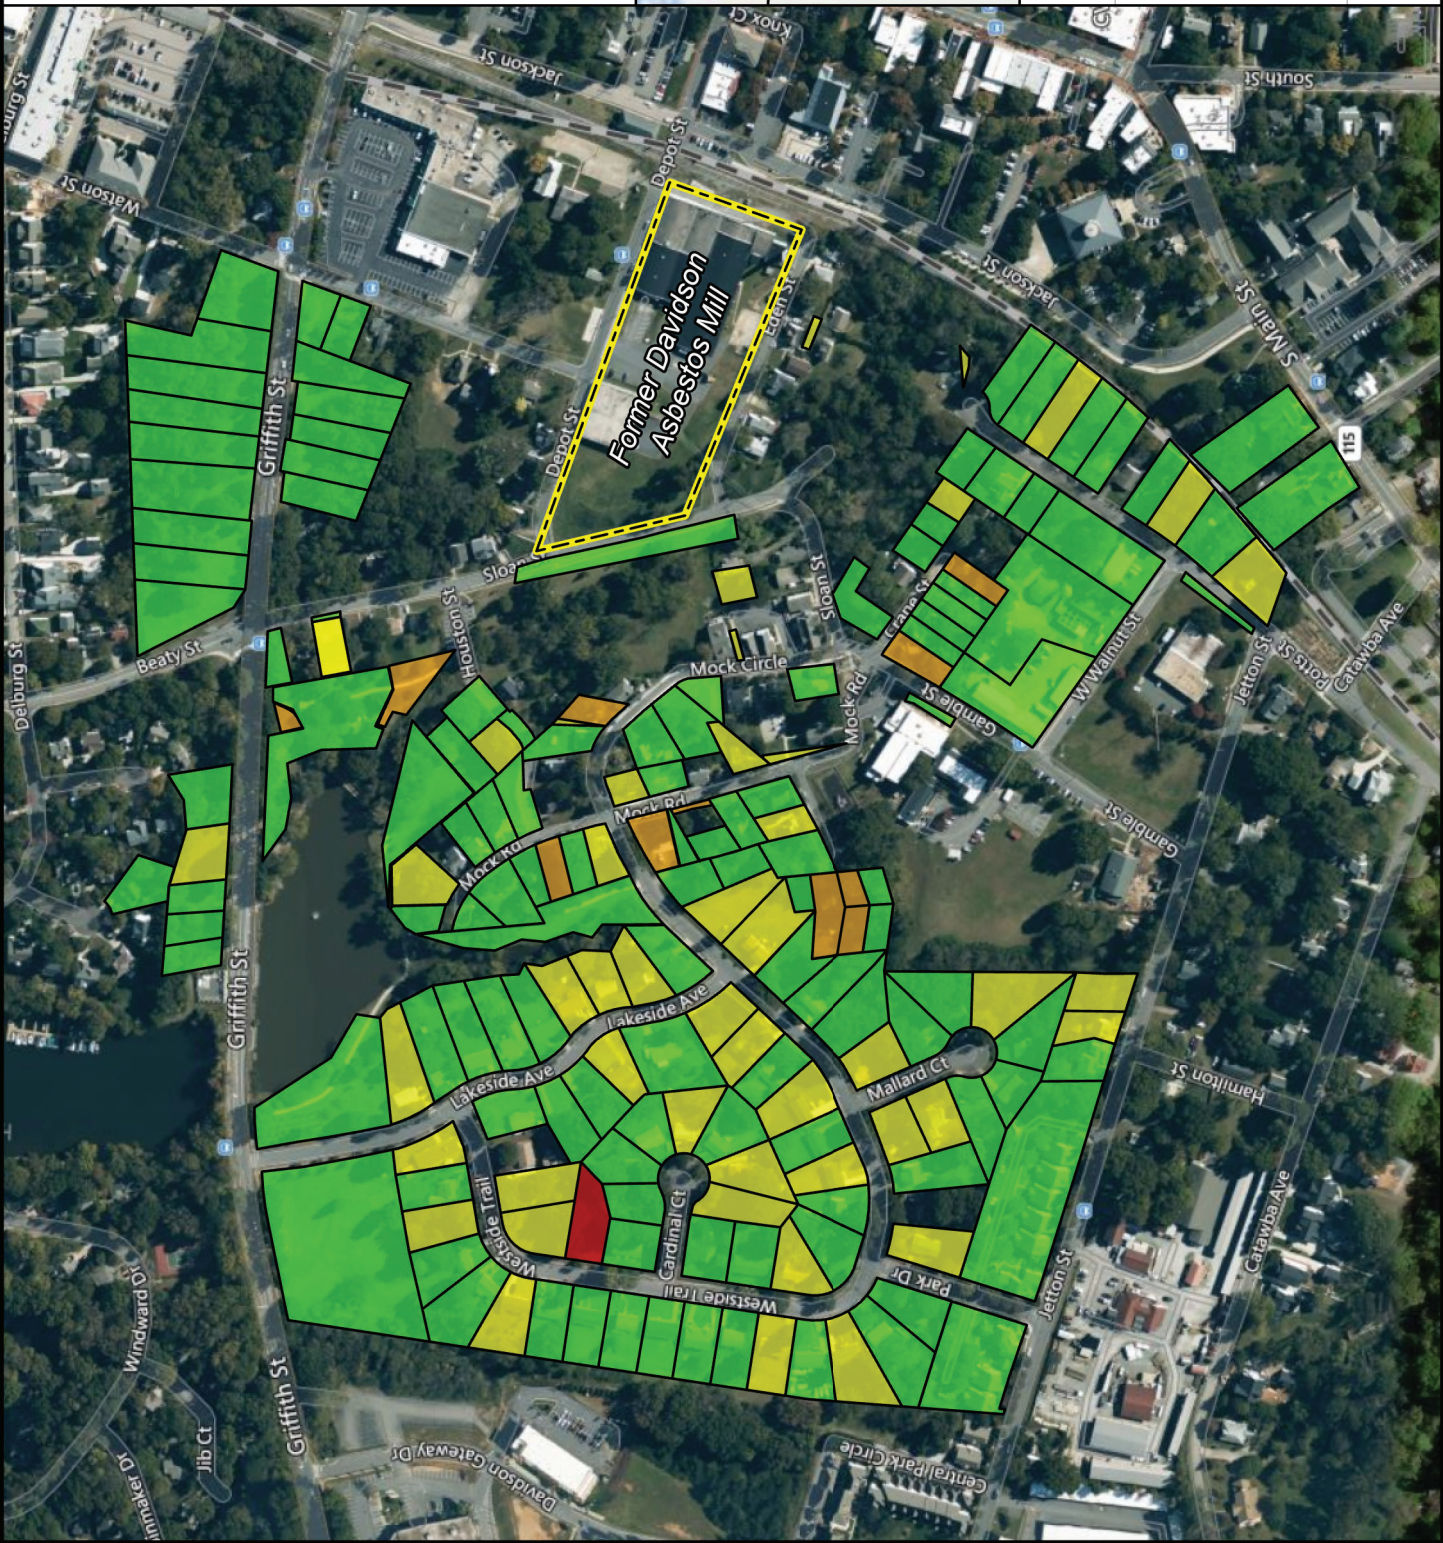
FIGURE 2

Figure 2 in Enclosure 1 depicts locations of parcels sampled during the RSE.

Site Status

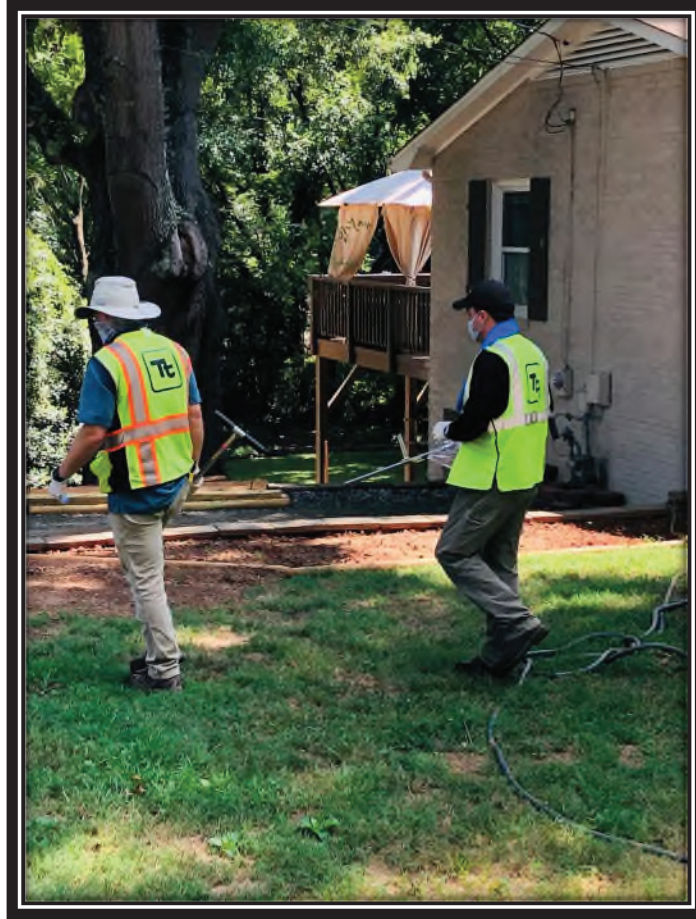
OFFICIAL PHOTOGRAPH NO. 1
U.S. ENVIRONMENTAL PROTECTION AGENCY

TOLIN:	97-005	Location:	Davidson Community Asbestos Removal Site Evaluation
Orientation:	East	Date:	August 5, 2020
Photographer:	Christopher Tripp, U.S. Environmental Protection Agency (EPA)	Witness:	John Snyder, Tetra Tech Inc. (Tetra Tech), Superfund Technical Assessment and Response Team (START)
Subject:	Members of the START sampling team collected soil samples from residences along Mallard Court in Davidson, North Carolina.

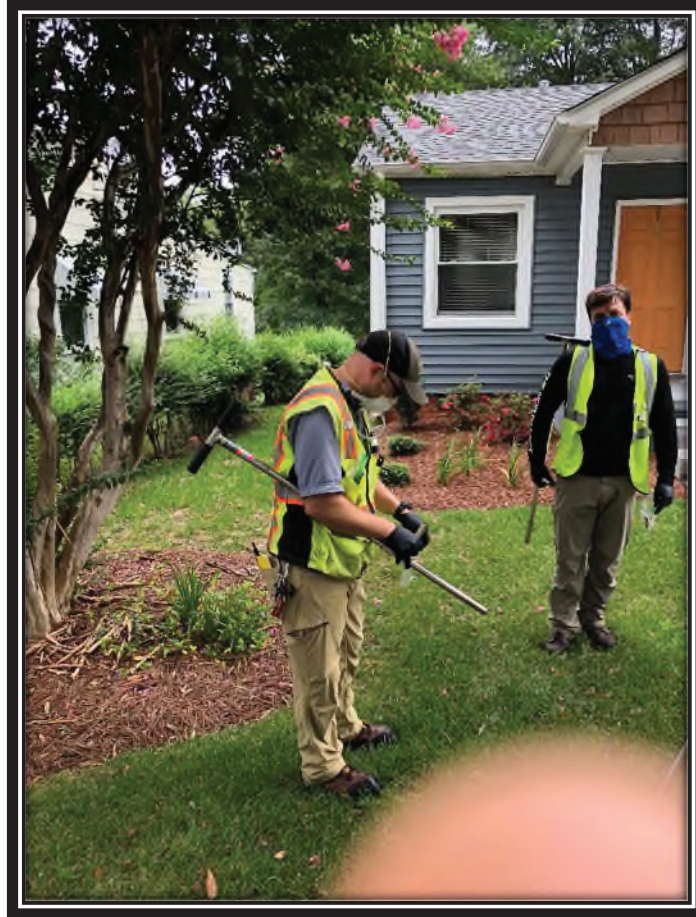
OFFICIAL PHOTOGRAPH NO. 2
U.S. ENVIRONMENTAL PROTECTION AGENCY

Subject: Members of the START sampling team prepared to collect soil samples from residences along Mock Road in Davidson, North Carolina.

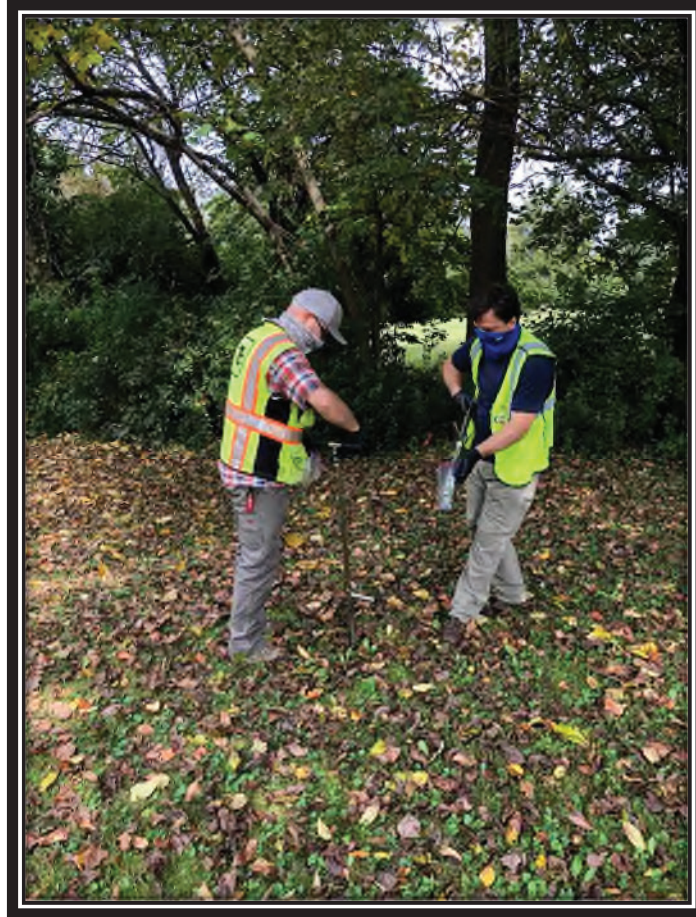
OFFICIAL PHOTOGRAPH NO. 3
U.S. ENVIRONMENTAL PROTECTION AGENCY

Subject: Members of the START sampling team collected soil samples from residences along Westside Terrace in Davidson, North Carolina.
