NC DEPARTMENT OF TRANSPORTATION
 DIVISION OF HIGHWAYS
 STRUCTURE MANAGEMENT UNIT

ATTENTION: **LADDER USED FOR INSPECTION / "PAR"s ISSUED**

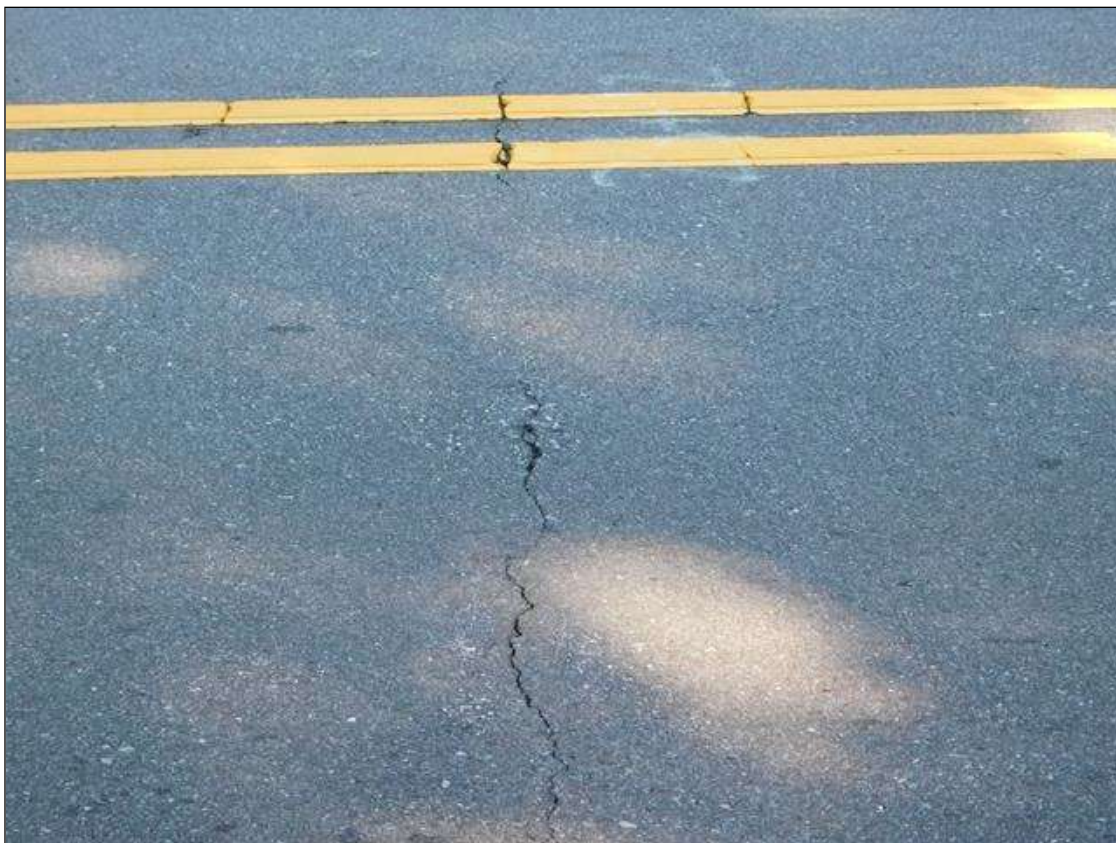
Span 1 Wearing Surface: SCATTERED TRANSVERSE CRACKS UP TO 1/8" WIDE OVER END BENT 1

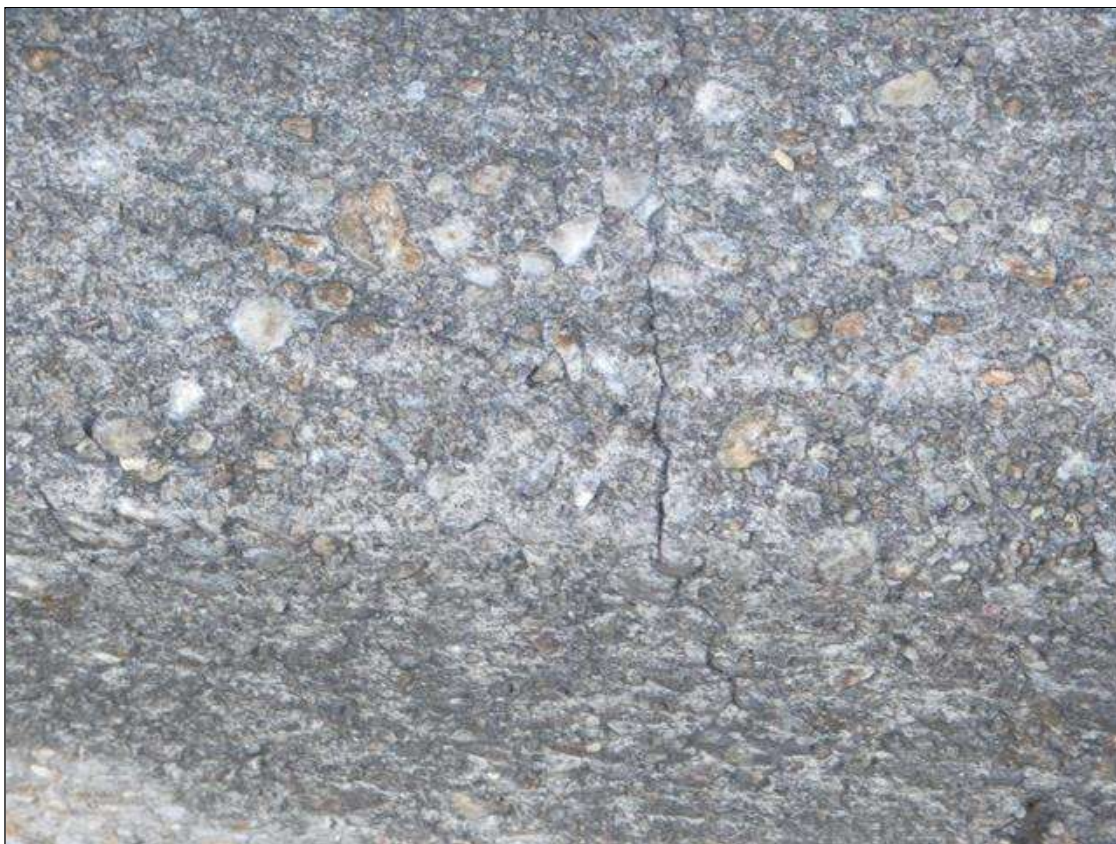
Span 1 Left Bridge Rail: SCATTERED HAIRLINE CRACKS IN FACE AND TOP OF CURB

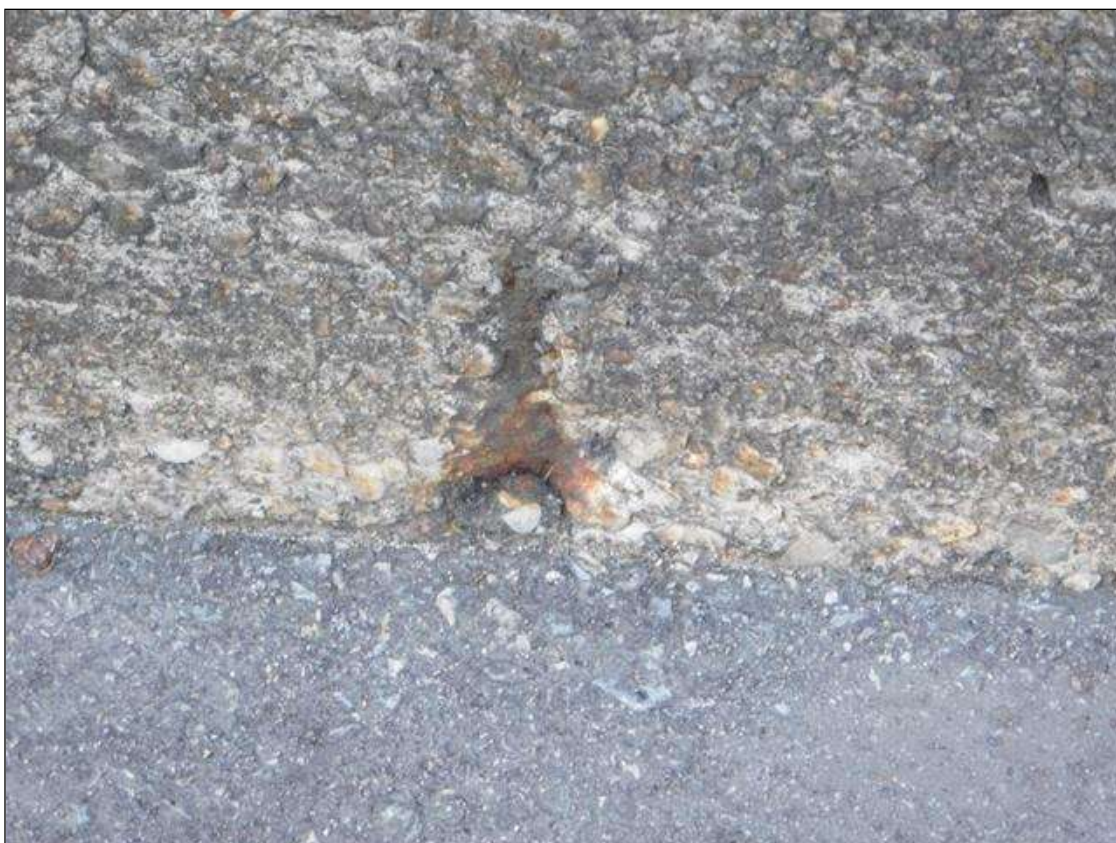
Span 1 Left Bridge Rail: 3" x 1" x 1/4" DEEP SPALL IN FACE OF CURB WITH RUST STAINS VISIBLE. 12' FROM END BENT 1

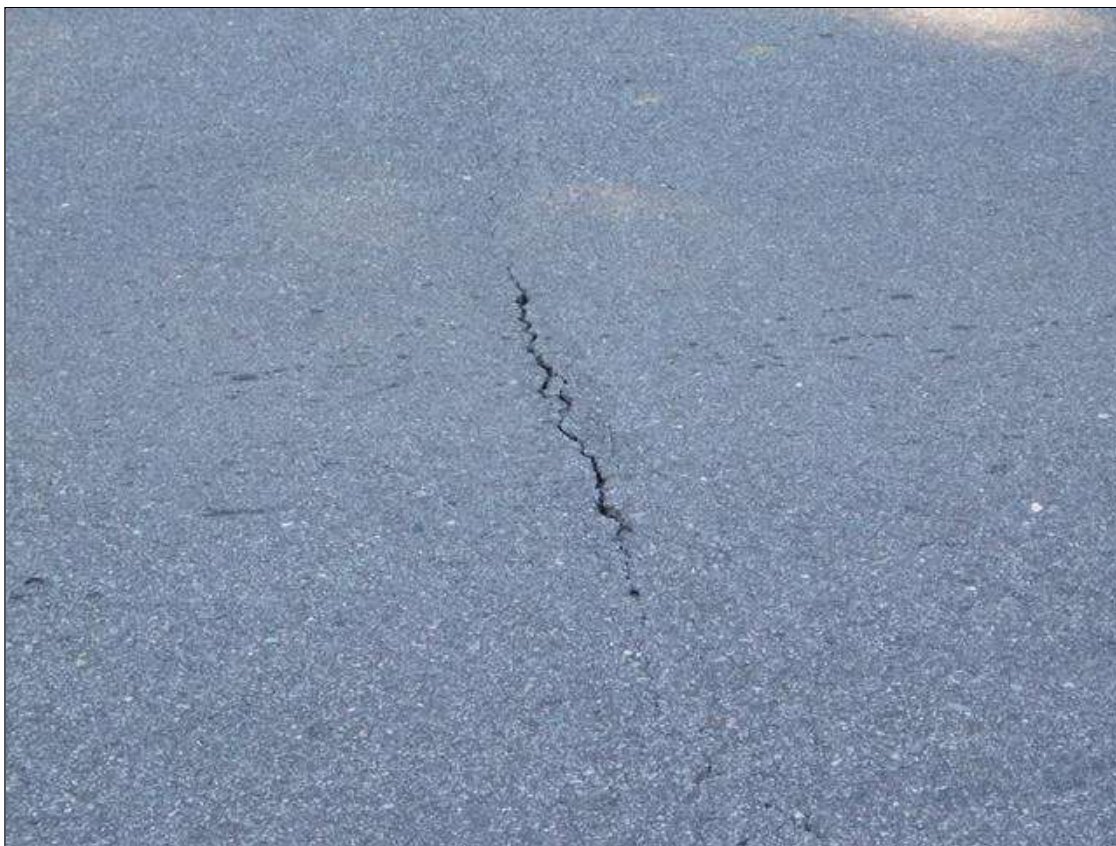
Span 2 Wearing Surface: SCATTERED TRANSVERSE CRACKS UP TO 1/8" WIDE OVER BENT 2

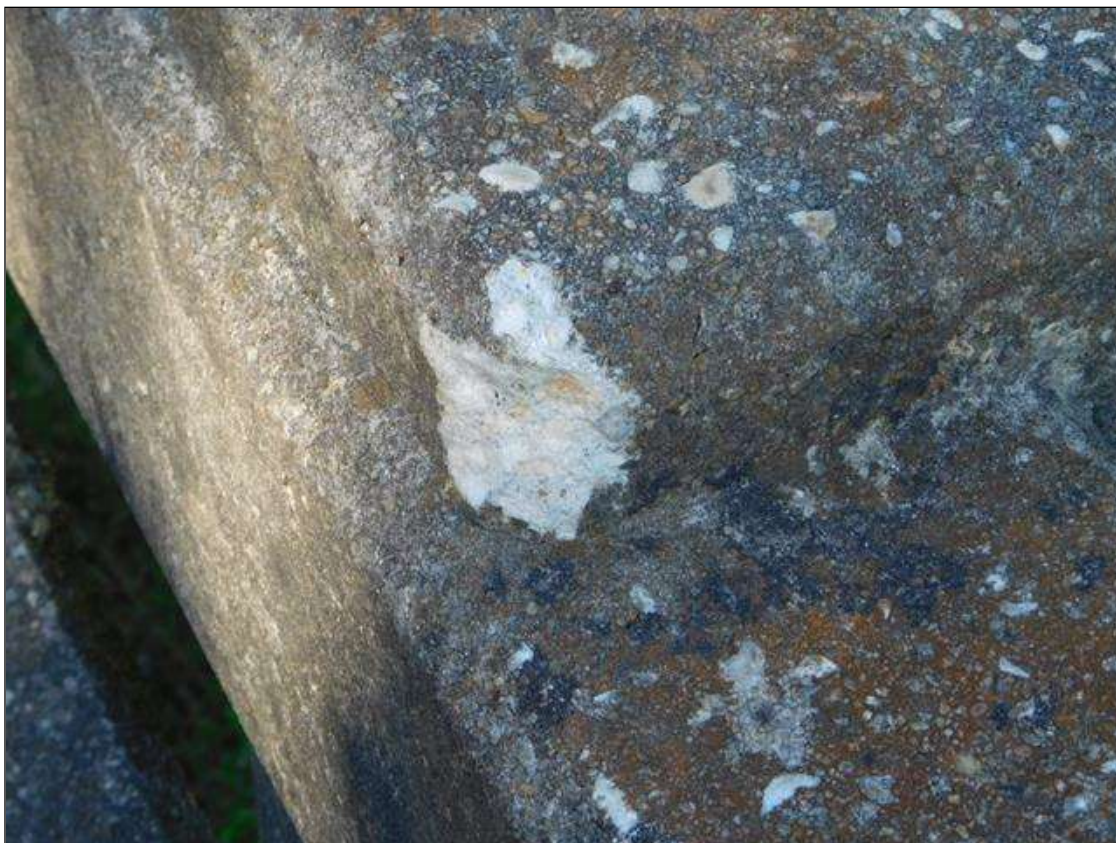
Span 2 Right Bridge Rail: SCATTERED SPALLS UP TO 4" x 3" x 1/2" DEEP IN FACE OF RAIL AND POST

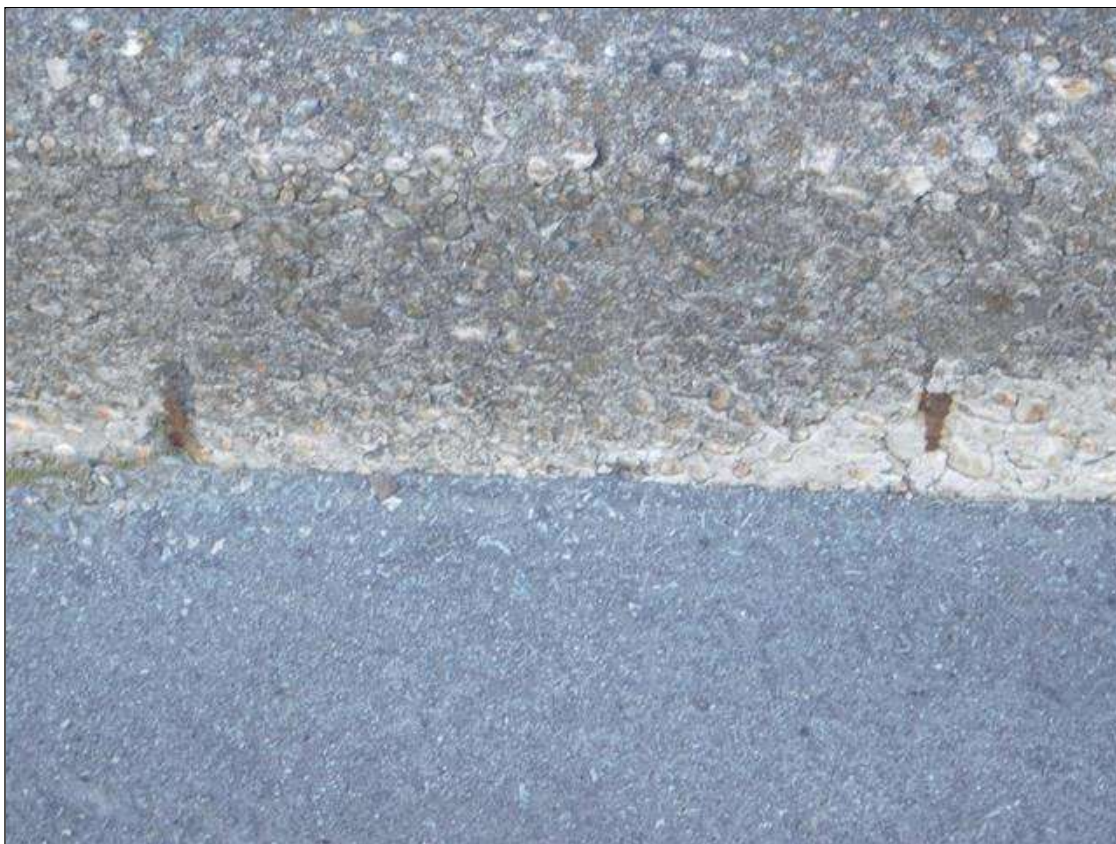
Span 2 Left Bridge Rail: (2) SPALLS IN FACE OF CURB WITH REBAR VISIBLE NEAR BENT 1. AREAS ARE 3" x 1" x 1/4" DEEP

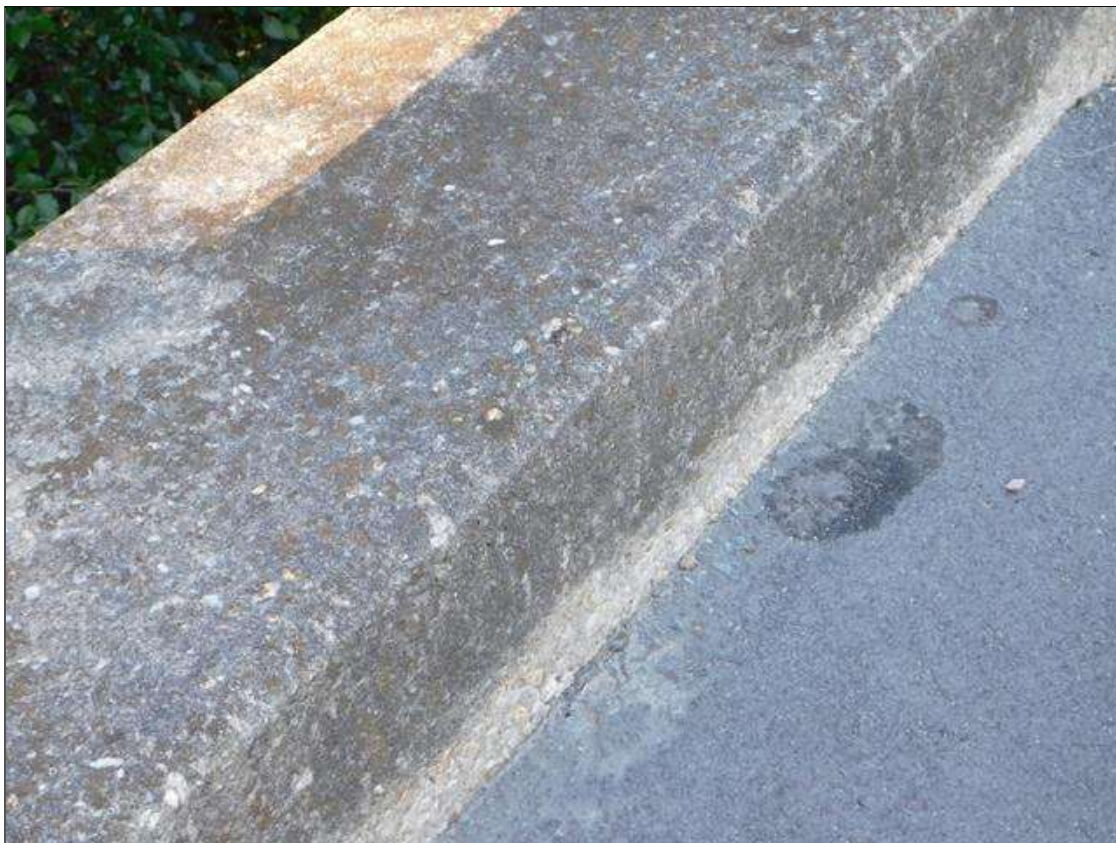
Span 3 Left Bridge Rail: EXPOSED SURFACE COARSE AGGREGATE THROUGHOUT THE BRIDGE RAIL

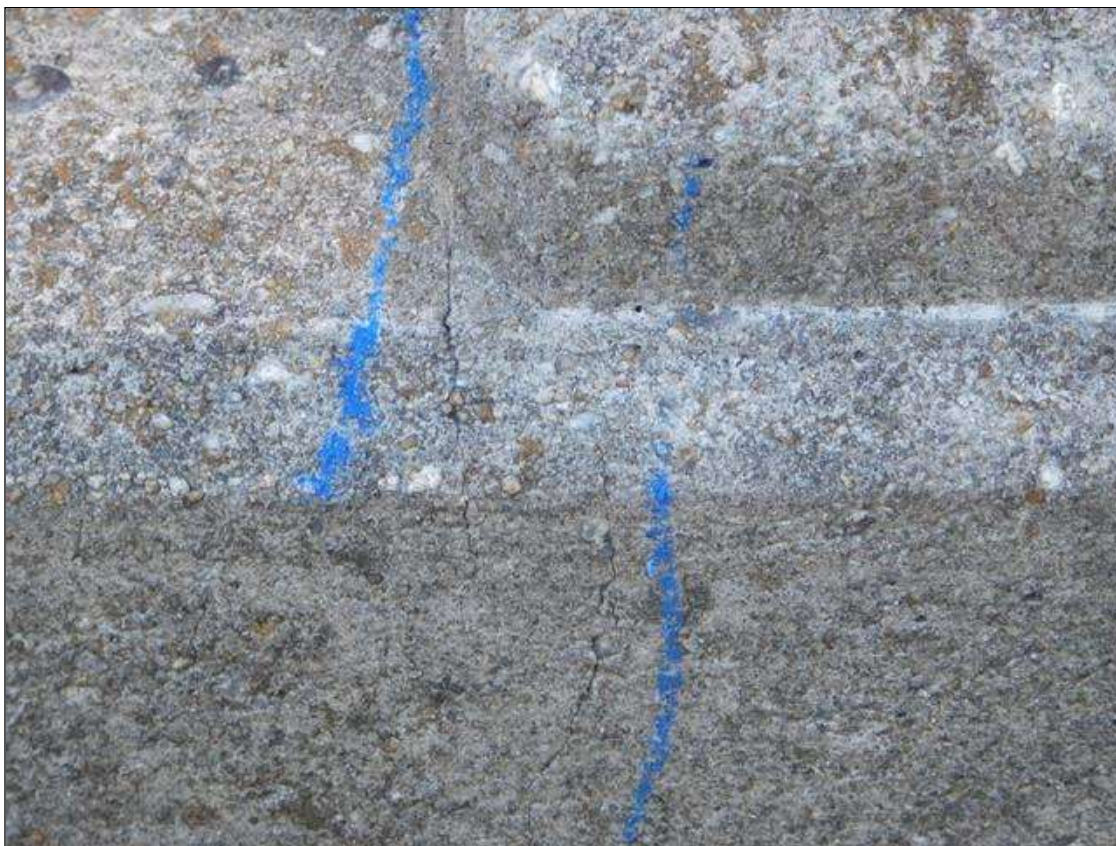
Span 6 Left Bridge Rail: SCATTERED HAIRLINE CRACKS IN RAIL AND CURB NEAR END BENT 2

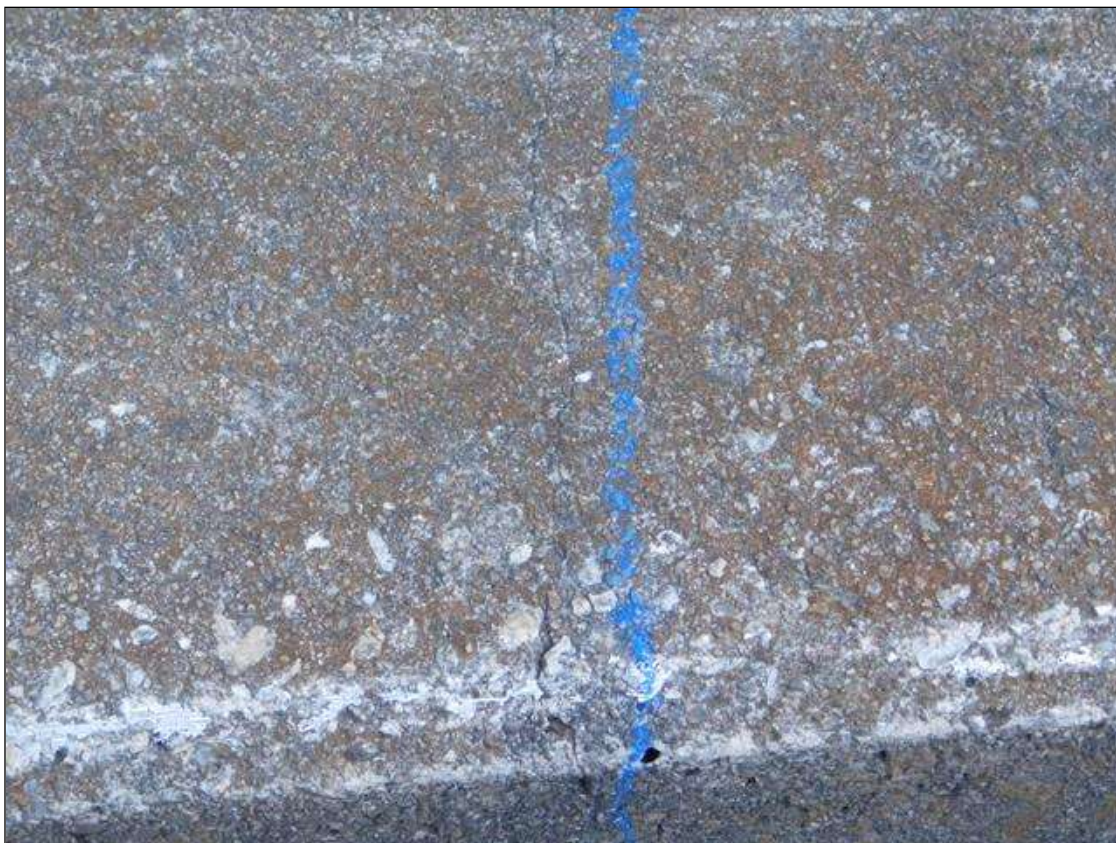
Span 6 Right Bridge Rail: 2'-9" LONG X 1/32" WIDE VERTICAL WRAP AROUND CRACK IN THE EAST CURB, 3' FROM BENT 5

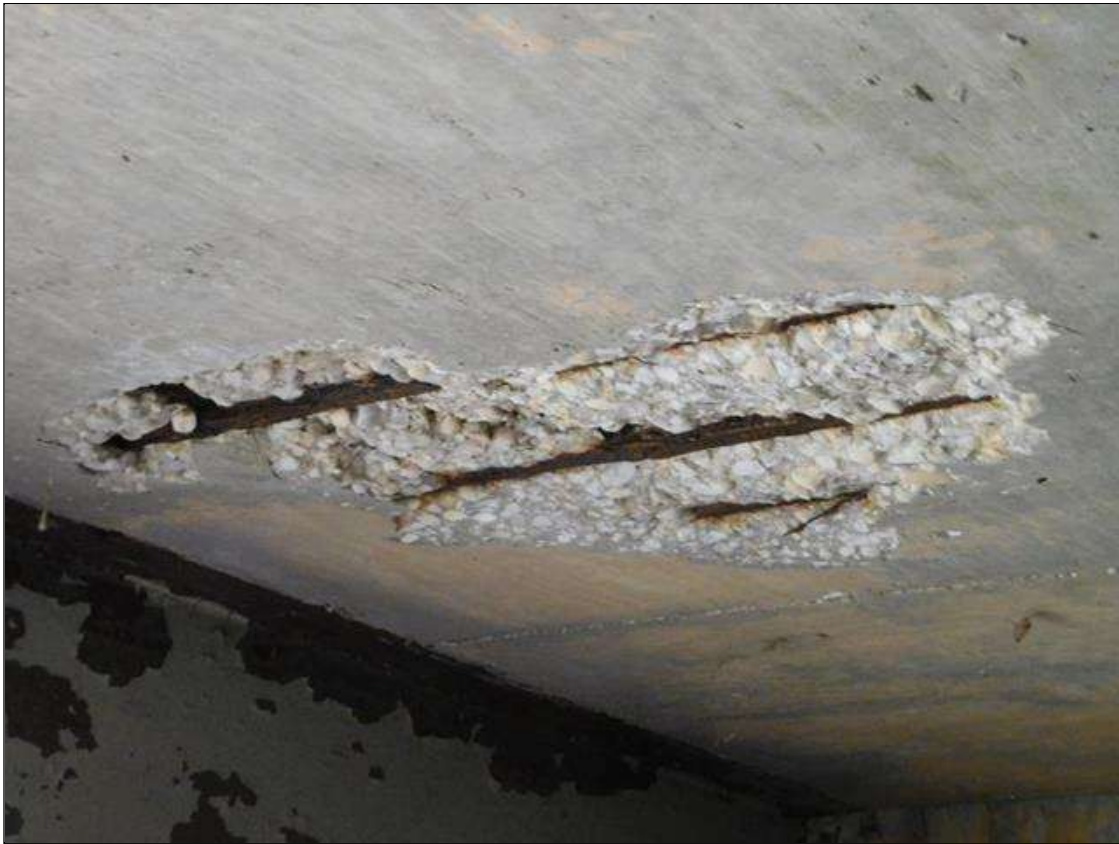
Span 1 Deck: 2' LONG X 2'-8" WIDE X 2" DEEP SPALLED AREA WITH EXPOSED REINFORCEMENT IN THE UNDERSIDE OF THE DECK IN BAY 4, 3' FROM END BENT 1

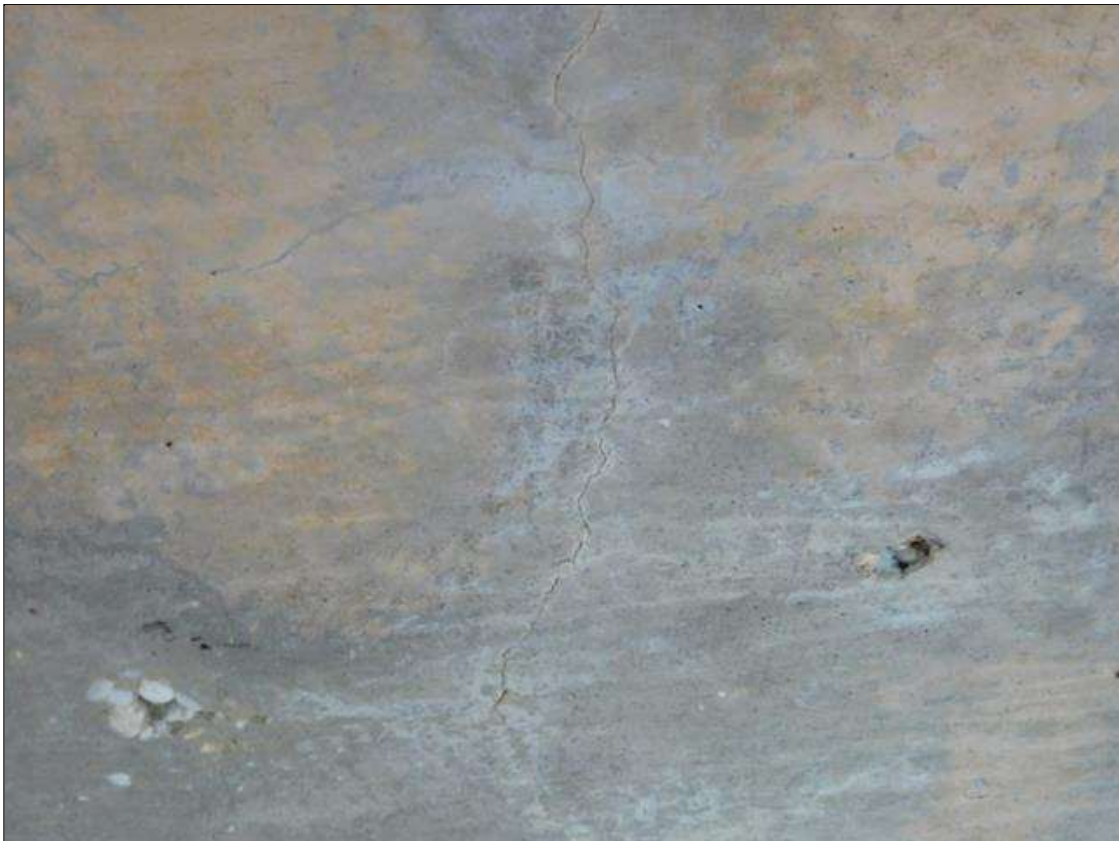
Span 1 Deck: INTERMITTENT FULL WIDTH X 1/32" WIDE TRANSVERSE CRACKS WITH EFFLORESCENCE IN THE UNDERSIDE OF THE DECK AT 1' TO 3' SPACING

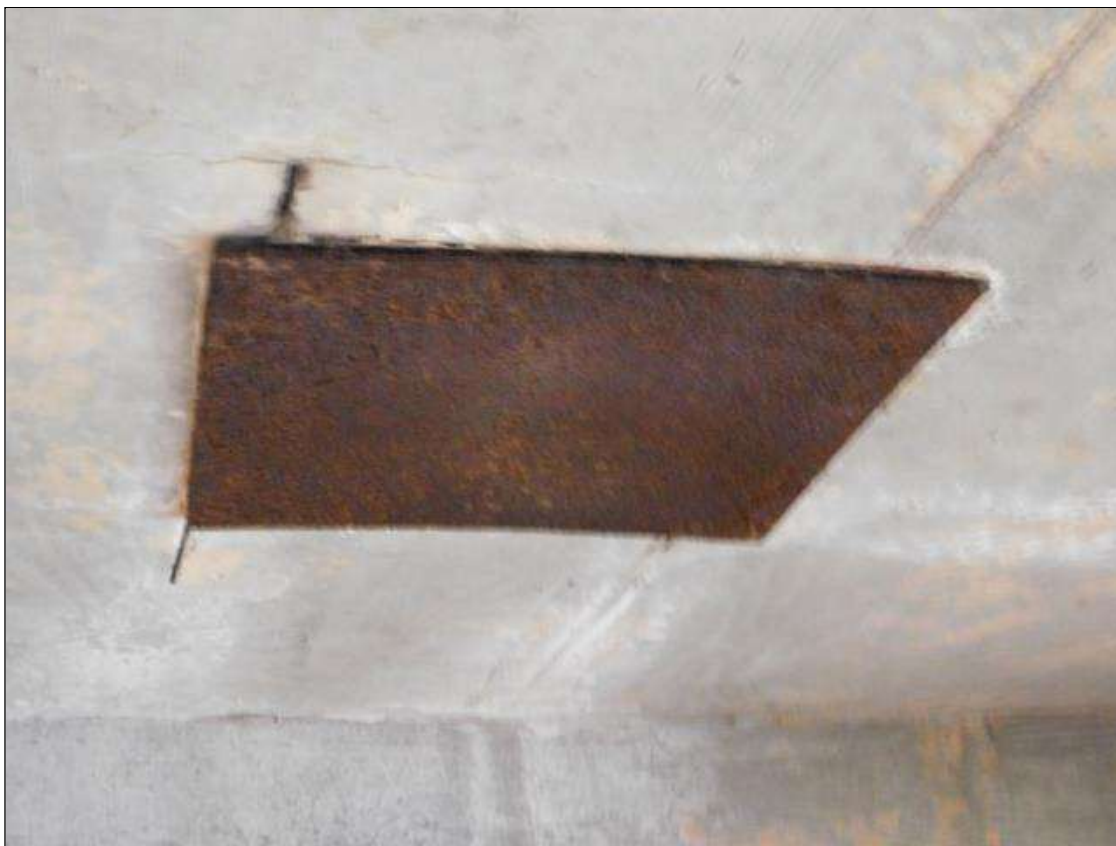
Span 1 Deck: METAL PLATE ATTACHED TO BOTTOM OF DECK IN BAYS 1, 3 AND 4 NEAR BENT 1

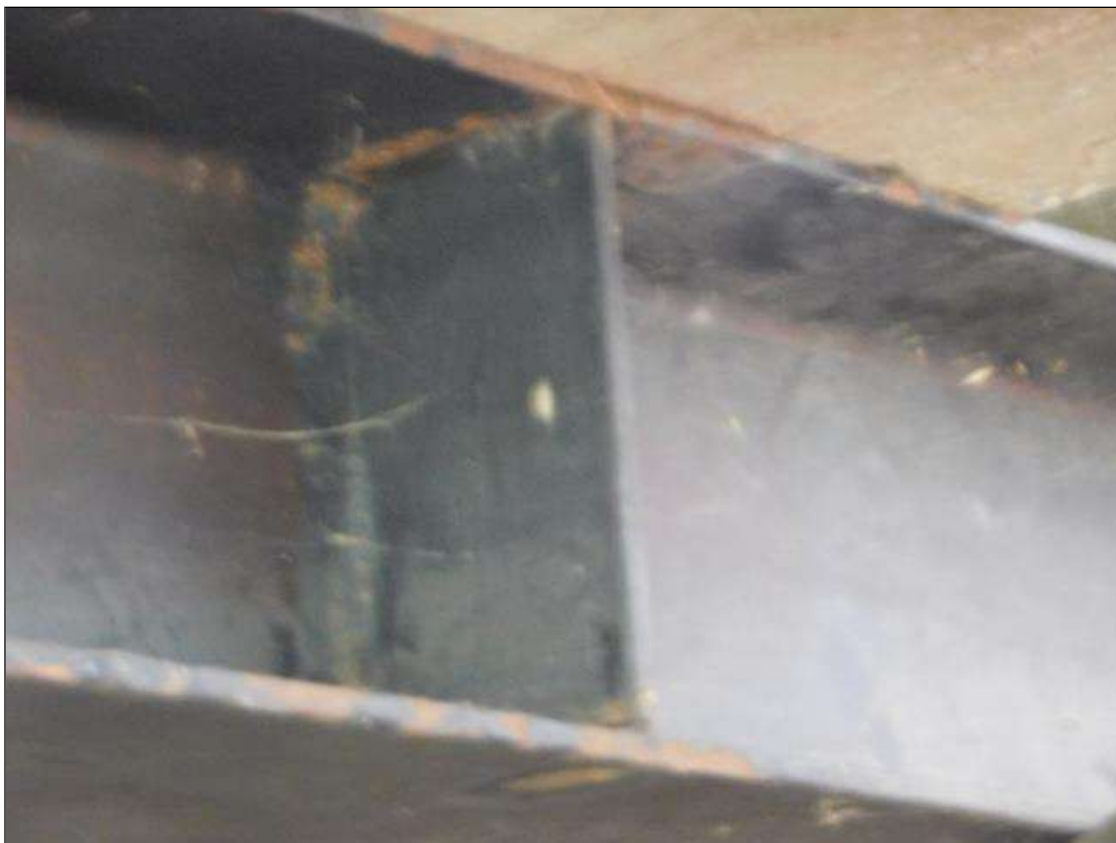
Bent 1 Pile 2 (Crutch Bent): SCATTERED AREAS OF SURFACE RUST (6 FT.)

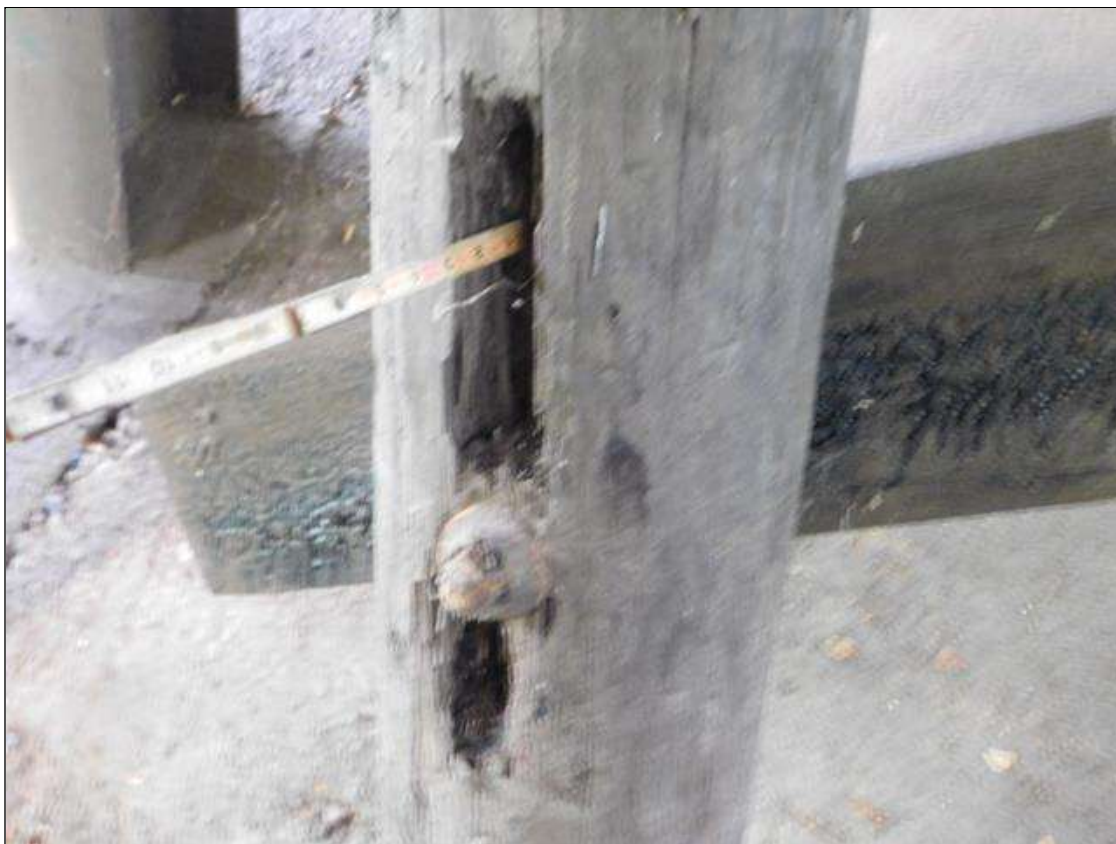
Bent 1 Pile 4: 17" TALL x 3" WIDE x 2" DEEP AREA OF 100% SECTION LOSS ON NORTH FACE AT LOWER CROSS-BRACE

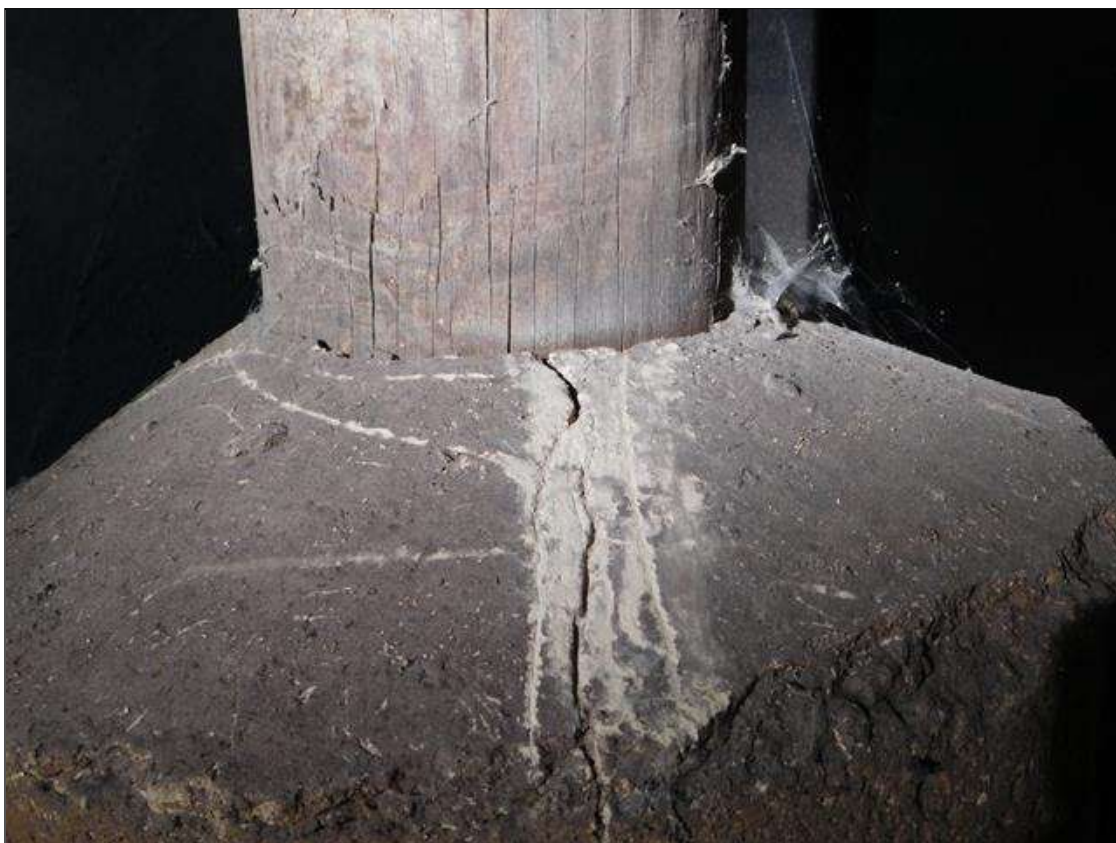
Bent 1 Pile 6: SCATTERED CHECKS UP TO 1/16" WIDE AND CONCRETE ENCASEMENT HAS SCATTERED CRACKS UP TO 1/8" WIDE

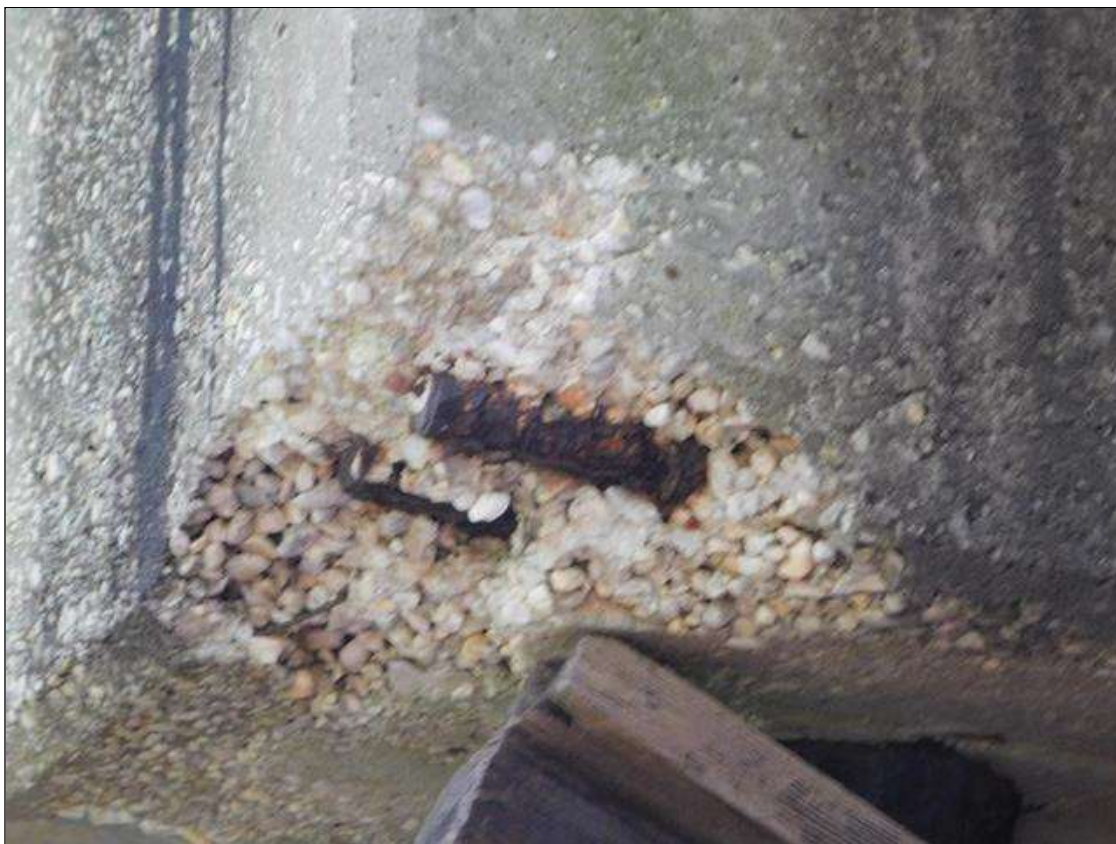
Bent 2 Cap 1: BOTTOM SOUTHWEST CORNER HAS A 14" x 10" x UP TO 7" DEEP SPALL WITH (2) MAIN REBAR EXPOSED. "PAR" ISSUED

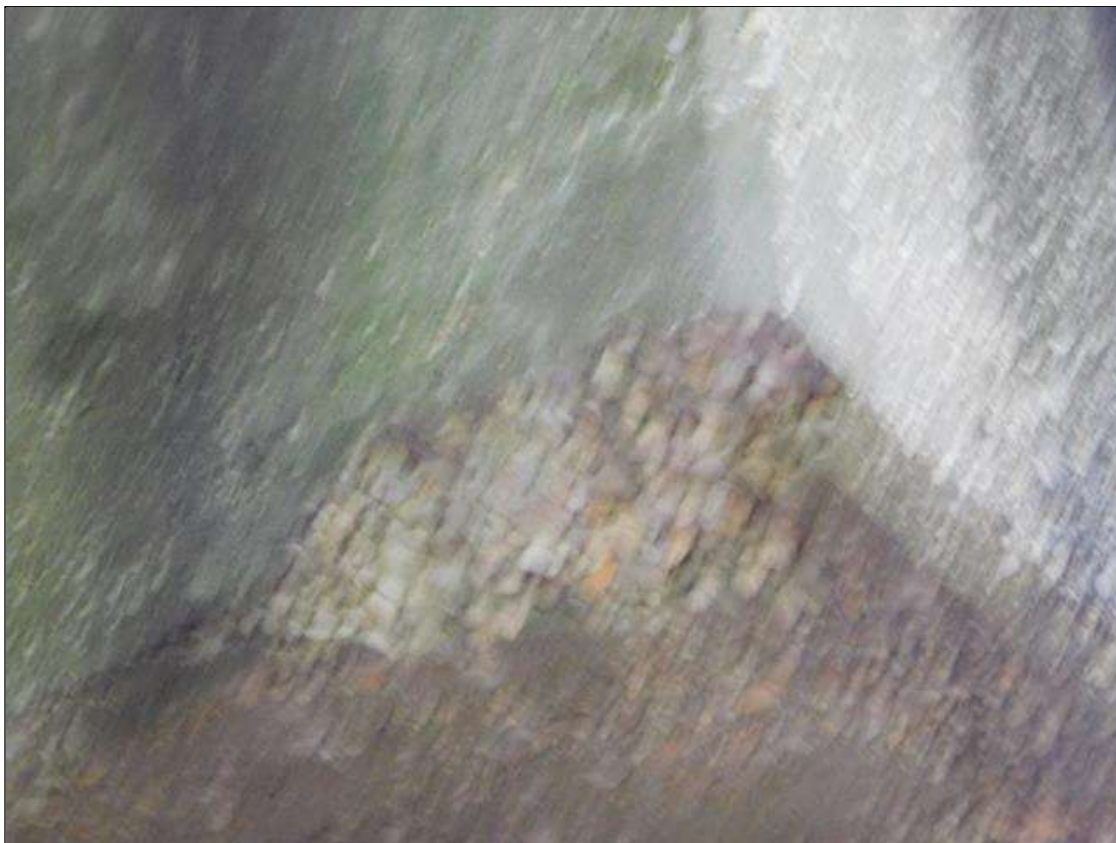
Bent 2 Cap 1: 12" x 6" x 2" DEEP SPALL IN BOTTOM NORTHWEST CORNER

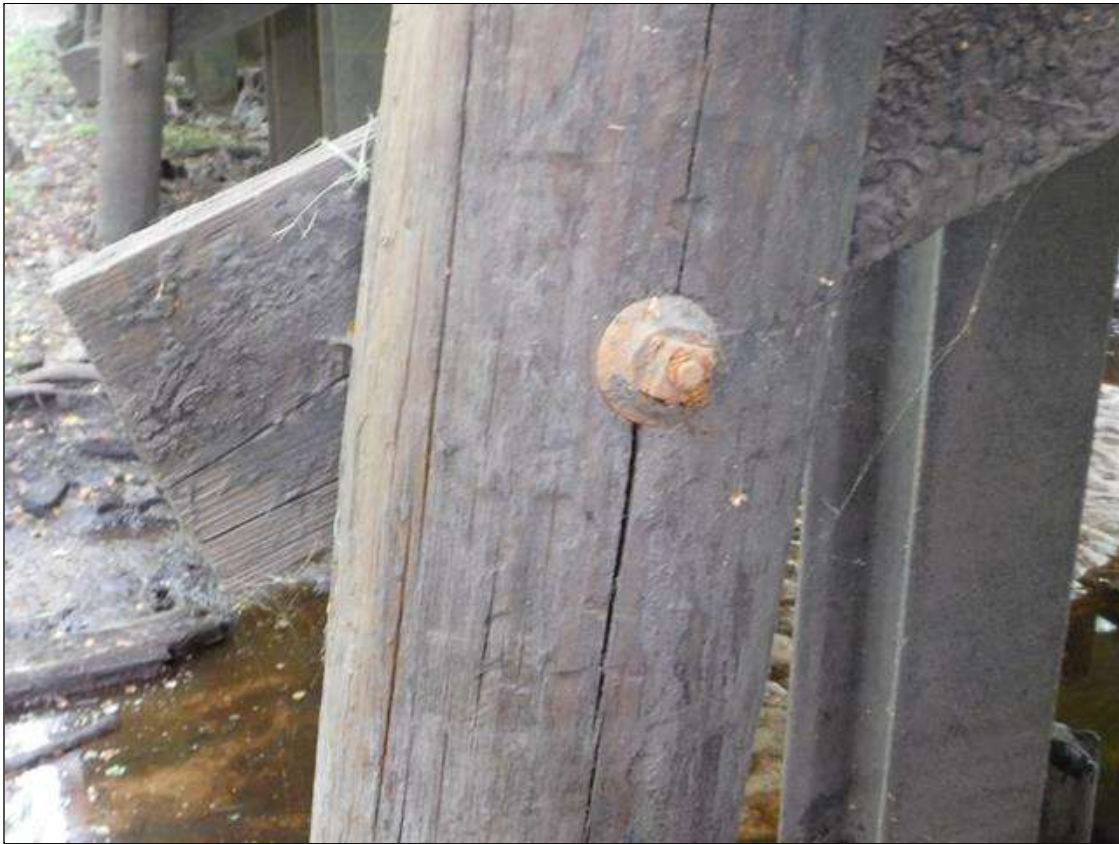
Bent 2 Pile 1: SCATTERED CHECKS UP TO 1/4" WIDE

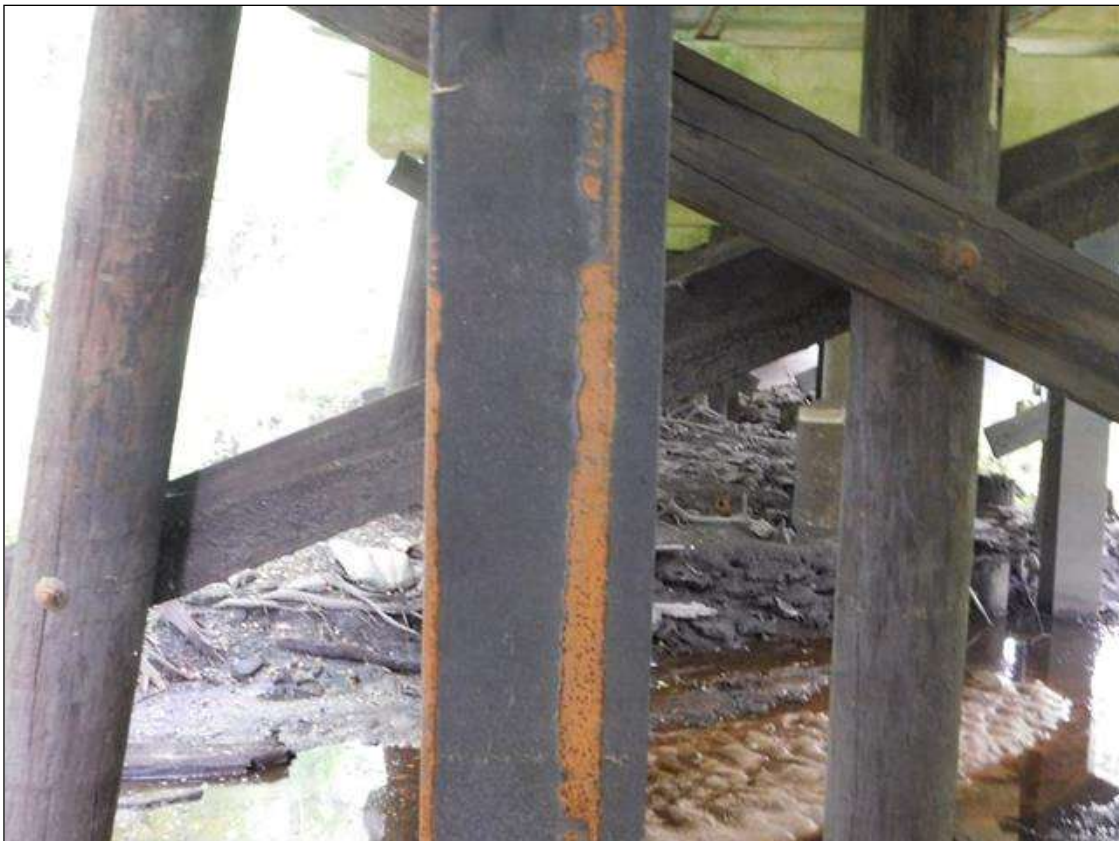
Bent 2 Pile 2 (Crutch Bent): SCATTERED AREAS OF SURFACE RUST (14 FT.)

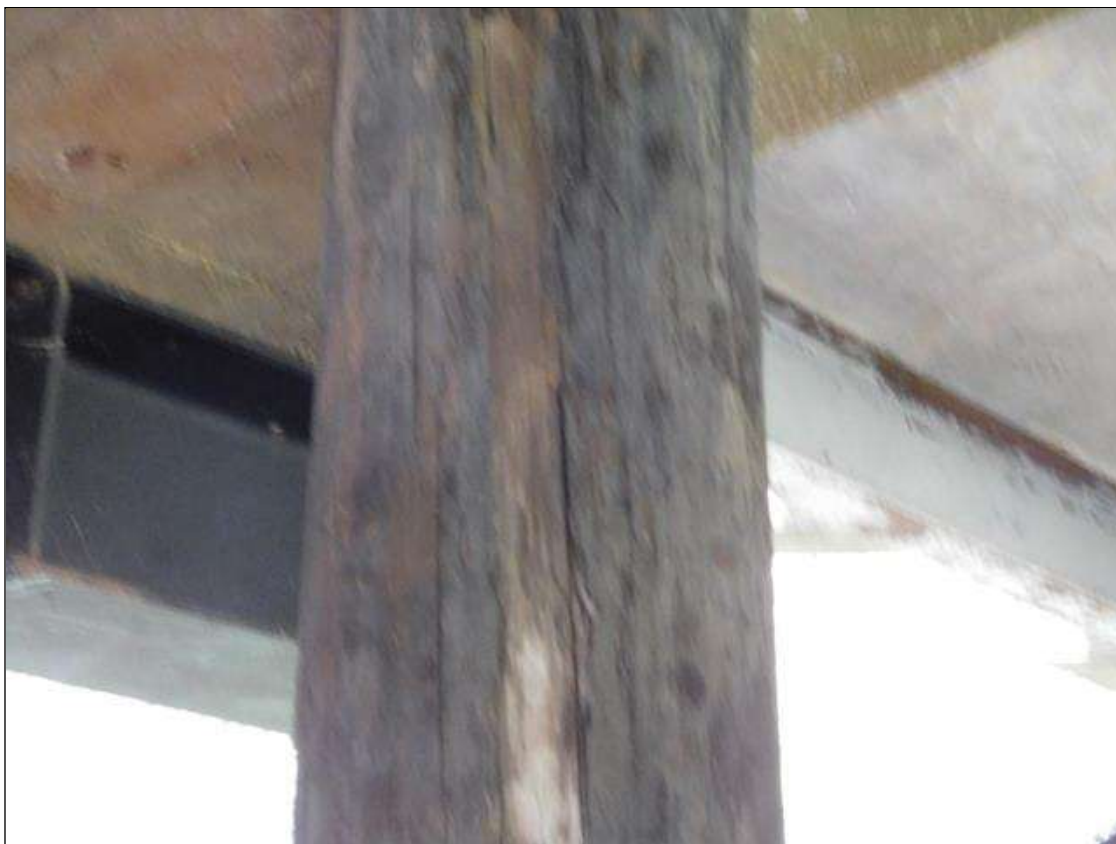
Bent 2 Pile 3: 30" TALL x 3" WIDE x 1/2" DEEP AREA OF DECAY IN SOUTH FACE AT TOP

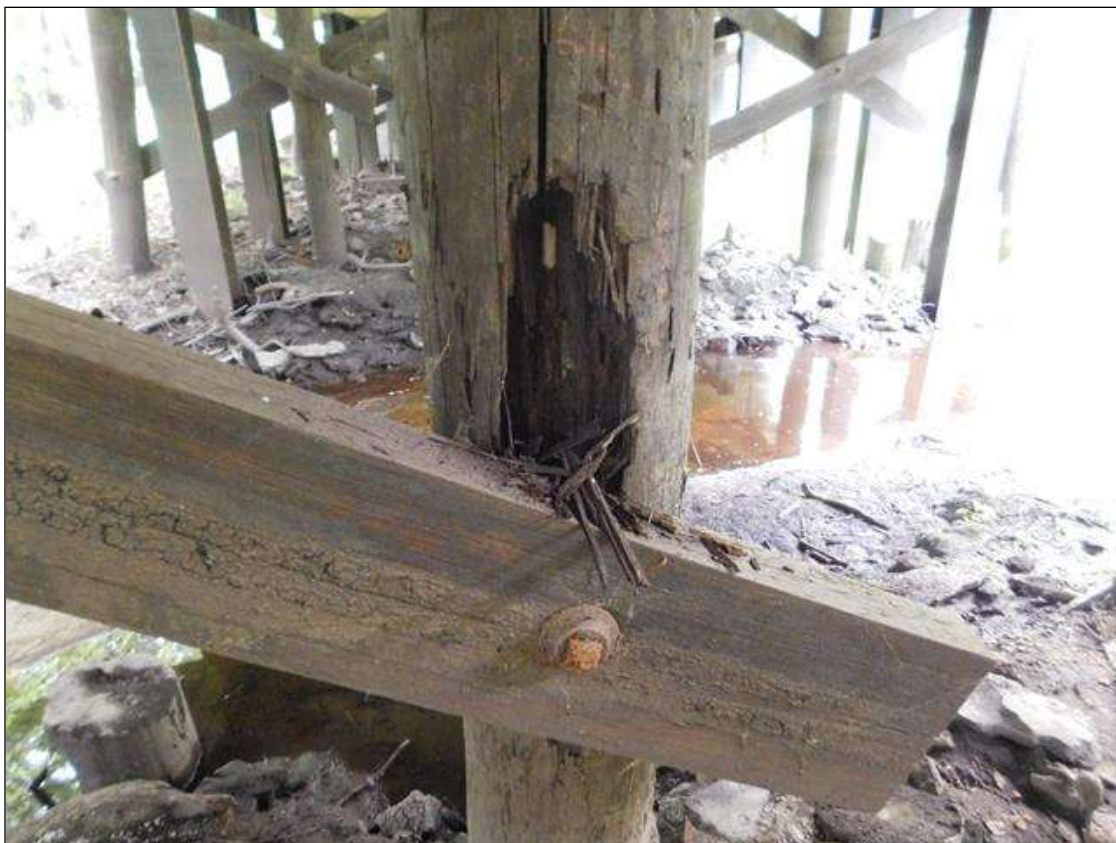
Bent 2 Pile 4: 24" TALL x 8" WIDE x 3" DEEP AREA OF DECAY IN SOUTH FACE AT LOWER CROSS-BRACE. "PAR ISSUED

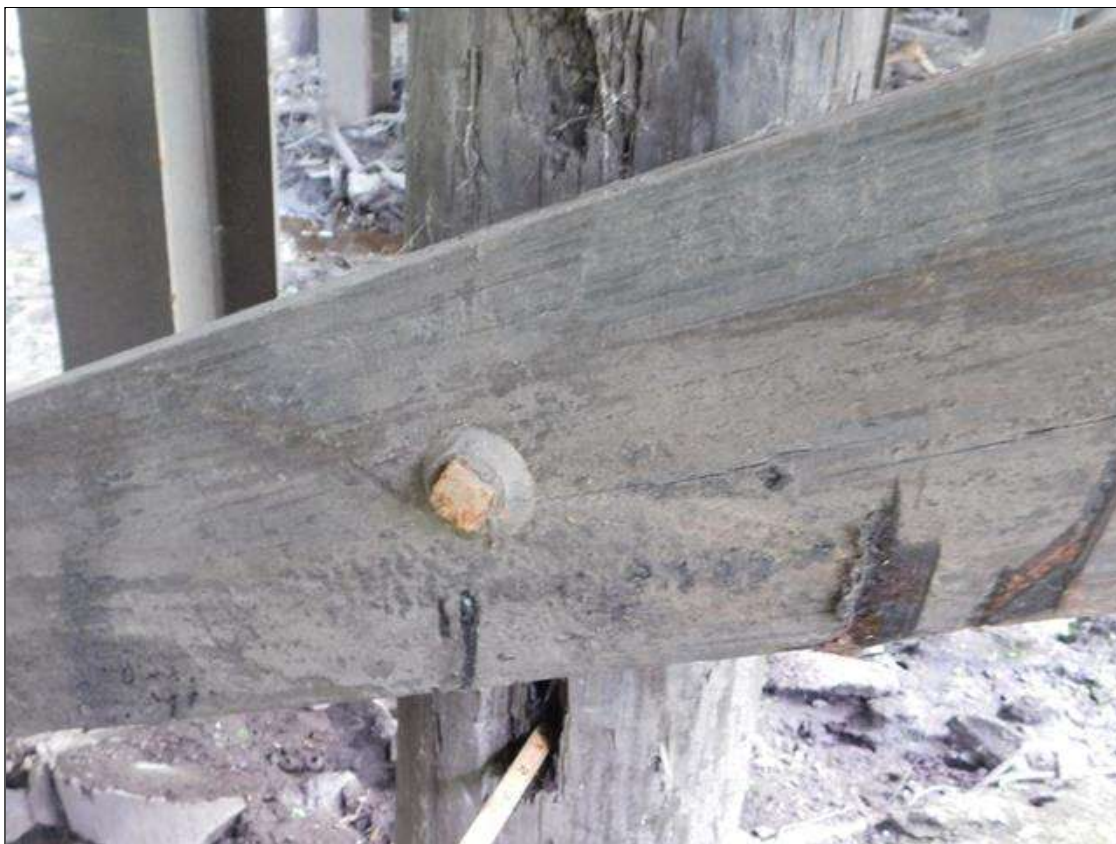
Bent 2 Pile 6: 18" TALL x 3" WIDE x 1 1/2" DEEP AREA OF DECAY IN SOUTH FACE AT LOWER CROSS-BRACE.

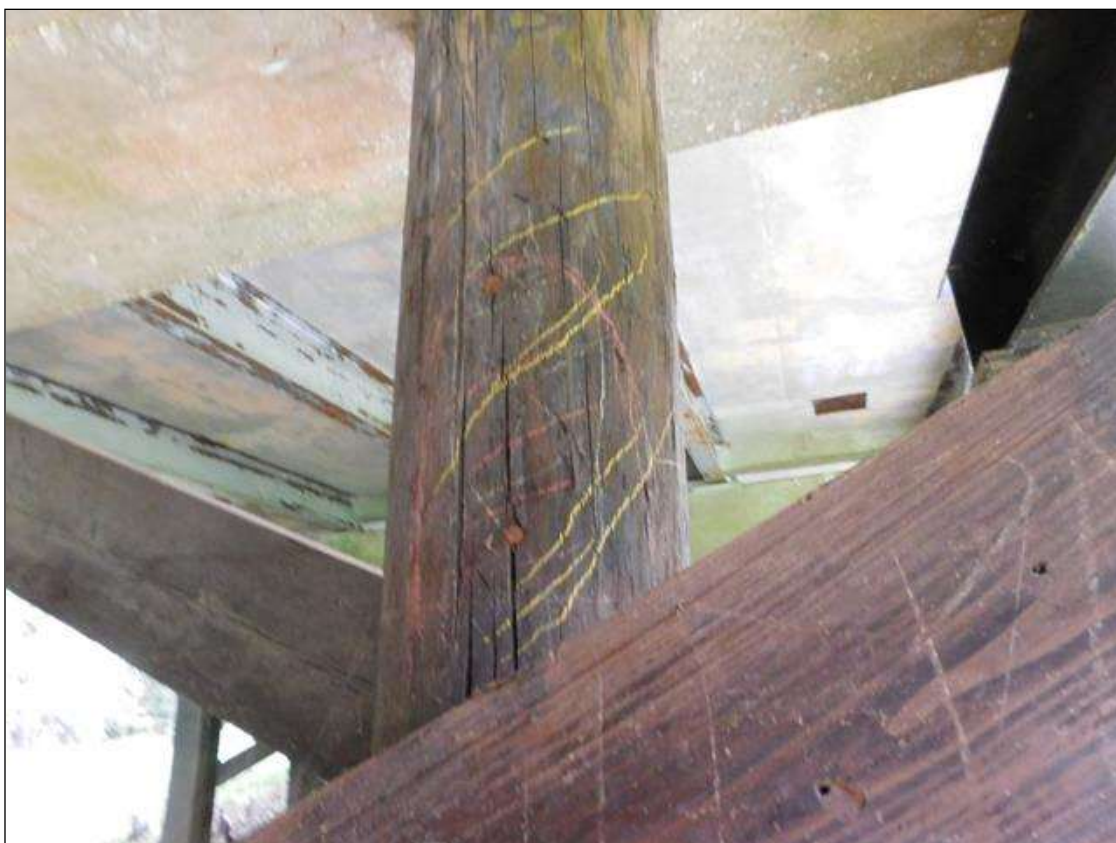
Bent 2 Pile 7: 5' HIGH x 1/2 CIRCUMFERENCE OF DELAMINATION WITH HOLLOW SOUND IN EAST FACE FROM TOP DOWN. "PAR" ISSUED

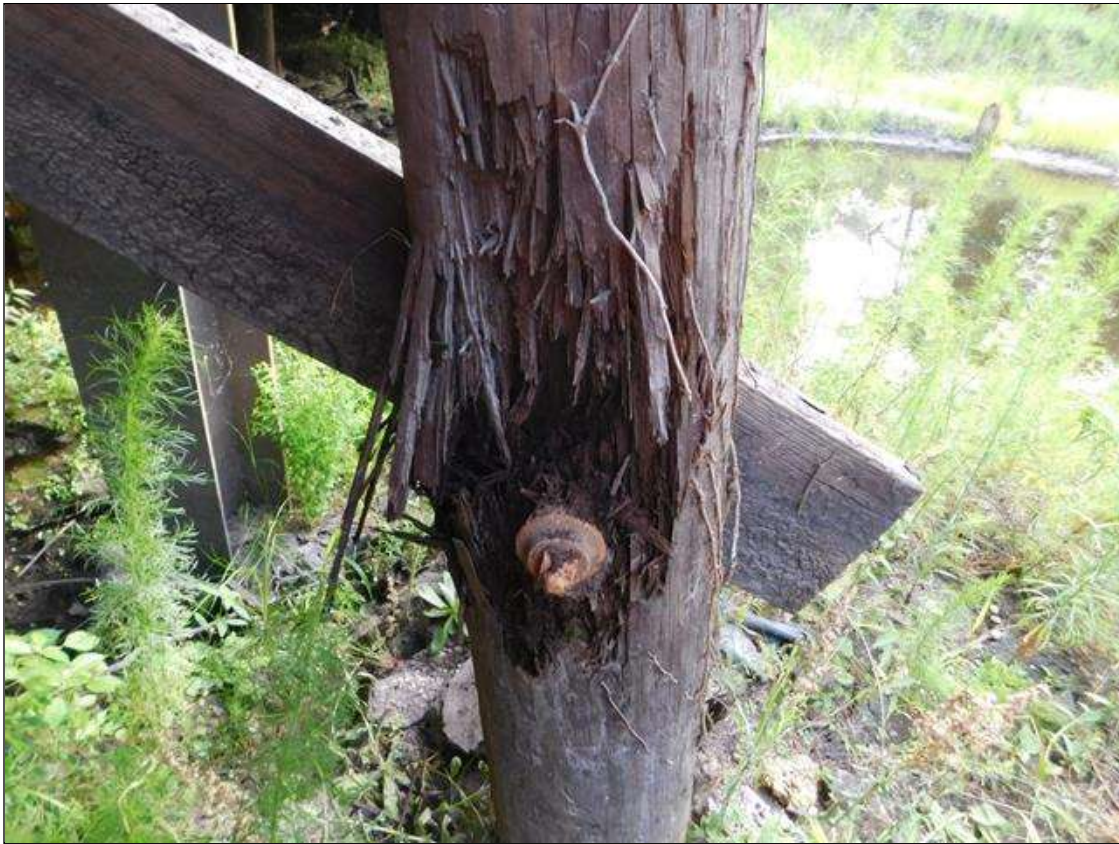
Bent 2 Pile 9: 2' TALL x 1/2 CIRCUMFERENCE x 3" DEEP AREA OF HEAVY DECAY ON SOUTH FACE AT LOWER CROSS-BRACE. "PAR"
