NC DEPARTMENT OF TRANSPORTATION
 DIVISION OF HIGHWAYS
 STRUCTURE MANAGEMENT UNIT

ATTENTION: **LADDER USED FOR INSPECTION / "PAR"s ISSUED**

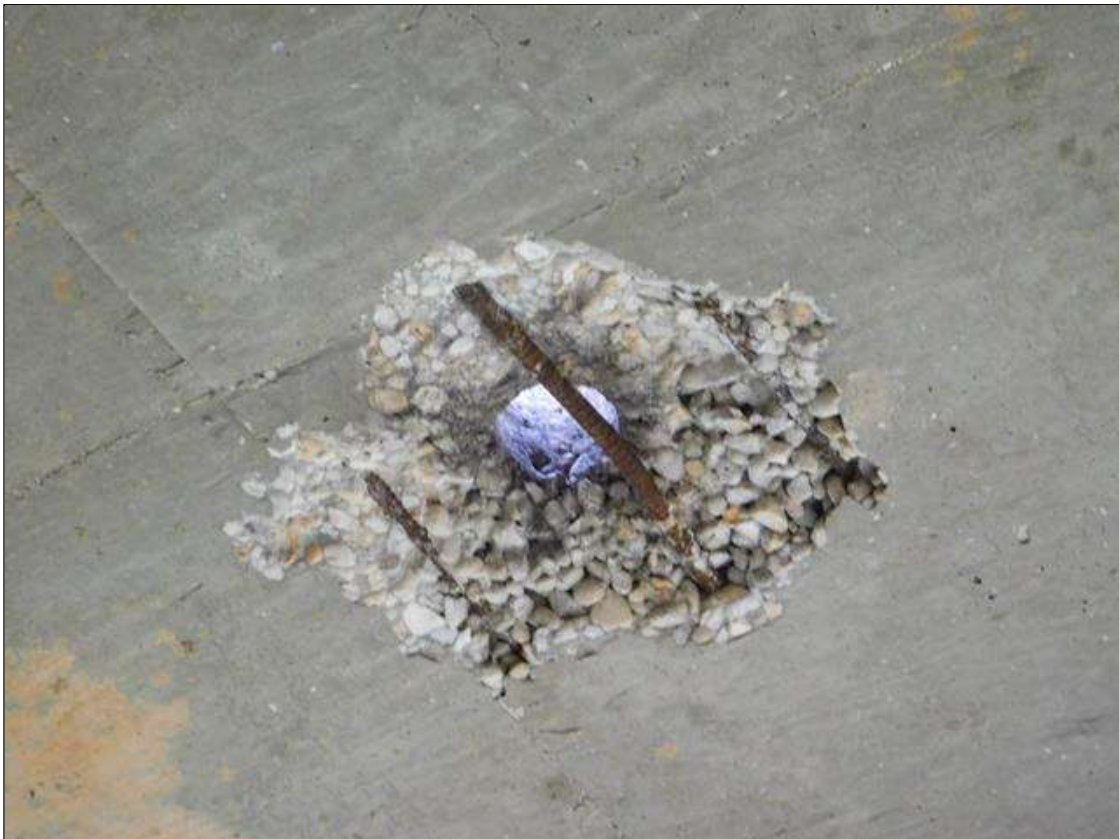
Span 2 Deck: 2' DIAMETER x UP TO 3" DEEP SPALL WITH (3) REBAR EXPOSED. BOTTOM OF DECK BAY 4 AT MID-SPAN. "PAR"

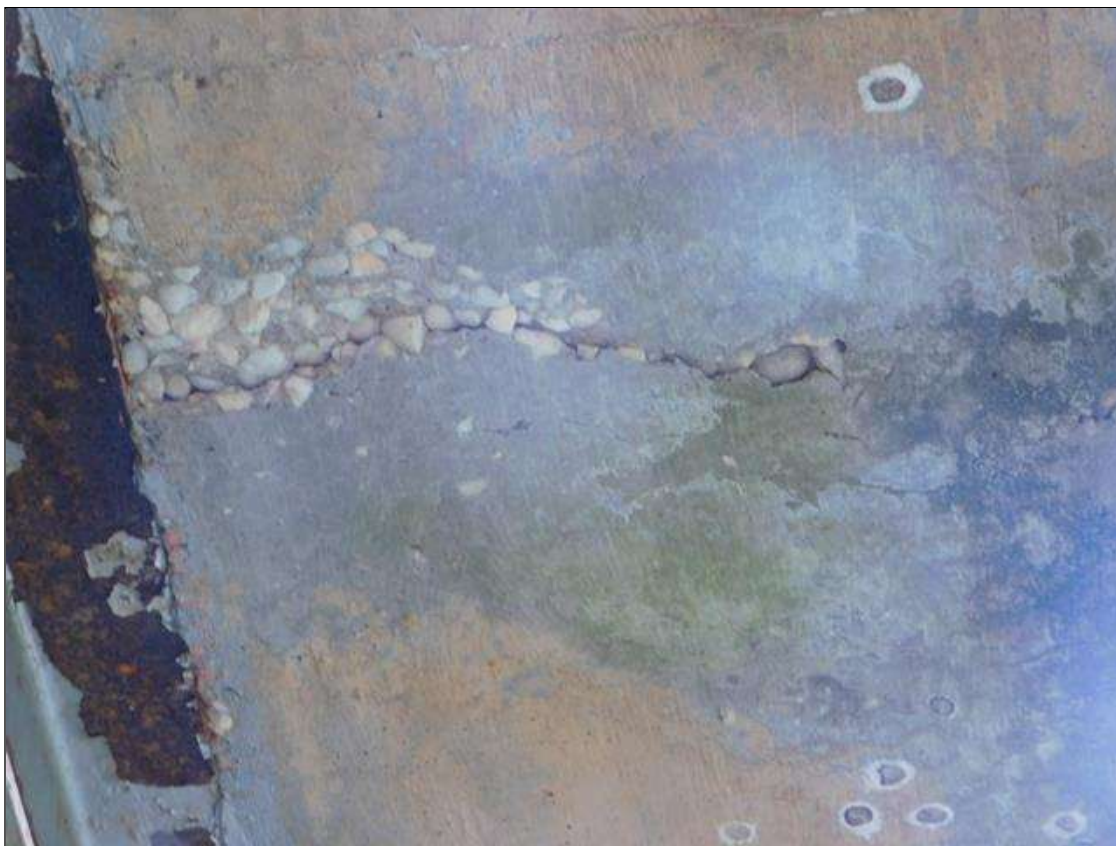
Span 2 Deck: 3' WIDE x 18" LONG CRACKED AND DELAMINATED AREA IN BOTTOM OF RIGHT OVERHANG. 5' FROM BENT 2

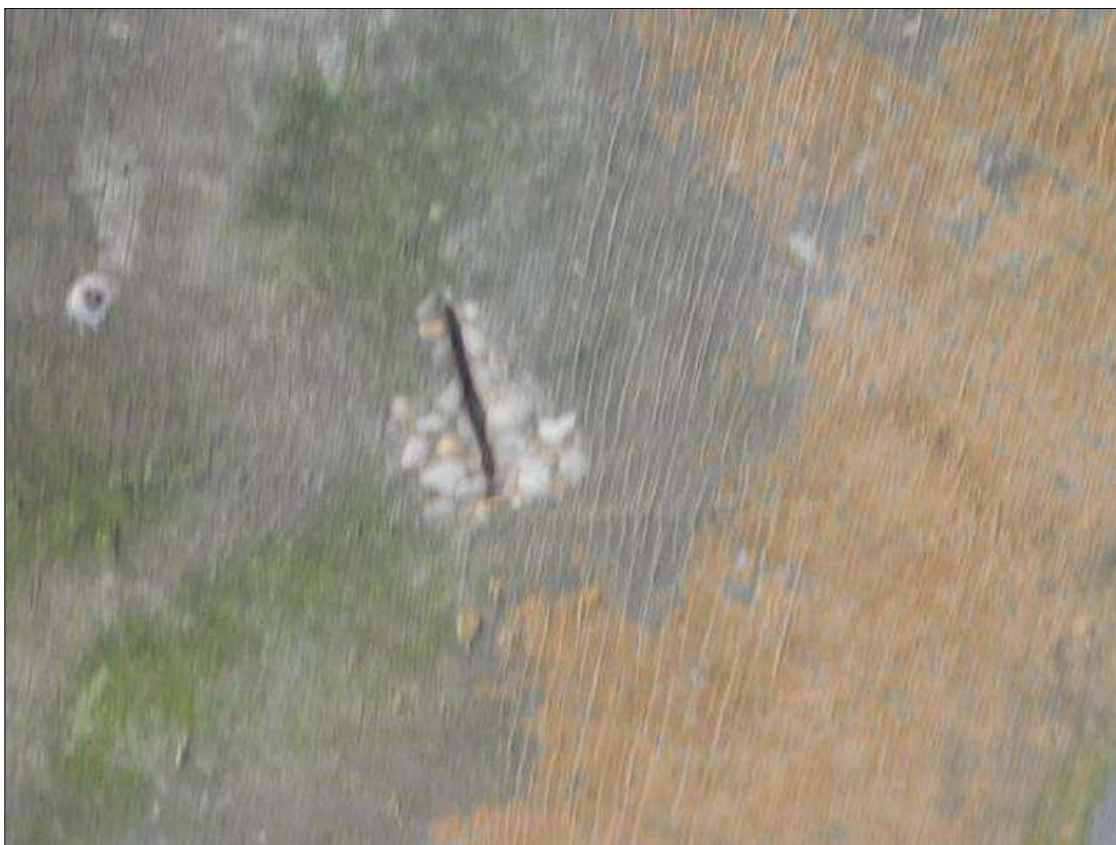
Span 2 Deck: 6" x 3" x 1/4" DEEP SPALL WITH REBAR VISIBLE IN BOTTOM OF LEFT OVERHANG. 6' FROM BENT

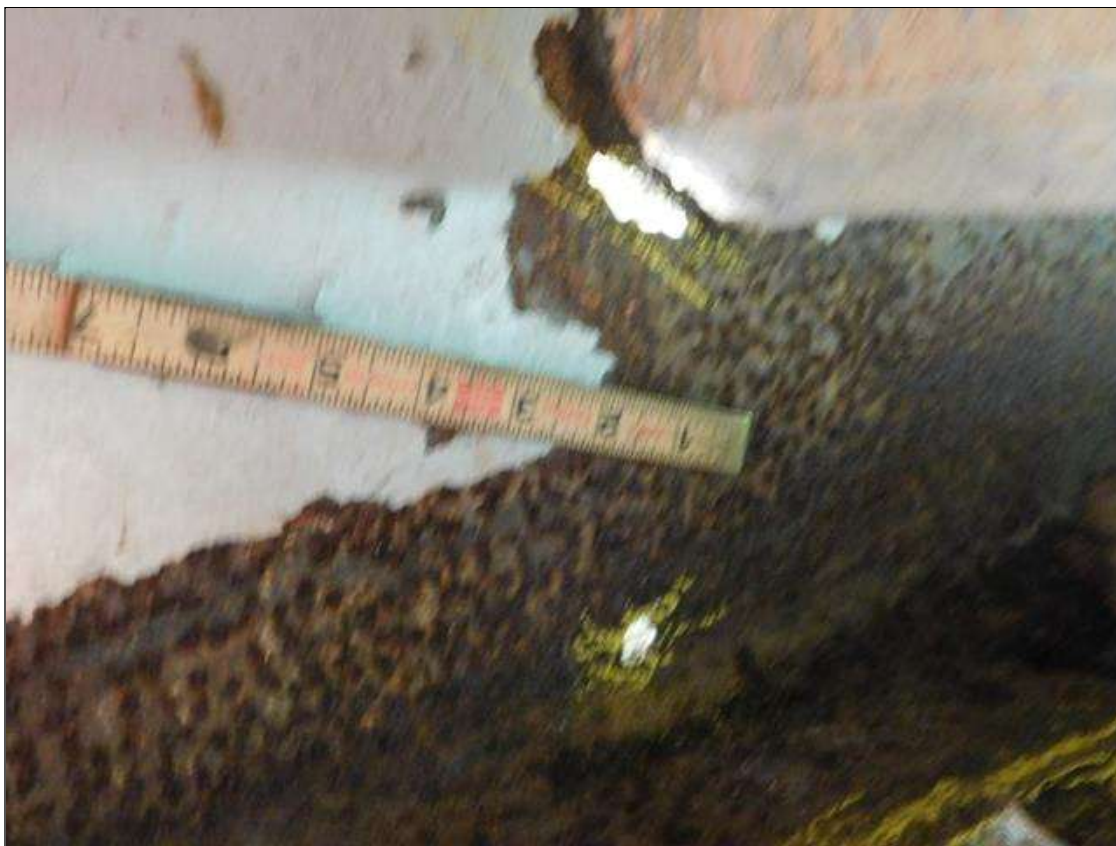
Span 1 Beam 1: WEB OVER BENT 2 HAS (2) AREAS OF 100% SECTION LOSS UP TO 1 1/2" x 1". "PAR" ISSUED

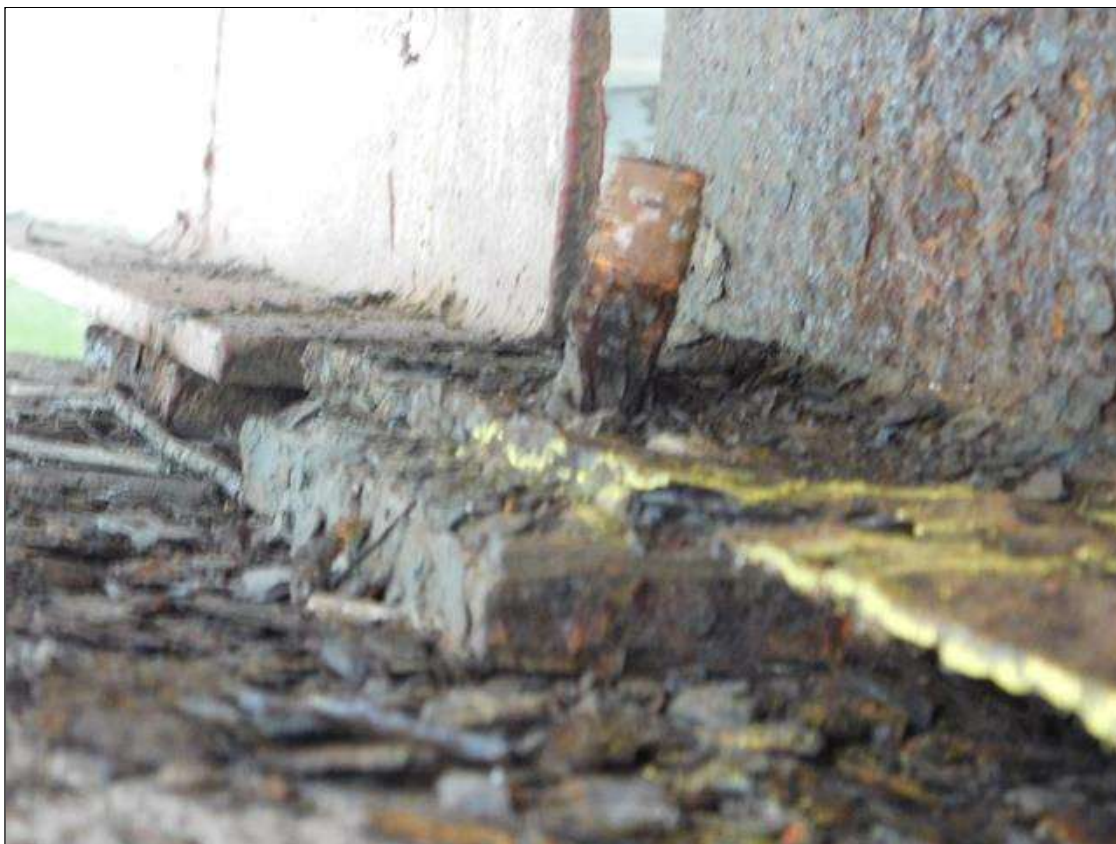
Span 1 Beam 1 - Far Bearing: SECTION LOSS WITH 3/4" REMAINING THRU-OUT BEARING AND LEFT ANCHOR BOLT NUT MISSING. "PAR" ISSUED

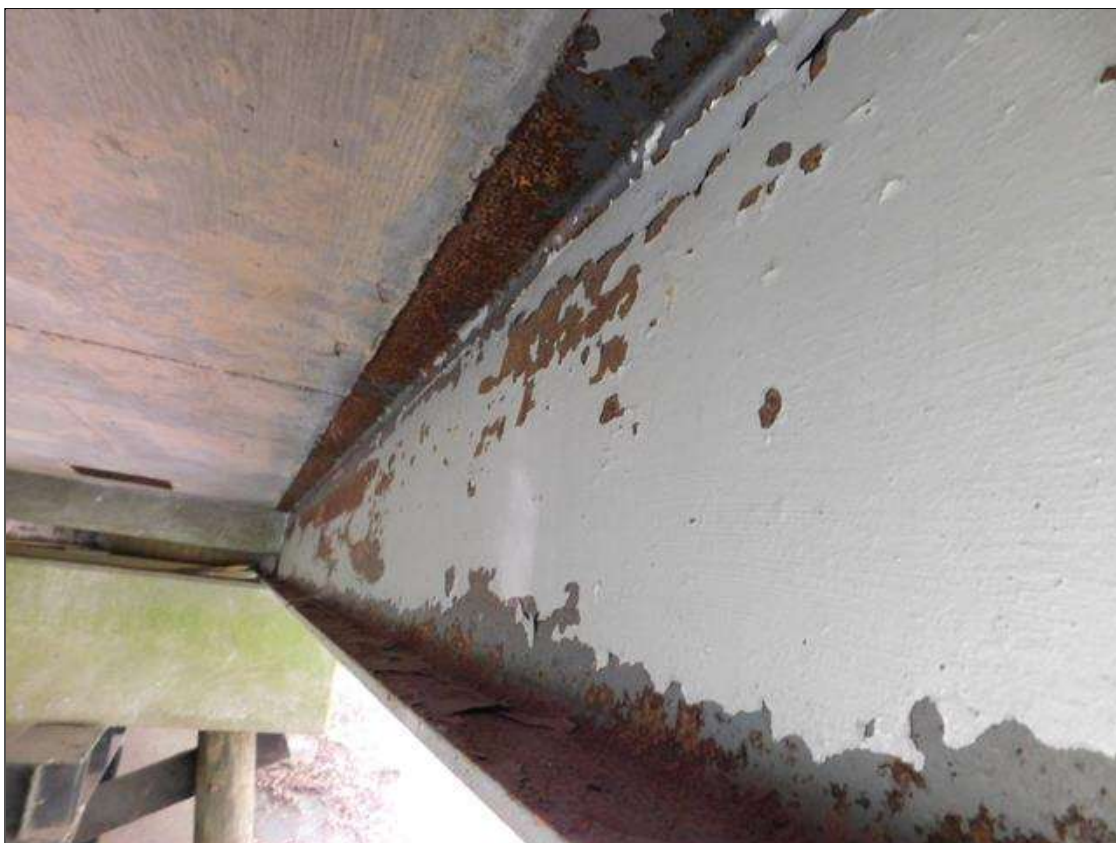
Span 1 Beam 1: SCATTERED AREAS OF RUST AND FLAKING IN BOTH FLANGES AND WEB

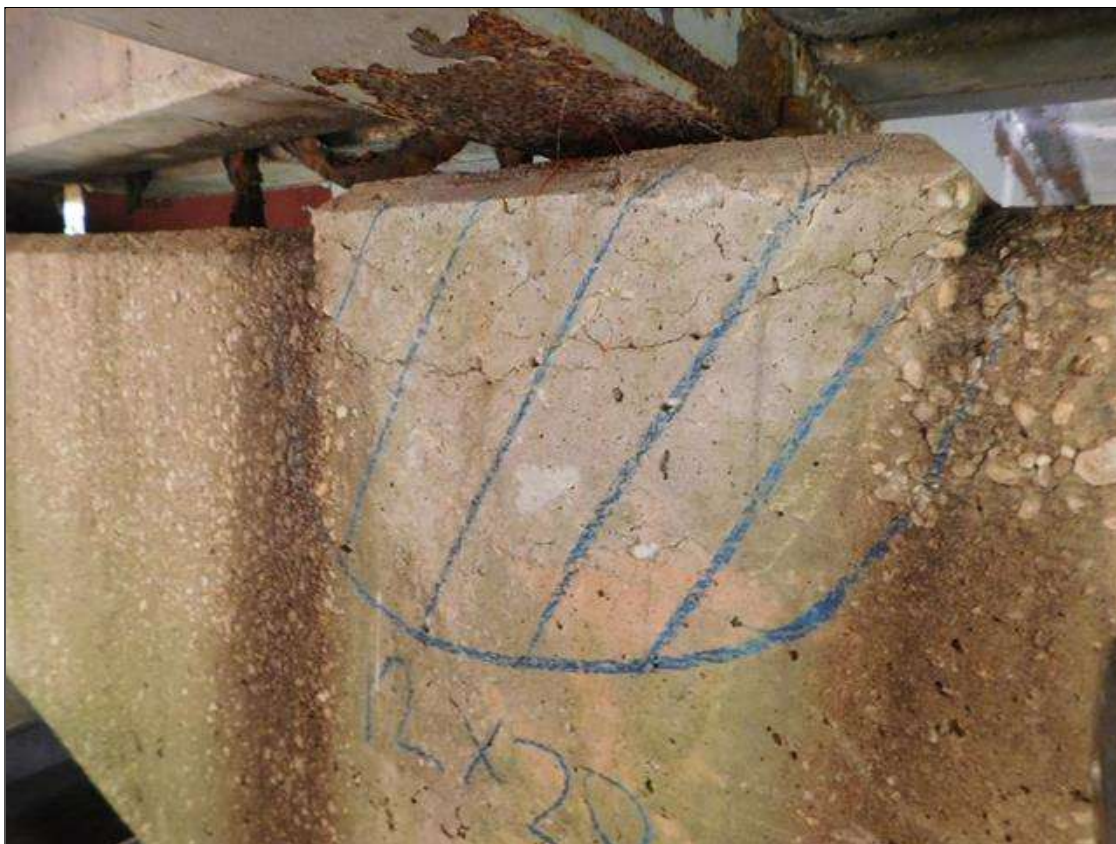
Bent 2 Cap 1: SOUTH FACE UNDER BEAM 2 HAS A 12" x 20" AREA THAT IS CRACKED AND DELAMINATED.
SIMILAR AREA SOUTH FACE UNDER BEAM 3

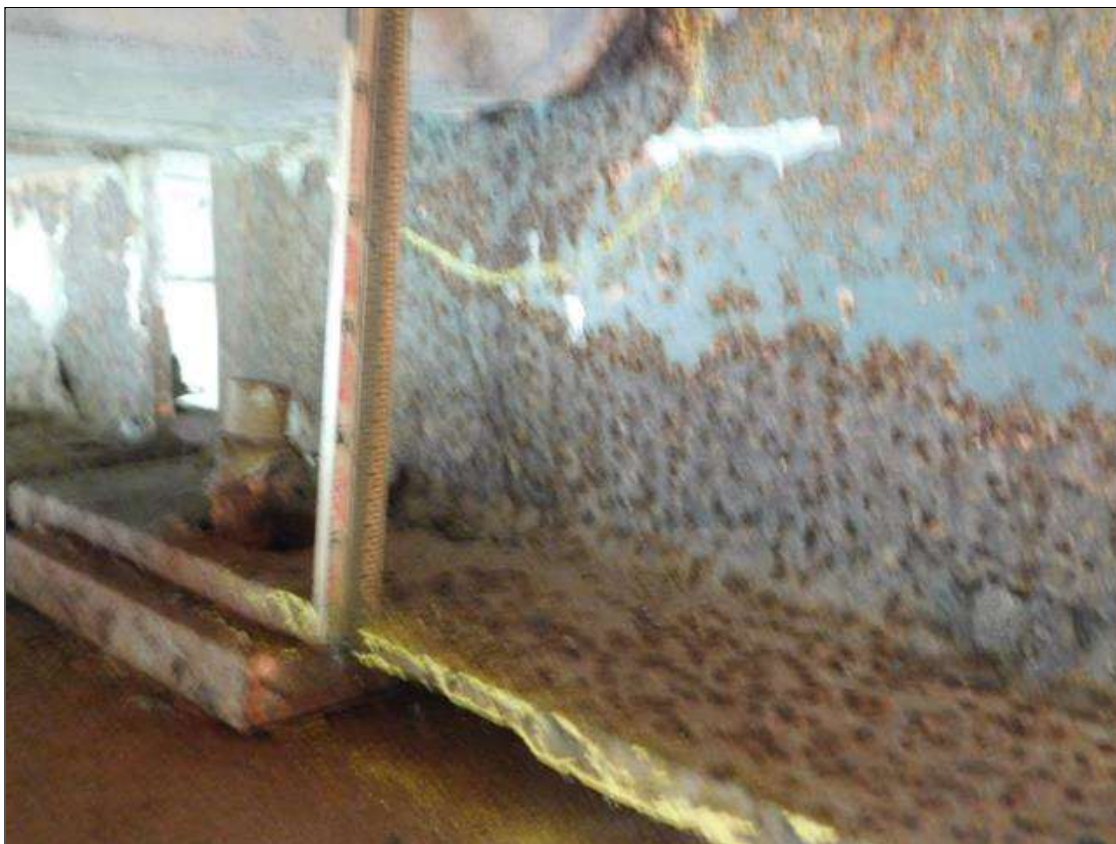
Span 1 Beam 2: BOTTOM FLANGE AND WEB OVER BENT 2 HAS AREAS OF SECTION LOSS. WEB AREA IS: 6" LONG x 1" TALL WITH 1/4" REMAINING. BOTTOM FLANGE AREA IS: 12" LONG x FULL WIDTH WITH DOWN TO 1/4" REMAINING. "PAR"

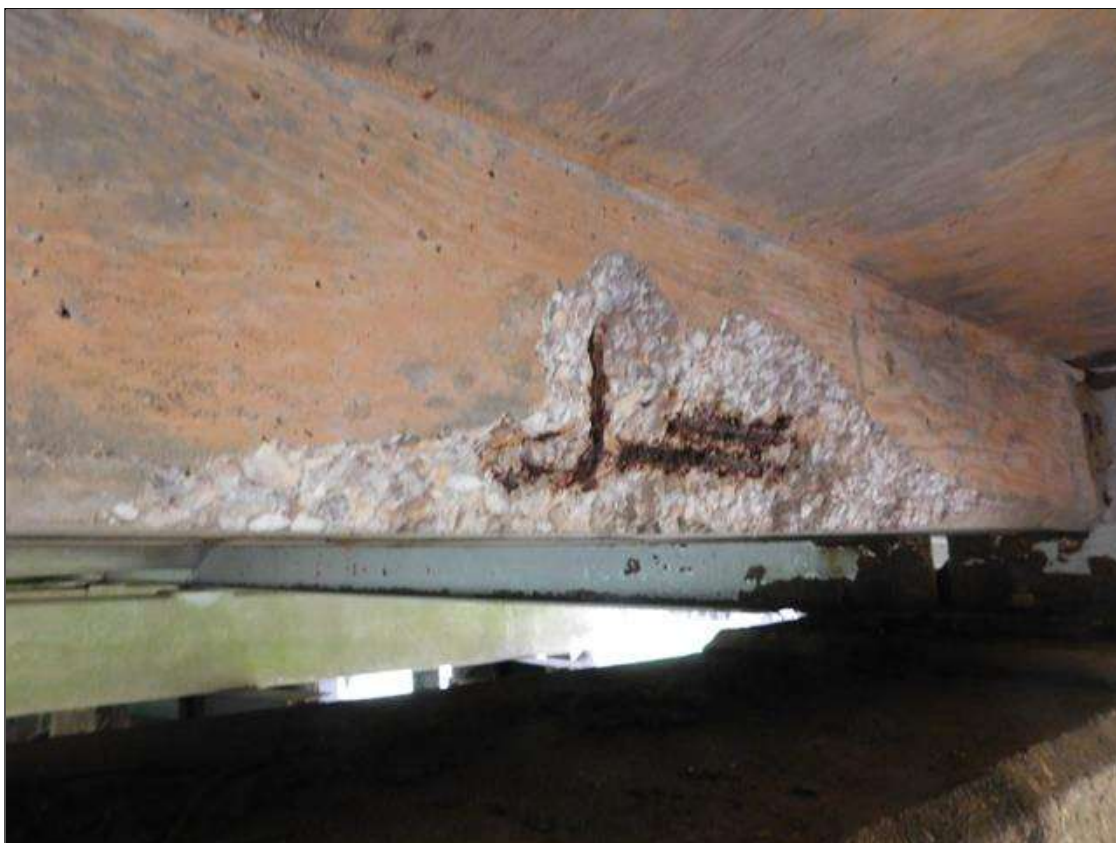
END DIAPHRAGM OVER BENT 2 IN BAY 2. HAS A 34" LONG x 8" HIGH x 2" DEEP SPALL WITH REBAR EXPOSED

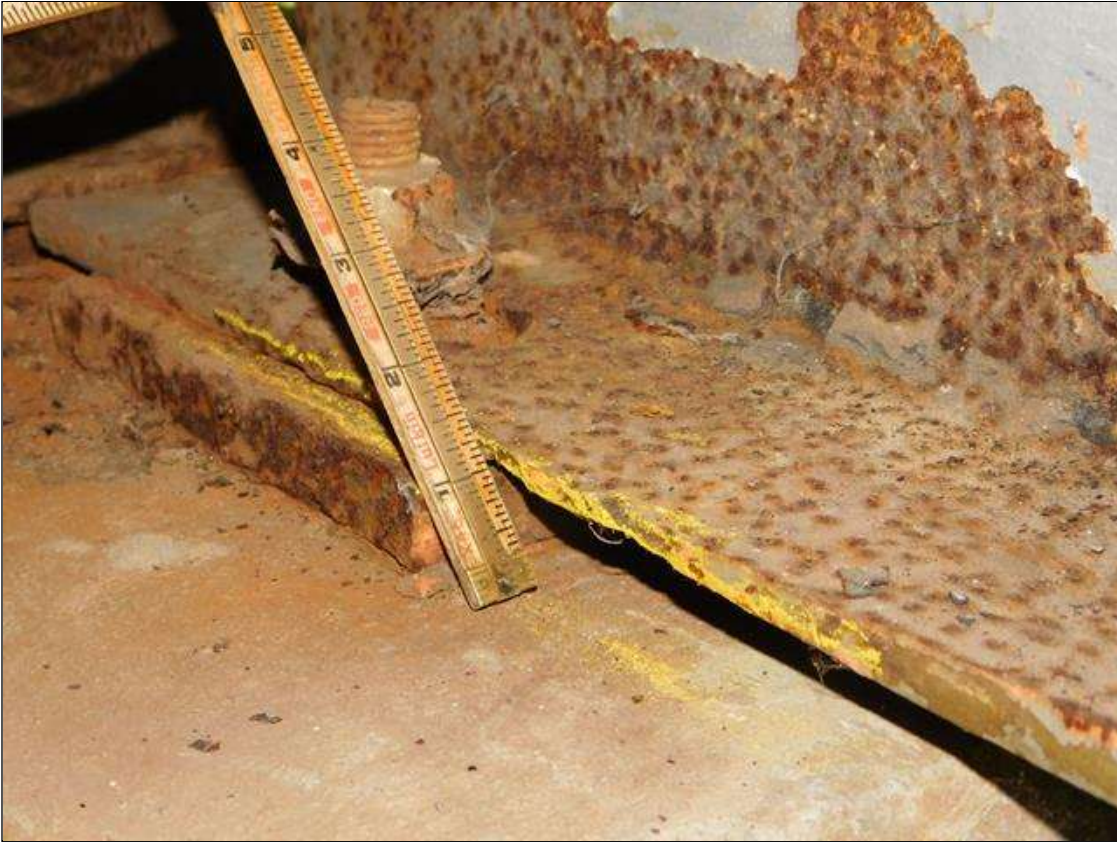
Span 1 Beam 3: BOTTOM FLANGE OVER BENT 2 HAS A AREA OF SECTION LOSS WITH DOWN TO 1/4" REMAINING. AREA IS: 10" LONG x FULL WIDTH. "PAR"

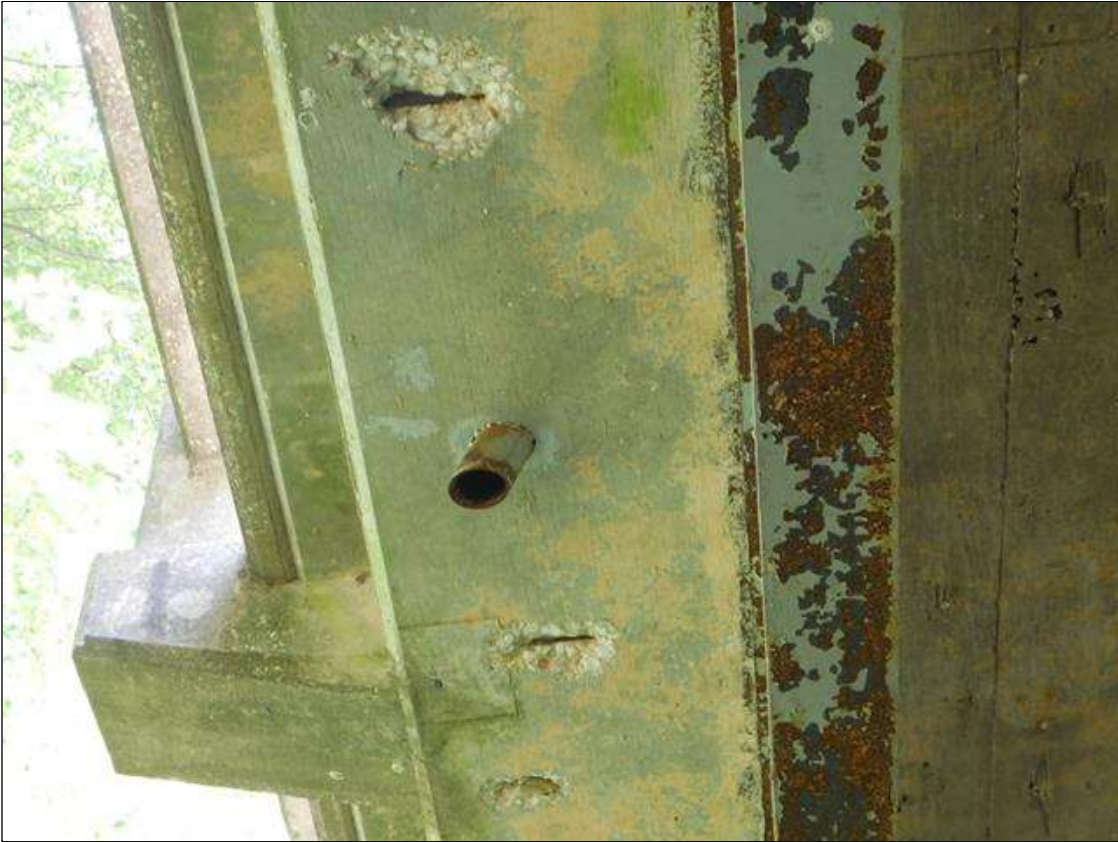
Span 3 Deck: (3) SPALLED AREAS WITH REBAR VISIBLE IN SCATTERED LOCATIONS. BOTTOM OF LEFT OVERHANG. AREAS AREA UP TO: 10" DIAMETER x 2" DEEP

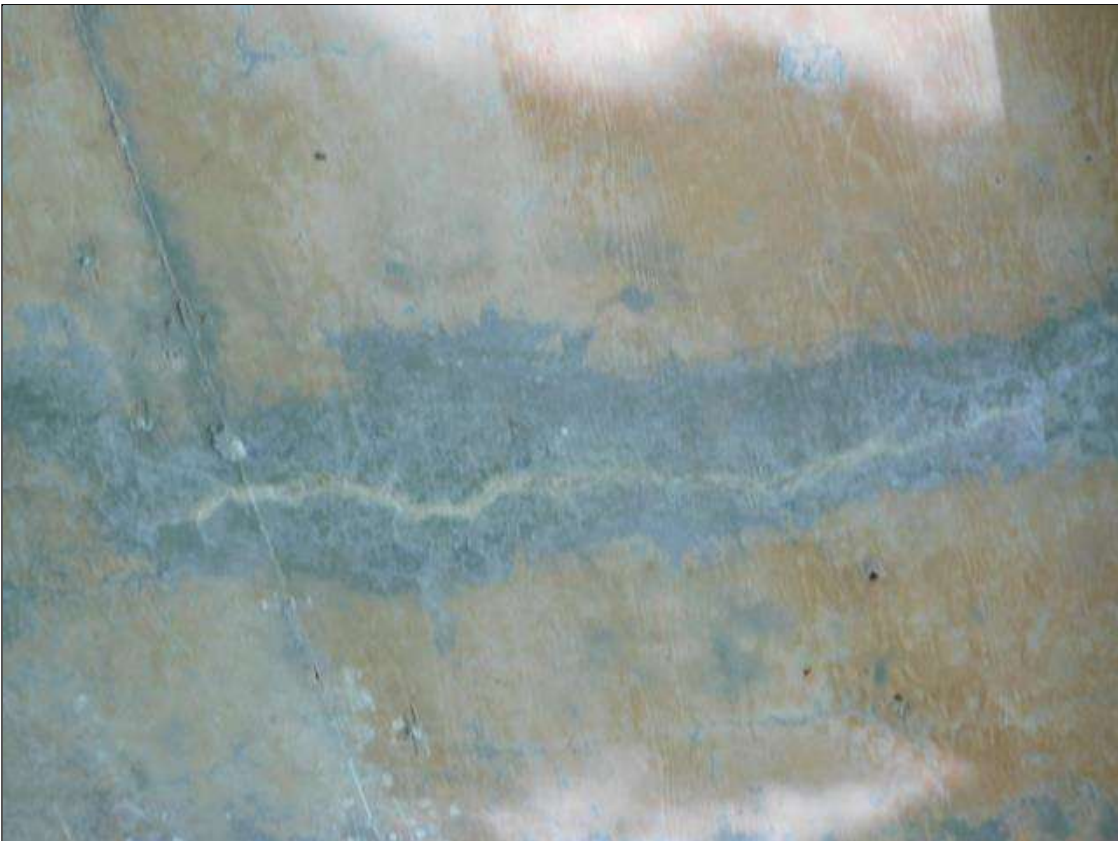
Span 3 Deck: SCATTERED HAIRLINE TRANSVERSE CRACKS UP TO FULL WIDTH WITH SOME EFFLO IN BOTTOM OF DECK

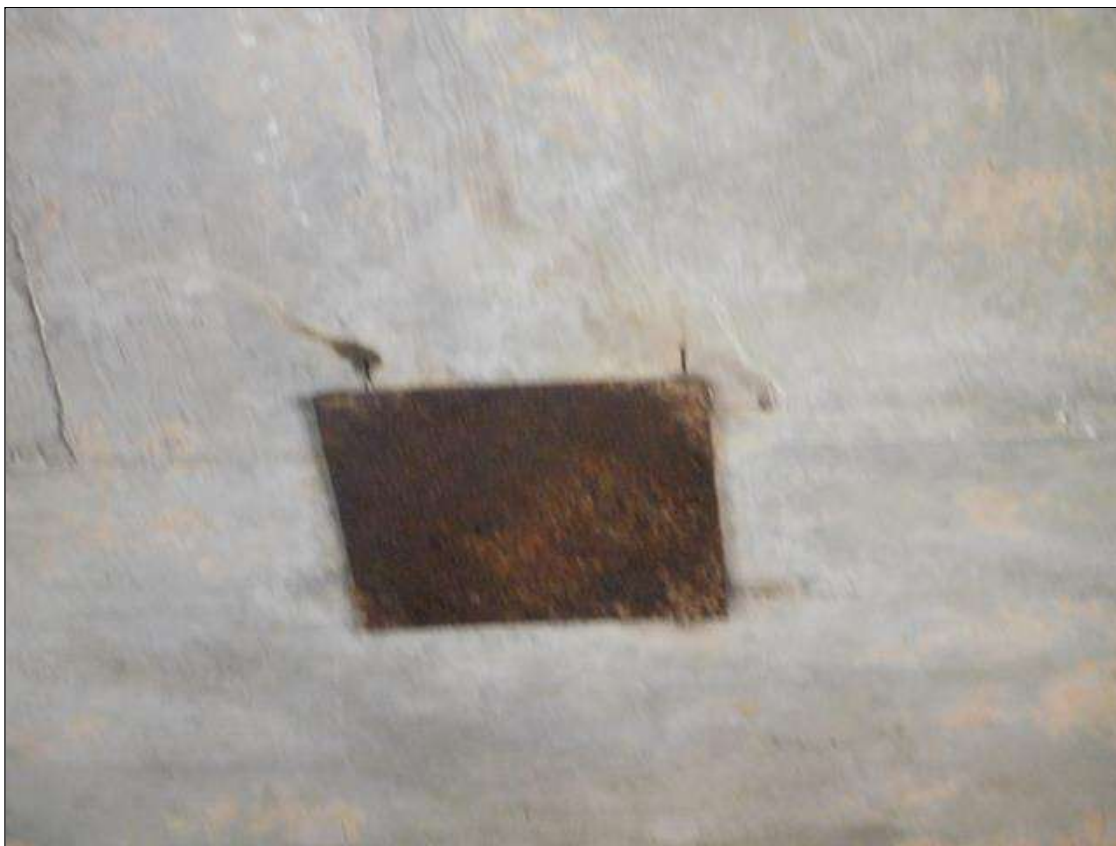
Span 3 Deck: METAL PLATE BOLTED TO BOTTOM OF DECK IN BAYS 1 AND 3 AT BENTS 2 AND 3.

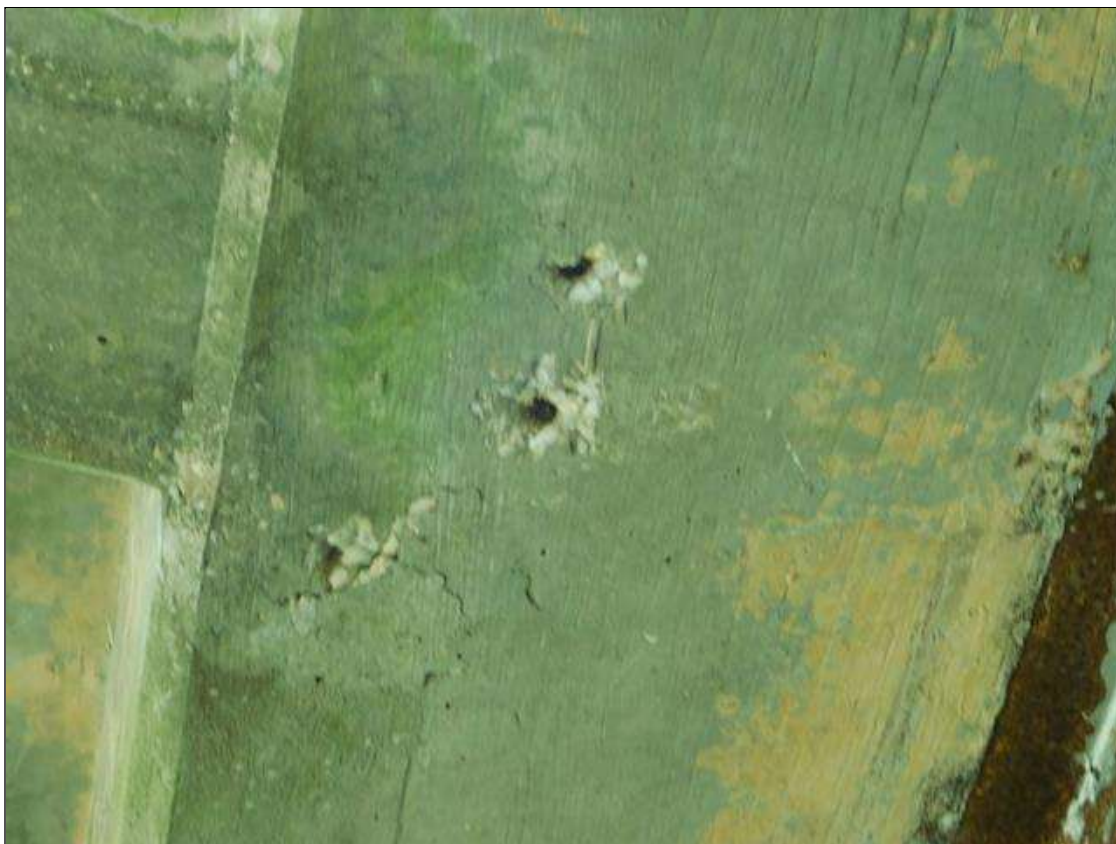
Span 4 Deck: (3) SPALLS UP TO 3" DIAMETER x 1" DEEP WITH REBAR VISIBLE AND ADJACENT 8" DIAMETER AREA OF DELAMINATION IN BOTTOM OF LEFT OVERHANG 4' FROM BENT 3.

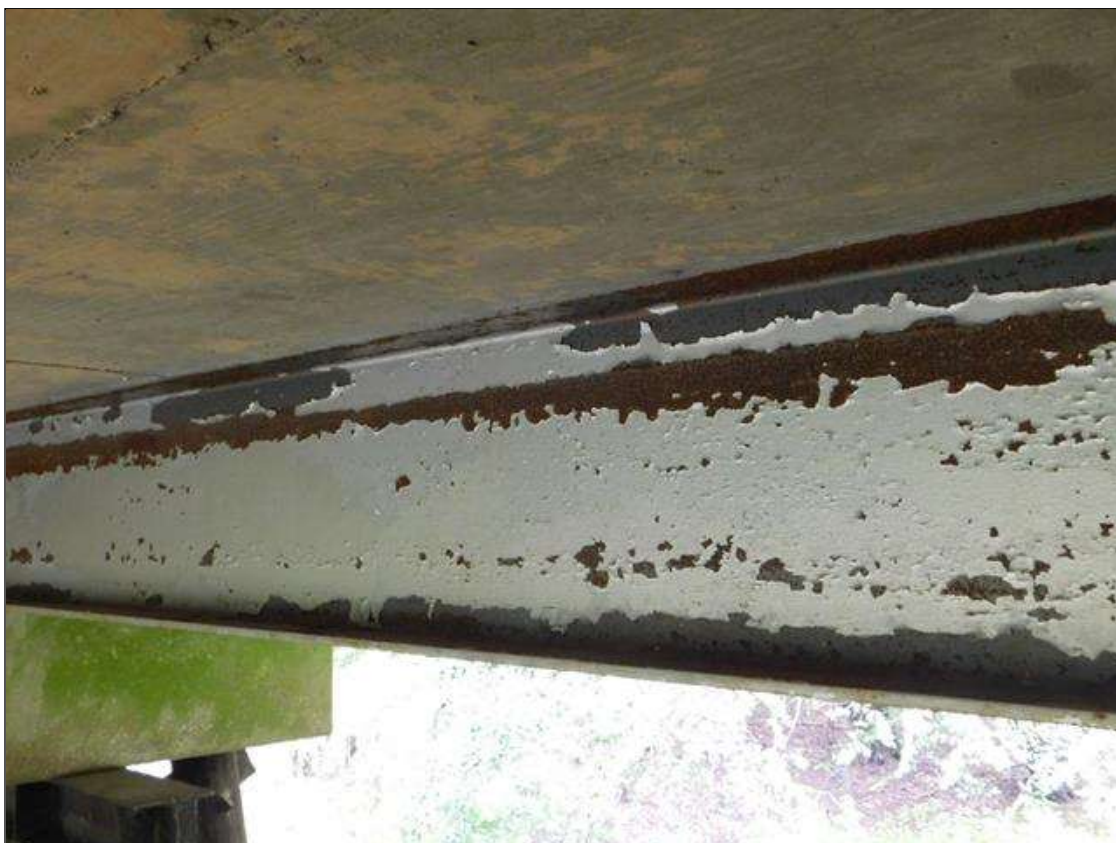
Span 3 Beam 2: SCATTERED AREAS OF RUST AND FLAKING IN BOTH FLANGES AND WEB

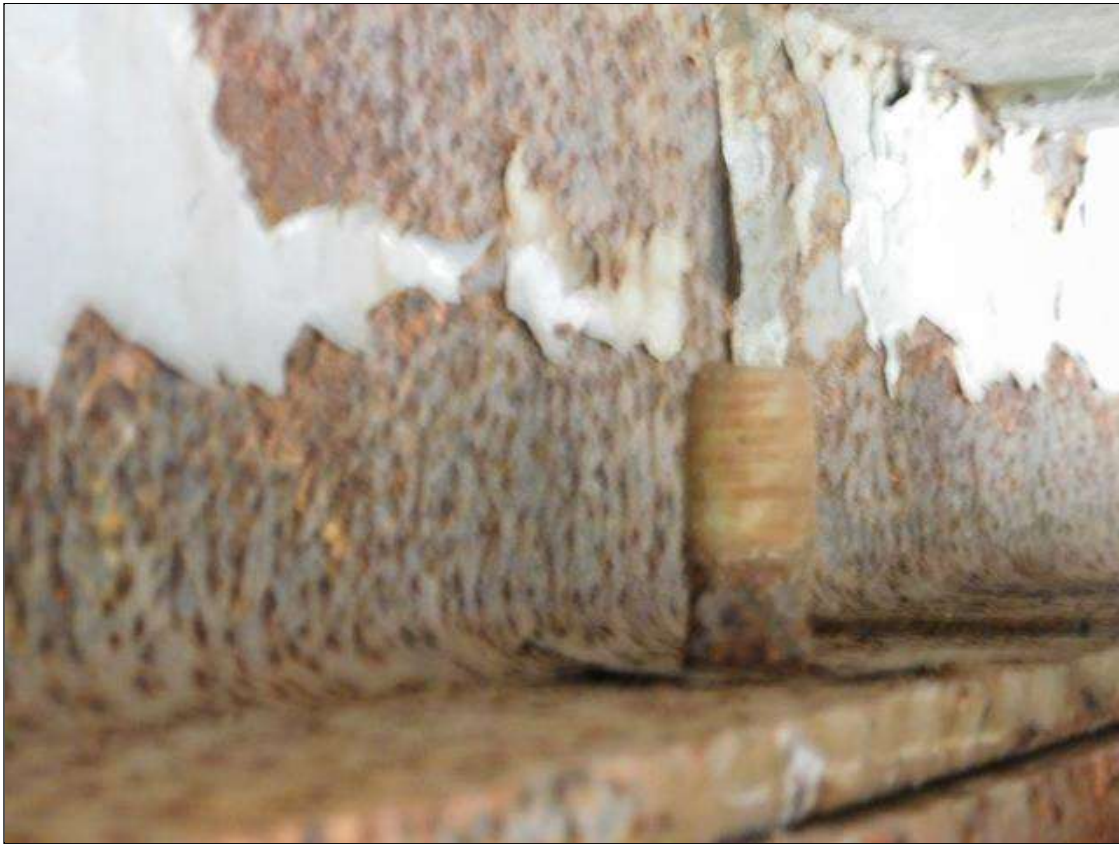
Span 3 Beam 2 - Far Bearing: ANCHOR BOLT NUT MISSING ON BOTH SIDES. "PAR"

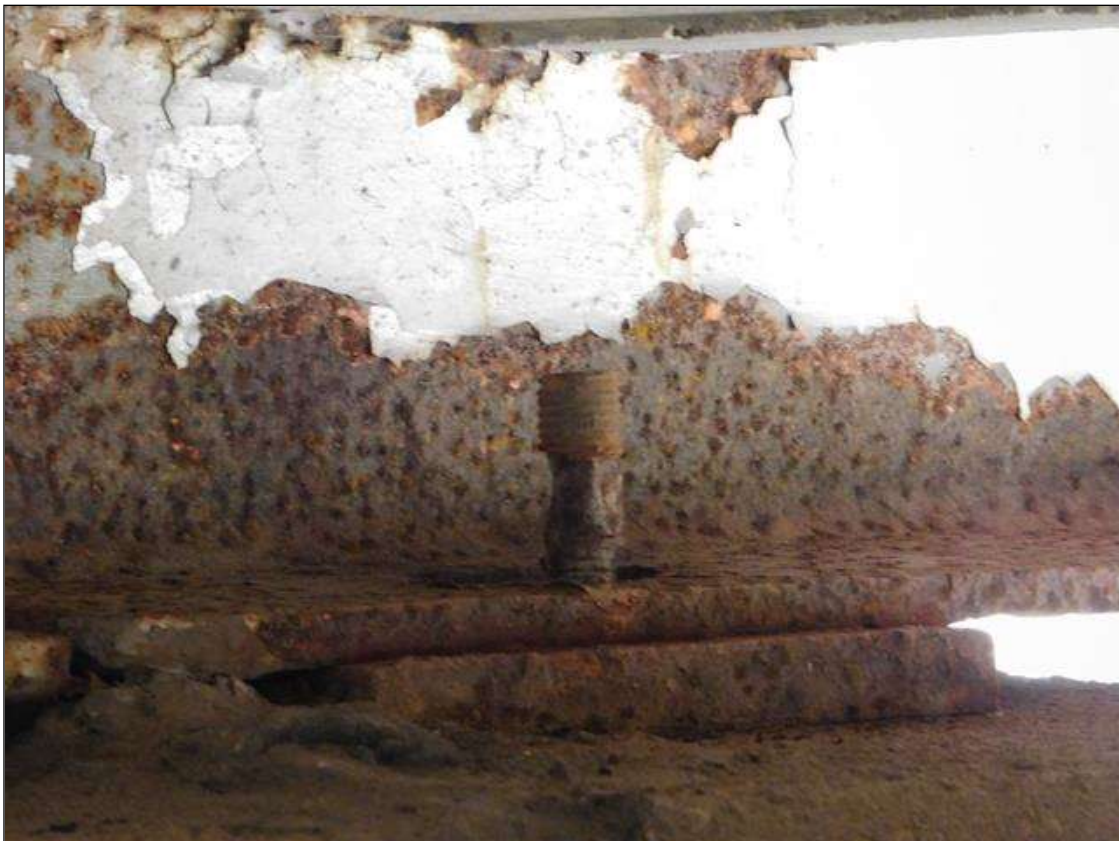
Span 5 Beam 2 - Near Bearing: RIGHT ANCHOR BOLT NUT MISSING. "PAR"

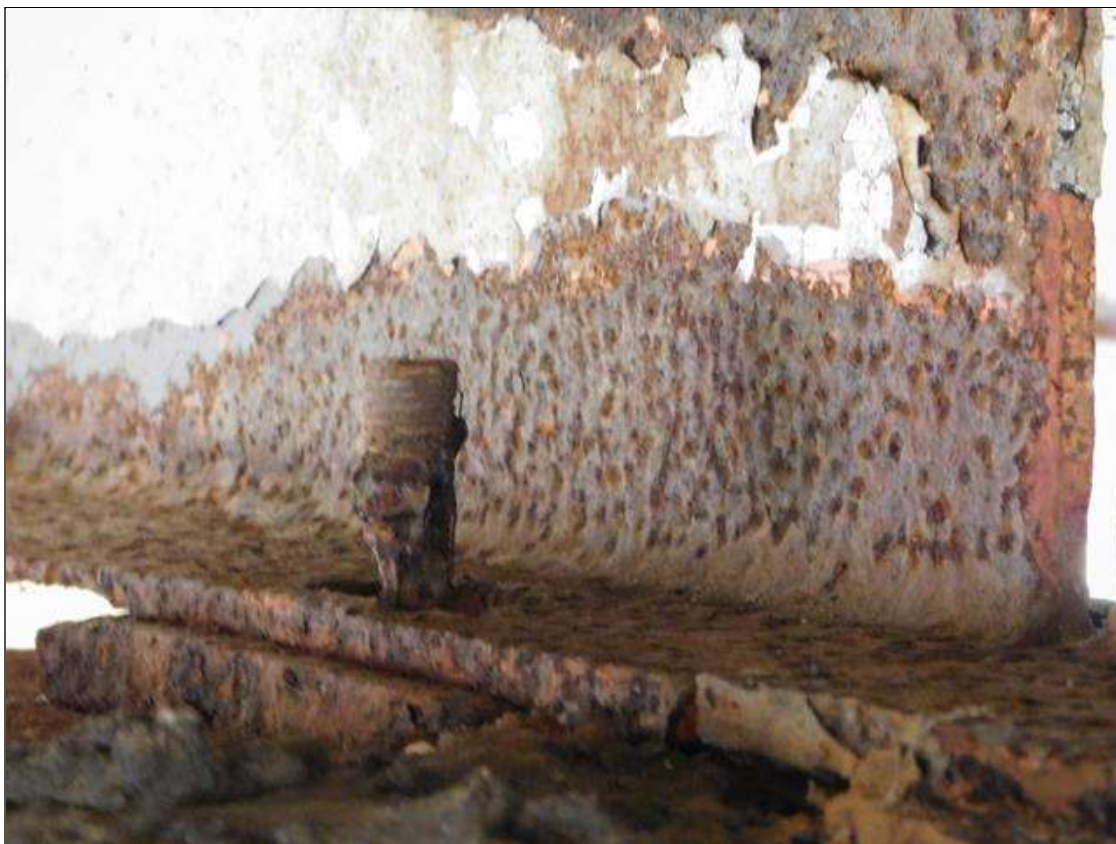
Span 5 Beam 3 - Near Bearing: ANCHOR BOLT NUT MISSING ON BOTH SIDES. "PAR"

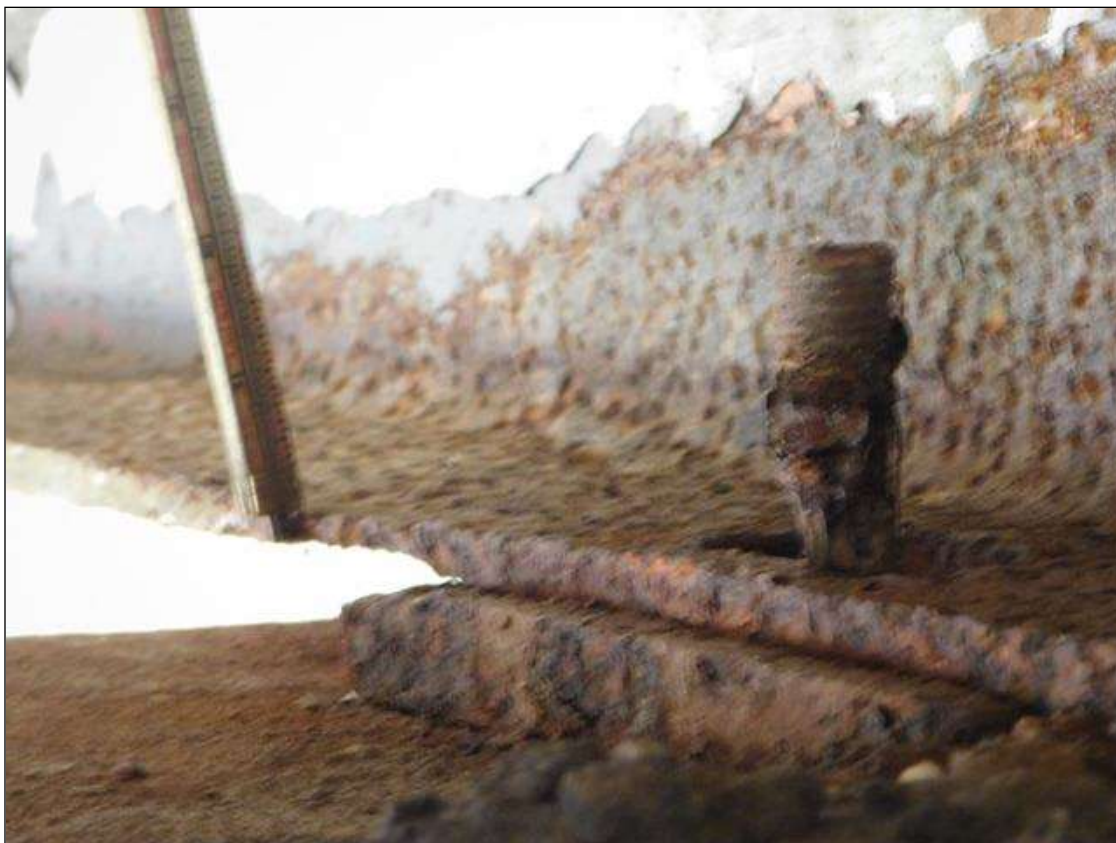
Span 5 Beam 3: BOTTOM FLANGE OVER BENT 4 HAS A AREA OF SECTION LOSS WITH 1/4" REMAINING. AREA IS: 10" LONG x FULL WIDTH. "PAR"

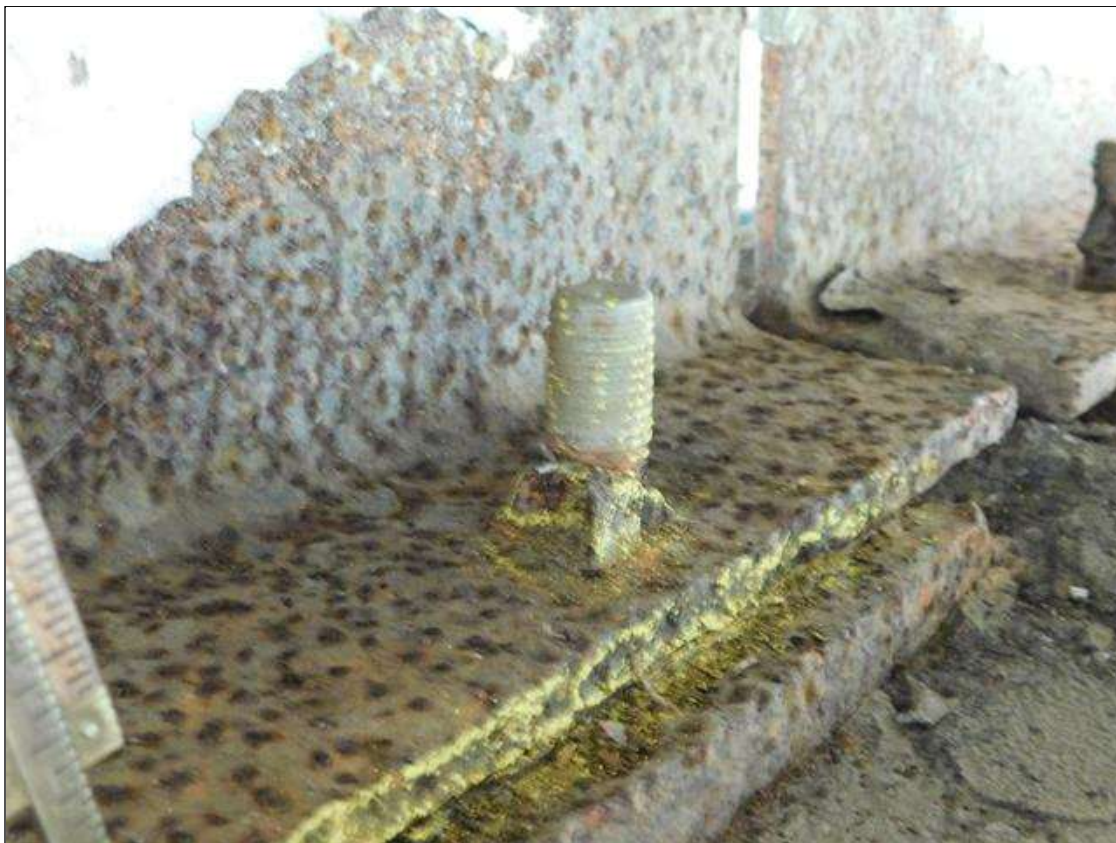
Span 3 Beam 3 - Far Bearing: RIGHT ANCHOR BOLT NUT MISSING. "PAR"

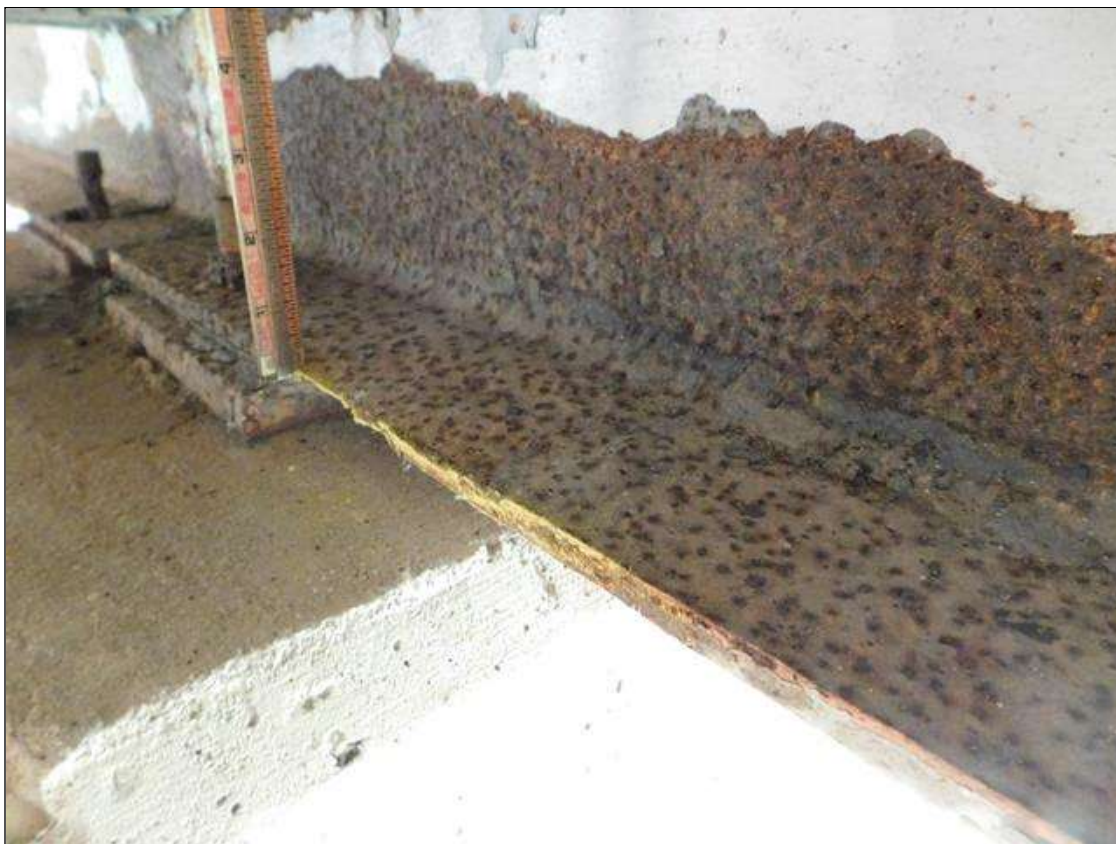
Span 3 Beam 4: BOTTOM FLANGE OVER BENT 4 HAS A AREA OF SECTION LOSS WITH 1/8" REMAINING. AREA IS: 10" LONG x FULL WIDTH. "PAR"

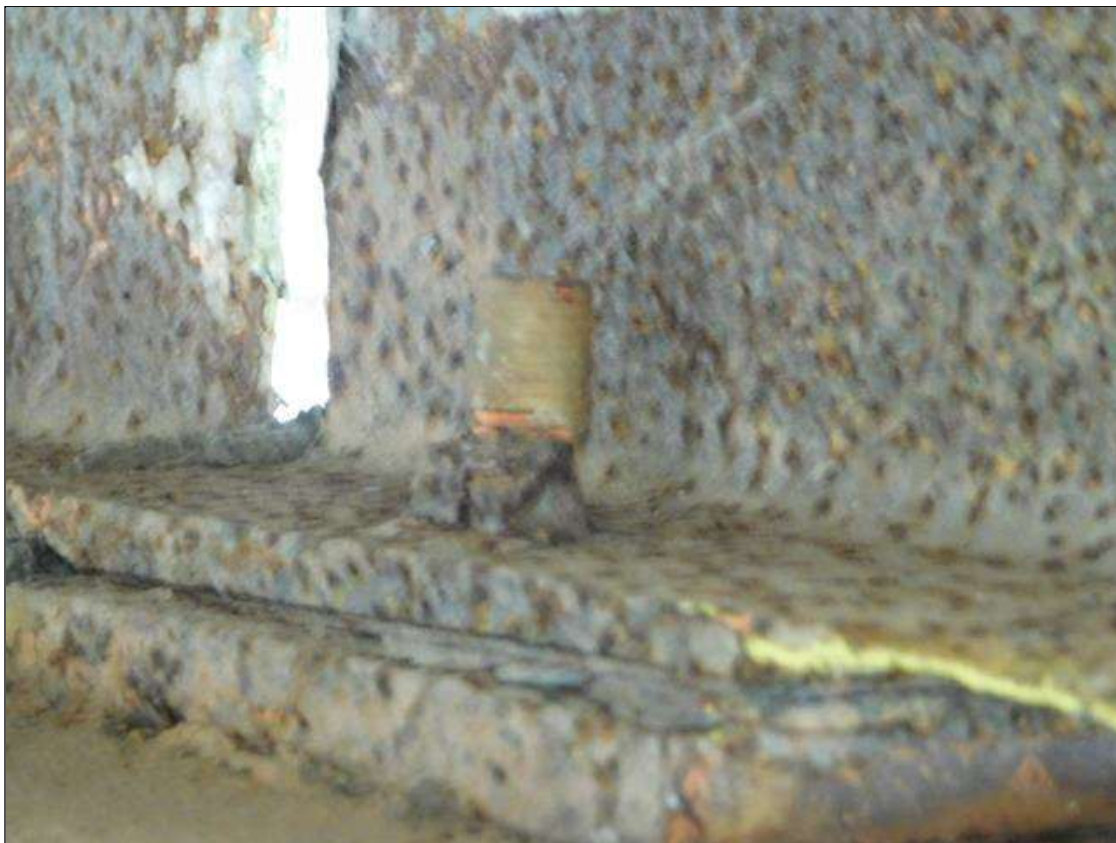
Span 3 Beam 4 - Far Bearing: LEFT ANCHOR BOLT NUT MISSING. "PAR"

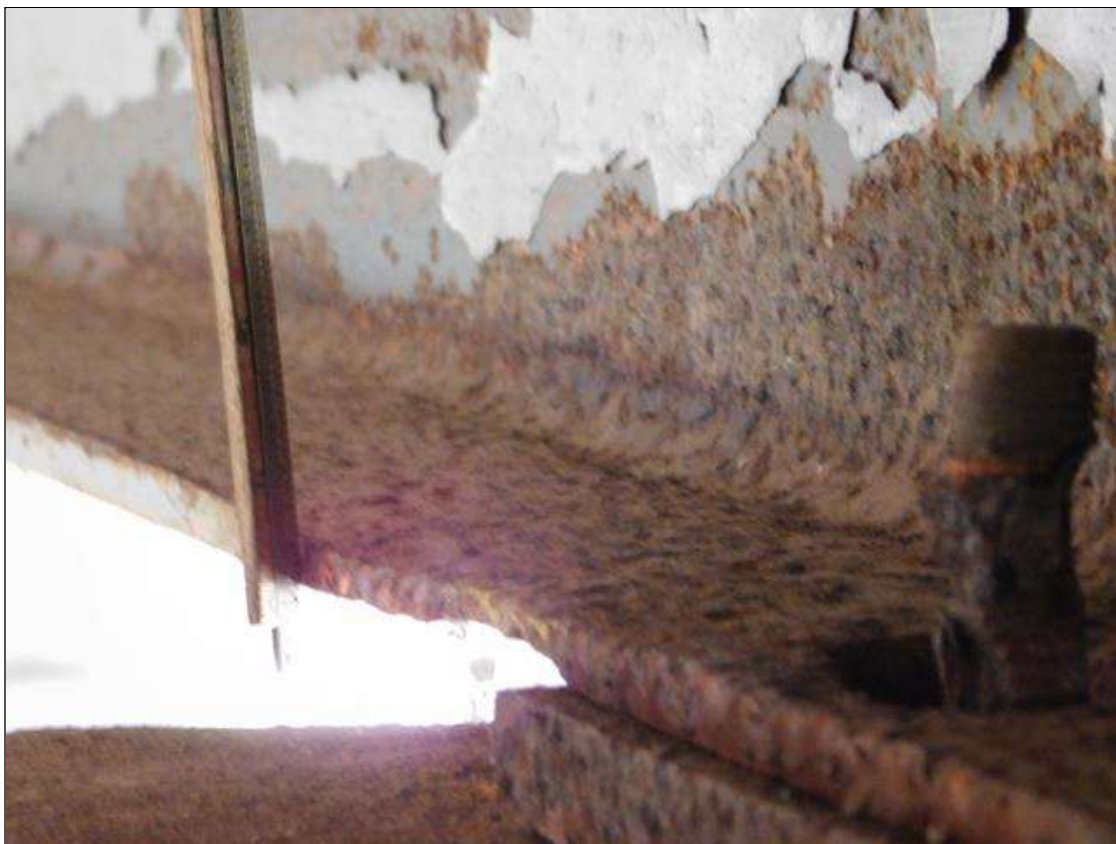
Span 5 Beam 4: BOTTOM FLANGE OVER BENT 4 HAS A AREA OF SECTION LOSS WITH DOWN TO 1/8" REMAINING. AREA IS UP TO 20" LONG x FULL WIDTH. "PAR"

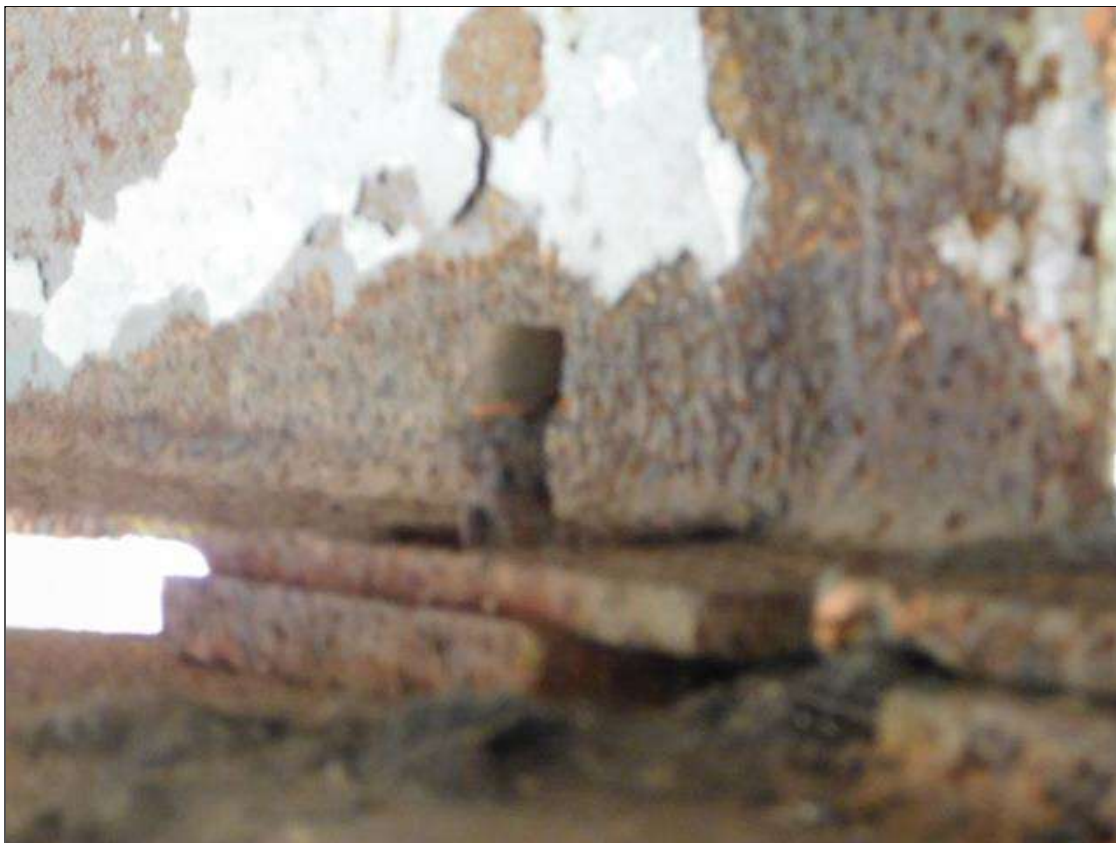
Span 5 Beam 4 - Near Bearing: BOTH ANCHOR BOLT NUTS MISSING. "PAR"
