NC DEPARTMENT OF TRANSPORTATION
 DIVISION OF HIGHWAYS
 STRUCTURE MANAGEMENT UNIT

ATTENTION: **LADDER USED FOR INSPECTION / "PAR"s ISSUED**

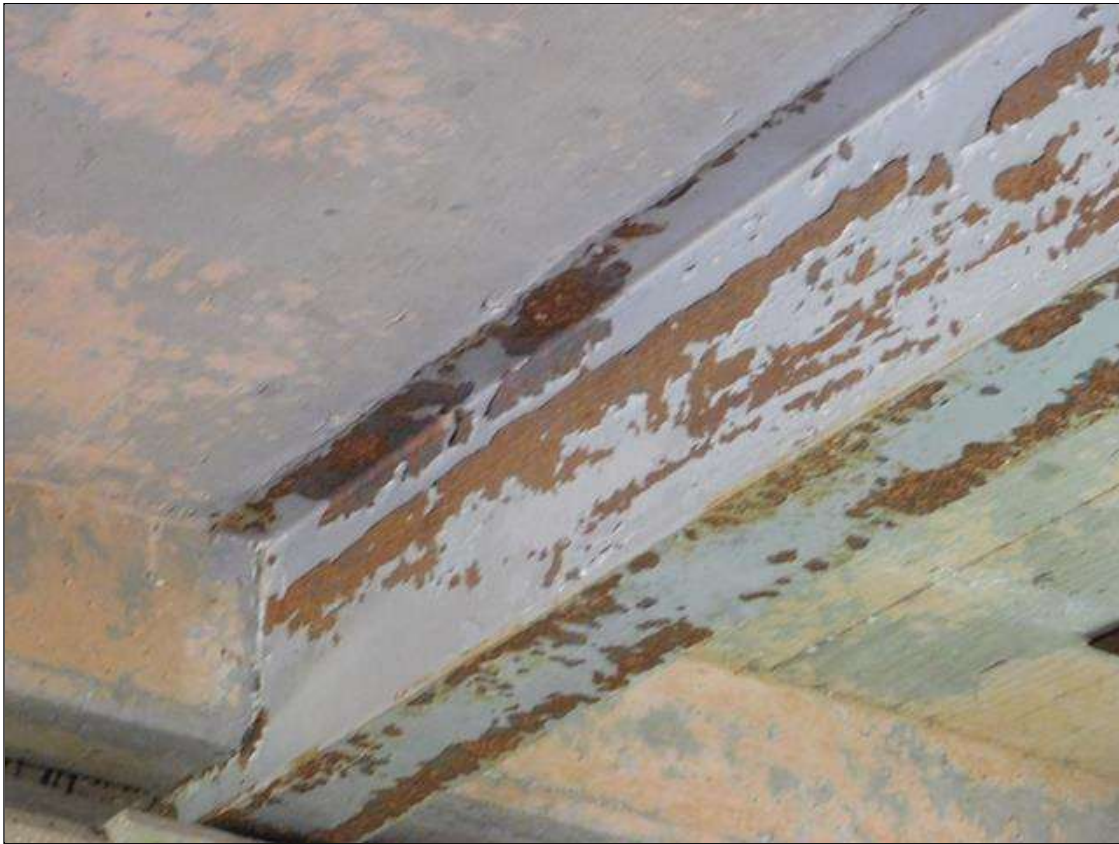
Span 5 Beam 2: SCATTERED AREAS OF RUST AND FLAKING IN BOTH FLANGES AND WEB

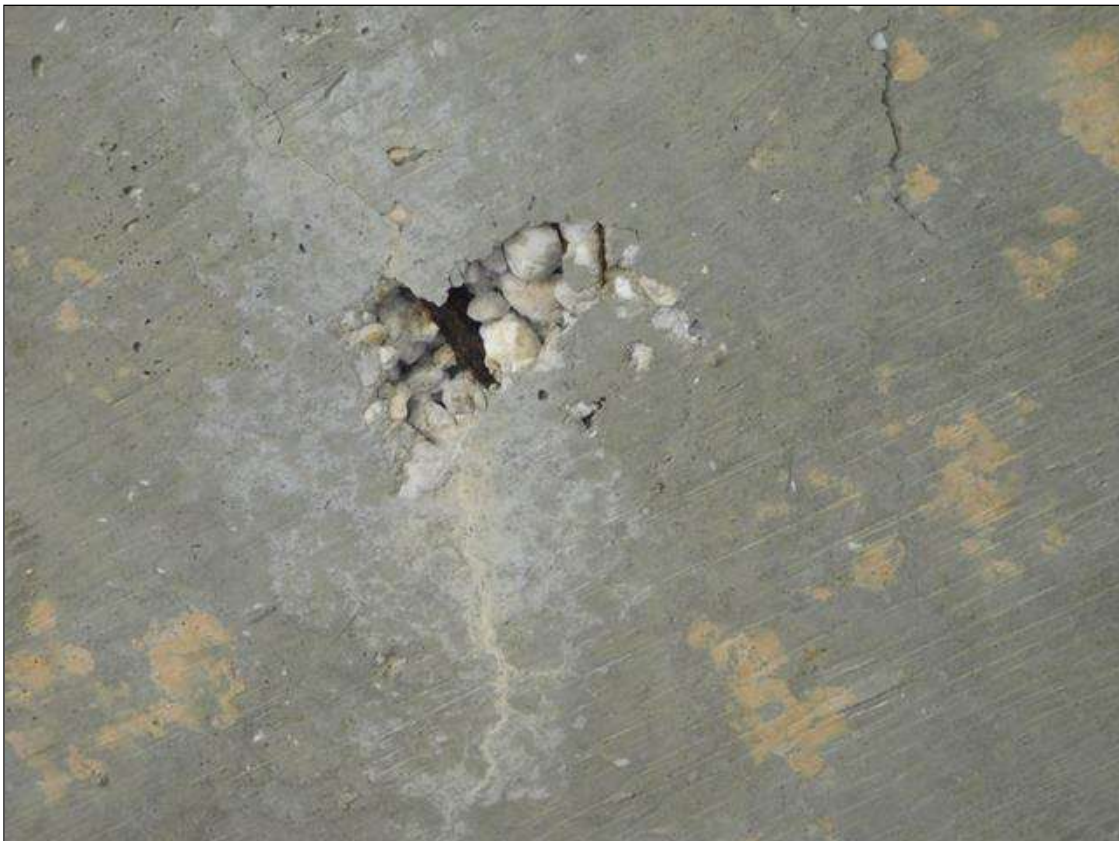
Span 5 Deck: 7" LONG X 7" WIDE X 1 1/2" DEEP SPALLED AREA WITH EXPOSED REINFORCEMENT IN THE UNDERSIDE OF THE DECK IN BAY 4, 7' FROM BENT 5

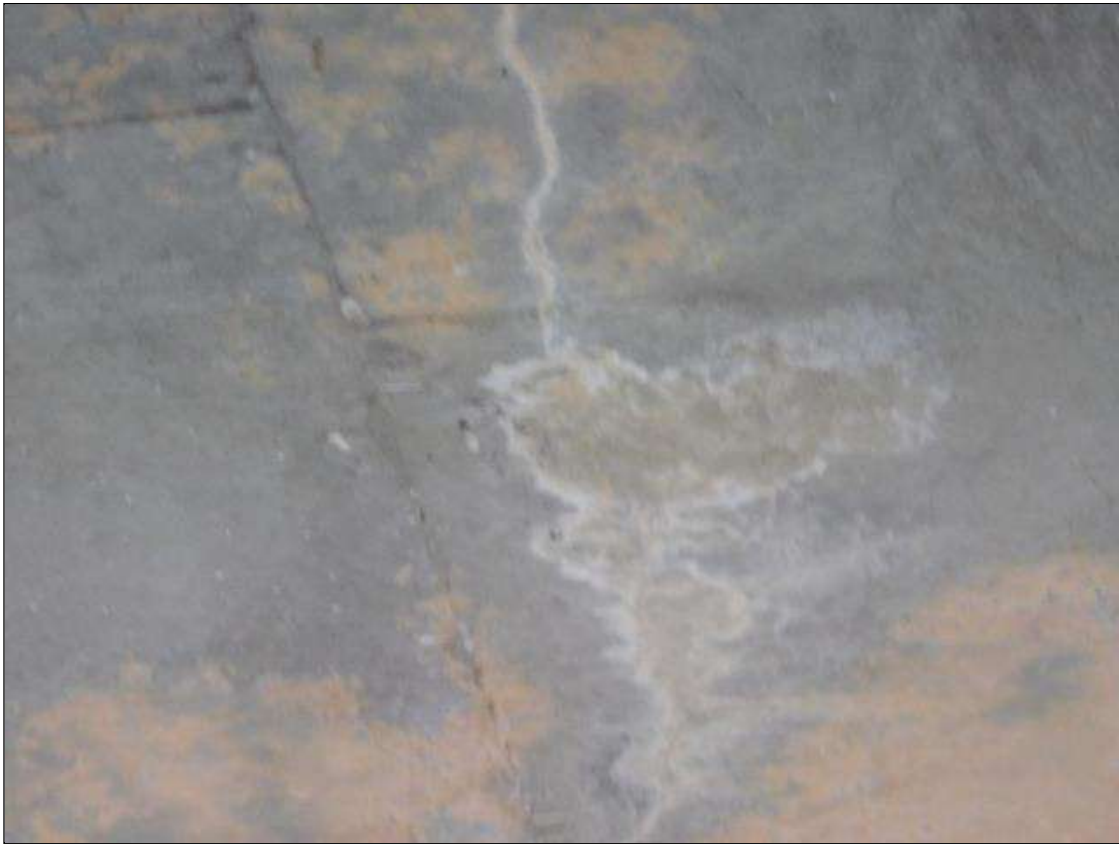
Span 5 Deck: INTERMITTENT FULL WIDTH X 1/32" WIDE TRANSVERSE CRACKS WITH EFFLORESCENCE IN THE UNDERSIDE OF THE DECK AT 1' TO 3' SPACING

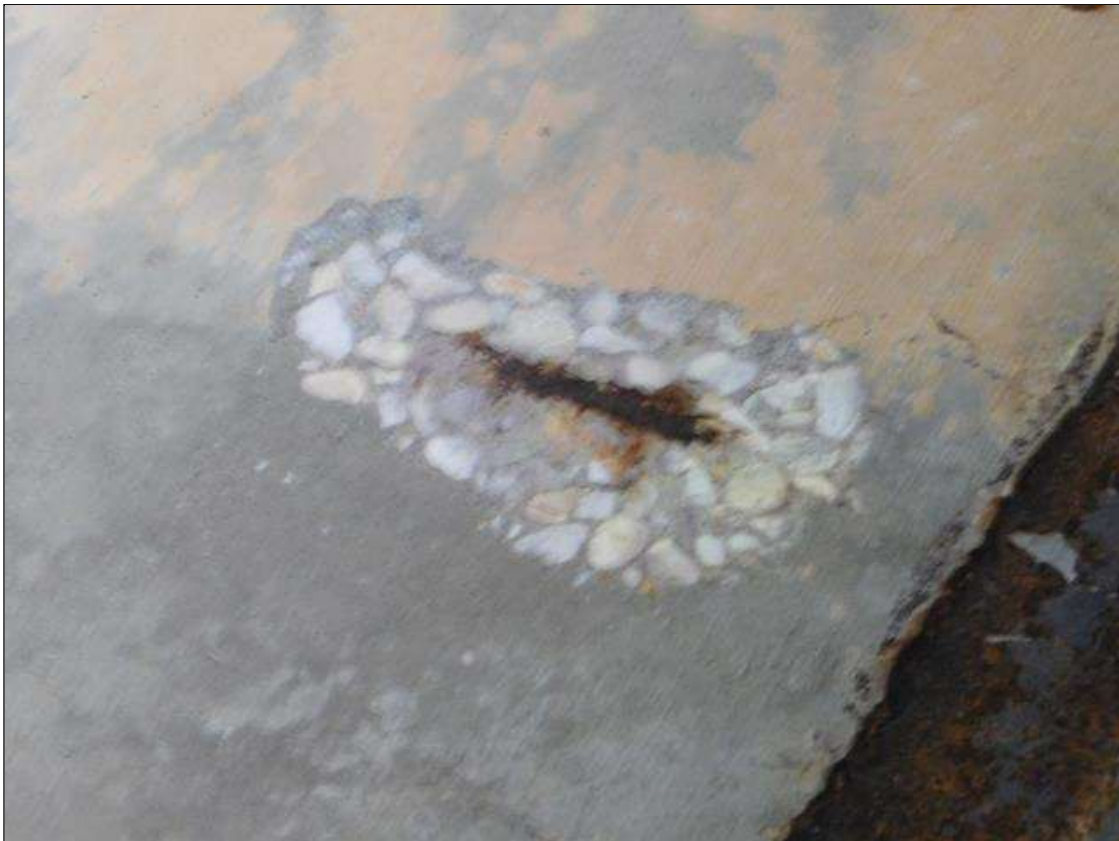
Span 5 Deck: 8" x 6" x 1 1/2" DEEP SPALL WITH REBAR EXPOSED IN BOTTOM OF DECK IN BAY 3, 4' FROM BENT 5

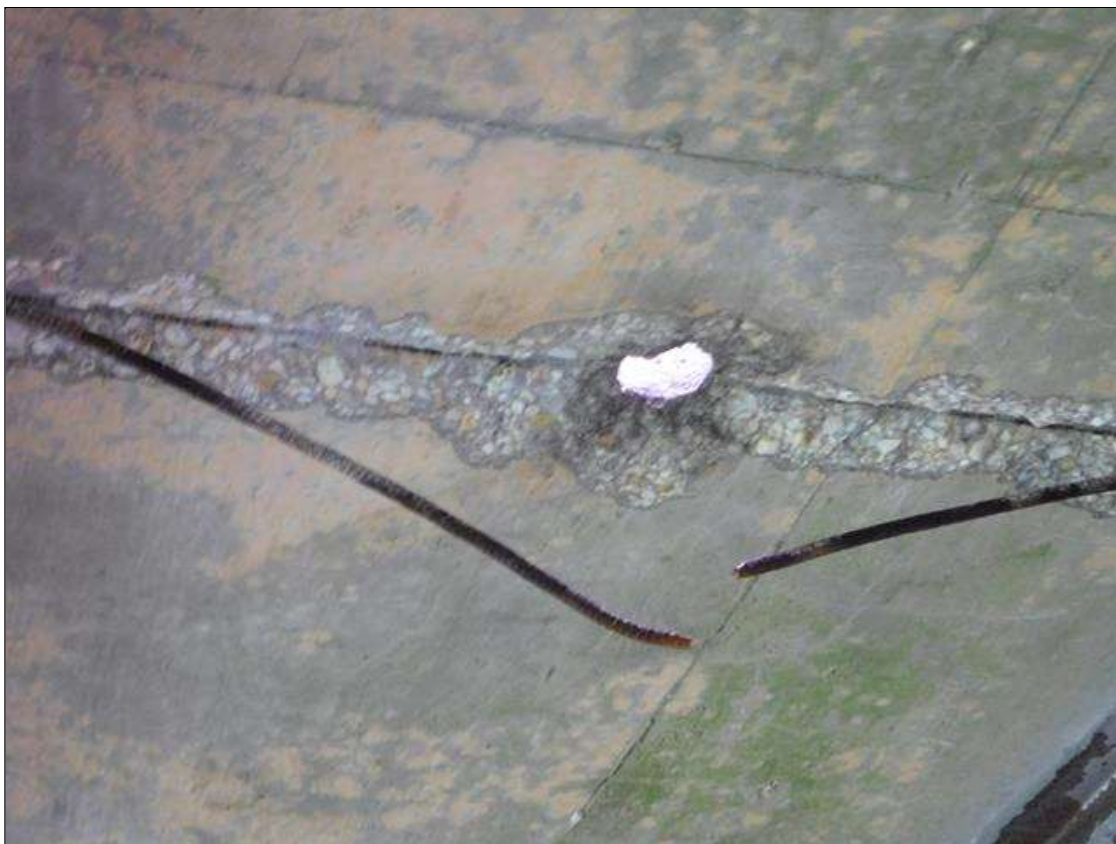
Span 5 Deck: 4' x 12" x 2" DEEP SPALL WITH BROKEN REBAR EXPOSED. BOTTOM OF DECK BAY 1 NEAR MID-SPAN. "PAR"

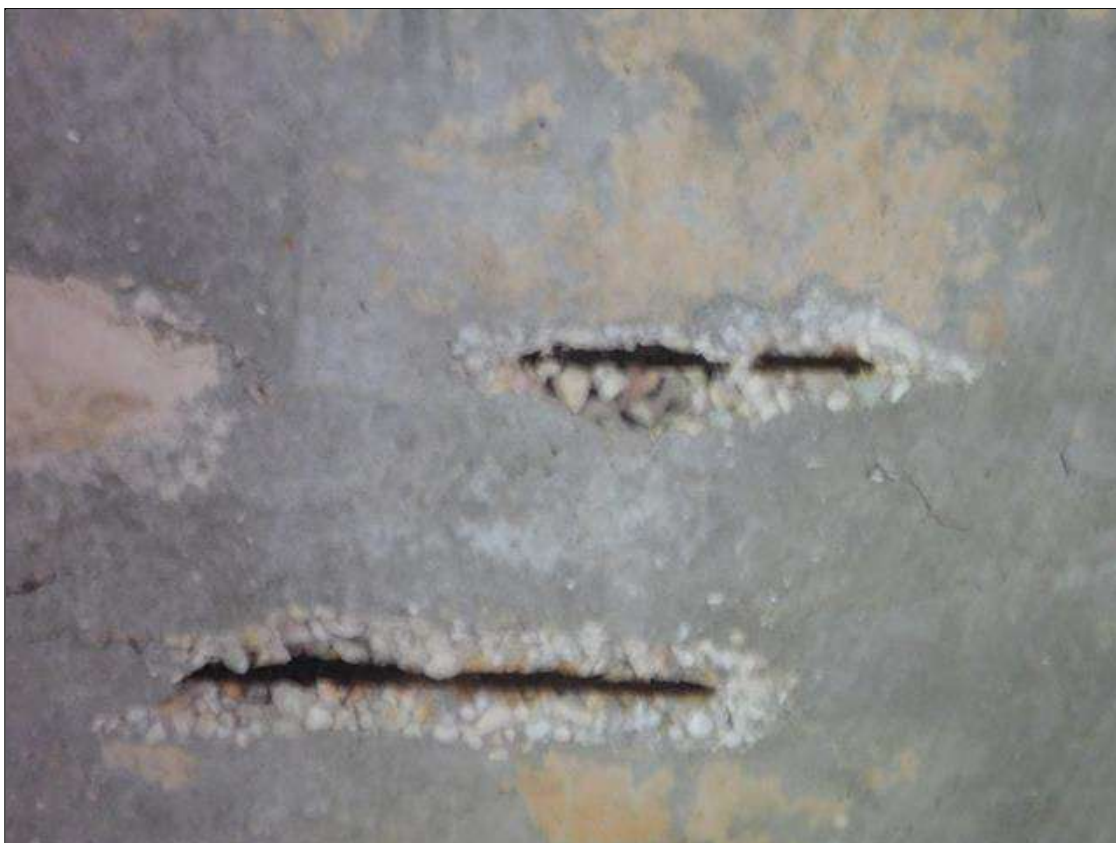
Span 5 Deck: (2) SPALLED AREAS WITH REBAR EXPOSED AND ADJACENT DELAMINATION. AREAS ARE UP TO 2' x 8" x 2" DEEP

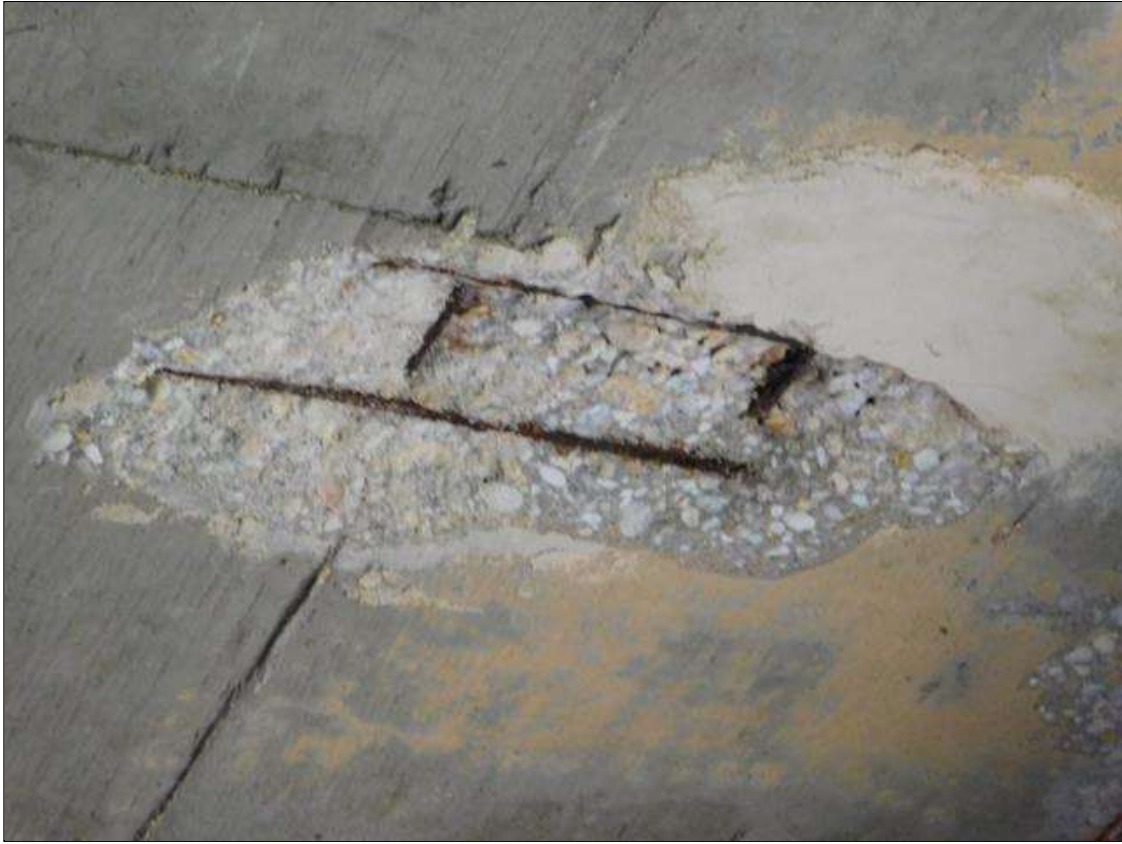
Span 6 Deck: 24" x 14" x 2" DEEP SPALL WITH EXPOSED REBAR. BOTTOM OF DECK BAY 4 NEAR MID-SPAN

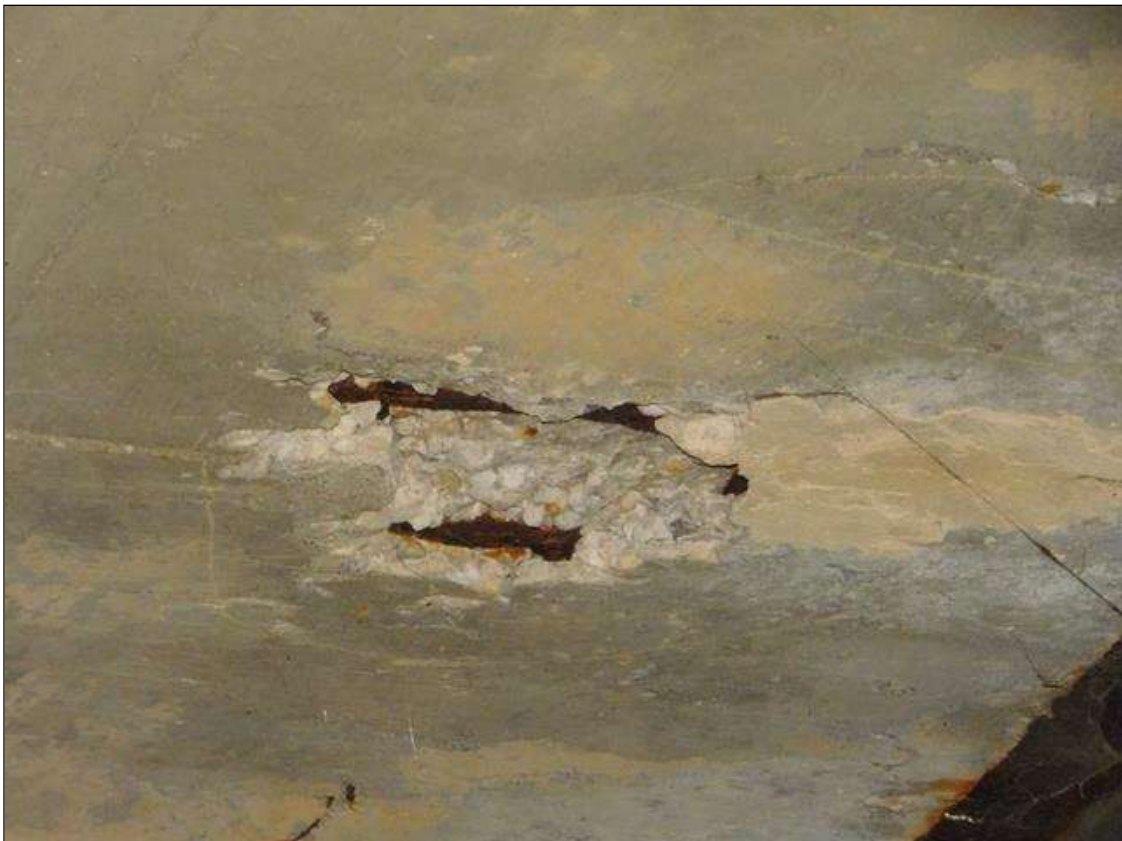
Span 6 Deck: 16" DIAMETER x 2" DEEP SPALL WITH EXPOSED REBAR. BOTTOM OF DECK BAY 4 AT END BENT

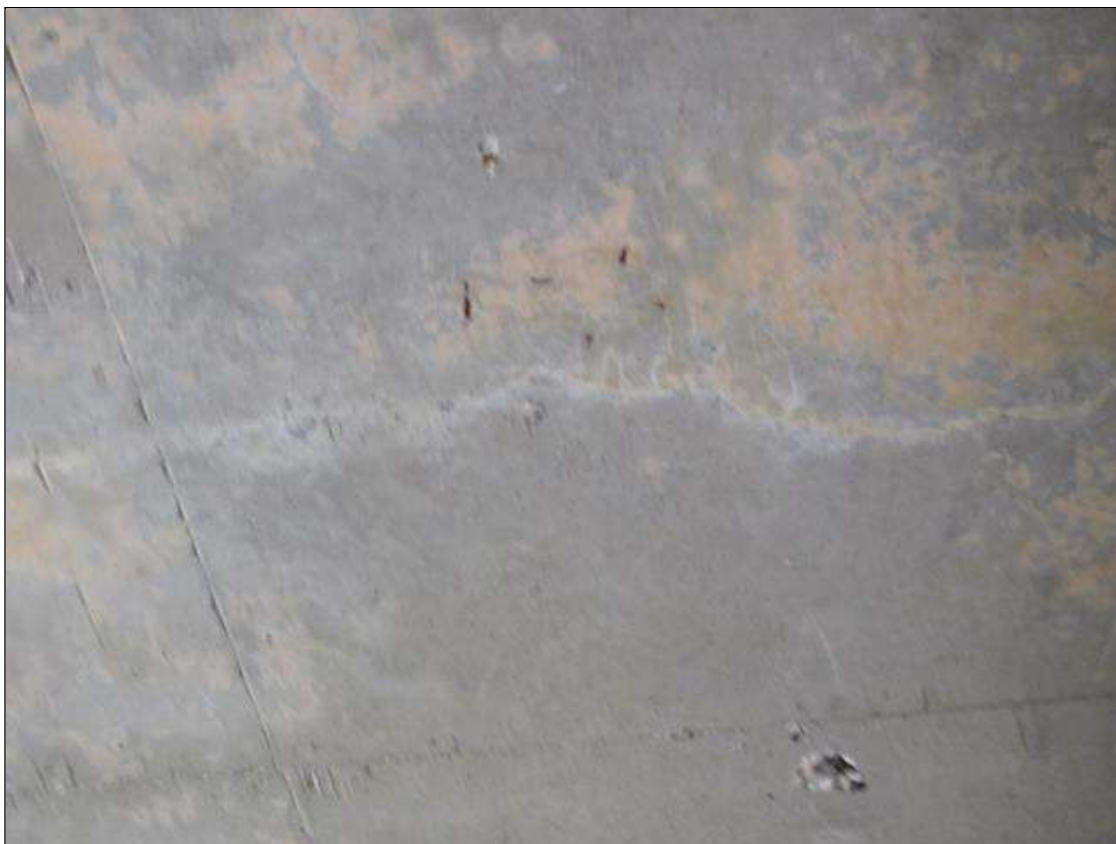
Span 6 Deck: SCATTERED HAIRLINE TRANSVERSE CRACKS UP TO FULL WIDTH IN BOTTOM OF DECK

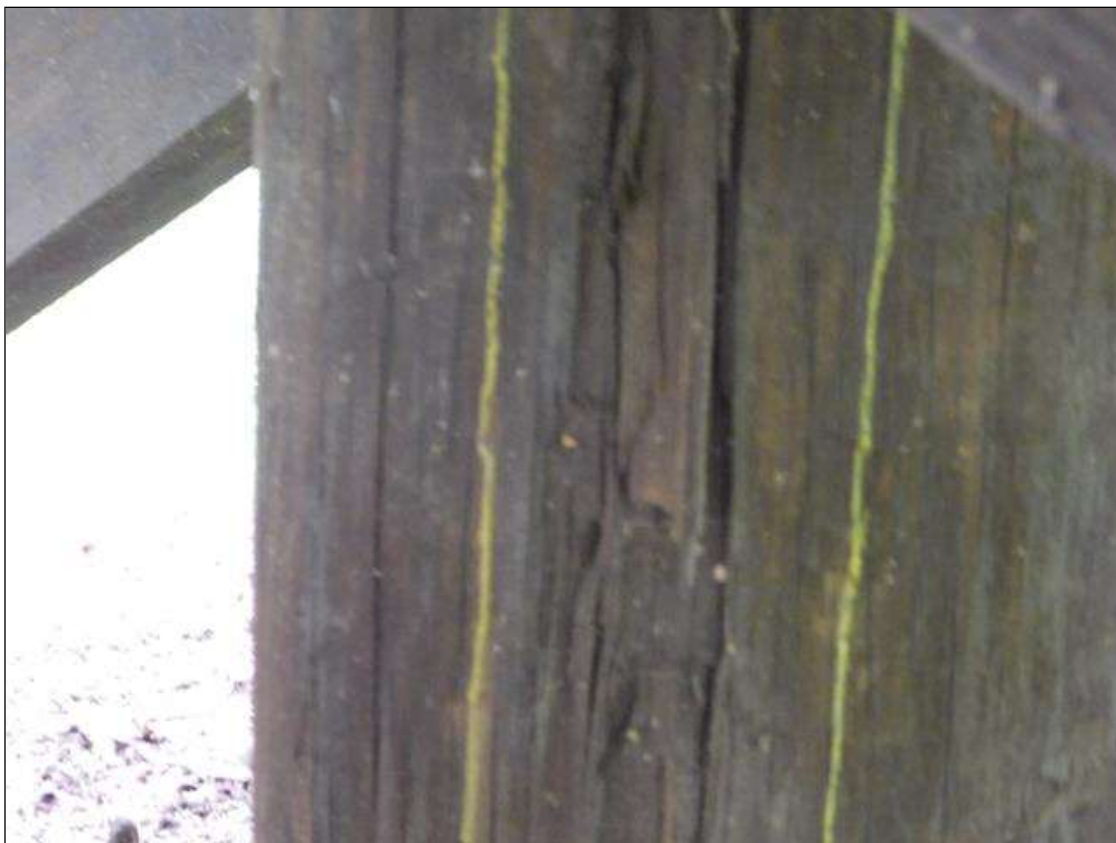
Bent 3 Pile 3: 36" TALL x 2" WIDE x 1/4" DEEP AREA OF DECAY ON SOUTH FACE BELOW CROSS-BRACE

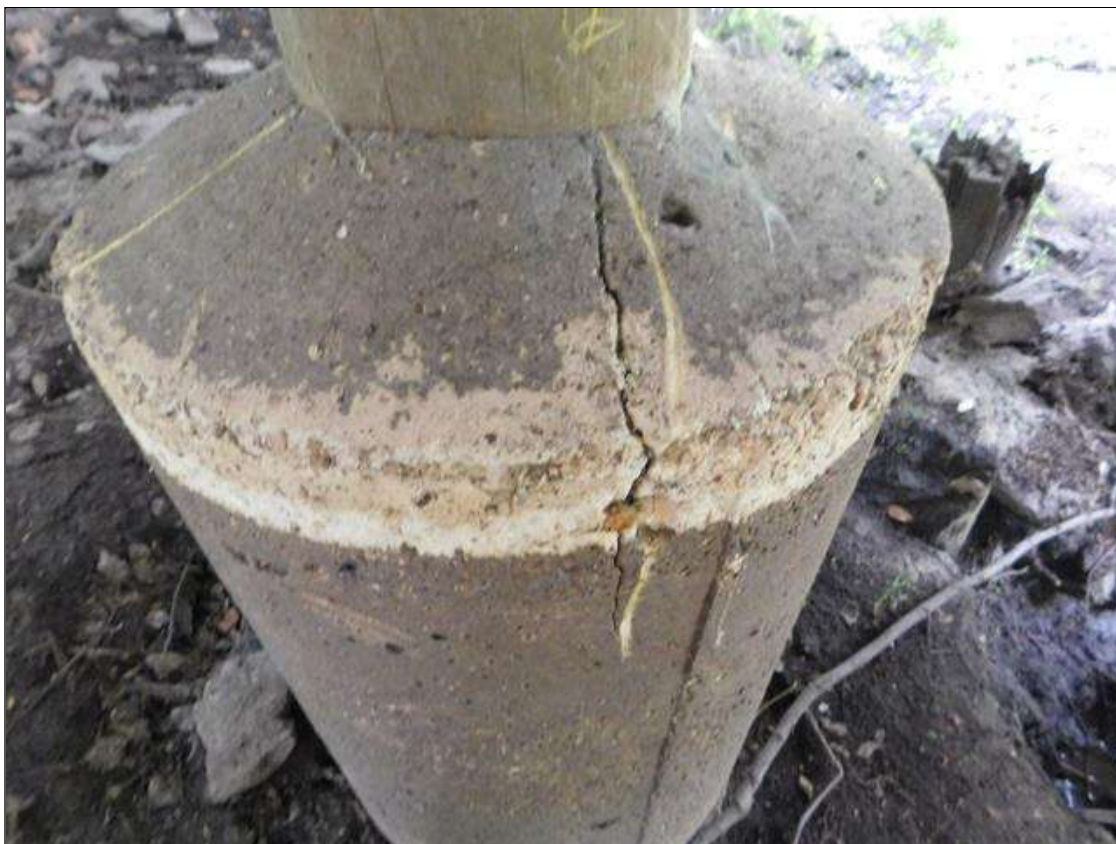
Bent 3 Pile 4: SCATTERED CHECKS UP TO 1/8" WIDE. CONCRETE ENCASEMENT HAS SCATTERED CRACKS UP TO 1/4" WIDE.

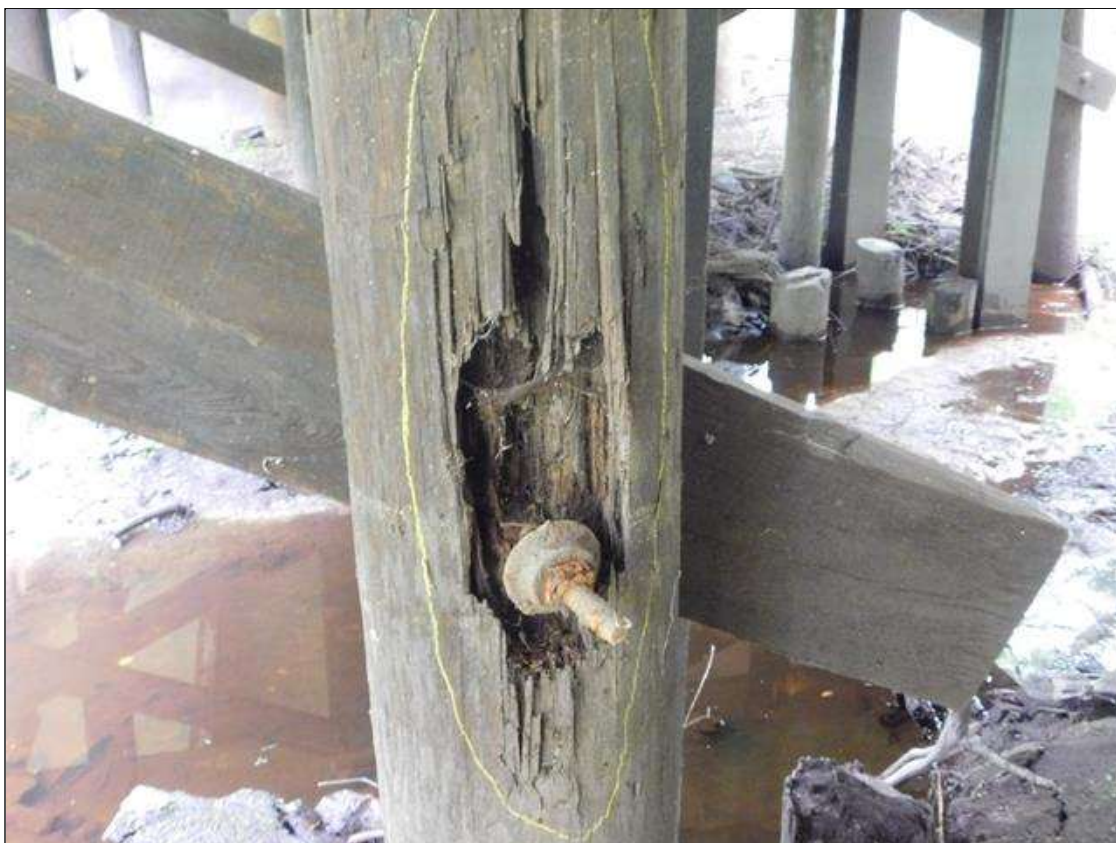
Bent 3 Pile 6: 28" x 5" x 4" DEEP AREA OF DECAY ON NORTH FACE OF LOWER CROSS-BRACE. "PAR"

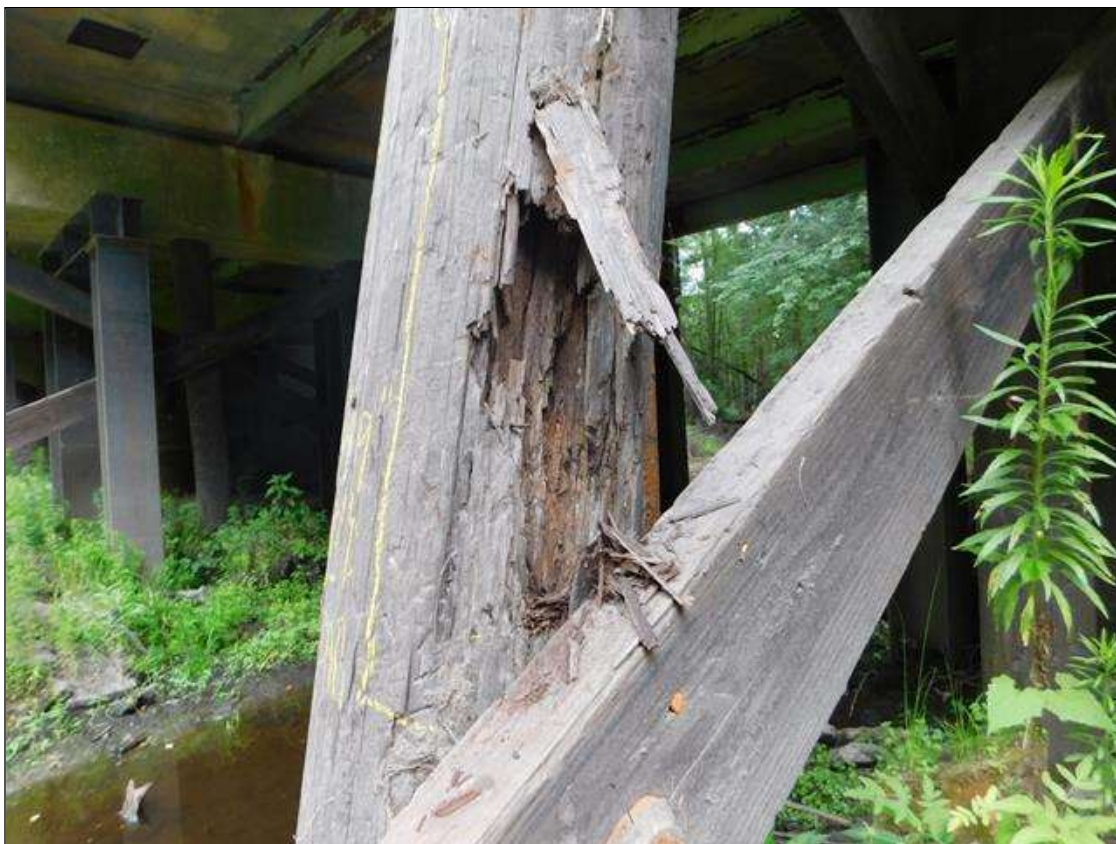
Bent 3 Pile 9: 4' x 9" x 3" DEEP AREA OF DECAY NORTH FACE OF LOWER CROSS-BRACE. "PAR"

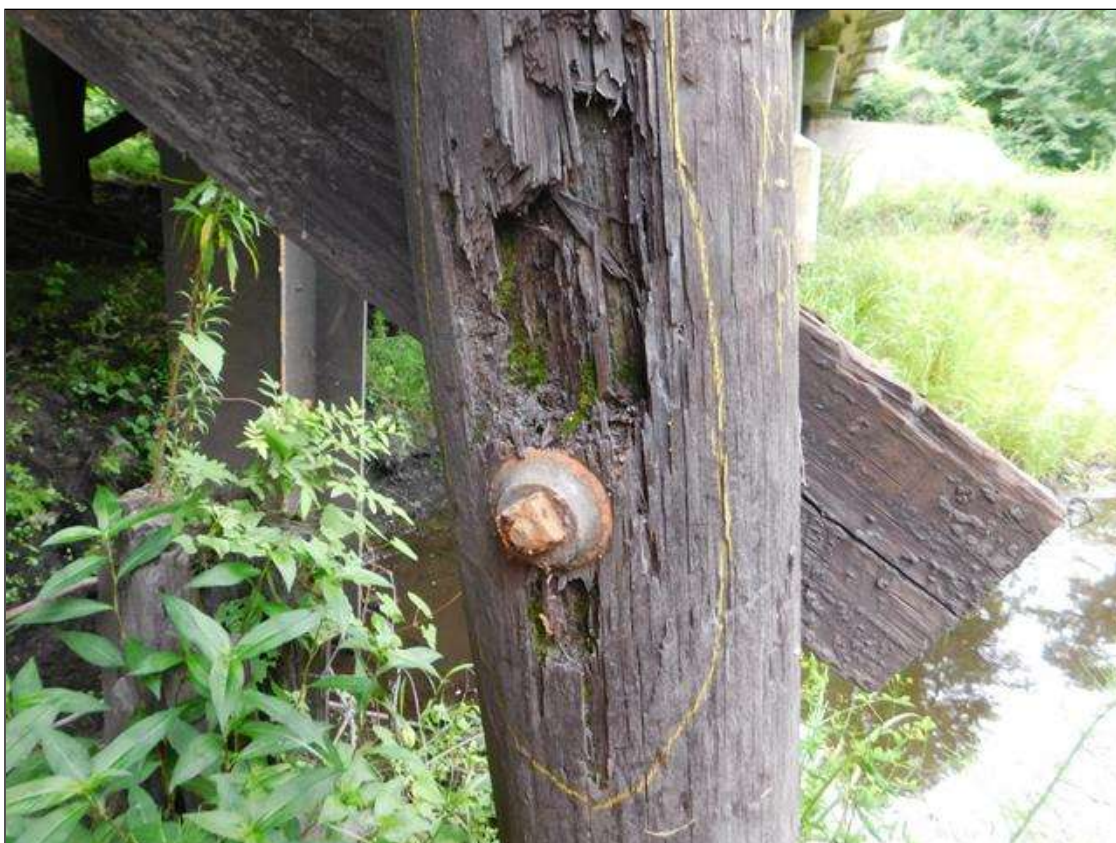
Bent 3 Pile 9: 23" x 6" x 2" DEEP AREA OF DECAY IN SOUTH FACE AND LOWER CROSS-BRACE. "PAR"

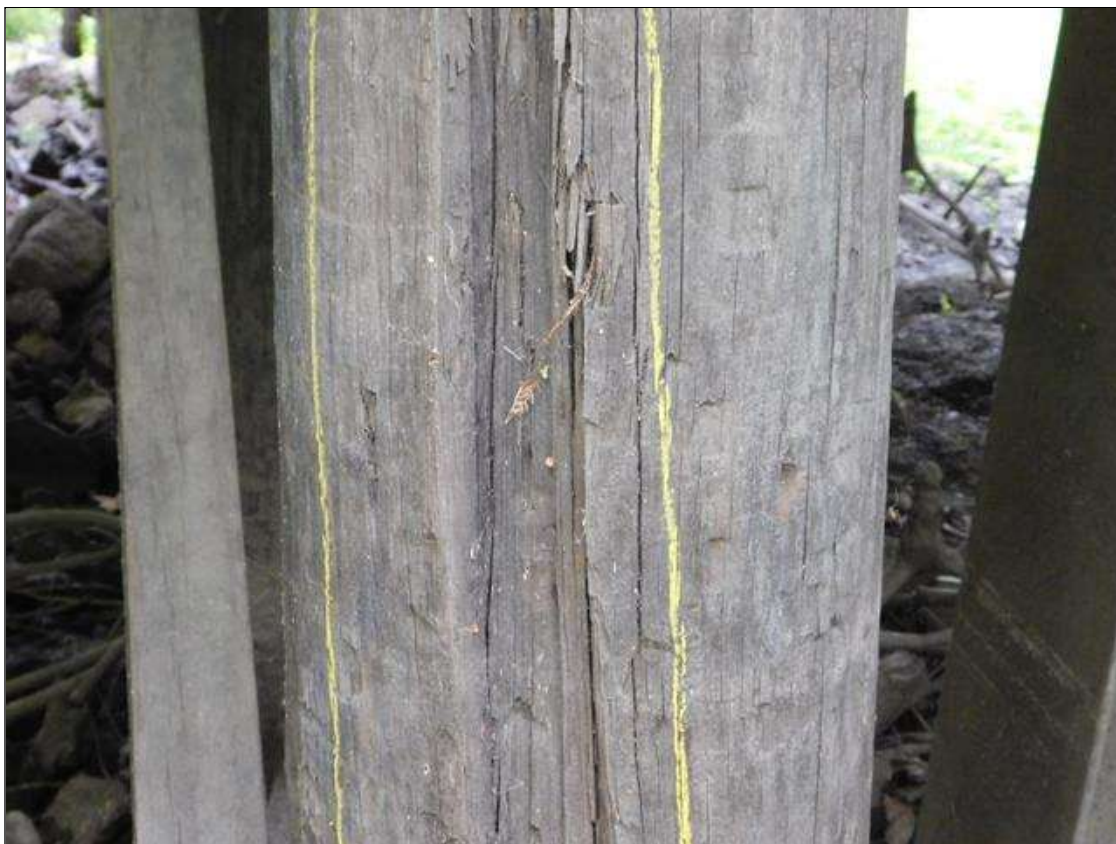
Bent 4 Pile 1: 30" x 2 1/2" x 1 1/2" DEEP AREA OF DECAY IN WEST FACE 2' BELOW CAP

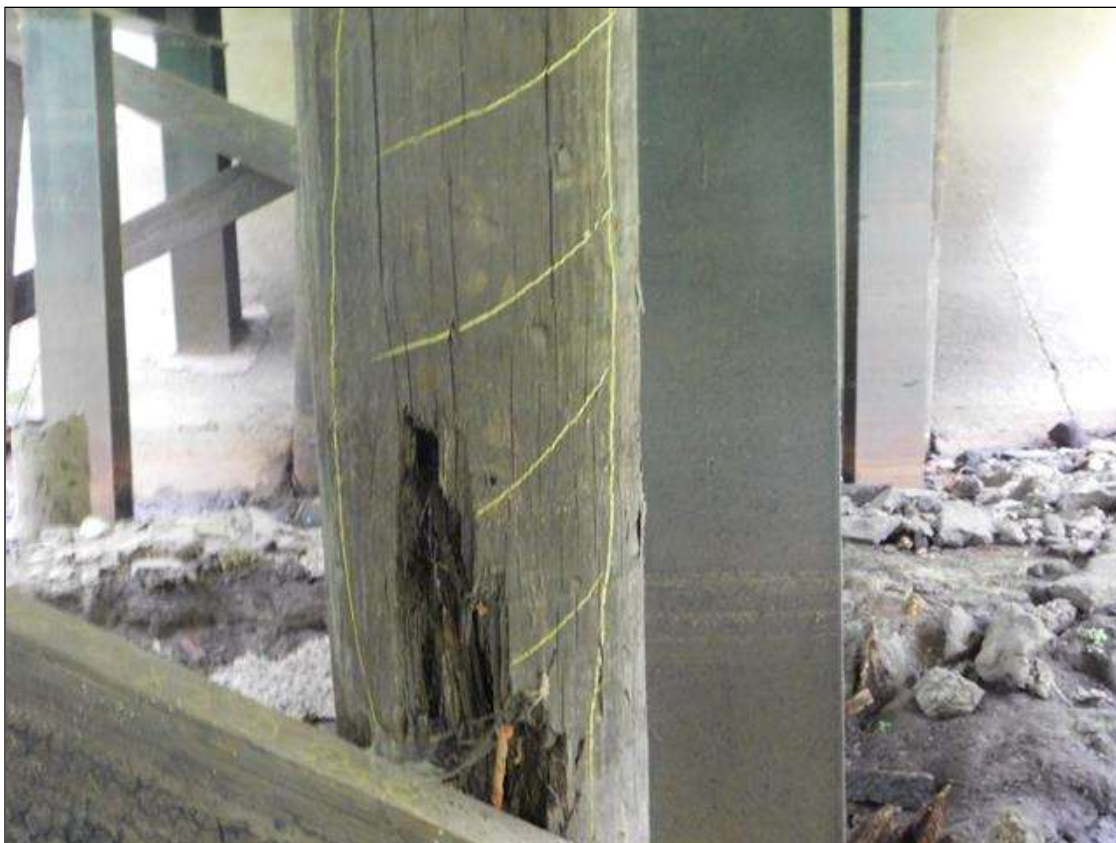
Bent 4 Pile 4: SOUTH FACE HAS A AREA OF DECAY WITH ADJACENT HOLLOW SOUNDS. AREA IS: FROM BOTTOM OF CAP DOWN 6' x 10" x 3" DEEP. "PAR"

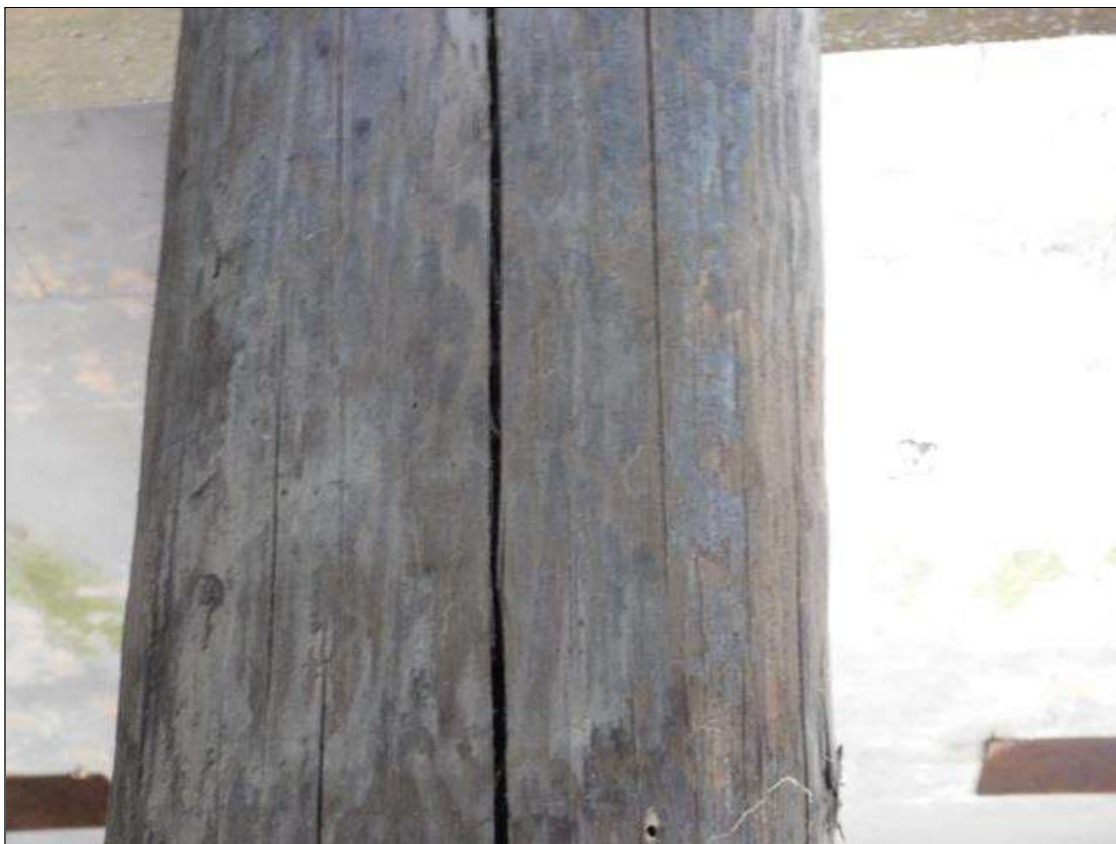
Bent 4 Pile 7: SCATTERED CHECKS UP TO 1/4" WIDE

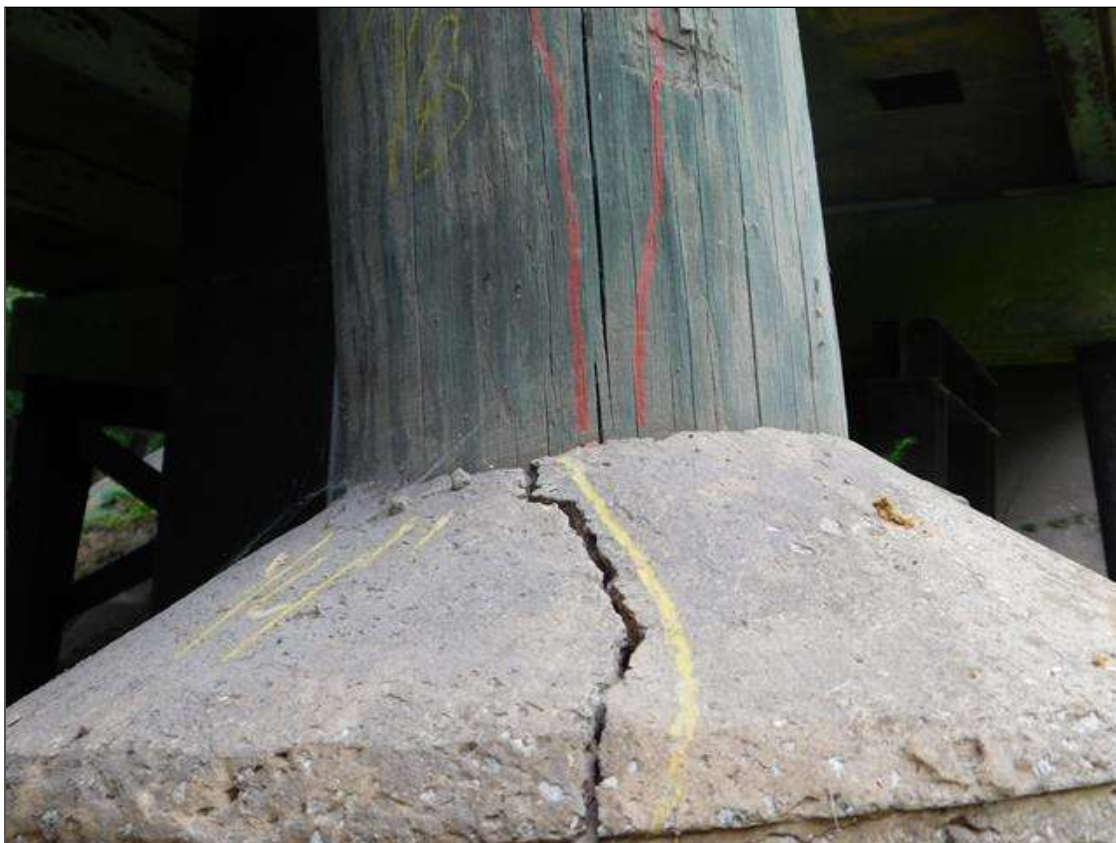
Bent 4 Pile 9: SCATTERED CHECKS UP TO 1/8" WIDE AND A CONCRETE ENCASEMENT THAT HAS SCATTERED CRACKS UP TO 1/4" WIDE

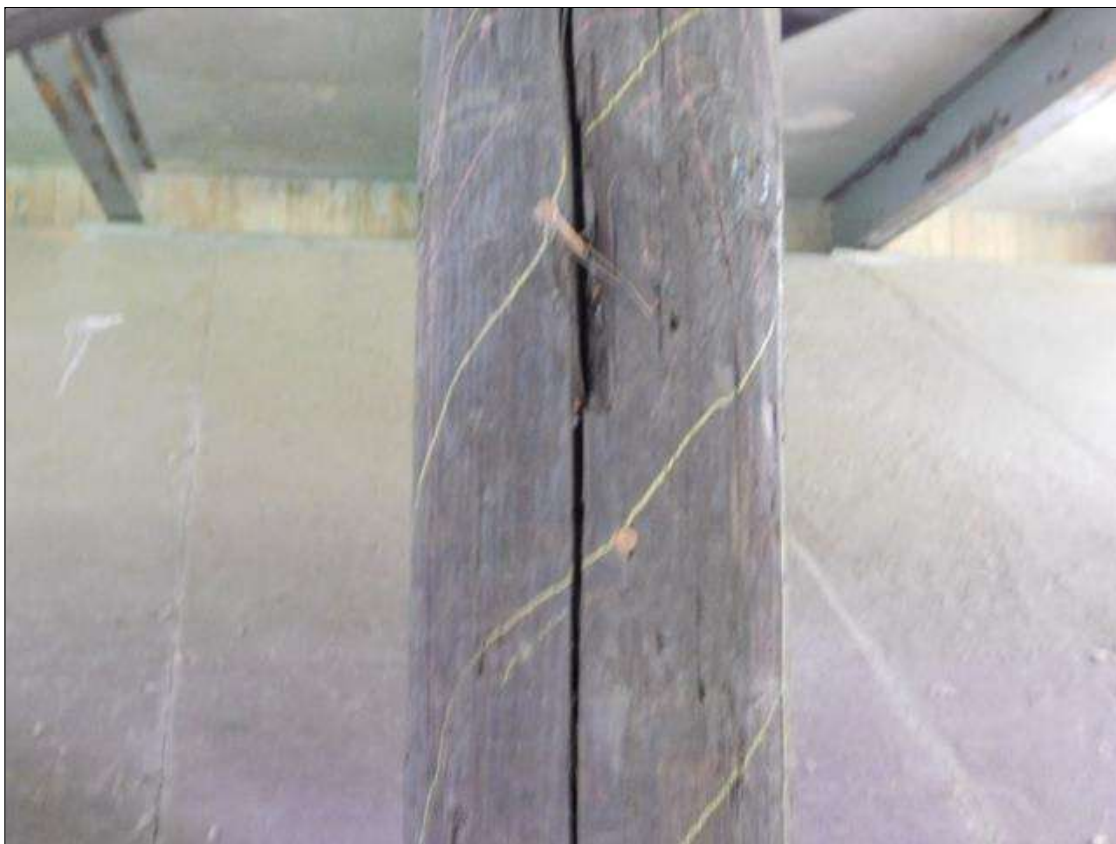
Bent 5 Pile 4: SOUTH FACE FROM BOTTOM OF CAP DOWN 5' x 1/2 CIRCUMFERENCE IS HOLLOW SOUNDING WITH A 10" x 1 1/2" x 2" DEEP AREA OF DECAY

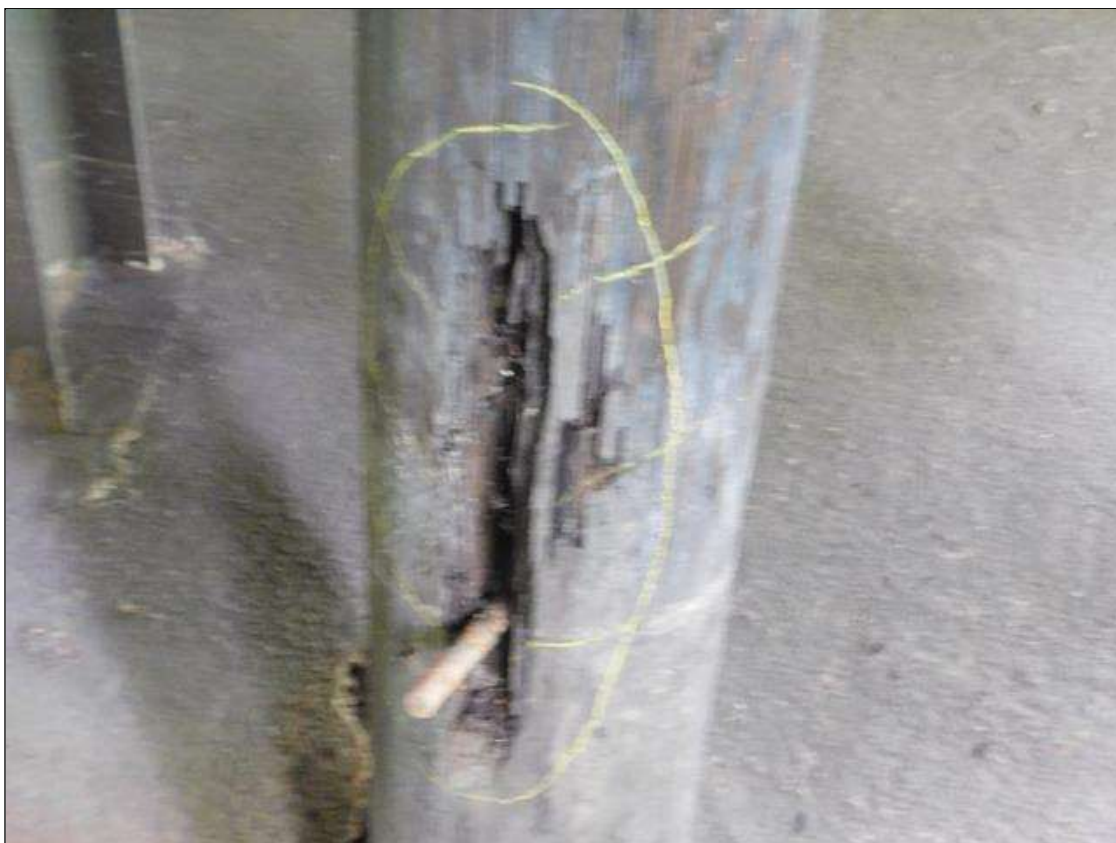
Bent 5 Pile 6: SOUTH AND NORTH FACE 4' BELOW CAP HAS AREAS OF DECAY UP TO 19" x 8" x 3" DEEP. "PAR"

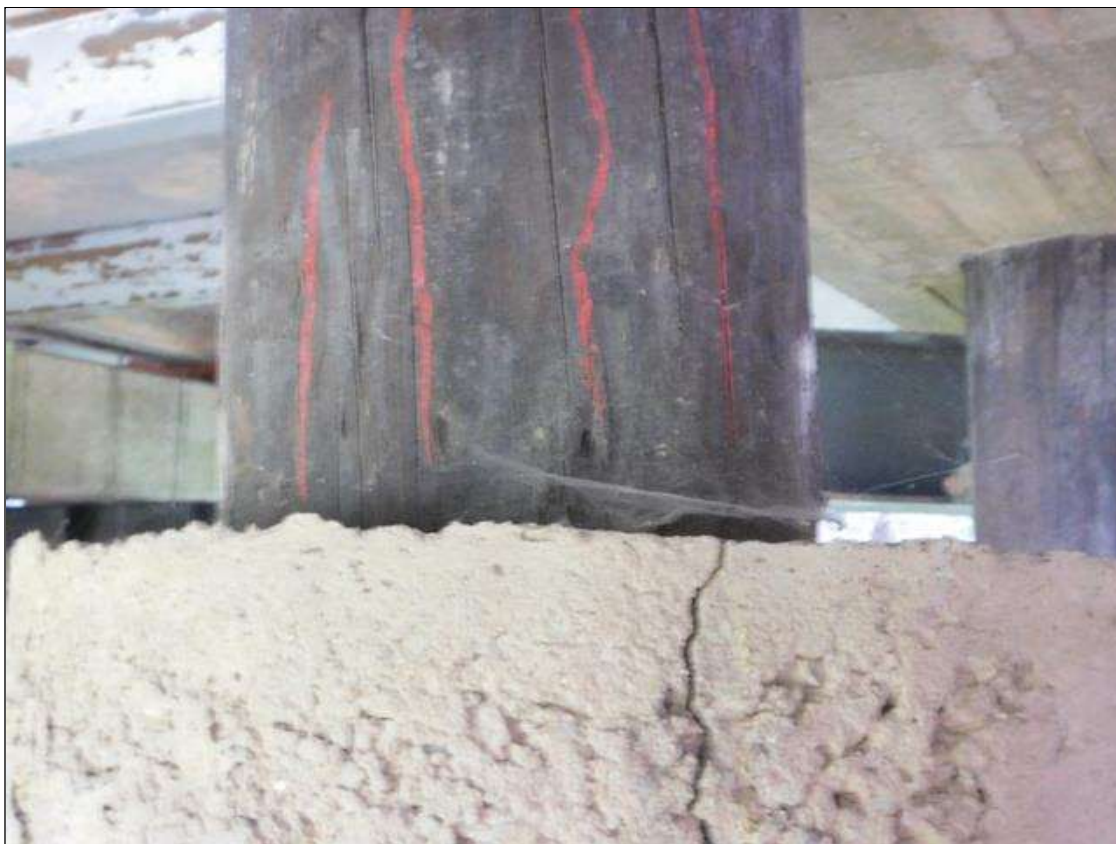
Bent 5 Pile 7: SCATTERED CHECKS UP TO 1/8" WIDE WITH A CONCRETE ENCASEMENT ON EAST FACE THAT HAS A FULL HEIGHT x 1/4" WIDE CRACK

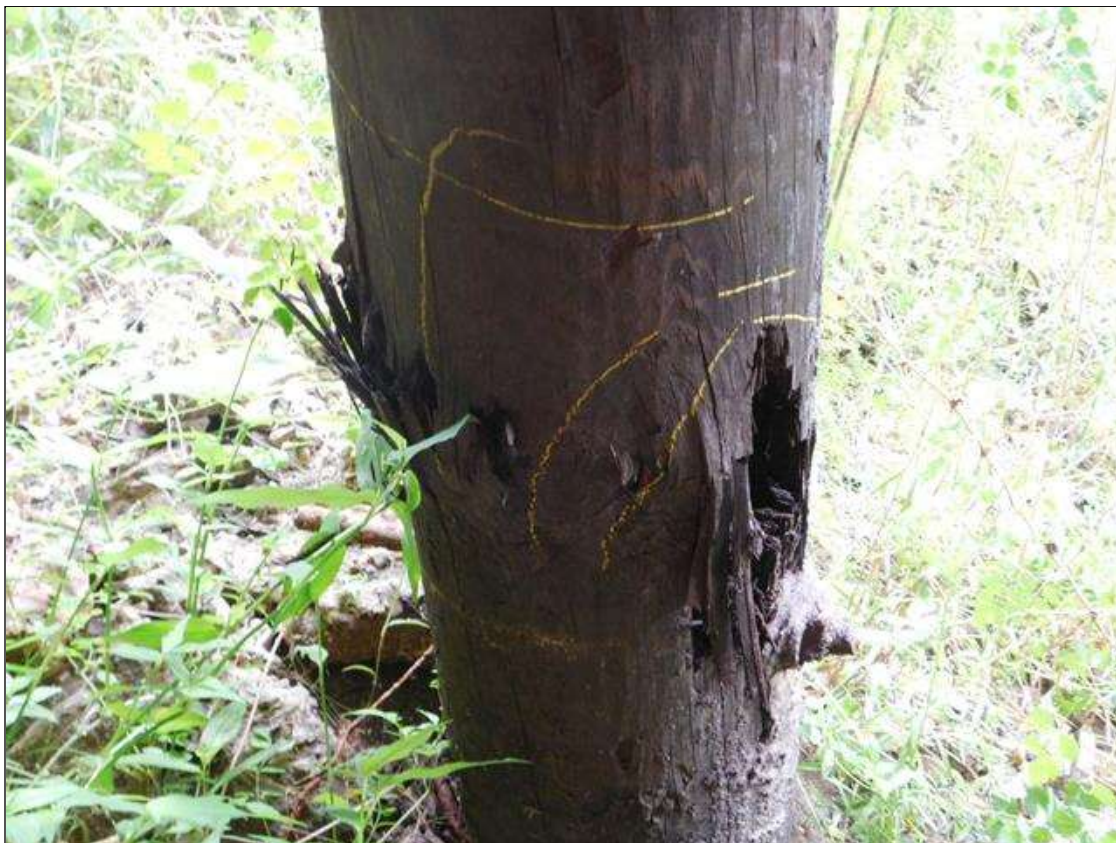
Bent 5 Pile 9: 12" TALL x FULL CIRCUMFERENCE x 2" DEEP AREA OF DECAY. 16" ABOVE GROUNDLINE. "PAR"

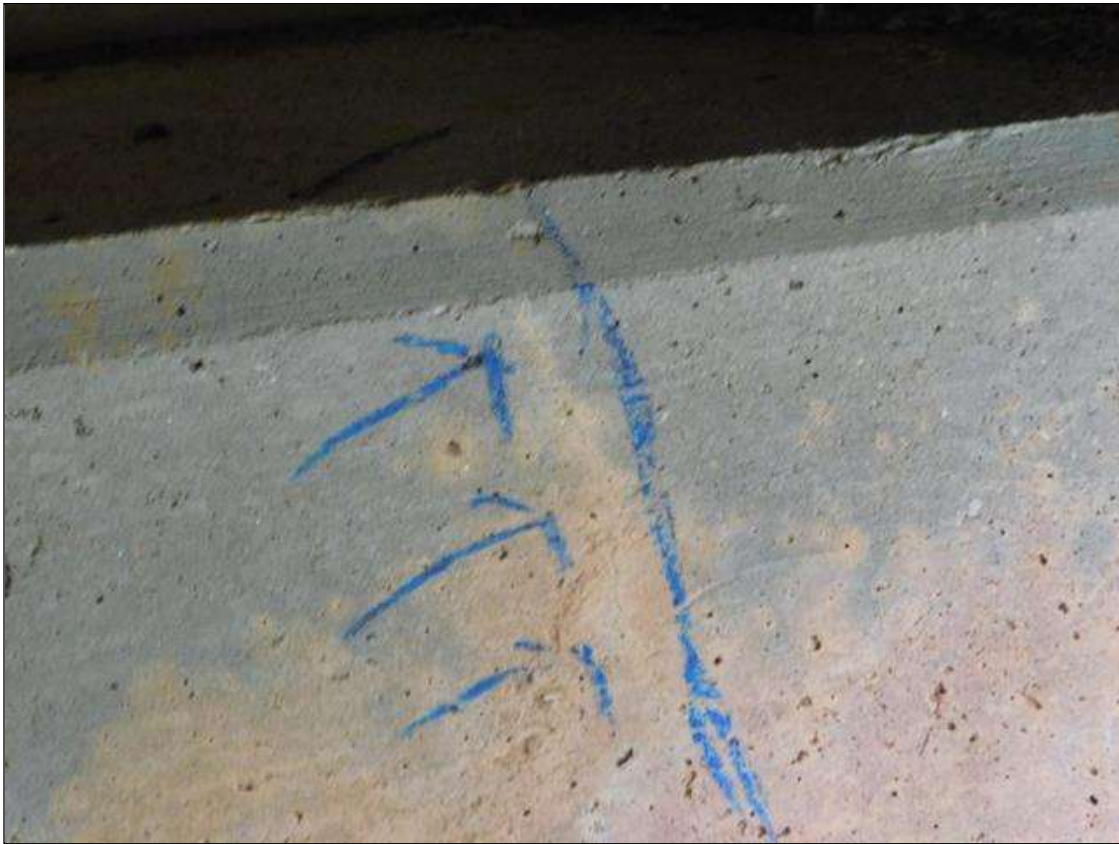
End Bent 2 Cap 1: SCATTERED HAIRLINE VERTICAL CRACKS

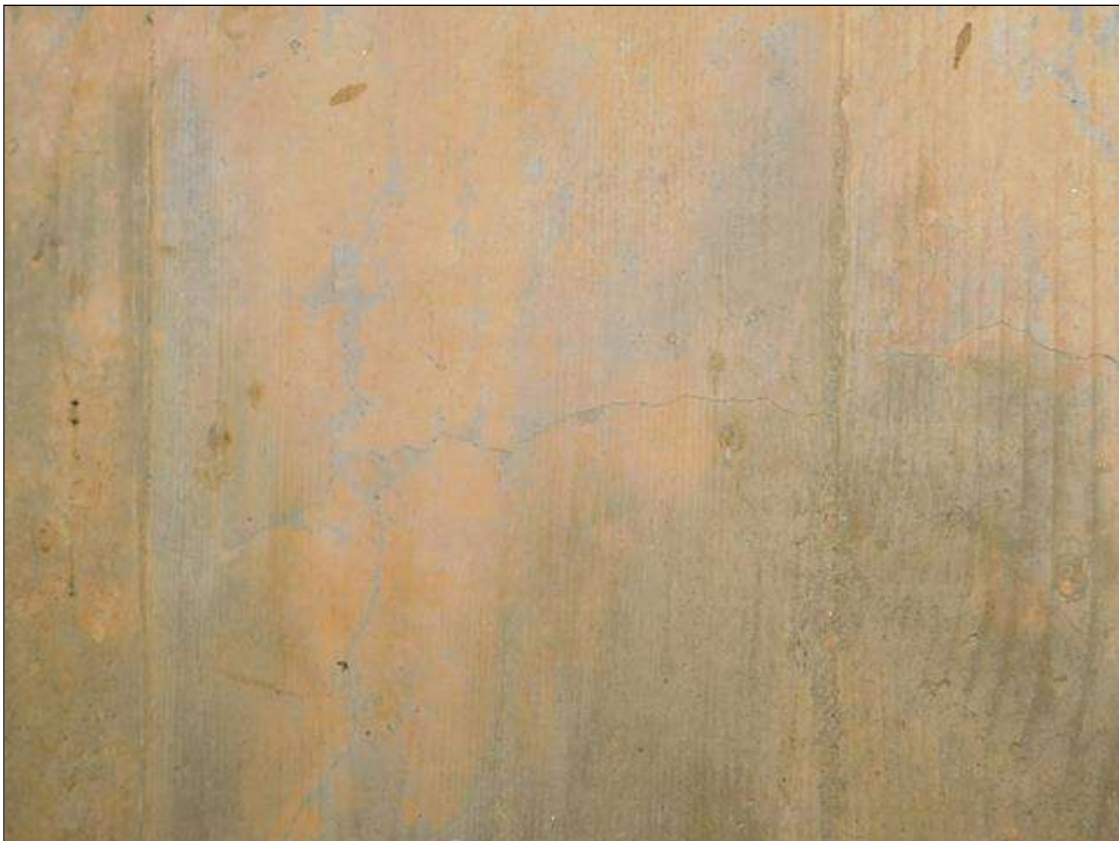
End Bent 2 Abutment: SCATTERED AREAS OF HAIRLINE MAP CRACKING
