NC DEPARTMENT OF TRANSPORTATION
 DIVISION OF HIGHWAYS
 STRUCTURE MANAGEMENT UNIT

ATTENTION: **LADDER USED FOR INSPECTION / "PAR"s ISSUED**

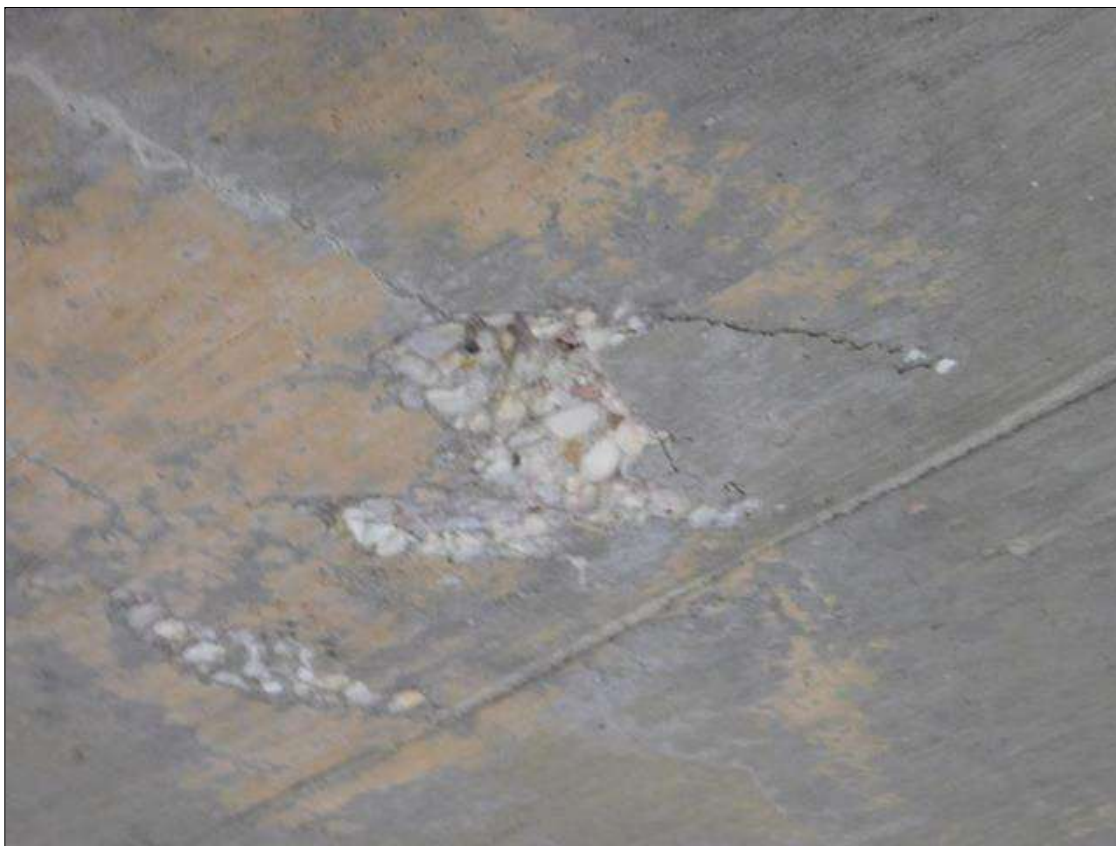
Span 6 Deck: 20" x 16" AREA THAT IS CRACKED AND DELAMINATED WITH (2) SPALLS UP TO 10" x 8" x 1" DEEP.
BOTTOM OF DECK IN BAY 1 NEAR MID-SPAN

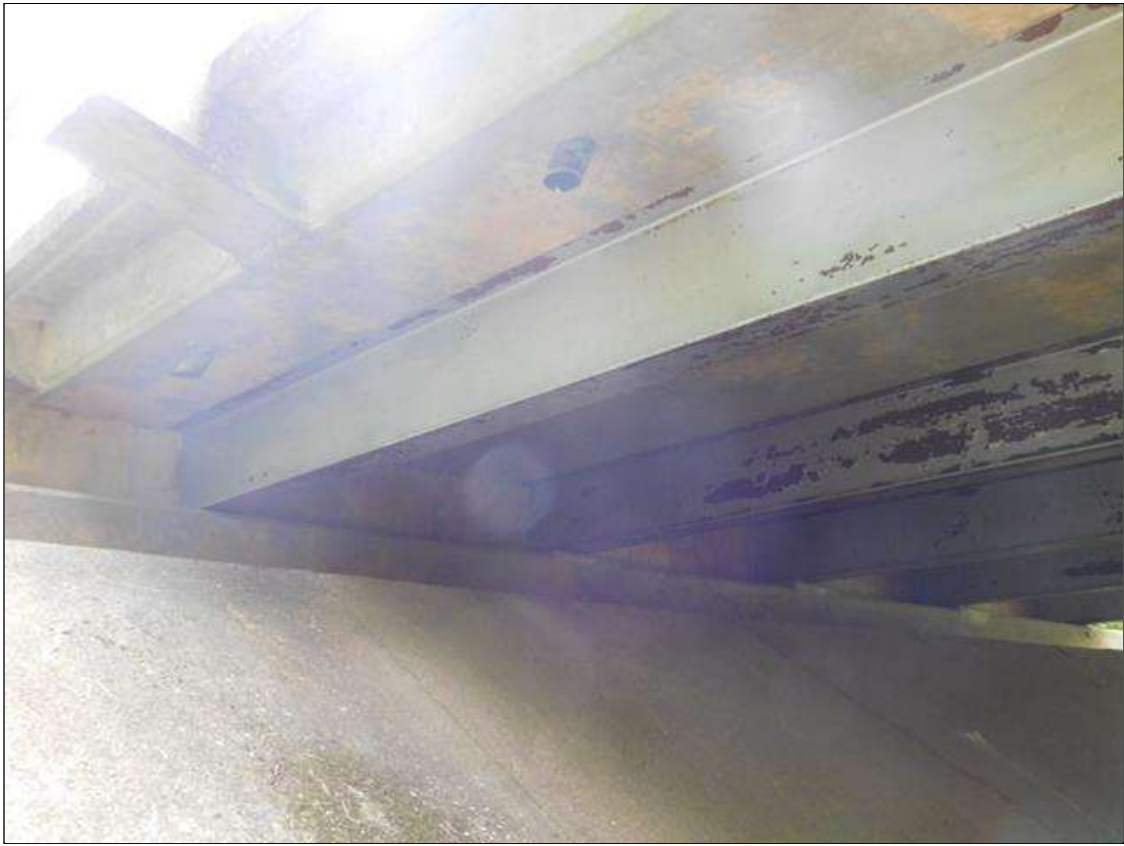
LADDER USED FOR INSPECTION

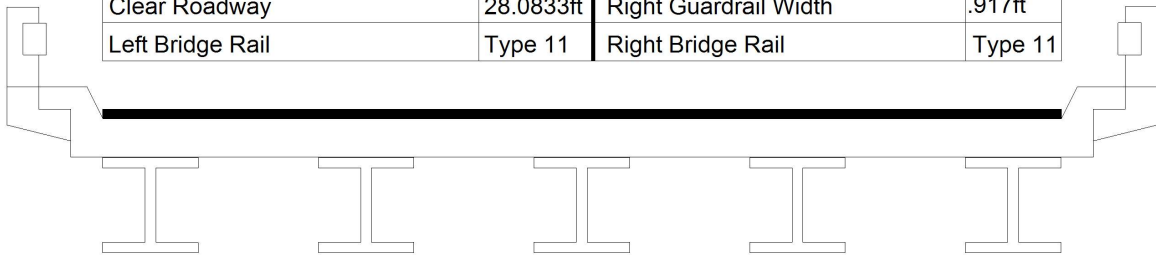
Measurements for Span #	2		
Deck Thickness	0.54167	Left Overhang	4.042
Top of Rail to Bottom of Beam	4.50ft	Right Overhang	4.042

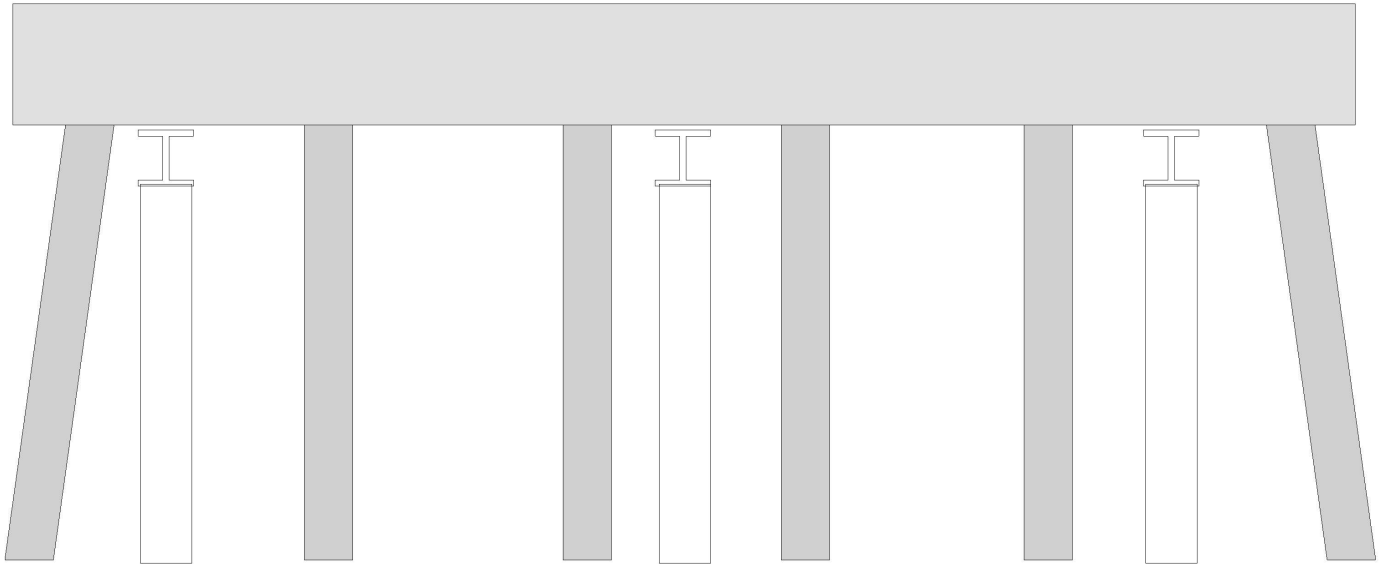
Cap Information			Material Cast-in-Place Concrete							
Length	Width	Height	Left Overhang	Right Overhang	Left Beam to End of Cap.	Right Beam to End of Cap.

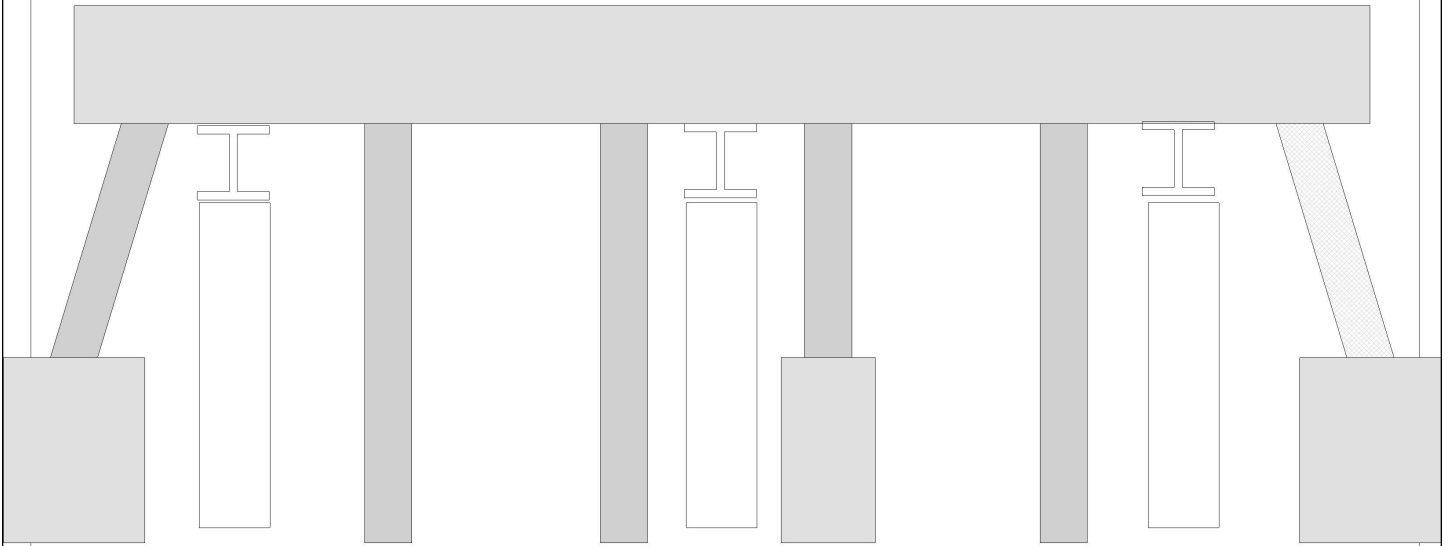
Cap Information			Material Cast-in-Place Concrete							
Length	Width	Height	Left Overhang	Right Overhang	Left Beam to End of Cap.	Right Beam to End of Cap.

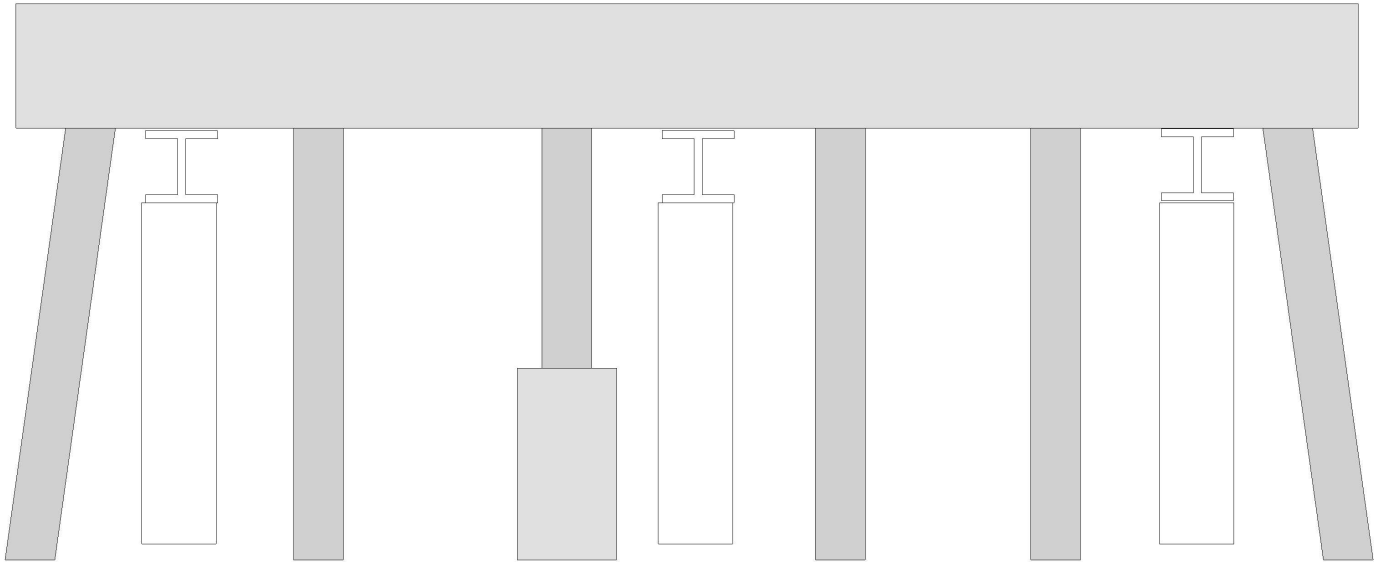
Cap Information			Material Cast-in-Place Concrete							
Length	Width	Height	Left Overhang	Right Overhang	Left Beam to End of Cap.	Right Beam to End of Cap.

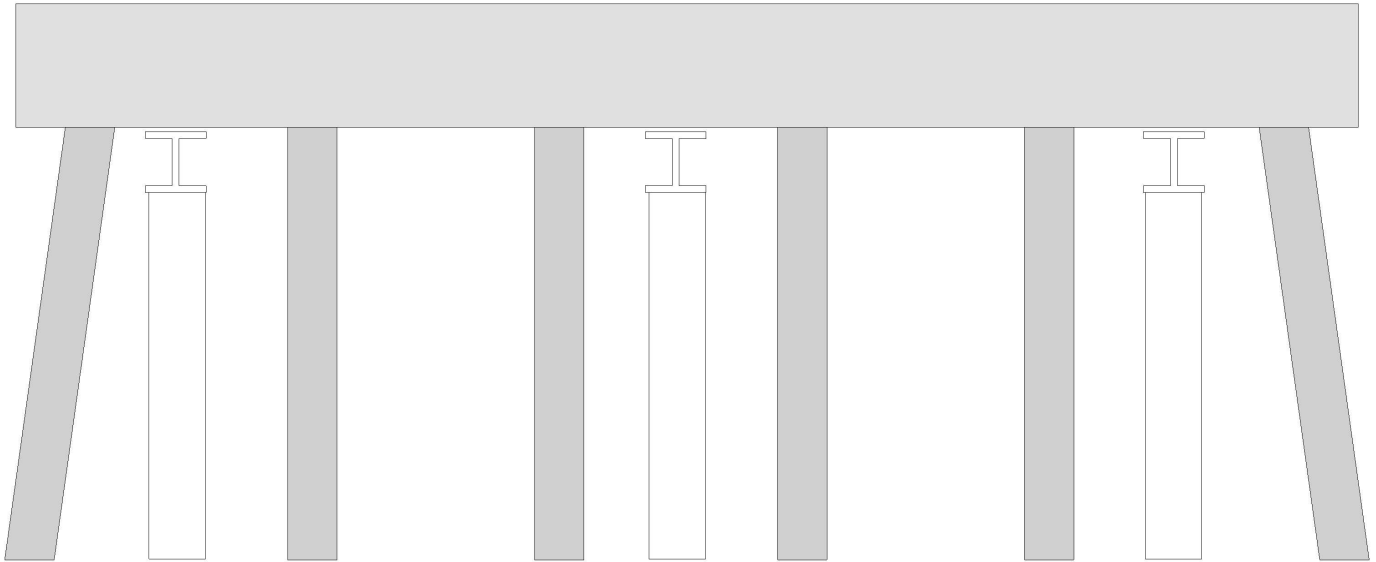
Cap Information			Material Cast-in-Place Concrete							
Length	Width	Height	Left Overhang	Right Overhang	Left Beam to End of Cap.	Right Beam to End of Cap.

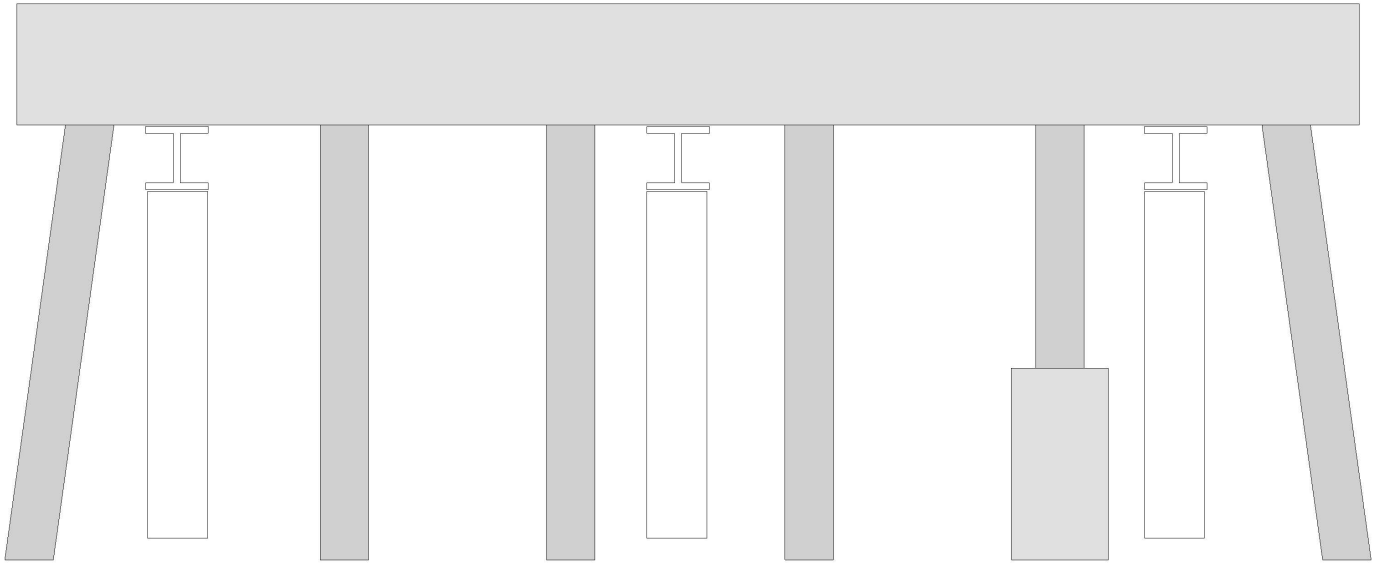
Cap Information			Material Cast-in-Place Concrete							
Length	Width	Height	Left Overhang	Right Overhang	Left Beam to End of Cap.	Right Beam to End of Cap.
