PROJECT NO. HI-0015 **COLUMBUS** COUNTY

230086

STATE OF NORTH CAROLINA DEPARTMENT OF TRANSPORTATION

DECK UNDERSIDE REPAIR SPAN A

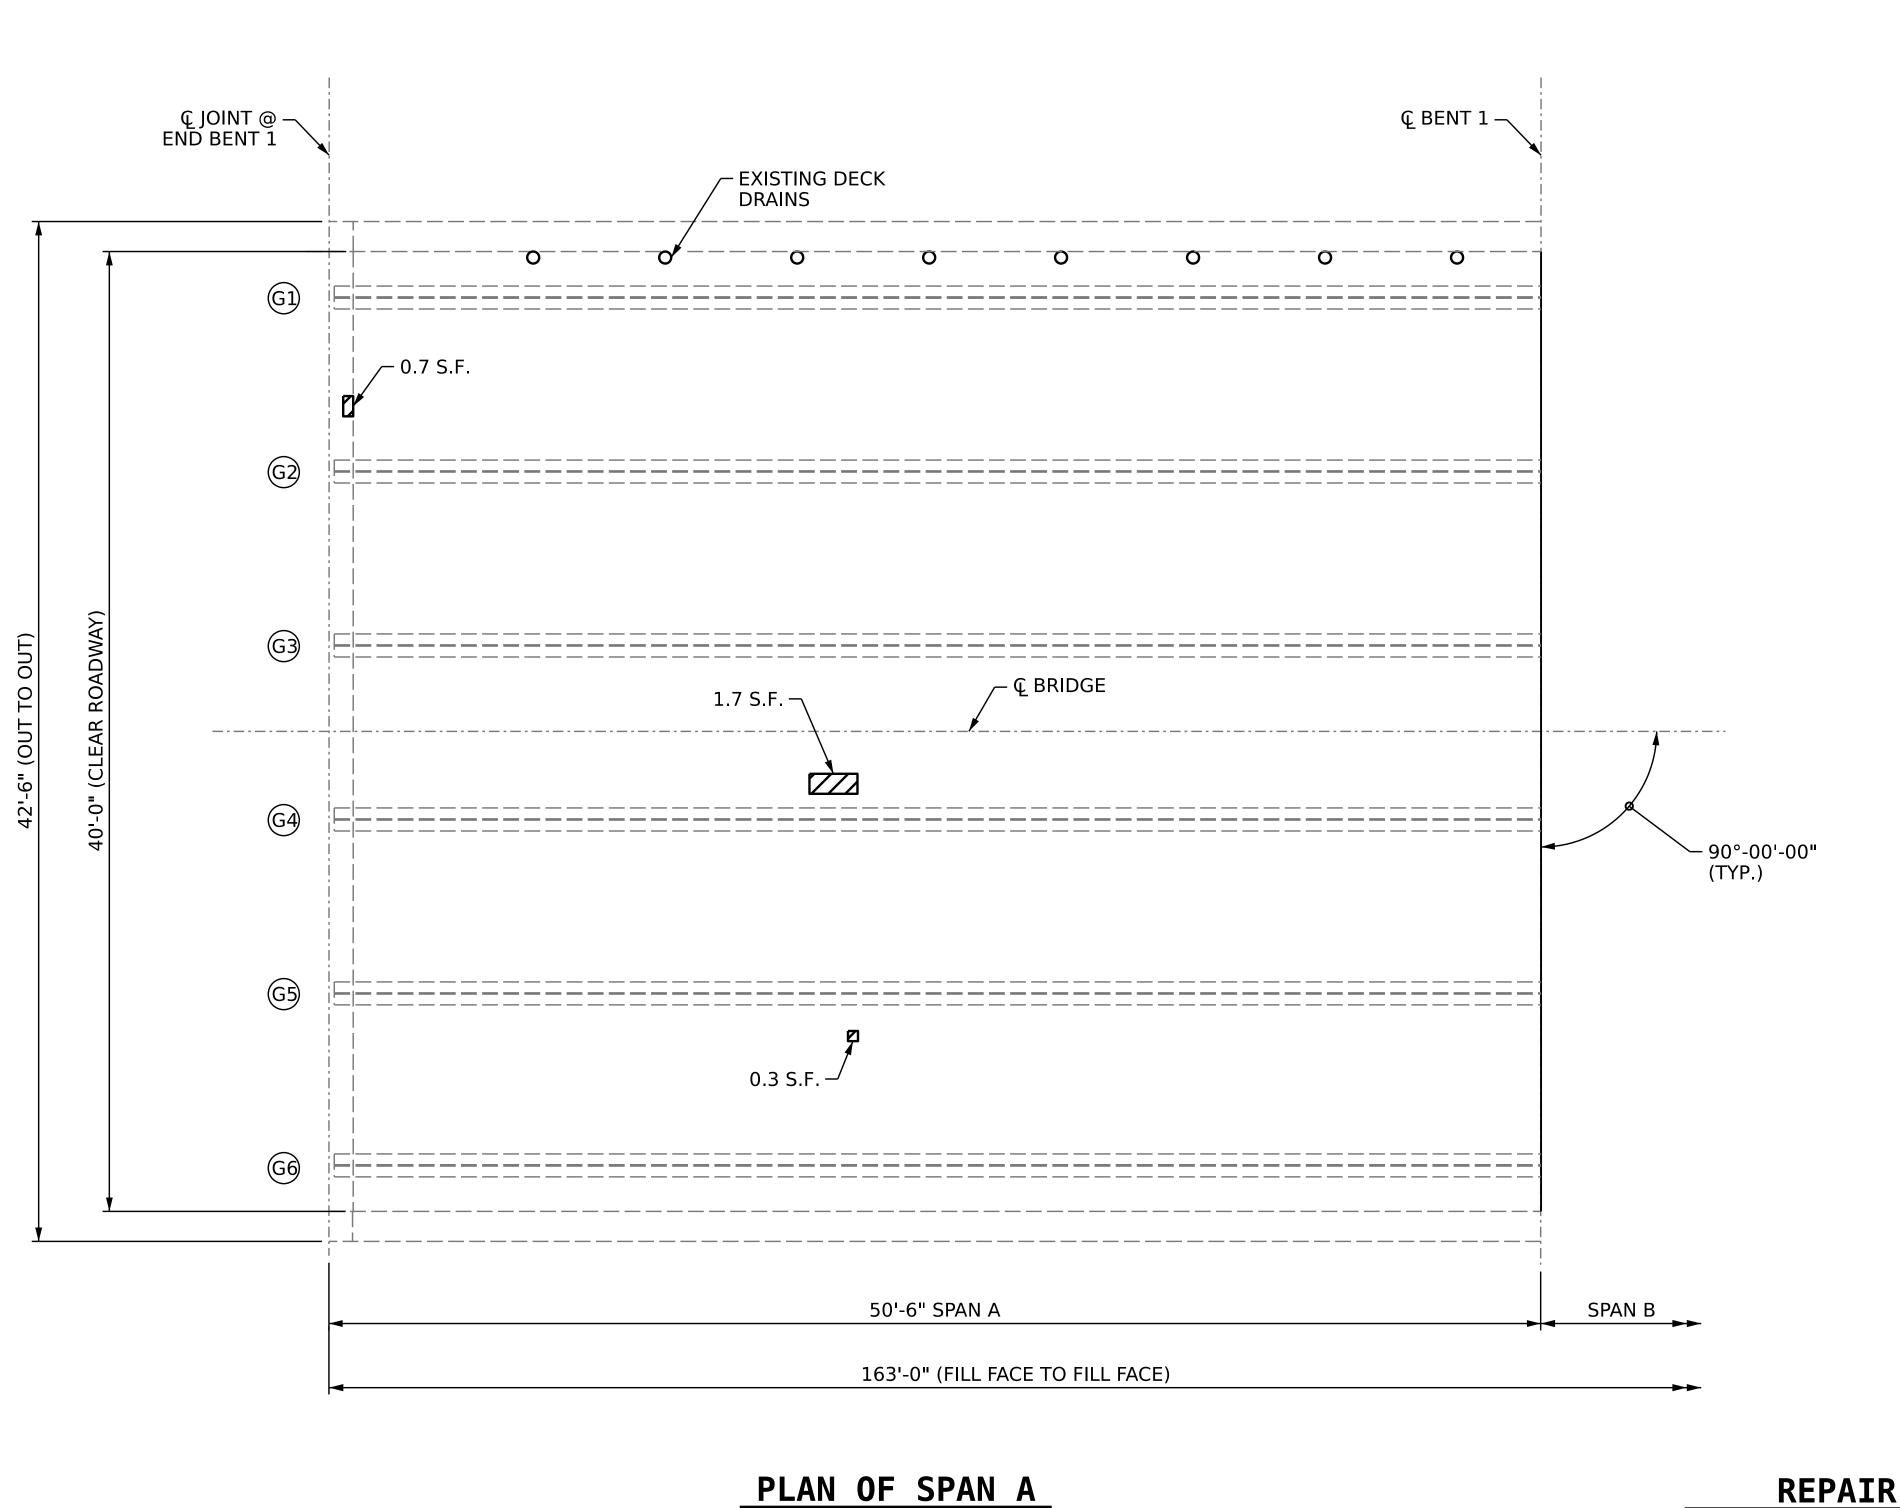
SHEET NO REVISIONS S2**-**6 DATE: DOCUMENT NOT CONSIDERED FINAL UNLESS ALL SIGNATURES COMPLETED

DECK UNDERSIDE REPAIR QUANTITY TABLE DECK UNDERSIDE REPAIRS SPAN A QUANTITIES **ESTIMATE** ACTUAL AREA VOLUME AREA VOLUME SHOTCRETE REPAIRS SF UNDERSIDE OF DECK 2.0 0.7 CONCRETE DIAPHRAGM 0.7 0.2 OVERHANG 0 VOLUME VOLUME CONCRETE REPAIRS CF UNDERSIDE OF DECK 0 0 CONCRETE DIAPHRAGM **OVERHANG**

VALUES IN CHART REPRESENT ESTIMATED REPAIR TOTALS AFTER REMOVAL OF UNSOUND CONCRETE, MIN. OF 1" BEHIND REBAR AND MIN. 1" CLEAR TO SAWCUT. SEE REPAIR DETAILS.

FOR DECK REPAIR DETAILS, SEE SHEET S2-9.

FOR OVERHANG & DIAPHRAGM REPAIR DETAILS, SEE S2-10.
