PROJECT NO. HI-0015 **COLUMBUS** COUNTY

230086 BRIDGE NO. ___

SHEET 2 OF 3 STATE OF NORTH CAROLINA

UNDERSIDE REPAIR SPAN B

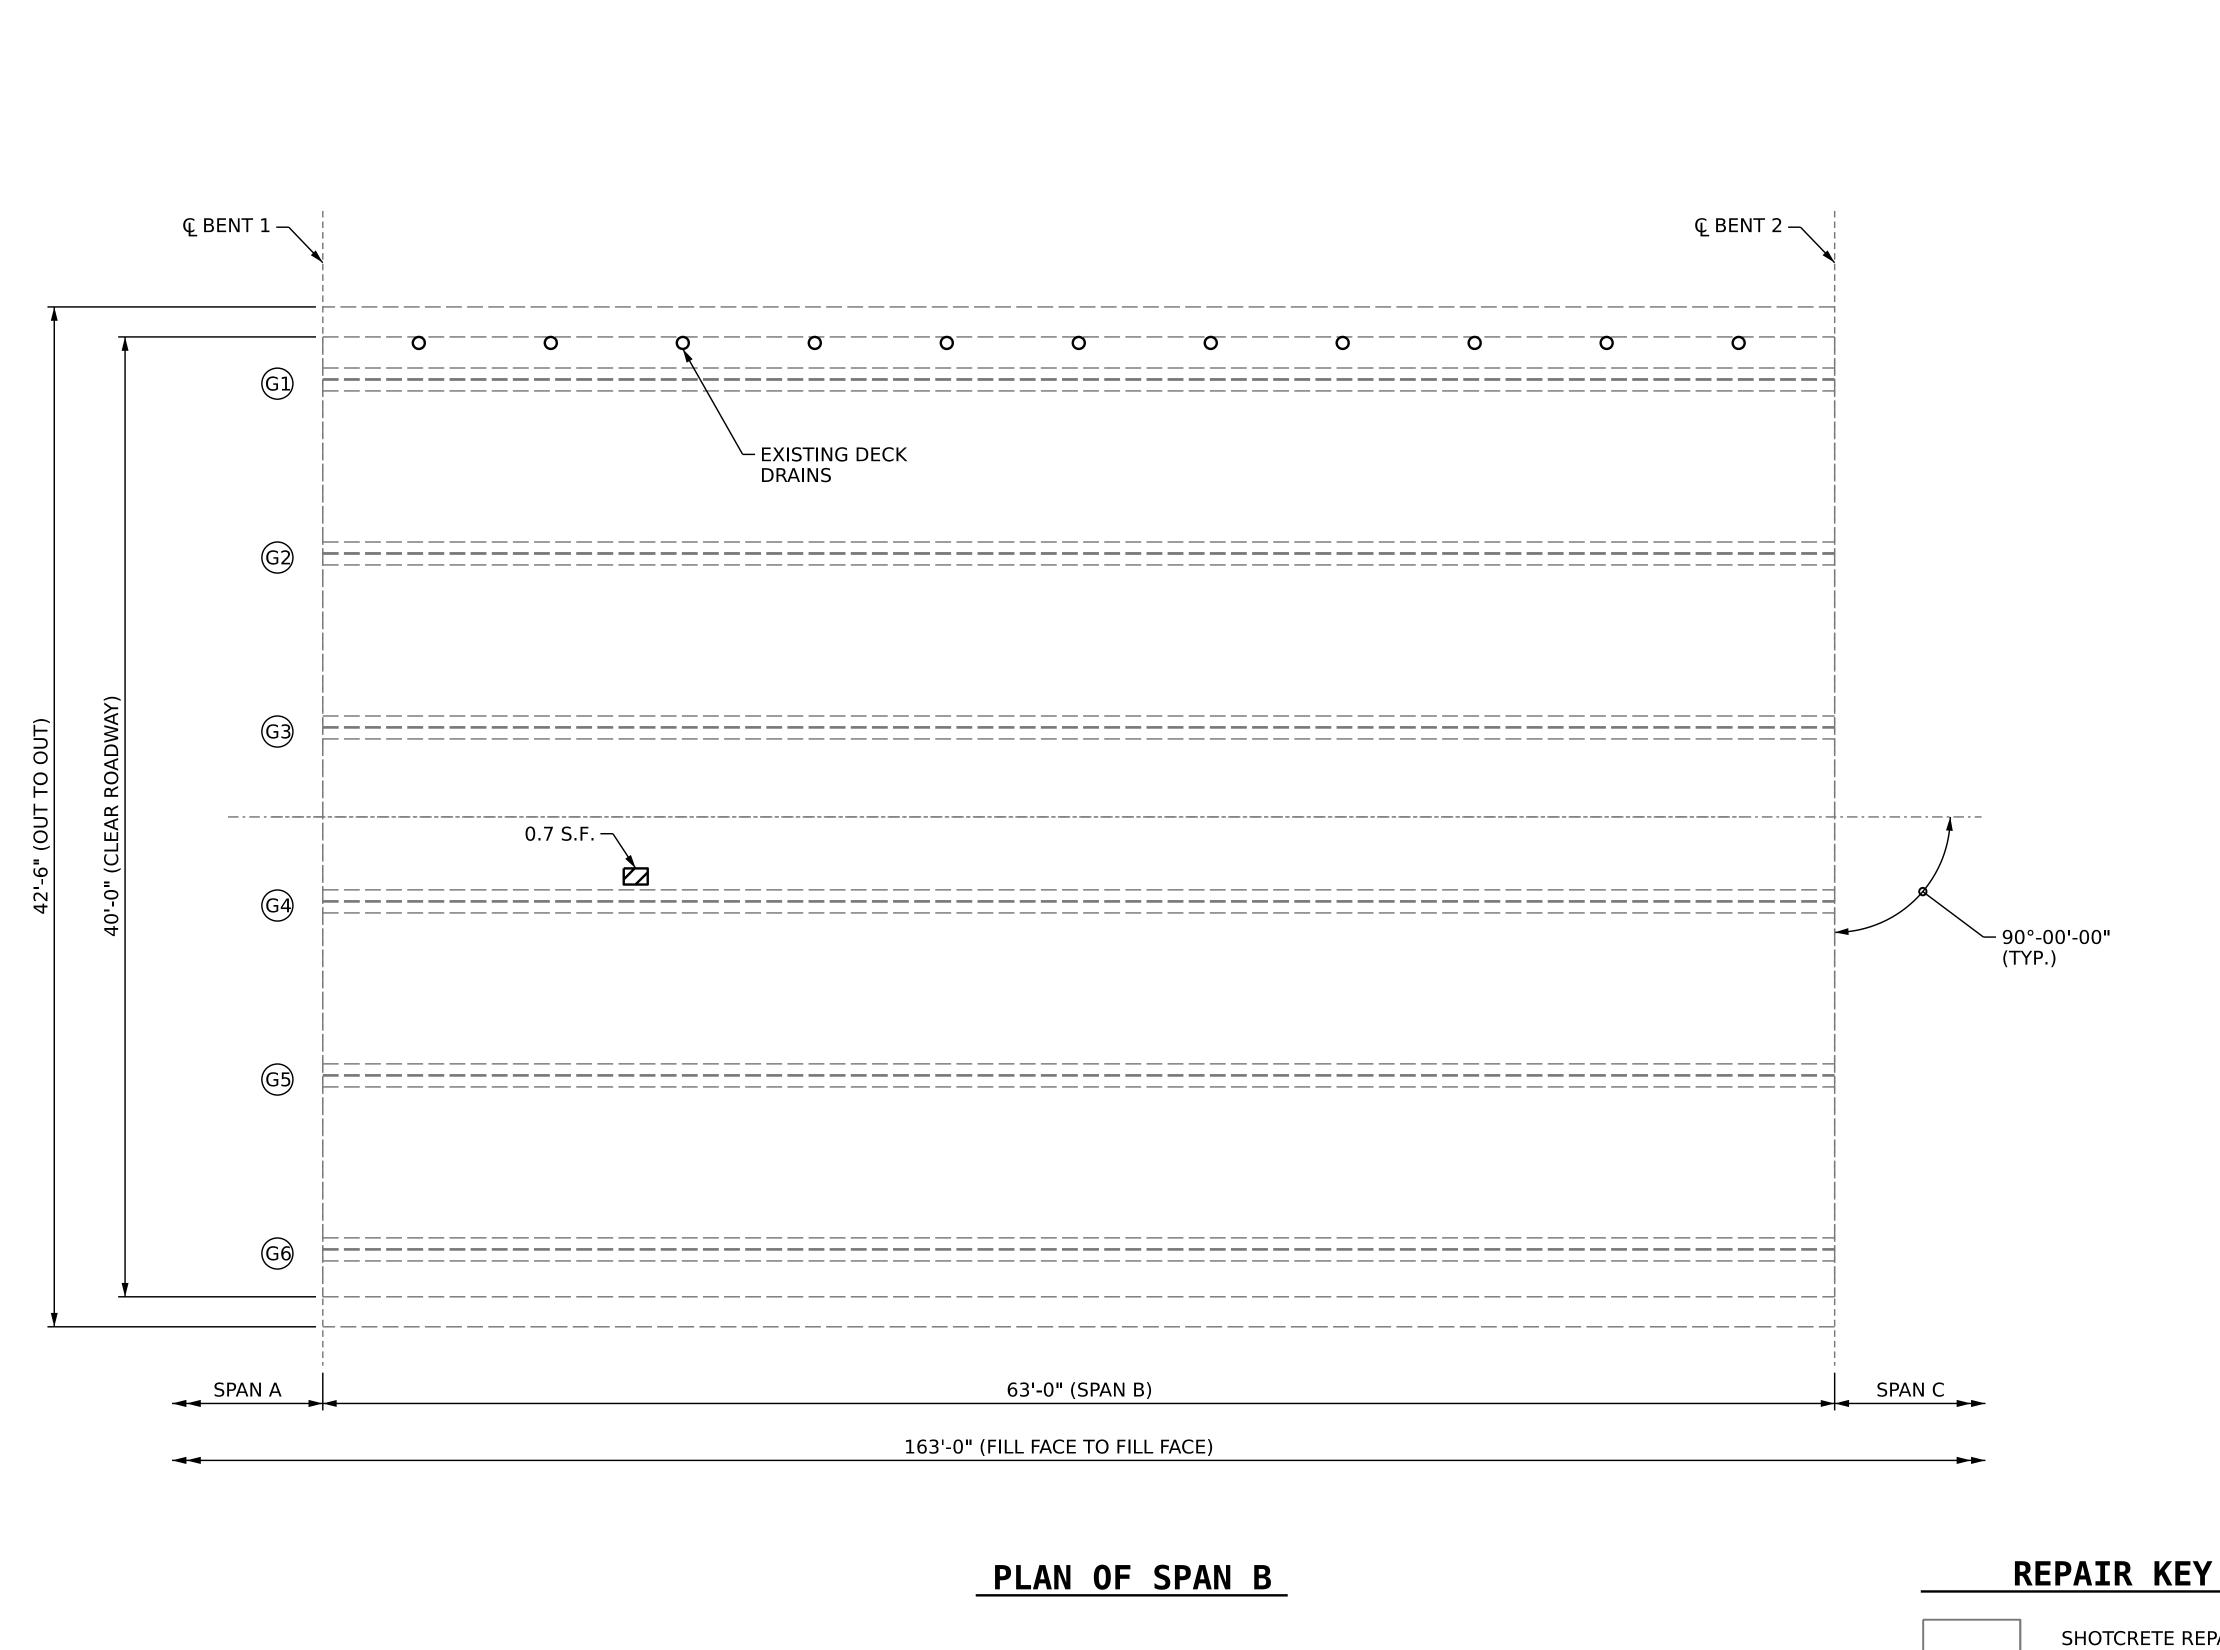
SHEET NO REVISIONS S2-7 DATE: DATE: BY: DOCUMENT NOT CONSIDERED FINAL UNLESS ALL SIGNATURES COMPLETED

DECK UNDERSIDE REPAIR QUANTITY TABLE DECK UNDERSIDE REPAIRS SPAN B QUANTITIES **ESTIMATE** ACTUAL VOLUME AREA VOLUME AREA SHOTCRETE REPAIRS SF UNDERSIDE OF DECK 0.7 0.2 CONCRETE DIAPHRAGM 0 0 OVERHANG 0 VOLUME AREA VOLUME CONCRETE REPAIRS CF UNDERSIDE OF DECK 0 0 CONCRETE DIAPHRAGM **OVERHANG**

VALUES IN CHART REPRESENT ESTIMATED REPAIR TOTALS AFTER REMOVAL OF UNSOUND CONCRETE, MIN. OF 1" BEHIND REBAR AND MIN. 1" CLEAR TO SAWCUT. SEE REPAIR DETAILS.

FOR DECK REPAIR DETAILS, SEE SHEET S2-9.
