PROJECT NO. I-5941				
	DURHAM COUNTY				
BRIDGE NO. 310108					
SHEET 3 OF 4					
DOCUMENT NOT CONSIDERED FINAL UNLESS ALL SIGNATURES COMPLETED Docusigned by: Havain AseAning 19141A6AF2EAN TH CAROL SEAL 20103 MGNEER	STATE OF NORTH CAROLINA DEPARTMENT OF TRANSPORTATION RALEIGH SUBSTRUCTURE REPAIR BENT 1 SPAN B FACE				
11/13/2023	REVISIONS SHEET NO.				
E.L. ROBINSON E N G I N E E R I N G LE N G I N E E R I N G LE N G I N E E R I N G LI Status S	NO. BY: DATE: NO. BY: DATE: S1-10 1 3

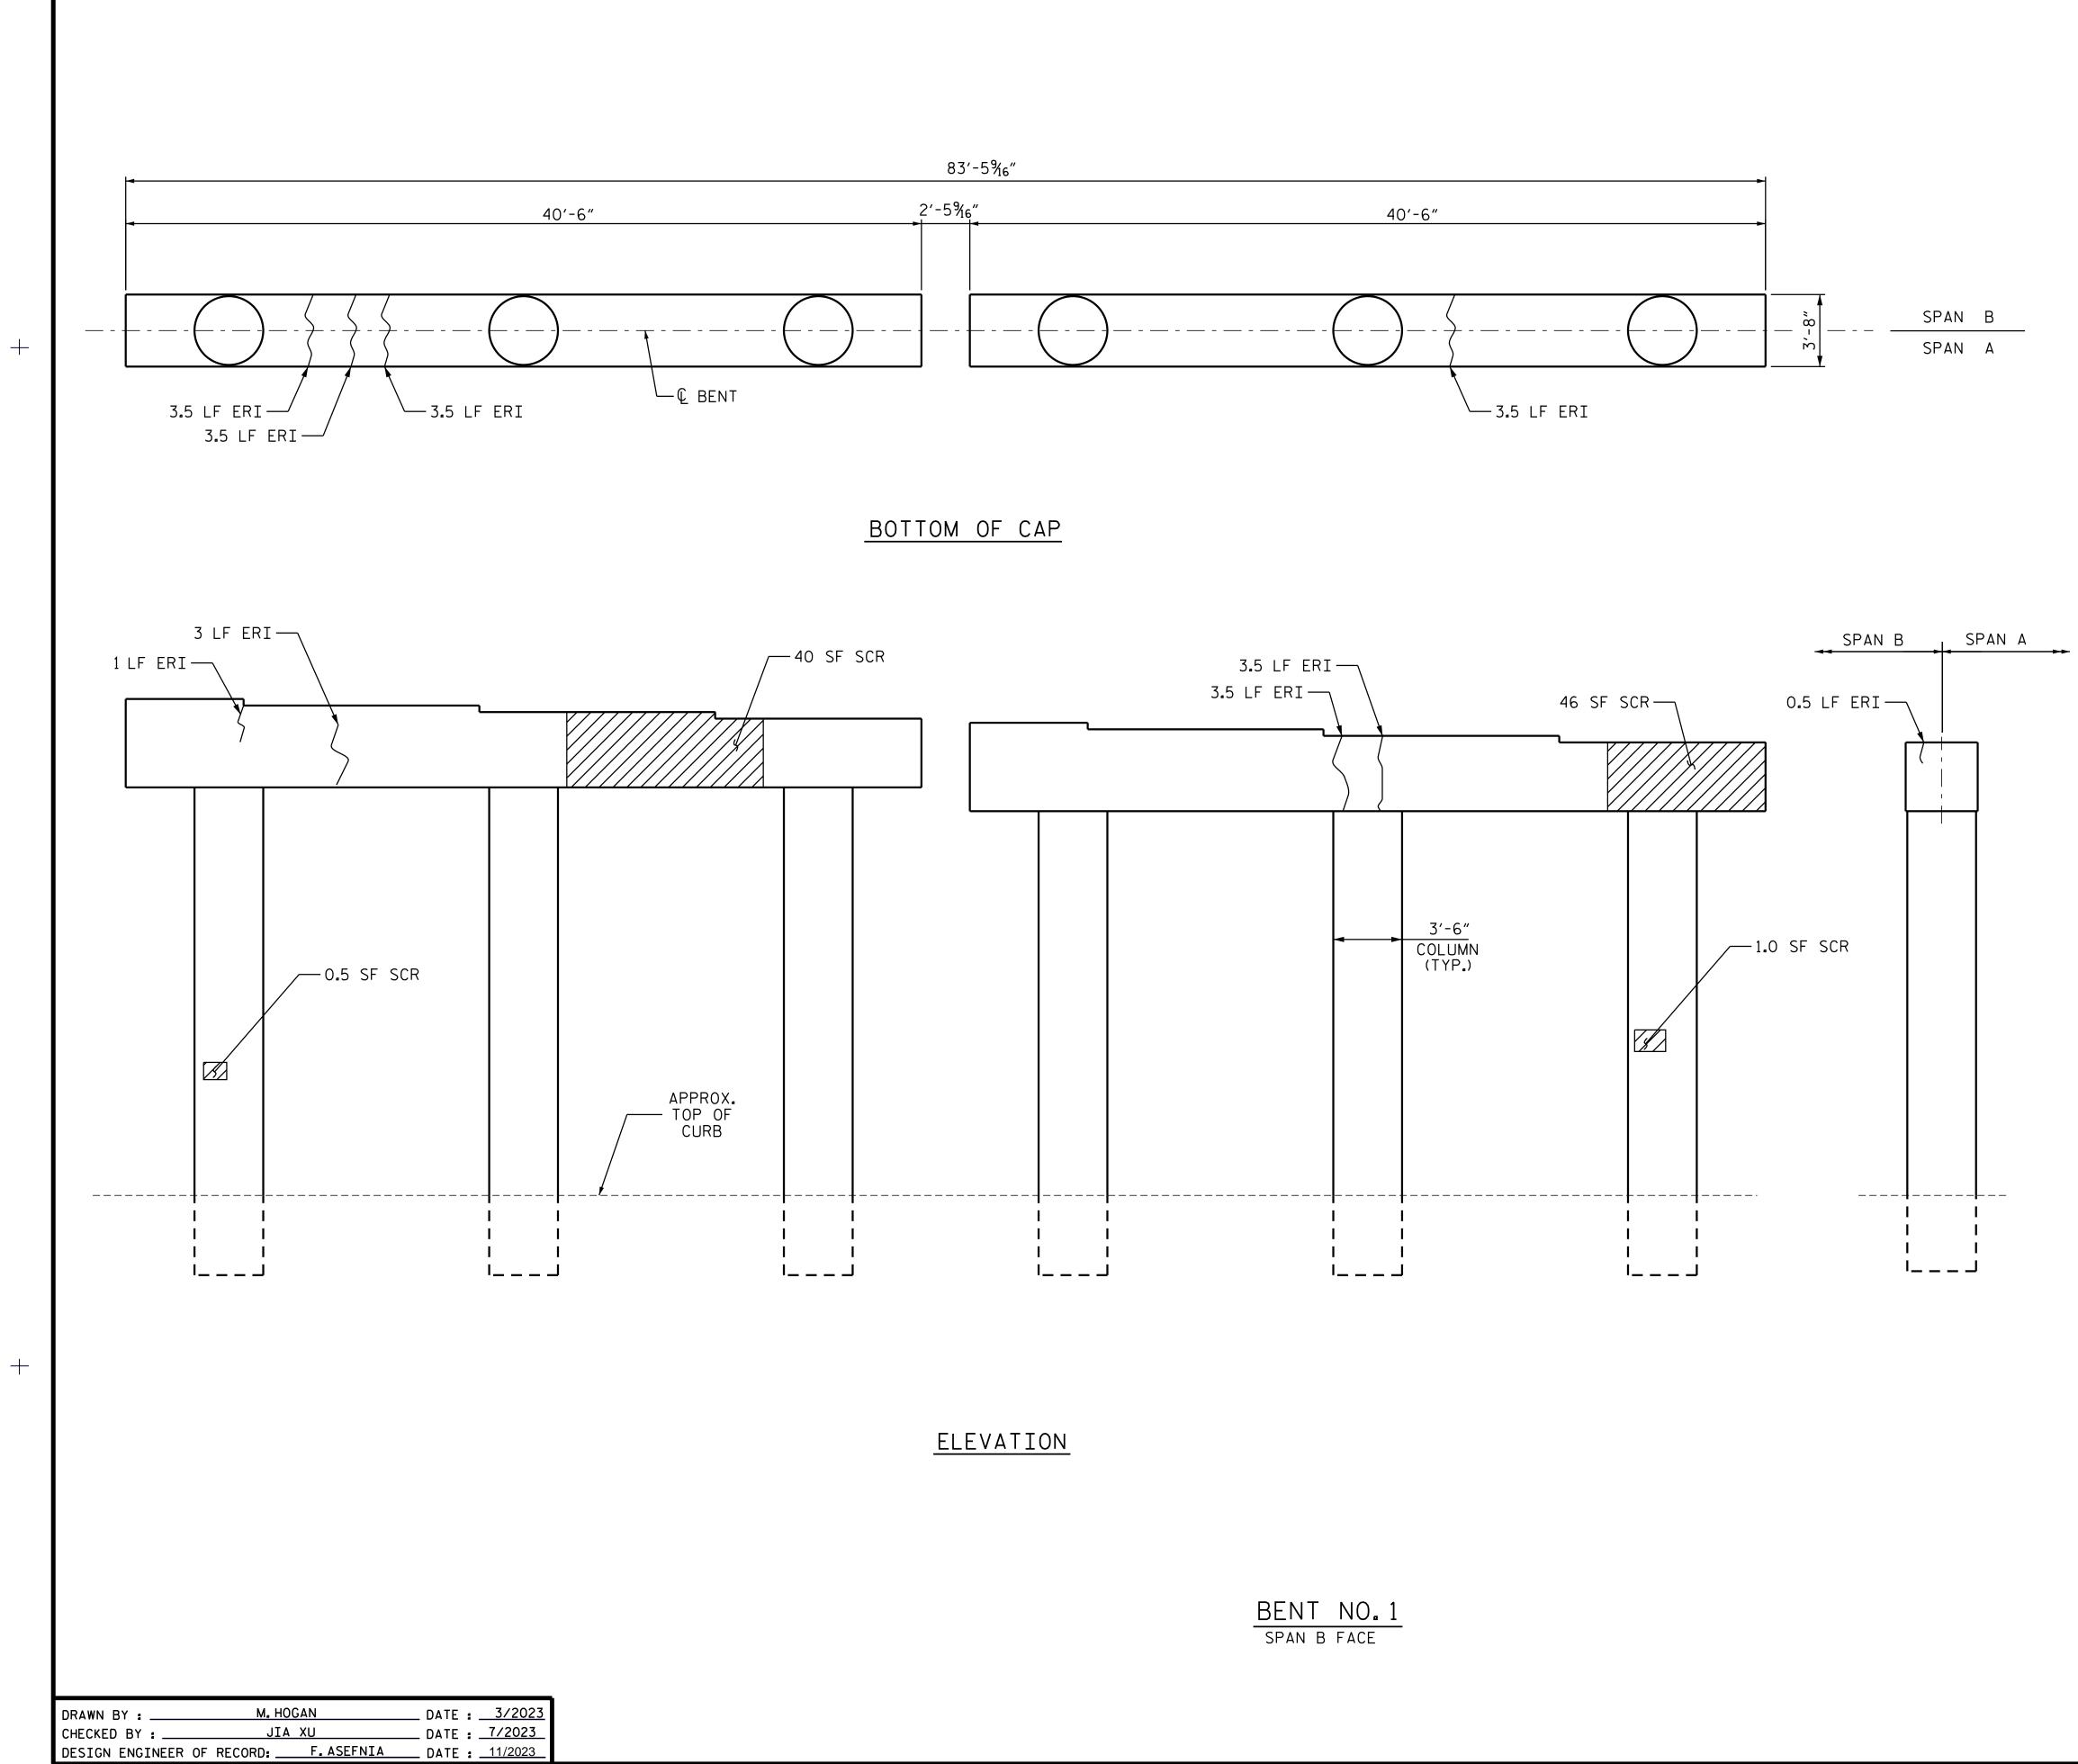
AS-BUILT REPAIR QUANTITY TABLE					
BENT 1 SPAN B FACE	QUANTITIES				
	ESTIMATE		ACTUAL		
SHOTCRETE REPAIRS	AREA SF	VOLUME CF	AREA SF	VOLUME CF	
САР	86.0	21.5			
COLUMN	1.5	0.4			
CONCRETE REPAIRS	AREA SF	VOLUME CF	AREA SF	VOLUME CF	
САР	0.0	0.0			
EPOXY RESIN INJECTION		LN.FT.		LN.FT.	
CAP		25.5			
COLUMN		0.0

CLEAN AND REMOVE DEBRIS FROM THE TOP OF THE CAP AND APPLY EPOXY PROTECTIVE COATING. EPOXY COATING SHALL BE APPLIED TO THE TOP SURFACE OF THE CAP. THE CONTRACTOR SHALL NOT COAT THE AREA OF THE CAP BENEATH THE MASONARY PLATES.FOR EPOXY COATING, SEE SPECIAL PROVISIONS.

SHOTCRETE REPAIRS MAY BE REPLACED WITH CONCRETE REPAIRS WITH THE APPROVAL OF THE ENGINEER.
