Structure Safety Report

4 Year Underwater Element Inspection

COUNTY: JOHNSTON STRUCTURE NUMBER: 500050 FREQUENCY: 48 MONTHS

FEATURE INTERSECTED: MIDDLE CREEK

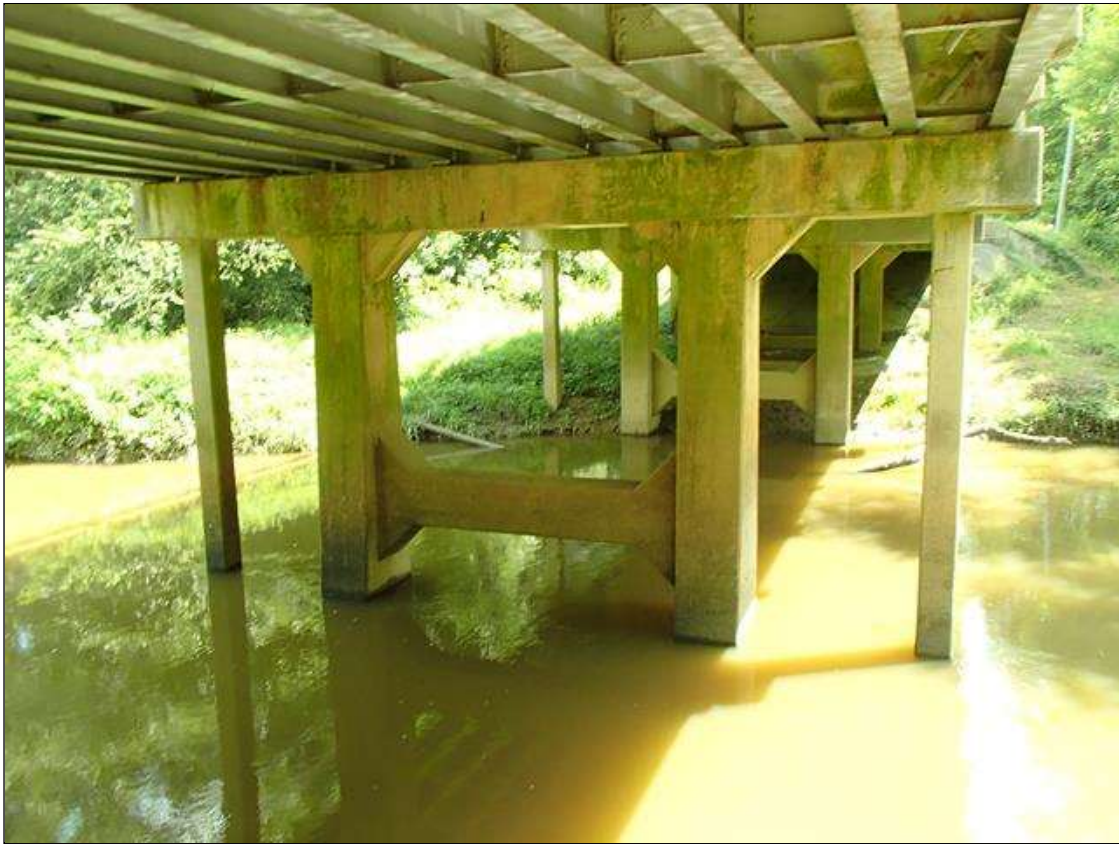
bent 1, span 1

Bent 1	Row 1	Piles and Columns	1							
Element: 226	Name	Prestressed Concrete Pile	Qty: 1	Lvl 2: 1	Lvl 3: 0	Lvl 4: 0	Maint. Qty: 0	5		
Defect Description:										
Underwater inspection:										
5' of Abrasion/Wear (PSC): Abrasion or wearing has exposed coarse aggregate but the aggregate remains secure in the concrete.

Bent 1	Row 1	Piles and Columns	2							
Element: 205	Name	Reinforced Concrete Column	Qty: 1	Lvl 2: 1	Lvl 3: 0	Lvl 4: 0	Maint. Qty: 0	5		
Defect Description:										
Underwater inspection:										
5 Feet of Abrasion/Wear (RC): Abrasion or wearing has exposed coarse aggregate but the aggregate remains secure in the concrete. 1/16" cracks on f-2 and f-4 from m/l to w/l.

Bent 1	Row 1	Piles and Columns	3							
Element: 205	Name	Reinforced Concrete Column	Qty: 1	Lvl 2: 1	Lvl 3: 0	Lvl 4: 0	Maint. Qty: 0	5		
Defect Description:										
Underwater inspection:										
5 Feet of Abrasion/Wear (RC): Abrasion or wearing has exposed coarse aggregate but the aggregate remains secure in the concrete. 1/16" cracks on f-2 and from m/l to w/l.

Bent 1	Row 1	Piles and Columns	4							
Element: 226	Name	Prestressed Concrete Pile	Qty: 1	Lvl 2: 1	Lvl 3: 0	Lvl 4: 0	Maint. Qty: 0	5		
Defect Description:										
Underwater inspection:										
5' of Abrasion/Wear (PSC): Abrasion or wearing has exposed coarse aggregate but the aggregate remains secure in the concrete.

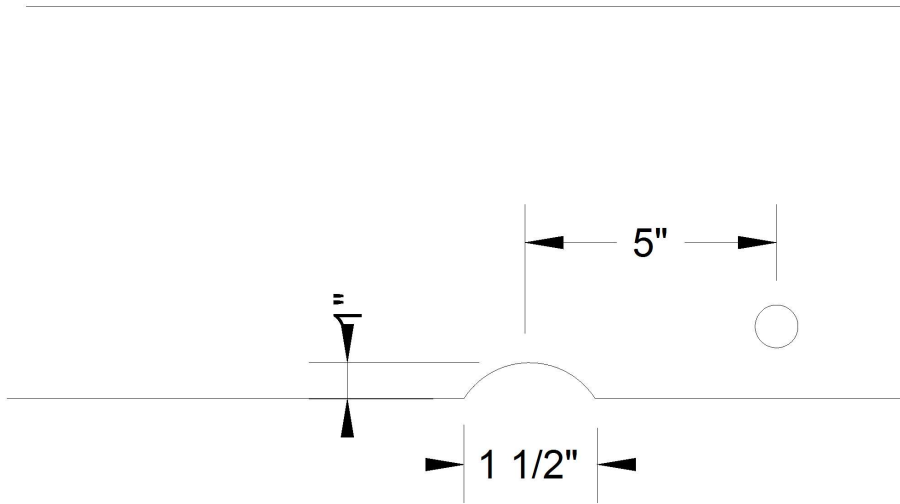
Title
CONDITION 2

RT BOTTOM FLANGE OF BEAM 1 SPAN 2 AT BENT 2
