NC DEPARTMENT OF TRANSPORTATION  
 DIVISION OF HIGHWAYS  
 STRUCTURE MANAGEMENT UNIT

ATTENTION: **prompt action request, sketches revised, lateral clearances revised**

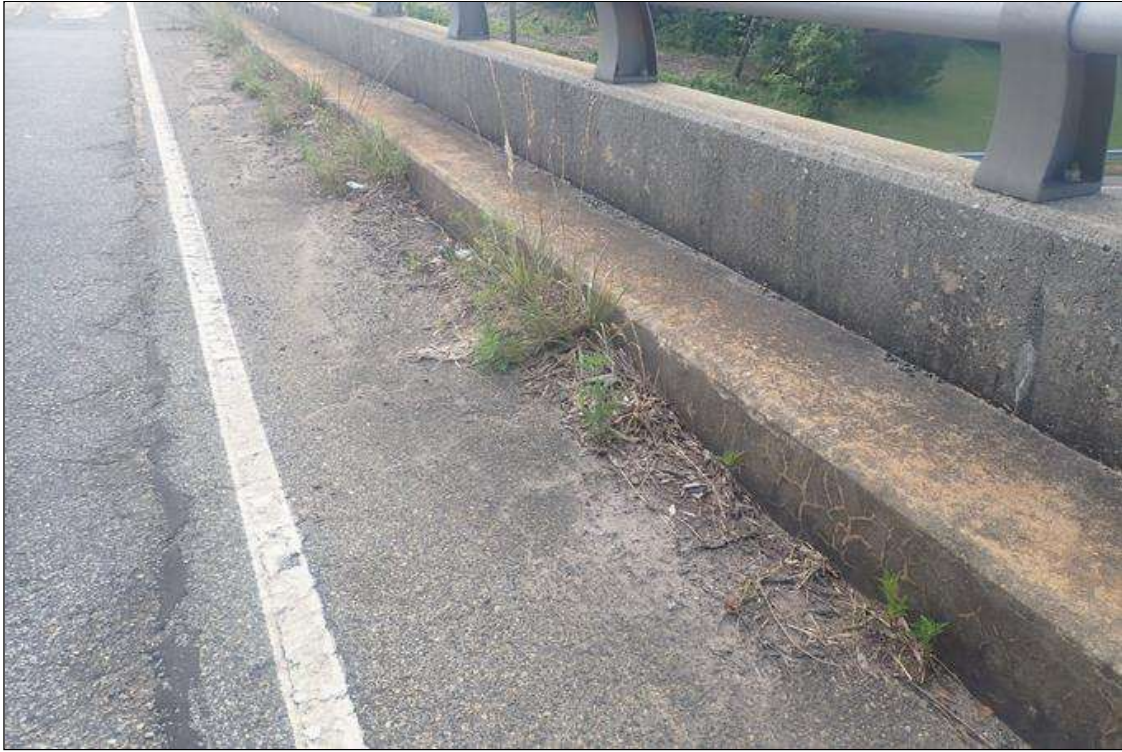
along both curbs, debris and vegetation, inhibits drainage

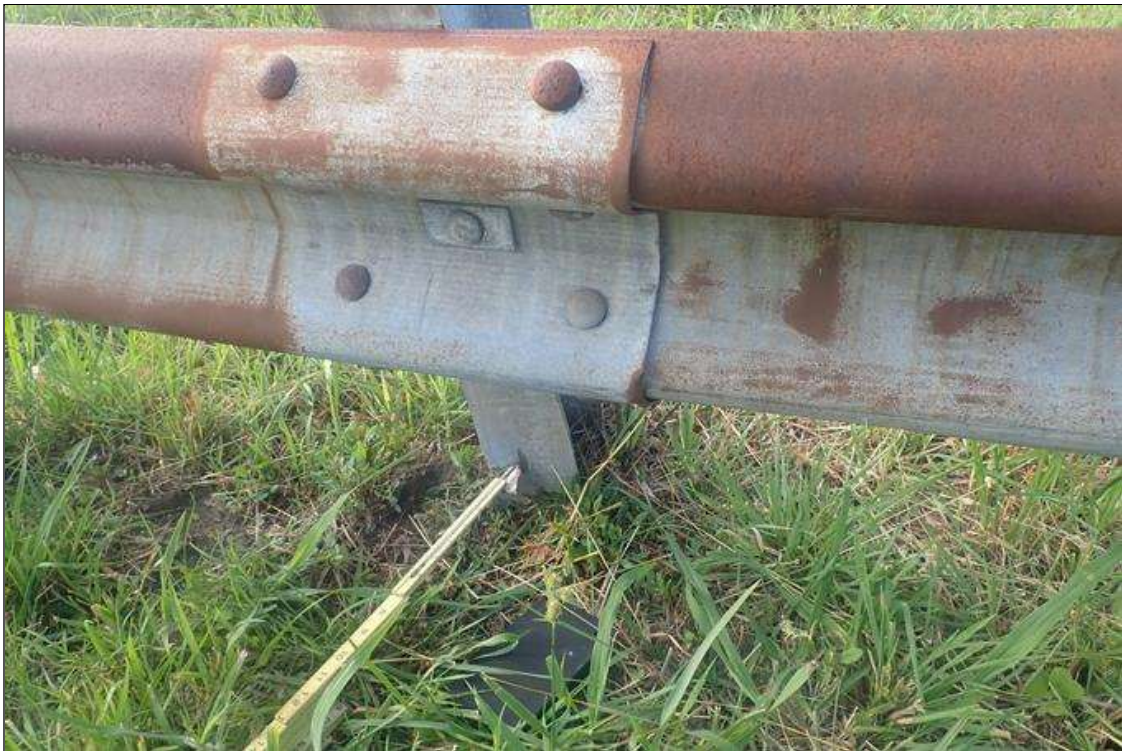
(PAR) northwest guardrail, at center, improper lap and torn post

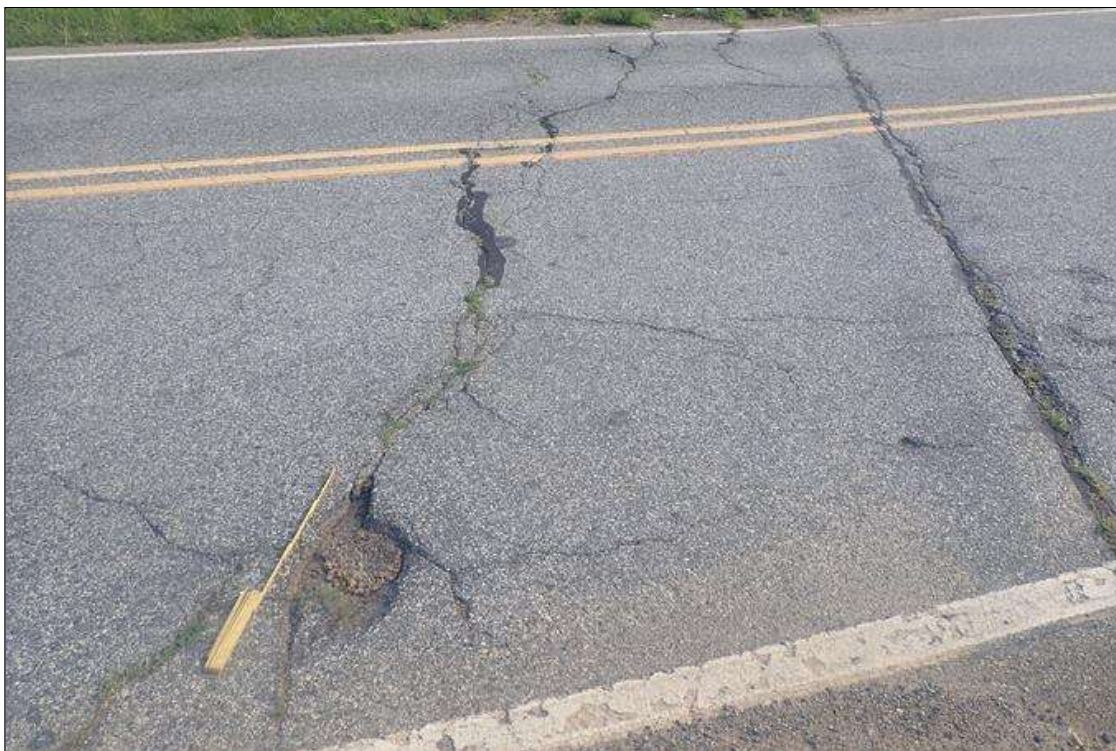
north approach asphalt, at bridge, transverse/map cracks (up to 1/2 inch); southbound lane, pothole (2 feet x 1 foot x 2 inch deep)

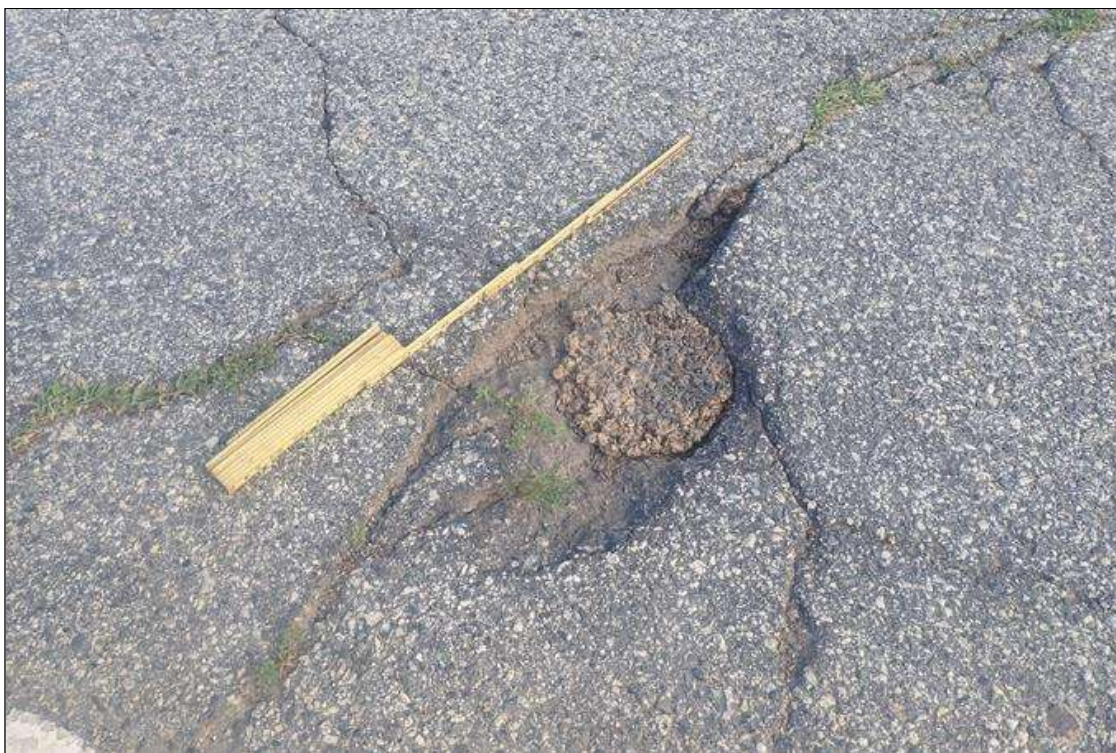
north approach asphalt, at bridge, transverse/map cracks (up to 1/2 inch); southbound lane, pothole (2 feet x 1 foot x 2 inch deep)

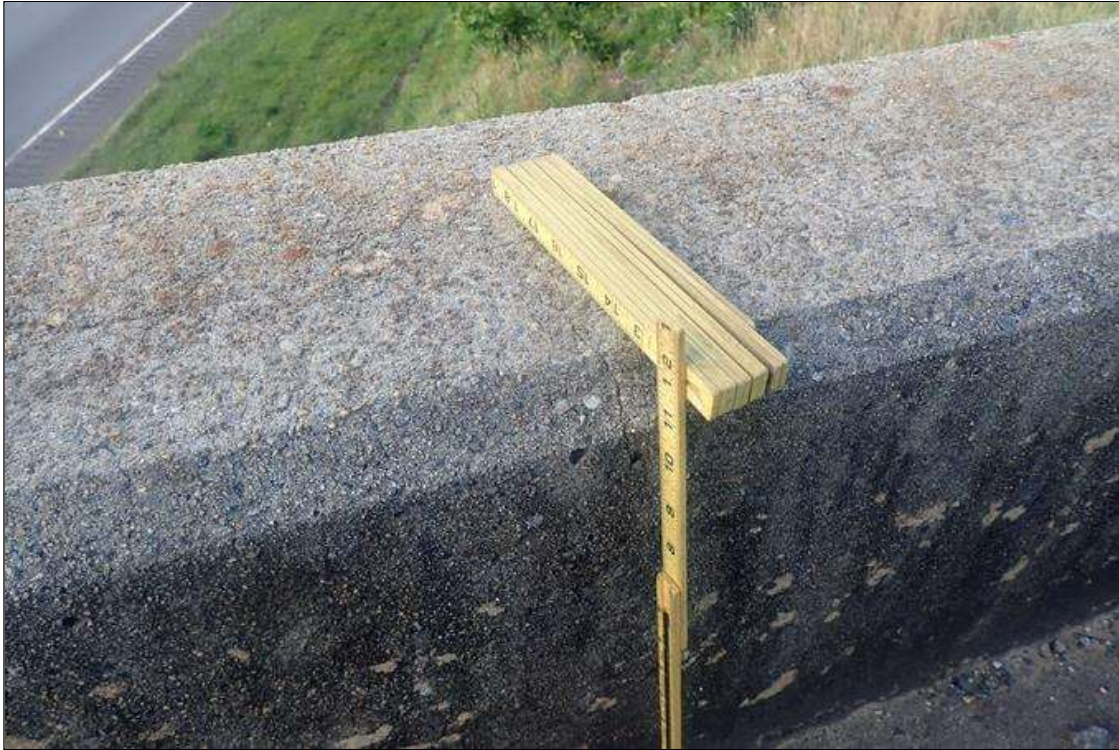
Span 4 Left Bridge Rail: HAIRLINE MAP CRACKING IN CURB PORTION OF RAIL AND HAIRLINE TRANSVERSE CRACKS IN TOP OF PARAPET AT VARIOUS LOCATIONS ALONG RAIL

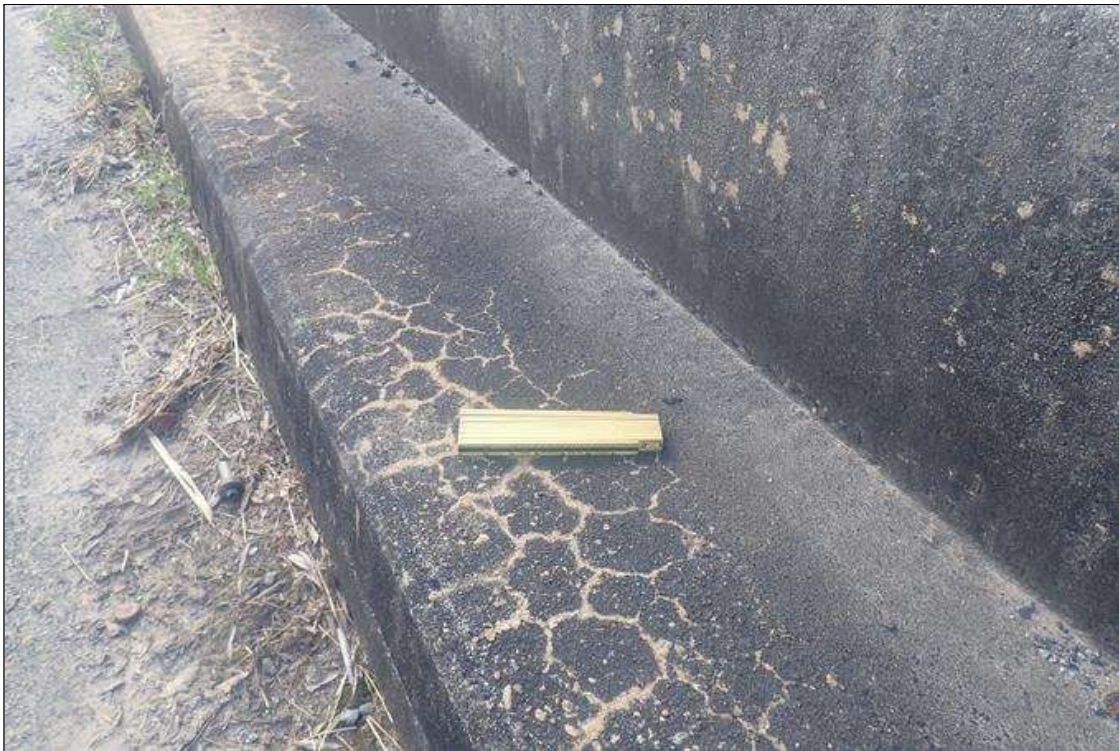
Span 4 Left Bridge Rail: HAIRLINE MAP CRACKING IN CURB PORTION OF RAIL AND HAIRLINE TRANSVERSE CRACKS IN TOP OF PARAPET AT VARIOUS LOCATIONS ALONG RAIL

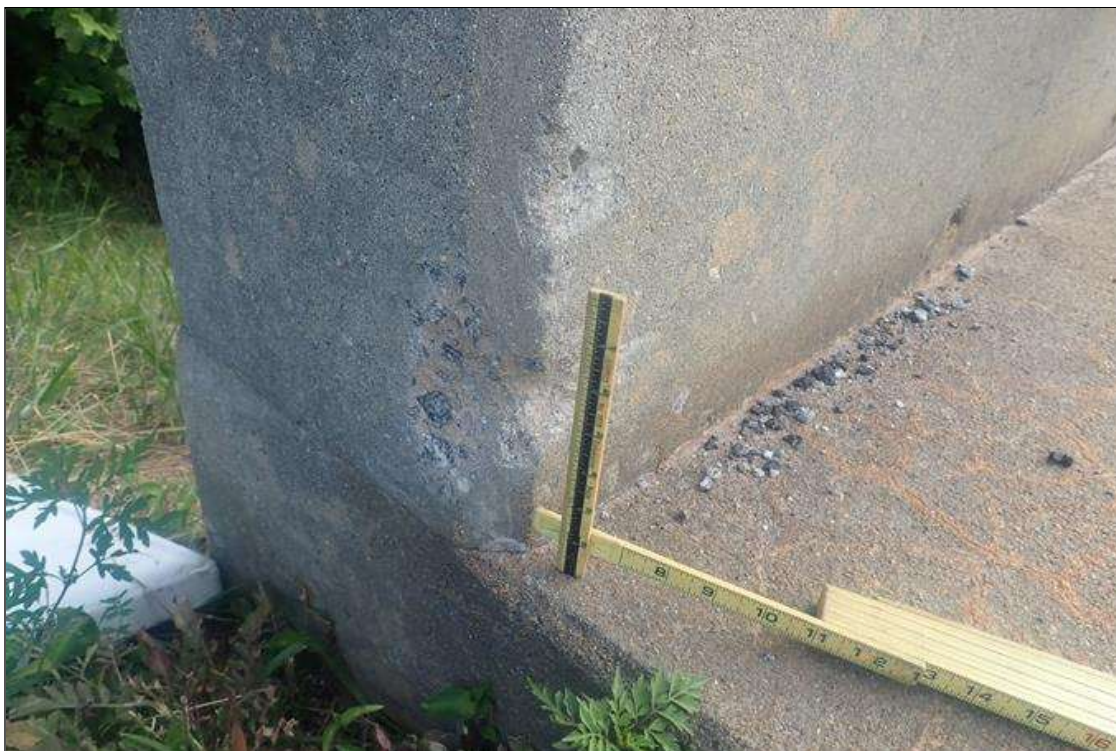
Span 4 Right Bridge Rail: concrete end post, spall (4 inch x 2 inch x 1/2 inch deep)

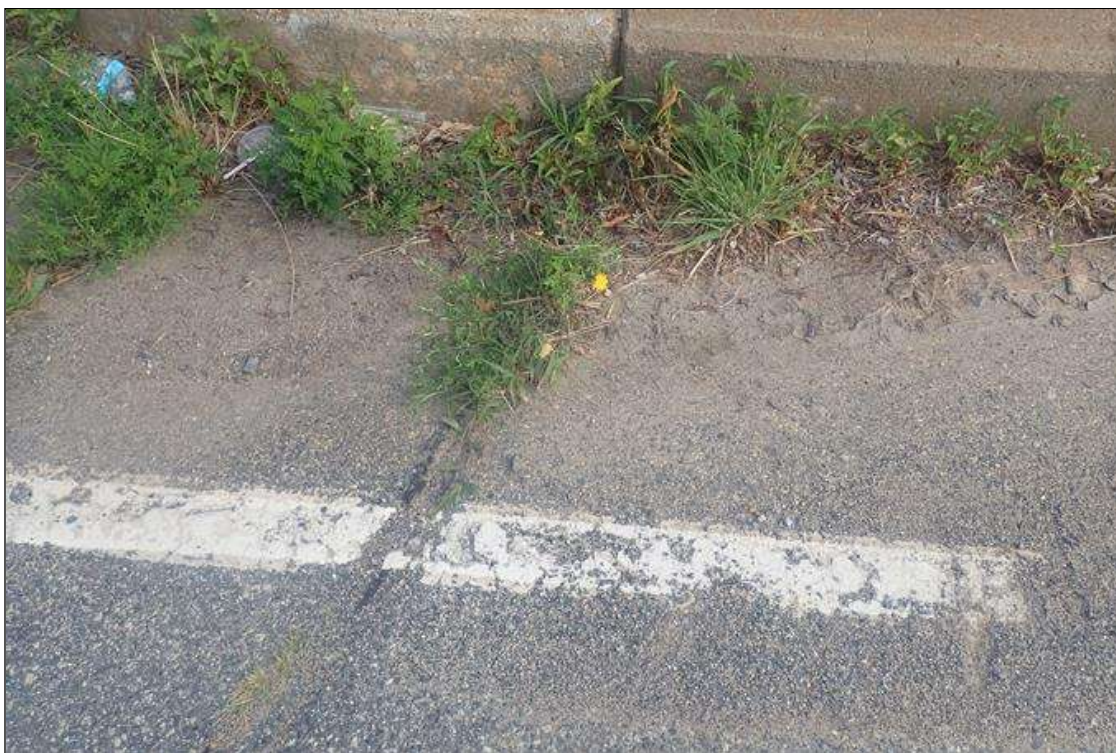
Span 4 Expansion Joint: DEBRIS IMPACTION AND VEGETATION GROWTH IN JOINT AT BOTH GUTTERLINES FOR FIRST 3 FEET

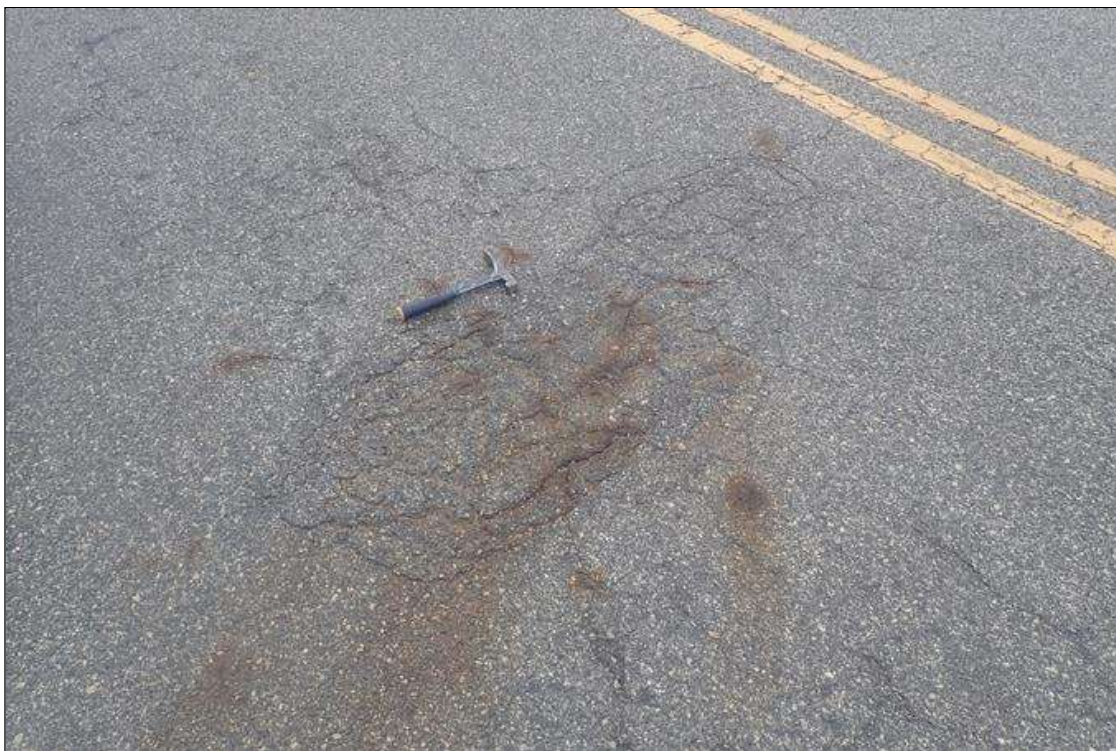
Span 4 Wearing Surface: northbound lane, 10 feet from end bent 2, map cracks (up to 1/2 inch x 7 feet x 4 feet) with rust stains, area sounds delaminated

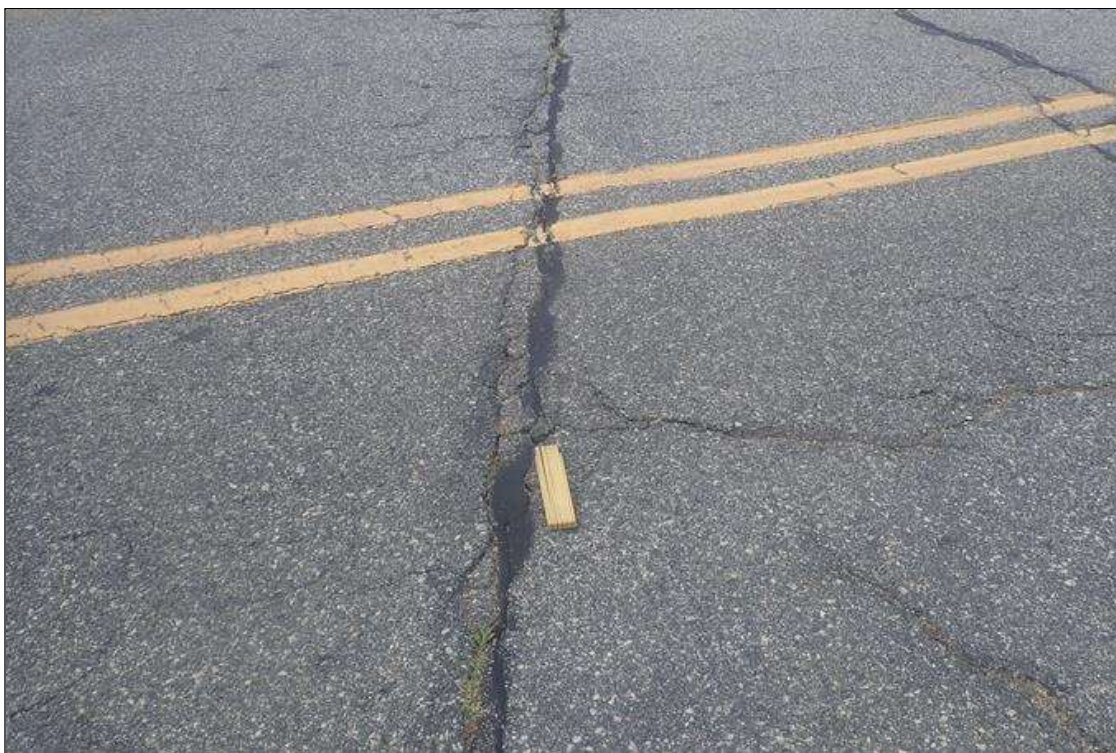
Span 4 Wearing Surface: 1/2 inch full length transverse crack at abutment 2

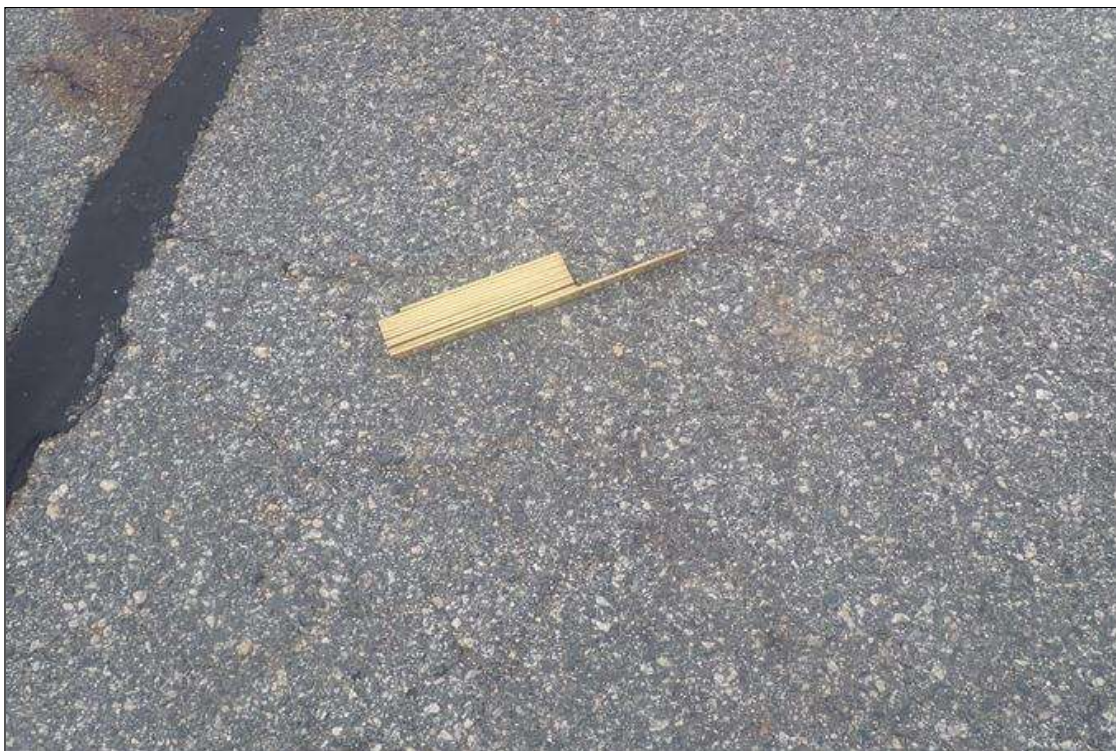
Span 4 Wearing Surface: northbound lane, at random, areas of map cracks (up to 1/8 inch x 2 feet x 3 feet), some areas sound delaminated

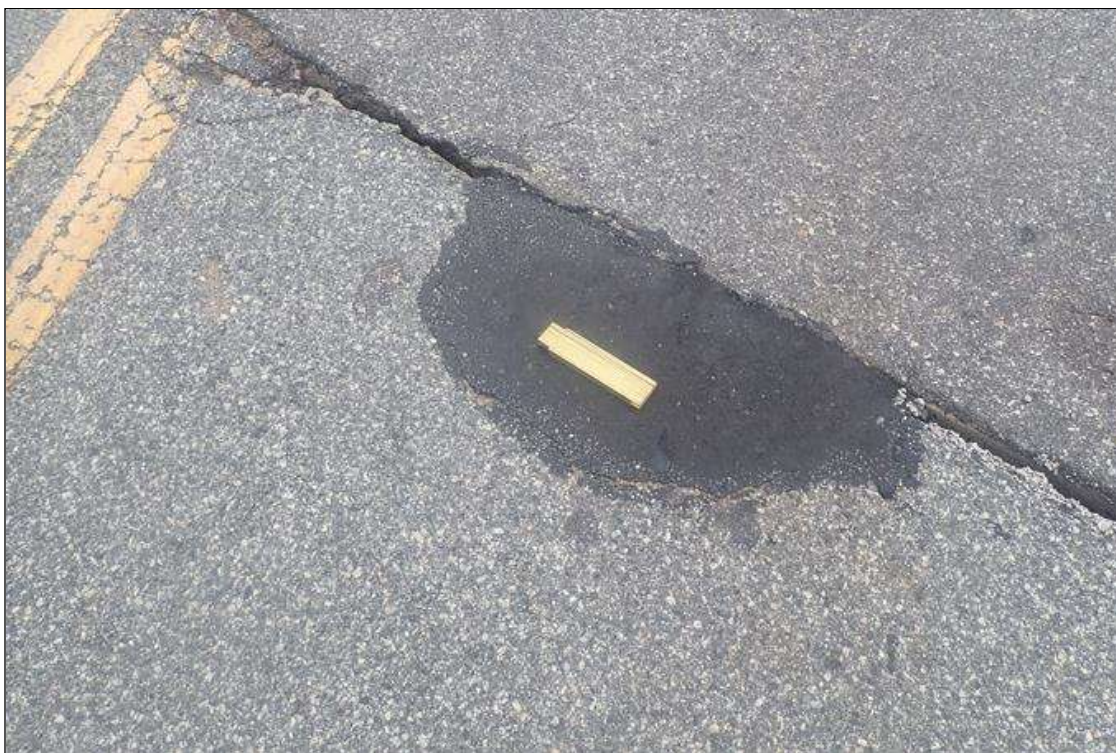
Span 4 Wearing Surface: southbound lane, at bent 3, patch (2.5 feet x 1.5 feet)

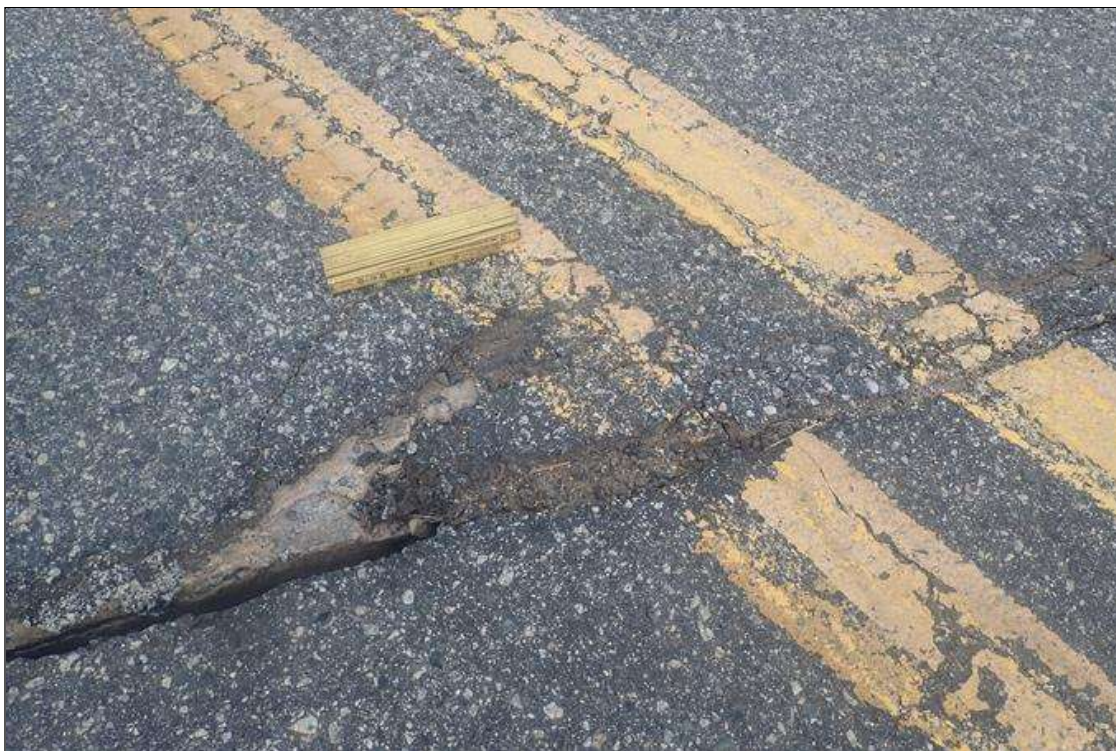
Span 4 Wearing Surface: centerline, at bent 3, pothole (2 feet x 9 inch x full depth)

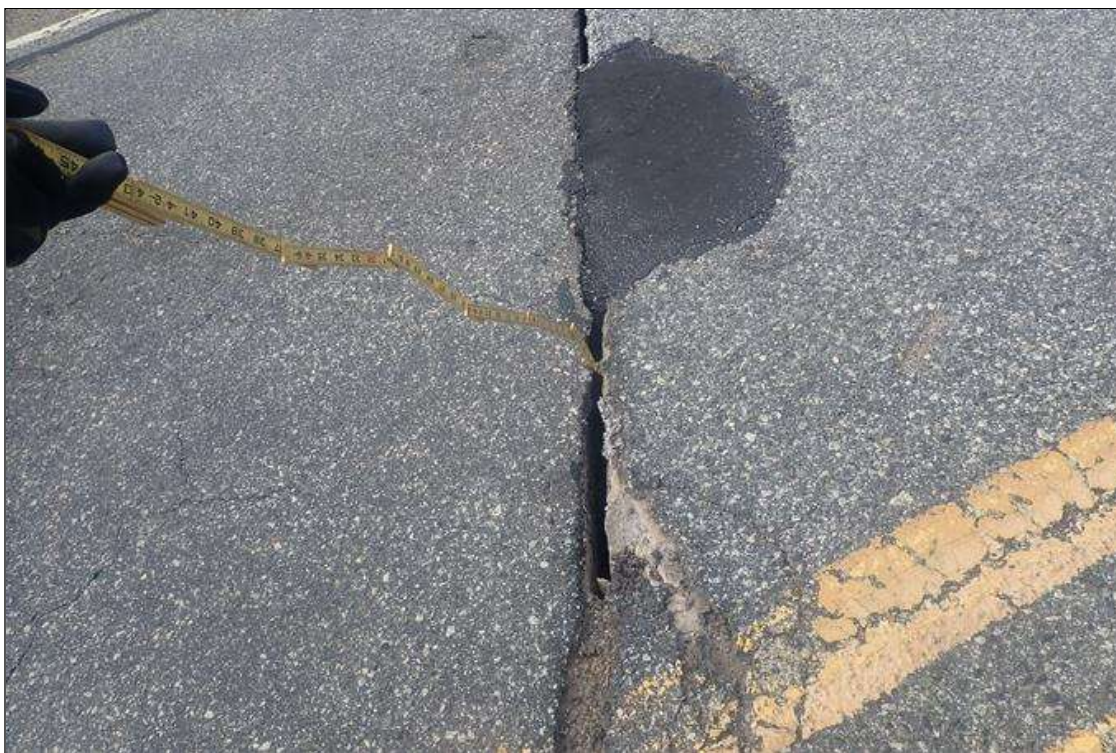
Span 4 Expansion Joint: southbound lane, joint material missing (9 feet)

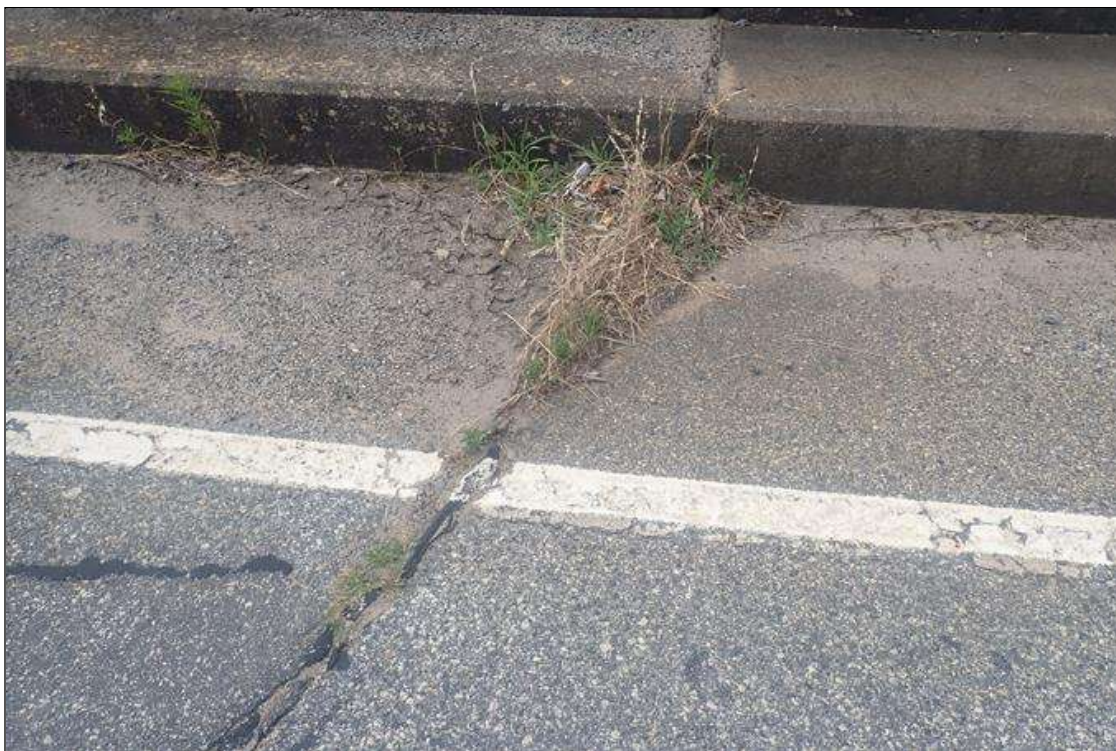
Span 4 Expansion Joint: DEBRIS IMPACTION AND VEGETATION GROWTH IN JOINT AT BOTH GUTTERLINES FOR FIRST 3 FEET

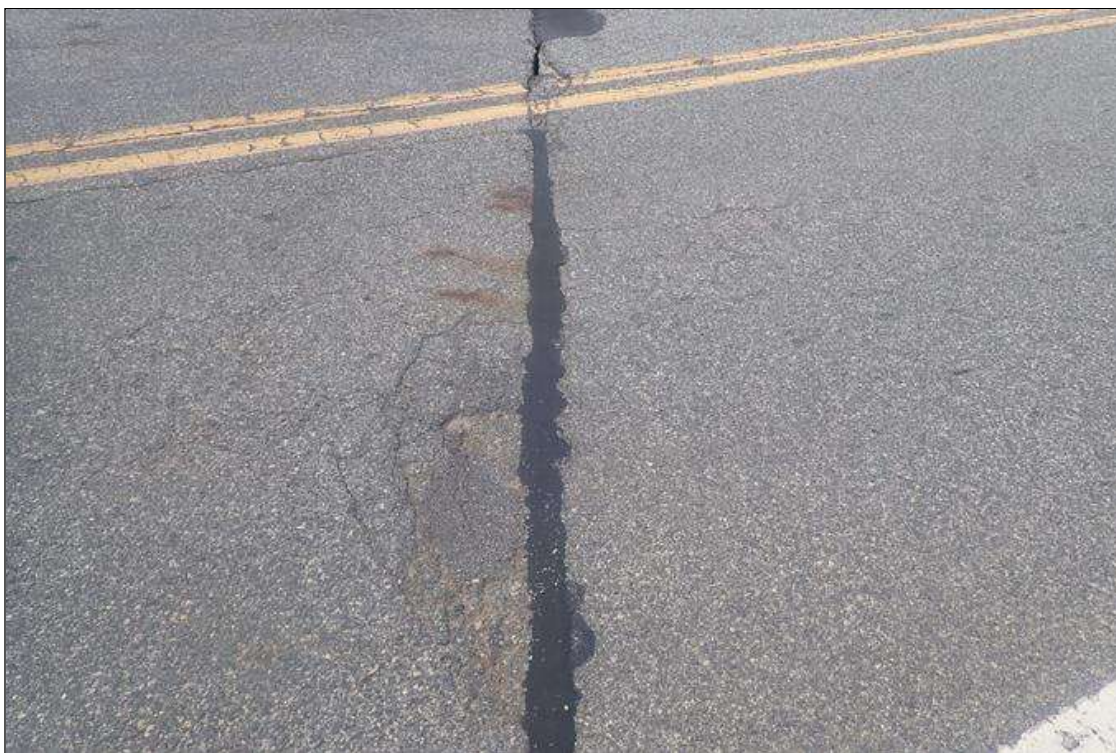
Span 3 Wearing Surface: northbound lane at bent 3 joint, sealed transverse crack (12 foot)

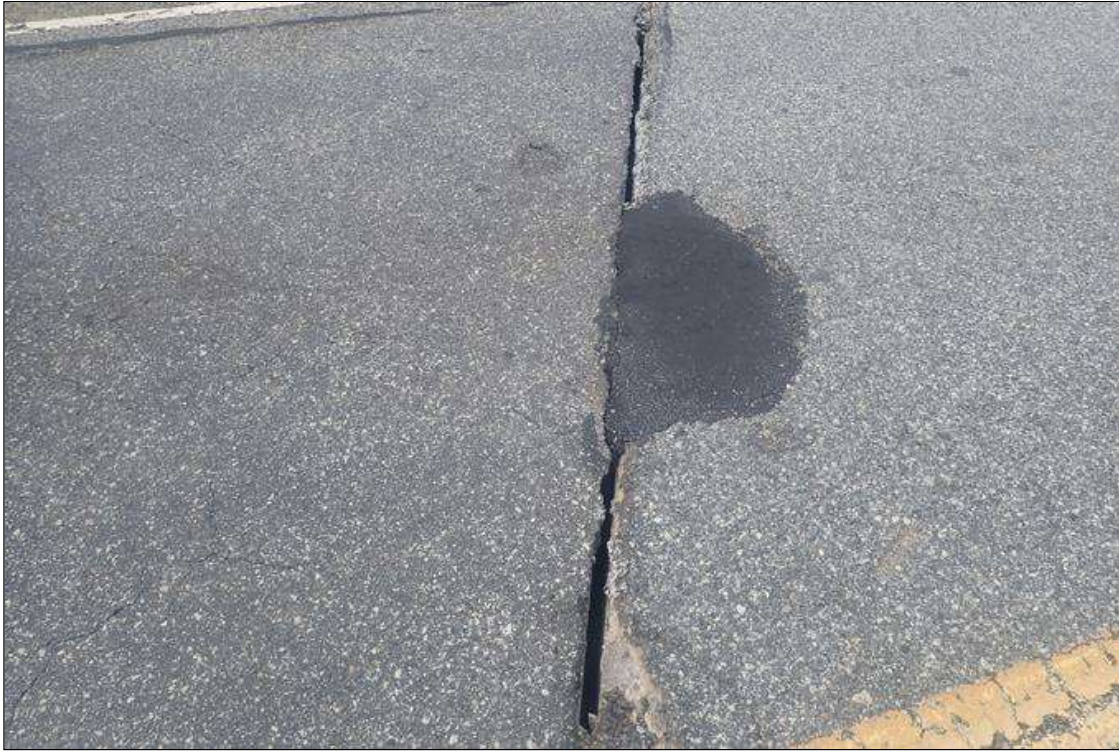
Span 3 Wearing Surface: ASPHALT PATCH MISSING OVER PIER 3 JOINT 9 FEET LONG. JOINT IS MISSING WITH TOP OF CAP VISIBLE THROUGH OPENING.

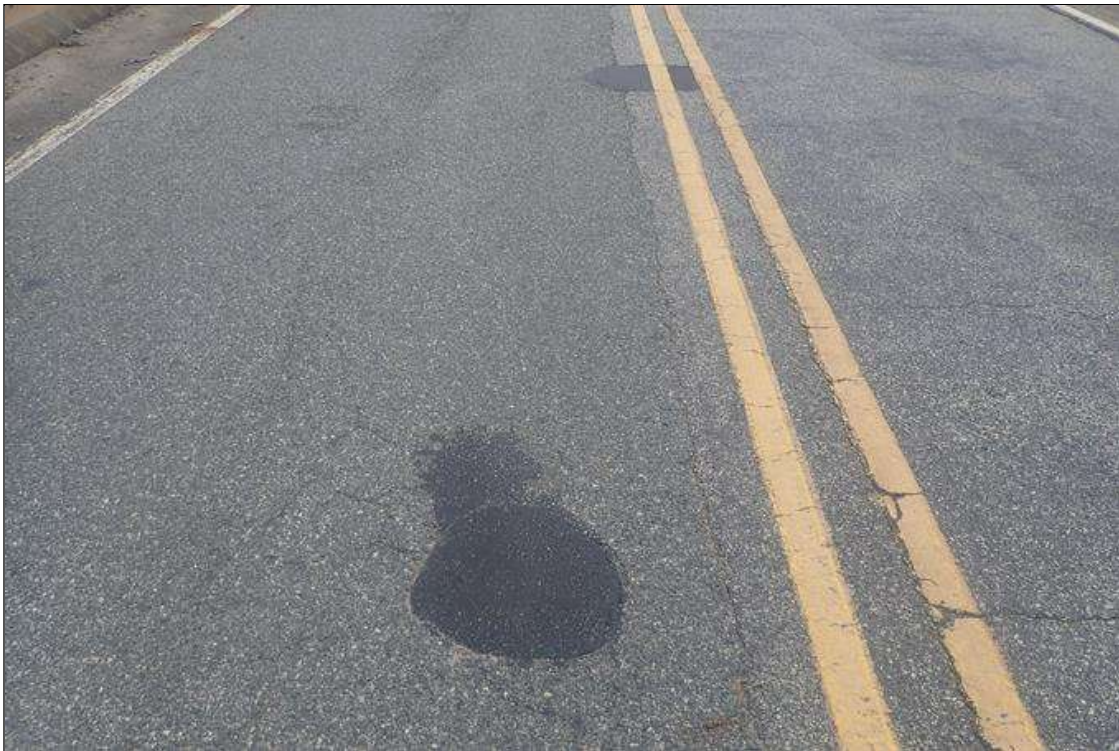
Span 3 Wearing Surface: TWO SOUND ASPHALT PATCHED AREAS UP TO 2 FEET X 2 FEET IN NORTH BOUND TRAVEL LANE

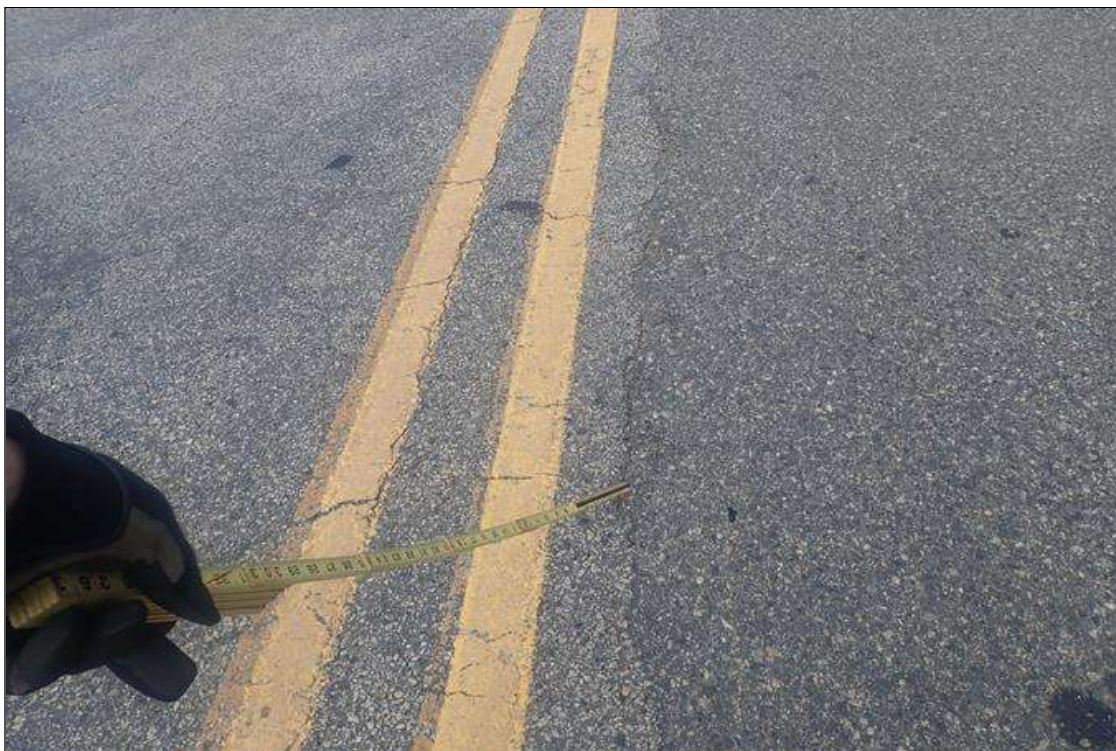
Span 3 Wearing Surface: FULL LENGTH 1/2 INCH LONGITUDINAL CRACK NEAR CENTERLINE

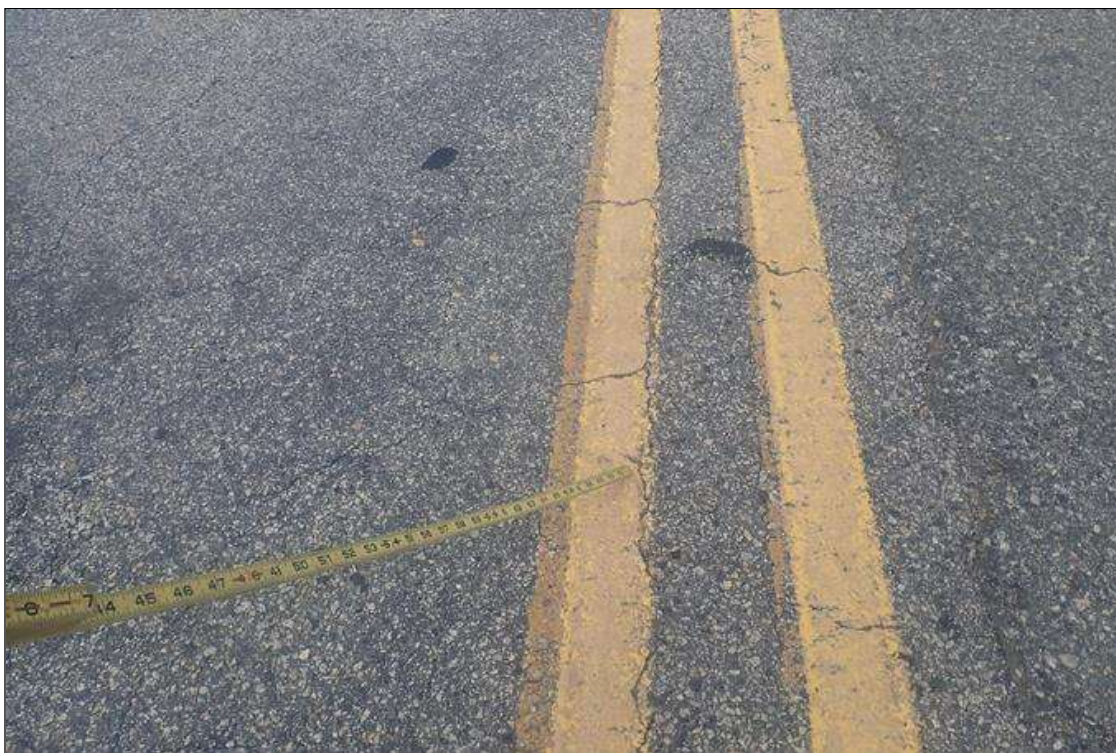
Span 3 Wearing Surface: (1) FULL LENGTH X UP TO 1/4 INCH WIDE LONGITUDINAL CRACK IN ASPHALT WEARING SURFACE NEAR CENTERLINE

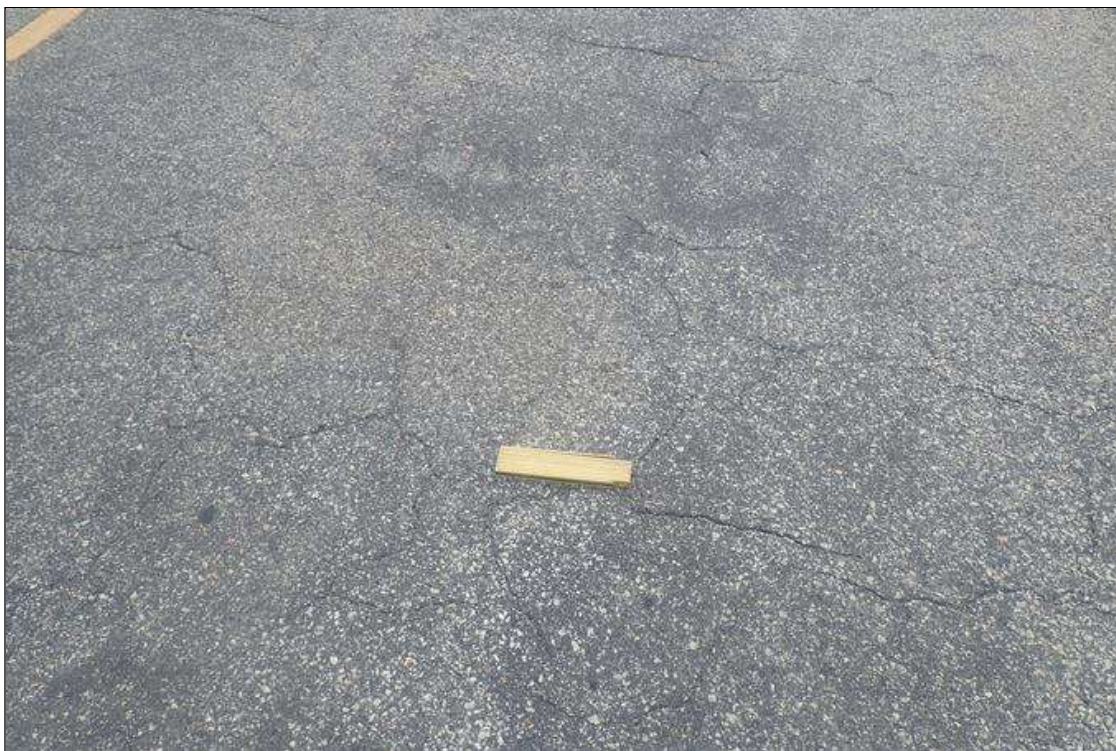
Span 3 Wearing Surface: throughout southbound lane, and at random in northbound lane, longitudinal/map cracks (up to 1/2 inch), some with rust stains, some areas sound delaminated

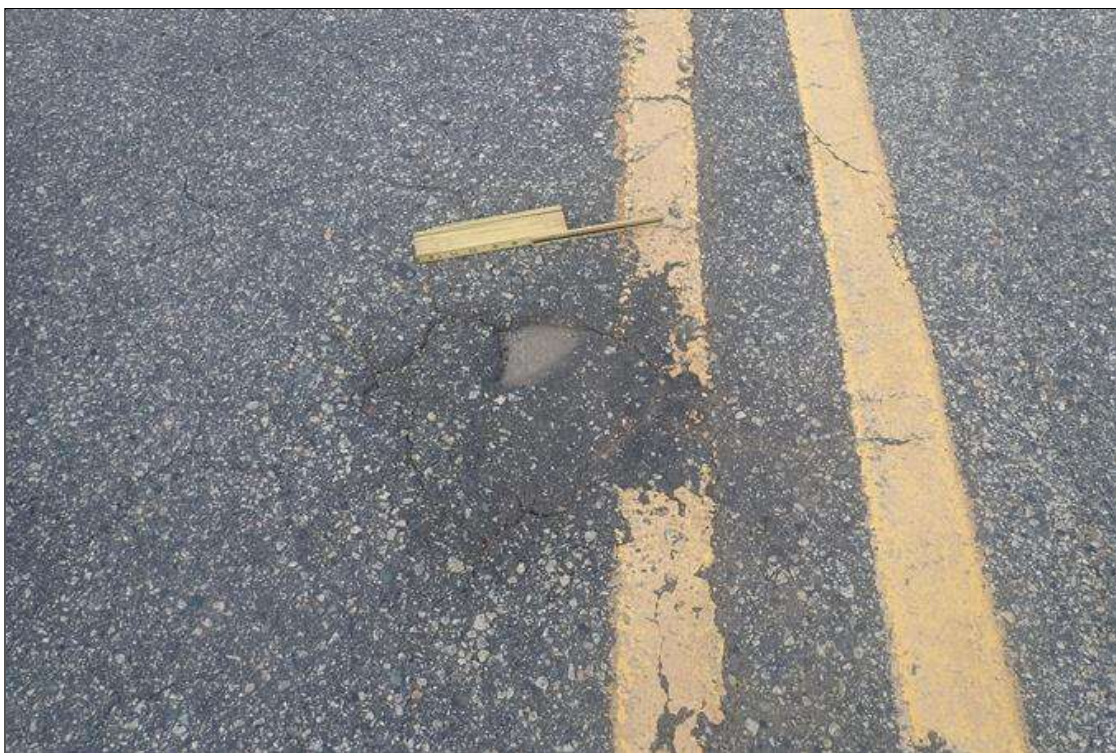
Span 3 Wearing Surface: centerline, near bent 3, (2) potholes (up to 12 inch diameter x full depth)

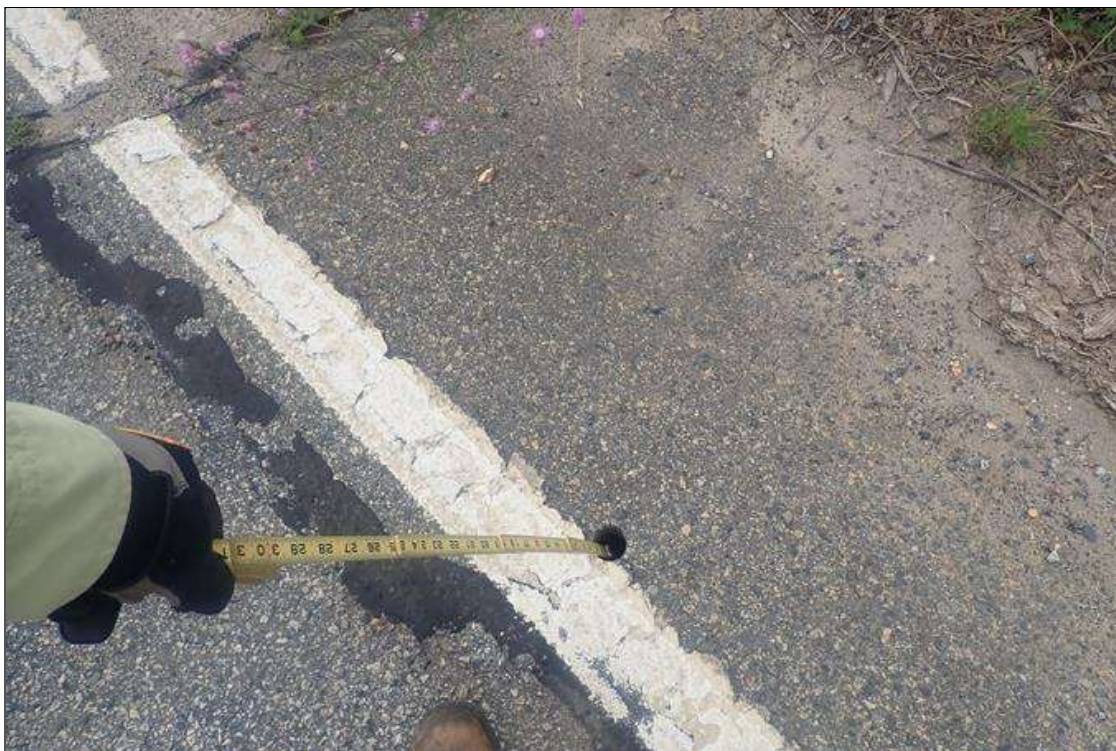
Span 3 Deck: left shoulder, near bent 2, core hole (1.5 inch diameter)

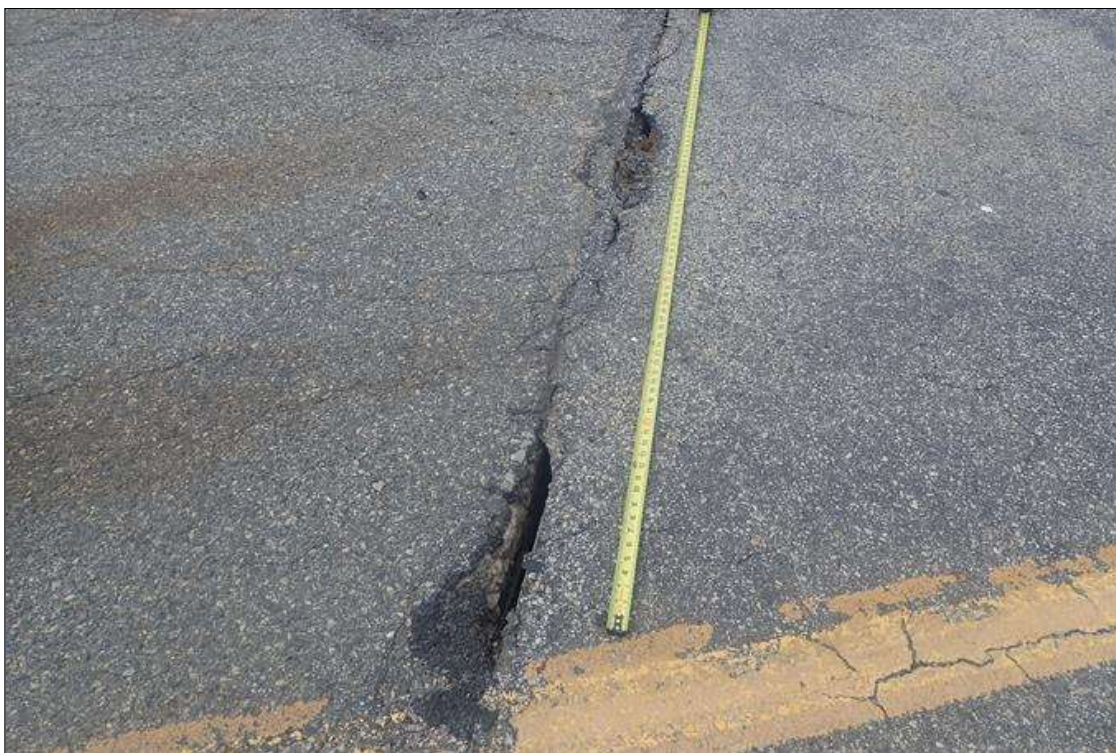
Span 3 Expansion Joint: southbound lane, joint material missing (7 feet)

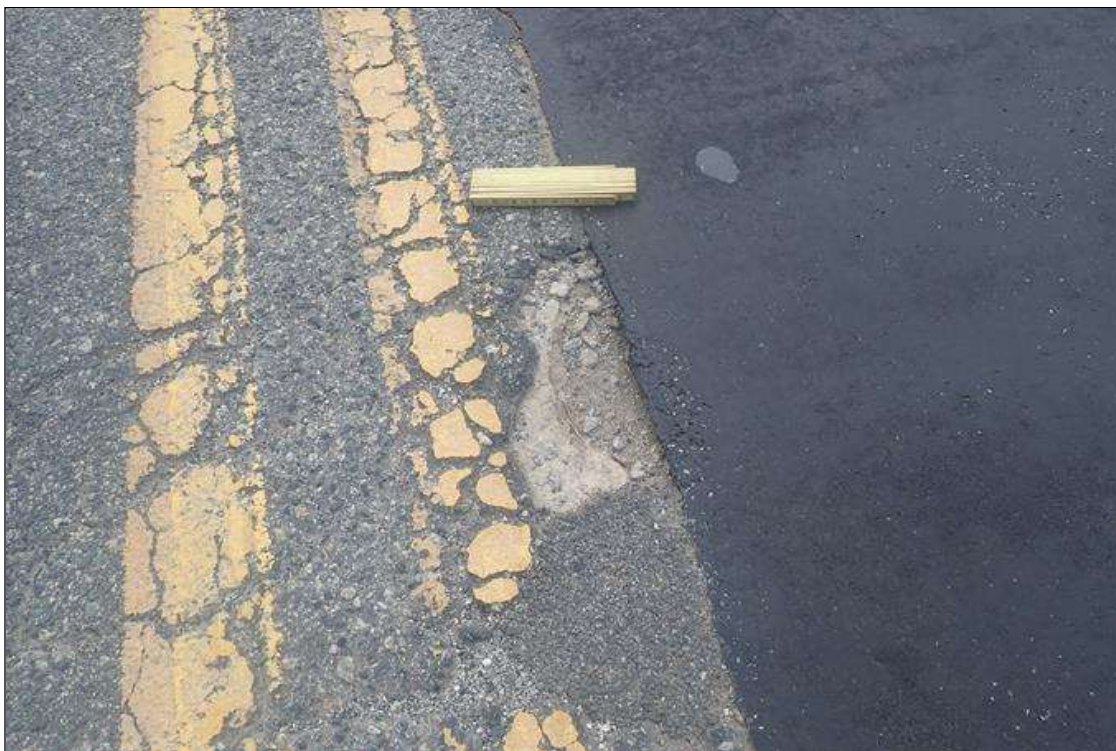
Span 2 Wearing Surface: multiple full depth potholes up to 15 inches wide x 8 inches long near centerline roadway and northbound lane

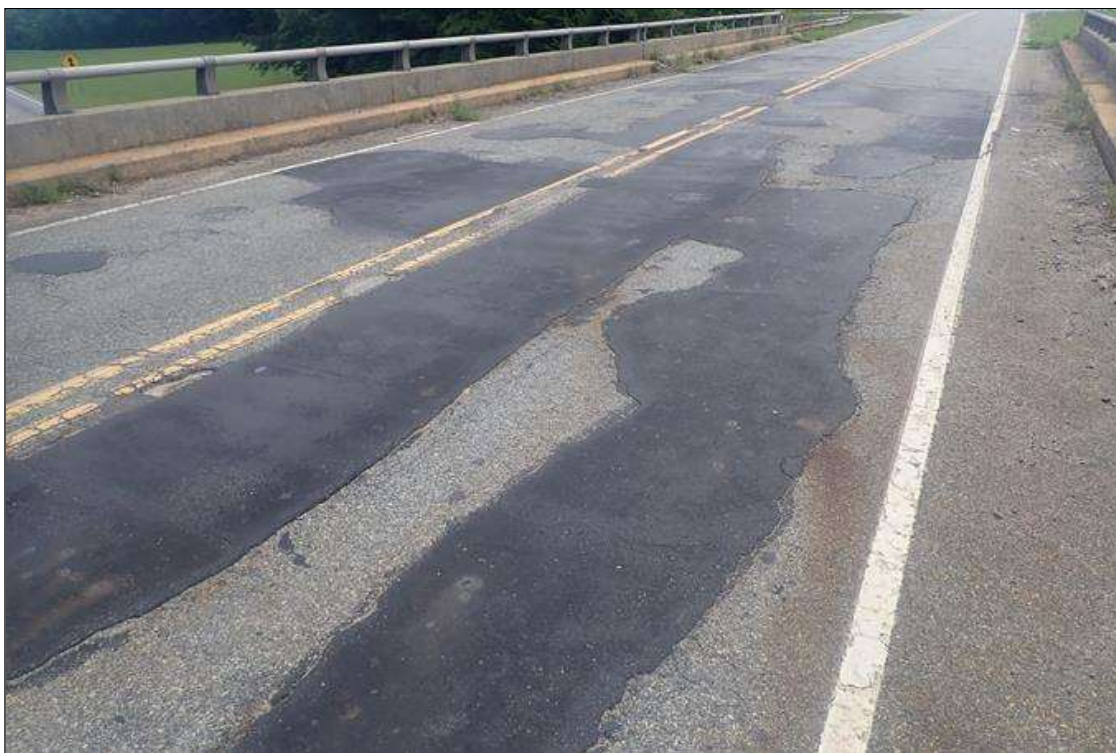
Span 2 Wearing Surface: Several large sound asphalt patches in travel lanes
