NC DEPARTMENT OF TRANSPORTATION  
 DIVISION OF HIGHWAYS  
 STRUCTURE MANAGEMENT UNIT

ATTENTION: **prompt action request, sketches revised, lateral clearances revised**

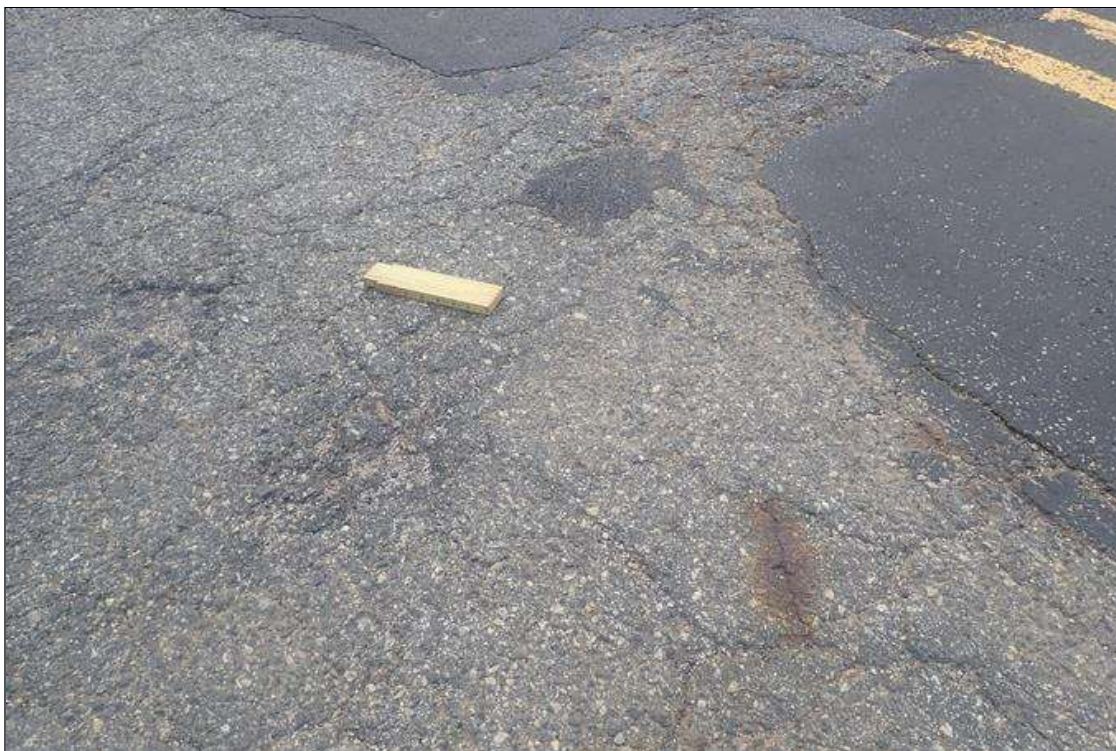
Span 2 Wearing Surface: SEVERAL AREAS TRANSVERSE AND MAP CRACKING / DETERIORATED ASPHALT WITH CRACKS UP TO 1/2 INCH, SOME WITH RUST STAINS, SOME AREAS DELAMINATED

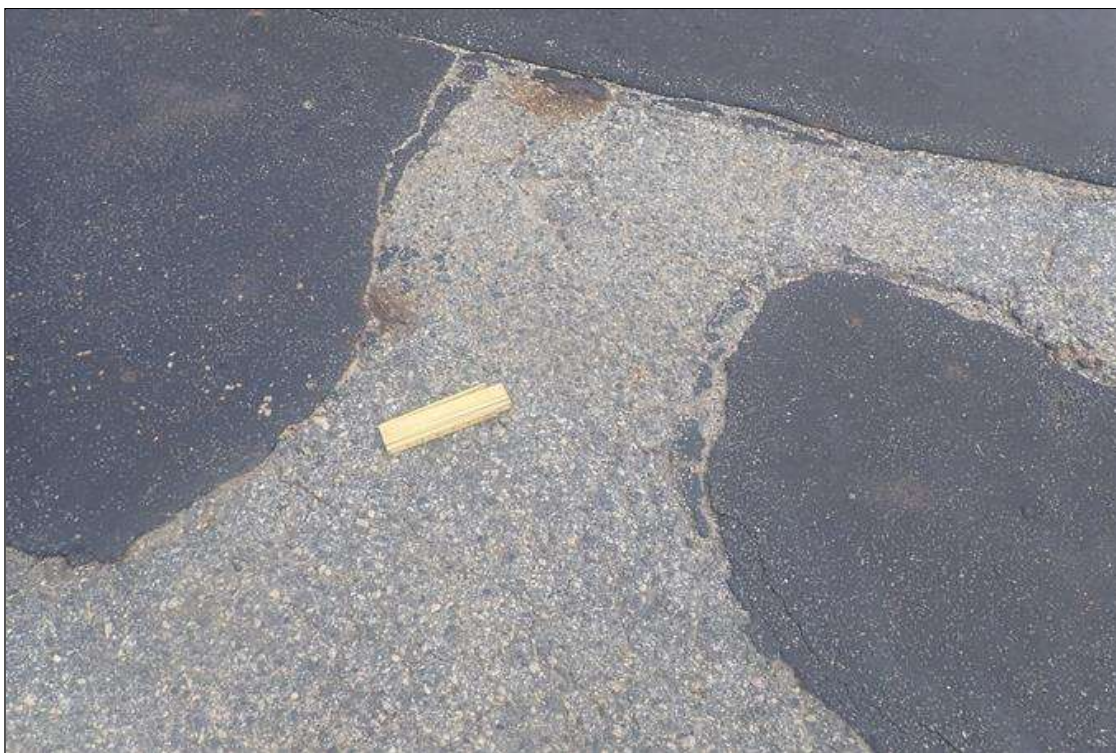
Span 2 Wearing Surface: SEVERAL AREAS TRANSVERSE AND MAP CRACKING / DETERIORATED ASPHALT WITH CRACKS UP TO 1/2 INCH, SOME WITH RUST STAINS, SOME AREAS DELAMINATED

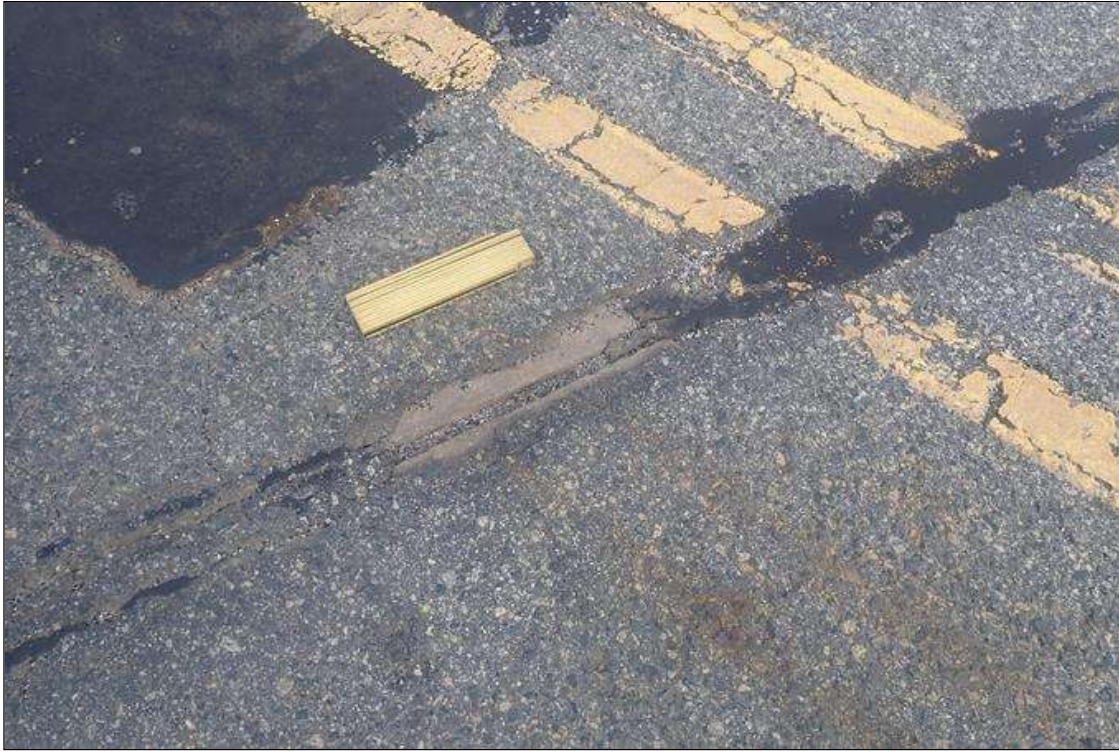
Span 2 Wearing Surface: 14 INCH LONG X 3 INCH WIDE X FULL DEPTH SPALL IN ASPHALT WEARING SURFACE EXPOSING JOINT OVER BENT 1

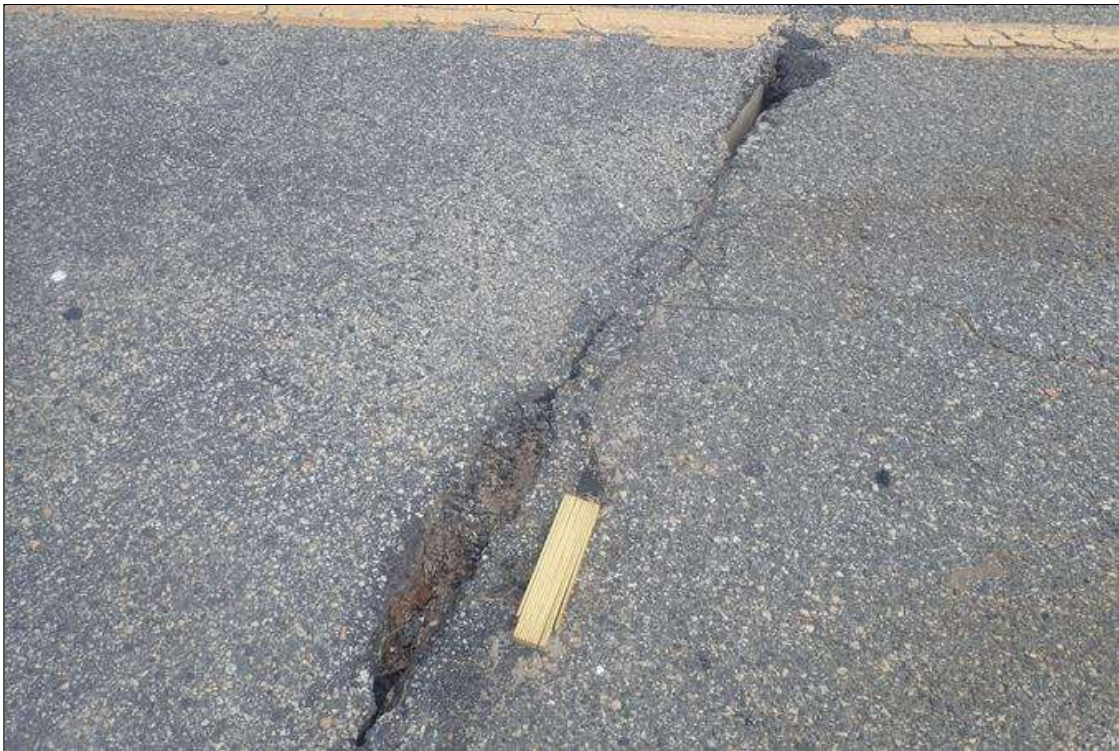
Span 3 Wearing Surface: southbound lane, over bent 2 joint, (2) potholes (up to 20 inch x 4 inch x full depth)

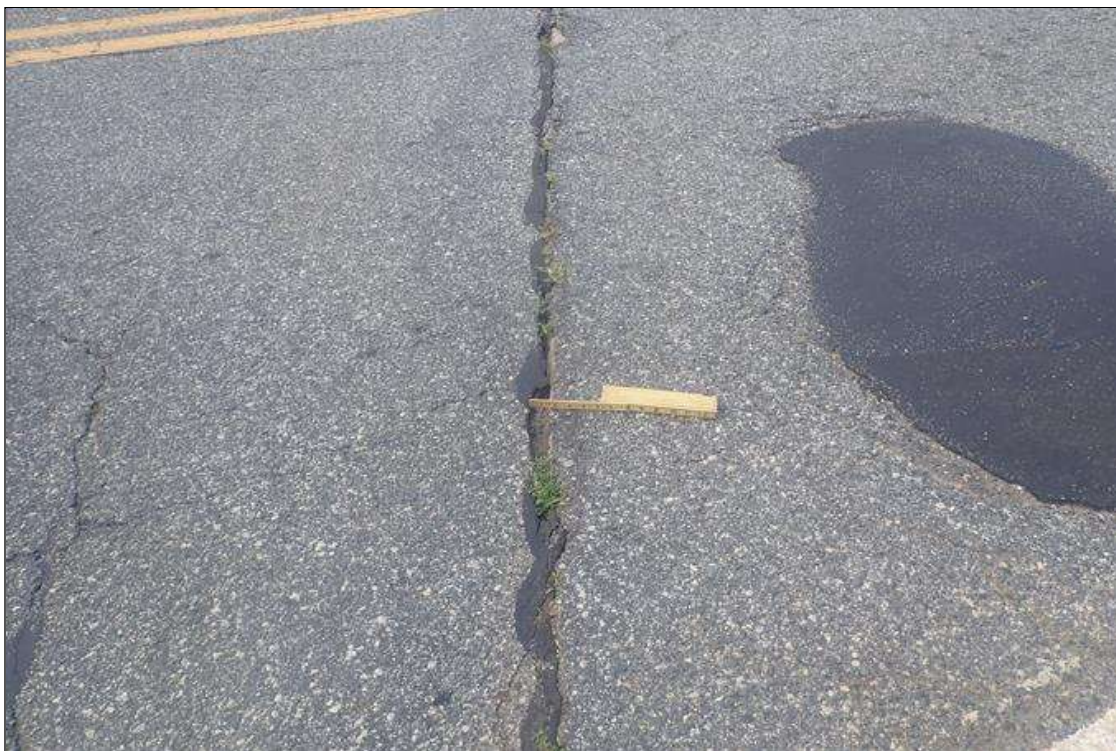
Span 1 Wearing Surface: Full width transverse cracks up to 1.5 inch at abutment 1 with failed sealant

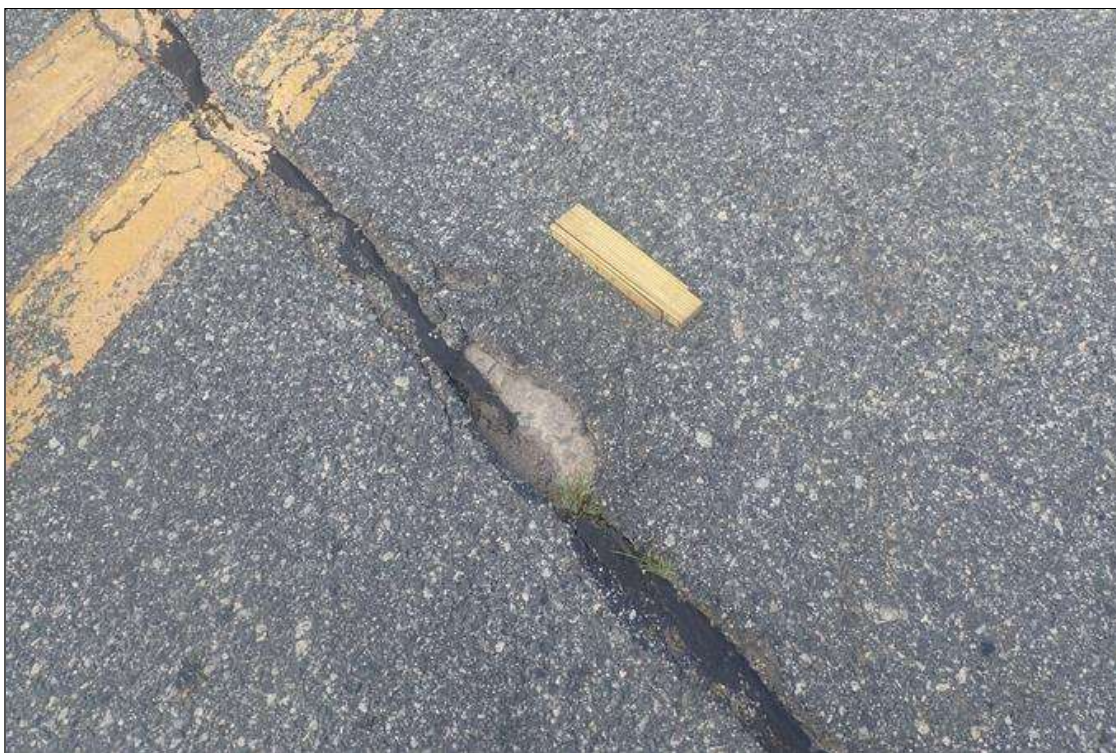
Span 1 Wearing Surface: 6 INCH LONG X 3 INCH WIDE X 1 INCH DEEP POTHOLE AT JOINT OVER END BENT 1

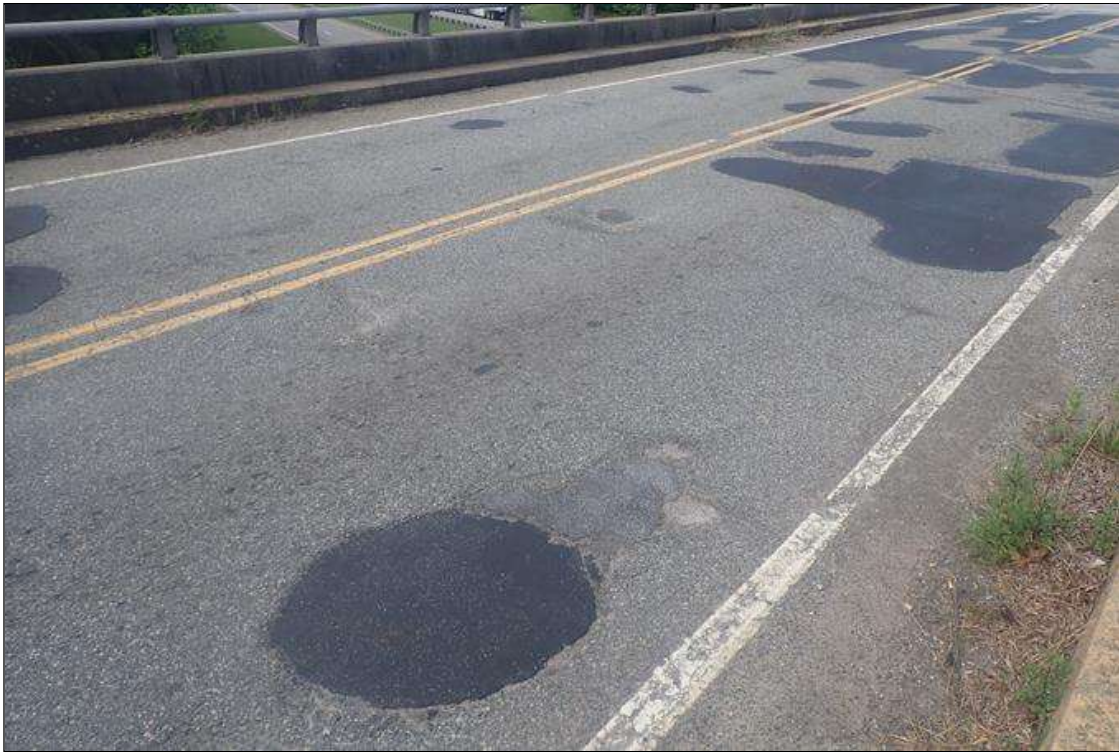
Span 1 Wearing Surface: Several sound asphalt patches in travel lanes

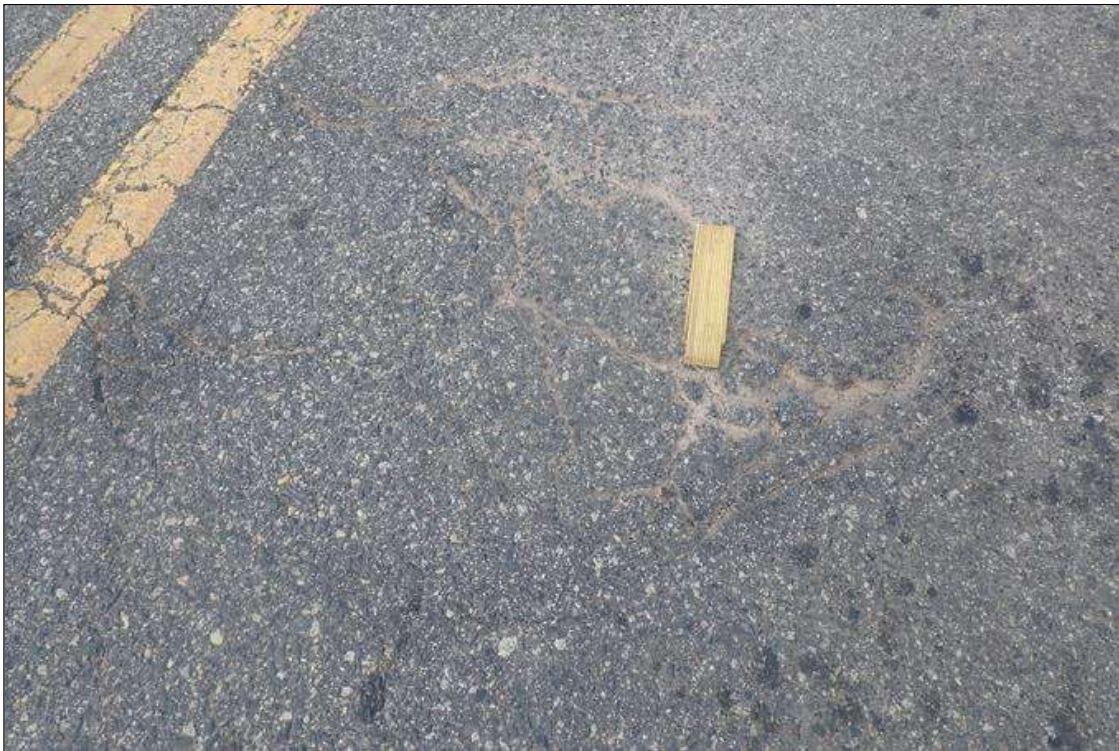
Span 1 Wearing Surface: SEVERAL AREAS TRANSVERSE AND MAP CRACKING / DETERIORATED ASPHALT WITH CRACKS UP TO 1/2 INCH, SOME AREAS SOUND DELAMINATED

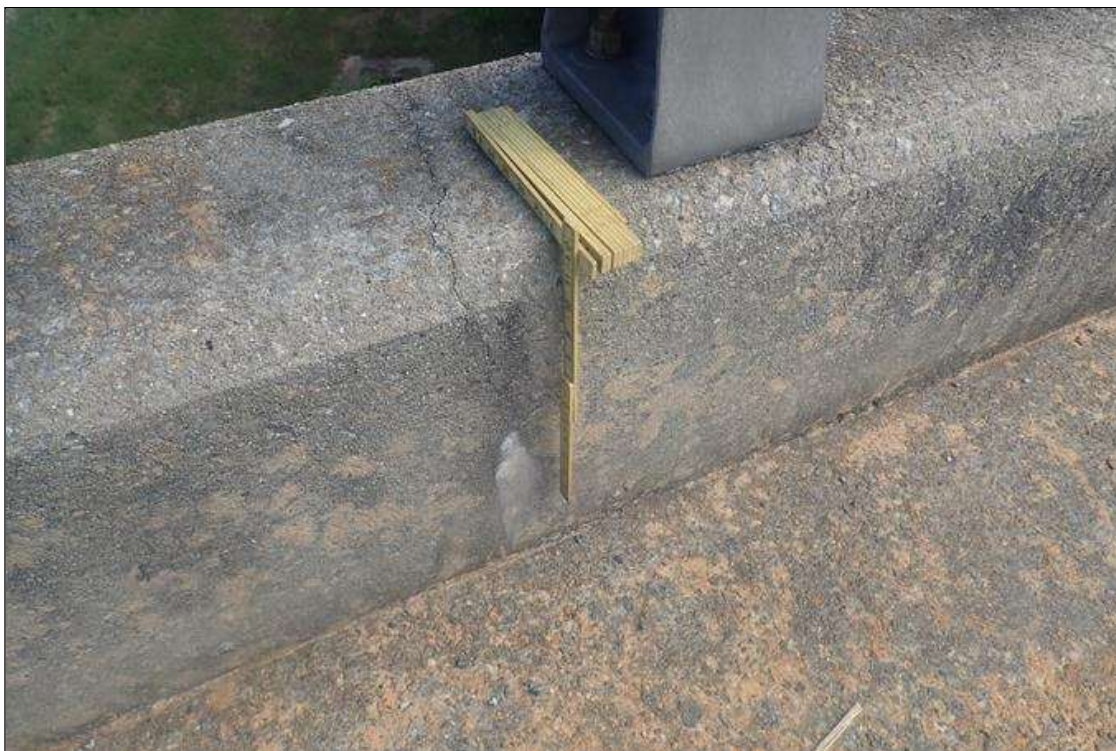
Span 1 Right Bridge Rail: parapet, at midspan, transverse crack (1/32 inch x full height) with efflorescence

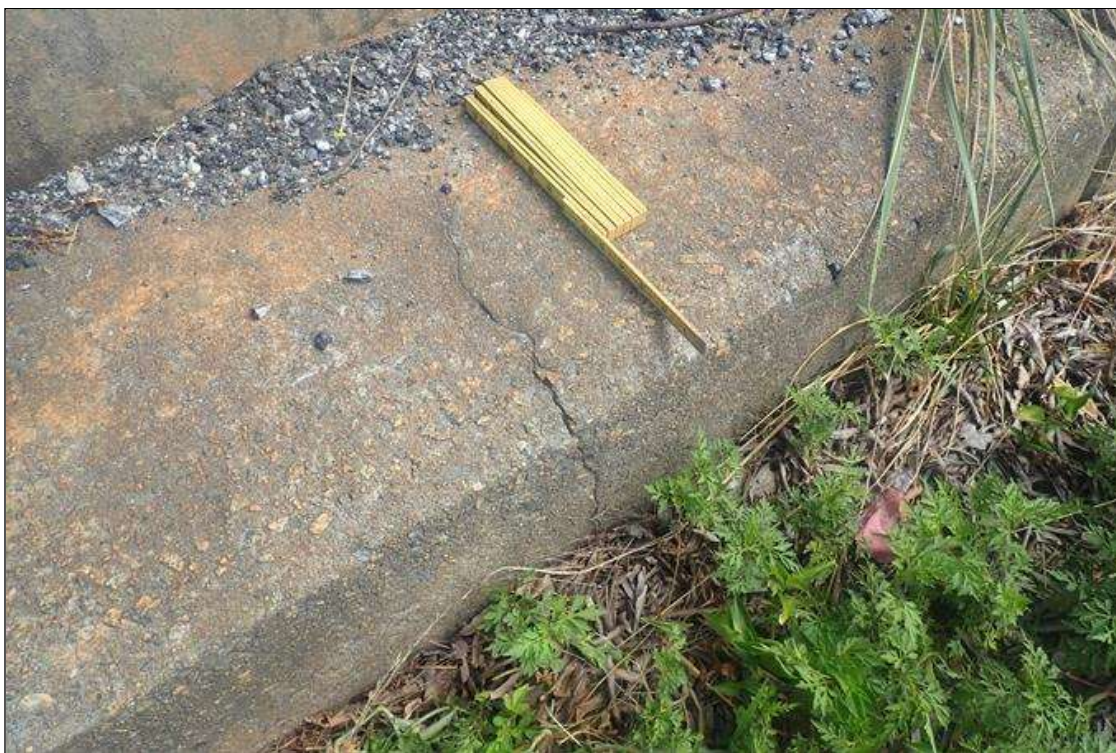
Span 1 Right Bridge Rail: curb, at end bent 1, transverse crack (1/16 inch x full width)

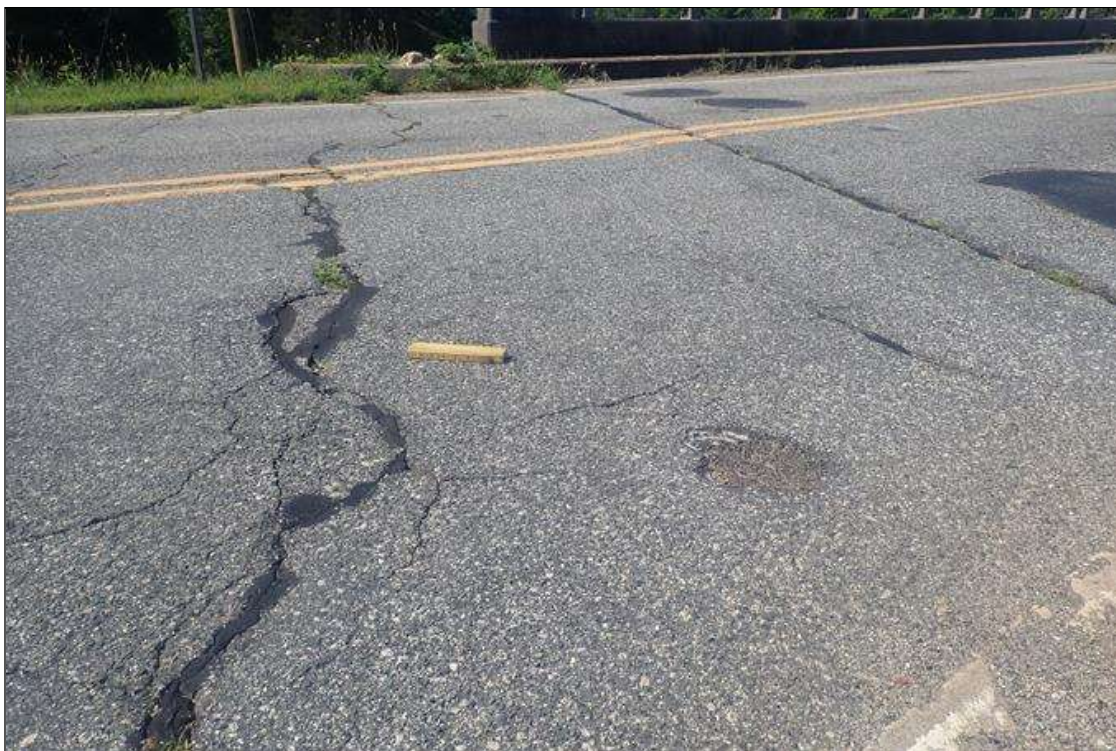
south approach asphalt, at bridge, transverse crack (up to 1/4 inch x full width) with settlement (7 feet x full width x approximately 1 inch deep)

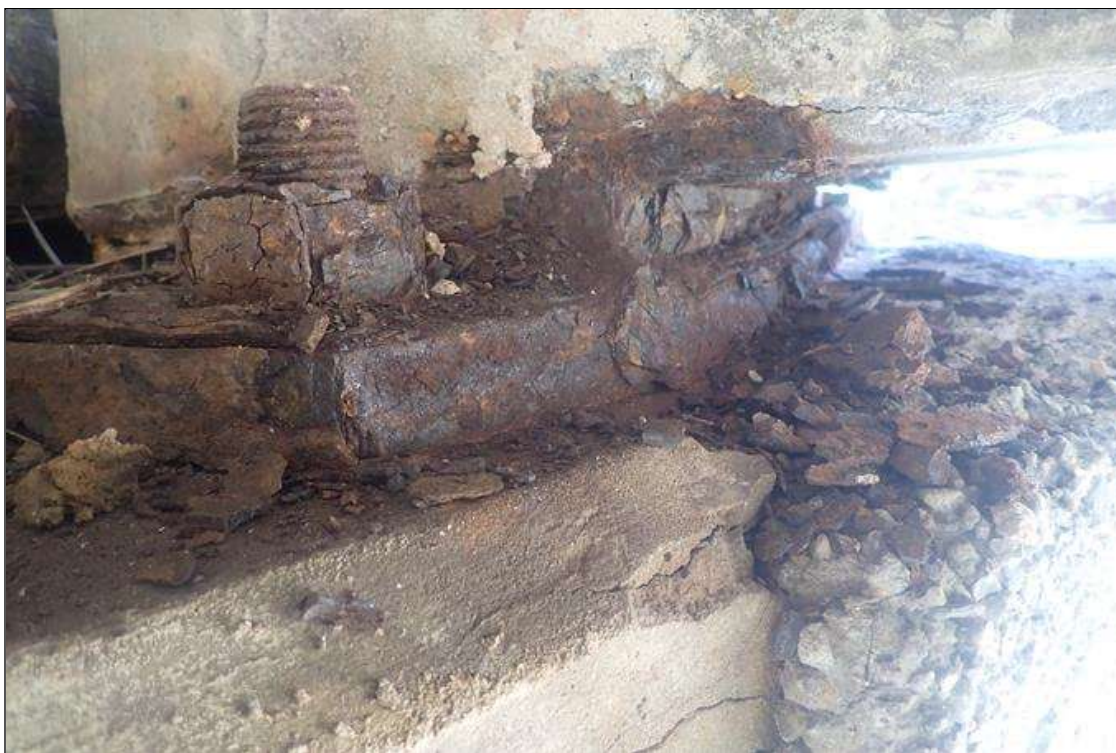
Span 2 Beam 1 - Near Bearing 1: rust scale/pack rust

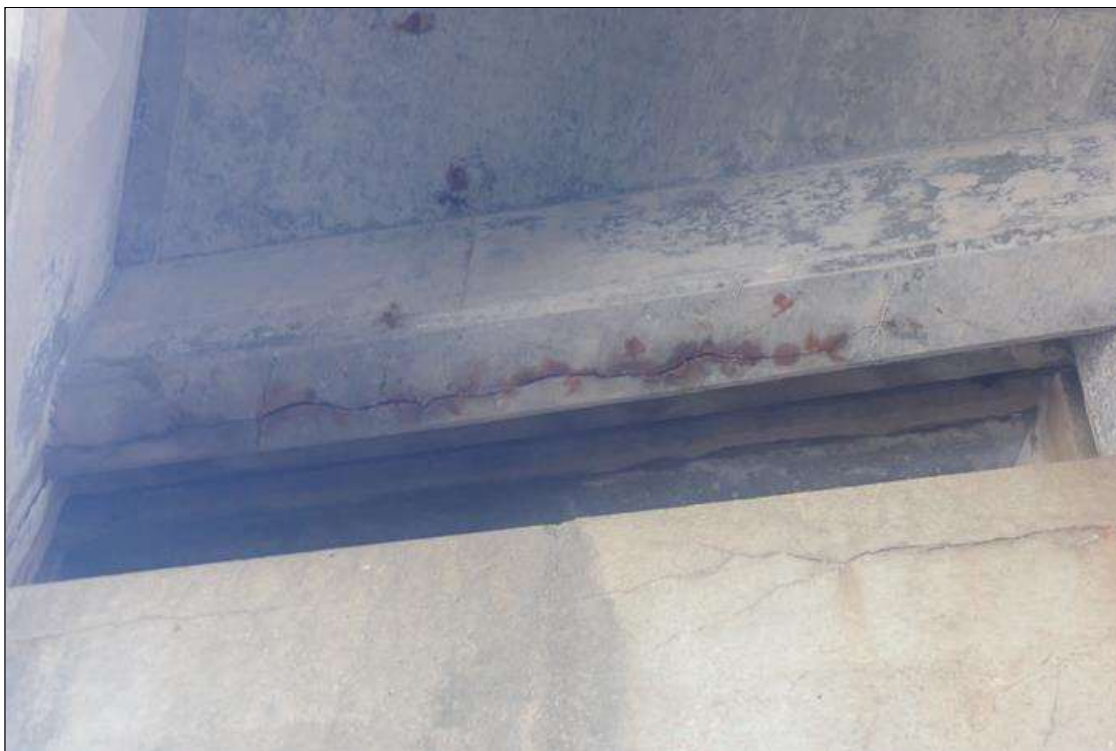
Span 2 Deck: (PAR) bent 1 end diaphragm, bays 1, 2, 3 and right overhang, longitudinal cracks (up to 1/8 inch x 6 feet long) with rust stains and some efflorescence buildup

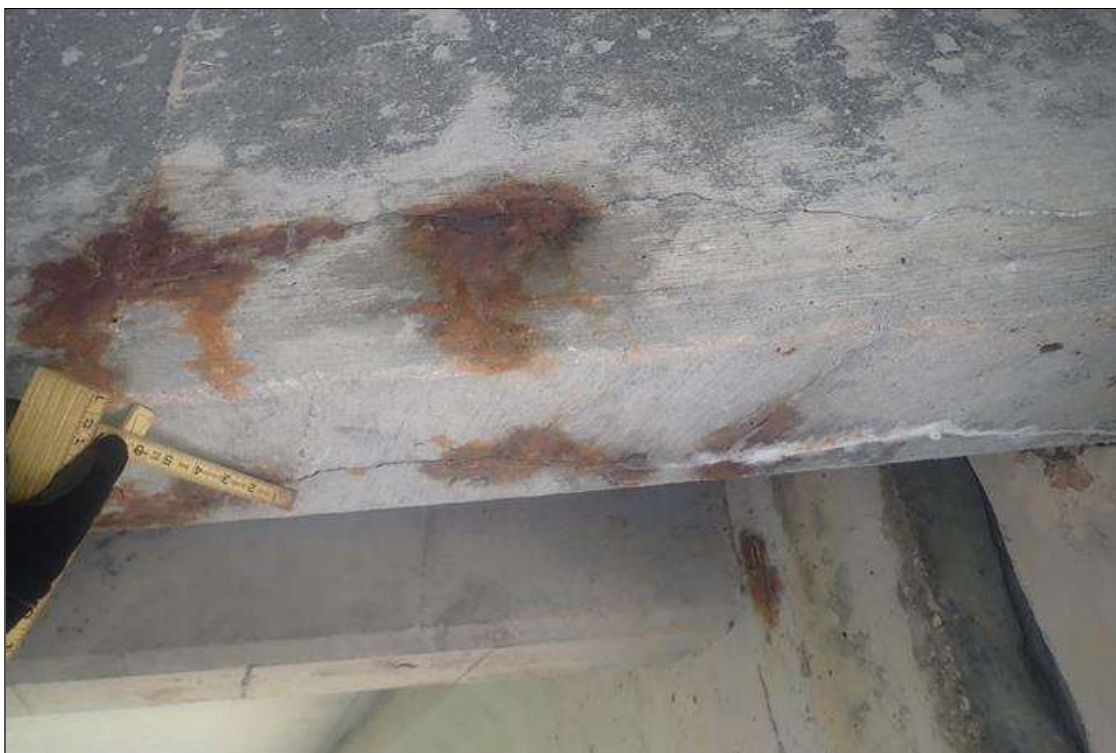
Span 2 Deck: (PAR) bent 1 end diaphragm, bays 1, 2, 3 and right overhang, longitudinal cracks (up to 1/8 inch x 6 feet long) with rust stains and some efflorescence buildup

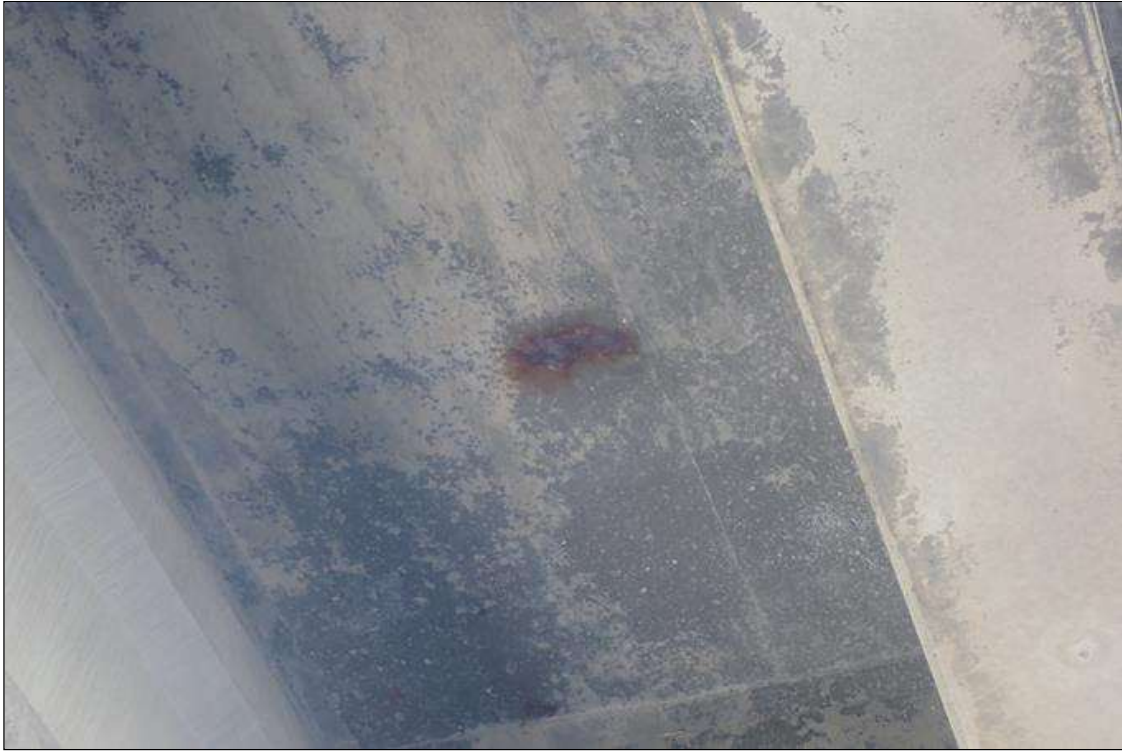
Span 2 Deck: (PAR) underside, at random, areas of transverse/map cracks (hairline) with rust stains

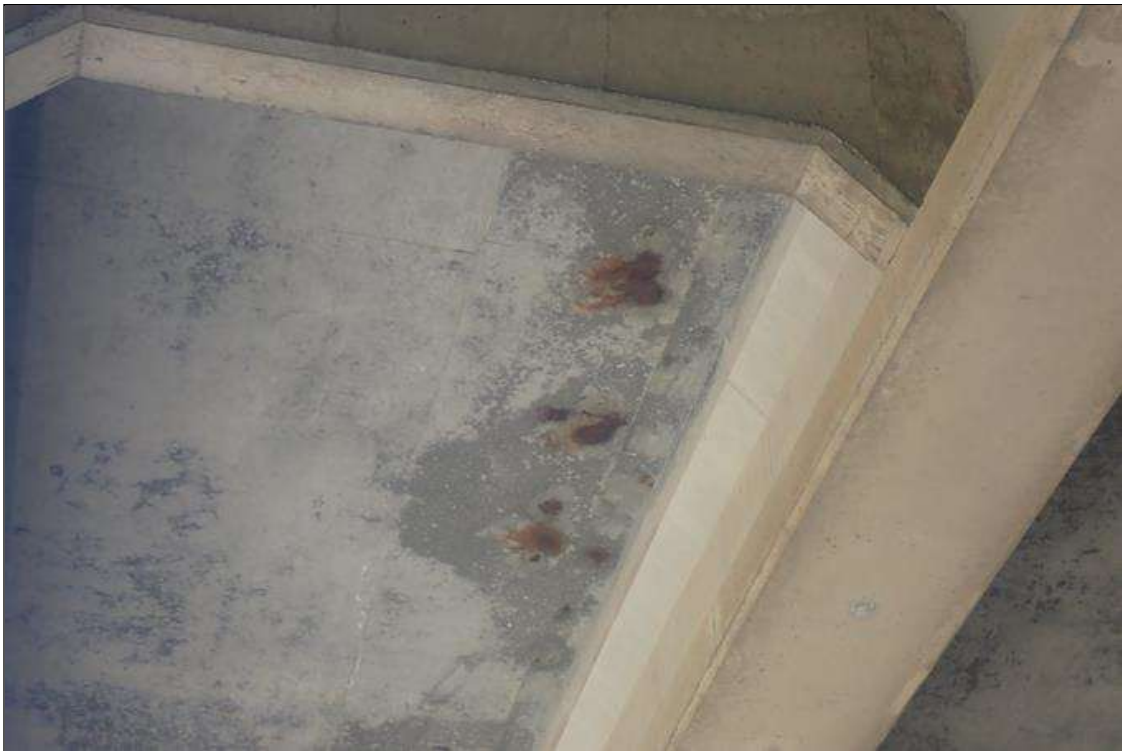
Span 2 Deck: (PAR) underside, at random, areas of transverse/map cracks (hairline) with rust stains

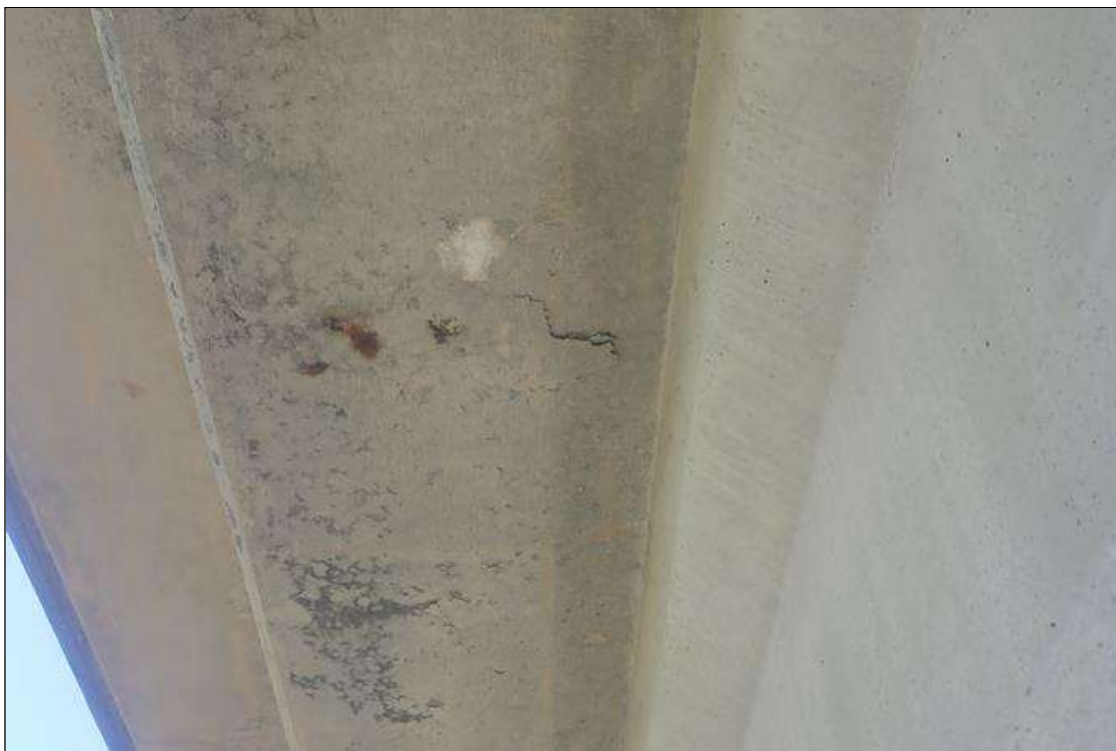
Span 2 Deck: (PAR) left overhang, 4 feet from bent 1, delamination (2 feet x 5 inch) with rust stains

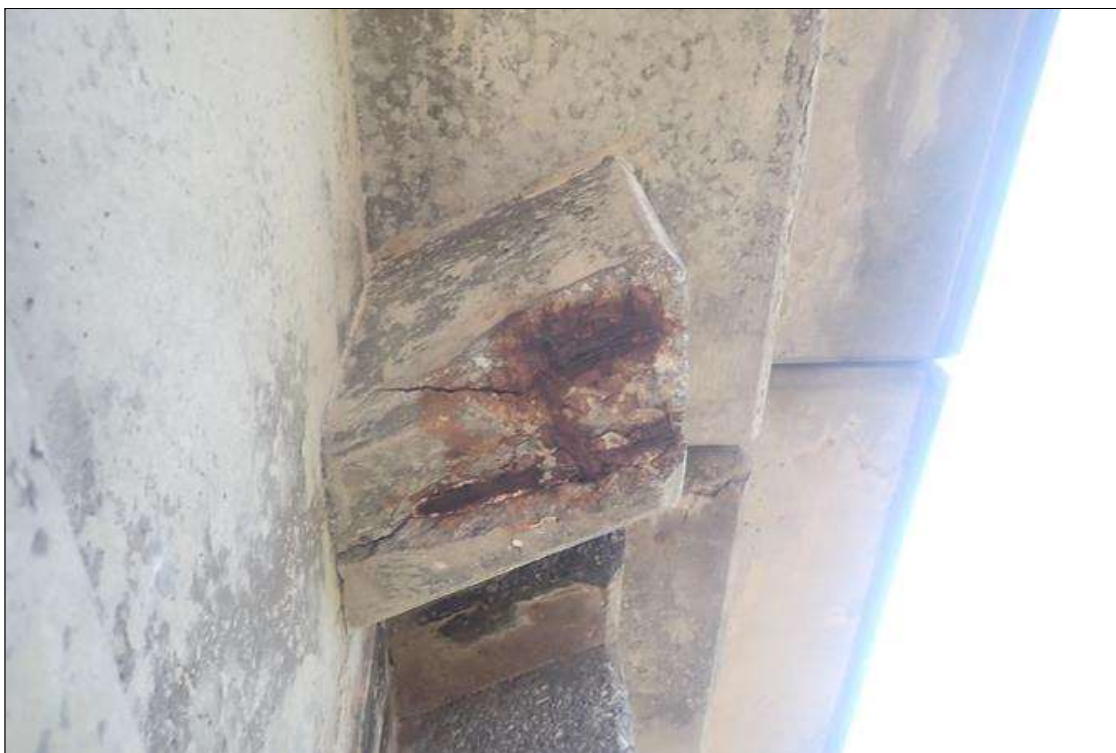
Span 2 Deck: bent 1 end diaphragm, left overhang, spall (16 inch x 8 inch x 2 inch deep) with exposed rusted rebar

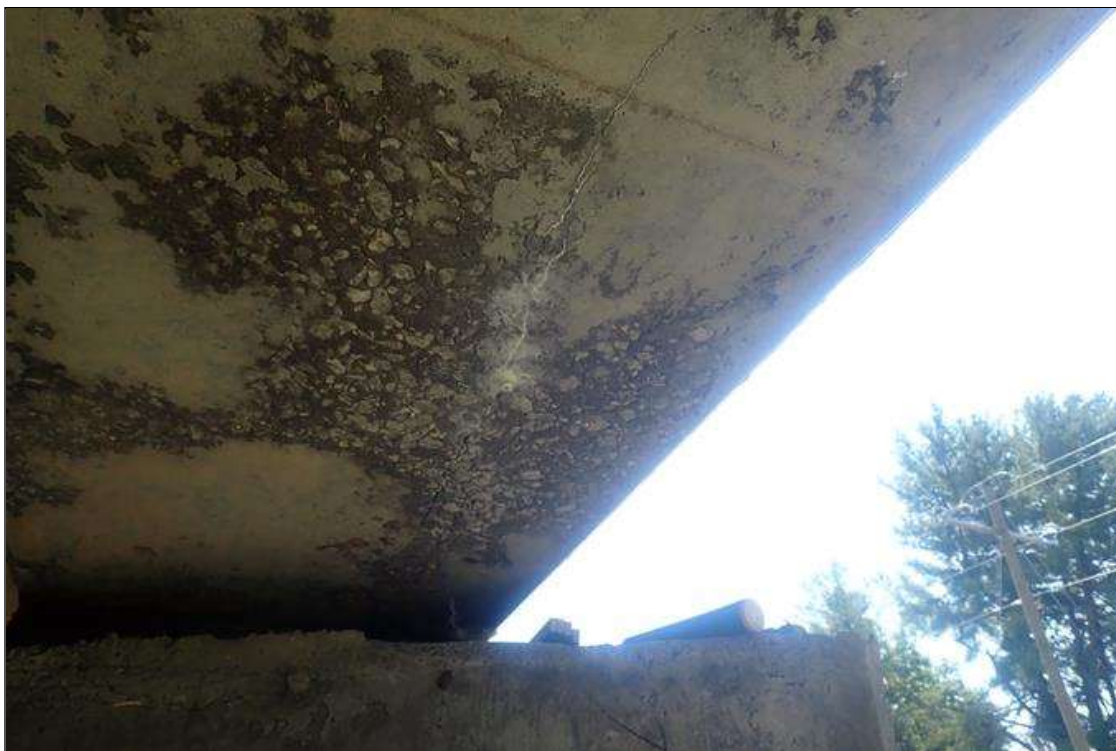
Span 2 Beam 1: (PAR) at bent 1, bottom flange, left side, spall (1 foot long x 8 inch high x 2 inch deep) with exposed rusted strand, and longitudinal cracks (up to 0.02 inch x 5 feet) with efflorescence buildup

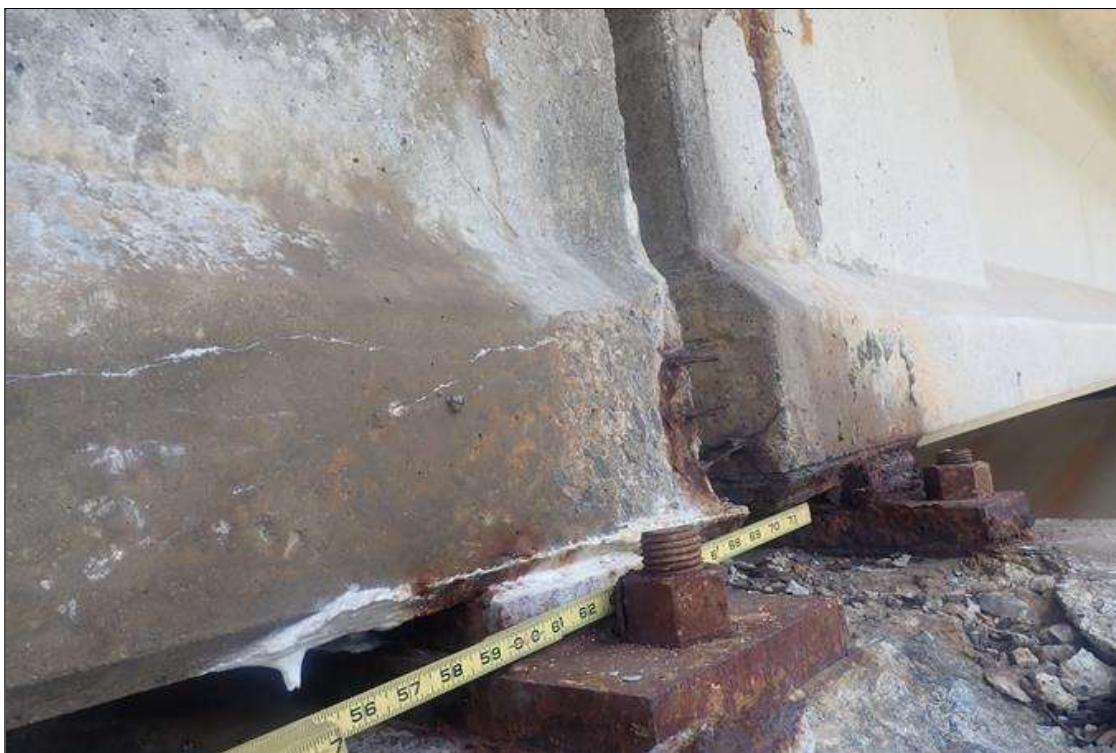
Span 2 Beam 1: (PAR) at bent 1, bottom flange, left side, spall (1 foot long x 8 inch high x 2 inch deep) with exposed rusted strand, and longitudinal cracks (up to 0.02 inch x 5 feet) with efflorescence buildup

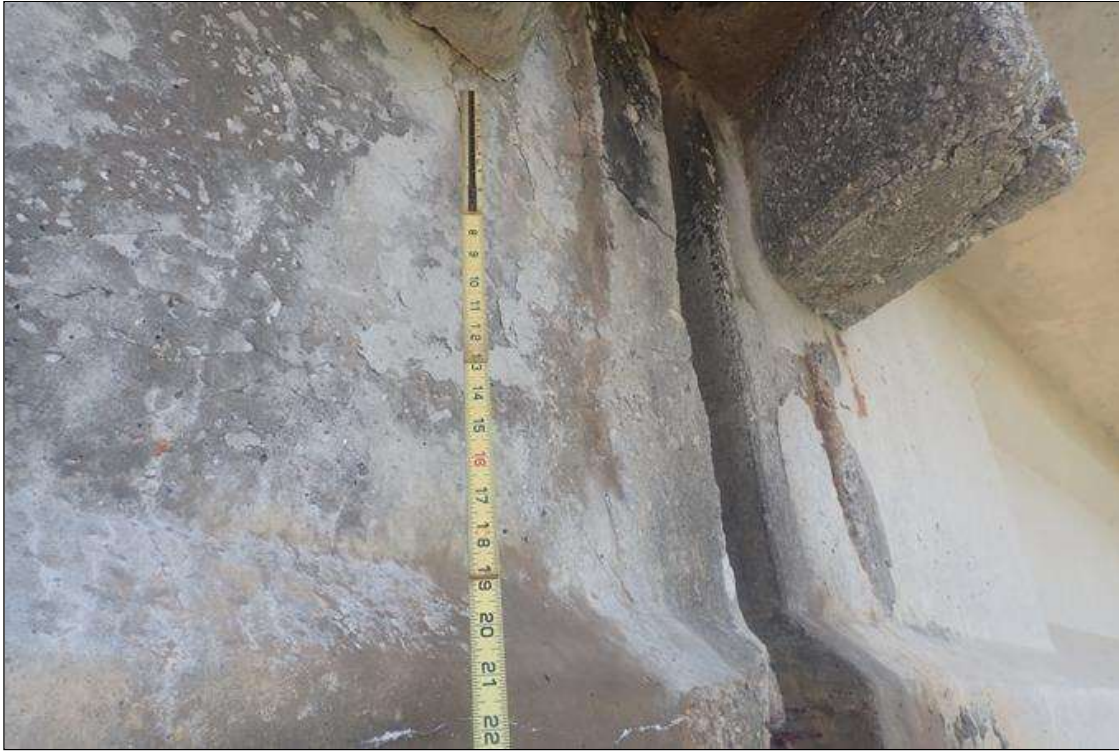
Span 2 Beam 1: 12 INCH WIDE X FULL HEIGHT DELAMINATION IN LEFT SIDE WEB AT BENT 1

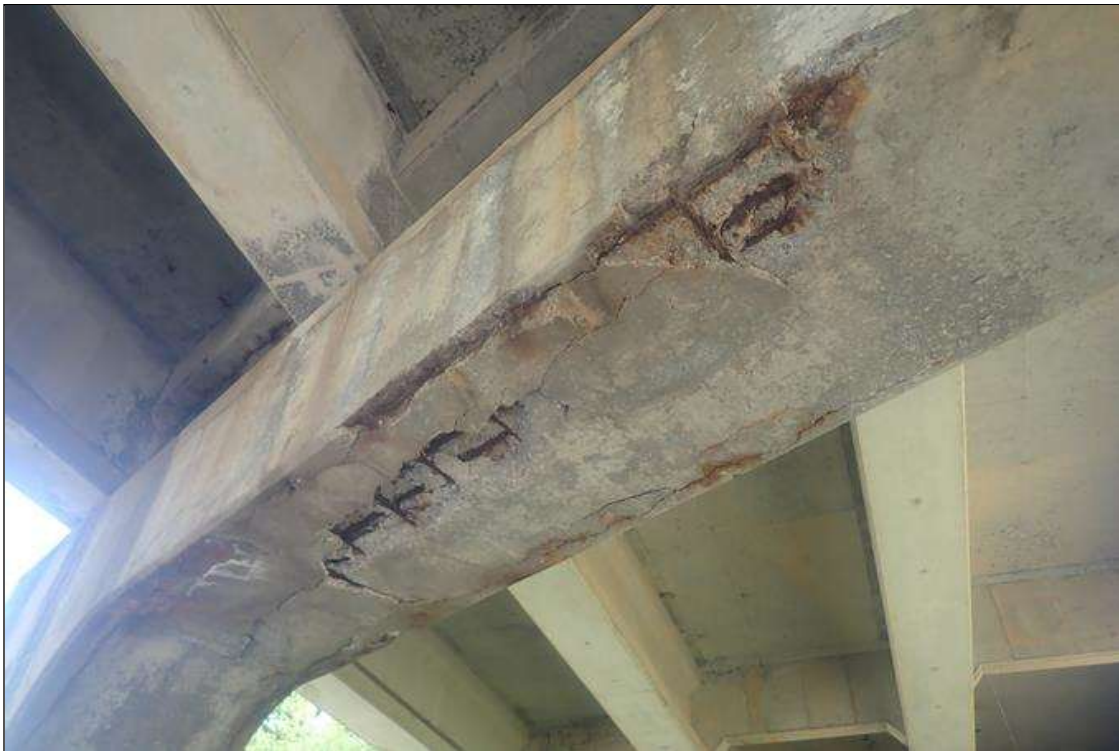
Bent 1 Cap 1: (PAR) SPALL AND DELAMINATION ALONG BOTTOM CAP BETWEEN COLUMNS 15 FEET LONG X FULL WIDTH X 3 INCHES DEEP WITH EXPOSED STEEL. EXPOSED STEEL HAS UP TO 1/8 INCH LOSS.

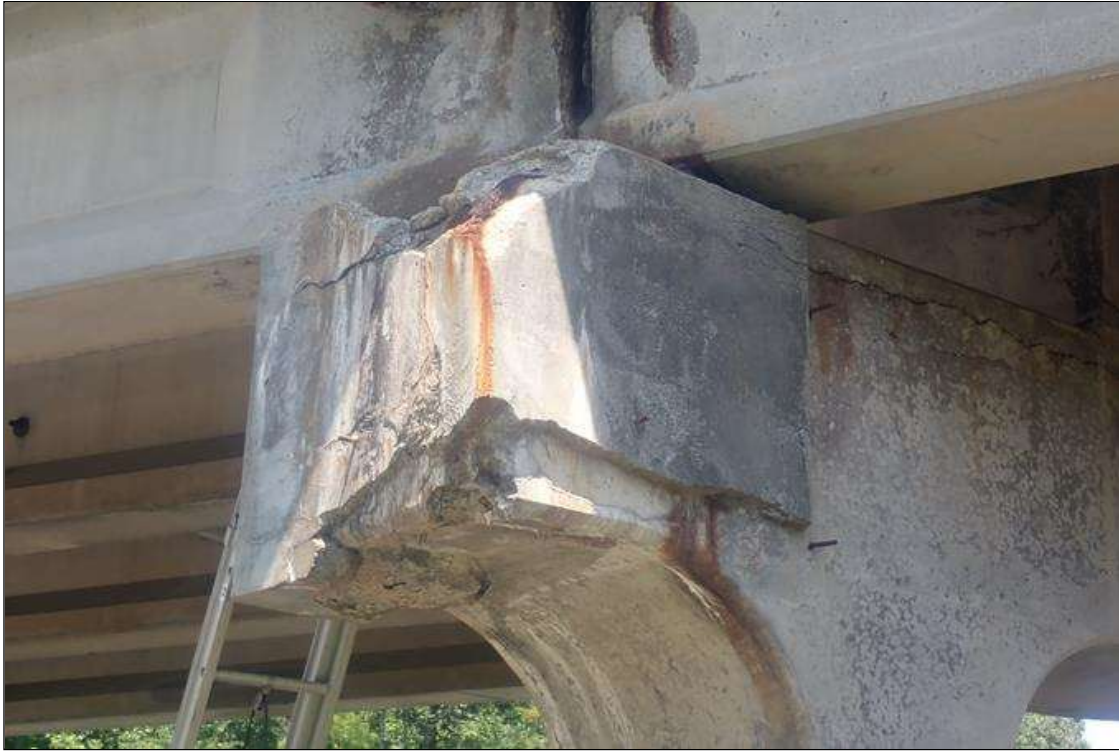
Bent 1 Cap 1: (PAR) west end of cap, delaminated/partially failed previous repair (3.5 feet long x full height x full width), with spalls (up to 2 feet x 16 inch x 2 inch deep) with exposed rusted rebar, rust stains, efflorescence buildup, and cracks (up to 1/8 inch)

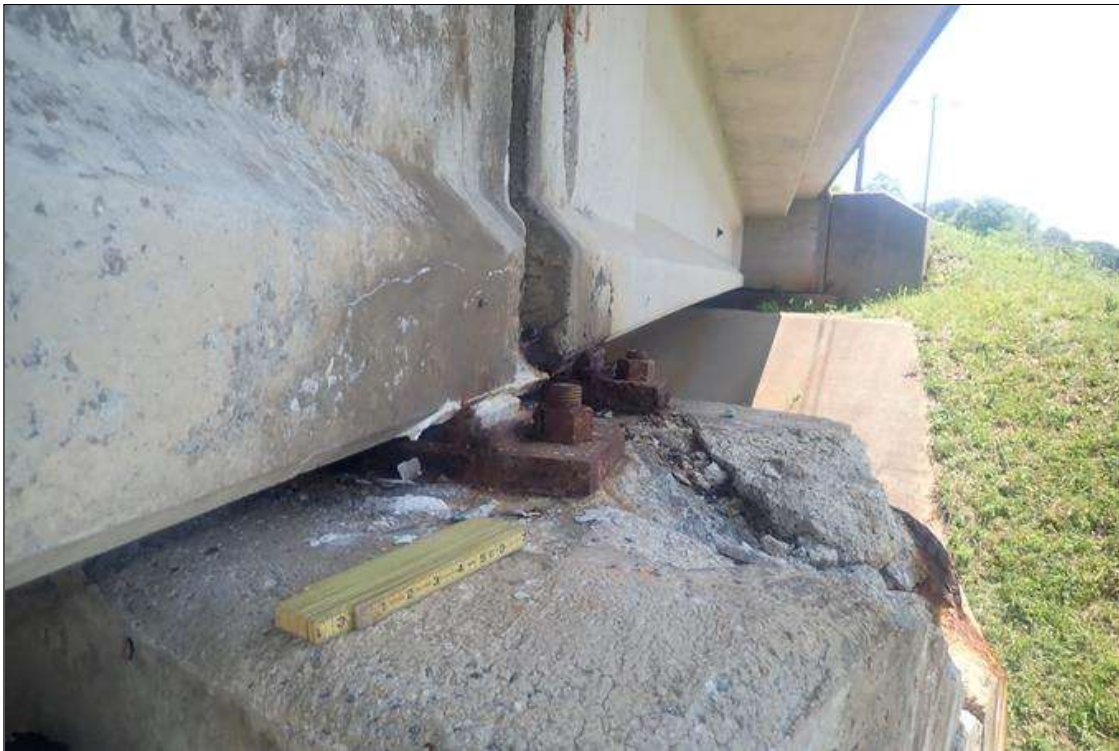
Bent 1 Cap 1: (PAR) west end of cap, delaminated/partially failed previous repair (3.5 feet long x full height x full width), with spalls (up to 2 feet x 16 inch x 2 inch deep) with exposed rusted rebar, rust stains, efflorescence buildup, and cracks (up to 1/8 inch)

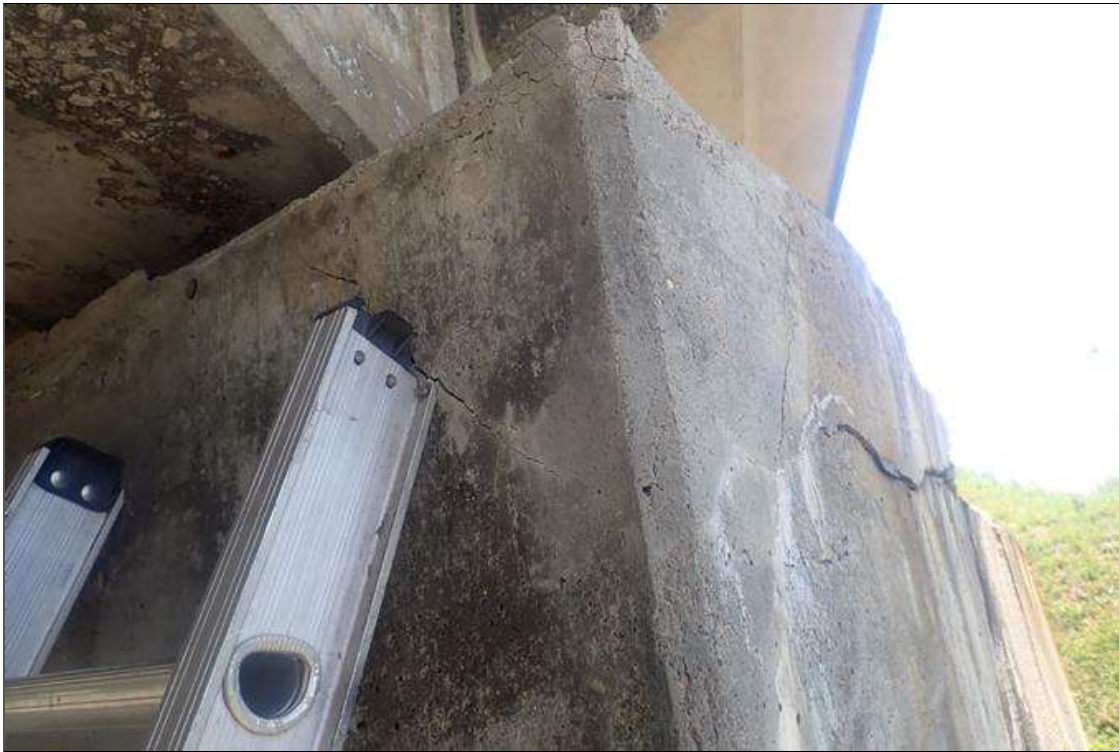
Bent 1 Cap 1: (PAR) west end of cap, delaminated/partially failed previous repair (3.5 feet long x full height x full width), with spalls (up to 2 feet x 16 inch x 2 inch deep) with exposed rusted rebar, rust stains, efflorescence buildup, and cracks (up to 1/8 inch)

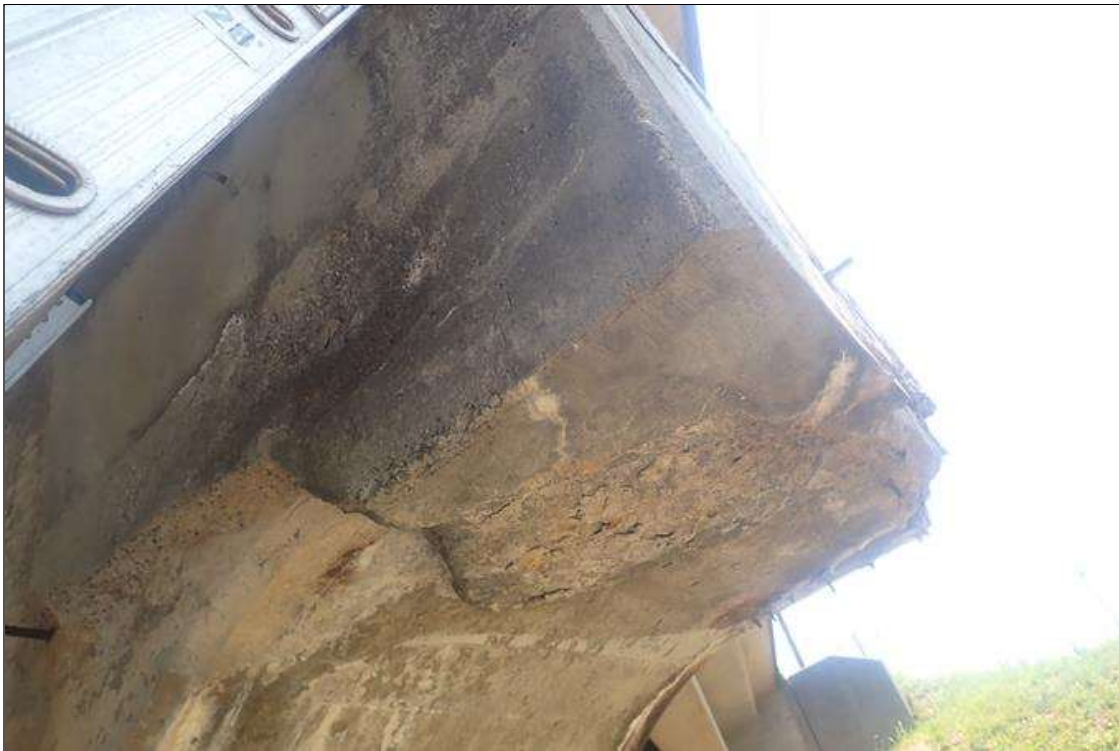
Bent 1 Cap 1: (PAR) west end of cap, delaminated/partially failed previous repair (3.5 feet long x full height x full width), with spalls (up to 2 feet x 16 inch x 2 inch deep) with exposed rusted rebar, rust stains, efflorescence buildup, and cracks (up to 1/8 inch)
