NC DEPARTMENT OF TRANSPORTATION  
 DIVISION OF HIGHWAYS  
 STRUCTURE MANAGEMENT UNIT

ATTENTION: **prompt action request, sketches revised, lateral clearances revised**

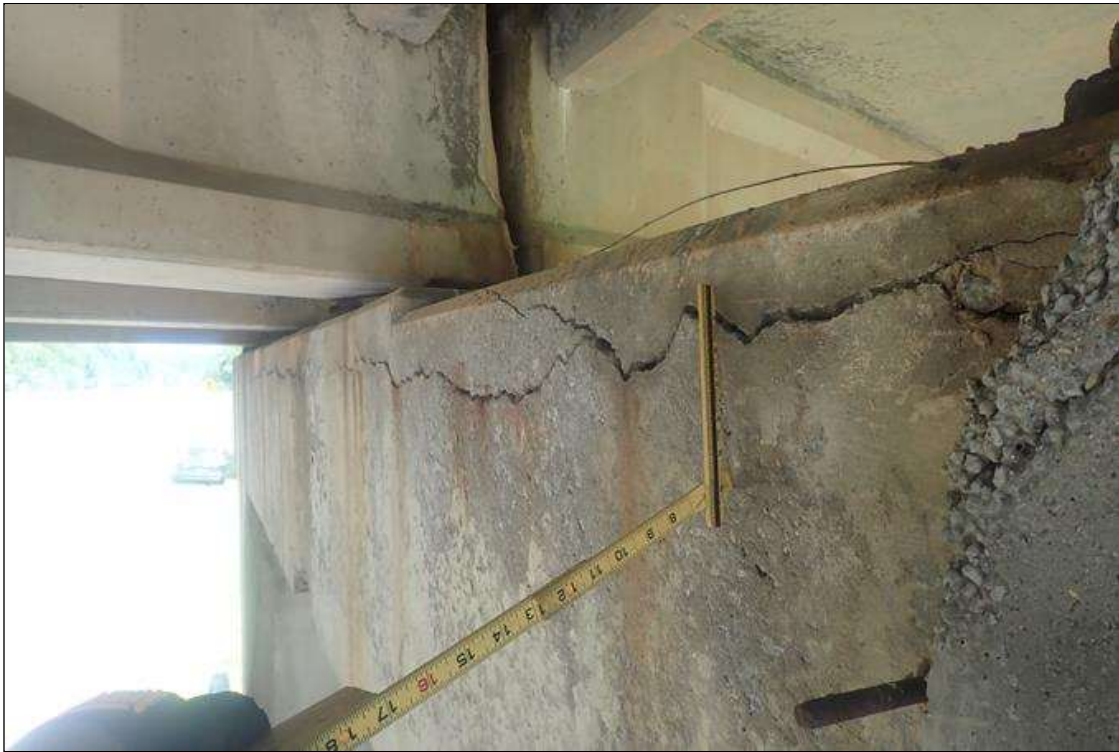
Bent 1 Cap 1: (PAR) HORIZONTAL CRACKING UP TO 1/4 INCH WITH SEVERAL AREAS OF DELAMINATIONS AND RUST STAINS WHICH EXTENDS 6 INCHES ON TOP OF CAP ALONG LENGTH OF BOTH FACES.

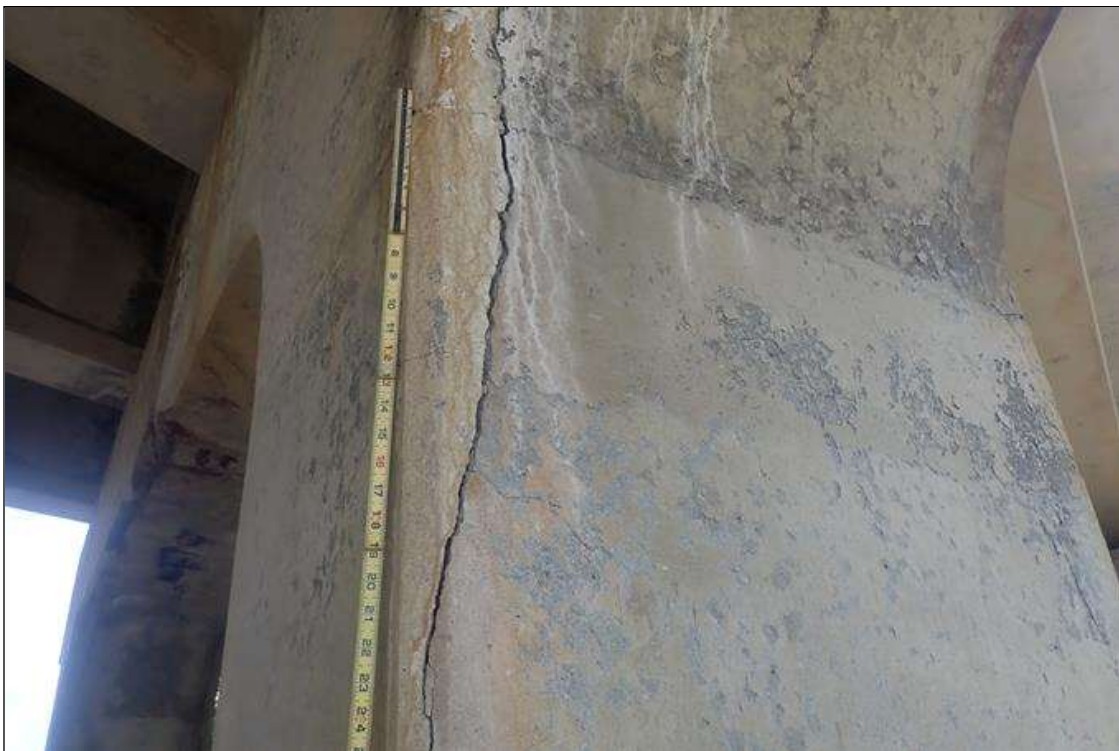
Bent 1 Pile 1: VERTICAL CRACKS UP TO 1/8 INCH ALONG EDGES FROM TOP DOWN 4 FEET WITH EFFLORESCENCE AND DELAMINATIONS (UP TO 6 INCH WIDE) AT WEST FACE CORNERS.

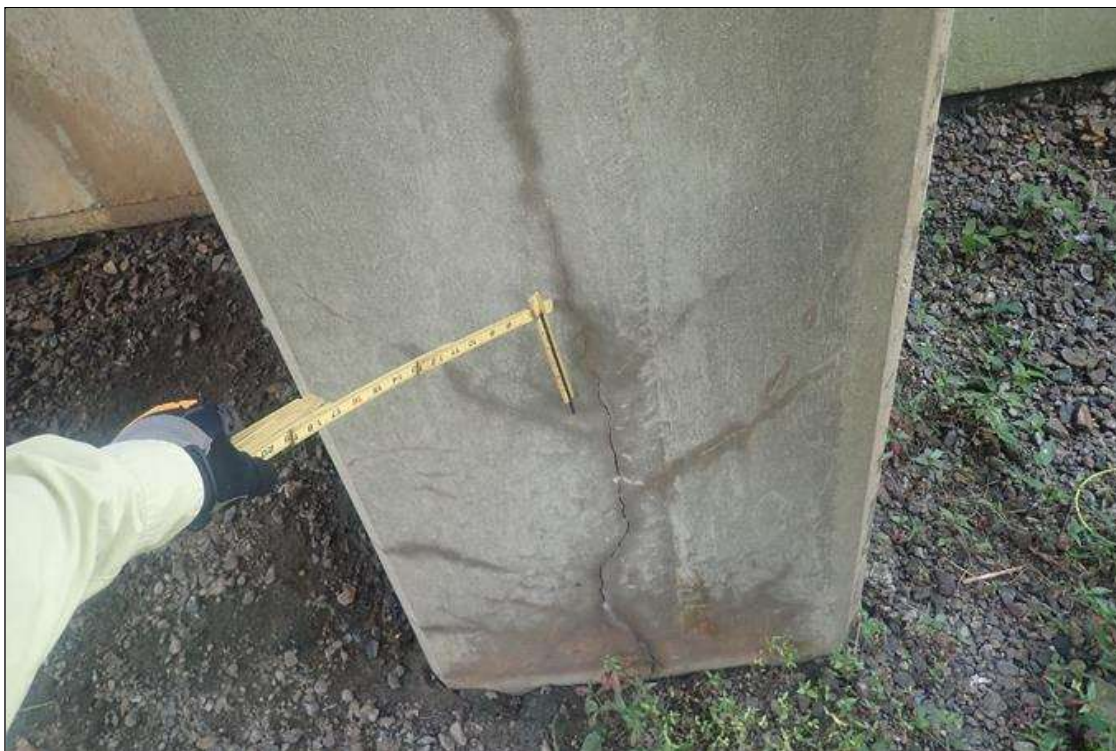
Bent 1 Pile 2: 1/8 inch vertical crack 3 feet long starting at ground line on south face, with map cracks (hairline)

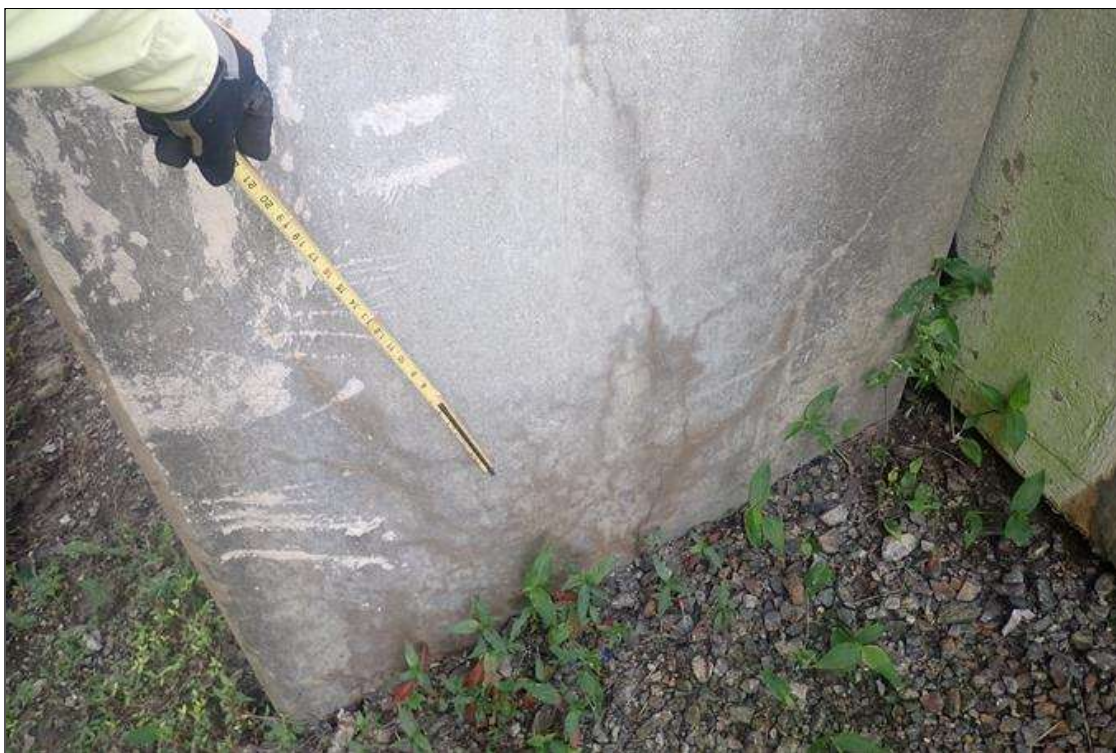
Bent 1 Pile 2: at ground, east and west faces, map cracks (hairline x 2 feet x 3 feet)

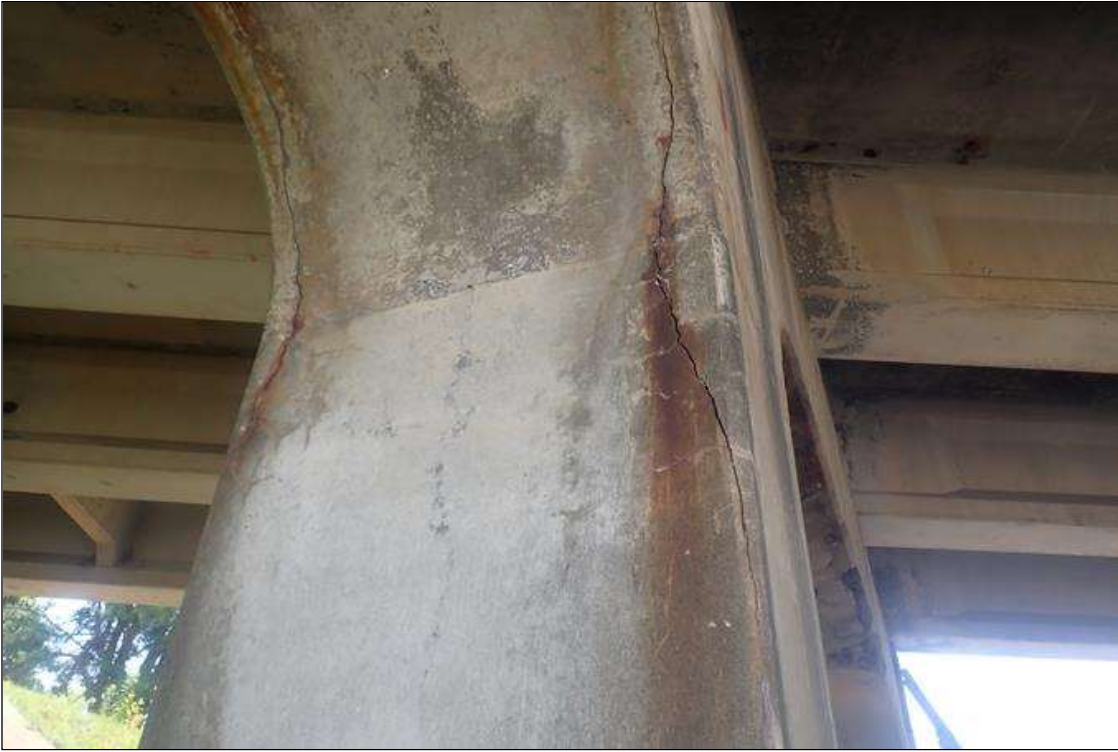
Bent 1 Pile 2: (PAR) VERTICAL CRACKS UP TO 1/8 INCH ALONG EDGES WITH DELAMINATIONS (UP TO 8 INCHES WIDE) FROM TOP DOWN 6 FEET WITH RUST STAINS ALL CORNERS.

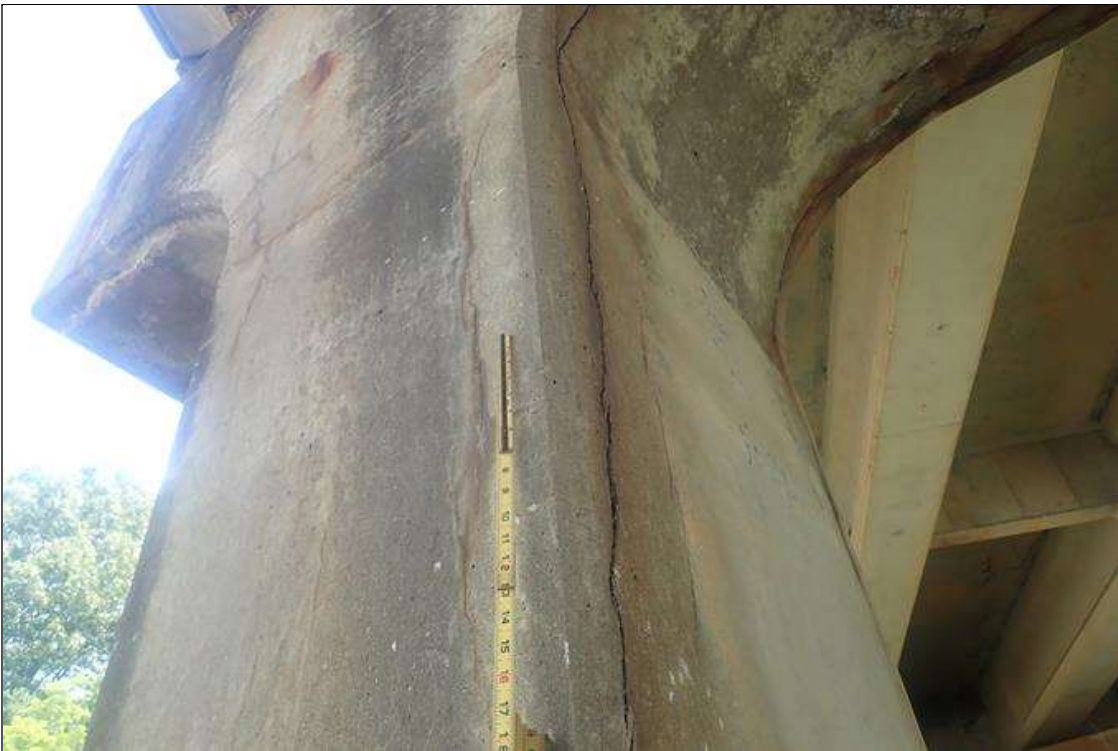
Bent 1 Pile 2: (PAR) VERTICAL CRACKS UP TO 1/8 INCH ALONG EDGES WITH DELAMINATIONS (UP TO 8 INCHES WIDE) FROM TOP DOWN 6 FEET WITH RUST STAINS ALL CORNERS.

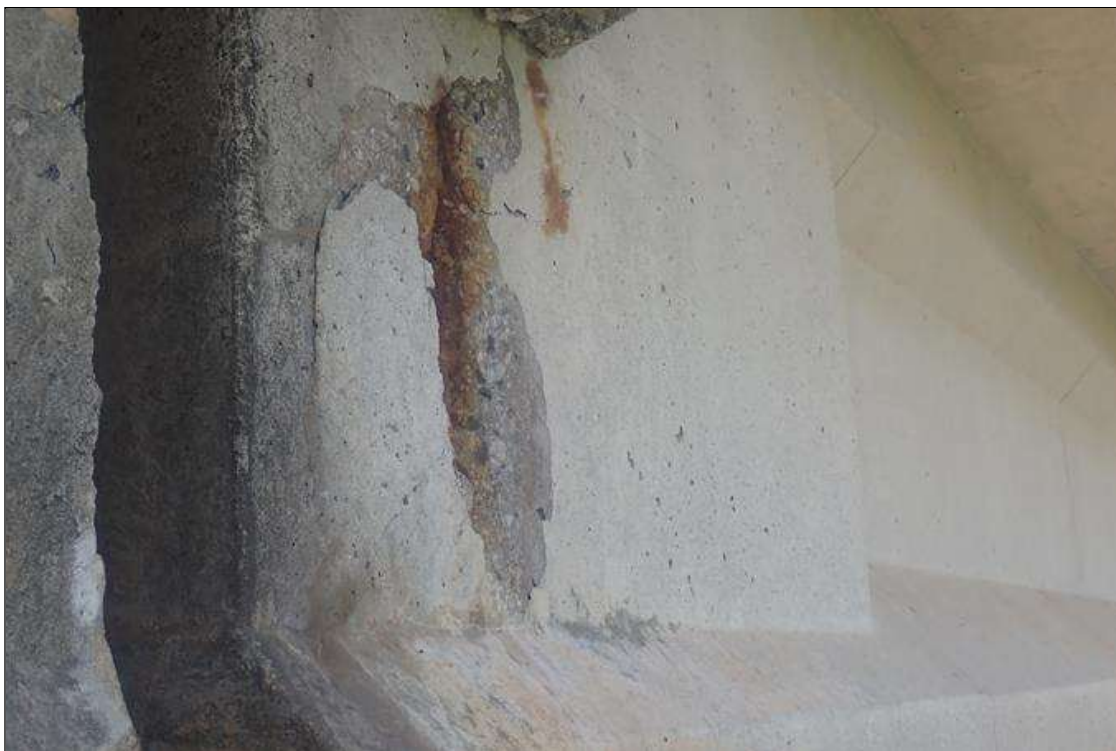
Span 1 Beam 1: 1 FOOT HIGH X 6 INCH LONG X 1 INCH DEEP SPALL ON LEFT SIDE WITH EXPOSED RUSTED REBAR OVER PIER 1.

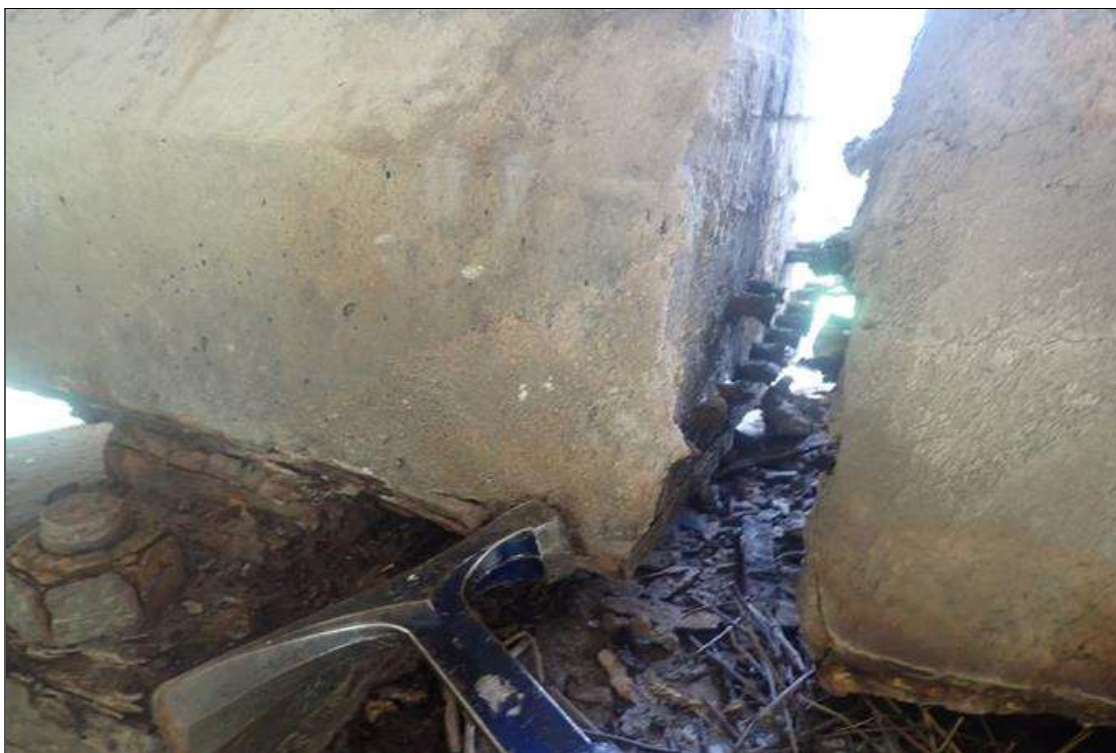
Span 1 Beam 1: 6 INCH X 5 INCH PATCHED AREA THAT IS SOUND ON RIGHT SIDE OF BOTTOM FLANGE OVER PIER 1.

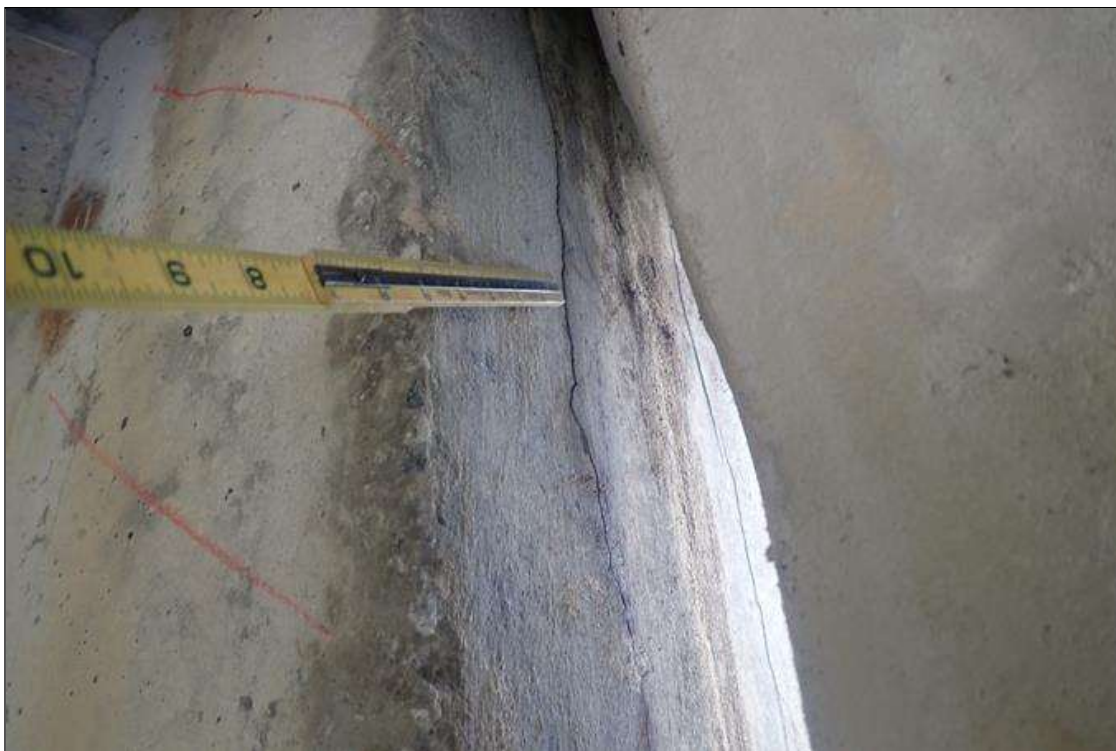
Span 1 Beam 1: (PAR) at bent 1, web, right face, delamination (12 inch x full height) with rust stains; end face, (2) vertical cracks (0.06 inch x full height)

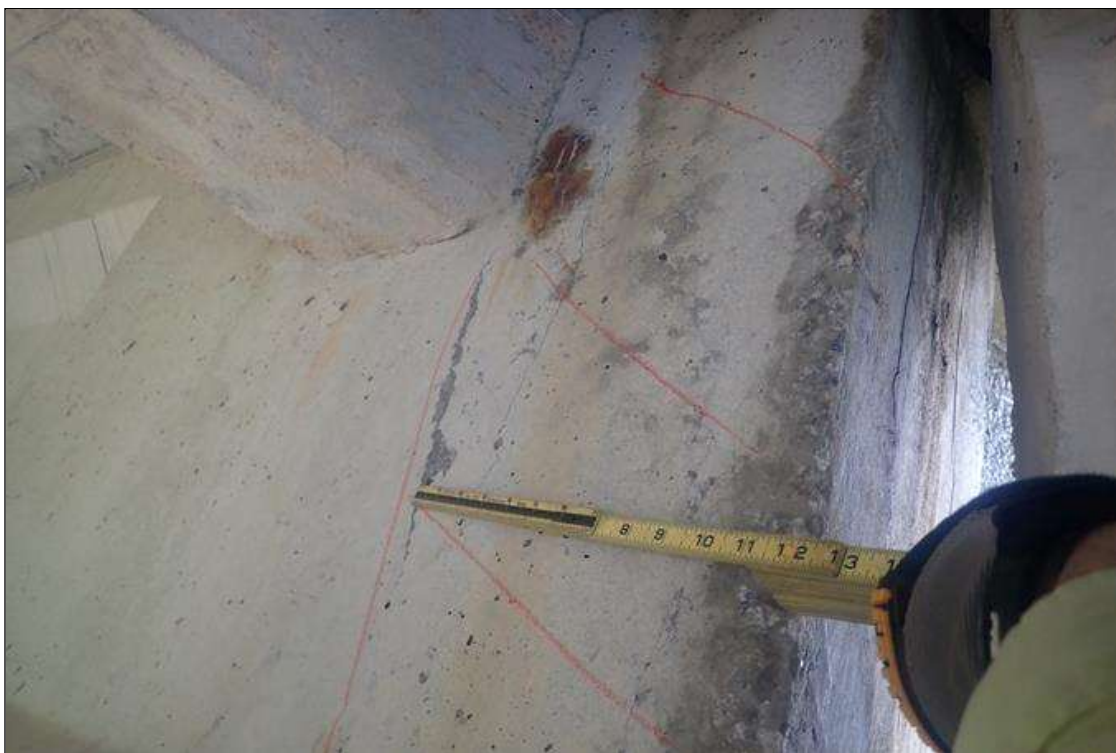
Span 1 Beam 1: (PAR) at bent 1, web, right face, delamination (12 inch x full height) with rust stains; end face, (2) vertical cracks (0.06 inch x full height)

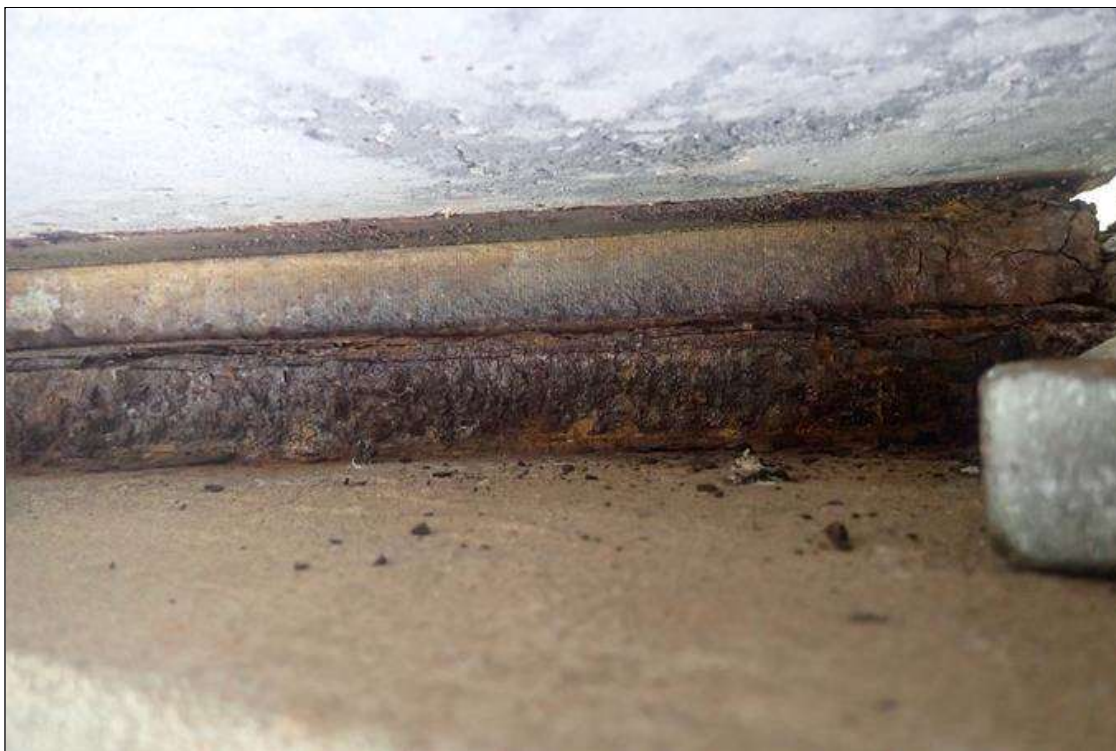
Span 2 Beam 2 - Near Bearing 2: rust scale/pack rust

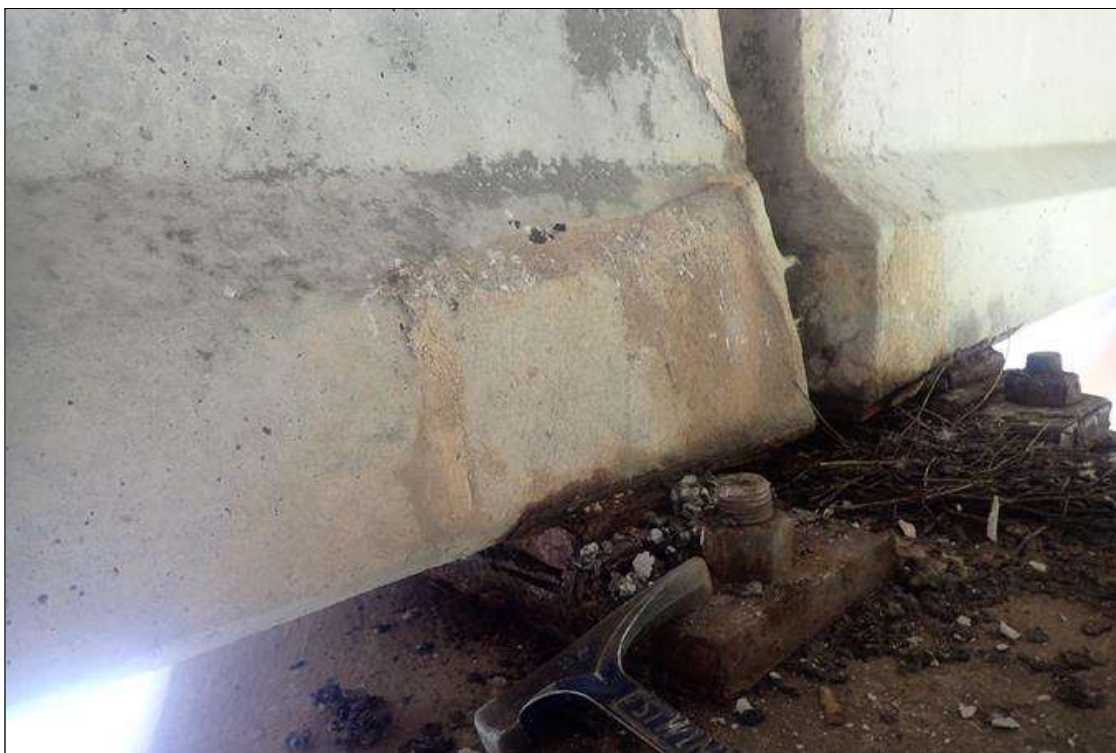
Span 2 Beam 2: FULL HEIGHT X 1.5 FOOT LONG PATCHED AREA ON BOTH SIDES OF BOTTOM FLANGE AND WEB OVER PIER 1.

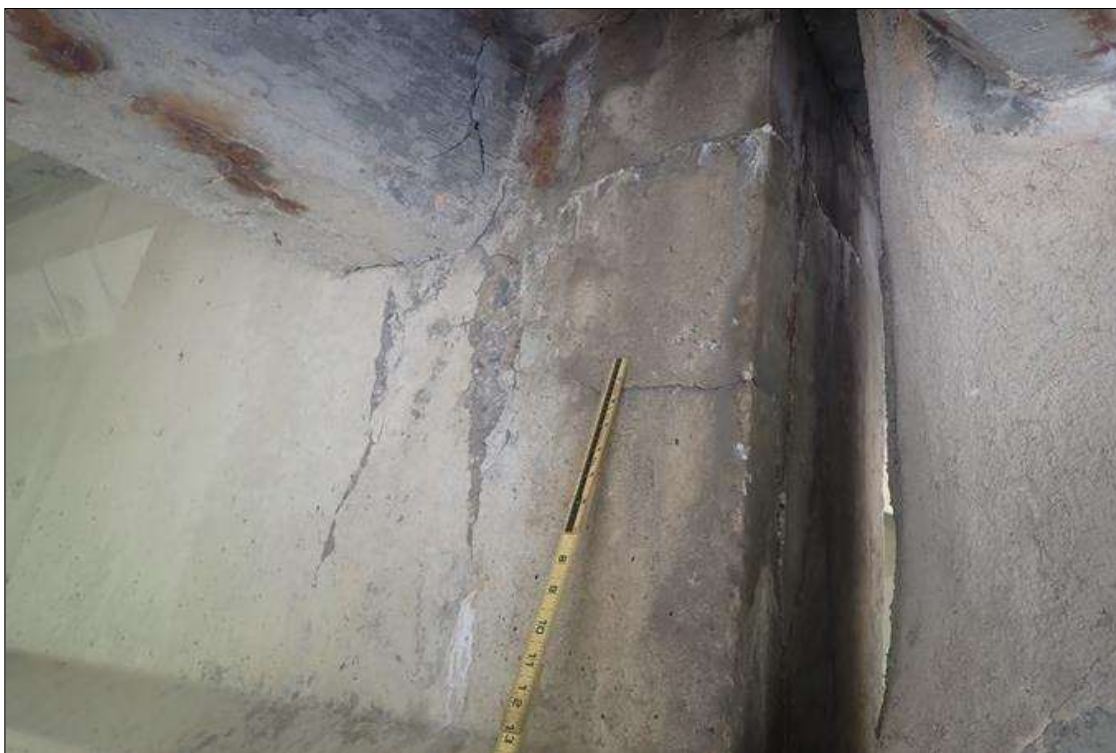
Span 1 Beam 2: (PAR) at bent 1, right face, delamination/spall (19 inches x full height x up to 3/4 inch deep) with efflorescence and rust stains

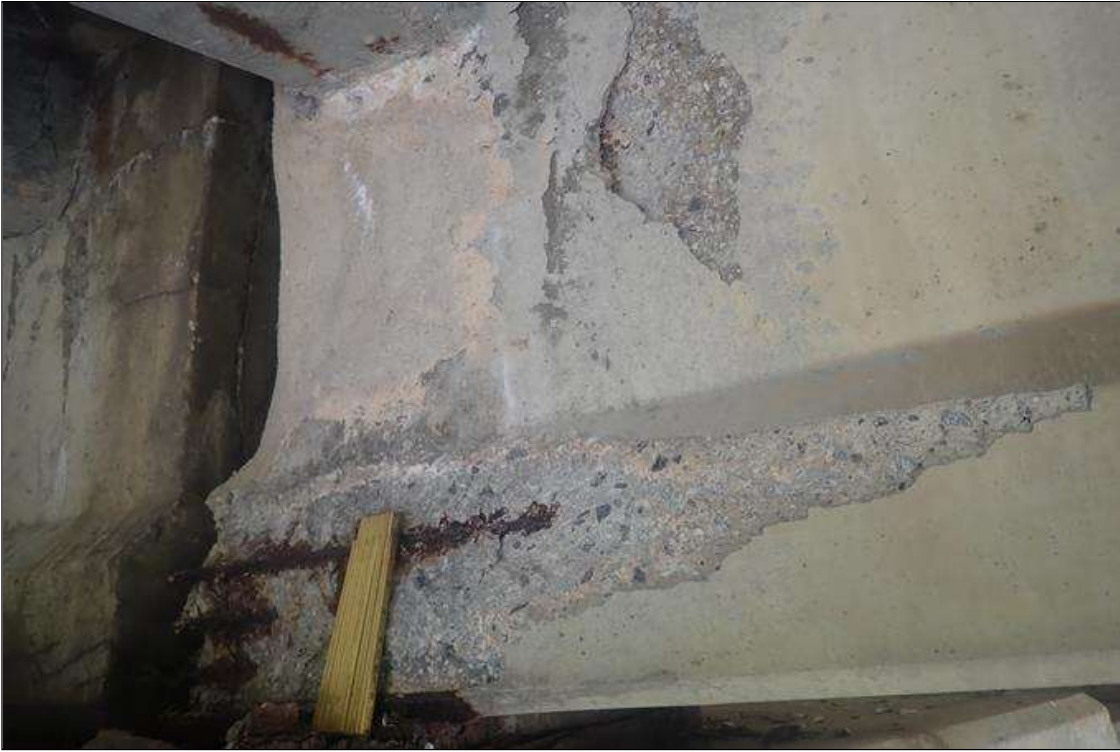
Span 2 Beam 2: (PAR) at bent 1, right face, spall/delamination (3 feet x full height) with exposed rusted strands and rebar, with partial patch in web

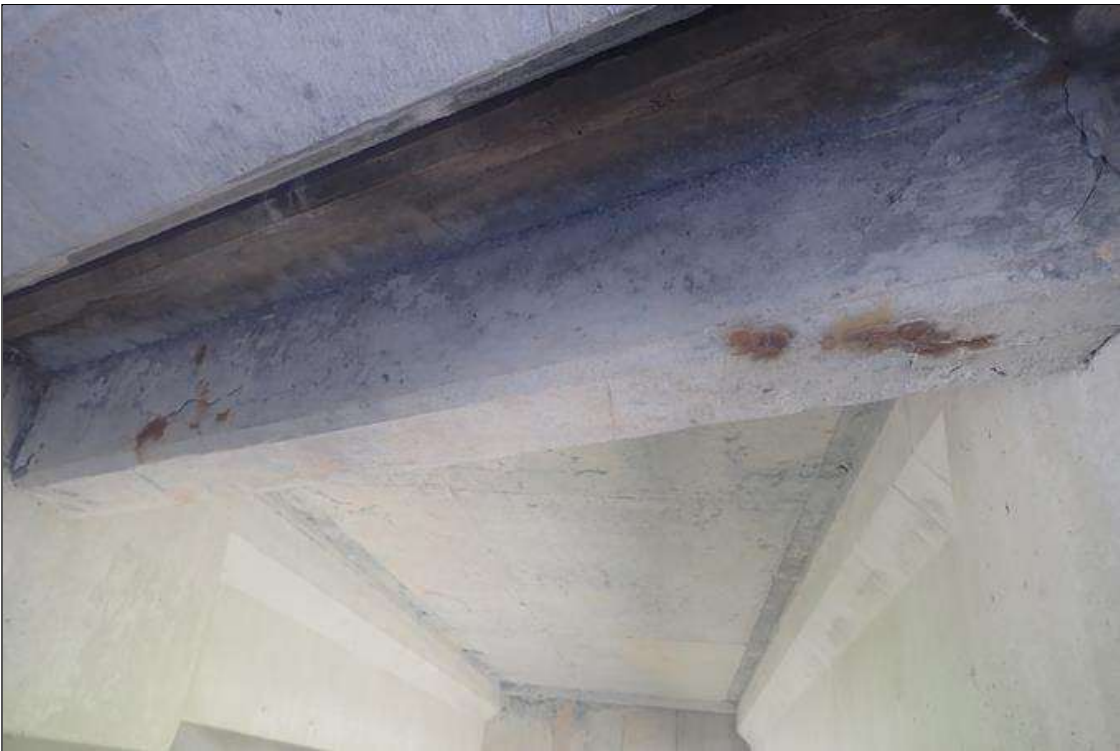
Span 1 Deck: (PAR) bent 1 end diaphragm, bay 2, longitudinal crack (up to 1/16 inch x 7 feet) with rust stains

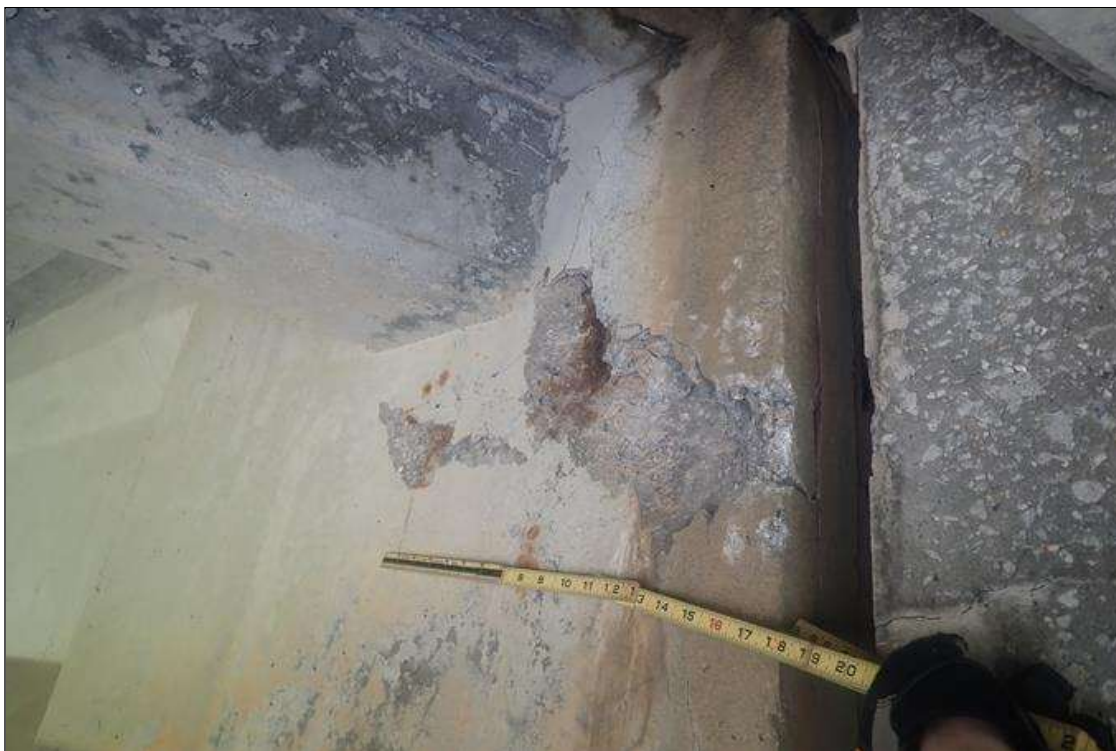
Span 1 Beam 3: (PAR) at bent 1, end of beam, both faces, spalls (up to 4 inch x 28 inch x 2.5 inch deep) with exposed rusted rebar

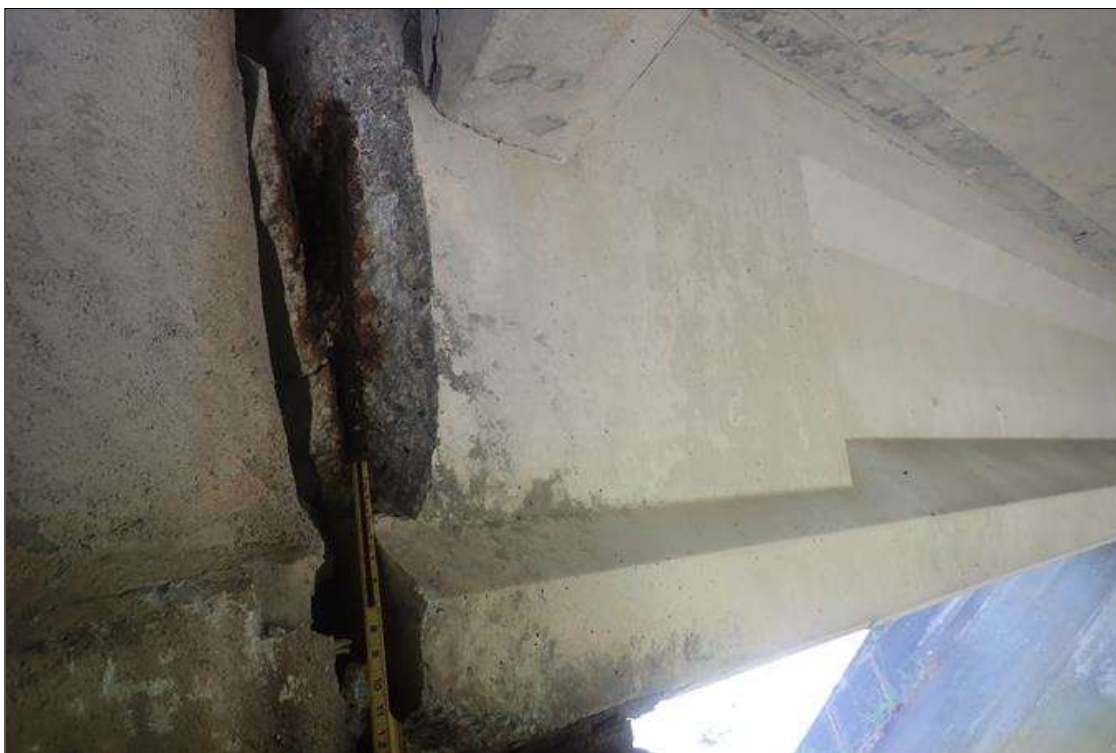
Span 1 Beam 3: (PAR) at bent 1, end of beam, both faces, spalls (up to 4 inch x 28 inch x 2.5 inch deep) with exposed rusted rebar

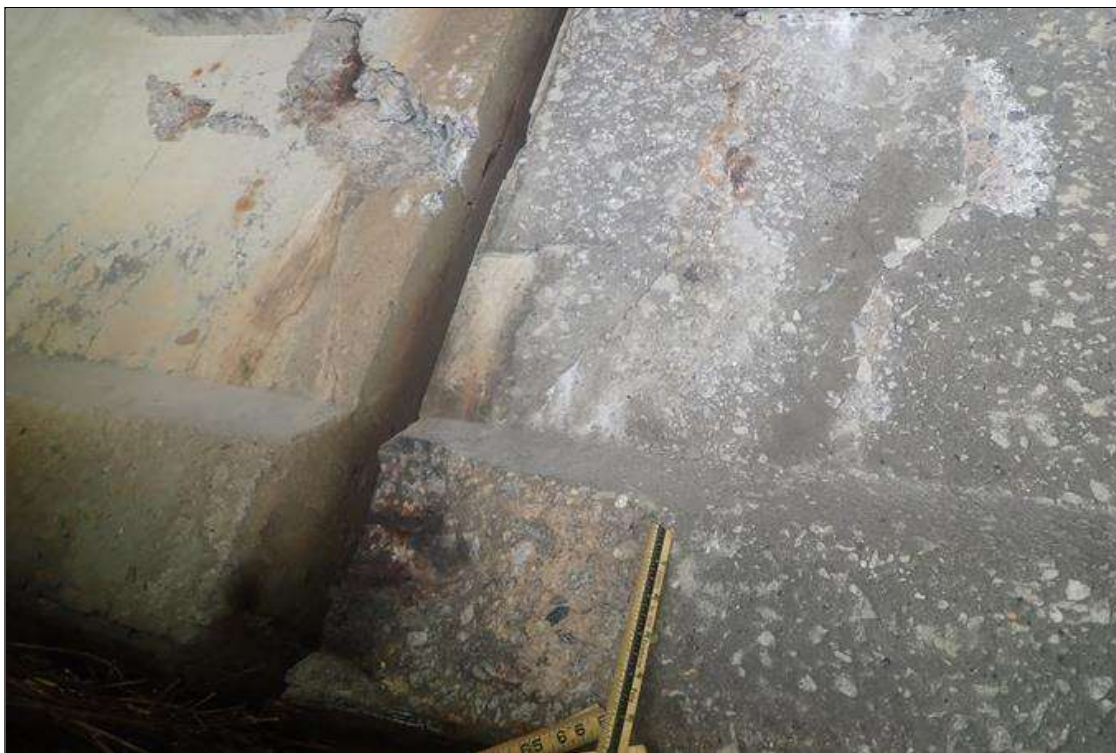
Span 2 Beam 3: (PAR) at bent 1, right face, spall/delamination (16 inch x full height x 2 inch deep) with exposed rusted strand

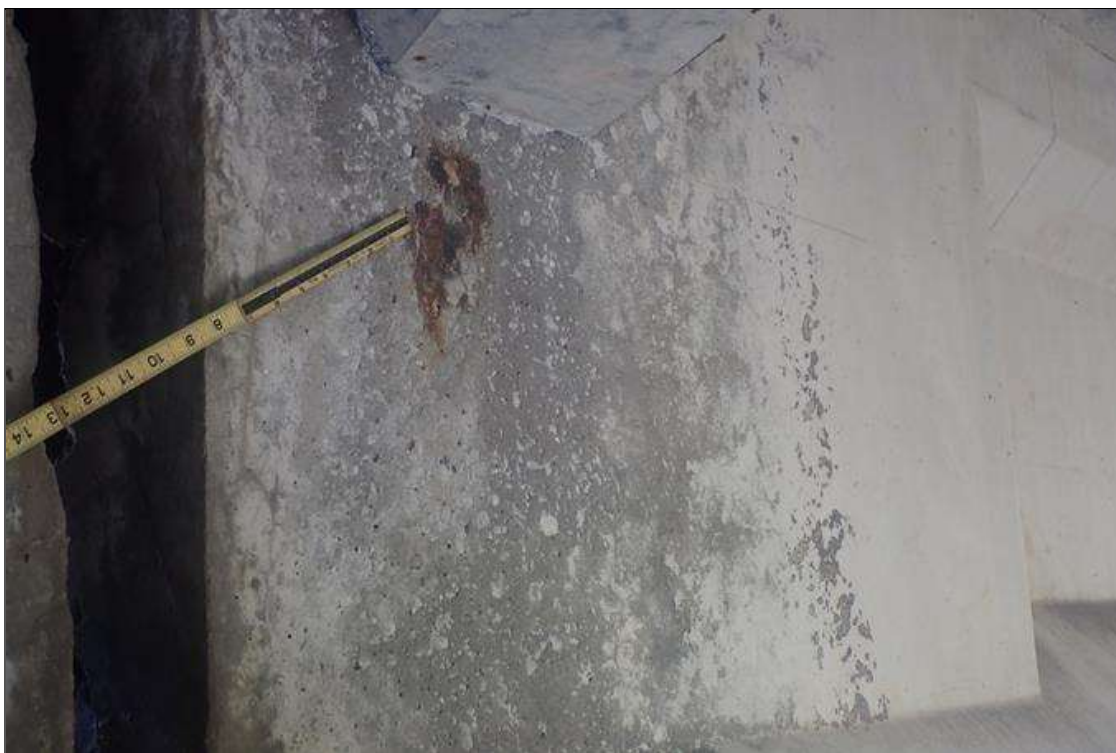
Span 1 Beam 4: (PAR) at bent 1, left face, web, rust stains (3 inch)

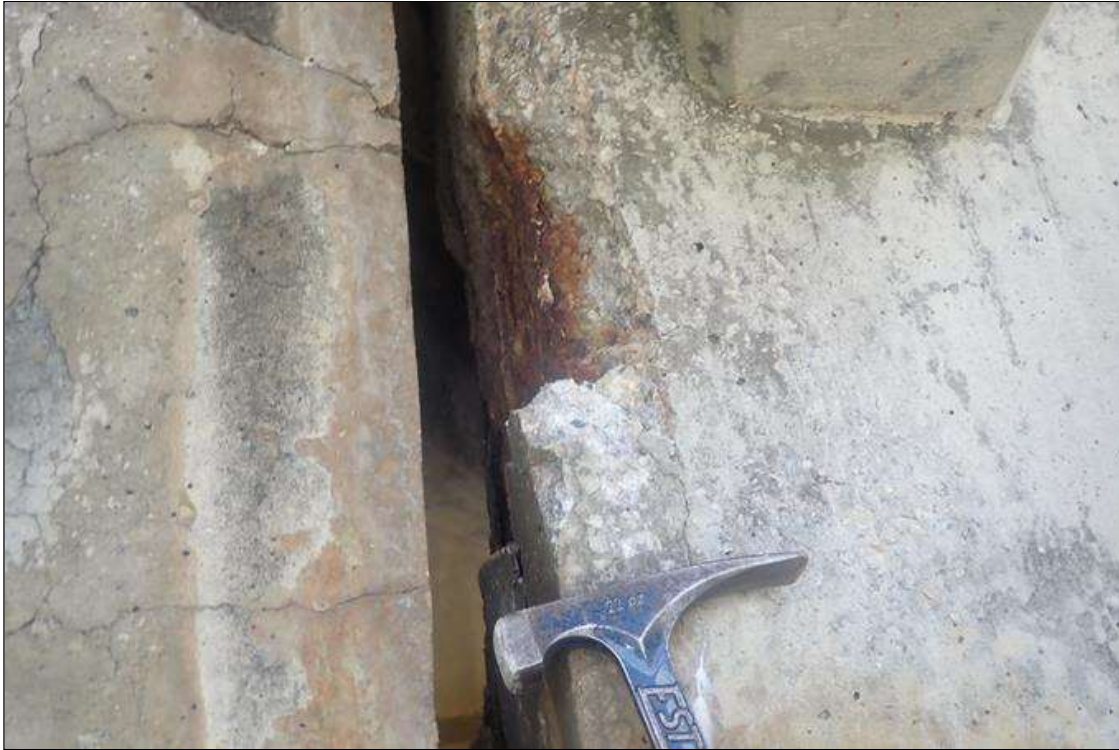
Span 2 Beam 4: (PAR) at bent 1, end of web, spall/delamination (30 inch high x full width x 2 inch deep) with exposed rusted rebar (up to 1/8 inch loss), extends along face of web (up to 10 inch)

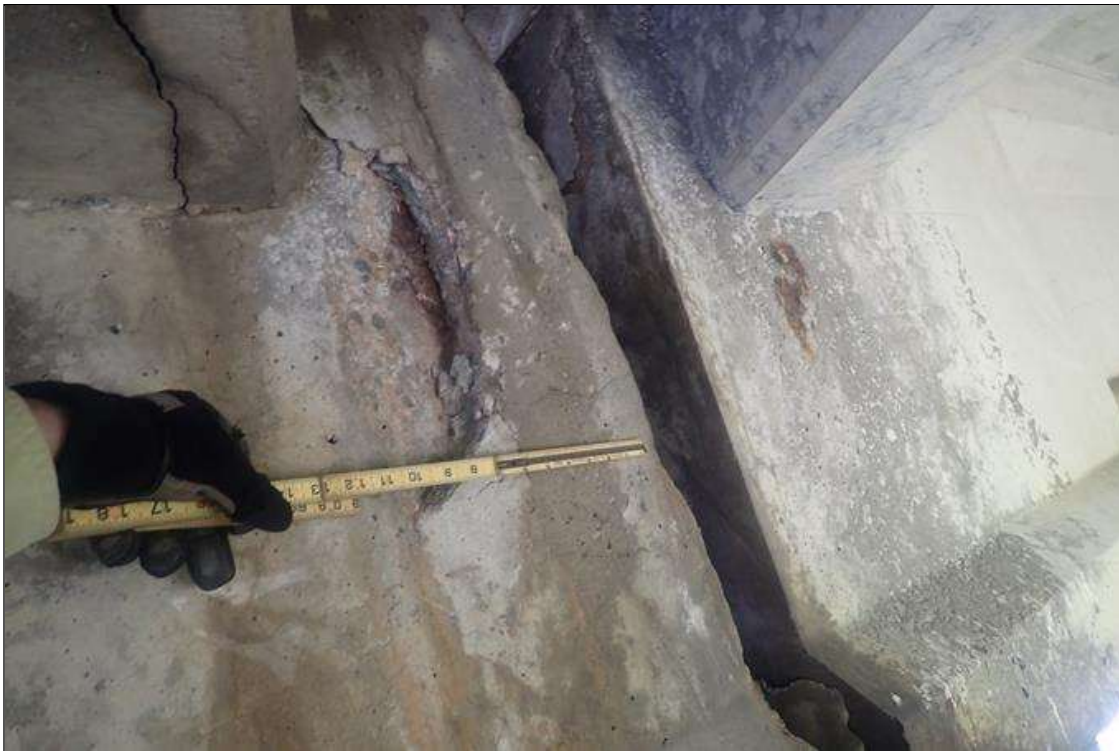
Span 2 Beam 4: (PAR) at bent 1, end of web, spall/delamination (30 inch high x full width x 2 inch deep) with exposed rusted rebar (up to 1/8 inch loss), extends along face of web (up to 10 inch)

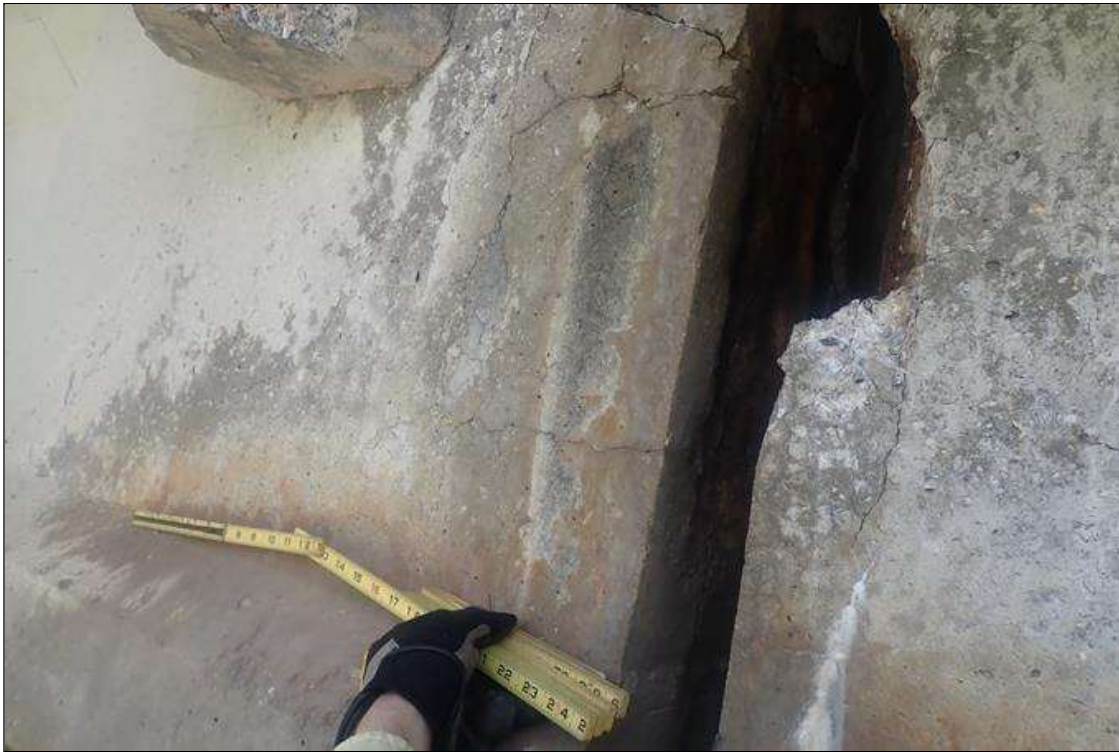
Span 1 Beam 4: (PAR) at bent 1, end of web, spall (30 inch high x 10 inch wide x 1 inch deep) with exposed rusted rebar, with delamination extending along right face with map cracks (up to 0.03 inch x 2 feet x full height)

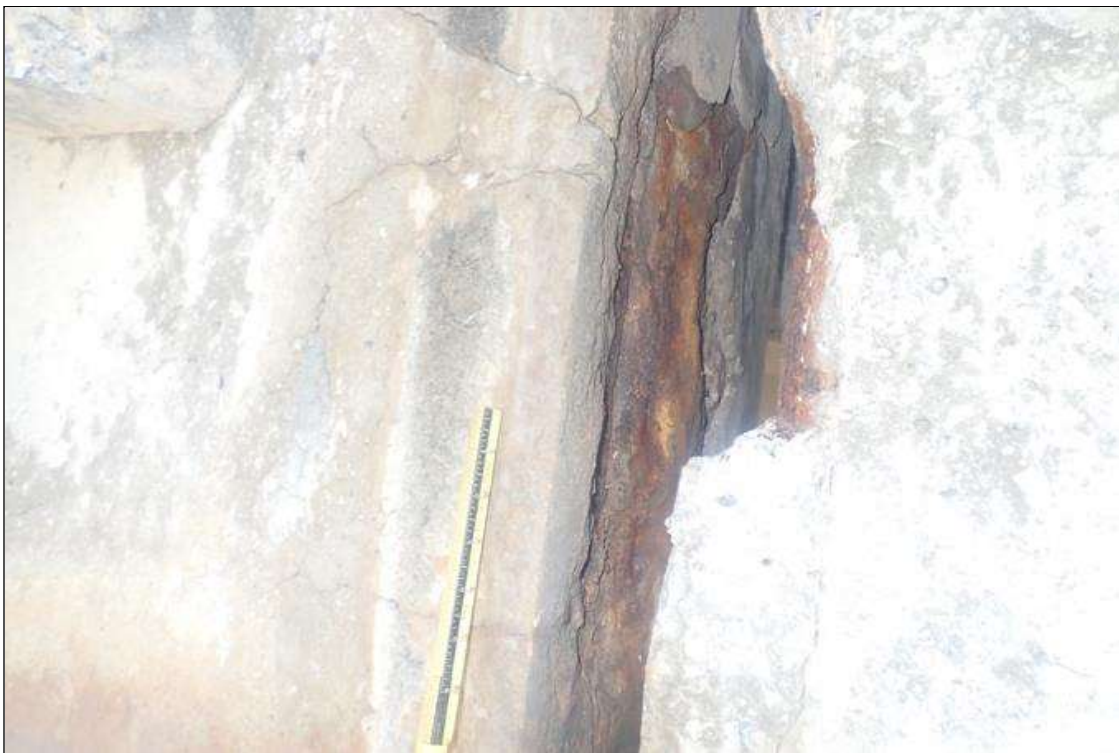
Span 1 Beam 4: (PAR) at bent 1, end of web, spall (30 inch high x 10 inch wide x 1 inch deep) with exposed rusted rebar, with delamination extending along right face with map cracks (up to 0.03 inch x 2 feet x full height)

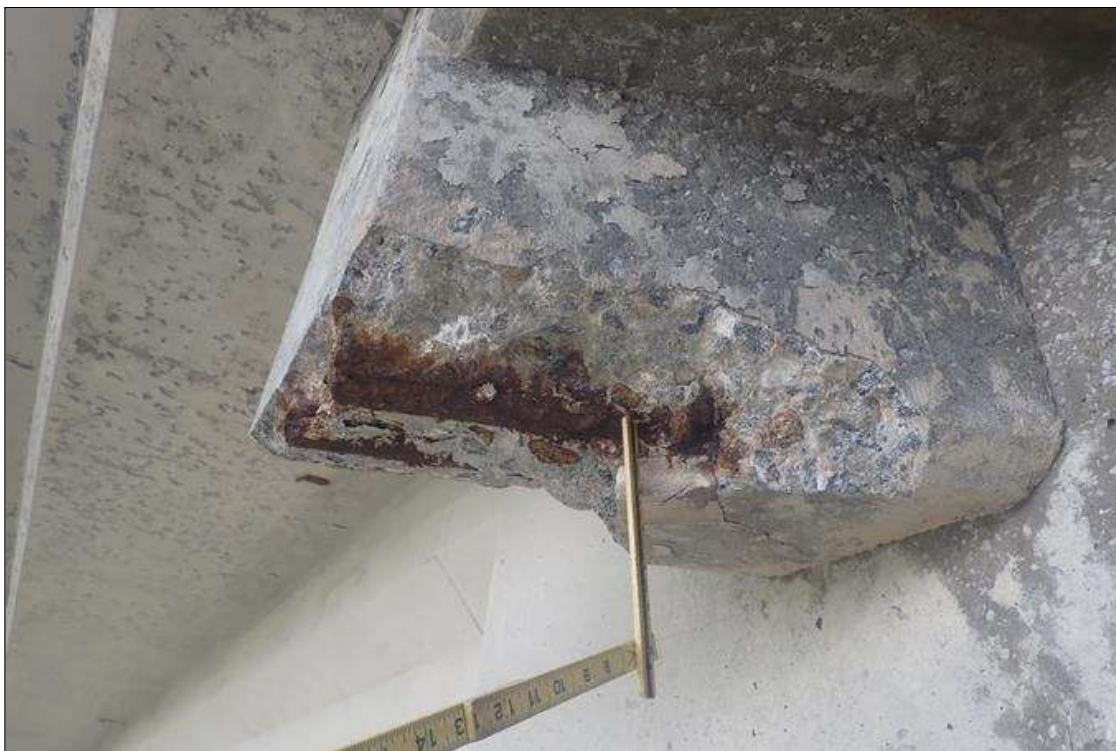
Span 1 Deck: bent 1 end diaphragm, right overhang, spall (12 inch x 8 inch x 2 inch deep) with exposed rusted rebar

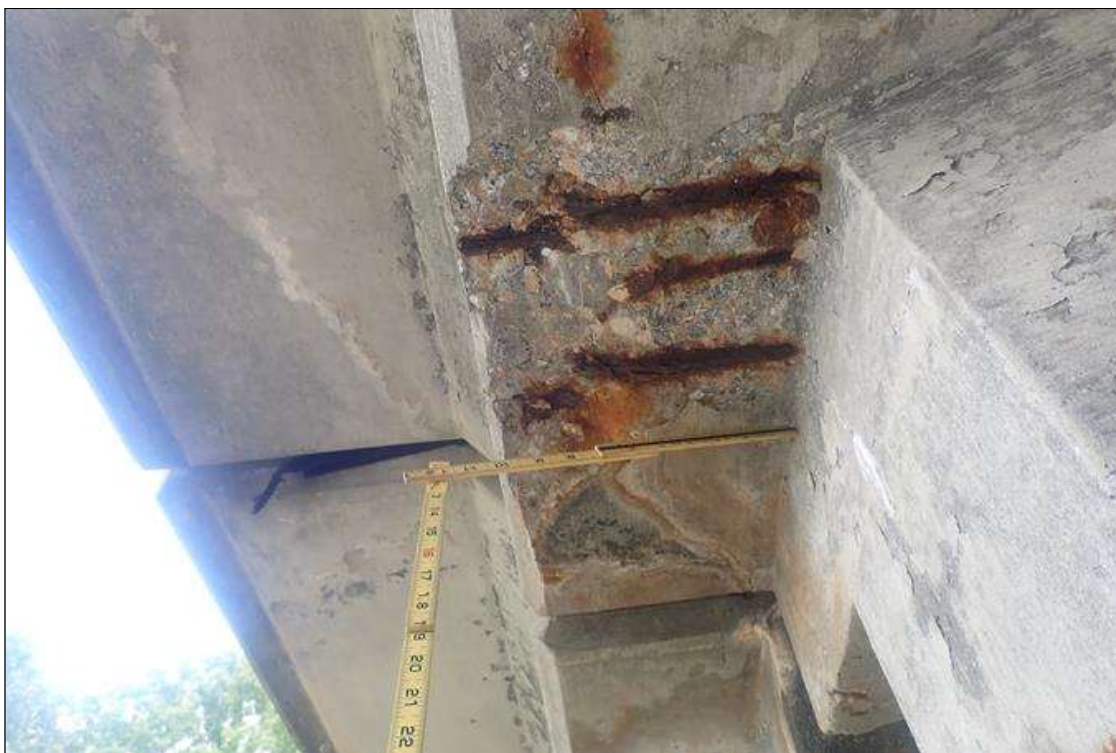
Span 2 Deck: (PAR) right overhang, at bent 1, spall (10 inch x 12 inch x 1.5 inch deep) with exposed rusted rebar

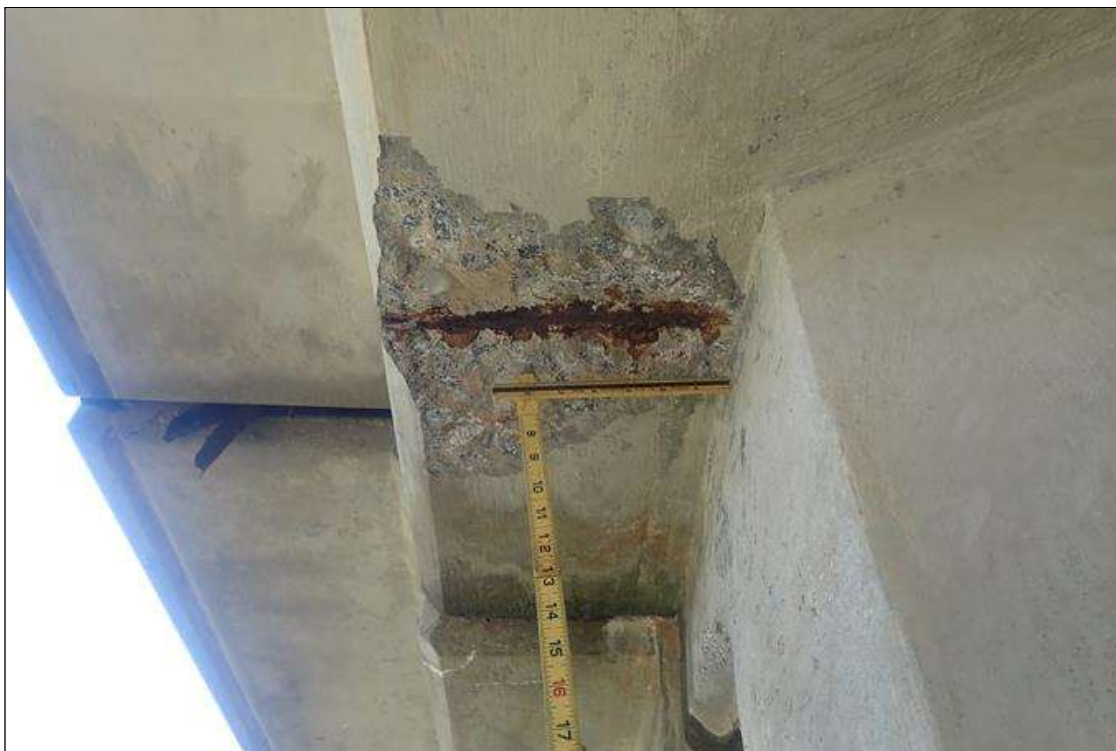
Span 2 Deck: (PAR) left overhang, at bent 2, spall (10 inch x 12 inch x 1.5 inch deep) with exposed rusted rebar
