NC DEPARTMENT OF TRANSPORTATION  
 DIVISION OF HIGHWAYS  
 STRUCTURE MANAGEMENT UNIT

ATTENTION: **prompt action request, sketches revised, lateral clearances revised**

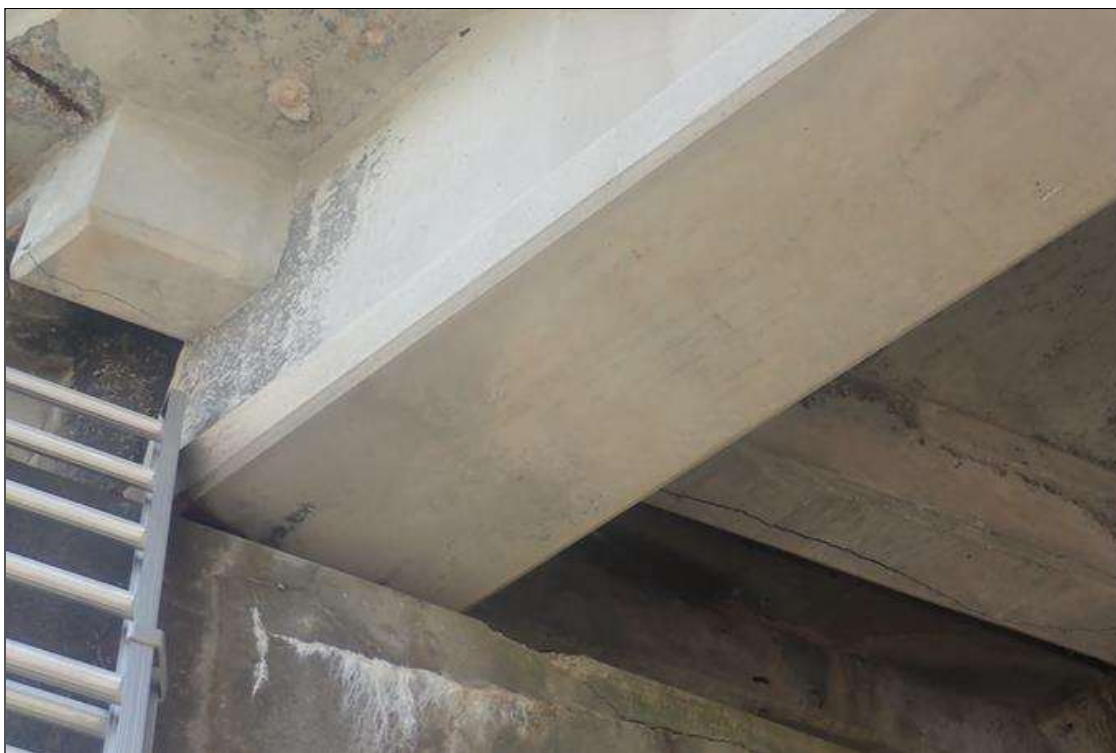
Span 2 Deck: (PAR) bent 2 end diaphragm, longitudinal crack (up to 1/4 inch x full length) with rust stains

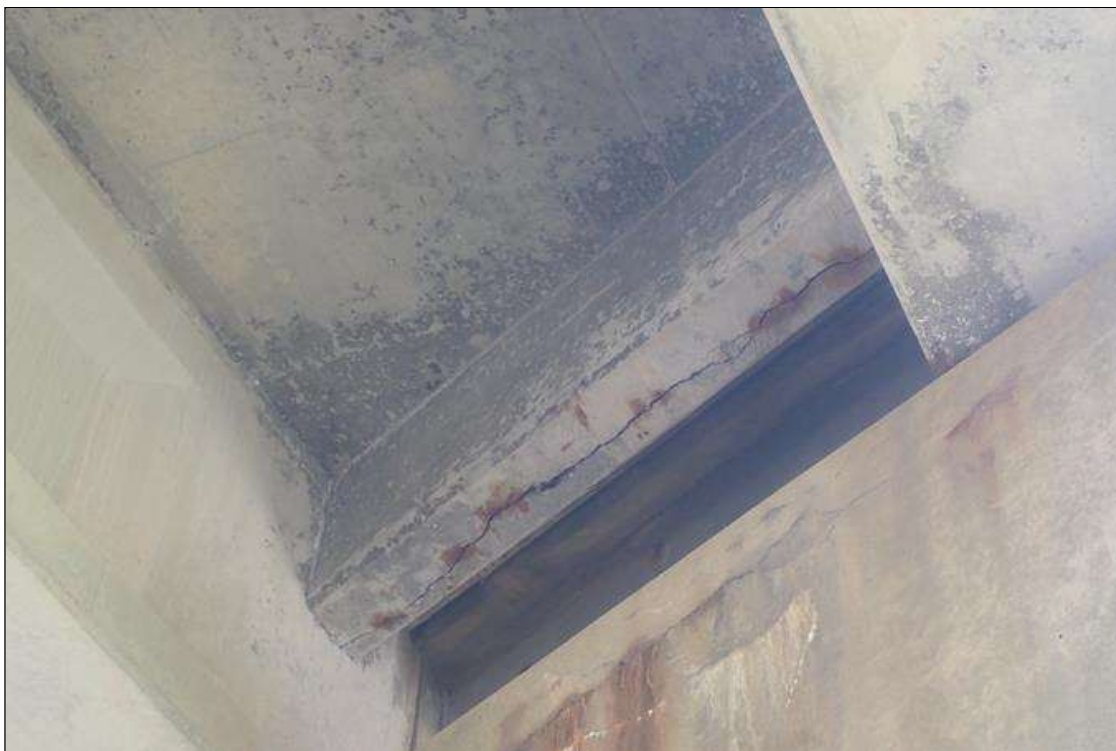
Span 2 Deck: (PAR) bent 2 end diaphragm, longitudinal crack (up to 1/4 inch x full length) with rust stains

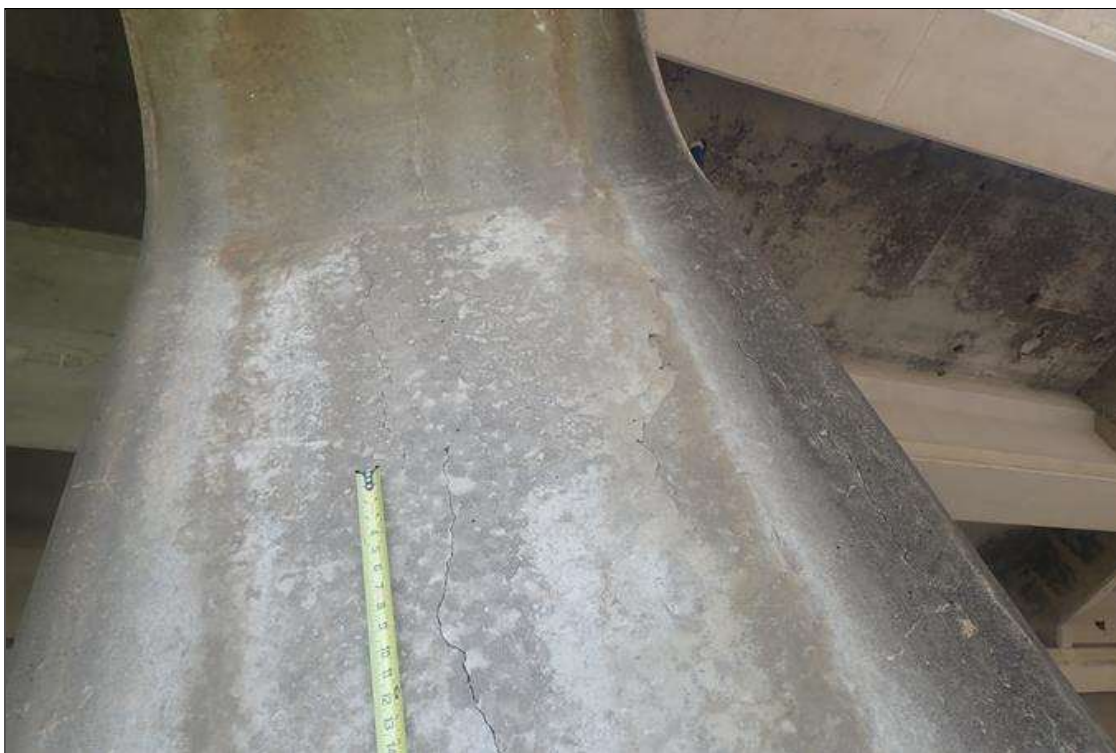
Bent 2 Pile 1: west face, multiple vertical cracks (up to 1/16 inch x full height) with delamination (2 feet wide) at top

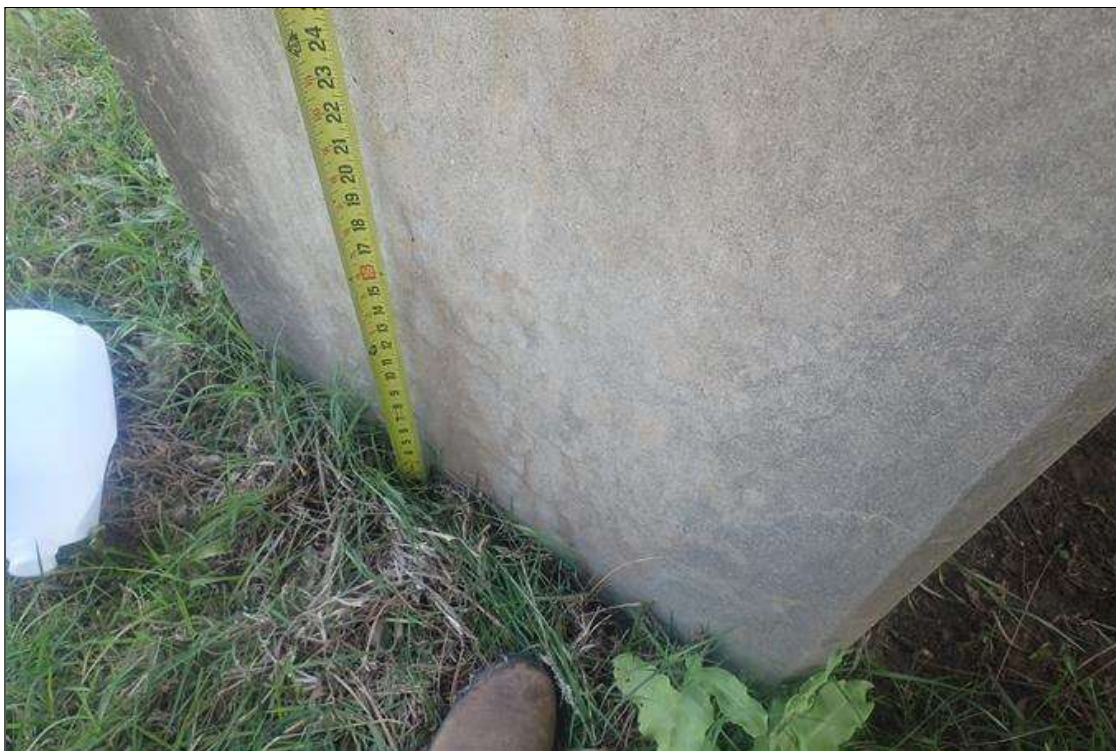
Bent 2 Pile 1: at ground, all faces, map cracks (hairline x 2 feet high)

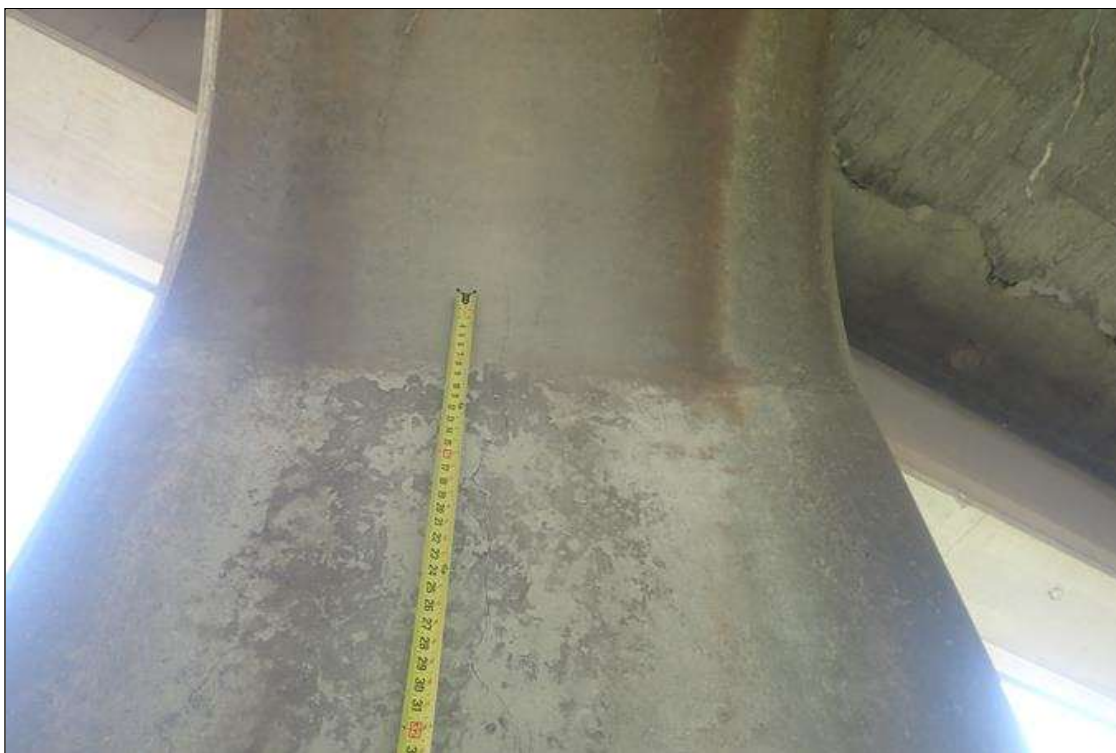
Bent 2 Pile 1: east face, at top, vertical crack (1/32 inch x 3 feet)

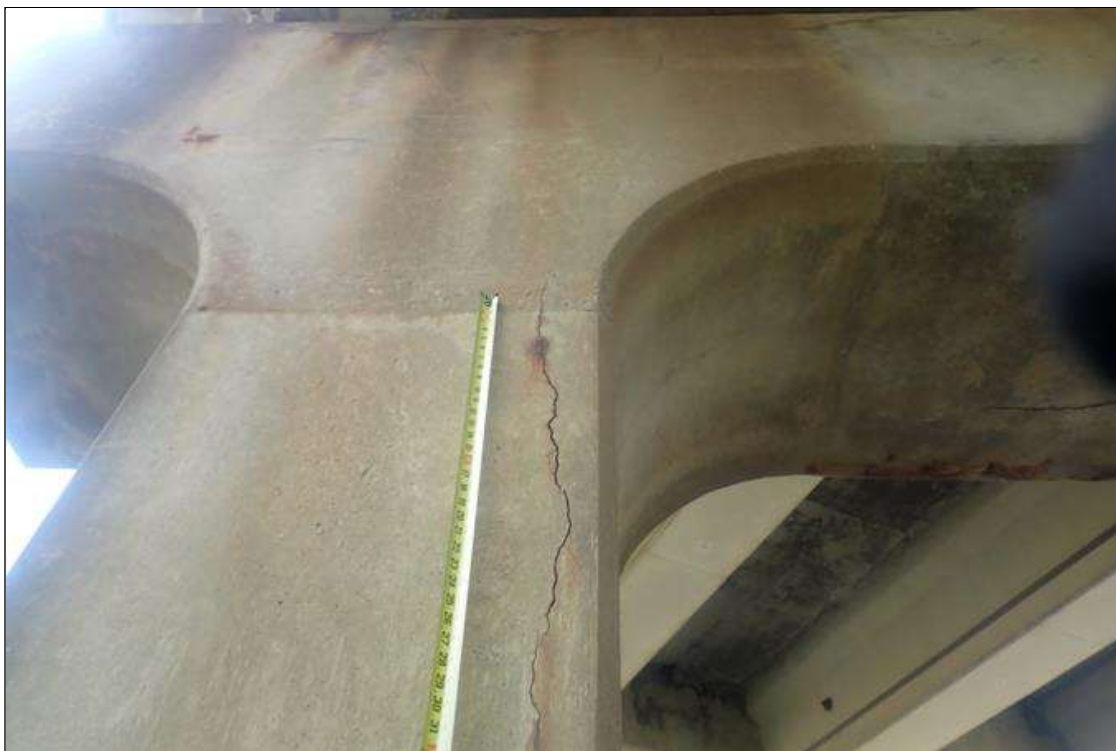
Bent 2 Pile 2: (PAR) 1/8 inch vertical crack 4 feet long with rust stains on northwest corner near top

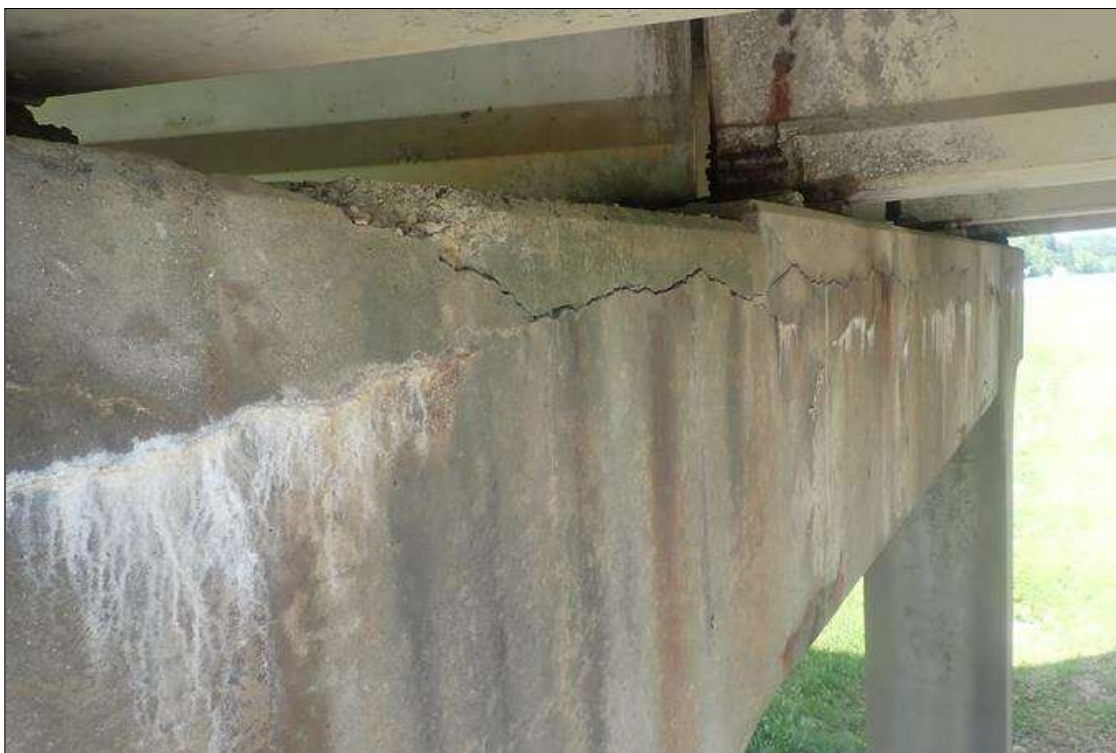
Bent 2 Cap 1: (PAR) HORIZONTAL CRACKING UP TO 1/4 INCH WITH DELAMINATIONS/SPALLS (UP TO 1 INCH DEEP), EFFLORESCENCE BUILDUP AND RUST STAINS AT TOP EDGE ALONG LENGTH OF BOTH FACES.

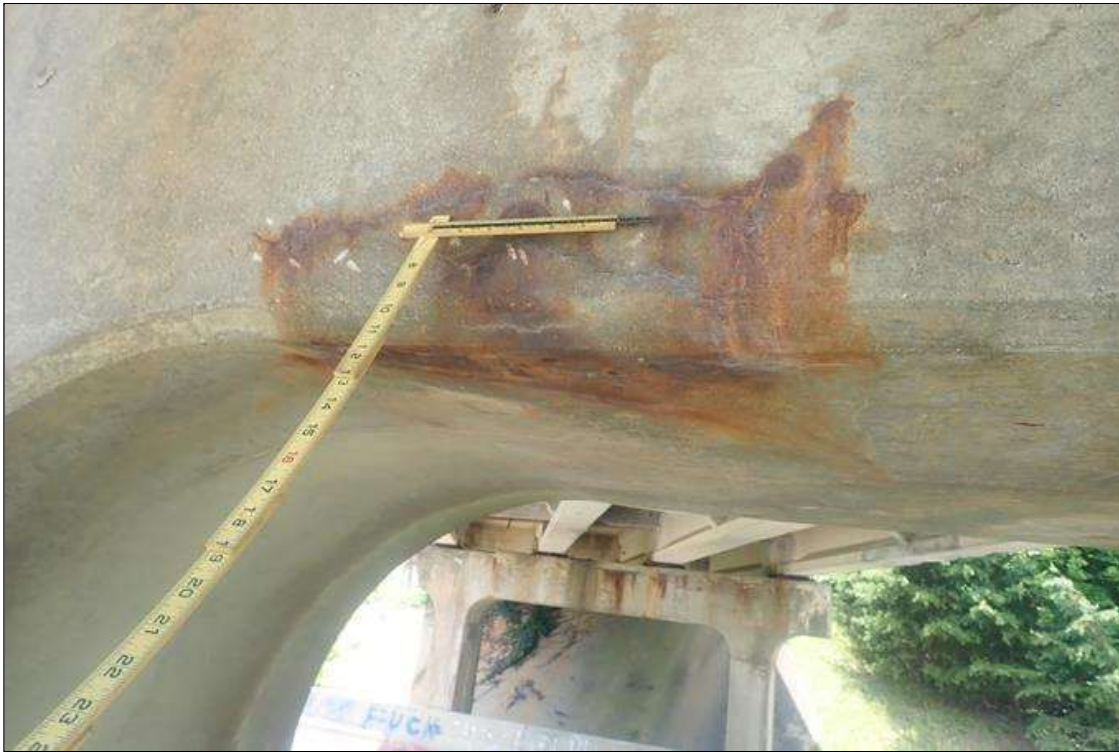
Bent 2 Cap 1: (PAR) south face blow bay 1, bottom corner, longitudinal crack (1/32 inch x 2 feet) with rust stains

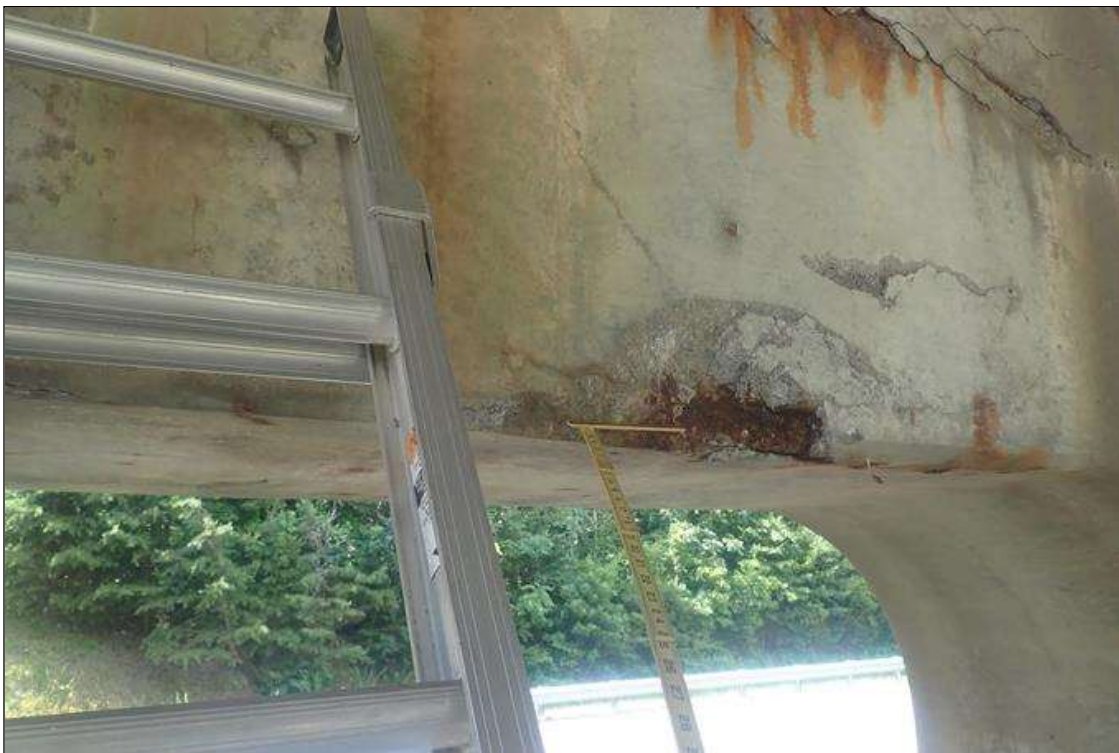
Bent 2 Cap 1: (PAR) south face, below bay 2, bottom corner, longitudinal crack (1/16 inch x 9.5 feet) with rust stains, and spall/delamination (3 feet x 1 foot x 2 inch deep) with exposed rusted rebar

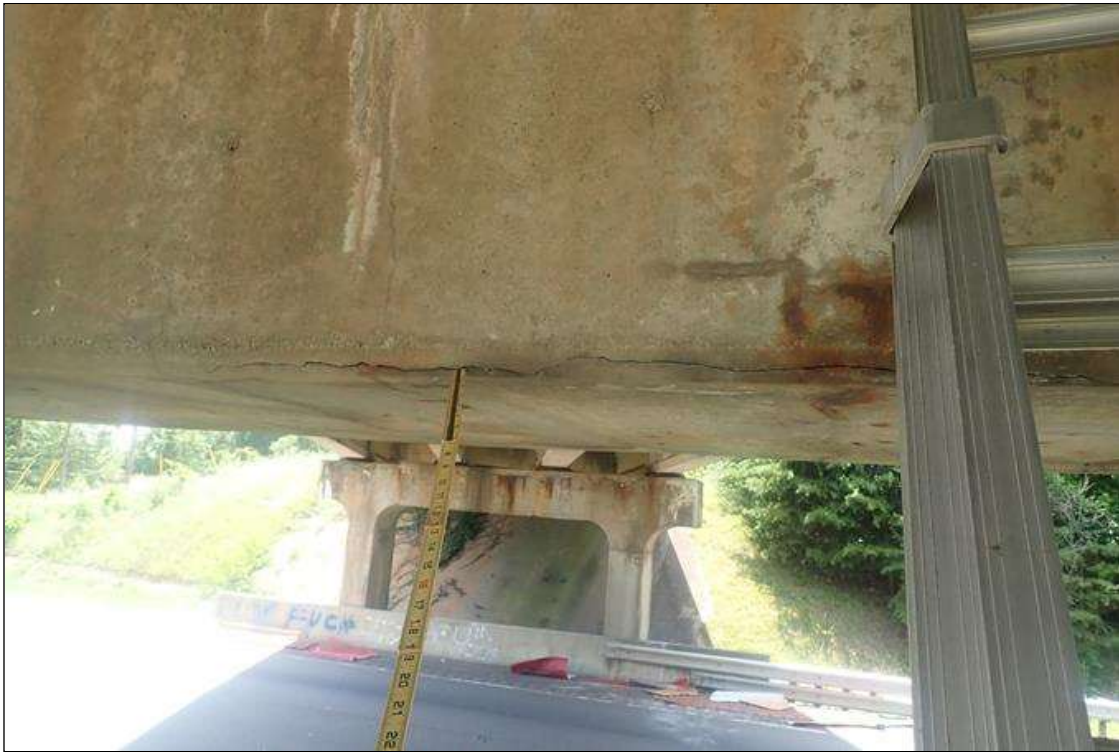
Bent 2 Cap 1: (PAR) south face, below bay 2, bottom corner, longitudinal crack (1/16 inch x 9.5 feet) with rust stains, and spall/delamination (3 feet x 1 foot x 2 inch deep) with exposed rusted rebar

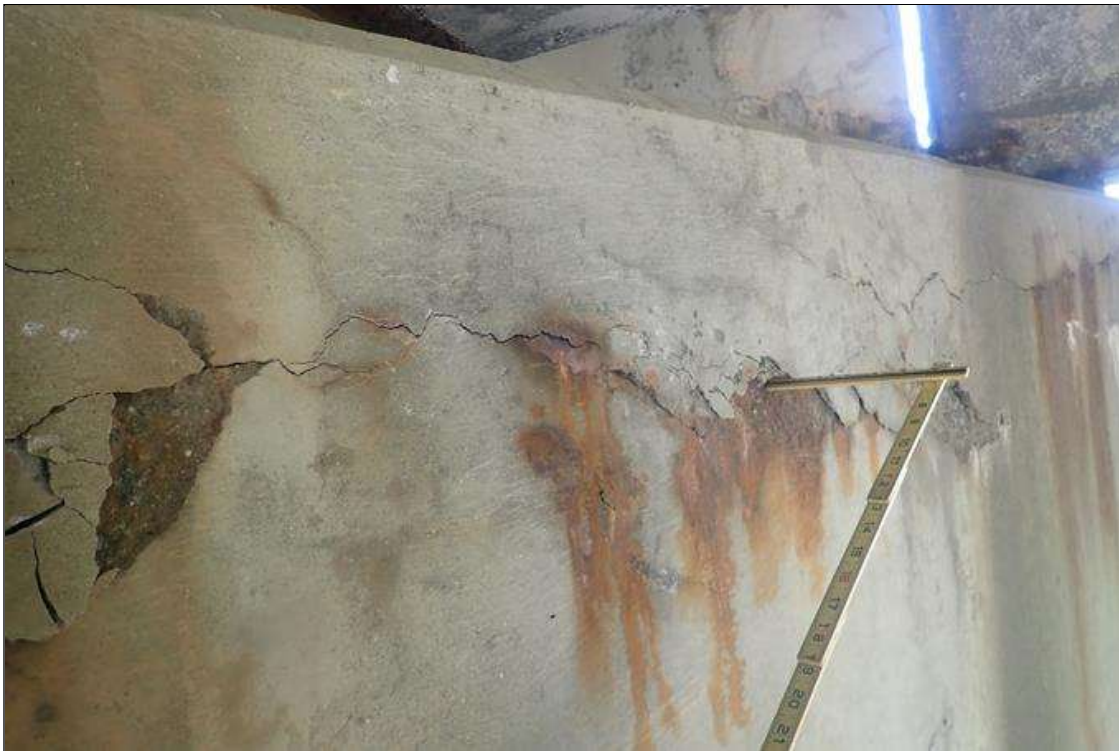
Bent 2 Cap 1: (PAR) HORIZONTAL CRACKING UP TO 1/4 INCH WITH DELAMINATIONS/SPALLS (UP TO 1 INCH DEEP), EFFLORESCENCE BUILDUP AND RUST STAINS AT TOP EDGE ALONG LENGTH OF BOTH FACES.

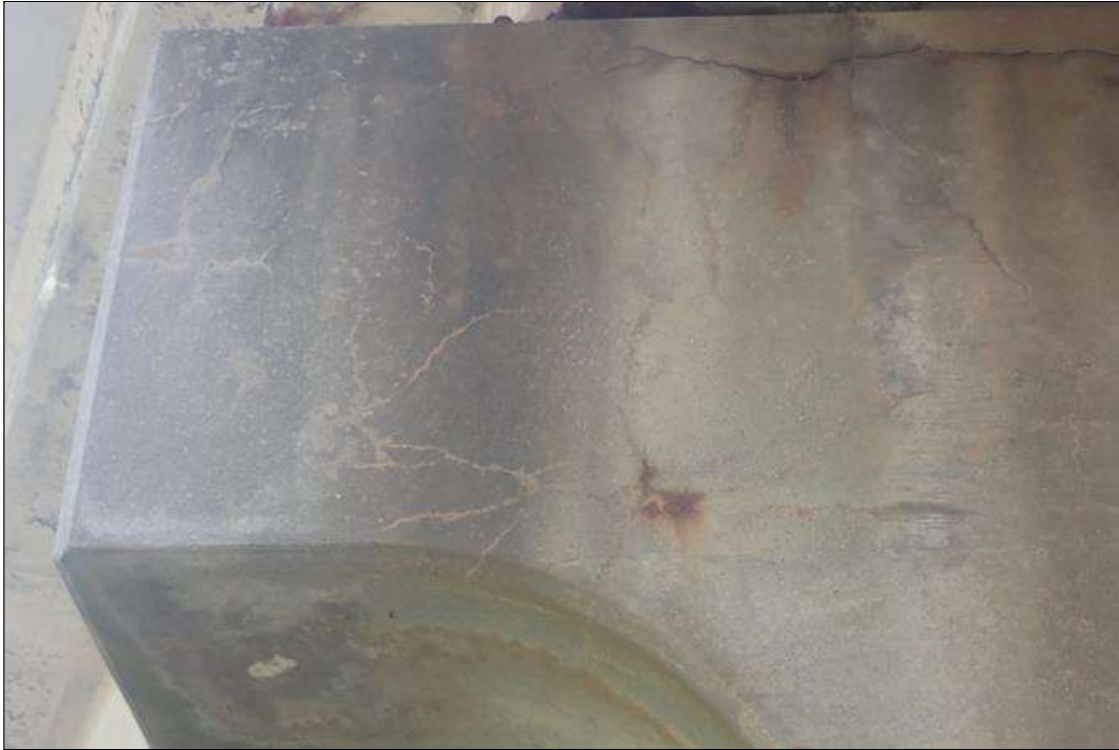
Bent 2 Cap 1: (PAR) north face, right end, map cracks (hairline x 3 feet x full height) with efflorescence and rust stains

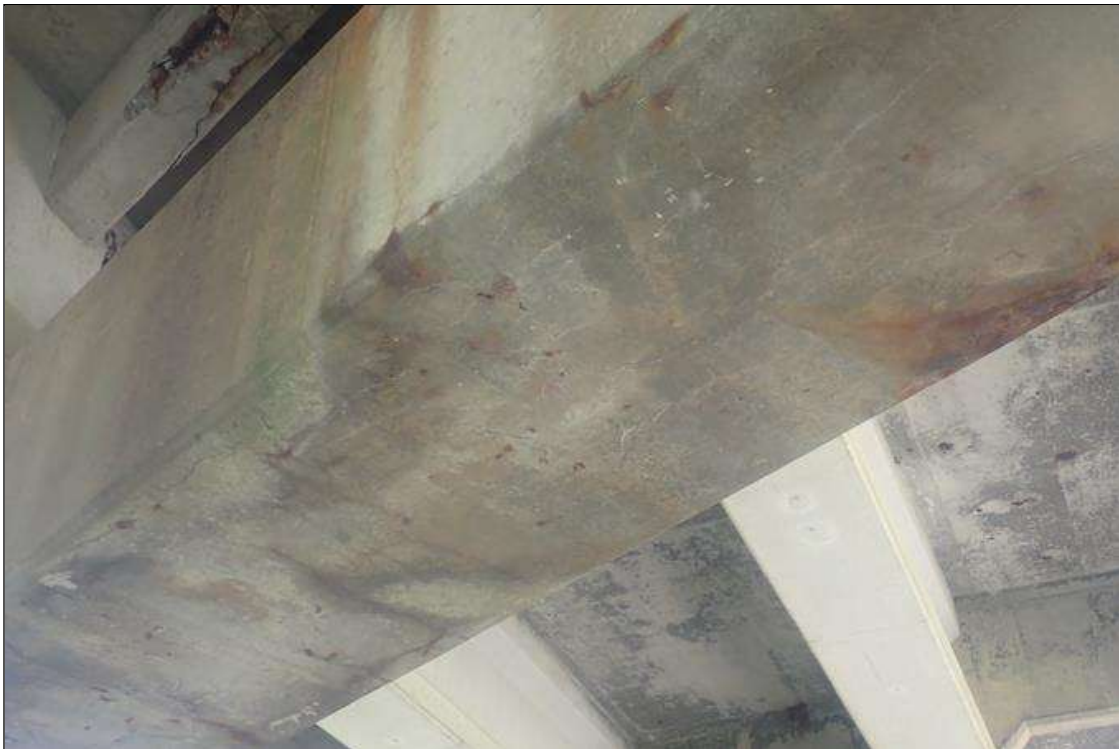
Bent 2 Cap 1: (PAR) underside of cap, longitudinal/transverse cracks (hairline up to 1/16 inch x full width x 12 feet) with rust stains and delamination/spall (up to full width x 1 inch deep)

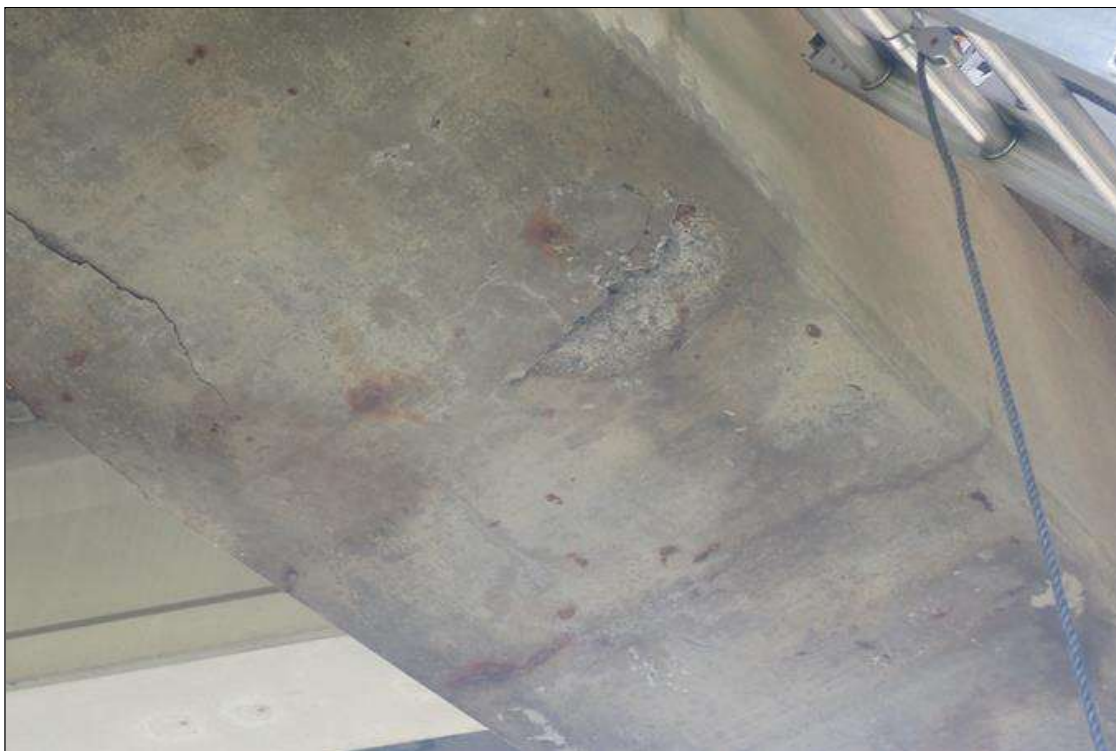
Bent 2 Cap 1: (PAR) underside of cap, longitudinal/transverse cracks (hairline up to 1/16 inch x full width x 12 feet) with rust stains and delamination/spall (up to full width x 1 inch deep)

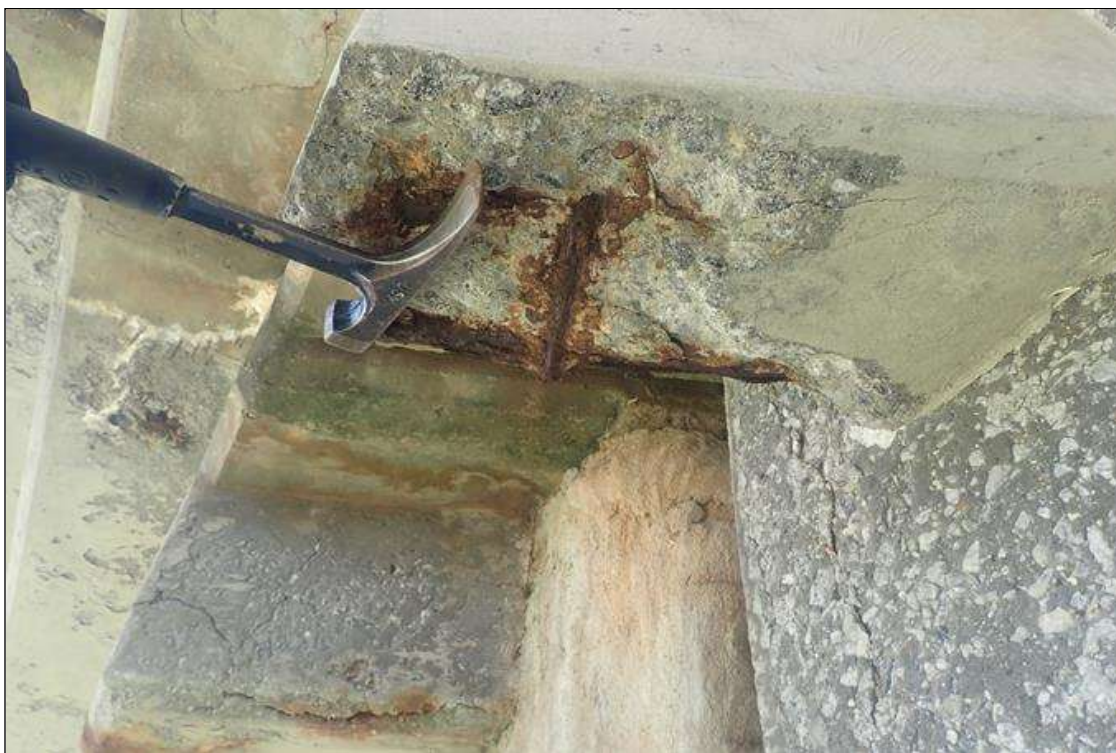
Span 3 Deck: bent 2 end diaphragm, right overhang, spall (12 inch x 8 inch x 2 inch deep)

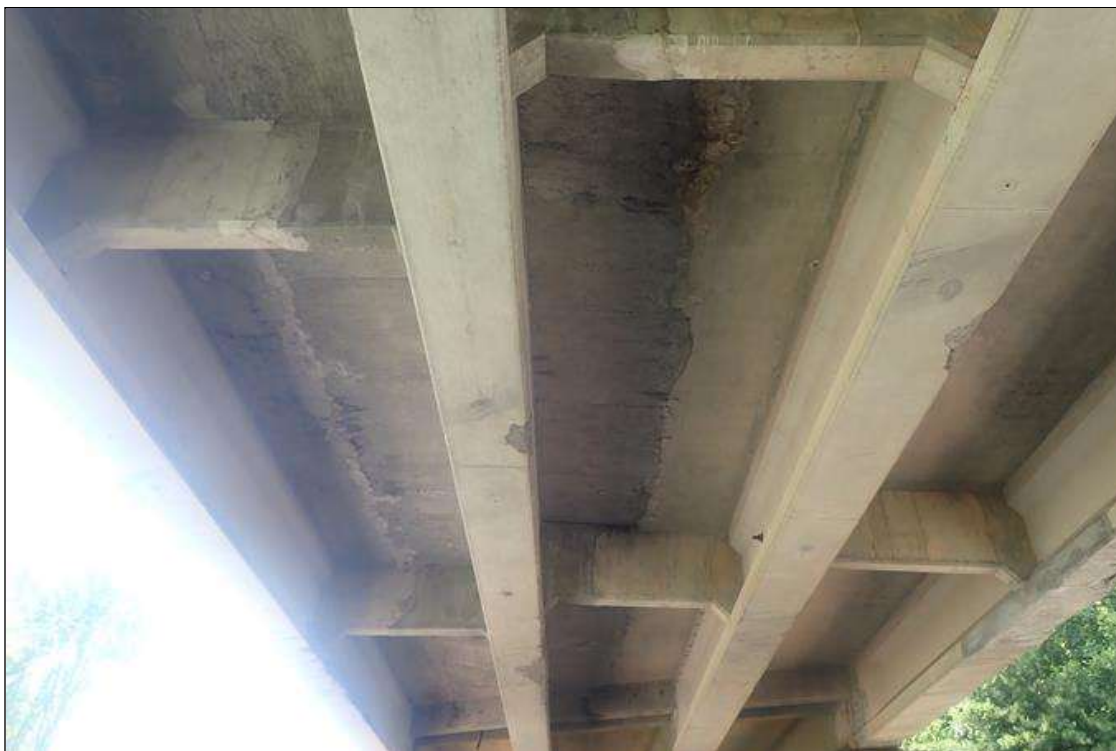
Span 3 Deck: FULL LENGTH SOUND PATCHED AREAS 4 FEET WIDE UNDERSIDE OF DECK BAYS 1 AND 2 ADJACENT TO BEAM 2.

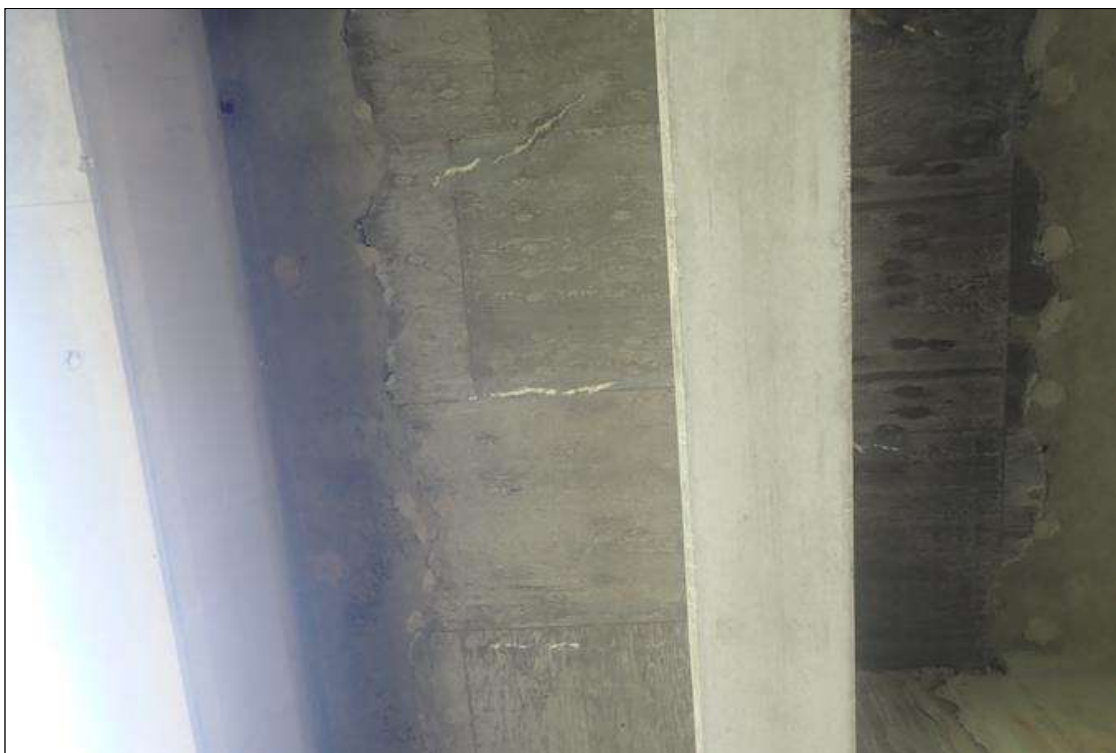
Span 3 Deck: underside, bays 1 and 2, transverse cracks (hairline x 6 feet) with efflorescence

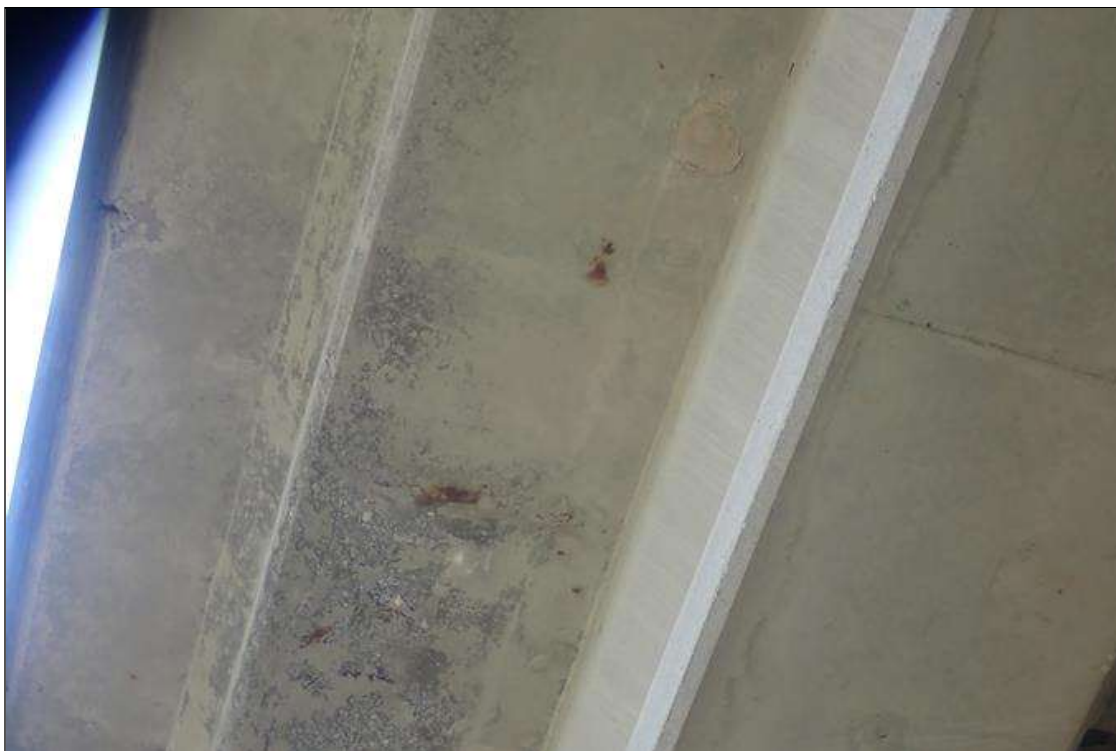
Span 3 Deck: (PAR) left overhang, at random, transverse cracks (hairline) with rust stains

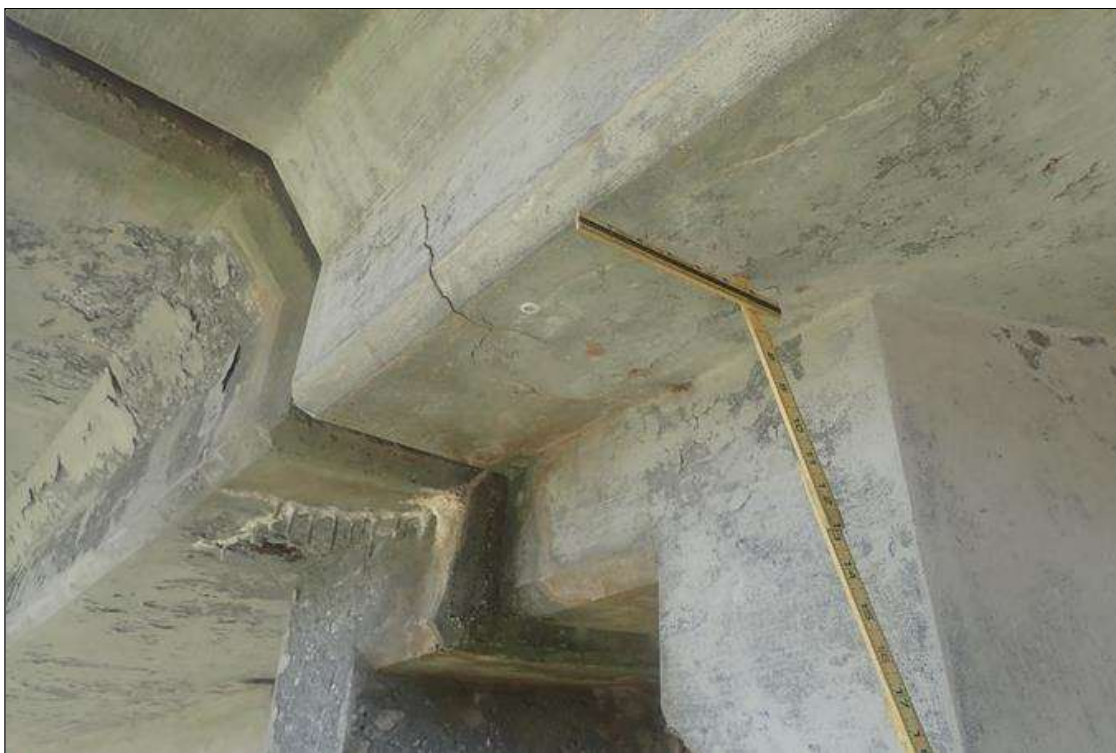
Span 3 Deck: right overhang, at bent 2, delamination (6 inch x 2 feet) with cracks (1/16 inch)

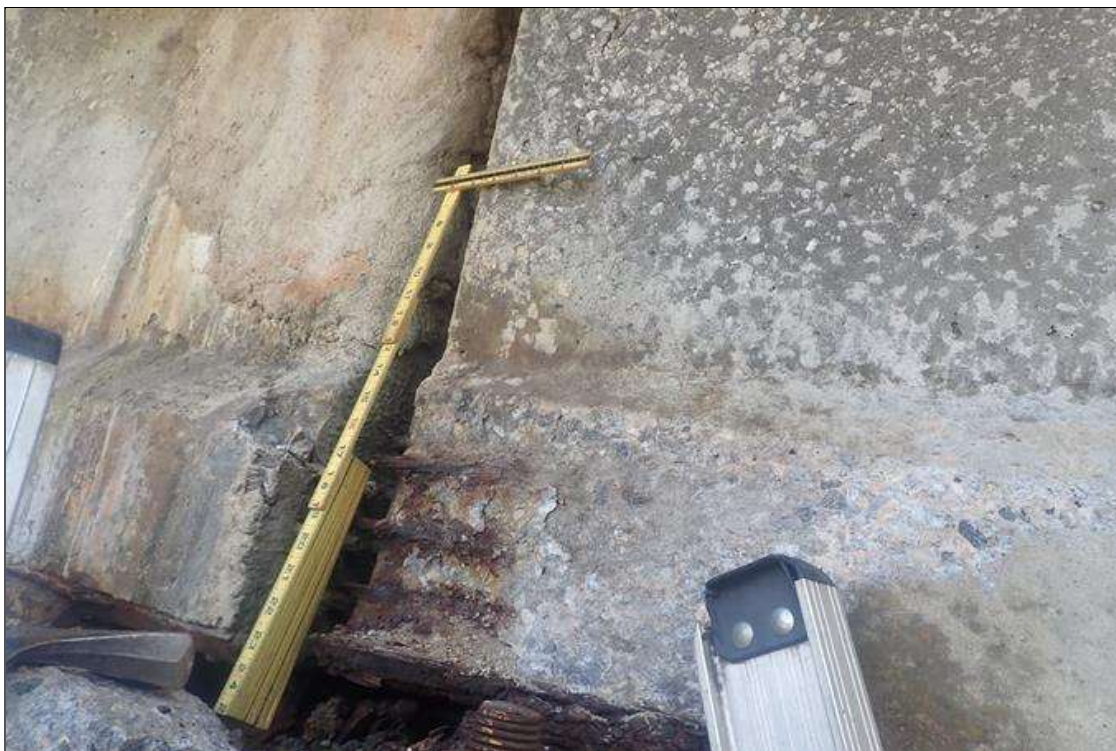
Span 3 Beam 4: (PAR) at bent 2, bottom flange, right face, spall (16 inch x 8 inch x 2 inch deep) with exposed rusted strands; web, delamination (4 inch x full height)

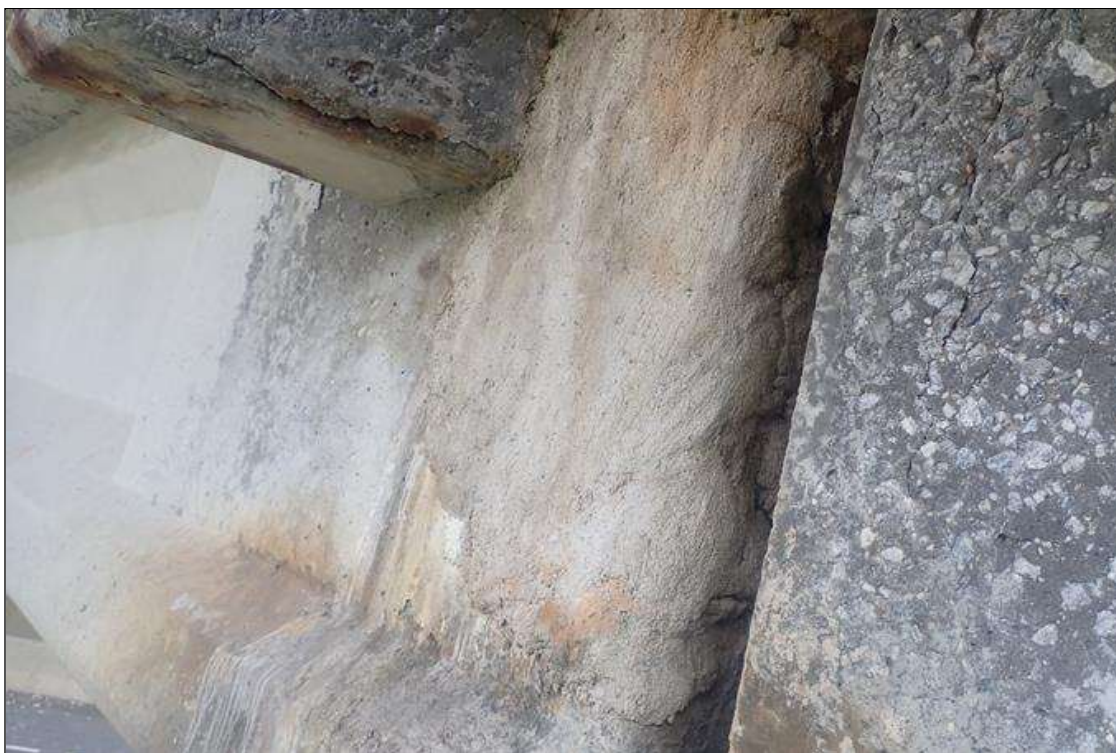
Span 2 Beam 4: Full height x 1 foot long sound patched area in right side of web at pier 2

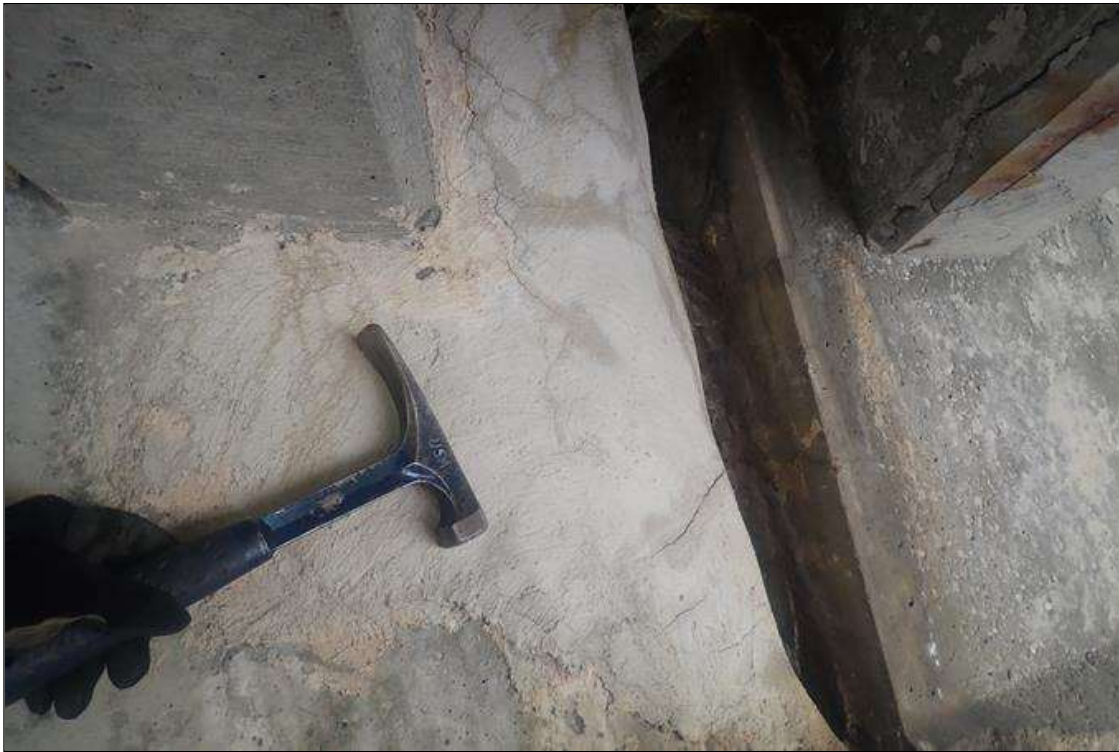
Span 3 Beam 4: FULL HEIGHT X 2 FEET LONG PATCHED AREA THAT IS SOUND WITH CRACKS UP TO 1/32 INCH ON LEFT SIDE WEB OVER PIER 2.

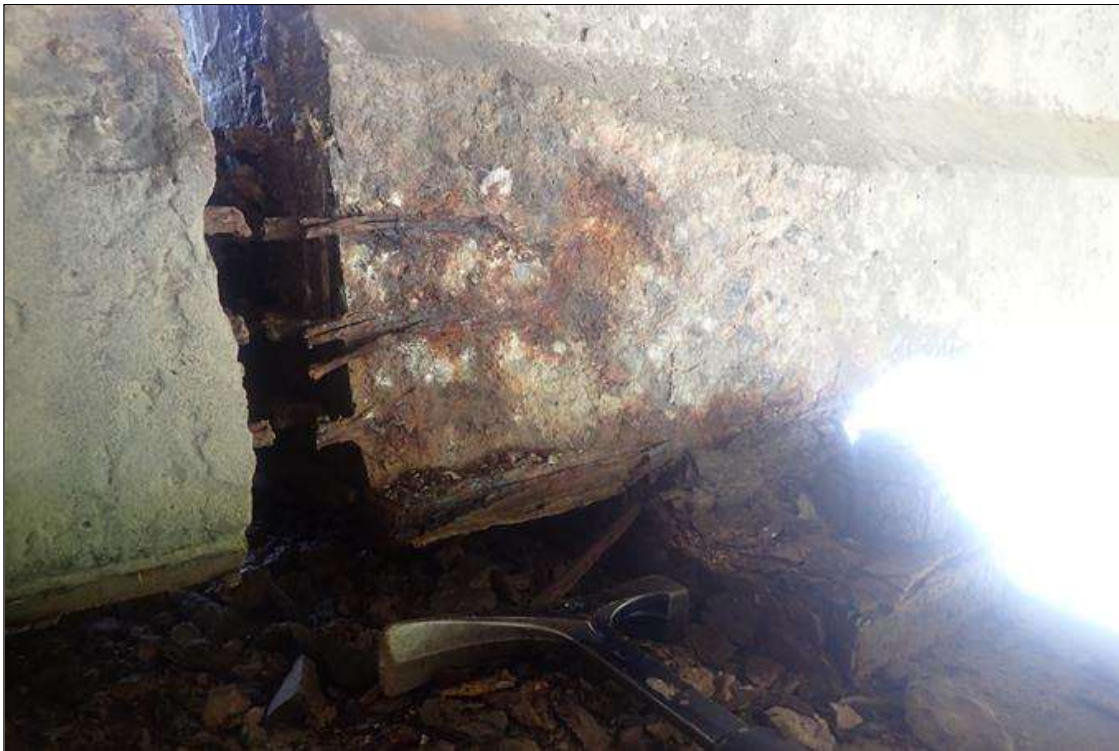
Span 2 Beam 4: (PAR) 9 INCH HIGH X 1 FOOT LONG X 2 INCH DEEP SPALL ON LEFT SIDE BOTTOM FLANGE WITH 3 STRANDS EXPOSED WITH 1/16 INCH SECTION LOSS OVER PIER 2.

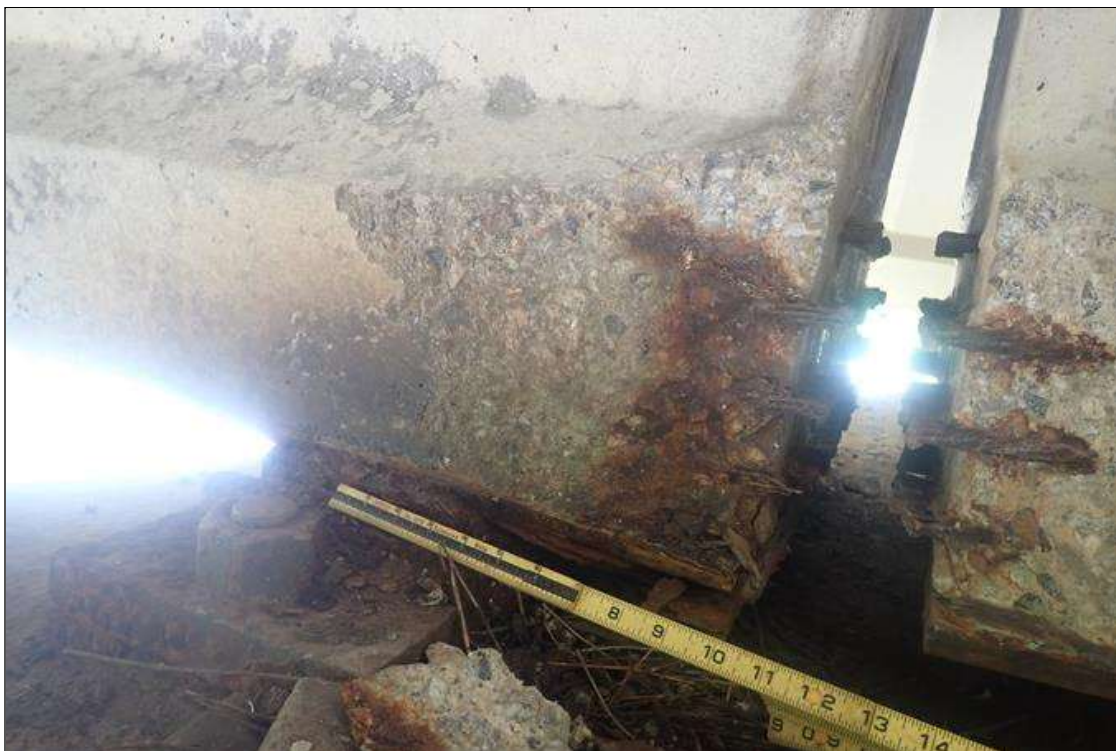
Span 2 Beam 3: (PAR) 8 INCH LONG X 1 FOOT HIGH X 2 INCH DEEP spall with exposed strands on right bottom flange at pier 2

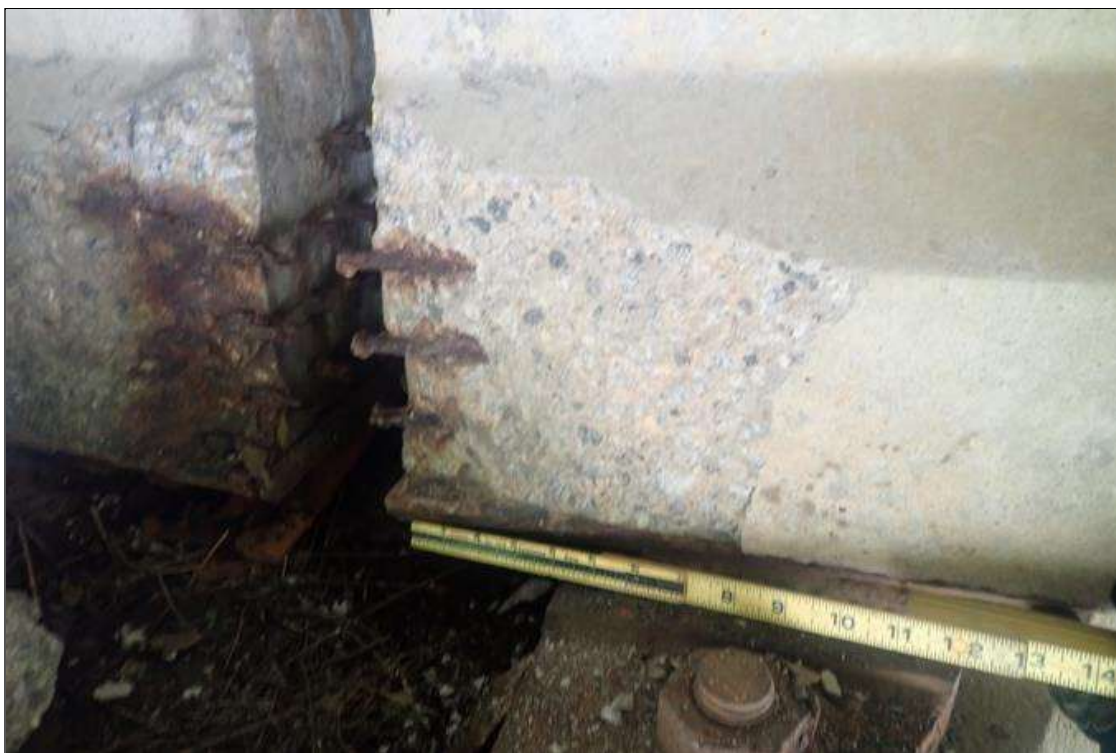
Span 3 Beam 3: (PAR) 8 INCHES LONG X 8 INCHES HIGH X 2 INCHES DEEP SPALL WITH EXPOSED STRANDS ON RIGHT BOTTOM FLANGE AT PIER 2

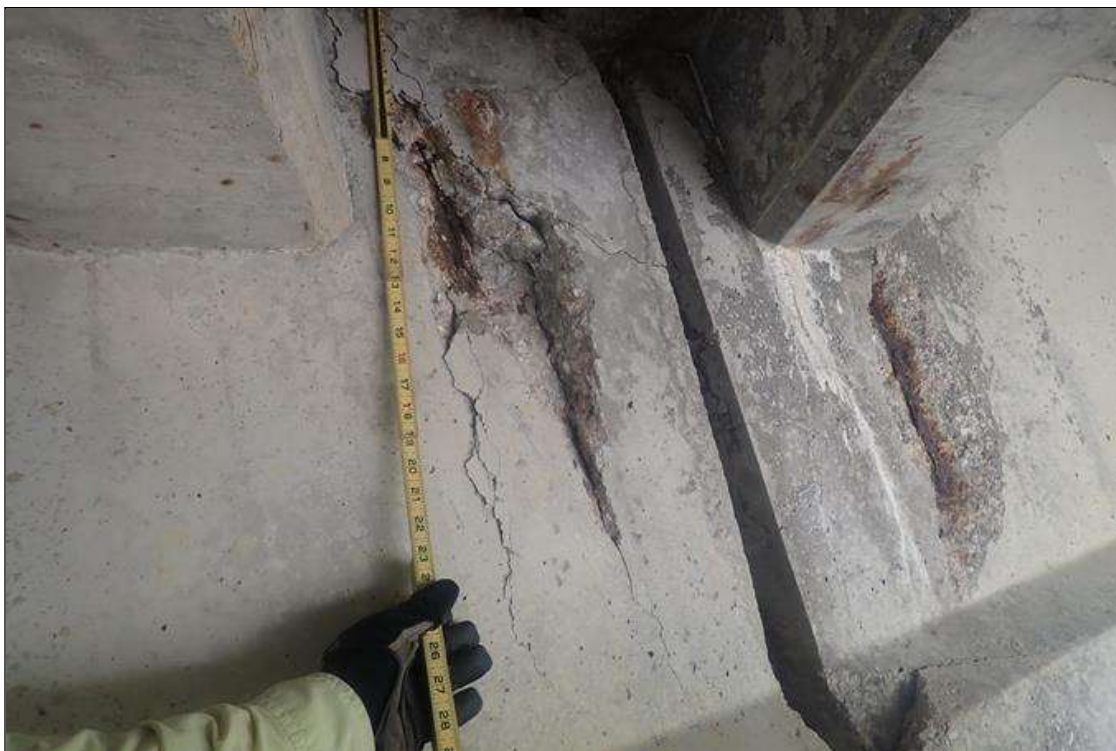
Span 3 Beam 3: 30 INCHES HIGH X 8 INCHES WIDE X 2 INCHES DEEP SPALL AND DELAMINATION ON LEFT SIDE WEB WITH EXPOSED STEEL OVER PIER 2. EXPOSED STEEL HAS NO MEASURABLE LOSS. SIMILAR RIGHT SIDE WEB.
