NC DEPARTMENT OF TRANSPORTATION  
 DIVISION OF HIGHWAYS  
 STRUCTURE MANAGEMENT UNIT

ATTENTION: **prompt action request, sketches revised, lateral clearances revised**

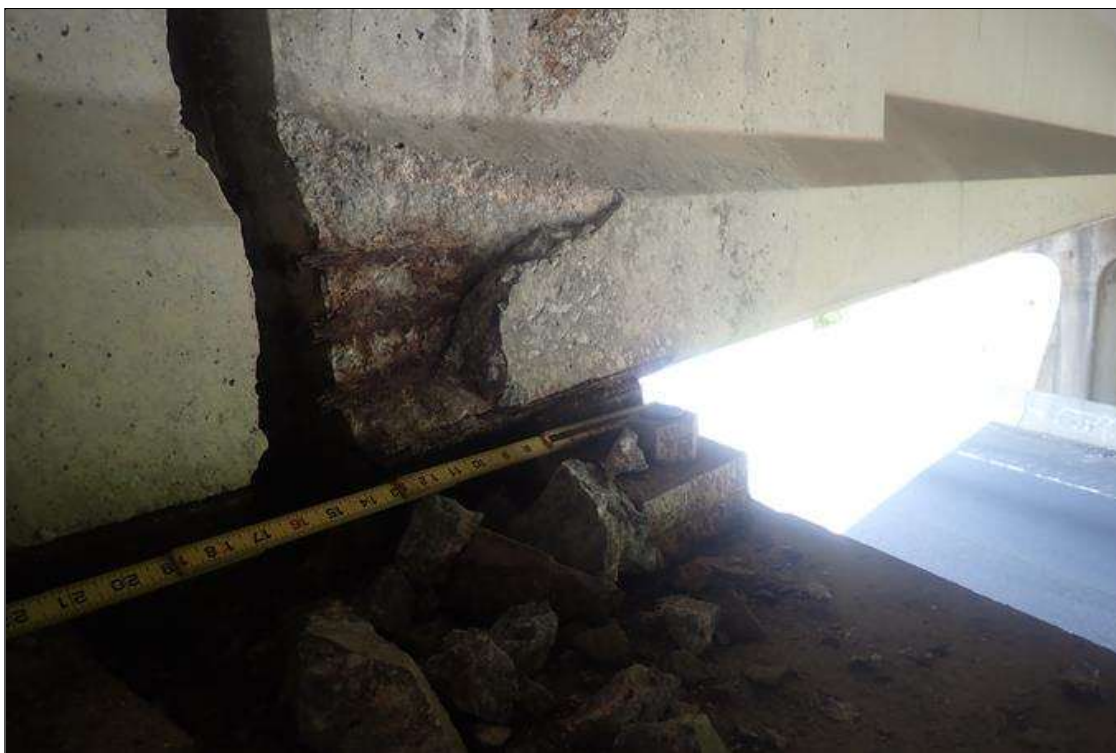
Span 2 Beam 3: (PAR) 16 inch x 9 inch x 2 inch deep spall with exposed rusted strands in left side bottom flange at pier 2

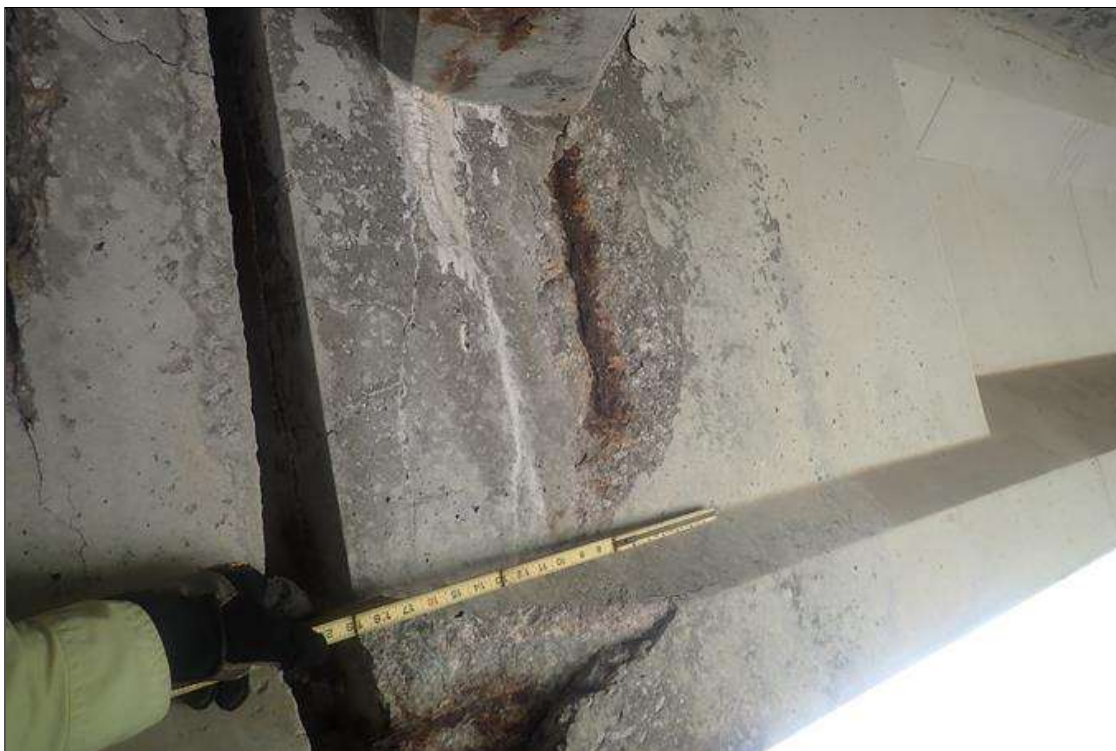
Span 2 Beam 3: (PAR) at bent 2, web, left face, delamination/spall (20 inch x 24 inch x 1 inch deep) with exposed rusted rebar, with cracks (0.02 inch) extending onto right face, and efflorescence buildup

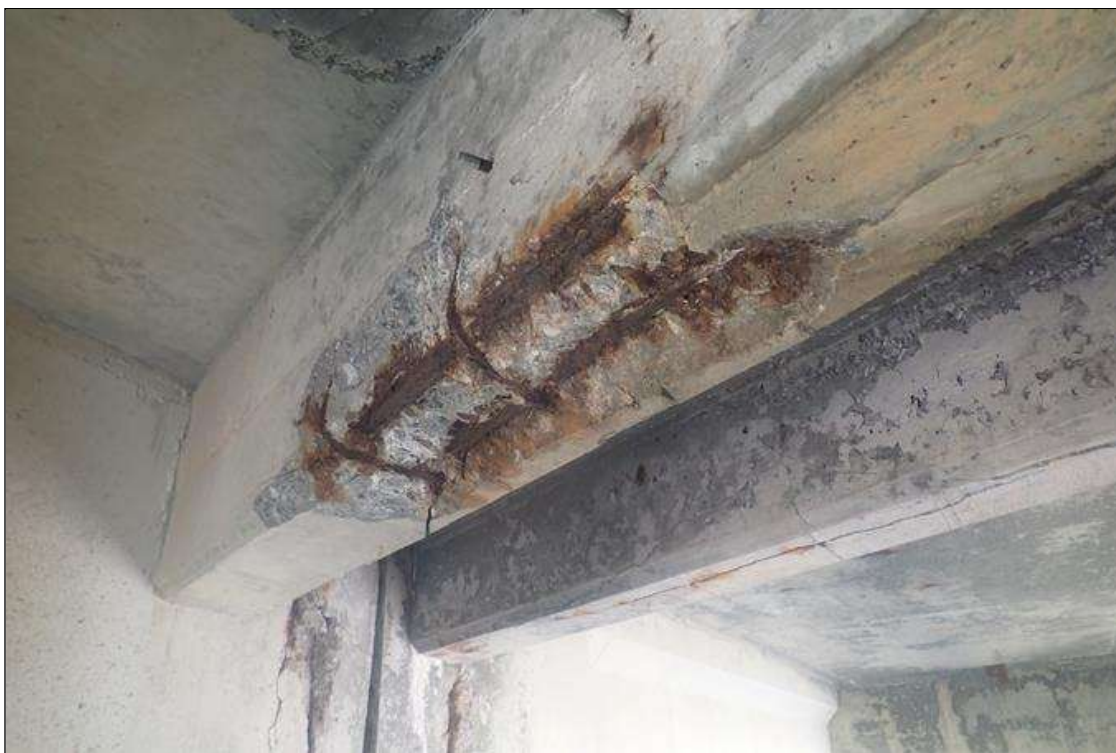
Span 3 Deck: bent 2 end diaphragm, bay 2, spall (4 feet x 8 inch x 2 inch) with exposed rusted rebar

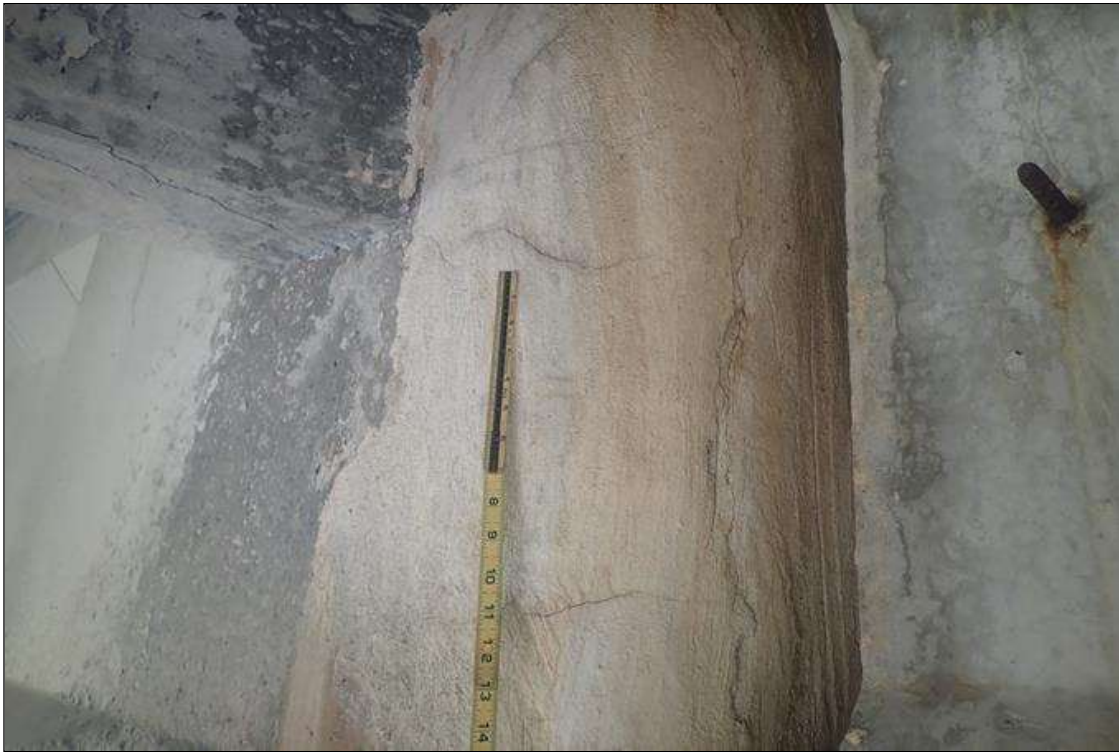
Span 2 Beam 2: Full height x 10 inch long patched area with cracks (up to 1/32 inch) in right side web at pier 2

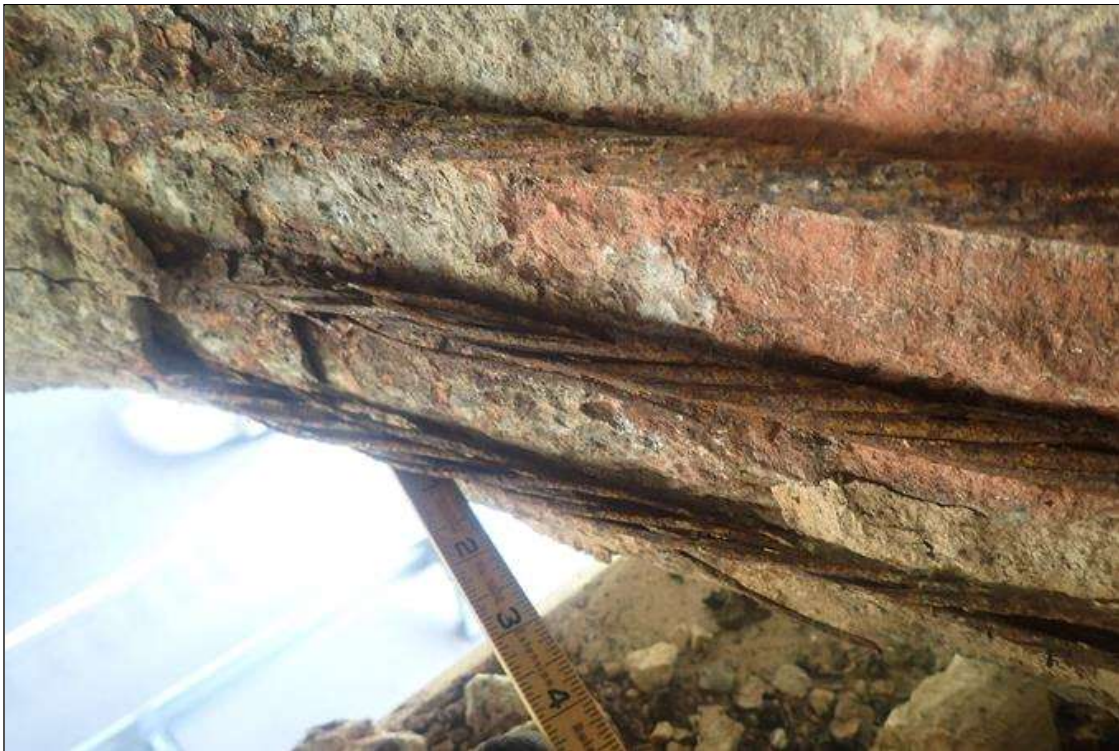
Span 2 Beam 2: (PAR) at bent 2, right face, bottom flange, spall (3.5 feet x 11 inch x 2 inch deep) with (2) broken strands and (1) rusted strand; similar left face

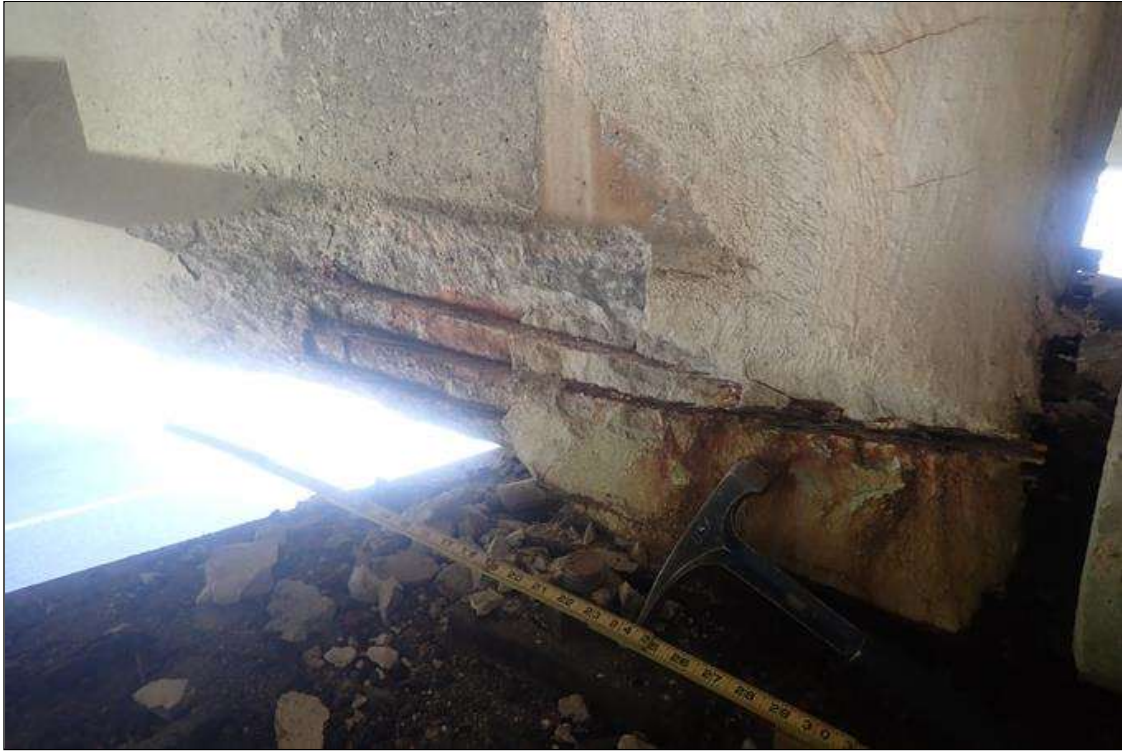
Span 2 Beam 2: (PAR) at bent 2, right face, bottom flange, spall (3.5 feet x 11 inch x 2 inch deep) with (2) broken strands and (1) rusted strand; similar left face

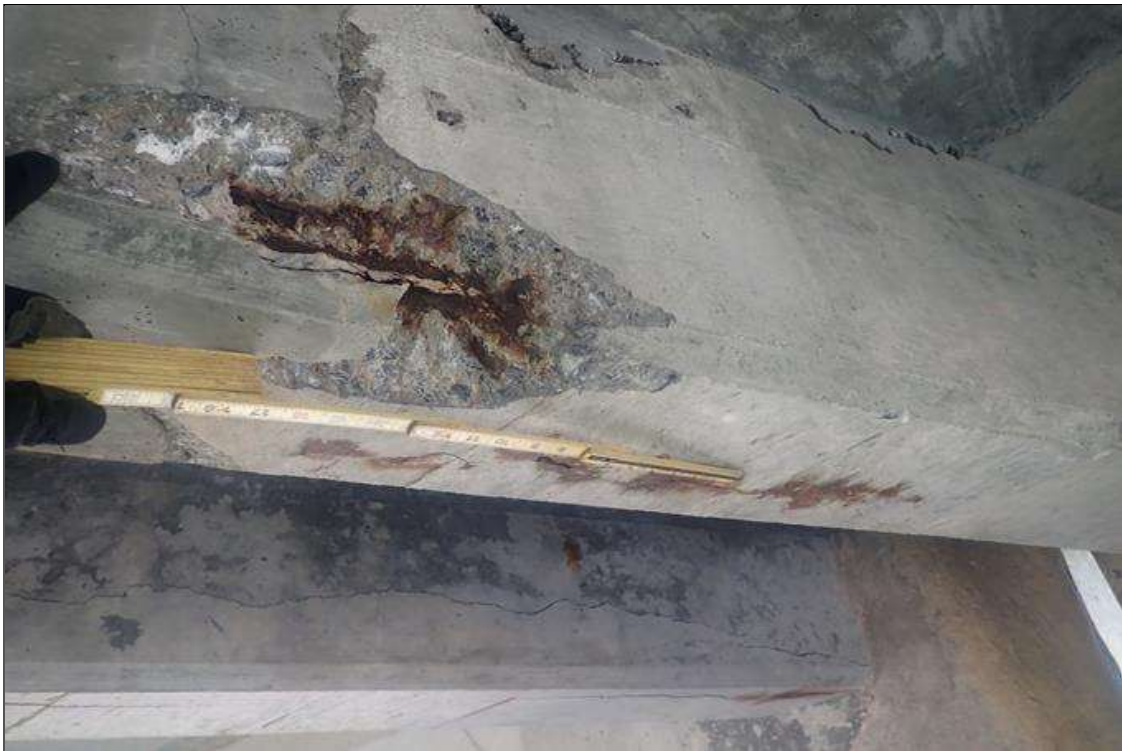
Span 3 Deck: (PAR) bent 2 end diaphragm, bay 1, longitudinal crack (1/16 inch x 3 feet) with rust stains and spall (16 inch x 6 inch x 2 inch deep) with exposed rusted rebar

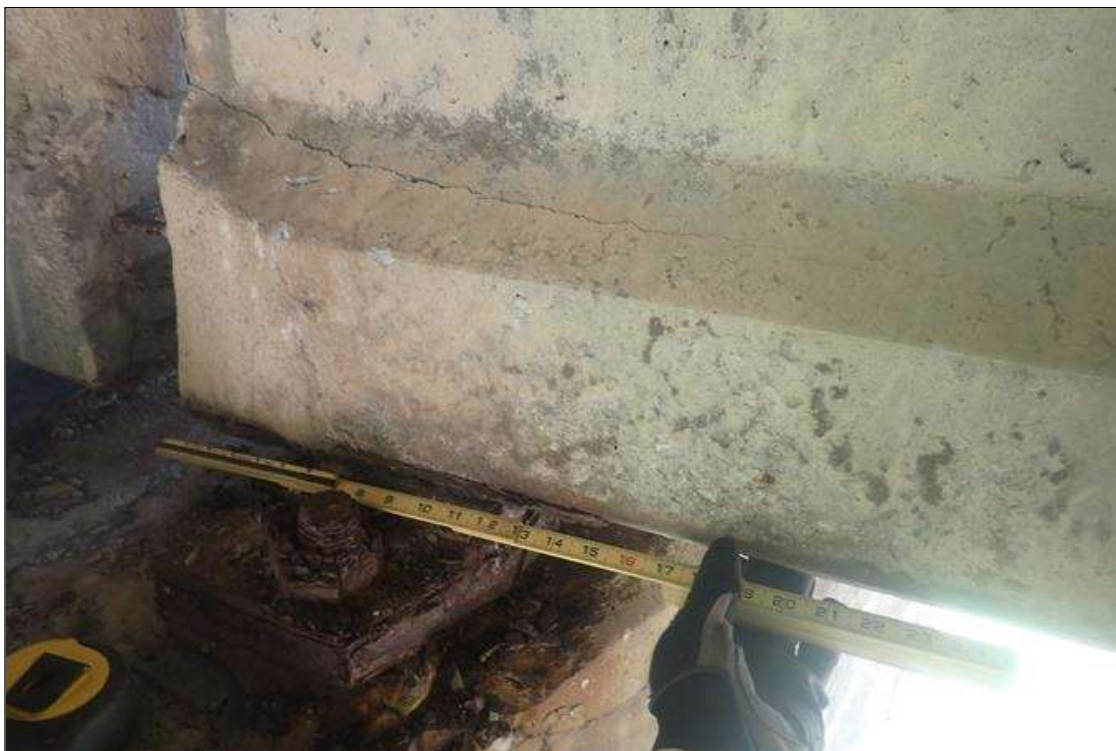
Span 3 Beam 1: at bent 2, right side, bottom flange, previous patch (6 inch x 6 inch) with delamination (2 feet x 8 inch)

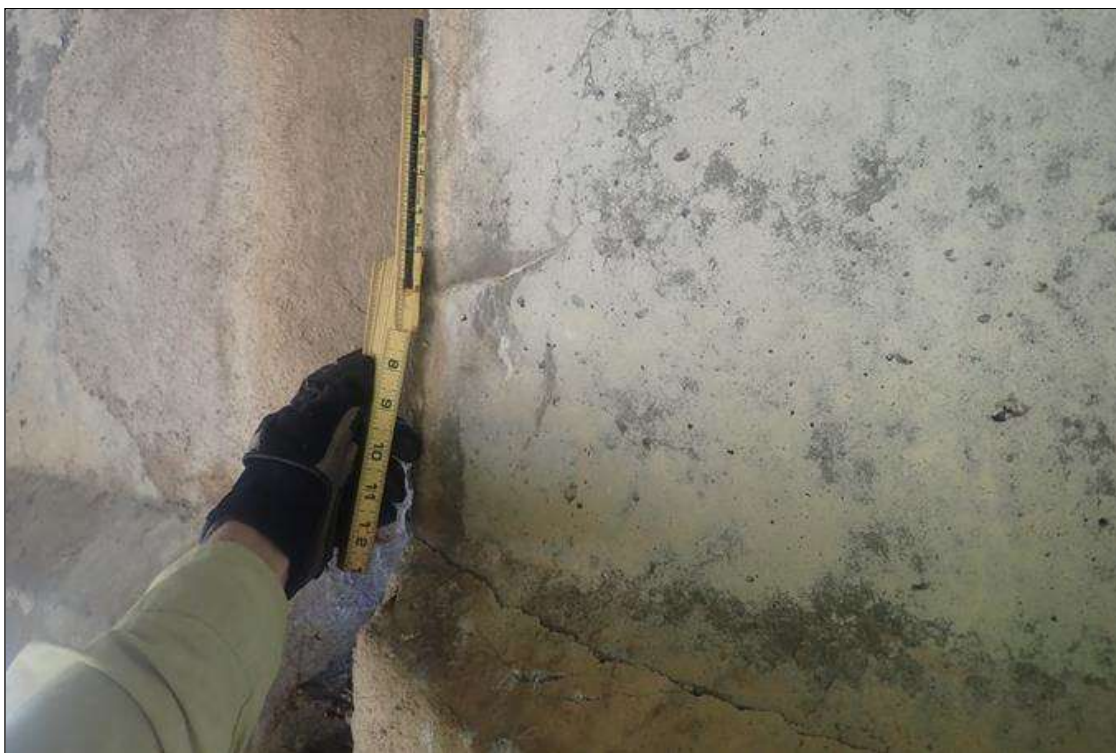
Span 3 Beam 1: at bent 2, right face, web, map cracks (hairline x 6 inch x 8 inch) with efflorescence

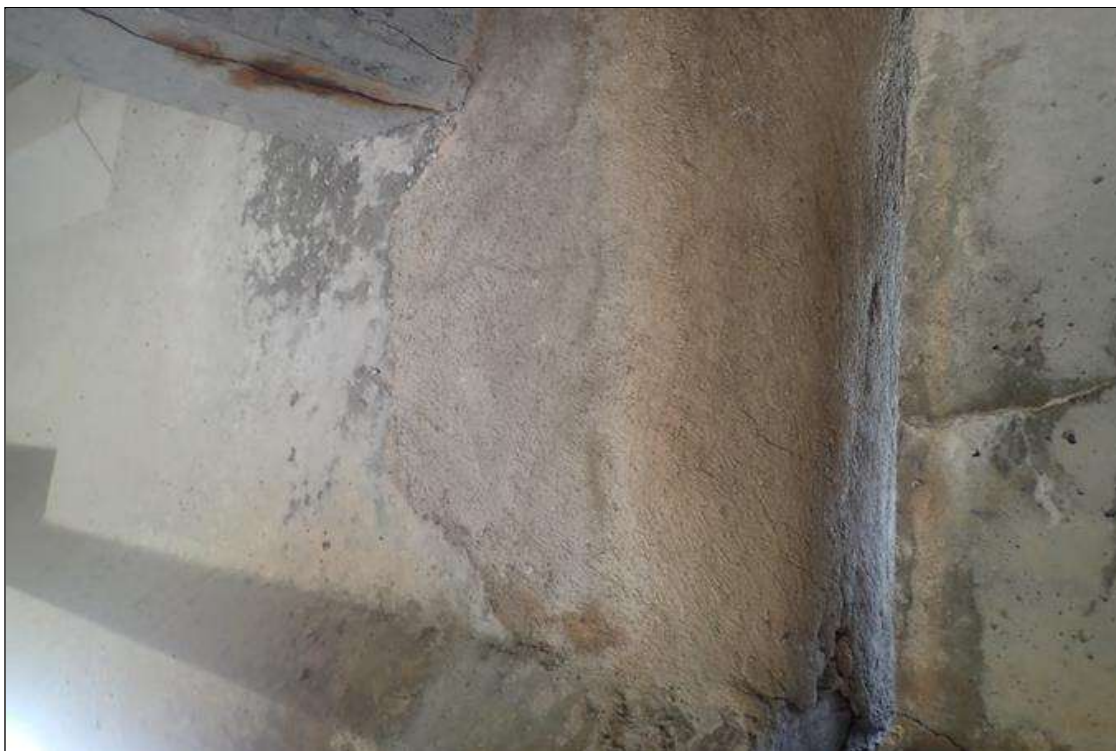
Span 2 Beam 1: PATCHED AREA FULL HEIGHT 1 FOOT LONG THAT IS SOUND ON RIGHT SIDE OVER PIER 2.

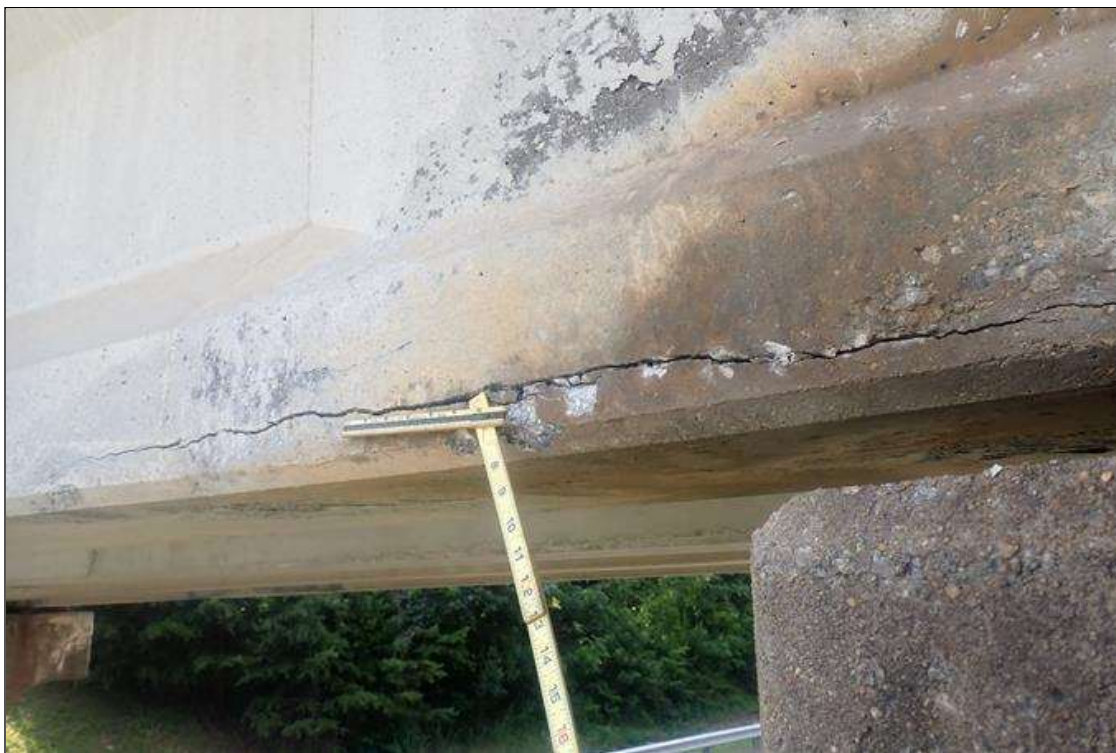
Span 3 Beam 1: (PAR) at bent 2, bottom flange, left face, longitudinal cracks (up to 1/8 inch x 4 feet)

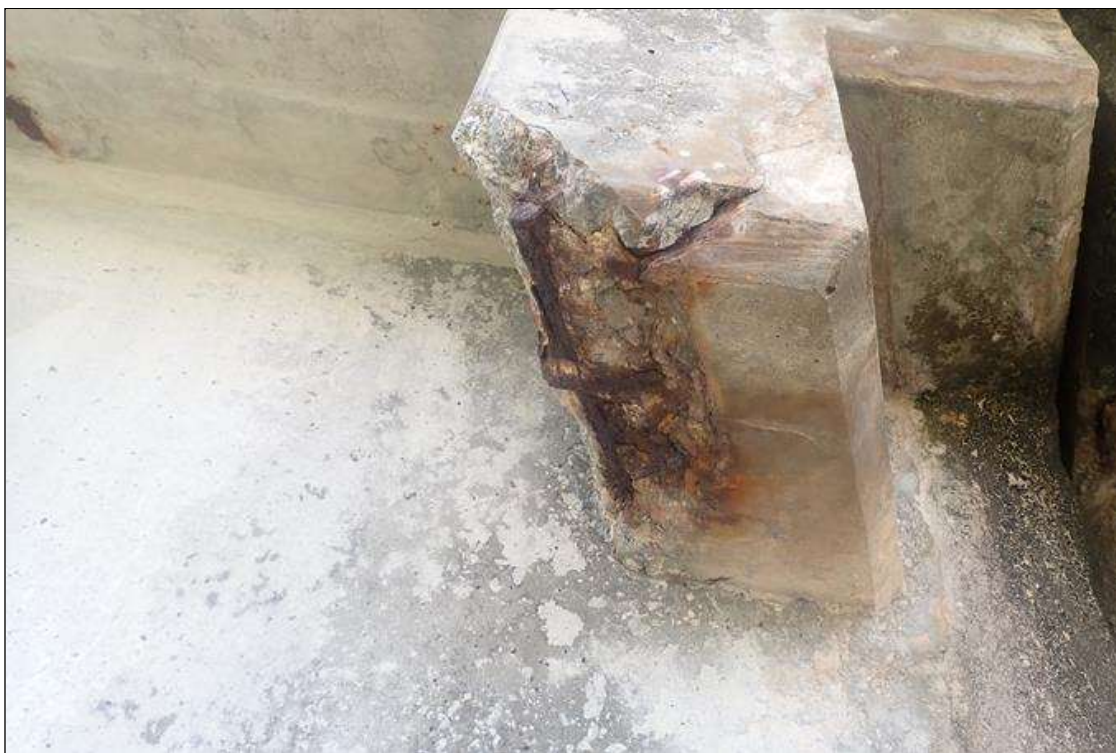
Span 3 Deck: bent 2 end diaphragm, left overhang, spall (12 inch x 6 inch x 2 inch deep) with exposed rusted rebar

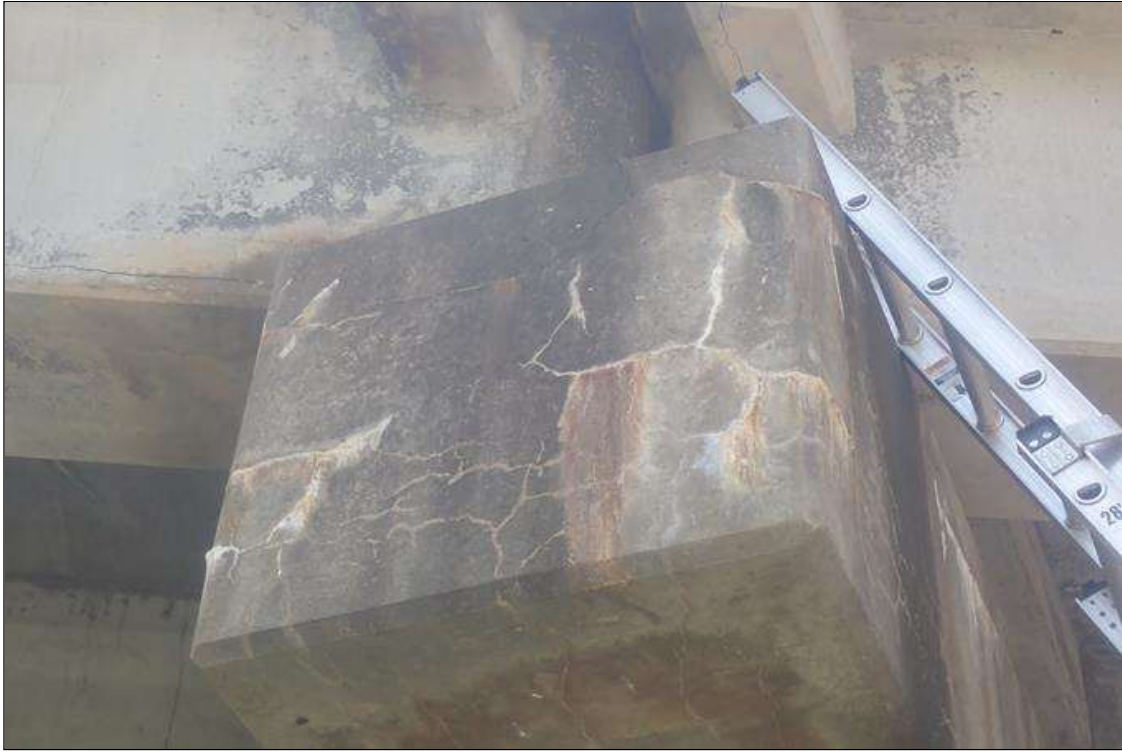
Bent 2 Cap 1: (PAR) hairline to 1/32 inch map cracking with efflorescence buildup and rust stains on west face cap

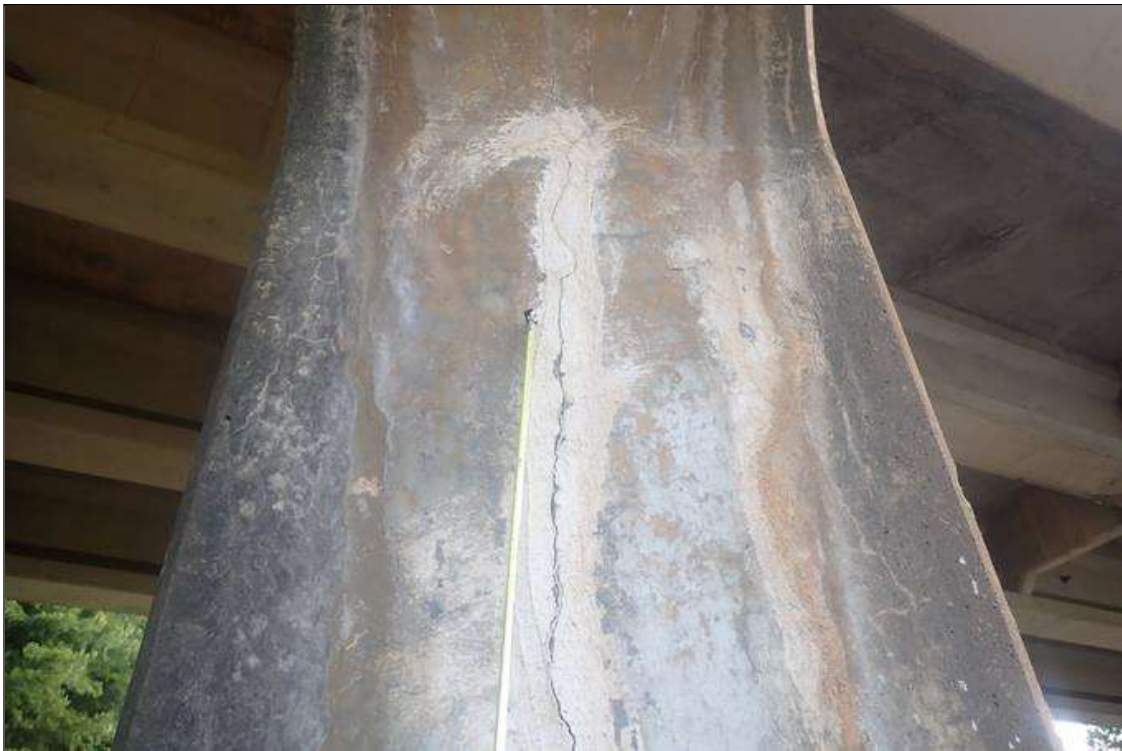
Bent 3 Pile 1: (PAR) VERTICAL CRACKING UP TO 1/8 INCH AND DELAMINATION UP TO 6 INCH WIDE ON ALL 4 SIDES WITH SOME OF CRACKS SEALED OVER BUT STILL CRACKED THROUGH TOP TO BOTTOM WITH RUST STAINS.

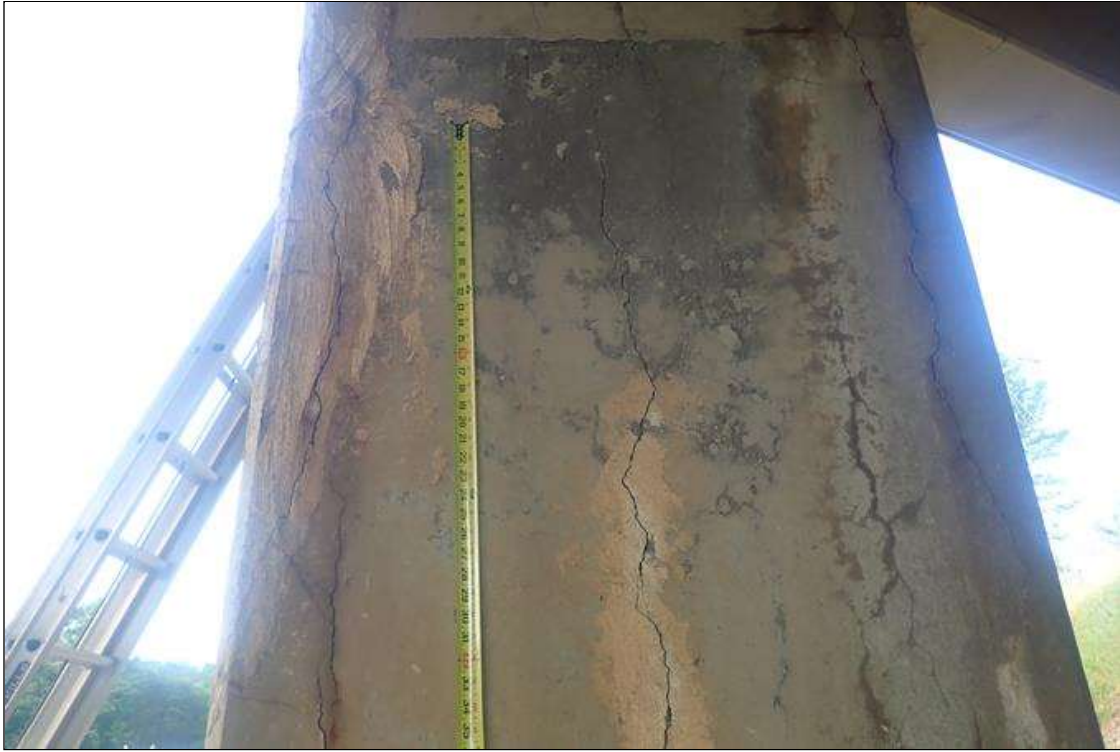
Bent 3 Pile 1: (PAR) VERTICAL CRACKING UP TO 1/8 INCH AND DELAMINATION UP TO 6 INCH WIDE ON ALL 4 SIDES WITH SOME OF CRACKS SEALED OVER BUT STILL CRACKED THROUGH TOP TO BOTTOM WITH RUST STAINS.

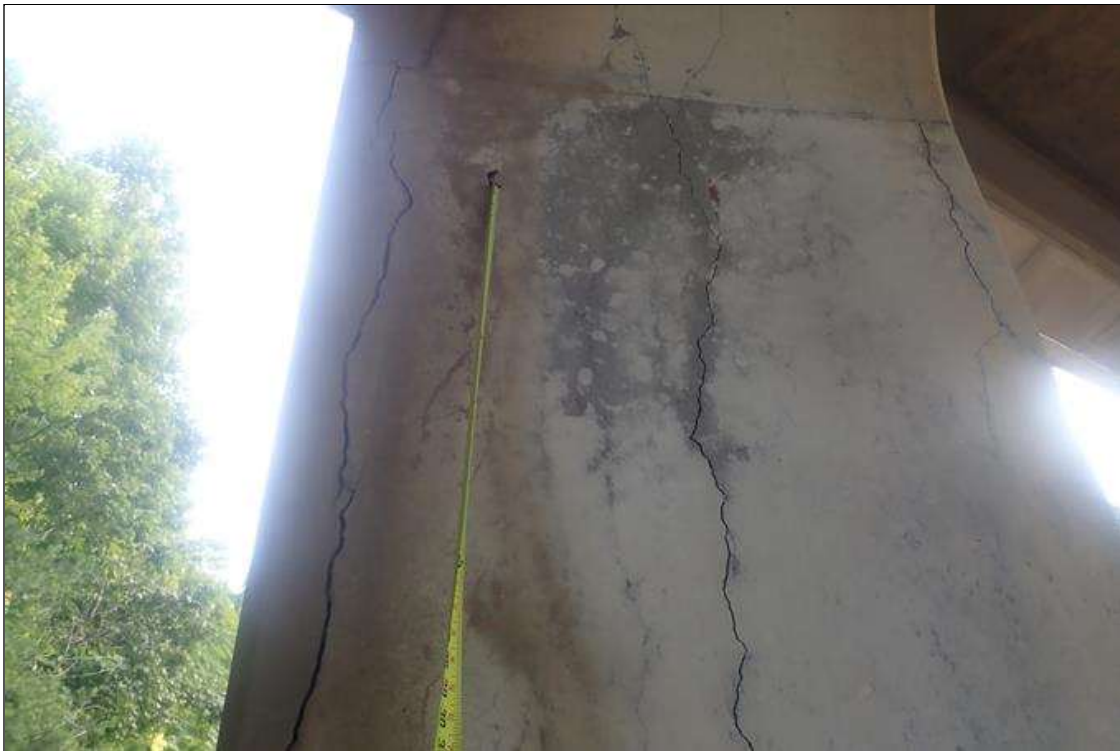
Bent 3 Pile 2: (PAR) VERTICAL CRACKING UP TO 3/16 INCH AND DELAMINATION UP TO 6 INCH WIDE ON ALL 4 SIDES WITH SOME OF CRACKS SEALED OVER BUT STILL CRACKED THROUGH TOP TO BOTTOM WITH RUST STAINS.

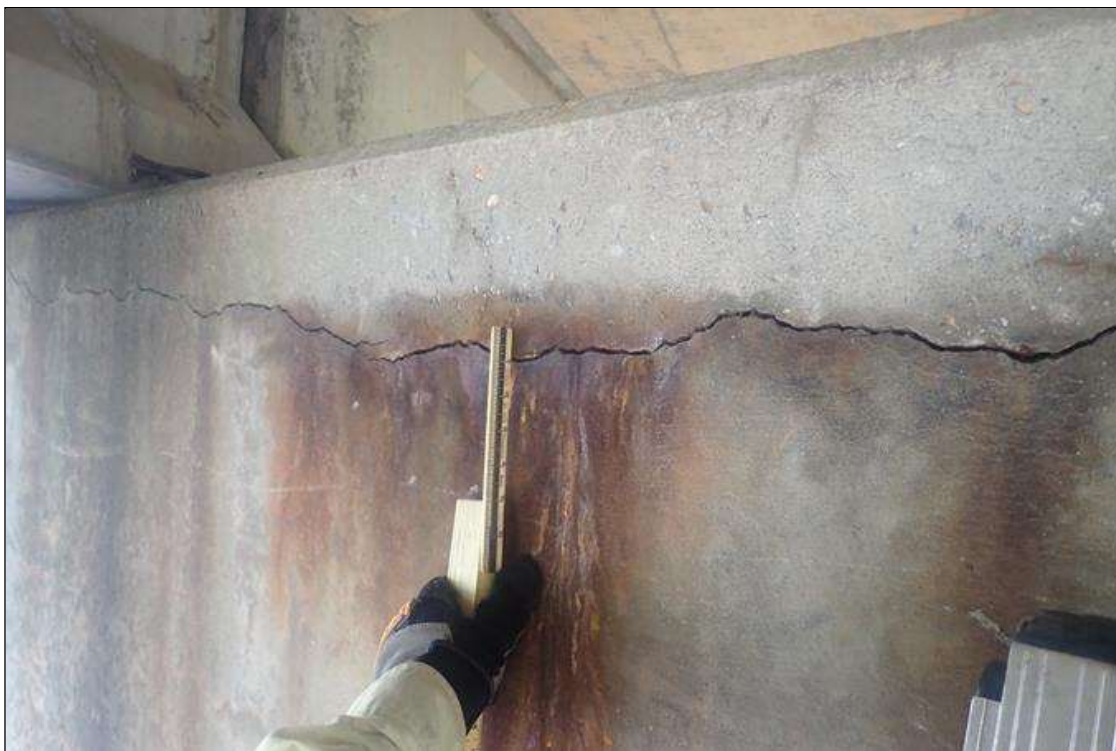
Bent 3 Cap 1: (PAR) 1/8 inch Horizontal crack on both faces of cap near top full length, with rust stains and some efflorescence buildup

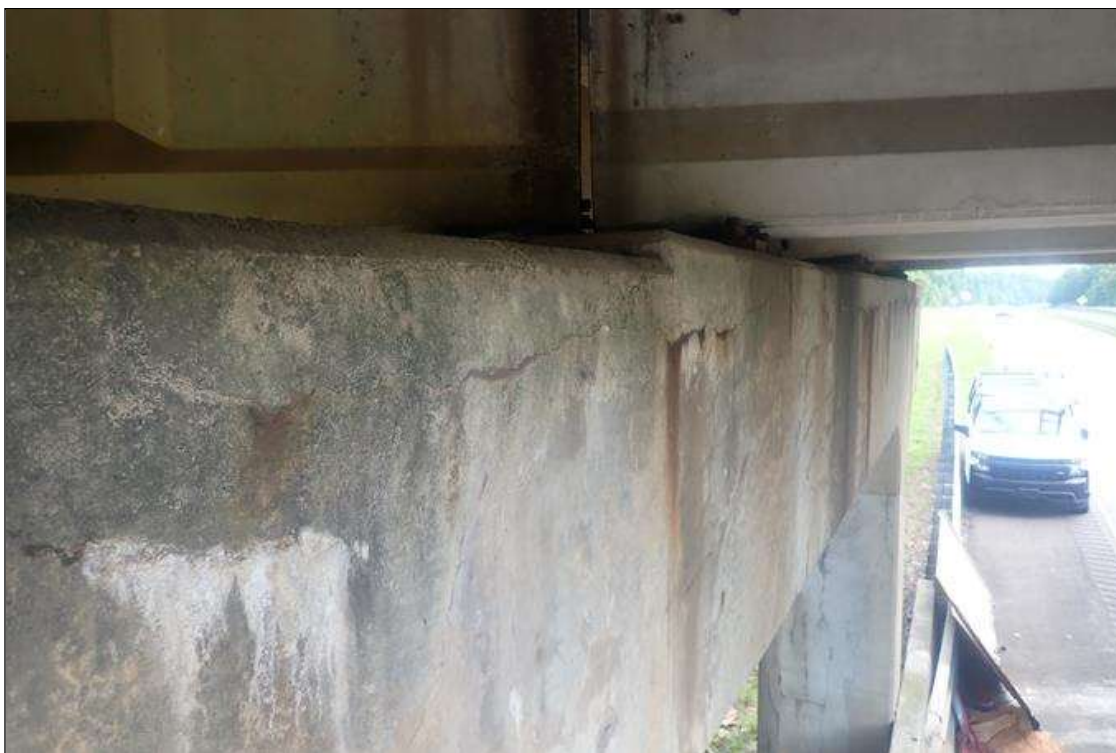
Bent 3 Cap 1: (PAR) 1/8 inch Horizontal crack on both faces of cap near top full length, with rust stains and some efflorescence buildup

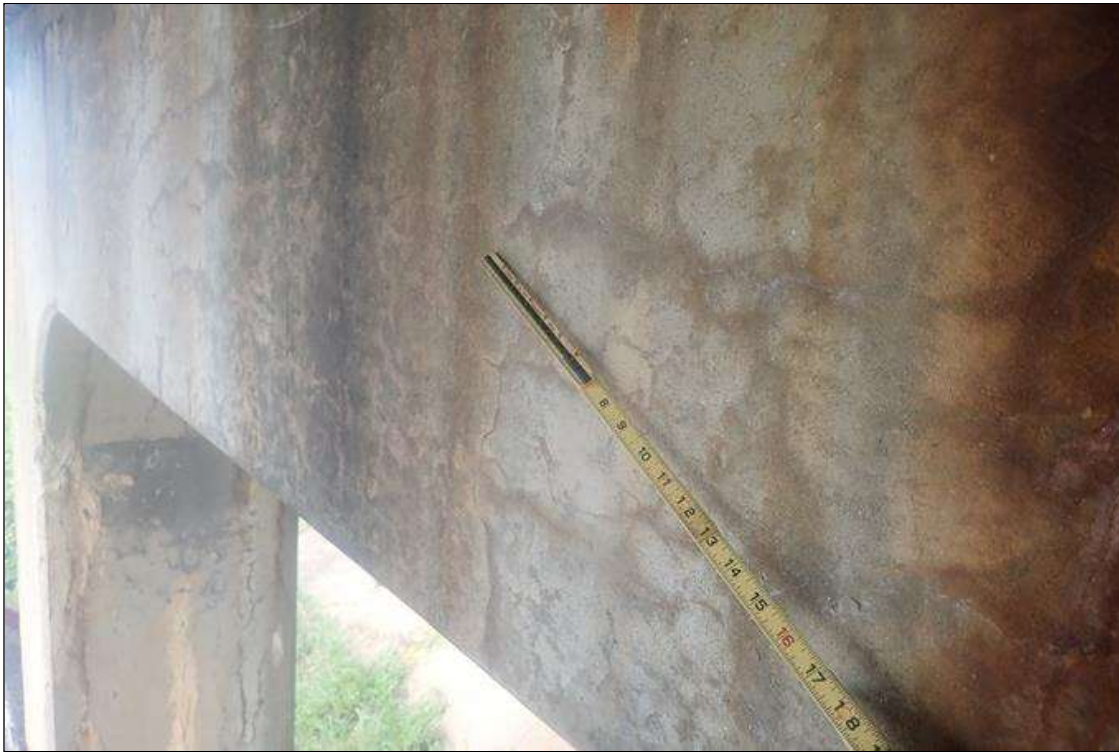
Bent 3 Cap 1: SCATTERED AREAS OF HAIRLINE MAP CRACKS WITH EFFLORESCENCE THROUGH OUT CAP

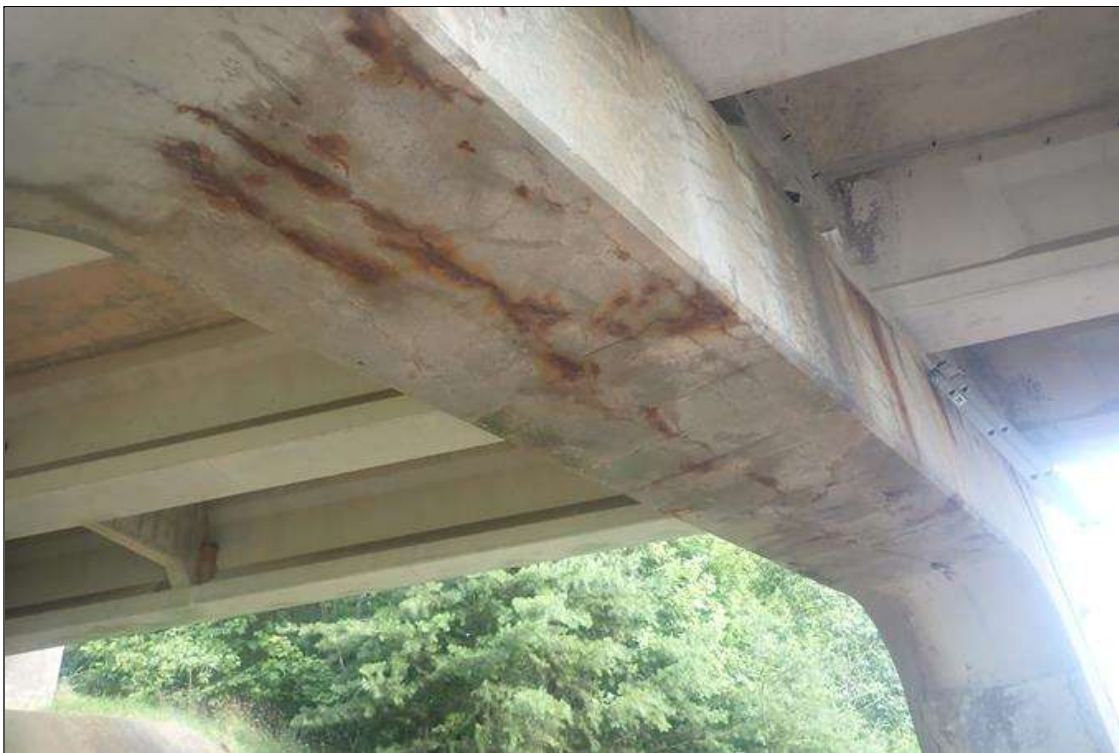
Bent 3 Cap 1: (PAR) underside, between columns, delamination/spall (18 feet x full width x 1 inch deep) with exposed rusted rebar, with cracks (up to 1/16 inch) and rust stains

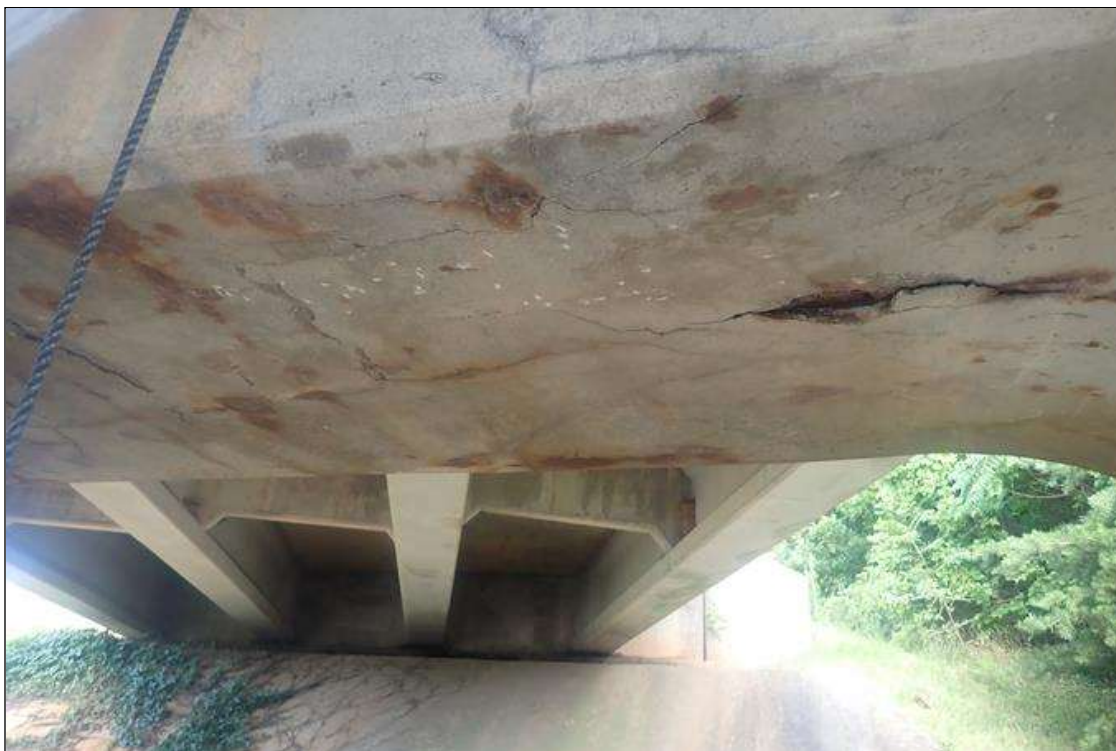
Bent 3 Cap 1: (PAR) underside, between columns, delamination/spall (18 feet x full width x 1 inch deep) with exposed rusted rebar, with cracks (up to 1/16 inch) and rust stains

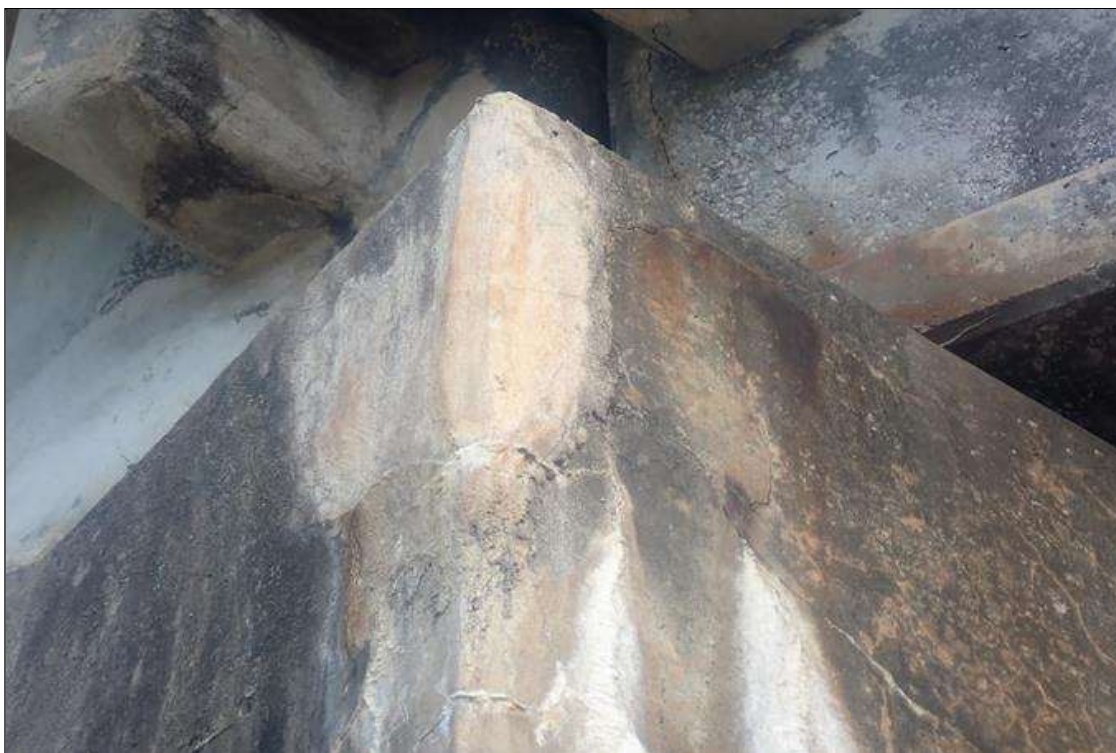
Bent 3 Cap 1: southwest corner, at top, patch (6 inch x 12 inch)

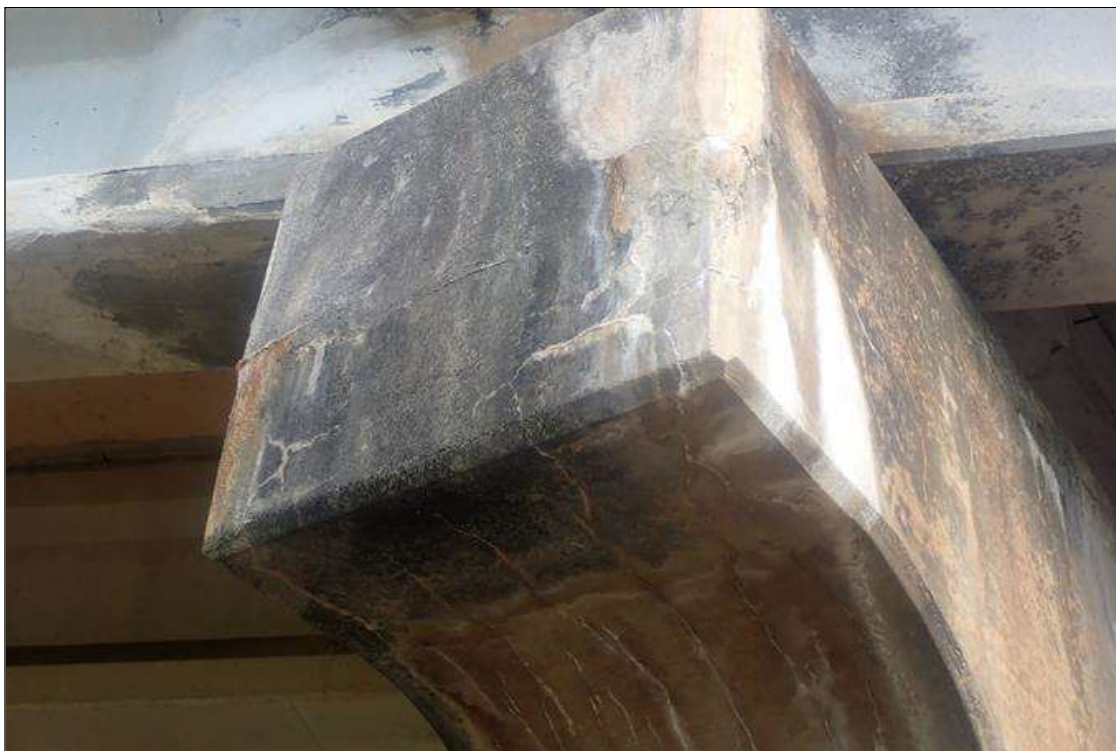
Bent 3 Cap 1: (PAR) both ends of cap, map cracks (hairline) with efflorescence buildup

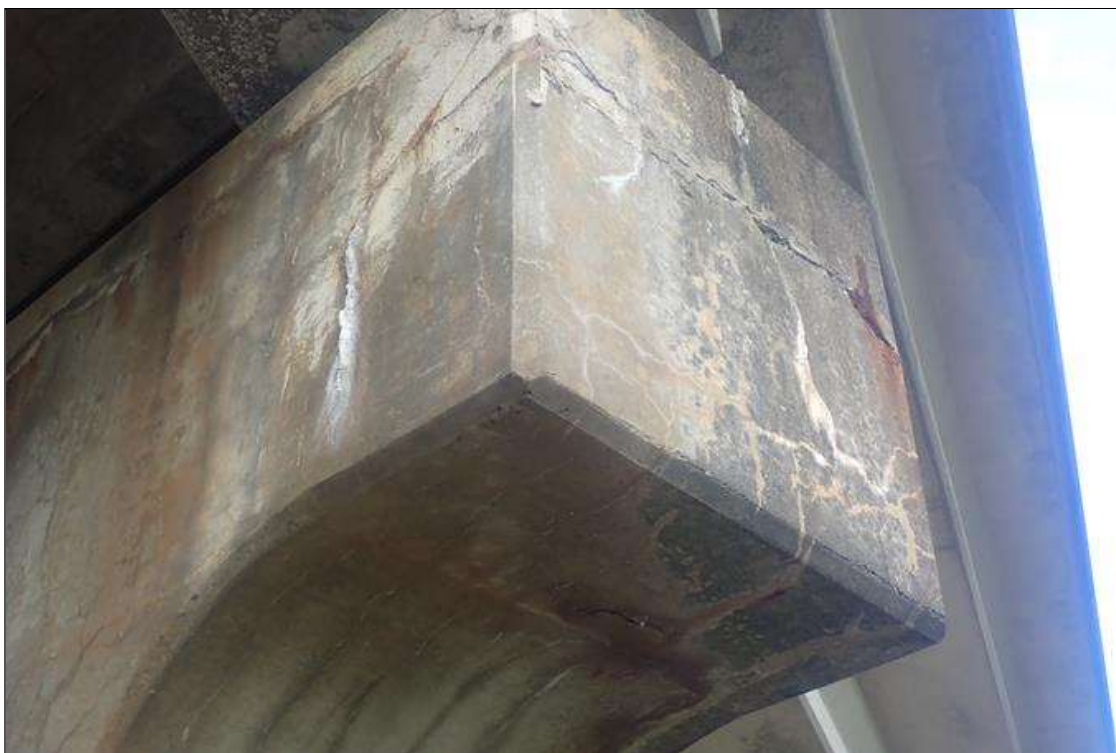
Bent 3 Cap 1: (PAR) both ends of cap, map cracks (hairline) with efflorescence buildup

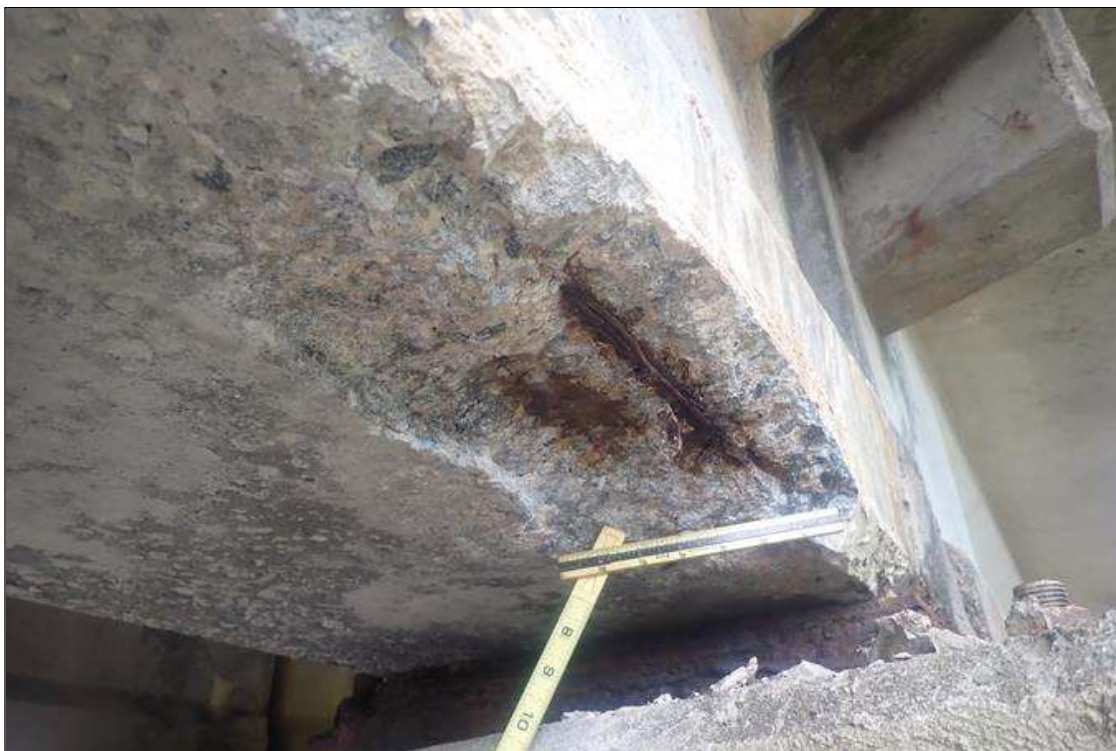
Span 3 Beam 4: (PAR) 1 foot from bent 3, bottom flange, right face, spall (16 inch x 7 high x 2 inch deep) with (1) broken strand and (1) rusted strand

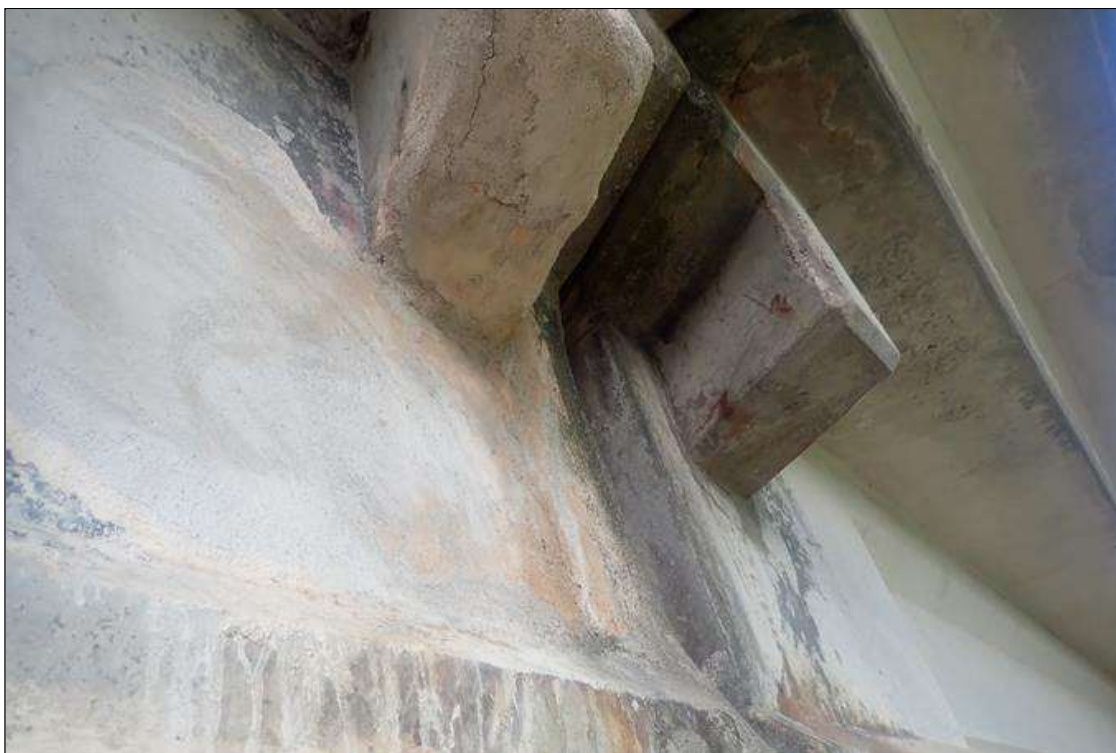
Span 3 Beam 4: FULL HEIGHT X UP TO 3 FEET LONG PATCHED AREA THAT IS SOUND ON WEB AND BOTTOM FLANGE BOTH SIDES OVER PIER 3.
