NC DEPARTMENT OF TRANSPORTATION  
 DIVISION OF HIGHWAYS  
 STRUCTURE MANAGEMENT UNIT

ATTENTION: **prompt action request, sketches revised, lateral clearances revised**

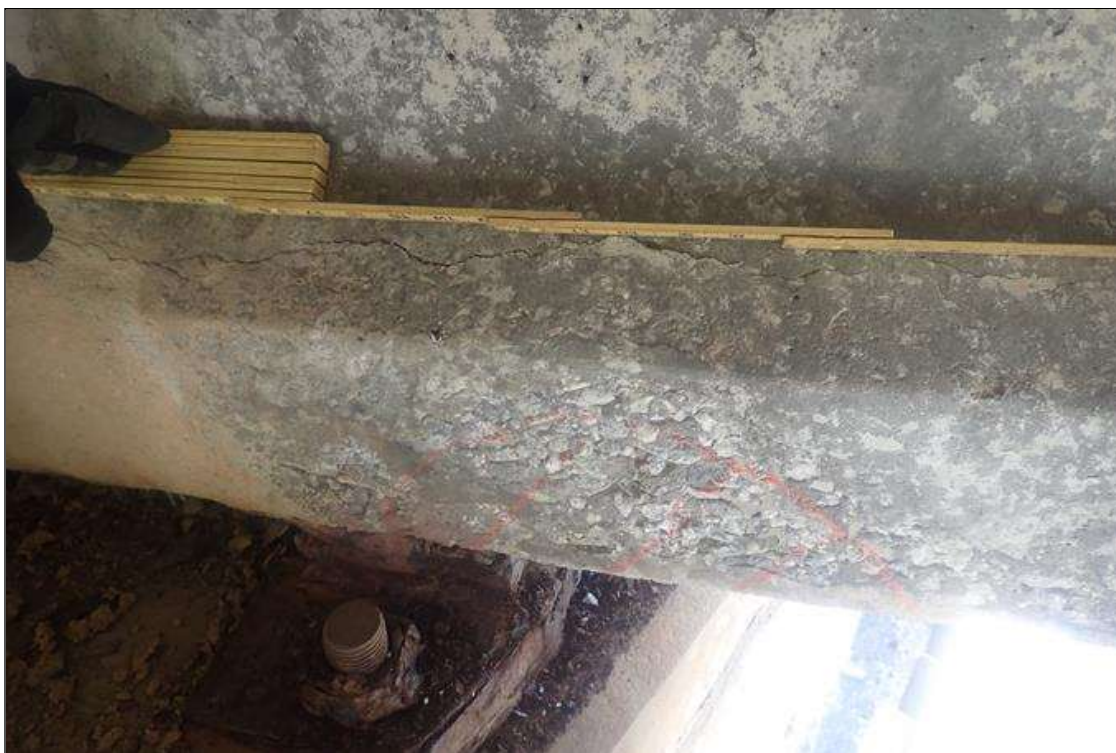
Span 3 Beam 4: (PAR) at bent 3, left face, bottom flange, delamination (12 inch x 6 inch) with (2) longitudinal cracks (up to 1/16 inch x 2 feet)

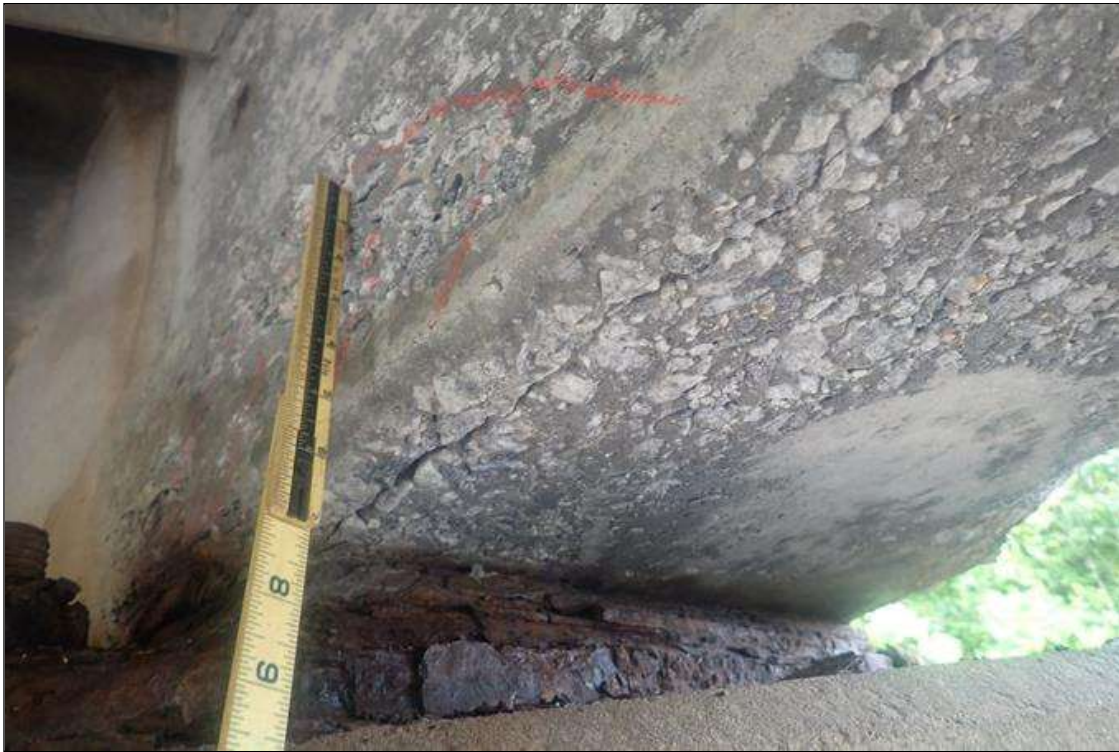
Span 3 Beam 4: (PAR) at bent 3, left face, bottom flange, delamination (12 inch x 6 inch) with (2) longitudinal cracks (up to 1/16 inch x 2 feet)

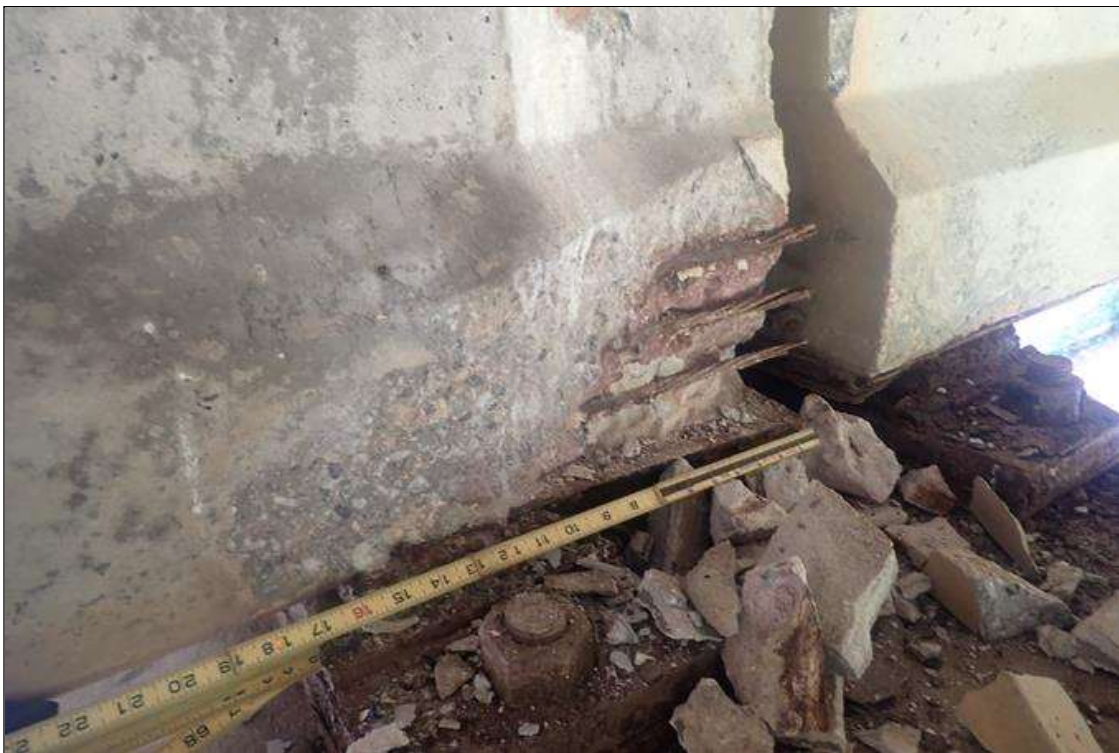
Span 3 Beam 3: (PAR) at bent 3, right face, bottom flange, failed patch (18 inch x 9 inch x 3 inch deep) with exposed rusted strands

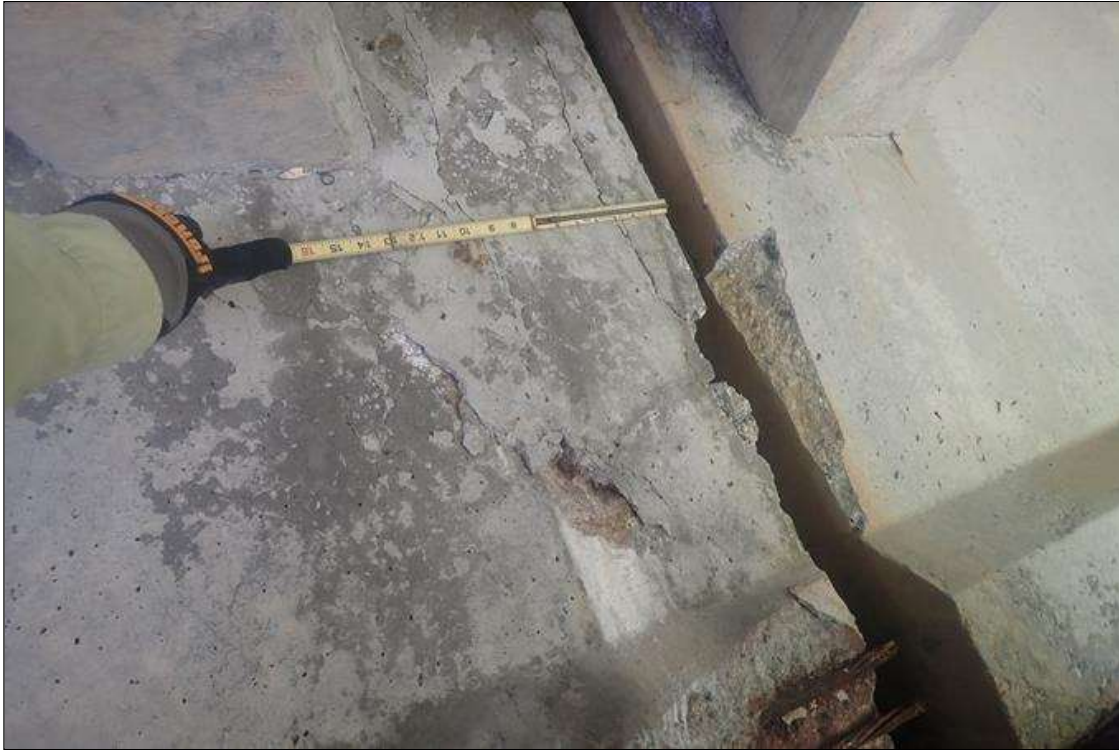
Span 3 Beam 3: (PAR) at bent 3, at right face, web, delamination/spall (16 inch x 30 inch x 1 inch deep) with cracks (up to 1/16 inch)

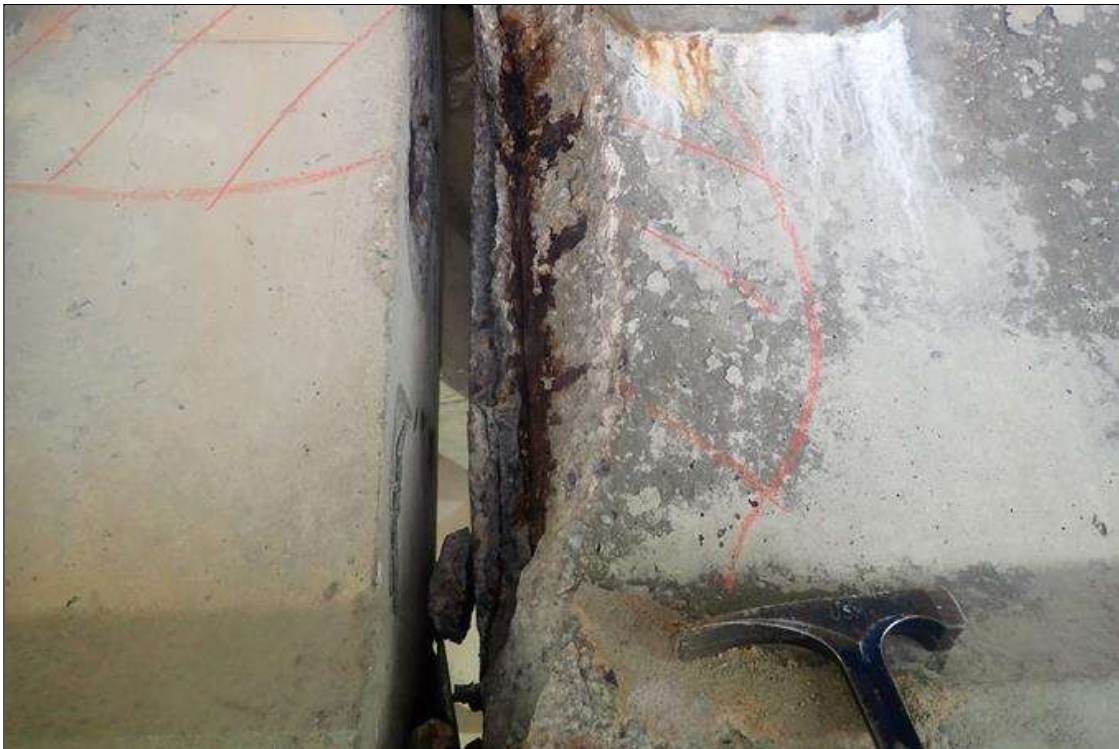
Span 3 Beam 3: (PAR) at bent 3, left face, failed patch/spall (12 inch x 39 inch x 3 inch deep) with exposed rusted strands and rebar, with efflorescence buildup at diaphragm

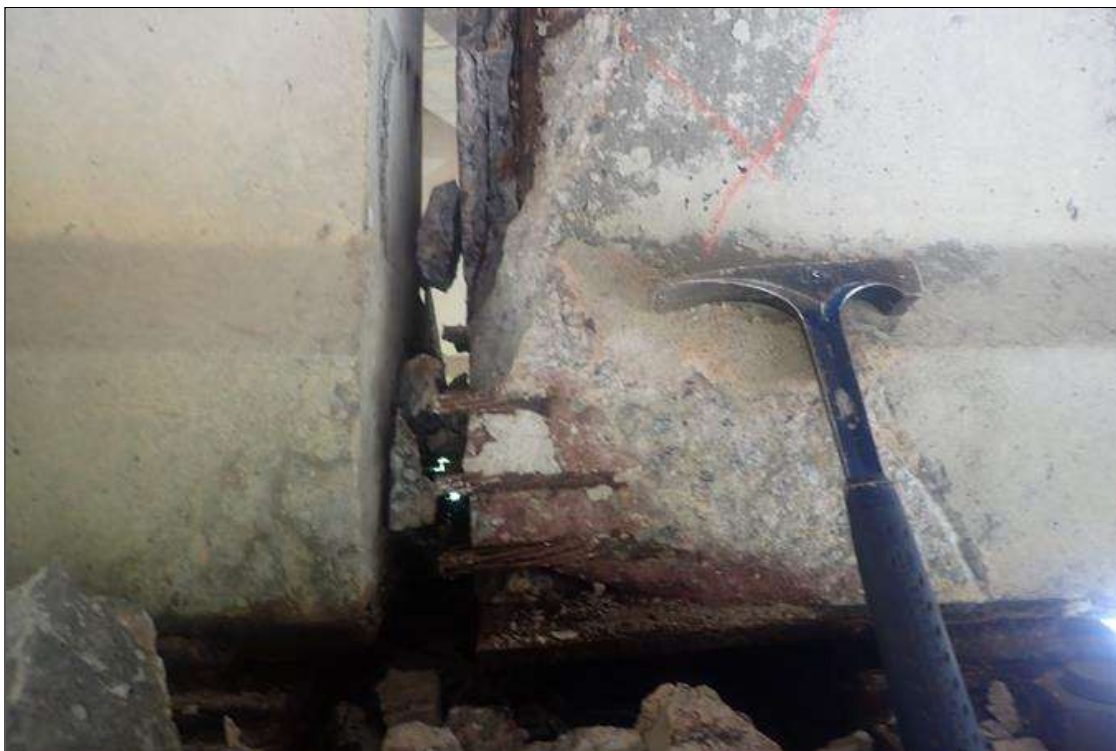
Span 3 Beam 3: (PAR) at bent 3, left face, failed patch/spall (12 inch x 39 inch x 3 inch deep) with exposed rusted strands and rebar, with efflorescence buildup at diaphragm

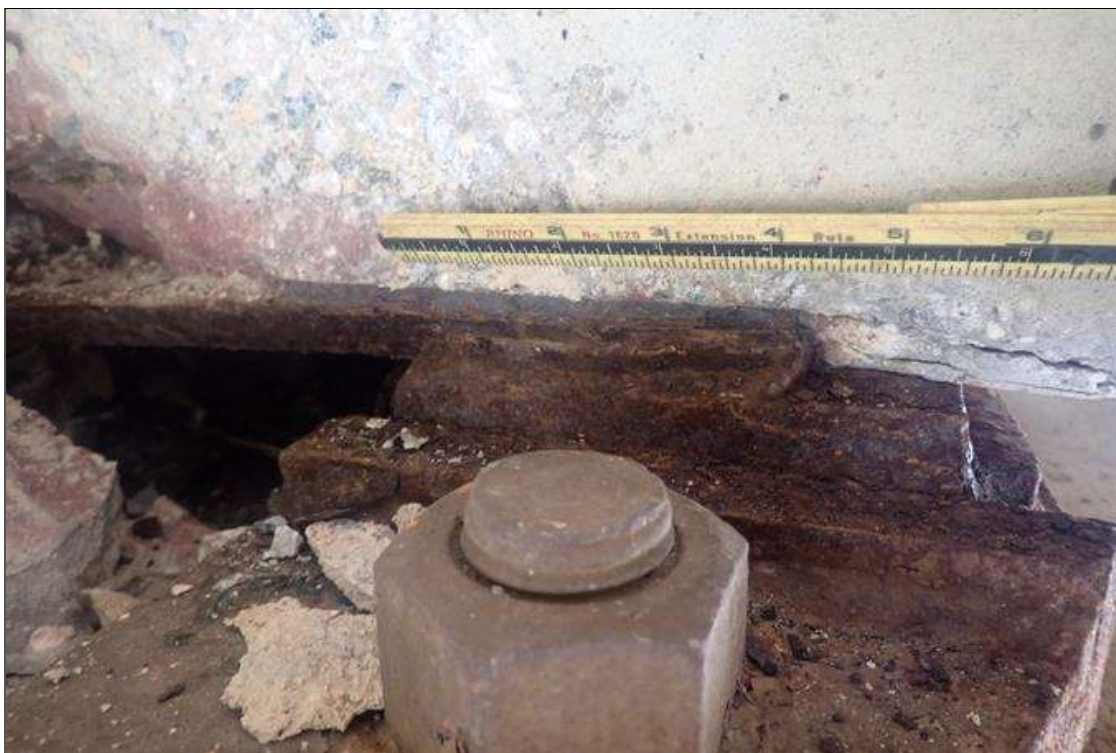
Span 3 Beam 3 - Far Bearing 3: beam installed with 4 inches of sole plate on bearing plate; no signs of distress

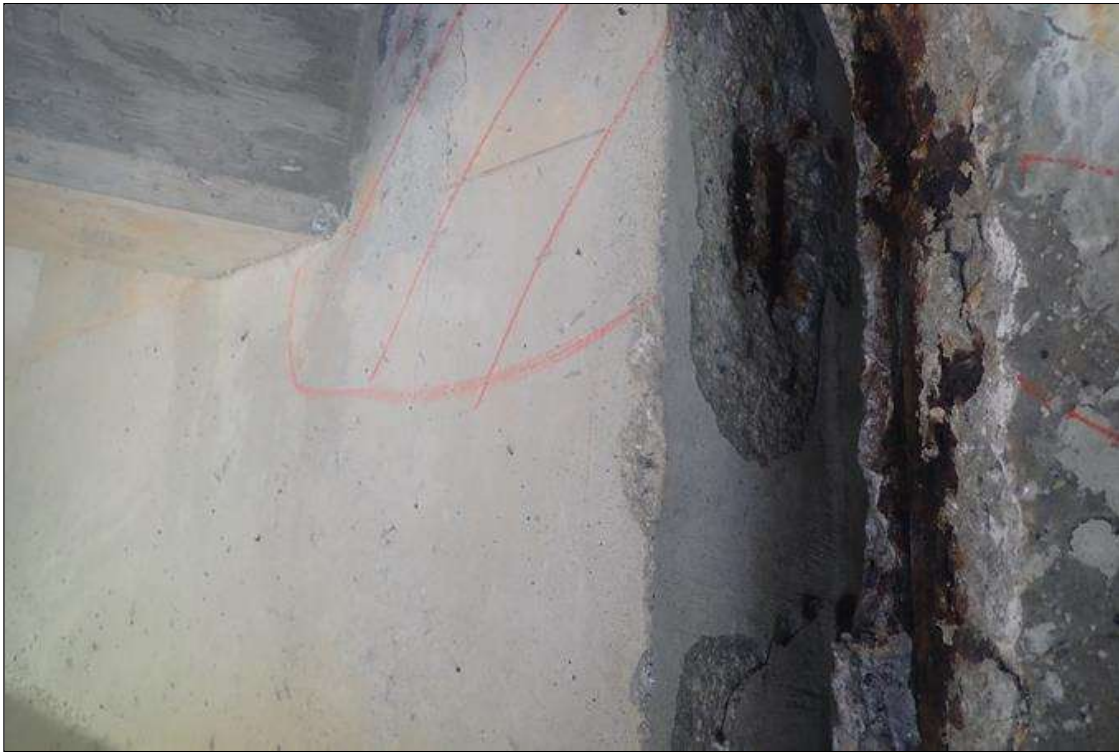
Span 4 Beam 3: at bent 3, end of web, spall/delamination (29 inch high x full width x up to 1.5 inch deep) with exposed rusted rebar extending along faces (up to 16 inches)

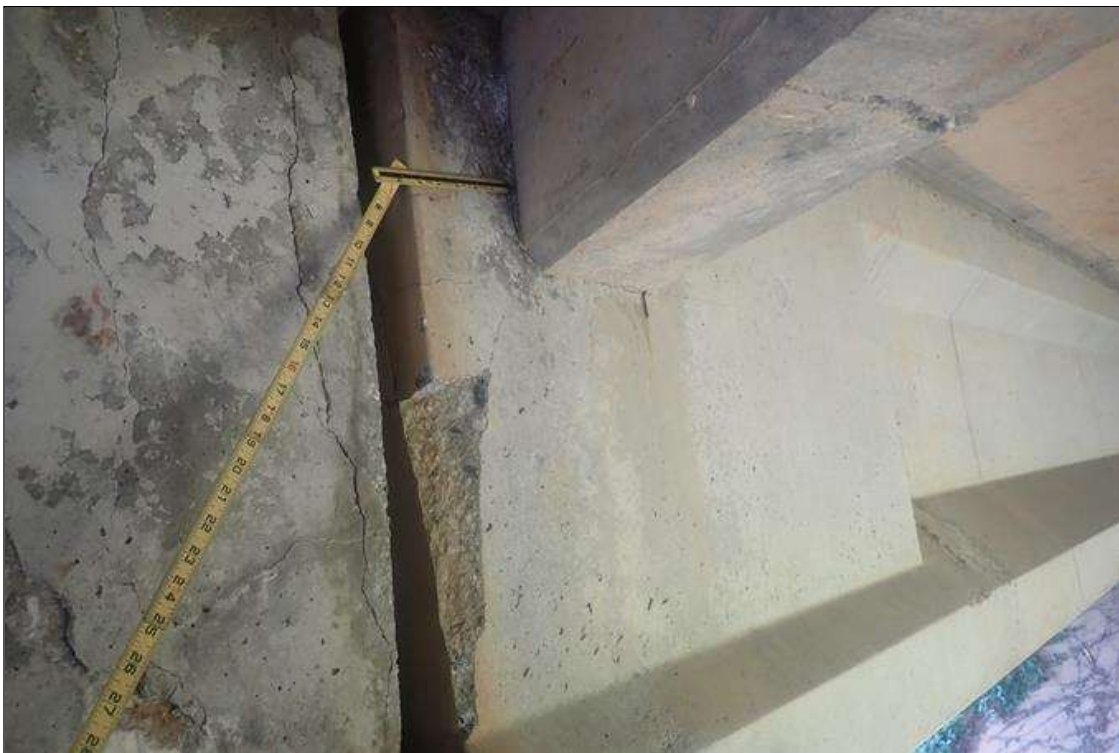
Span 4 Beam 3: at bent 3, end of web, spall/delamination (29 inch high x full width x up to 1.5 inch deep) with exposed rusted rebar extending along faces (up to 16 inches)

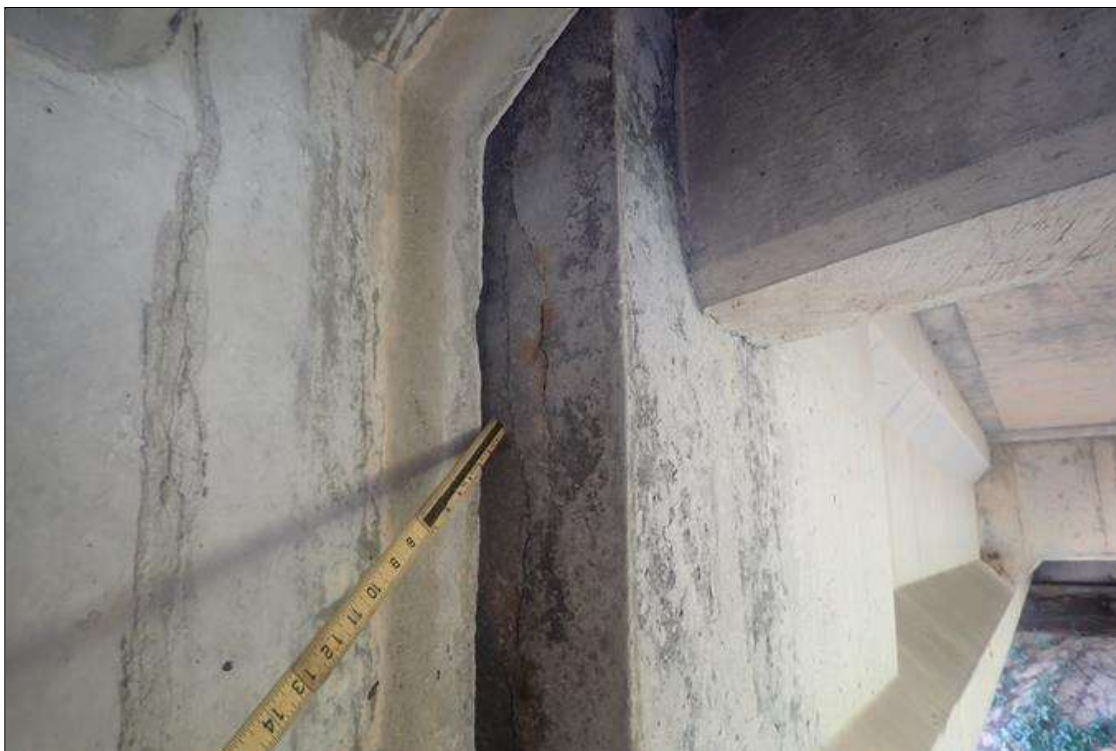
Span 4 Beam 2: (PAR) at bent 3, end of web, vertical crack (0.03 inch x 30 inch)

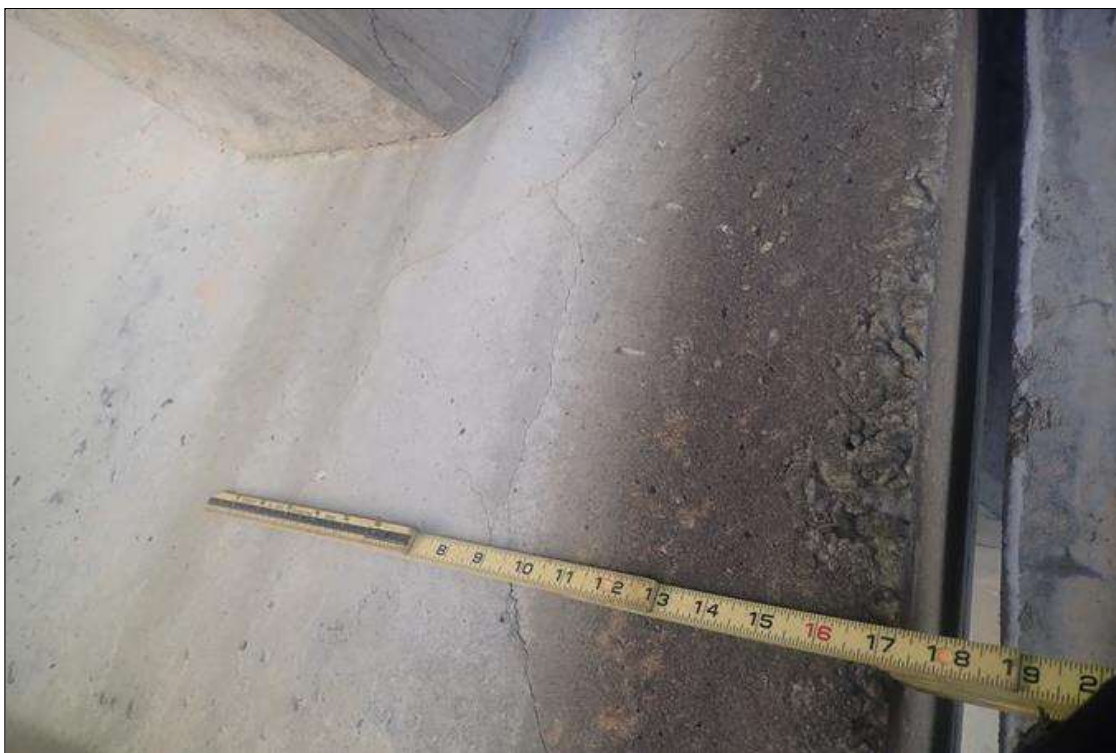
Span 4 Beam 2: (PAR) at bent 3, left face, web, map cracks (up to 0.018 inch x 16 inch x 30 inch)

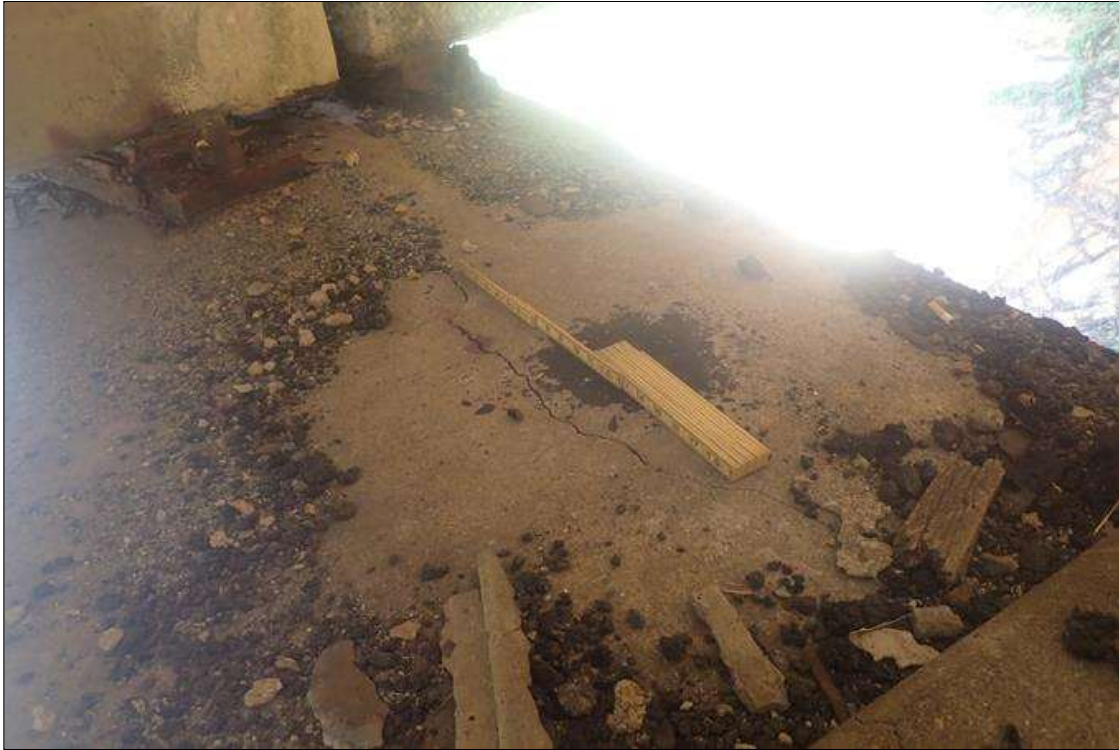
Bent 3 Cap 1: top face, bay 1, longitudinal crack (up to 1/8 inch x 7 feet)

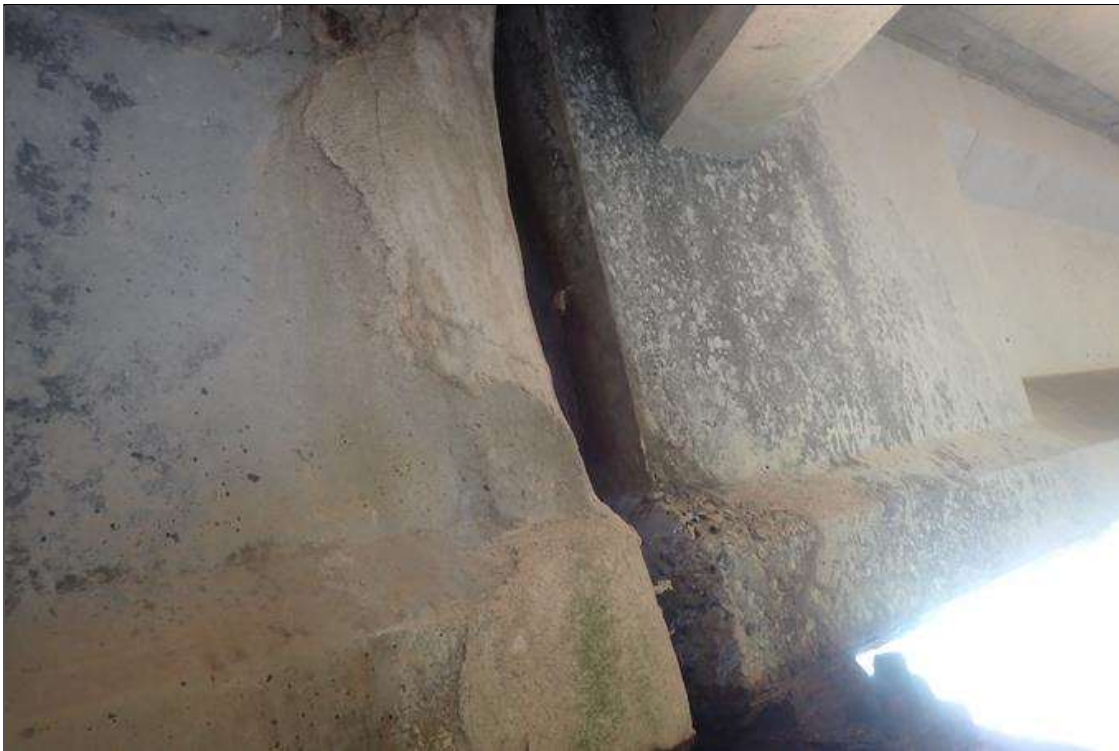
Span 3 Beam 1: FULL HEIGHT PATCHED AREA BOTTOM FLANGE AND WEB 10 INCHES LONG THAT IS SOUND ON RIGHT SIDE OVER PIER 3.

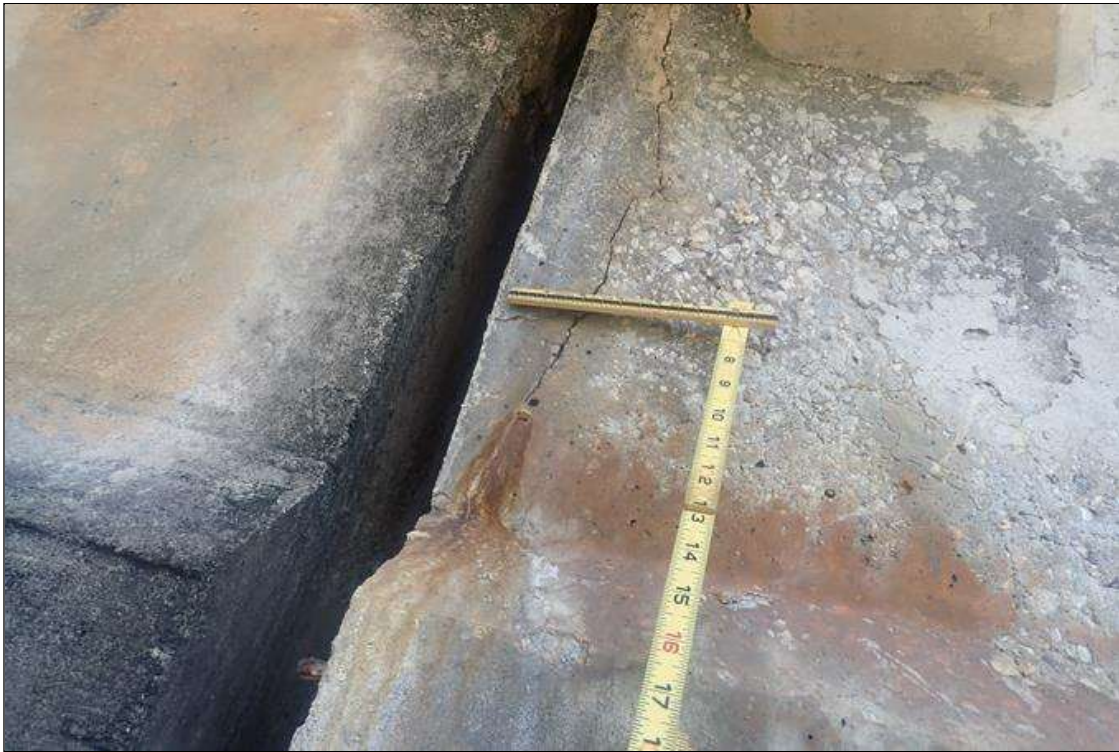
Span 3 Beam 1: (PAR) 1/16 INCH FULL HEIGHT VERTICAL CRACK, AND DELAMINATION (6 INCH WIDE), AND RUST STAINS IN LEFT SIDE OF WEB AT PIER 3.

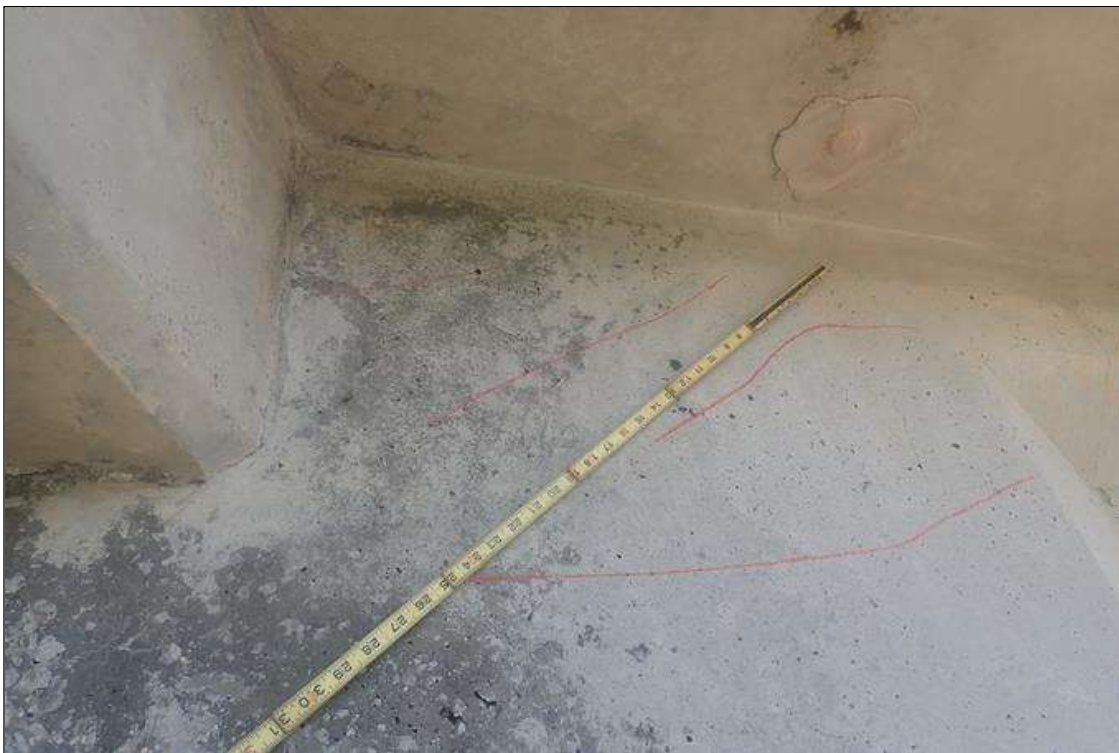
Span 3 Beam 1: 2 feet from bent 3, left face, top of web, multiple diagonal cracks (up to 0.008 inch x 4 feet)

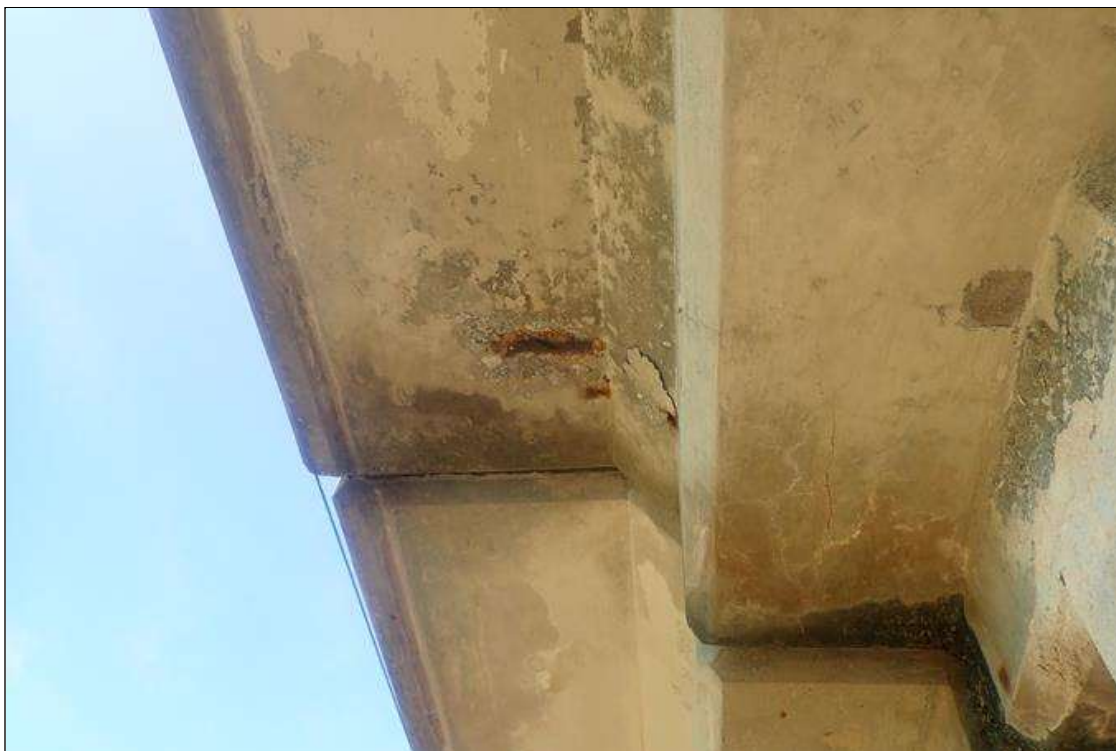
Span 3 Deck: (PAR) 6 INCH LONG X 4 INCHES WIDE X 3/4 INCH SPALL WITH EXPOSED RUSTED REBAR UNDER LEFT OVERHANG AT PIER 3

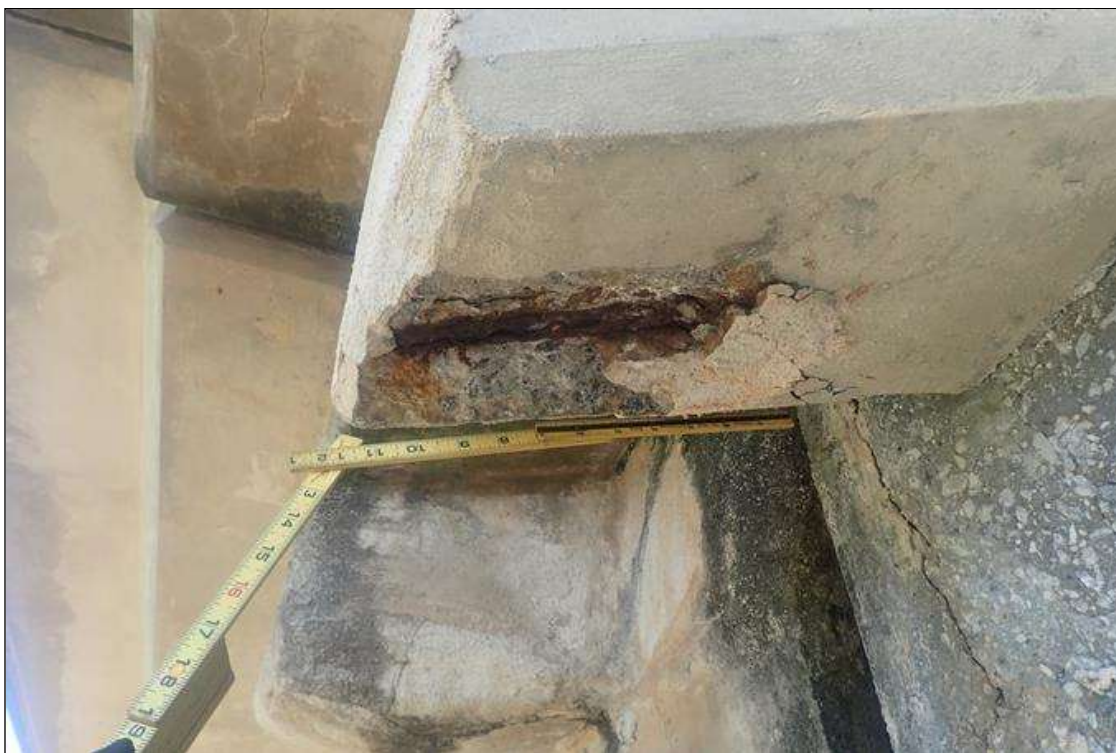
Span 3 Deck: bent 3 end diaphragm, left overhang, partially failed patch (12 inch x 6 inch x 1 inch deep) with exposed rusted rebar

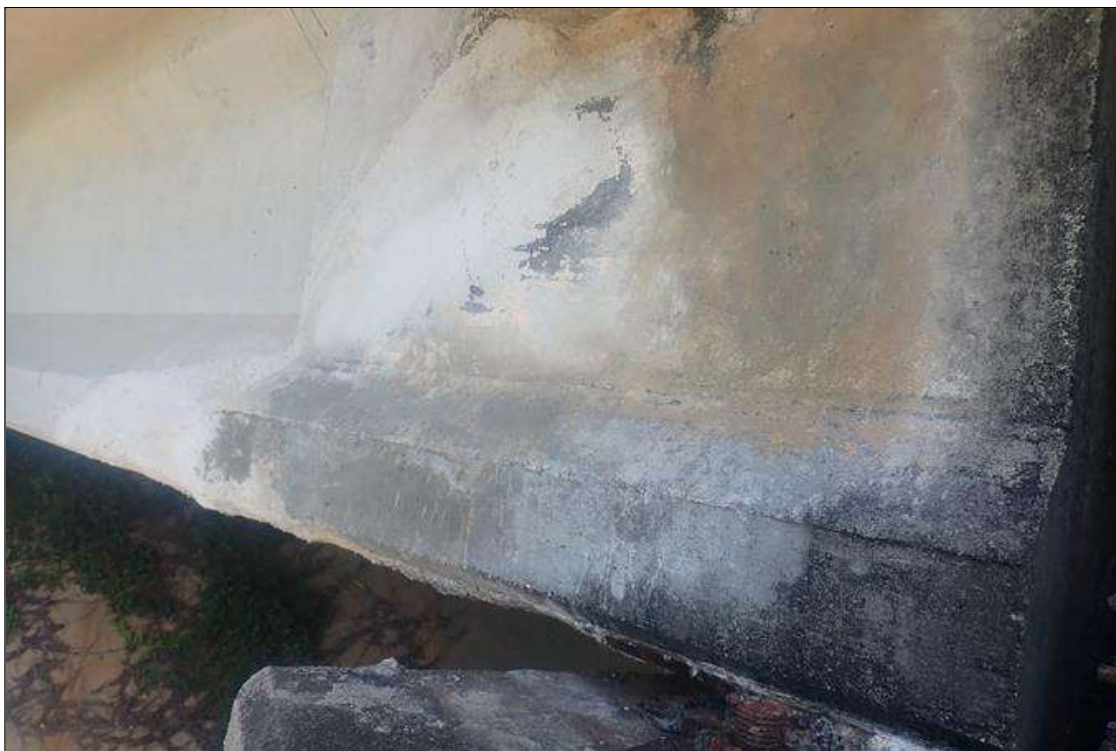
Span 4 Beam 1: 6 FOOT LONG X UP TO FULL HEIGHT PATCHED AREA THAT IS SOUND ON LEFT SIDE OF WEB AND BOTTOM FLANGE AT PIER 3.

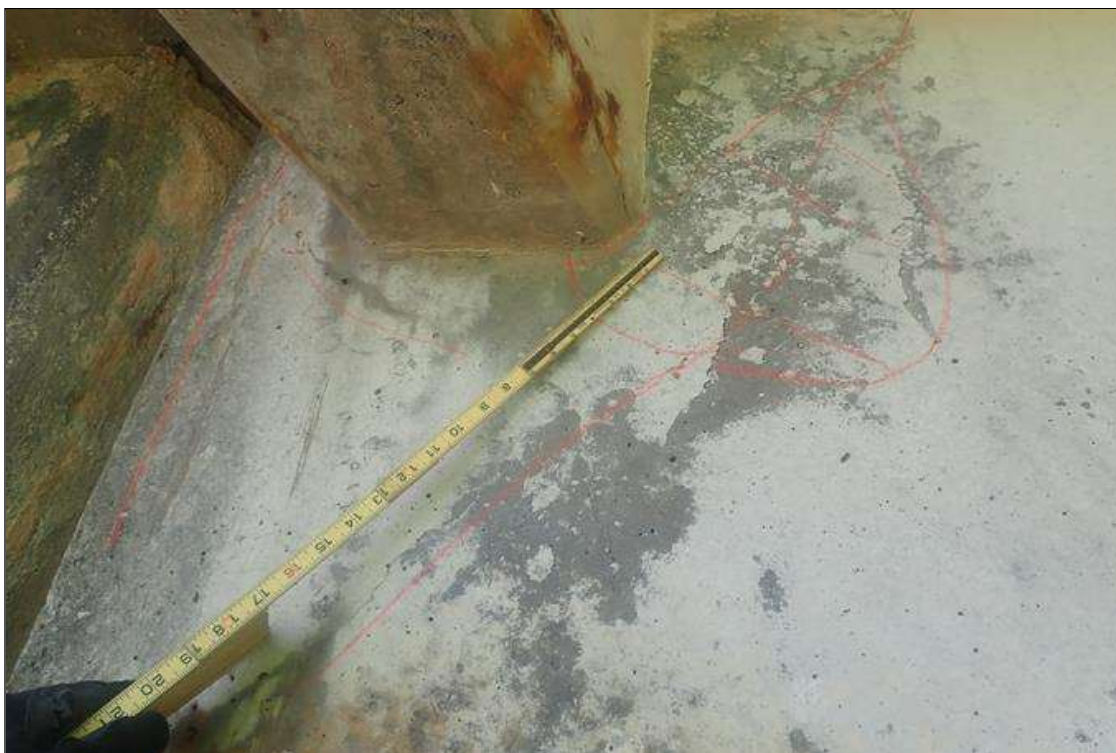
Span 4 Beam 4: (PAR) at bent 3, right face, web, vertical and diagonal crack (up to 0.01 inch x 4 feet) with delamination (12 inch x 16 inch)

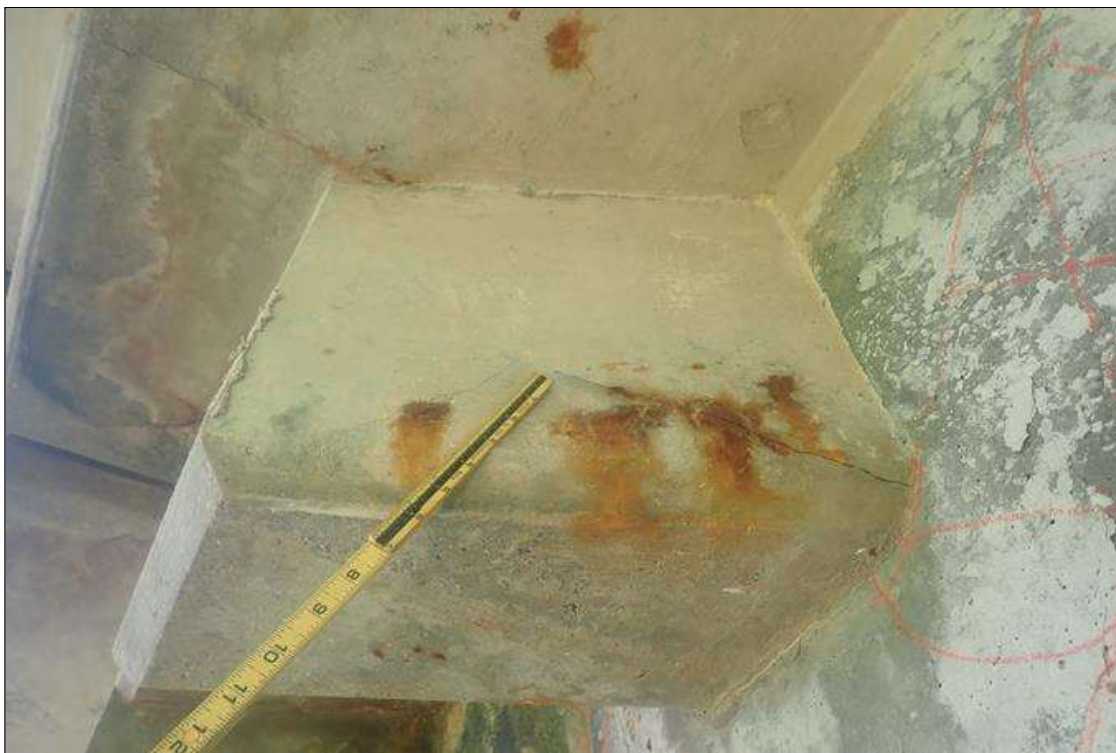
Span 4 Deck: (PAR) bent 3 end diaphragm, right overhang, longitudinal crack (1/32 inch x 12 inch) with rust stains

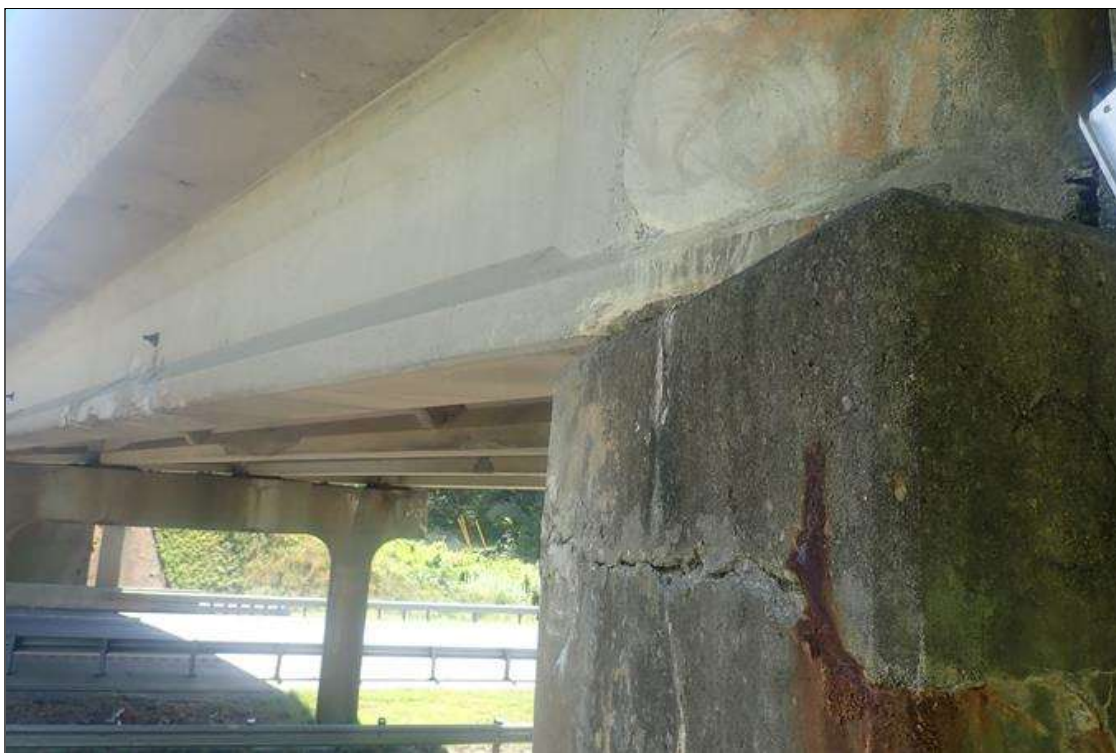
Bent 3 Cap 1: NORTH FACE OF CAP AT TOP, FULL WIDTH X 1.5 FOOT HIGH PATCHED AREA THAT HAS 2.5 INCHES OF EXPOSED REBAR

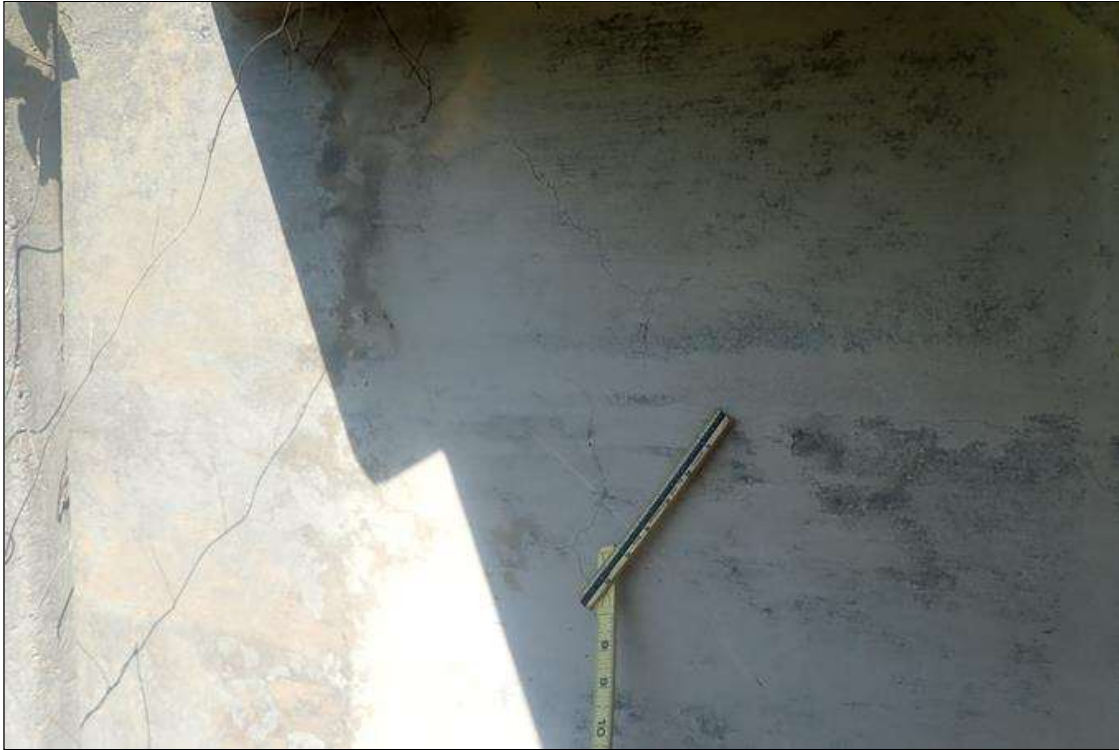
End Bent 2 Abutment: left end, map cracks (hairline x 2 feet x 2 feet)

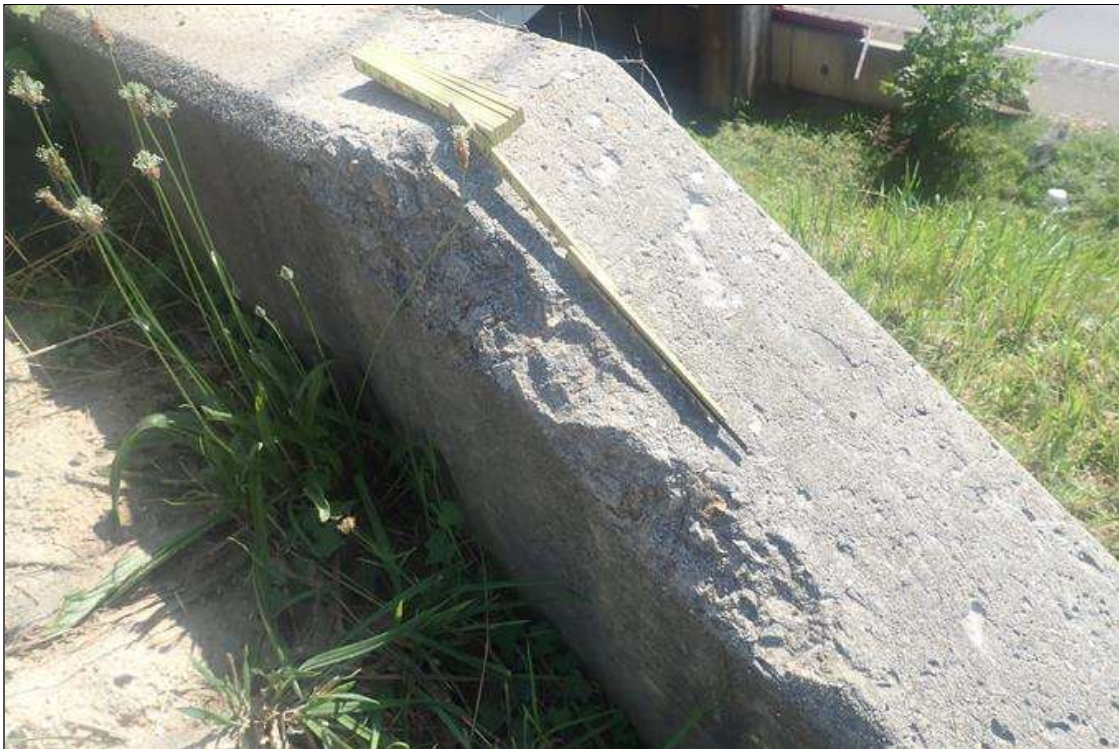
northwest wingwall, top corner, spall (2 foot x 3 inch x 1.5 inch deep)

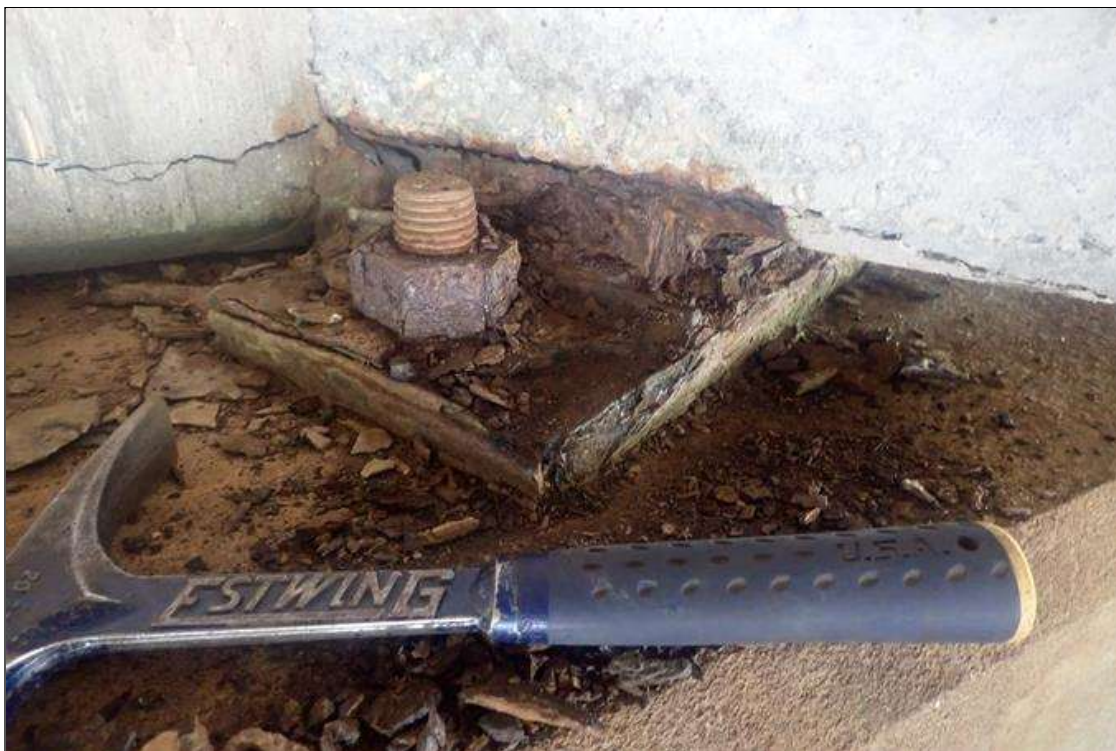
Span 4 Beam 4 - Far Bearing 4: rust scale/pack rust

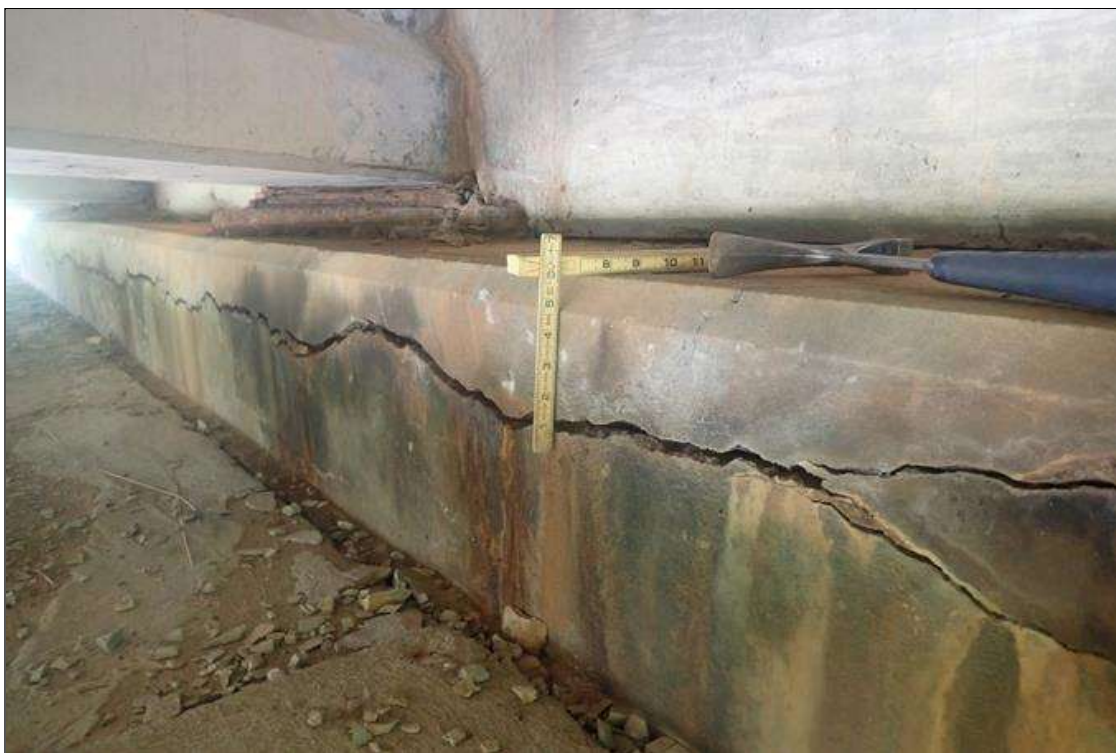
End Bent 2 Cap 1: (PAR) Full length area of delamination 12 inches high with horizontal cracks up to 3/4 inch with efflorescence and rust stains near top of cap which extend 6 inches on to top of cap.

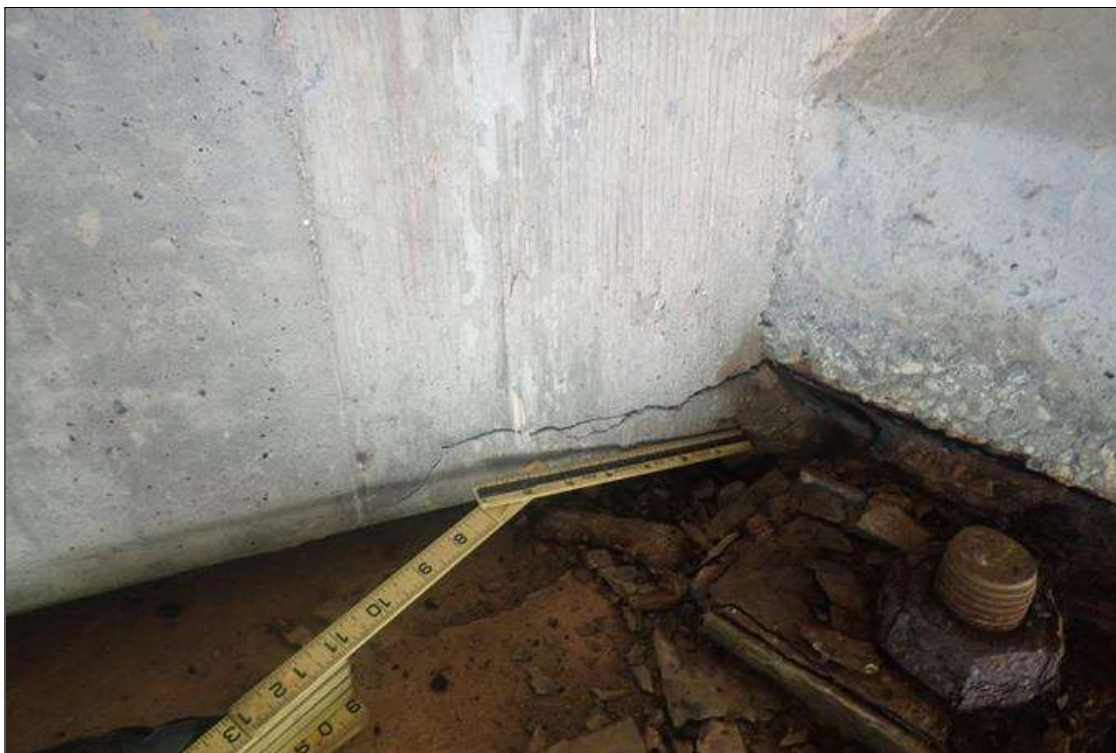
End Bent 2 Abutment: at multiple bottom flanges, longitudinal crack (up to 1/16 inch x 12 inch)
