NC DEPARTMENT OF TRANSPORTATION  
 DIVISION OF HIGHWAYS  
 STRUCTURE MANAGEMENT UNIT

ATTENTION: **prompt action request, sketches revised, lateral clearances revised**

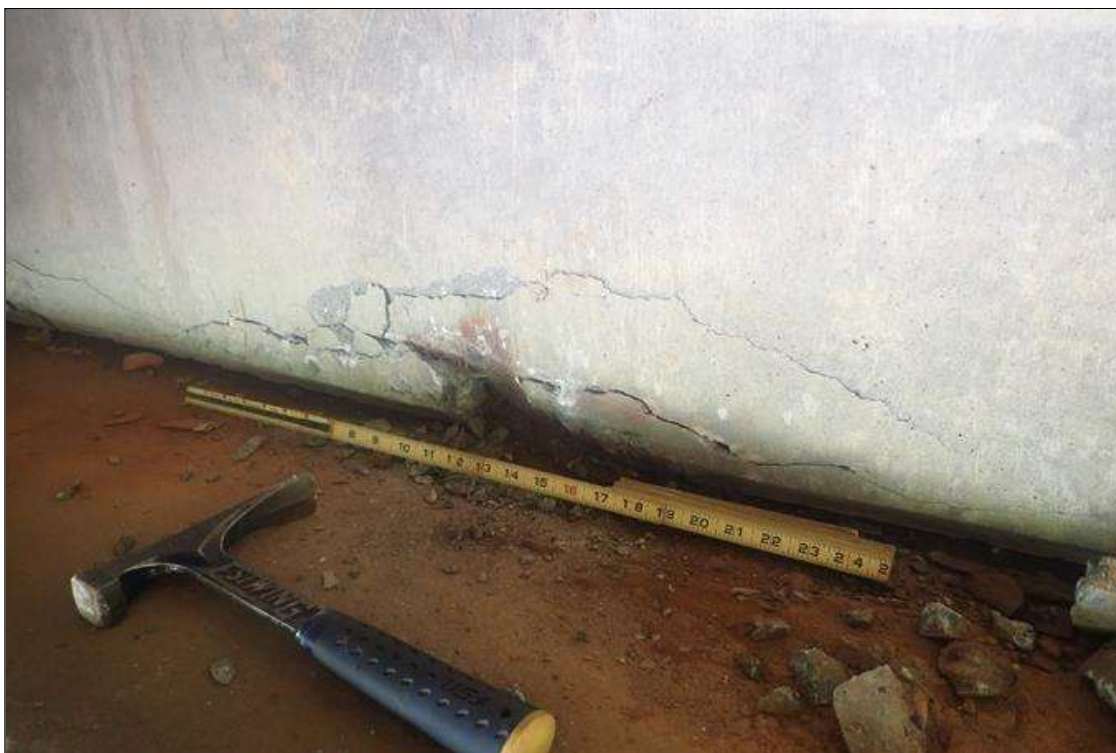
End Bent 2 Abutment: bay 2, bottom corner, spall/delamination (2 feet x 6 inch x 2 inch deep) with exposed rusted rebar

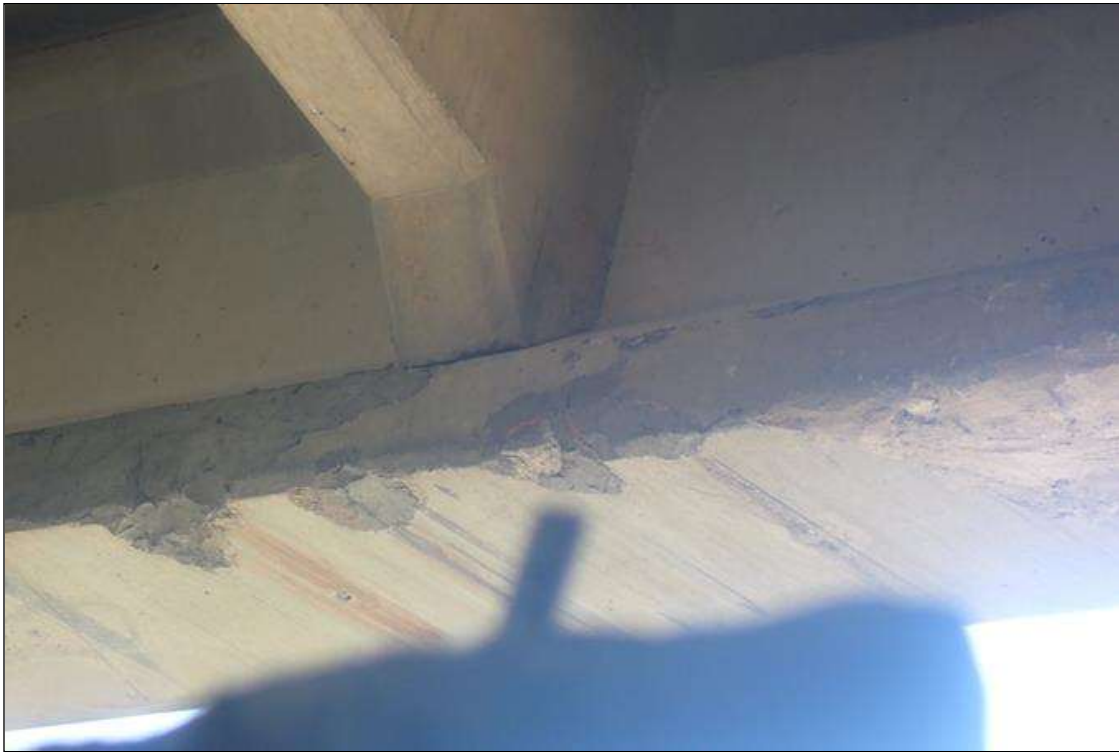
Span 3 Beam 1: (PAR) 07-07-2023 no change since supplemental inspection, right corner, previously noted as: IMPACT DAMAGE - LOCATED 19 FEET 4 INCHES FROM BENT 3; DIMENSIONS ARE 4 INCHES LONG X 3 INCHES HIGH X 1/2 INCH DEEP

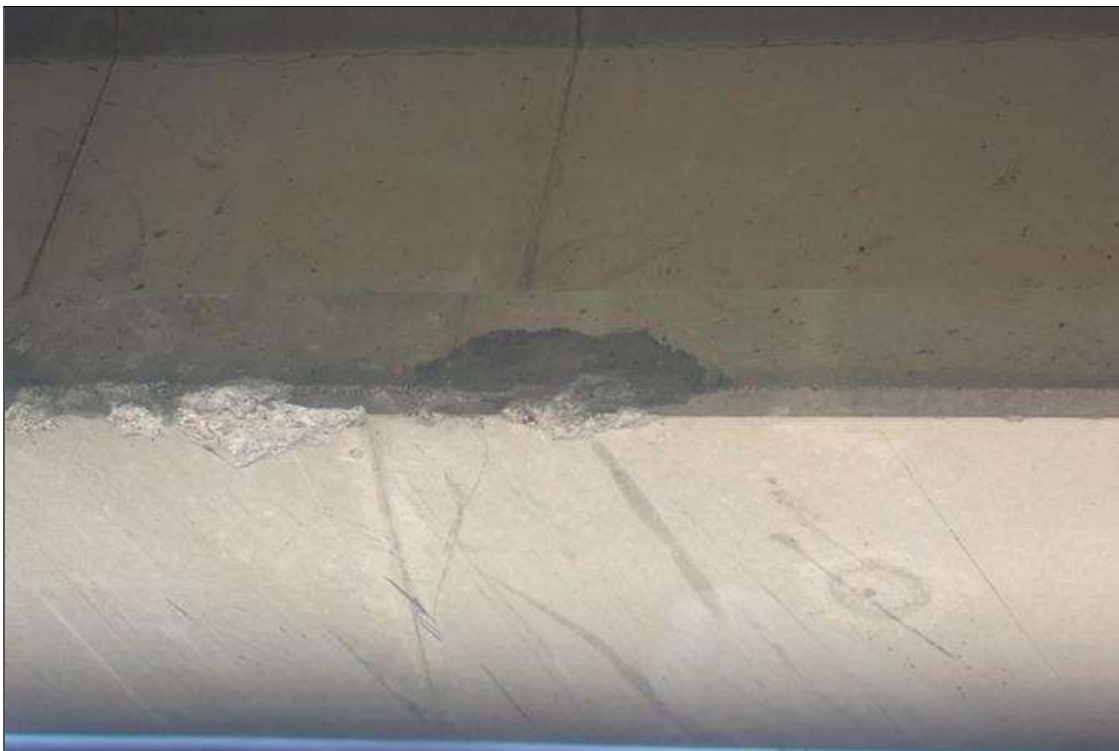
Span 3 Beam 1: (PAR) PATCHED AREAS THAT IS SOUND ALONG BOTTOM EDGE FROM IMPACT DAMAGE STARTING 12 FEET FROM PIER 3. - 02/16/2023 - IMPACT DAMAGE INSPECTION - LOCATED 12 FEET FROM BENT 3; DIMENSIONS ARE 7 INCHES LONG X 2 INCHES HIGH X 1 INCH DEEP ON PREVIOUS IMPACT REPAIR - 07-07-2023 no change since supplemental inspection, right corner

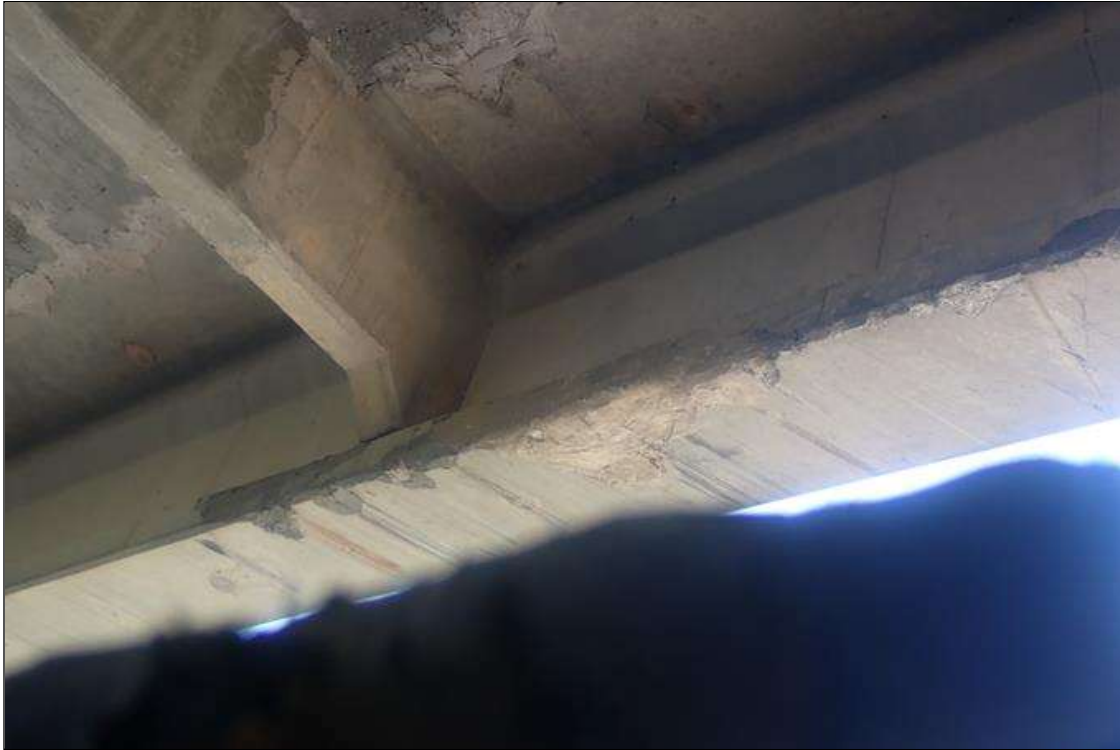
Span 3 Beam 1: 07-07-2023 no change since supplemental inspection, previously noted as: 2 FEET LONG X 10 INCHES HIGH PATCHED AREA OVERVIEW LOCATED 13 FEET FROM BENT 3 OVER SOUTHBOUND TRAVEL LANES

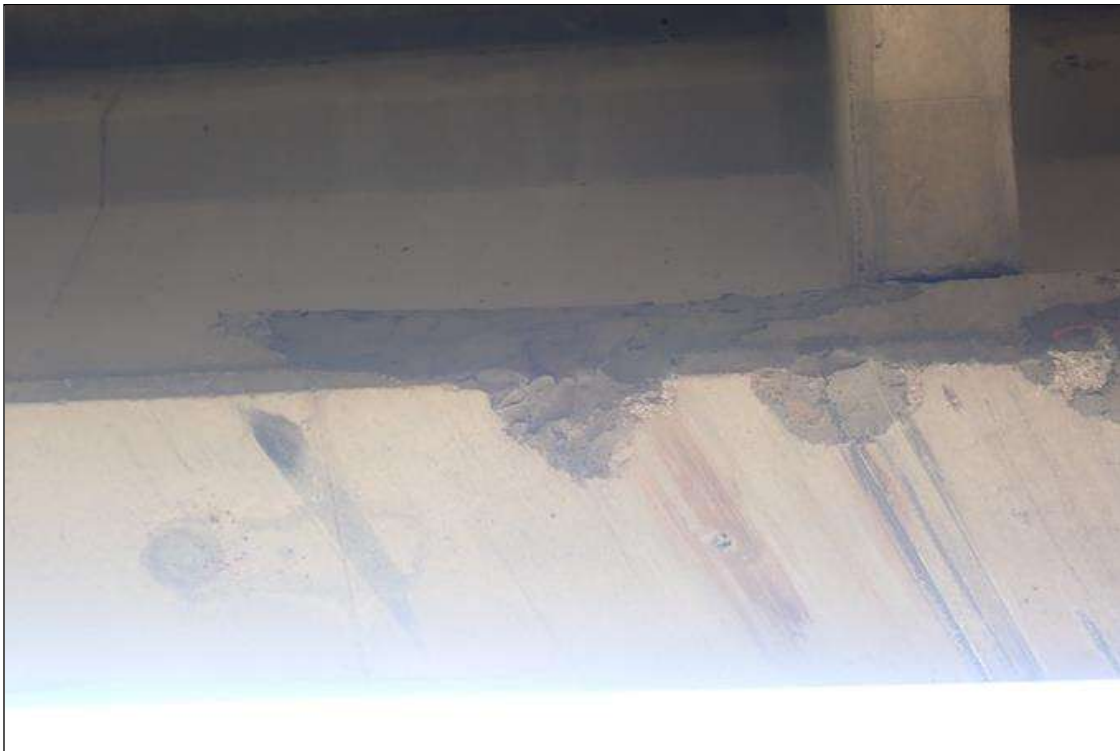
Span 3 Beam 1: (PAR) south side of second intermediate diaphragm, bottom flange, right face, patch (approximately 2 feet x 8 inch) with map cracks (approximately 1/32 inch), potentially delaminated

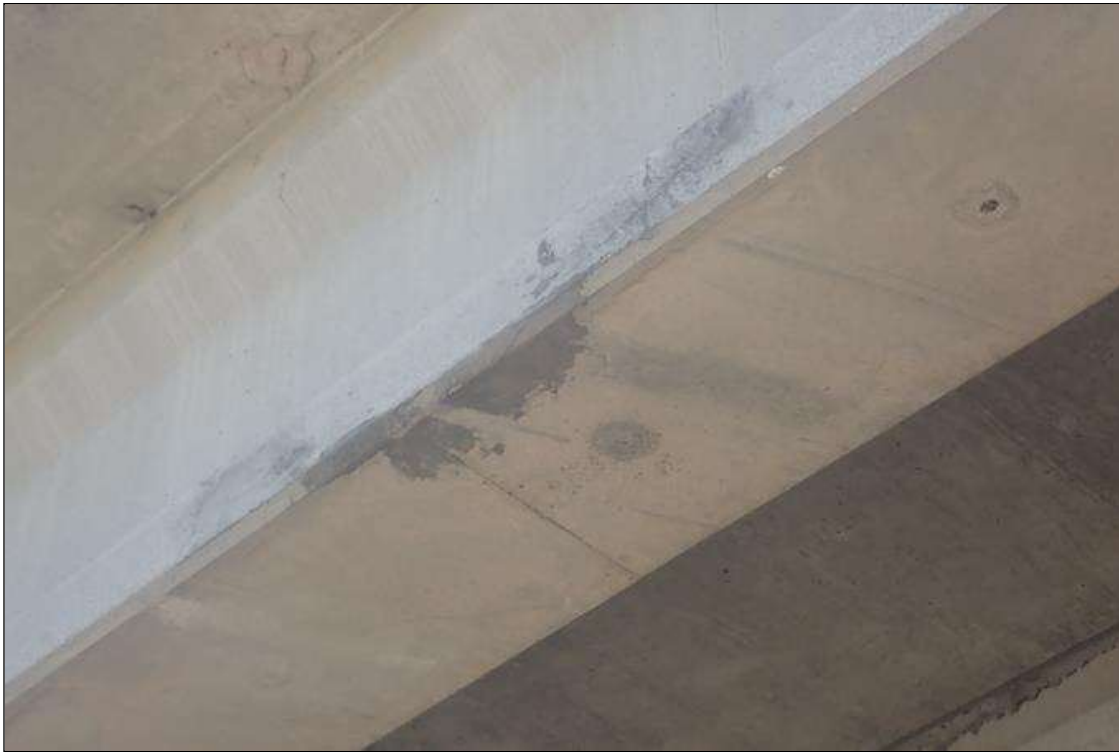
Span 3 Beam 1: 10 feet north of 1st intermediate diaphragm, bottom flange, left corner, patch (approximately 2 feet x 6 inch)

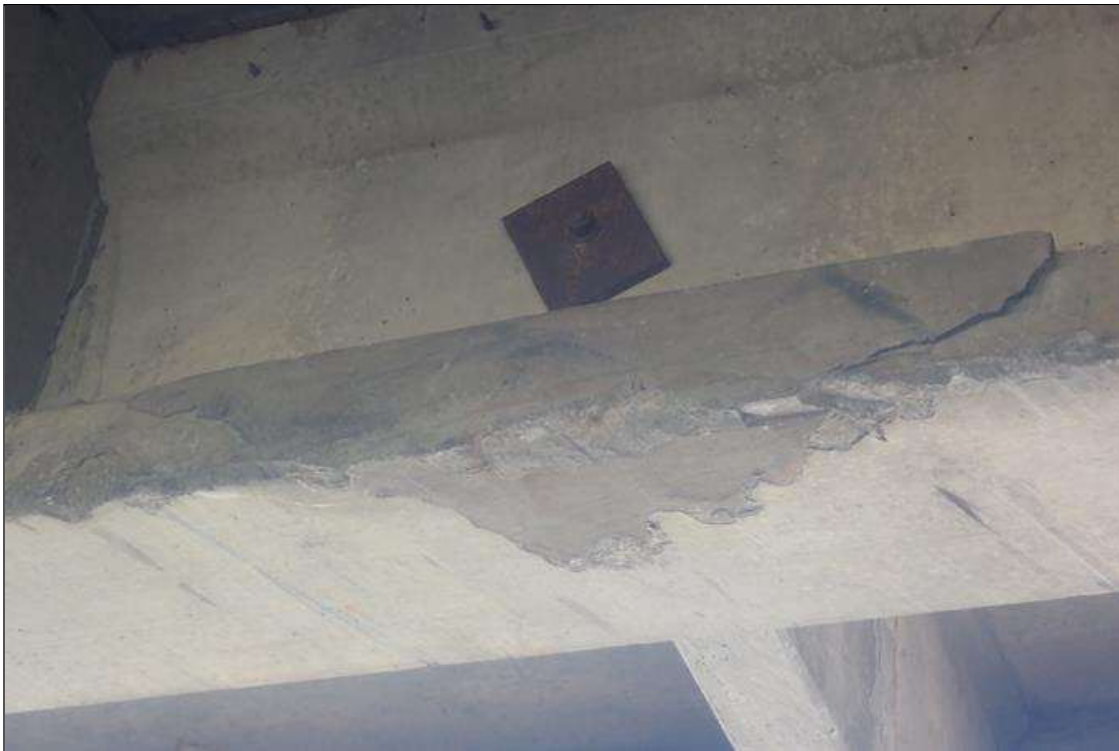
Span 3 Beam 2: (PAR) 07/07/2023 no apparent change since supplemental inspection, located at previous repair (5 feet long), previously noted as: IMPACT DAMAGE - LOCATED 14 FEET 1 INCH FROM BENT 3 ; DIMENSIONS ARE 2 FEET 6 INCHES LONG X 4 INCHES HIGH X 1/2 INCH DEEP

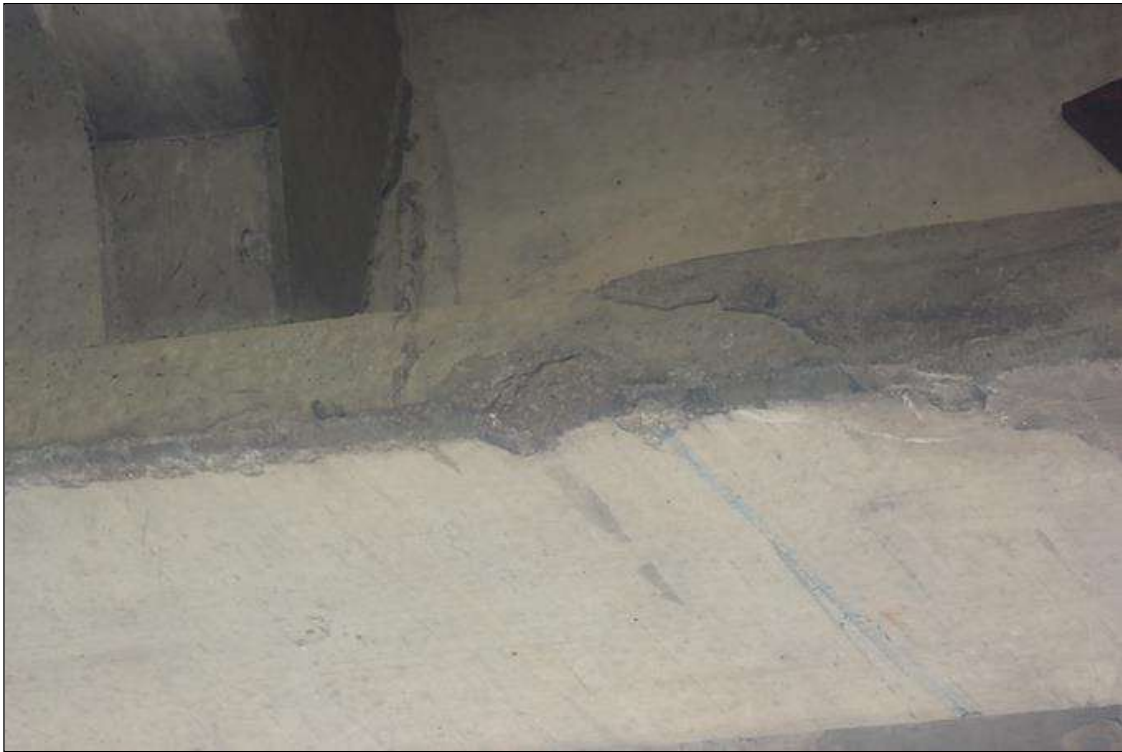
Span 3 Beam 2: (PAR) 07/07/2023 no apparent change since supplemental inspection, previously noted as: IMPACT DAMAGE - LOCATED 16 FEET FROM BENT 3; DIMENSIONS ARE 10 INCHES LONG X 5 INCHES HIGH X 1.25 INCHES DEEP

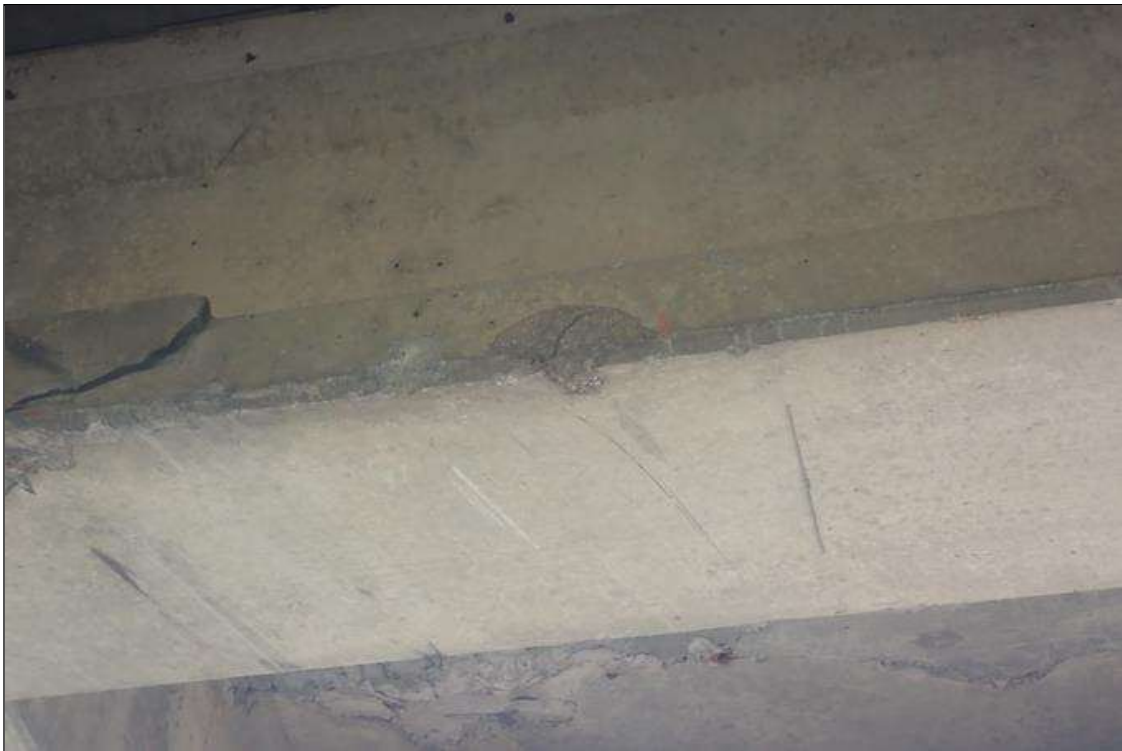
Span 3 Beam 2: (PAR) 07/07/2023 no apparent change since supplemental inspection, previously noted as: IMPACT DAMAGE- LOCATED 11 FEET 4 INCHES FROM BENT 3 WITH DIMENSIONS OF 1 FOOT 6 INCHES WIDE X 5 INCHES HIGH X 1/2 INCH DEEP

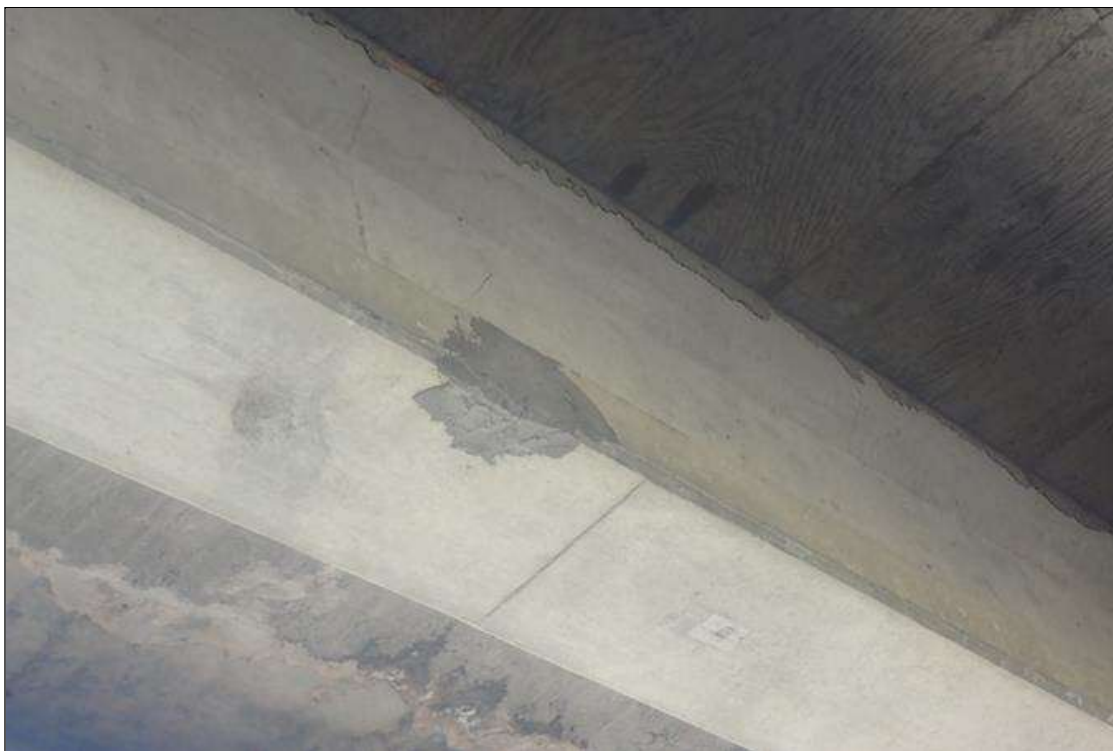
Span 3 Beam 2: (PAR) PATCHED AREA - LOCATED 25 FEET FROM BENT 3; 1 FOOT LONG X 8 INCHES HIGH, WITH MAP CRACKS UP TO APPROXIMATELY 1/32 INCH, POTENTIALLY DELAMINATED, OVER LEFT HAND SOUTHBOUND LANE

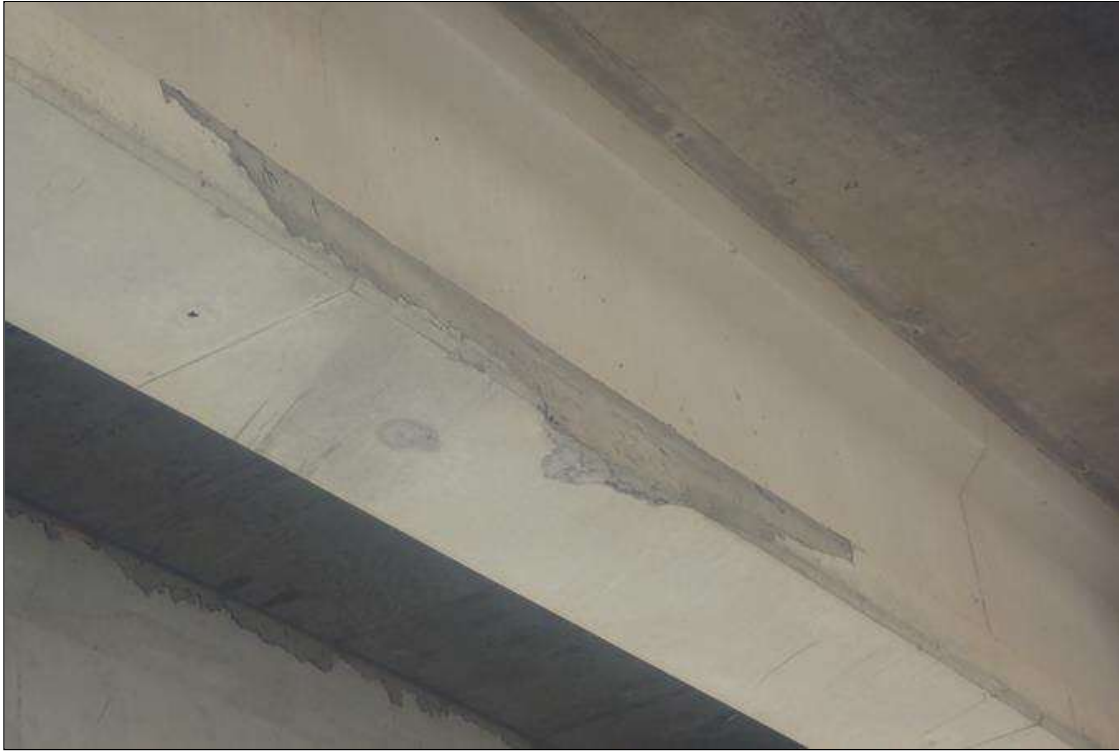
Span 3 Beam 3: PATCHED AREA THAT IS CRACKED ALONG BOTTOM FLANGE FROM IMPACT DAMAGE IN A 8 FEET LONG AREA OVER LEFT SOUTHBOUND LANE 02/16/2023 - IMPACT DAMAGE - OVERVIEW OF REPAIR AREA LOCATED OVER LEFT SOUTHBOUND LANE 25 FEET FROM BENT 3; DIMENSIONS ARE 8 FEET LONG ON NORTH SIDE OF BOTTOM FLANGE AND EXTEND APPROXIMATELY 10 INCHES UP 07/07/2023 no apparent change since supplemental inspection

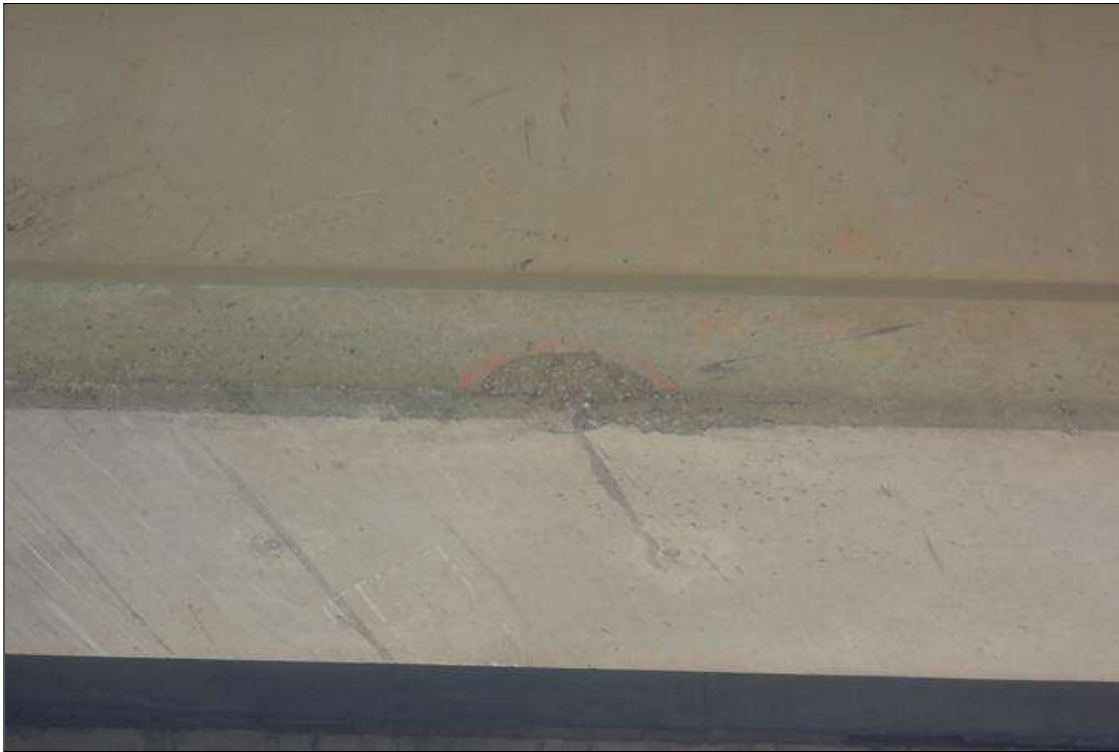
Span 3 Beam 3: (PAR) CHIPPED AREA FROM IMPACT DAMAGE ALONG BOTTOM EDGE OVER RIGHT LANE AND SEVERAL AREAS 3 INCHES X 5 INCHES - 02/16/2023 - IMPACT DAMAGE - LOCATED 11 FEET 2 INCHES FROM BENT 3; AREA DIMENSIONS ARE 10 INCHES LONG X 4 INCHES WIDE X 1/2 INCH DEEP ON NORTH SIDE OF BOTTOM FLANGE - 07/07/2023 no apparent change since supplemental inspection

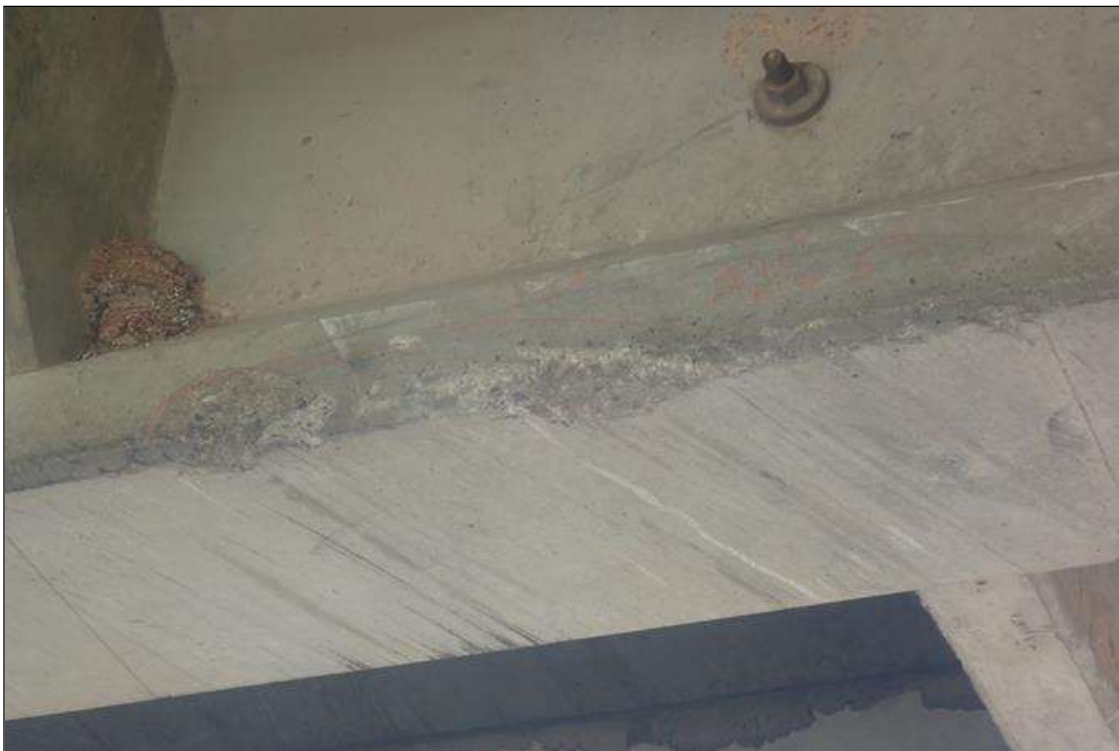
Span 3 Beam 3: (PAR) IMPACT DAMAGE - LOCATED 16 FEET 4 INCHES FROM BENT 3 - DIMENSIONS ARE 2.833 FEET LONG X 5 INCHES HIGH X 1 INCH DEEP ALONG NORTH EDGE OF BOTTOM FLANGE - 07/07/2023 no apparent change from supplemental inspection

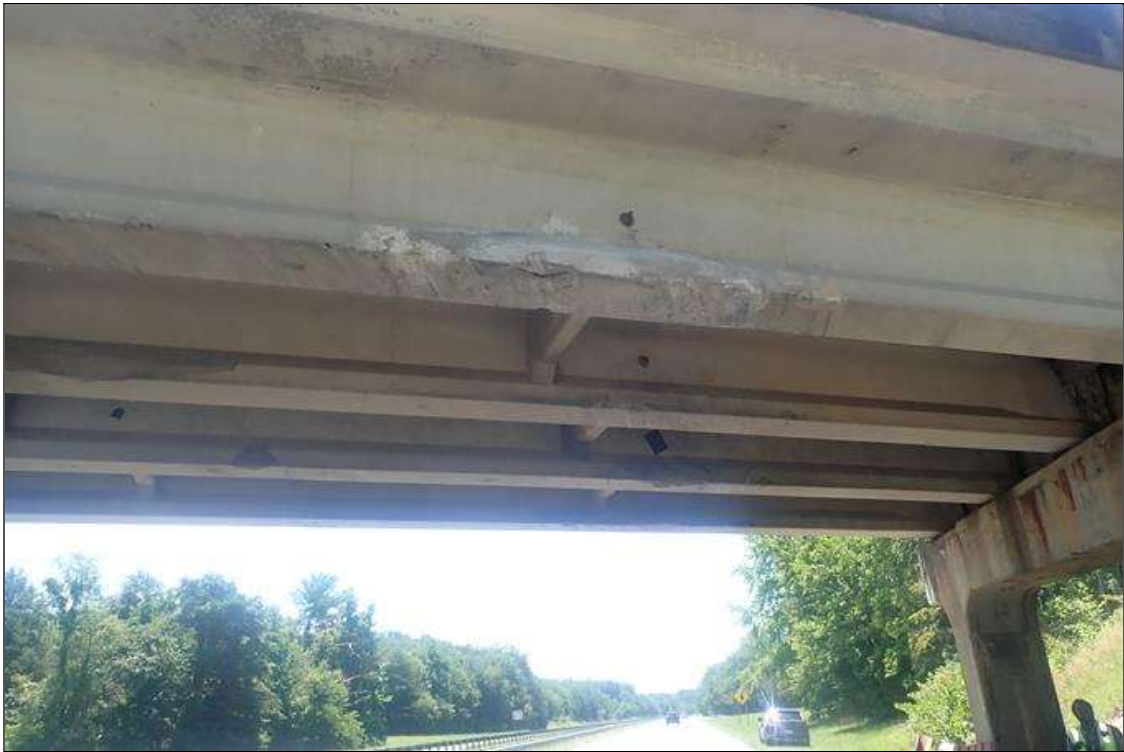
span 3, beam 4, impact damage over right southbound lane, overview

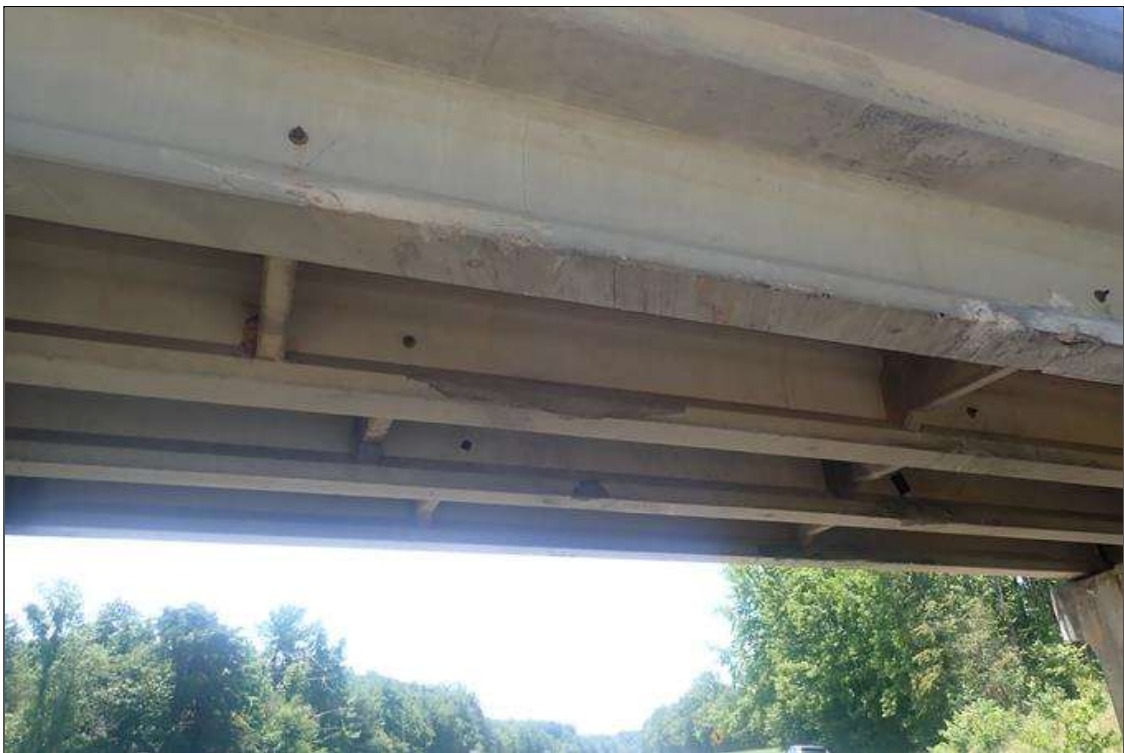
span 3, beam 4, impact damage over left southbound lane, overview

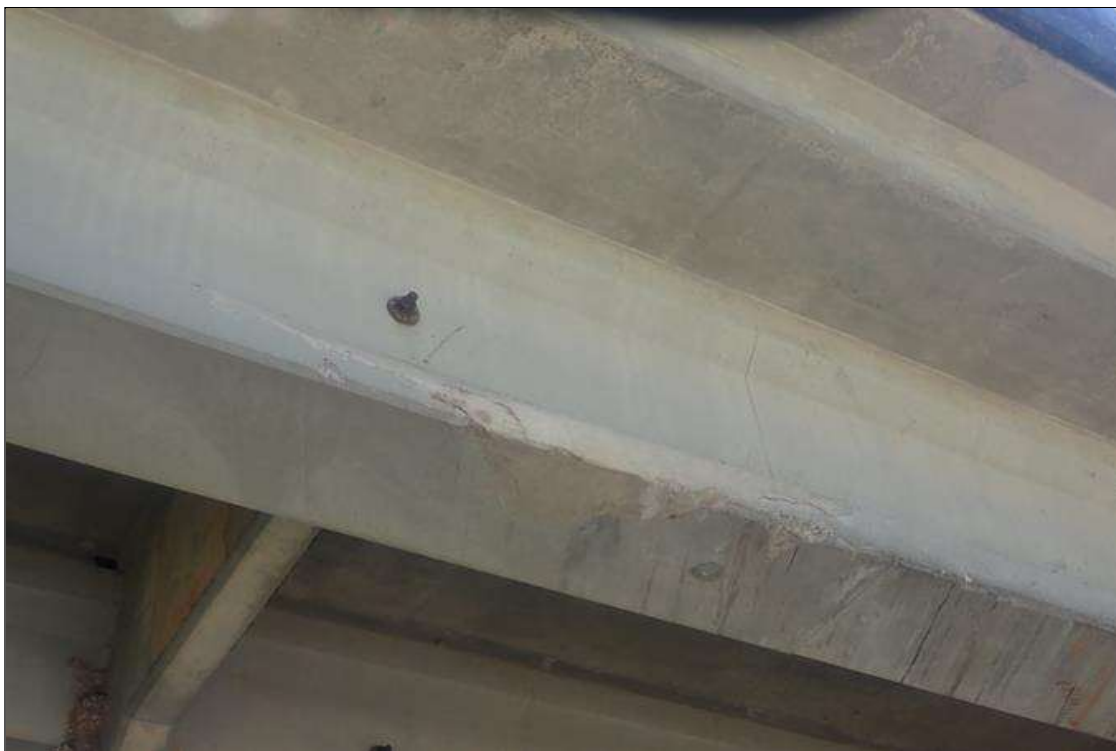
Span 3 Beam 4: 22 feet from bent 2, over left southbound lane, bottom flange right face, previous patch (approximately 8 feet long)

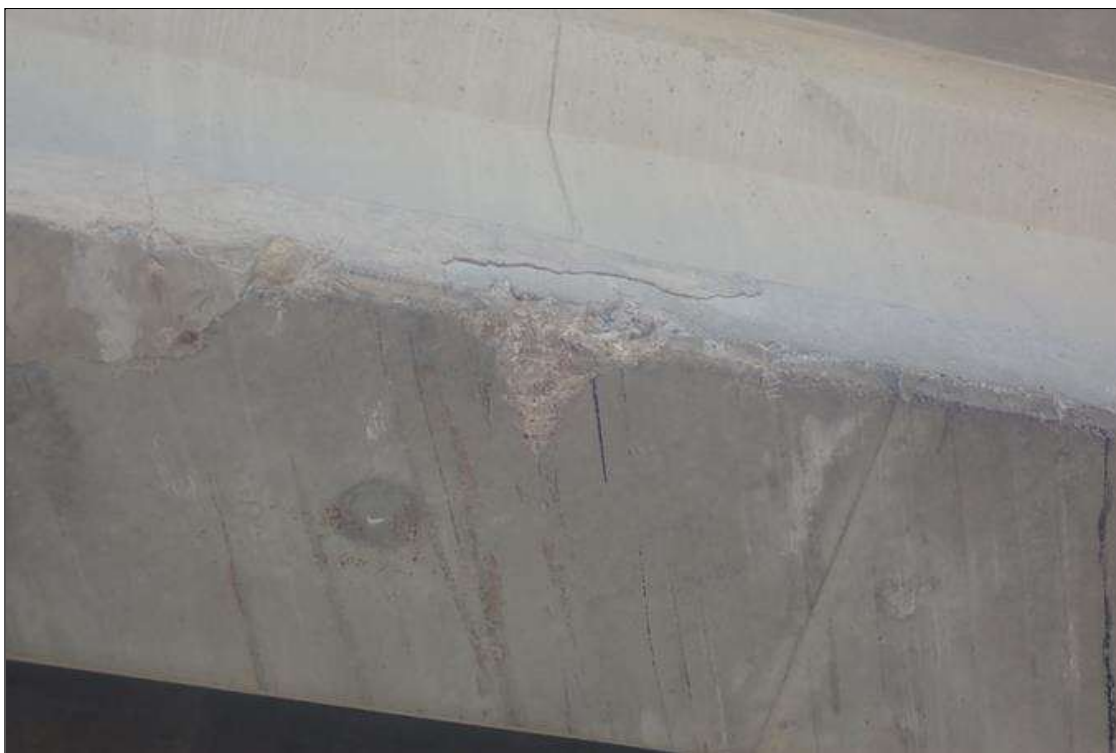
Span 3 Beam 4: (PAR) 25 feet from bent 2, over left southbound lane, bottom flange, right face, impact spall (approximately 10 inch x 6 inch x 2 inch deep)

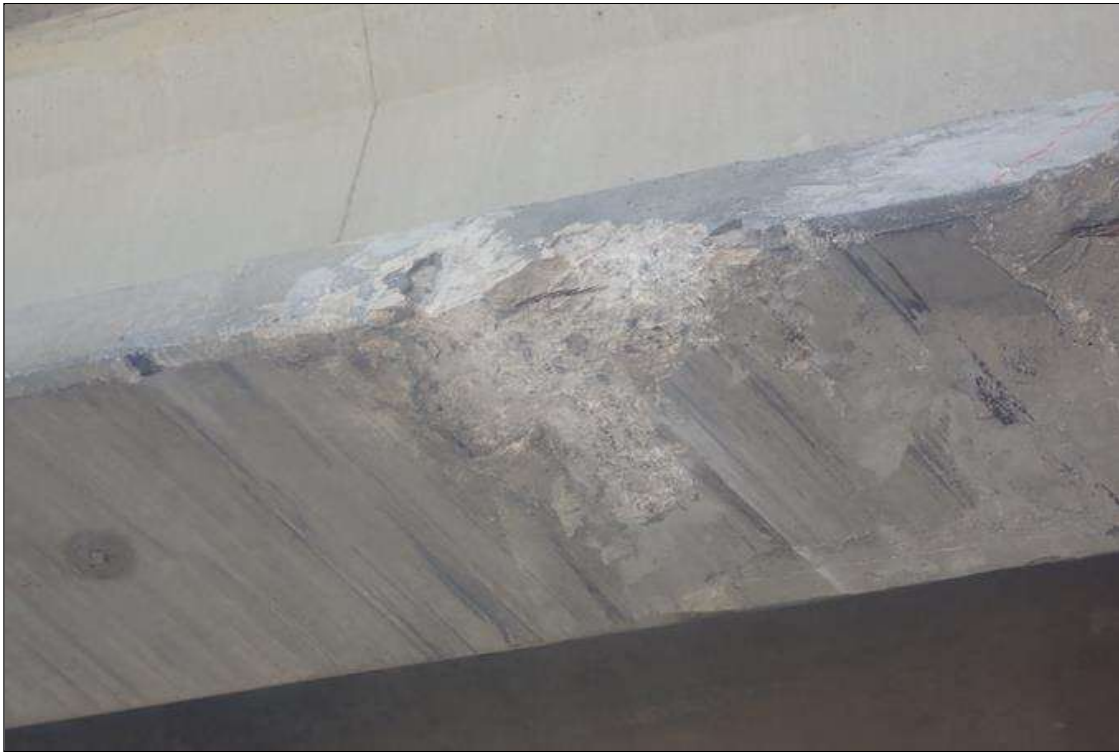
Span 3 Beam 4: (PAR) IMPACT DAMAGE - LOCATED 20 FEET FROM BENT 3; DIMENSIONS ARE 1.333 FEET LONG X 22 INCHES WIDE X 4 INCHES DEEP WITH EXPOSED RUSTED STRAND, ON NORTH EDGE OF BOTTOM FLANGE AND CONTINUING ACROSS FULL WIDTH OF BOTTOM FLANGE.

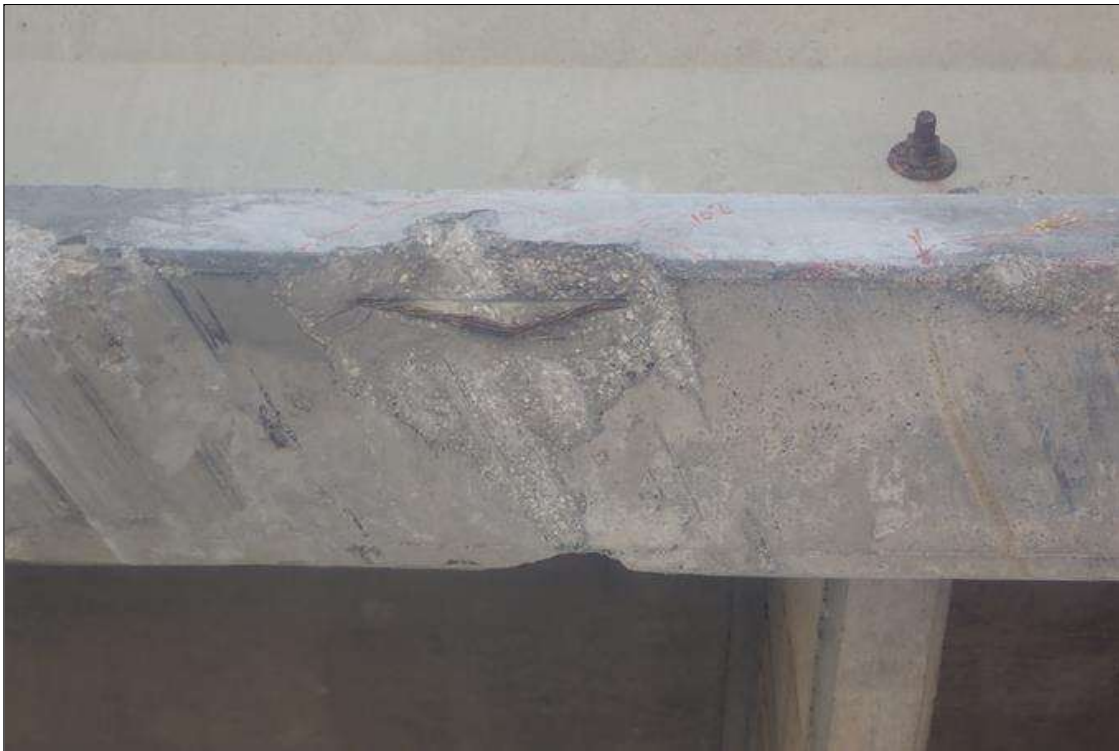
Span 3 Beam 4: (PAR) 5 FEET LONG PATCHED AREA THAT IS SOUND ON ALONG EAST SIDE OF BOTTOM FLANGE OVER LEFT SOUTHBOUND TRAVEL LANE - 02/16/2023 - IMPACT - LOCATED 18 FEET 2 INCHES FROM BENT 3 - DIMENSIONS ARE 10 INCHES LONG X 1.583 FEET WIDE X 4 INCHES DEEP; WITH EXPOSED TENSION CABLE - 07/07/2023 no apparent change from supplemental inspection

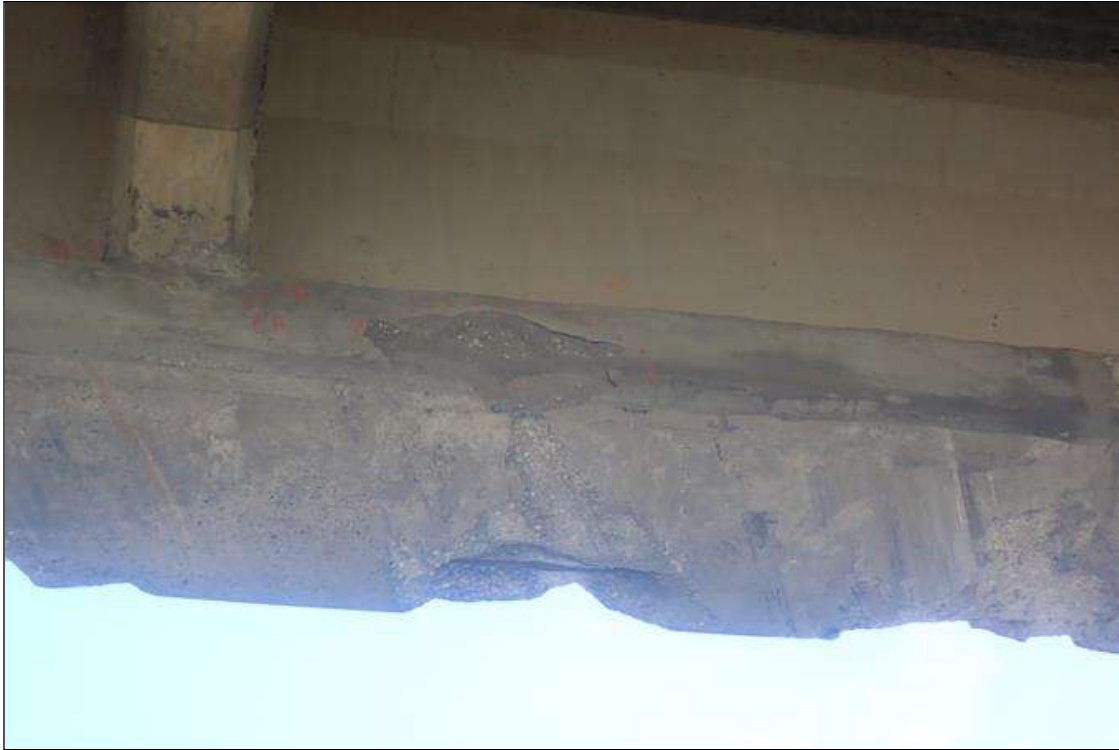
Span 3 Beam 4: (PAR) IMPACT - LEFT SIDE OF GIRDER LOCATED 18 FEET 2 INCHES FROM BENT 3- AREA OF PREVIOUS REPAIR DAMAGED - 1.417 FEET LONG X 7 INCHES HIGH X 1 INCH DEEP

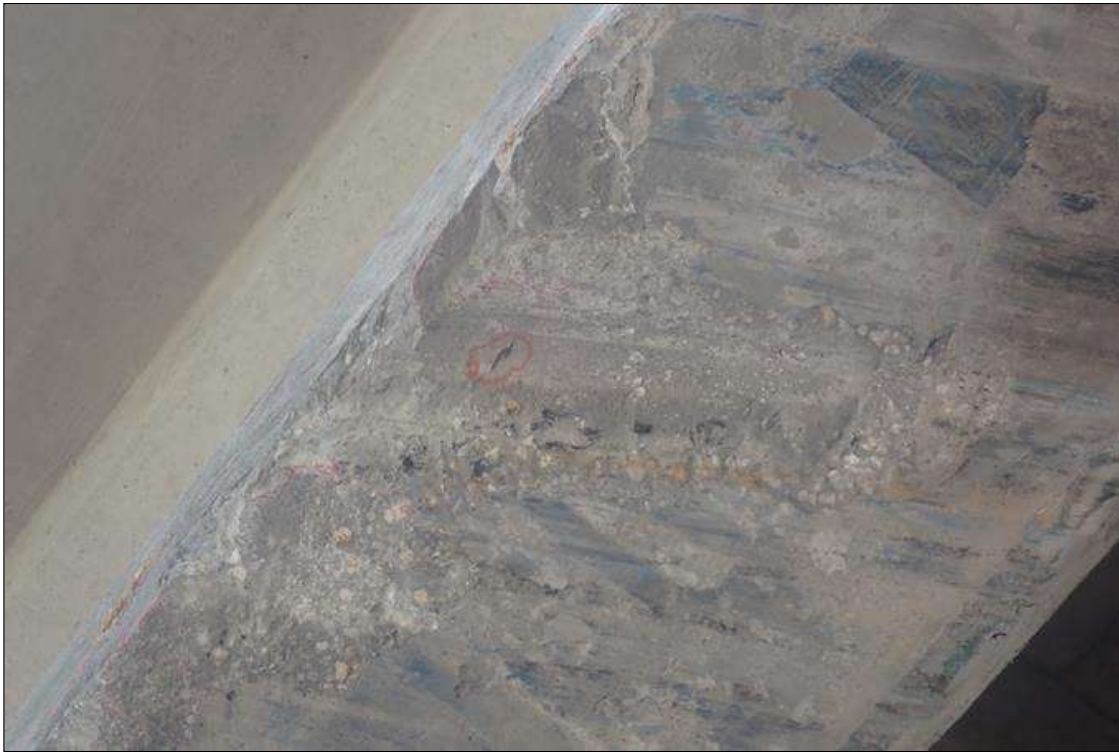
Span 3 Beam 4: (PAR) 8 INCHES X 8 INCHES X 1 INCH DEEP SPALL DUE TO IMPACT ON EAST SIDE OF BOTTOM FLANGE OVER left southbound TRAVEL LANE ADJACENT TO SOUND PATCH - 02/16/2023 - IMPACT DAMAGE - LOCATED 14 FEET 8 INCHES FROM BENT 3 OVER LEFT TRAVEL LANE - DIMENSIONS ARE 1-1/2 FEET X 8 INCHES HIGH X 1-1/2 INCHES DEEP WITH ONE (1) STRAND OF EXPOSED REBAR SHOWING ON BOTTOM OF GIRDER - 07/07/2023 defect is over right southbound lane; no apparent change from supplemental inspection

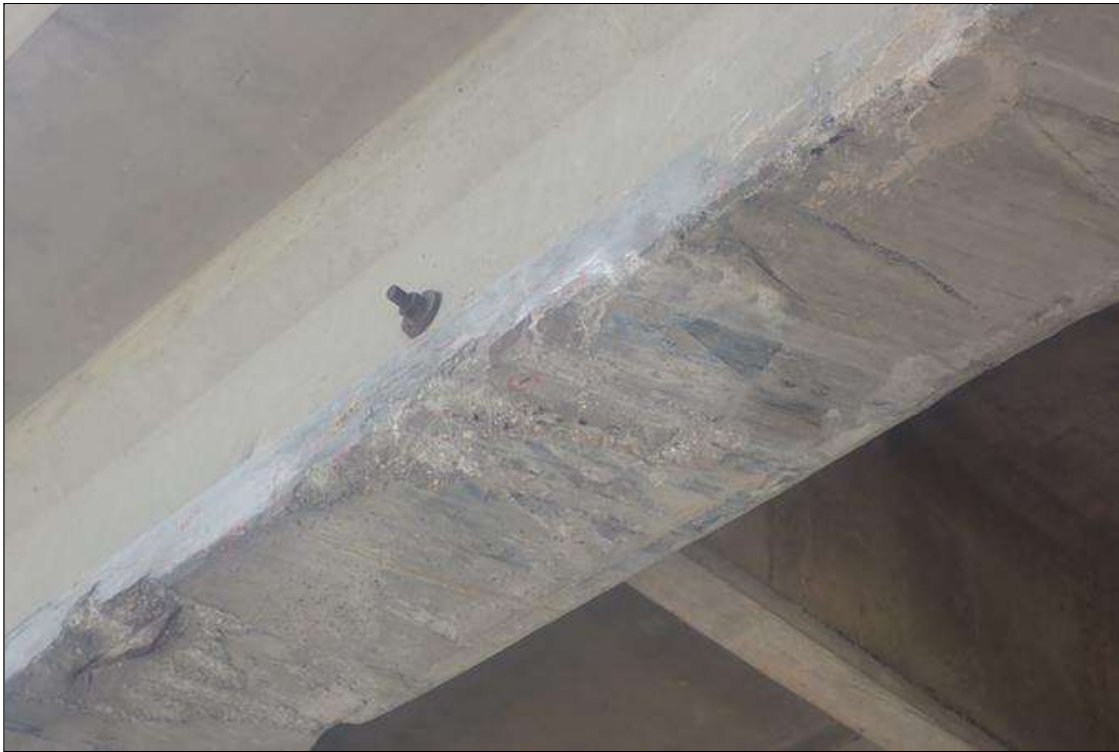
Span 3 Beam 4: (PAR) 08/18/2022 - IMPACT DAMAGE TO BEAM 4; EIGHT (8) FOOT LONG X FOURTEEN (14) INCHES HIGH X NINE (9) INCH DEEP SPALL WITH EIGHT (8) STEEL BRAIDED TENSION CABLES EXPOSED. TWO (2) BRAIDED STEEL TENSION CABLES COMPLETELY SEVERED AND SIX (6) CABLES WITH TWO (2) REMAINING TENSION CABLE STRANDS REMAINING INTACT. LOOSE CONCRETE PRESENT WITHIN TENSION CABLES EXPOSED. 02/16/2023- IMPACT DAMAGE - BEGINS 13 FEET 8 INCHES FROM BENT 3 ; EXTENDS 10 FEET ALONG BOTTOM FLANGE AREA- DIMENSIONS ARE 2 FEET 8 INCHES LONG X 22 INCHES WIDE X 3-1/2 INCHES DEEP ON NORTH EDGE OF GIRDER 4; 07/07/2023 damage on right edge of bottom flange; no apparent change since supplemental inspection

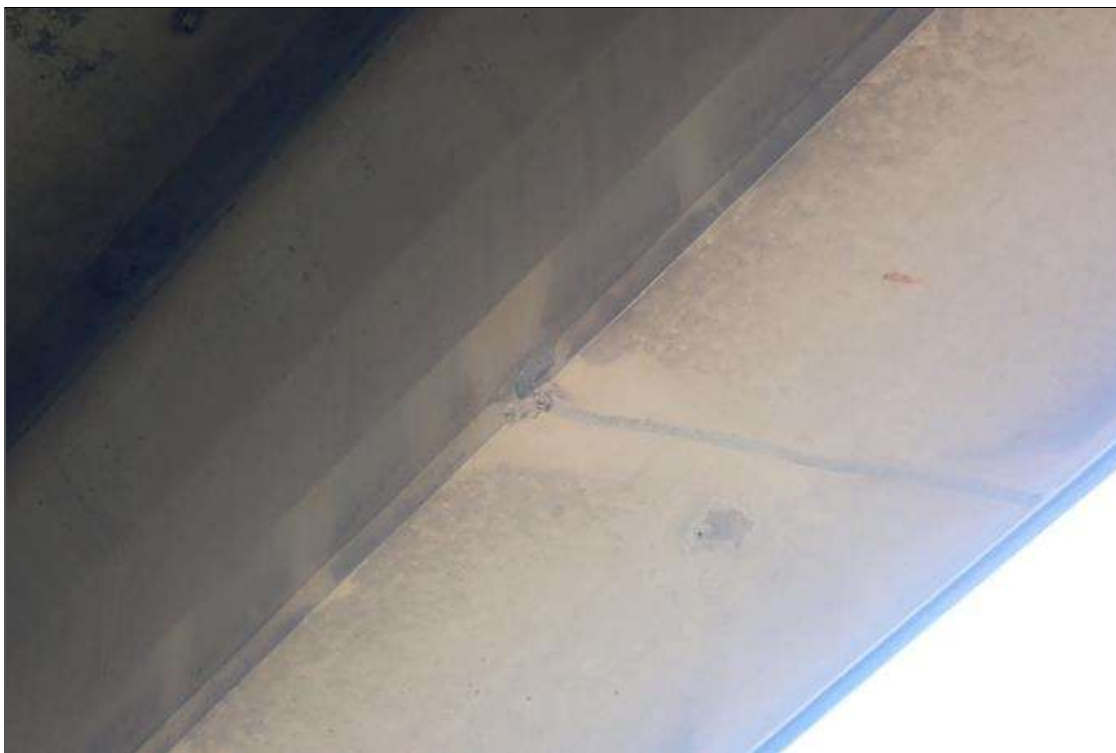
Span 2 Beam 1: CHIPPED AREA ALONG BOTTOM EDGES OF FLANGE UP TO 3 INCH X 3 INCH X 1/2 INCH DEEP FROM IMPACT DAMAGE AT MIDSPAN.

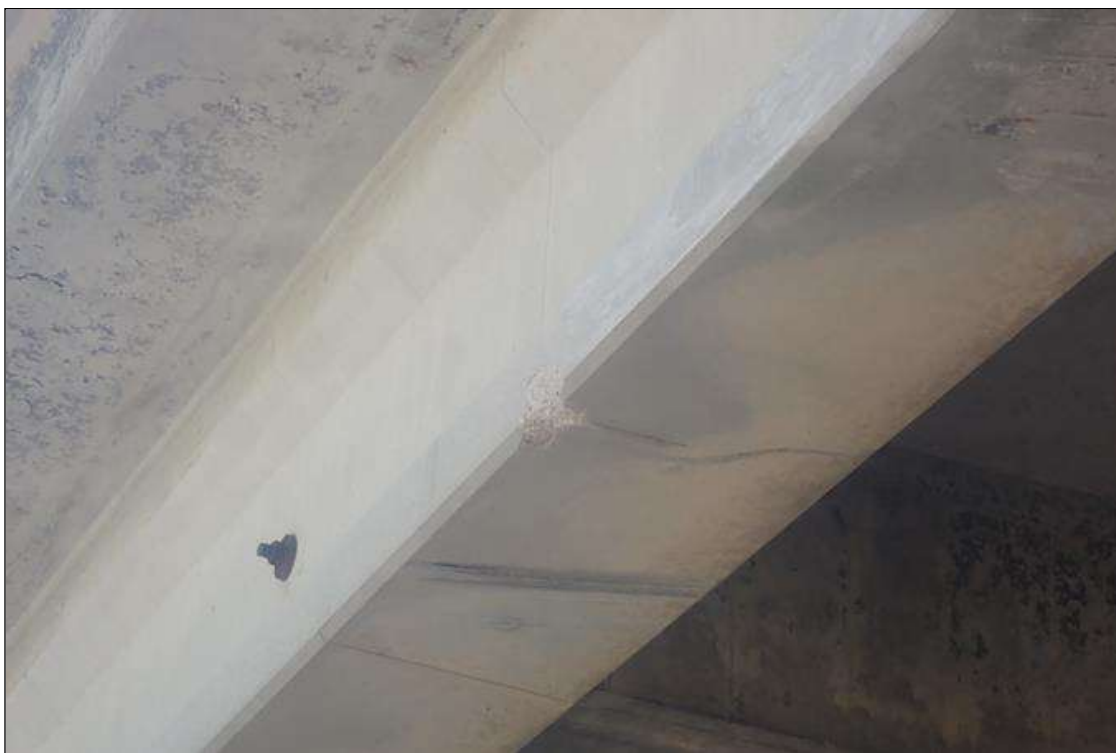
Span 2 Beam 4: 2 CHIPPED AREAS ALONG BOTTOM EDGES OF FLANGE UP TO 6 INCH X 6 INCH X 3/4 INCH DEEP FROM IMPACT DAMAGE AT MIDSPAN.

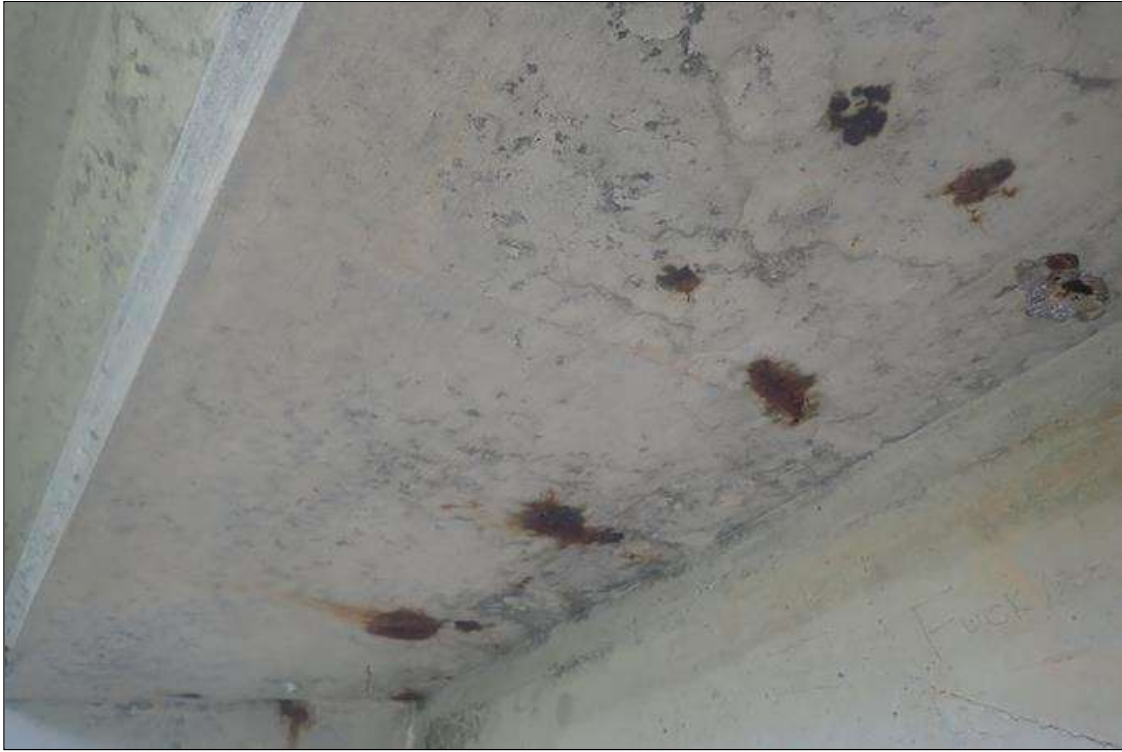
Span 1 Deck: (PAR) underside, at random, areas of transverse/map cracks (hairline) with rust stains
