NC DEPARTMENT OF TRANSPORTATION  
 DIVISION OF HIGHWAYS  
 STRUCTURE MANAGEMENT UNIT

ATTENTION: **prompt action request, sketches revised, lateral clearances revised**

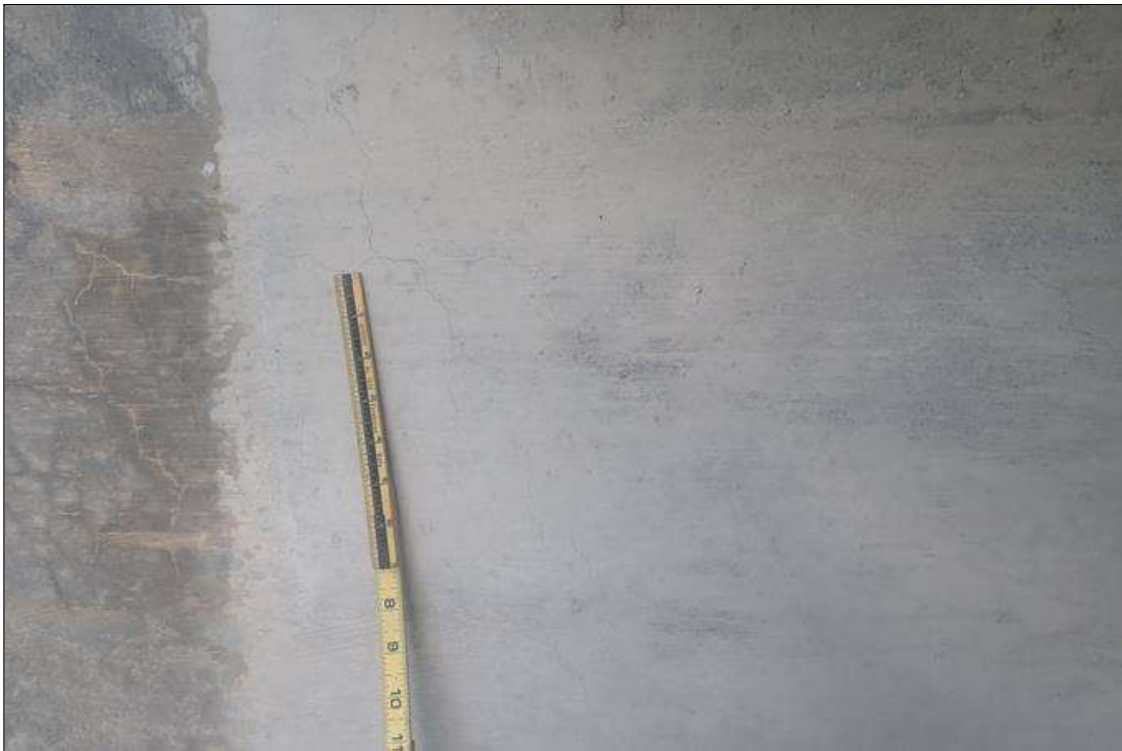
End Bent 1 Abutment: Area of hairline map cracks (4 feet x 2 feet) at east end of abutment

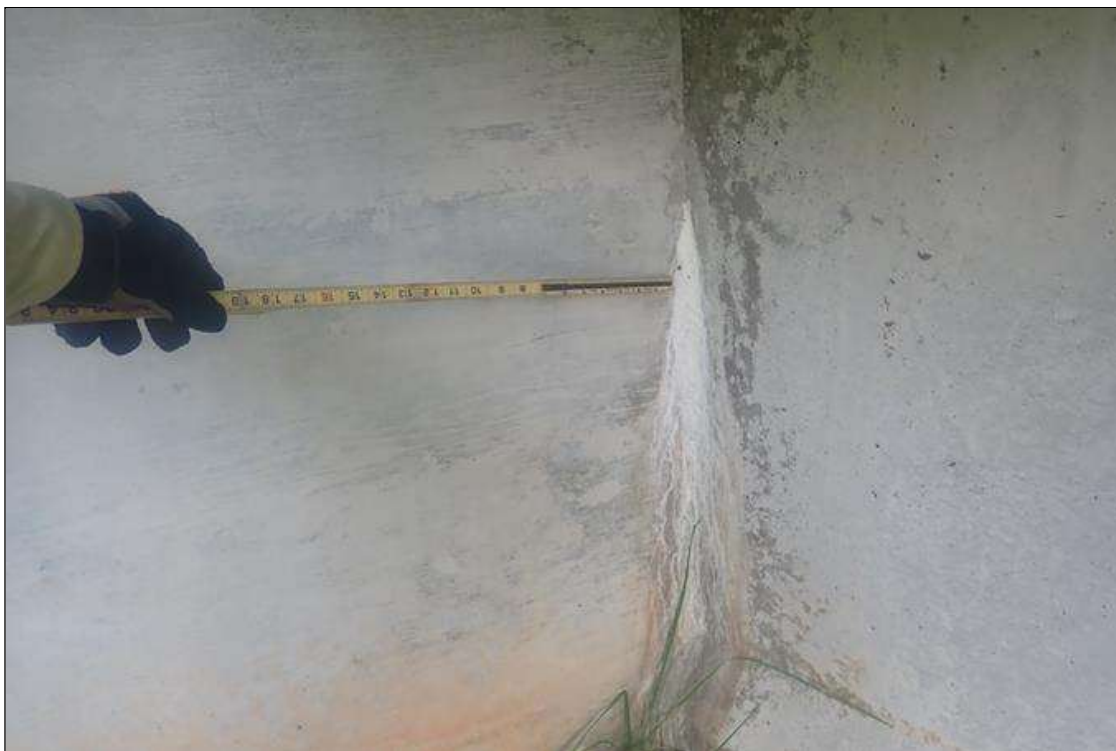
End Bent 1 Abutment: (PAR) right end, at beam 4 web, efflorescence buildup

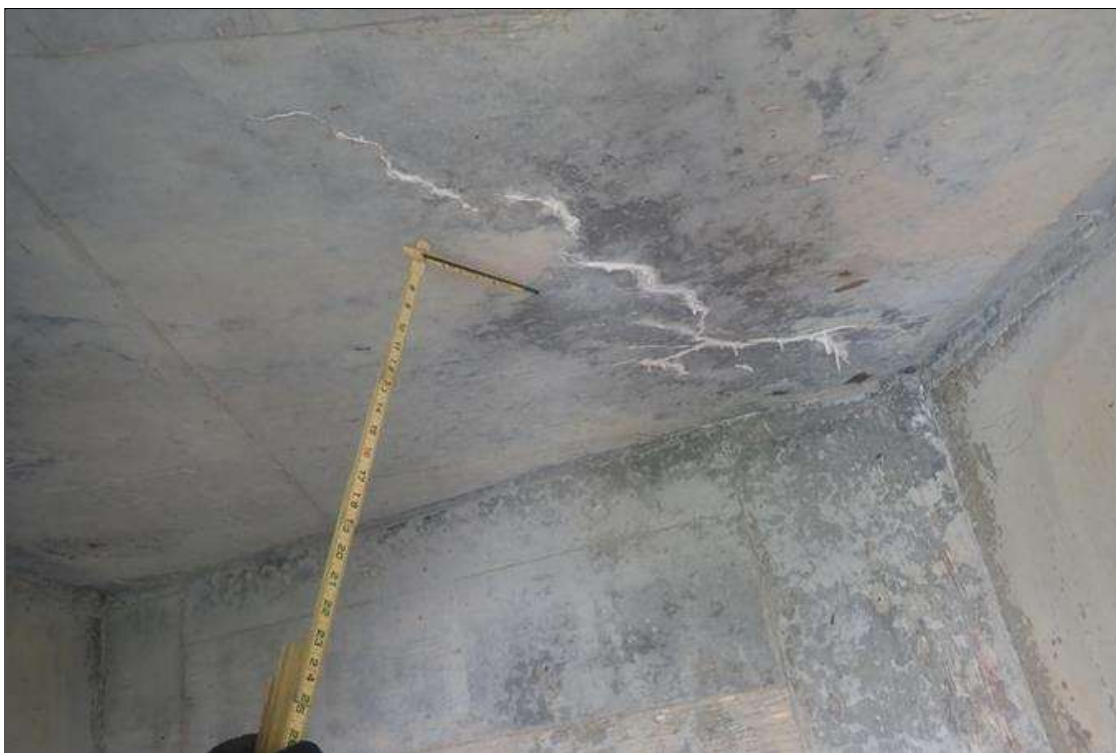
Span 1 Deck: (PAR) underside, bay 3, at end bent 1, diagonal crack (hairline x 5 feet) with efflorescence buildup

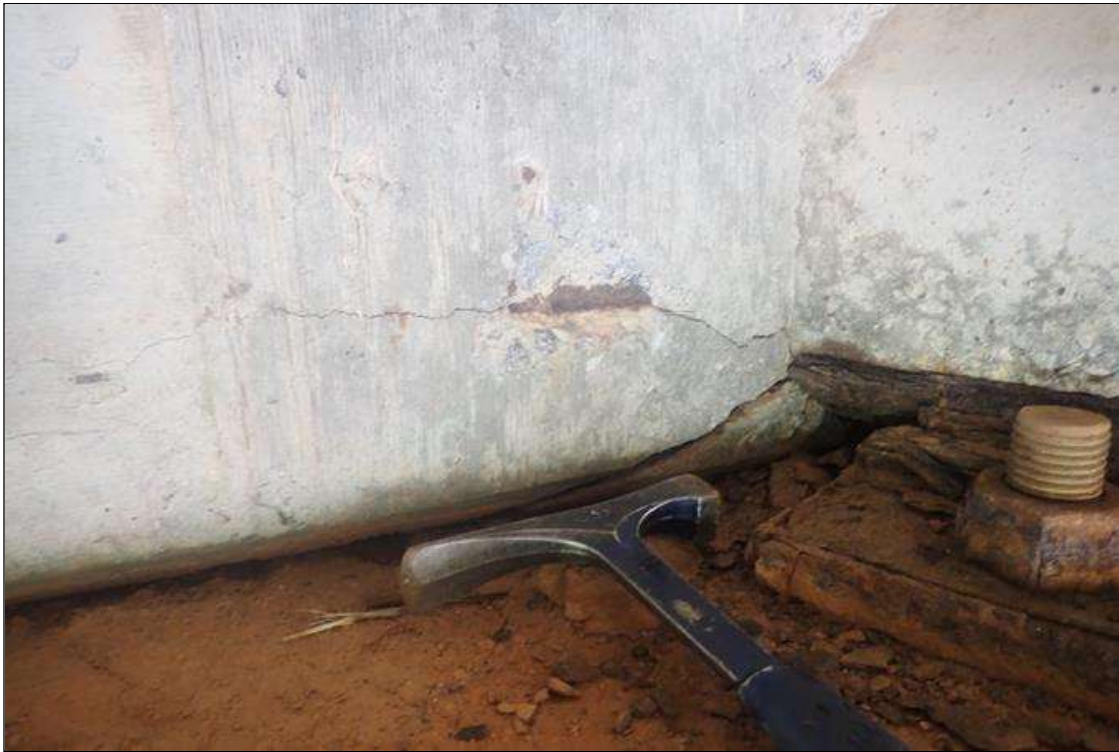
End Bent 1 Abutment: 4 inch long x 3 inch high x 1 inch deep spall with exposed rebar at right side of beam 2

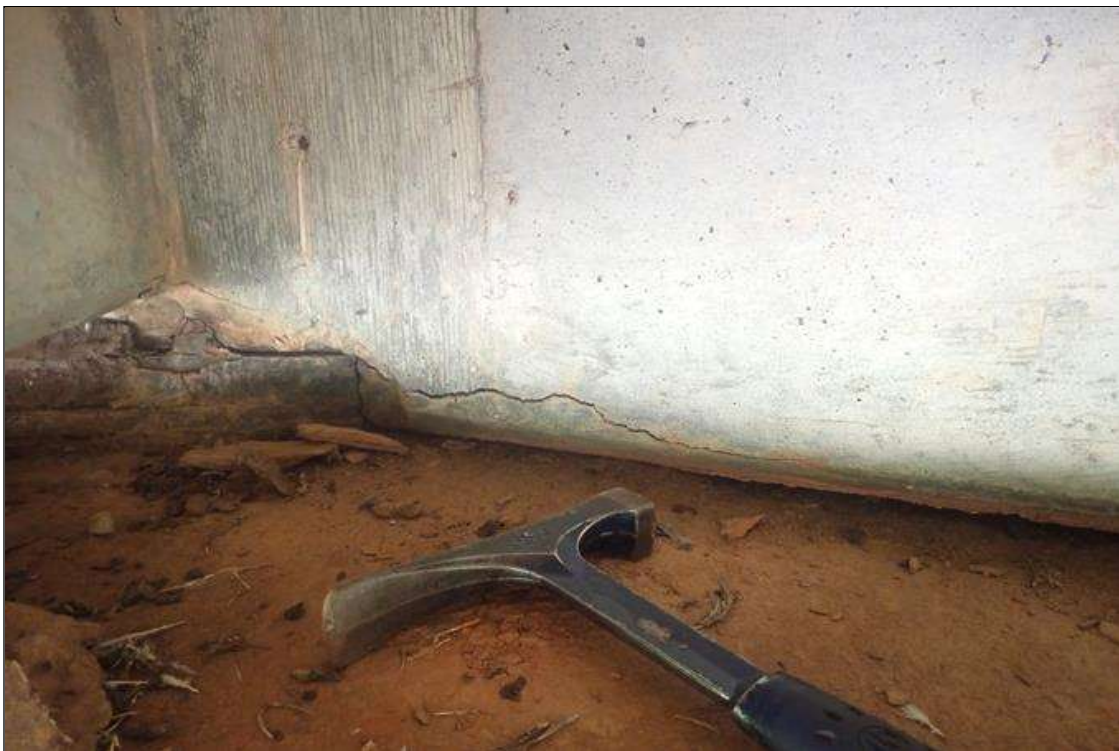
End Bent 1 Abutment: 1/16 inch horizontal cracks up to 1 foot long, some with efflorescence, starting at bottom corner of beams all bays

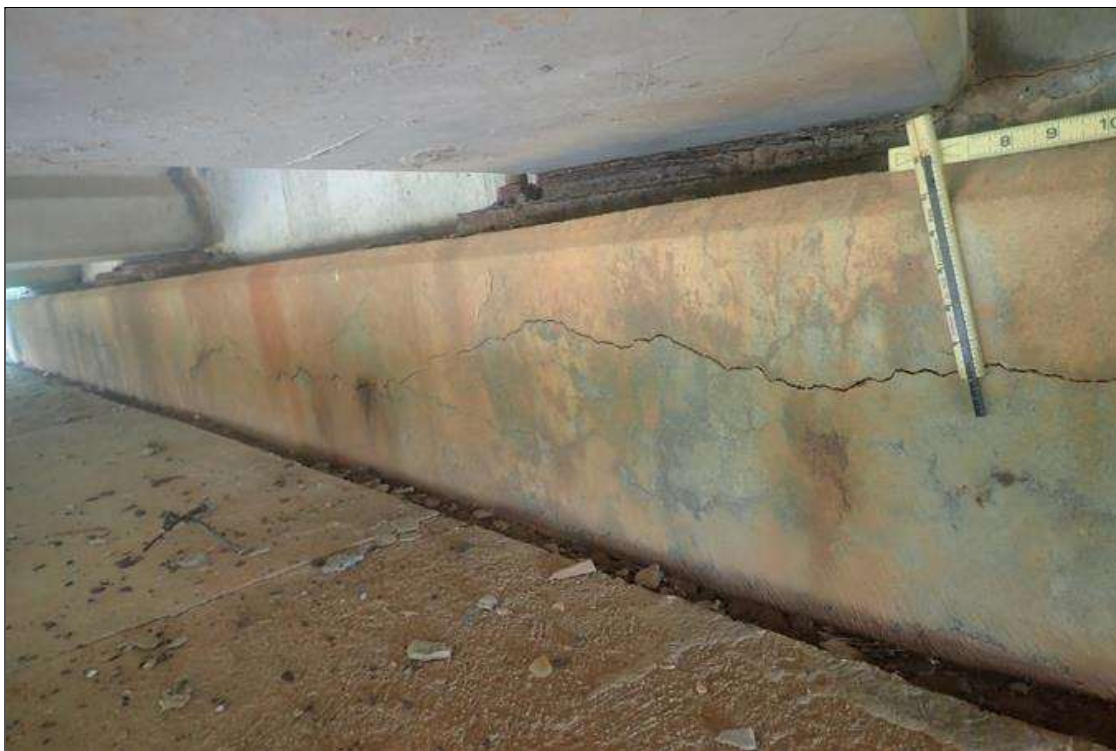
End Bent 1 Cap 1: (PAR) HORIZONTAL CRACK UP TO 3/16 INCH WITH DELAMINATION AND RUST STAINS ALONG FACE FOR FULL LENGTH

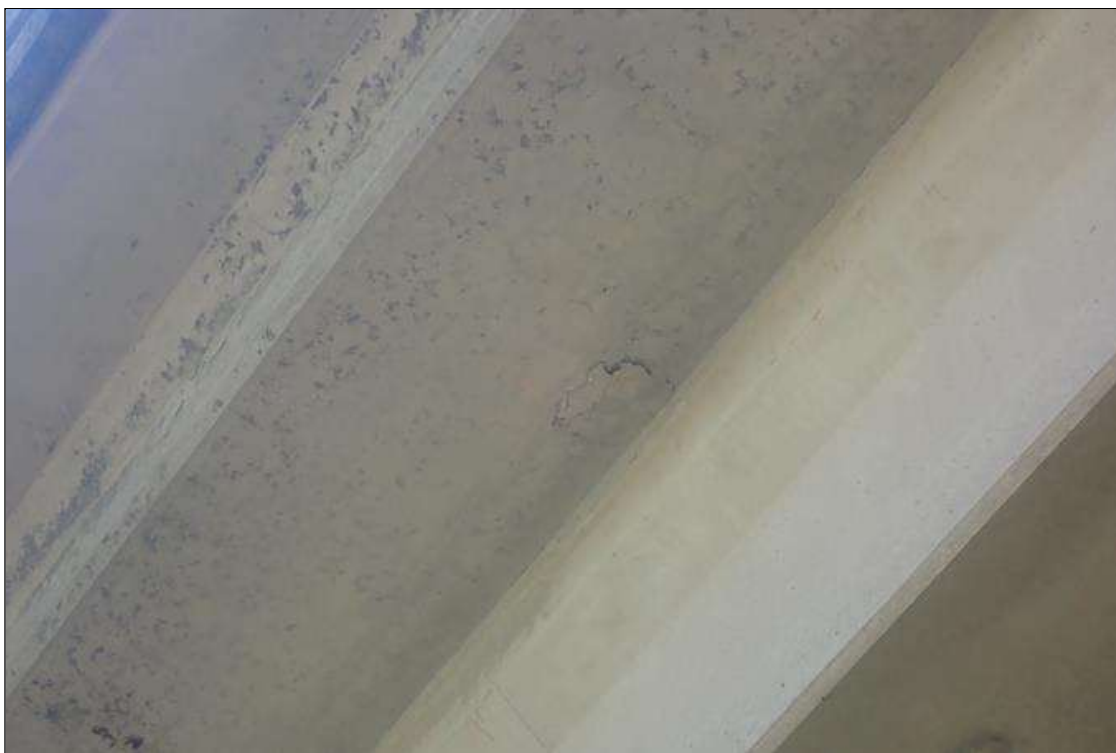
Span 1 Deck: underside, right overhang, midspan, delamination (6 inch diameter)

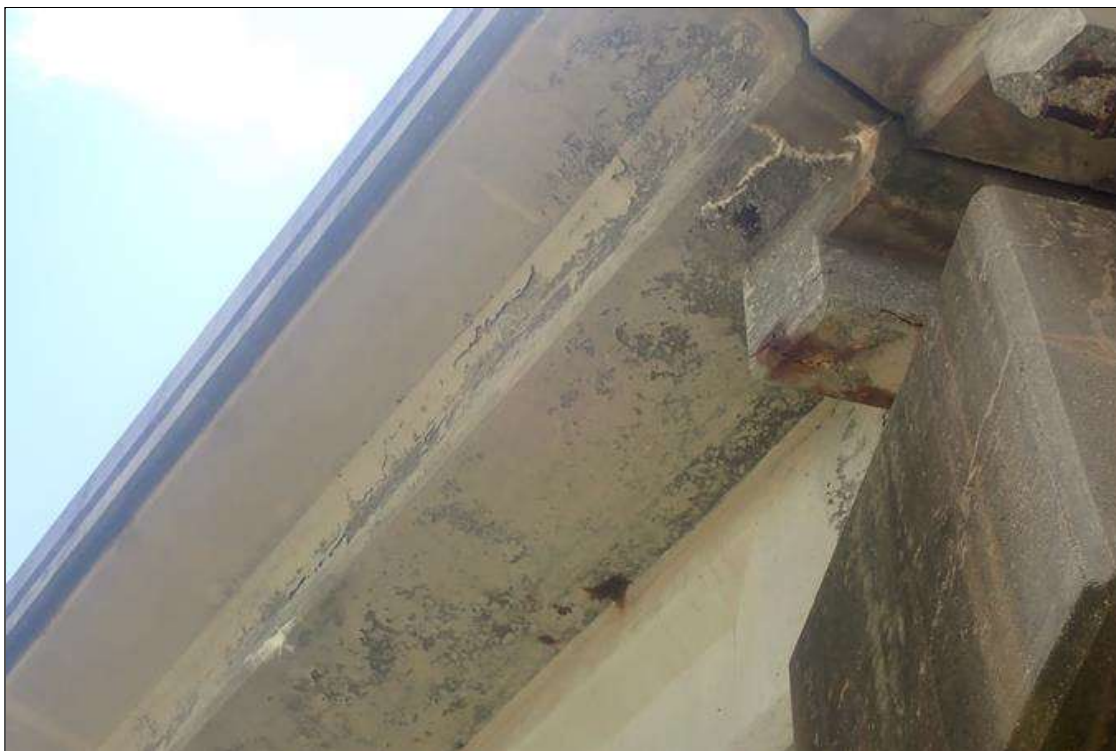
Span 2 Deck: (PAR) right overhang, near bent 2, (3) longitudinal/transverse cracks (hairline x 12 inch) with efflorescence buildup

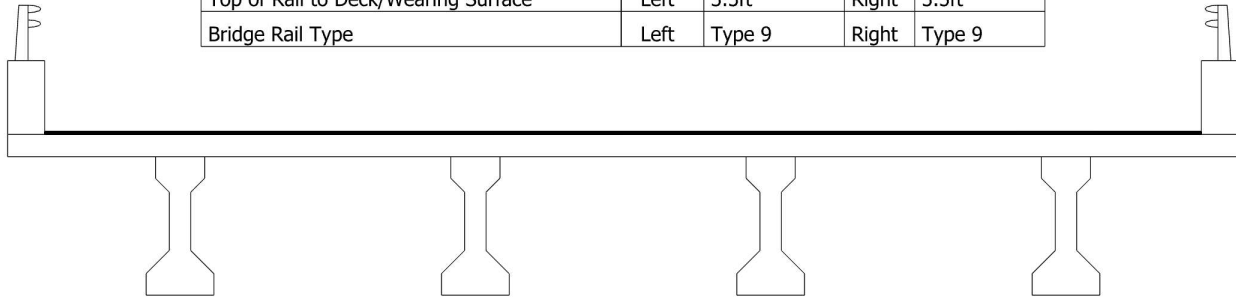
Measurements for Span #	1		
Deck Thickness	7.25in	Left Overhang	4.667ft
Top of Rail to Bottom of Beam (Avg)	7.854ft	Right Overhang	4.667ft

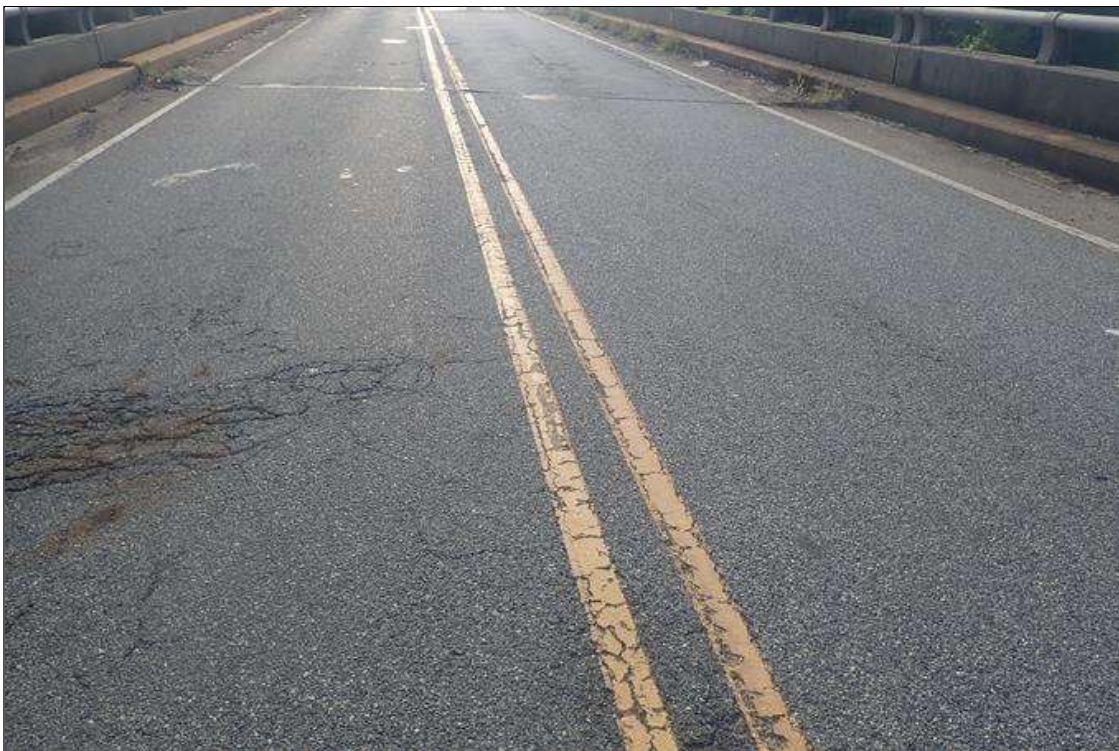
asphalt wearing surface
