# Structure Safety Report

## Routine Element Inspection

COUNTY: HAYWOOD STRUCTURE NUMBER: 430249 FREQUENCY: 24 MONTHS

FACILITY CARRIED: I40 WB MILE POST: 33

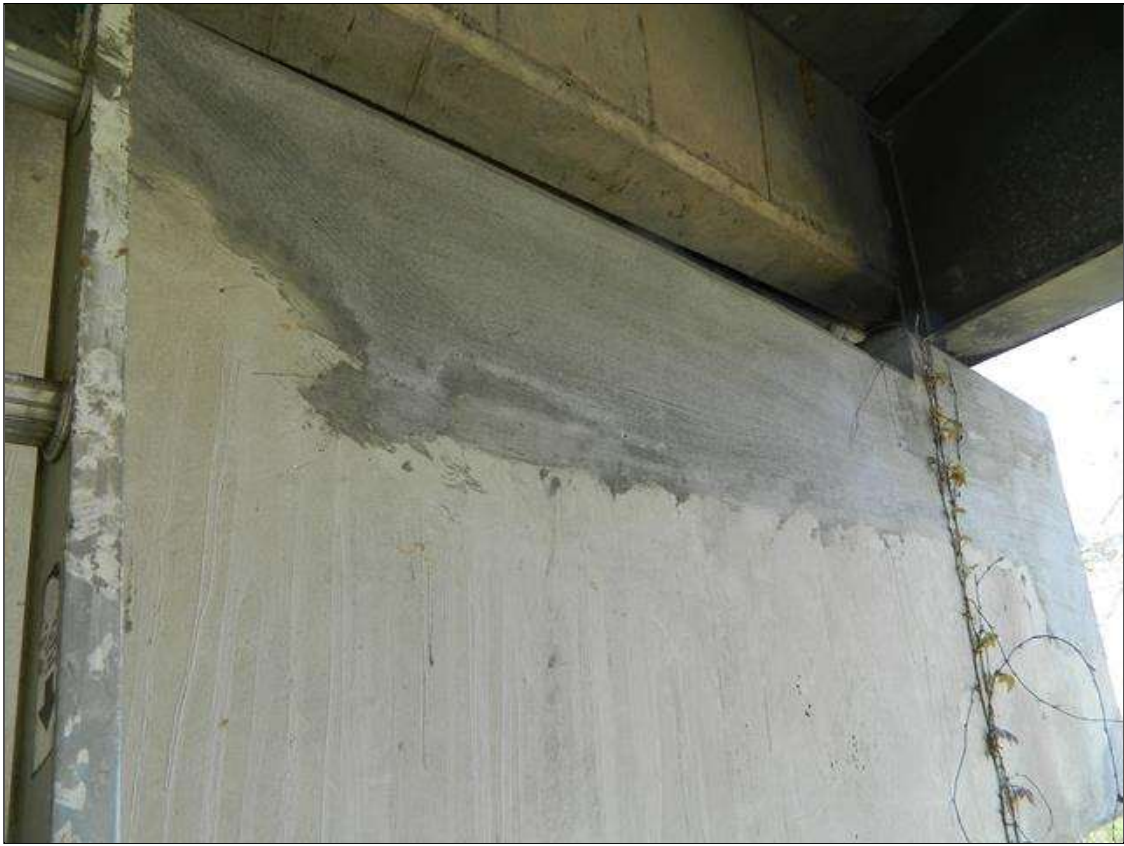
Element Number	Defect Type	Defect Description	CS	CS Qty	Maint Qty
234	Patched Area	MULTIPLE PATCHED AREAS THAT ARE SOUND.	2	14	Feet

Bent 1 Cap 1: MULTIPLE PATCHED AREAS THAT ARE SOUND.

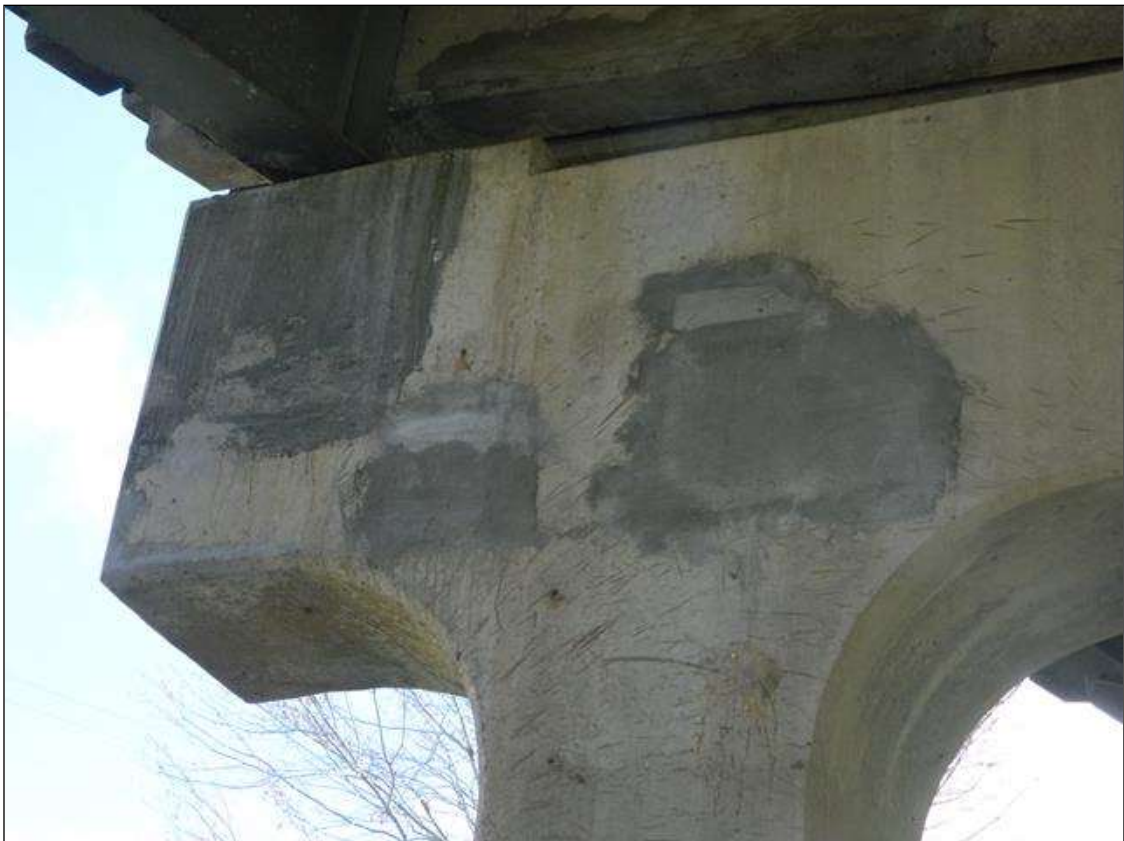
Element Number	Defect Type	Defect Description	CS	CS Qty	Maint Qty
234	Patched Area	MULTIPLE SOUND PATCHES.	2	14	Feet

Bent 2 Cap 1: MULTIPLE SOUND PATCHED AREAS

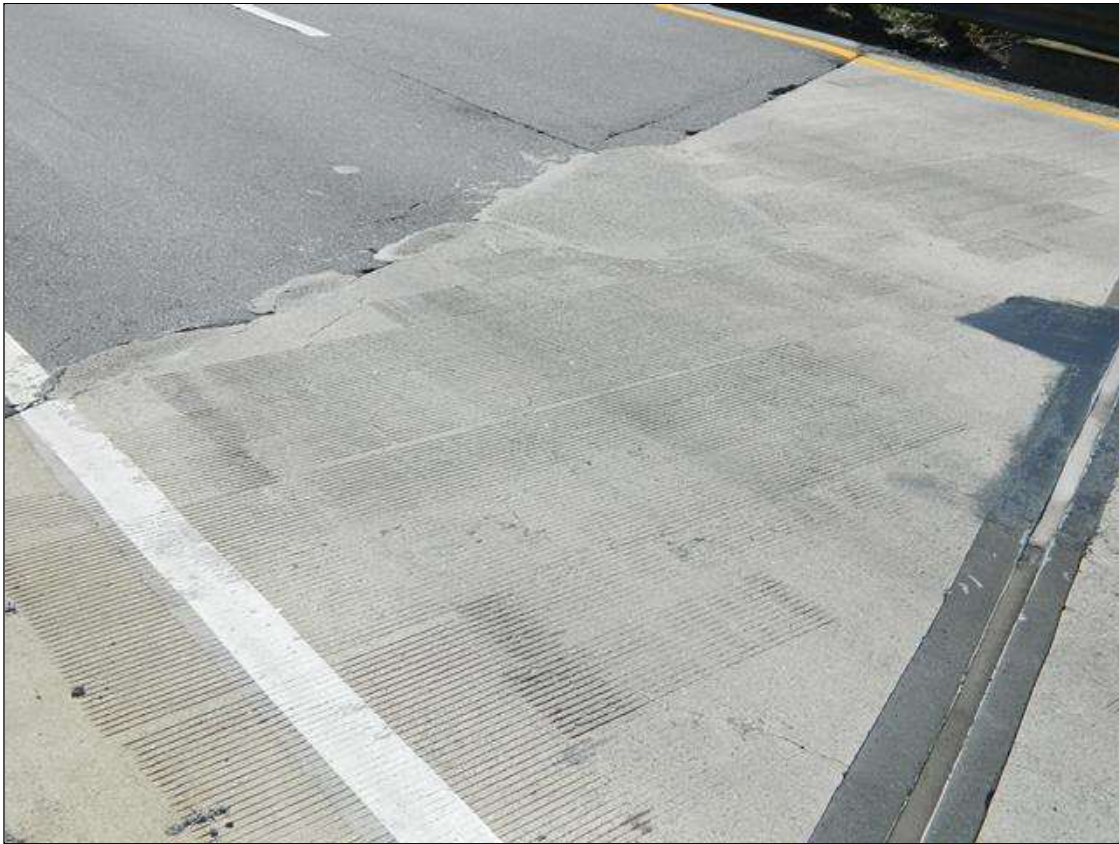
Element Number	Defect Type	Defect Description	CS	CS Qty	Maint Qty
321	Cracking (RC and Other)	DIAGONAL AND LONGITUDINAL CRACKS THROUGHOUT	2	75	75 Square Feet
321	Patched Area	SOUND PATHCES ALONG THE EDGE OF THE SLAB.	2	20	Square Feet

Approach 2: DIAGONAL AND LONGITUDINAL CRACKS THROUGHOUT

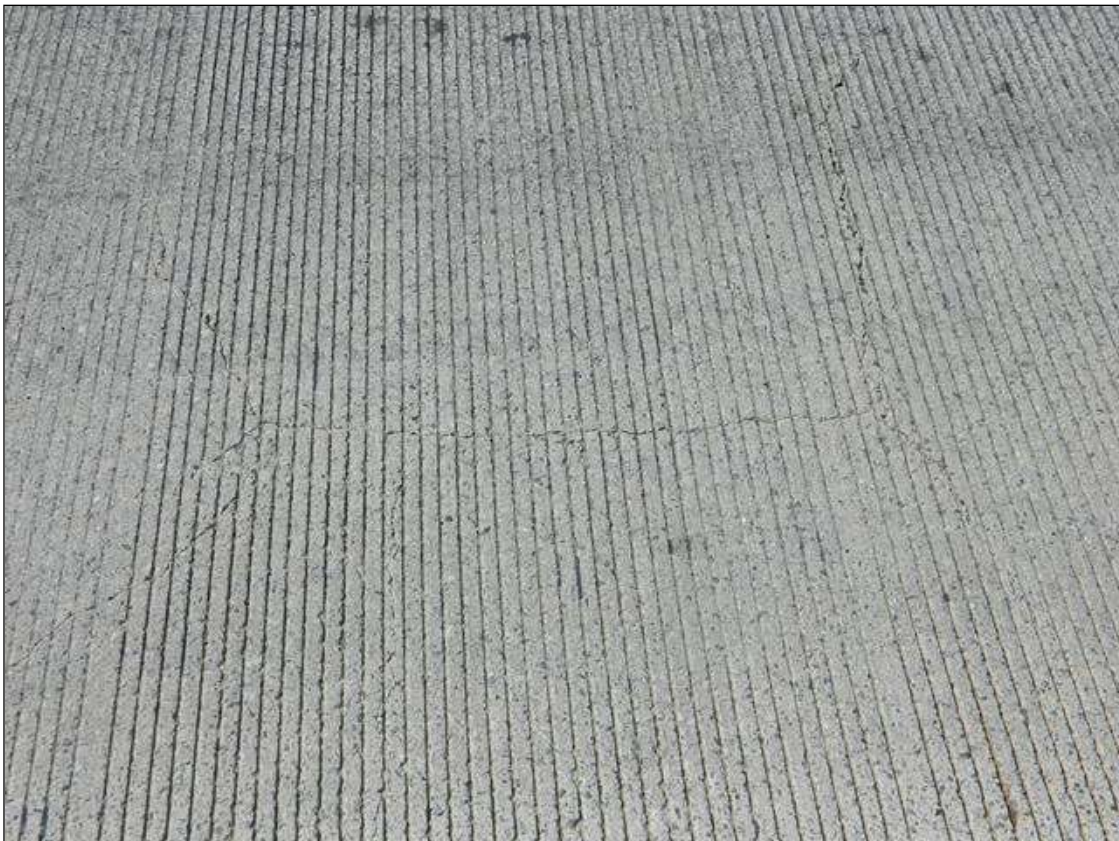
Element Number	Defect Type	Defect Description	CS	CS Qty	Maint Qty
510	Crack (Wearing Surface)	MULTIPLE HAIRLINE CRACKS SCATTERED THROUGHOUT THE WEARING SURFACE.	2	400	400 Square Feet

Span 3 Wearing Surface: MULTIPLE HAIRLINE CRACKS SCATTERED THROUGHOUT THE WEARING SURFACE.

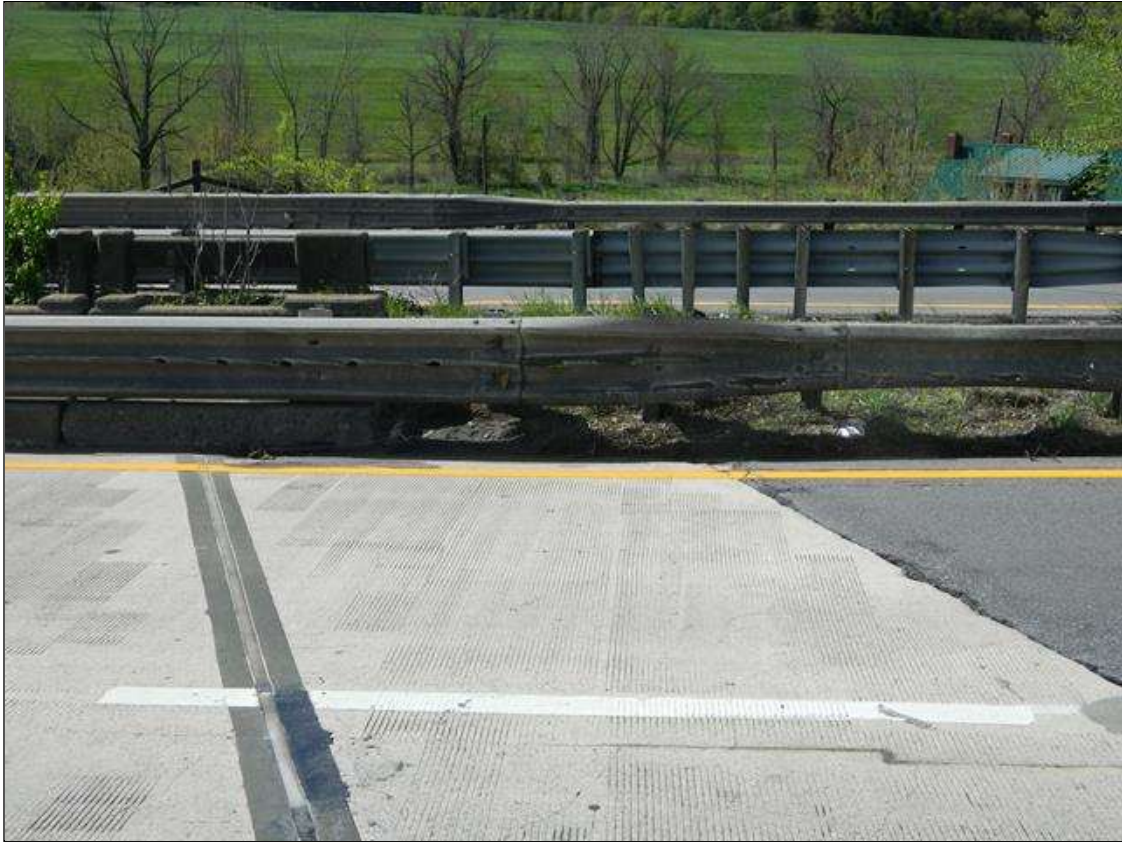
Element Number	Defect Type	Defect Description	CS	CS Qty	Maint Qty	
333	Damage	14' LONG SCRAPE DAMAGE AT THE NEAR END OF THE SPAN.	2	14	14	Feet
515	Effectiveness (Steel Protective Coatings)	PROTECTIVE SYSTEM IS DAMAGED FROM THE SCRAPE DAMAGE.	2	14	14	Square Feet

Span 1 Right Bridge Rail: 14' LONG SCRAPE DAMAGE AT THE NEAR END OF THE SPAN.

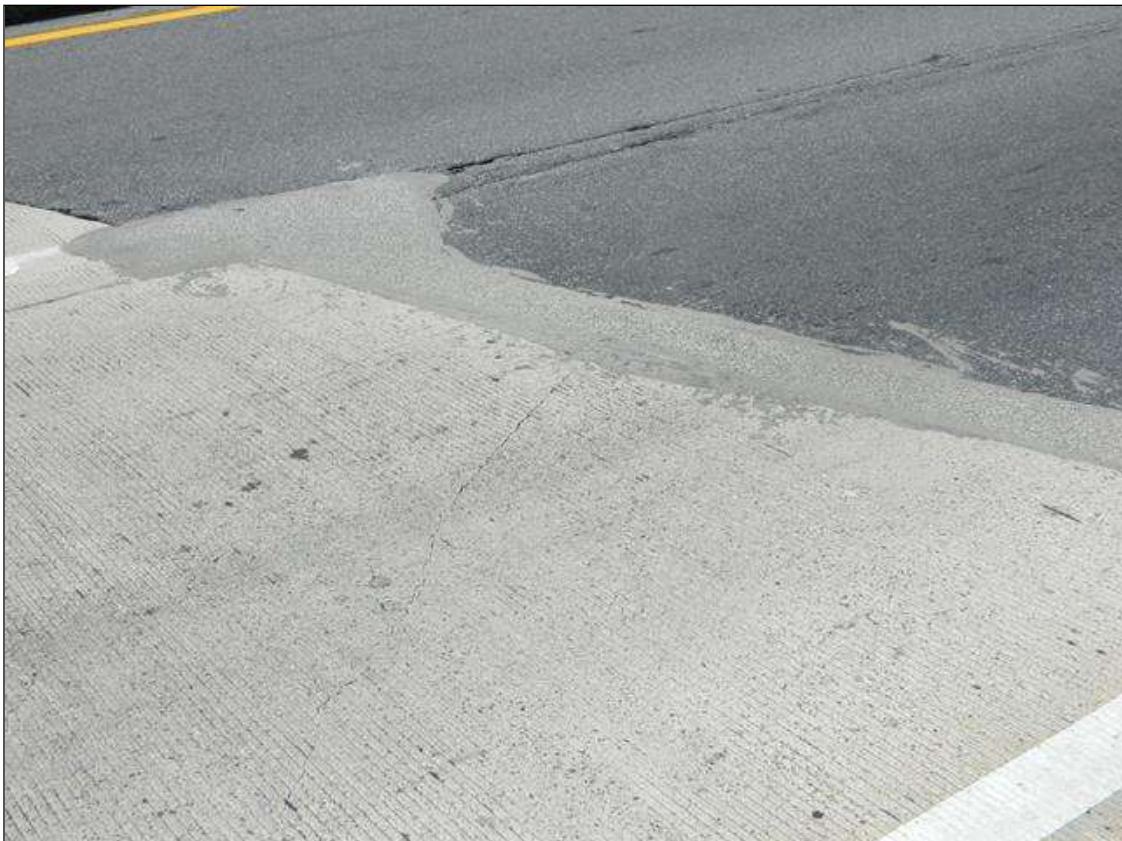
Element Number	Defect Type	Defect Description	CS	CS Qty	Maint Qty
321	Cracking (RC and Other)	MULTIPLE HAIRLINE CRACKS THROUGHOUT THE SLAB.	2	50	50 Square Feet
321	Patched Area	SOUND PATCHES ALONG THE EDGE OF THE SLAB	2	20	Square Feet

Approach 1: SOUND PATCHES ALONG THE EDGE OF THE SLAB
