NC DEPARTMENT OF TRANSPORTATION
 DIVISION OF HIGHWAYS
 STRUCTURE MANAGEMENT UNIT

ATTENTION: **PAR'S ISSUED, DATA CHANGES**

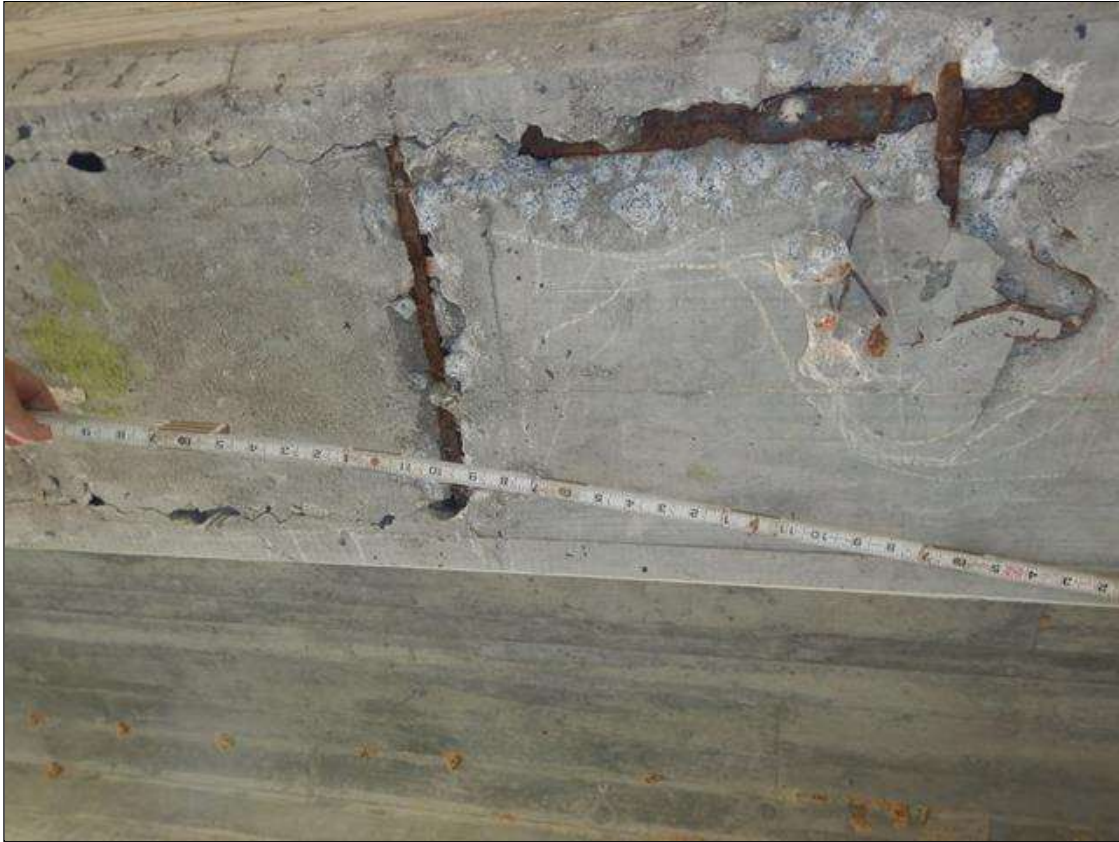
Span 10 Beam 3: PAR: 5' LONG X 18" WIDE AREA OF SPALLS WITH EXPOSED REINFORCEMENT AND UP TO 1/16" WIDE LONGITUDINAL CRACKS, STARTING 6' FROM END BENT 2 ON UNDERSIDE OF BEAM. SPALL SIZES VARY FROM 3" LONG X 6" WIDE X 1" DEEP TO 1'-6" LONG X 1' WIDE X 1 1/4" DEEP

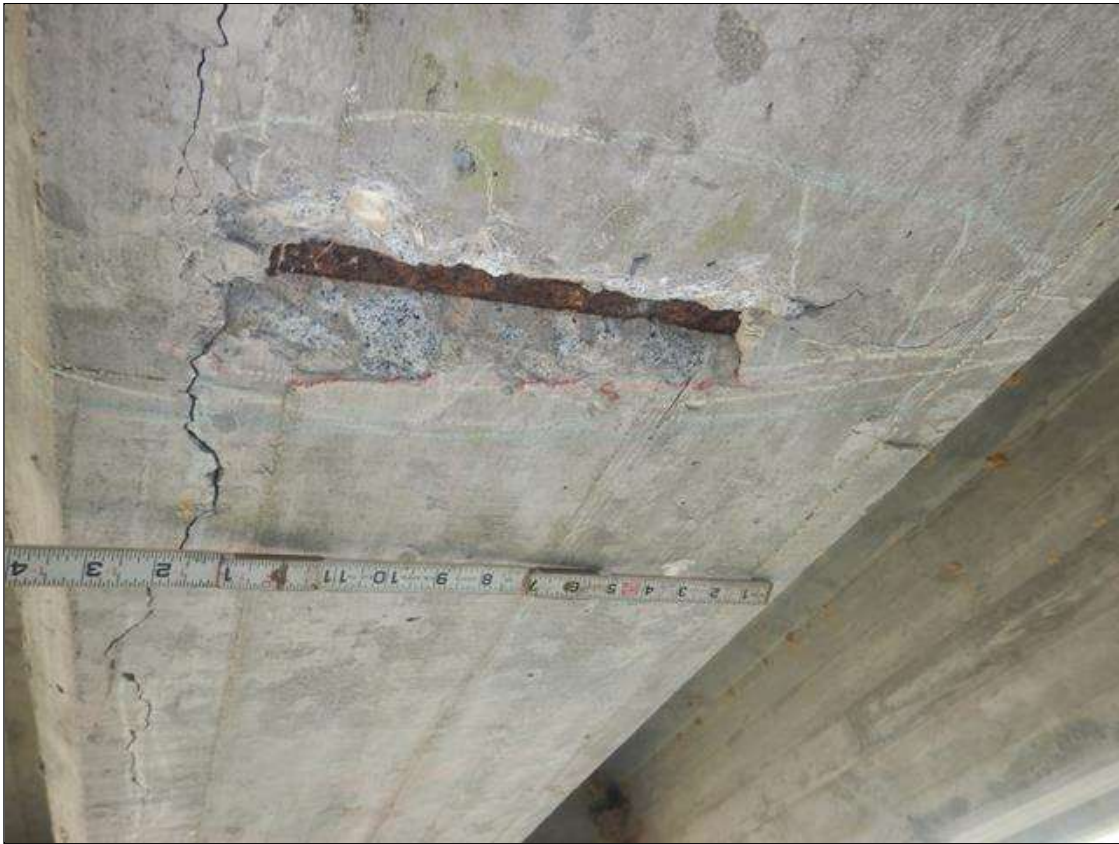
Span 10 Beam 3: PAR: 5' LONG X 18" WIDE AREA OF SPALLS WITH EXPOSED REINFORCEMENT AND UP TO 1/16" WIDE LONGITUDINAL CRACKS, STARTING 6' FROM END BENT 2 ON UNDERSIDE OF BEAM. SPALL SIZES VARY FROM 3" LONG X 6" WIDE X 1" DEEP TO 1'-6" LONG X 1' WIDE X 1 1/4" DEEP

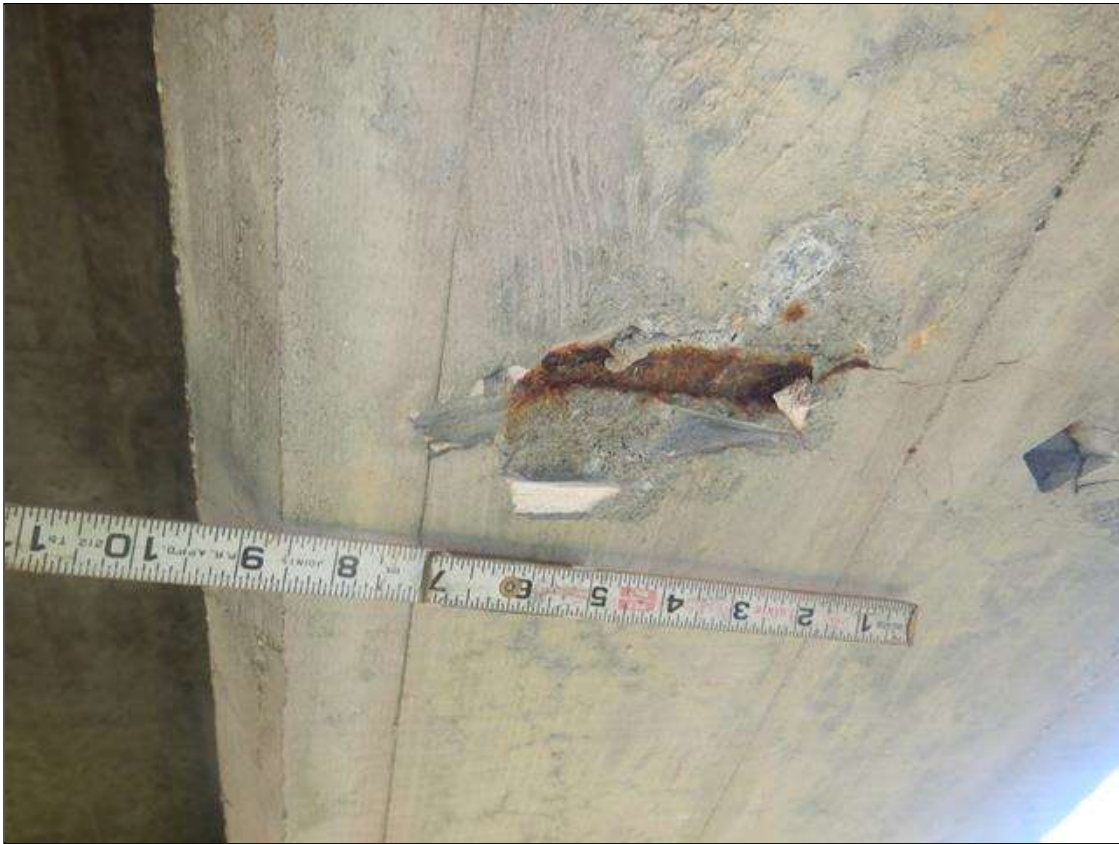
Span 10 Beam 1: 3" LONG X 4" WIDE X 1/2" DEEP SPALL WITH EXPOSED REINFORCEMENT IN BOTTOM FACE, LOCATED AT MIDSPAN. NO MEASURABLE SECTION LOSS IN EXPOSED REINFORCEMENT.

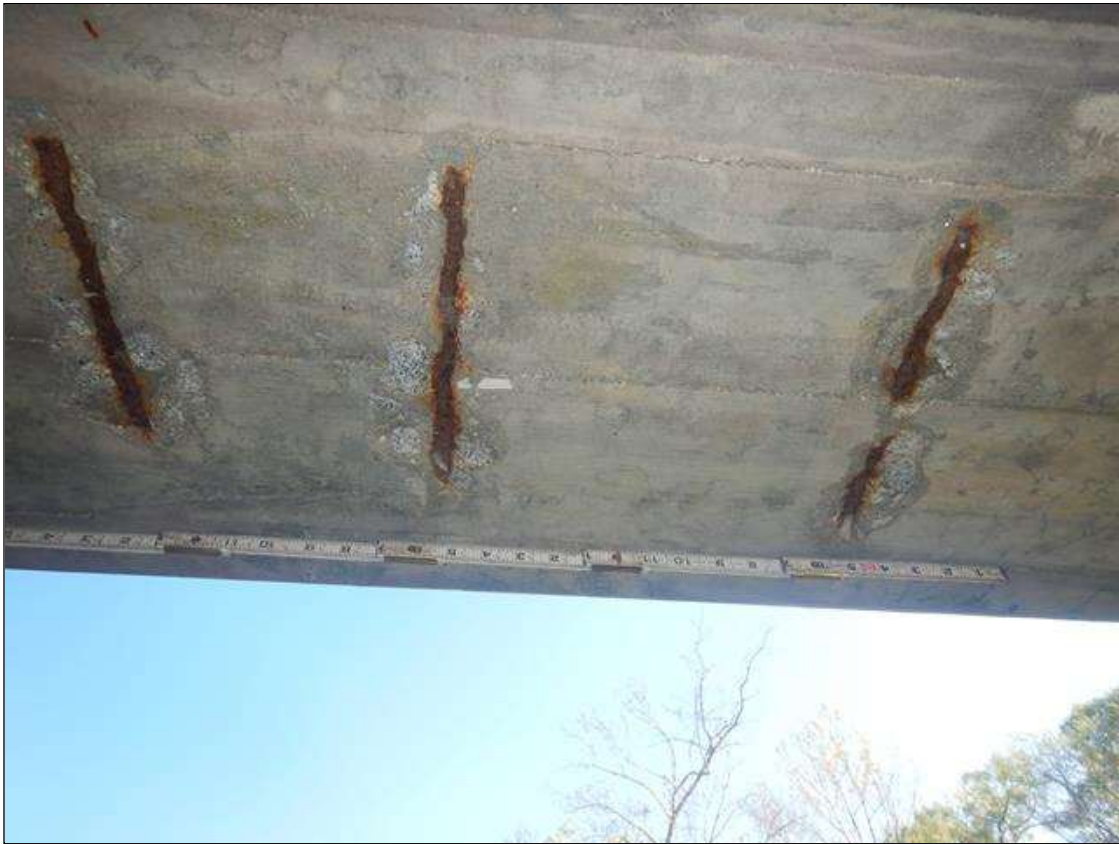
Span 10 Beam 1: THREE (3) 11" WIDE X 3" LONG X 1/2" DEEP SPALLS WITH EXPOSED REINFORCEMENT IN BOTTOM FACE, LOCATED AT 6 FT FROM BENT 9. NO MEASURABLE SECTION LOSS IN EXPOSED REINFORCEMENT.

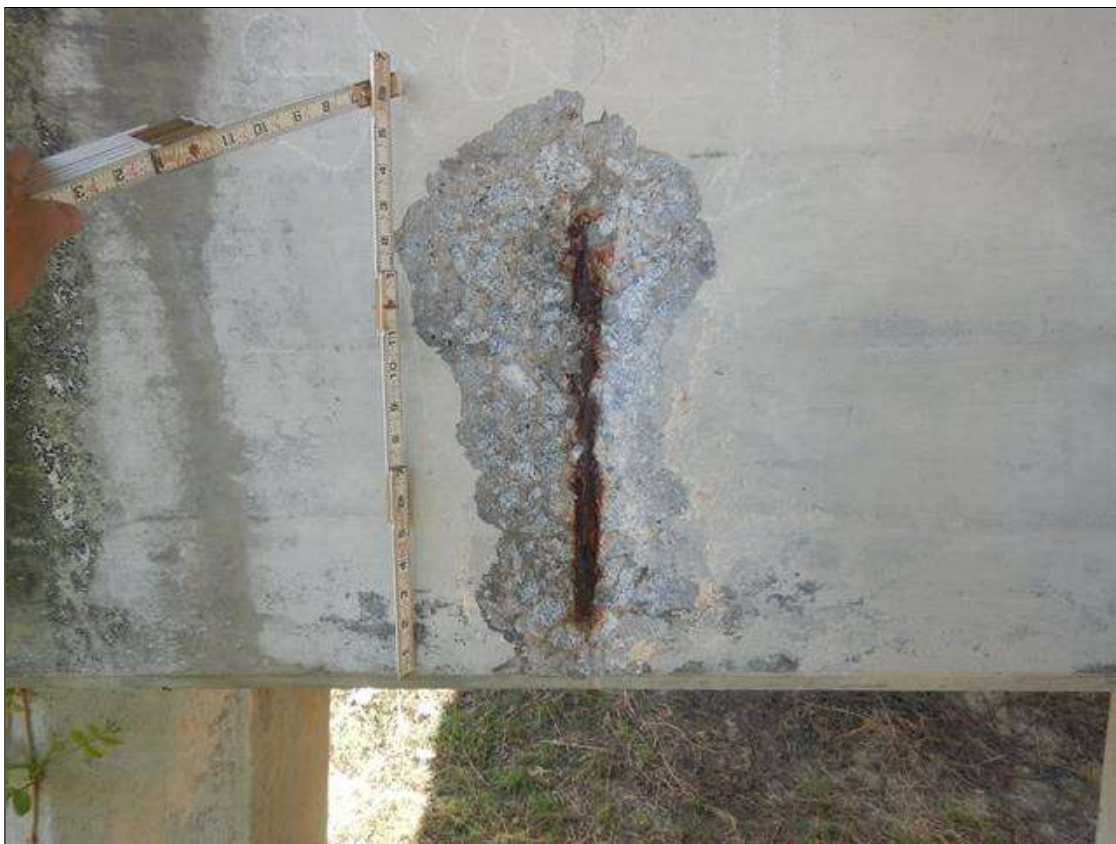
Bent 9 Cap 1: 1'-7" HIGH X 9 1/2" WIDE X 2" DEEP SPALL WITH EXPOSED REINFORCEMENT ON WEST FACE BELOW BEAM 1, NO MEASURABLE SECTION LOSS

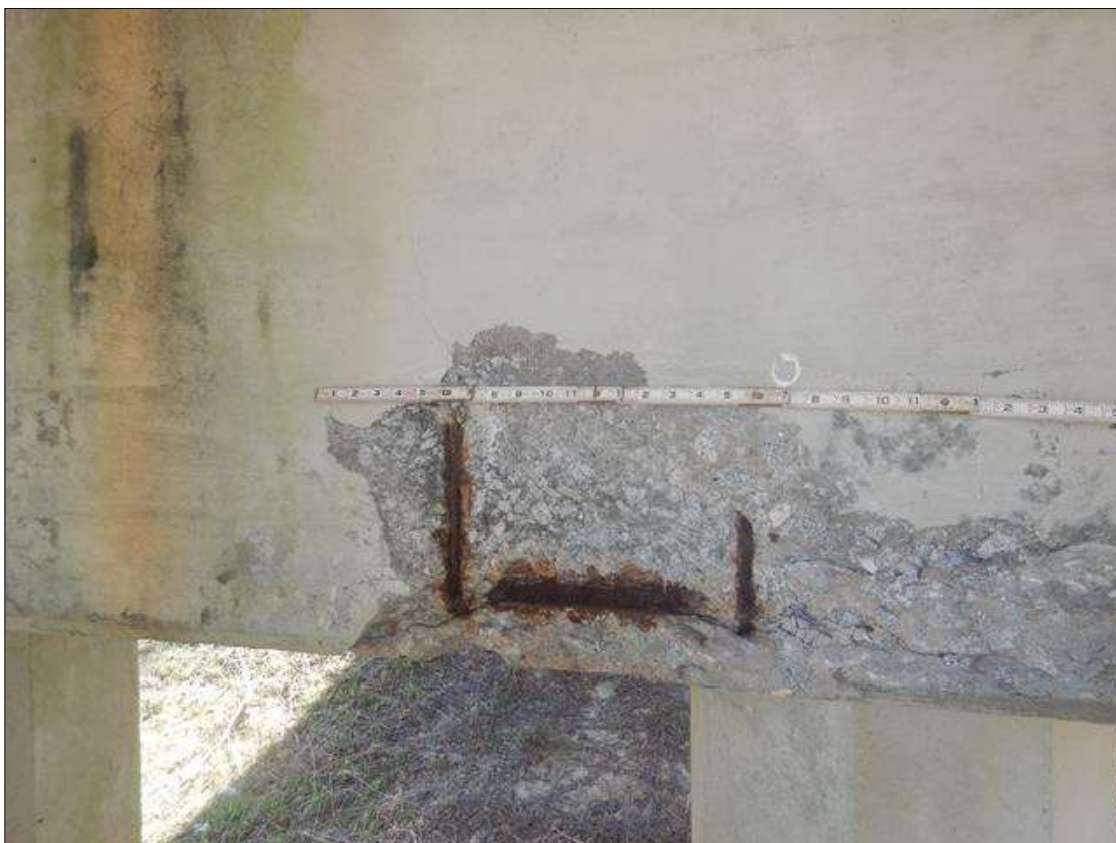
Bent 9 Cap 1: 3'-6" WIDE X 1'-2" HIGH X UP TO 3" DEEP SPALL WITH EXPOSED REINFORCEMENT ON WEST FACE ABOVE PILE 4, NO MEASURABLE SECTION LOSS

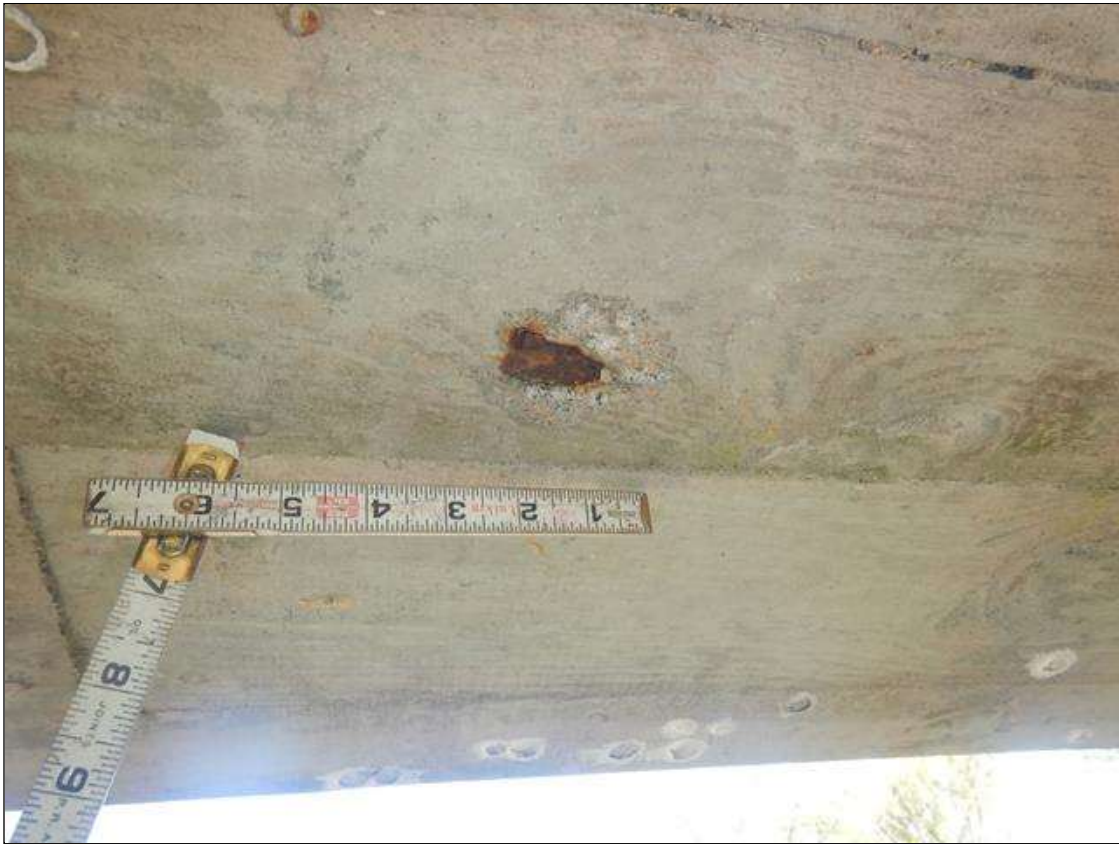
Span 9 Beam 1: 2" DIAMETER X 3/16" DEEP SPALL WITH EXPOSED REINFORCEMENT IN BOTTOM FACE, LOCATED AT 15 FT FROM BENT 9. NO MEASURABLE SECTION LOSS IN EXPOSED REINFORCEMENT.

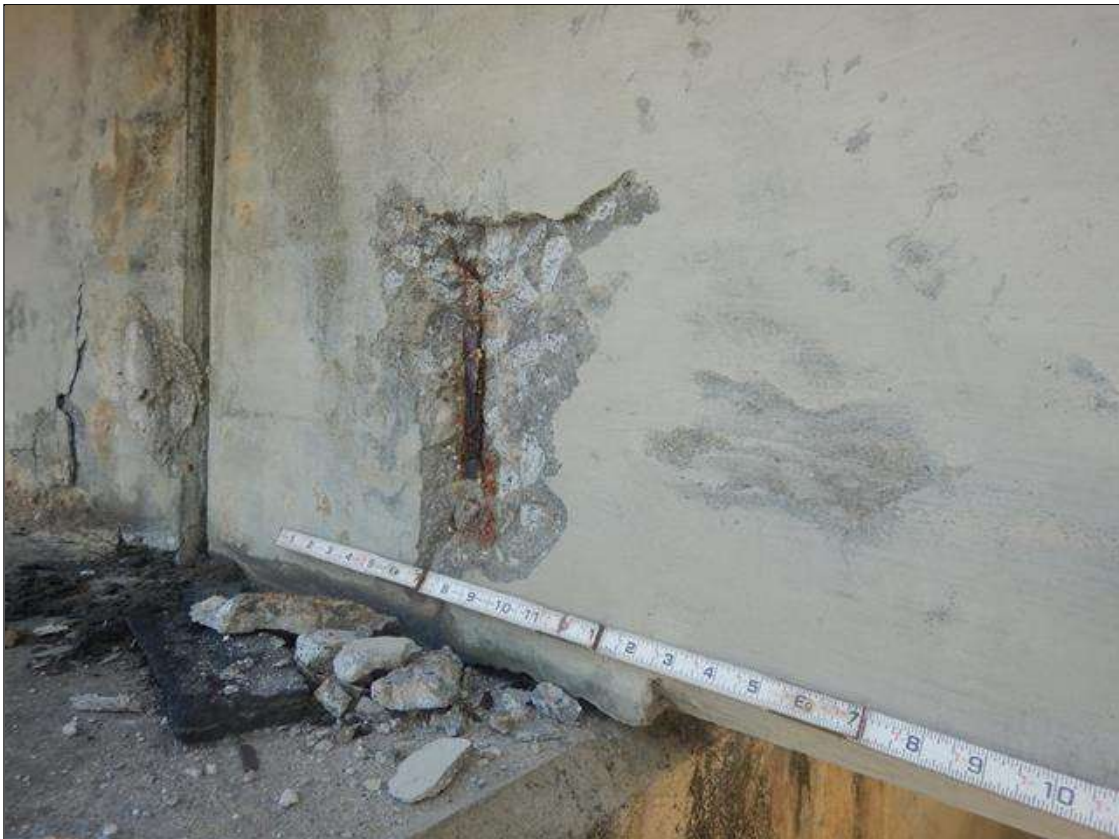
Span 9 Beam 4: 1' HIGH X 10" WIDE X 3/4 IN DEEP SPALL WITH EXPOSED REINFORCEMENT NO MEASURABLE SECTION LOSS IN SOUTH FACE AT BENT 8

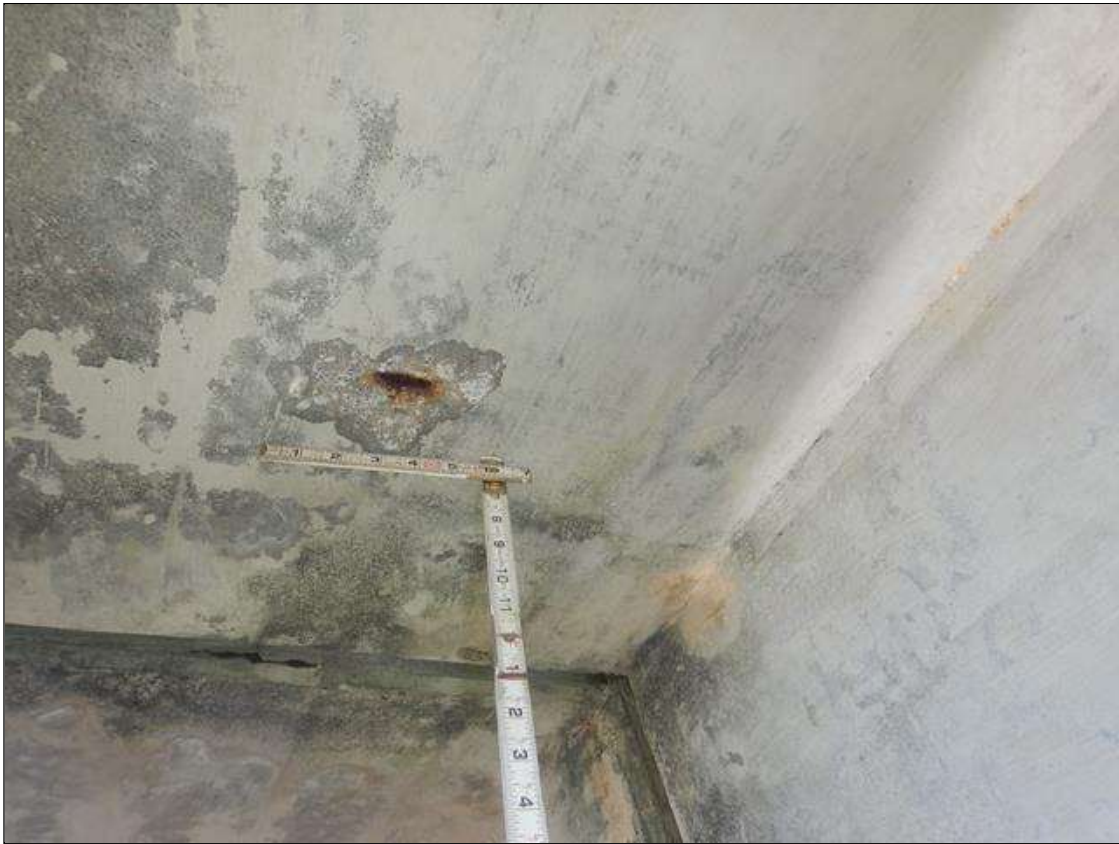
Span 9 Deck: 6" WIDE X 4" LONG X 1/2" DEEP SPALL WITH EXPOSED REBAR IN RIGHT OVERHANG AT BENT 8

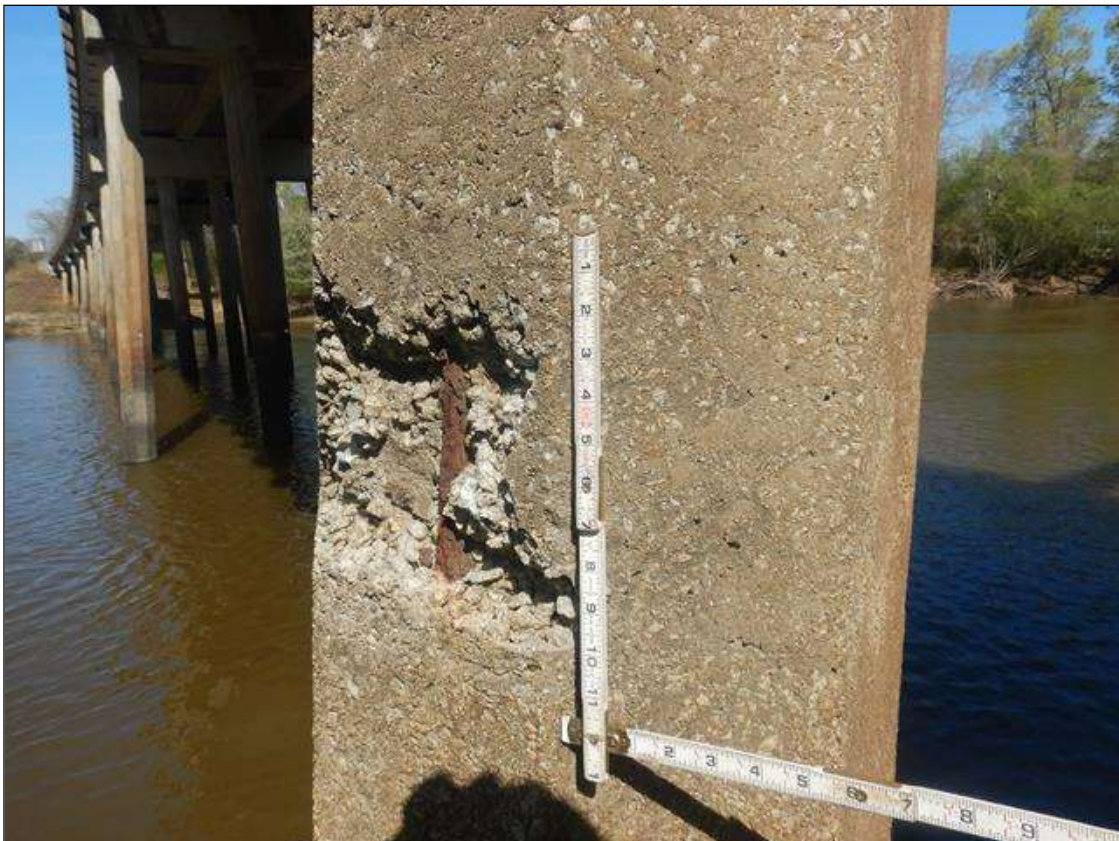
Bent 8 Pile 5: PAR: 7" HIGH X 1' WIDE X 2" DEEP SPALL WITH EXPOSED REINFORCEMENT WITH MINOR SECTION LOSS IN SOUTH FACE, AT 12' FROM WATER LEVEL.

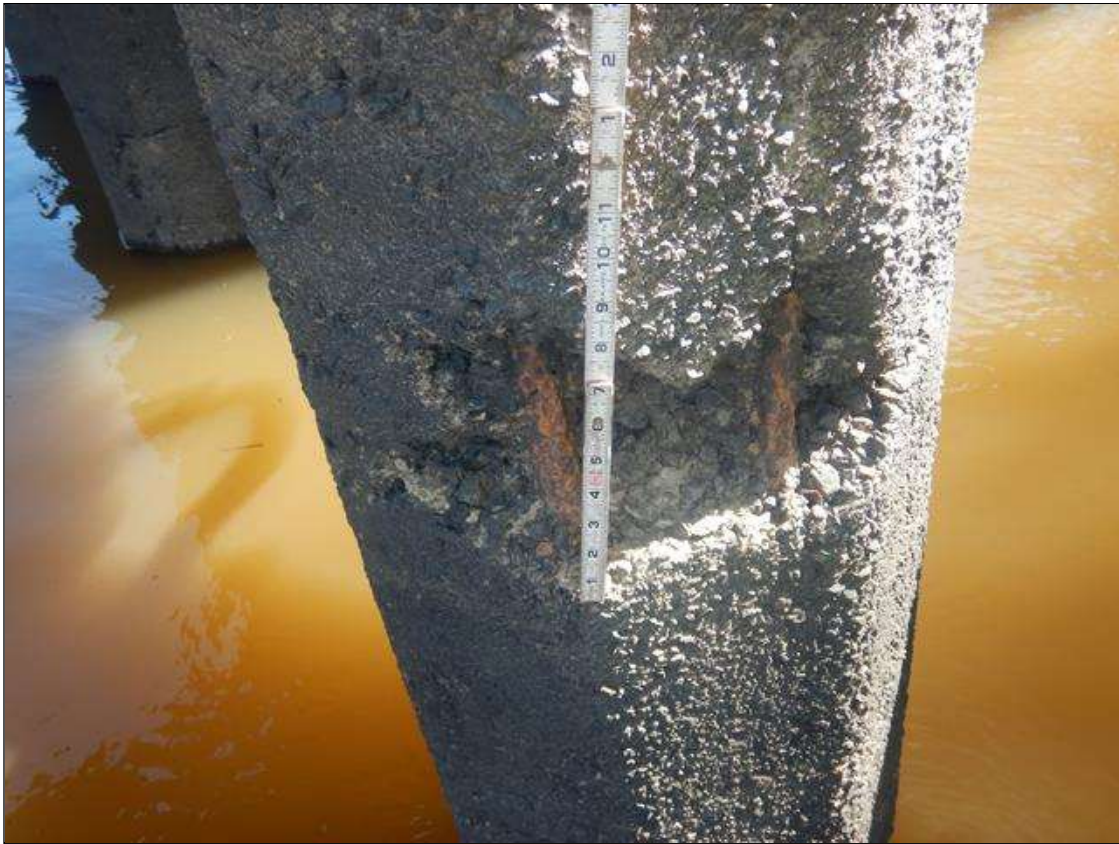
Bent 8 Pile 5: PAR: 18" WIDE X 10" HIGH X 3" DEEP SPALL WITH EXPOSED REBAR WITH NO MEASURABLE SECTION LOSS ON SOUTH FACE, 3' ABOVE WATERLINE

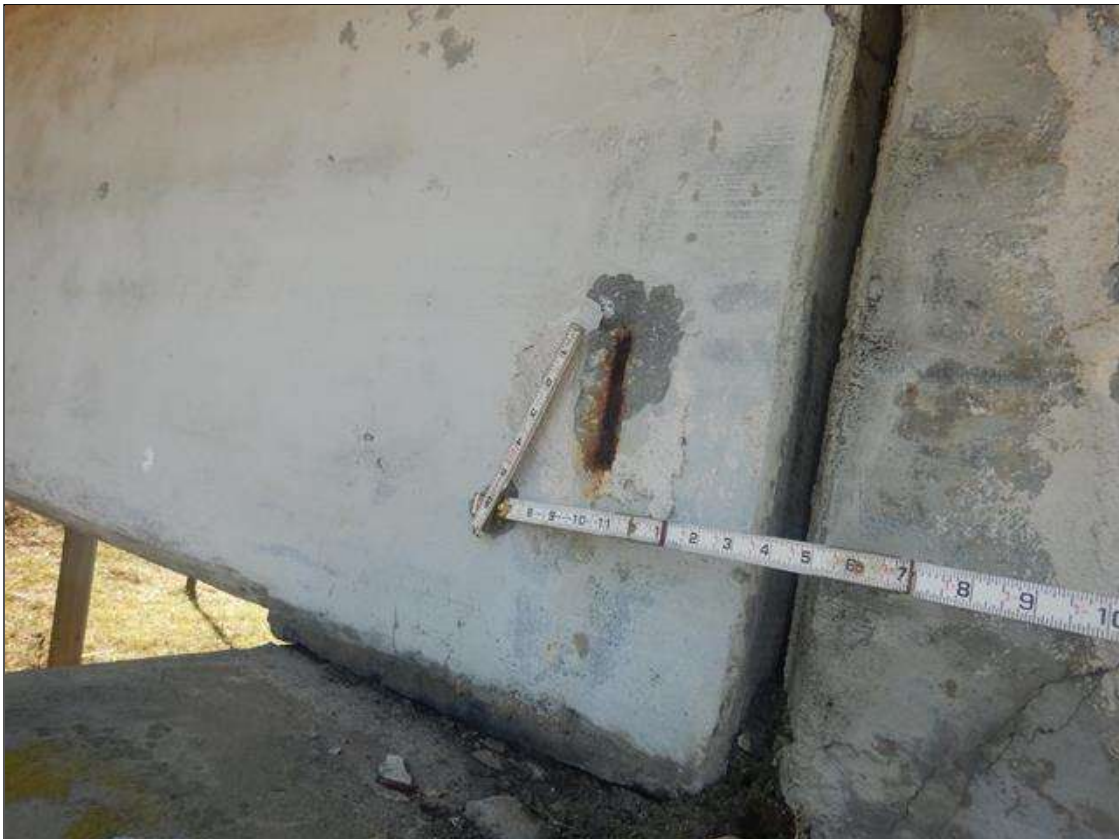
Span 9 Beam 1: 3" WIDE X 6" HIGH X 1/2" DEEP SPALL WITH EXPOSED REINFORCEMENT IN NORTH FACE, LOCATED OVER BENT 8. NO MEASURABLE SECTION LOSS IN EXPOSED REINFORCEMENT.

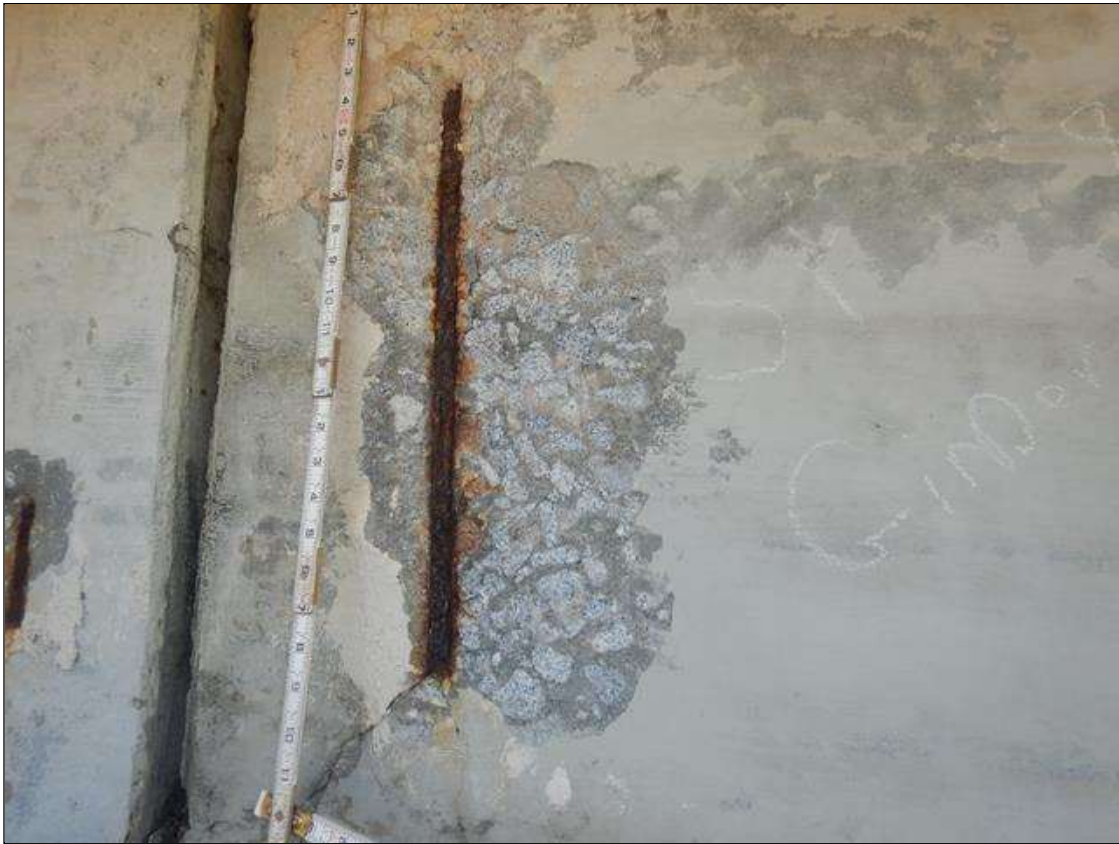
Span 8 Beam 1: 22" HIGH X UP TO 10" WIDE X 1" DEEP SPALL WITH EXPOSED REINFORCEMENT WITH NO MEASURABLE SECTION LOSS IN FORMERLY PATCHED AREA IN NORTH FACE, AT BENT 8

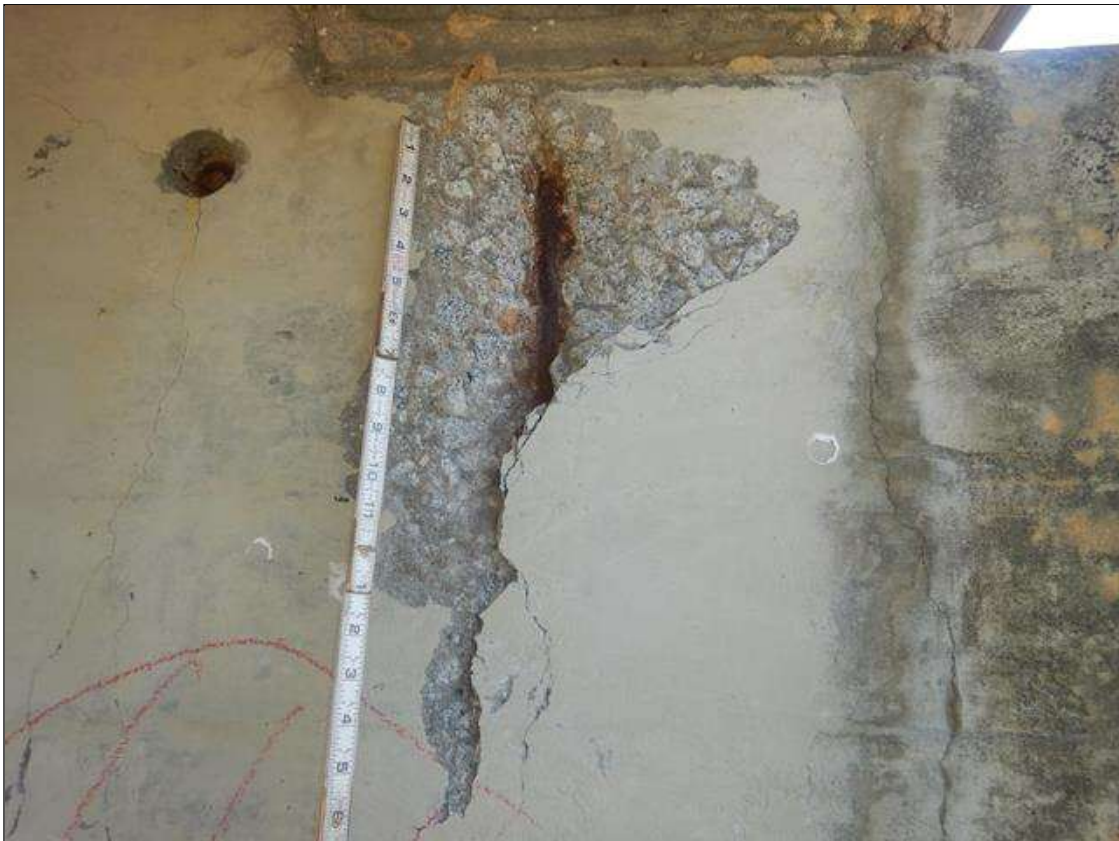
Bent 8 Cap 1: PAR: 1'-7" HIGH X 1' WIDE X 1 1/4" DEEP SPALL WITH EXPOSED REINFORCING ON WEST FACE BELOW BEAM 4, NO MEASURABLE SECTION LOSS

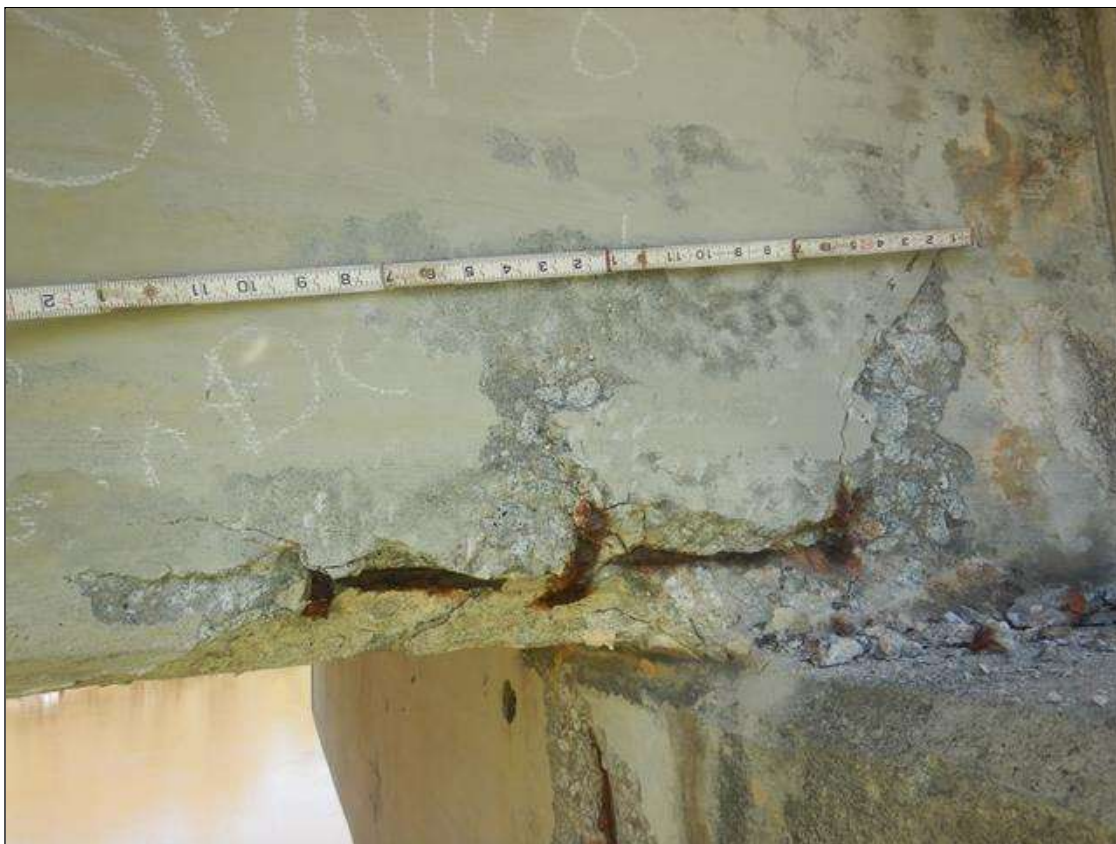
Span 8 Beam 4: PAR: 2' LONG X 1' HIGH X 6 1/2" WIDE ON BOTTOM FACE X 1 1/2" DEEP SPALL WITH EXPOSED REBAR, LOCATED ON BOTTOM RIGHT CORNER OVER BENT 8

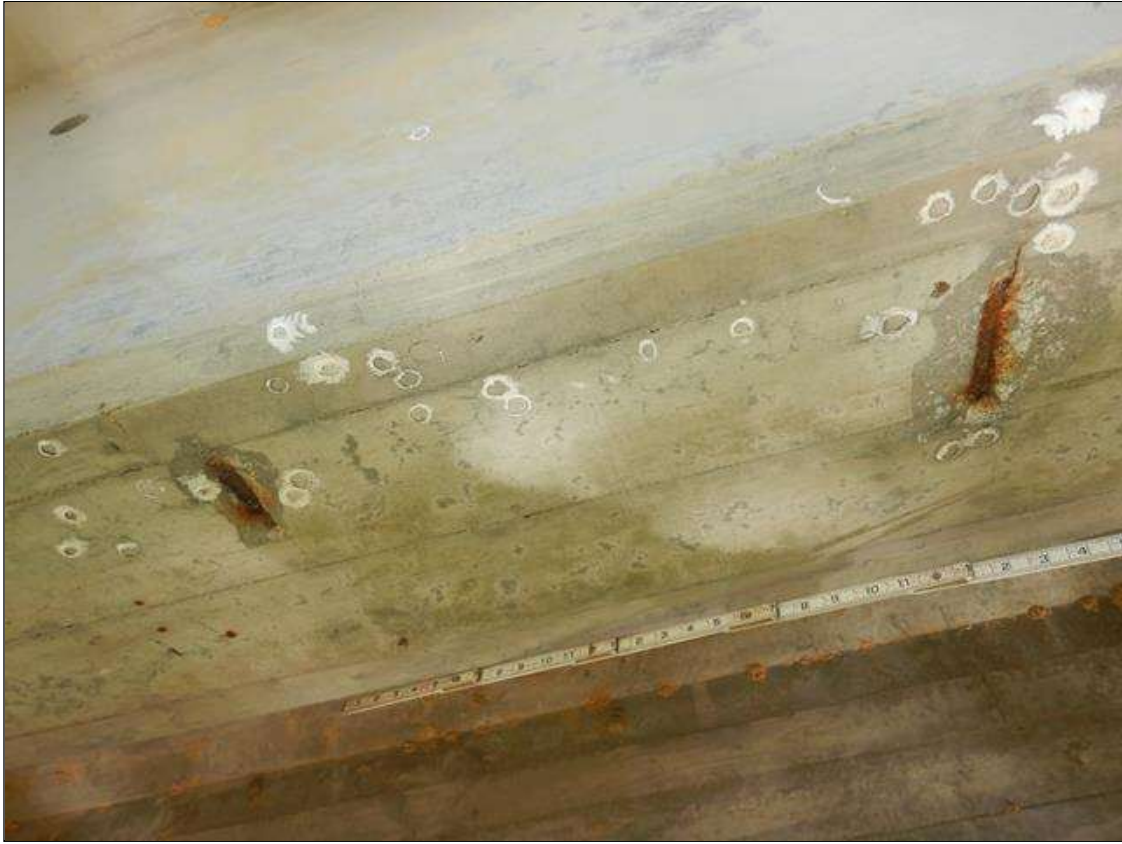
Span 8 Beam 4: (2) SPALLS ON UNDERSIDE OF BEAM LOCATED 12' AND 14' FROM BENT 8. 5" LONG X 6" WIDE X 1/2" DEEP AND 3" LONG X 4" WIDE X 1/2" DEEP, BOTH WITH EXPOSED REINFORCEMENT. NO MEASURABLE SECTION LOSS

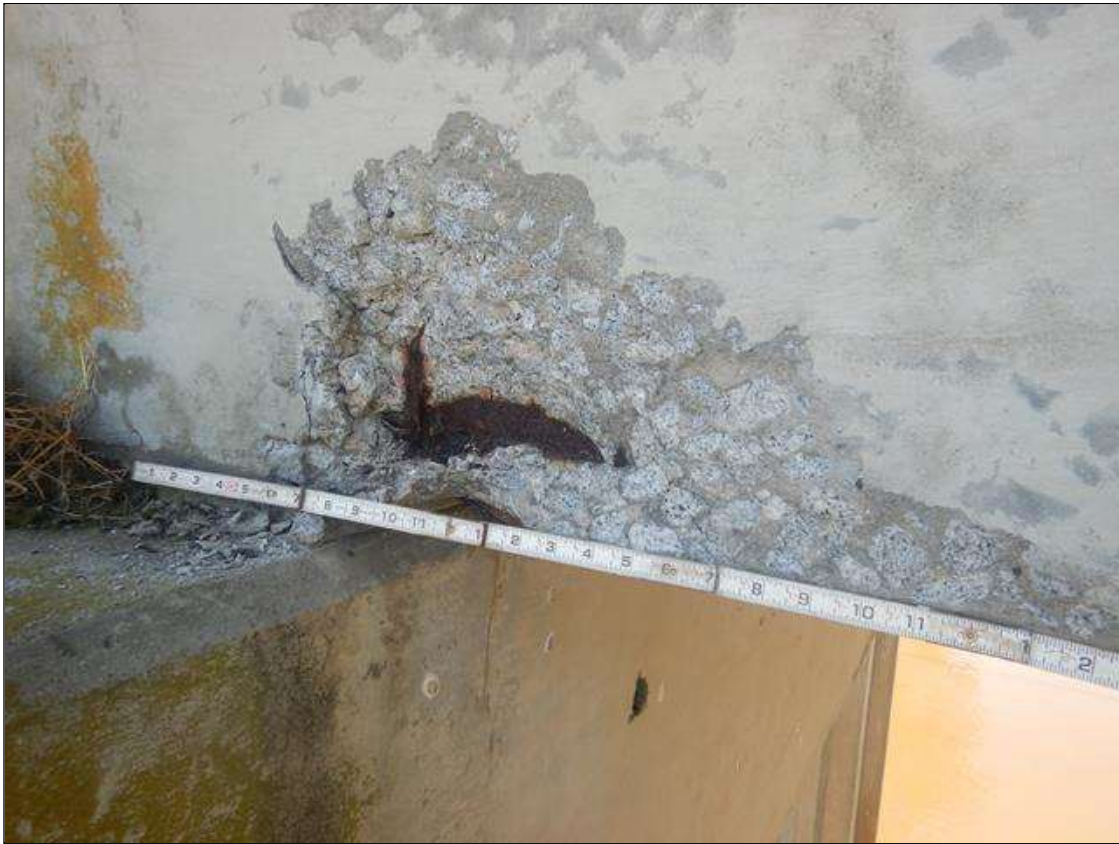
Span 7 Beam 1: 1'-3" LONG X 11" HIGH X 3/4 IN DEEP SPALL WITH EXPOSED REINFORCEMENT NO MEASURABLE SECTION LOSS, LOCATED IN NORTH FACE ABOVE BENT 7 CAP.

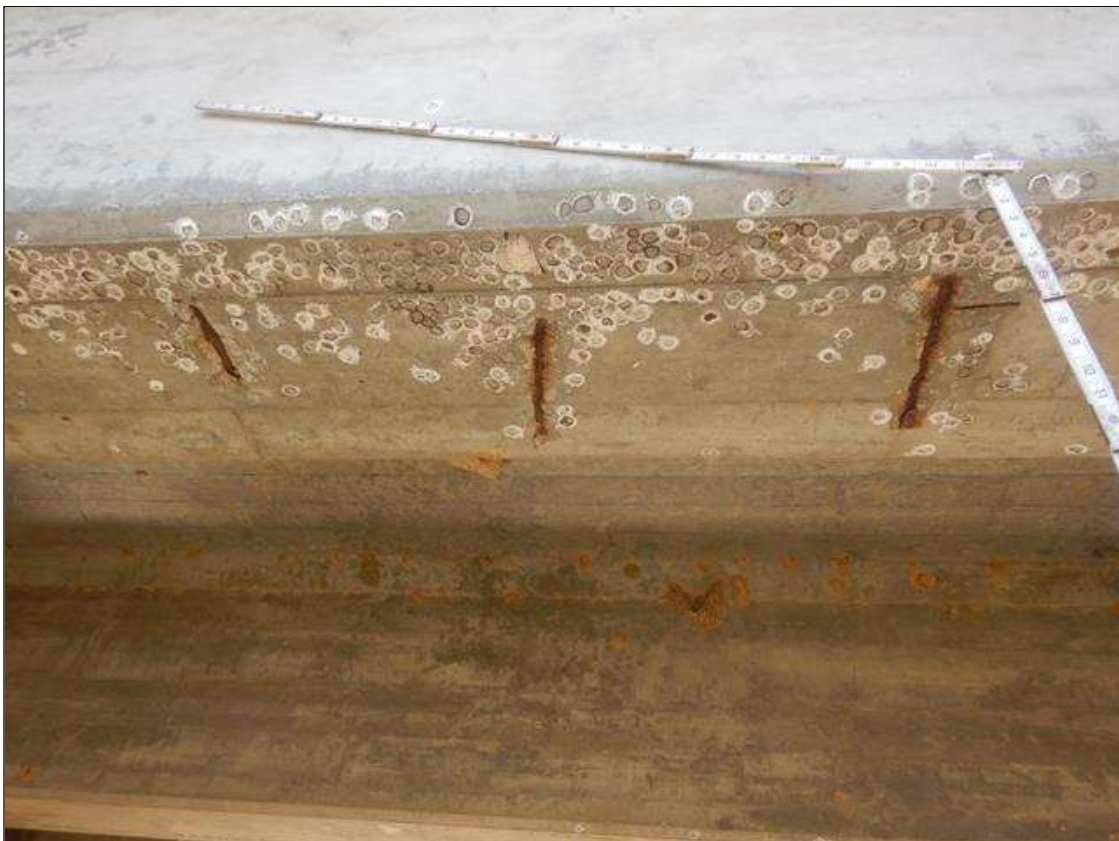
Span 7 Beam 1: (3) UP TO 10" WIDE X 1 1/2" LONG X 1/2" DEEP SPALLS WITH EXPOSED REINFORCEMENT AND NO MEASURABLE SECTION LOSS IN BOTTOM FACE, STARTING AT 11 1/2' FROM BENT 7

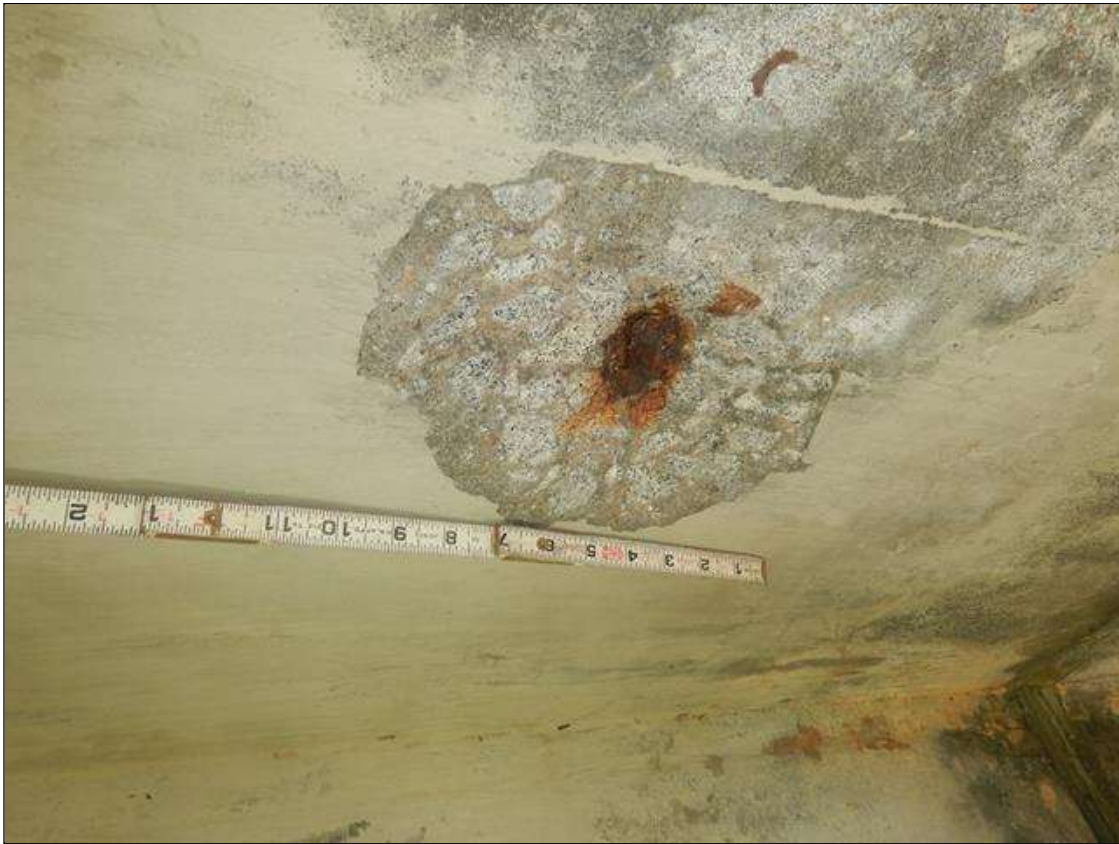
Span 7 Deck: 8" LONG X 6" WIDE X 1" DEEP SPALL IN RIGHT OVERHANG WITH EXPOSED REBAR, LOCATED OVER BENT 6 & 7. (OVER BENT 7 SHOWN)

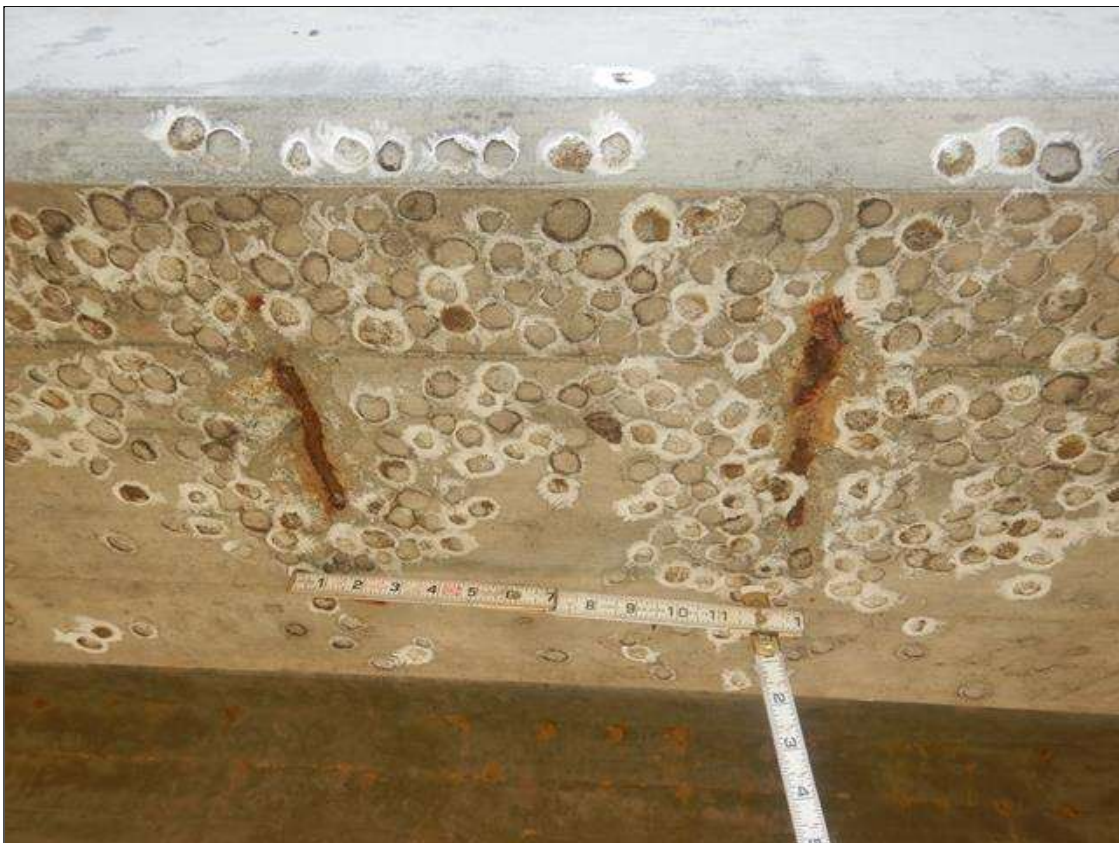
Span 7 Beam 1: (2) UP TO 7 IN WIDE X 2 IN LONG X 3/4 IN DEEP SPALLS WITH EXPOSED REINFORCEMENT IN BOTTOM FACE, LOCATED AT 7 FT FROM BENT 6

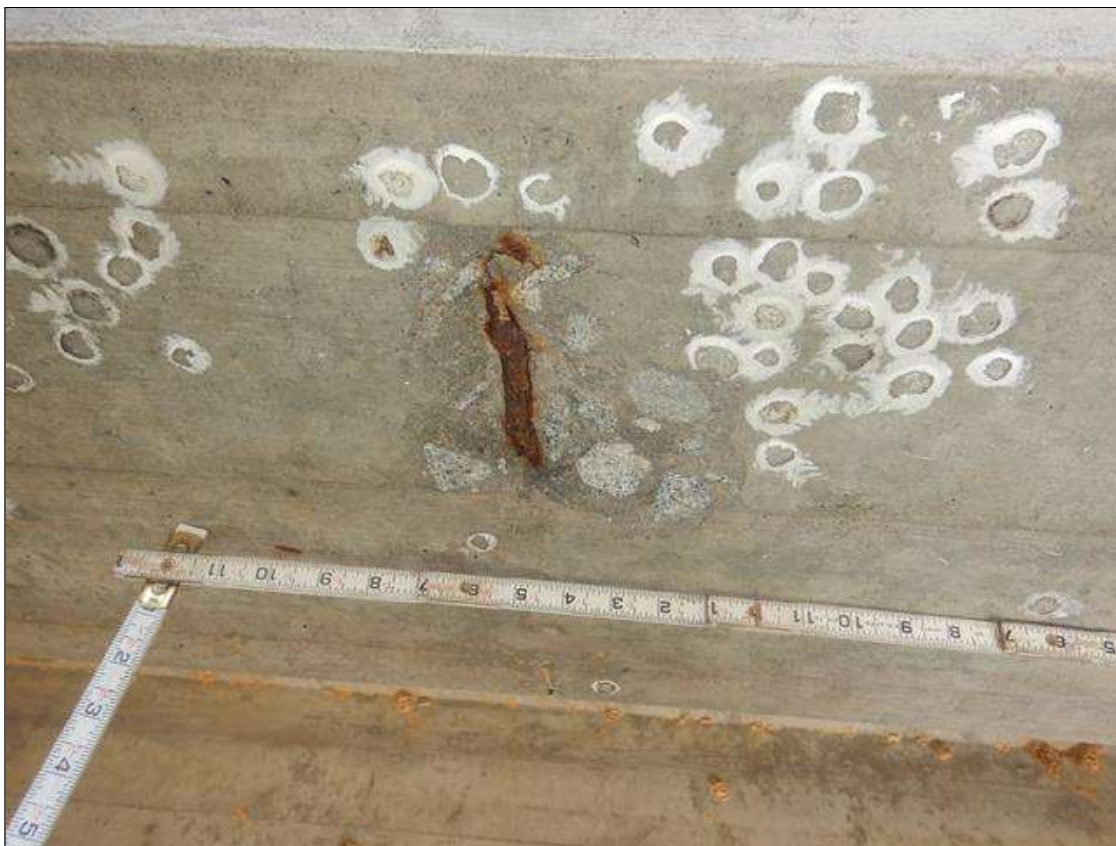
Span 7 Beam 4: (2) 7" LONG X 3" WIDE X 3/4" IN DEEP SPALL IN BOTTOM FACE WITH EXPOSED REINFORCEMENT, LOCATED AT 6 FT FROM BENT 7. NO MEASURABLE SECTION LOSS NOTED.

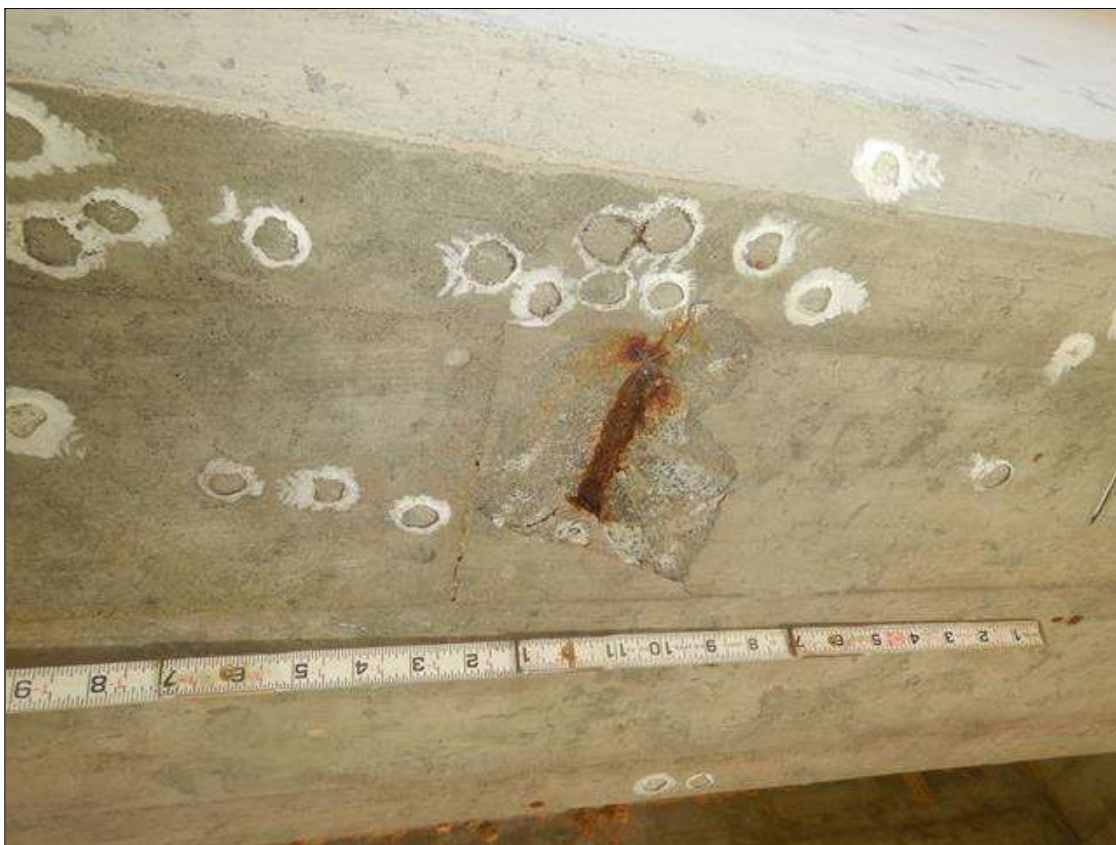
Span 7 Beam 4: (2) 7" LONG X 3" WIDE X 3/4" IN DEEP SPALL IN BOTTOM FACE WITH EXPOSED REINFORCEMENT, LOCATED AT 6 FT FROM BENT 7. NO MEASURABLE SECTION LOSS NOTED.

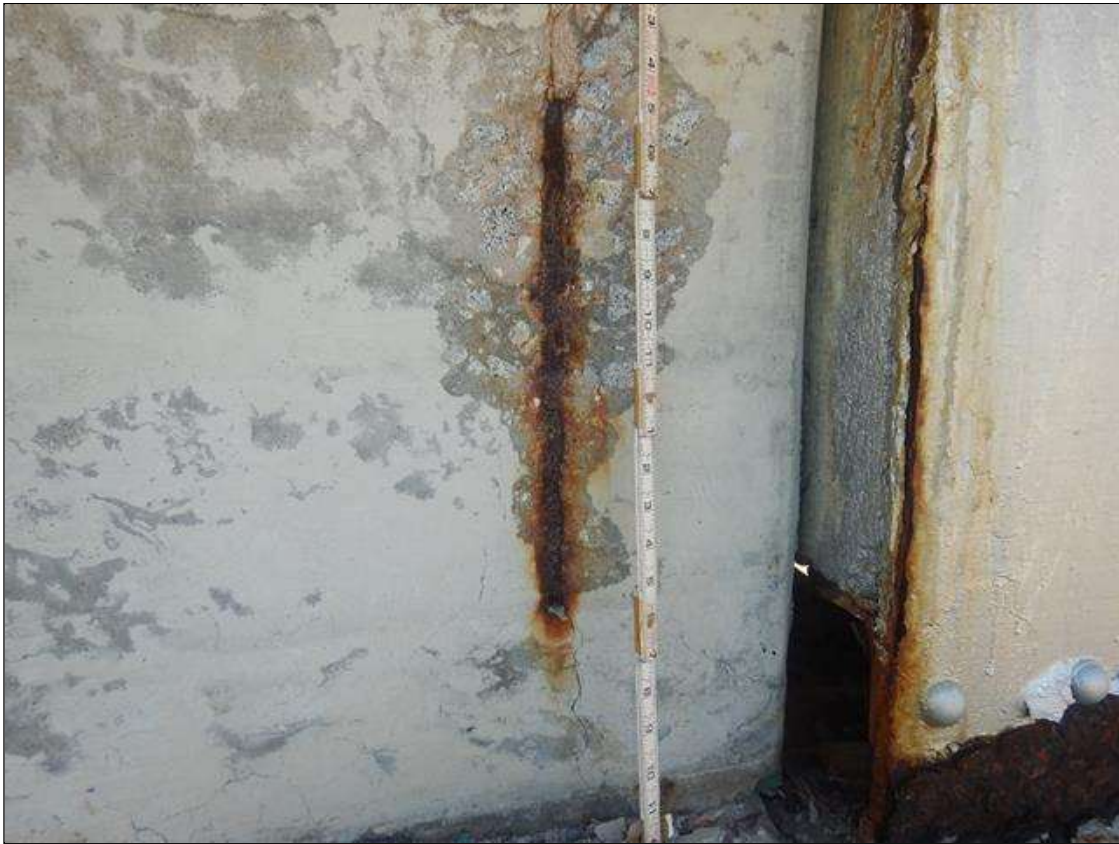
Span 7 Beam 1: 8" LONG X 1'-9" HIGH X UP TO 1" DEEP SPALL WITH EXPOSED REINFORCEMENT NO MEASURABLE SECTION LOSS IN NORTH FACE, AT BENT 6.
