NC DEPARTMENT OF TRANSPORTATION
 DIVISION OF HIGHWAYS
 STRUCTURE MANAGEMENT UNIT

ATTENTION: **PAR'S ISSUED, DATA CHANGES**

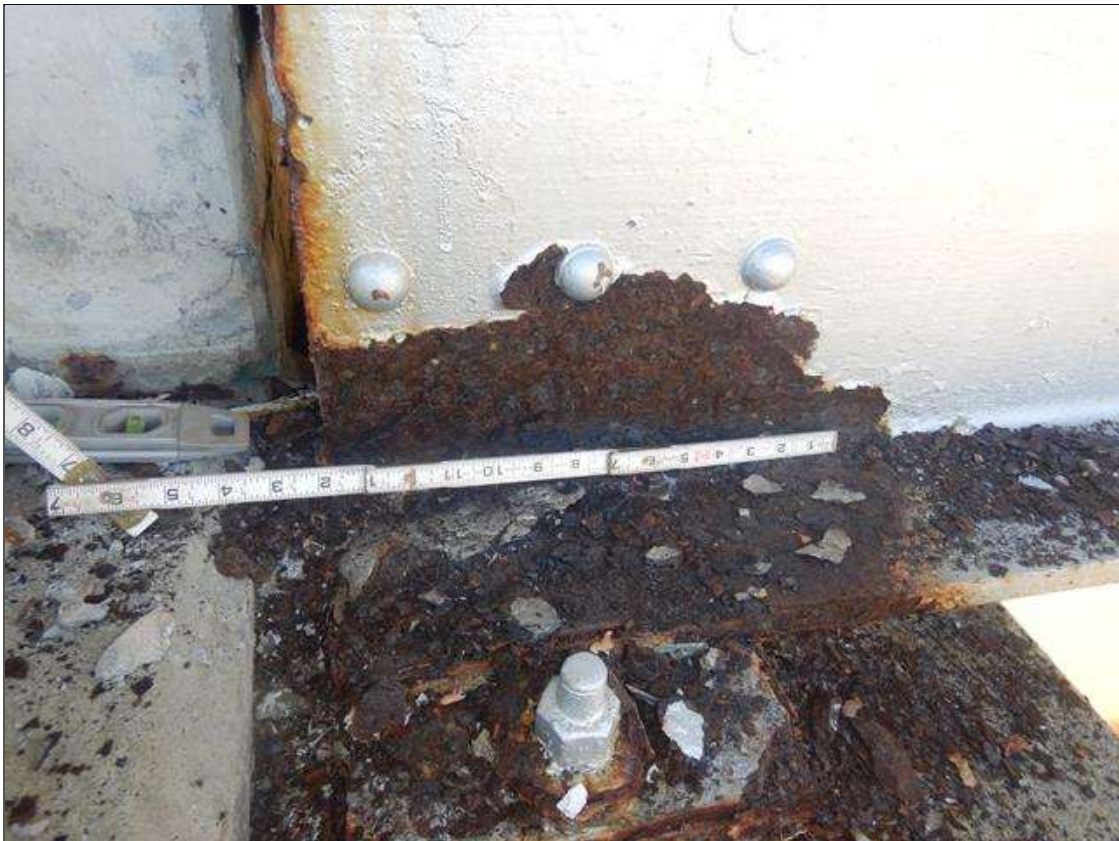
Span 6 Beam 1: 1' LONG X 6" HIGH AREA OF CORROSION WITH SECTION LOSS ON BOTTOM OF WEB AT BENT 6, 1/2" REMAINING

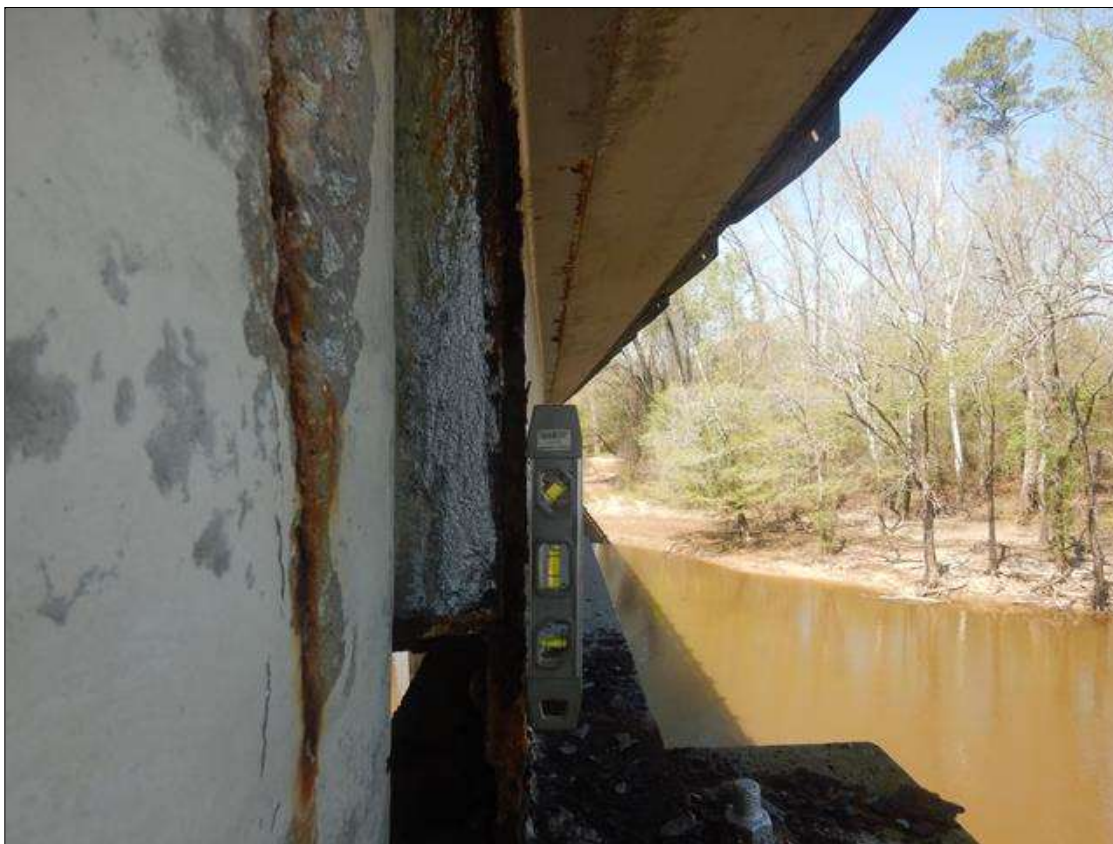
Span 6 Beam 1: PAR: UP TO 1'-6" LONG AREA OF DISTORTION IN THE WEB AT BOTH ENDS OF BEAM. WEB IS BOWED TO THE NORTH UP TO 1/2"

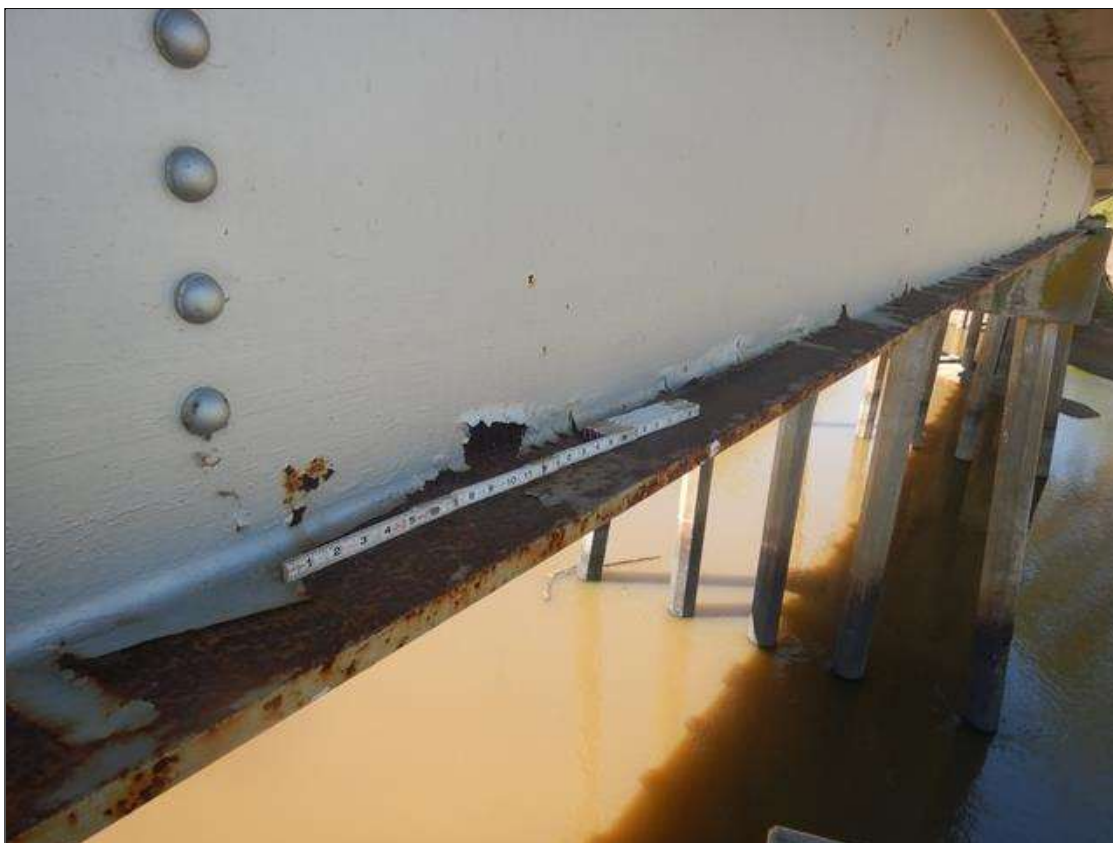
Span 6 Beam 1: MINOR SURFACE CORROSION ON TOP OF BOTTOM FLANGE AND WEB, FOR FULL LENGTH EXCEPT FOR BEAM ENDS.

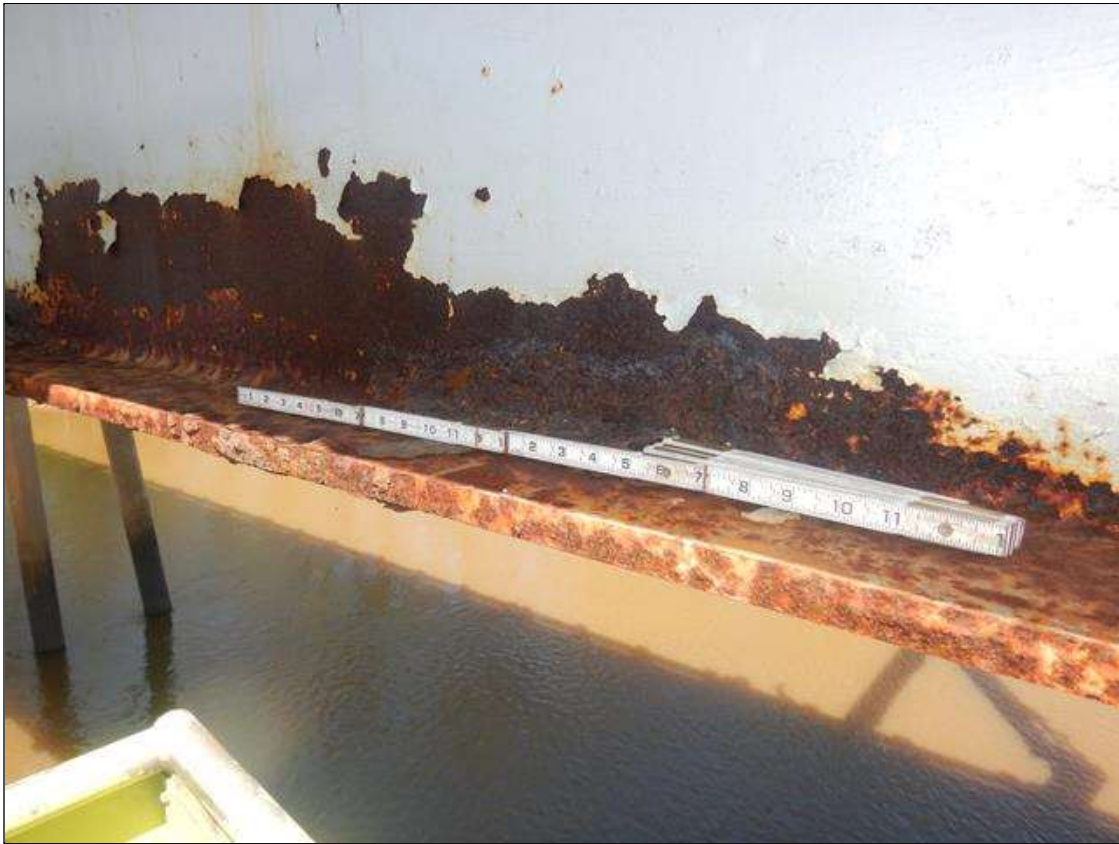
Span 6 Beam 5: CORROSION WITH MINOR DELAMINATION IN TOP AND BOTTOM FLANGES, AND BOTTOM 6 IN OF WEB FOR 11 FT LONG, STARTING AT 6 FT FROM BENT 6. NO MEASURABLE SECTION LOSS NOTED

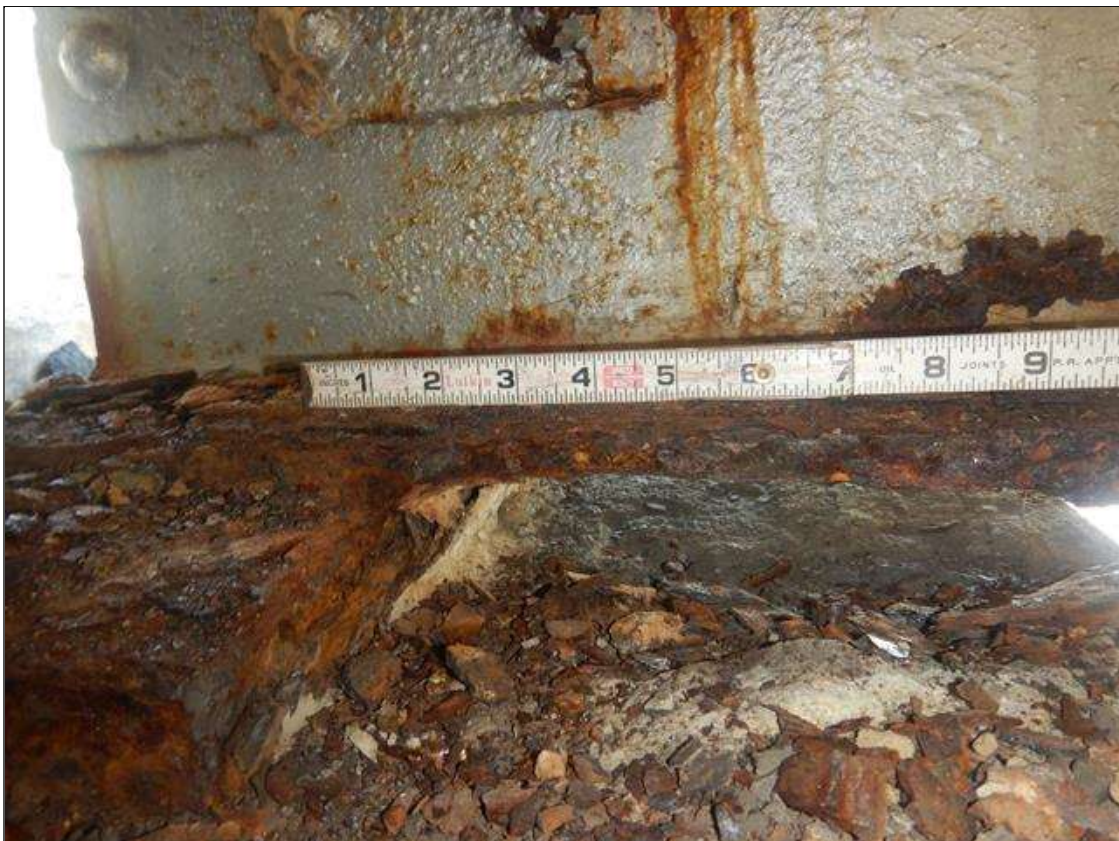
Span 6 Beam 5: PAR: 7" LONG X 2" WIDE AREA OF CORROSION WITH 3/8" SECTION LOSS ON NORTH SIDE OF BOTTOM FLANGE AT BENT 6. 5/8" REMAINING

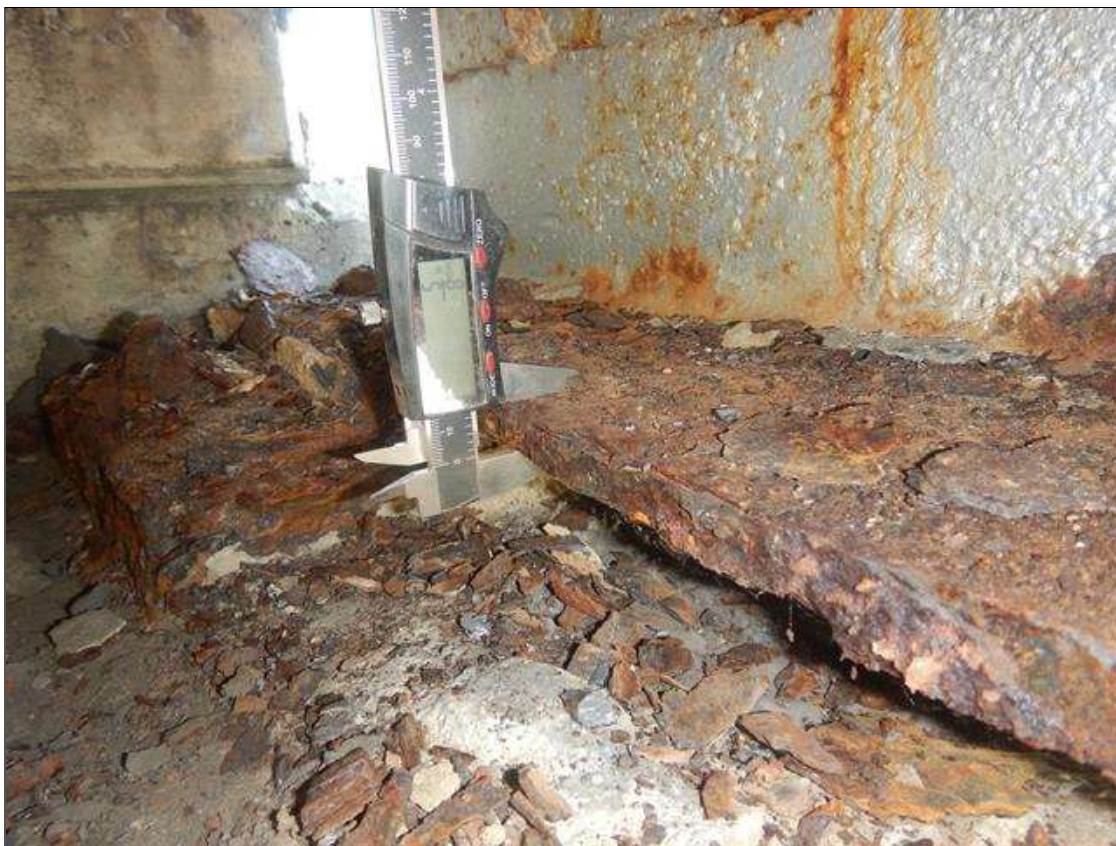
Span 6 Beam 5: PAR: 7" LONG X 2" WIDE AREA OF CORROSION WITH 3/8" SECTION LOSS ON NORTH SIDE OF BOTTOM FLANGE AT BENT 6. 5/8" REMAINING

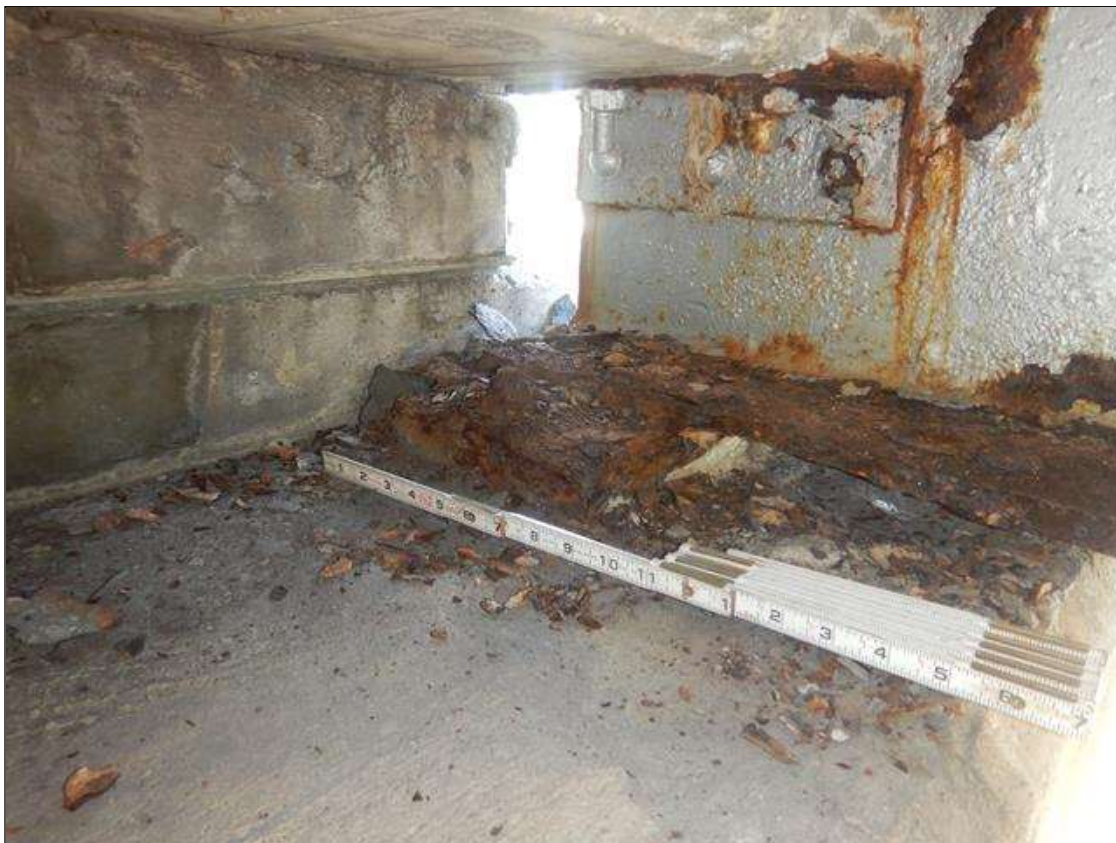
Span 6 Beam 5 - Far Bearing: CORROSION WITH MINOR DELAMINATION

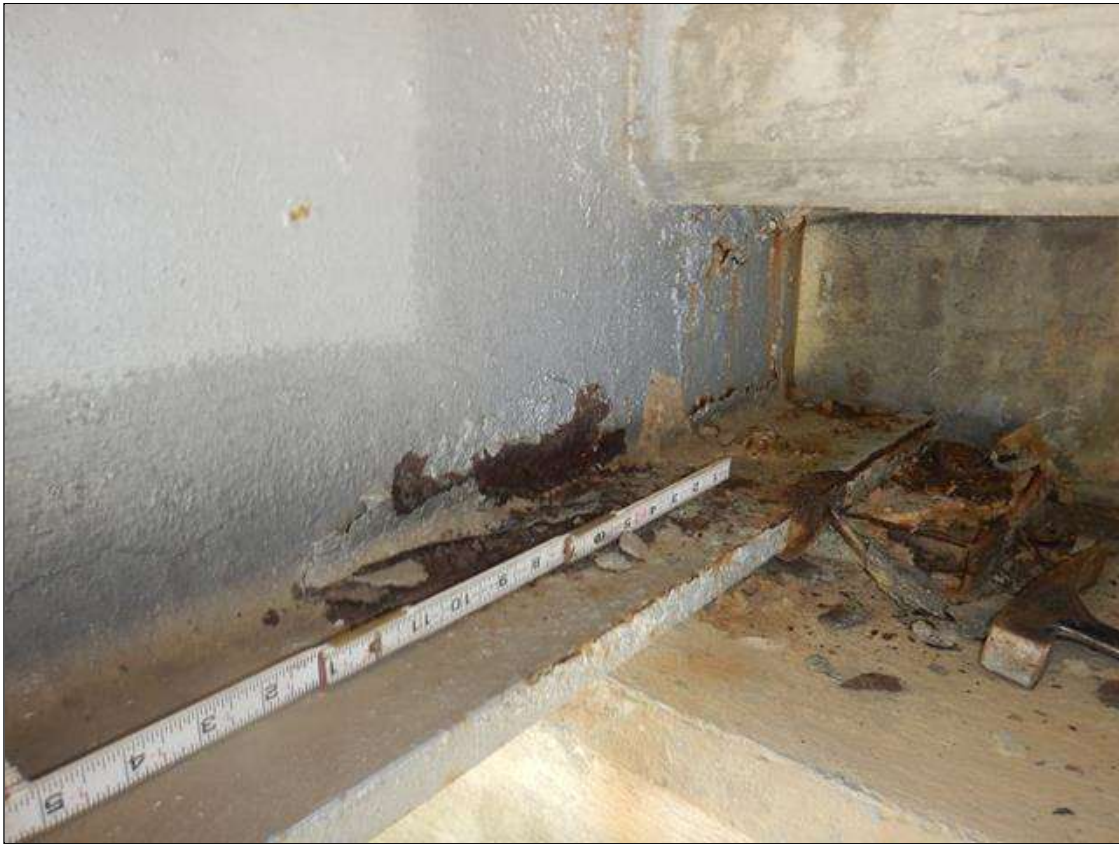
Span 6 Beam 2: 6" LONG X FULL WIDTH AREA OF SURFACE CORROSION WITH MINOR DELAMINATION ON BOTTOM FLANGE AND BOTTOM 3 IN OF WEB IN SOUTH FACE AT BENT 6 BEAM END. NO MEASURABLE SECTION LOSS NOTED.

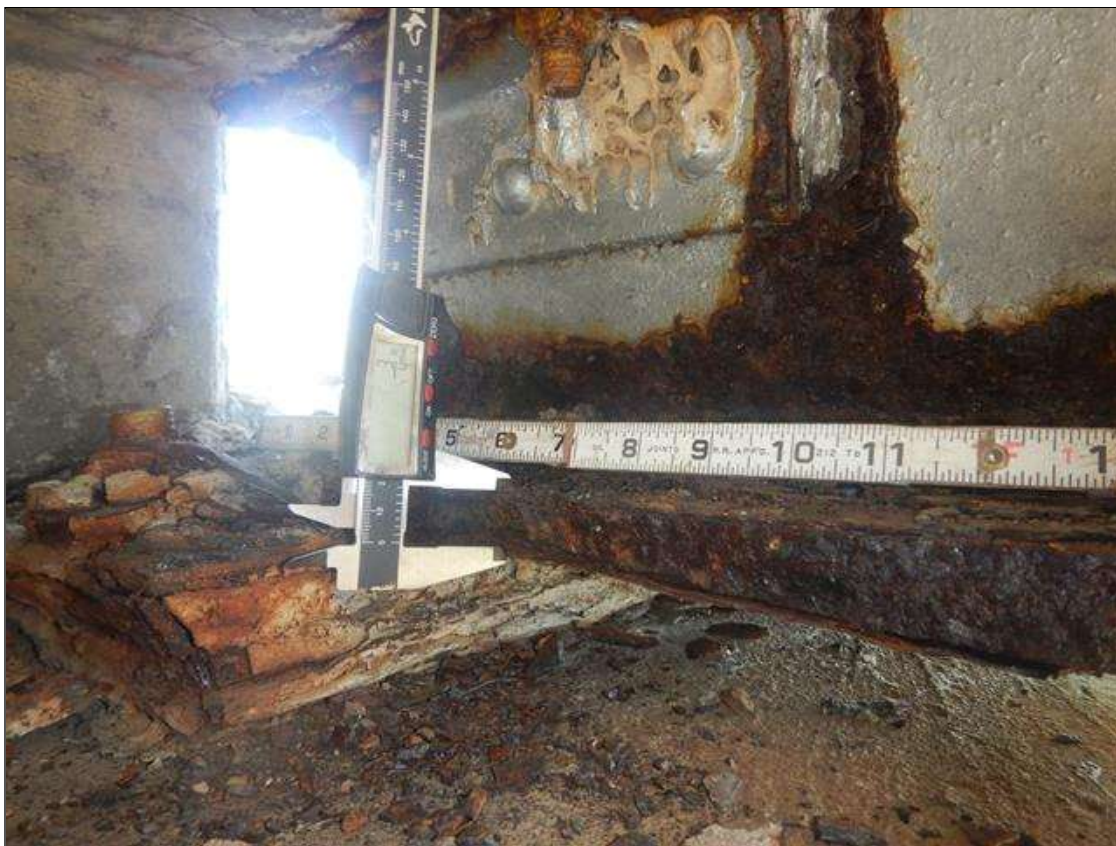
Span 6 Beam 1: PAR: 1' LONG X FULL WIDTH AREA OF CORROSION WITH 1/4" SECTION LOSS ON BOTTOM FLANGE AT BENT 5, 3/4" REMAINING

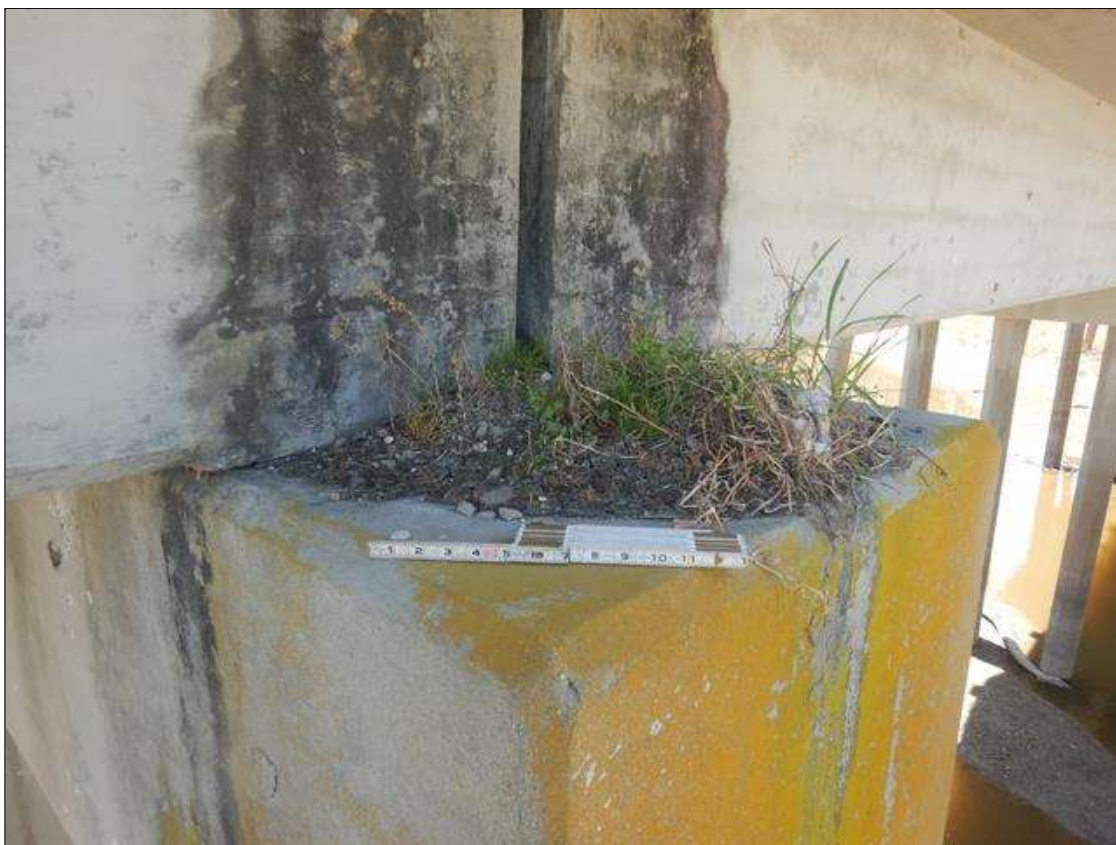
HEAVY VEGETATION GROWTH ON TOP FACE OF BENT 4 CAP BELOW NORTH OVERHANG

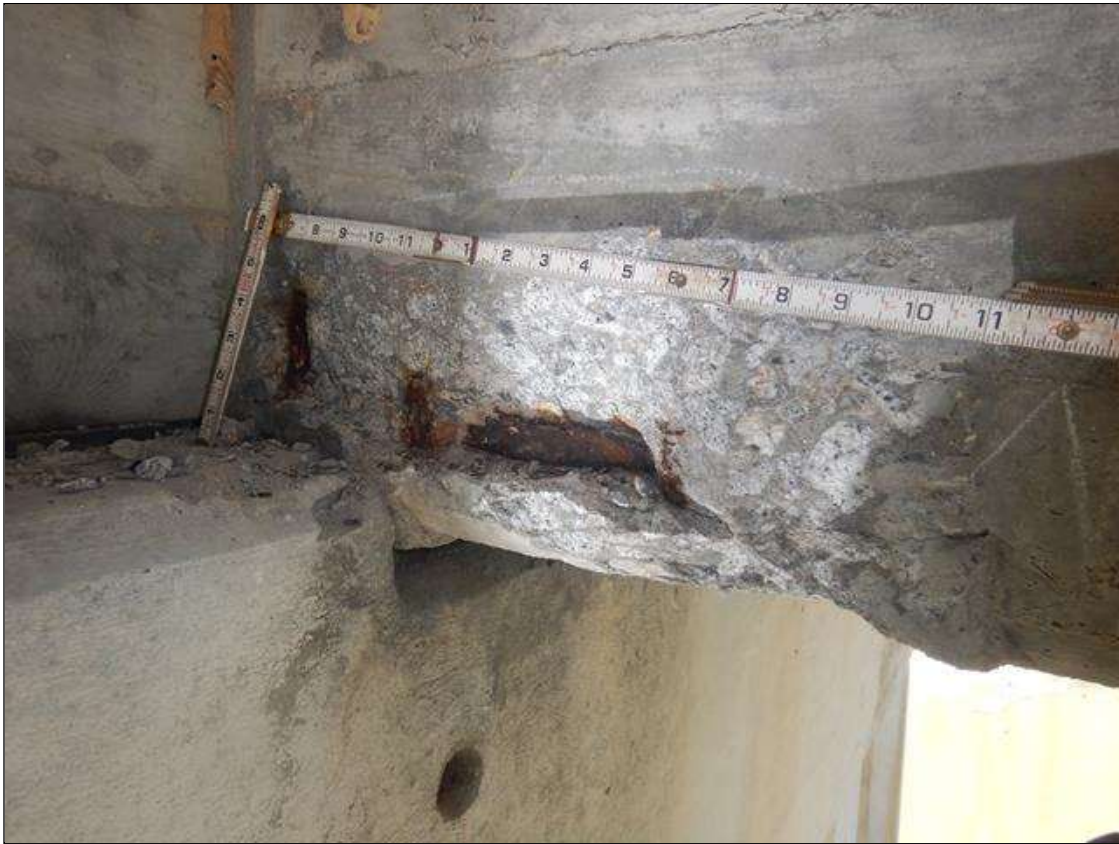
Span 5 Beam 3: PAR: 18" LONG X 7" HIGH X 1 1/2" DEEP SPALL WITH EXPOSED REINFORCING IN SOUTH FACE, STARTING AT BENT 4

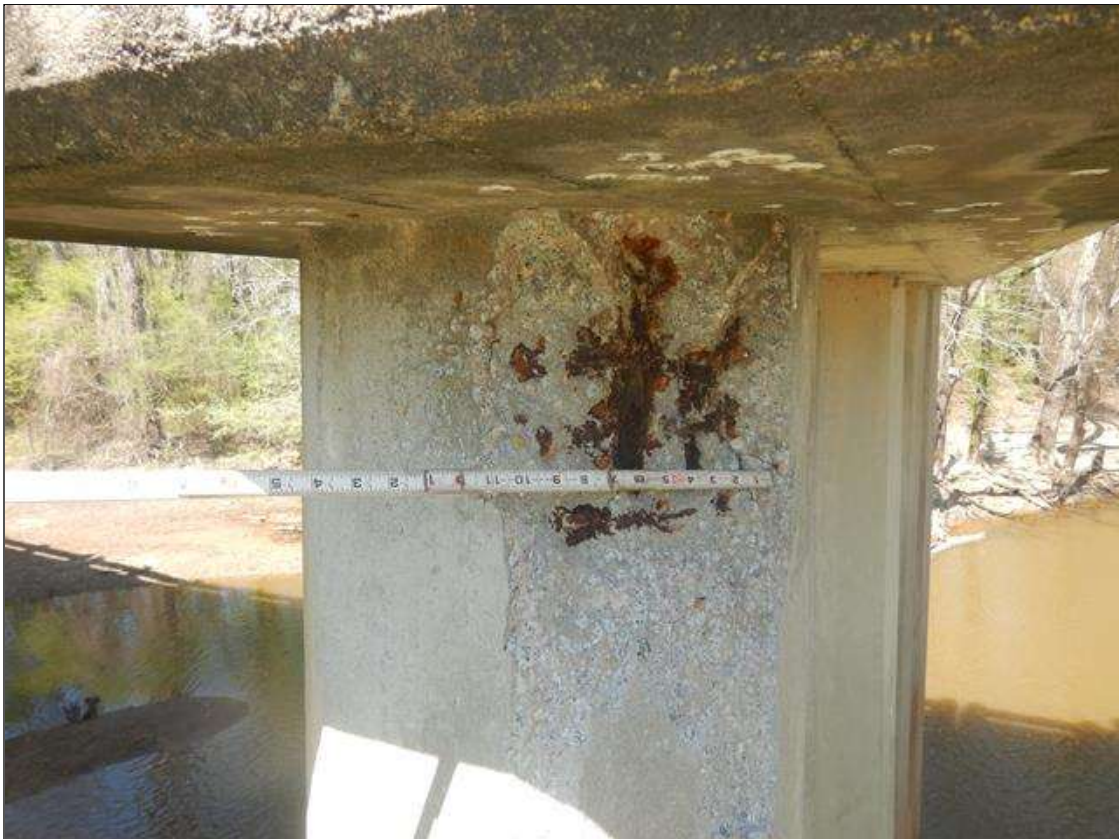
Bent 4 Pile 5: PAR: 2' HIGH X 11" WIDE X UP TO 2" DEEP SPALL WITH EXPOSED REINFORCEMENT IN SOUTHEAST FACE BELOW CAP

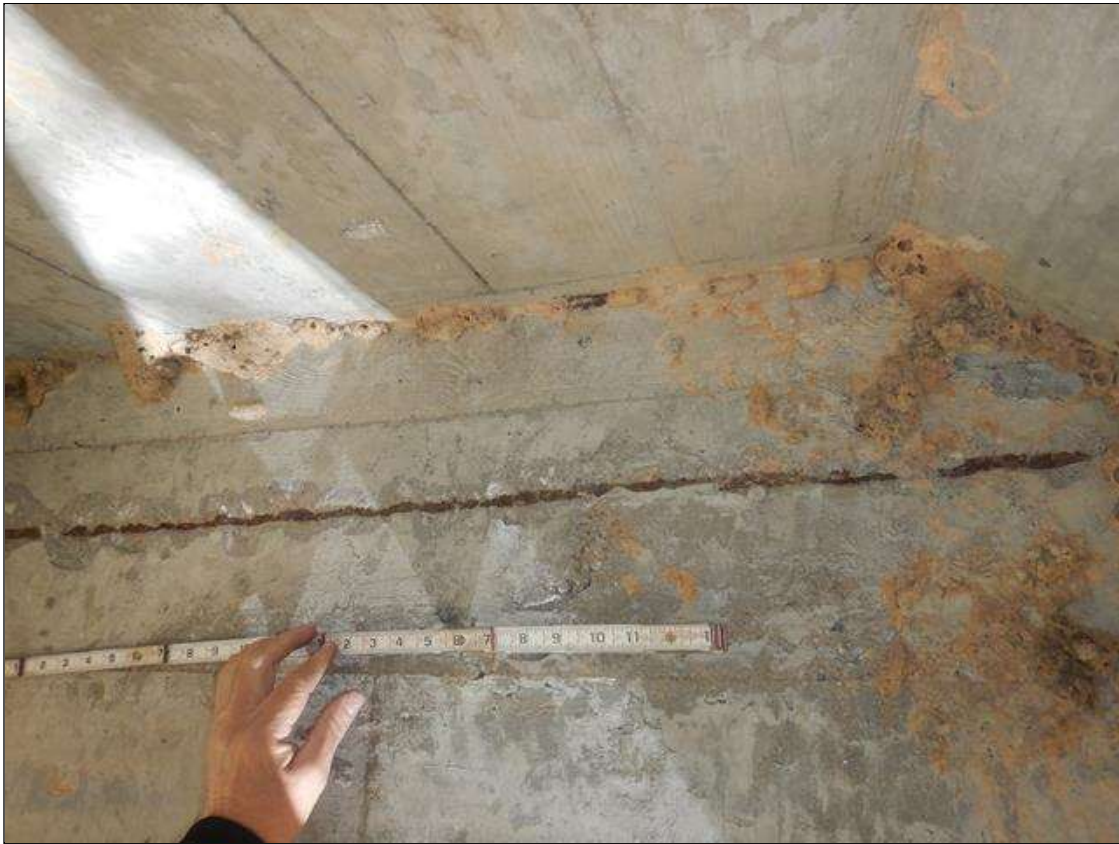
5 FT LONG X 2.5 IN HIGH X 1/2 IN DEEP SPALL WITH EXPOSED REINFORCEMENT IN INTERMEDIATE DIAPHRAGM SPAN 4 BAY 1, WEST FACE. NO MEASURABLE SECTION LOSS IN EXPOSED REINFORCEMENT

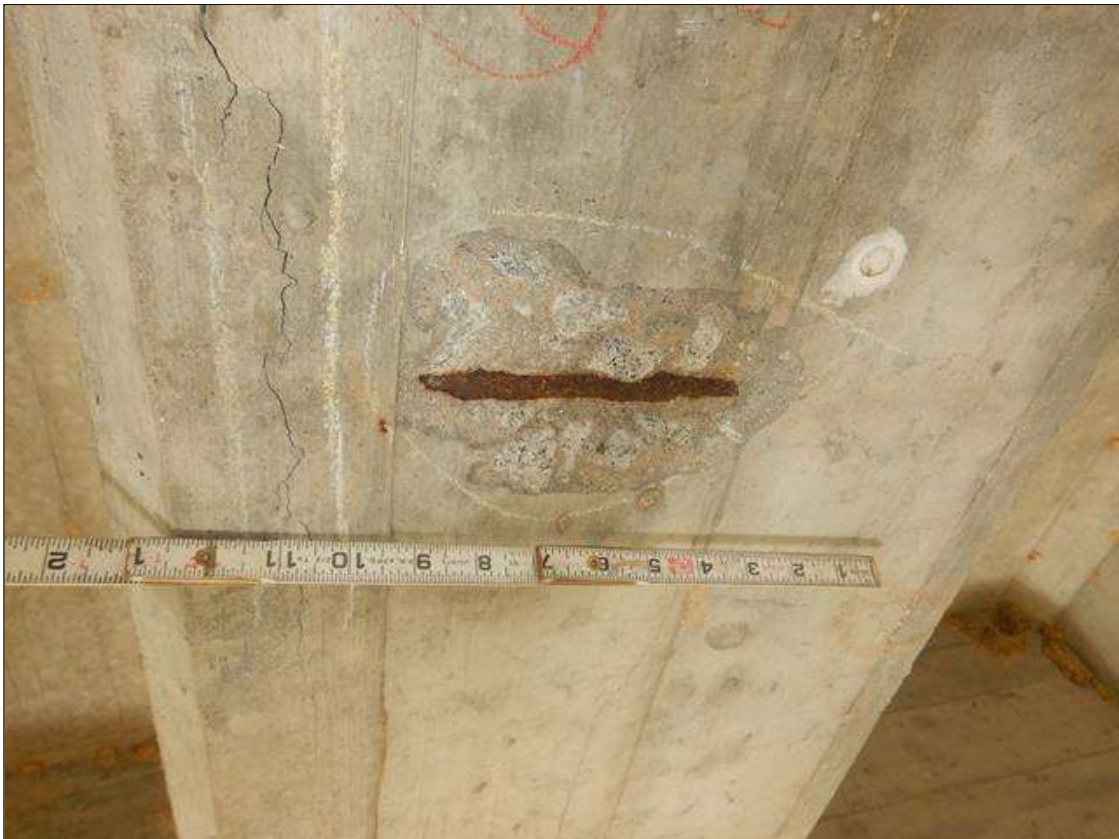
Span 4 Beam 3: (2) SPALLS WITH EXPOSED REINFORCEMENT IN BOTTOM FLANGE, 17' FROM BENT 4, UP TO 7" LONG X 4" WIDE X 1/2" DEEP. NO MEASURABLE SECTION LOSS IN EXPOSED REINFORCEMENT

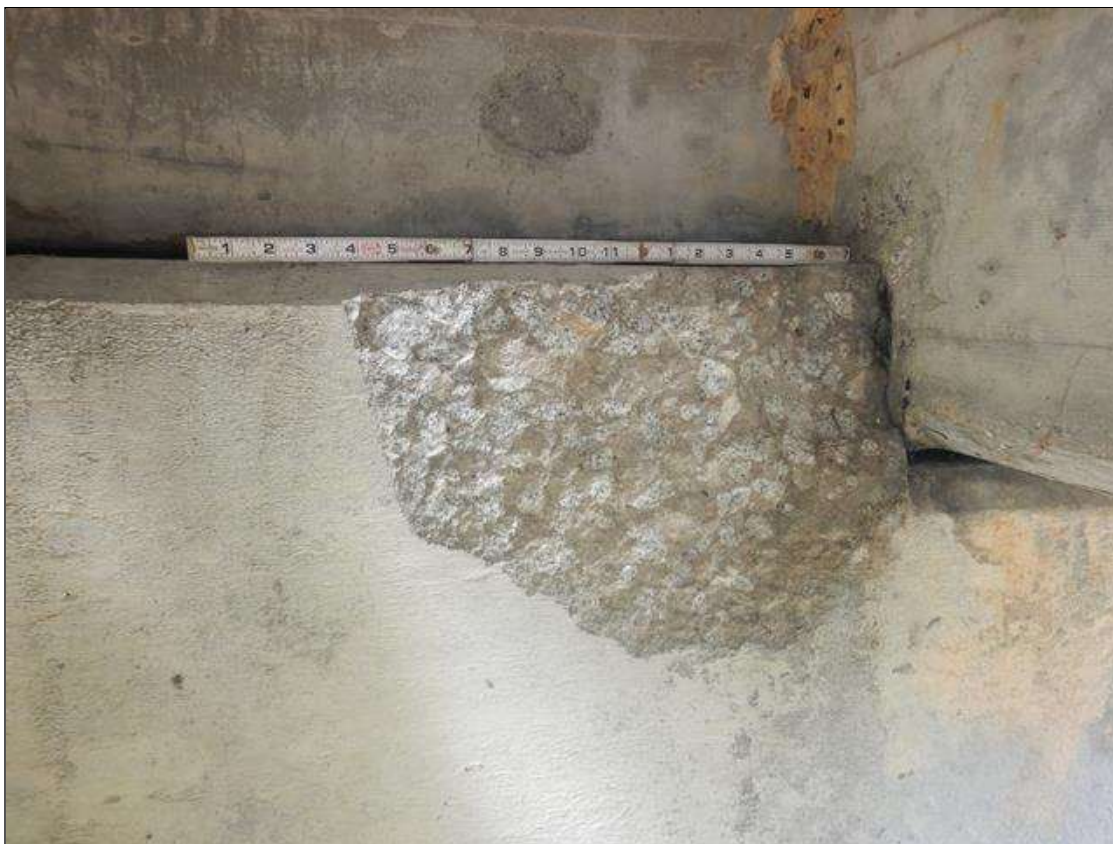
Bent 4 Cap 1: 1'-4" LONG X 10" HIGH X UP TO 2" DEEP SPALL IN TOP OF CAP, WEST FACE, BAY 3.

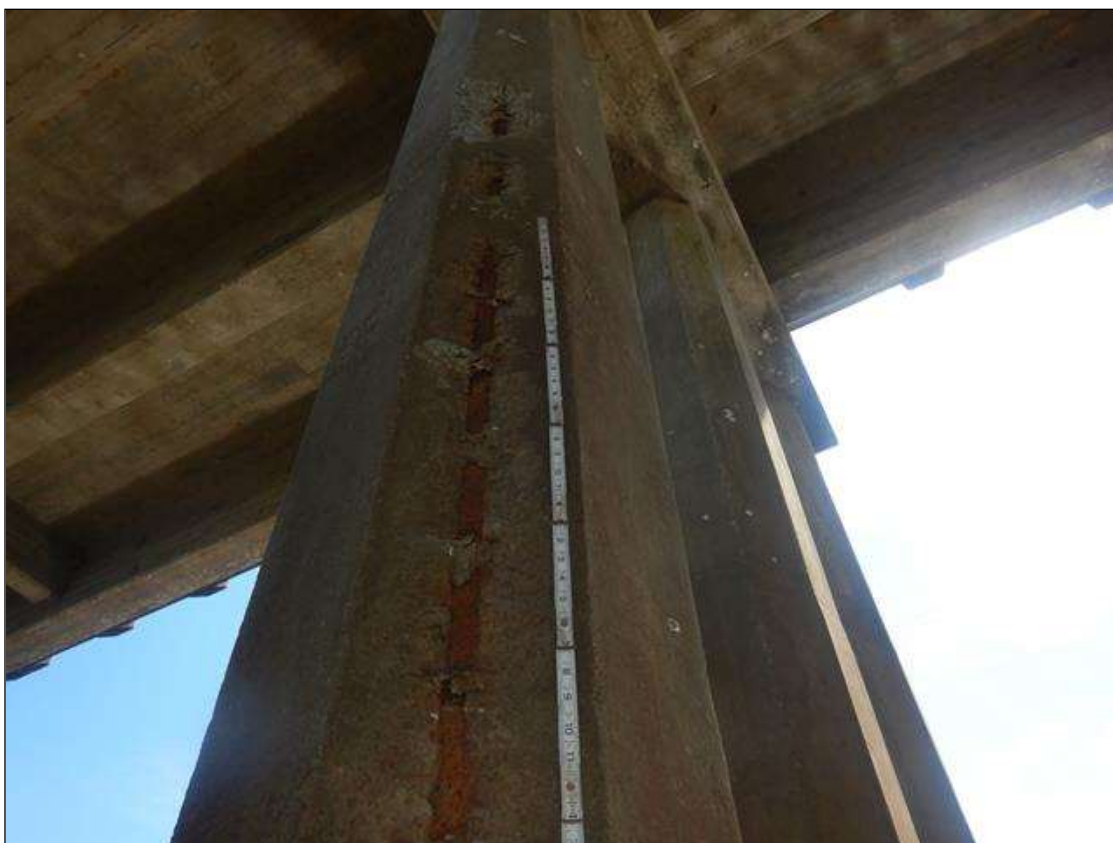
Bent 4 Pile 3: PAR: 9' HIGH X 8" WIDE X 1" DEEP SPALL AND DELAMINATION WITH EXPOSED REINFORCEMENT AND NO MEASURABLE SECTION LOSS AT NORTHWEST CORNER.

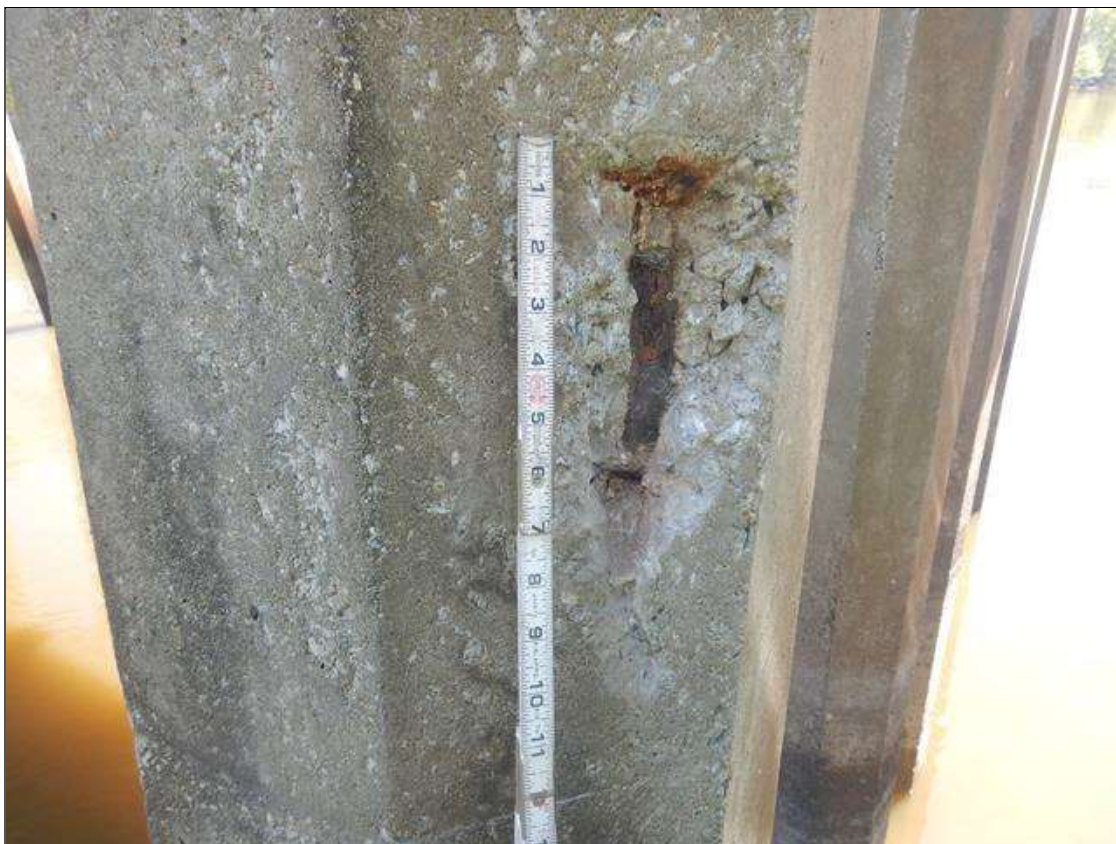
Bent 4 Pile 1: PAR: 10" HIGH X 6" WIDE X 2" DEEP SPALL WITH EXPOSED REINFORCEMENT WITH NO MEASURABLE SECTION LOSS AT NORTHWEST CORNER, MID HEIGHT

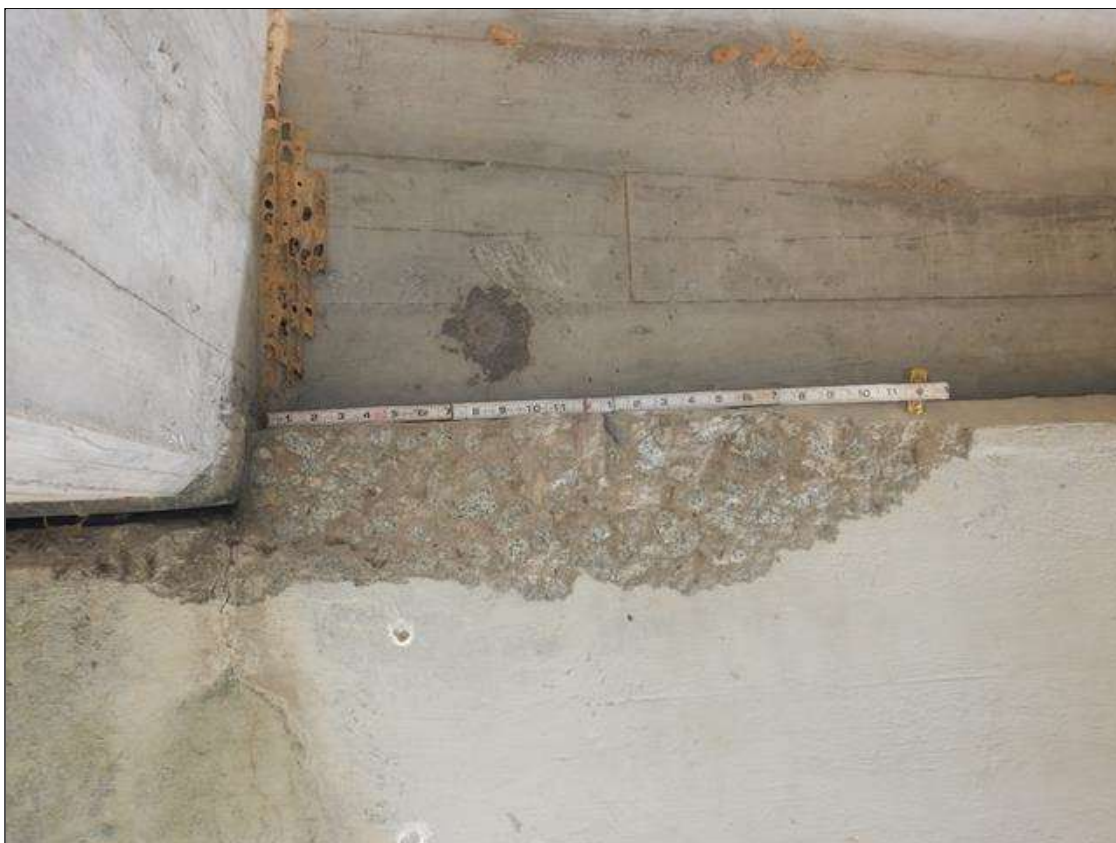
Bent 4 Cap 1: 2'-5" LONG X 6" HIGH X UP TO 4" DEEP SPALL IN TOP OF CAP, WEST FACE, BAY 1.

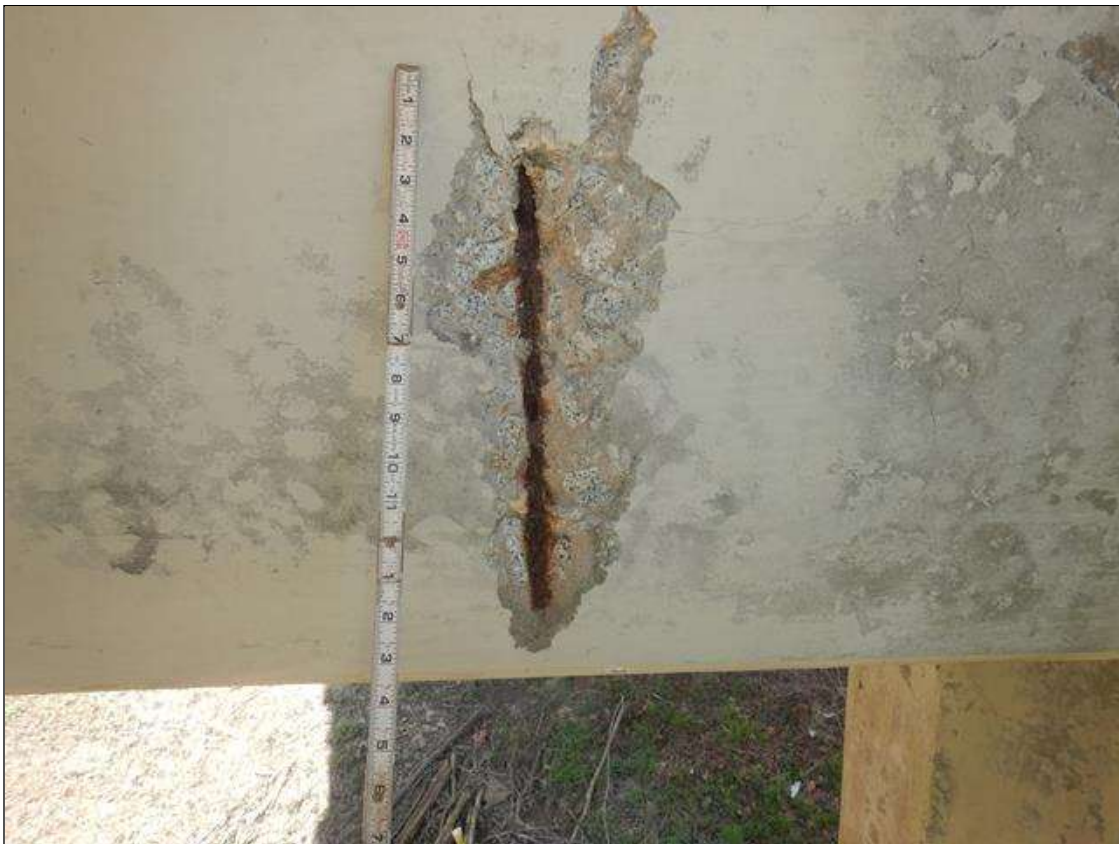
Bent 2 Cap 1: 17" HIGH X 5" WIDE X 1" DEEP SPALL WITH EXPOSED REINFORCEMENT WITH NO MEASURABLE SECTION LOSS ON EAST FACE BELOW BEAM 1

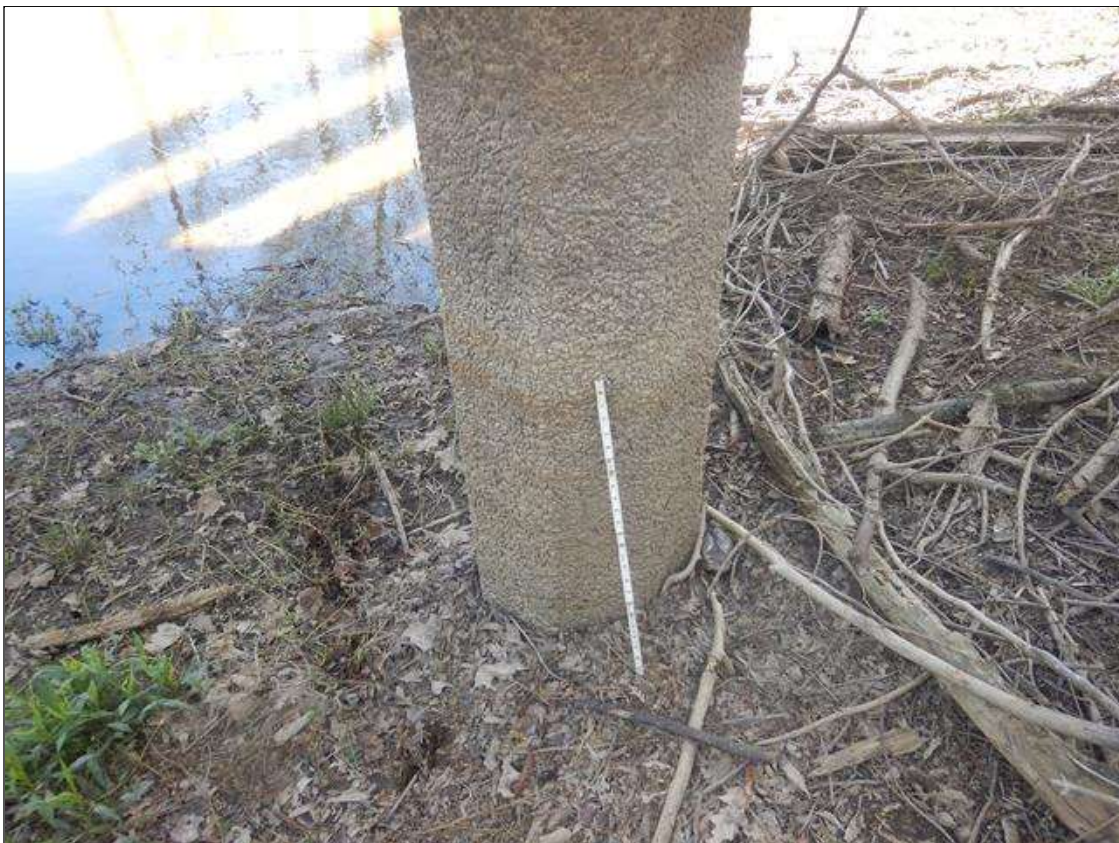
Bent 2 Pile 1: EXPOSED AGGREGATE AND ABRASION FOR 5 FT STARTING AT GROUND LEVEL.

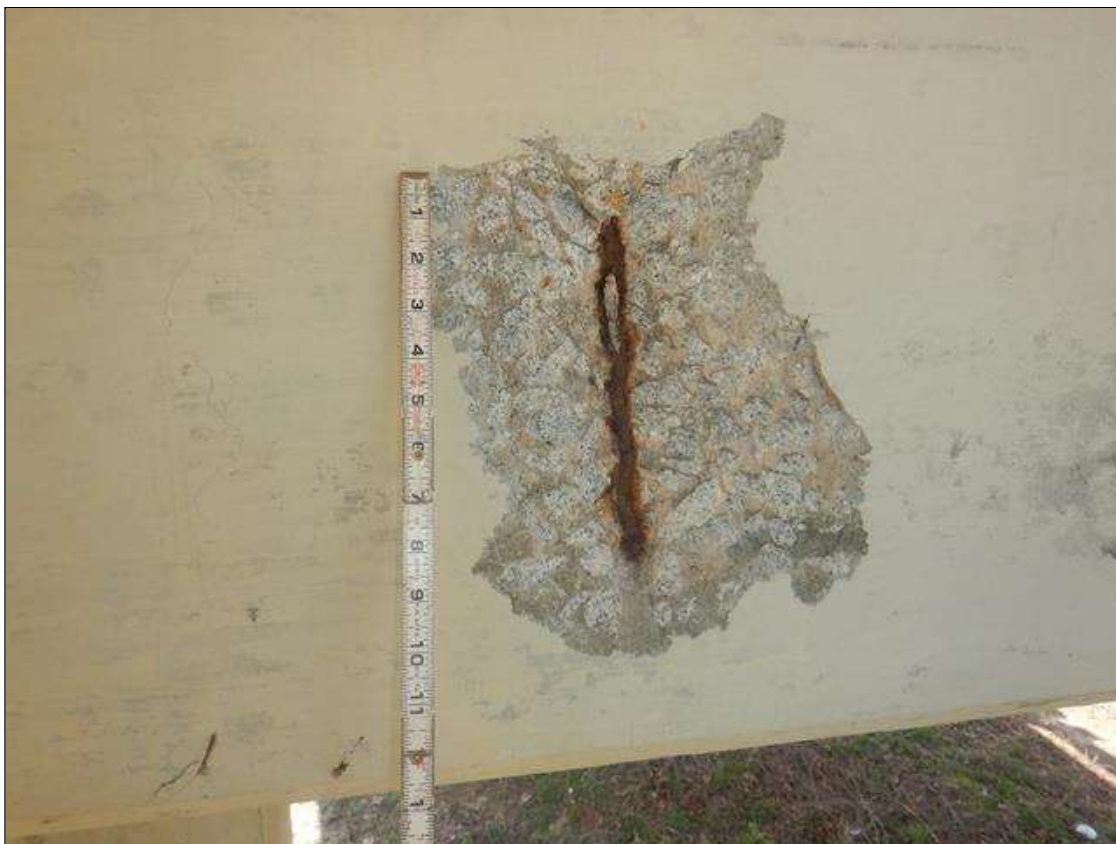
Bent 2 Cap 1: 1' HIGH X 9" WIDE X 1" DEEP SPALL ON EAST FACE BELOW BAY 1 WITH EXPOSED REINFORCING, NO MEASURABLE SECTION LOSS

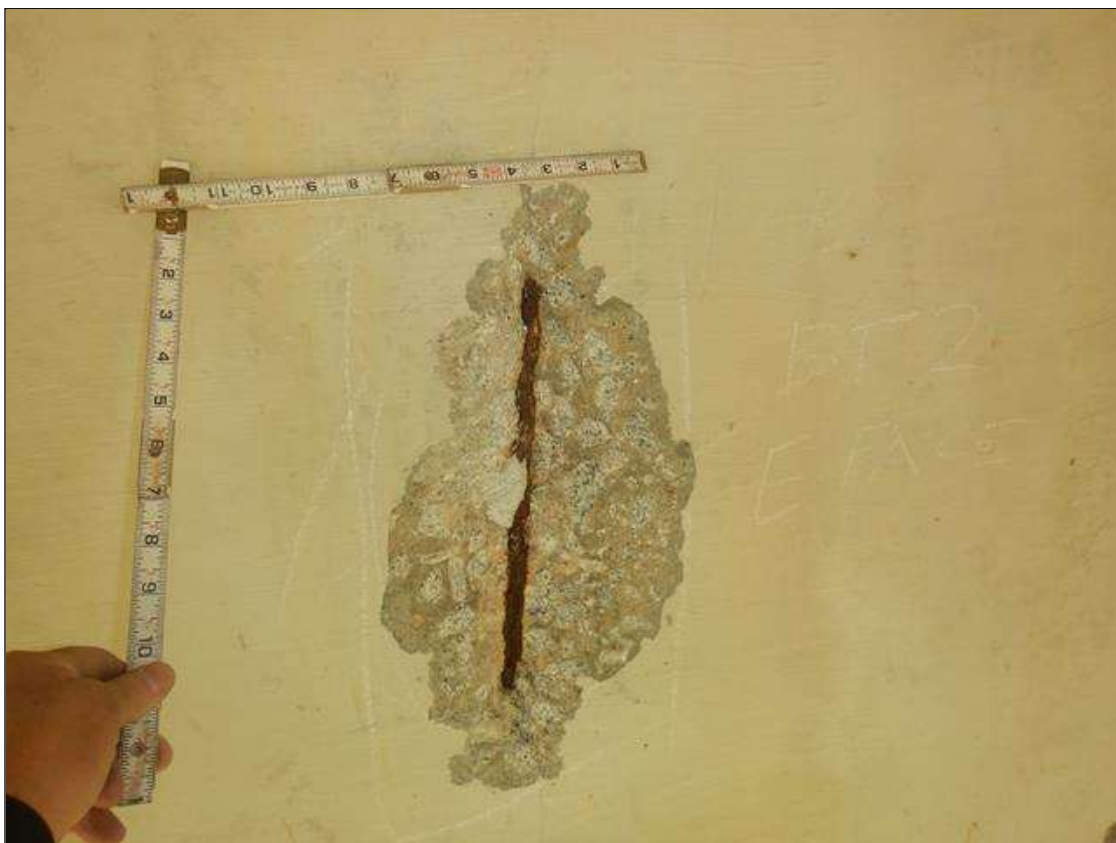
Bent 2 Cap 1: 1'-6" HIGH X 9" WIDE X 1" DEEP SPALL ON EAST FACE BELOW BAY 2 WITH EXPOSED REINFORCING, NO MEASURABLE SECTION LOSS

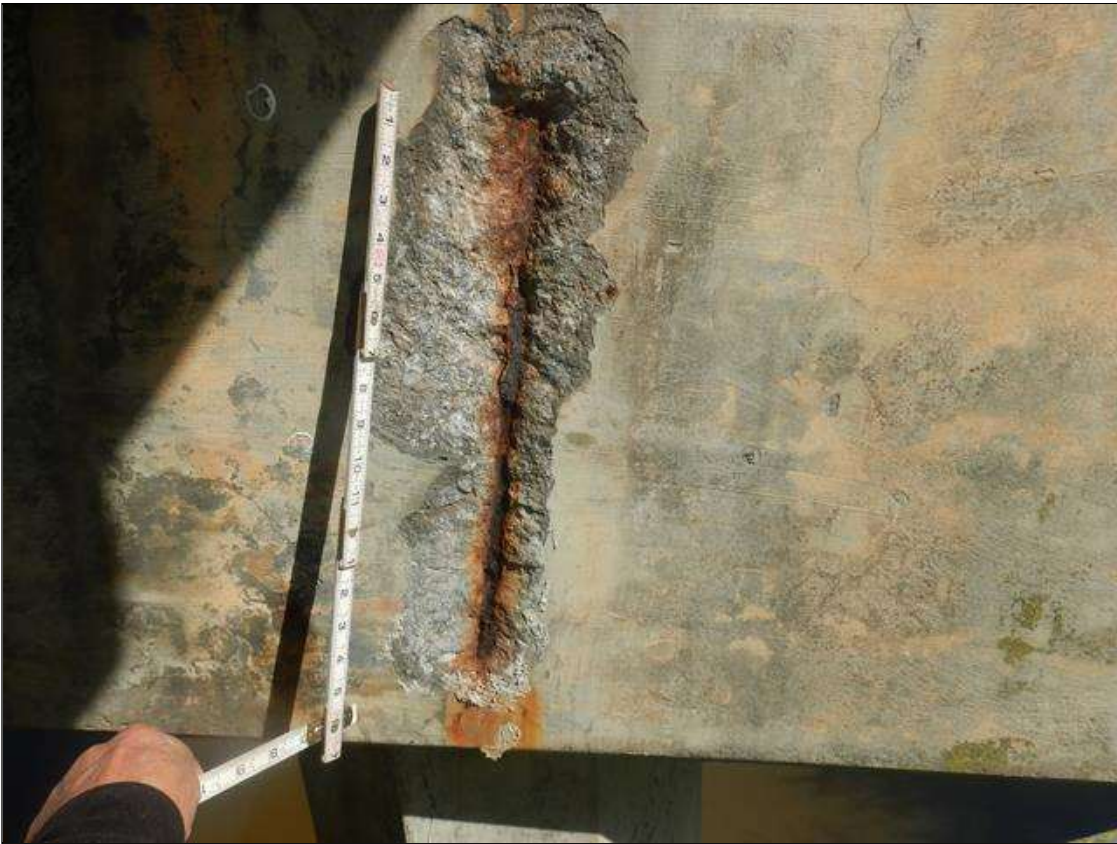
Bent 3 Cap 1: 1'-8" HIGH X 6" WIDE X 1" DEEP SPALL WITH EXPOSED REINFORCEMENT WITH NO MEASURABLE SECTION LOSS IN WEST FACE, BELOW BEAM 4.
