NC DEPARTMENT OF TRANSPORTATION
 DIVISION OF HIGHWAYS
 STRUCTURE MANAGEMENT UNIT

ATTENTION: **PAR'S ISSUED, DATA CHANGES**

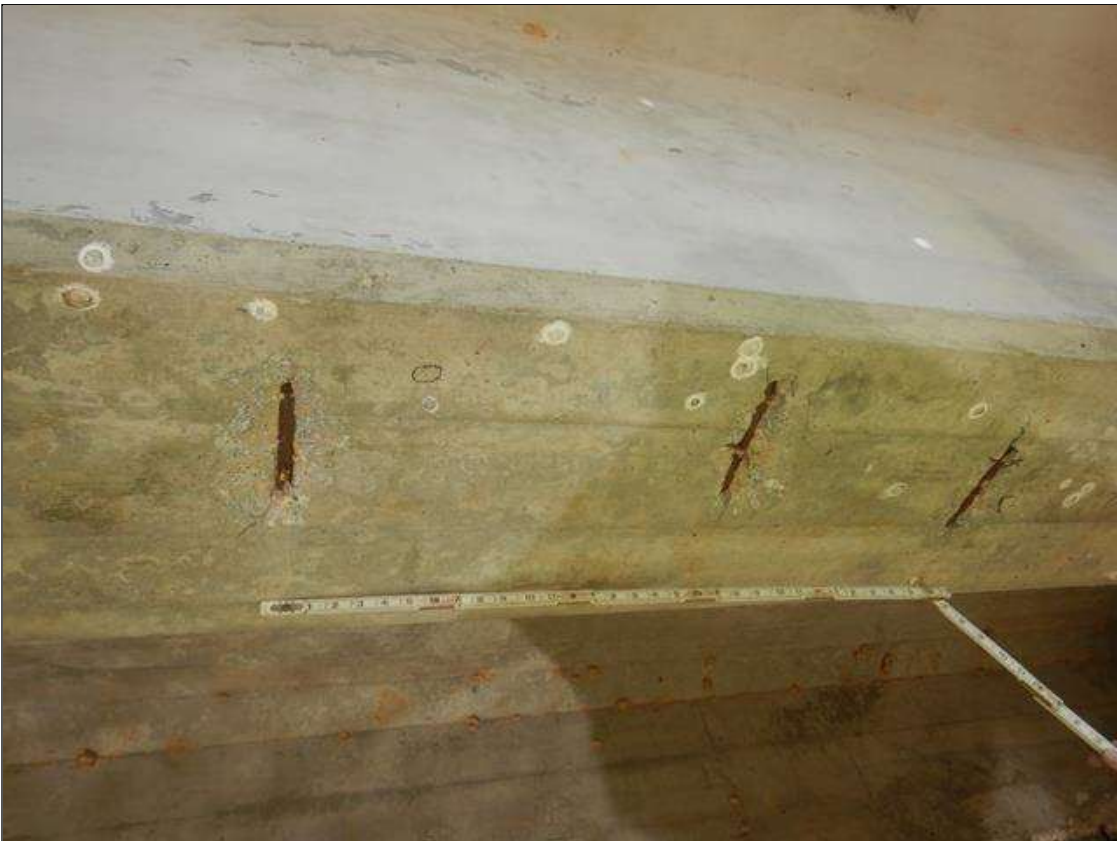
Span 3 Beam 4: THREE (3) 8" LONG X 3" WIDE X 1/2" DEEP SPALLS WITH EXPOSED REINFORCEMENT WITH NO MEASURABLE LOSS IN UNDERSIDE OF BEAM, STARTING AT 8 FT FROM BENT 3.

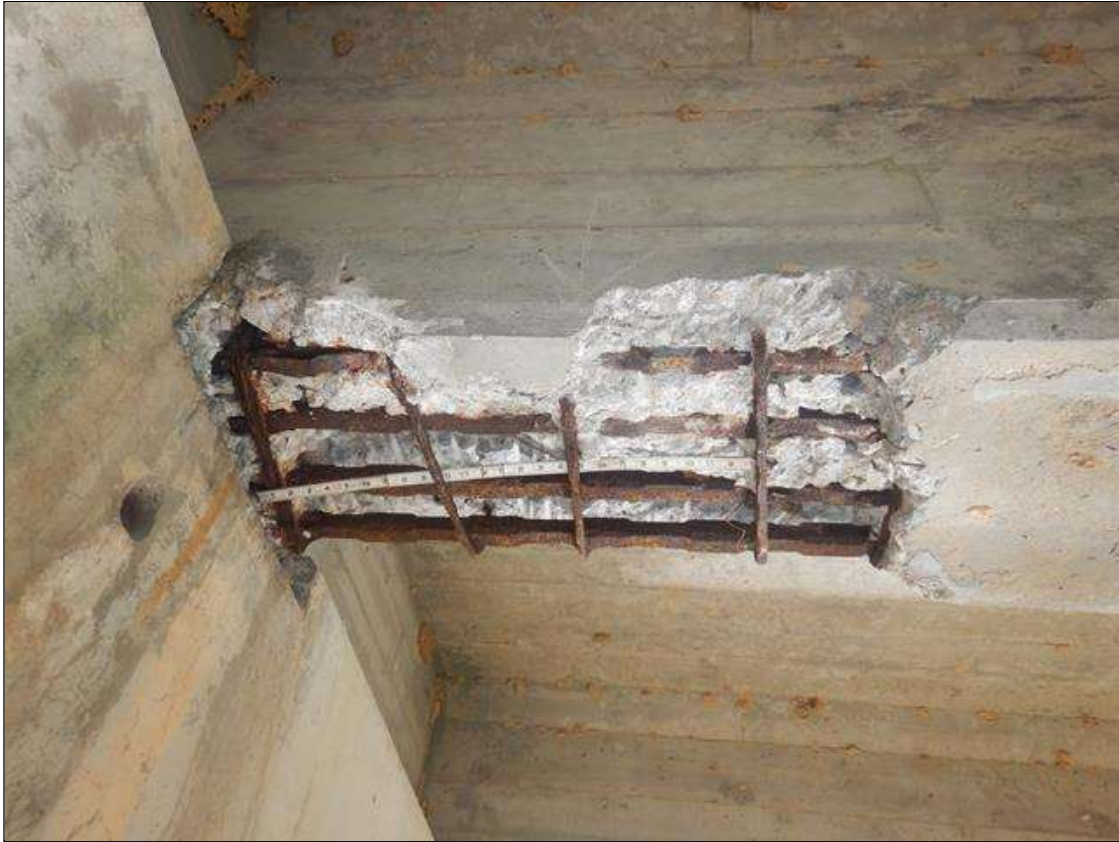
Span 3 Beam 3: PAR: 3'-8" LONG X 18" WIDE X UP TO 5" DEEP SPALL WITH EXPOSED REINFORCEMENT IN BOTTOM FLANGE AT BENT 3, EXTENDING 13" HIGH ON THE SOUTH FACE AND 4" HIGH ON THE NORTH FACE. FOUR LONGITUDINAL BARS AND 6 STIRRUPS EXPOSED WITH NO MEASURABLE SECTION LOSS IN LONGITUDINAL BARS AND 60% AVG SECTION REMAINING IN STIRRUPS.

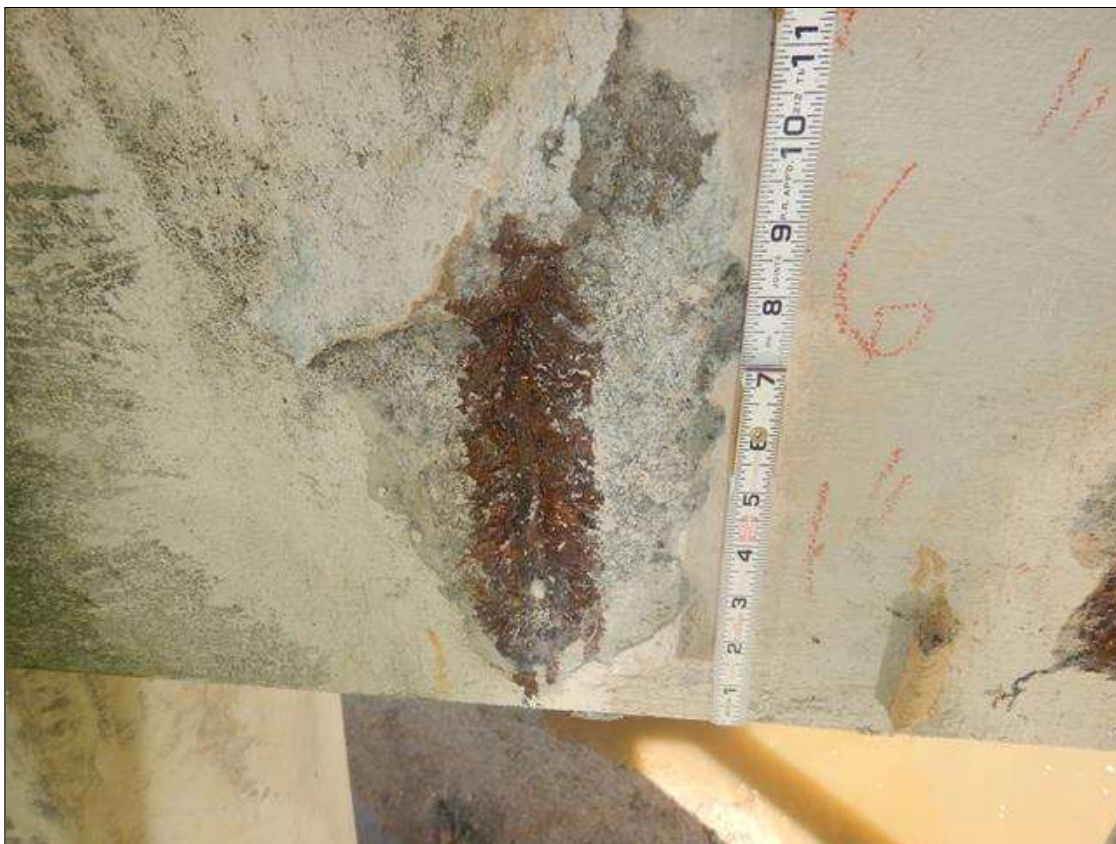
Bent 3 Cap 1: 1' HIGH X 6" WIDE X 1" DEEP SPALL WITH EXPOSED REINFORCING, NO MEASURABLE SECTION LOSS, AT BOTTOM OF WEST FACE BELOW BAY 1

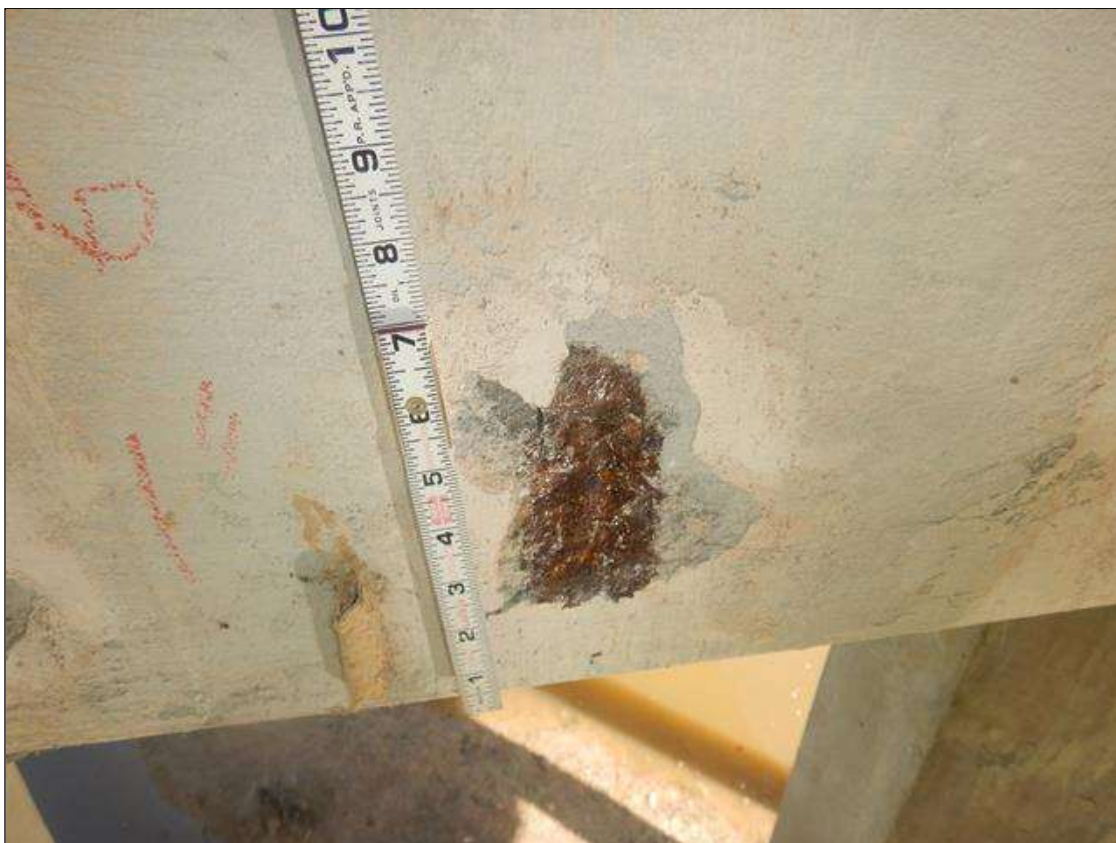
Bent 3 Cap 1: 6" HIGH X 4" WIDE X 1" DEEP SPALL WITH EXPOSED REINFORCING, NO MEASURABLE SECTION LOSS, AT BOTTOM OF WEST FACE BELOW BAY 1

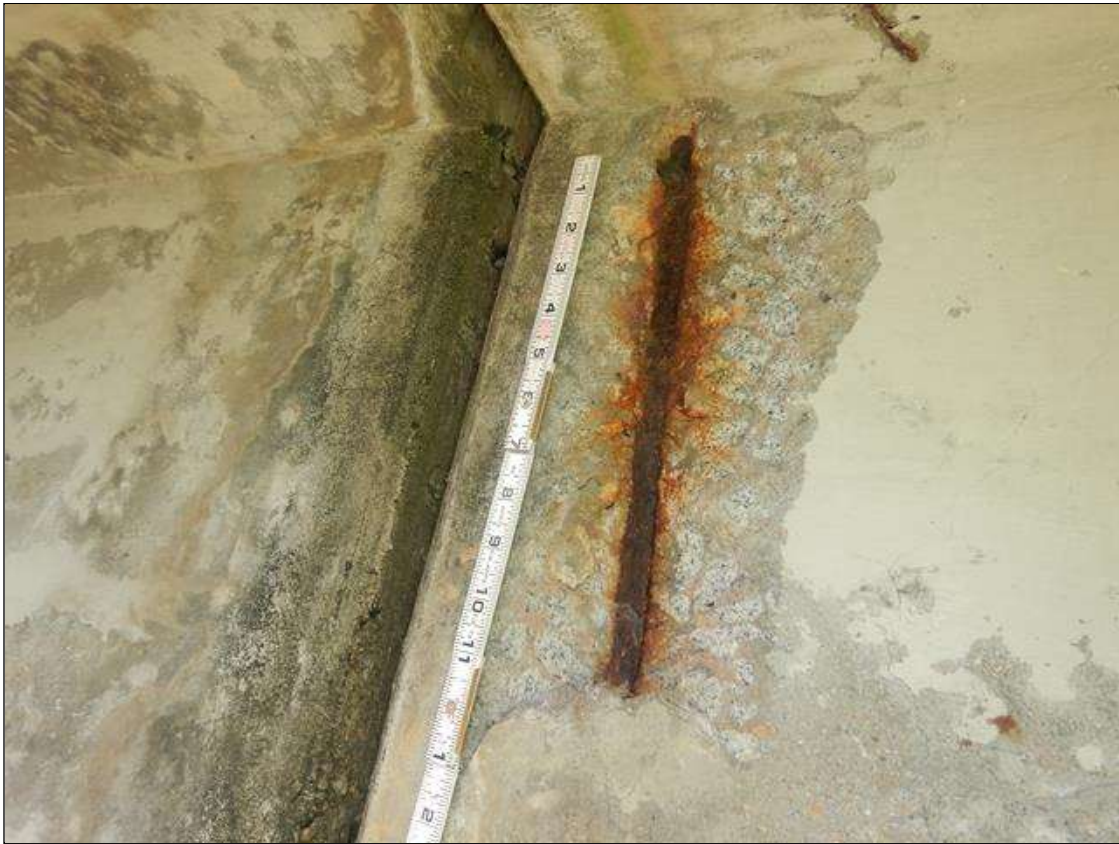
Span 2 Beam 4: PAR: 11" HIGH X 6" WIDE X 1" DEEP SPALL WITH EXPOSED REINFORCEMENT WITH MINOR SECTION LOSS (1/16") IN SOUTH FACE AT BENT 1.

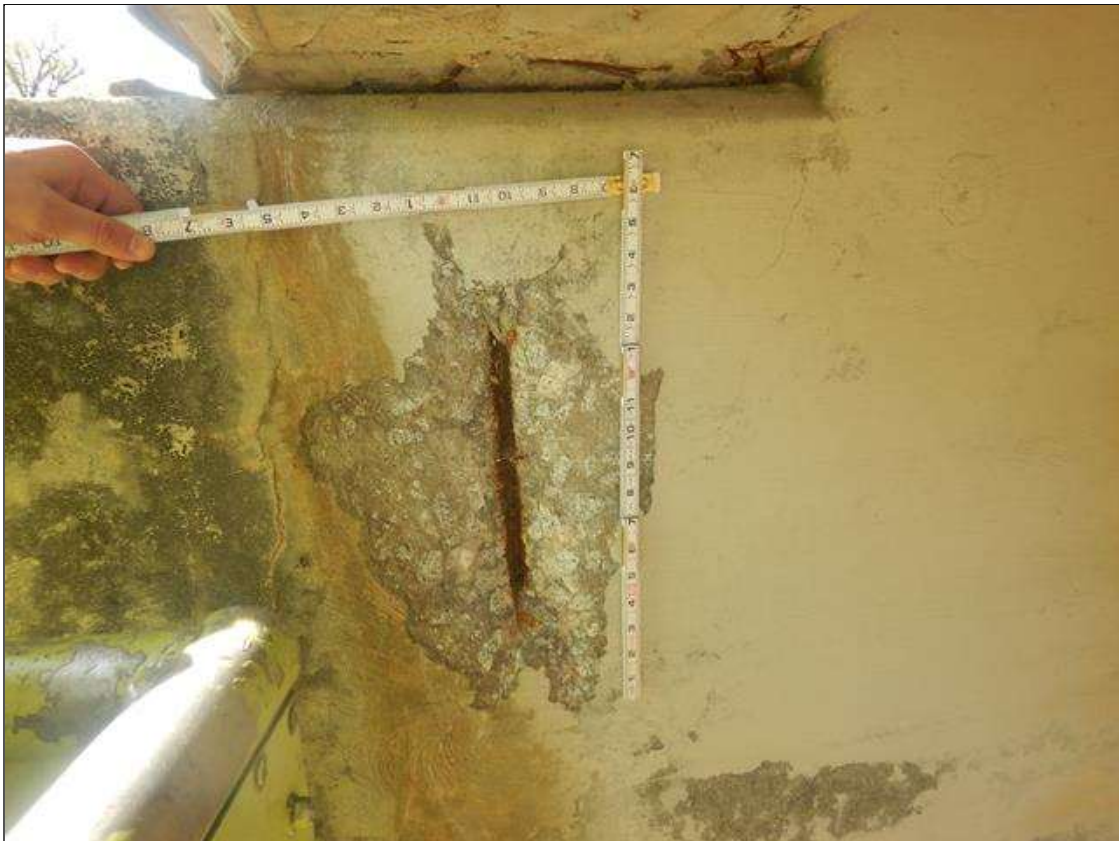
Bent 1 Cap 1: 16" HIGH X 11" WIDE X 1" DEEP SPALL WITH EXPOSED REINFORCEMENT WITH NO MEASURABLE SECTION LOSS EAST FACE UNDER BEAM 4

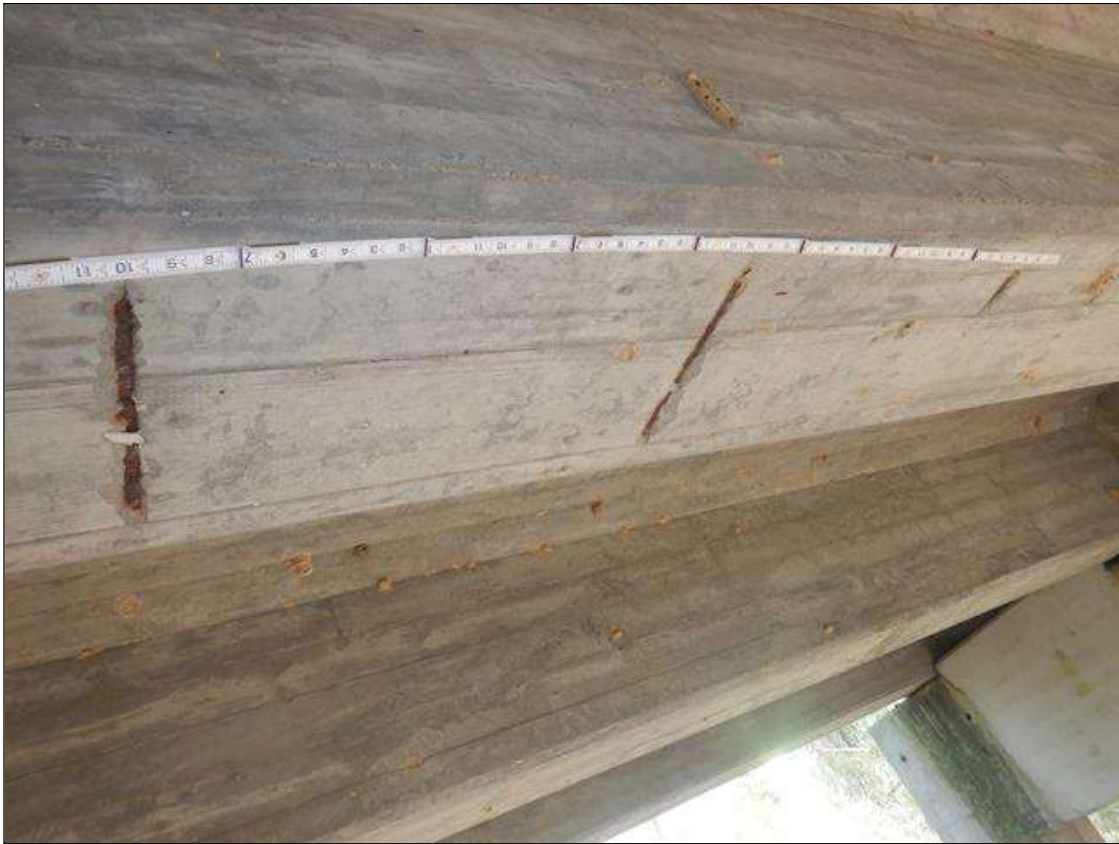
Span 1 Beam 3: (3) 11" LONG X 1" WIDE X 1/4" DEEP SPALLS WITH EXPOSED REINFORCEMENT WITH NO MEASURABLE SECTION LOSS IN BOTTOM FLANGE BETWEEN INTERIOR DIAPHRAGM AND BENT 1.

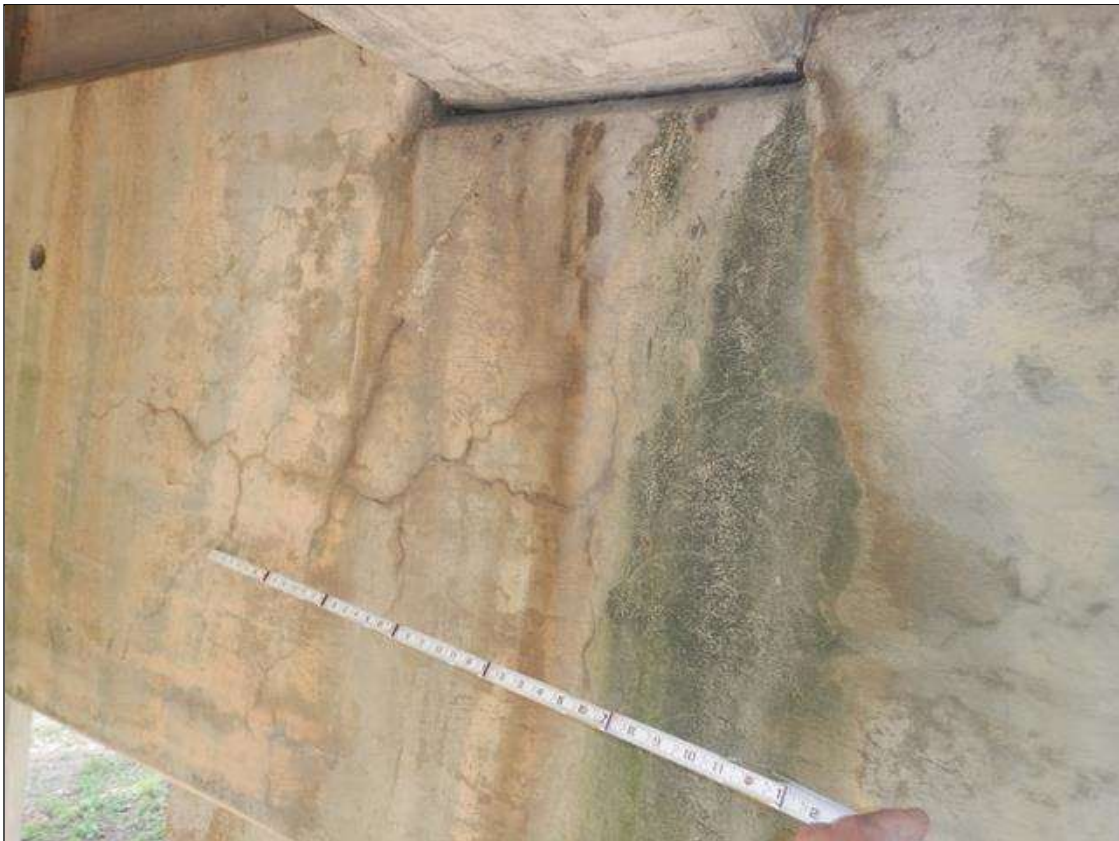
Bent 1 Cap 1: FULL HEIGHT AREA OF HAIRLINE MAP CRACKING WITH EFFLORESCENCE AND LEAKAGE STAINS IN WEST FACE, BELOW BAYS 2 AND 3

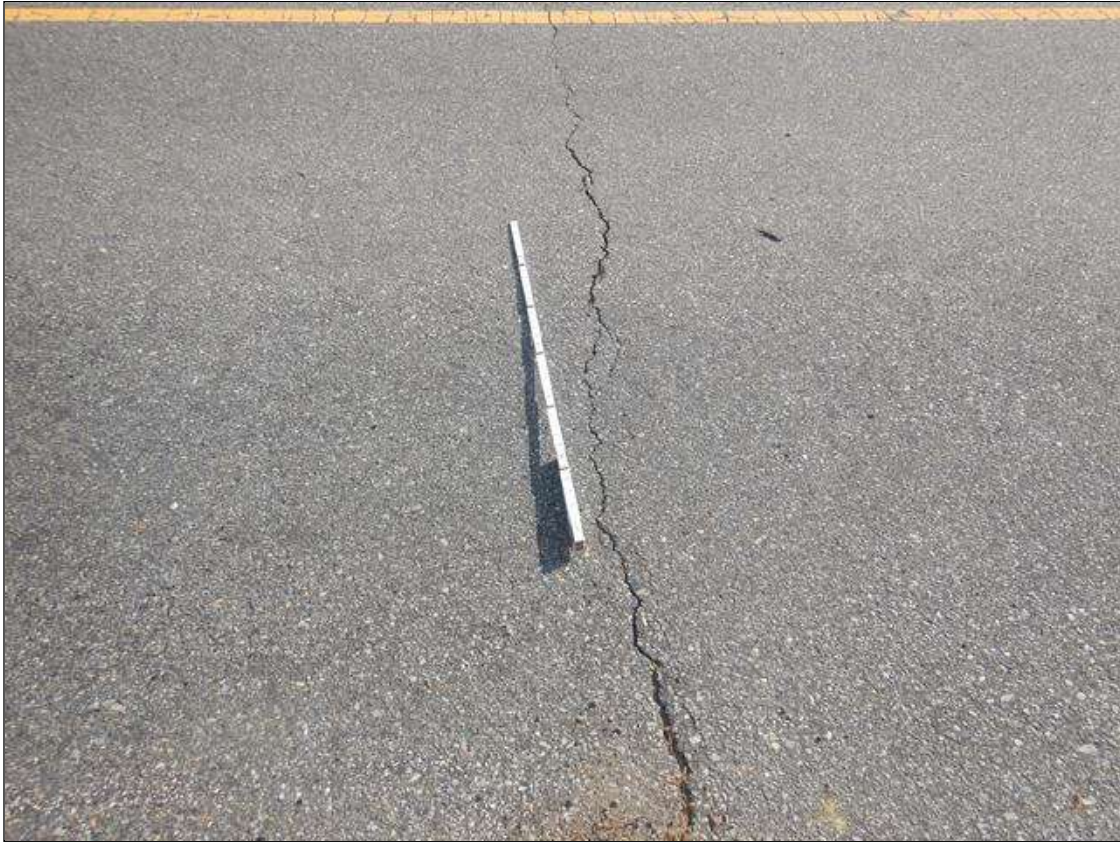
Span 1 Wearing Surface: UP TO 3/16" WIDE X FULL DECK WIDTH CRACK OVER BENT 1, CRACK EXPANDS TO 1 1/2" WIDE IN SHOULDERS

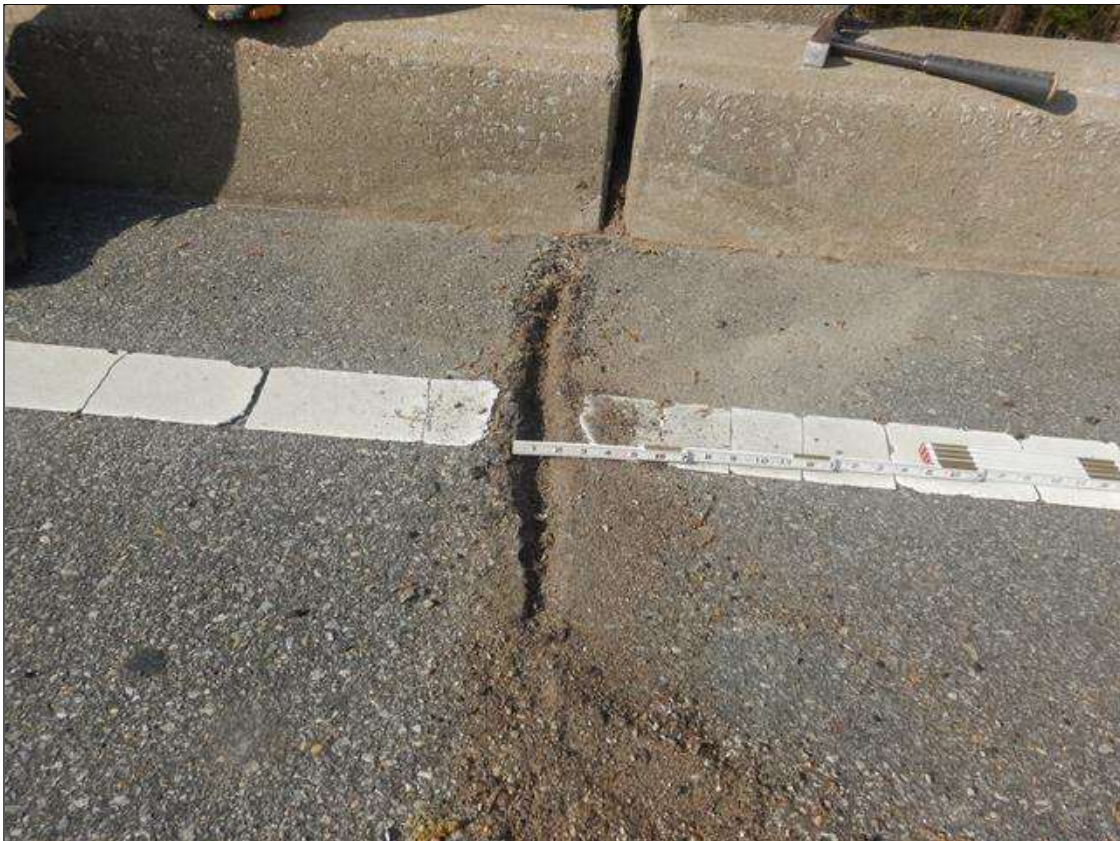
Span 1 Wearing Surface: UP TO 3/16" WIDE X FULL DECK WIDTH CRACK OVER BENT 1, CRACK EXPANDS TO 1 1/2" WIDE IN SHOULDERS

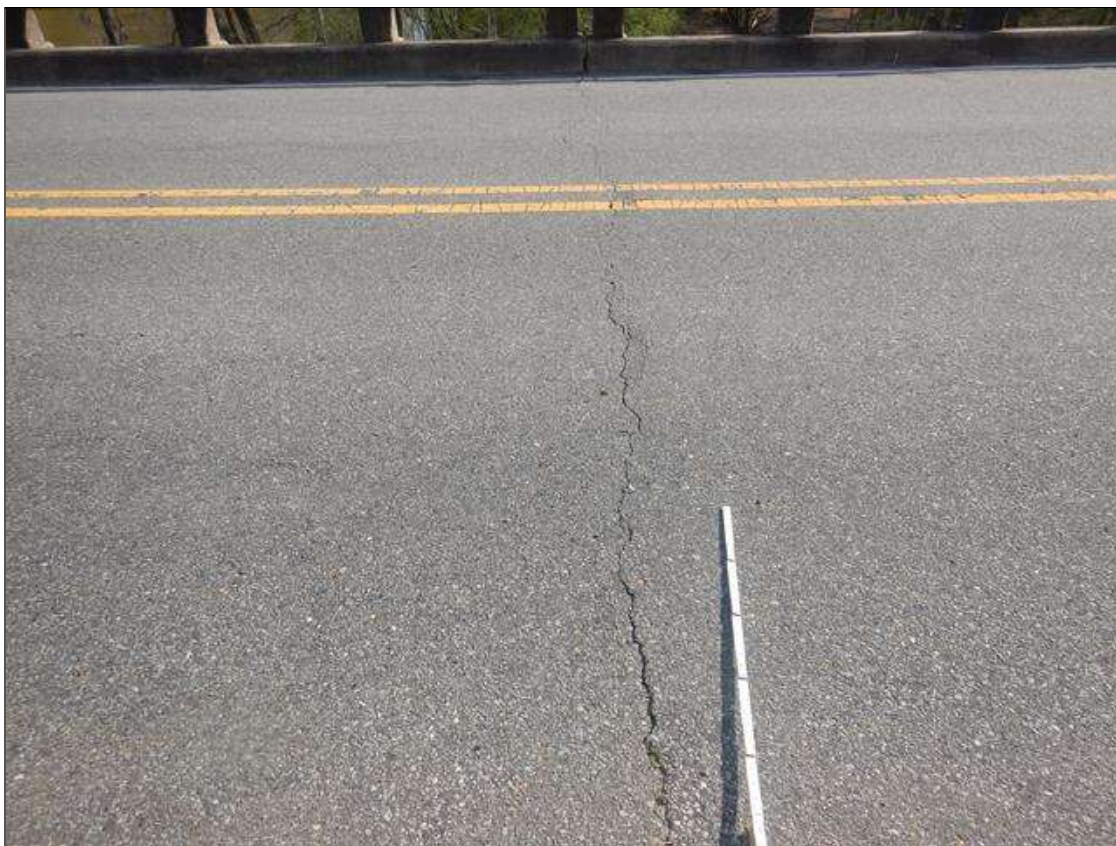
Span 2 Wearing Surface: UP TO 1/8" WIDE X FULL DECK WIDTH CRACK OVER BENT 2, CRACK EXPANDS TO 1 1/4" WIDE IN SHOULDERS

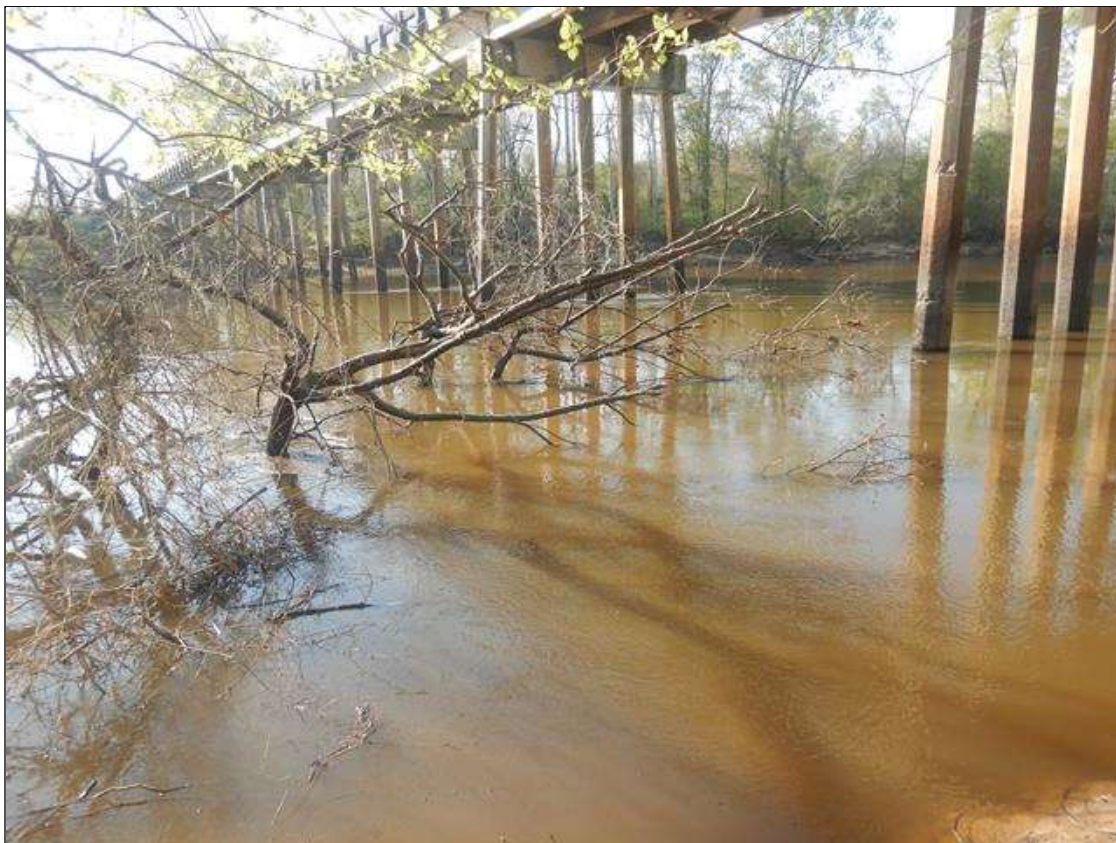
PAR: AREA OF FALLEN TREES AND DRIFT UPSTREAM OF BENTS 7 AND 8 CREATING A PARTIAL BLOCKAGE

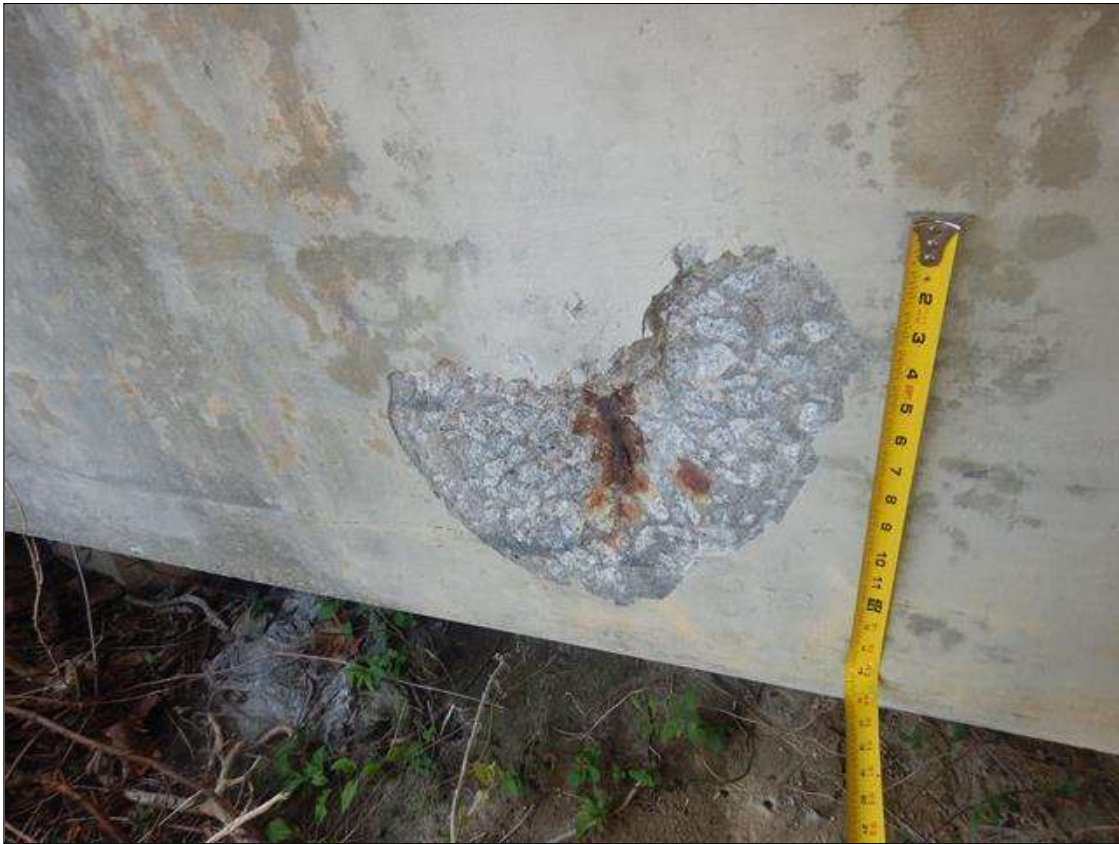
End bent 1 Cap 1: UP TO 15" WIDE X 12" HIGH X 1" DEEP SPALL WITH EXPOSED REINFORCEMENT UNDER BEAM 4 WITH NO MEASURABLE SECTION LOSS

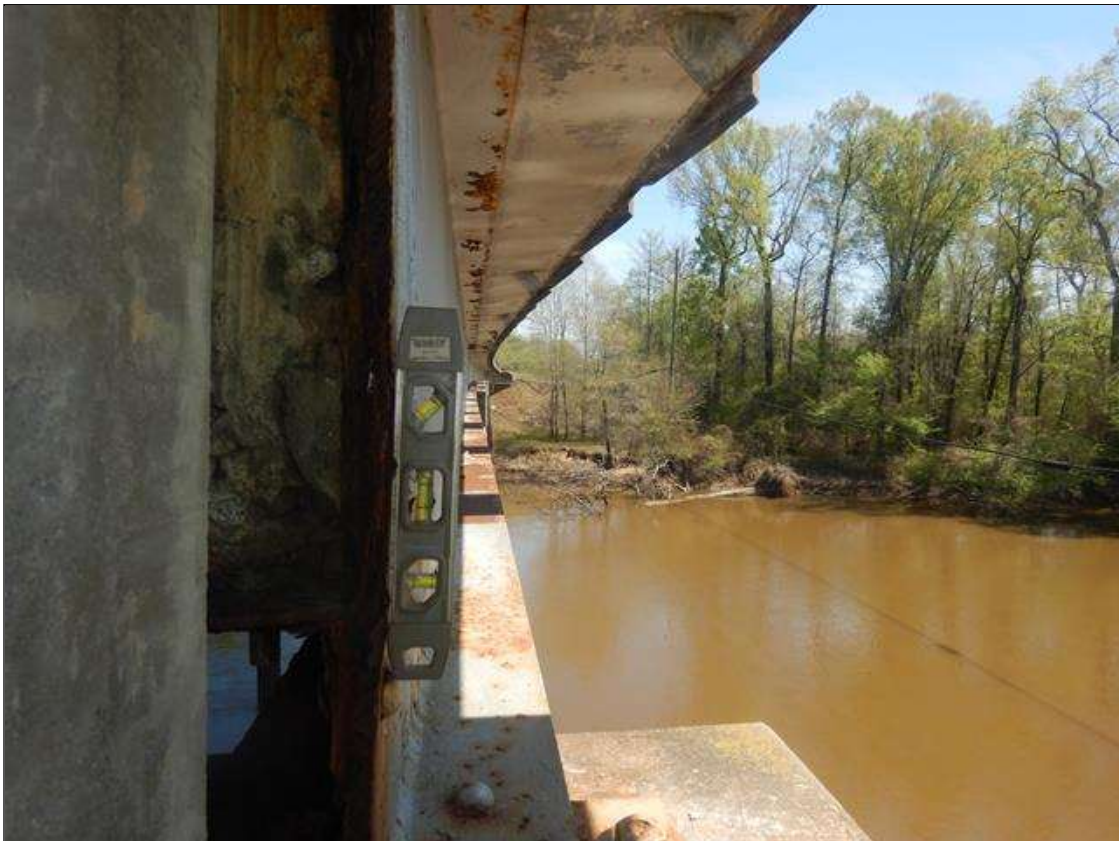
Span 6 Beam 5: PAR: UP TO 6" LONG AREA OF DISTORTION IN WEB AT BOTH ENDS OF BEAM. WEB IS BOWED TO THE SOUTH UP TO 1/2"

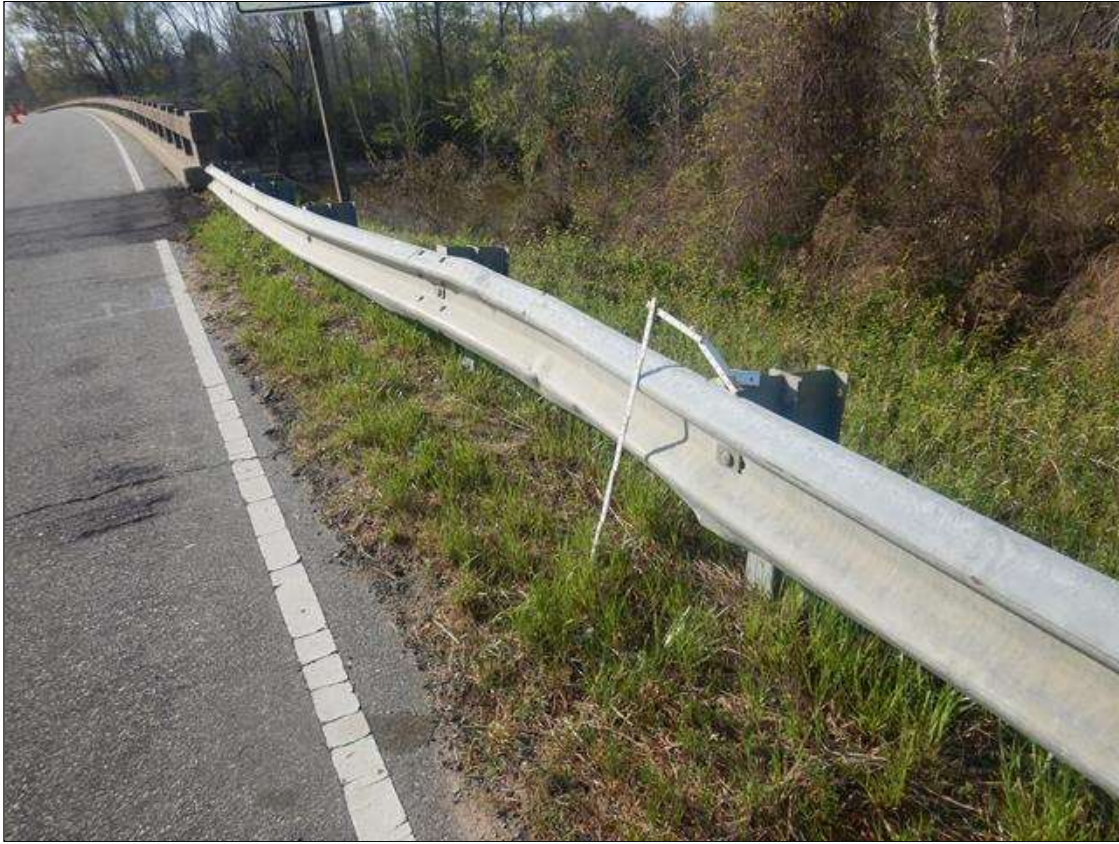
PAR: MODERATE AREA OF IMPACT DAMAGE ON NORTHWEST GUARDRAIL STARTING APPROXIMATELY 30' FROM EAST APPROACH, POSTS 5, 6, AND 7 ARE LEANING AND POSTS 6 AND 7 ARE TWISTED

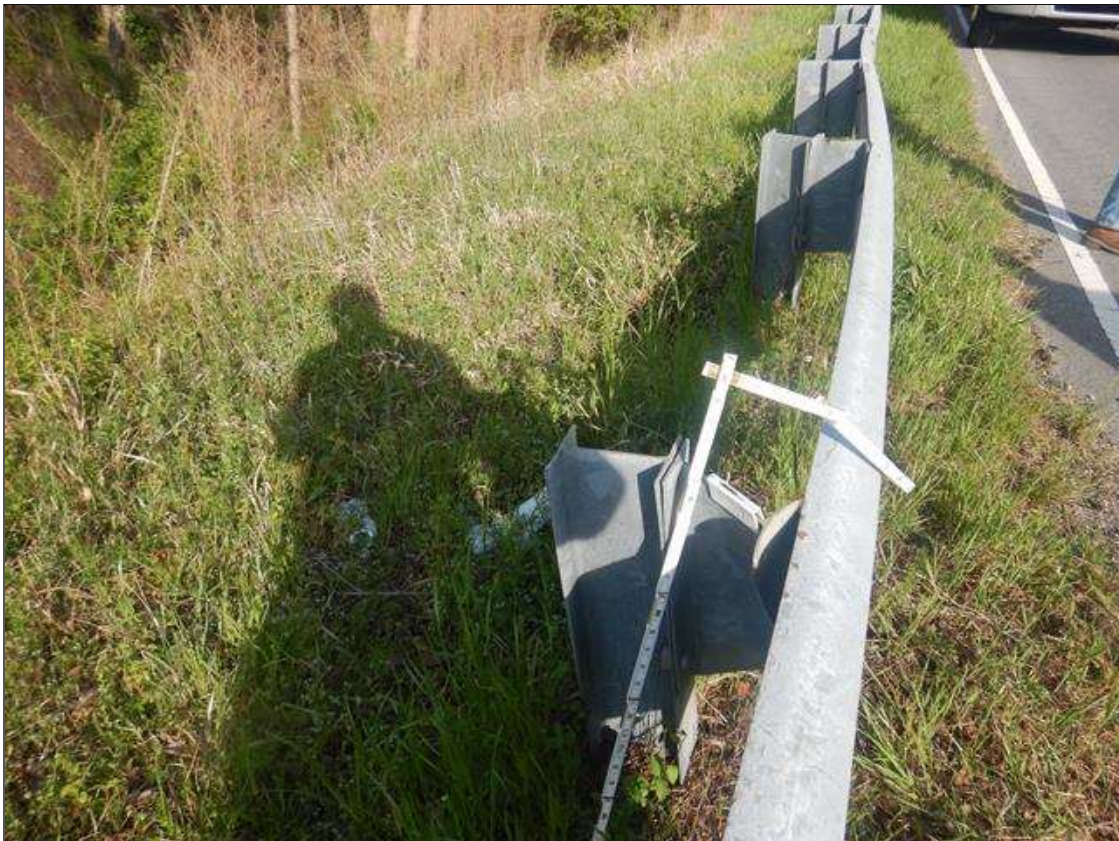
PAR: MODERATE AREA OF IMPACT DAMAGE ON NORTHWEST GUARDRAIL STARTING APPROXIMATELY 30' FROM EAST APPROACH, POSTS 5, 6, AND 7 ARE LEANING AND POSTS 6 AND 7 ARE TWISTED

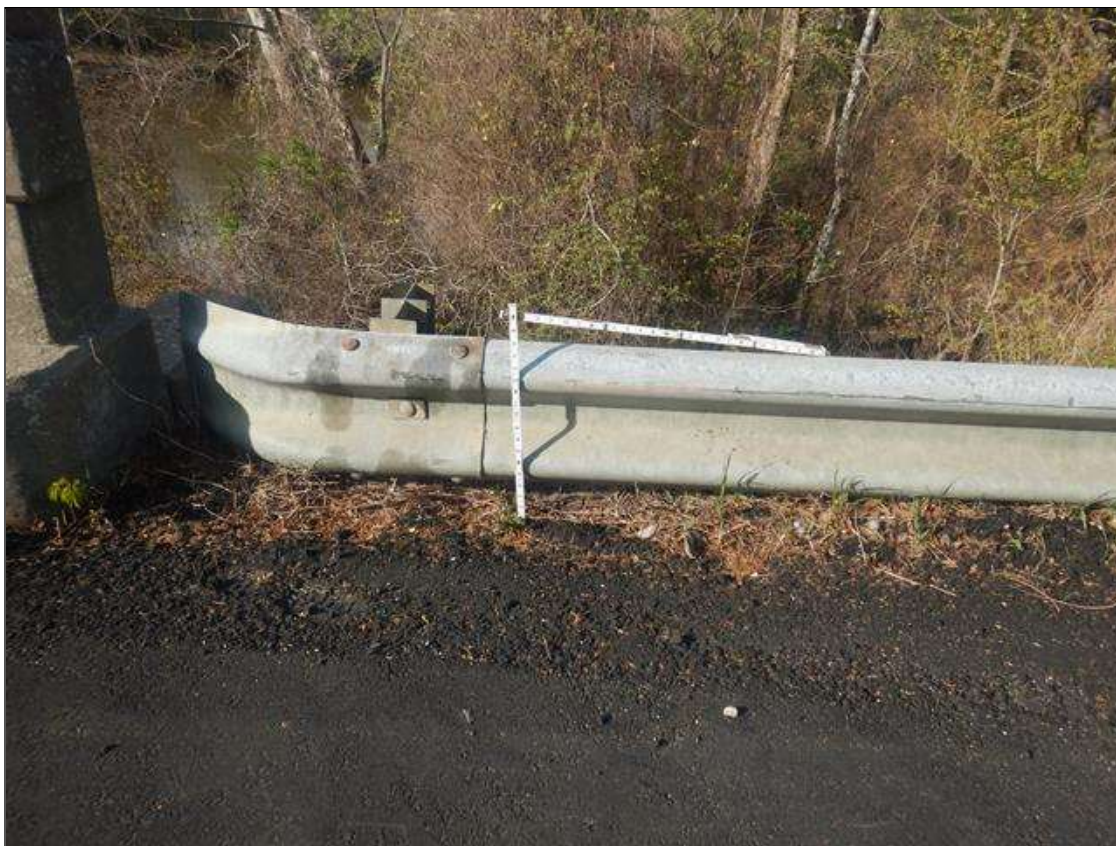
PAR: NORTHEAST GUARDRAIL IS SITTING ON GROUND, 14" HIGH CREATING A POTENTIAL SAFETY HAZARD

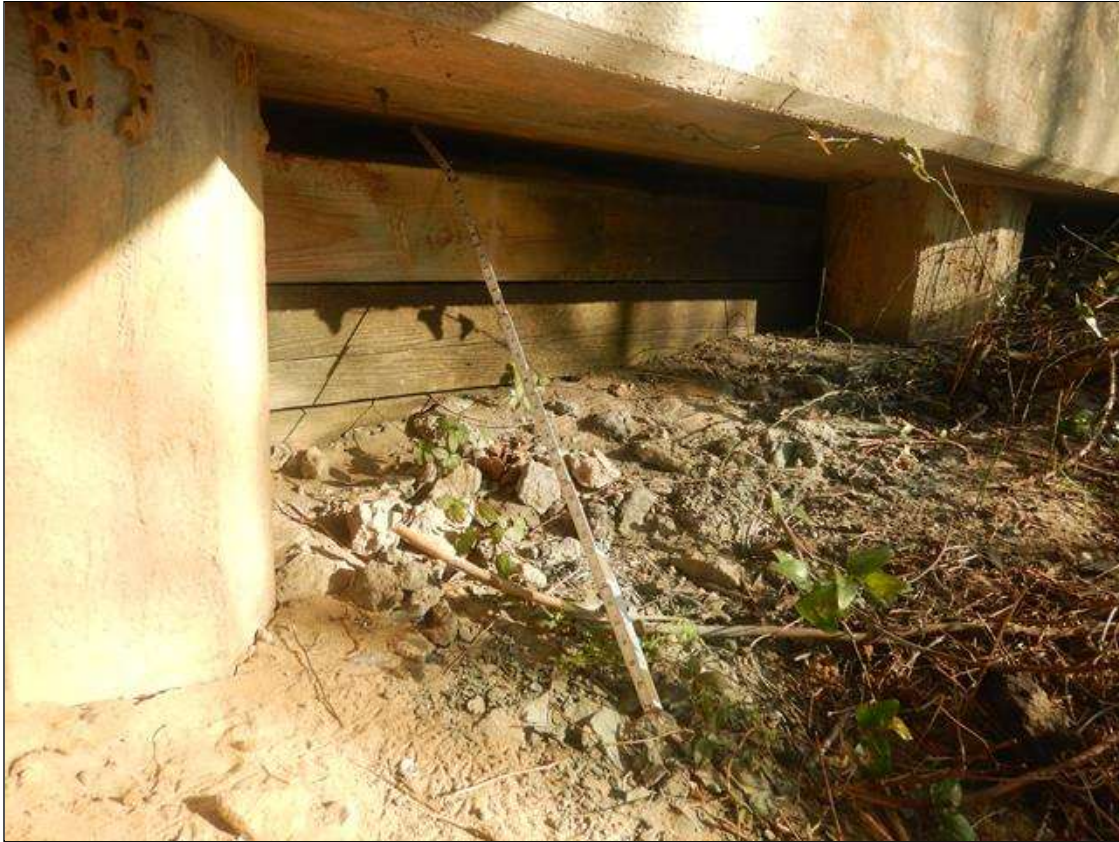
End bent 2 Abutment: PAR: FULL LENGTH X UP TO 1'-8" HIGH X FULL DEPTH VOID UNDER CAP WITH ALL PILES EXPOSED. THERE IS A TIMBER BACKWALL IN PLACE BEHIND PILES 4-5. THERE IS NO RETAINING MEASURE IN PLACE TO HOLD BACK FILL FOR THE REMAINDER OF CAP LENGTH

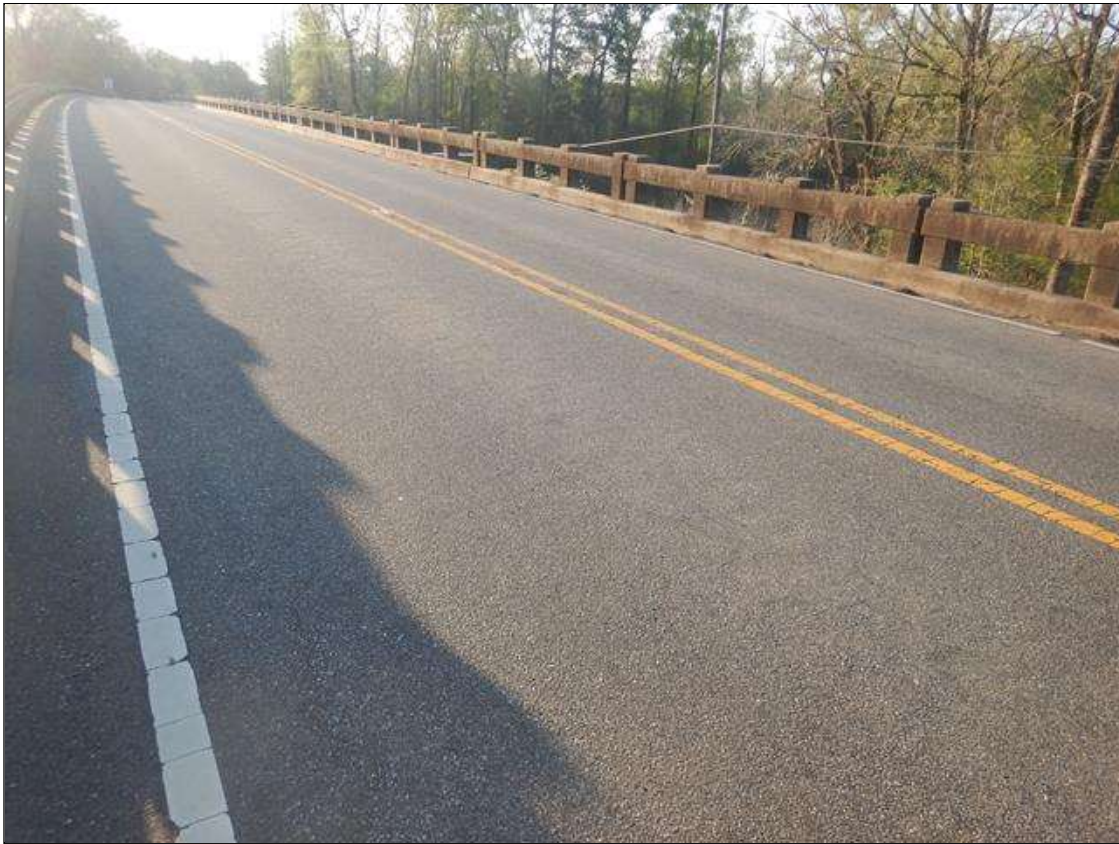
TYPICAL WEARING SURFACE, SPAN 1 SHOWN

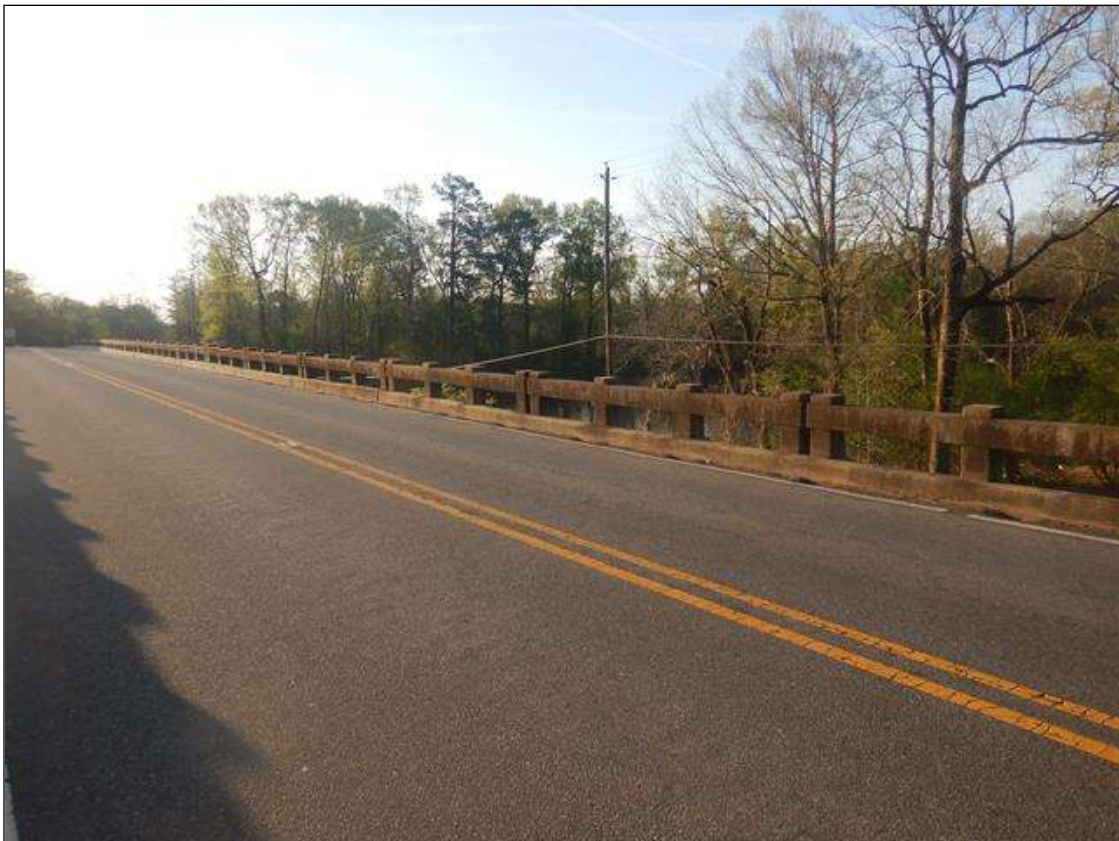
RIGHT BRIDGE RAIL, LEFT BRIDGE RAIL SIMILAR

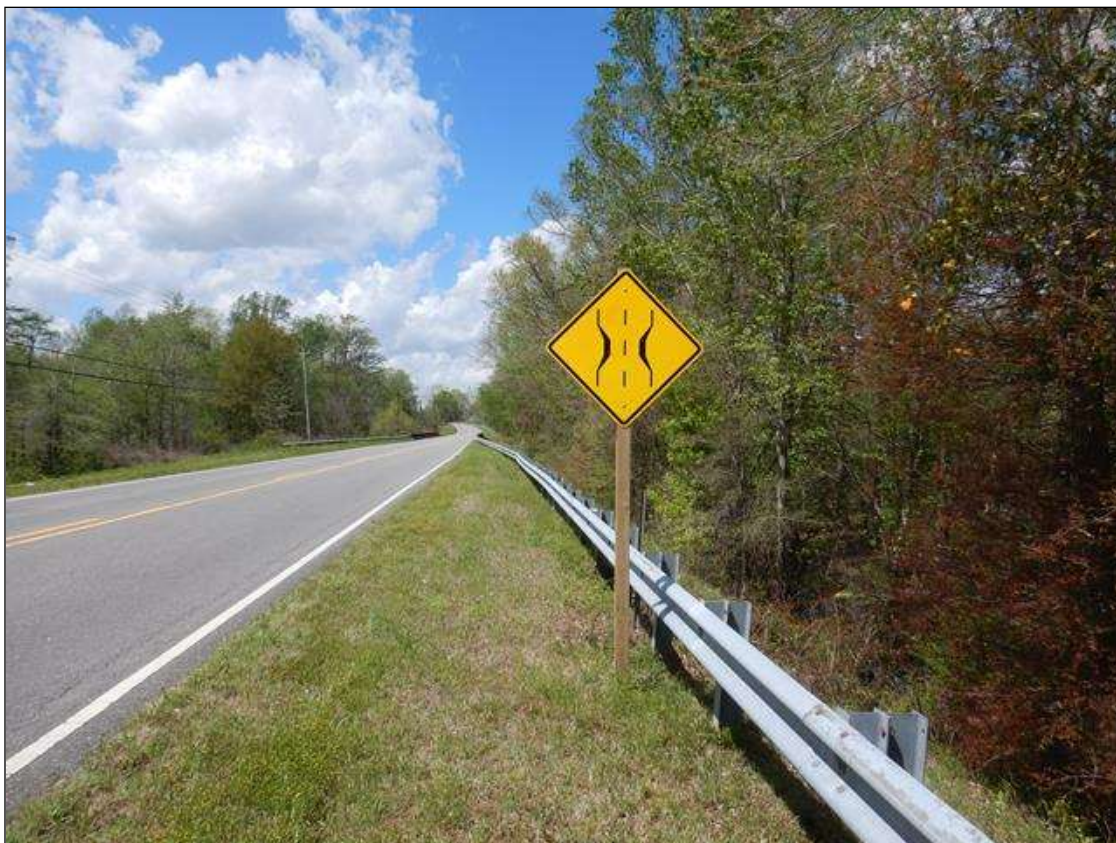
EAST APPROACH NARROW BRIDGE SIGN, 0.02 MILES FROM END BENT 2

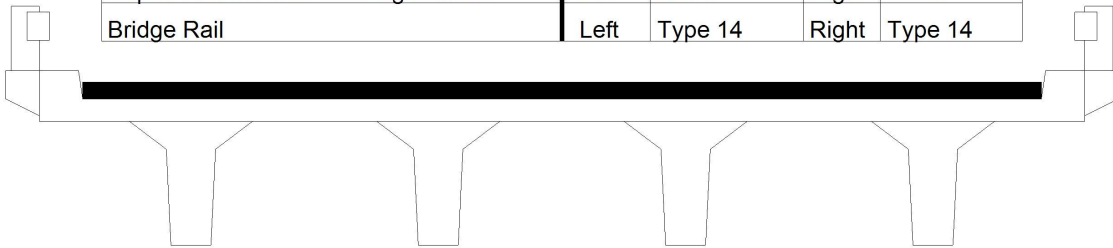
Measurements for Span #	1		
Deck Thickness	0.562'	Left Overhang	3.625'
Top of Rail to Bottom of Beam	6.375'	Right Overhang	3.625'

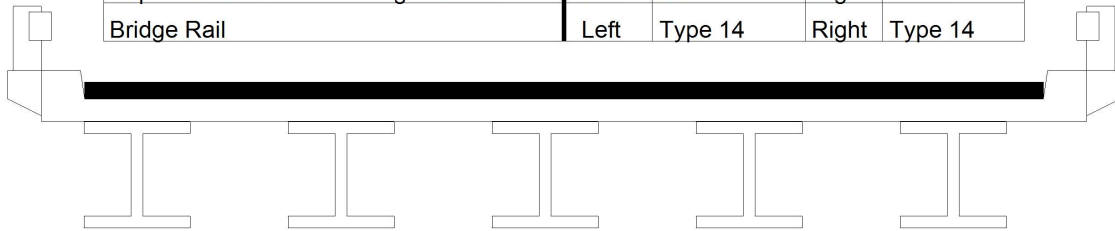
Measurements for Span #	5		
Deck Thickness	0.562	Left Overhang	2.625
Top of Rail to Bottom of Beam	6.521	Right Overhang	2.625

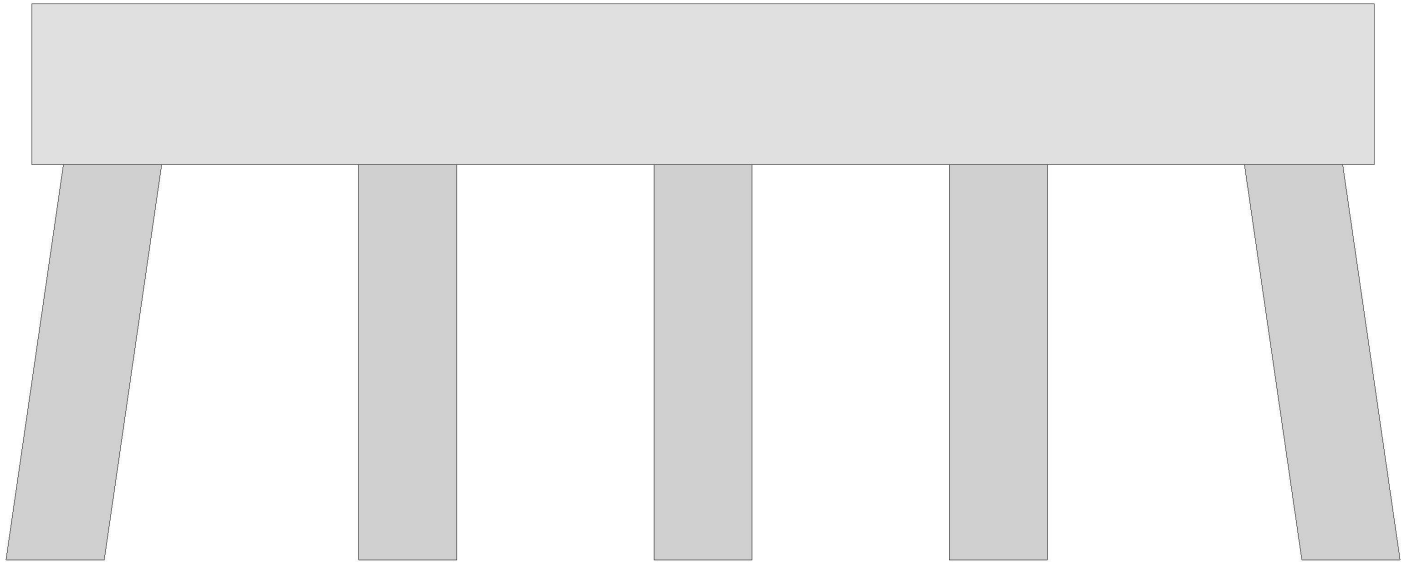
Cap Information			Material Cast-in-Place Concrete							
Length	Width	Height	Left Overhang	Right Overhang	Left Beam to End of Cap.	Right Beam to End of Cap.				
25.000 ft.	3.250 ft.	3.000 ft.	1.833 ft.	1.833 ft.	1.750 ft.	1.750 ft.				
Subcap Information			Material							
Length	Width	Height	Left Overhang	Right Overhang	Left Pile to Splice.					
Sill Information			Material							
Length	Width	Height								
Pile #	Material	Spacing	Width/Dia.	Height	Length	Orientation	Driven?	Replacement?	Removed?	Collar?
1	Concrete	5.5 ft.	1.667 ft.			Battered	Yes	No	No	No
2	Concrete	5.25 ft.	1.667 ft.			Vertical	Yes	No	No	No
3	Concrete	5.25 ft.	1.667 ft.			Vertical	Yes	No	No	No
4	Concrete	5.334 ft.	1.667 ft.			Vertical	Yes	No	No	No
5	Concrete		1.667 ft.			Battered	Yes	No	No	No
<p>MEASUREMENTS VERIFIED BY JSD 4/8/22</p>										
Bent/Abutment #: 1			Similar Bents: 1,2,3,4,7,8,9

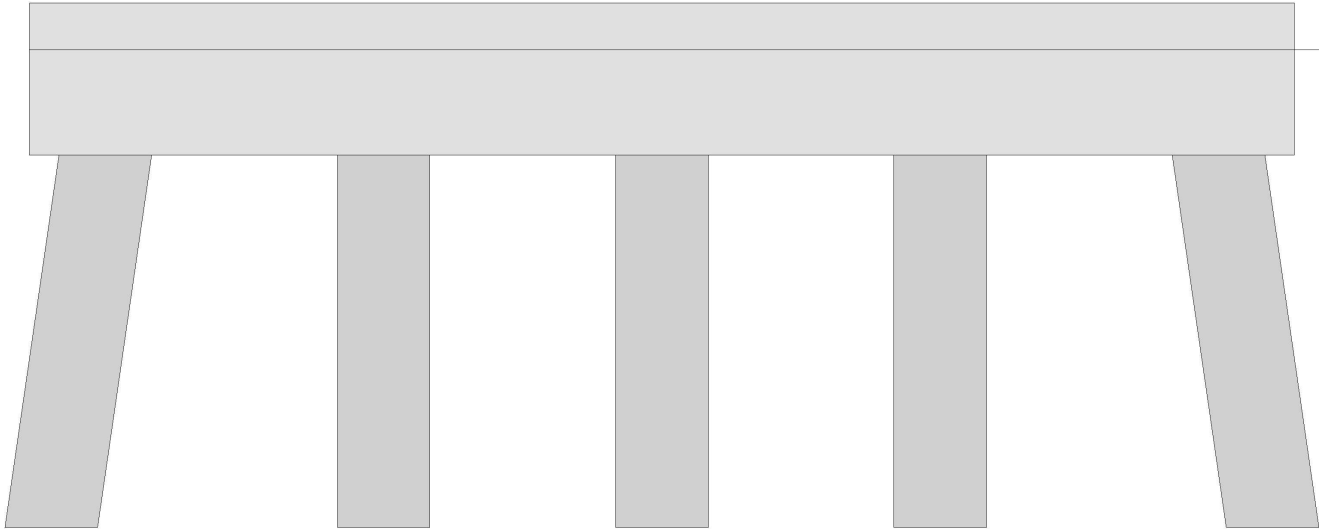
Cap Information			Material Cast-in-Place Concrete							
Length	Width	Height	Left Overhang	Right Overhang	Left Beam to End of Cap.	Right Beam to End of Cap.				
25.000 ft.	3.000 ft.	3.000 ft.	2.00 ft.	2.00 ft.	1.500 ft.	1.500 ft.				
Subcap Information			Material							
Length	Width	Height	Left Overhang	Right Overhang	Left Pile to Splice.					
Sill Information			Material							
Length	Width	Height								
Pile #	Material	Spacing	Width/Dia.	Height	Length	Orientation	Driven?	Replacement?	Removed?	Collar?
1	Concrete	5.167 ft.	1.667 ft.			Battered	Yes	No	No	No
2	Concrete	5.25 ft.	1.667 ft.			Vertical	Yes	No	No	No
3	Concrete	5.25 ft.	1.667 ft.			Vertical	Yes	No	No	No
4	Concrete	5.333 ft.	1.667 ft.			Vertical	Yes	No	No	No
5	Concrete		1.667 ft.			Battered	Yes	No	No	No
MEASUREMENTS VERIFIED BY JSD 4/8/22										
Bent/Abutment #: 5			Similar Bents: 6
