NC DEPARTMENT OF TRANSPORTATION
 DIVISION OF HIGHWAYS
 STRUCTURE MANAGEMENT UNIT

ATTENTION: **PAR'S ISSUED, DATA CHANGES**

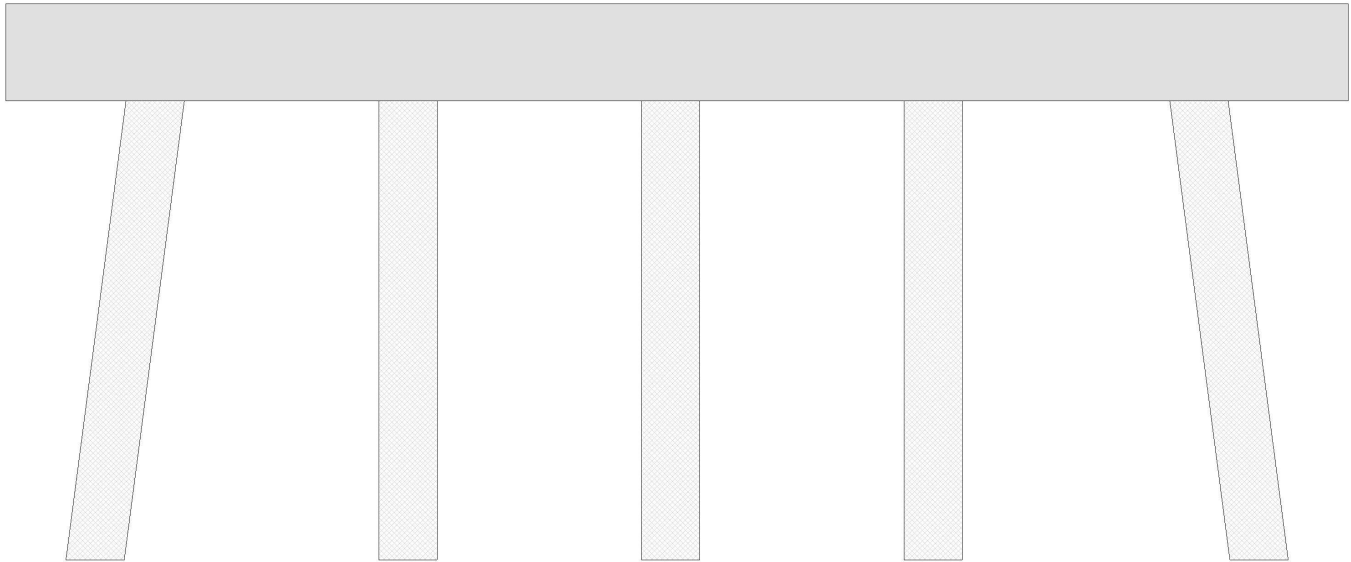
Cap Information			Material Cast-in-Place Concrete							
Length	Width	Height	Left Overhang	Right Overhang	Left Beam to End of Cap.	Right Beam to End of Cap.				
34.500 ft.	3.000 ft.	2.500 ft.	3.834 ft.	3.834 ft.	1.750 ft.	1.750 ft.				
Subcap Information			Material							
Length	Width	Height	Left Overhang	Right Overhang	Left Pile to Splice.					
Sill Information			Material							
Length	Width	Height								
Pile #	Material	Spacing	Width/Dia.	Height	Length	Orientation	Driven?	Replacement?	Removed?	Collar?
1	Concrete	6.5 ft.	1.5 ft.			Battered	Yes	No	No	No
2	Concrete	6.75 ft.	1.5 ft.			Vertical	Yes	No	No	No
3	Concrete	6.75 ft.	1.5 ft.			Vertical	Yes	No	No	No
4	Concrete	6.833 ft.	1.5 ft.			Vertical	Yes	No	No	No
5	Concrete		1.5 ft.			Battered	Yes	No	No	No
Bent/Abutment #: 1			Similar Bents: 2		MEASUREMENTS VERIFIED BY JSD 4/8/22
