NC DEPARTMENT OF TRANSPORTATION
 DIVISION OF HIGHWAYS
 STRUCTURE MANAGEMENT UNIT

ATTENTION: PRIORITY ACTION REQUEST, APPROACH ROADWAY SKETCH REVISED, TYPICAL SECTION SKETCH REVISED

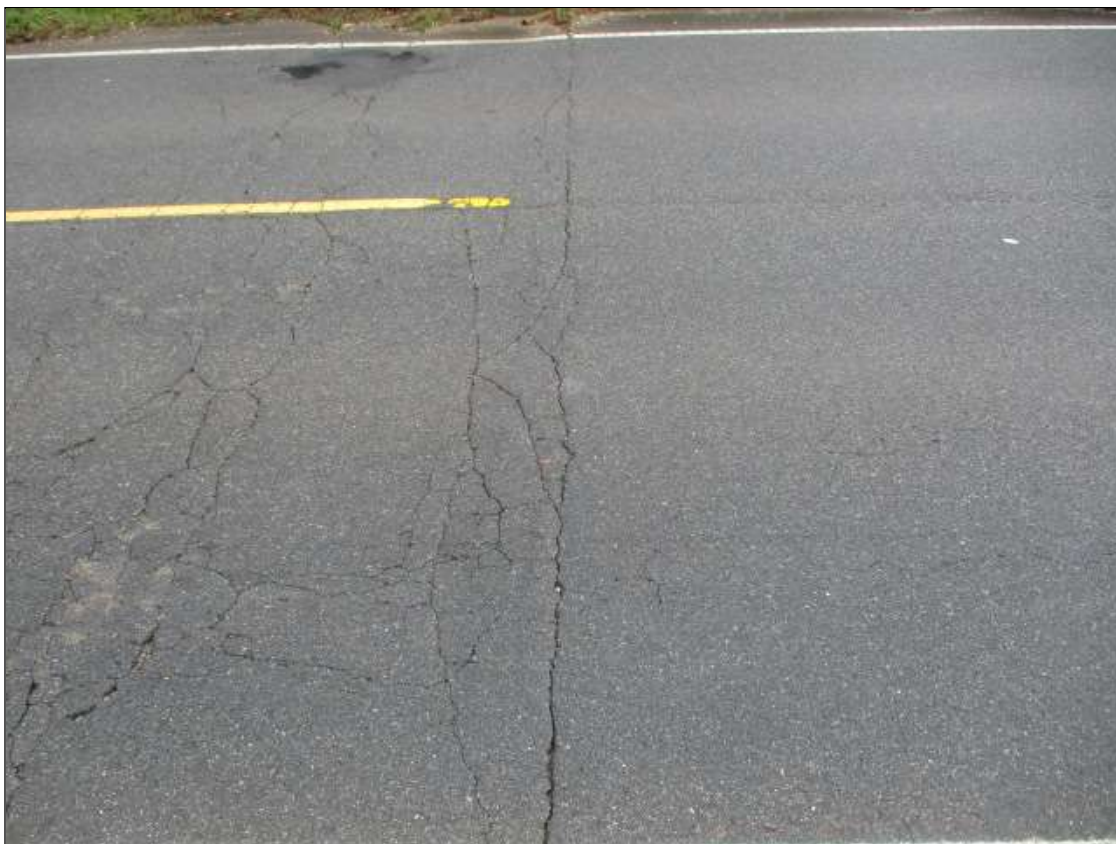
Span 3 Wearing Surface: FULL WIDTH TRANSVERSE CRACK UP TO 1/2" WIDE, WITH SCATTERED SPALLS UP TO 1" DIAMETER X 1" DEEP SCATTERED ALONG THE LENGTH OF CRACK, AT END BENT 2

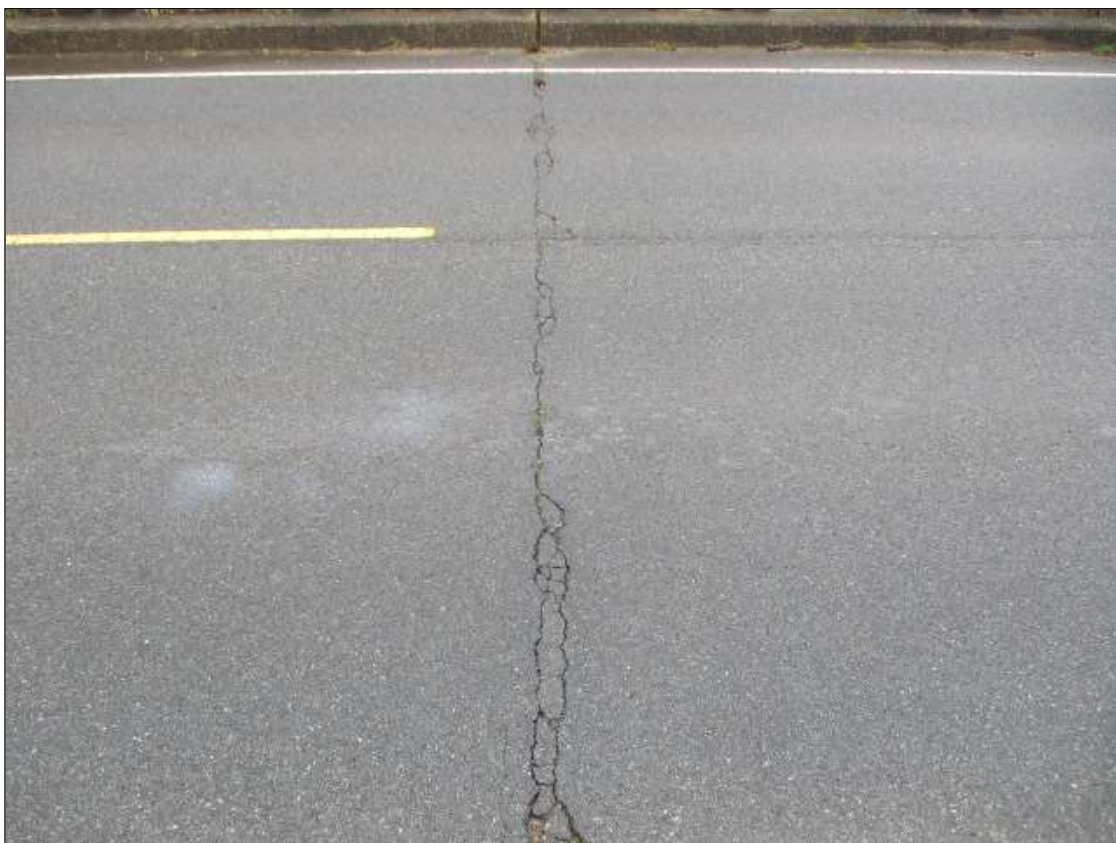
Span 3 Wearing Surface: FULL WIDTH TRANSVERSE CRACK UP TO 1/4" WIDE OVER BENT 2

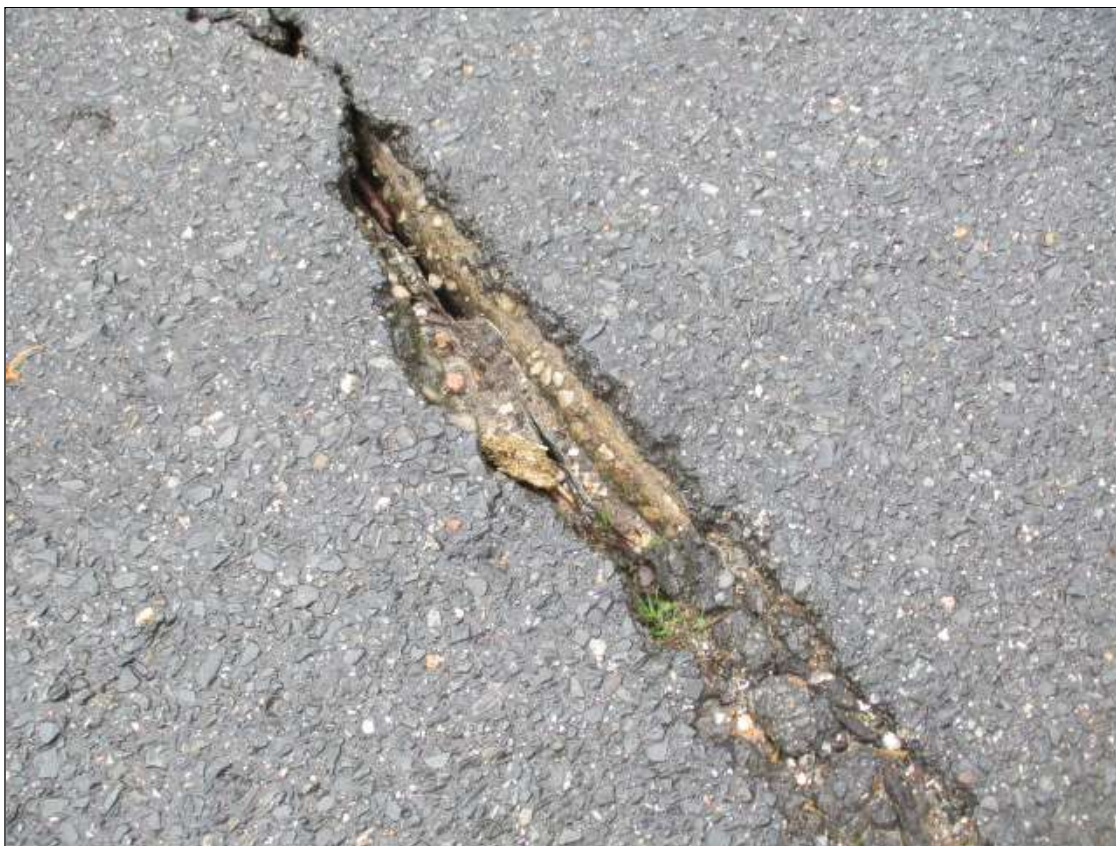
Span 3 Wearing Surface: 16" X 4" X 2" DEEP POTHOLE IN NORTH BOUND LANE OVER BENT 2

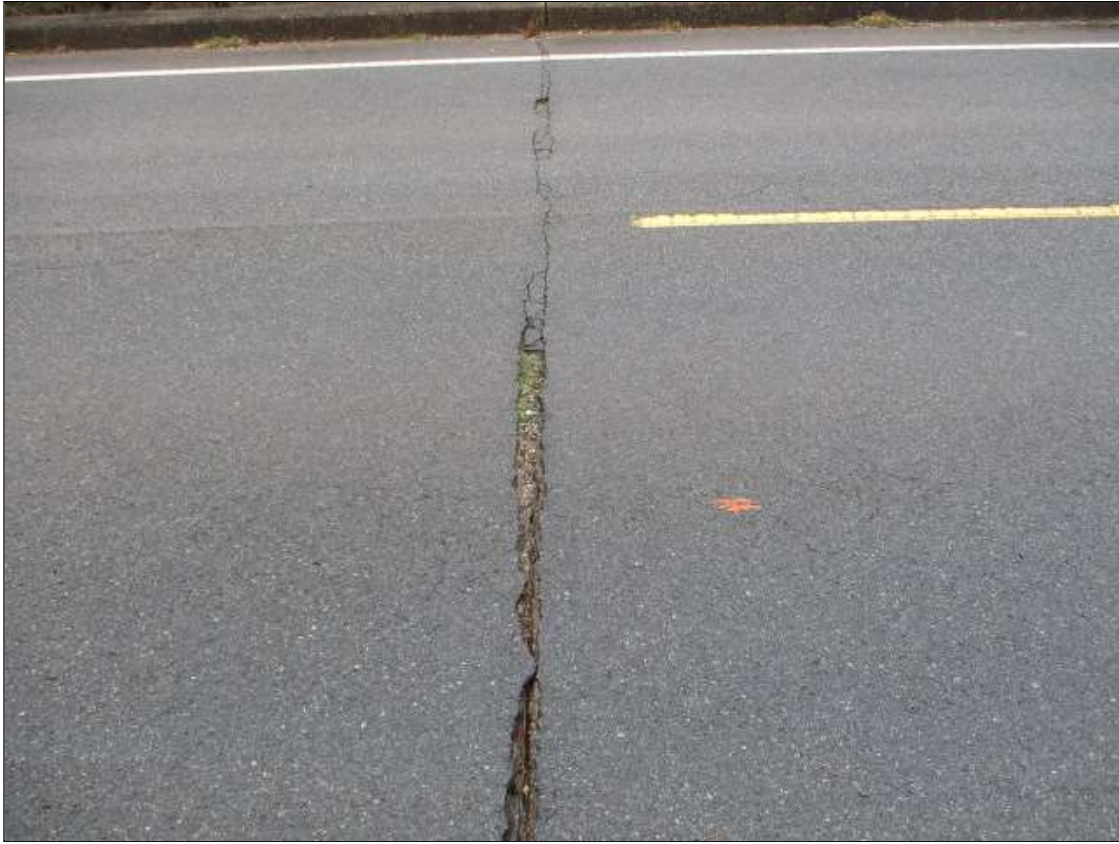
Span 2 Wearing Surface: FULL WIDTH TRANSVERSE CRACK UP TO 1/4" WIDE, WITH 1 SPALL UP TO 8 FT X 3" X 2" DEEP IN NORTH BOUND TRAVEL LANE AND 1 SPALL UP TO 9" X 4" X 2" DEEP IN SOUTH BOUND TRAVEL LANE, AT BENT 1

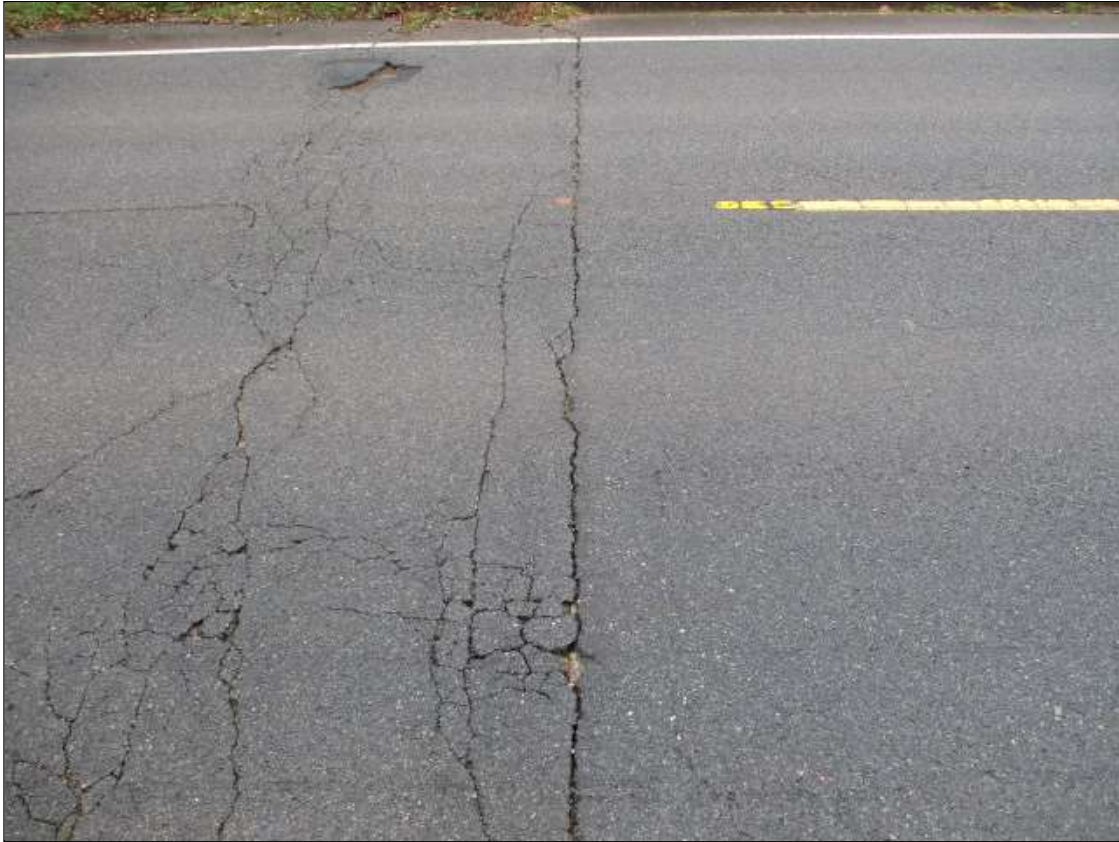
Span 1 Wearing Surface: FULL WIDTH TRANSVERSE CRACK UP TO 1/2" WIDE, WITH 3 SCATTERED SPALLS UP TO 1" DIAMETER X 1" DEEP SCATTERED ALONG THE LENGTH OF CRACK, AT END BENT 1

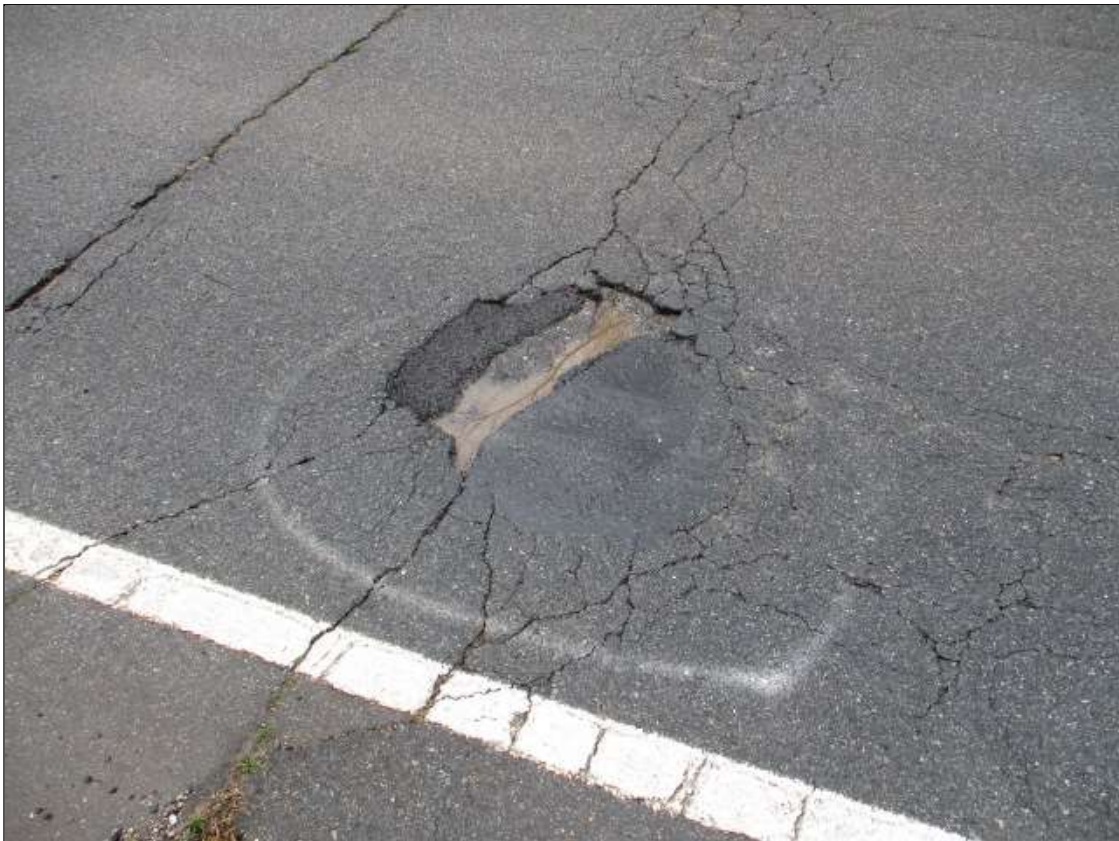
3' X 1' X 2 1/2" DEEP POTHOLE IN SOUTH APPROACH AT SOUTH BOUND LANE

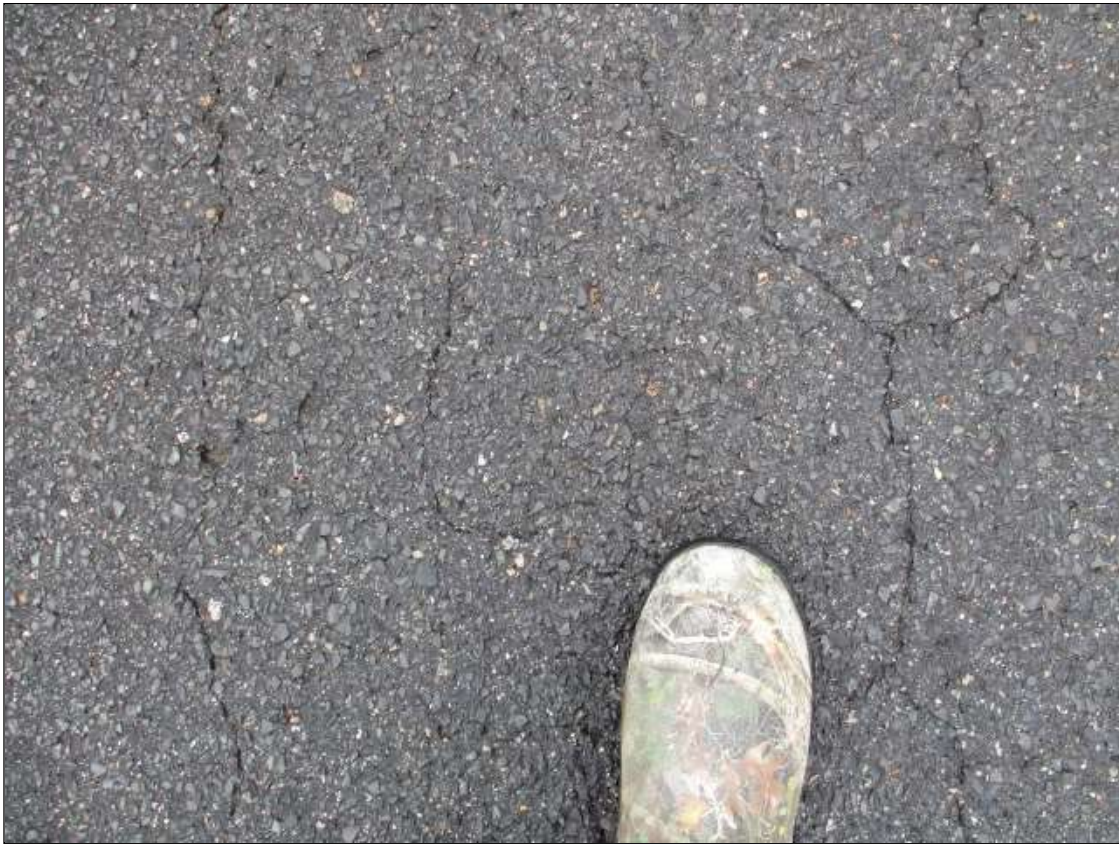
Span 1 Wearing Surface: 1/16" MAP CRACKING IN TRAVEL LANES

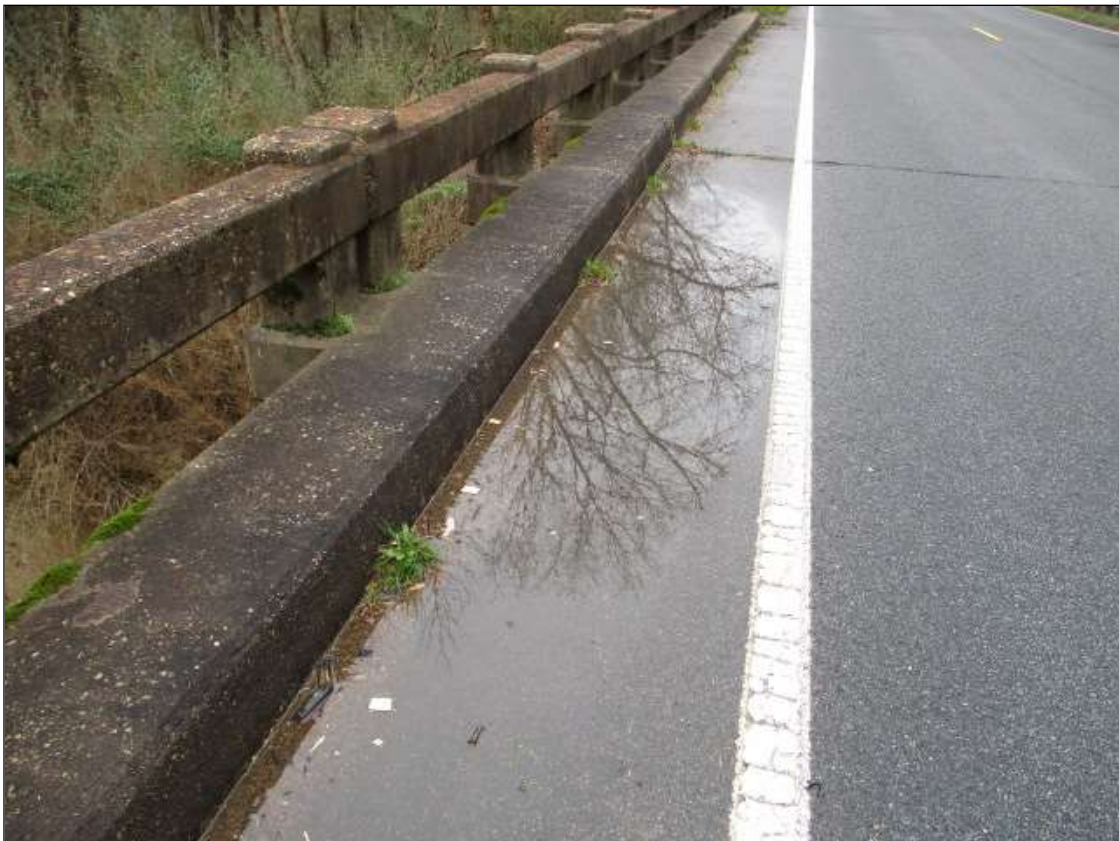
DEBRIS ALONG BOTH RAILS

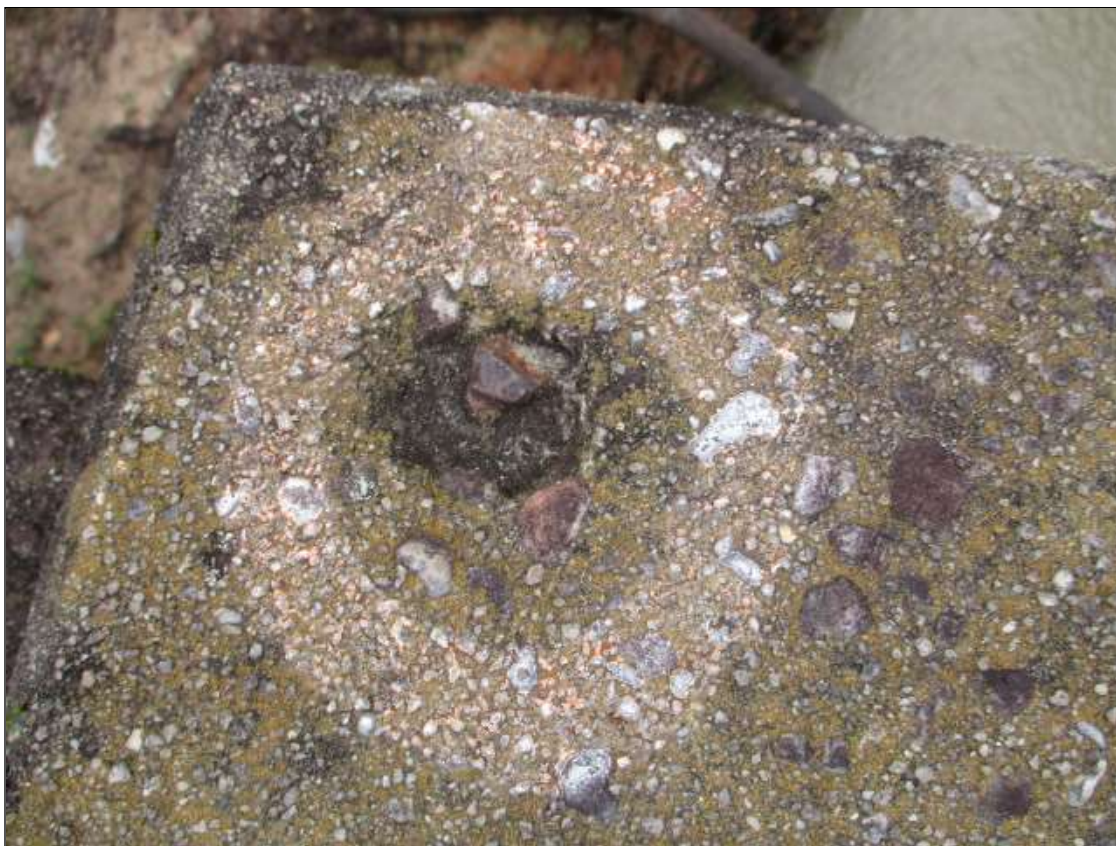
Span 2 Right Bridge Rail: 1" DIAMETER X 3/4" DEEP SPALL WITH EXPOSED REBAR ON TOP OF POST 8

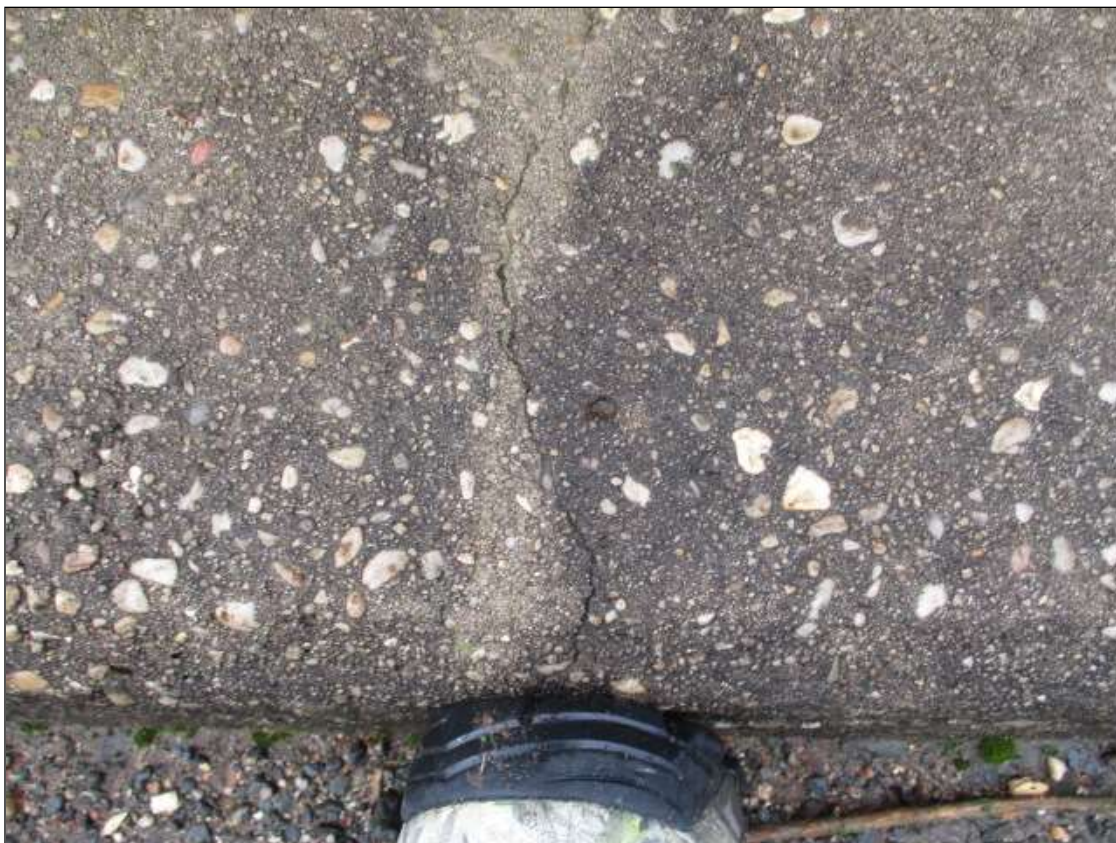
Span 3 Left Bridge Rail: 5 FULL WIDTH TRANSVERSE 1/32" CRACKS SCATTERED THROUGHOUT TOP OF PARAPET OF RAIL

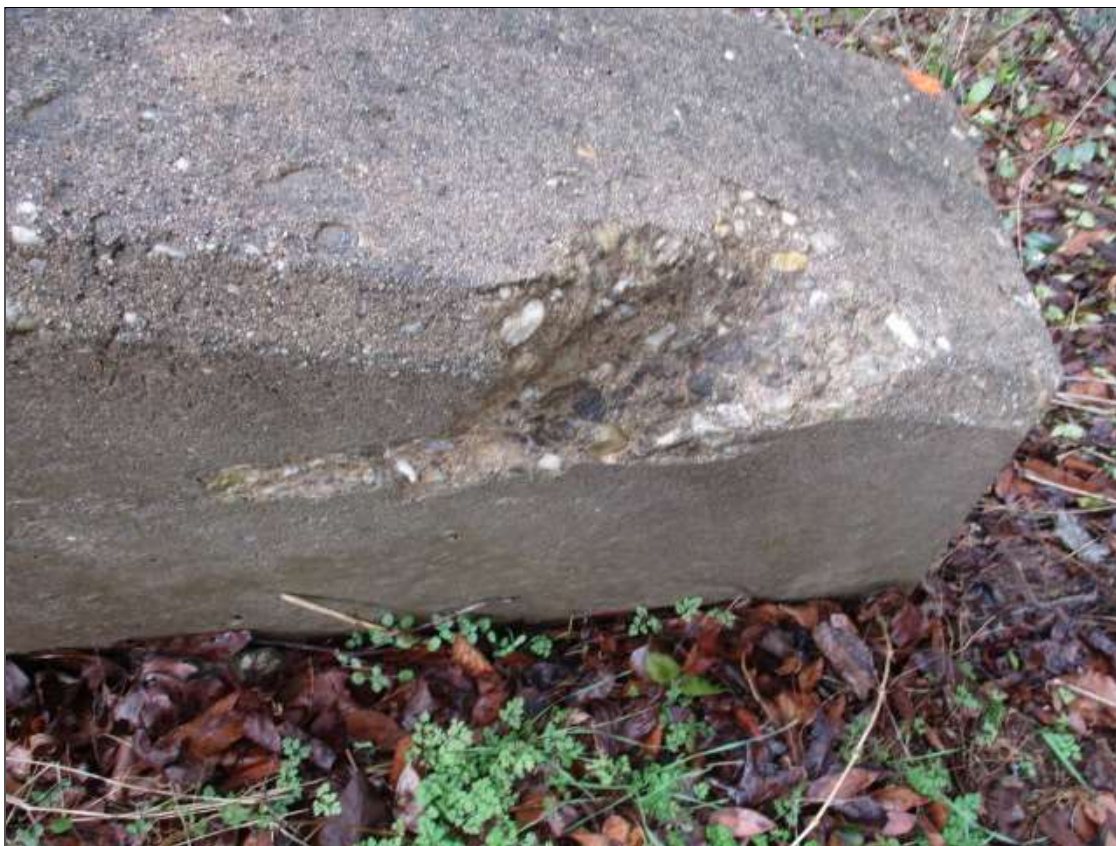
2' X 5" X 1" SPALL ON TOP OF SOUTHEAST WINGWALL

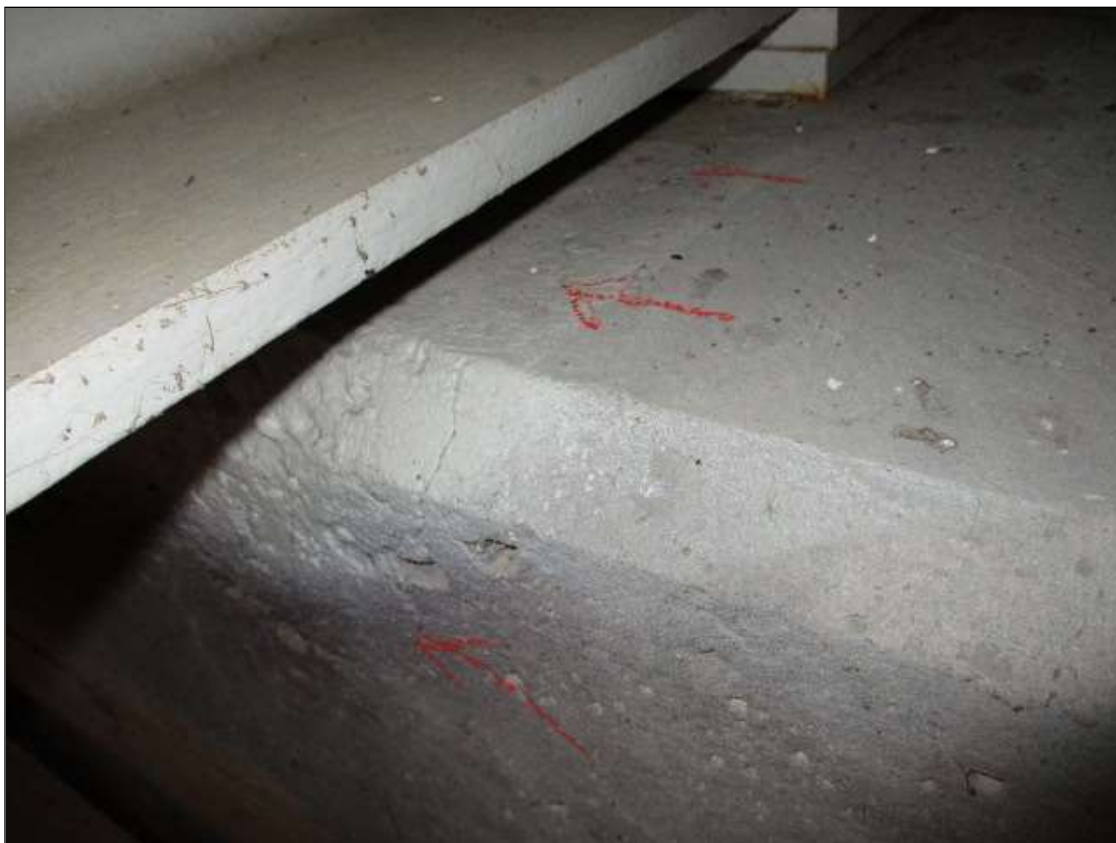
End Bent 1 Cap 1: 1/32" VERTICAL AND HORIZONTAL CRACKING

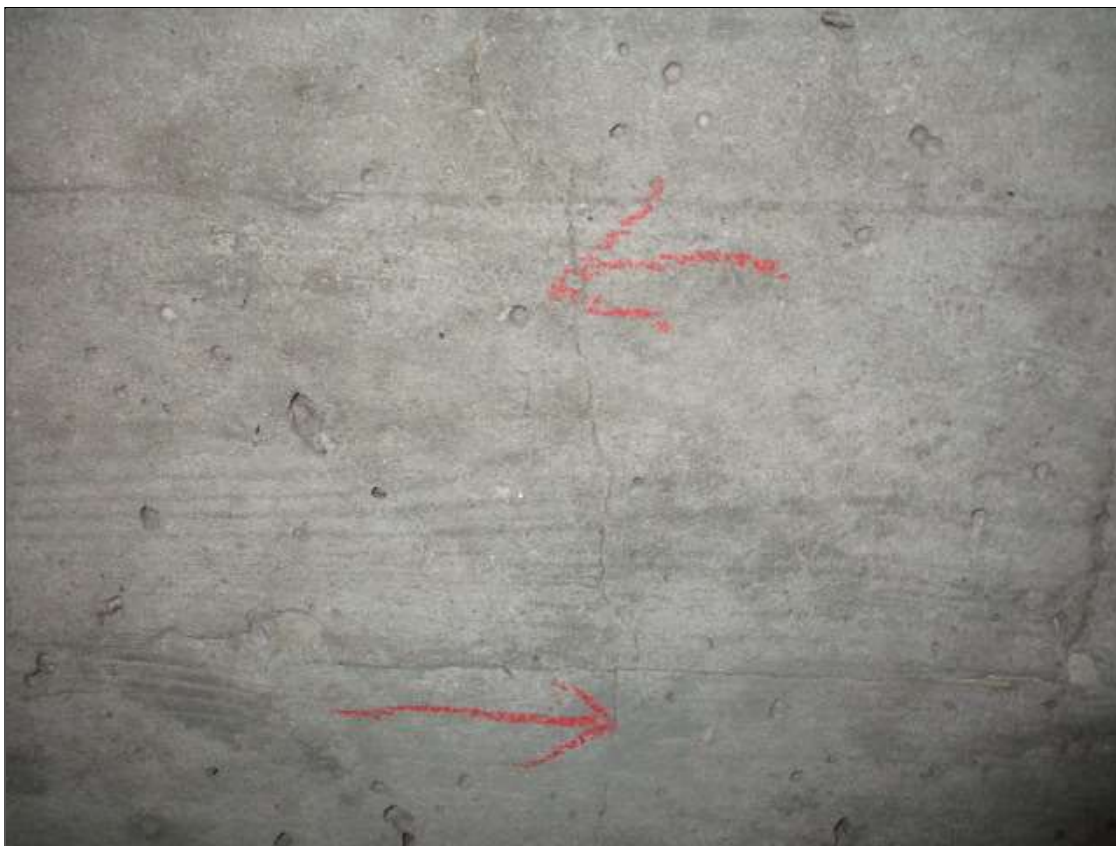
End Bent 1 Abutment: 1/32" VERTICAL CRACKING ALONG BACKWALL

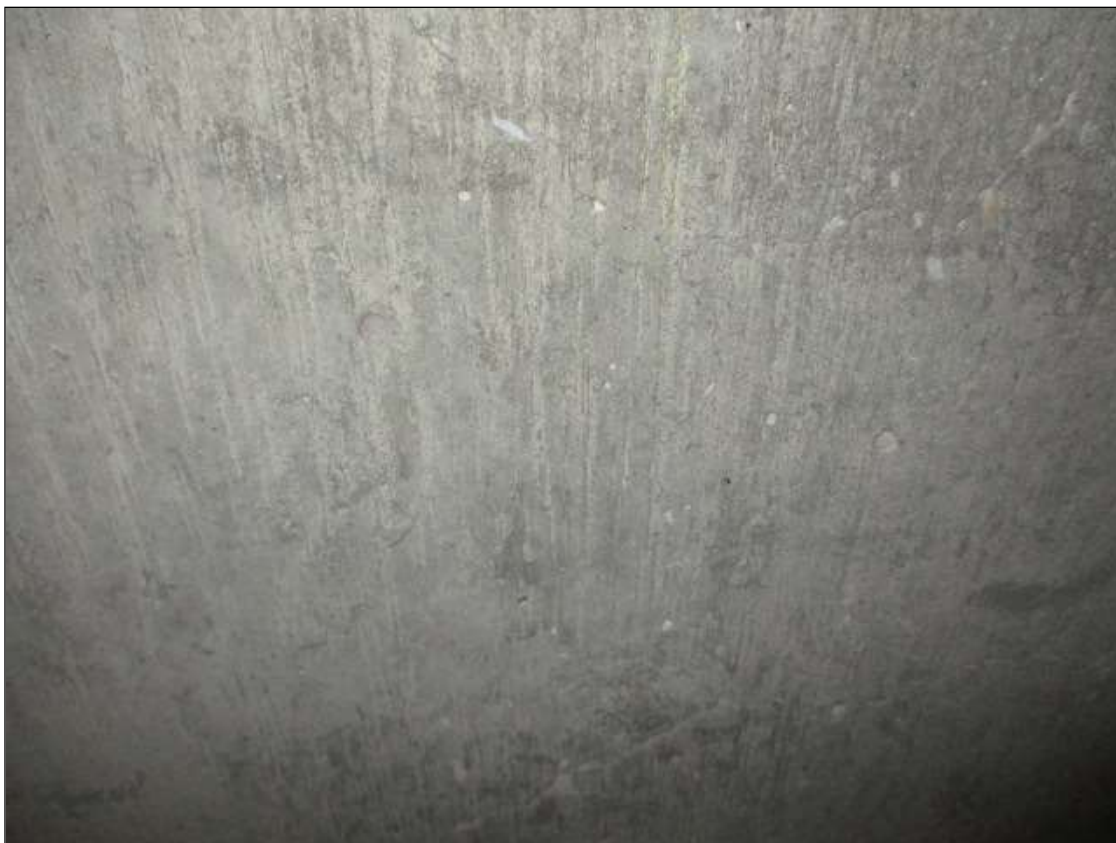
Span 1 Deck: 1/64" MAP CRACKING WITH EFFLORESCENCE SCATTERED THROUGHOUT UNDERSIDE OF DECK IN ALL BAYS

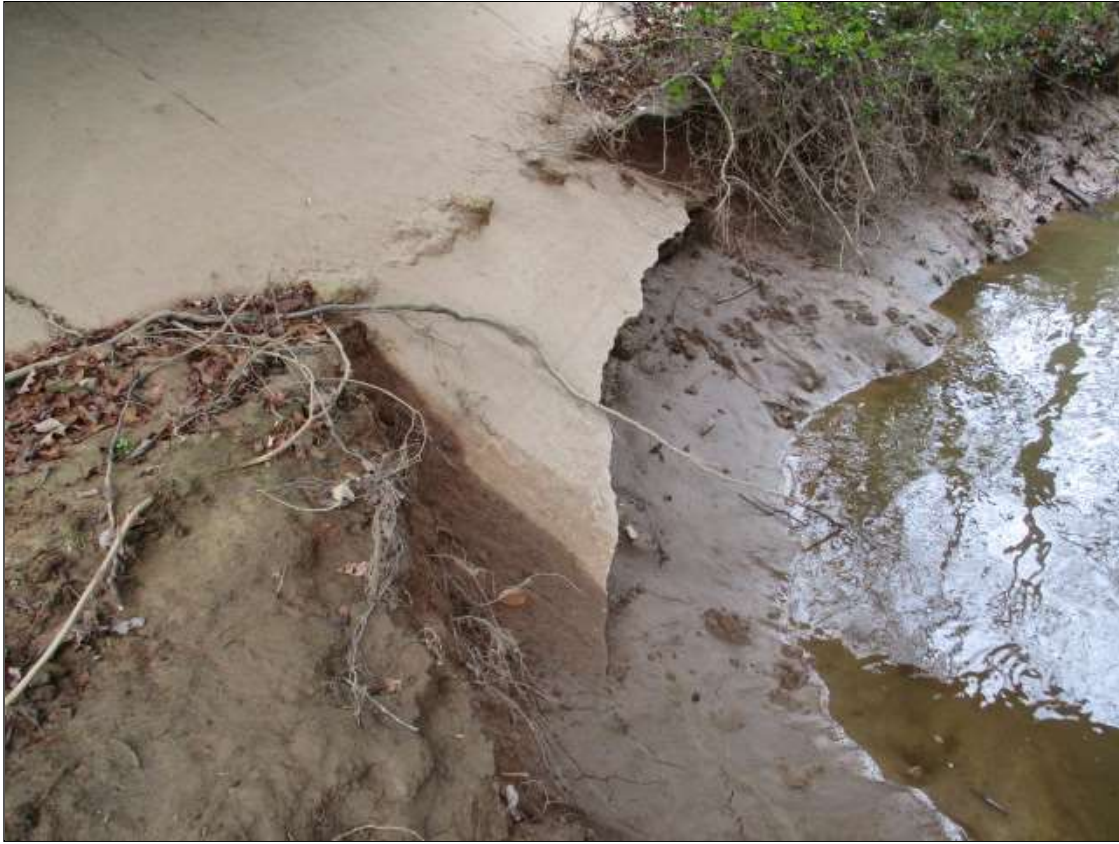
PAR: 13' WIDE X 8' LONG X 2' DEEP EROSION OF SPAN 1 SLOPE PROTECTION NEAR BENT 1

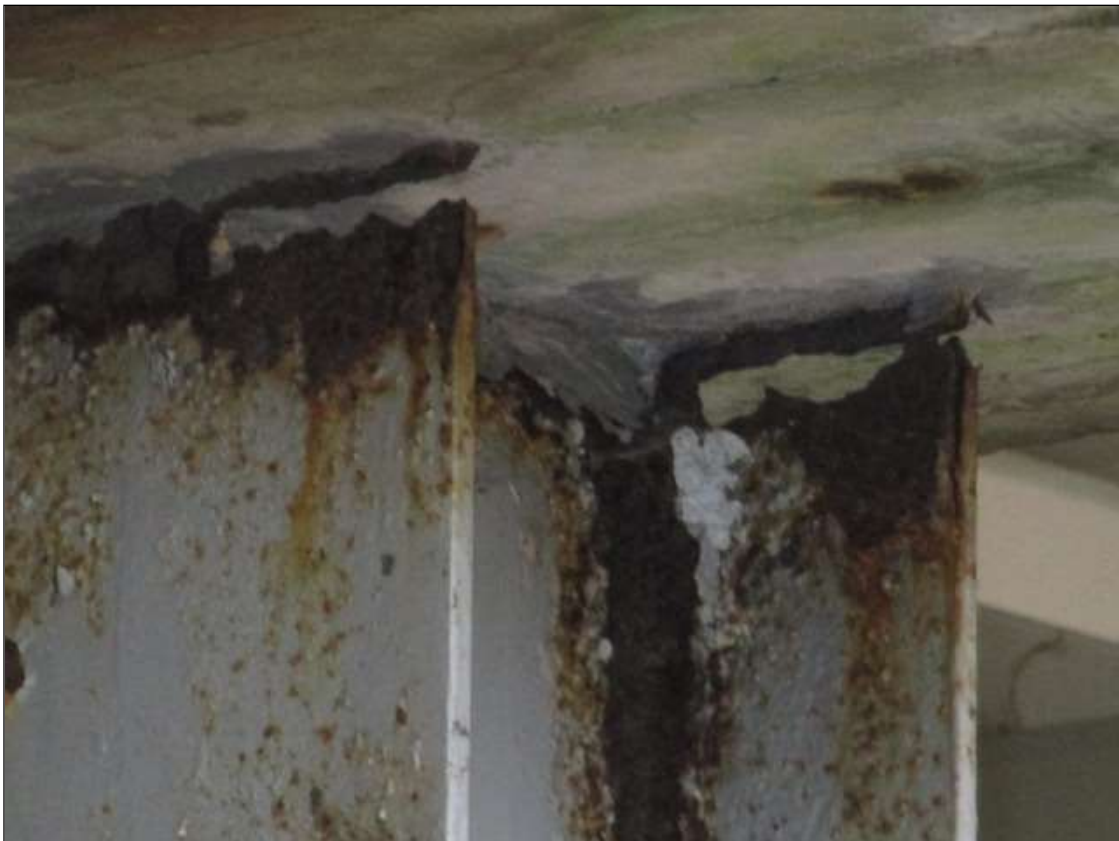
Bent 1 Pile 9: PAR: TOP OF PILE ACTIVE CORROSION BOTH DOWNSTREAM FLANGE PLATES WITH COMPLETE SECTION LOSS 5-1/2" X 1", AND SECTION LOSS WITH 3/8" REMAINING 6-1/2" X 2".

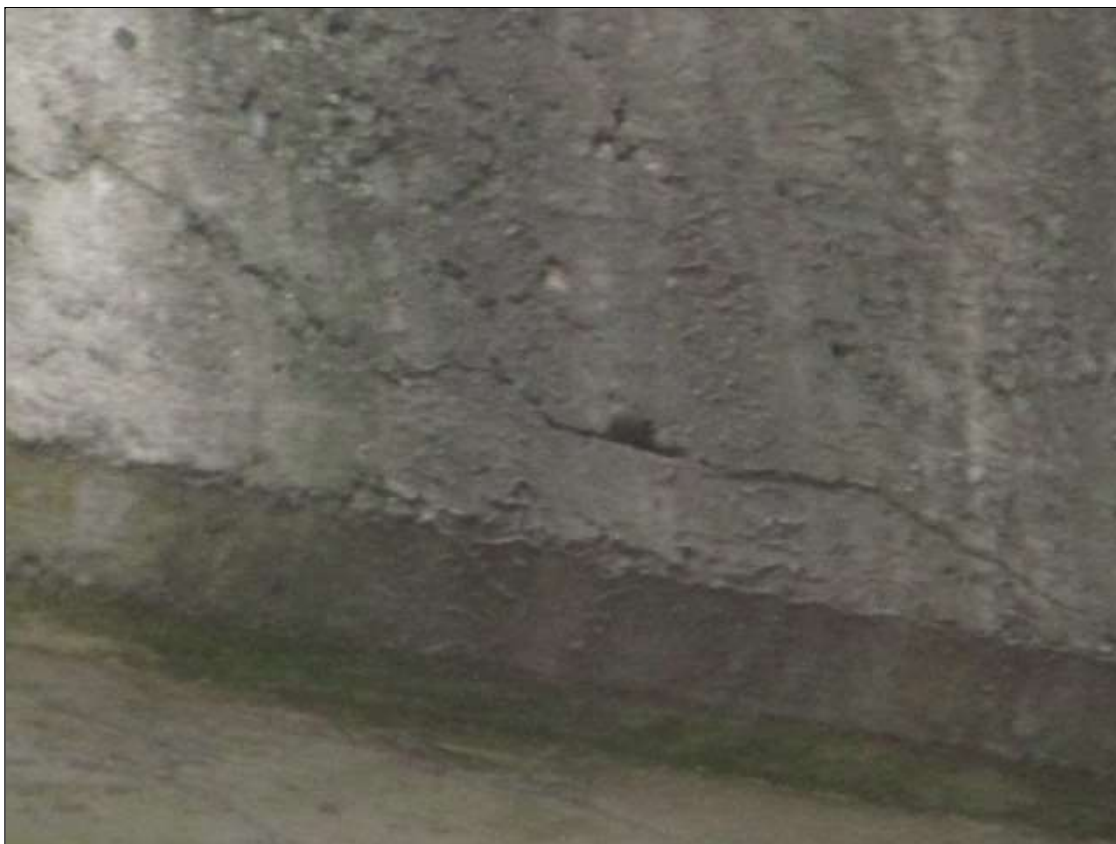
Bent 1 Cap 1: 3 FT LONG LONGITUDINAL CRACK UP TO 1/16" WIDE IN TOP OF NORTH FACE OF CAP ABOVE PILE 1 AND 6

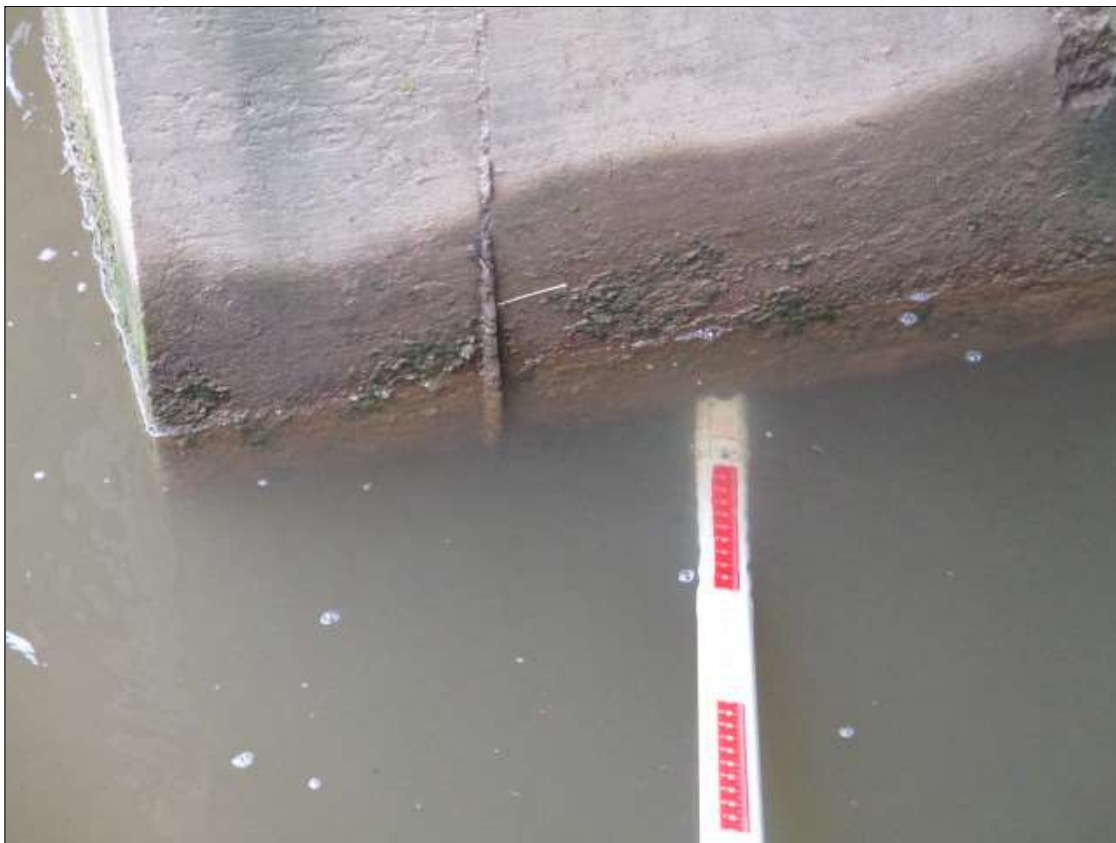
BENT 1 CONCRETE PILE ENCASEMENT IS NOT TOUCHING THE STREAMBED

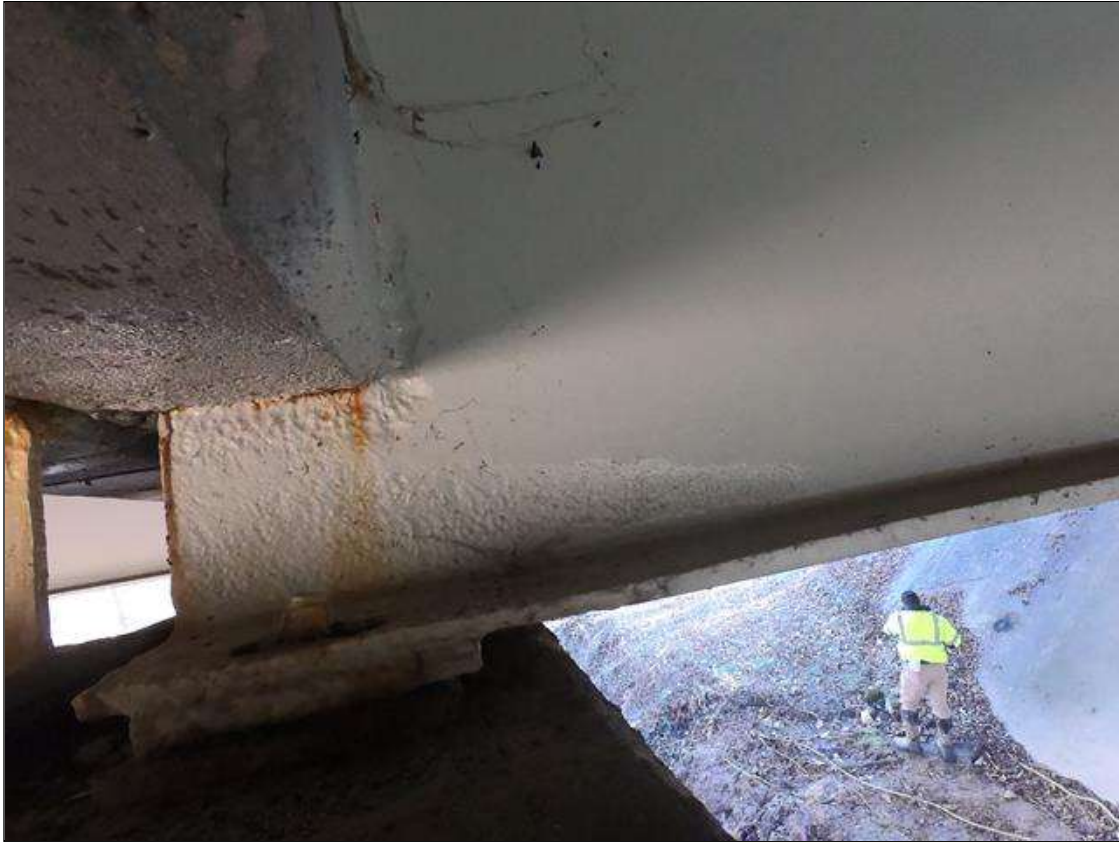
Span 1 Beam 2: PAR: ARRESTED CORROSION WITH SECTION LOSS AT BENT 1 IN WEB AROUND DIAPHRAGM, FOR 8" TALL X 2" WIDE WITH 7/16" OF WEB THICKNESS REMAINING, IN LOWER WEB FOR 3" TALL X 20" LONG WITH 7/16" OF WEB THICKNESS REMAINING, AND BOTTOM FLANGE FOR FULL WIDTH X 6" LONG WITH 1/2" OF FLANGE THICKNESS REMAINING

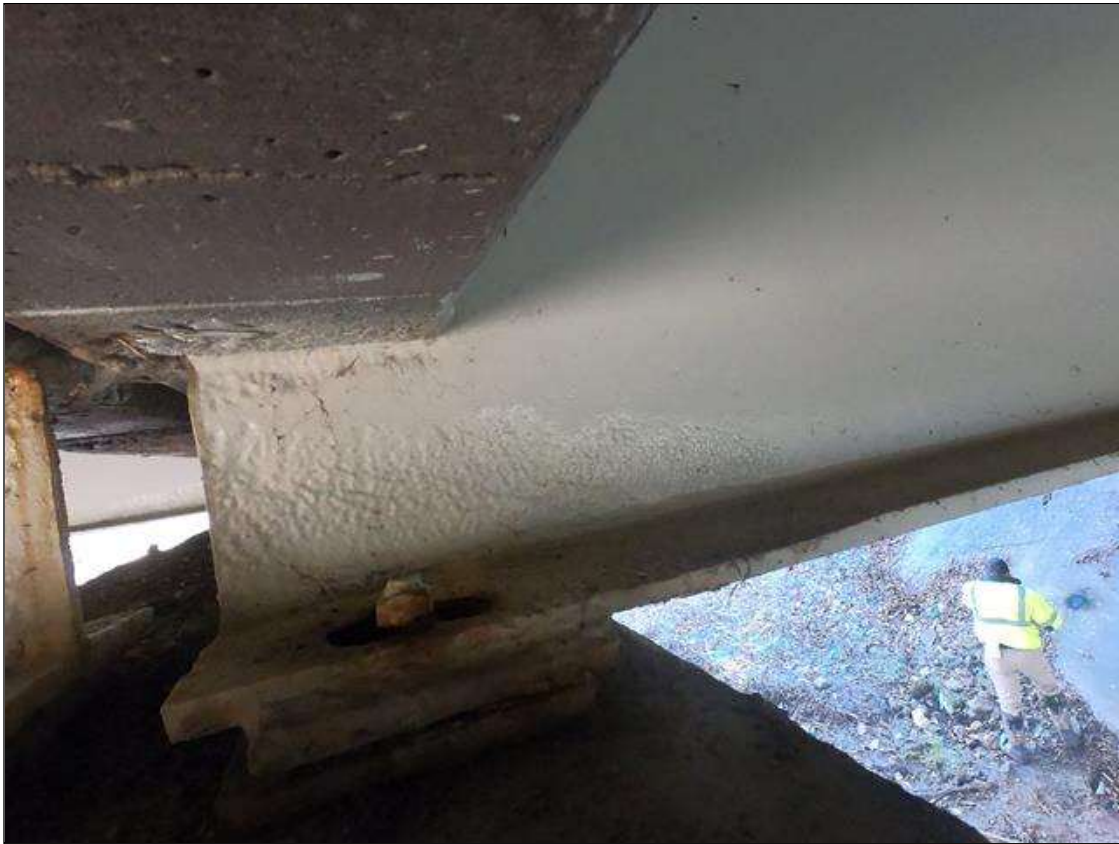
Span 1 Beam 3: PAR: AT BENT 1, SECTION LOSS IN WEB AROUND DIAPHRAGM 3/8" REMAINING 8" LONG X 1" WIDE, LOWER 5" X 20" LONG WITH 7/16" REMAINING, BOTTOM FLANGE SECTION LOSS DOWN TO 1/2" REMAINING X 8" LONG X FULL WIDTH, CORROSION ARRESTED

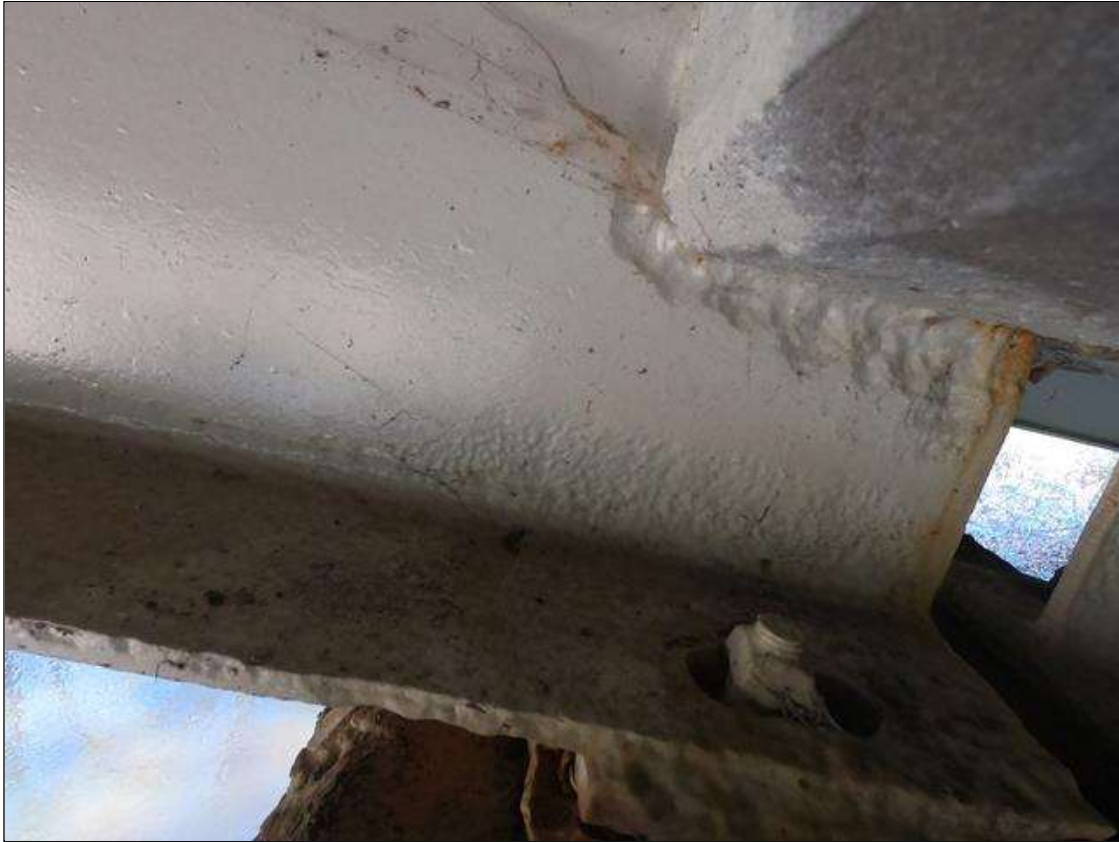
Span 2 Beam 3: PAR: AT BENT 1, SECTION LOSS IN WEB AROUND DIAPHRAGM 3/8" REMAINING 8" LONG X 2" WIDE, AND LOWER 5" X 13" LONG WITH 7/16" REMAINING, BOTTOM FLANGE SECTION LOSS DOWN TO 1/2" REMAINING X 8" LONG X FULL WIDTH, CORROSION ARRESTED.

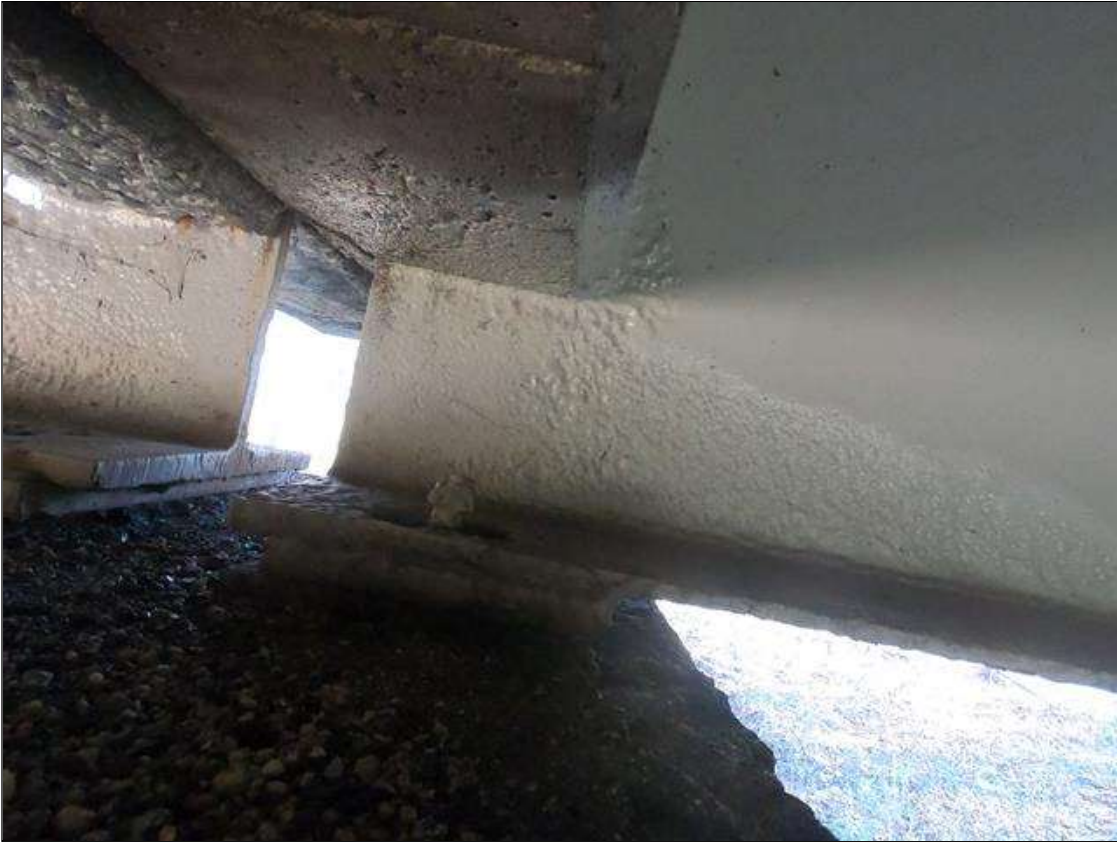
Span 1 Beam 4: PAR: AT BENT 1, SECTION LOSS IN WEB AROUND DIAPHRAGM 5/16" REMAINING 6" LONG X 2" WIDE, AND LOWER 3" X 24" LONG WITH 7/16" REMAINING, 3" X 24" LONG WITH 7/16" REMAINING, BOTTOM FLANGE SECTION LOSS DOWN TO 5/16" REMAINING X 16" LONG X FULL WIDTH, CORROSION ARRESTED.

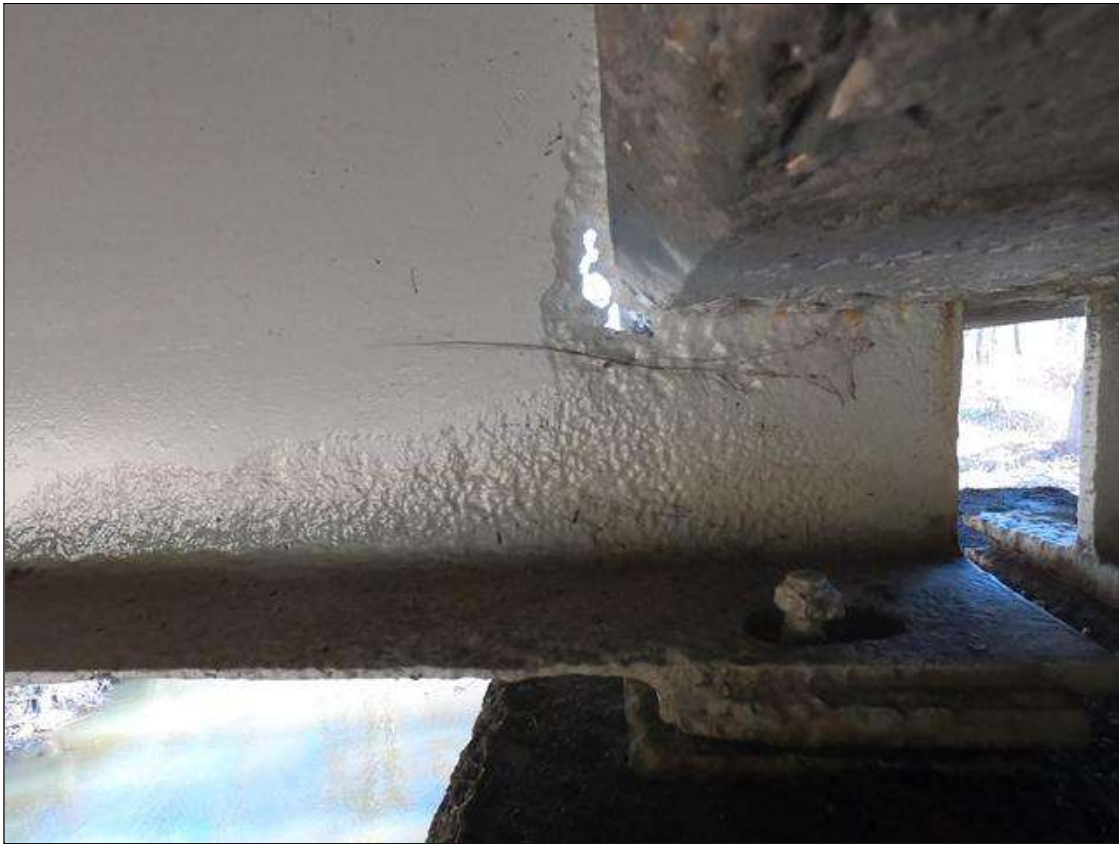
Span 2 Beam 4: PAR: AT BENT 1, SECTION LOSS IN WEB AROUND DIAPHRAGM 5/16" REMAINING FOR 8" LONG X 2.5" WIDE WITH RUST HOLE 3" X 1" LOCATED AT 6" FROM BEARING, LOWER 3" X 24" LONG WITH 7/16" REMAINING IN WEB, AND SECTION LOSS IN BOTTOM FLANGE DOWN TO 3/16" REMAINING FOR 36" LONG X FULL WIDTH, CORROSION ARRESTED
