NC DEPARTMENT OF TRANSPORTATION
 DIVISION OF HIGHWAYS
 STRUCTURE MANAGEMENT UNIT

ATTENTION: PRIORITY ACTION REQUEST, APPROACH ROADWAY SKETCH REVISED, TYPICAL SECTION SKETCH REVISED

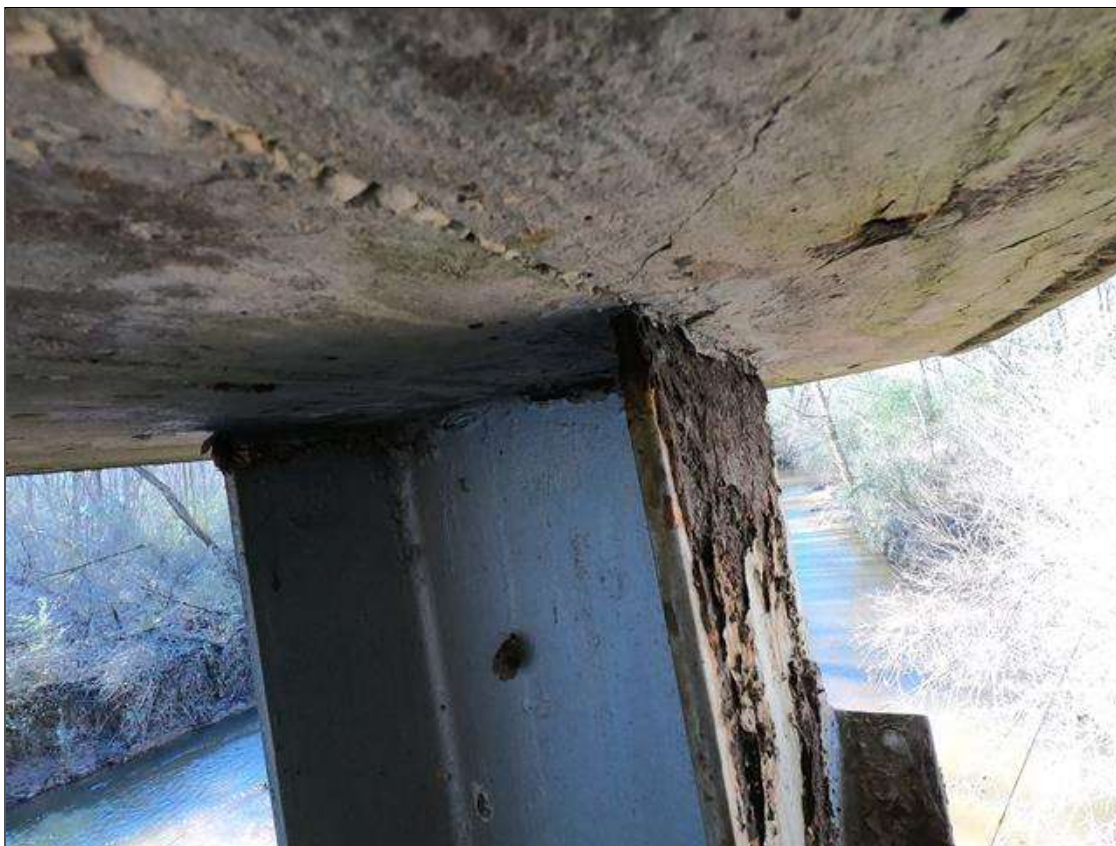
Bent 2 Pile 1: PAR: TOP OF PILE FAR FLANGE PLATE ACTIVE CORROSION WITH SECTION LOSS 1/4" REMAINING 2" TALL X 12" WIDE

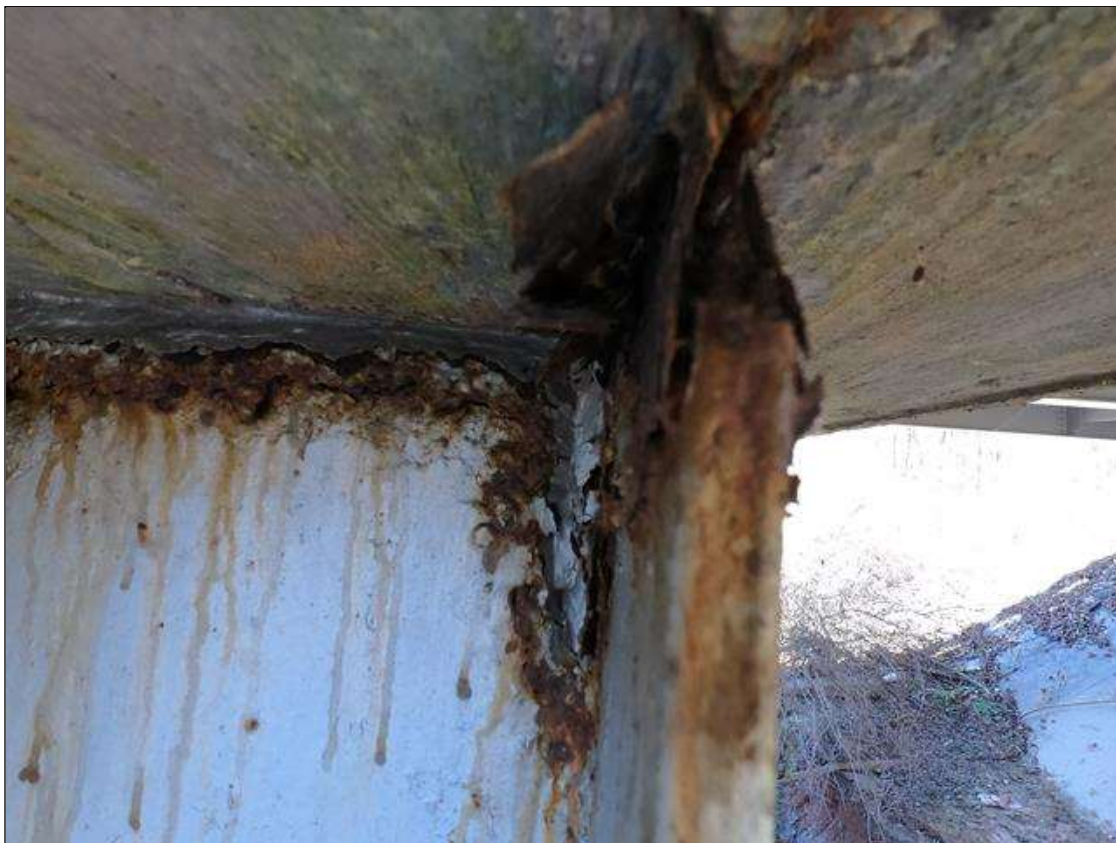
Bent 2 Pile 6: PAR: TOP OF PILE AT CAP: FAR FLANGE PLATE ACTIVE CORROSION WITH SECTION LOSS 6" WIDE X 1" TALL, DOWN TO 1/4" REMAINING.

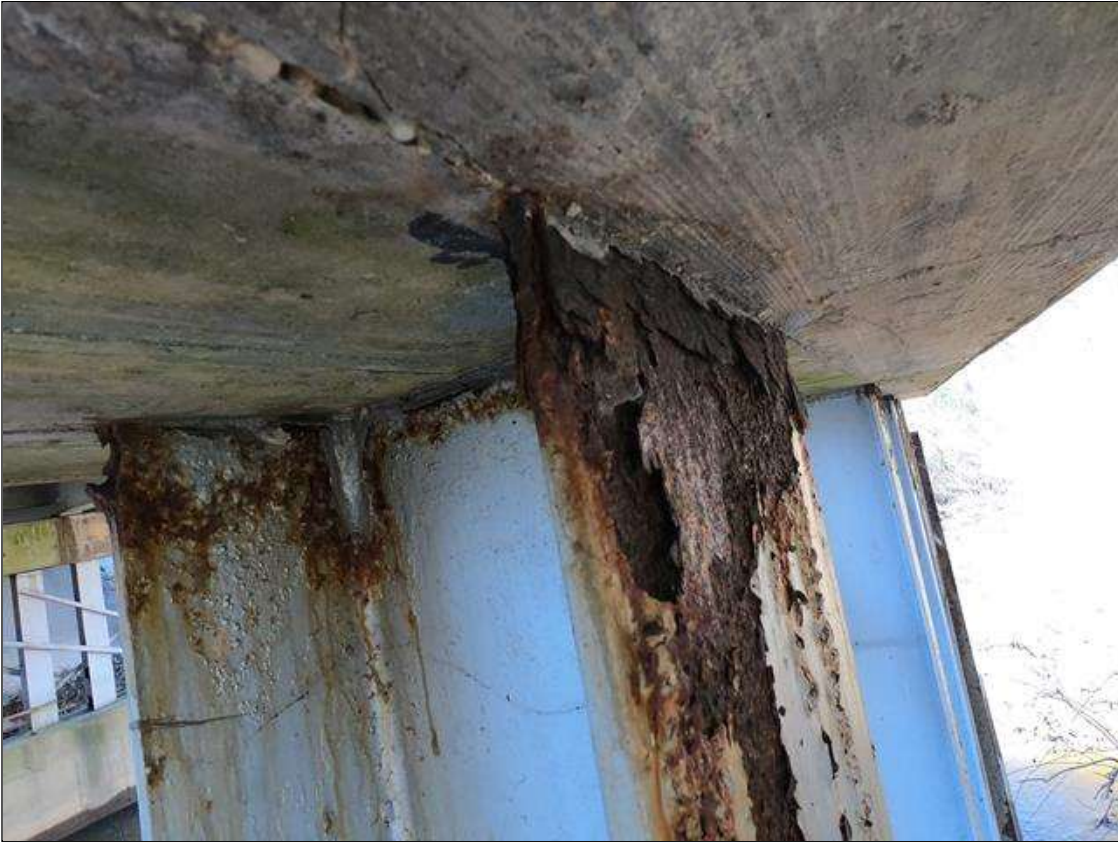
Bent 2 Pile 5: PAR: TOP OF PILE AT CAP ACTIVE CORROSION WITH SECTION LOSS 4" TALL X 12" WIDE X 1/4" REMAINING SECTION BOTH FLANGE PLATES AND WEB.

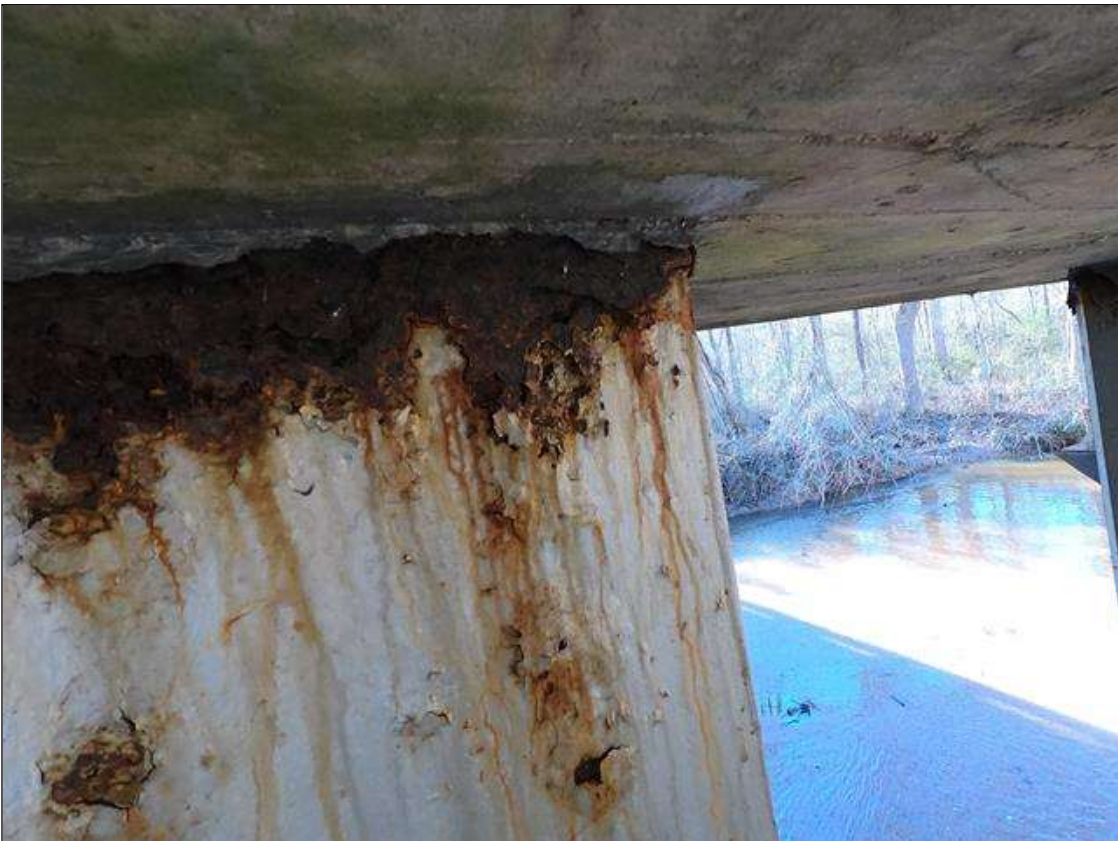
Bent 2 Pile 4: PAR: BENT 2 TOP OF PILE 4 ACTIVE CORROSION WITH SECTION LOSS 7/16" REMAINING X 12" WIDE X 2" TALL

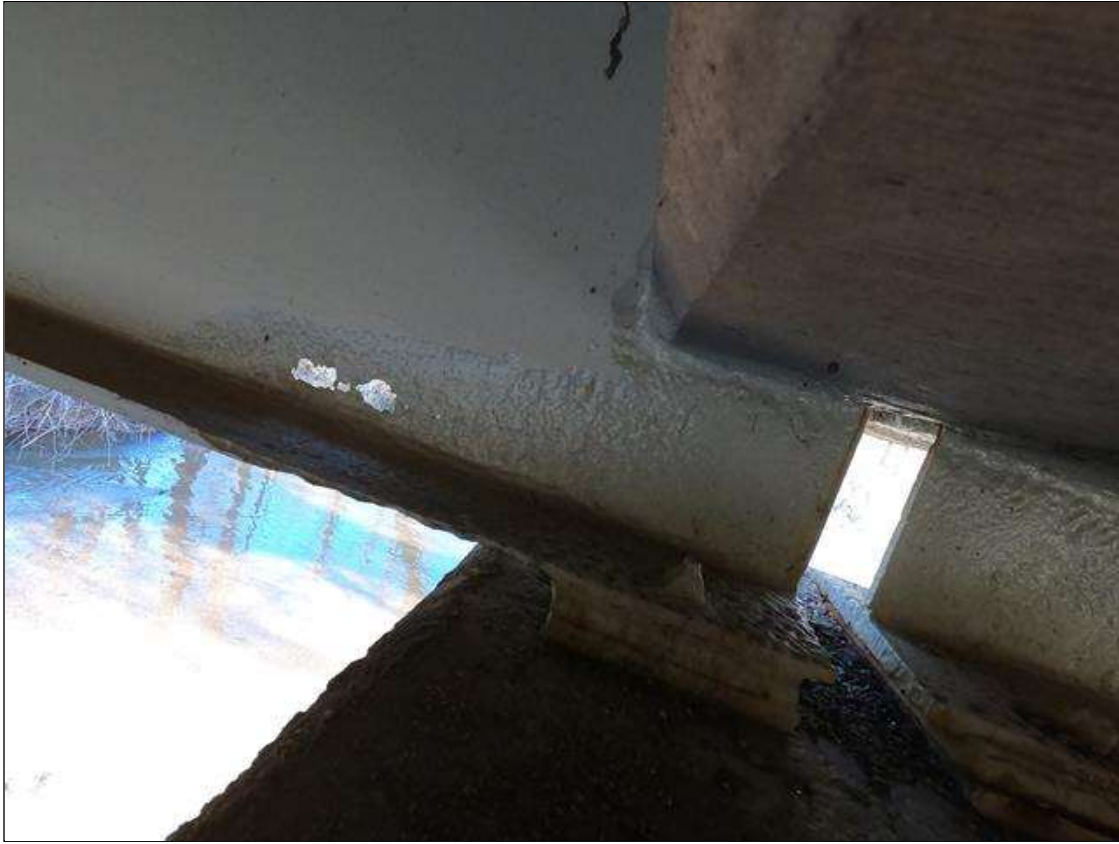
Span 2 Beam 1: PAR: 5" LONG X 2" TALL AREA OF 100% SECTION LOSS LOWER WEB, TWO RUSTED HOLES 1 FT FROM BENT 2, SECTION LOSS AREA UP TO 5" HIGH X 2.5 FT LONG IN BOTTOM OF WEB, CORROSION ARRESTED. AT BENT 2 IN BOTTOM FLANGE, 2 FT LONG X FULL WIDTH SECTION LOSS WITH 1/8" REMAINING, CORROSION ARRESTED.

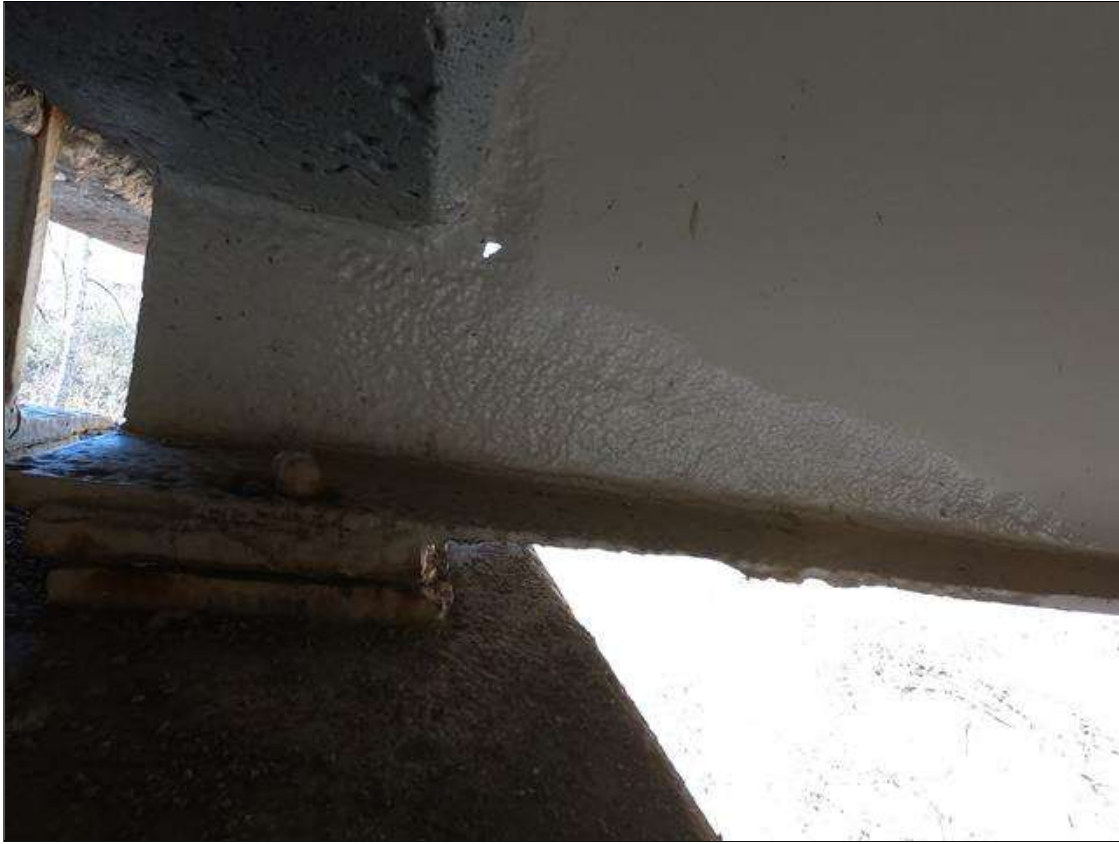
Span 3 Beam 1: PAR: AT BENT 2, SECTION LOSS 7/16" REMAINING LOWER WEB 6" X 30" LONG, AROUND END DIAPHRAGM IN WEB 7" LONG X 1" WIDE WITH 1/2" DIAMETER RUST HOLE, AND BOTTOM FLANGE DOWN TO 1/4" REMAINING FULL WIDTH X 16" LONG, CORROSION ARRESTED

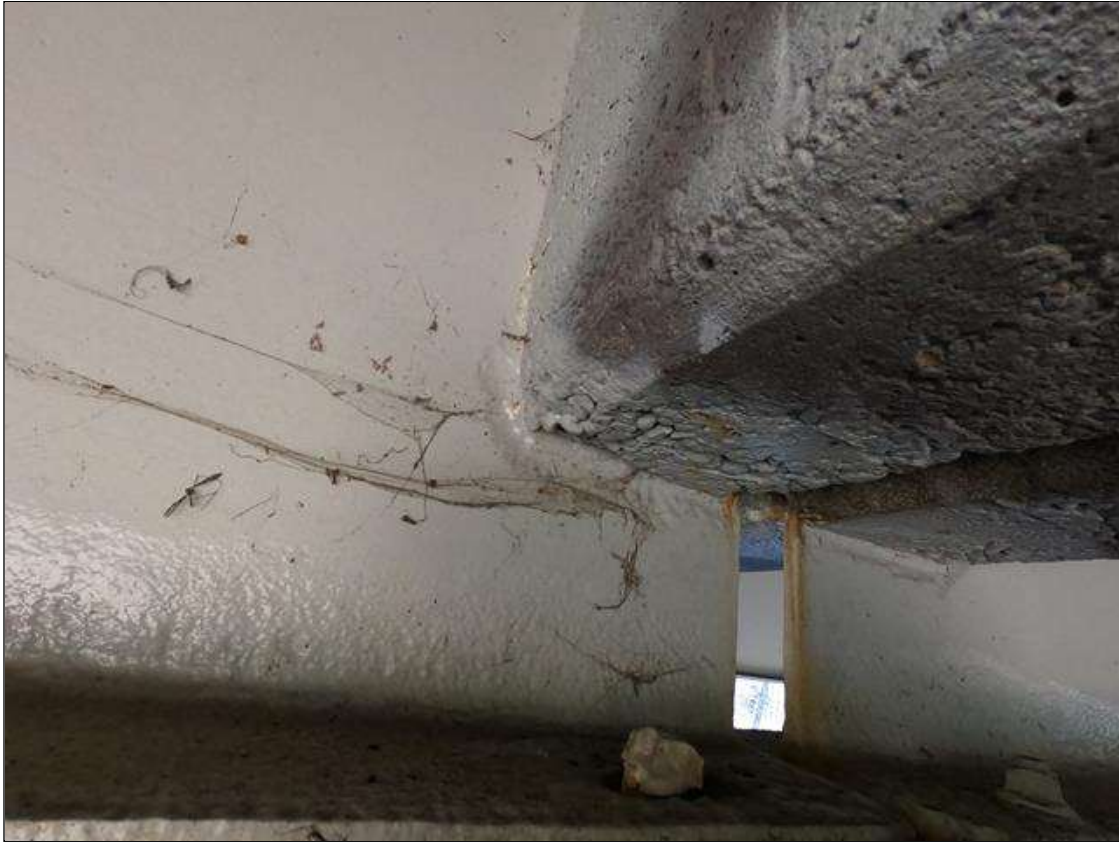
Span 3 Beam 3: PAR: ARRESTED CORROSION WITH SECTION LOSS IN BEAM AT BENT 2, IN BOTTOM FLANGE FOR FULL WIDTH X 24" LONG WITH 7/16" OF FLANGE THICKNESS REMAINING, AND IN WEB AROUND DIAPHRAGM FOR 8" LONG X 1" WIDE X 7/16" REMAINING

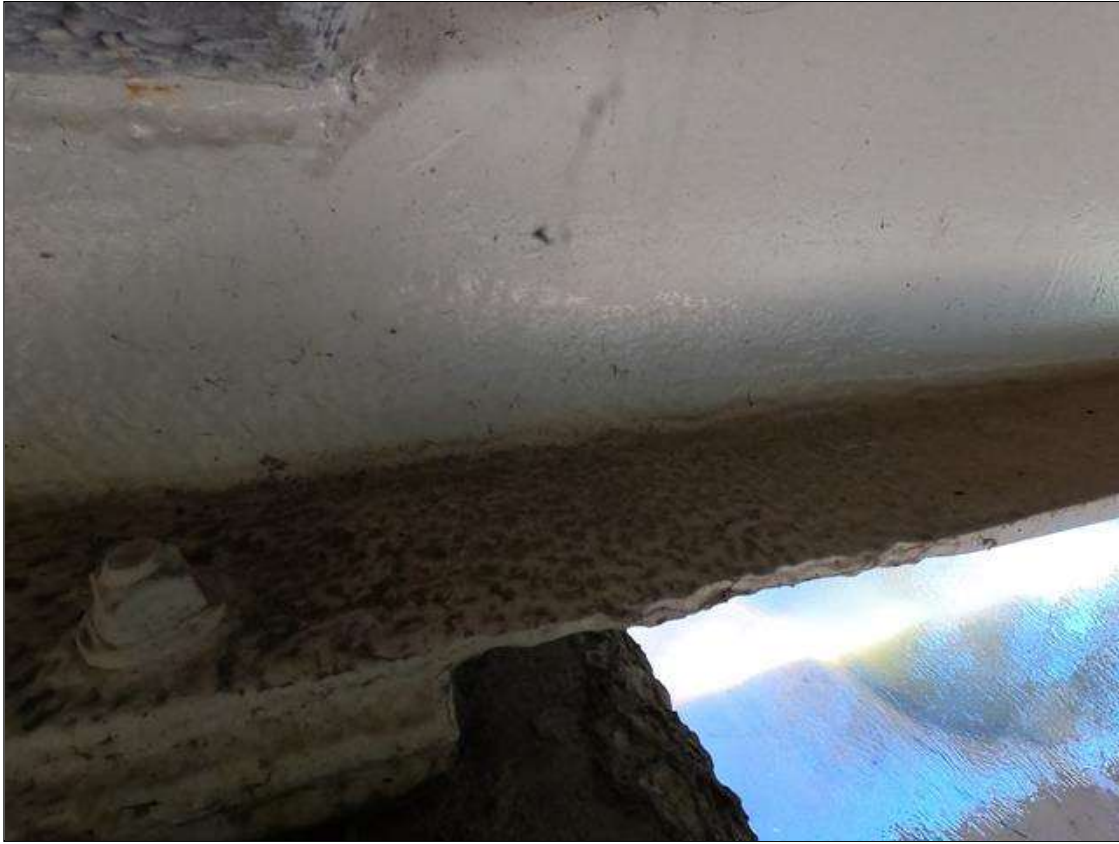
Span 2 Beam 3: PAR: ARRESTED CORROSION WITH SECTION LOSS AT BENT 2, IN LOWER WEB FOR 4" TALL X 34" LONG WITH 7/16" OF WEB THICKNESS REMAINING, IN BOTTOM FLANGE FOR FULL WIDTH X 12" LONG WITH 3/8" OF FLANGE THICKNESS REMAINING

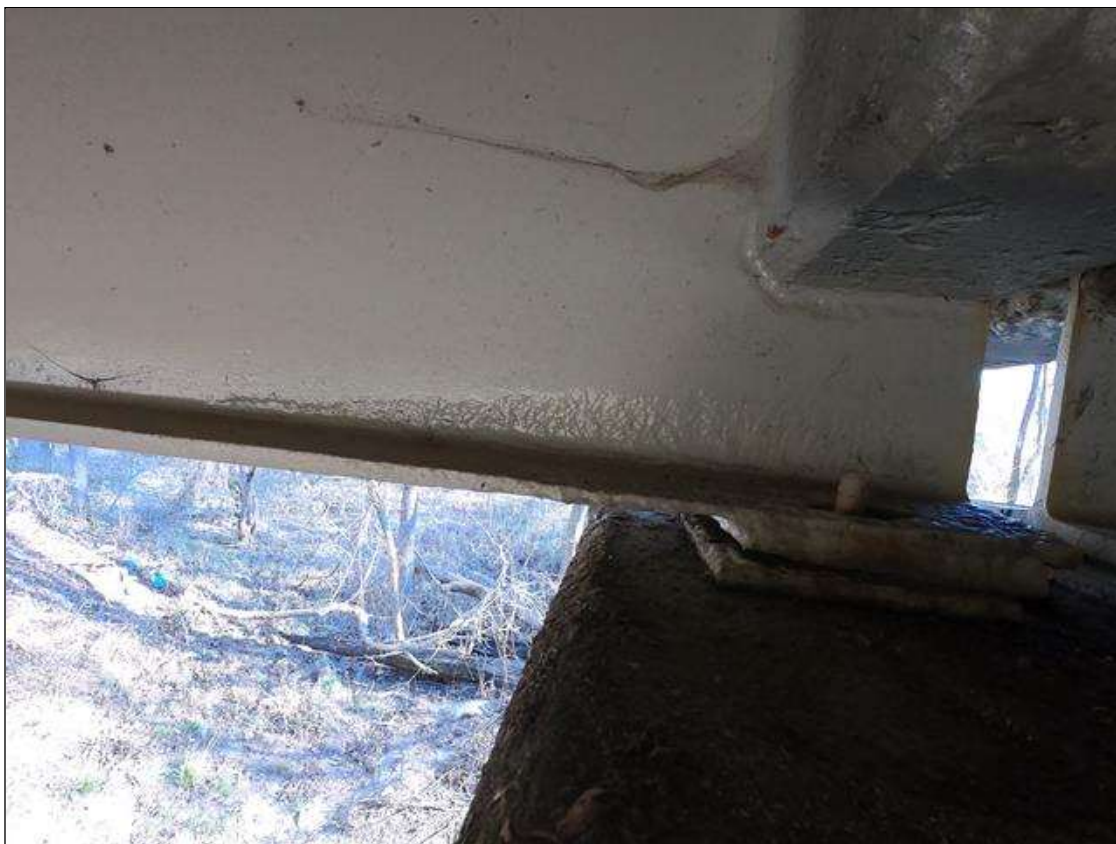
Span 3 Beam 4: PAR: AT BENT 2 SECTION LOSS LOWER WEB DOWN 7/16" REMAINING X 3" TALL X 36" LONG, AND BOTTOM FLANGE DOWN TO 3/8" REMAINING FULL WIDTH X 24" LONG, CORROSION ARRESTED.

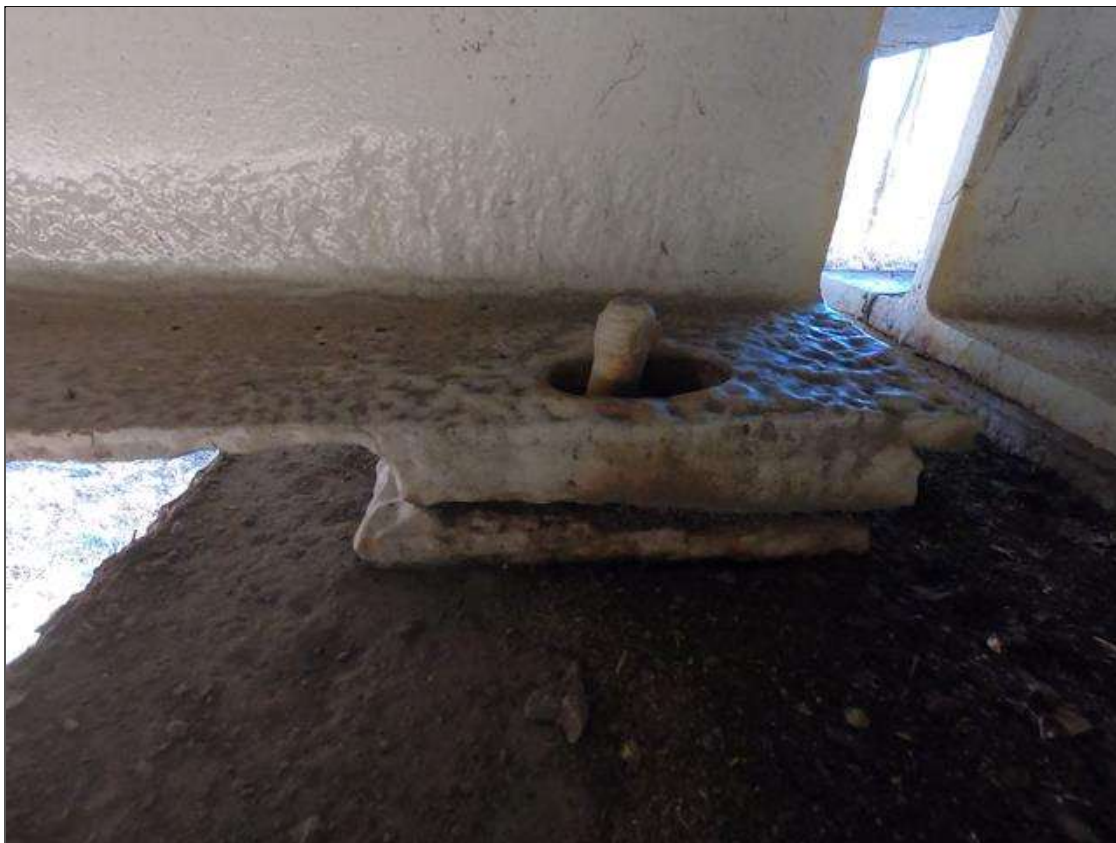
Span 3 Beam 4 - Near Bearing: PAR: COMPLETE SECTION LOSS IN LEFT ANCHOR BOLT NUT

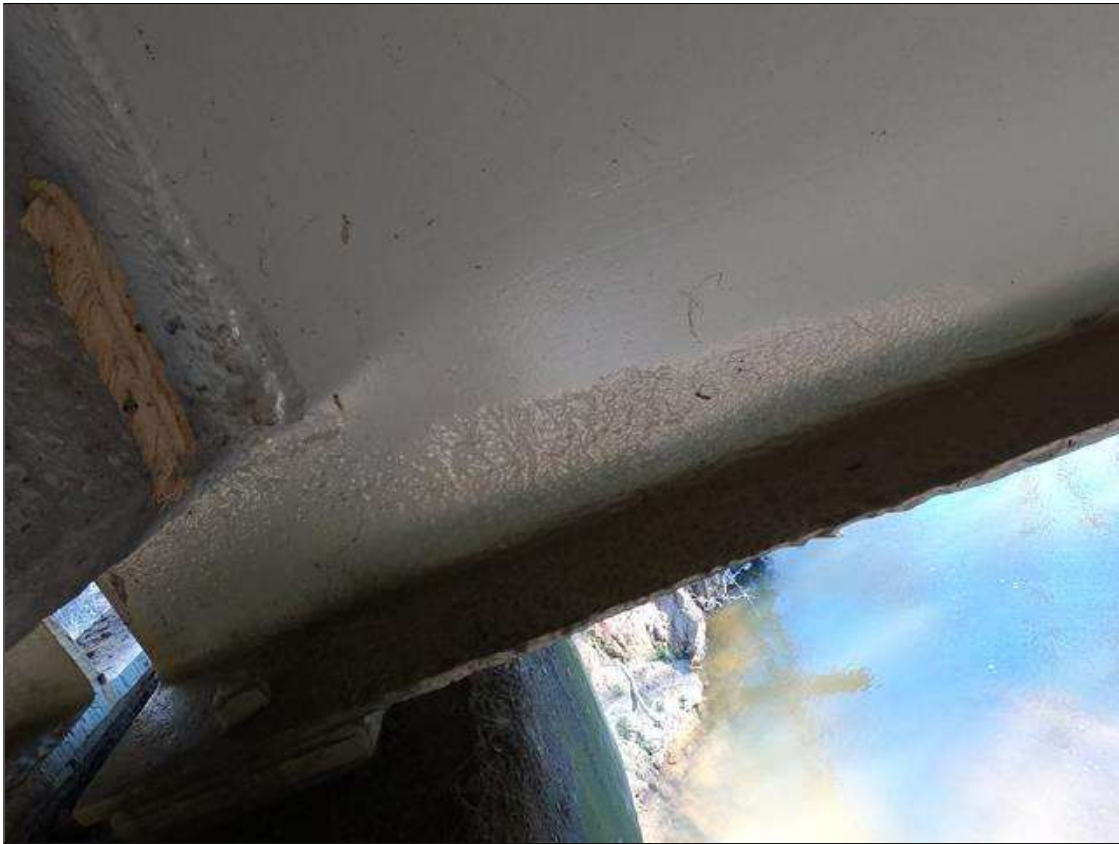
Span 2 Beam 4: PAR: AT BENT 2 SECTION LOSS BOTTOM FLANGE DOWN TO 5/16" REMAINING FULL WIDTH X 24" LONG, AND LOWER WEB DOWN TO 3/8" REMAINING FOR 6" TALL X 36" LONG, CORROSION ARRESTED

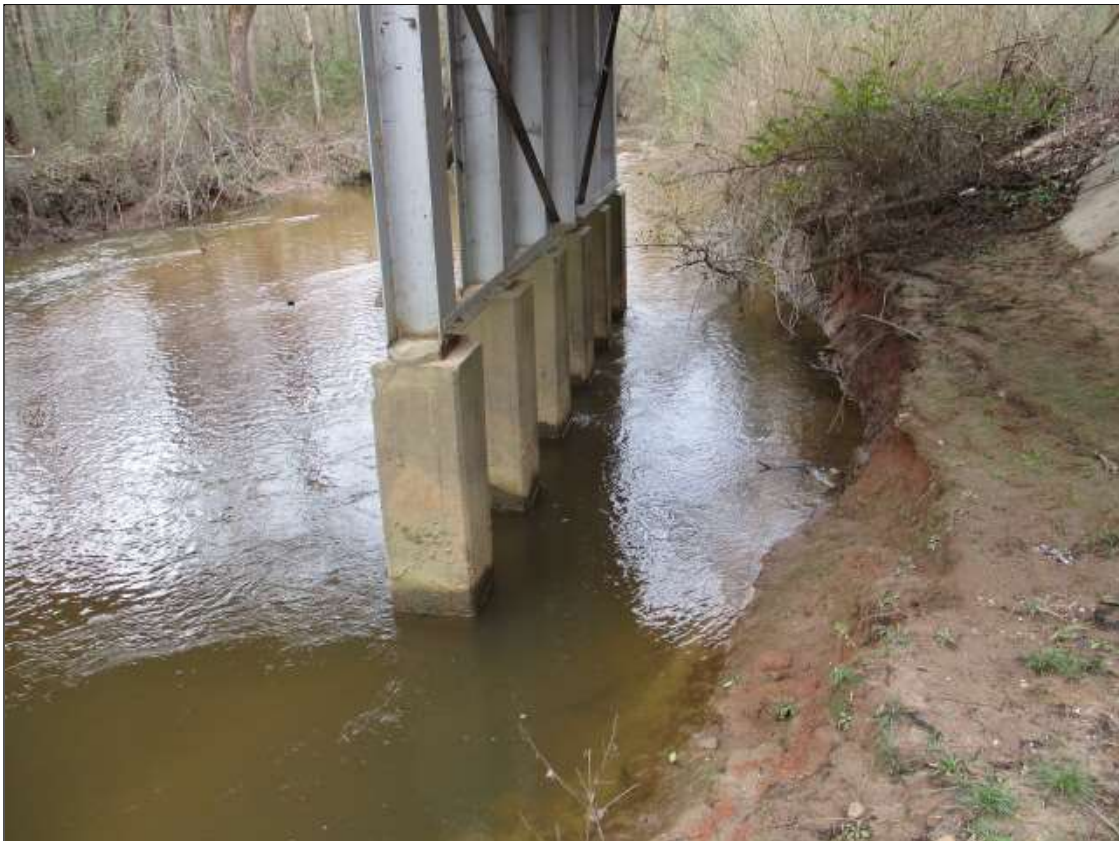
PAR: 15' LONG X 35' WIDE X 3' DEEP EROSION OF SPAN 3 SLOPE PROTECTION AROUND BENT 2 PILES

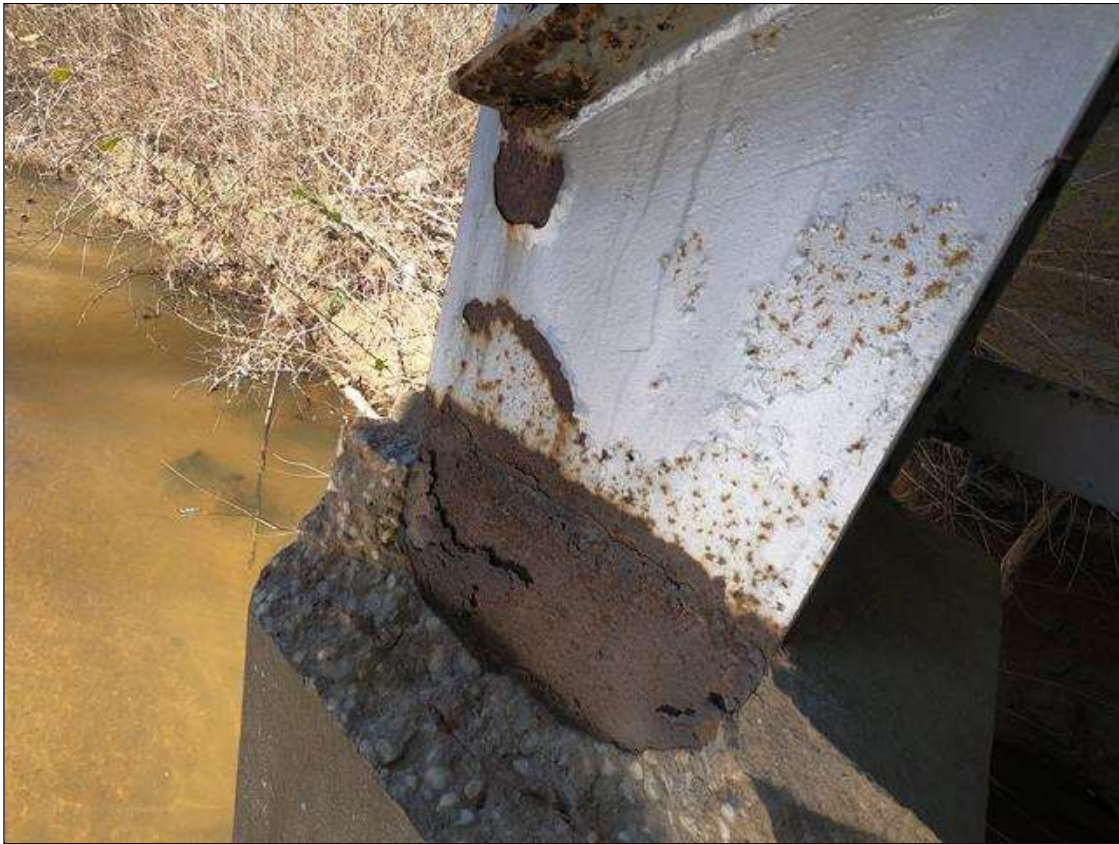
Bent 2 Pile 1: PAR: NEAR FLANGE PLATE AT CONCRETE ENCASEMENT ACTIVE CORROSION WITH SECTION LOSS 5" TALL X 12" WIDE, 7/16" REMAINING.

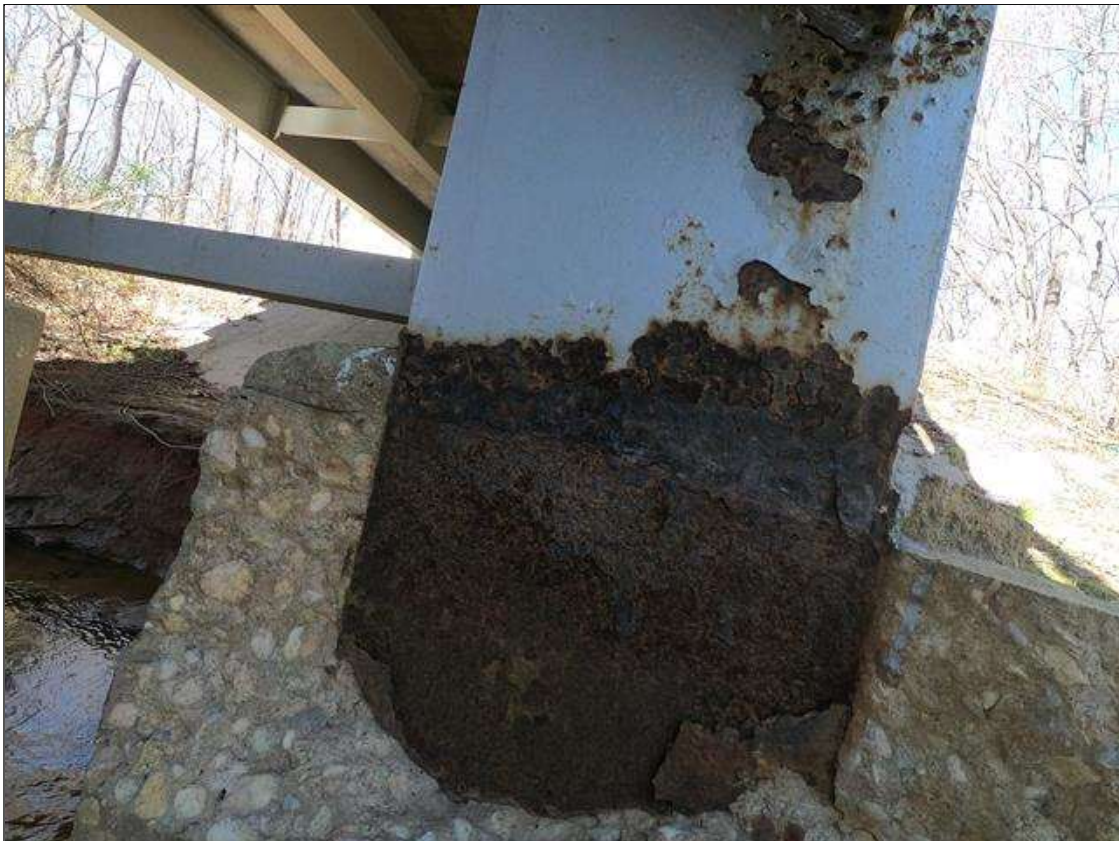
Bent 2 Pile 6: PAR: NEAR FLANGE PLATE AT CONCRETE ENCASEMENT: ACTIVE CORROSION WITH SECTION LOSS 1/4" REMAINING 12" WIDE X 8" TALL

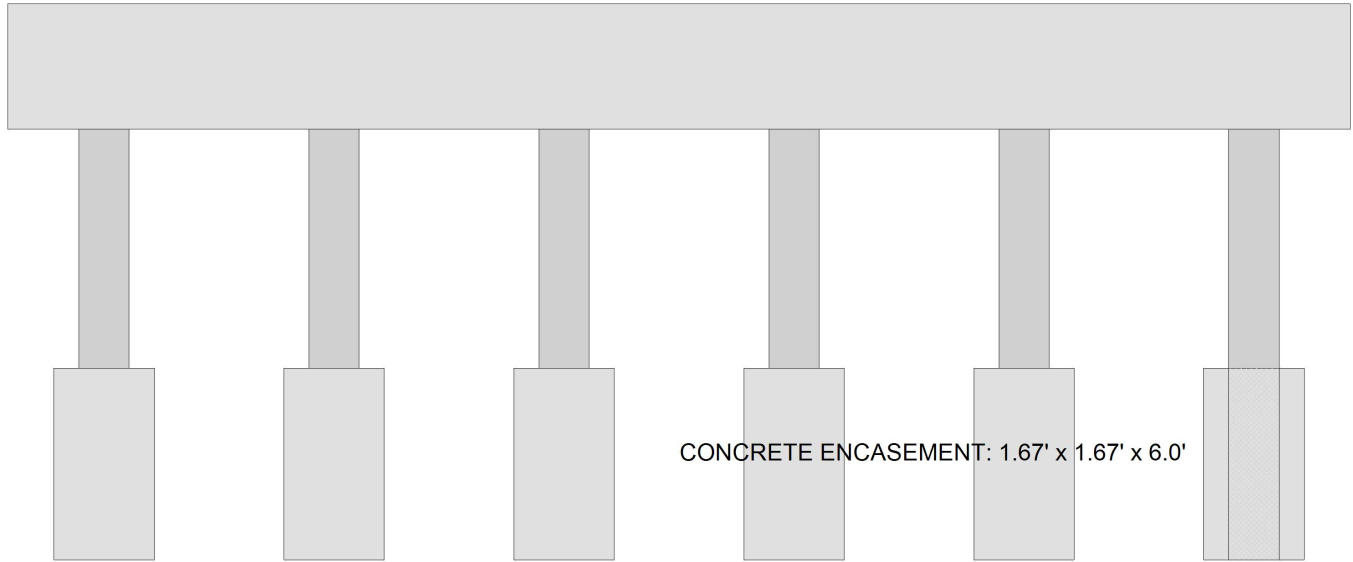
Cap Information			Material Cast-in-Place Concrete							
Length	Width	Height	Left Overhang	Right Overhang	Left Beam to End of Cap.	Right Beam to End of Cap.

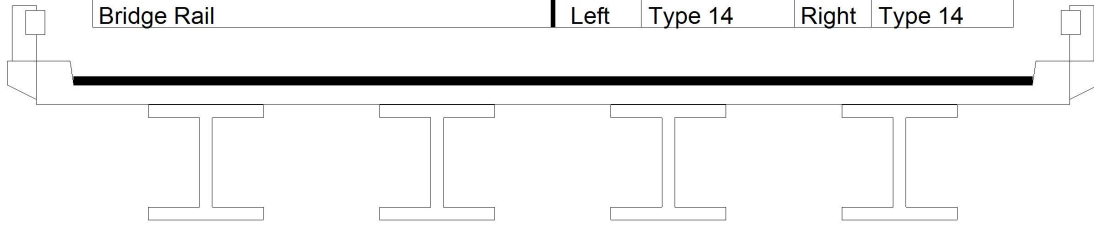
Measurements for Span #	1	Spans 2 & 3 Similar	
Deck Thickness	0.563	Left Overhang	4.583
Top of Rail to Bottom of Beam	6	Right Overhang	4.583
