NC DEPARTMENT OF TRANSPORTATION
 DIVISION OF HIGHWAYS
 STRUCTURE MANAGEMENT UNIT

ATTENTION: **PRIORITY MAINTENANCES (BEAMS, CAP, DECK SPALLS) CLEARANCES CHECKED TEMPORARY REPAIR (CAP)**

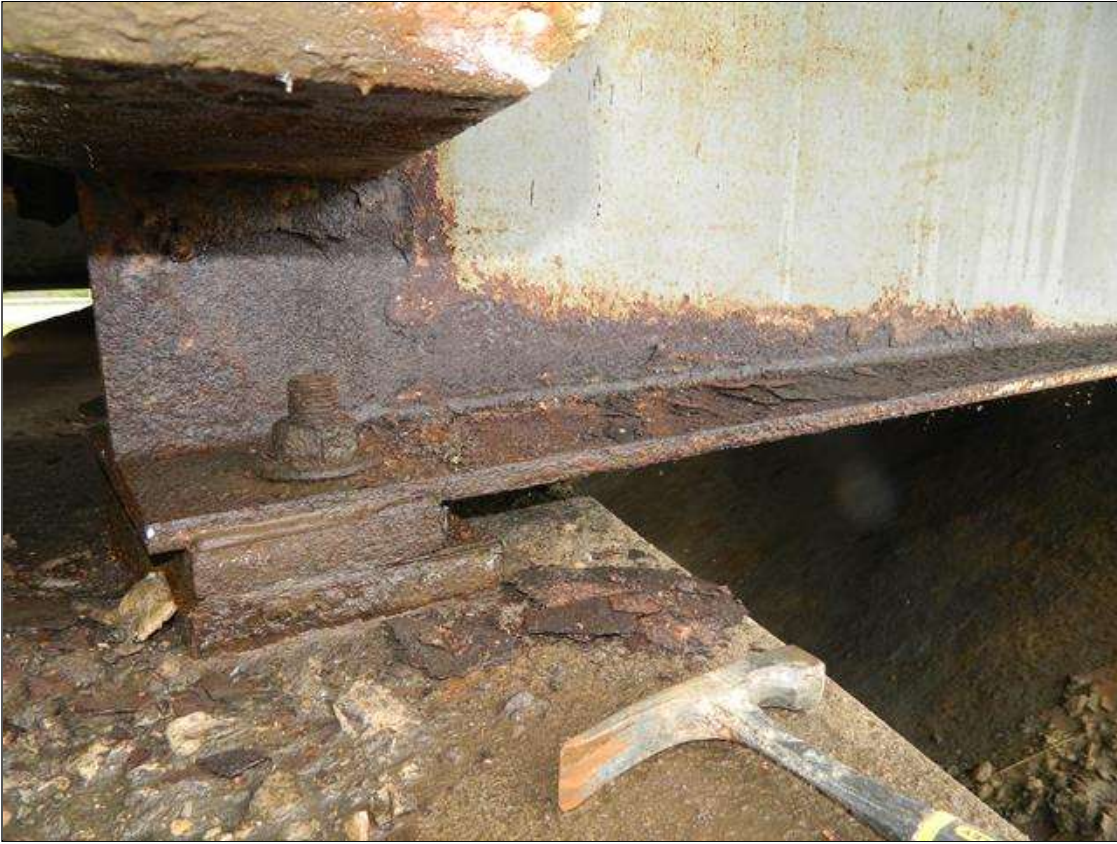
Span 3 Beam 10: THE FULL WIDTH OF THE BOTTOM FLANGE IS REDUCED TO 5/8" FOR 3' BEGINNING AT THE NEAR END OF THE BEAM. THE LOWER 9" OF THE WEB IS REDUCED TO 7/16" - 3/8" FOR 12" BEGINNING AT THE NEAR END OF THE BEAM. UPPER PORTION OF THE WEB IS NOT VISIBLE DUE TO END DIAPHRAGMS. ORIGINAL 11/16" FLANGE AND 1/2" WEB THICKNESSES. A PRIORITY MAINTENANCE IS REQUESTED.

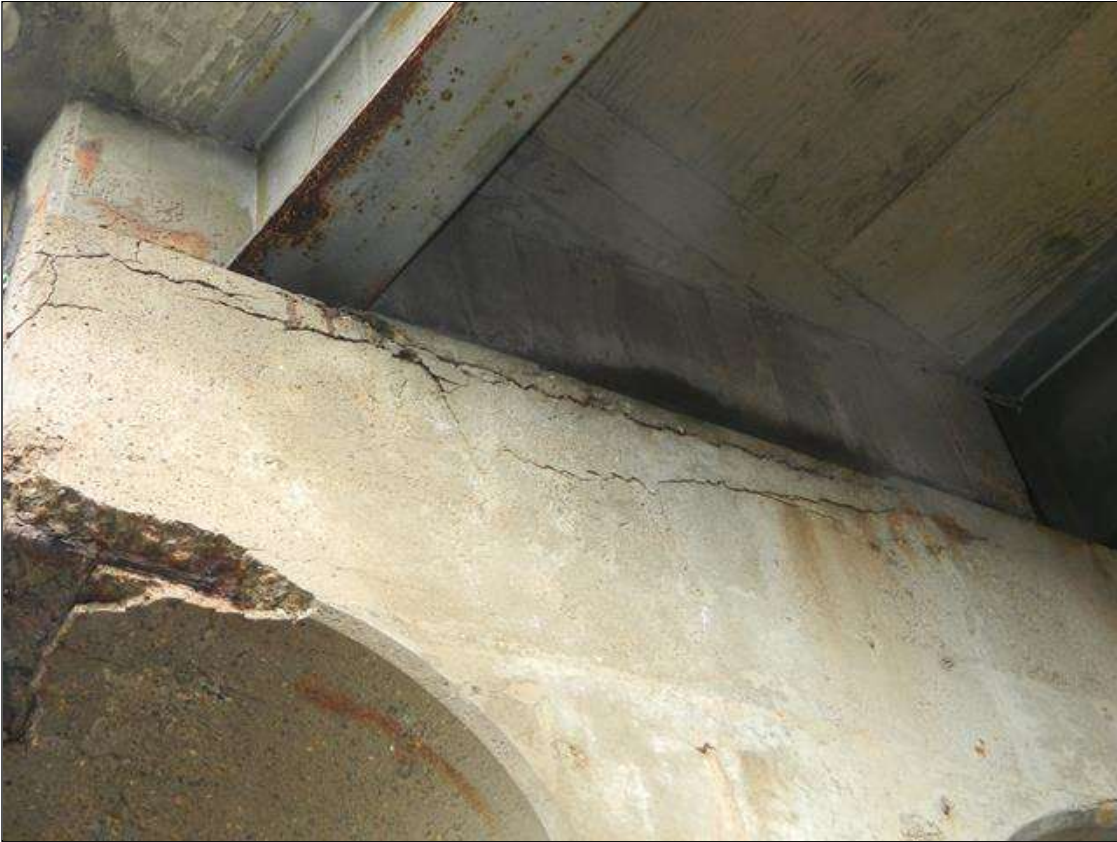
Bent 2 Cap 1: THE RIGHT END OF THE CAP HAS A FULL WIDTH X 3' LONG SPALL UP TO 3" DEEP WITH EXPOSED AND CORRODING REINFORCING STEEL TO THE UNDERSIDE OF THE CAP AND THE END OF THE CAP. MULTIPLE CRACKS UP TO 1/2" WIDE IN THE TOP FACE OF THE CAP, AND ALONG THE TOP EDGE OF THE CAP IN THE EAST FACE EXTENDING UNDERNEATH BEAM 10, AND UP TO BEAM 9. A PRIORITY MAINTENANCE IS REQUESTED.

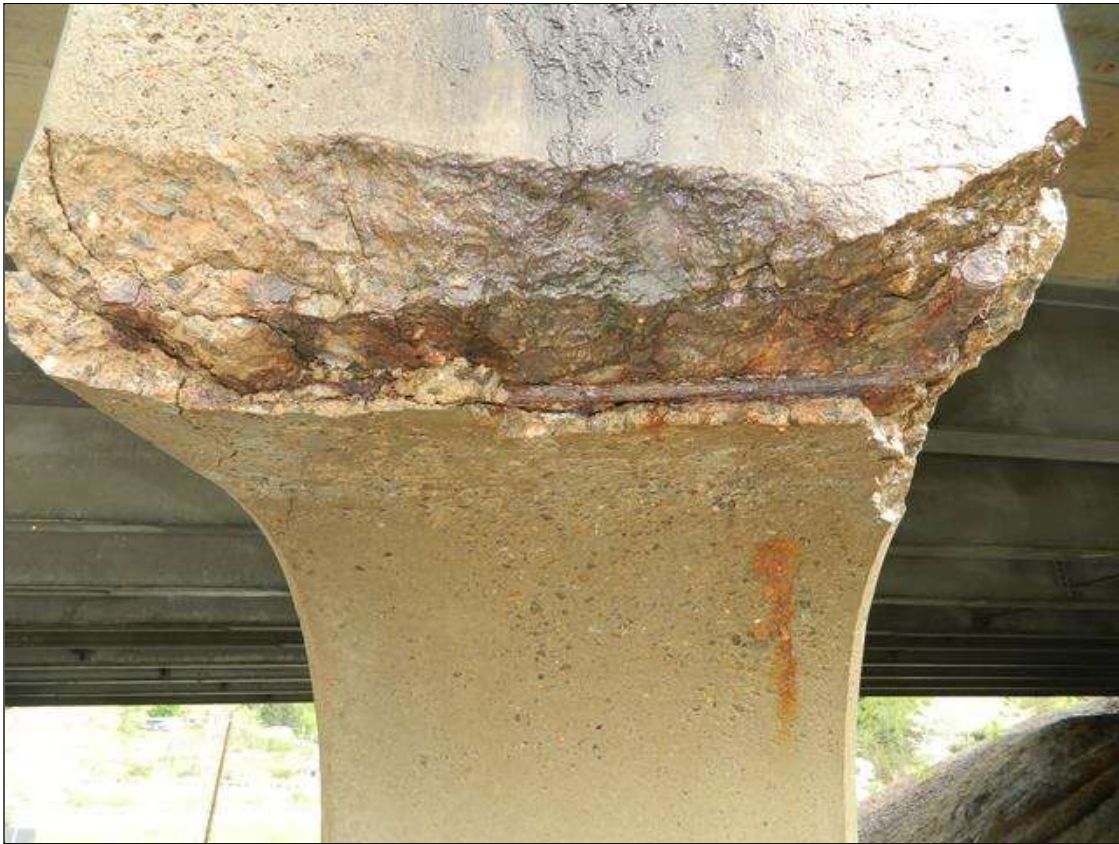
Bent 2 Cap 1: THE RIGHT END OF THE CAP HAS A FULL WIDTH X 3' LONG SPALL UP TO 3" DEEP WITH EXPOSED AND CORRODING REINFORCING STEEL TO THE UNDERSIDE OF THE CAP AND THE END OF THE CAP. MULTIPLE CRACKS UP TO 1/2" WIDE IN THE TOP FACE OF THE CAP, AND ALONG THE TOP EDGE OF THE CAP IN THE EAST FACE EXTENDING UNDERNEATH BEAM 10, AND UP TO BEAM 9. A PRIORITY MAINTENANCE IS REQUESTED.

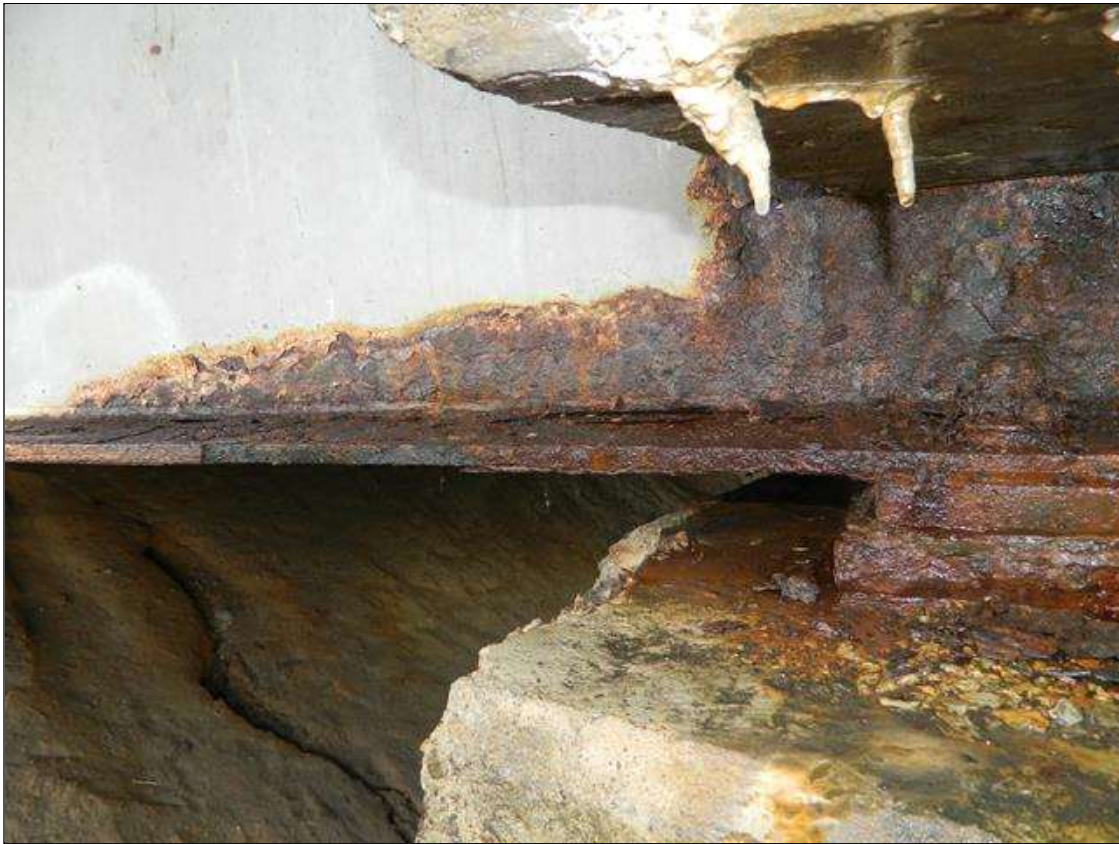
Span 3 Beam 1: THE FULL WIDTH OF THE BOTTOM FLANGE IS REDUCED TO 5/8" FOR 3' BEGINNING AT THE NEAR END OF THE BEAM. THE LOWER 9" OF THE WEB IS REDUCED TO 7/16" - 3/8" FOR 12" BEGINNING AT THE NEAR END OF THE BEAM. UPPER PORTION OF THE WEB IS NOT VISIBLE DUE TO END DIAPHRAGMS. ORIGINAL 11/16" FLANGE AND 1/2" WEB THICKNESSES. A PRIORITY MAINTENANCE IS REQUESTED.

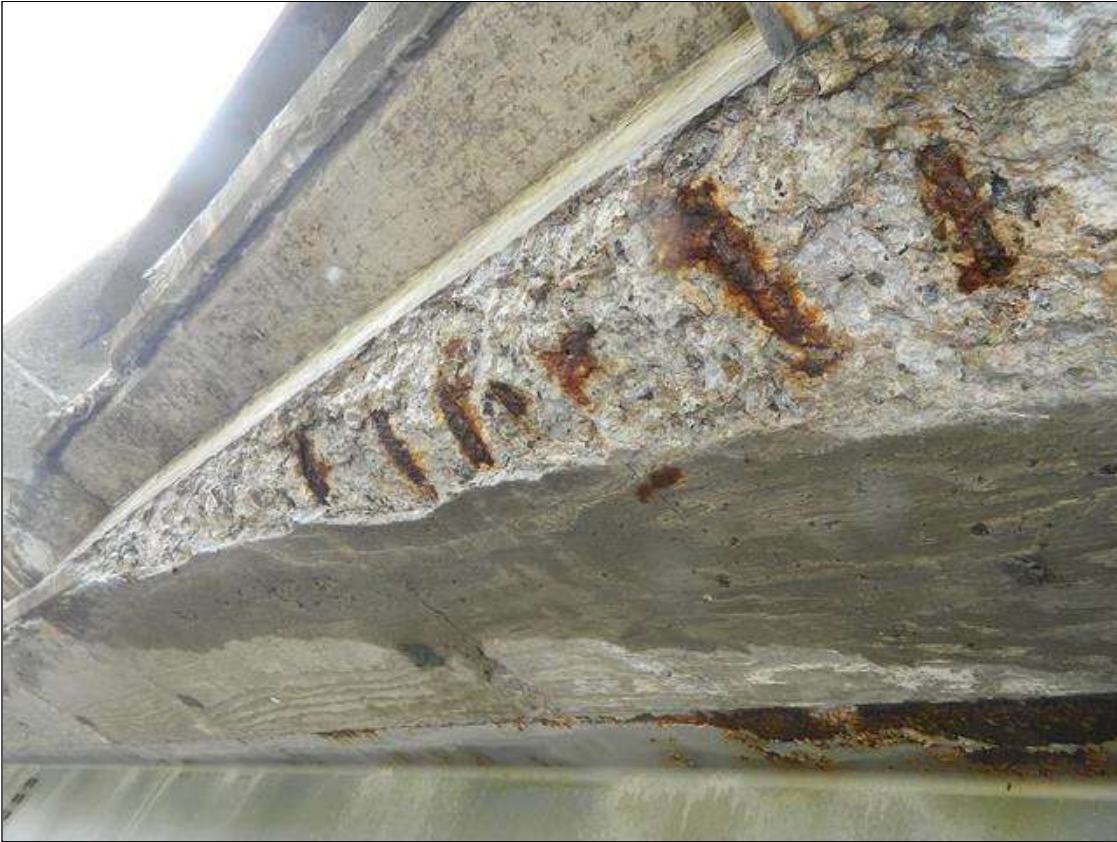
Span 3 Deck: 7' LONG X 1.5' WIDE X 2.5" DEEP DELAMINATION IN THE LEFT OVERHANG WITH EXPOSED AND CORRODING REINFORCING STEEL BEGINNING AT THE NEAR END OF THE SPAN. THE CURB, BEGINNING AT THE SAME AREA HAS 15' LONG FULL WIDTH X FULL HEIGHT X UP TO 3" DEEP DELAMINATION WITH EXPOSED AND CORRODING REINFORCING STEEL. A PRIORITY MAINTENANCE IS REQUESTED.

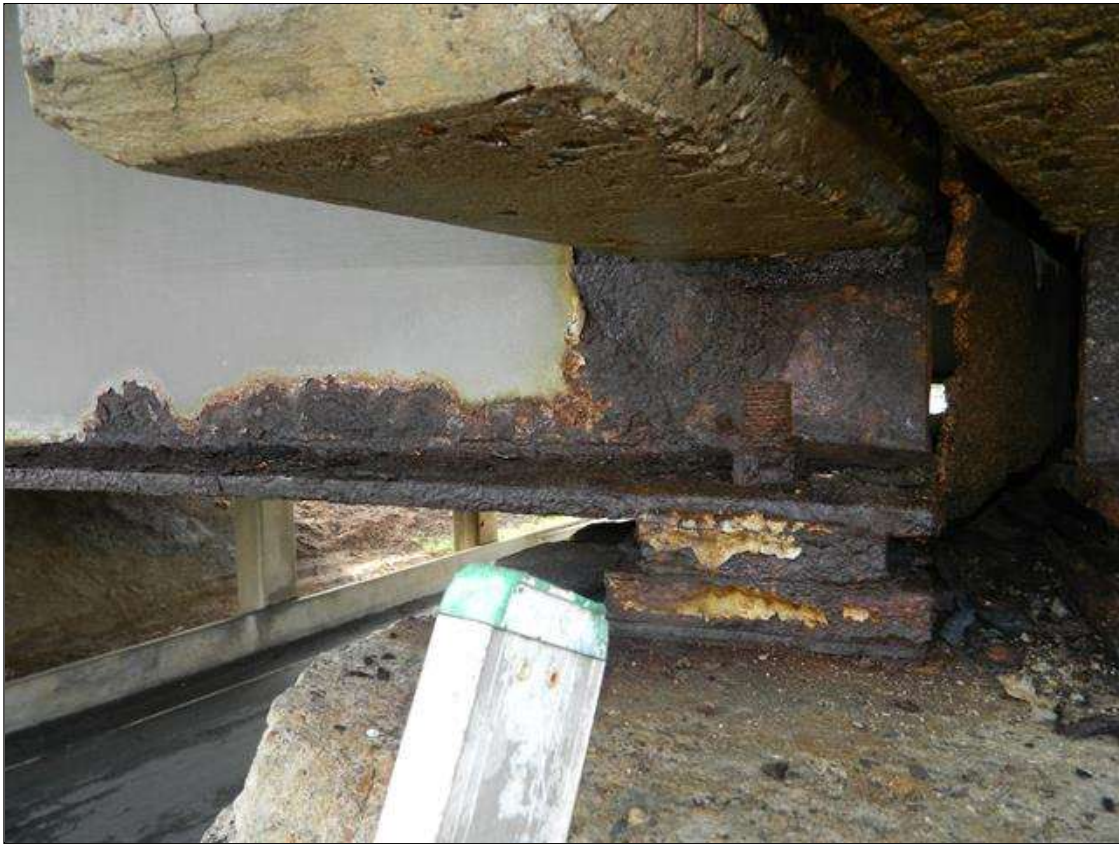
Span 2 Beam 1: THE FULL WIDTH OF THE BOTTOM FLANGE IS REDUCED TO 5/8" FOR 4' BEGINNING AT THE NEAR END OF THE BEAM. THE LOWER 9" OF THE WEB IS REDUCED TO 3/8" - 7/16" FOR 1' BEGINNING AT THE NEAR END OF THE BEAM. UPPER PORTION OF THE WEB IS NOT VISIBLE DUE TO END DIAPHRAGMS. ORIGINAL 11/16" FLANGE AND 1/2" WEB THICKNESSES. A PRIORITY MAINTENANCE IS REQUESTED.

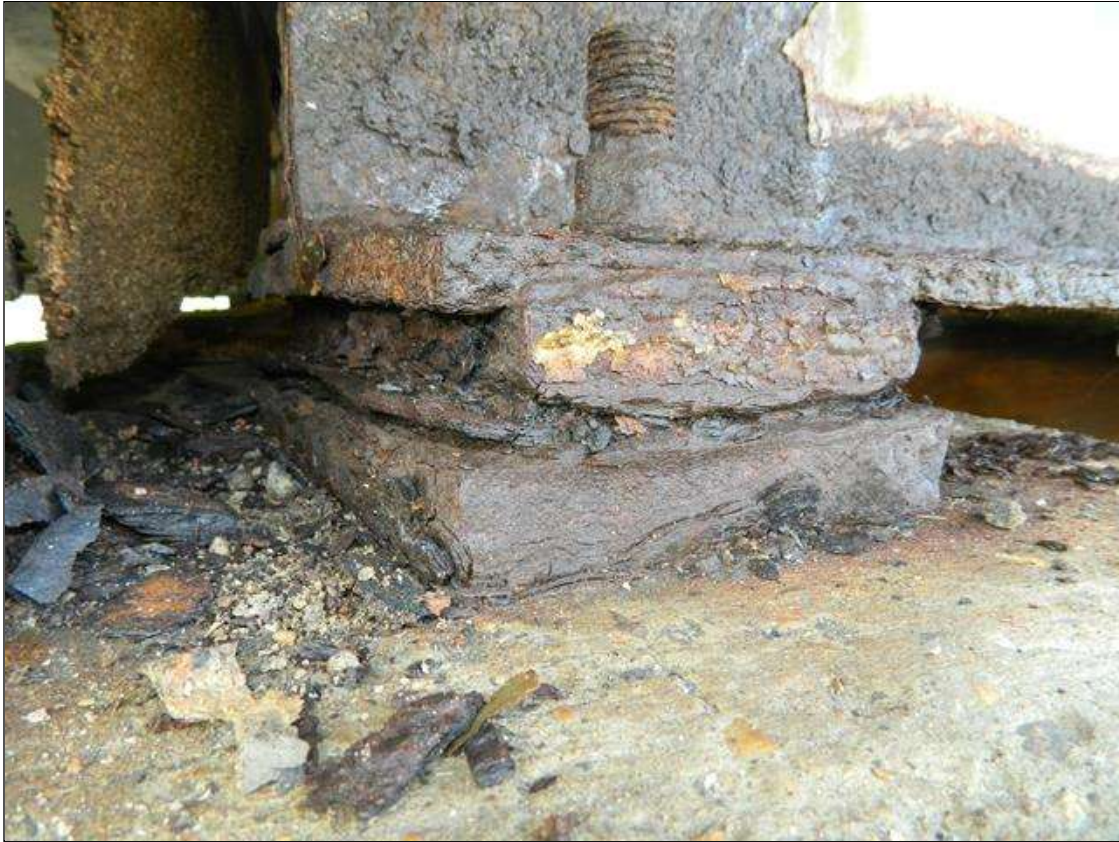
Span 1 Beam 1 Near Bearing: BEARING DEVICE CORRODED WITH 1/16" - 1/8" SCALE SECTION LOSS TO BOTH THE MASONRY AND SOLE PLATES. THE ANCHOR NUTS HAVE UP TO 75 PERCENT LOSS.

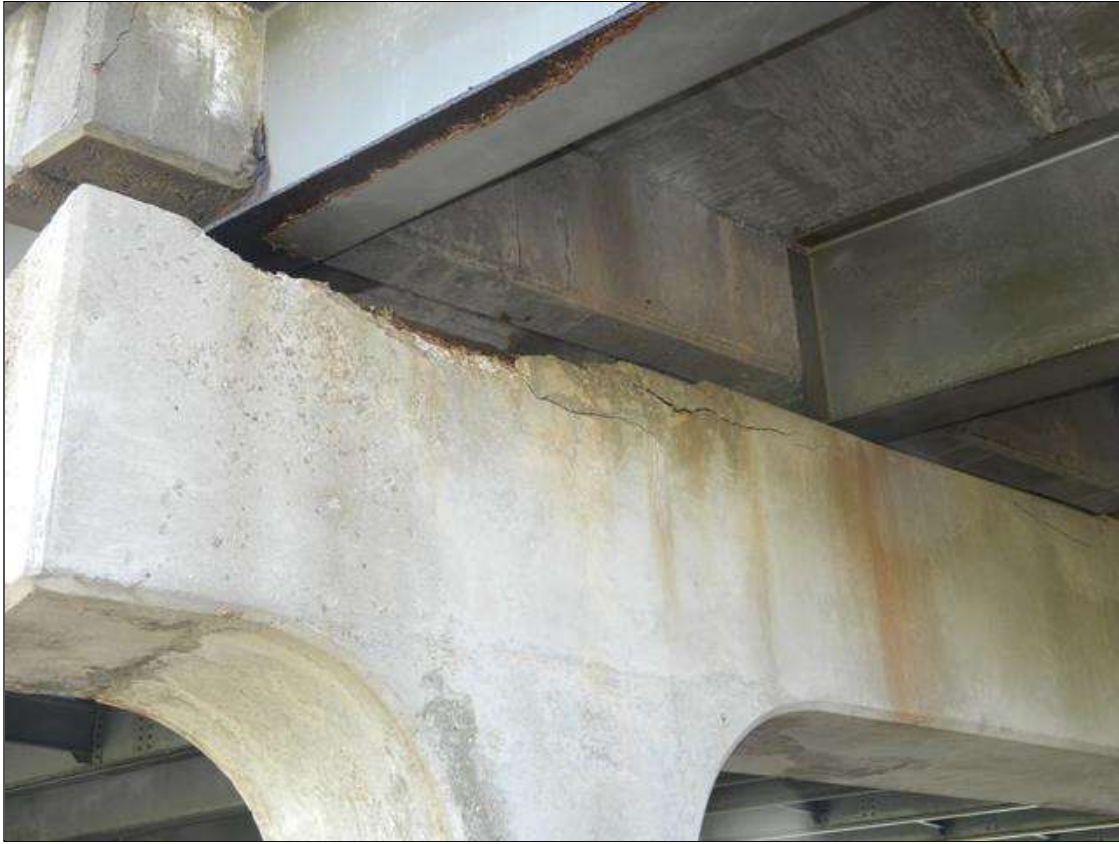
Bent 1 Cap 1: 9" HIGH X 4' LONG DELAMINATIONS UP TO 3" DEEP IN BOTH THE EAST AND WEST FACES OF THE CAP BEGINNING AT THE LEFT END. THESE DELAMINATIONS EXTEND UP TO THE EDGE OF THE BEARING PLATE OF BEAM 1 IN BOTH SPANS 1 AND 2. THE EXPOSED REINFORCING STEEL IS CORRODING WITH SCALE SECTION LOSS. THERE ARE MULTIPLE CRACKS UP TO 1/2" WIDE EXTENDING FROM THE DELAMINATION UP TO THE BEARING AREA OF BEAM 2 ON THE CAP. A PRIORITY MAINTENANCE IS REQUESTED.

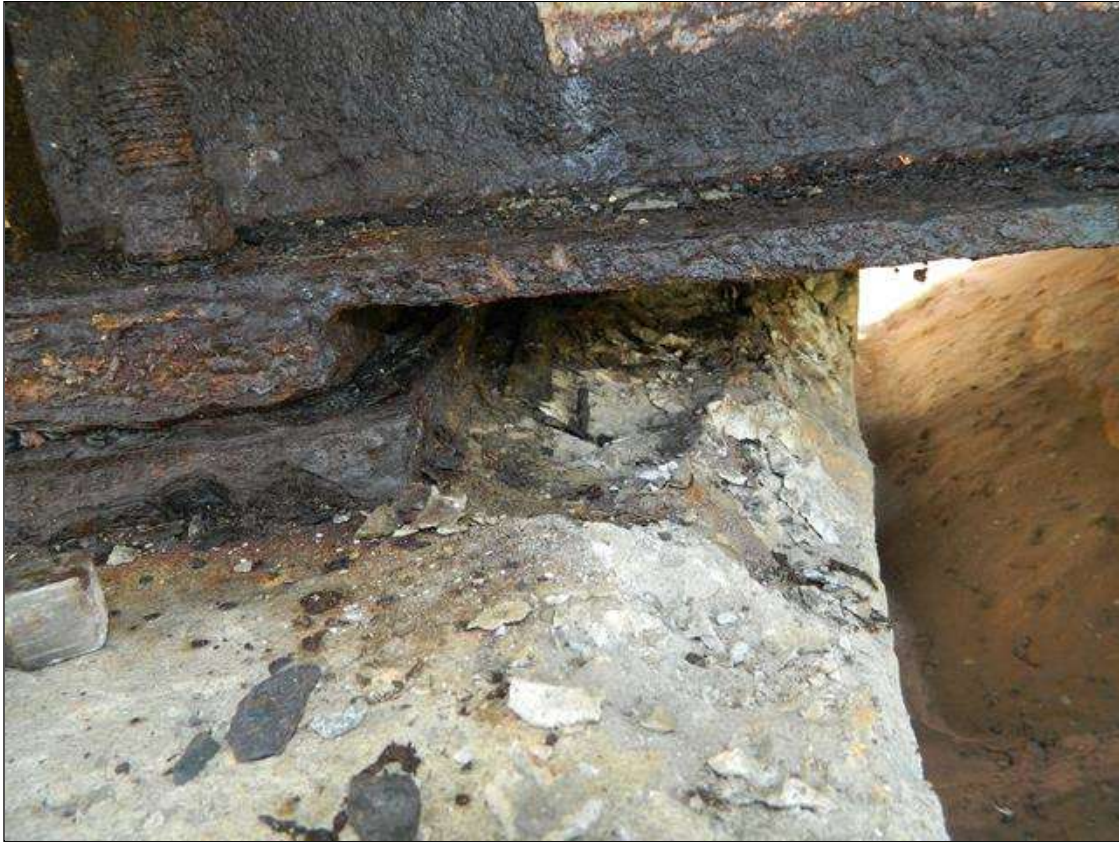
Bent 1 Cap 1: 9" HIGH X 4' LONG DELAMINATIONS UP TO 3" DEEP IN BOTH THE EAST AND WEST FACES OF THE CAP BEGINNING AT THE LEFT END. THESE DELAMINATIONS EXTEND UP TO THE EDGE OF THE BEARING PLATE OF BEAM 1 IN BOTH SPANS 1 AND 2. THE EXPOSED REINFORCING STEEL IS CORRODING WITH SCALE SECTION LOSS. THERE ARE MULTIPLE CRACKS UP TO 1/2" WIDE EXTENDING FROM THE DELAMINATION UP TO THE BEARING AREA OF BEAM 2 ON THE CAP. A PRIORITY MAINTENANCE IS REQUESTED.

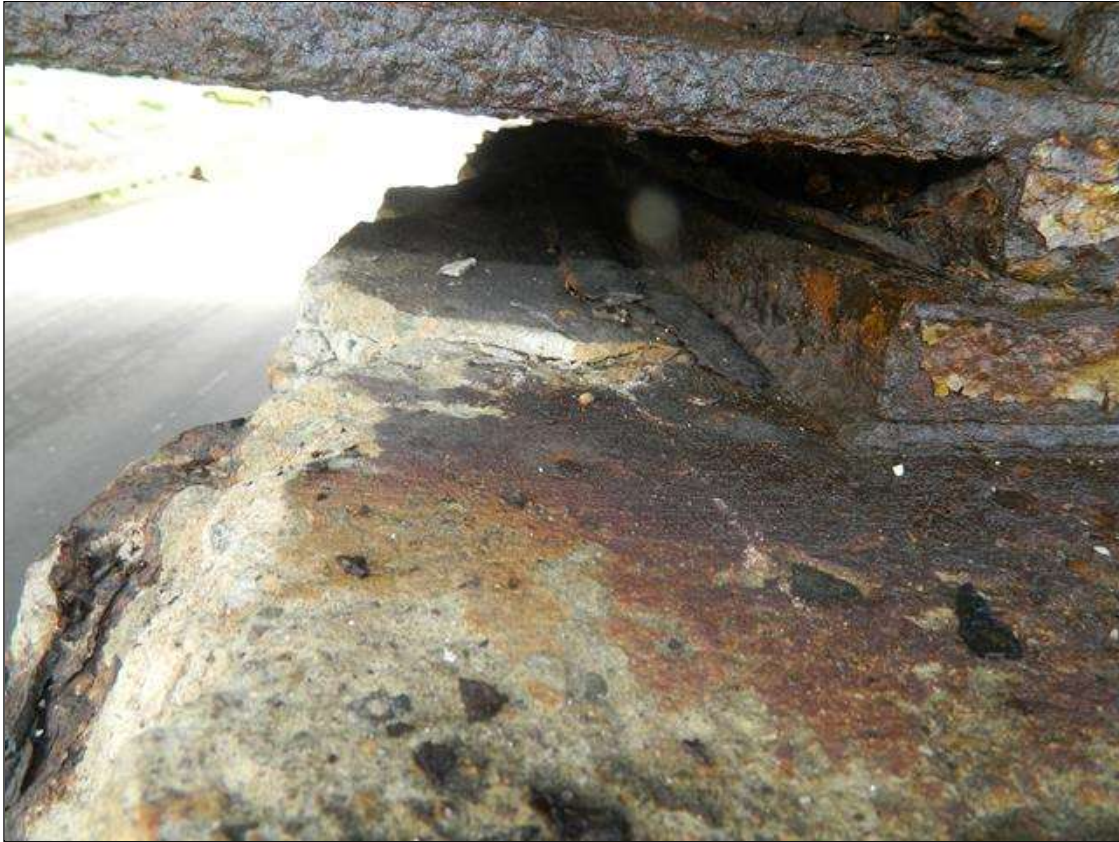
Bent 1 Cap 1: 9" HIGH X 4' LONG DELAMINATIONS UP TO 3" DEEP IN BOTH THE EAST AND WEST FACES OF THE CAP BEGINNING AT THE LEFT END. THESE DELAMINATIONS EXTEND UP TO THE EDGE OF THE BEARING PLATE OF BEAM 1 IN BOTH SPANS 1 AND 2. THE EXPOSED REINFORCING STEEL IS CORRODING WITH SCALE SECTION LOSS. THERE ARE MULTIPLE CRACKS UP TO 1/2" WIDE EXTENDING FROM THE DELAMINATION UP TO THE BEARING AREA OF BEAM 2 ON THE CAP. A PRIORITY MAINTENANCE IS REQUESTED.

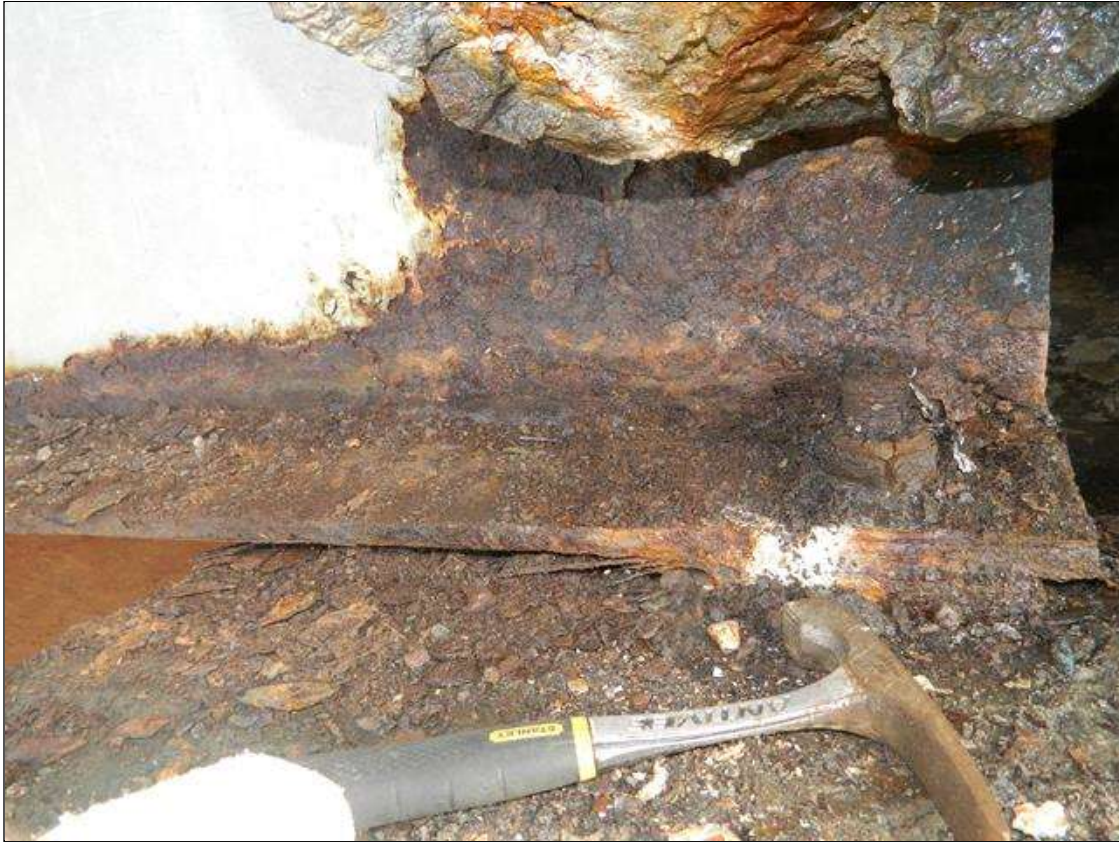
Span 1 Beam 10: THE FULL WIDTH OF THE BOTTOM FLANGE IS REDUCED TO 1/8" - 3/16" FOR 2'-6" BEGINNING AT THE FAR END OF THE BEAM, AND 5/16" - 3/8" FOR 1.5' ADJACENT TO PREVIOUS AREA. THE LOWER 9" OF THE WEB IS REDUCED TO 1/16" - 1/8" FOR 12" BEGINNING AT THE FAR END WITH A 3" WIDE X 1/2" HIGH COMPLETE LOSS BEGINNING 4" FROM THE FAR END OF THE BEAM AT 8" UP FROM THE BASE OF THE WEB. A PRIORITY MAINTENANCE IS REQUESTED.

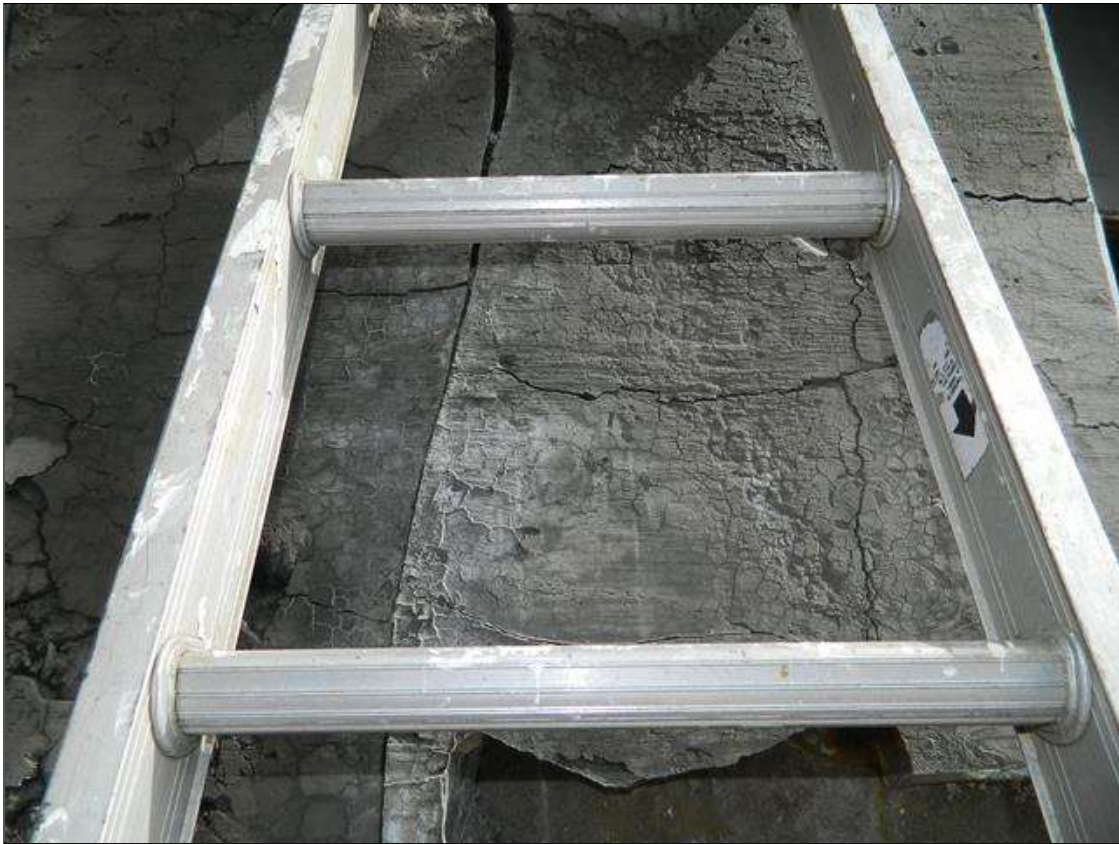
Bent 1 Cap 1: PATCH ON THE RIGHT END OF THE CAP HAS MULTIPLE CRACKS UP TO 1/2" WIDE THROUGHOUT ALL FACES AND THE END. THE PATCH IS DULL SOUNDING TO THE HAMMER, AND COULD EASILY BE KNOCKED LOOSE FROM THE CAP. LARGE PIECES OF THE PATCH HAVE ALREADY FALLEN OUT. A PRIORITY MAINTENANCE IS REQUESTED.

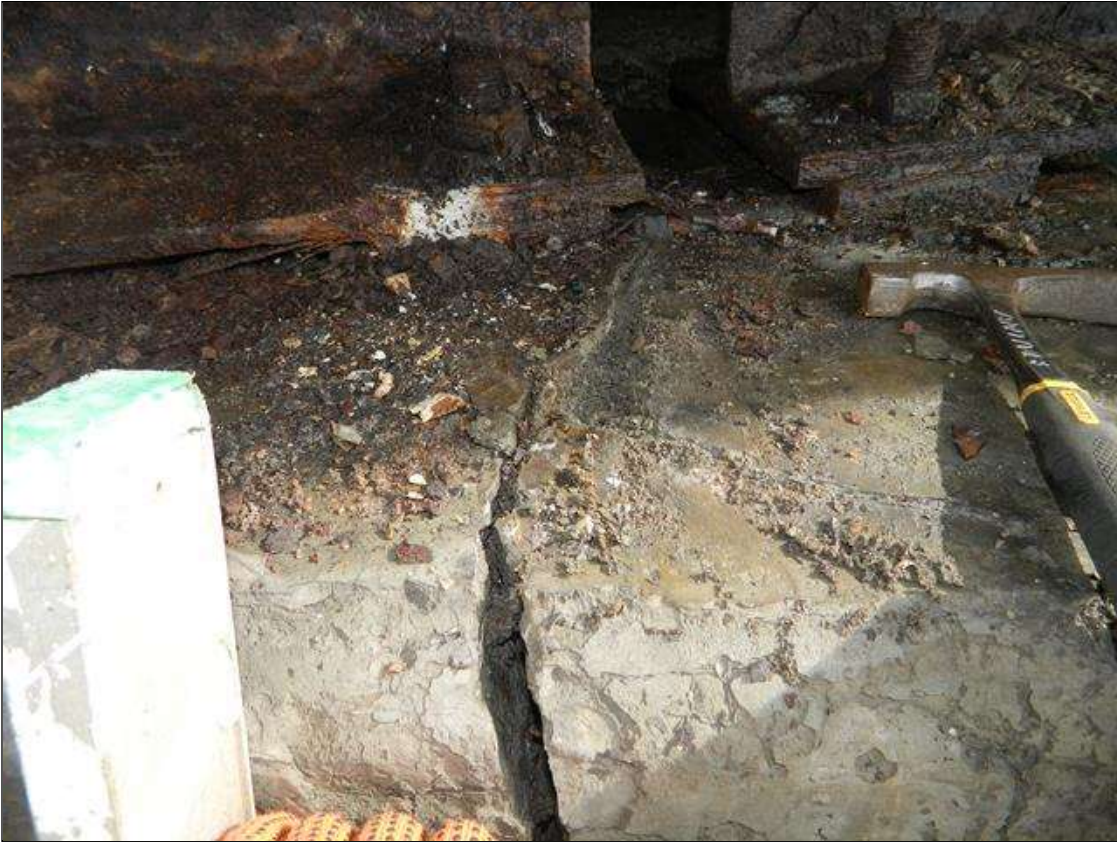
Bent 1 Cap 1: PATCH ON THE RIGHT END OF THE CAP HAS MULTIPLE CRACKS UP TO 1/2" WIDE THROUGHOUT ALL FACES AND THE END. THE PATCH IS DULL SOUNDING TO THE HAMMER, AND COULD EASILY BE KNOCKED LOOSE FROM THE CAP. LARGE PIECES OF THE PATCH HAVE ALREADY FALLEN OUT. A PRIORITY MAINTENANCE IS REQUESTED.

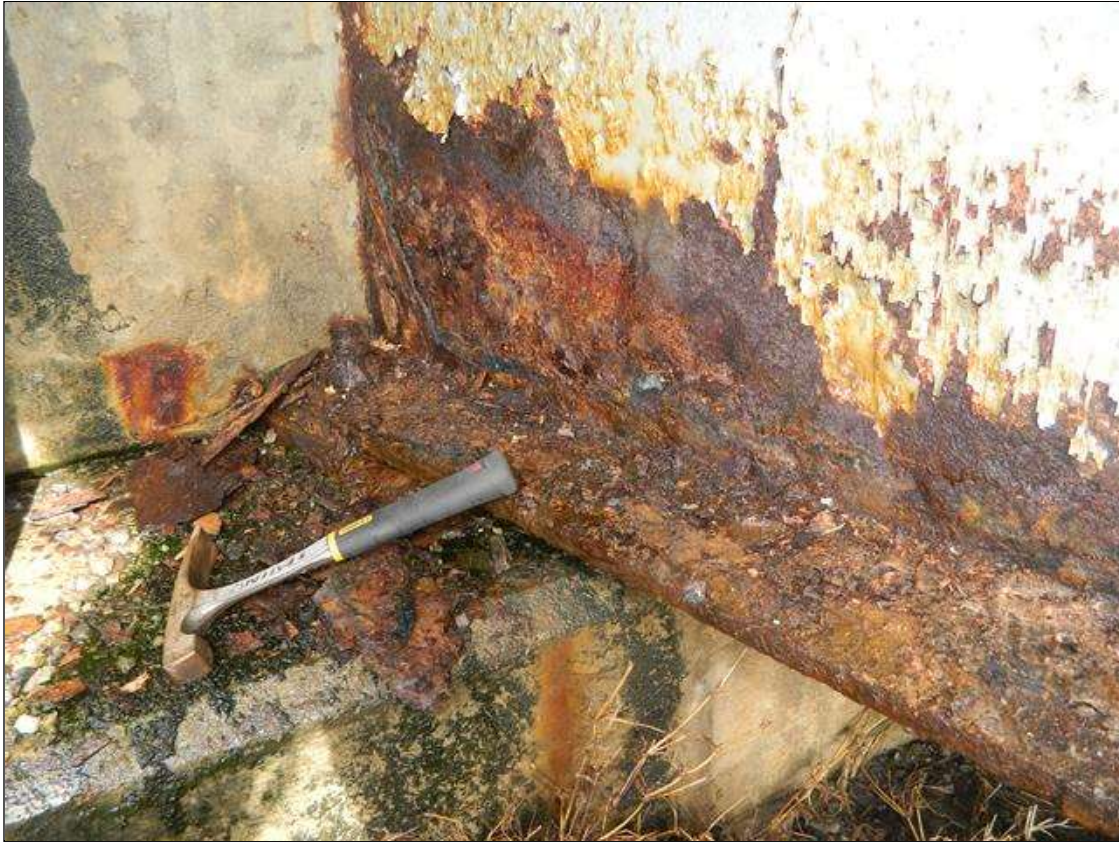
Span 1 Beam 10: THE FULL WIDTH OF THE BOTTOM FLANGE IS REDUCED TO $9/16'' - 5/8''$ FOR 4' BEGINNING AT THE NEAR END OF THE BEAM. THE LOWER 16" OF THE WEB IS REDUCED TO $1/4'' - 5/16''$ FOR 2' BEGINNING AT THE NEAR END OF THE BEAM. ORIGINAL $11/16''$ FLANGE AND $1/2''$ WEB THICKNESSES. A PRIORITY MAINTENANCE IS REQUESTED.

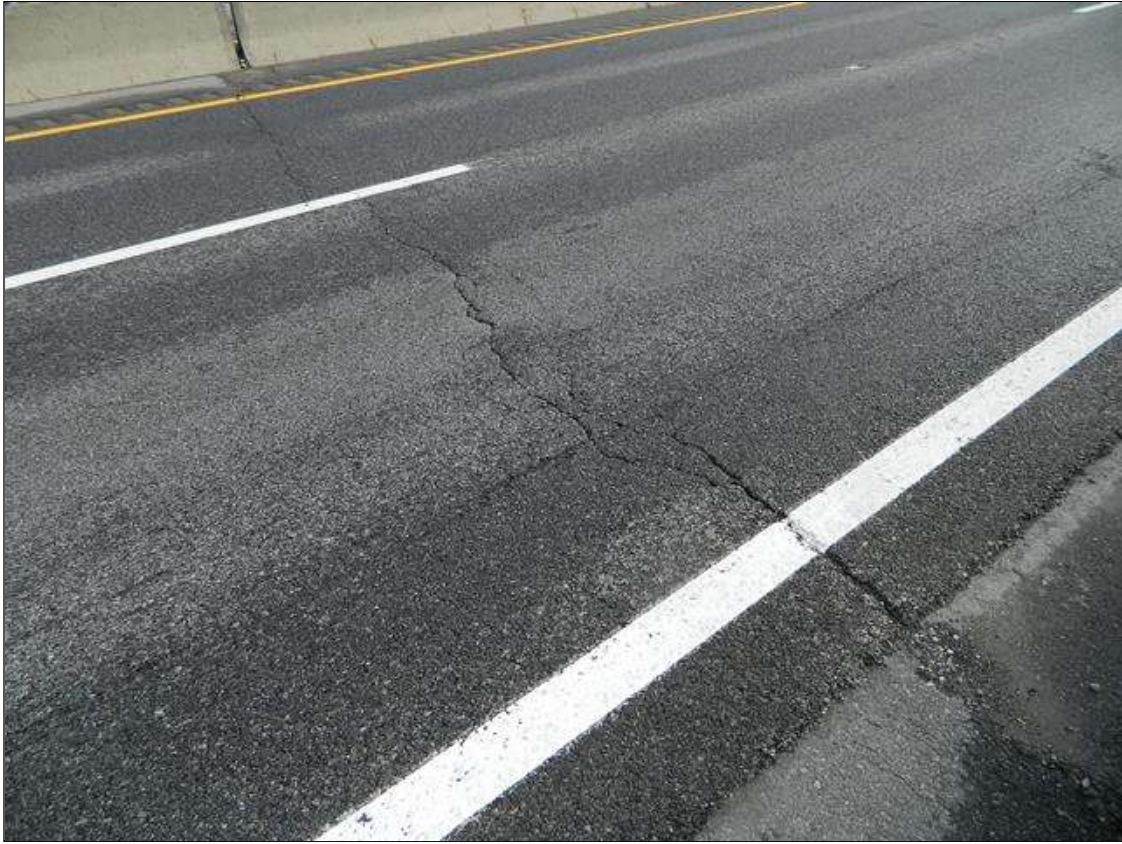
Span 1 Wearing Surface: 1/4" - 1/2" WIDE TRANSVERSE CRACKS AT THE EXPANSION JOINTS.

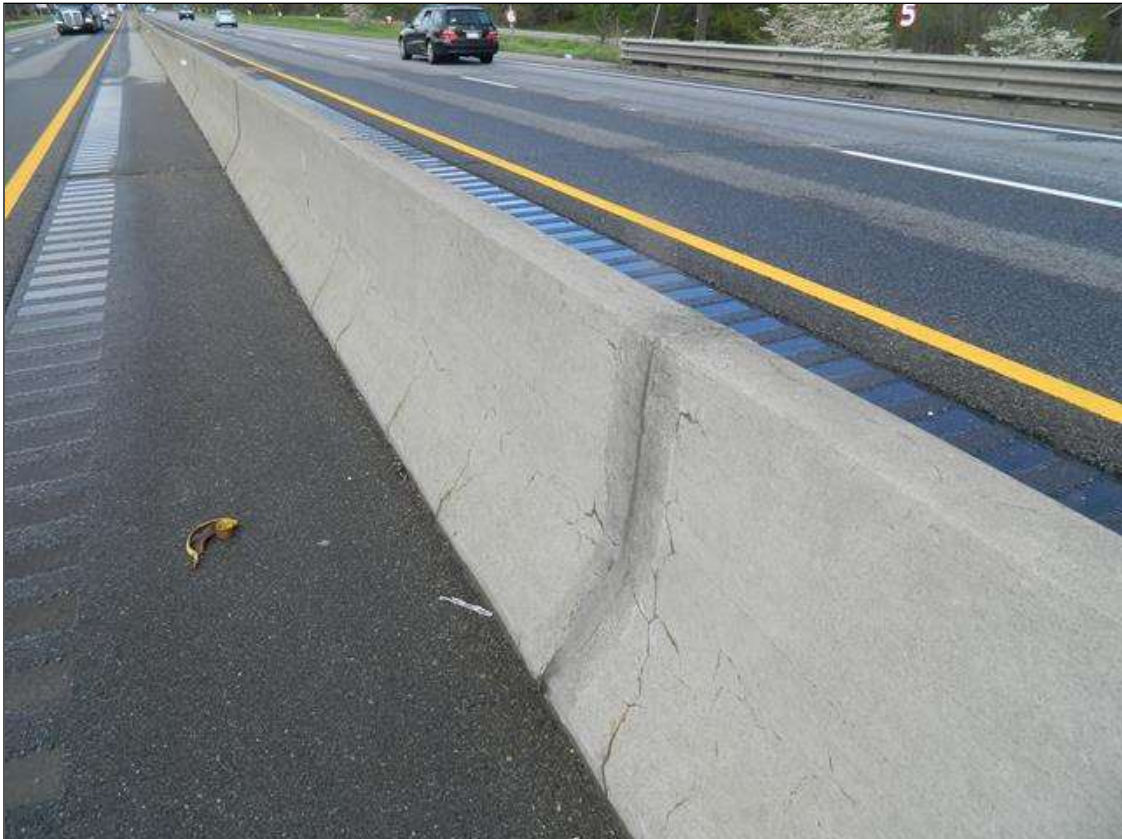
Span 1 Median Rail: 6" - 1' HIGH HAIRLINE MAP CRACKS ALONG THE BASE OF THE RAIL, BOTH FACES.

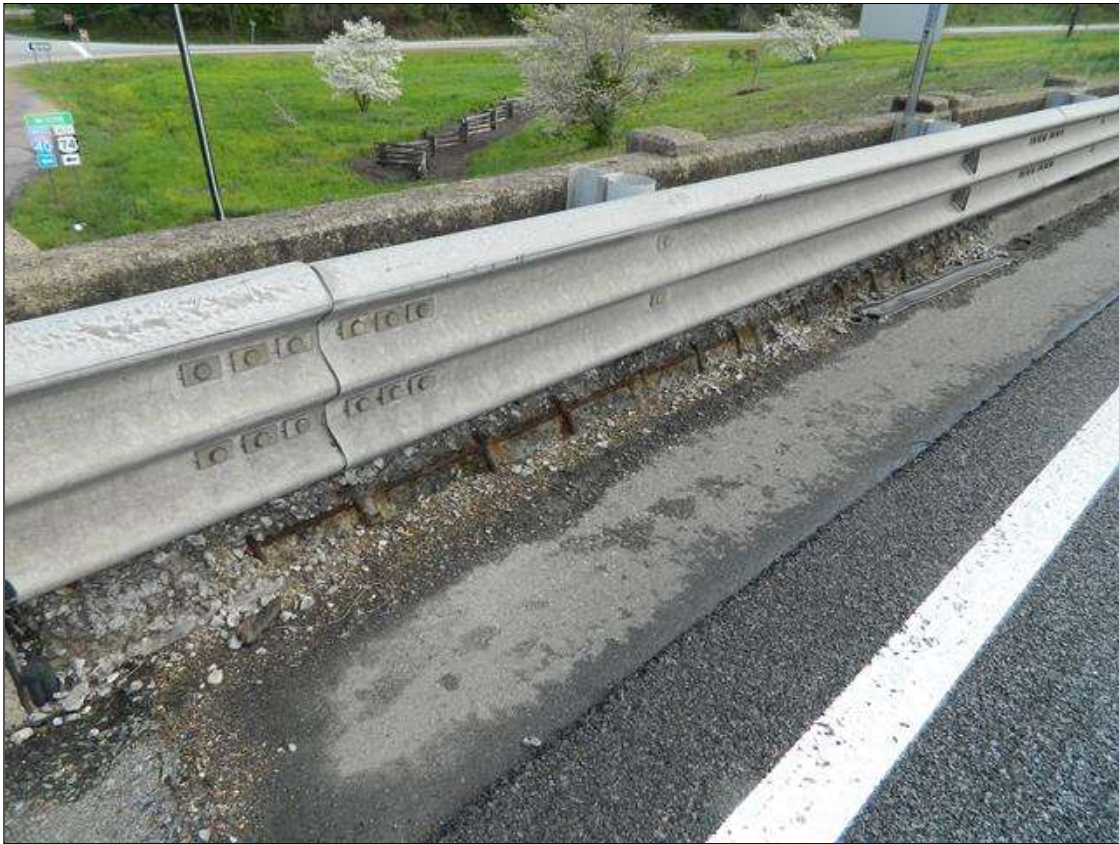
Span 3 Deck: 7' LONG X 1.5' WIDE X 2.5" DEEP DELAMINATION IN THE LEFT OVERHANG WITH EXPOSED AND CORRODING REINFORCING STEEL BEGINNING AT THE NEAR END OF THE SPAN. THE CURB, BEGINNING AT THE SAME AREA HAS 15' LONG FULL WIDTH X FULL HEIGHT X UP TO 3" DEEP DELAMINATION WITH EXPOSED AND CORRODING REINFORCING STEEL. A PRIORITY MAINTENANCE IS REQUESTED.

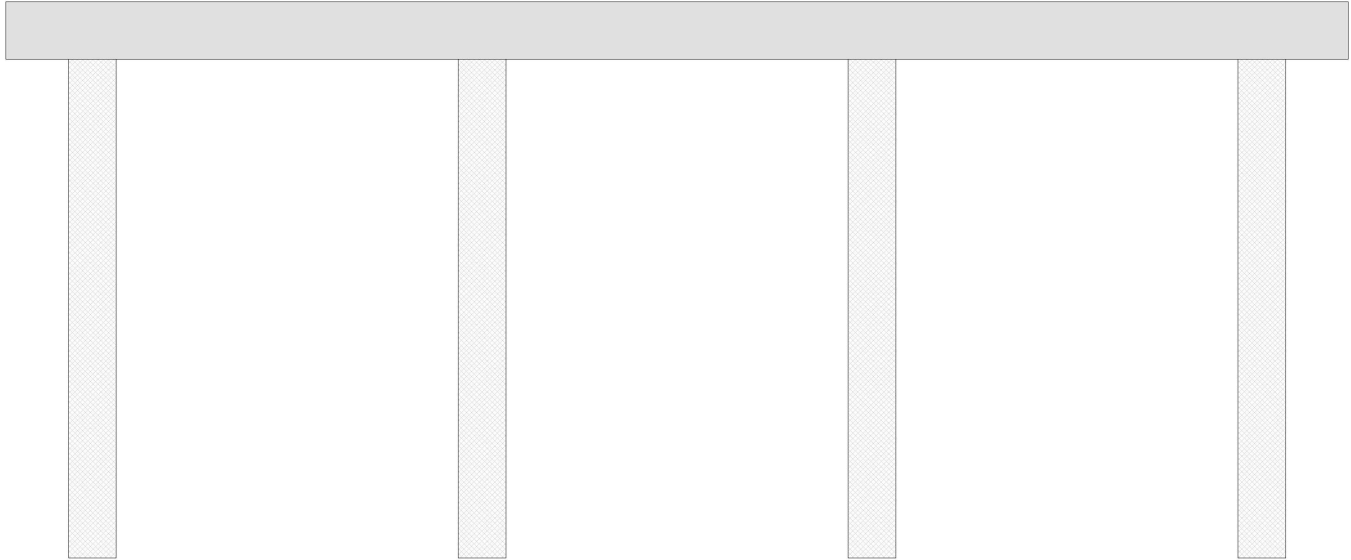
Cap Information			Material Cast-in-Place Concrete							
Length	Width	Height	Left Overhang	Right Overhang	Left Beam to End of Cap.	Right Beam to End of Cap.				
70.000 ft.	3.000 ft.	3.000 ft.	4.500 ft.	4.500 ft.	1.833 ft.	1.833 ft.				
Subcap Information			Material							
Length	Width	Height	Left Overhang	Right Overhang	Left Pile to Splice.					
Sill Information			Material							
Length	Width	Height								
Pile #	Material	Spacing	Width/Dia.	Height	Length	Orientation	Driven?	Replacement?	Removed?	Collar?
1	Concrete	20.333 ft.	2.5 ft.	3 ft.		Vertical	No	No	No	No
2	Concrete	20.333 ft.	2.5 ft.	3 ft.		Vertical	No	No	No	No
3	Concrete	20.333 ft.	2.5 ft.	3 ft.		Vertical	No	No	No	No
4	Concrete		2.5 ft.	3 ft.		Vertical	No	No	No	No
Bent/Abutment #: 1			Similar Bents: 2
