**Phase II Site Assessment Report  
December 1, 2021  
WBS Element: 45786.1.1  
State Project: B-5833  
Yadkin County**

**Parcel #: 011  
Add-On Venture Properties, LLC Property  
5652 and 5704 US Hwy 21; Jonesville, NC, 28642  
PIN #: 4869563147, 4869562417, 4869563091  
Facility ID No.: 00-0-0000023364  
Groundwater Incident #: 37795**

**Mr. Gordon Box  
NCDOT, Geotechnical Engineering Unit  
GeoEnvironmental Section  
1589 Mail Service Center  
Raleigh, NC 27699-1589**

**Seramur & Associates, PC  
165 Knoll Drive  
Boone, NC 28607**

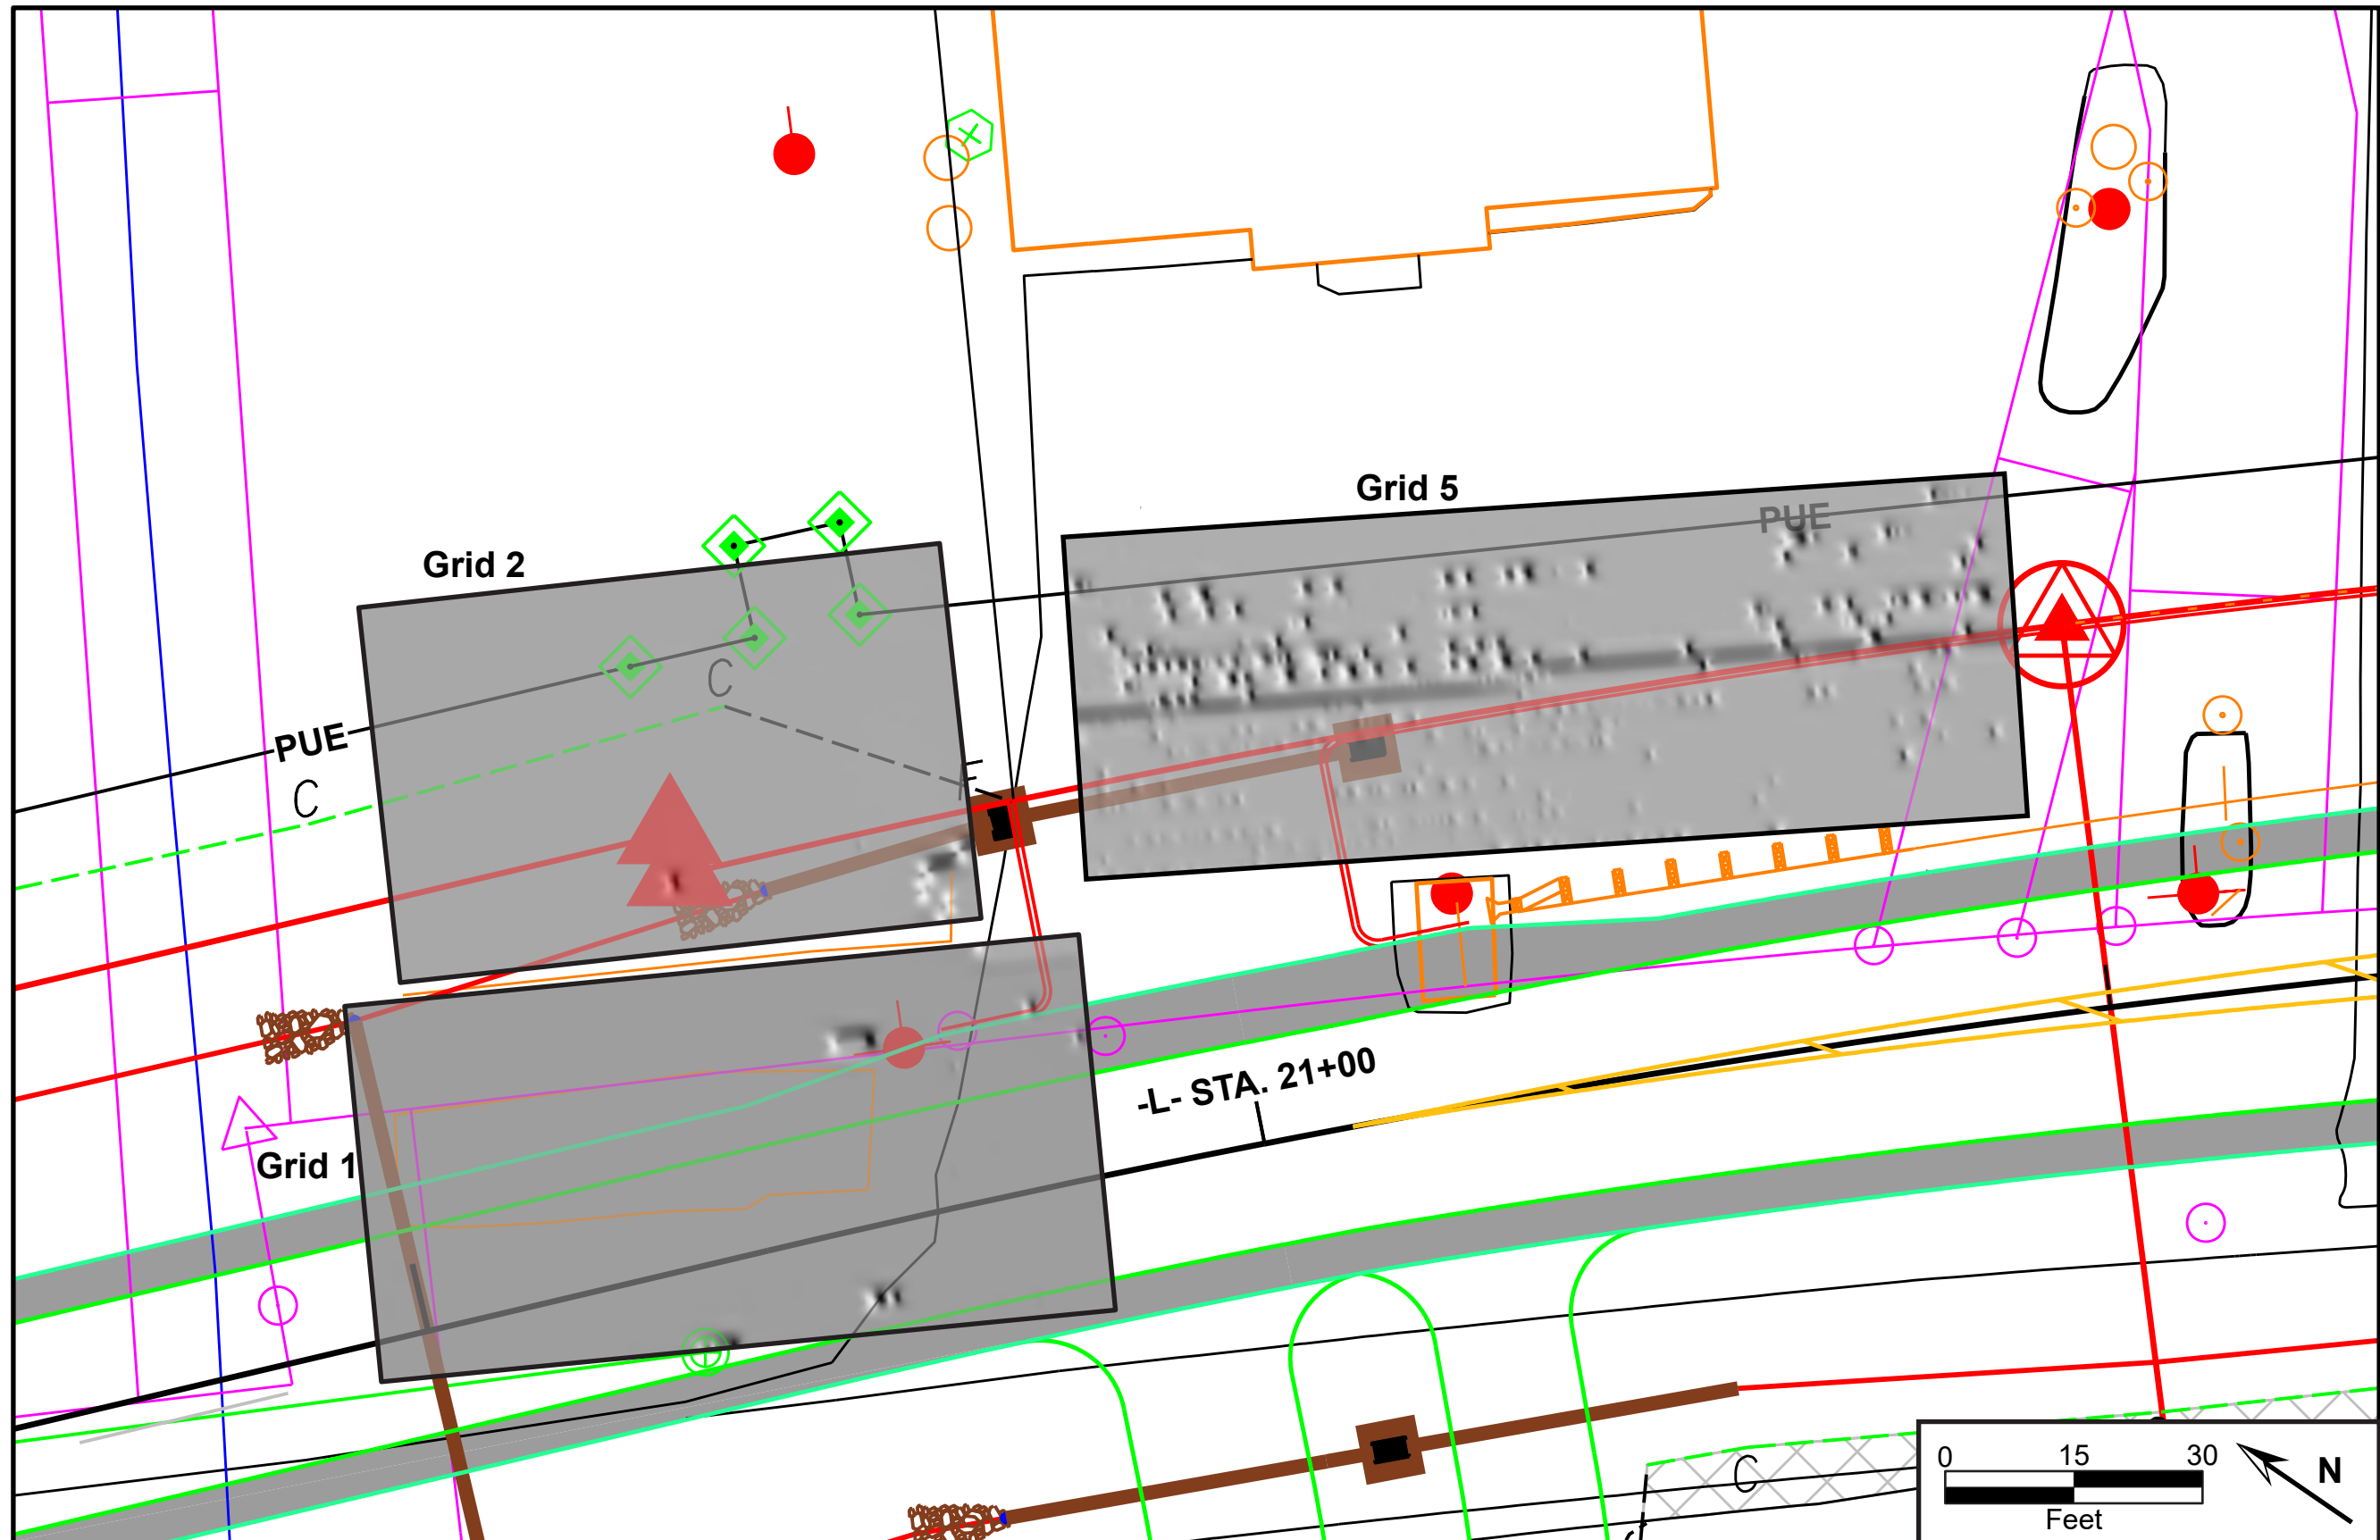
**Figure 5a**  
Magnetometer Survey  
Hillshade Map

Grids 1 and 2 were collected in the northwestern corner of the parcel along Highway 21. A few small magnetic anomalies were detected in Grid 1 which are most likely related to utilities along the edge of the highway. A larger magnetic anomaly was detected in Grid 2 near the end of a fence (Figure 5a). Grid 5 was collected across the paved parking lot in front of the restaurant. This grid shows numerous small point anomalies that could be related to changes in the lithology of the stone used as aggregate in the pavement (Figure 5a).

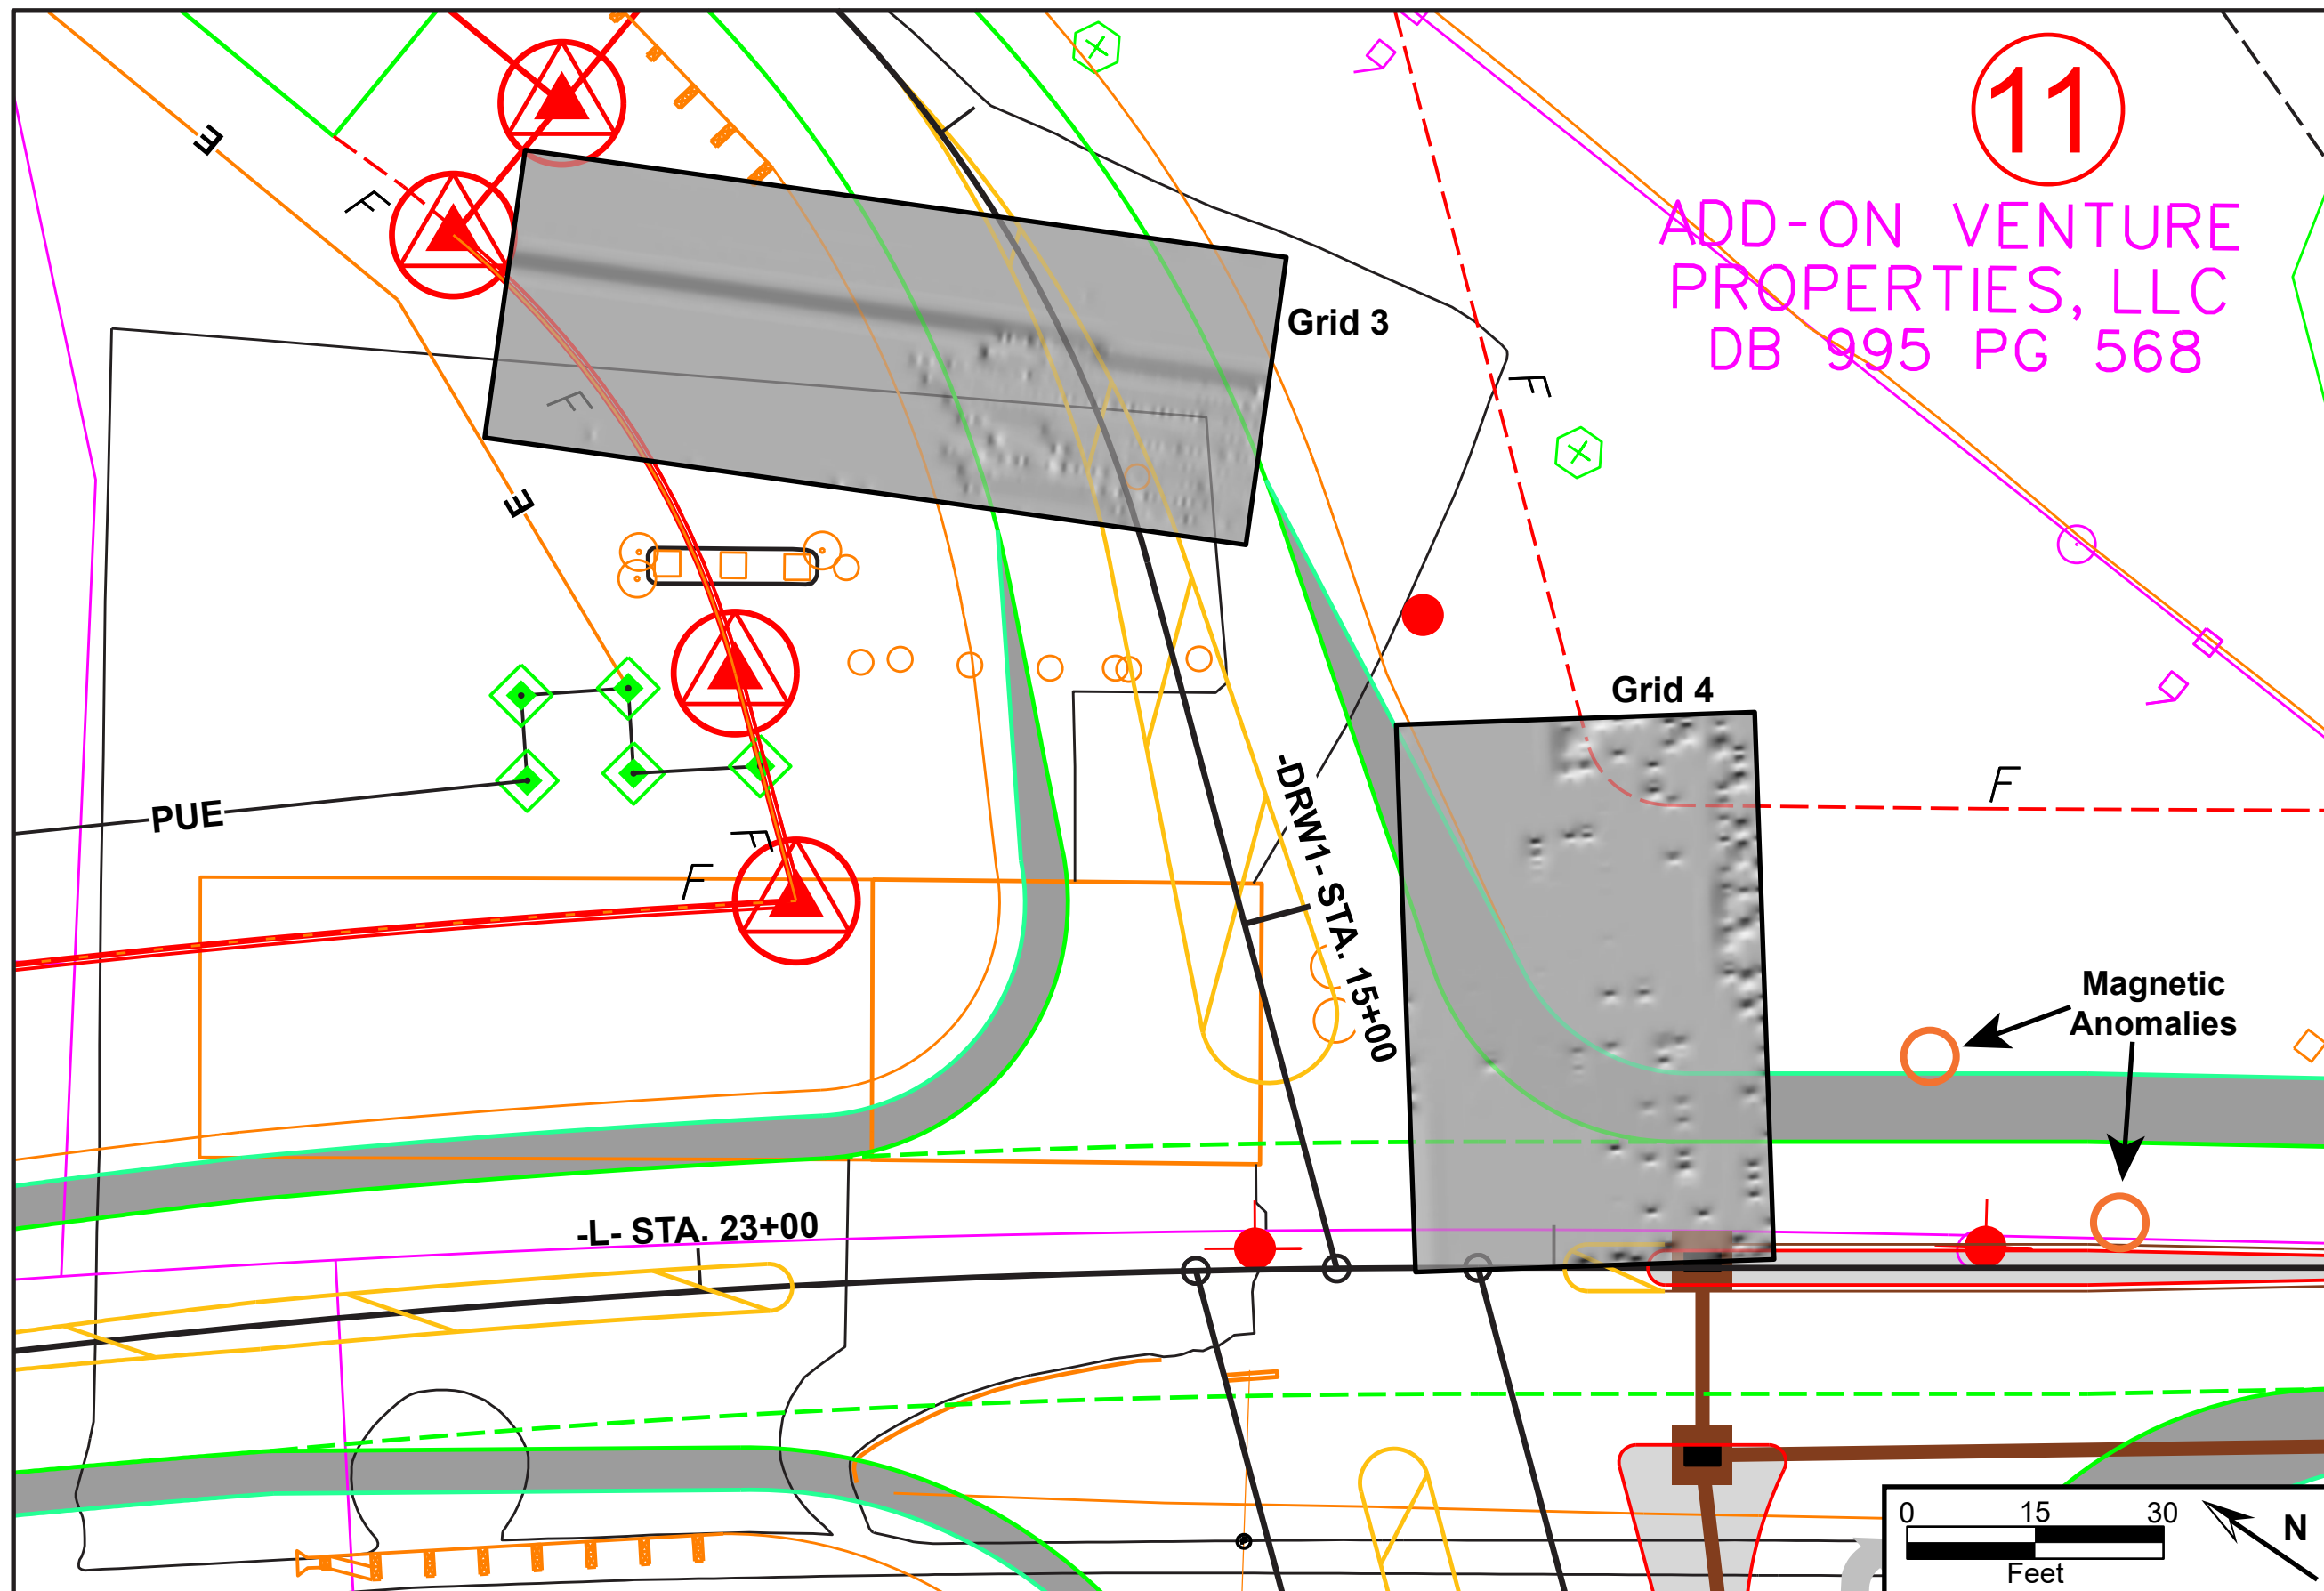
Grids 3 was collected northeast of the convenient store, the diesel pump island, and the UST tank pit (Figure 4). Numerous small magnetic anomalies were detected in the area of the grid over a reinforced concrete slab (Figure 5b). Grid 4 was in a grass lawn southeast of the convenience store (Figure 4). Abundant small magnetic anomalies are observed in the septic drain field and there are a higher density of these anomalies around the edge of the former excavation for the drain field.

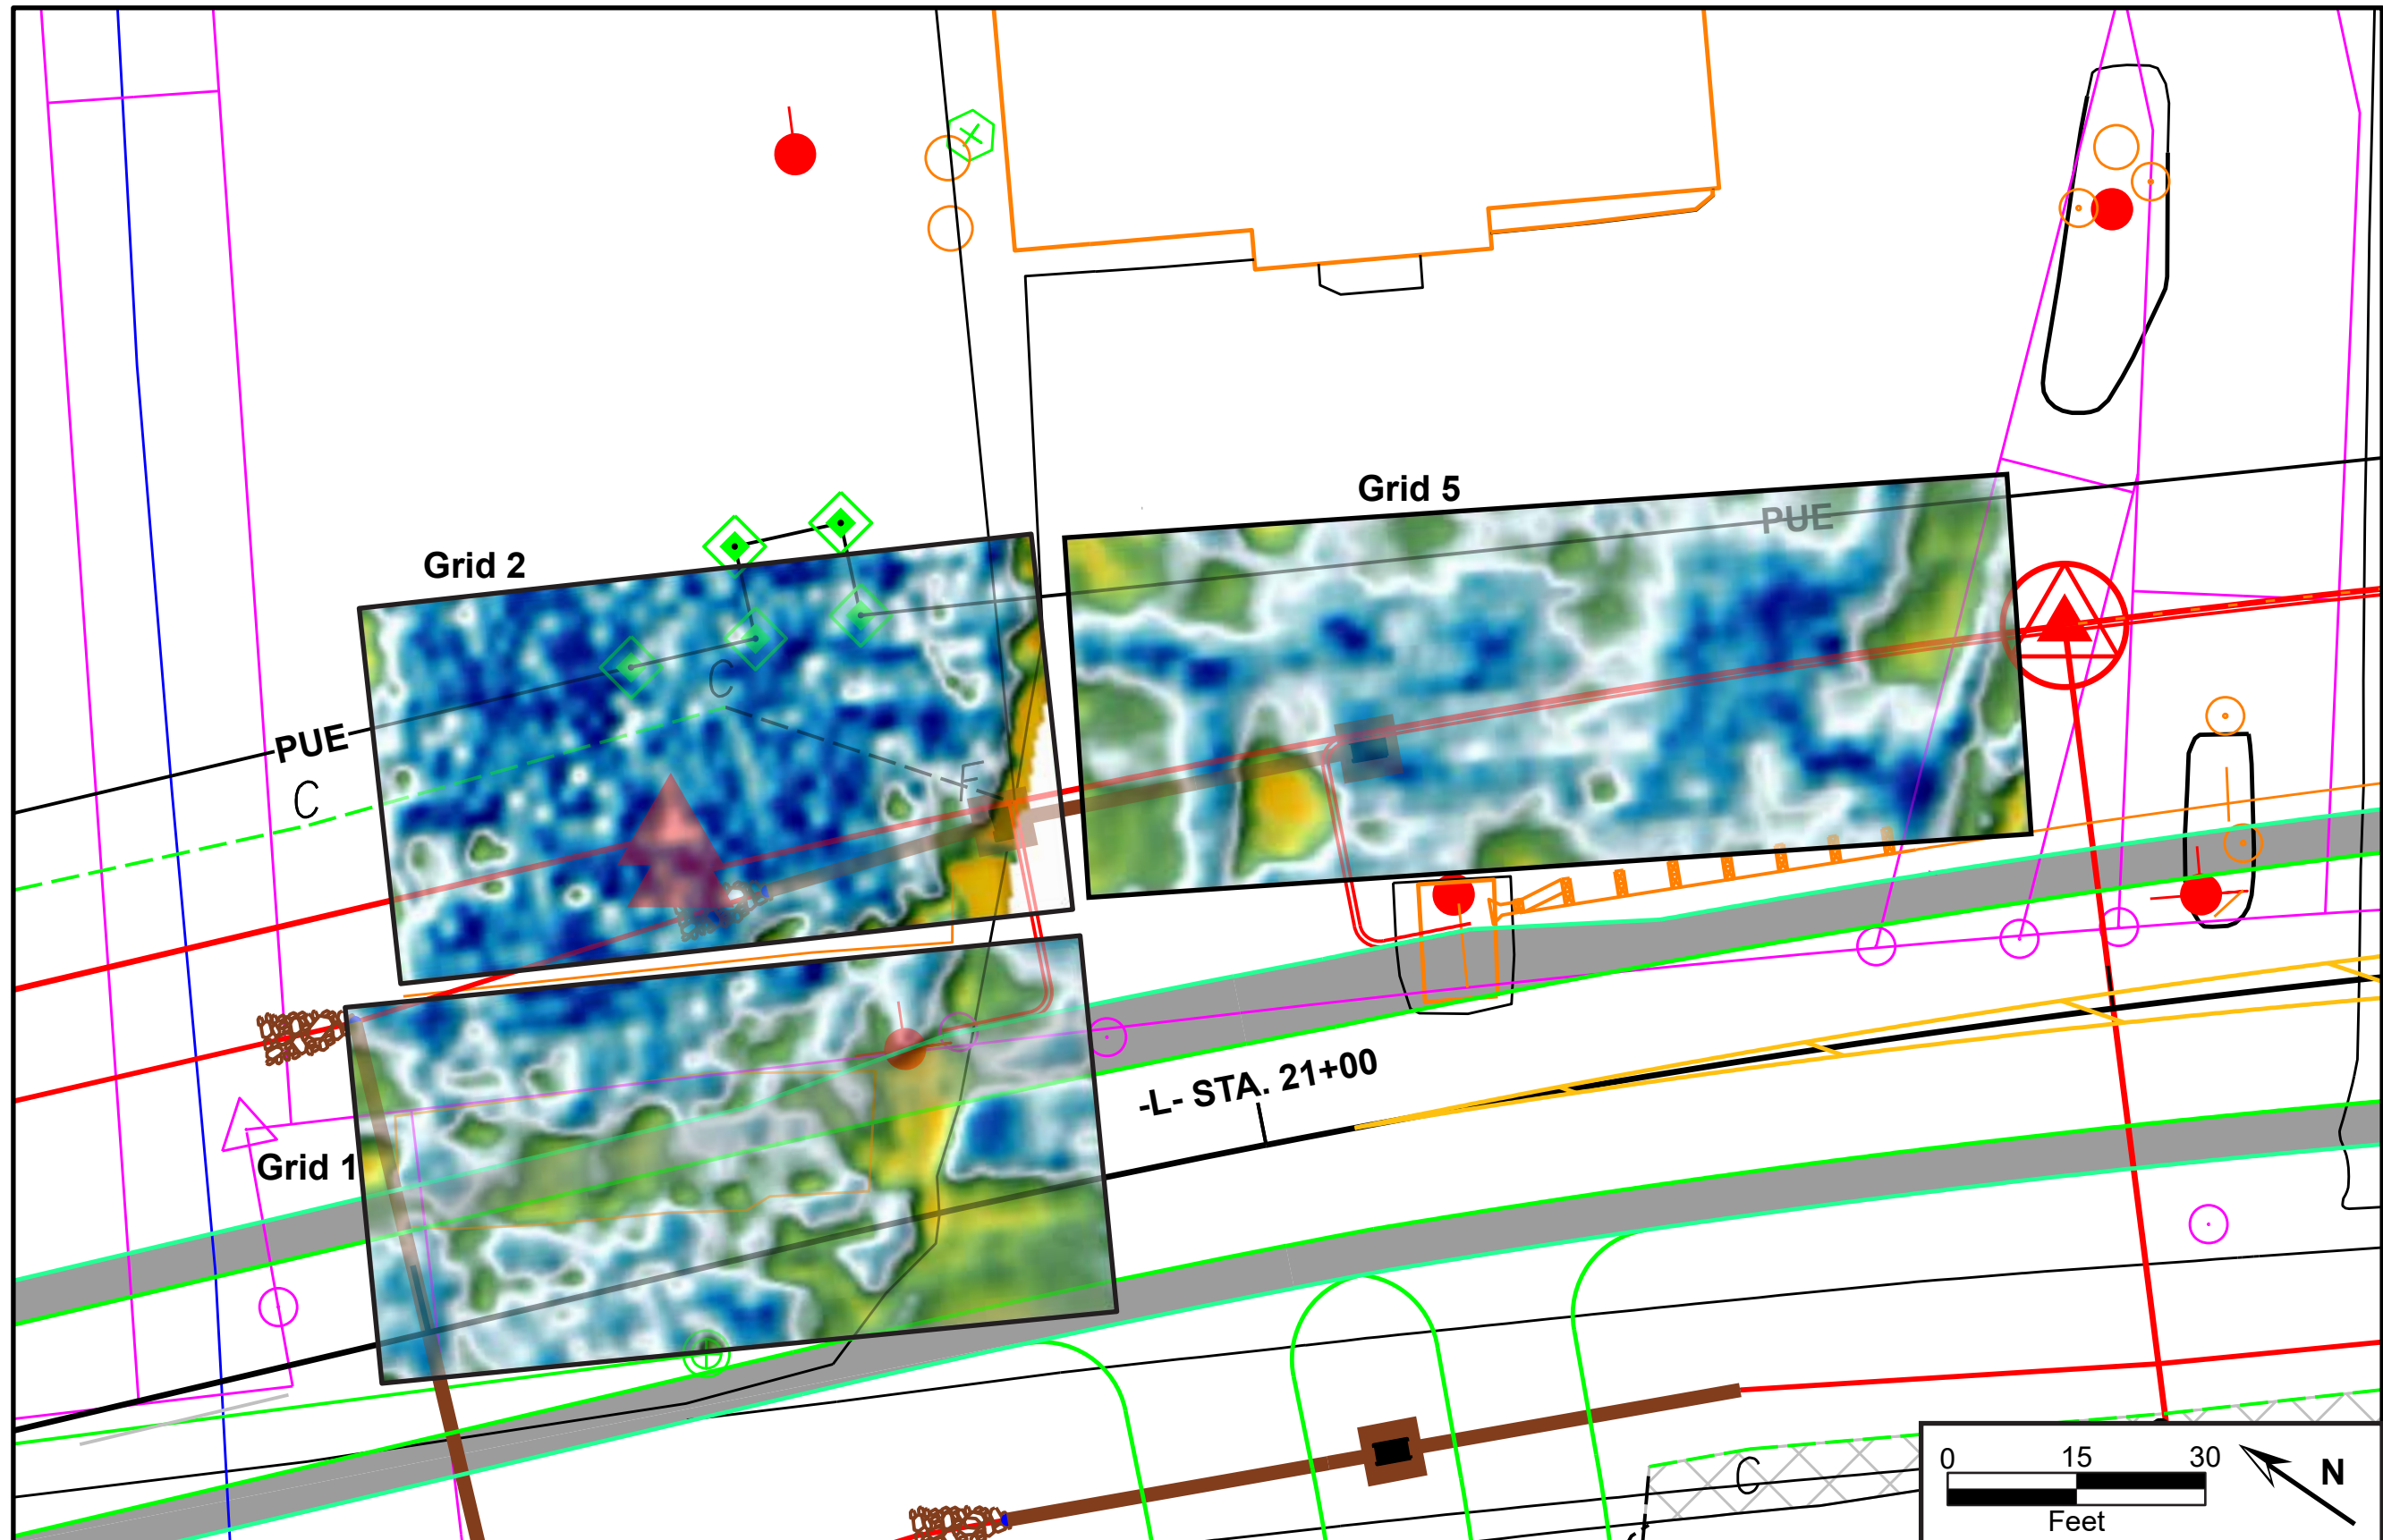
The shallow GPR depth slices are shown in Figures 6a and 6b. The only apparent organized set of reflections is a linear high amplitude reflector in Grid 2 which could be related to a septic drain line. Otherwise, the shallow GPR depth slices only show disorganized random reflections unrelated to a UST system.

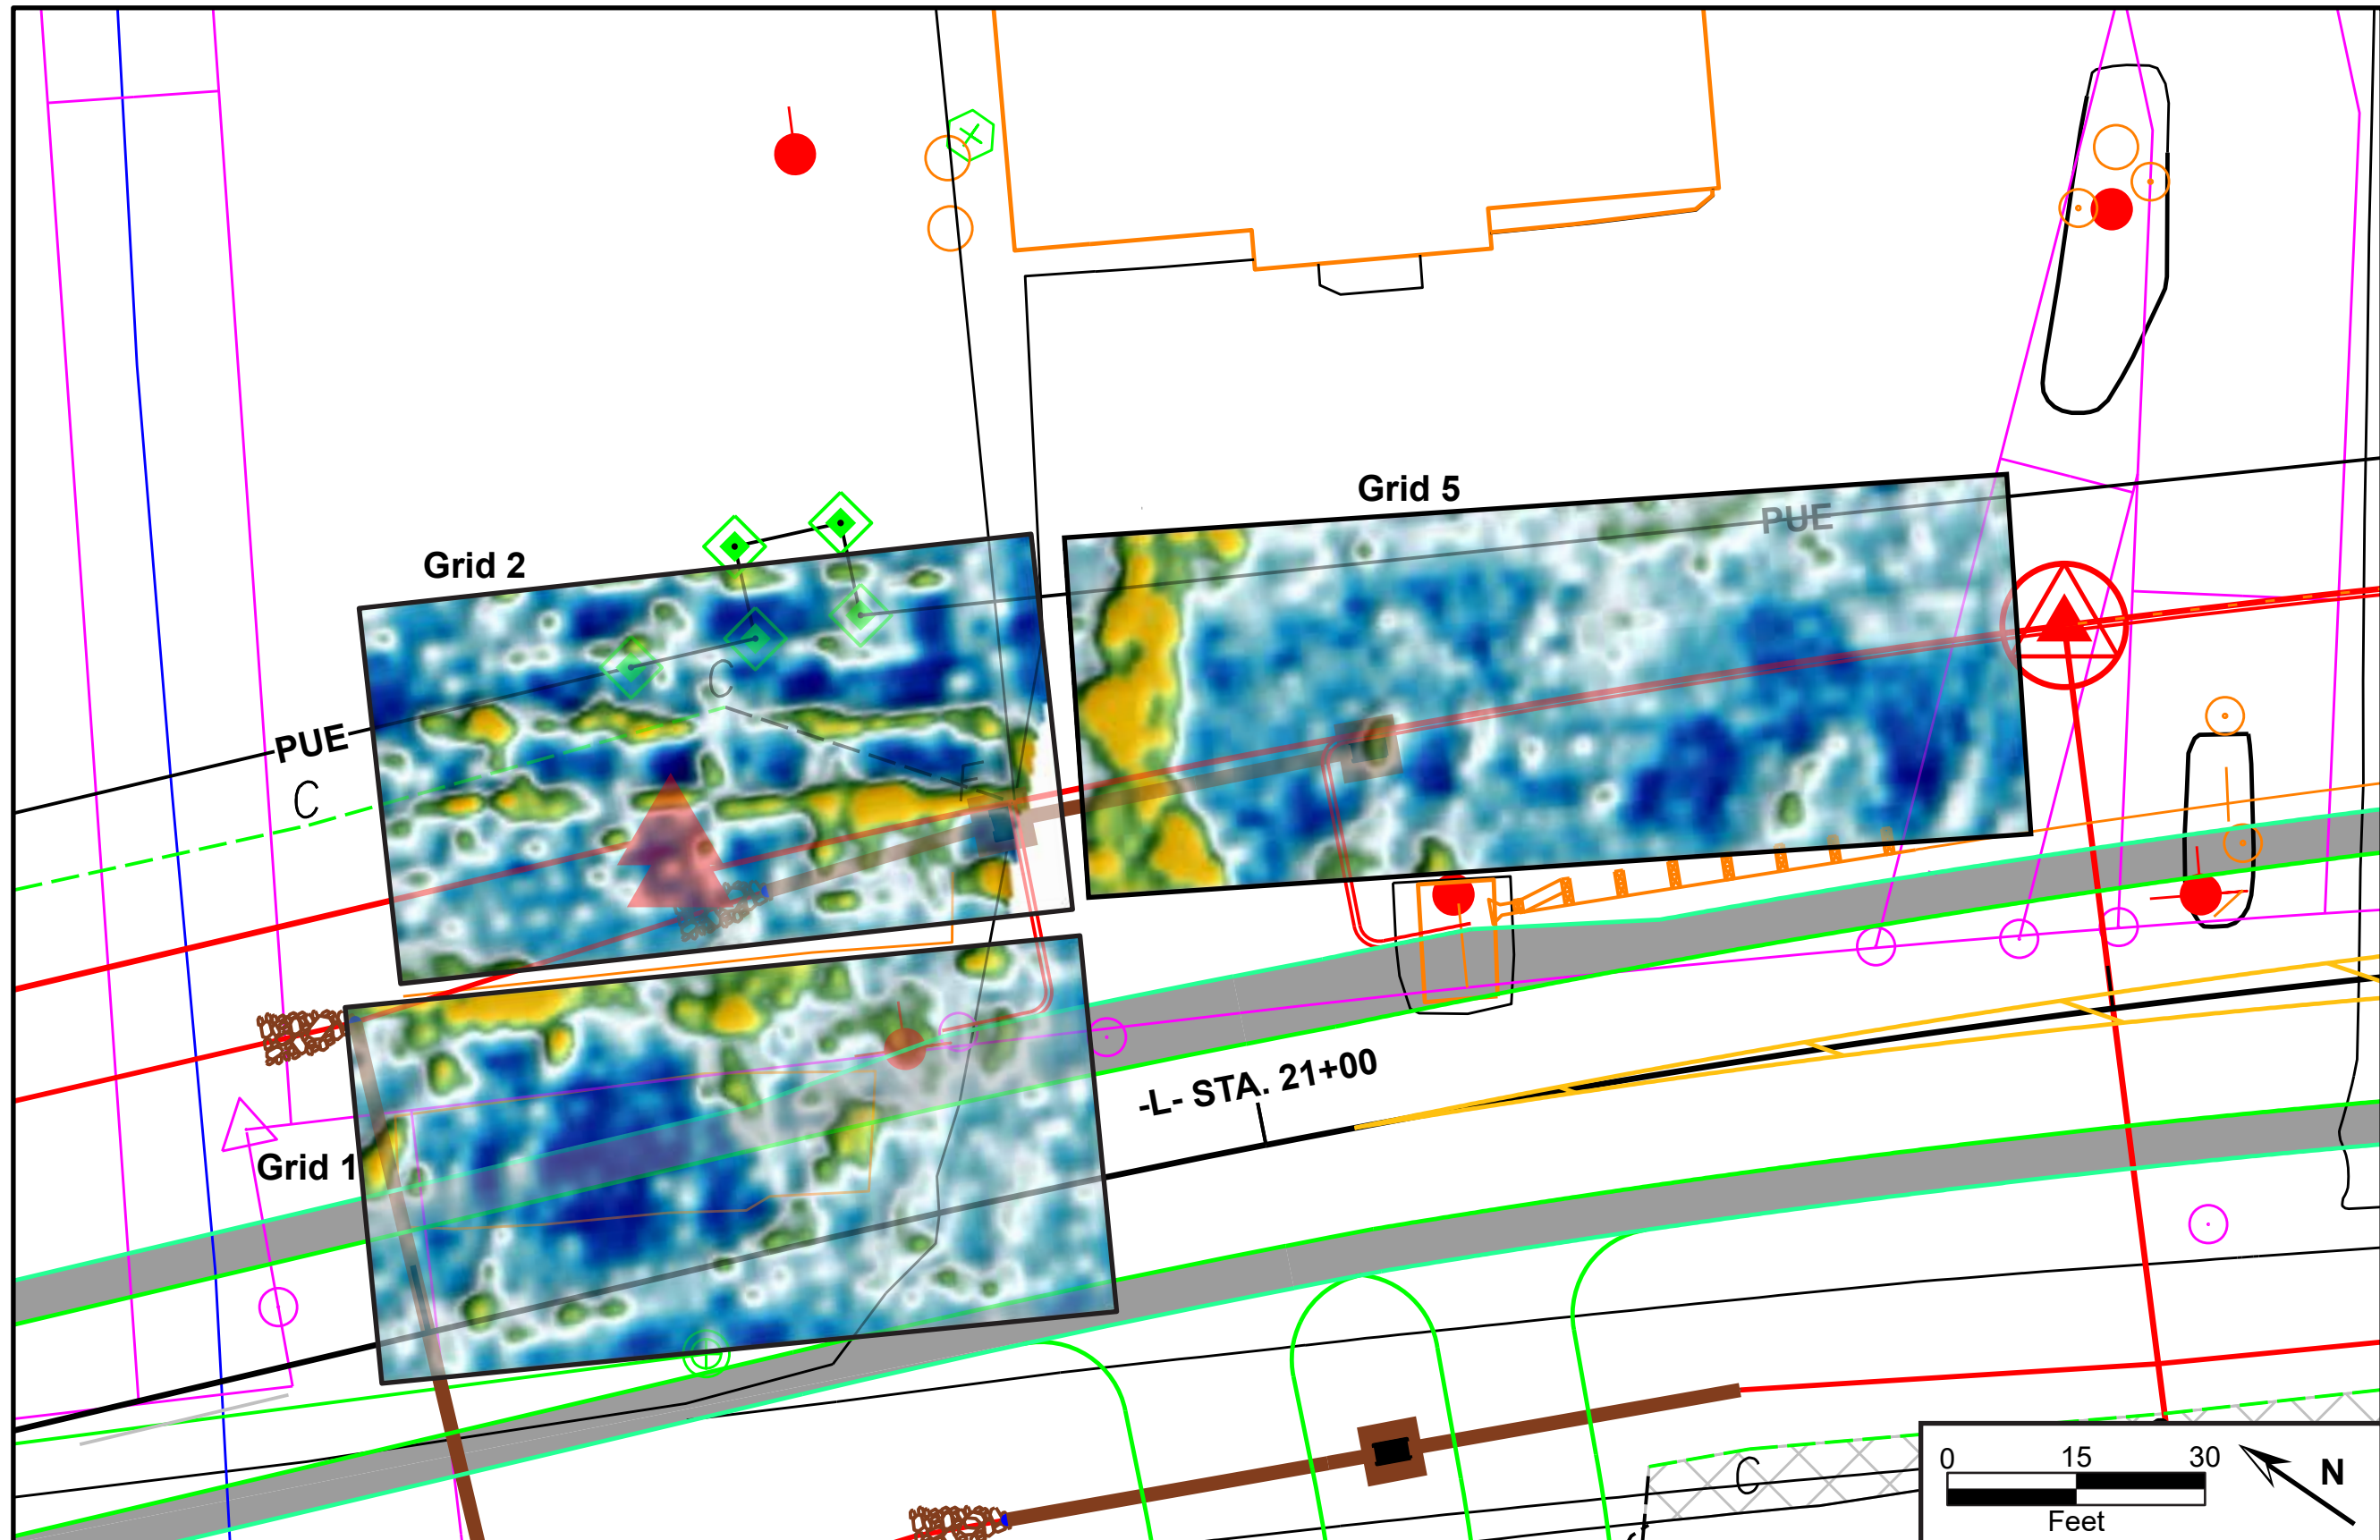
The intermediate depth GPR depth slices are shown of Figures 7a and 7b. Grids 2 and 4 show high amplitude linear reflections along drain lines for the septic fields for each business. Grid 3 shows the edge of the UST system as five reflection free areas. This is likely because of the reinforced concrete above the tanks. The intermediate GPR depth slices for Grids 1 and 5 only show disorganized random reflections unrelated to a UST system.

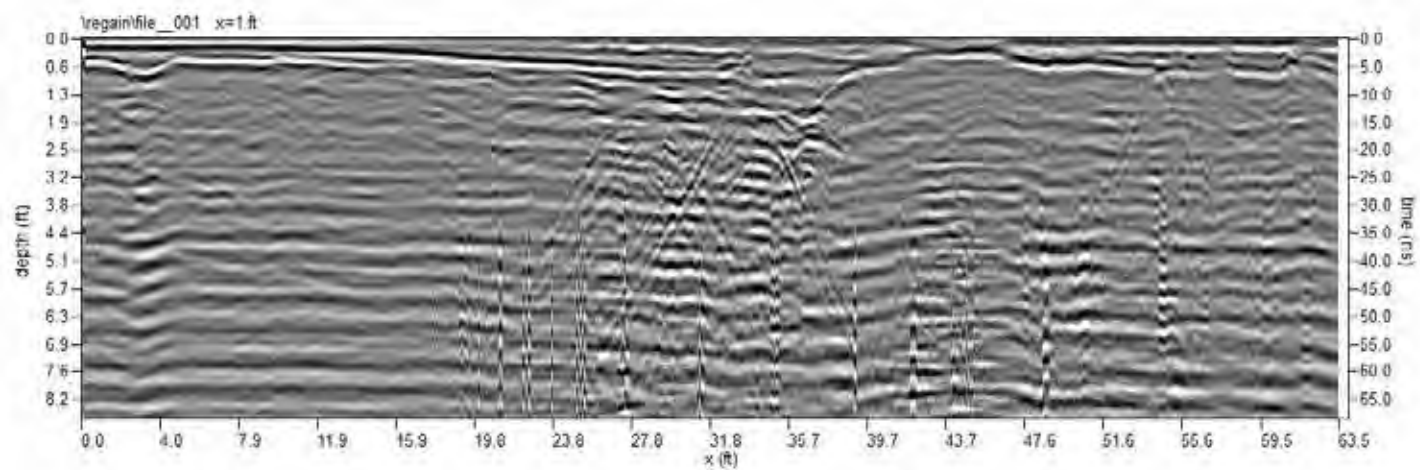
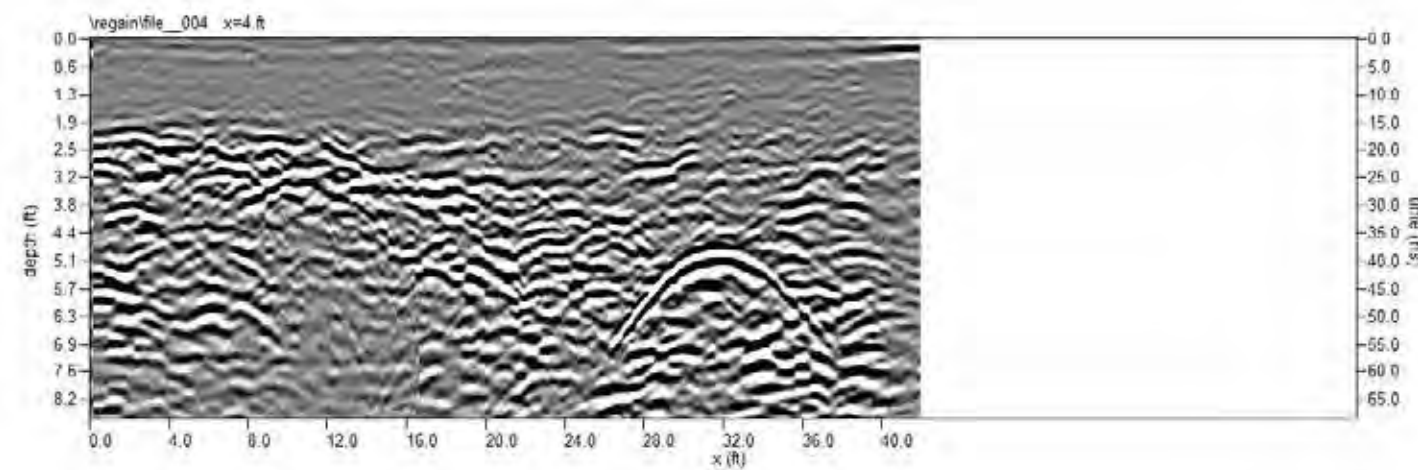
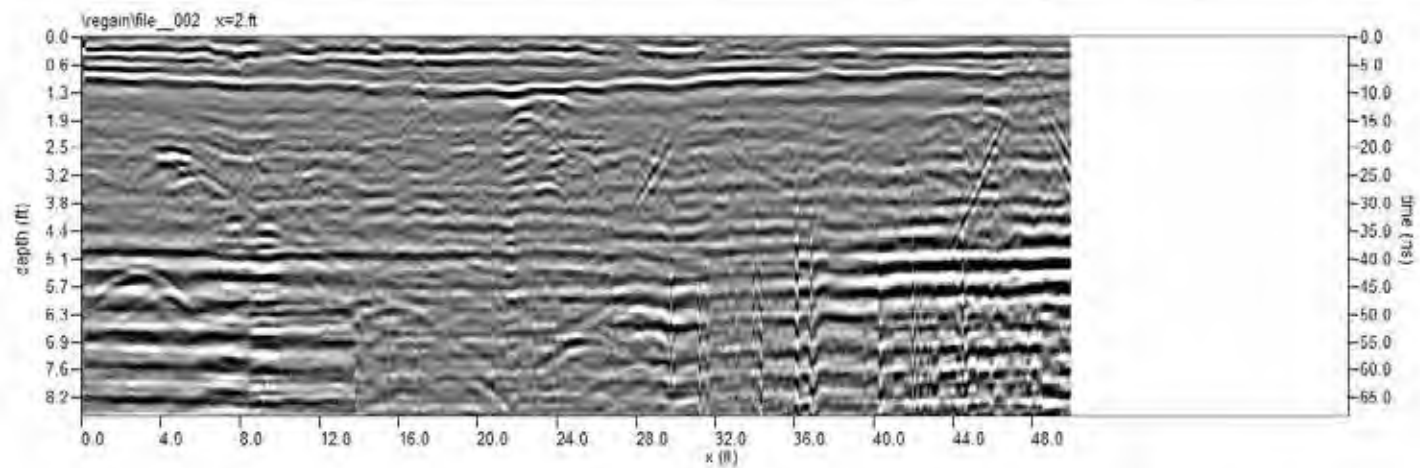
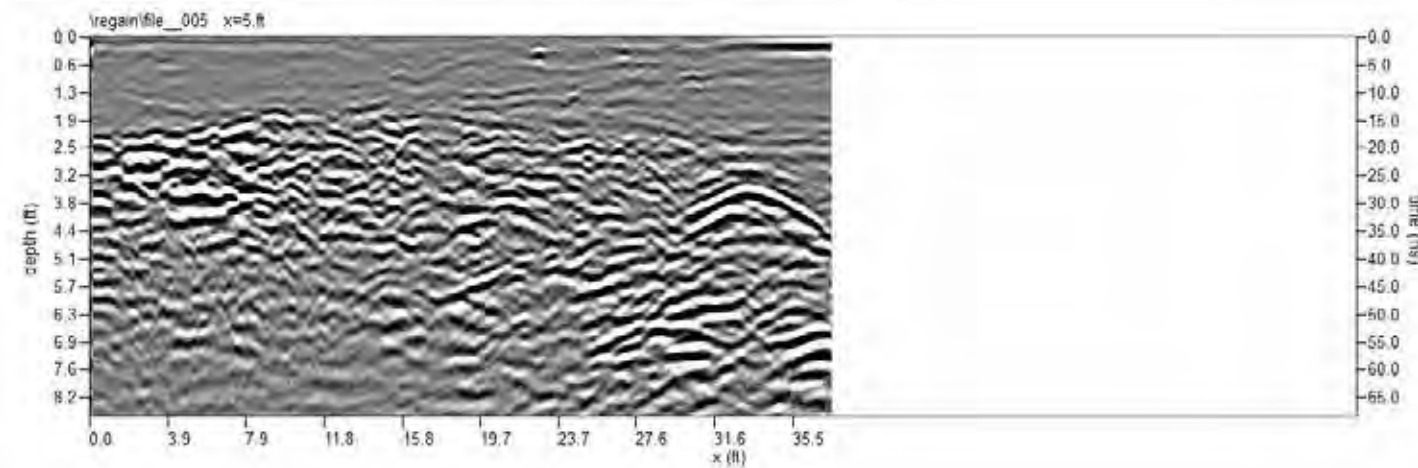
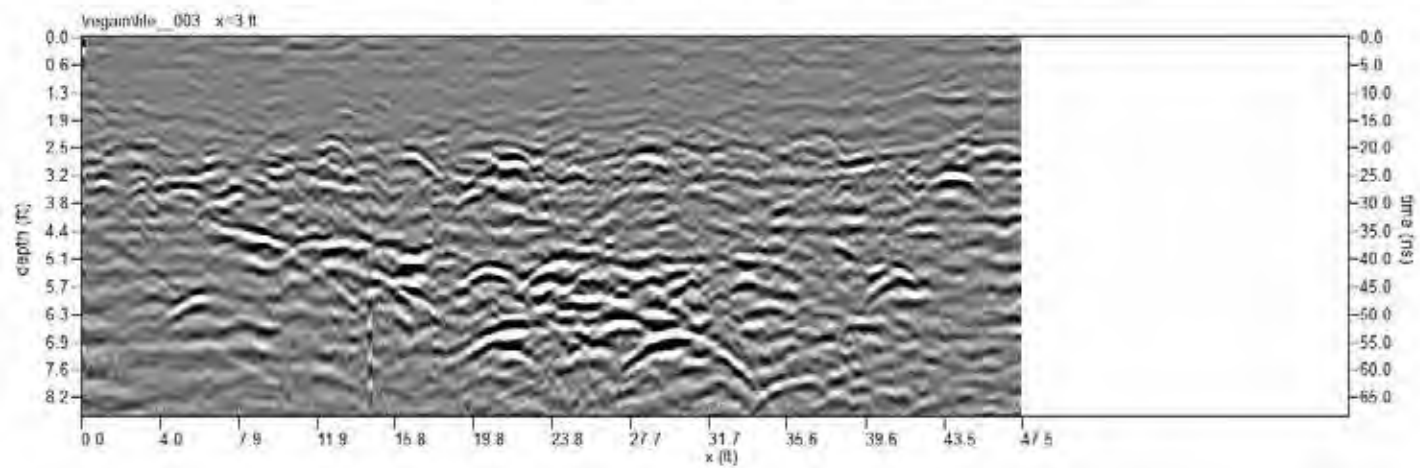
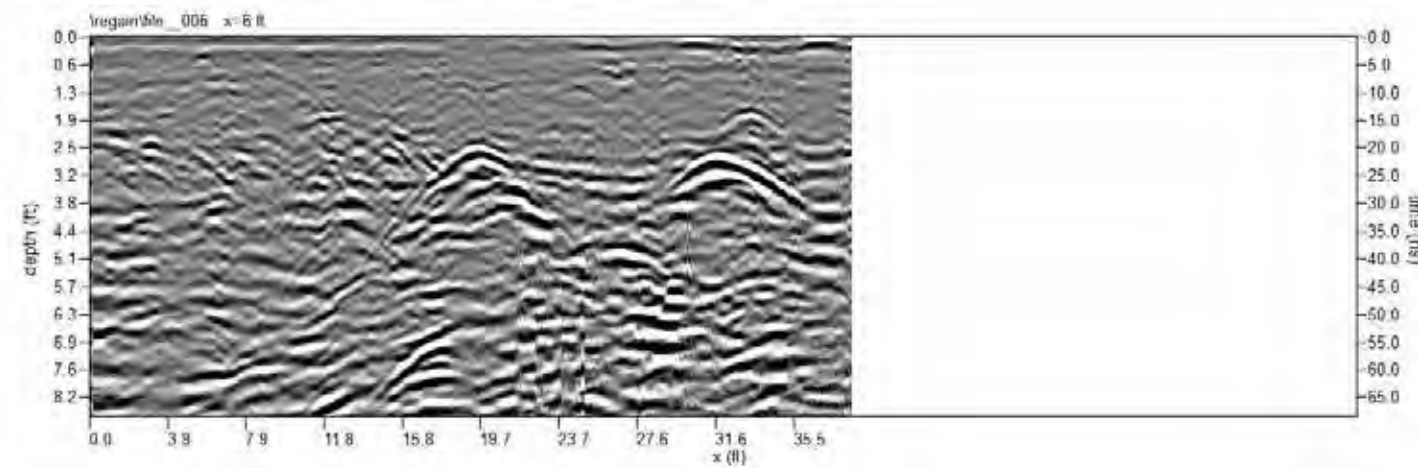
**Figure 9a**  
Profiles of GPR Transects 1 - 6

- Large hyperbola on Transects 4, 5, and 6 are existing drainpipes along the northeast edge of the parcel;
- Some type of utility line was crossed on Transect 16;
- The five registered USTs were crossed on Transect 17;
- Half of a large hyperbola was imaged on both Transects 24 and 25 and this is most likely produced by the footing of the convenience store; and
- GPR anomalies on Transects 28, 29, and 30 are drain lines in the septic drain field.
