**Phase II Site Assessment Report  
December 1, 2021  
WBS Element: 45786.1.1  
State Project: B-5833  
Yadkin County**

**Parcel #: 011  
Add-On Venture Properties, LLC Property  
5652 and 5704 US Hwy 21; Jonesville, NC, 28642  
PIN #: 4869563147, 4869562417, 4869563091  
Facility ID No.: 00-0-0000023364  
Groundwater Incident #: 37795**

**Mr. Gordon Box  
NCDOT, Geotechnical Engineering Unit  
GeoEnvironmental Section  
1589 Mail Service Center  
Raleigh, NC 27699-1589**

**Seramur & Associates, PC  
165 Knoll Drive  
Boone, NC 28607**

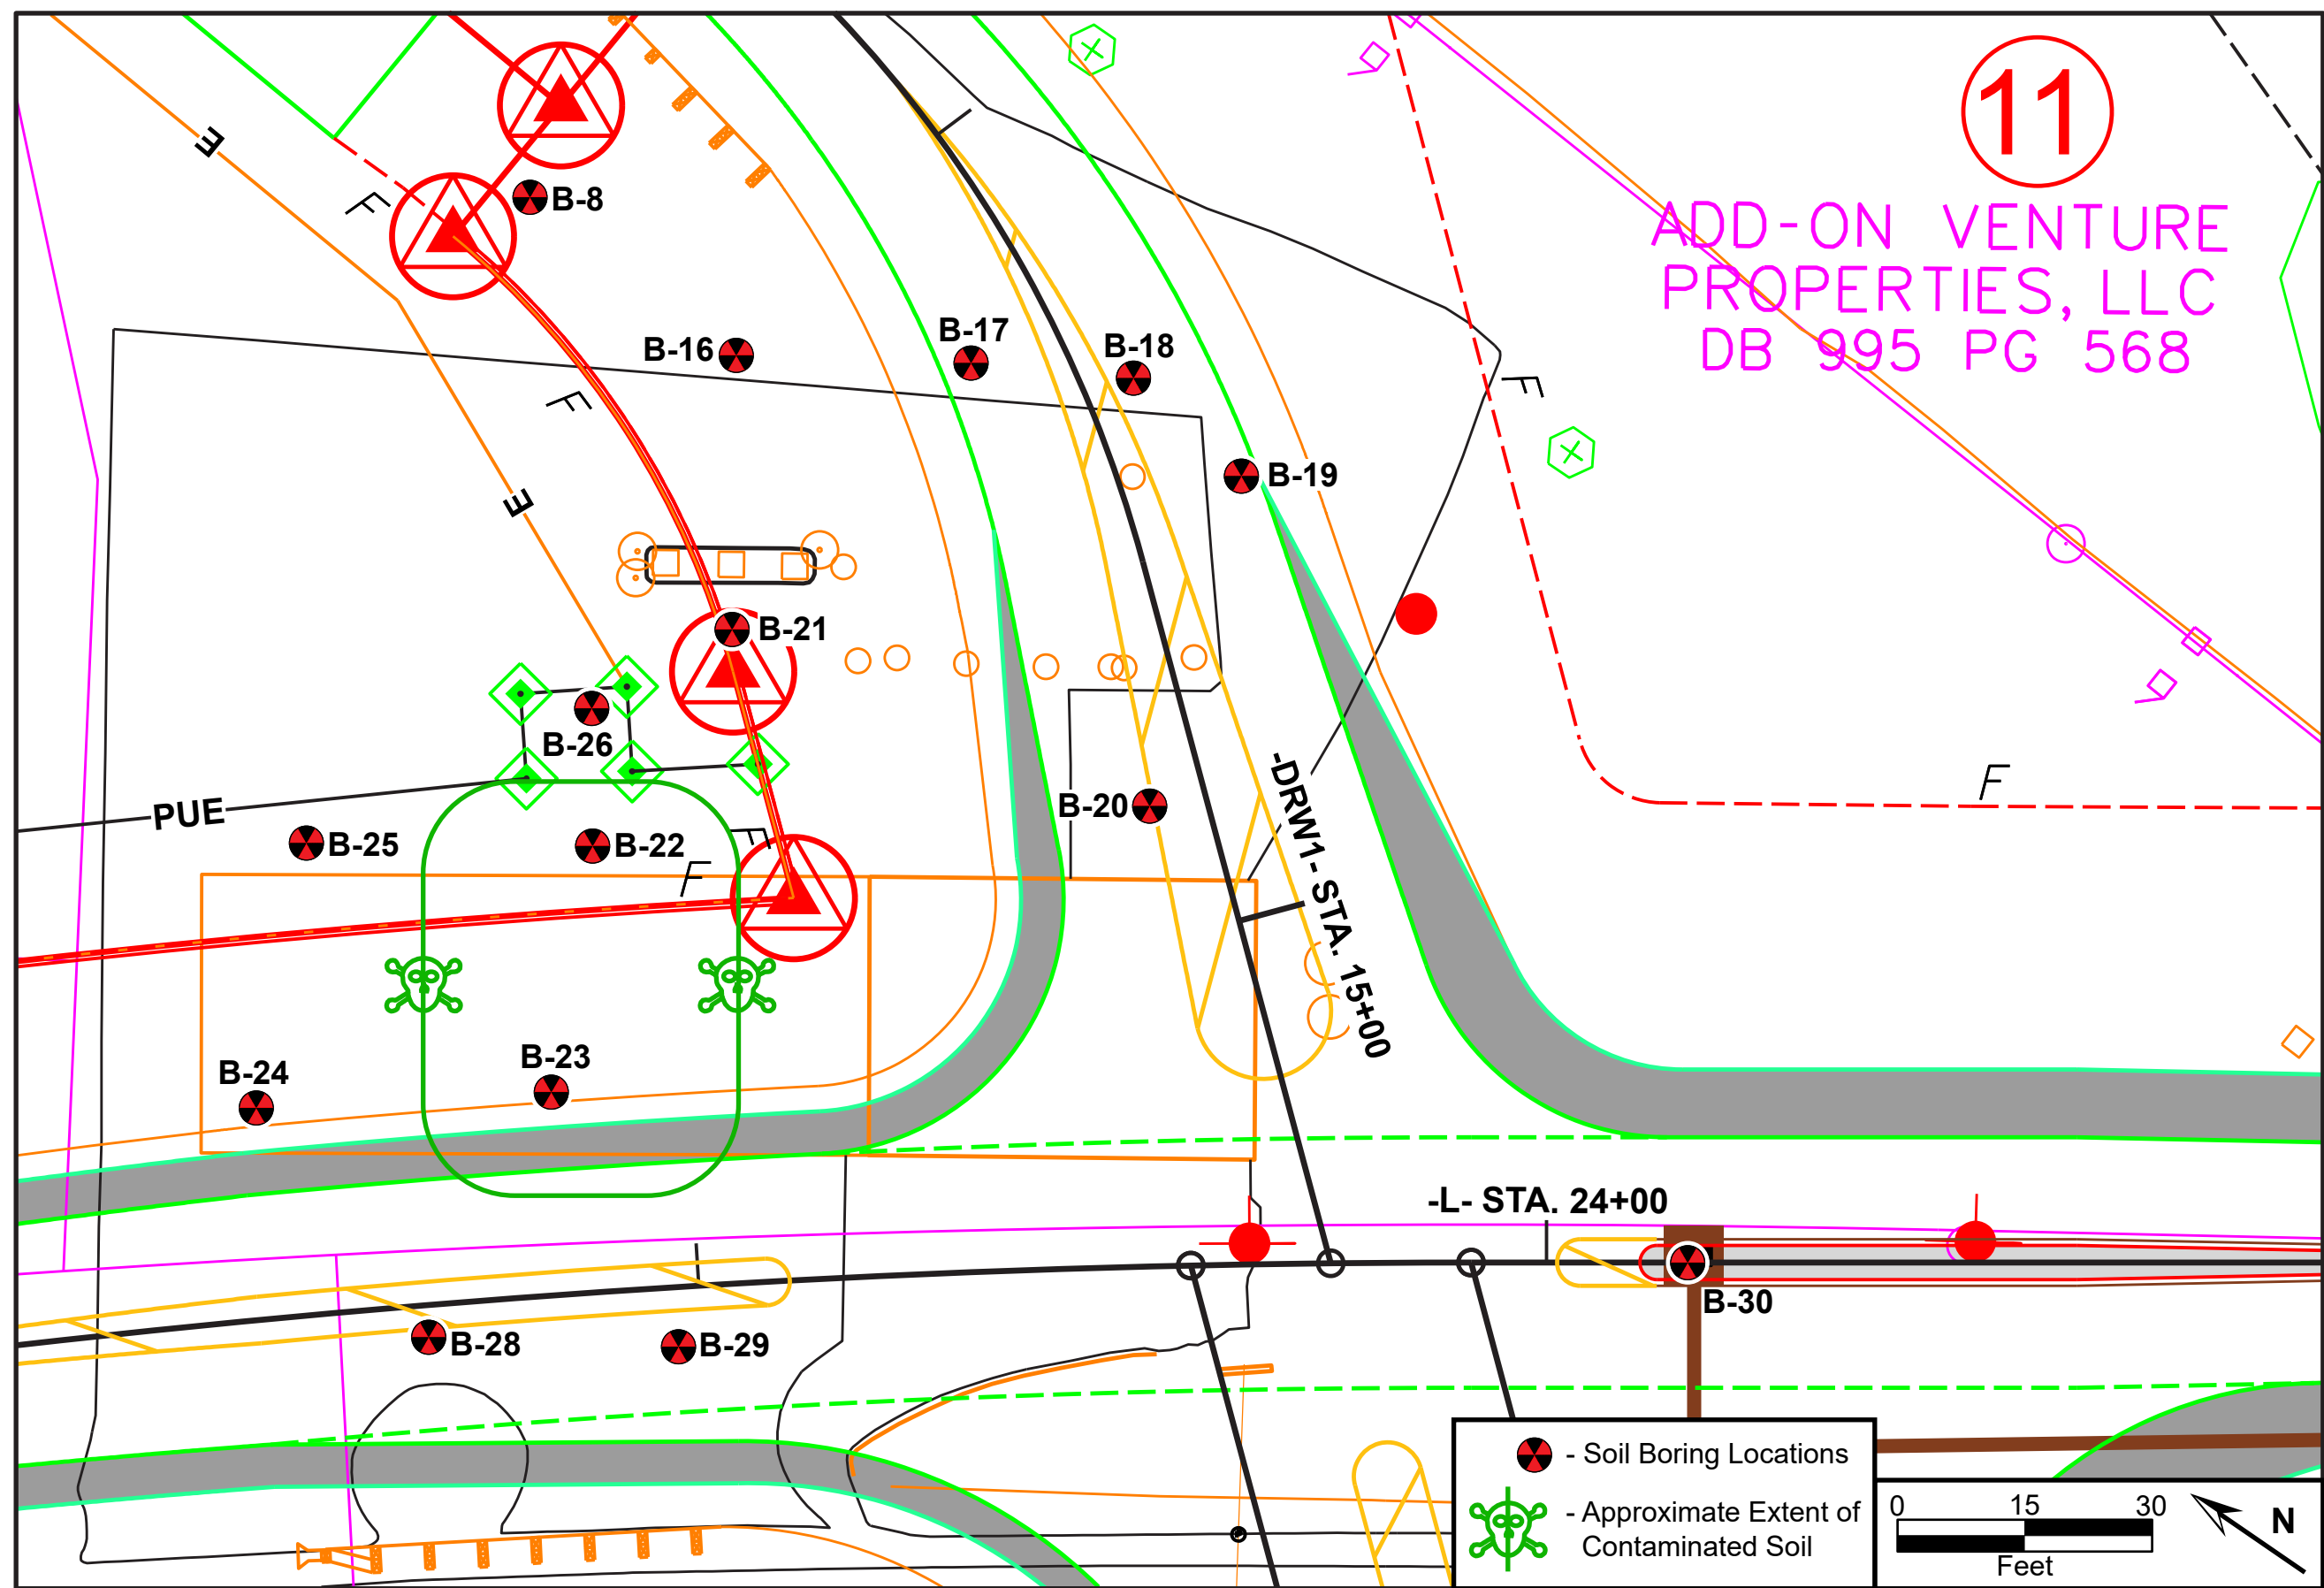
Contaminated soil defined as GRO concentrations above 50 ppm and DRO concentrations above 100 ppm was detected in two soil samples collected at Parcel #011. The source of this soil contamination appears to be from leaking product lines. Patched pavement indicates that an old set of product lines could have been replaced in the past.

An estimate of the volume of contaminated soil in the vicinity of borings B-22 and B-23 can be calculated using the thickness of the contaminated soil horizon and the horizontal extent (Figure 11). An estimated soil contamination thickness of four feet will be used in our calculations. The area of contaminated soil is approximately 1,700 square feet. This number was estimated using rectangles overlaid onto the area of contamination (Figure 11). The estimated volume of contaminated soil in the vicinity of borings B-22 and B-23 is calculated as follows:

The total volume of contaminated soil detected at the Parcel #011 is estimated to be 251.9 yd<sup>3</sup> or 377.8 tons.

SAPC recommends that the UST system and associated dispensers be properly closed. Contaminated soil was detected in borings B-22 and B-23 in front of the gasoline dispensers. It is possible that additional contamination may be encountered under product lines, dispensers and the USTs that could not be tested during our investigation.

SAPC recommends that a licensed geologist or engineer supervise the excavation and removal of the UST system, associated product lines and dispensers and any contaminated soil encountered over the course of this work. Contaminated soil removed from Parcel #011 should be sent to a remediation facility.

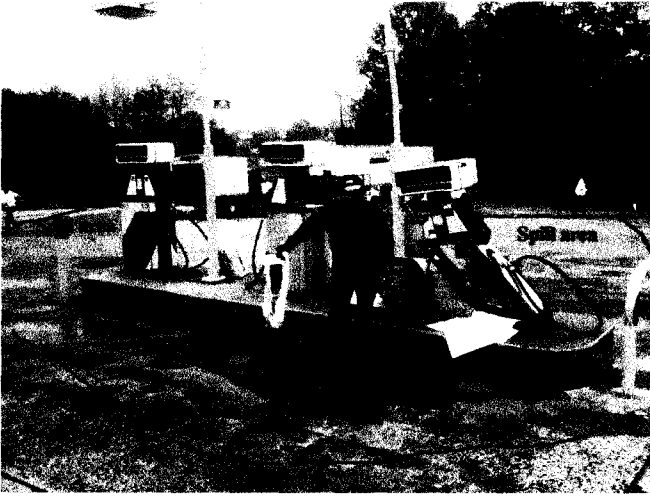
At approximately 12:30 AM, Saturday, April 23, 2011 an unidentified semi/tractor trailer went through the parking lot and hit the #12 Diesel Fuel Pump. The pump was struck hard enough to knock the pump off the mount and break the shear valve. The shear valve did not function properly allowing 536 gallons of diesel fuel to leak from the valve. The owner of the site contacted JT Alexander and Son, Inc (JTA) at 6:28 AM when they arrived to open the store. The Fire Dept, Yadkin County Emergency Management, Spectrum Environmental and JTA personnel were dispatched immediately.

Damaged #12 Diesel Pump- source of spill.
