NC DEPARTMENT OF TRANSPORTATION
 DIVISION OF HIGHWAYS
 BRIDGE MANAGEMENT UNIT

BRIDGE INSPECTION REPORT

COUNTY WILKES BRIDGE NUMBER 960029 INSPECTION CYCLE 0 YRS
SR1001 (OAKWOODS RD)
 ROUTE SR1001 ACROSS CUB CREEK M.P. 0
.15 MILES SOUTH OF JUNCTION WITH NC18,NC268
 LOCATION .15 MI.S.JCT.NC18,NC268

INSPECTION DATE 04/08/2013

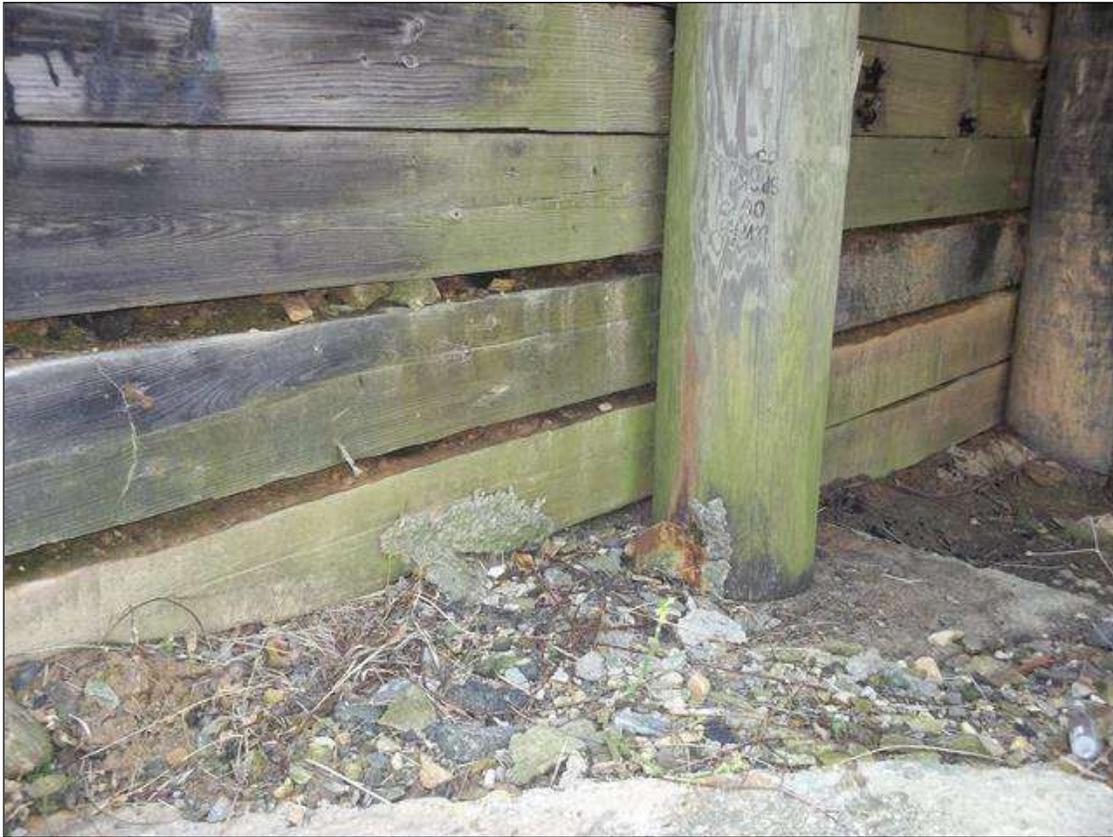
MMS Code	MMS Description	Quantity
3344	Repair / Replace Timber Substructure Components	20 LF
Location:		
Abutment Substructure	Bent/Span No. 1	BULKHEAD
Priority Level	Status	
Priority Maintenance	Division Bridge Maintenance Notification Received	
Submitted Date:	Submitted By:	Assisted By:
04/08/2013	MICHAEL T. MILLS	TOMMY GRAHAM
Details		
END BENT 1 BULKHEAD, GAPS IN BOARDS WITH BACKFILL LOSS (20LF)

(PM) END BENT 1 BULKHEAD, GAPS IN BOARDS WITH BACKFILL LOSS (20LF)

3344	Repair / Replace Timber Substructure Components	LF	20	END BENT 1 BULKHEAD, GAPS IN BOARDS WITH BACKFILL LOSS (20LF)

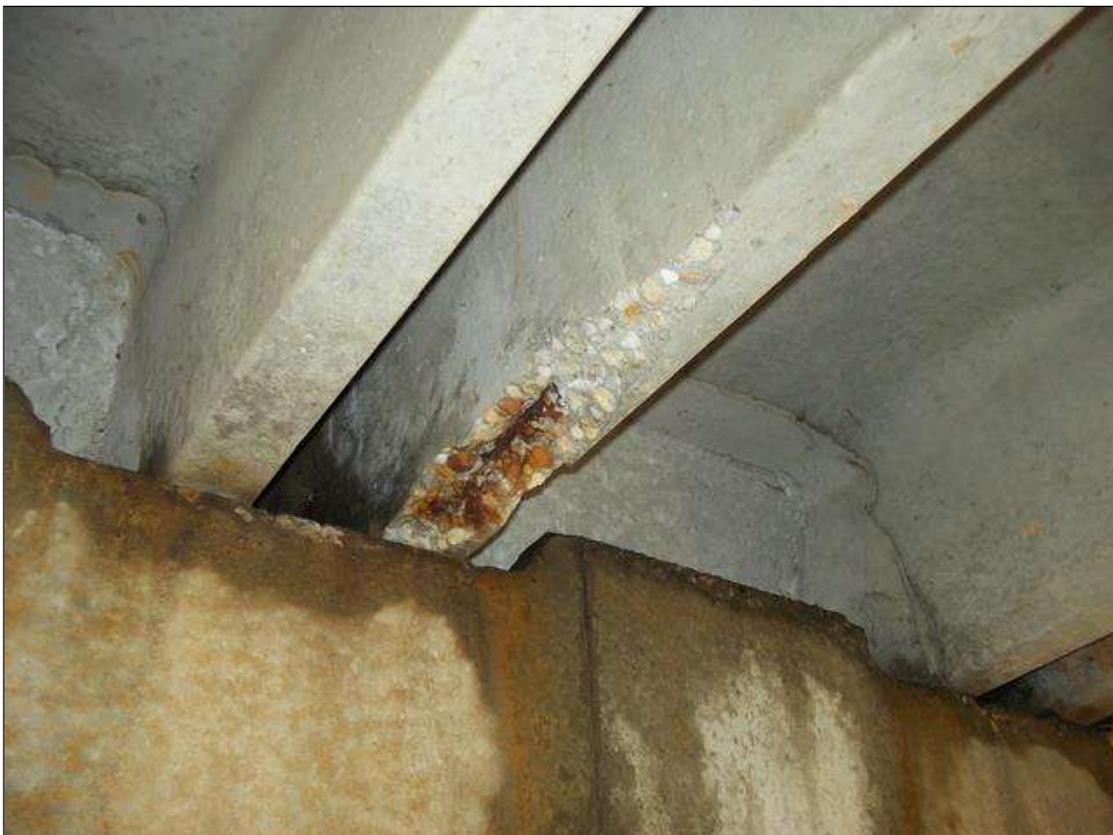
MMS Code	MMS Description	Quantity
3306	Maintain Concrete Superstructure Components	1 SF
Location:		
Beams and Girders	Bent/Span No. 1	BEAM
Priority Level	Status	
Priority Maintenance	Division Bridge Maintenance Notification Received	
Submitted Date:	Submitted By:	Assisted By:
04/08/2013	MICHAEL T. MILLS	TOMMY GRAHAM
Details		
END BENT 1 BEAM 1 LEG 2 BEARING, SPALL (12IN X 2-1/2IN X 2IN) WITH EXPOSED STRAND

(PM) END BENT 1 BEAM 1 LEG 2 BEARING, SPALL (12IN X 2-1/2IN X 2IN) WITH EXPOSED STRAND

3306	Maintain Concrete Superstructure Components	SF	1	END BENT 1 BEAM 1 LEG 2 BEARING, SPALL (12IN X 2-1/2IN X 2IN) WITH EXPOSED STRAND

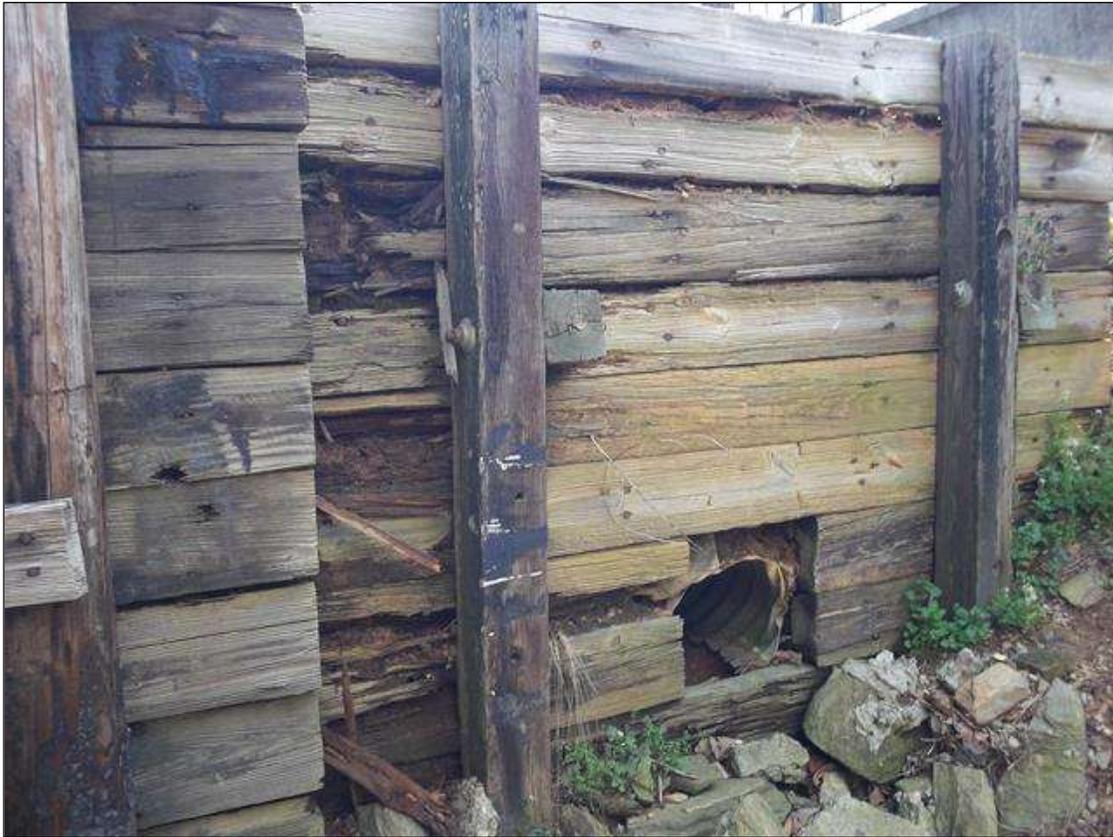
MMS Code	MMS Description	Quantity
3344	Repair / Replace Timber Substructure Components	7 LF
Location:		
Abutment Substructure	Bent/Span No. 1	WINGWALL
Priority Level	Status	
Priority Maintenance	Division Bridge Maintenance Notification Received	
Submitted Date:	Submitted By:	Assisted By:
04/08/2013	MICHAEL T. MILLS	TOMMY GRAHAM
Details		
SOUTHWEST WINGWALL, DECAY (80%) WITH BACKFILL LOSS (36SF)

(PM) SOUTHWEST WINGWALL, DECAY (80%) WITH BACKFILL LOSS (36SF)

3344	Repair / Replace Timber Substructure Components	LF	7	SOUTHWEST WINGWALL, DECAY (80%) WITH BACKFILL LOSS (36SF)	
3306	Maintain Concrete Superstructure Components	SF	40	SPALLS ON BEAMS AND END DIAPHRAGMS

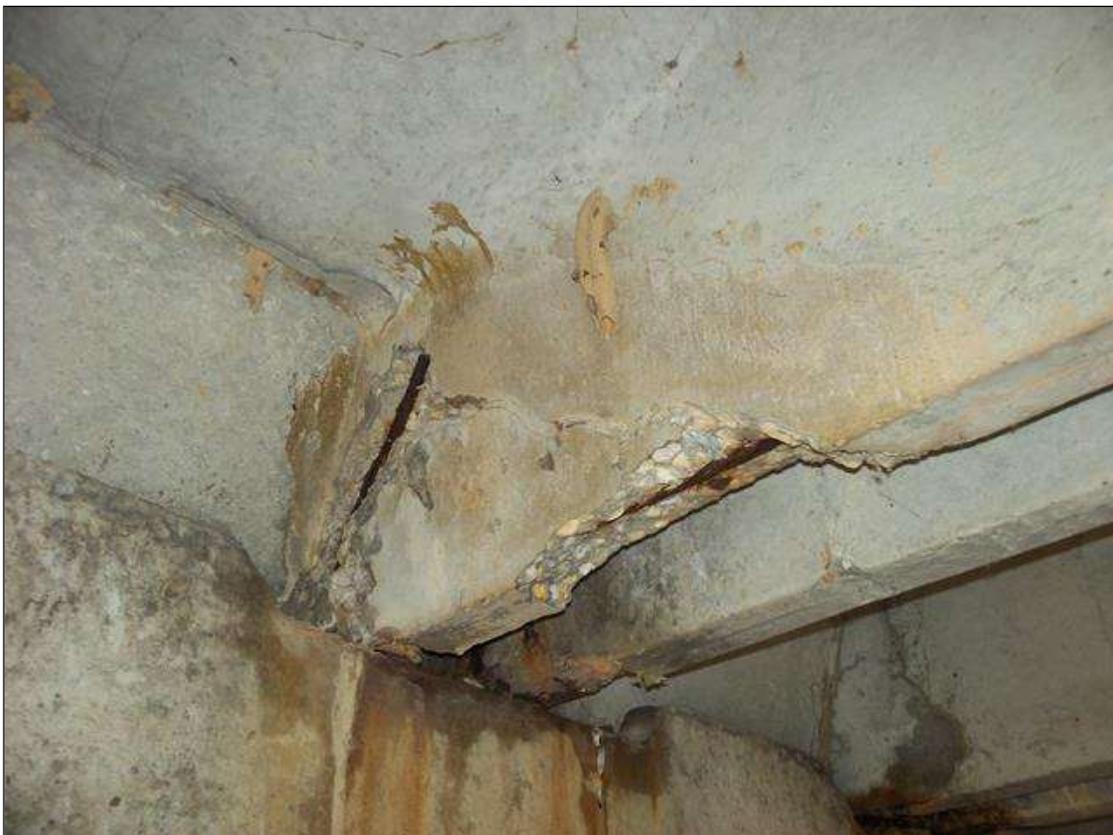
MMS Code	MMS Description	Quantity
3306	Maintain Concrete Superstructure Components	2 SF
Location:		
Beams and Girders	Bent/Span No. 1	BEAM
Priority Level	Status	
Priority Maintenance	Division Bridge Maintenance Notification Received	
Submitted Date:	Submitted By:	Assisted By:
04/08/2013	MICHAEL T. MILLS	TOMMY GRAHAM
Details		
SPAN 1 BENT 1 BEAM 1 LEG 2, SPALL/DELAMINATION (18IN X 8IN) WITH EXPOSED STRAND

(PM) BENT 1 BEAM 1 LEG 2, SPALL/DELAMINATION (18IN X 8IN) WITH EXPOSED STRAND

3306	Maintain Concrete Superstructure Components	SF	2	SPAN 1 BENT 1 BEAM 1 LEG 2, SPALL/DELAMINATION (18IN X 8IN) WITH EXPOSED STRAND

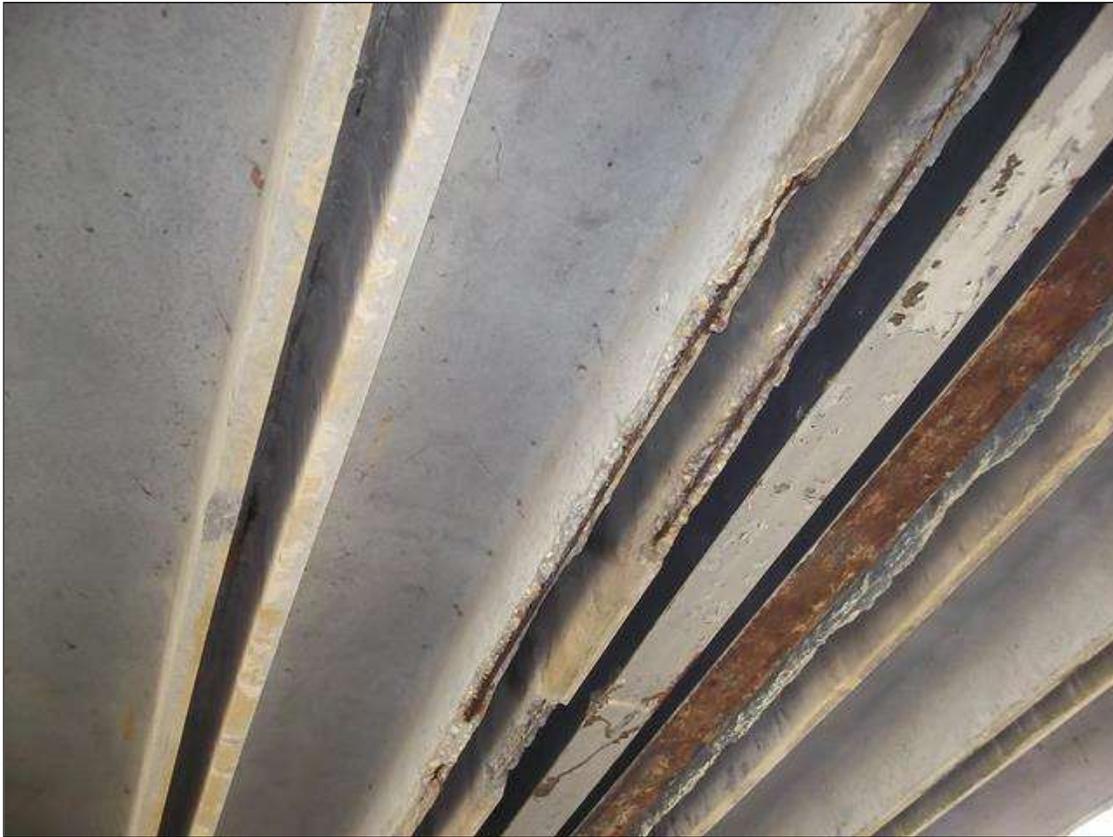
MMS Code	MMS Description	Quantity
3306	Maintain Concrete Superstructure Components	10 SF
Location:		
Beams and Girders Bent/Span No. 2 BEAM		
Priority Level		Status
Priority Maintenance		Division Bridge Maintenance Notification Received
Submitted Date:	Submitted By:	Assisted By:
04/08/2013	MICHAEL T. MILLS	TOMMY GRAHAM
Details		
SPAN 2 BEAM 9 LEG 2 MID SPAN, SPALL (9-1/2FT) WITH EXPOSED STRAND

(PM) SPAN 2 BEAM 9 LEG 2 MID SPAN, SPALL (9-1/2FT) WITH EXPOSED STRAND

3306	Maintain Concrete Superstructure Components	SF	10	SPAN 2 BEAM 9 LEG 2 MID SPAN, SPALL (9-1/2FT) WITH EXPOSED STRAND

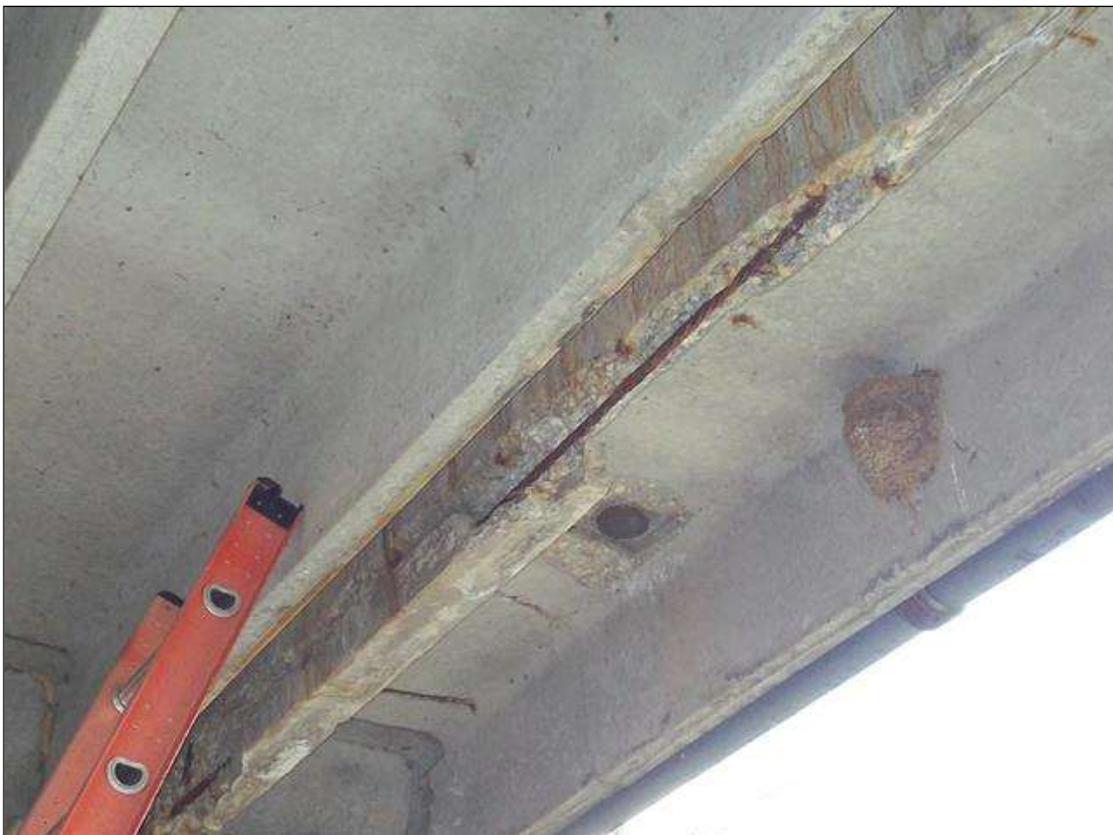
(PM) BENT 1 SPAN 2 BEAM 1 LEG 2, SPALL (9FT X 2-1/2IN X 5IN) WITH EXPOSED STRAND

3306	Maintain Concrete Superstructure Components	SF	19 TSE 6/12/13	BENT 1 SPAN 2 BEAM 1 LEG 2, SPALL (9FT X 2-1/2IN X 5IN) WITH EXPOSED STRAND SPAN 2 BEAM 1 LEG 2 10FT FROM BENT 2, SPALL (10FT X 2-1/2IN X 1IN) WITH FAILED REPAIR

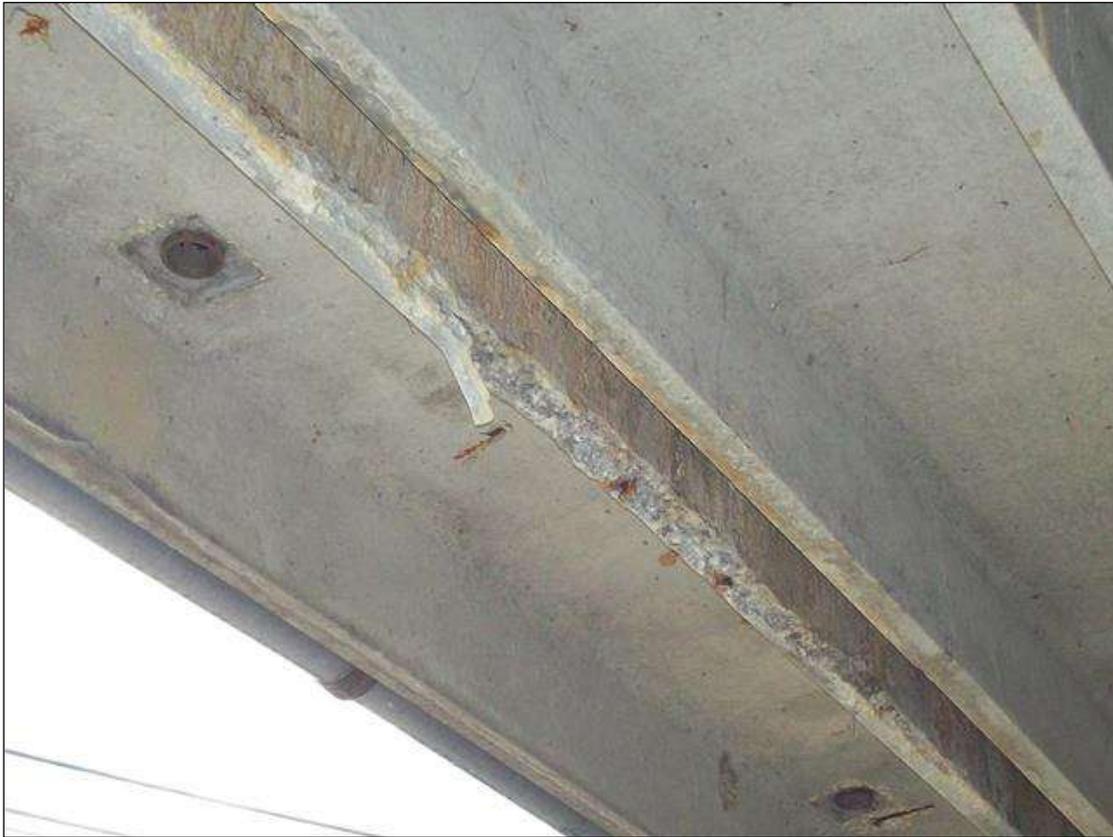
MMS Code	MMS Description	Quantity
3306	Maintain Concrete Superstructure Components	19 SF
Location:		
Beams and Girders	Bent/Span No. 2	BEAMS
Priority Level	Status	
Priority Maintenance	Division Bridge Maintenance Notification Received	
Submitted Date:	Submitted By:	Assisted By:
04/08/2013	MICHAEL T. MILLS	TOMMY GRAHAM
Details		
BENT 1 SPAN 2 BEAM 1 LEG 2, SPALL (9FT X 2-1/2IN X 5IN) WITH EXPOSED STRAND SPAN 2 BEAM 1 LEG 2 10FT FROM BENT 2, SPALL (10FT X 2-1/2IN X 1IN) WITH FAILED REPAIR

(PM) SPAN 2 BEAM 1 LEG 2 10FT FROM BENT 2, SPALL (10FT X 2-1/2IN X 1IN) WITH FAILED REPAIR

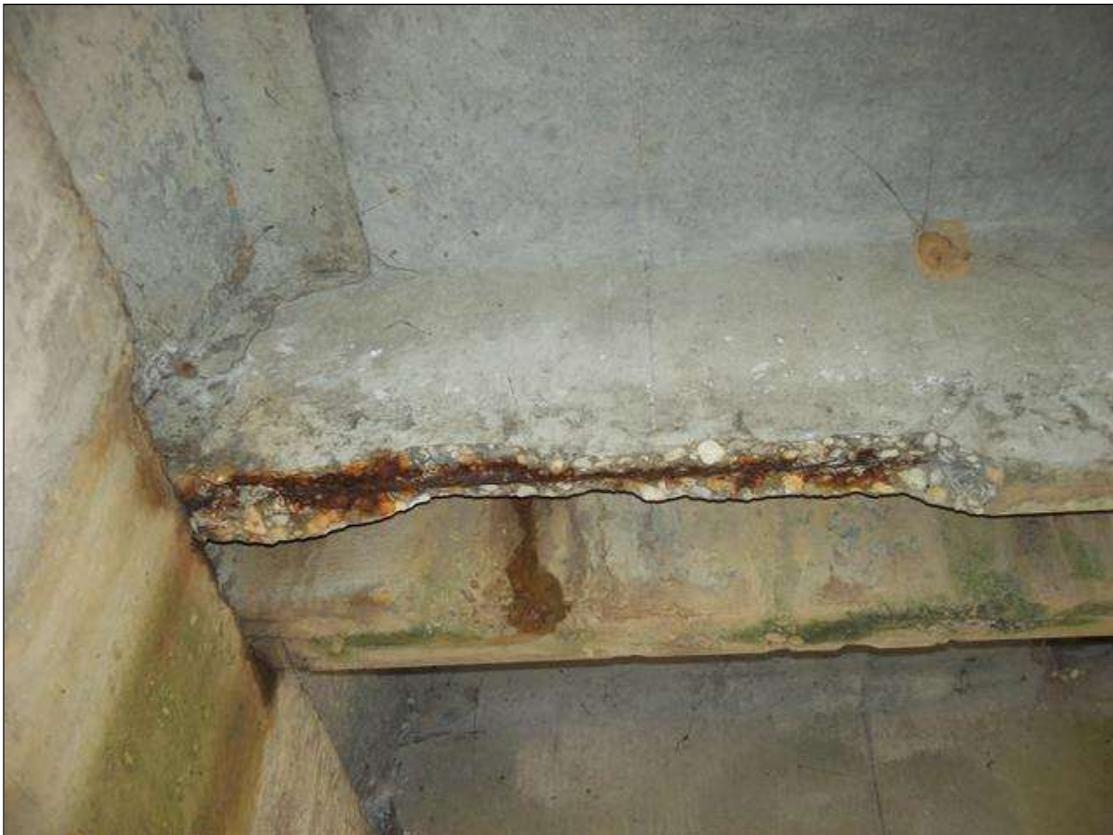
MMS Code	MMS Description	Quantity
3306	Maintain Concrete Superstructure Components	2 SF
Location:		
Beams and Girders Bent/Span No. 2 BEARING		
Priority Level		Status
Priority Maintenance		Division Bridge Maintenance Notification Received
Submitted Date:	Submitted By:	Assisted By:
04/08/2013	MICHAEL T. MILLS	TOMMY GRAHAM
Details		
BENT 2 SPAN 2 BEAM 11 LEG 2 BEARING, SPALL (2FT X 2-1/2IN X 2IN) WITH EXPOSED STRAND

(PM) BENT 2 SPAN 2 BEAM 11 LEG 2 BEARING, SPALL (2FT X 2-1/2IN X 2IN) WITH EXPOSED STRAND

3306	Maintain Concrete Superstructure Components	SF	2	BENT 2 SPAN 2 BEAM 11 LEG 2 BEARING, SPALL (2FT X 2-1/2IN X 2IN) WITH EXPOSED STRAND

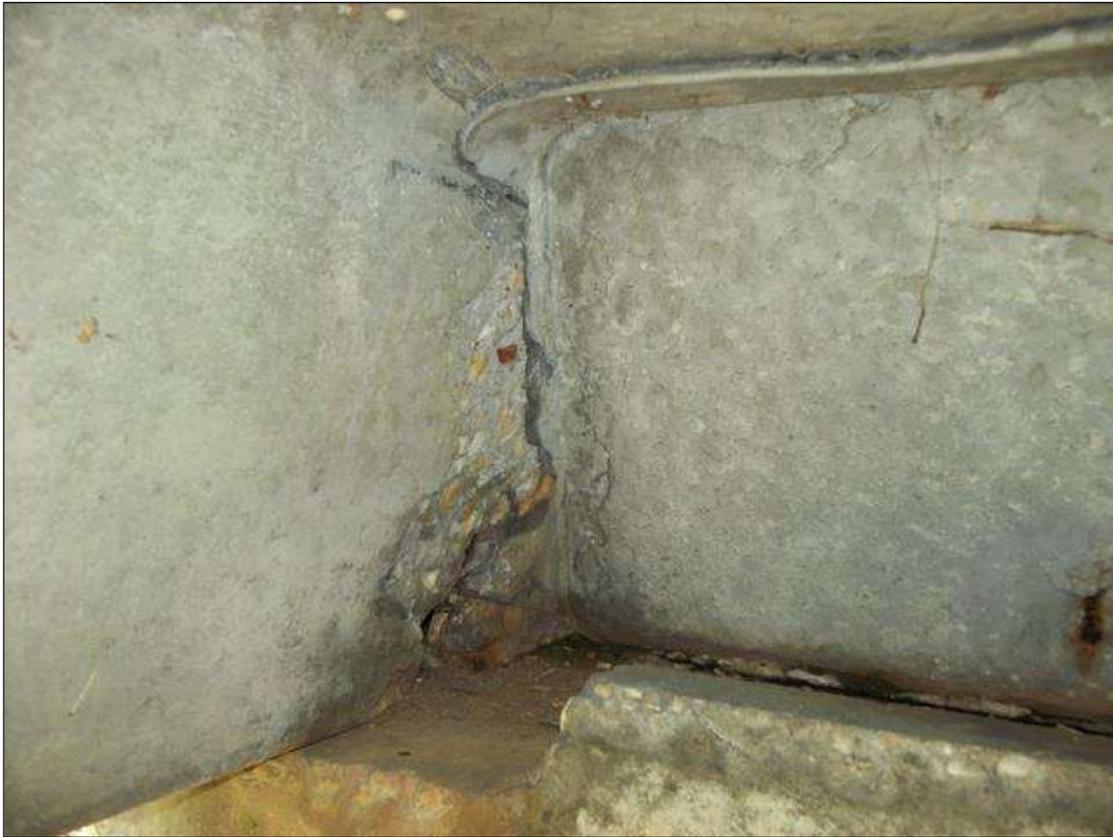
MMS Code	MMS Description	Quantity
3306	Maintain Concrete Superstructure Components	1 SF
Location:		
Beams and Girders	Bent/Span No. 3	BEARING
Priority Level	Status	
Priority Maintenance	Division Bridge Maintenance Notification Received	
Submitted Date:	Submitted By:	Assisted By:
04/08/2013	MICHAEL T. MILLS	TOMMY GRAHAM
Details		
END BENT 2 BEAM 1 LEG 1 BEARING, SPALL (7IN X 6IN X 2-1/2IN) 1IN BEARING REMAINING

(PM) END BENT 2 BEAM 1 LEG 1 BEARING, SPALL (7IN X 6IN X 2-1/2IN) 1IN BEARING REMAINING

3306	Maintain Concrete Superstructure Components	SF	1	END BENT 2 BEAM 1 LEG 1 BEARING, SPALL (7IN X 6IN X 2-1/2IN) 1IN BEARING REMAINING

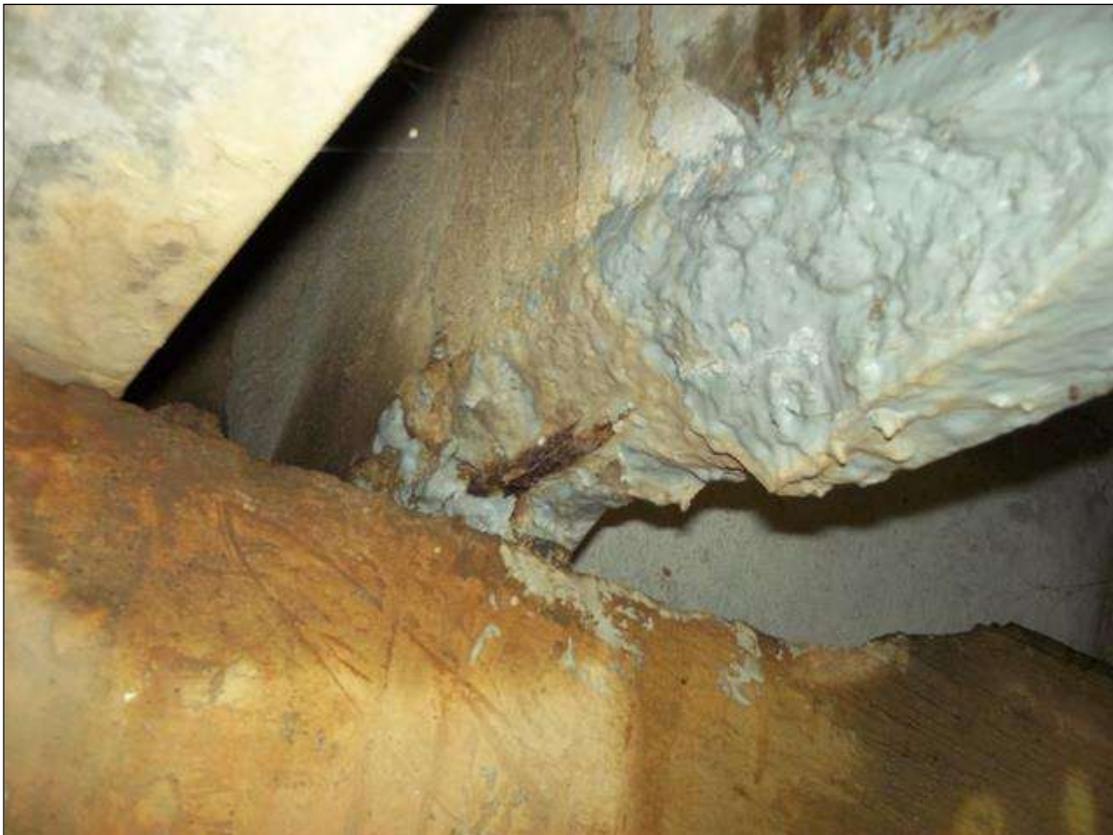
MMS Code	MMS Description	Quantity
3306	Maintain Concrete Superstructure Components	1 SF
Location:		
Beams and Girders	Bent/Span No. 3	BEAM
Priority Level	Status	
Priority Maintenance	Division Bridge Maintenance Notification Received	
Submitted Date:	Submitted By:	Assisted By:
04/08/2013	MICHAEL T. MILLS	TOMMY GRAHAM
Details		
END BENT 2 BEAM 11 LEG 1 BEARING, SPALL (9IN X 2-1/2IN X 2IN) WITH EXPOSED STRAND

(PM) END BENT 2 BEAM 11 LEG 1 BEARING, SPALL (9IN X 2-1/2IN X 2IN) WITH EXPOSED STRAND

3306	Maintain Concrete Superstructure Components	SF	1	END BENT 2 BEAM 11 LEG 1 BEARING, SPALL (9IN X 2-1/2IN X 2IN) WITH EXPOSED STRAND

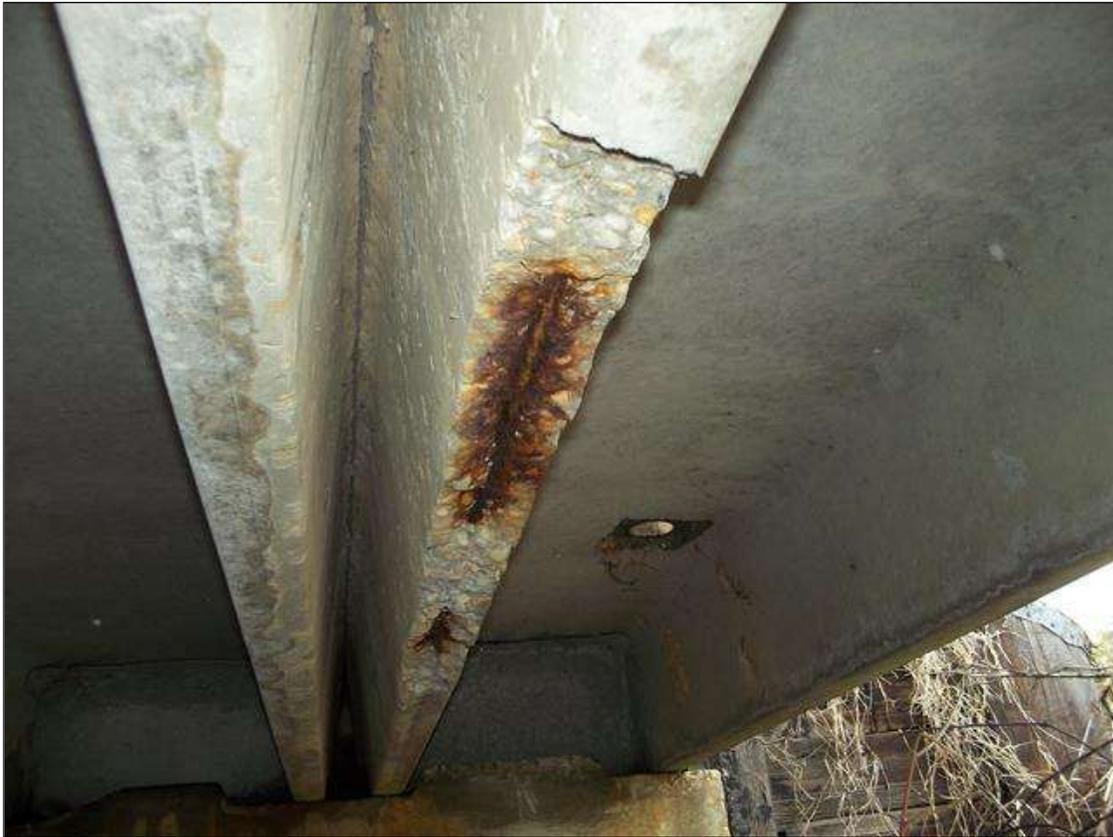
MMS Code	MMS Description	Quantity
3306	Maintain Concrete Superstructure Components	4 SF
Location:		
Beams and Girders	Bent/Span No. 3	BEAM
Priority Level	Status	
Priority Maintenance	Division Bridge Maintenance Notification Received	
Submitted Date:	Submitted By:	Assisted By:
04/08/2013	MICHAEL T. MILLS	TOMMY GRAHAM
Details		
SPAN 3 BEAM 12 LEG 1 6FT FROM END BENT 2, SPALL (4FT X 2-1/2IN X 1IN) WITH EXPOSED STRAND

(PM) SPAN 3 BEAM 12 LEG 1 6FT FROM END BENT 2, SPALL (4FT X 2-1/2IN X 1IN) WITH EXPOSED STRAND

3306	Maintain Concrete Superstructure Components	SF	A TSE	SPAN 3 BEAM 12 LEG 1 6FT FROM END BENT 2, SPALL (4FT X 2-1/2IN X 1IN) WITH EXPOSED STRAND

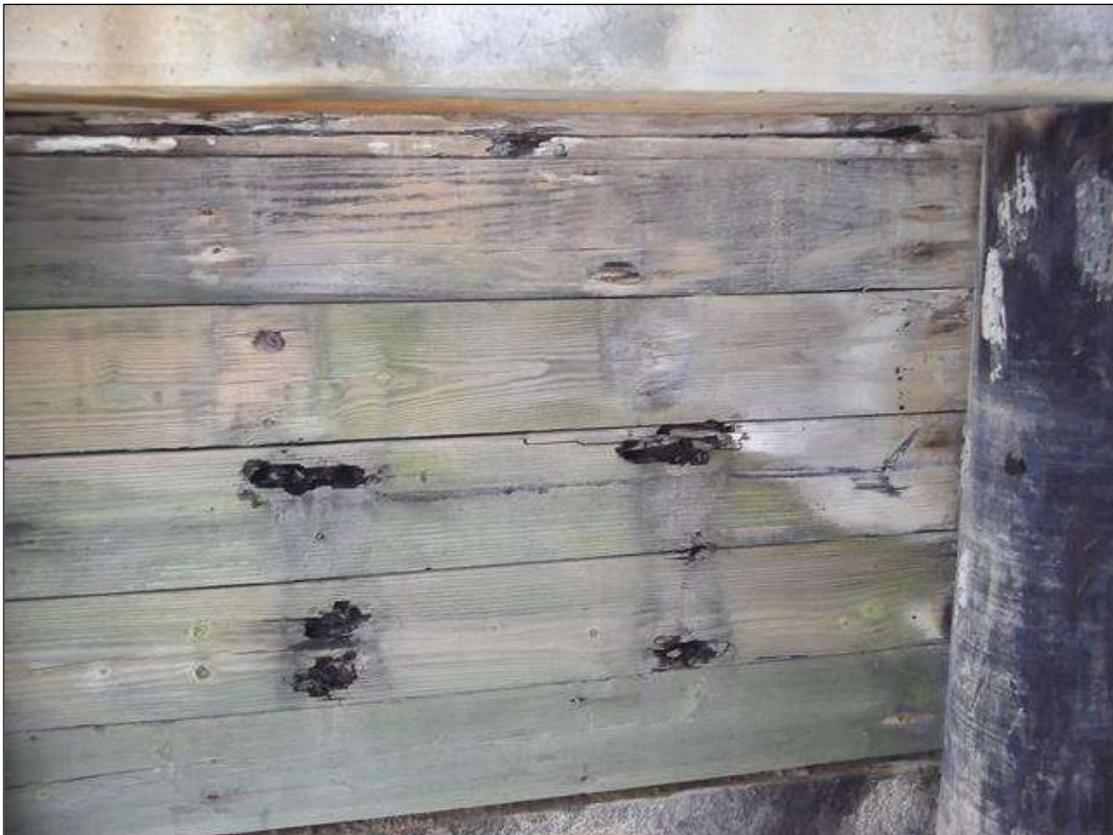
END BENT 1 BULKHEAD BAY 5, SIX (6) DECAYED AREAS (8IN DIAMETER)

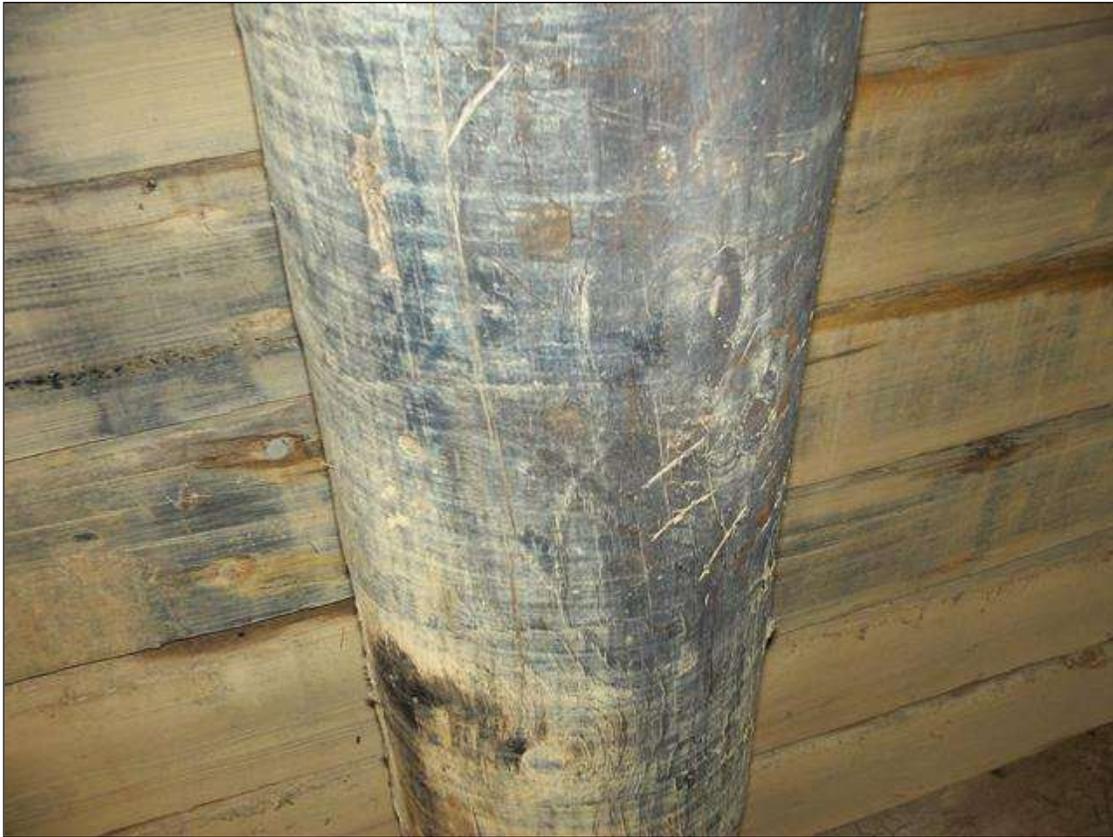
END BENT 1 PILES, CHECKS THROUGHOUT

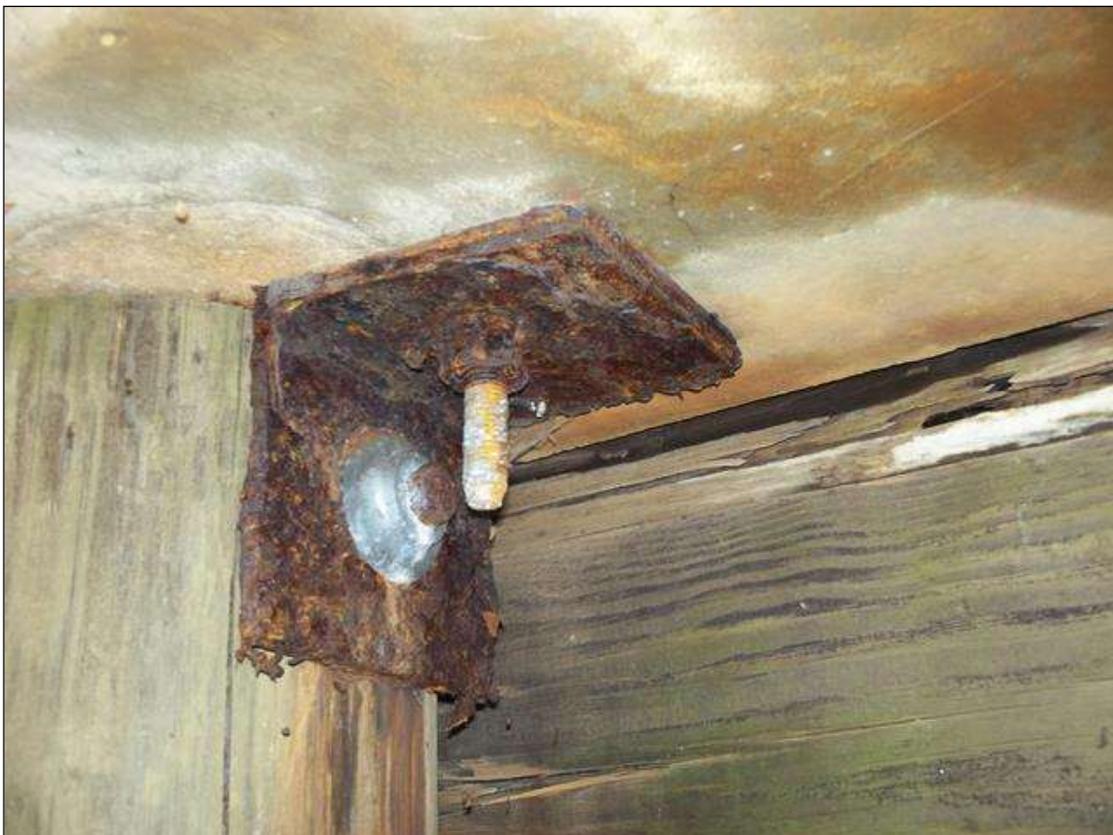
END BENT 1 PILE 6 CONNECTION PLATES, FLAKING STEEL

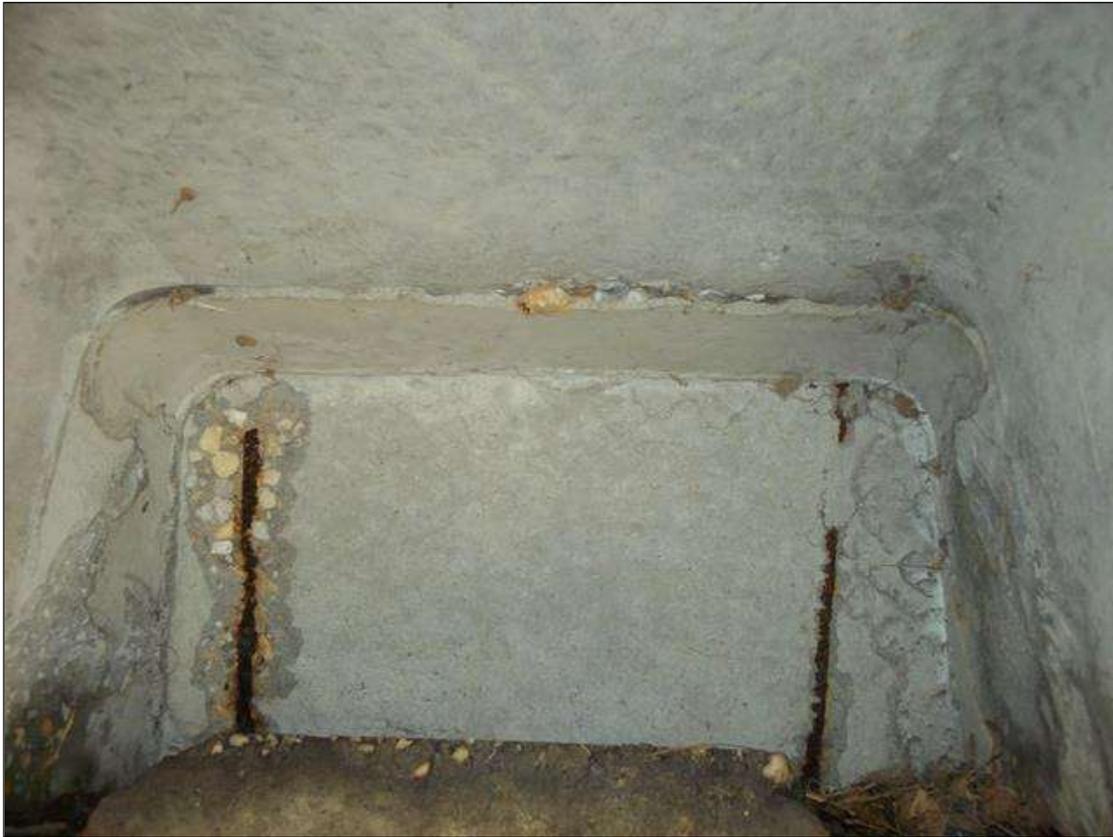
END BENT 1 END DIAPHRAGM BAY 2, SPALL WITH EXPOSED RUSTED REBAR (1SF)

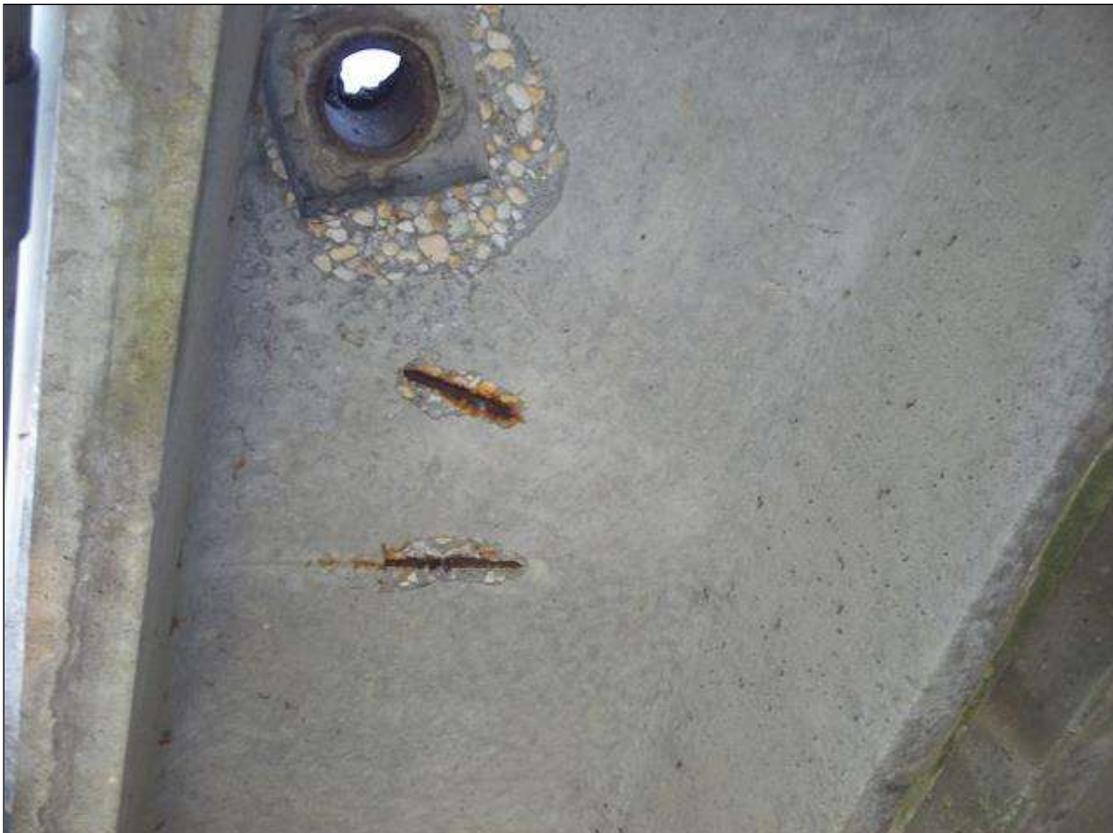
SPAN 1 BEAM 1 NEAR END BENT 1, TWO (2) EXPOSED RUSTED REBAR (8IN)

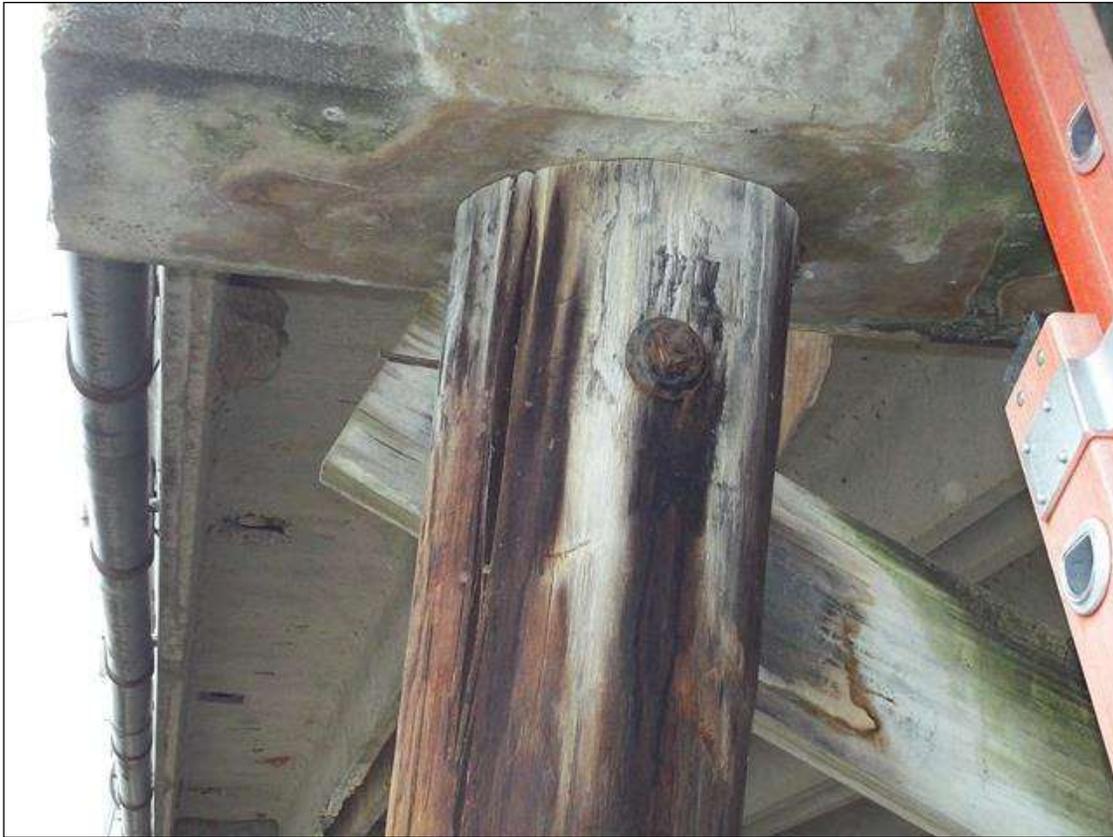
BENT 1 PILE 1 AT TOP, CHECK (1/2IN)

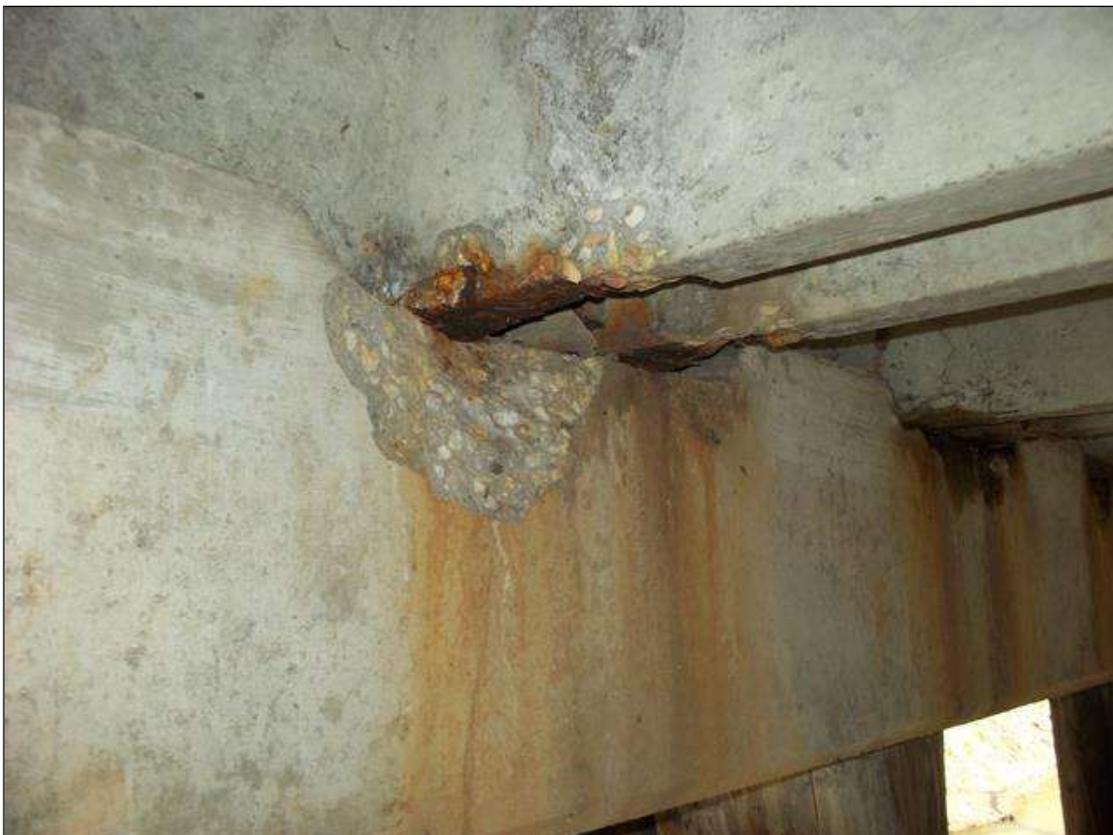
SPAN 1 BENT 1 CAP UNDER BEAM 4 BEARING, SPALL (10IN X 5IN X 1IN)

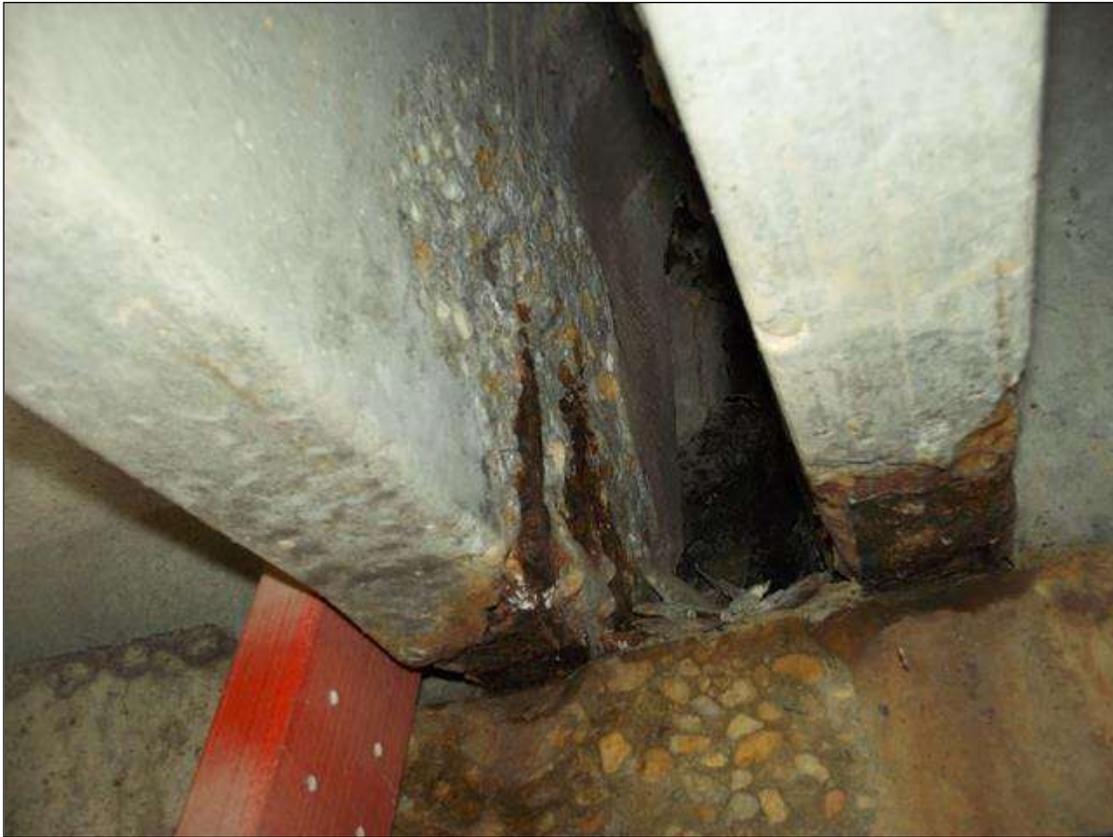
SPAN 1 BENT 1 BEAM 3 LEG 2, SPALL (10IN X 9IN X 1/2IN) WITH EXPOSED RUSTED REBAR

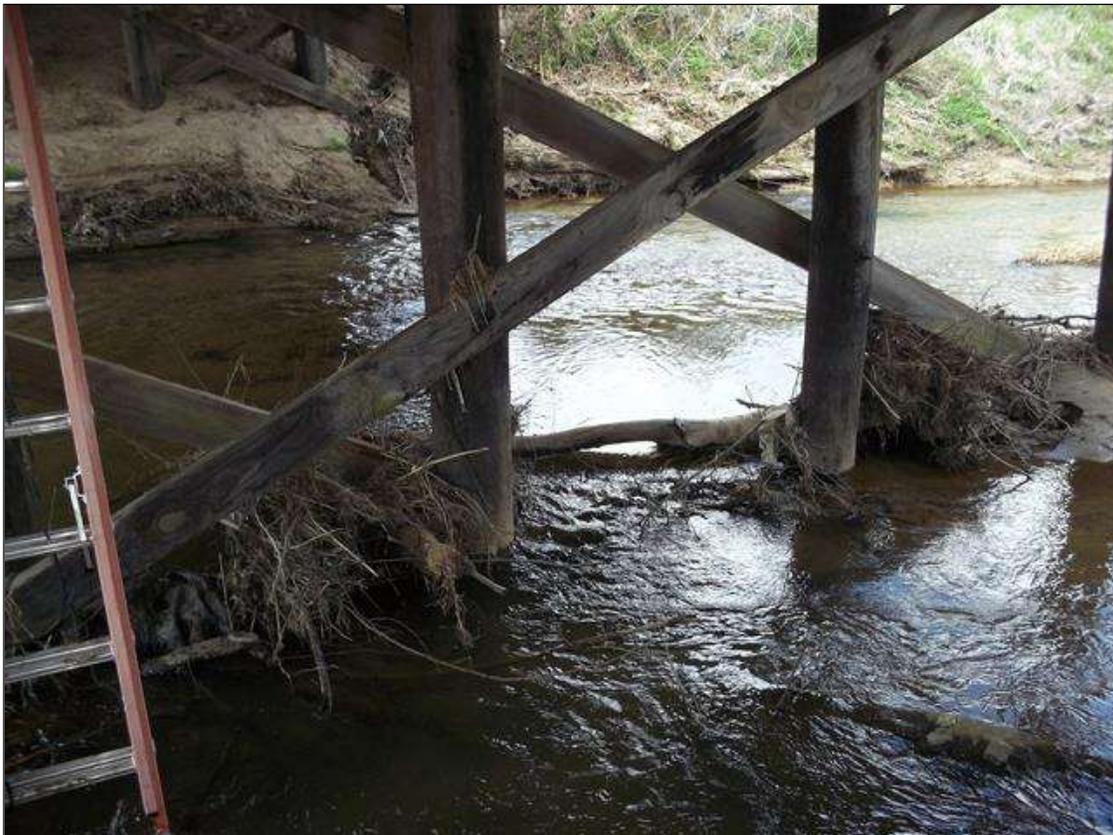
BENT 1, DRIFT (30CF)

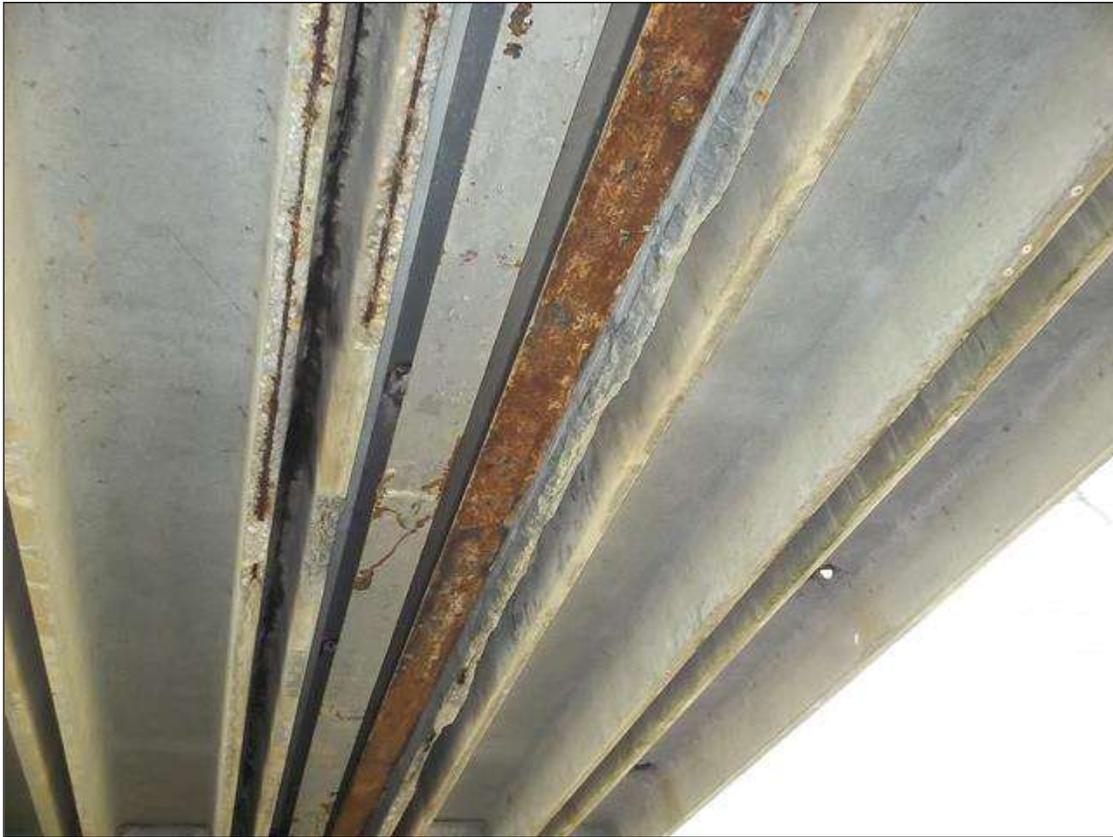
SPAN 2 BEAM 10, TEMPORARY REPAIR TO BEAM

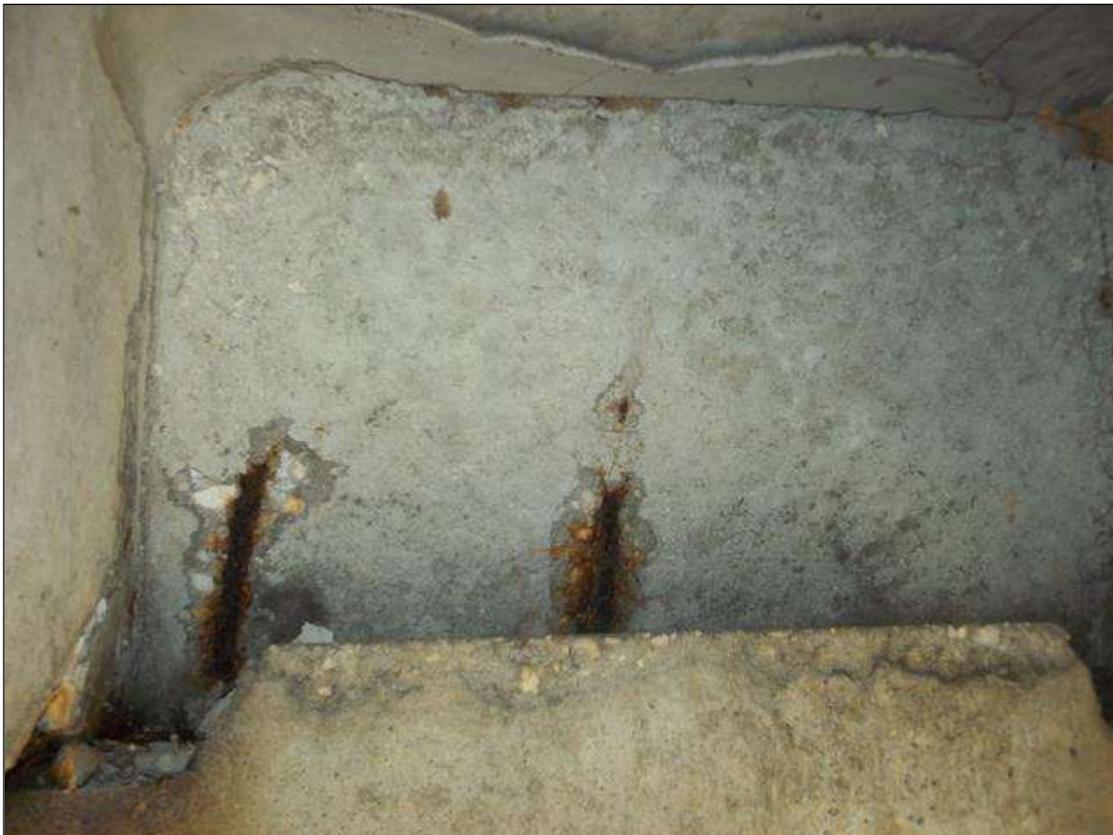
SPAN 2 BENT 1 BAY 5 END DIAPHRAGM, EXPOSED RUSTED REBAR
