NC DEPARTMENT OF TRANSPORTATION
 DIVISION OF HIGHWAYS
 BRIDGE MANAGEMENT UNIT

BRIDGE INSPECTION REPORT

COUNTY WILKES BRIDGE NUMBER 960029 INSPECTION CYCLE 0 YRS
SR1001 (OAKWOODS RD)
 ROUTE SR1001 ACROSS CUB CREEK M.P. 0
.15 MILES SOUTH OF JUNCTION WITH NC18,NC268
 LOCATION .15 MI.S.JCT.NC18,NC268

INSPECTION DATE 04/08/2013

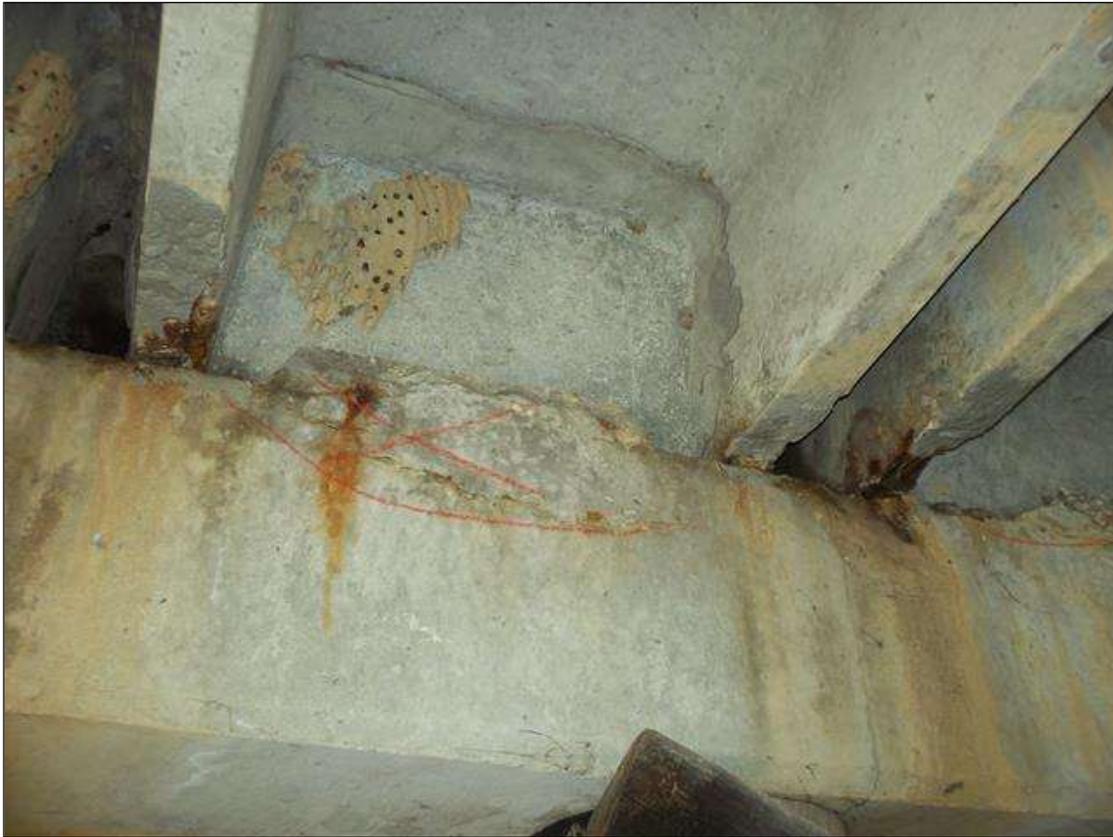
BENT 2 CAP SOUTH FACE UNDER BEAM 5, DELAMINATION (18IN X 7IN) (SIMILAR BEAM 6)

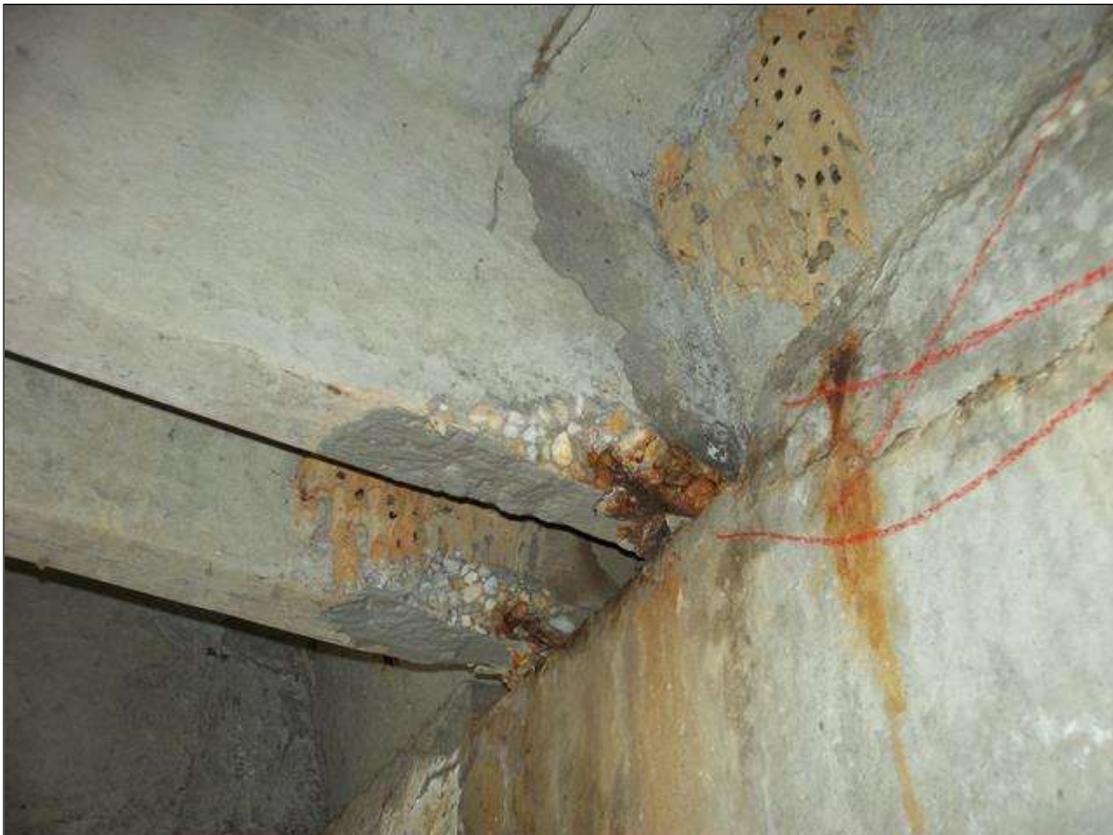
SPAN 2 BENT 2 BEAM 5 LEG 1, FAILED SPALL REPAIR AT BEARING (5IN X 2IN X 1/2IN) (SIMILAR BEAM 6,7)

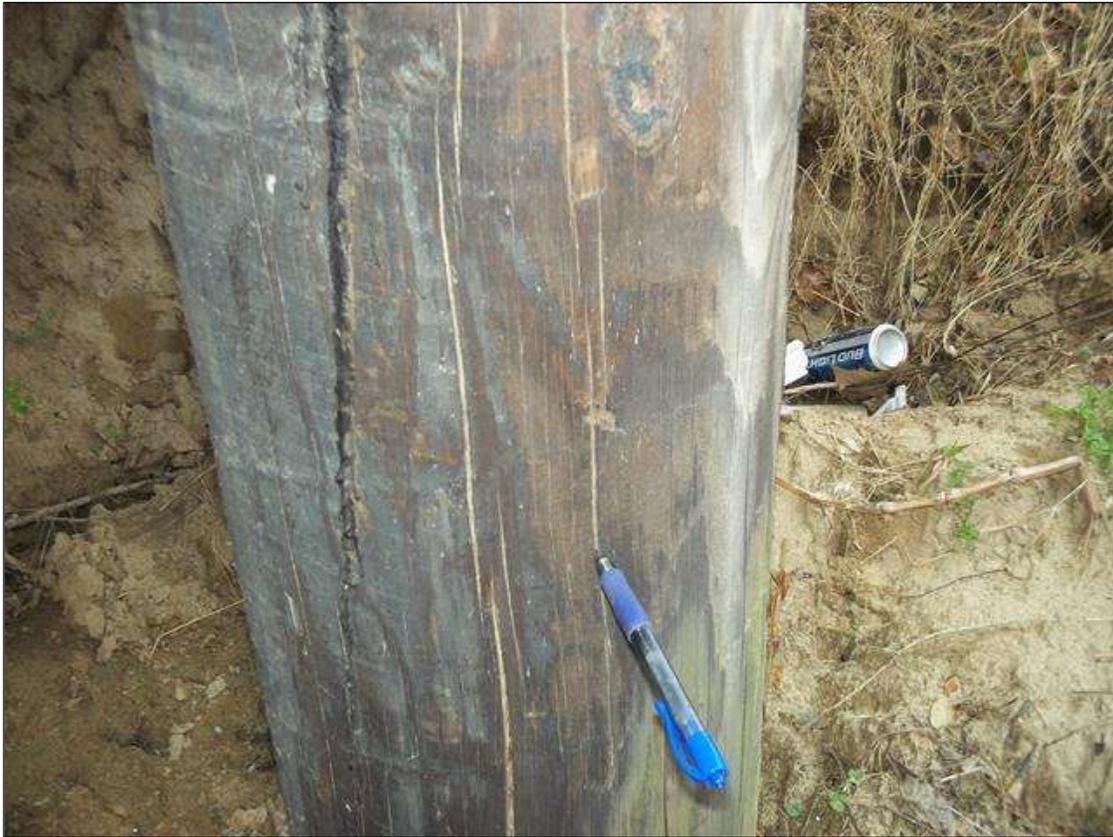
BENT 2 PILES AND BRACING, CHECKS THROUGHOUT

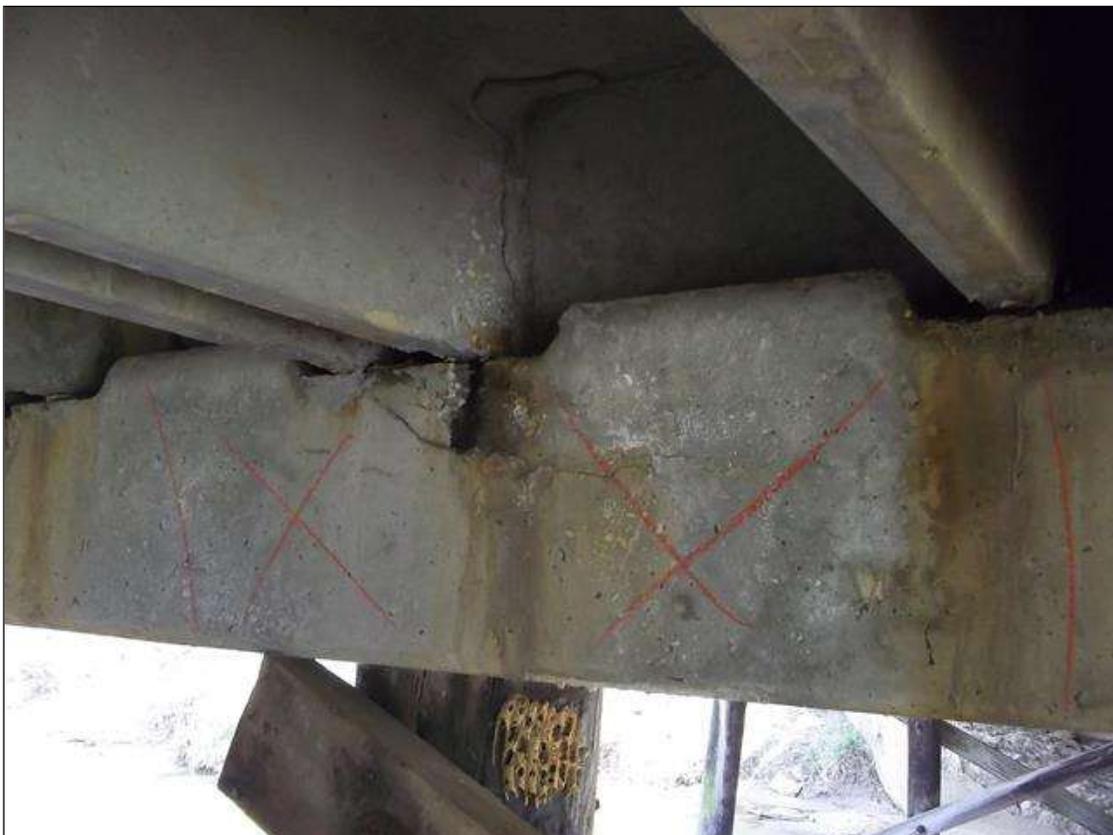
BENT 2 CAP NORTH FACE AT BEAM 7, DELAMINATION (4FT X 16IN)

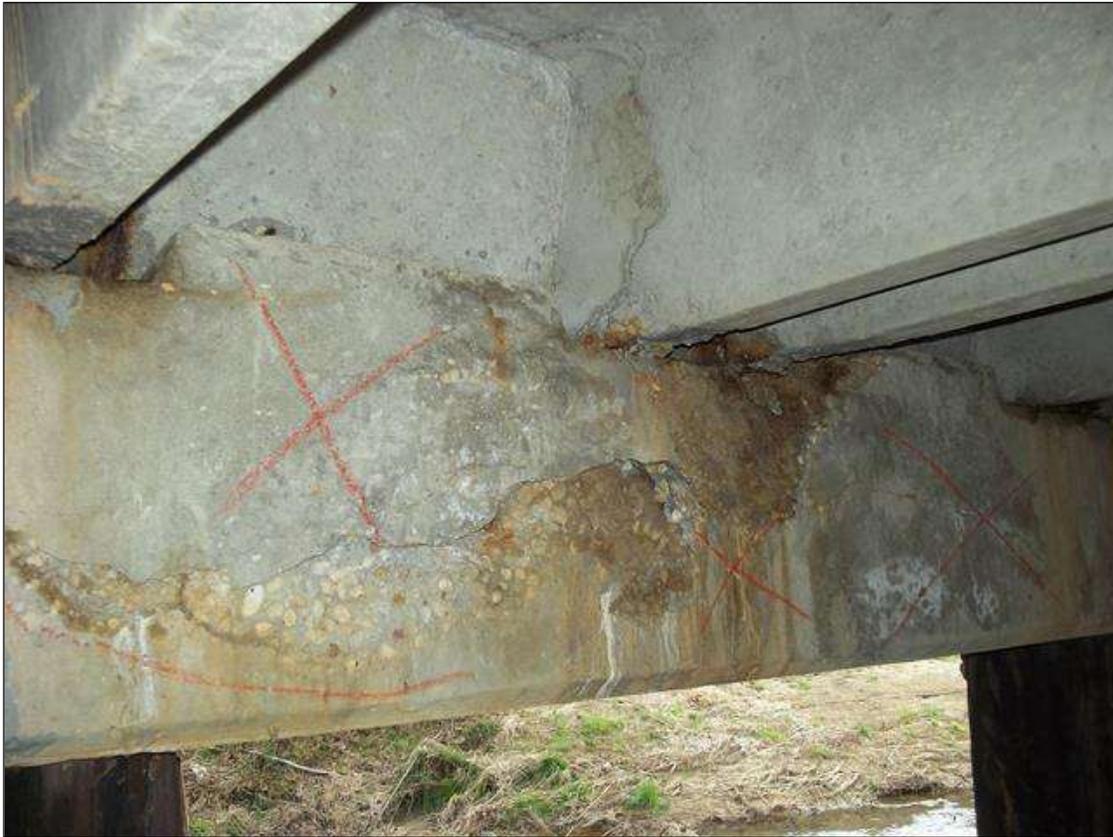
BENT 2 CAP NORTH FACE AT BEAM 5, SPALL/DELAMINATION (7FT X 16IN)

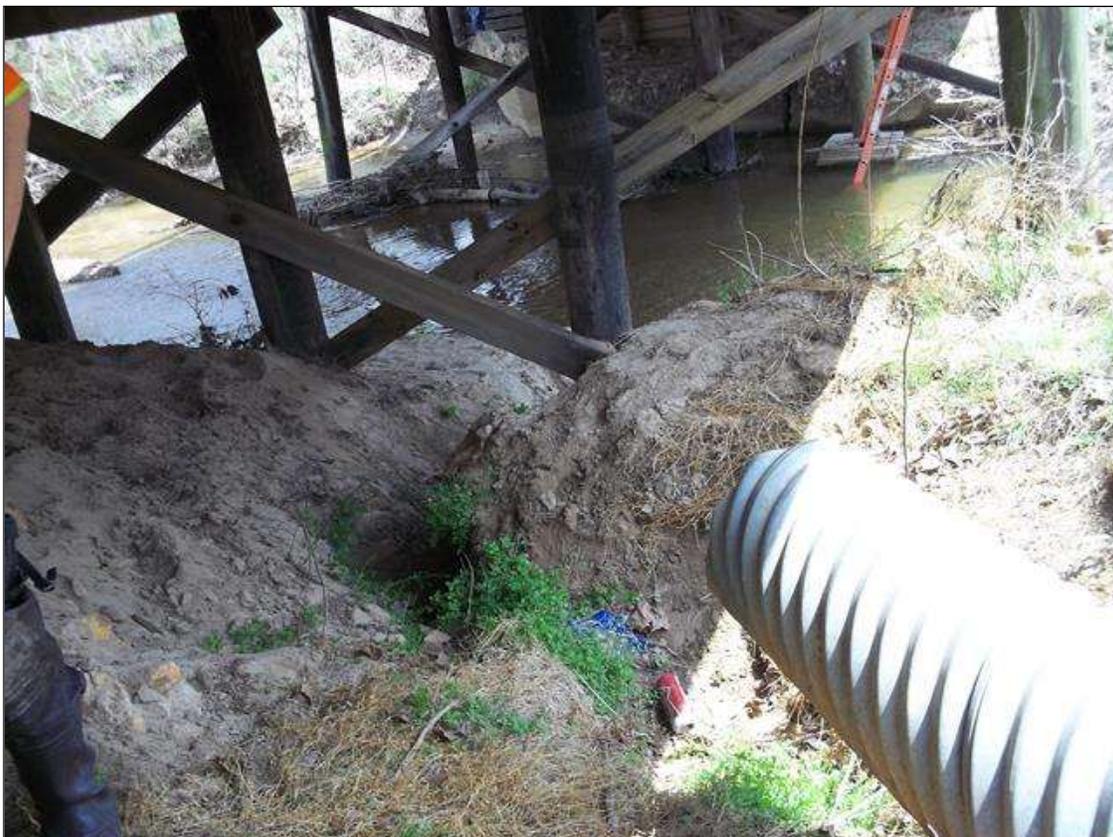
END BENT 2 BANK AT CORRUGATED METAL PIPE OUTLET, EROSION (5FT X 20FT X 4FT DEEP)

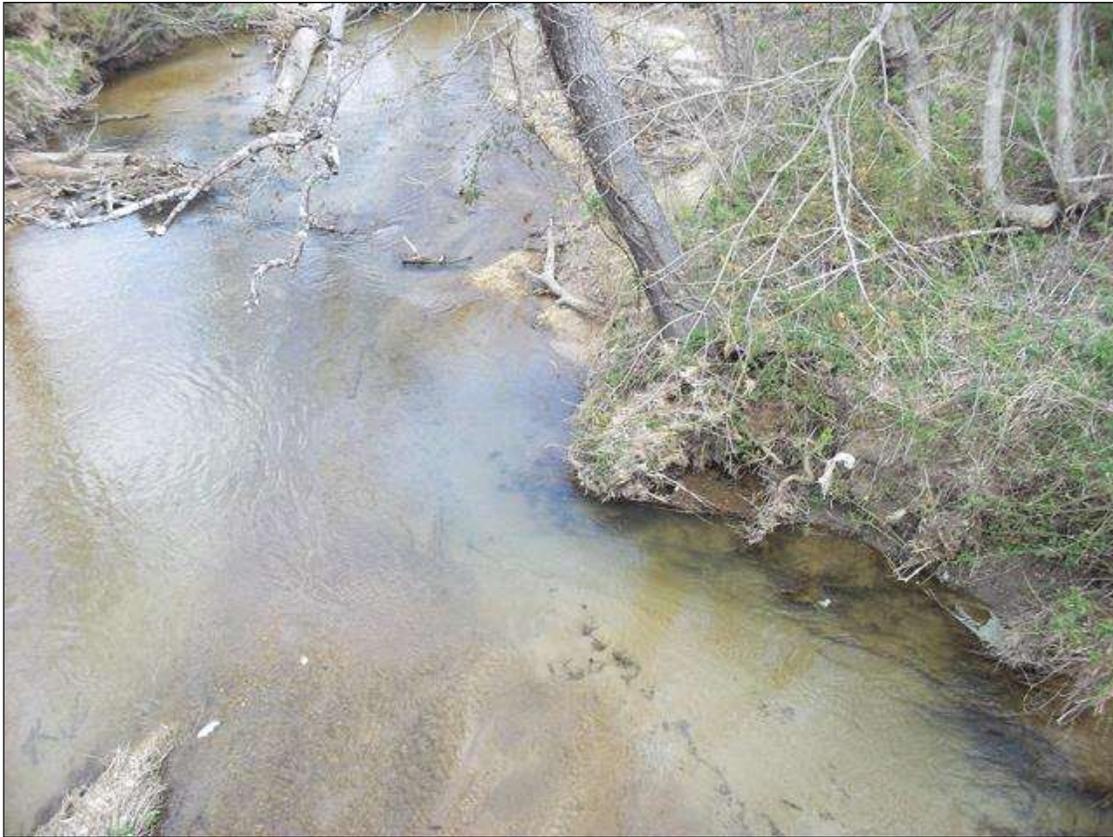
SOUTHEAST BANK 30FT FROM BRIDGE, BANK SCOUR WITH 3FT VERTICAL SLOPES

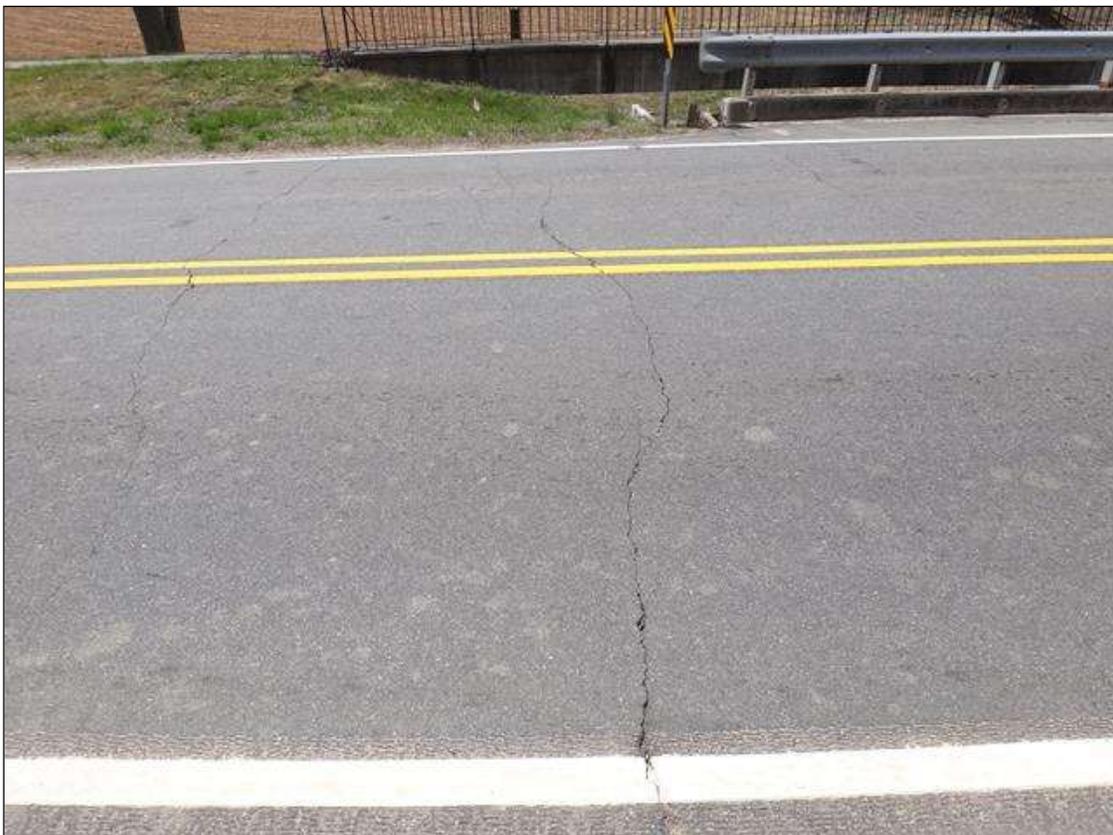
SOUTH APPROACH ASPHALT WEARING SURFACE, MULTIPLE PARTIAL TO FULL WIDTH TRANSVERSE CRACKS (UP TO 1/8IN WIDE)

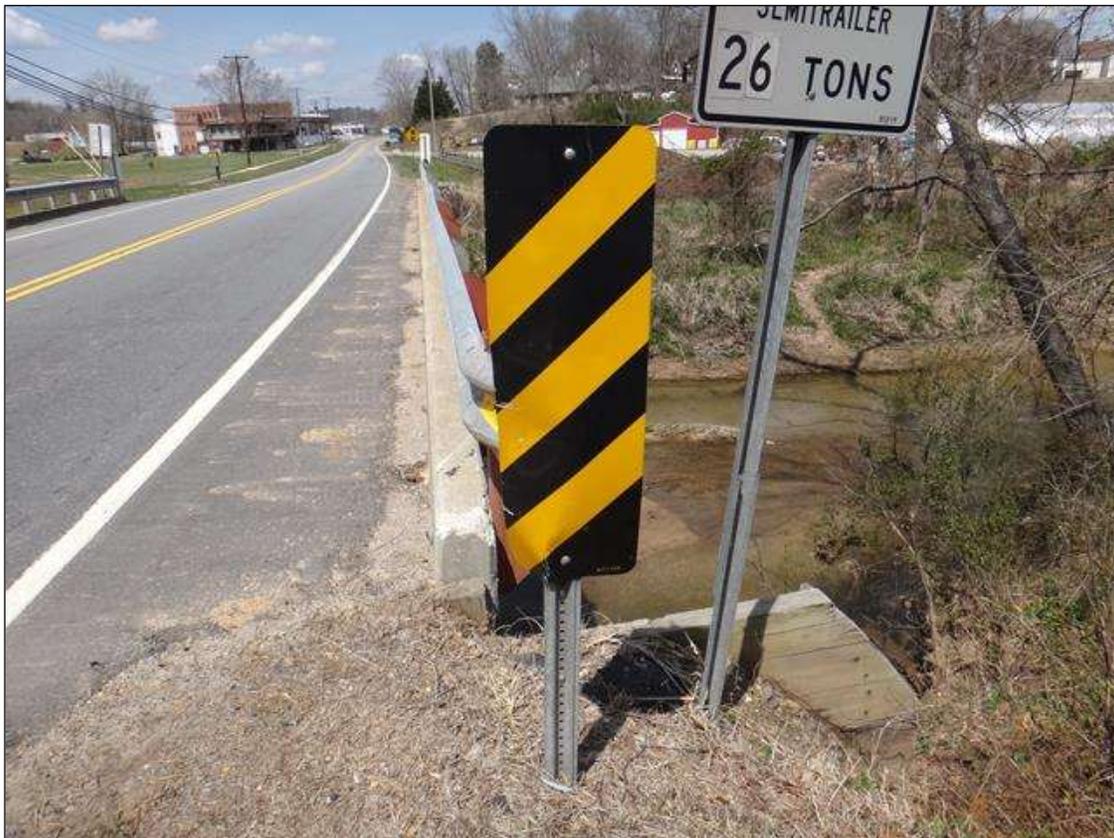
SOUTH APPROACH RIGHT SHOULDER, IMPACT DAMAGE TO DELINEATOR

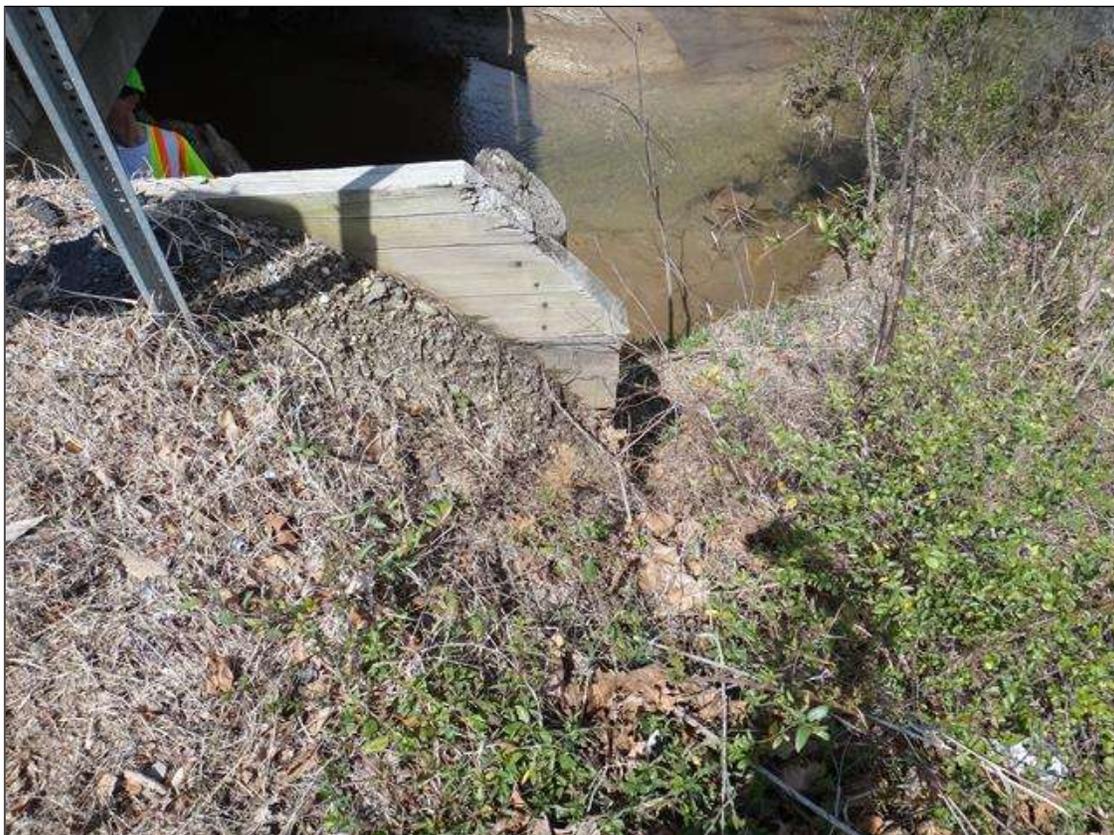
SOUTH APPROACH RIGHT SHOULDER, SLOPE EROSION BEHIND WINGWALL (2FT X 6FT X 1FT DEEP)

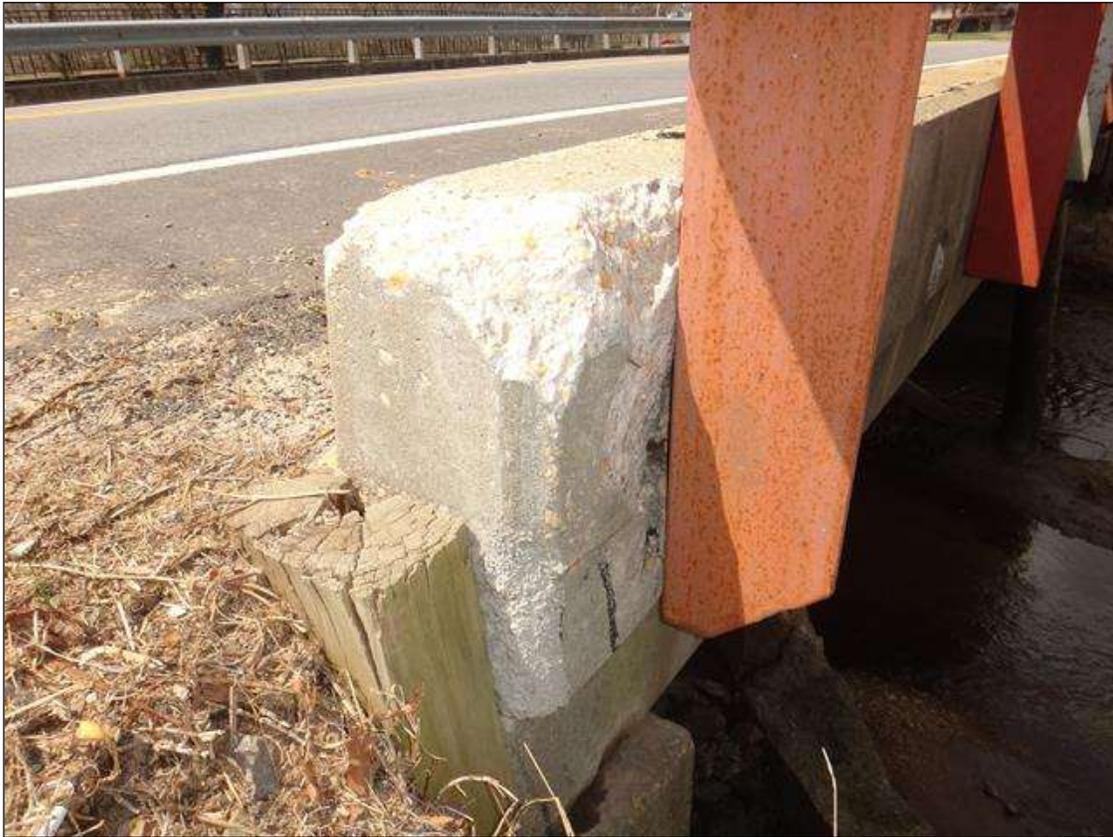
END BENT 1 RIGHT PARAPET, SPALL AT RAIL CONNECTION AND END

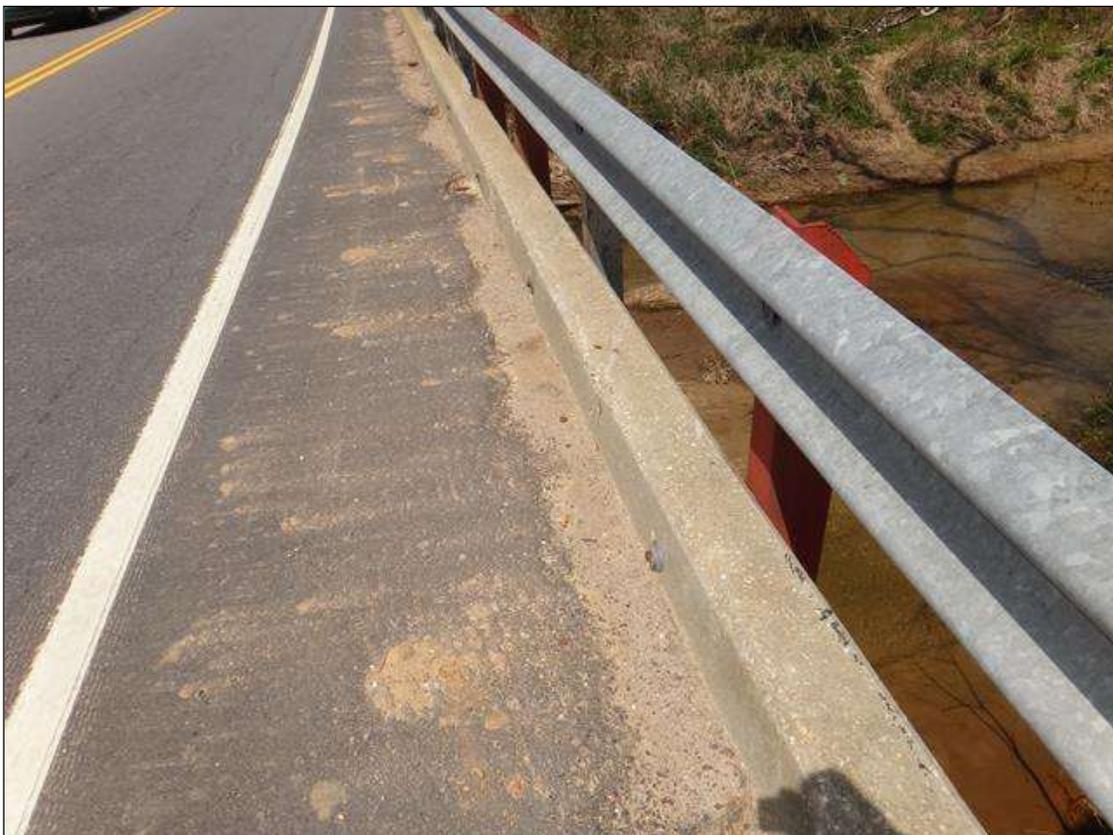
SPAN 1 RIGHT SHOULDER, DEBRIS ACCUMULATION WITH 1 CLOGGED SCUPPER DRAIN

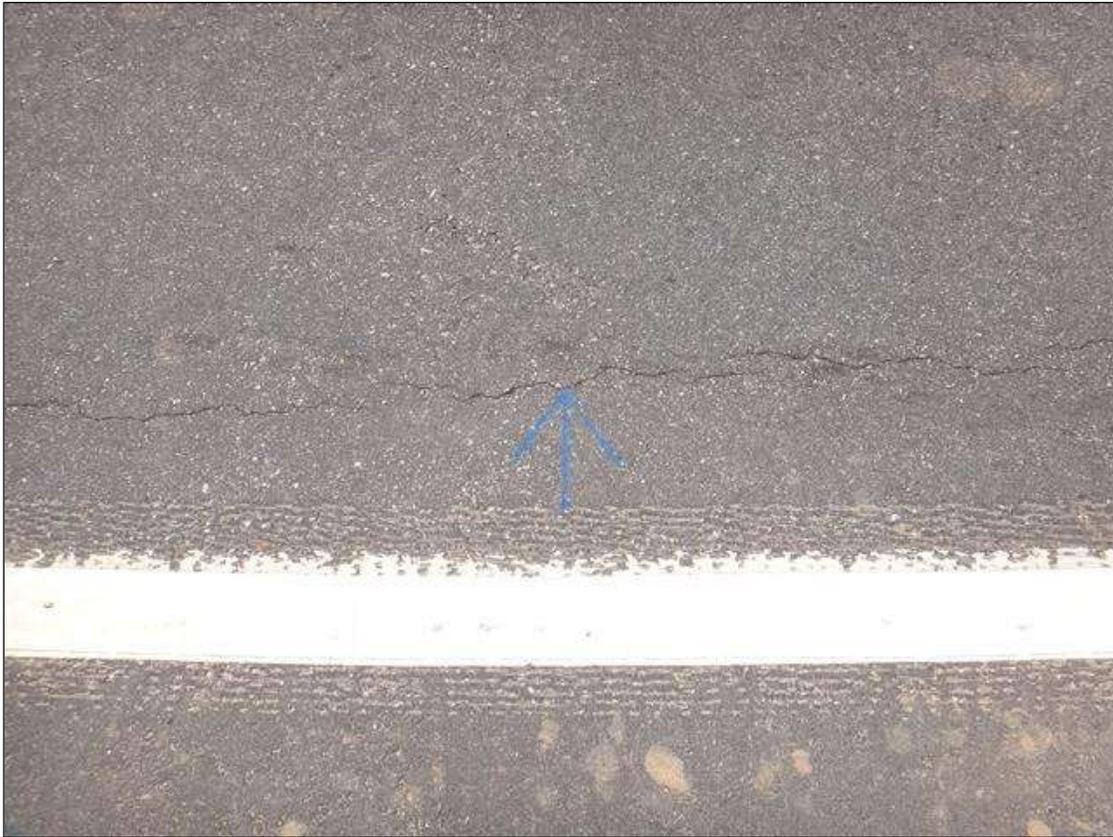
SPAN 1 NORTHBOUND LANE, FULL LENGTH LONGITUDINAL CRACK (UP TO 1/16IN WIDE) (SIMILAR SPAN 2,3)

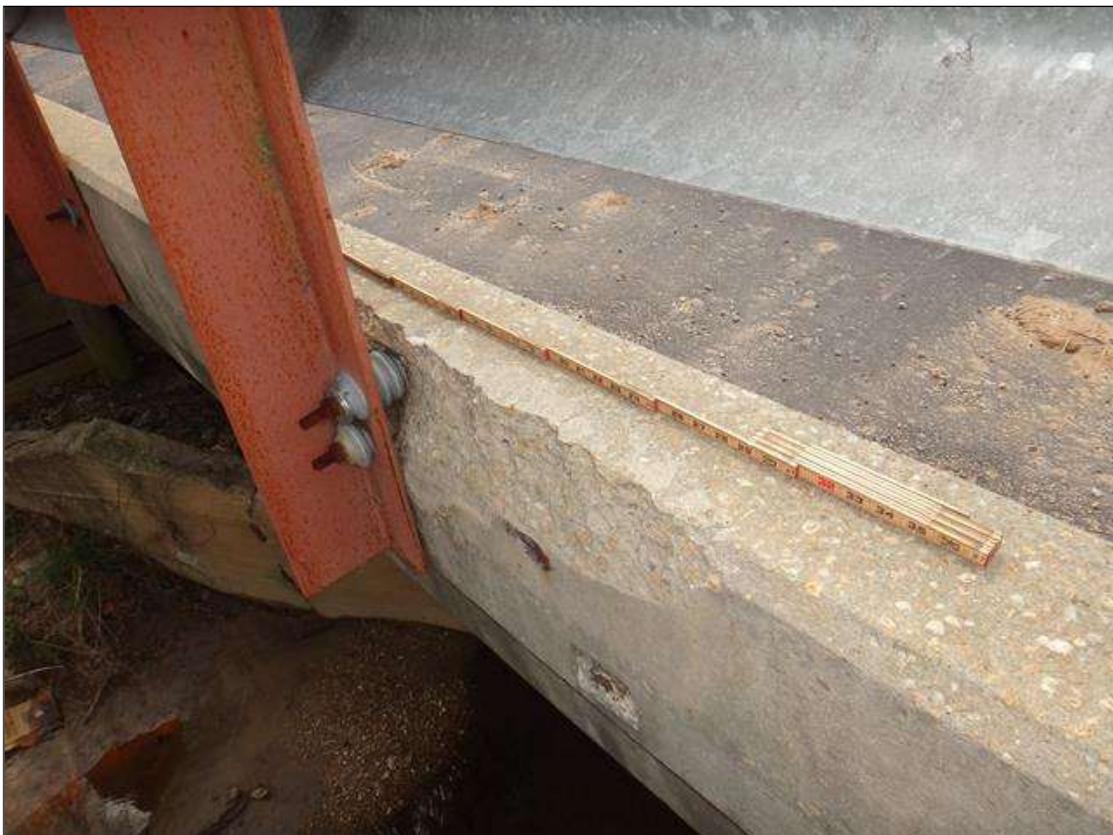
SPAN 1 RIGHT PARAPET, SPALL (30IN X 8IN X 3IN DEEP) WITH EXPOSED RUSTED REBAR AT RAIL POST 5

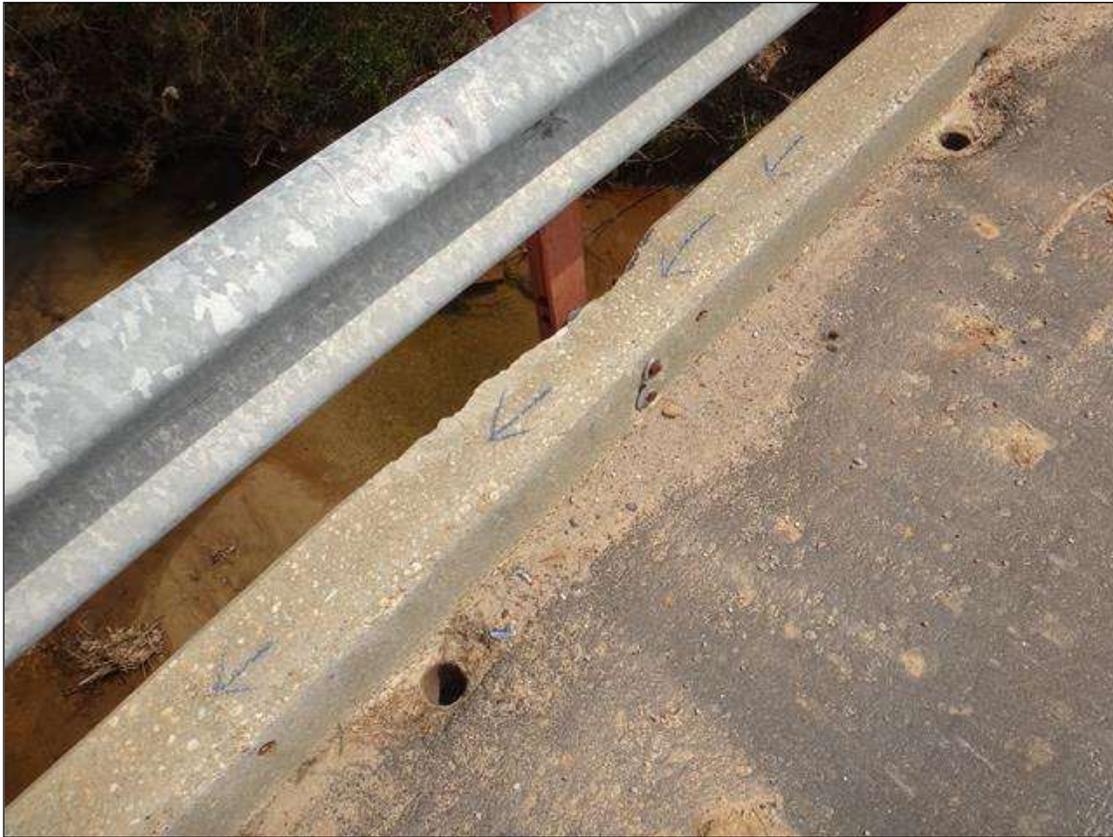
SPAN 1 RIGHT PARAPET, FOUR (4) FULL WIDTH HAIRLINE CRACKS IN PARAPET AT RAIL POST 5

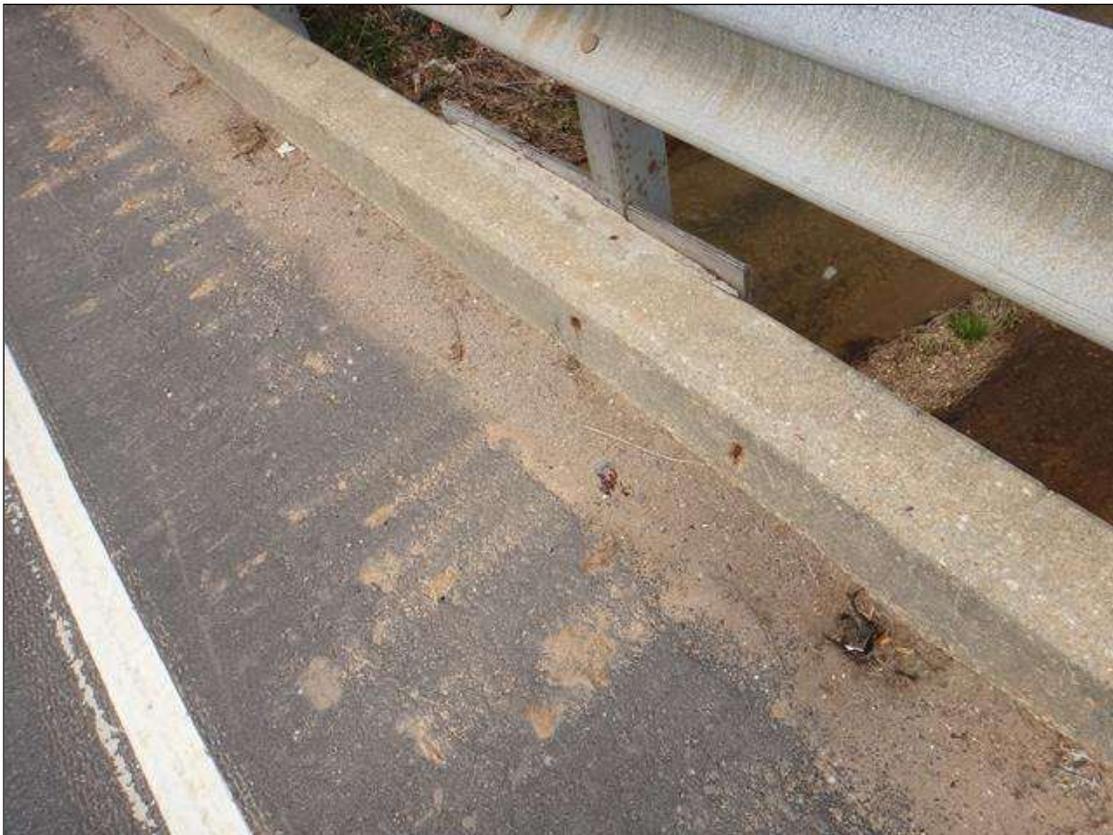
SPAN 2 RIGHT SHOULDER, THREE (3) CLOGGED SCUPPER DRAINS AND DEBRIS ACCUMULATION

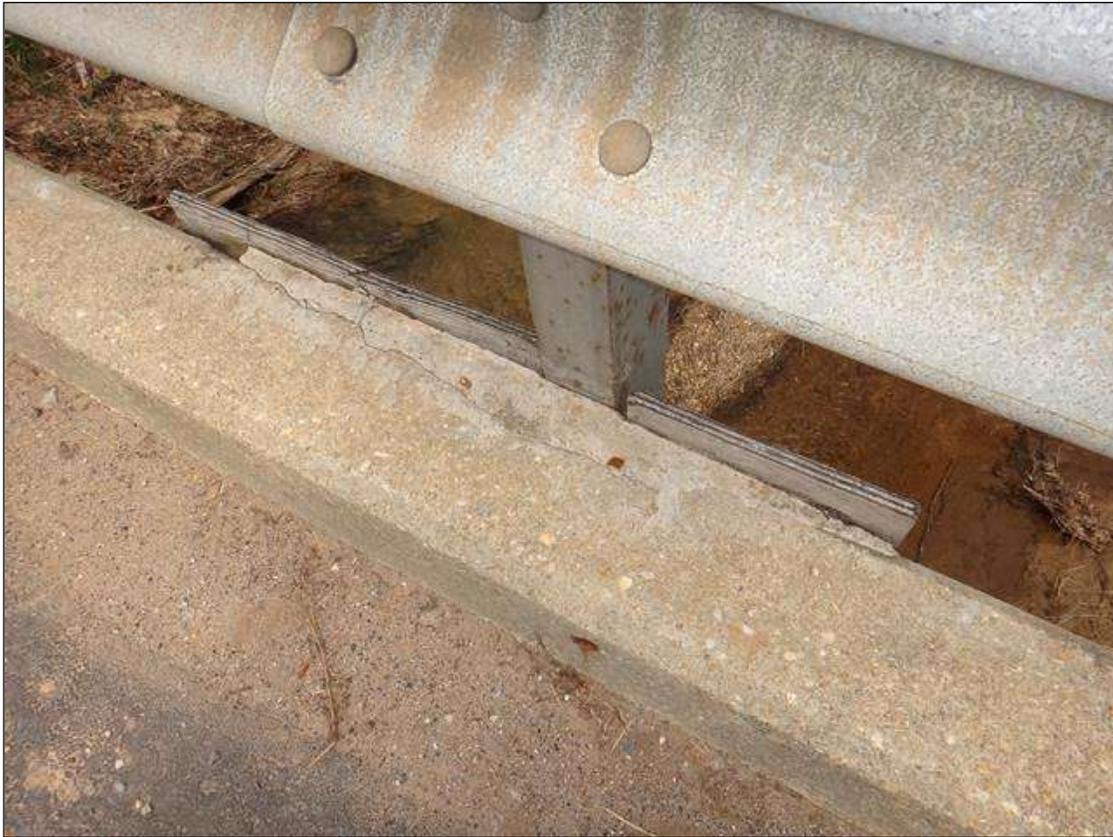
SPAN 2 RIGHT PARAPET, FAILED REPAIR AT RAIL POST 2 CONNECTION

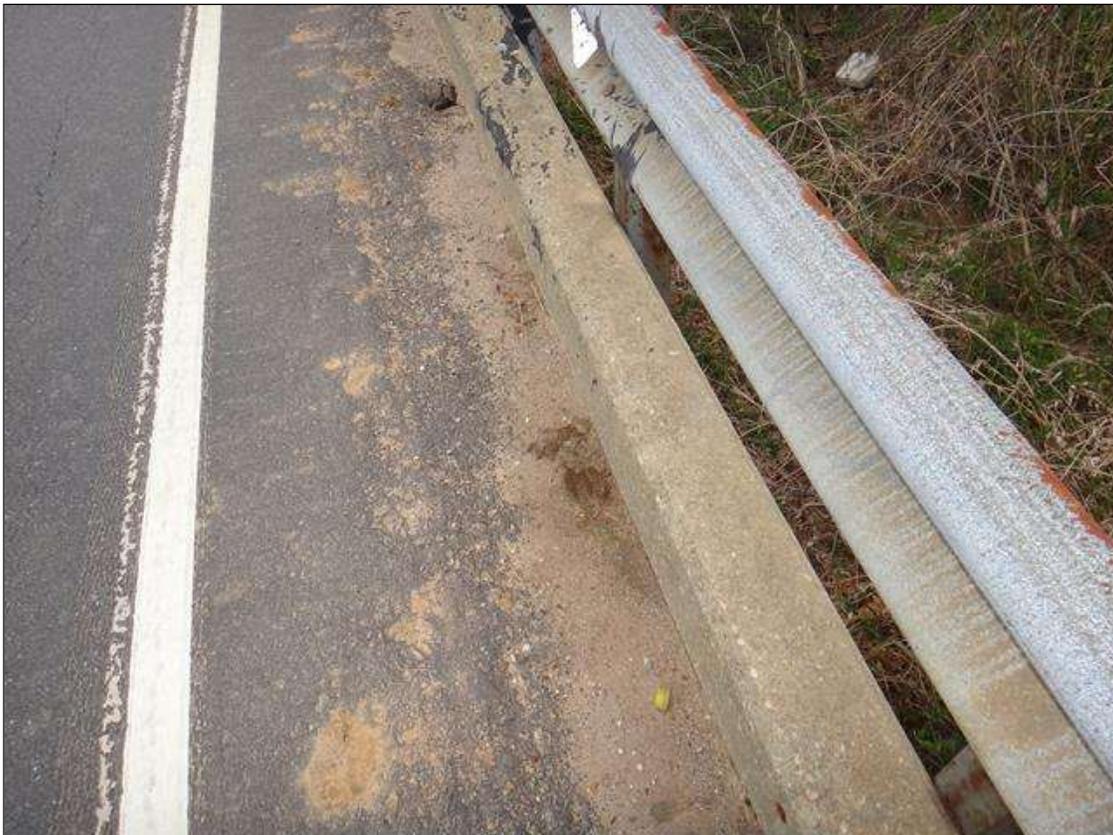
SPAN 3 RIGHT SHOULDER, ONE (1) CLOGGED SCUPPER DRAIN

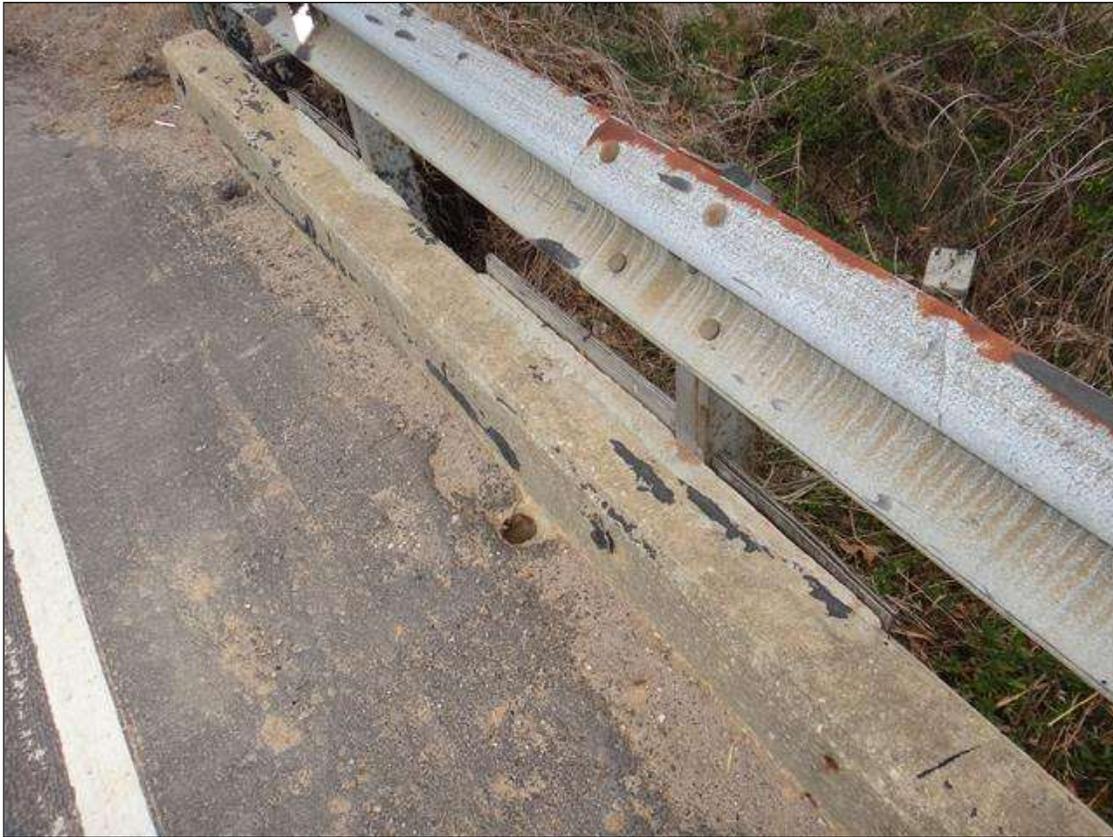
SPAN 3 RIGHT PARAPET, PREVIOUS REPAIRED SPALLS AT RAIL POST 4,5

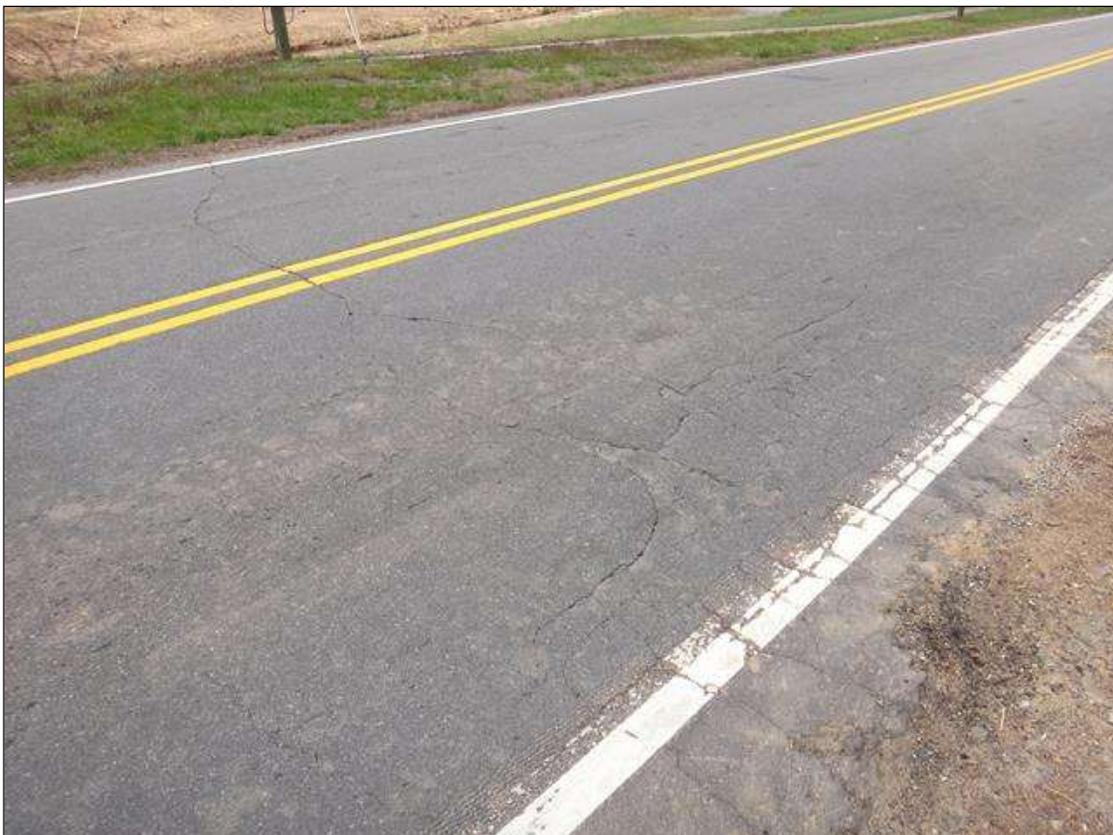
NORTH APPROACH NORTHBOUND LANE, BROKEN AND DEPRESSED ASPHALT (50FT X 4FT WIDE) WITH FULL WIDTH TRANSVERSE CRACK

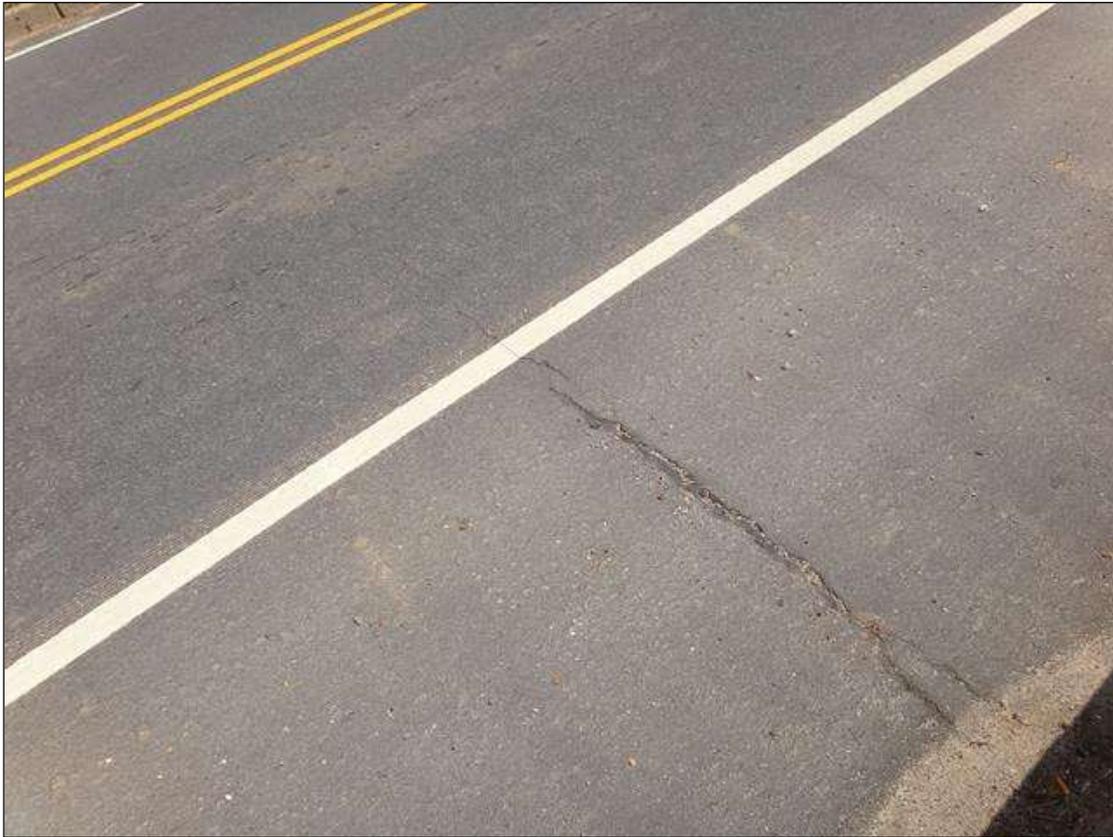
SOUTHBOUND LANE ASPHALT WEARING SURFACE AT BENT 2, TRANSVERSE CRACK (12FT X UP TO 1/8IN WIDE)

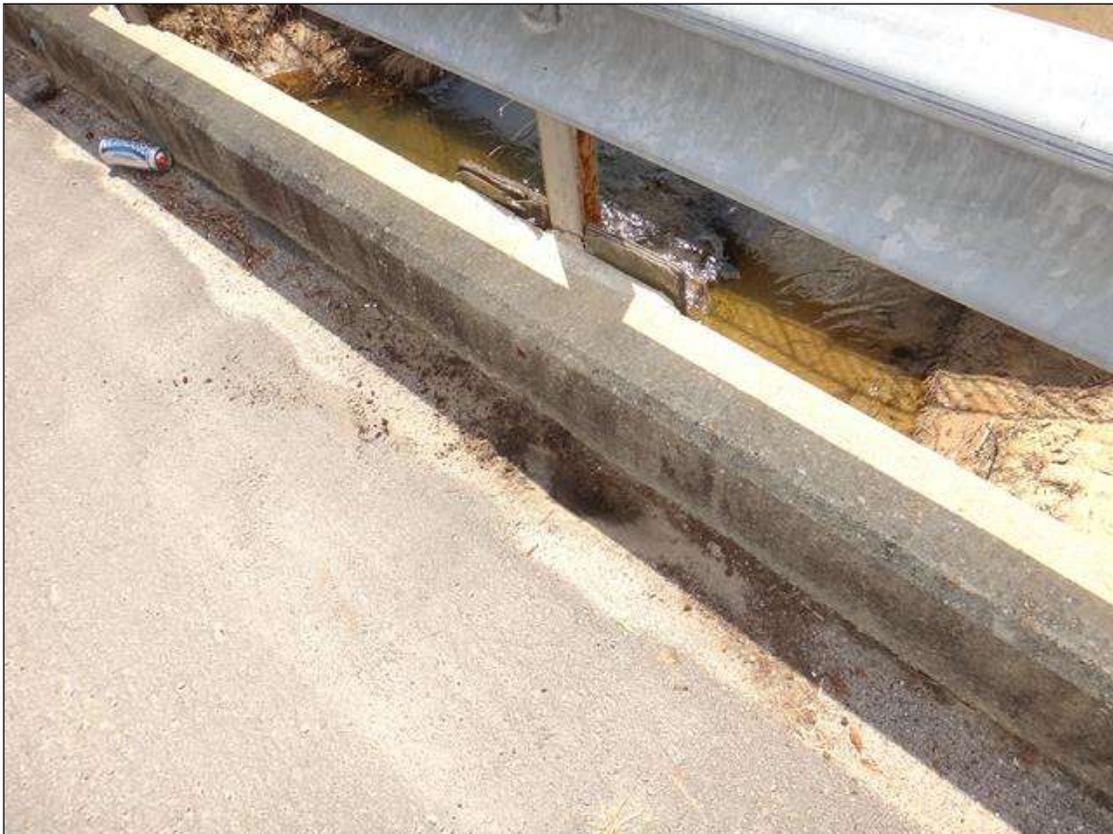
SPAN 2 LEFT SHOULDER, ONE (1) CLOGGED SCUPPER DRAIN WITH DEBRIS ACCUMULATION

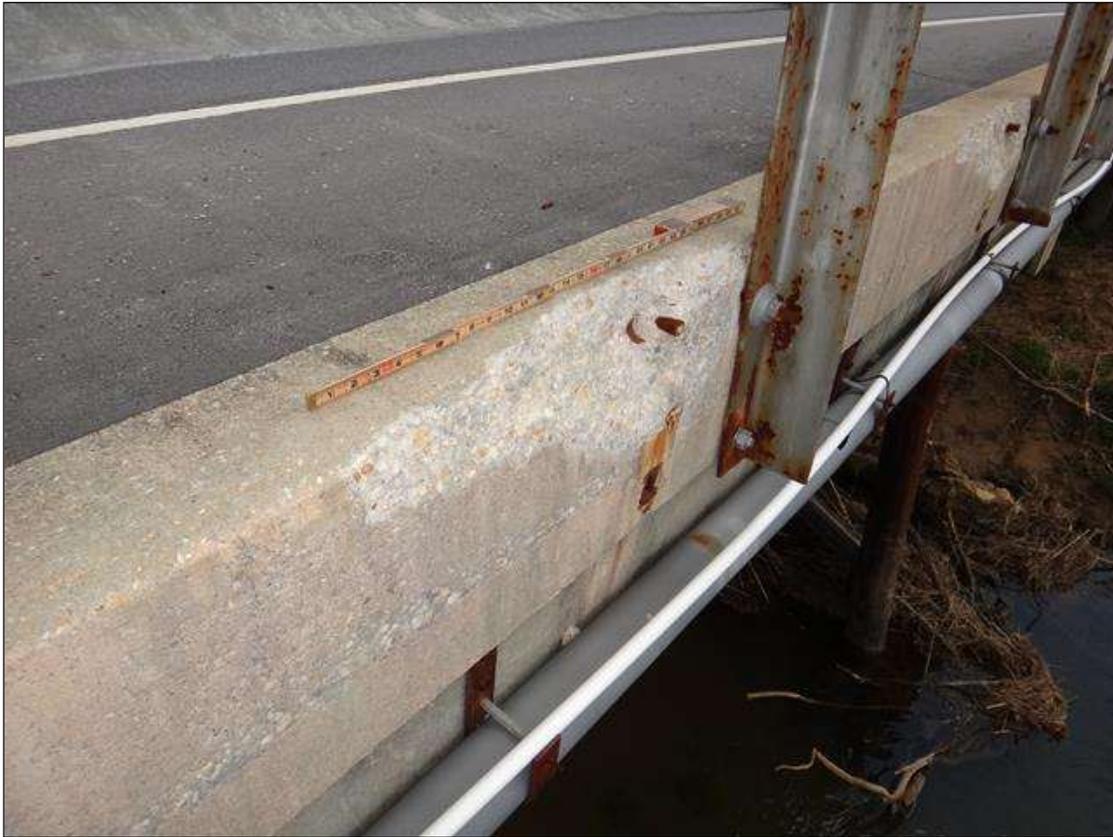
SPAN 2 LEFT PARAPET, SPALL (30IN X 9IN X 2-1/2IN DEEP) WITH EXPOSED RUSTED REBAR AT RAIL POST 3

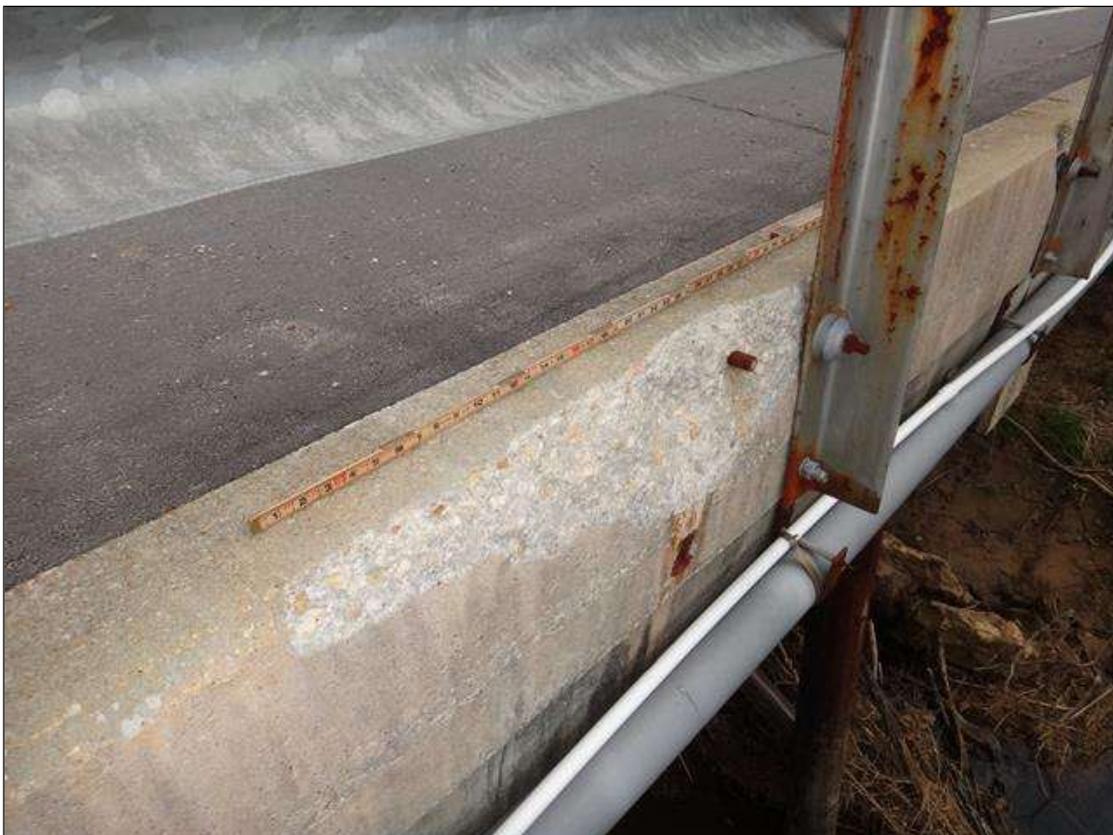
SPAN 2 LEFT PARAPET, SPALL (38IN X 9IN X 2-3/4IN DEEP) WITH EXPOSED RUSTED REBAR
