NC DEPARTMENT OF TRANSPORTATION
 DIVISION OF HIGHWAYS
 BRIDGE MANAGEMENT UNIT

BRIDGE INSPECTION REPORT

COUNTY WILKES BRIDGE NUMBER 960029 INSPECTION CYCLE 0 YRS
SR1001 (OAKWOODS RD)
 ROUTE SR1001 ACROSS CUB CREEK M.P. 0
.15 MILES SOUTH OF JUNCTION WITH NC18,NC268
 LOCATION .15 MI.S.JCT.NC18,NC268

INSPECTION DATE 04/08/2013

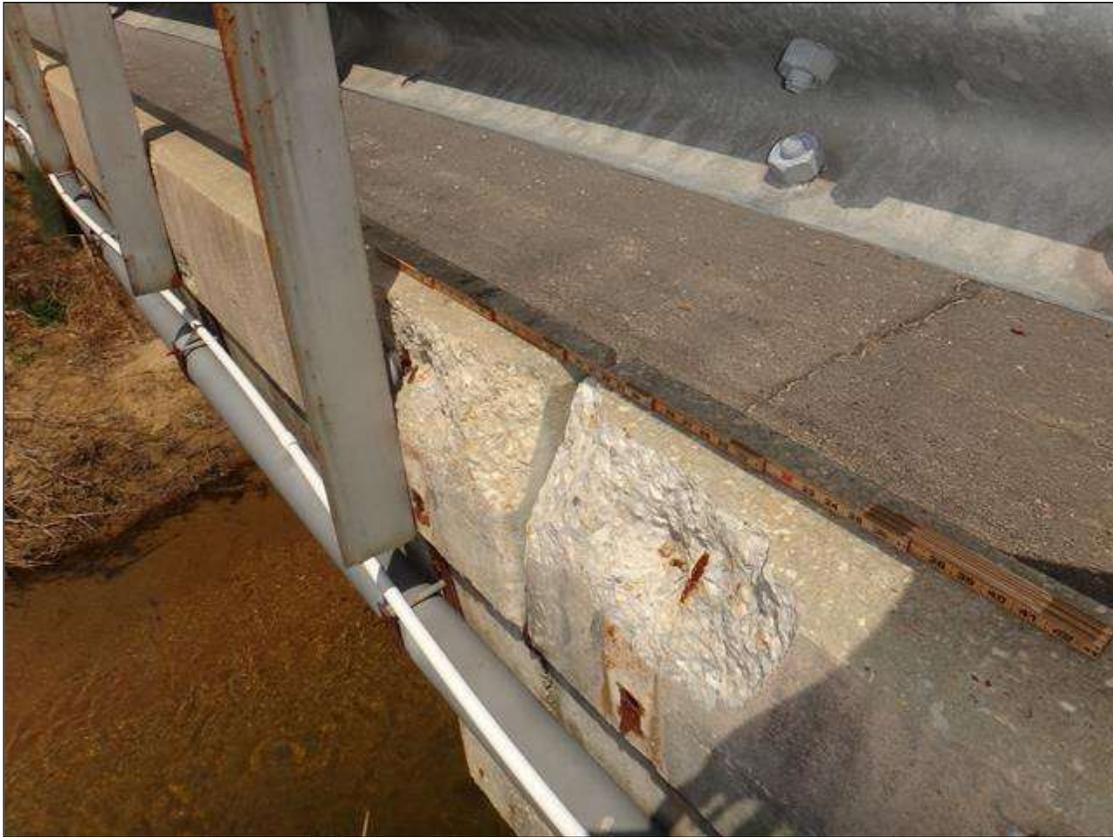
BENT 1 LEFT PARAPET, SPALL (36IN X 10IN X 4IN DEEP) WITH EXPOSED RUSTED REBAR

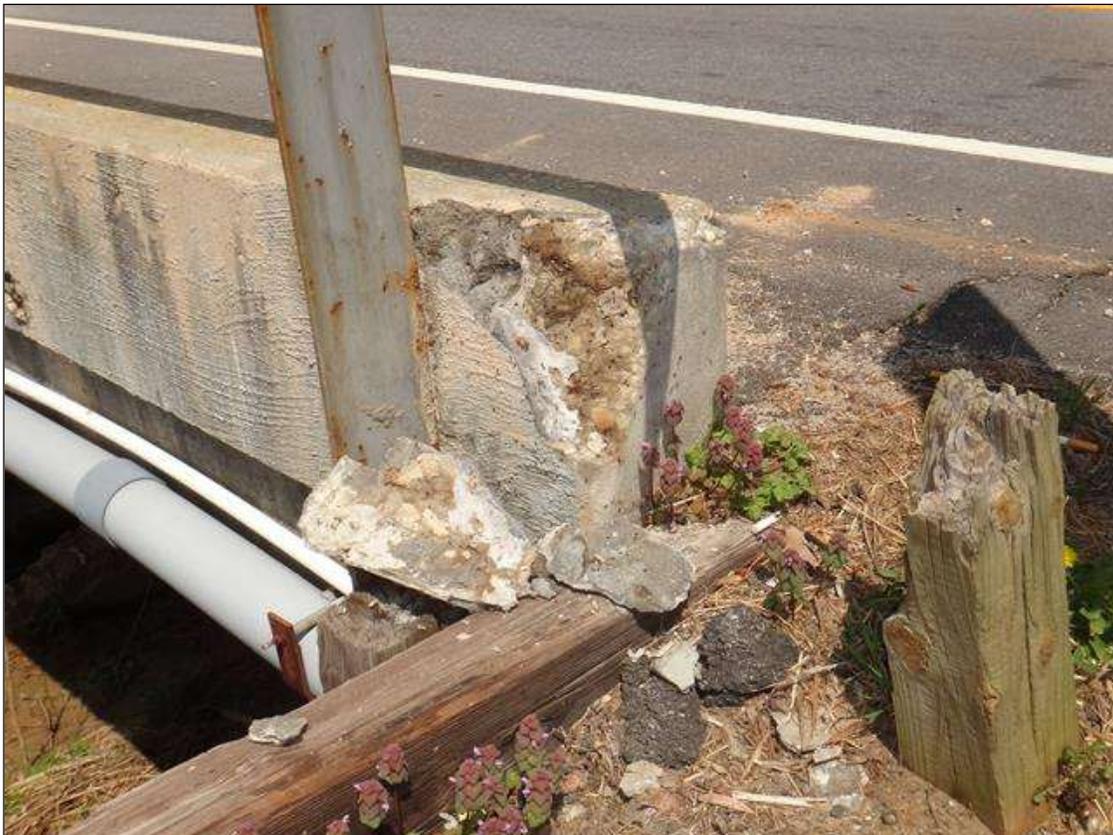
LEFT BARRIER RAIL AT END BENT 1, SPALL (10IN X 12IN X 4IN DEEP)

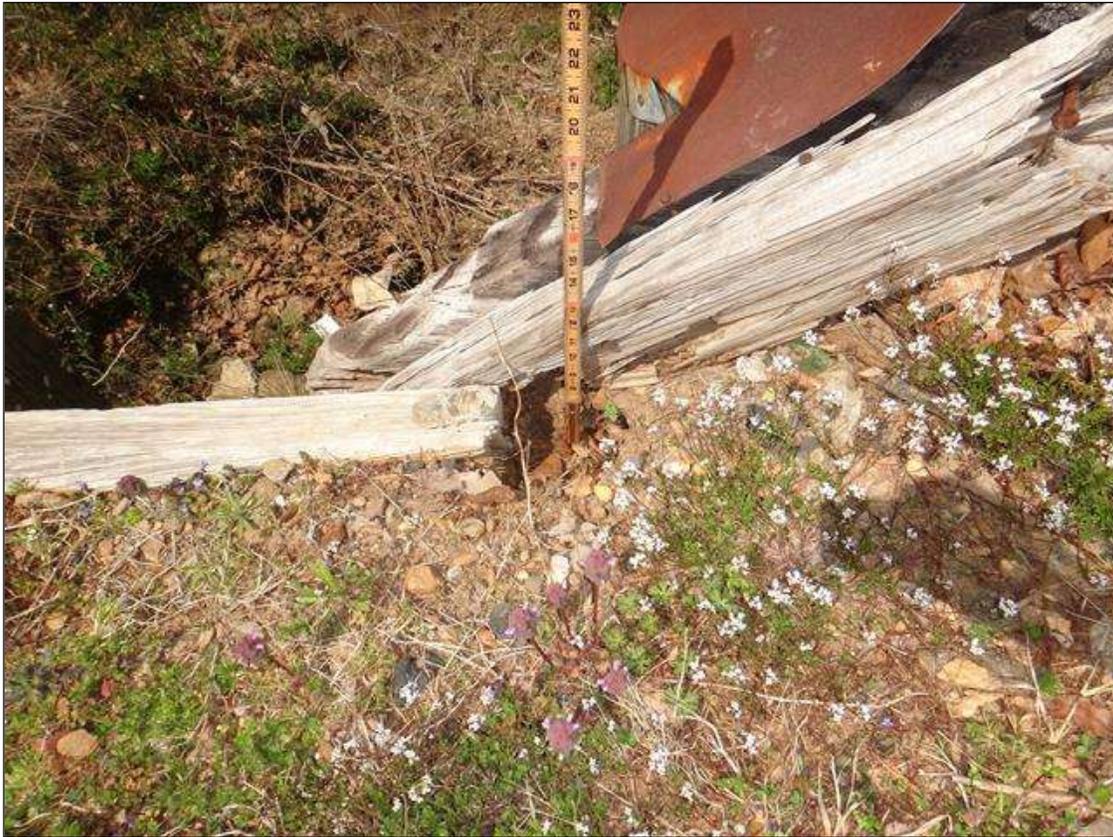
SOUTH APPROACH LEFT SHOULDER, LOSS OF BACKFILL (6IN DIAMETER X 8IN DEEP) WITH SLOPE EROSION (18IN X 18IN X 24IN DEEP)

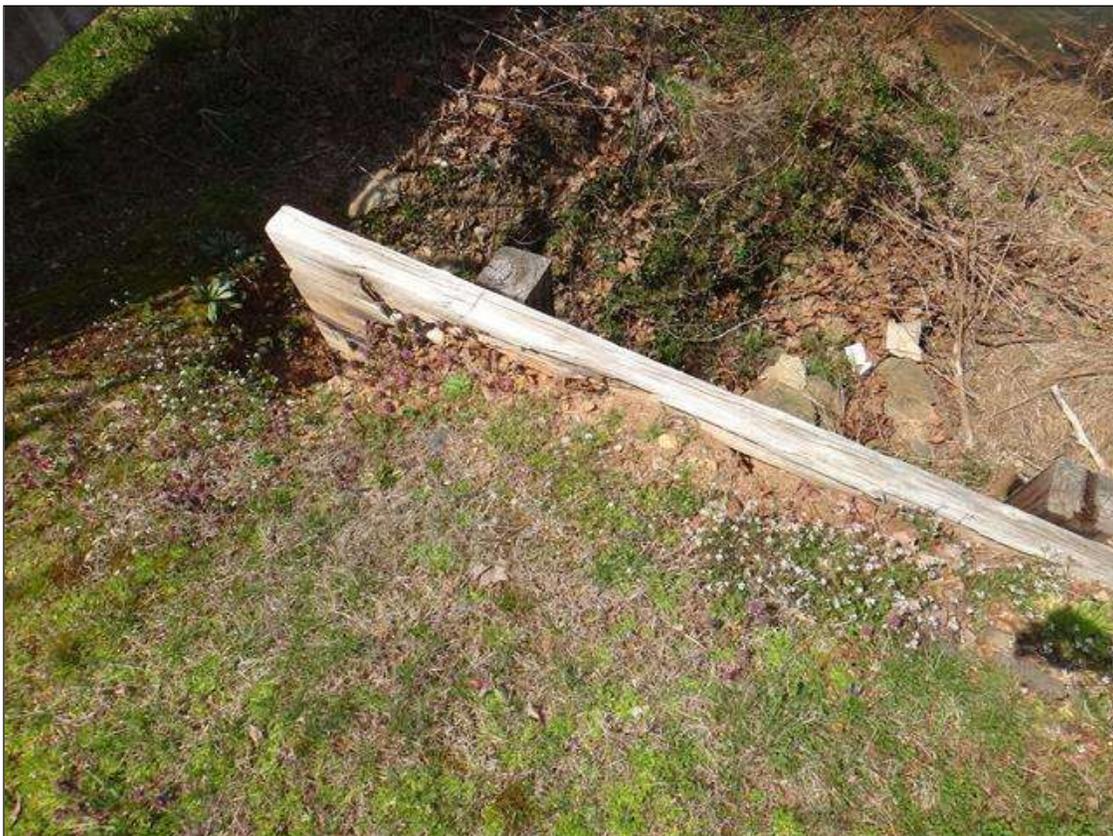
SOUTH APPROACH LEFT SHOULDER BACKFILL LOSS (6FT) WITH SLOPE EROSION (18IN X 18IN X 24IN DEEP)

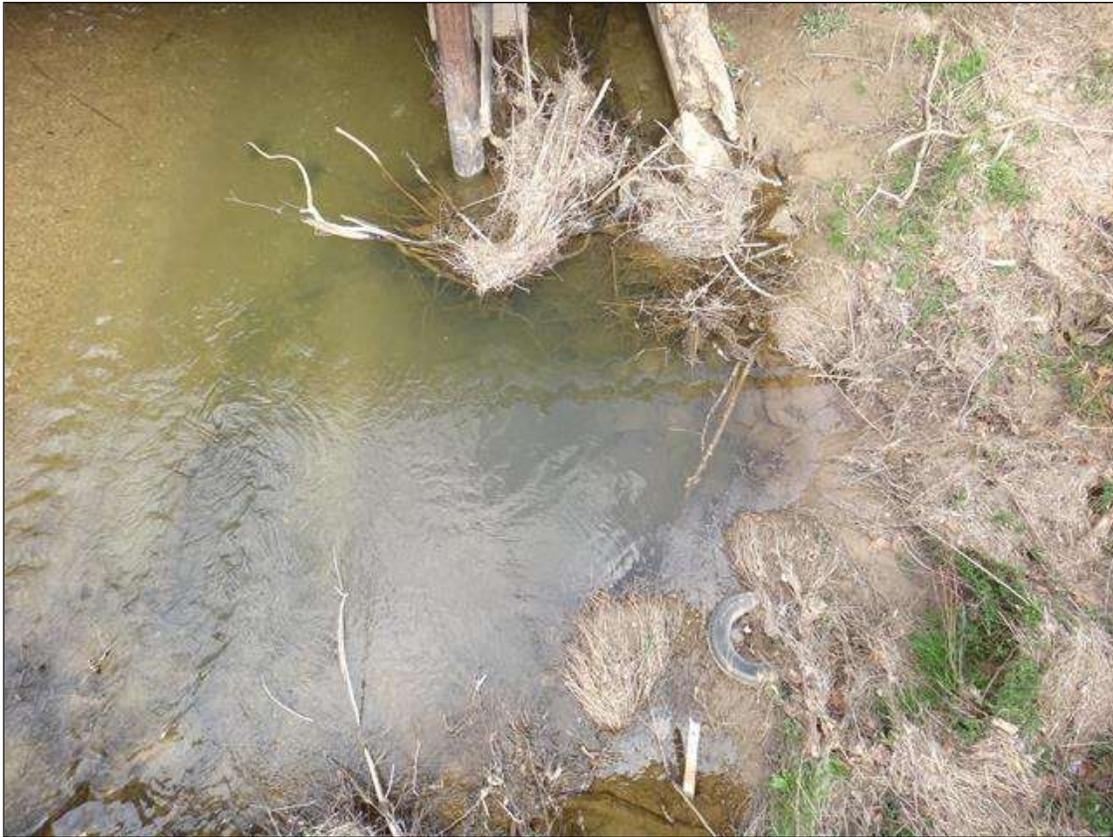
STREAMBED AT BENT 1, SCOUR HOLE (10FT X 15FT X 3FT DEEP)
