NC DEPARTMENT OF TRANSPORTATION
DIVISION OF HIGHWAYS
STRUCTURE MANAGEMENT UNIT

Structure Safety Report

Routine Element Inspection - Contract

STRUCTURE NUMBER: 600229 SAP STRUCTURE NO: 0610229 FHWA STRUCTURE NO: 000000001210229
DIVISION: 13 COUNTY: MITCHELL INSPECTION DATE: 10/17/2023 FREQUENCY: 24 MONTHS
FACILITY CARRIED: SR1357 MILE POST: _____
LOCATION: .01 N.JCT.SR1336
FEATURE INTERSECTED: NORTH TOE RIVER
LATITUDE: 35° 59' 33.58" LONGITUDE: 82° 15' 28.3"
SUPERSTRUCTURE: RC FL.& PPC DECK PANELS ON PPC GDR.(S.I.P.METAL FORMS)
SUBSTRUCTURE: E.BTS&INT.BT4:RC CAPS/H-PILES;INT.BTS1-3:REINF.CONC.P&B
SPANS: 5 SPANS. SEE SPAN PROFILE SHEET FOR SPAN DETAILS
☐ FRACTURE CRITICAL ☐ TEMPORARY SHORING ☐ SCOUR CRITICAL ☐ SCOUR PLAN OF ACTION
GRADES: (Inspector/NBI Coding) DECK 7 / 7 SUPERSTRUCTURE 6 / 6 SUBSTRUCTURE 7 / 7 CULVERT N / N
POSTED SV: Not Posted POSTED TTST: Not Posted
OTHER SIGNS PRESENT: ONE (1) DELINEATOR

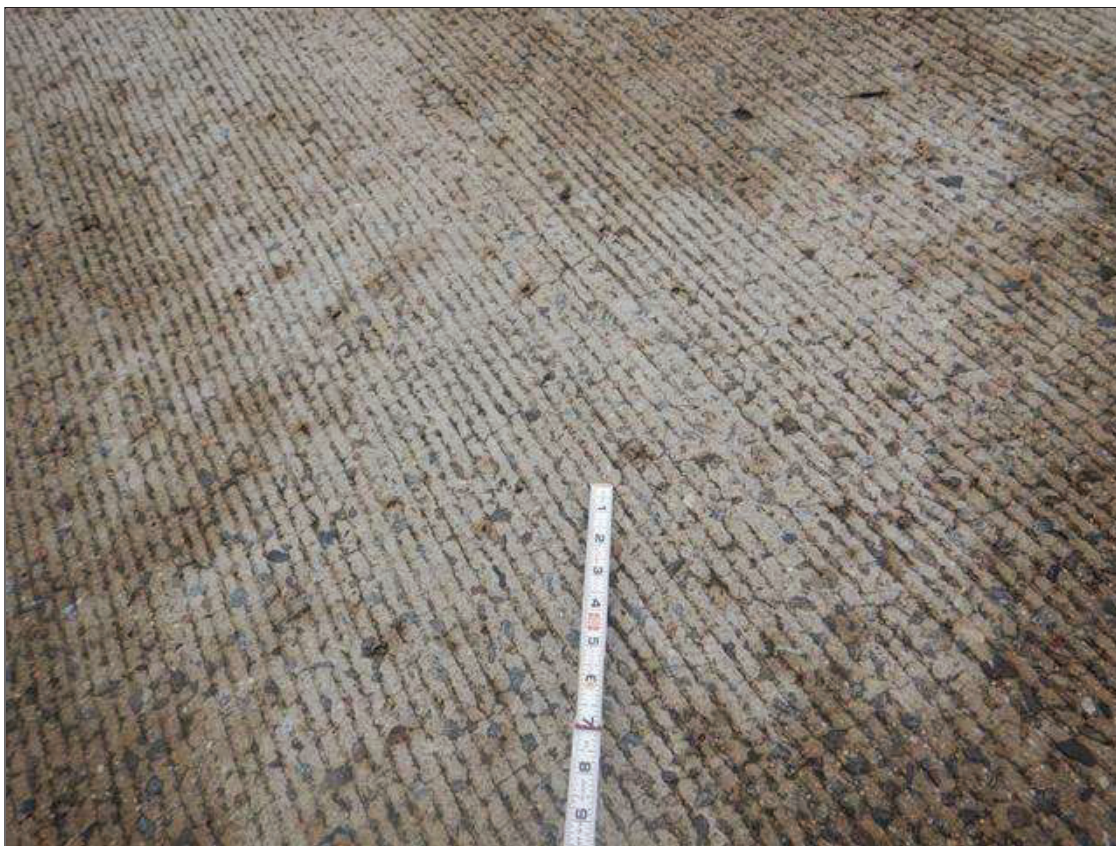
Element Number	Defect Type	Defect Description	CS	CS Qty	Maint Qty	
<input checked="" type="checkbox"/> 12	Cracking (RC and Other)	HAIRLINE MAP CRACKING THROUGHOUT	1	1,500		Square Feet
General Comments

Span 2 Deck: HAIRLINE MAP CRACKING THROUGHOUT

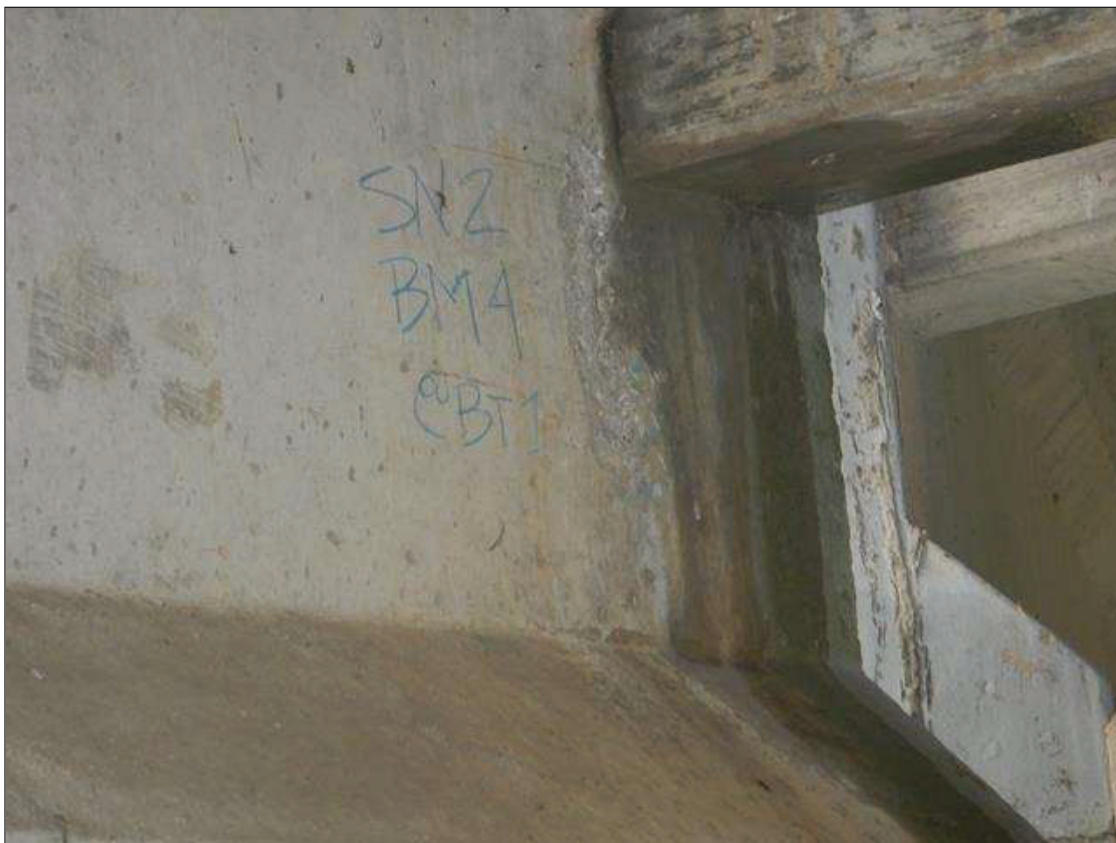
Element Number	Defect Type	Defect Description	CS	CS Qty	Maint Qty	
<input checked="" type="checkbox"/> 109	Delamination/Spall	WEST FACE OF WEB AT BENT 1, SPALL (11 INCHES LONG X 3 INCHES HIGH X 3/4 INCH DEEP) WITH ADJACENT DELAMINATION (11 INCHES LONG X 4 INCHES HIGH)	3	1	1	Feet
<input checked="" type="checkbox"/> 109	Delamination/Spall	WEST FACE OF WEB AT BENT 2, SPALL (4 INCHES LONG X 10 INCHES HIGH X 1 INCH DEEP) WITH ADJACENT DELAMINATION (10 INCHES LONG X 12 INCHES HIGH)	3	1	1	Feet

Span 2 Beam 4: WEST FACE OF WEB AT BENT 1, SPALL (11 INCHES LONG X 3 INCHES HIGH X 3/4 INCH DEEP) WITH ADJACENT DELAMINATION (11 INCHES LONG X 4 INCHES HIGH)

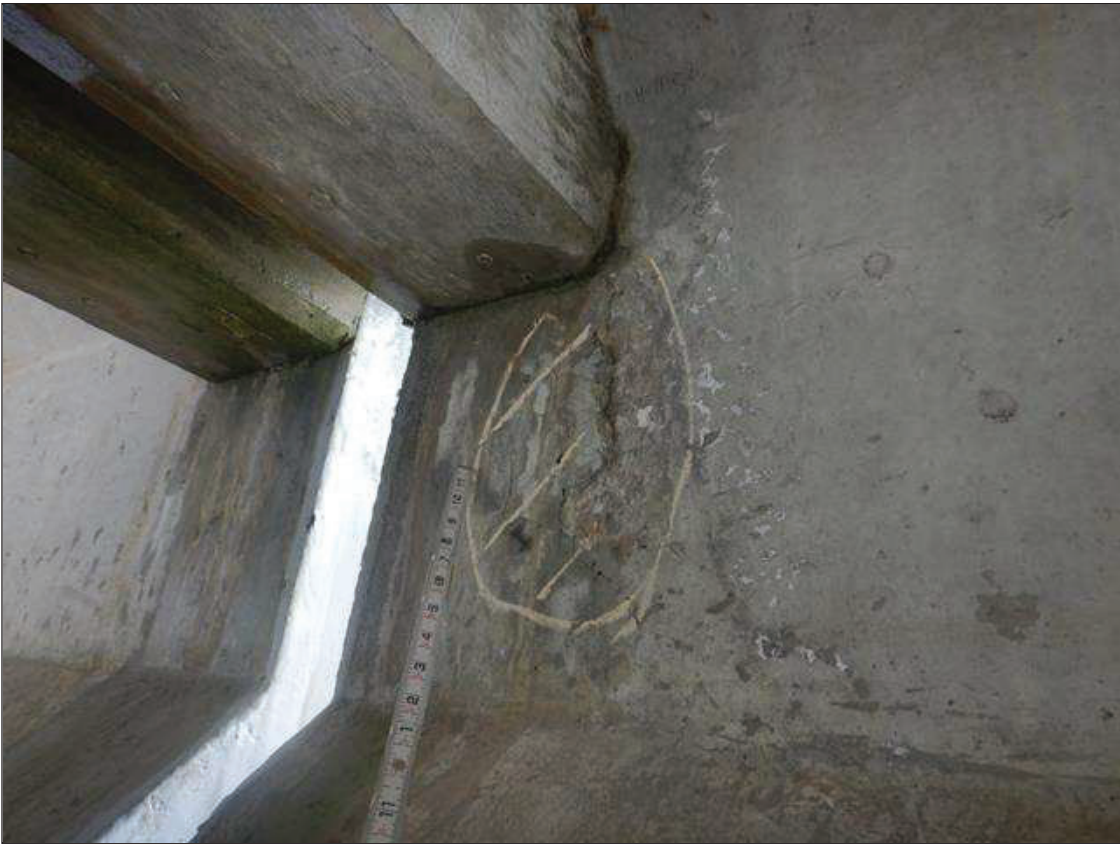
Span 2 Beam 4: WEST FACE OF WEB AT BENT 2, SPALL (4 INCHES LONG X 10 INCHES HIGH X 1 INCH DEEP) WITH ADJACENT DELAMINATION (10 INCHES LONG X 12 INCHES HIGH)

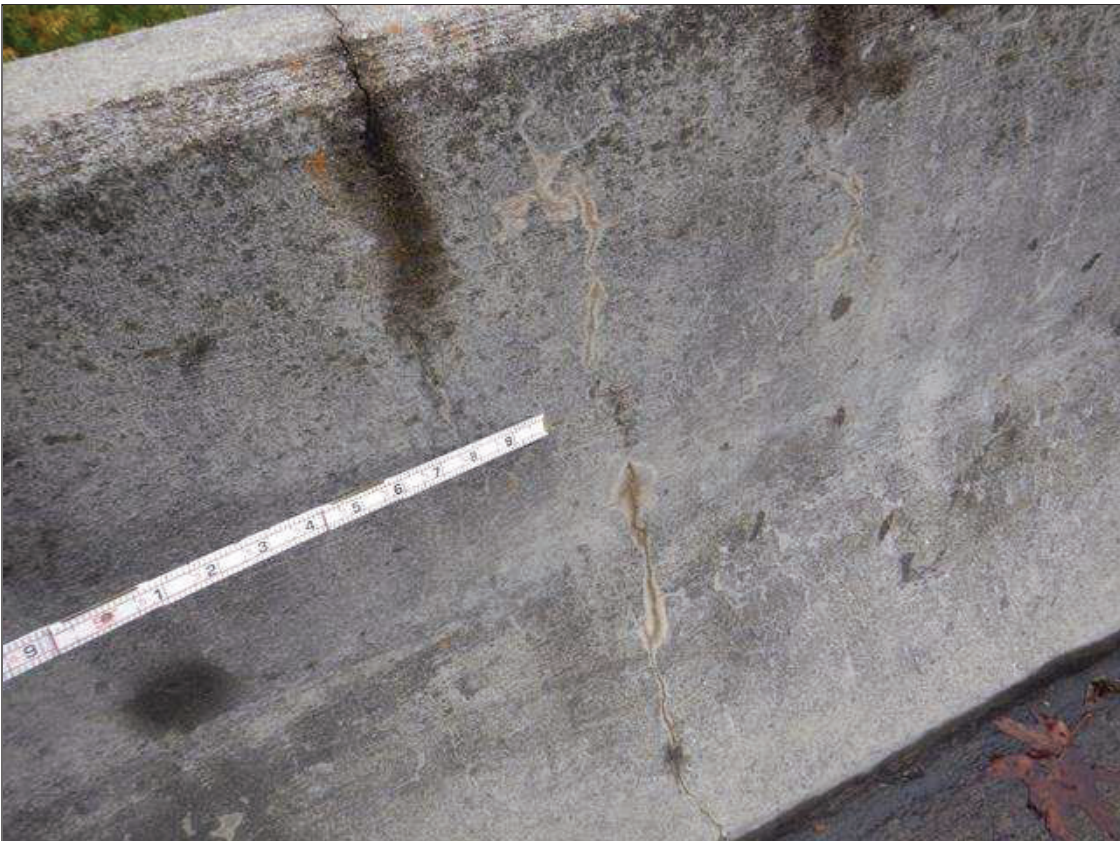
Span 2 Left Bridge Rail: ALONG LENGTH AT MULTIPLE LOCATIONS, VERTICAL CRACKS (UP TO FULL HEIGHT X UP TO 1/32 INCH WIDE) SOME WRAPAROUND AND SOME EFFLORESCENCE

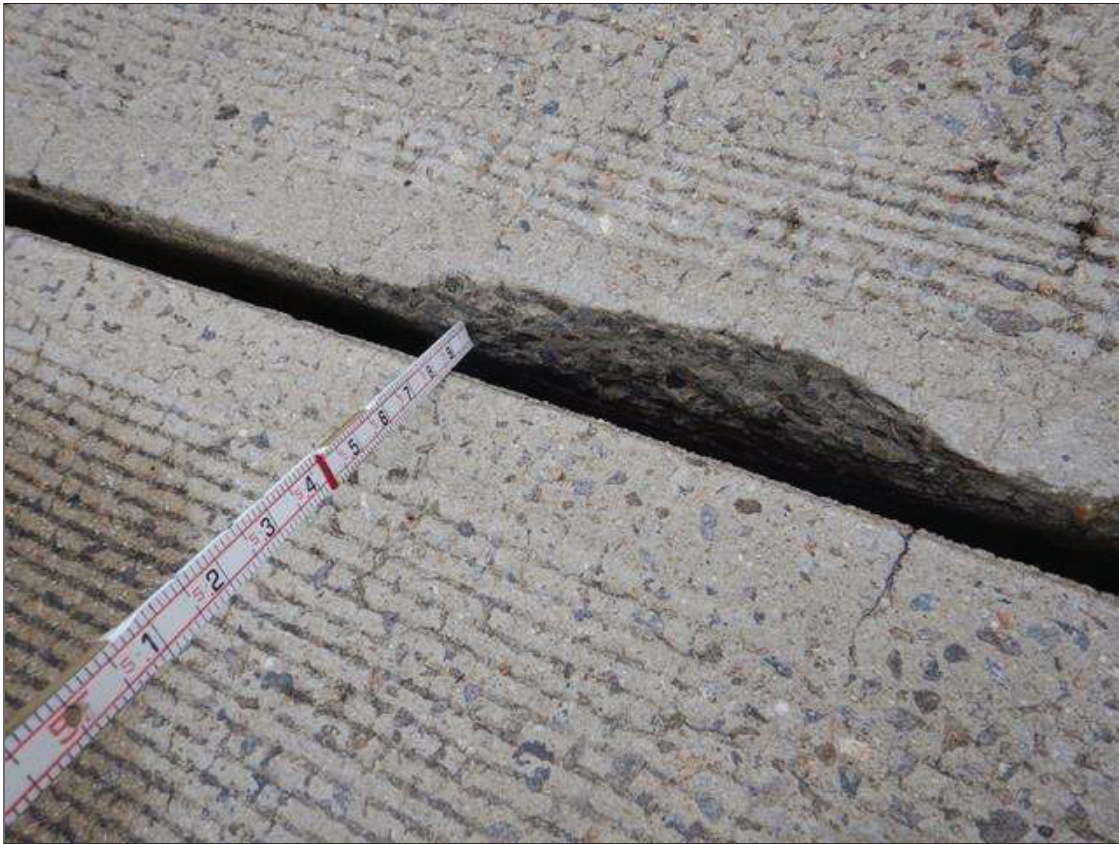
Element Number	Defect Type	Defect Description	CS	CS Qty	Maint Qty
<input checked="" type="checkbox"/> 304	Adjacent Deck or Header	NEAR CENTERLINE AT BENT 2 JOINT ON SPAN 2 SIDE, SPALL (4 INCHES LONG X 12 INCHES WIDE X 2 INCHES DEEP)	3	1	1 Feet

Span 3 Expansion Joint: NEAR CENTERLINE AT BENT 2 JOINT ON SPAN 2 SIDE, SPALL (4 INCHES LONG X 12 INCHES WIDE X 2 INCHES DEEP)

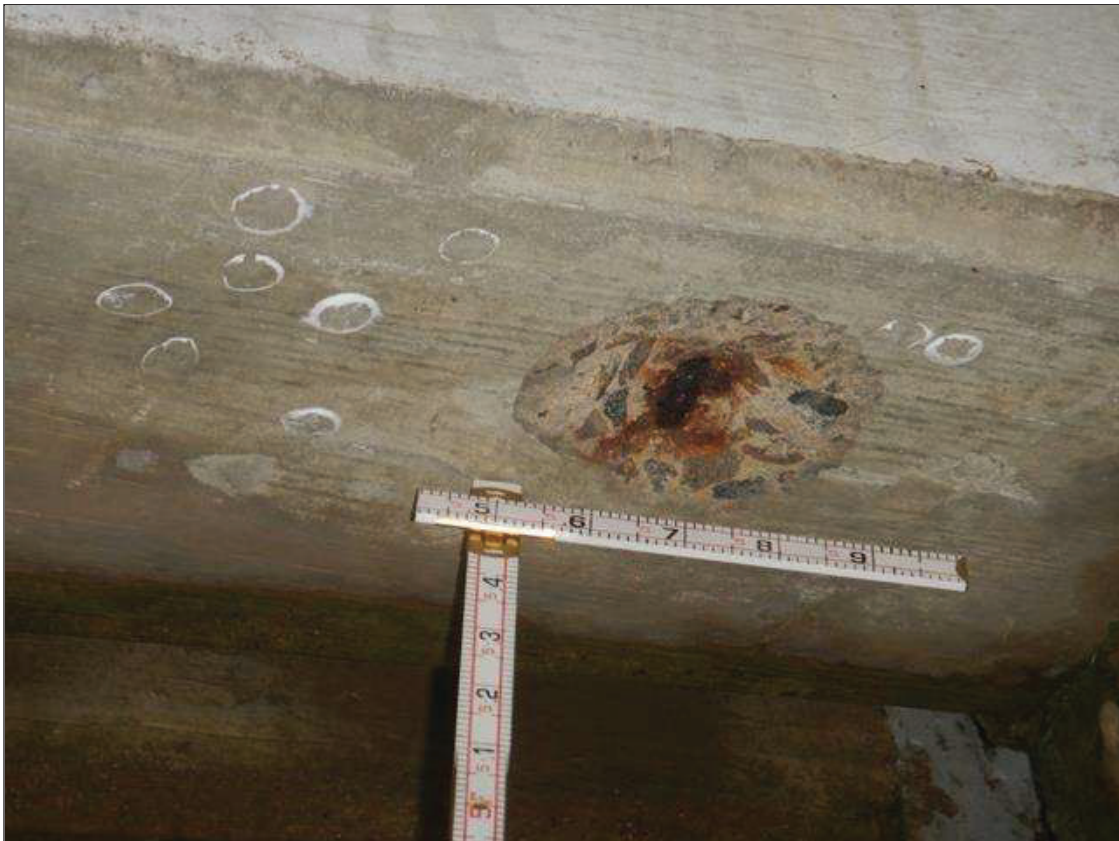
Element Number	Defect Type	Defect Description	CS	CS Qty	Maint Qty
<input checked="" type="checkbox"/> 109	Exposed Rebar	END DIAPHRAGM AT BAY 3 BENT 2, SPALL WITH EXPOSED REBAR (4 INCH DIAMETER X 1/2 INCH DEEP) WITH EXPOSED REBAR (90 PERCENT REMAINING)	3		1 Feet
General Comments

Span 3 Beam 3: END DIAPHRAGM AT BAY 3 BENT 2, SPALL WITH EXPOSED REBAR (4 INCH DIAMETER X 1/2 INCH DEEP) WITH EXPOSED REBAR (90 PERCENT REMAINING)

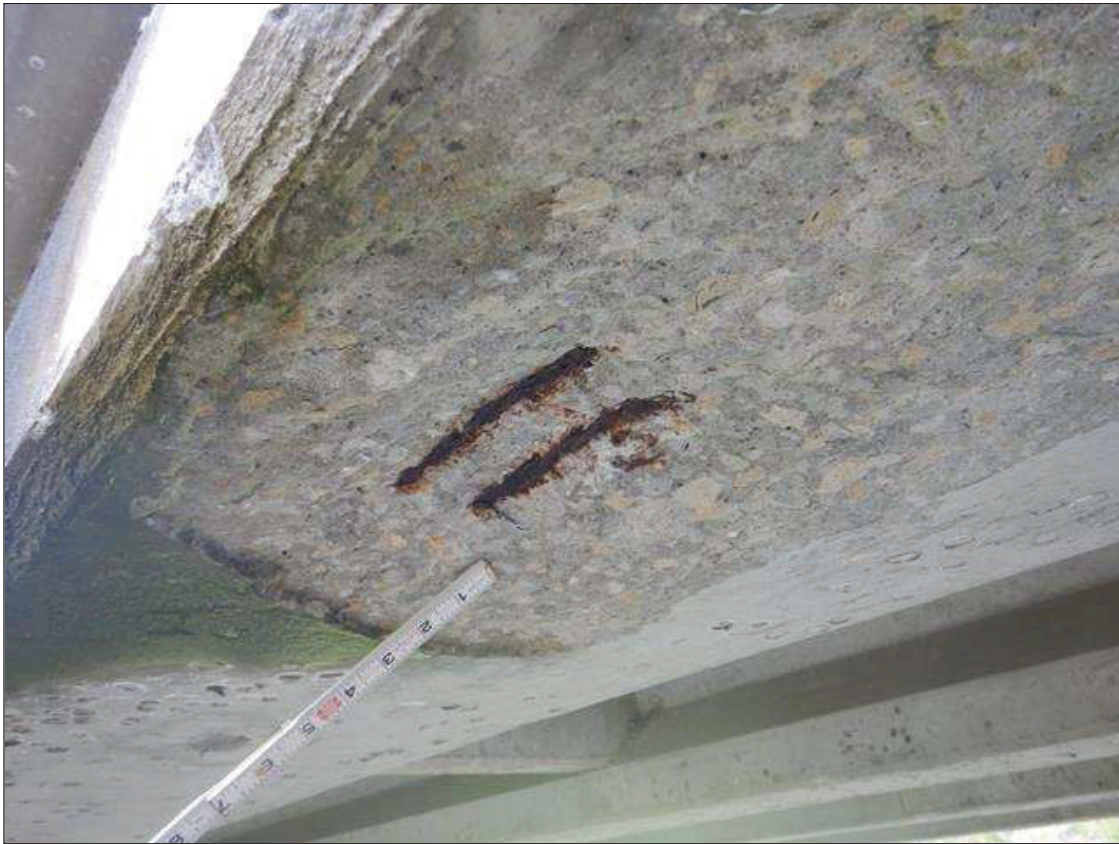
Priority Level	Defect Type	Quantity	Defect Description
2	Exposed Prestressing	2	Span 4 Beam 1: (PAR) AT 24 FEET FROM BENT 3, UNDERSIDE OF BOTTOM FLANGE, SPALL (20 INCHES LONG X UP TO 18 INCHES WIDE X UP TO 1 INCH DEEP) WITH TWO (2) EXPOSED AND RUSTED PRESTRESSED STRANDS (75 PERCENT REMAINING)

Element Number	Defect Type	Defect Description	CS	CS Qty	Maint Qty
<input checked="" type="checkbox"/> 109	Exposed Prestressing	(PAR) AT 24 FEET FROM BENT 3, UNDERSIDE OF BOTTOM FLANGE, SPALL (20 INCHES LONG X UP TO 18 INCHES WIDE X UP TO 1 INCH DEEP) WITH TWO (2) EXPOSED AND RUSTED PRESTRESSED STRANDS (75 PERCENT REMAINING)	3	2	2 Feet

Span 4 Beam 1: (PAR) AT 24 FEET FROM BENT 3, UNDERSIDE OF BOTTOM FLANGE, SPALL (20 INCHES LONG X UP TO 18 INCHES WIDE X UP TO 1 INCH DEEP) WITH TWO (2) EXPOSED AND RUSTED PRESTRESSED STRANDS (75 PERCENT REMAINING)

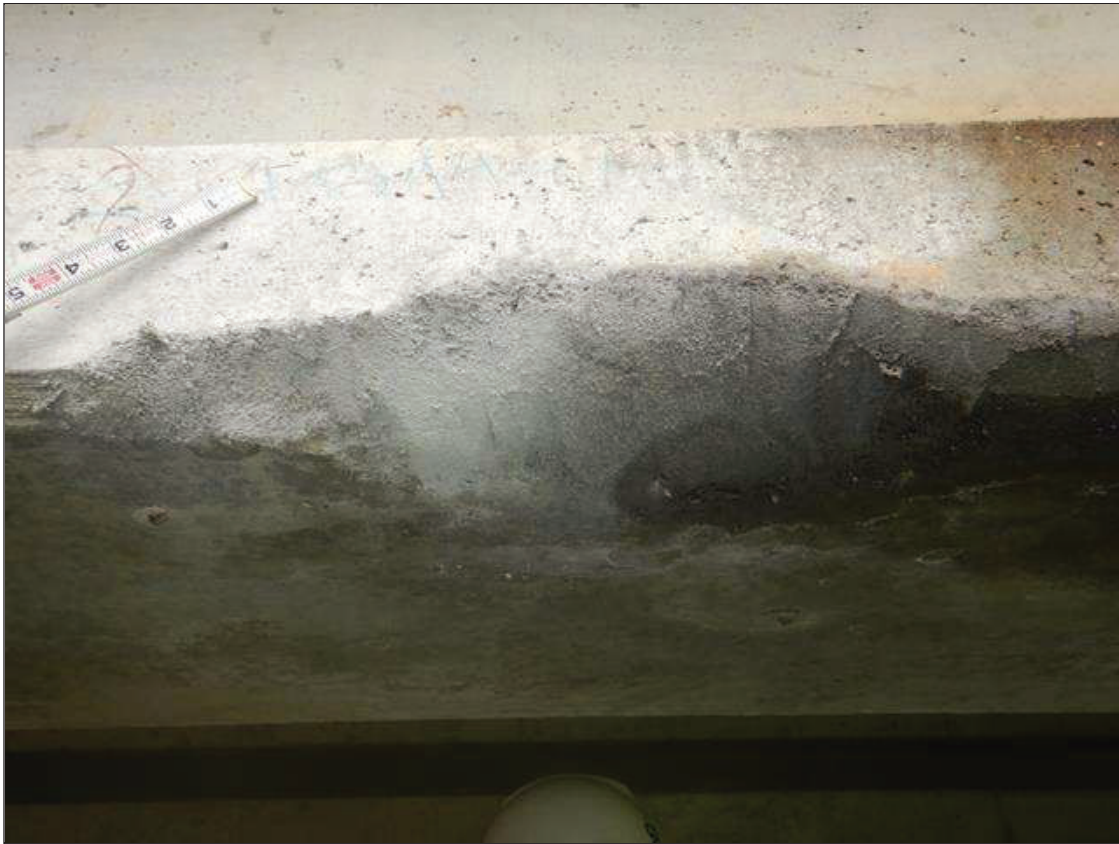
Span 4 Beam 4: NEW REPAIR: EAST FACE BOTTOM FLANGE 15 FEET SOUTH OF BENT 4, SPALL (26 INCHES LONG X 5 INCHES WIDE X UP TO 2.5 INCHES DEEP) WITH ONE EXPOSED PRESTRESSED STRANDS WITH LOSS UP TO 100 PERCENT ON MULTIPLE INDIVIDUAL STRANDS-PATCHED SINCE PREVIOUS INSPECTION 2023

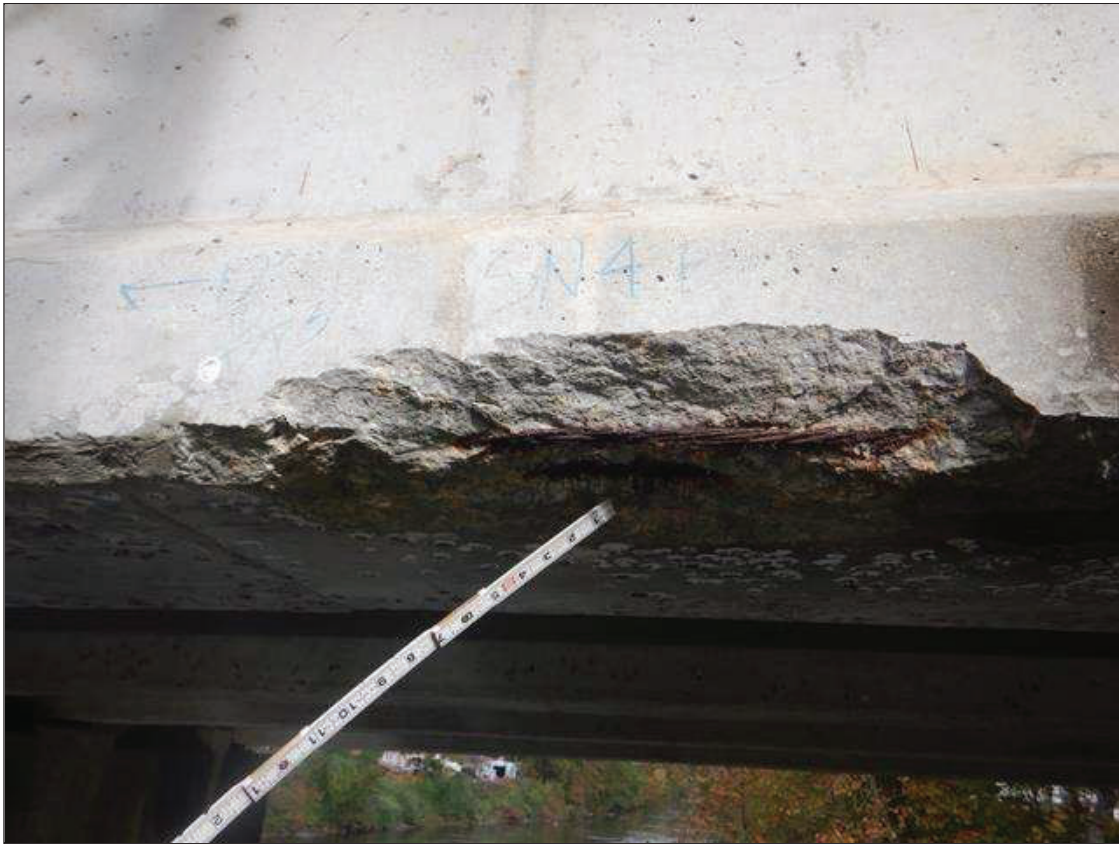
Priority Level	Defect Type	Quantity	Defect Description
2	Exposed Prestressing	3	Span 4 Beam 4: (PAR) AT 12 FEET FROM BENT 3, EAST FACE OF BOTTOM FLANGE, SPALL (26 INCHES LONG X 7 INCHES WIDE X UP TO 4 INCHES DEEP) WITH TWO (2) EXPOSED AND RUSTED PRESTRESSED STRANDS (80 PERCENT REMAINING)

<input checked="" type="checkbox"/>	109	Exposed Prestressing	(PAR) AT 12 FEET FROM BENT 3, EAST FACE OF BOTTOM FLANGE, SPALL (26 INCHES LONG X 7 INCHES WIDE X UP TO 4 INCHES DEEP) WITH TWO (2) EXPOSED AND RUSTED PRESTRESSED STRANDS (80 PERCENT REMAINING)	3	3	3 Feet
<input checked="" type="checkbox"/>	109	Patched Area	NEW REPAIR: EAST FACE BOTTOM FLANGE 15 FEET SOUTH OF BENT 4, SPALL (26 INCHES LONG X 5 INCHES WIDE X UP TO 2.5 INCHES DEEP) WITH ONE EXPOSED PRESTRESSED STRANDS WITH LOSS UP TO 100 PERCENT ON MULTIPLE INDIVIDUAL STRANDS-PATCHED SINCE PREVIOUS INSPECTION 2023	2	3	Feet

Span 4 Beam 4: (PAR) AT 12 FEET FROM BENT 3, EAST FACE OF BOTTOM FLANGE, SPALL (26 INCHES LONG X 7 INCHES WIDE X UP TO 4 INCHES DEEP) WITH TWO (2) EXPOSED AND RUSTED PRESTRESSED STRANDS (80 PERCENT REMAINING)

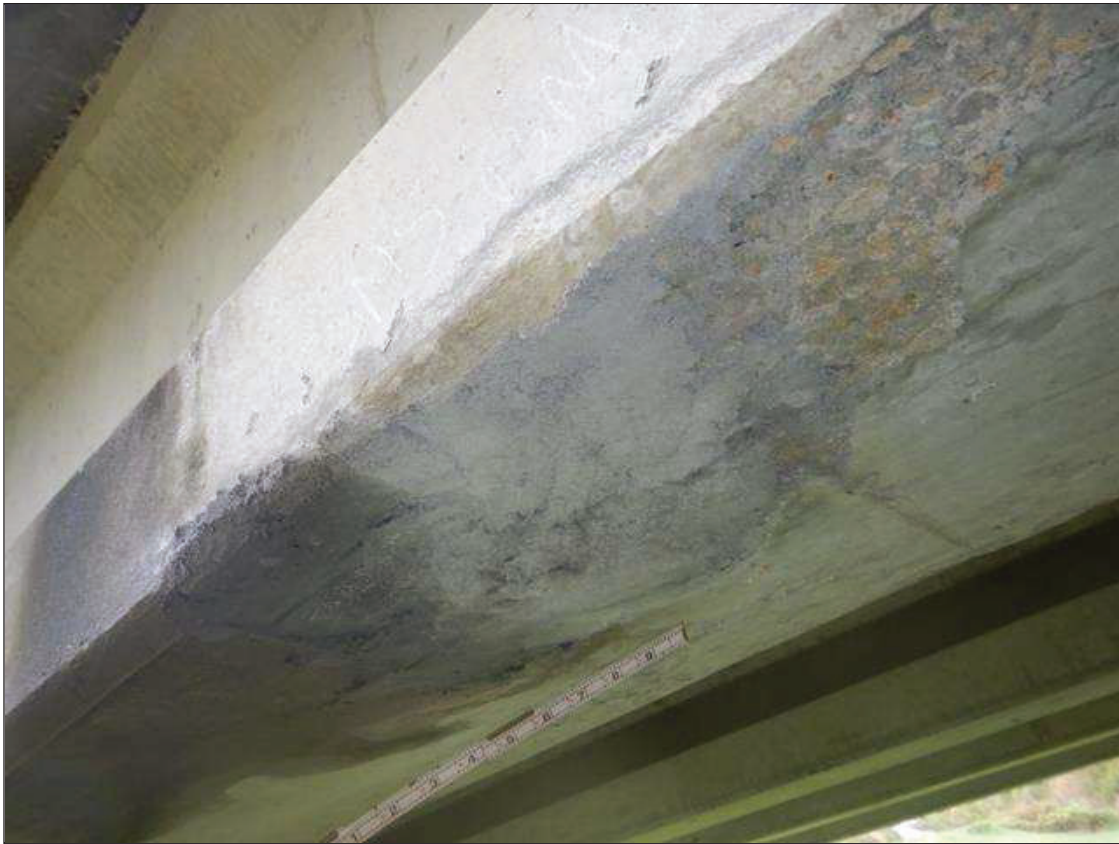
Span 5 Beam 1: NEW REPAIR: UNDERSIDE BOTTOM FLANGE AT 14 FEET FROM BENT 4, SPALL (20 INCHES LONG X 14 INCHES WIDE X UP TO 1.5 INCH DEEP) WITH MULTIPLE EXPOSED PRESTRESS STRANDS, LOSS UP TO 100 PERCENT ON INDIVIDUAL STRANDS-PATCHED SINCE PREVIOUS INSPECTION 2023

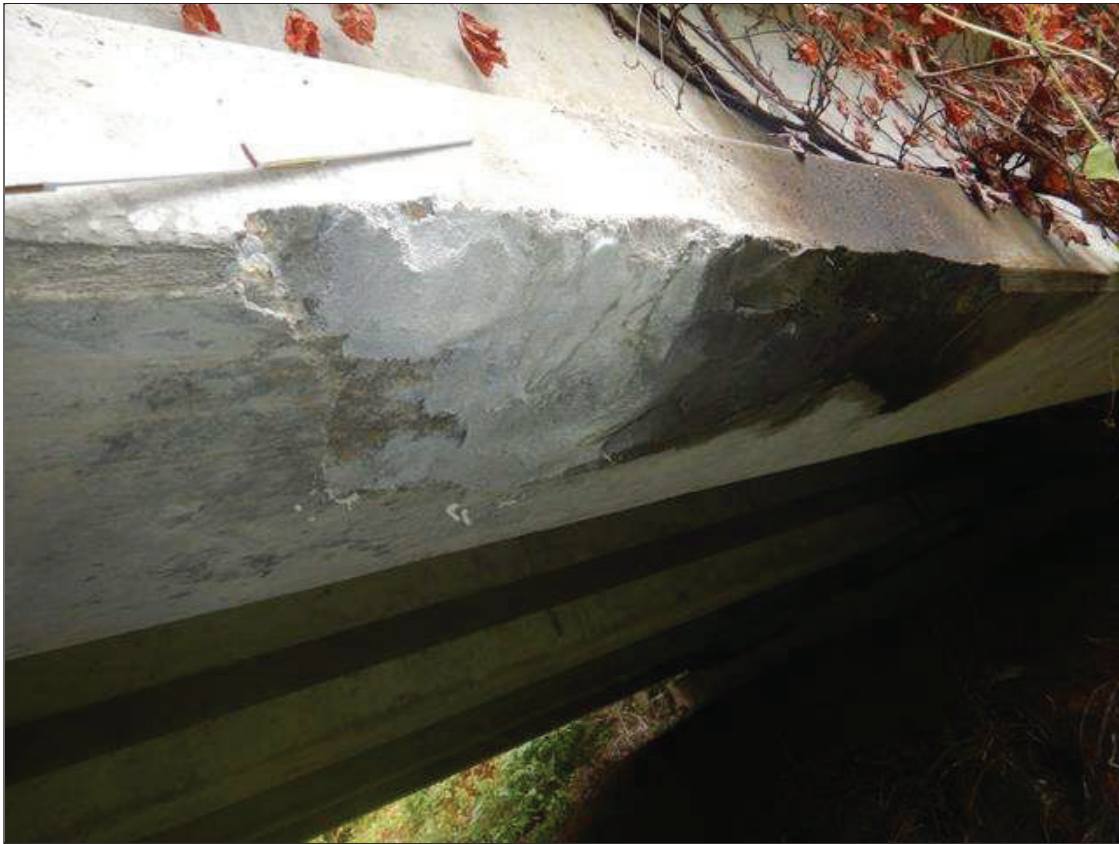
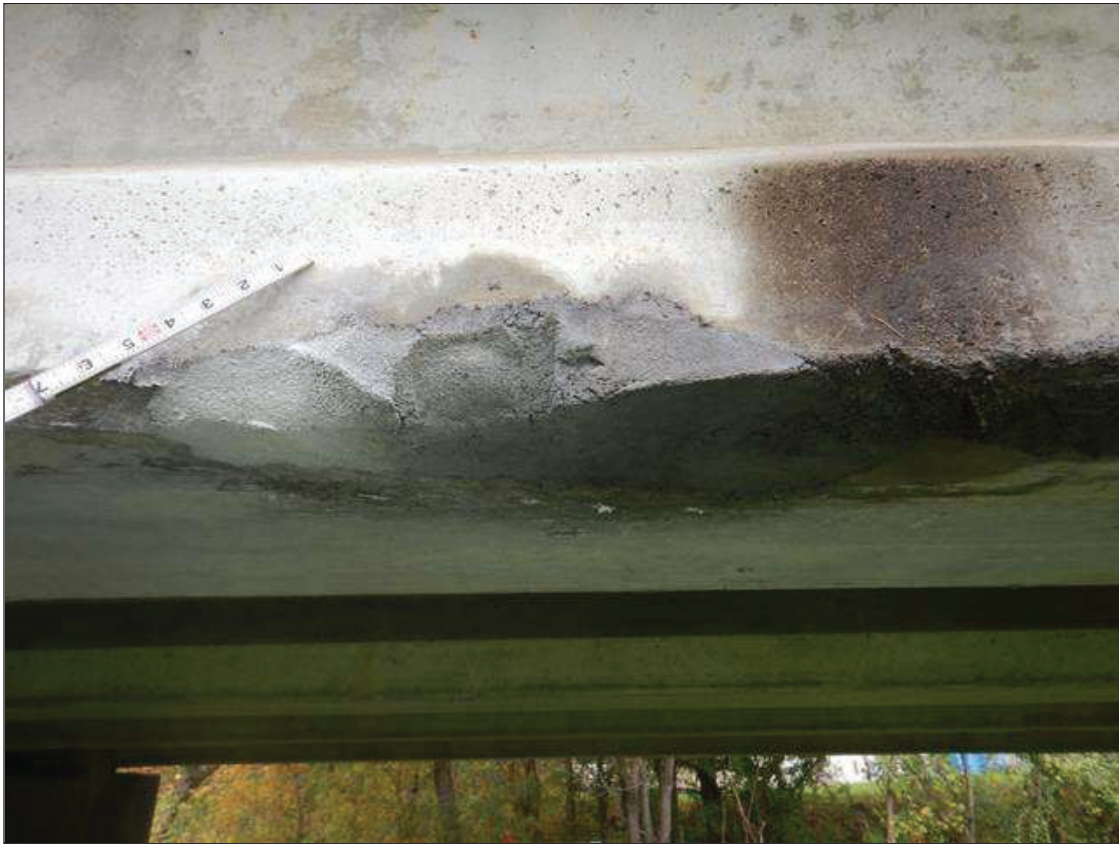
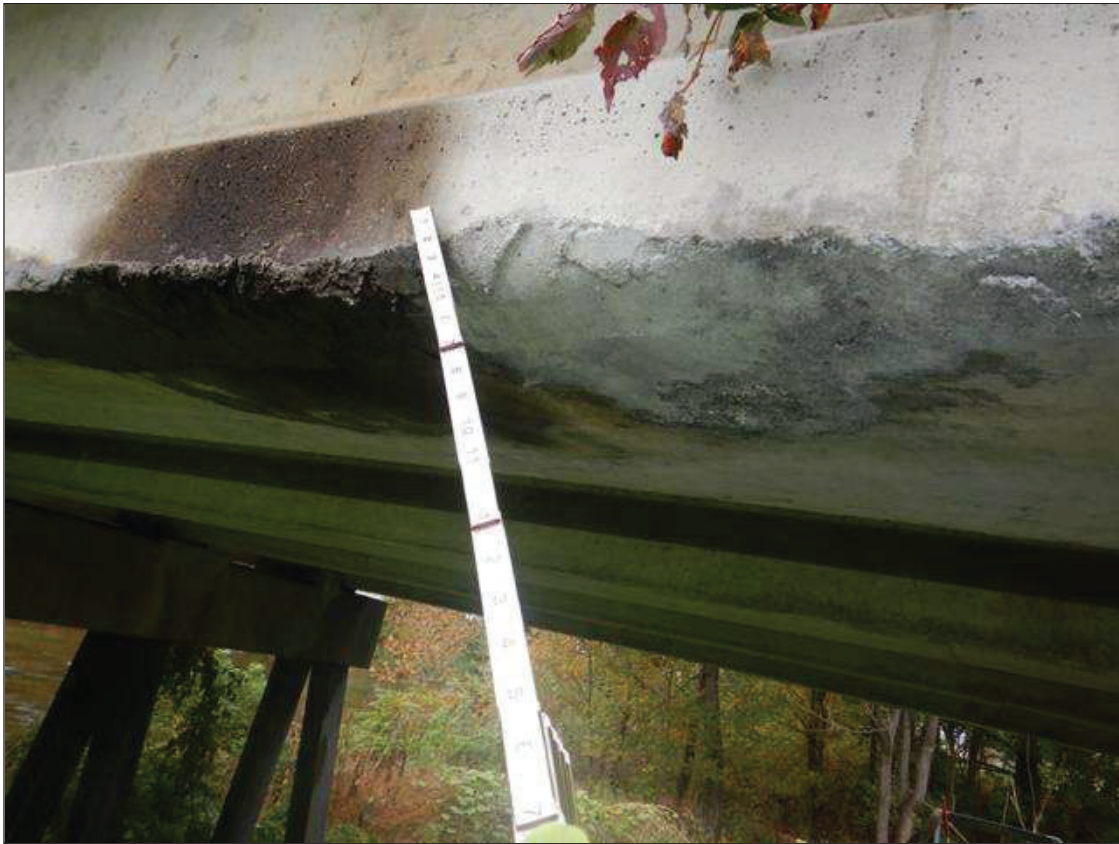
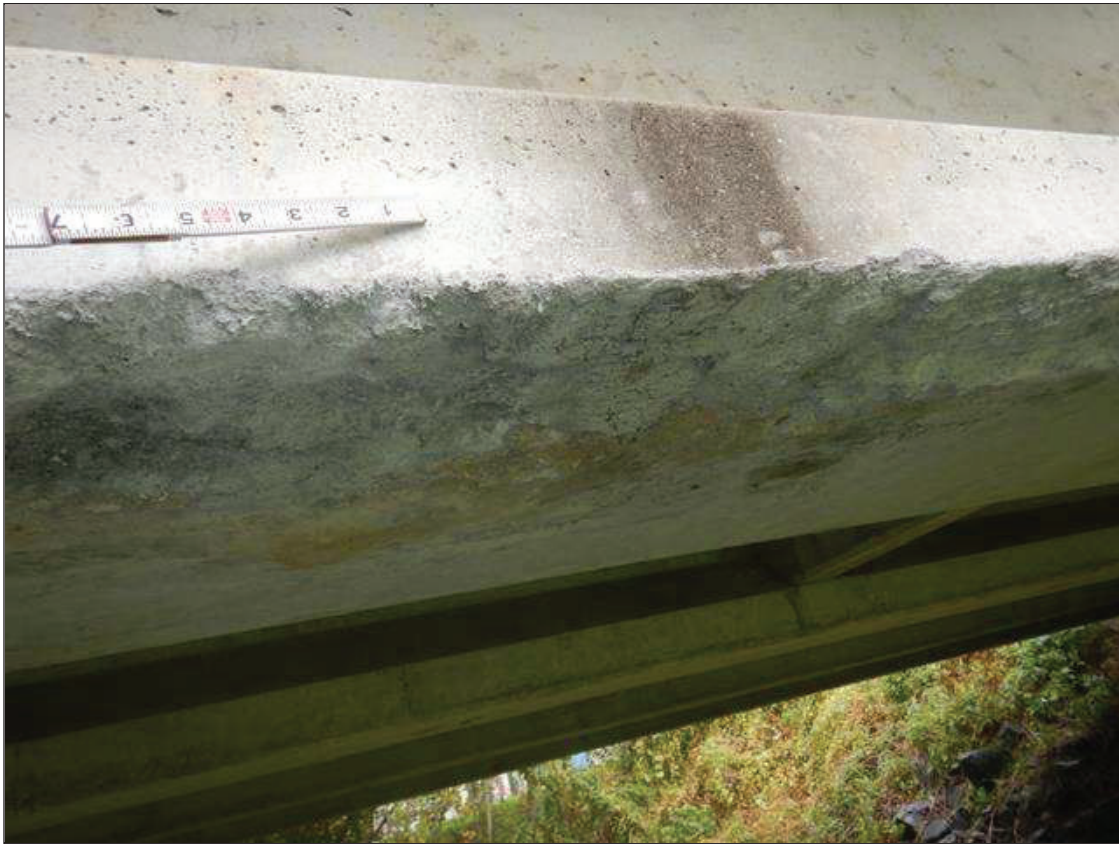
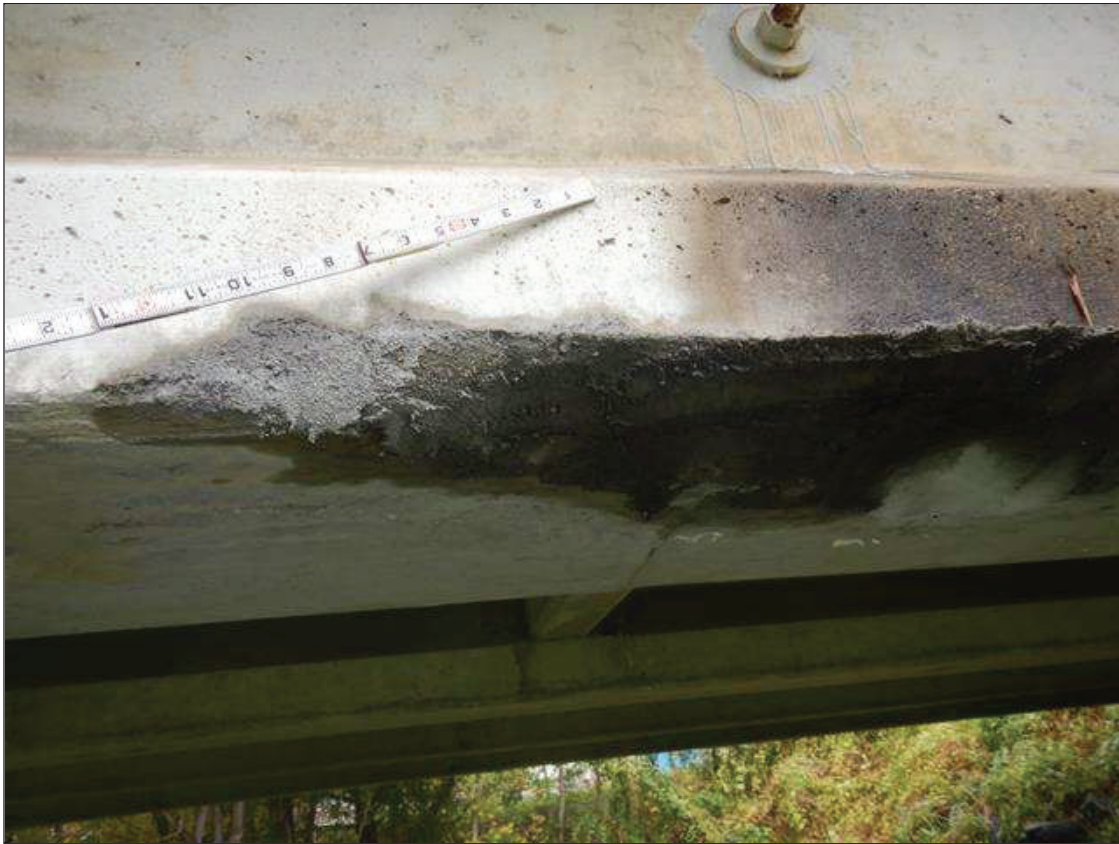
Element Number	Defect Type	Defect Description	CS	CS Qty	Maint Qty	
<input checked="" type="checkbox"/> 109	Patched Area	NEW REPAIRS: UNDERSIDE OF BOTTOM FLANGE AT 12 FEET (FOR 40 INCHES), AT 17 FEET (FOR 61 INCHES), AT 23 FEET (FOR 54 INCHES), AT 30 FEET (FOR 35 INCHES), AT 41 FEET (FOR 34 INCHES) FROM BENT 4, SPALLS (UP TO 14 INCHES X UP TO 2.75 INCHES DEEP) WITH MULTIPLE EXPOSED PRESTRESSED STRANDS, LOSS UP TO 100 PERCENT ON INDIVIDUAL STRANDS-ALL SPALLS HAVE BEEN PATCHED SINCE PREVIOUS INSPECTION 2023	2	19		Feet

Span 5 Beam 4: NEW REPAIRS: UNDERSIDE OF BOTTOM FLANGE AT 12 FEET (FOR 40 INCHES), AT 17 FEET (FOR 61 INCHES), AT 23 FEET (FOR 54 INCHES), AT 30 FEET (FOR 35 INCHES), AT 41 FEET (FOR 34 INCHES) FROM BENT 4, SPALLS (UP TO 14 INCHES X UP TO 2.75 INCHES DEEP) WITH MULTIPLE EXPOSED PRESTRESSED STRANDS, LOSS UP TO 100 PERCENT ON INDIVIDUAL STRANDS-ALL SPALLS HAVE BEEN PATCHED SINCE PREVIOUS INSPECTION 2023

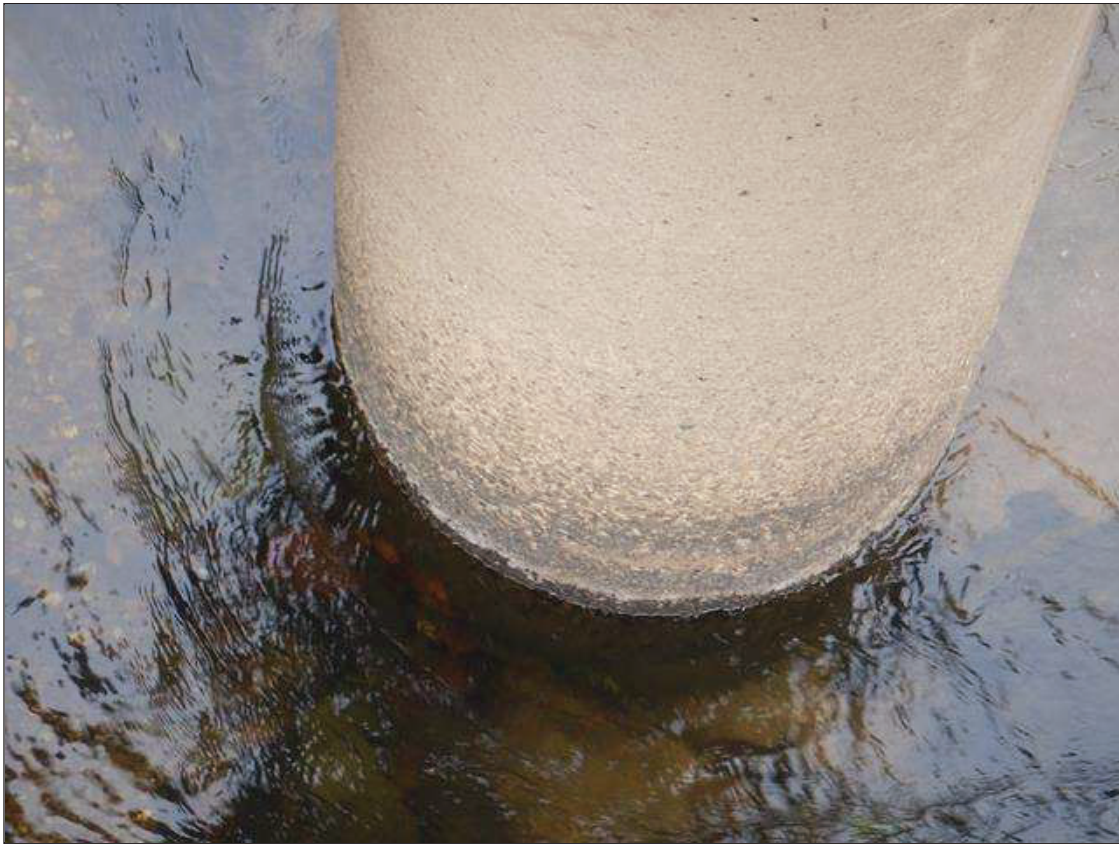
Bent 2 Pile 1: AT BASE OF COLUMN, ABRASION WITH EXPOSED AGGREGATE

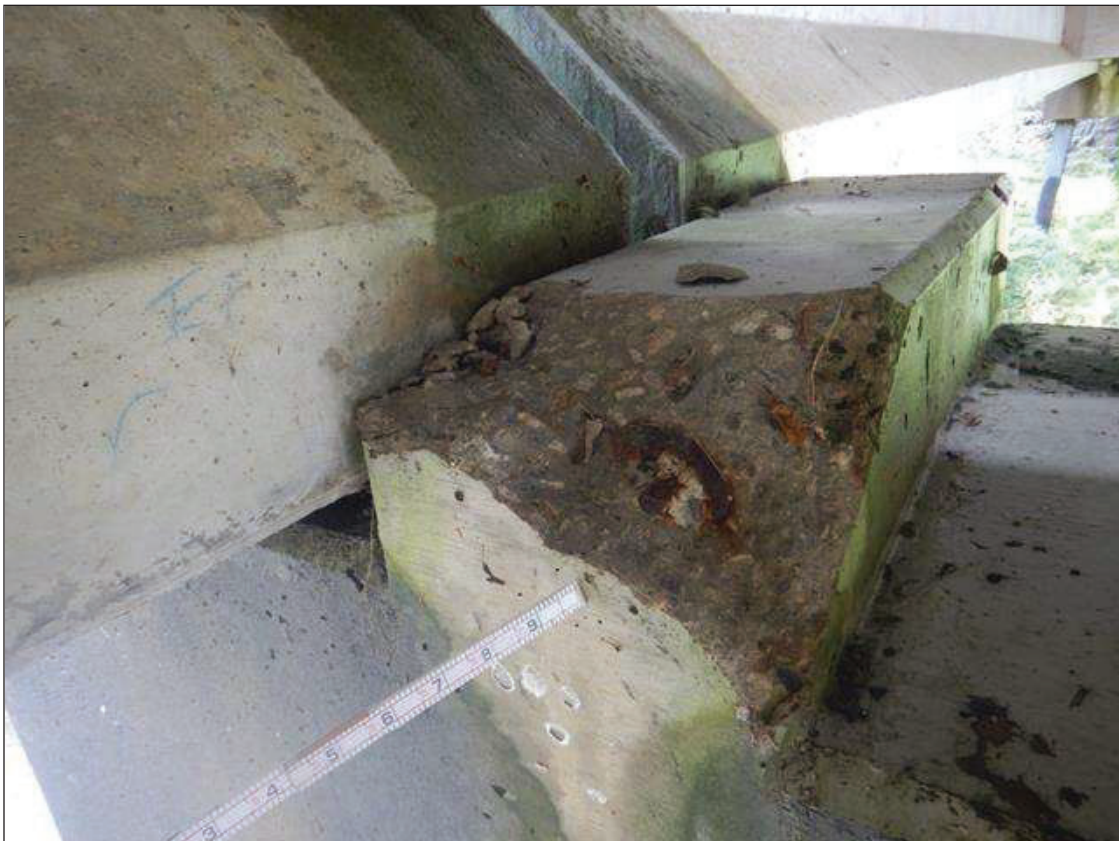
Bent 3 Cap 1: KEEPER BLOCK AT SPAN 3 BEAM 1, SPALL (12 INCHES LONG X 9 INCHES HIGH X UP TO 4 INCHES DEEP)

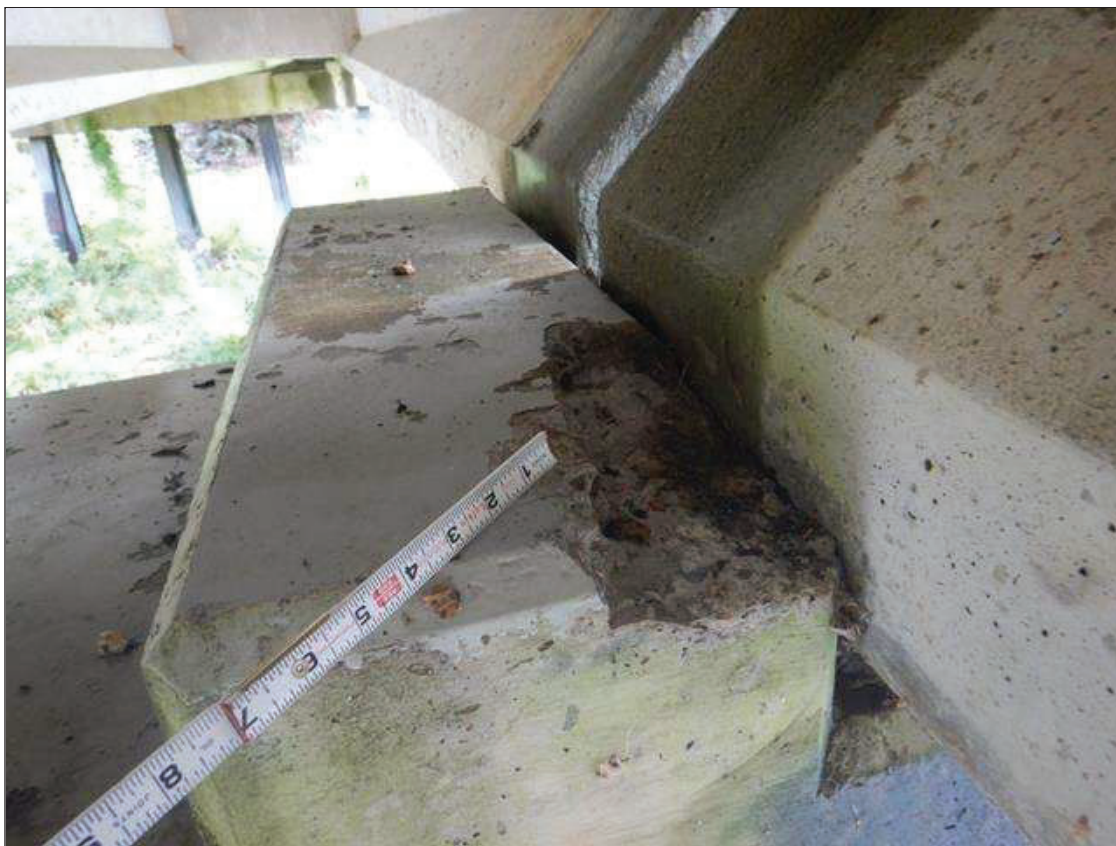
Bent 3 Cap 1: KEEPER BLOCK AT SPAN 3 BEAM 4, SPALL (UP TO 5 INCHES LONG X 8 INCHES WIDE X UP TO 2 INCHES DEEP)

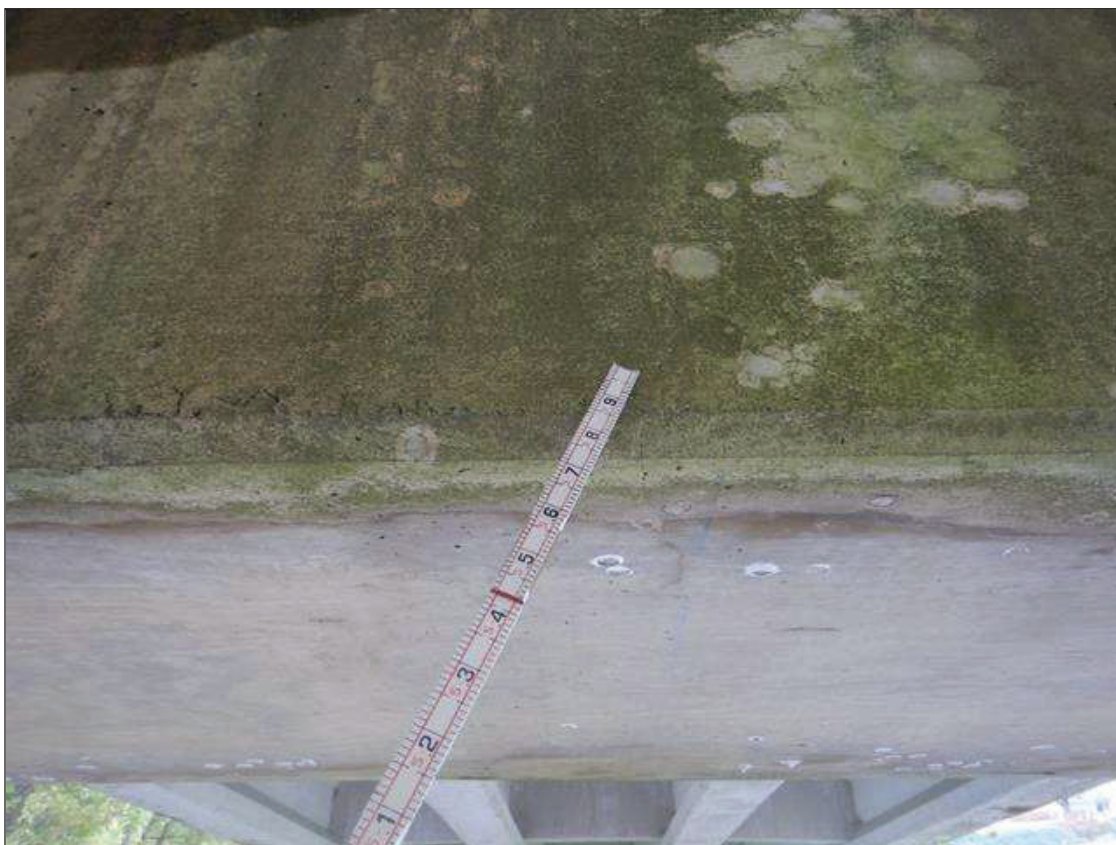
Bent 3 Cap 1: UNDERSIDE BETWEEN COLUMNS, MULTIPLE TRANSVERSE CRACKS (8 INCHES LONG X HAIRLINE) SOME EXTEND UP TO VERTICAL FACE

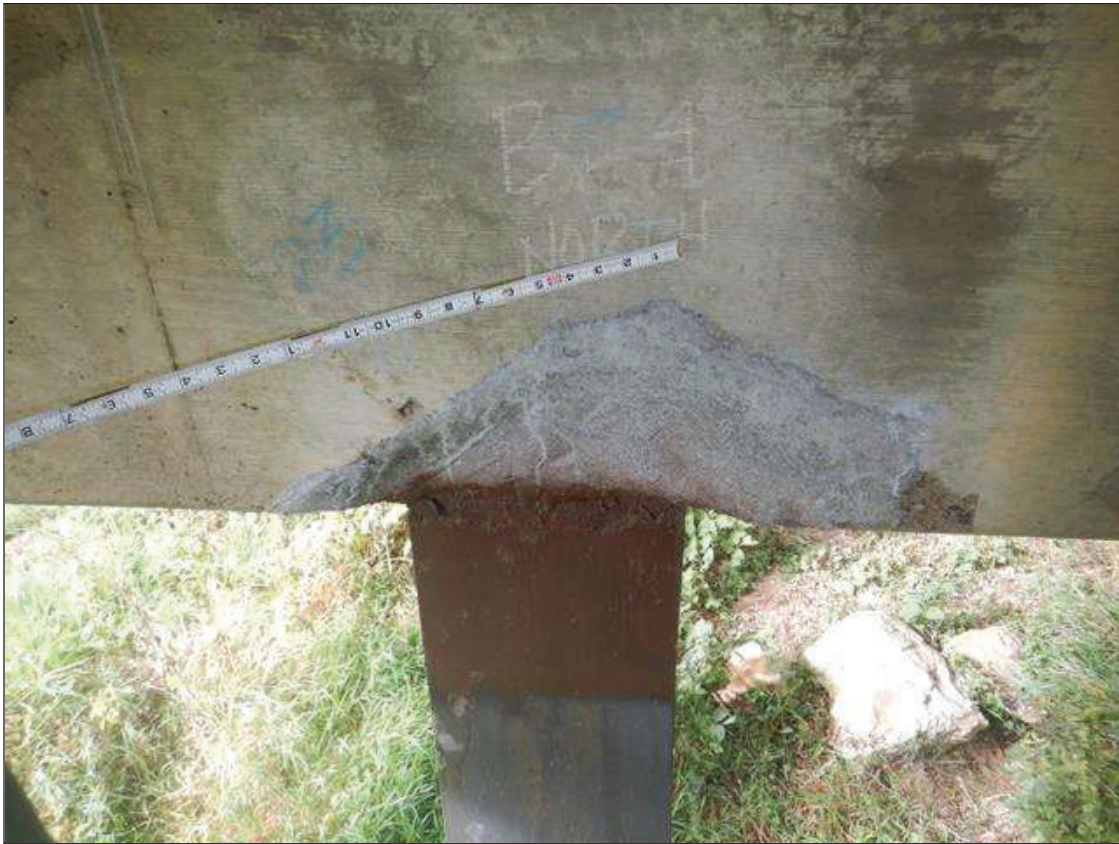
Bent 4 Cap 1: NEW REPAIR: NORTH FACE AT PILE 3, SPALL, (28 INCHES LONG X 9.5 INCHES HIGH X UP TO 3.5 INCHES DEEP) WITH EXPOSED RUSTED REINFORCING, NO LOSS NOTED-PATCHED SINCE PREVIOUS INSPECTION 2023

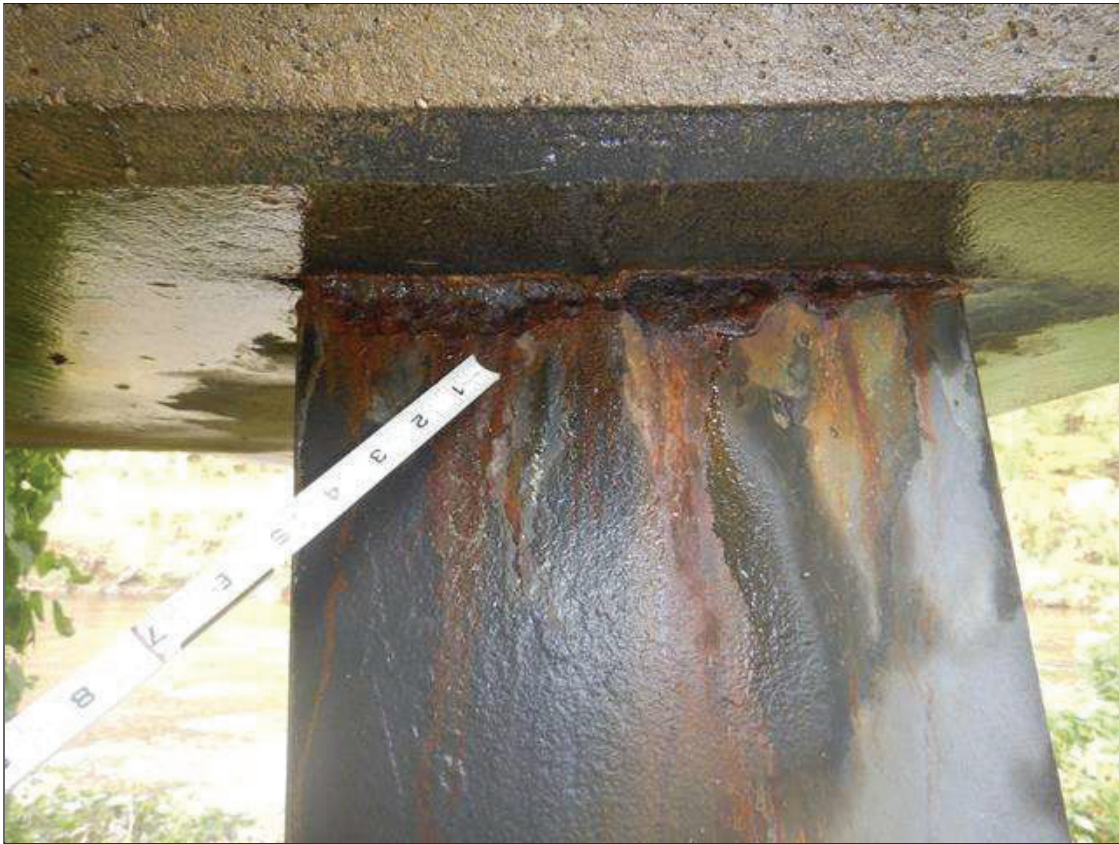
Priority Level	Defect Type	Quantity	Defect Description
2	Corrosion	1	Bent 4 Row 2 Pile 1: (PAR) NORTH FACE AT CAP, ACTIVE CORROSION WITH SECTION LOSS (FULL WIDTH X 1 INCH HIGH X 0.3125 INCH AVERAGE REMAINING)

Element Number	Defect Type	Defect Description	CS	CS Qty	Maint Qty
<input checked="" type="checkbox"/> 225	Corrosion	(PAR) NORTH FACE AT CAP, ACTIVE CORROSION WITH SECTION LOSS (FULL WIDTH X 1 INCH HIGH X 0.3125 INCH AVERAGE REMAINING)	4	1	1 Each
<input checked="" type="checkbox"/> 515	Effectiveness (Steel Protective Coatings)	NORTH FACE AT CAP, FAILED COATING	4	1	1 Square Feet

Bent 4 Row 2 Pile 1: (PAR) NORTH FACE AT CAP, ACTIVE CORROSION WITH SECTION LOSS (FULL WIDTH X 1 INCH HIGH X 0.3125 INCH AVERAGE REMAINING)

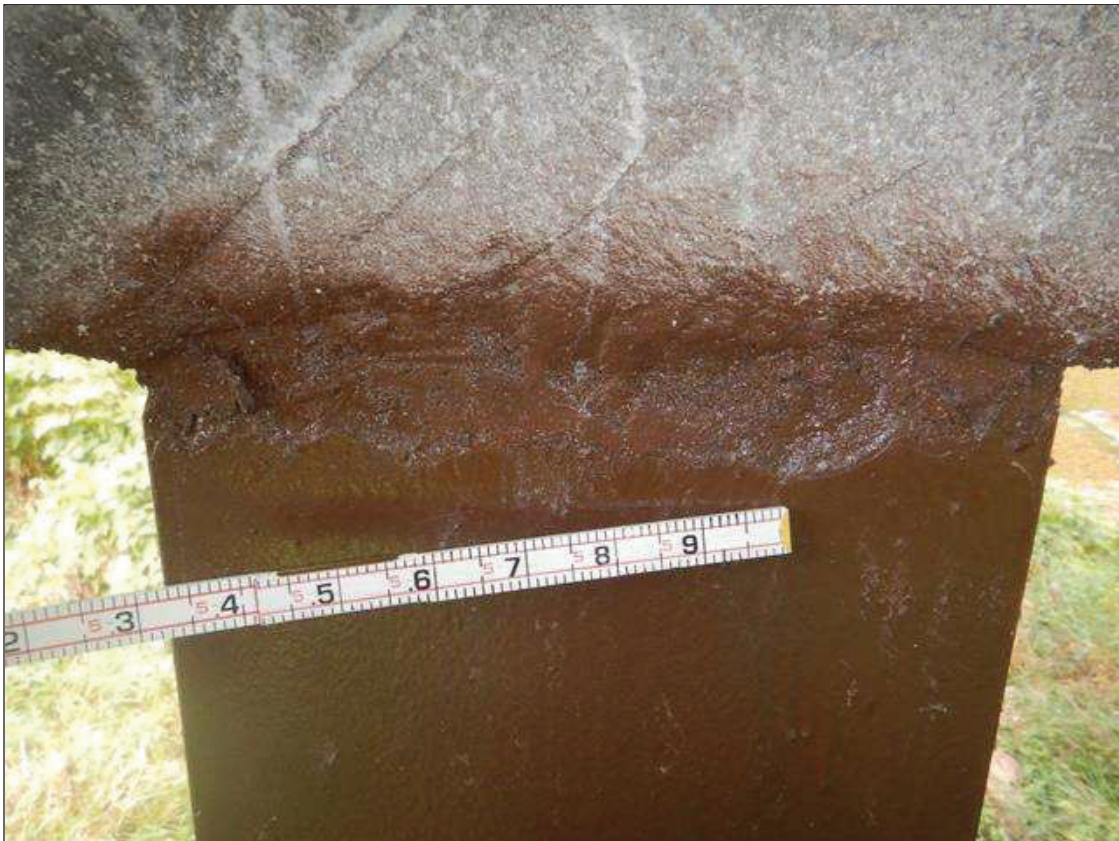
Priority Level	Defect Type	Quantity	Defect Description
2	Corrosion	1	Bent 4 Row 2 Pile 3: (PAR) TOP NORTH FACE AT CAP, ARRESTED CORROSION WITH SECTION LOSS (FULL WIDTH X UP TO 2 INCHES HIGH X 0.25 INCH AVERAGE REMAINING)

Element Number	Defect Type	Defect Description	CS	CS Qty	Maint Qty	
<input checked="" type="checkbox"/> 225	Corrosion	(PAR) TOP NORTH FACE AT CAP, ARRESTED CORROSION WITH SECTION LOSS (FULL WIDTH X UP TO 2 INCHES HIGH X 0.25 INCH AVERAGE REMAINING)	4	1	1	Each
<input checked="" type="checkbox"/> 515	Effectiveness (Steel Protective Coatings)	TOP NORTH FACE AT CAP, FAILED COATING-PAINTED OVER	1			Square Feet

Bent 4 Row 2 Pile 3: (PAR) TOP NORTH FACE AT CAP, ARRESTED CORROSION WITH SECTION LOSS (FULL WIDTH X UP TO 2 INCHES HIGH X 0.25 INCH AVERAGE REMAINING)
