NC DEPARTMENT OF TRANSPORTATION
DIVISION OF HIGHWAYS
STRUCTURE MANAGEMENT UNIT

Structure Safety Report

Routine Element Inspection - Contract

STRUCTURE NUMBER: 600229 SAP STRUCTURE NO: 0610229 FHWA STRUCTURE NO: 000000001210229
DIVISION: 13 COUNTY: MITCHELL INSPECTION DATE: 10/17/2023 FREQUENCY: 24 MONTHS
FACILITY CARRIED: SR1357 MILE POST: _____
LOCATION: .01 N.JCT.SR1336
FEATURE INTERSECTED: NORTH TOE RIVER
LATITUDE: 35° 59' 33.58" LONGITUDE: 82° 15' 28.3"
SUPERSTRUCTURE: RC FL.& PPC DECK PANELS ON PPC GDR.(S.I.P.METAL FORMS)
SUBSTRUCTURE: E.BTS&INT.BT4:RC CAPS/H-PILES;INT.BTS1-3:REINF.CONC.P&B
SPANS: 5 SPANS. SEE SPAN PROFILE SHEET FOR SPAN DETAILS
☐ FRACTURE CRITICAL ☐ TEMPORARY SHORING ☐ SCOUR CRITICAL ☐ SCOUR PLAN OF ACTION
GRADES: (Inspector/NBI Coding) DECK 7 / 7 SUPERSTRUCTURE 6 / 6 SUBSTRUCTURE 7 / 7 CULVERT N / N
POSTED SV: Not Posted POSTED TTST: Not Posted
OTHER SIGNS PRESENT: ONE (1) DELINEATOR

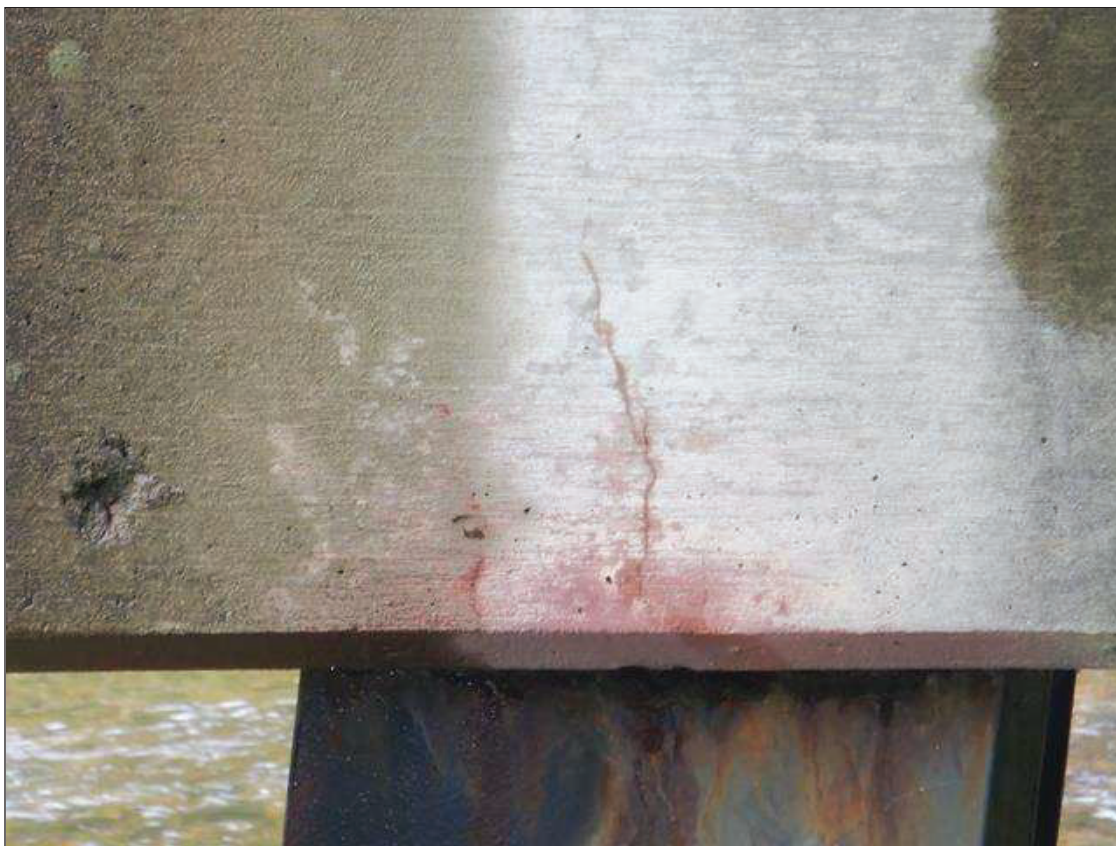
Element Number	Defect Type	Defect Description	CS	CS Qty	Maint Qty
<input checked="" type="checkbox"/> 234	Cracking (RC and Other)	NORTH FACE OVER PILE 4, VERTICAL CRACK (6 INCHES HIGH X UP TO 1/32 INCH WIDE)	2	1	Feet
<input checked="" type="checkbox"/> 234	Efflorescence/Rust Staining	LEAKAGE STAINING ALONG FACES OF CAP	2		Feet
<input checked="" type="checkbox"/> 234	Patched Area	NEW REPAIR: NORTH FACE AT PILE 3, SPALL, (28 INCHES LONG X 9.5 INCHES HIGH X UP TO 3.5 INCHES DEEP) WITH EXPOSED RUSTED REINFORCING, NO LOSS NOTED-PATCHED SINCE PREVIOUS INSPECTION 2023	2	3	Feet

Bent 4 Cap 1: NORTH FACE OVER PILE 4, VERTICAL CRACK (6 INCHES HIGH X UP TO 1/32 INCH WIDE)

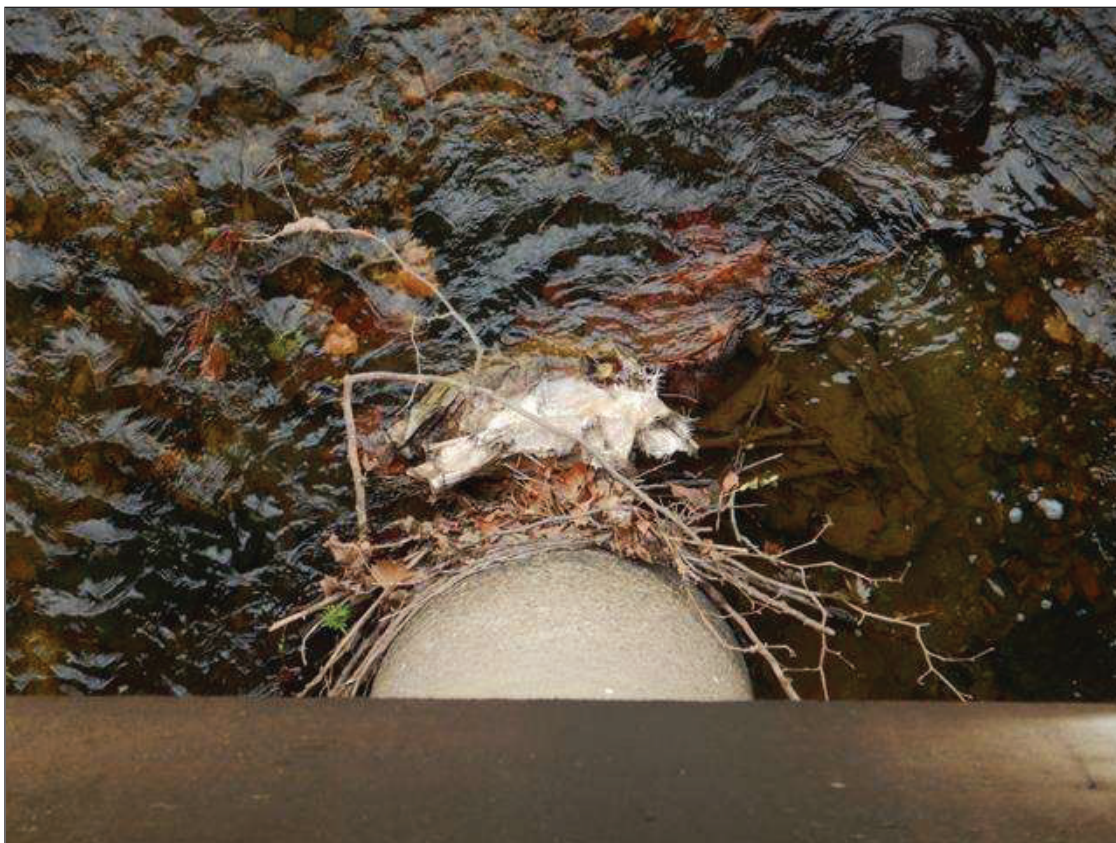
Drift: AT SOUTHEAST FACE OF BENT 3, DRIFT ACCUMULATION (2 FEET LONG X 4 FEET WIDE X UP TO 1 FOOT HIGH)

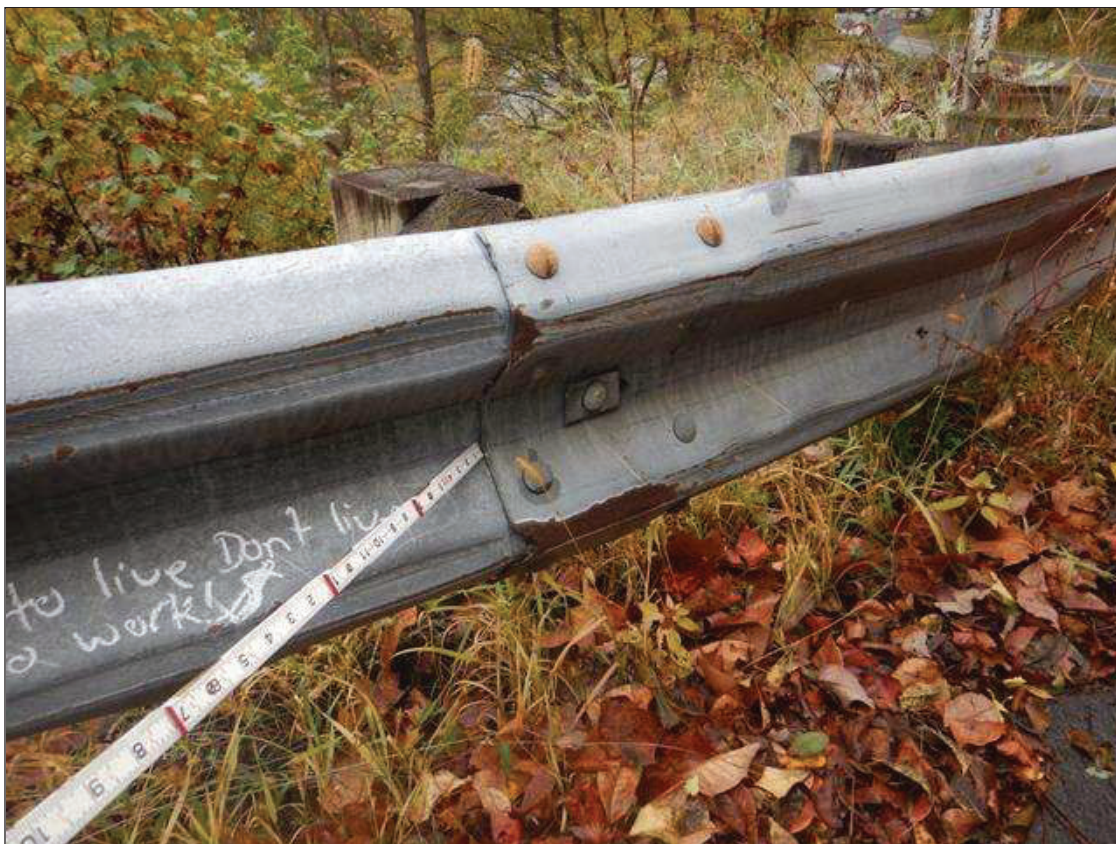
Guardrails: SOUTHEAST GUARDRAIL NEAR SOUTH APPROACH, SCRAPE MARKS (10 FEET LONG)

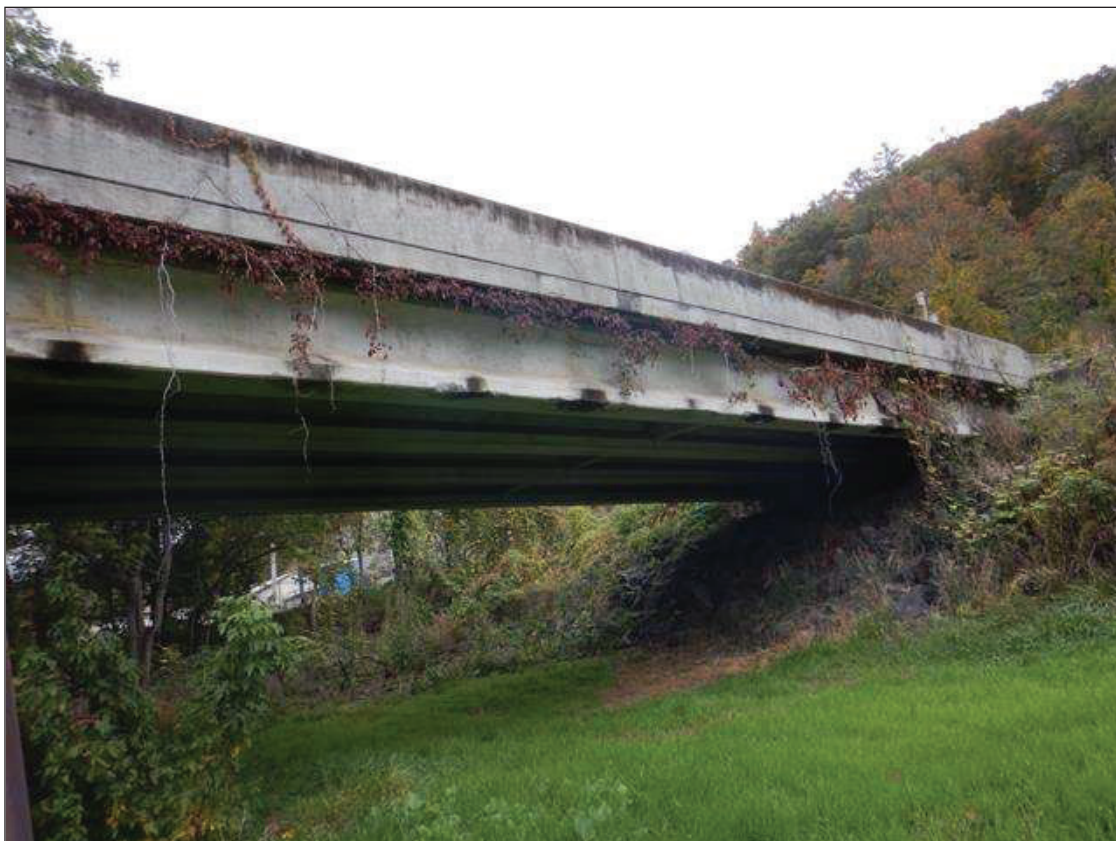
General: ALONG RIGHT OVERHANG AT SPANS 4 AND 5, VEGETATION GROWTH

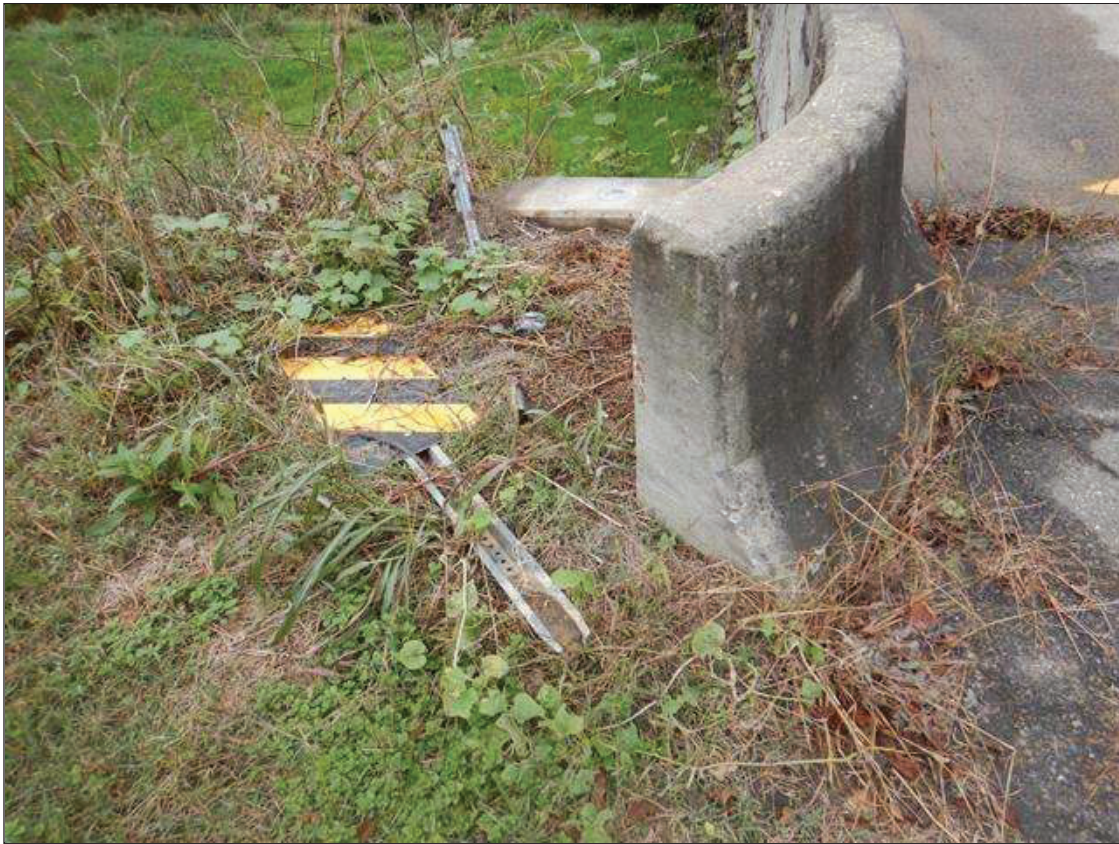
Priority Level	Defect Type	Quantity	Defect Description
2	General Condition	1	Span 5 Northeast Delineator: (PAR) NORTHEAST DELINEATOR IS LAYING ON GROUND

Span 5		Northeast Delineator					
Delineator							
Element Number	Element Name		Total Qty	CS1 Qty	CS2 Qty	CS3 Qty	CS4 Qty
602	Warning Signs		1	0	0	0	1 Each
Element Number	Defect Type	Defect Description			CS	CS Qty	Maint Qty
<input checked="" type="checkbox"/> 602	General Condition	(PAR) NORTHEAST DELINEATOR IS LAYING ON GROUND			4	1	1 Each

Span 5 Northeast Delineator: (PAR) NORTHEAST DELINEATOR IS LAYING ON GROUND
