NC DEPARTMENT OF TRANSPORTATION  
DIVISION OF HIGHWAYS  
BRIDGE MANAGEMENT UNIT

# BRIDGE INSPECTION REPORT

COUNTY WILKES BRIDGE NUMBER 960106 INSPECTION CYCLE 0 YRS

ROUTE SR1300 ACROSS N.PRONG LEWIS FORK CREEK M.P. 0

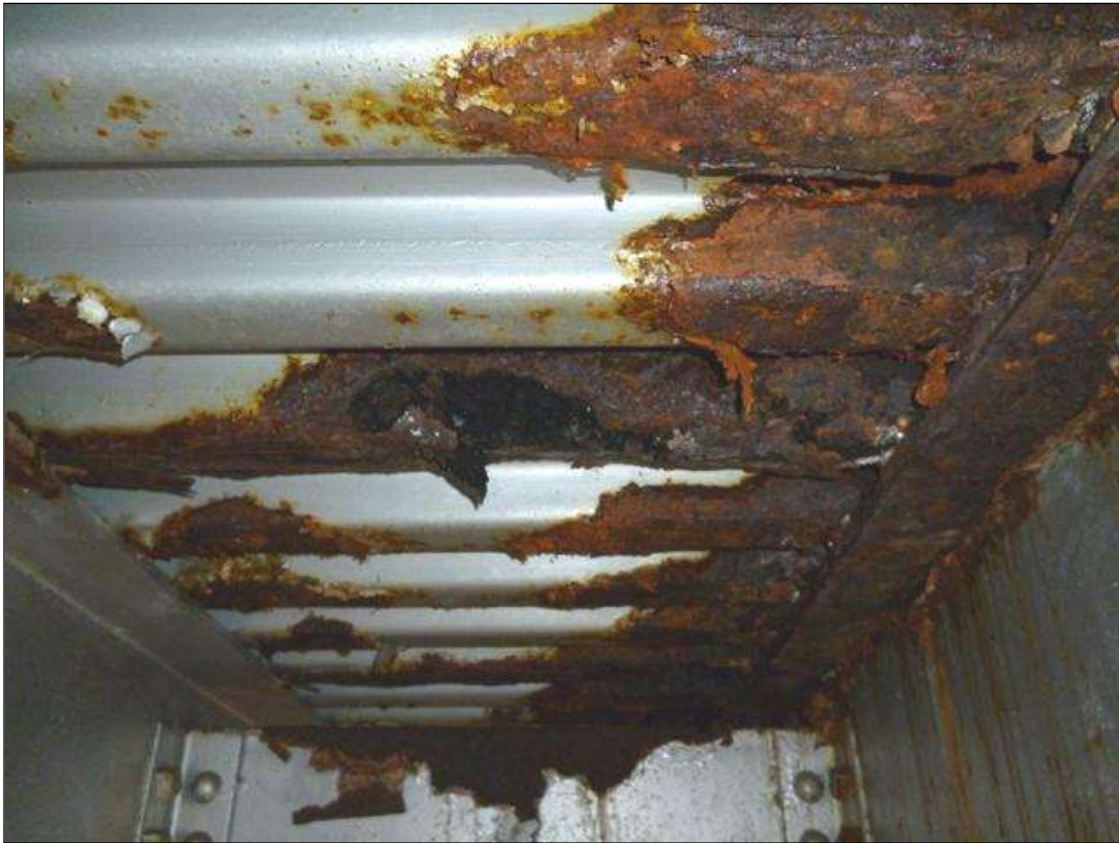
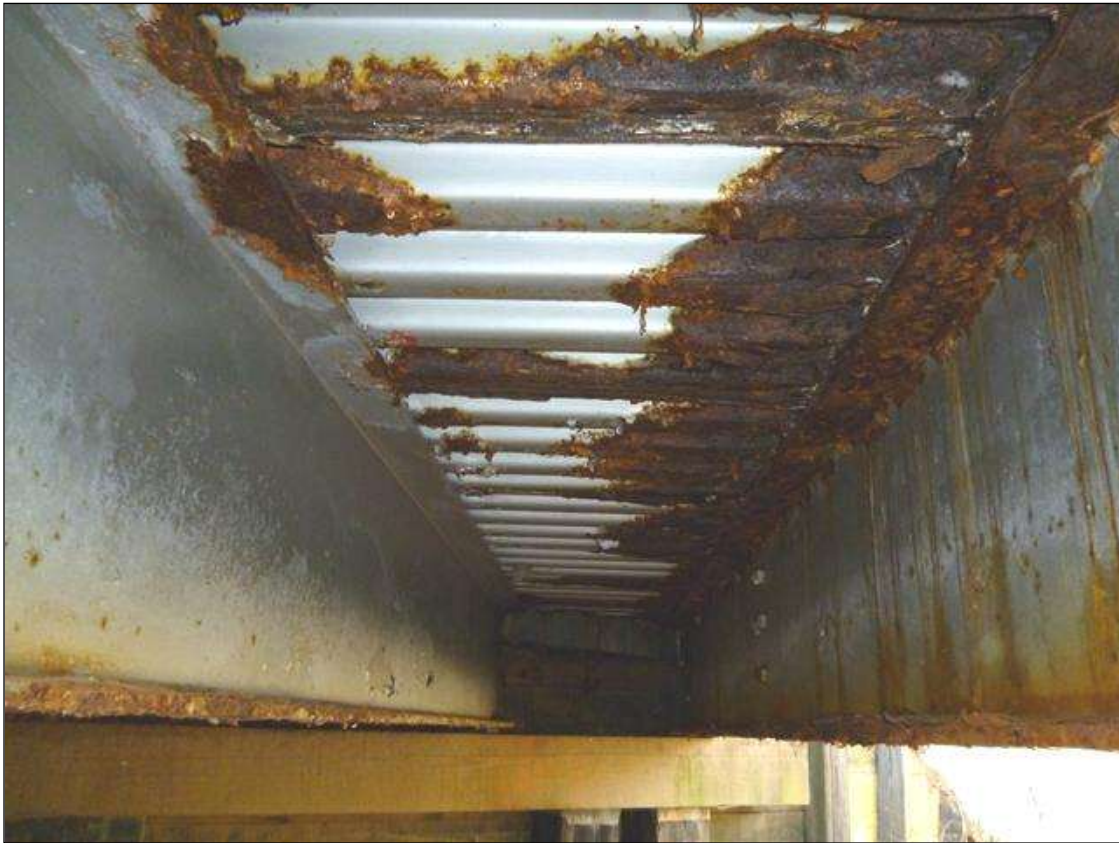
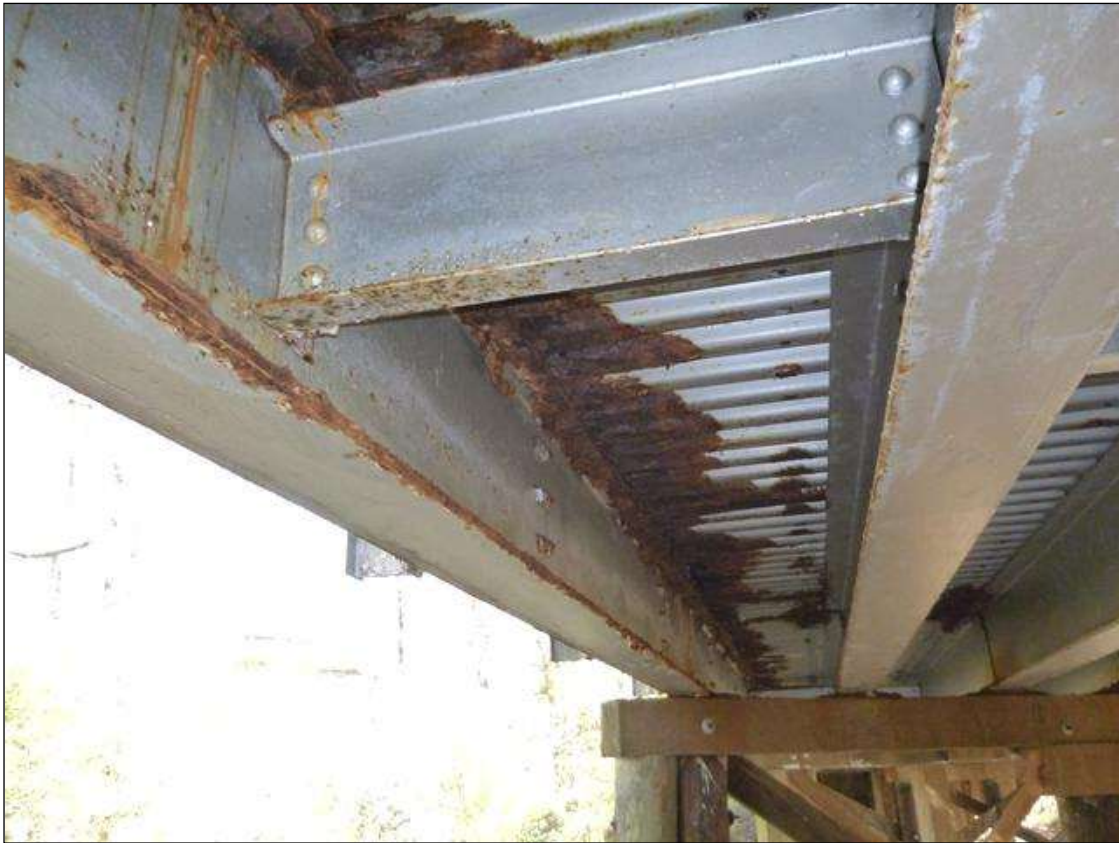
| Bridge I&A Form 1(82)H<br>State of North Carolina<br>Dept. of Transportation<br>Division of Highways | | <b>FIELD INSPECTION REPORT</b><br><u>Bridge Inspection &amp; Analysis</u> | |
|---|---|---|--|
| 2c | F | HEAVY RUST SCALE WITH COMPLETE SECTION LOSS ON UNDERSIDE OF STEEL PLANK DECK, BAY 1, SPAN 1, (SIMILAR FULL-LENGTH OF STRUCTURE) (PRIORITY MAINTENANCE)<br>HEAVY RUST SCALE WITH COMPLETE SECTION LOSS ON UNDERSIDE OF STEEL PLANK DECK, BAY 9, SPAN 1, (SIMILAR FULL-LENGTH OF STRUCTURE) (PRIORITY MAINTENANCE)<br>RANDOM SURFACE RUST WITH SCALE UNDERSIDE OF STEEL PLANK DECK OVER BENT 1 WITH SOME SECTION LOSS. (SIMILAR OVER BENT 2). | |

HEAVY RUST SCALE WITH COMPLETE SECTION LOSS ON UNDERSIDE OF STEEL PLANK DECK, BAY 1, SPAN 1, (SIMILAR FULL-LENGTH OF STRUCTURE) (PRIORITY MAINTENANCE)

| MMS Code | Description of Function | Unit | Quantity | Remarks | Est. Cost |
|---|---|---|---|---|---|
| 3328 | Maintenance/Repair/ Replace Steel Plank Bridge Floor | SF | 360 | HEAVY RUST SCALE WITH COMPLETE SECTION LOSS ON UNDERSIDE OF STEEL PLANK DECK IN BAY 1, SPAN 1' (SIMILAR FULL-LENGTH OF STRUCTURE) | |

| MMS Code | MMS Description | Quantity |
|---|---|---|
| HEAVY RUST SCALE WITH COMPLETE SECTION LOSS ON UNDERSIDE OF STEEL PLANK DECK IN BAY 1, SPAN 1' (SIMILAR FULL-LENGTH OF STRUCTURE) | | |

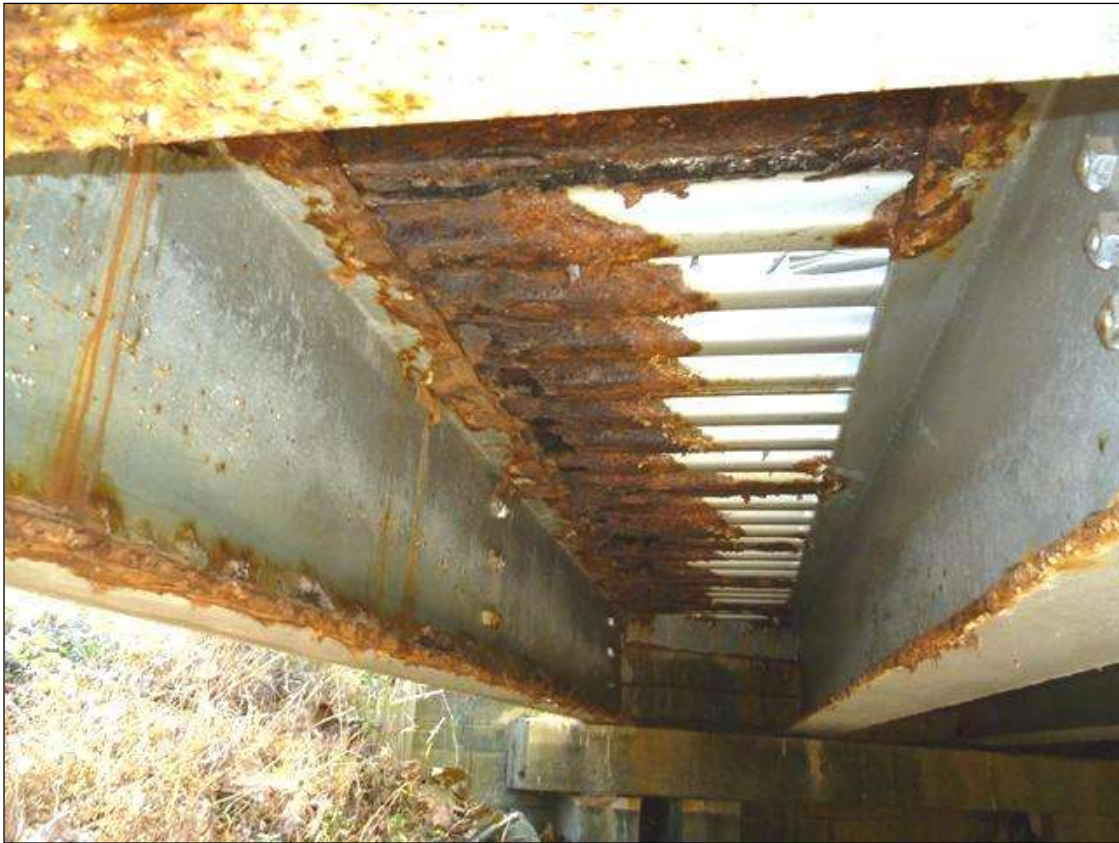
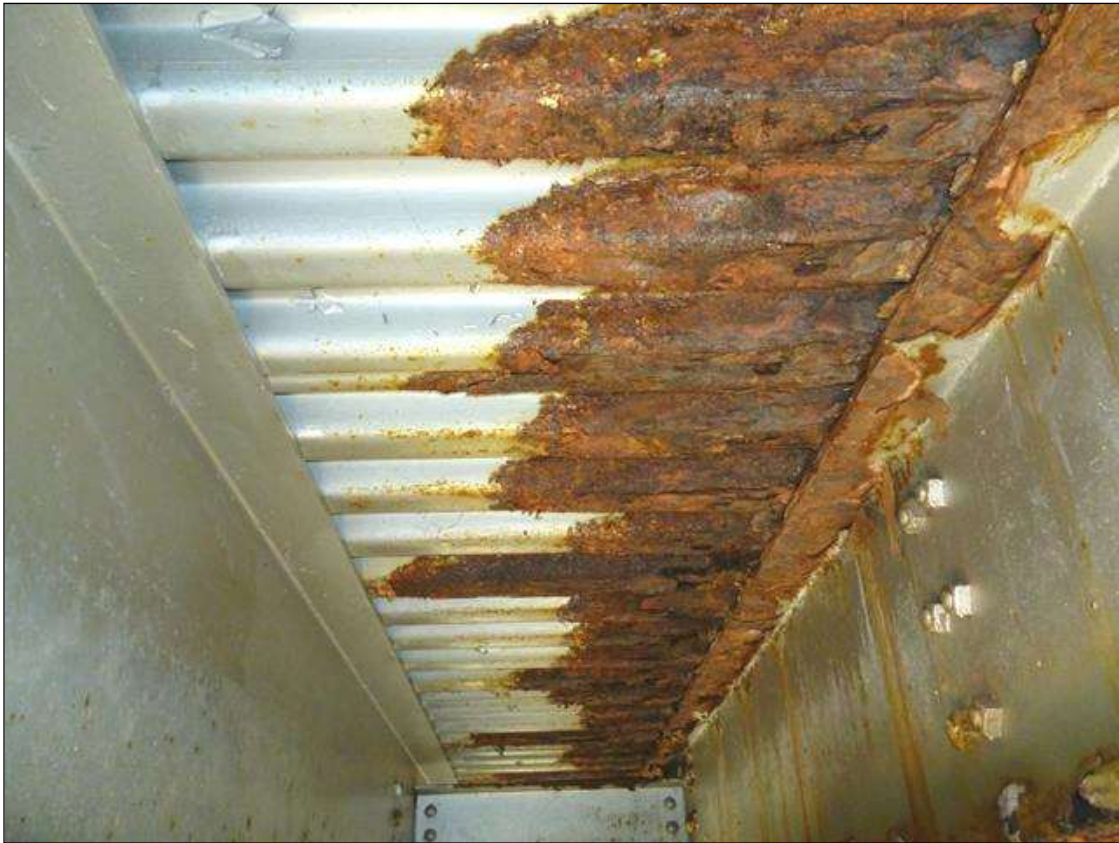
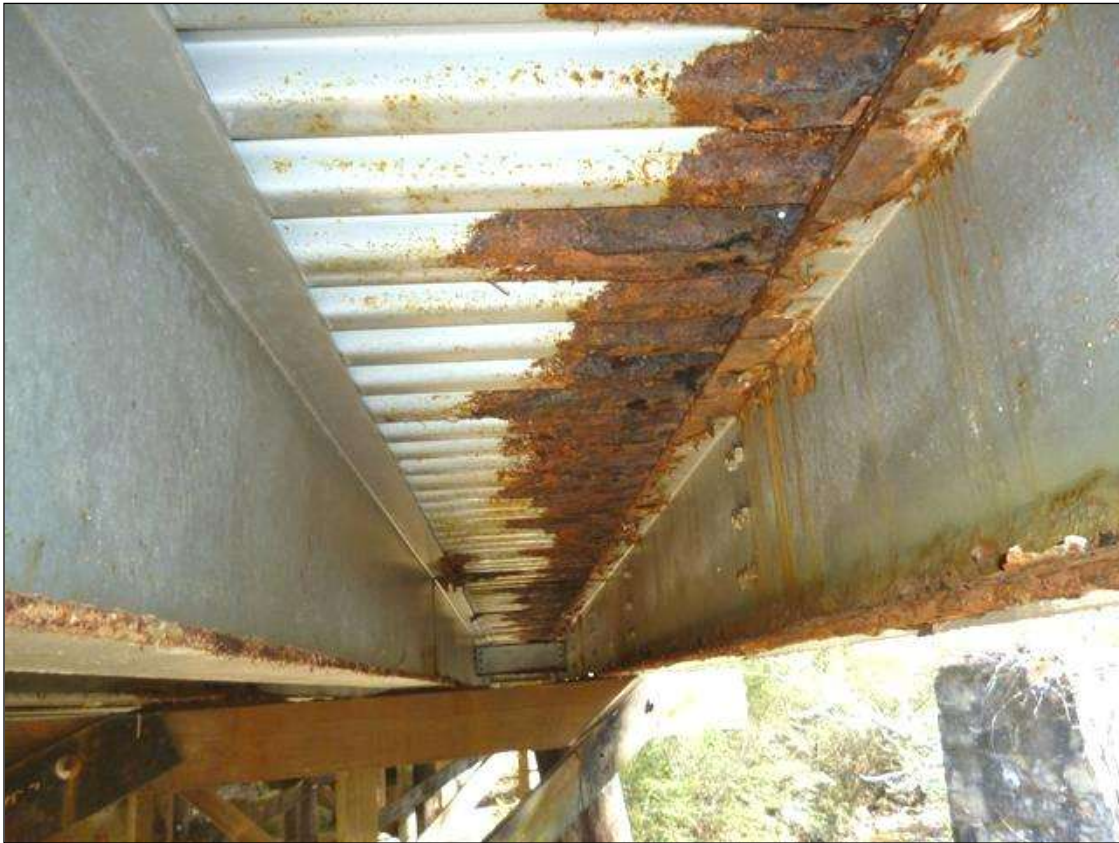
HEAVY RUST SCALE WITH COMPLETE SECTION LOSS ON UNDERSIDE OF STEEL PLANK DECK, BAY 9, SPAN 1, (SIMILAR FULL-LENGTH OF STRUCTURE) (PRIORITY MAINTENANCE)

| MMS Code | Description of Function | Unit | Quantity | Remarks | Est. Cost |
|---|---|---|---|---|---|
| 3328 | Maintenance/Repair/ Replace Steel Plank Bridge Floor | SF | 360 | HEAVY RUST SCALE WITH COMPLETE SECTION LOSS ON UNDERSIDE OF STEEL PLANK DECK IN BAY 9, SPAN 1. (SIMILAR FULL-LENGTH OF STRUCTURE) | |

| MMS Code | MMS Description | Quantity |
|---|---|---|
| HEAVY RUST SCALE WITH COMPLETE SECTION LOSS ON UNDERSIDE OF STEEL PLANK DECK IN BAY 9, SPAN 1. (SIMILAR FULL-LENGTH OF STRUCTURE) | | |

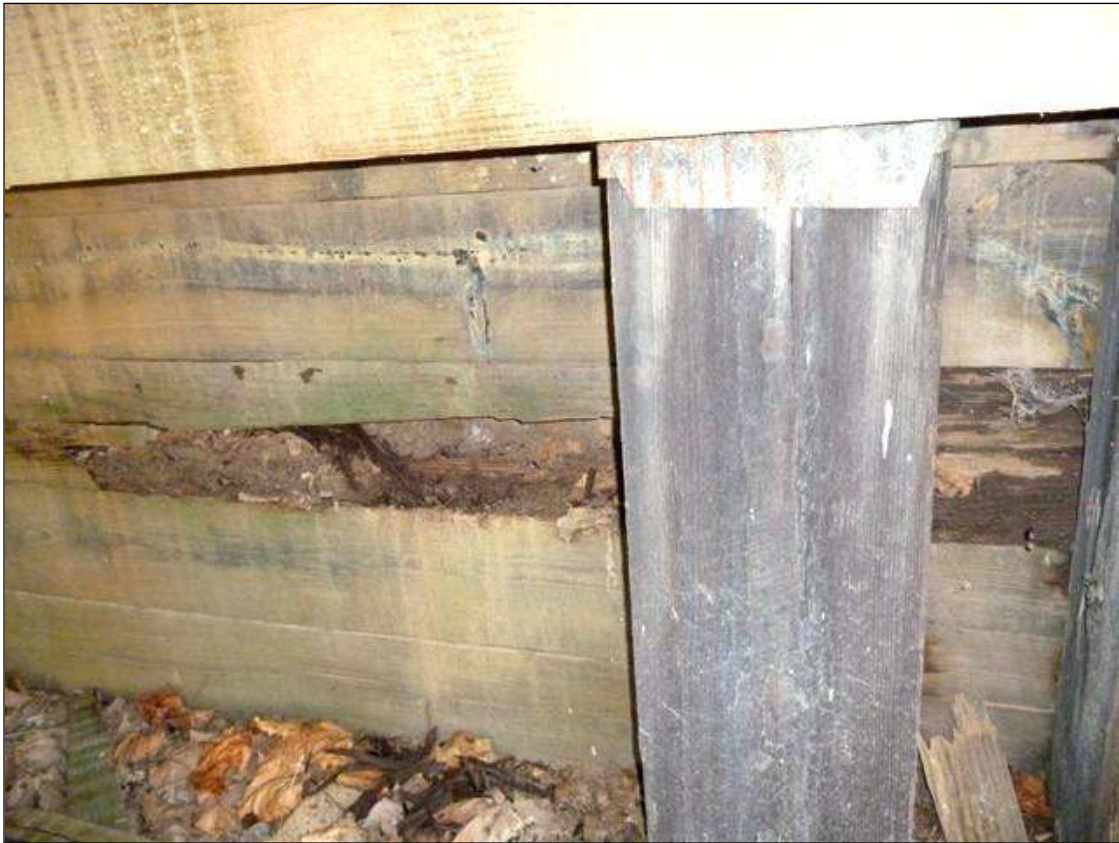
| Bridge I&A Form 1(82)H<br>State of North Carolina<br>Dept. of Transportation<br>Division of Highways | | <h1 style="text-align: center;">FIELD INSPECTION REPORT</h1> <h2 style="text-align: center;"><u>Bridge Inspection &amp; Analysis</u></h2> | |
|---|---|---|--|
| 35c | P | 5' X 8" AREA OF DECAY IN END BENT 1 BULKHEAD FROM PILES 1 TO 3 WITH SOIL SPILLING THROUGH. (PRIORITY MAINTENANCE)<br>9' X 8" AREA OF DECAY ON TOP BOARD AT END BENT 2 BULKHEAD, OUTSIDE BEAM 1 TO BAY 2 WITH SOIL COMING THROUGH. (PRIORITY MAINTENANCE)<br>NORTHWEST WINGWALL PILE COMPLETELY DECAYED ABOVE GROUND.<br>2' X 2' AREA OF DECAY, BOTTOM OF NORTHEAST WINGWALL.<br>11' X 8" DECAY BEHIND PILE 1 IN END BENT 2 BULKHEAD, 3RD BOARD BELOW CAP<br>3' X 8" AREA OF DECAY IN END BENT 2 BULKHEAD OUTSIDE OF PILE 1, 6TH BOARD BELOW CAP.<br>4' X 8" AREA OF DECAY IN END BENT 2 BULKHEAD OUTSIDE PILE 8, 9TH BOARD DOWN.<br>TOP 3' OF PILE 2 IN SOUTHEAST WINGWALL IS SPLIT OFF.<br>7' X 8" AREA OF DECAY IN SOUTHEAST WINGWALL, 7TH BOARD DOWN.<br>4' X 8" AREA OF DECAY IN END BENT 2 BULKHEAD OUTSIDE PILE 8, 5TH BOARD DOWN. | |

5' X 8" AREA OF DECAY IN END BENT 1 BULKHEAD FROM PILES 1 TO 3 WITH SOIL SPILLING THROUGH.  
(PRIORITY MAINTENANCE)

| MMS Code | Description of Function | Unit | Quantity | Remarks | Est. Cost |
|---|---|---|---|---|---|
| 3344 | Repair / Replace Timber Substructure Components | LF | 5 | 5' X 8" AREA OF DECAY IN END BENT 1 BULKHEAD FROM PILES 1 TO 3 WITH SOIL SPILLING THROUGH. | |

| MMS Code | MMS Description | Quantity |
|---|---|---|
| 5' X 8" AREA OF DECAY IN END BENT 1 BULKHEAD FROM PILES 1 TO 3 WITH SOIL SPILLING THROUGH. | | |

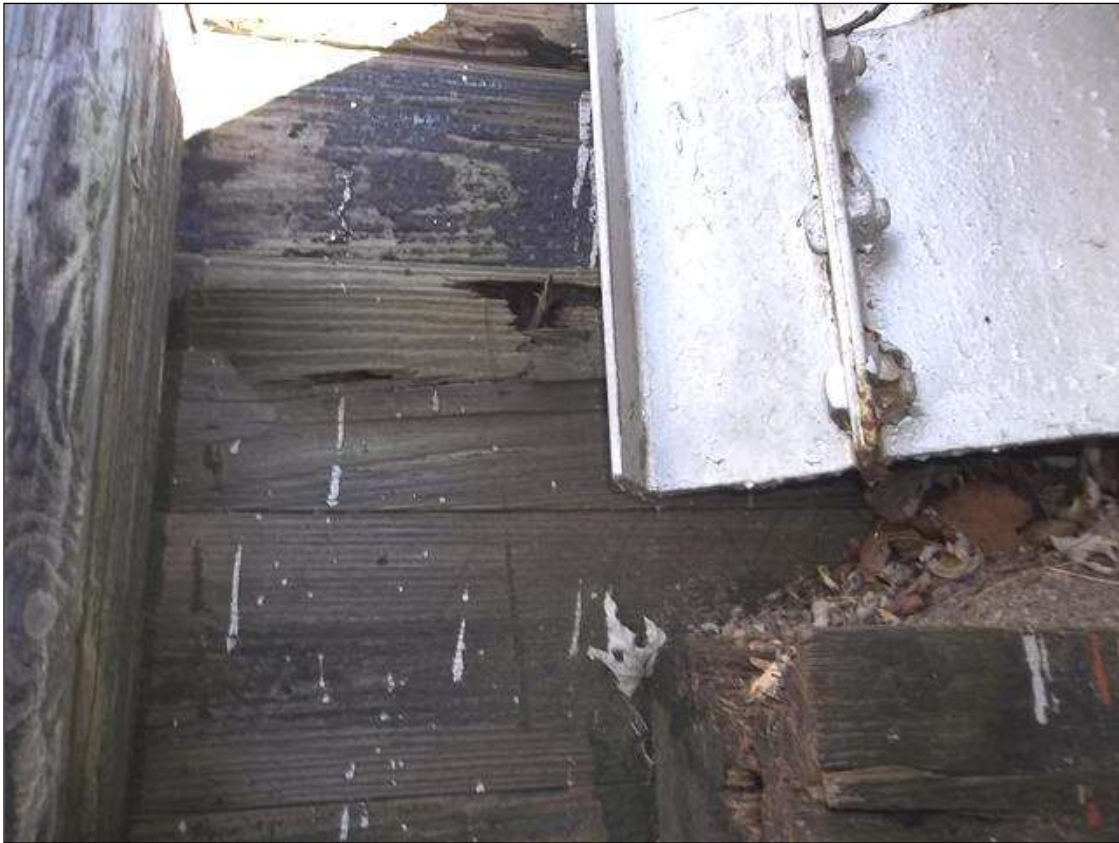
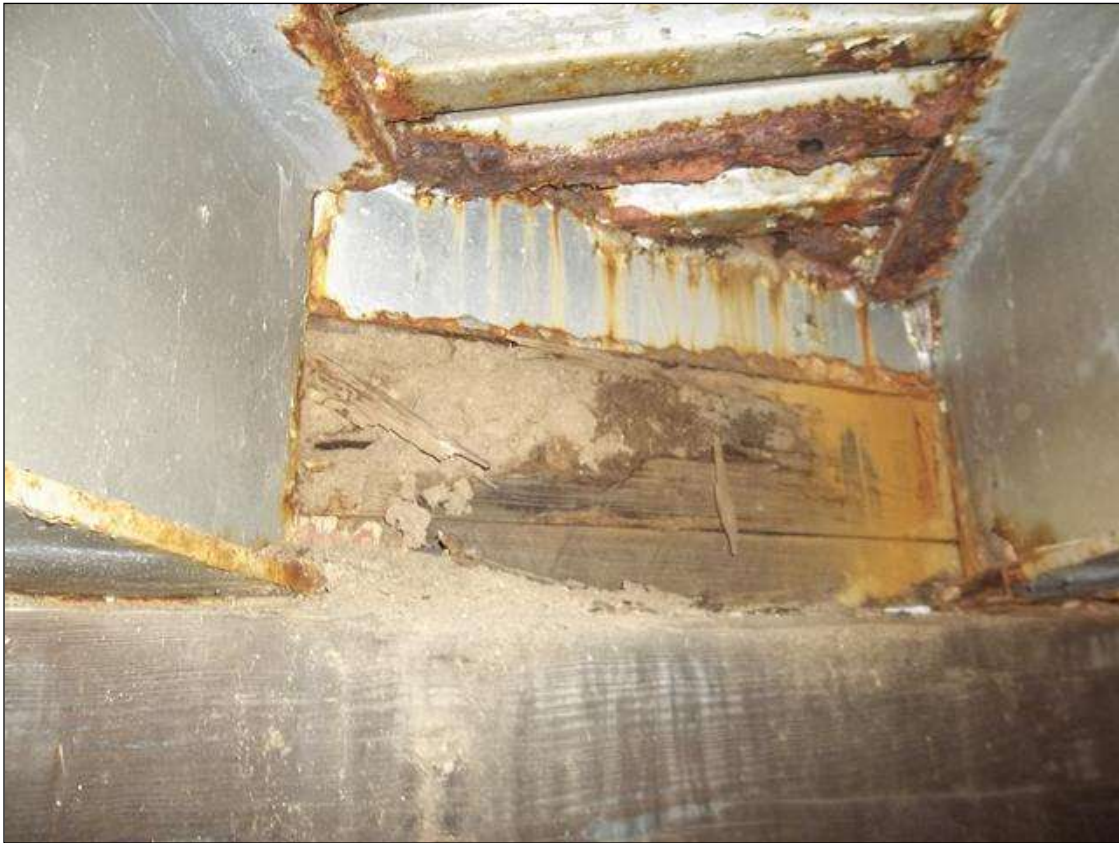
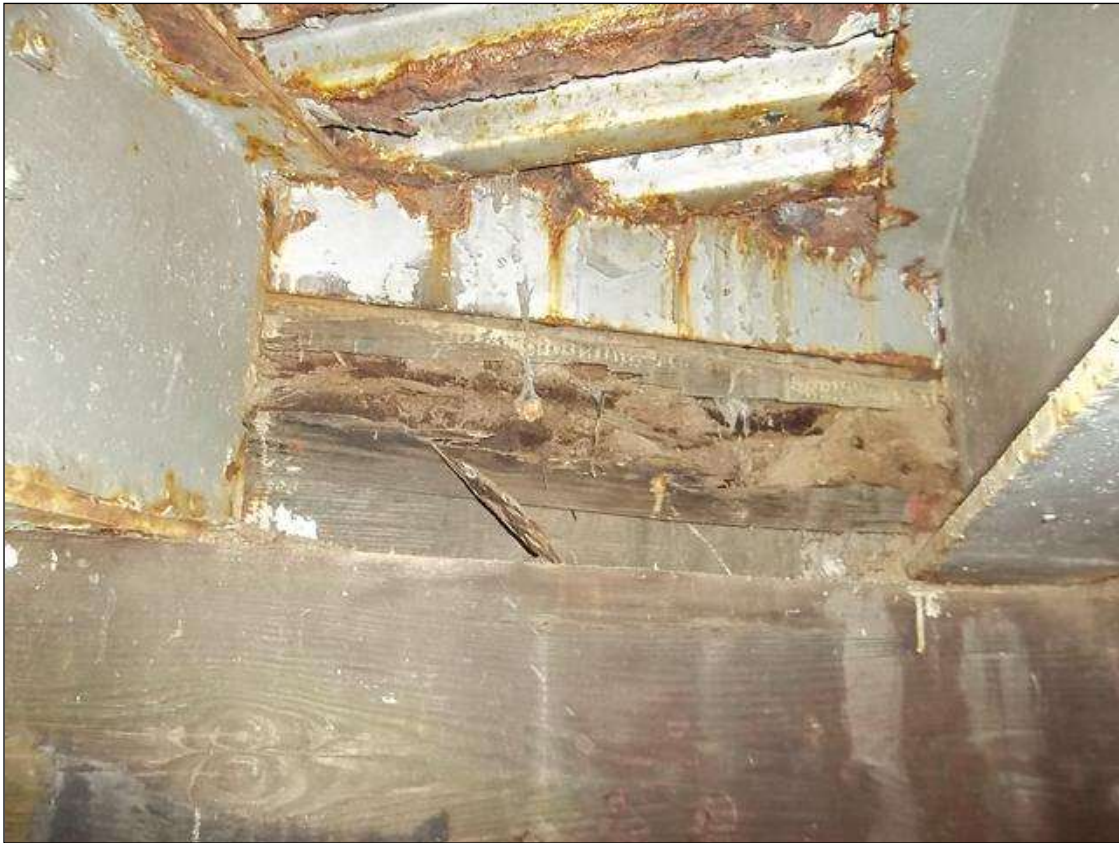
9' X 8" AREA OF DECAY ON TOP BOARD AT END BENT 2 BULKHEAD, OUTSIDE BEAM 1 TO BAY 2 WITH SOIL COMING THROUGH. (PRIORITY MAINTENANCE)

| MMS Code | Description of Function | Unit | Quantity | Remarks | Est. Cost |
|---|---|---|---|---|---|
| 3344 | Repair / Replace Timber Substructure Components | LF | 9 | 9' X 8" AREA OF DECAY ON TOP BOARD AT END BENT 2 BULKHEAD, OUTSIDE BEAM 1 TO BAY 2 WITH SOIL COMING THROUGH. | |

| MMS Code | MMS Description | Quantity |
|---|---|---|
| 9' X 8" AREA OF DECAY ON TOP BOARD AT END BENT 2 BULKHEAD, OUTSIDE BEAM 1 TO BAY 2 WITH SOIL COMING THROUGH. | | |

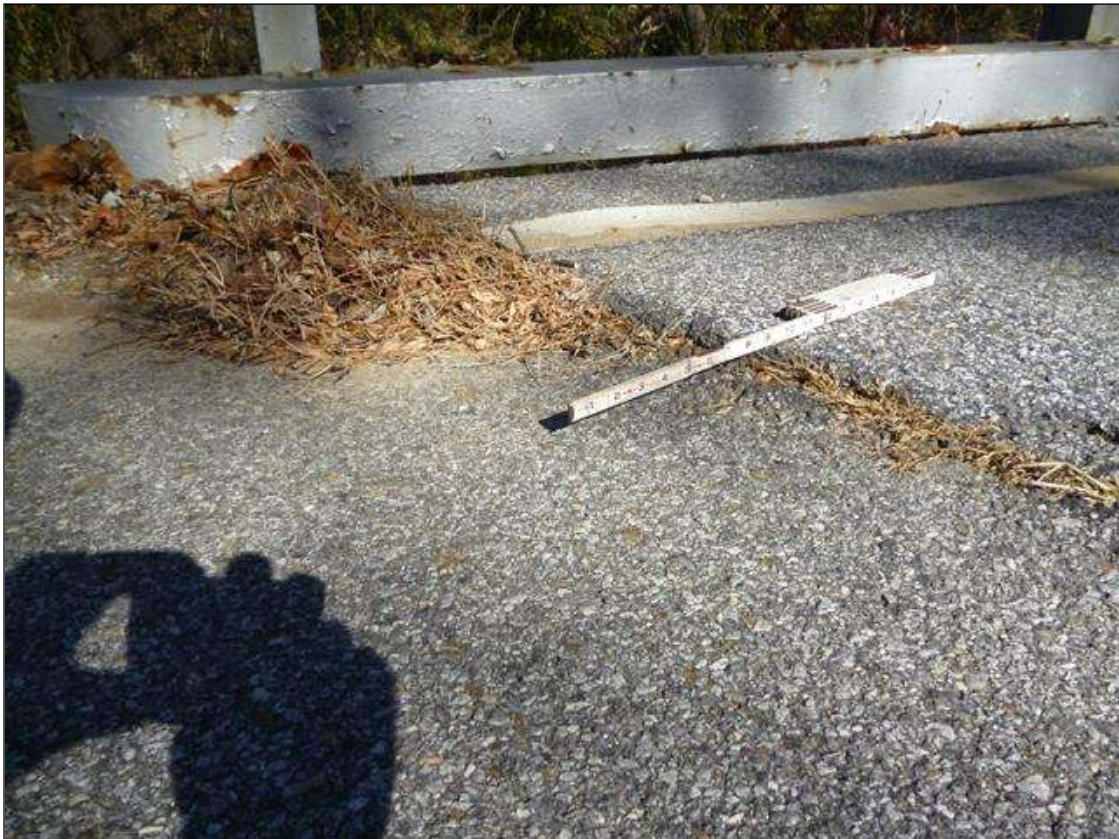
SETTLEMENT UP TO 1 1/2" IN WEST APPROACH AT END BENT 1, WEST BOUND LANE.

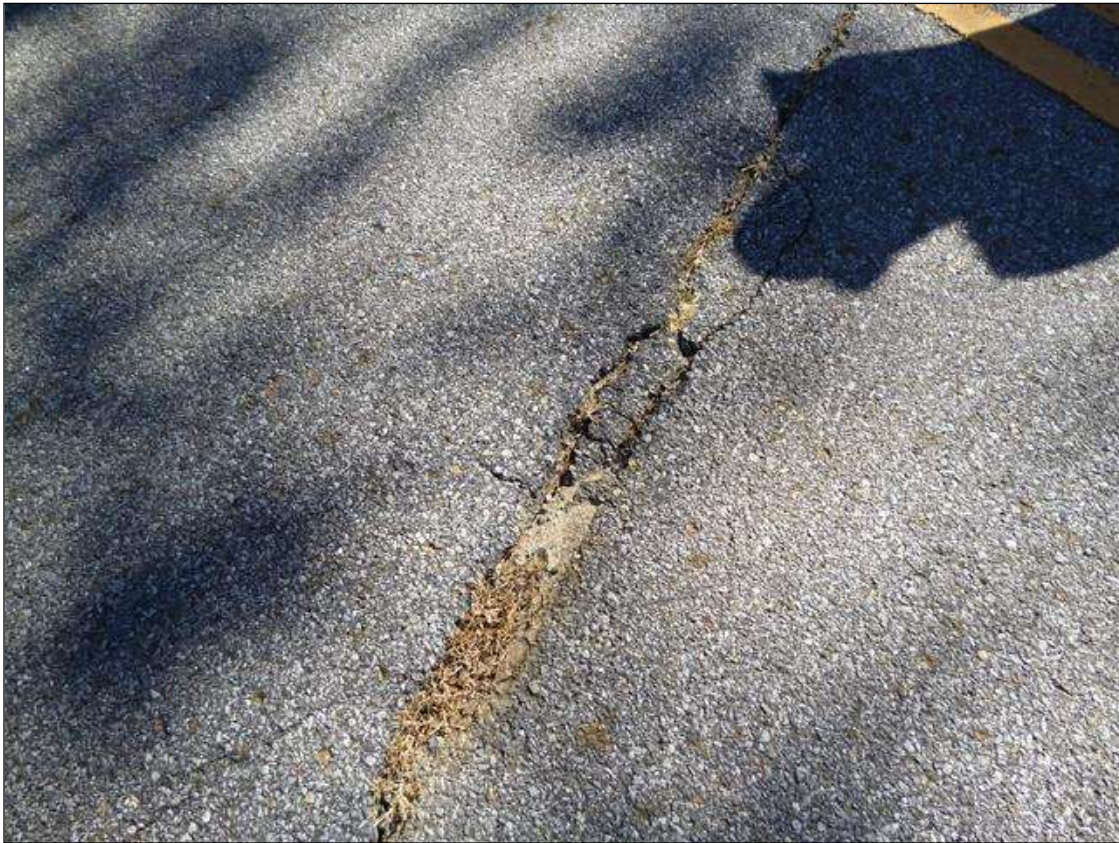
6" X 44" POTHOLE IN ASPHALT WEARING SURFACE OVER END BENT 1, CENTER OF WEST BOUND LANE.

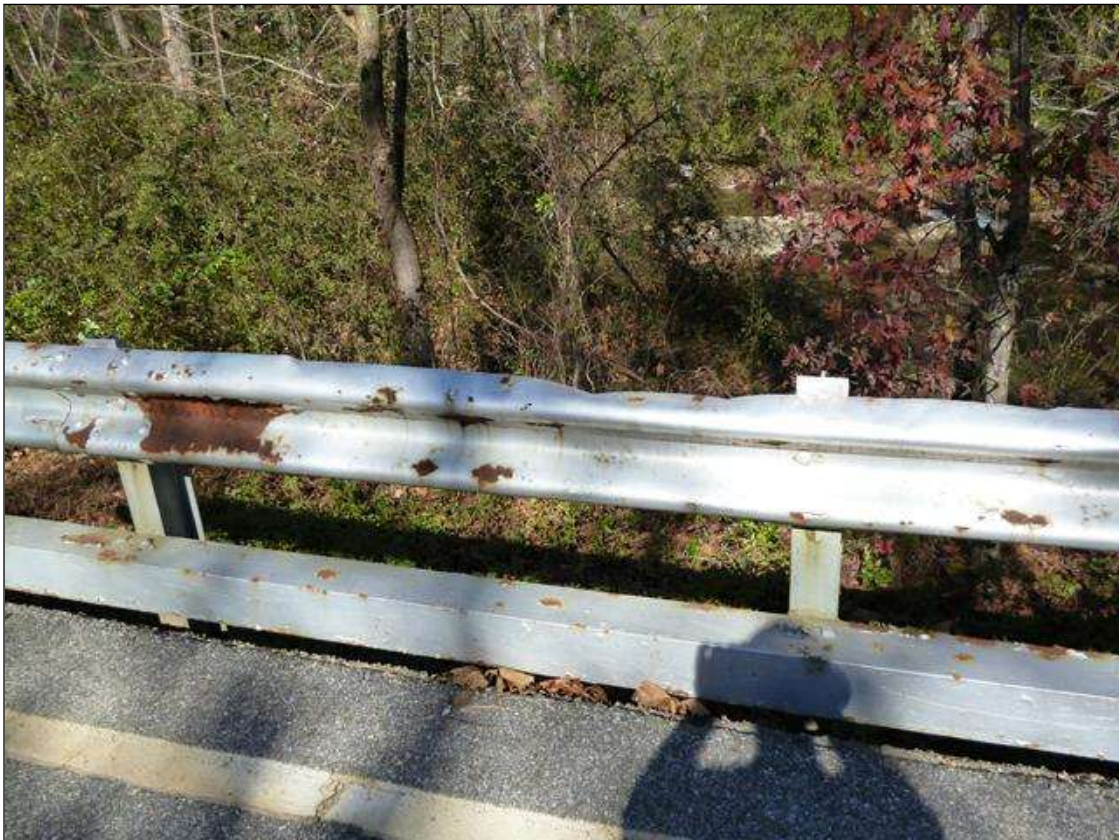
| Bridge I&A Form 1(82)H<br>State of North Carolina<br>Dept. of Transportation<br>Division of Highways | | <b>FIELD INSPECTION REPORT</b><br><u>Bridge Inspection &amp; Analysis</u> | |
|---|---|---|--|
| 3d | F | 4' IMPACT DAMAGE ON NORTH BRIDGE RAIL, 10' FROM END BENT 1, SPAN 1.<br>PAINT PEELING AND FLAKING THROUGHOUT BOTH RAILS AND RAIL POSTS UP TO 50%. | |

4' IMPACT DAMAGE ON NORTH BRIDGE RAIL, 10' FROM END BENT 1, SPAN 1.

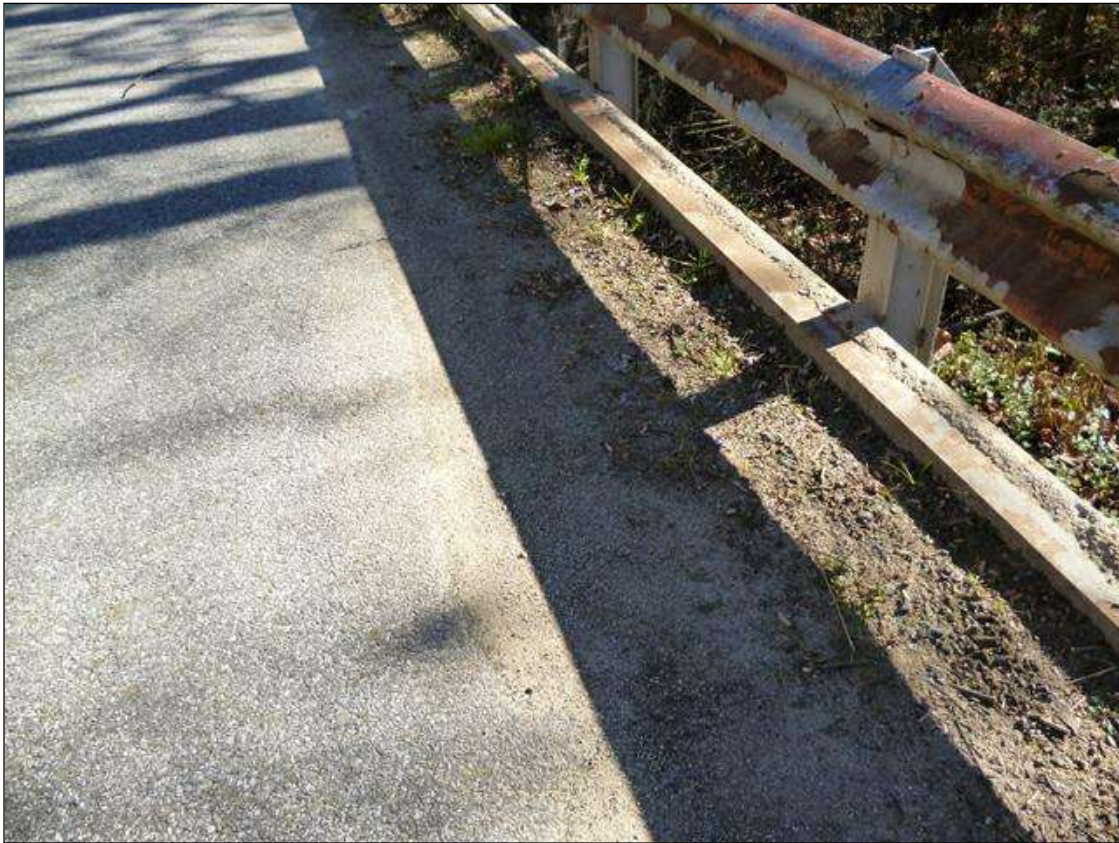
DIRT AND DEBRIS ALONG BOTH CURBS UP TO 2' WIDE.

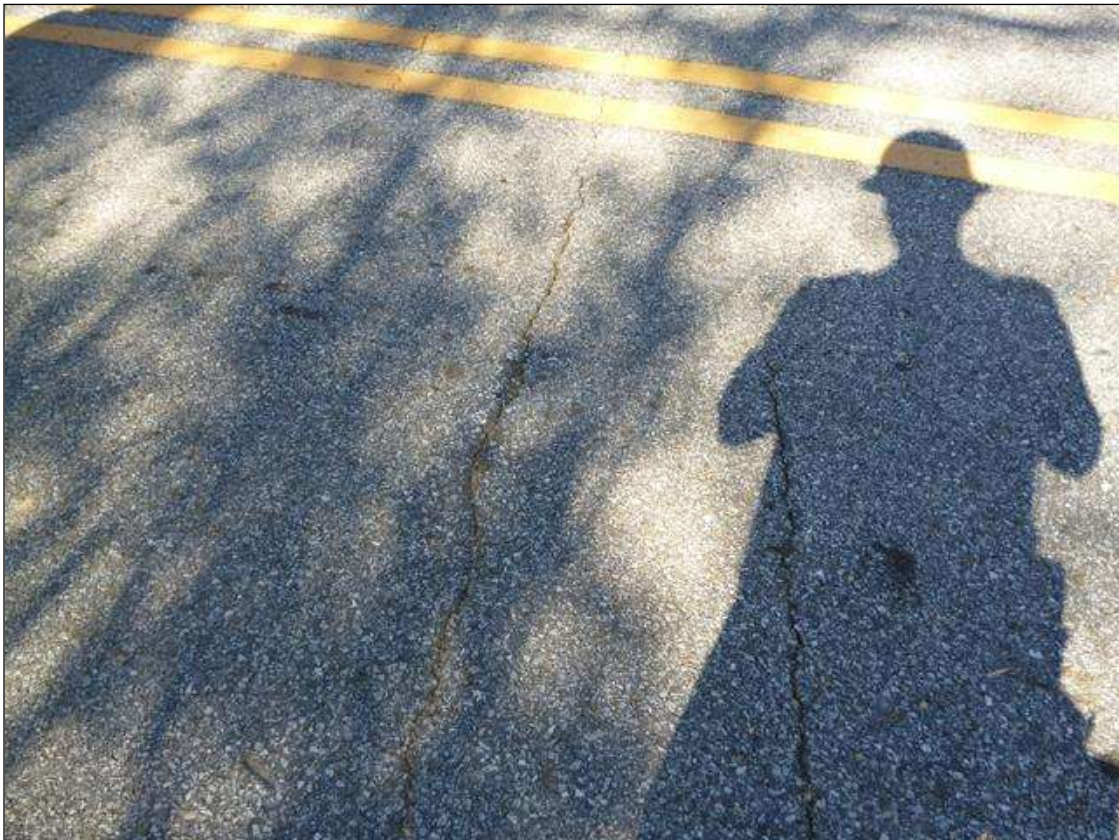
(3) 12' LONG TRANSVERSE CRACKS UP TO 1/4" IN ASPHALT WEARING SURFACE OVER BENT 1. (BENT 2 SIMILAR)

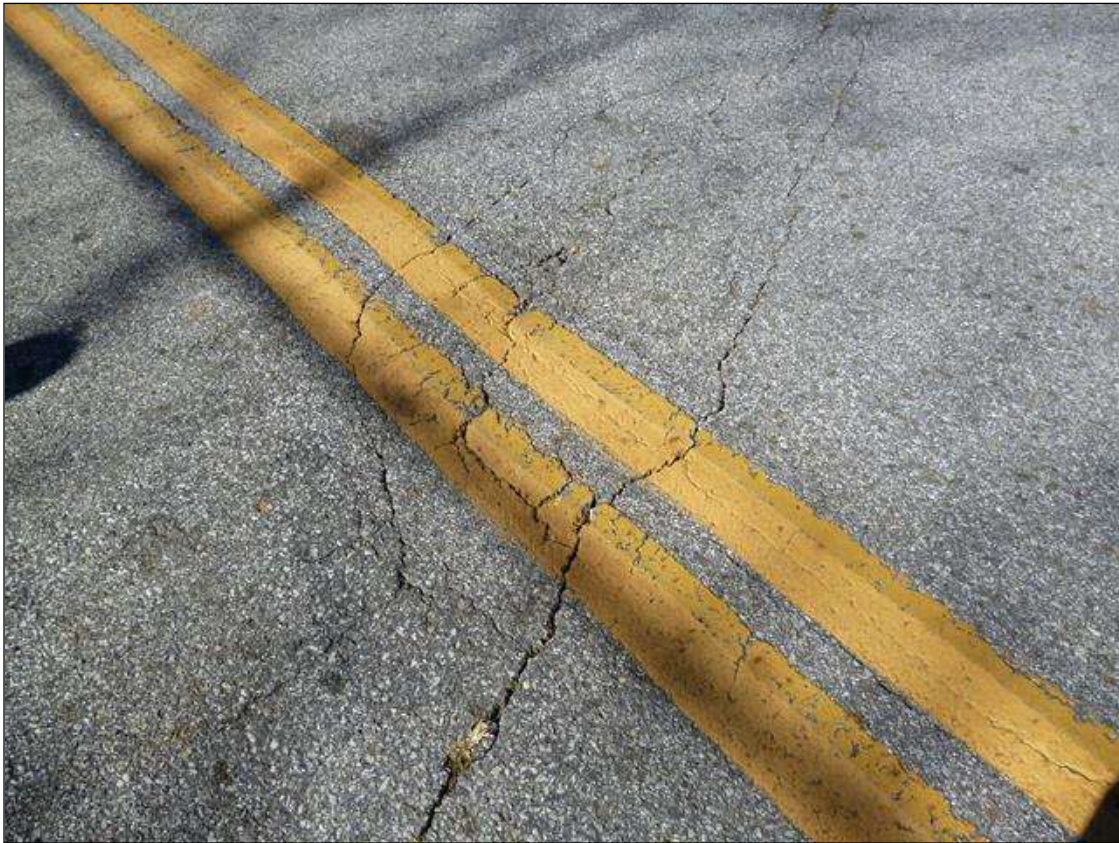
32" X 6' AREA OF SETTLEMENT UP TO 1" AND POT HOLE IN ASPHALT WEARING SURFACE AT CENTERLINE OF BRIDGE, OVER END BENT 1.

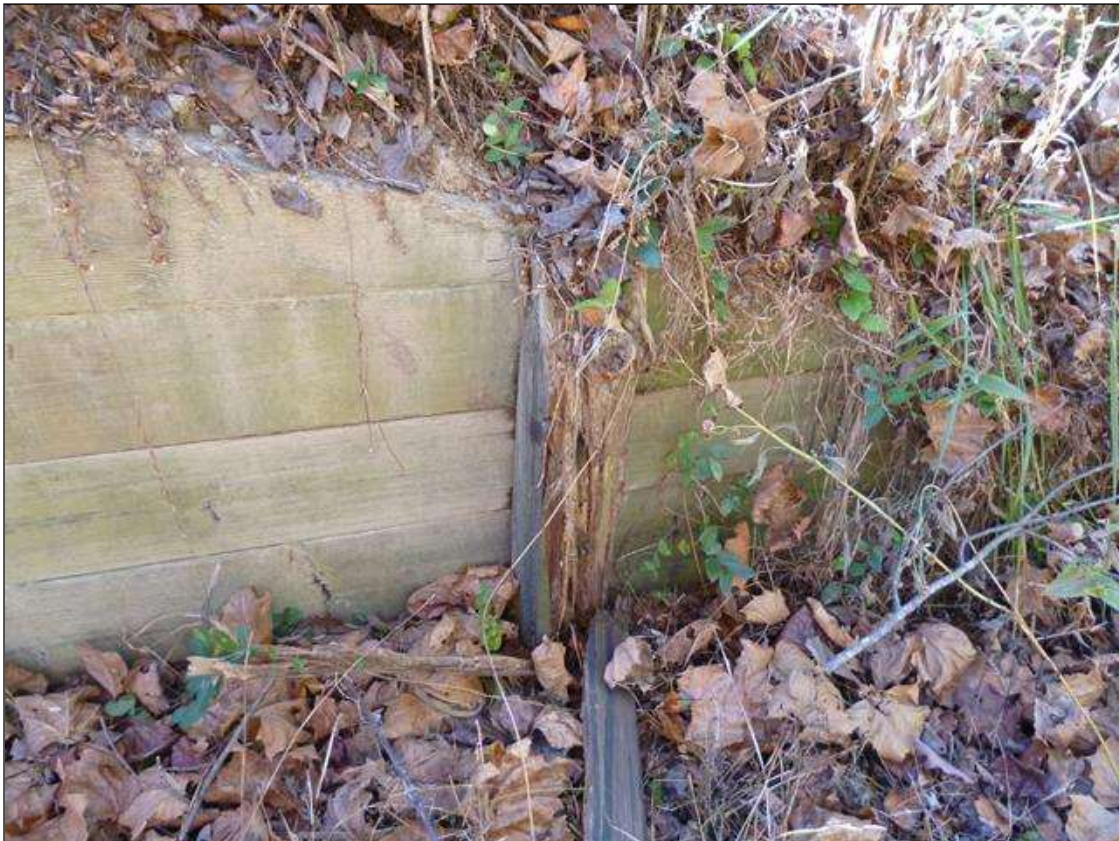
NORTHWEST WINGWALL PILE COMPLETELY DECAYED ABOVE GROUND.

| MMS Code | Description of Function | Unit | Quantity | Remarks | Est. Cost |
|---|---|---|---|---|---|
| 3346 | Repair / Maintain Timber Wings & Blkhds | SF | 75 | REPAIR DECAYED BULKHEADS AND WINGWALLS | |

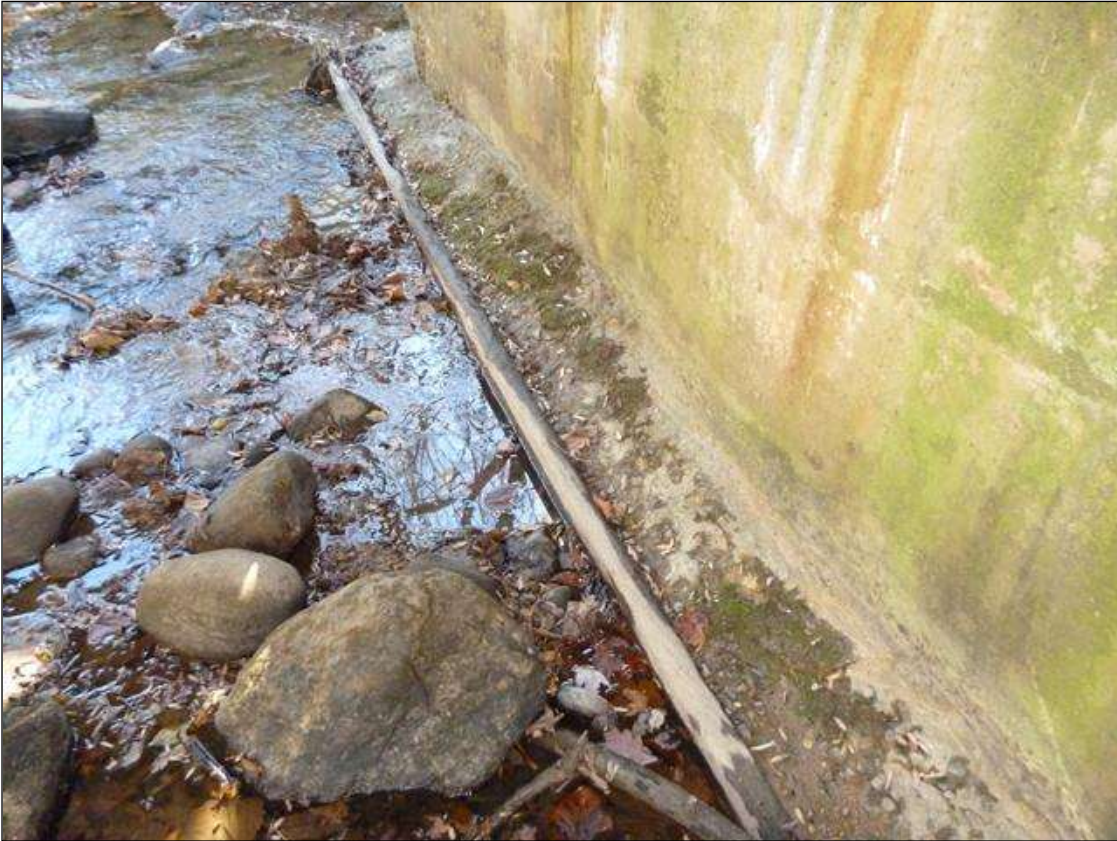
16' OF BENT 1 FOOTING EXPOSED WITH HEAVY SCALE AT DOWNSTREAM END.

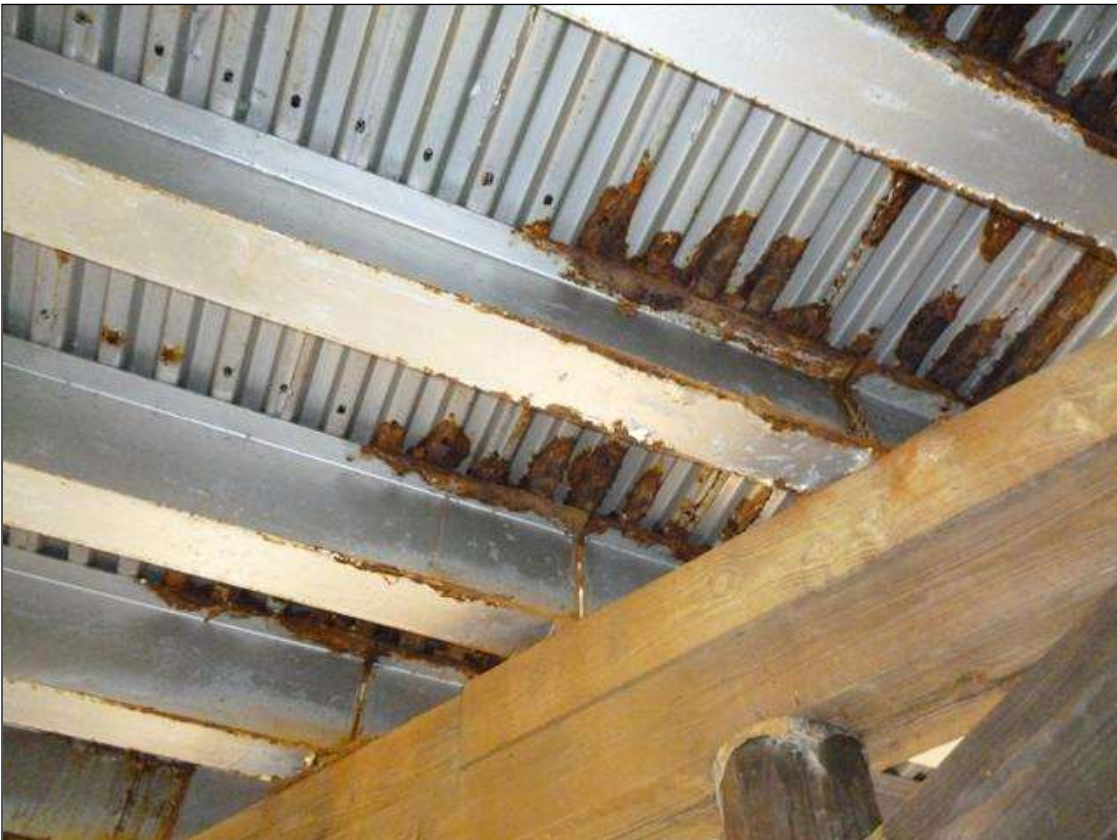
RANDOM SURFACE RUST WITH SCALE UNDERSIDE OF STEEL PLANK DECK OVER BENT 1 WITH SOME SECTION LOSS. (SIMILAR OVER BENT 2).

| MMS Code | Description of Function | Unit | Quantity | Remarks | Est. Cost |
|---|---|---|---|---|---|
| 3328 | Maintenance/Repair/ Replace Steel Plank Bridge Floor | SF | 200 | REPAIR RUSTED STEEL PLANK DECK ALONG EXTERIOR BEAMS AND ALONG END BENTS | |

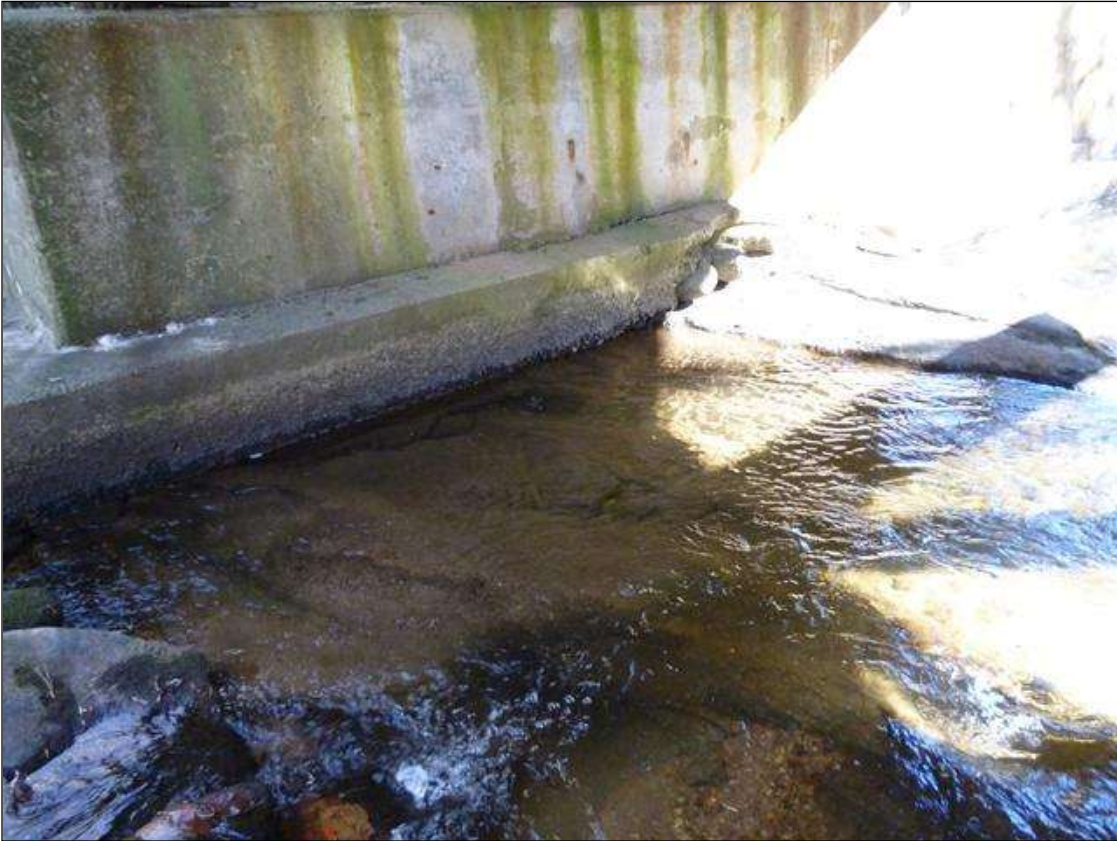
FULL LENGTH OF BENT 2 FOOTING EXPOSED, SPAN 2 SIDE WITH UP TO 12" UNDERMINING BELOW PILE 1.

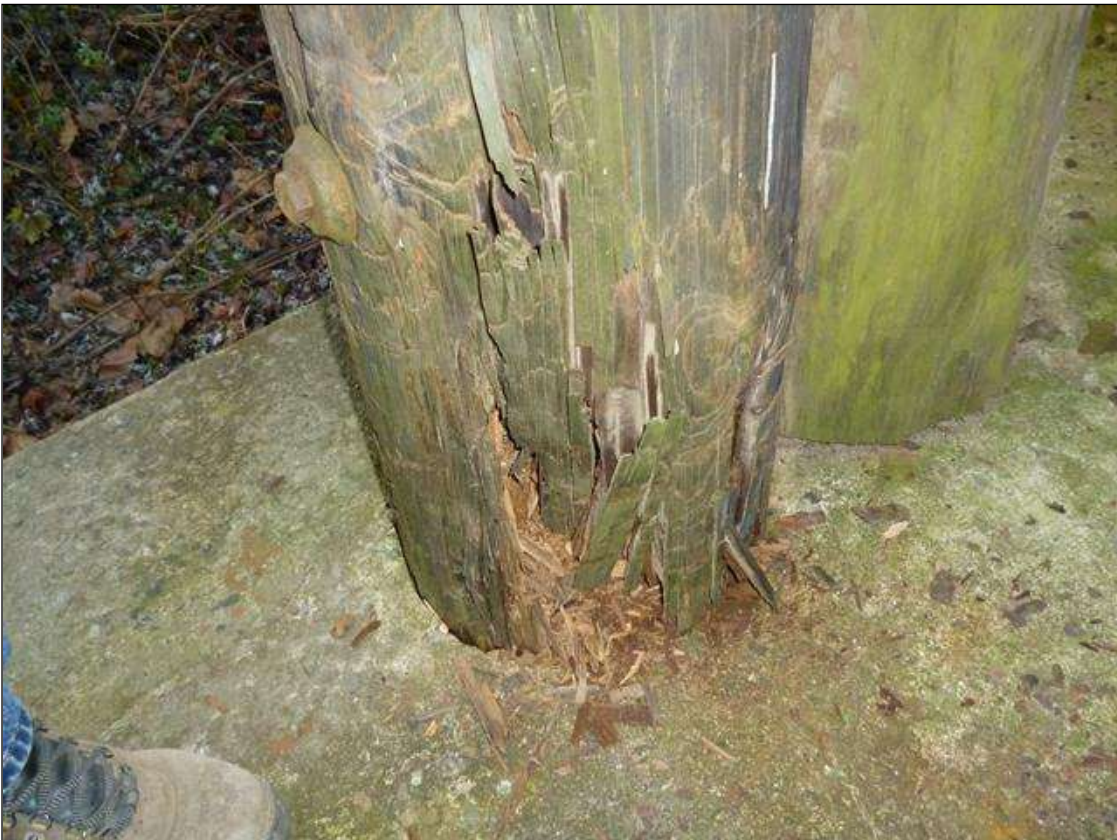
| Bridge I&A Form 1(82)H<br>State of North Carolina<br>Dept. of Transportation<br>Division of Highways | | <b>FIELD INSPECTION REPORT</b><br><u>Bridge Inspection &amp; Analysis</u> | |
|---|---|---|--|
| 35b | F | BOTTOM 2' OF PILE 1 AT BENT 2 IS COMPLETELY DECAYED. (NEW PILE HAS BEEN ADDED NEXT TO PILE 1) | |

BOTTOM 2' OF PILE 1 AT BENT 2 IS COMPLETELY DECAYED.

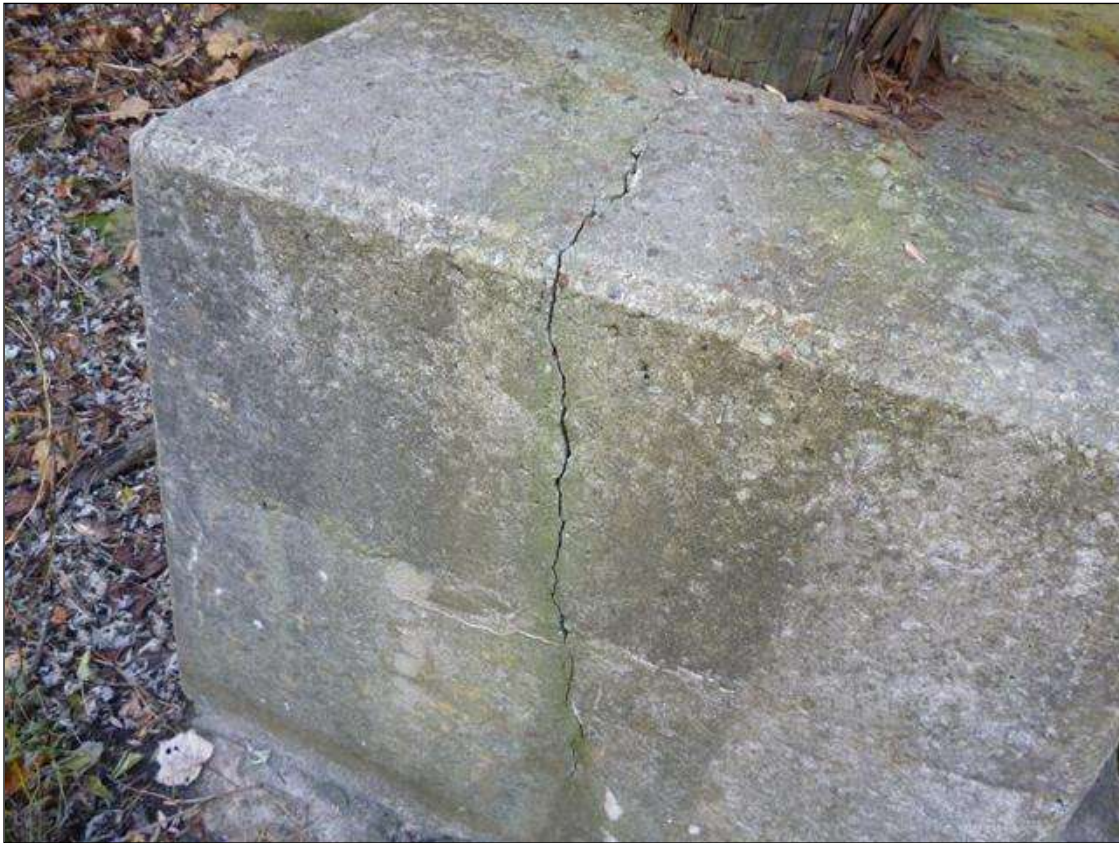
FULL HEIGHT VERTICAL CRACK UP TO 1/8" ON NORTH END OF BENT 2 SILL, EXTENDS ON TOP TO PILE 1.
