NC DEPARTMENT OF TRANSPORTATION  
DIVISION OF HIGHWAYS  
BRIDGE MANAGEMENT UNIT

# BRIDGE INSPECTION REPORT

COUNTY WILKES BRIDGE NUMBER 960106 INSPECTION CYCLE 0 YRS

ROUTE SR1300 ACROSS N.PRONG LEWIS FORK CREEK M.P. 0

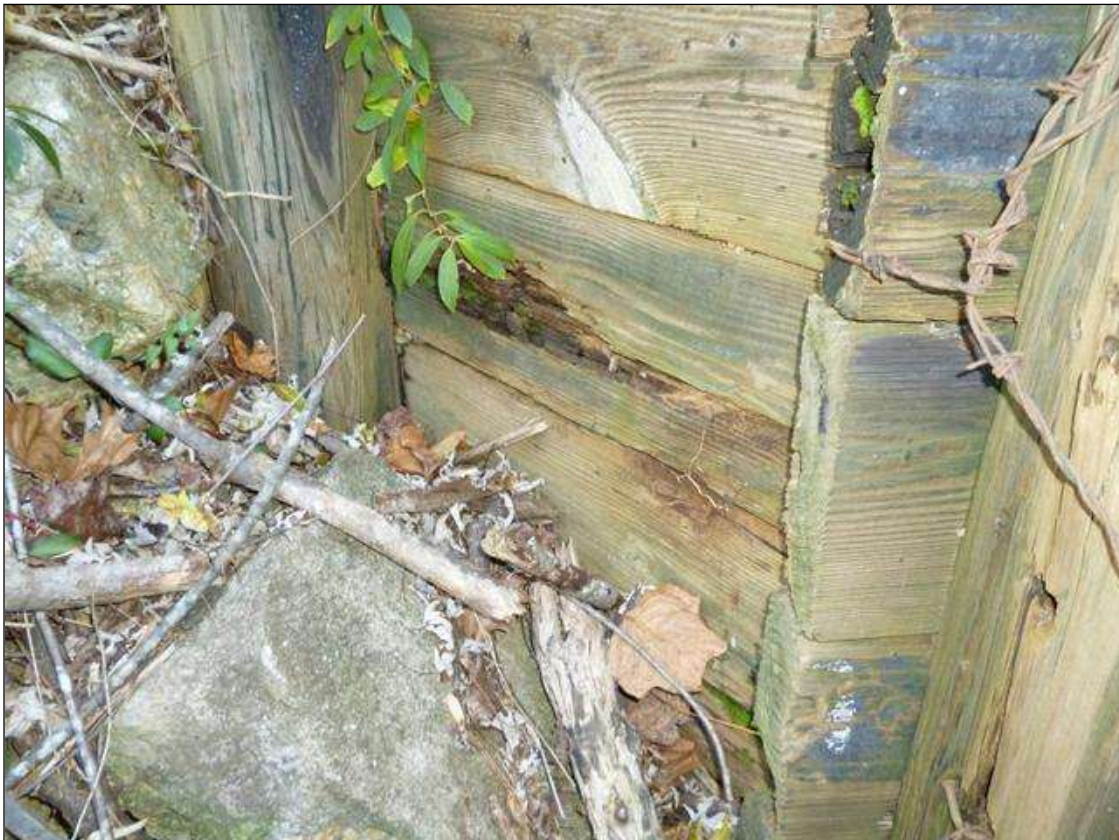
2' X 2' AREA OF DECAY, BOTTOM OF NORTHEAST WINGWALL.

| MMS Code | Description of Function | Unit | Quantity | Remarks | Est. Cost |
|---|---|---|---|---|---|
| 3346 | Repair / Maintain Timber Wings & Blkhds | SF | 75 | REPAIR DECAYED BULKHEADS AND WINGWALLS | |

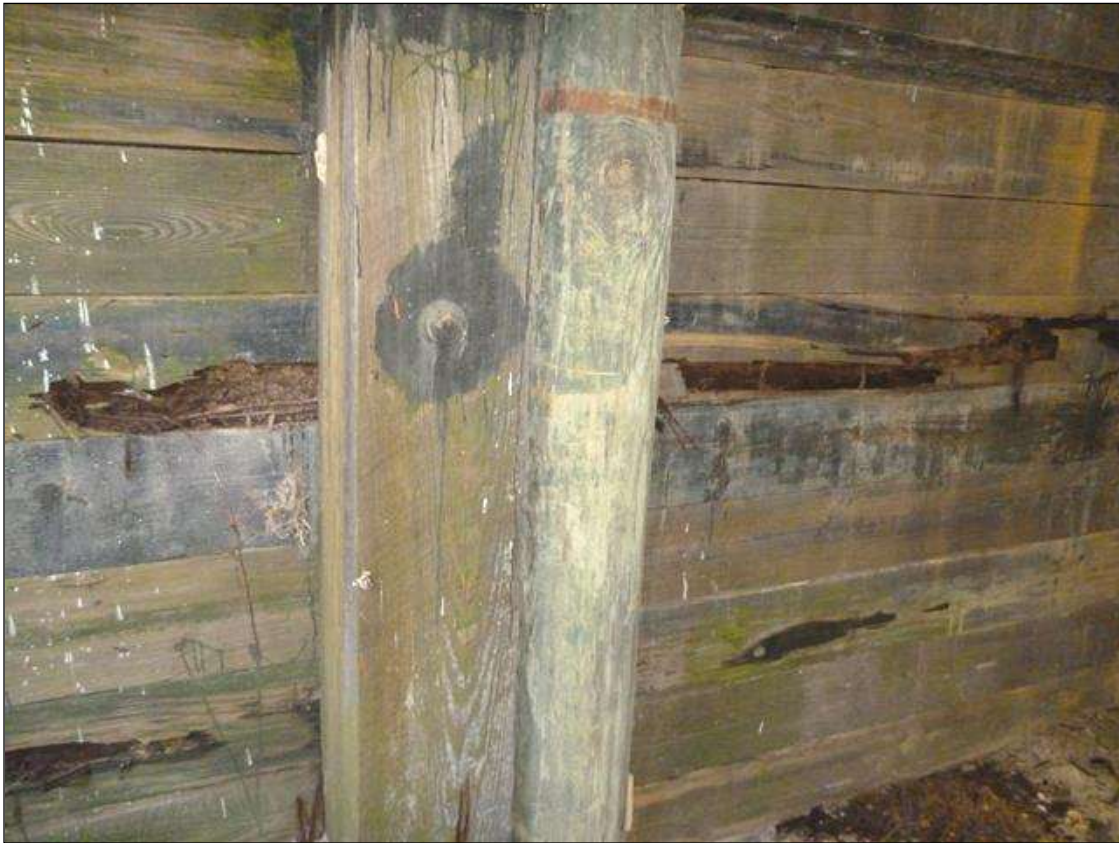
11' X 8" DECAY BEHIND PILE 1 IN END BENT 2 BULKHEAD, 3RD BOARD BELOW CAP

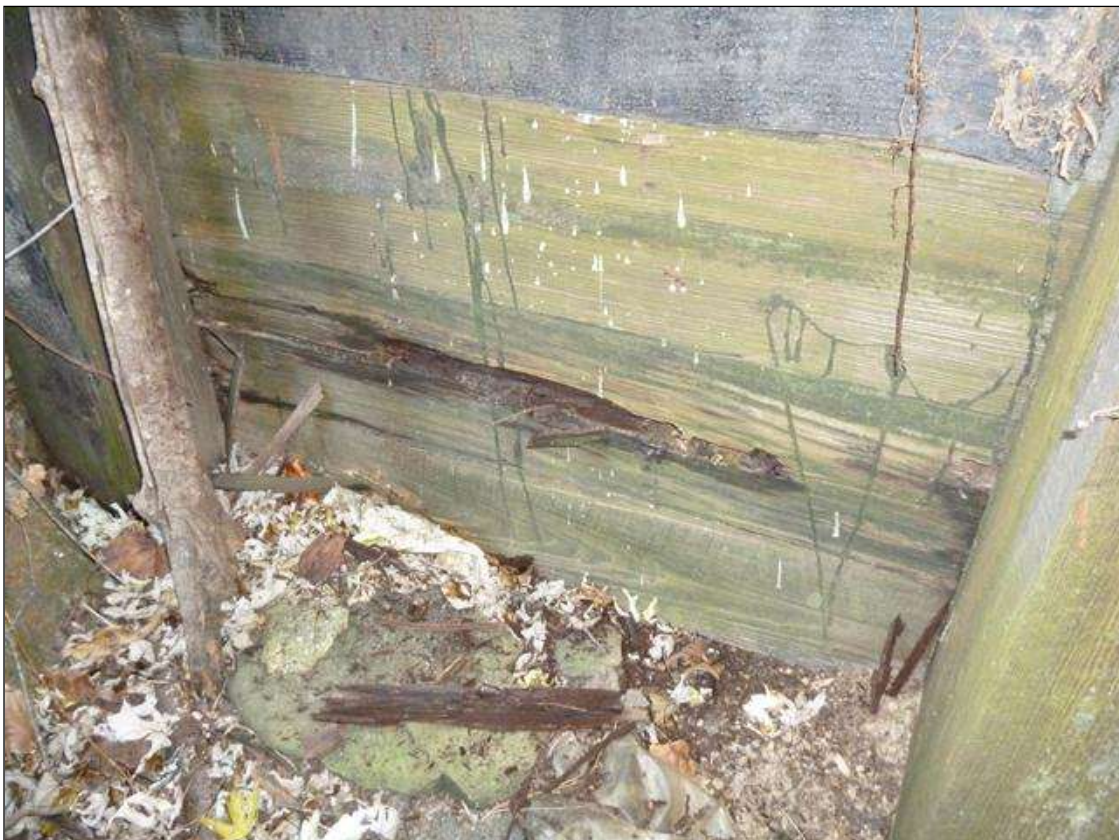
3' X 8" AREA OF DECAY IN END BENT 2 BULKHEAD OUTSIDE OF PILE 1, 6TH BOARD BELOW CAP.

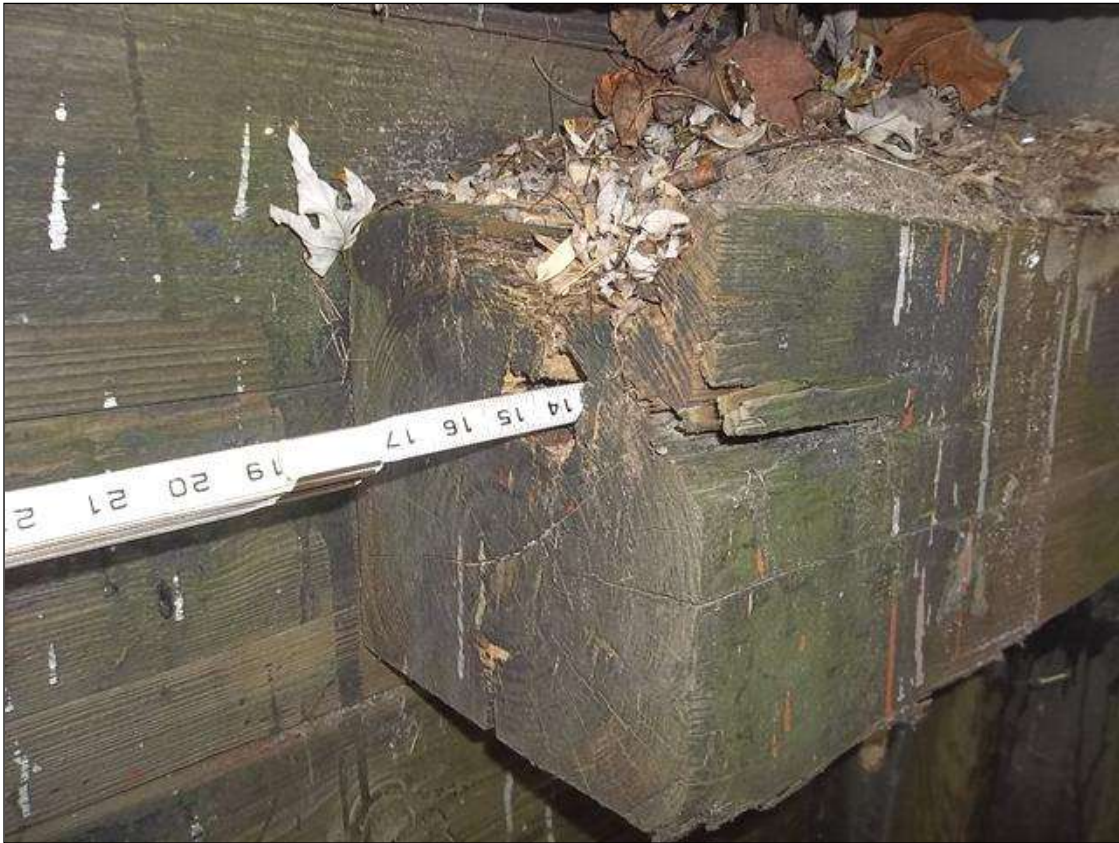
| Bridge I&A Form 1(82)H<br>State of North Carolina<br>Dept. of Transportation<br>Division of Highways | | <b>FIELD INSPECTION REPORT</b><br><u>Bridge Inspection &amp; Analysis</u> | |
|---|---|---|--|
| 35a | F | END BENT 2 CAP HAS END DECAY ON NORTH END UP TO 14" DEEP. | |

END BENT 2 CAP HAS END DECAY ON NORTH END UP TO 14" DEEP.

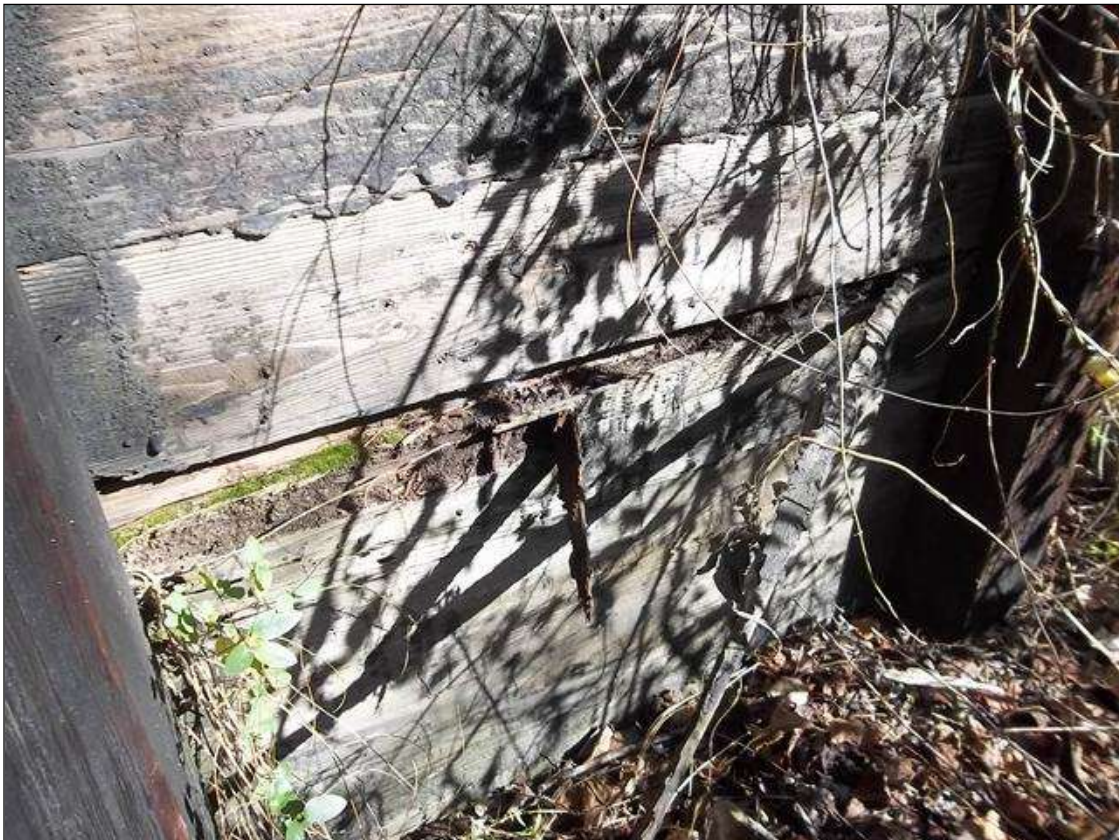
4' X 8" AREA OF DECAY IN END BENT 2 BULKHEAD OUTSIDE PILE 8, 9TH BOARD DOWN.

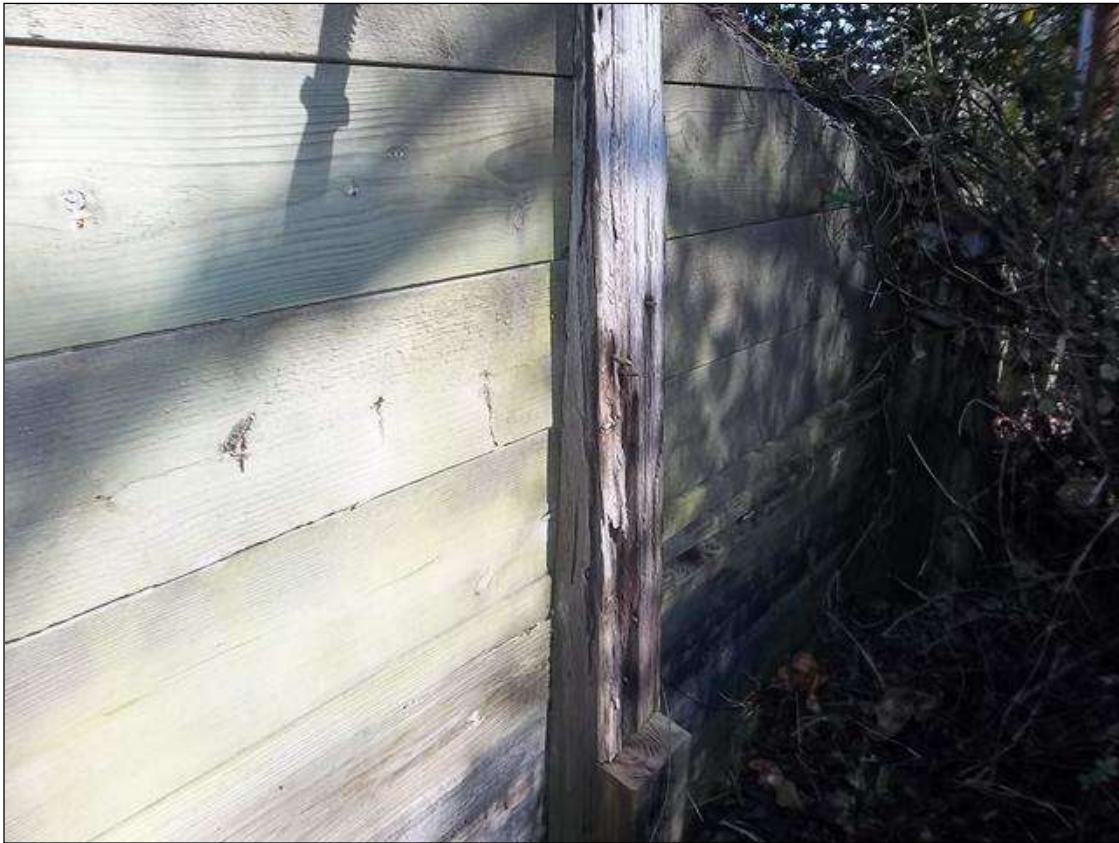
TOP 3' OF PILE 2 IN SOUTHEAST WINGWALL IS SPLIT OFF.

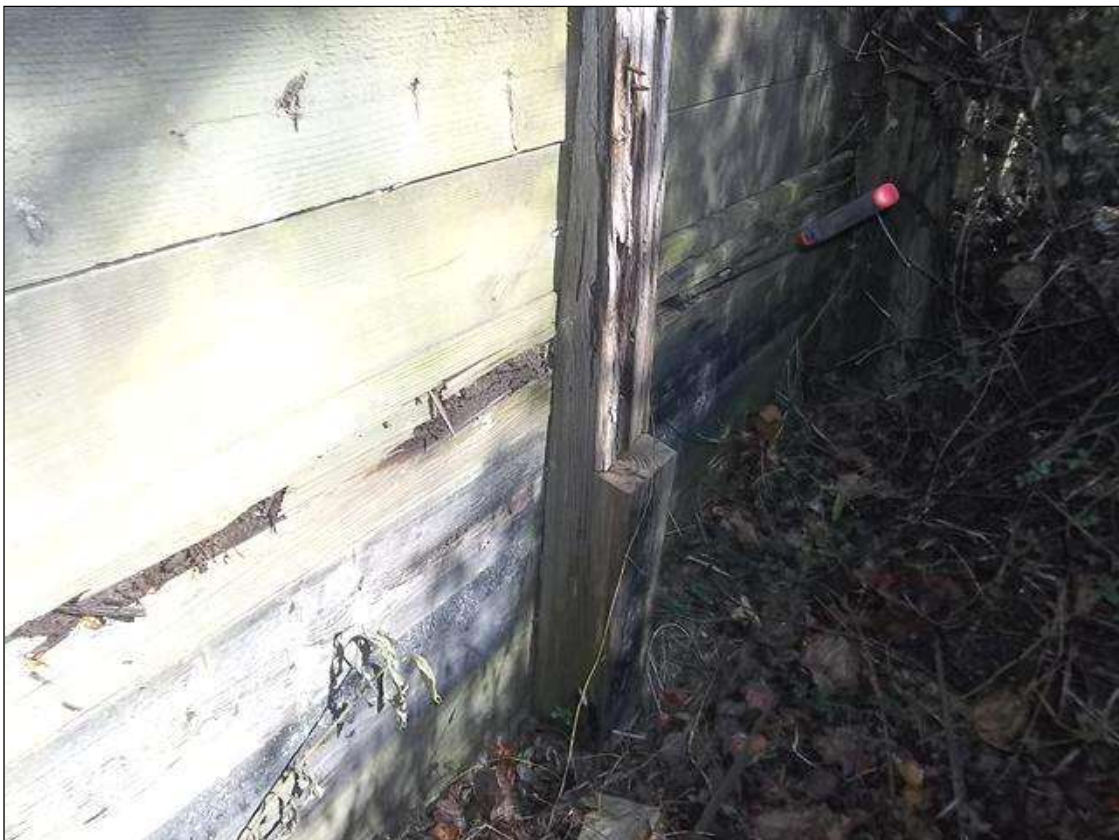
7' X 8" AREA OF DECAY IN SOUTHEAST WINGWALL, 7TH BOARD DOWN.

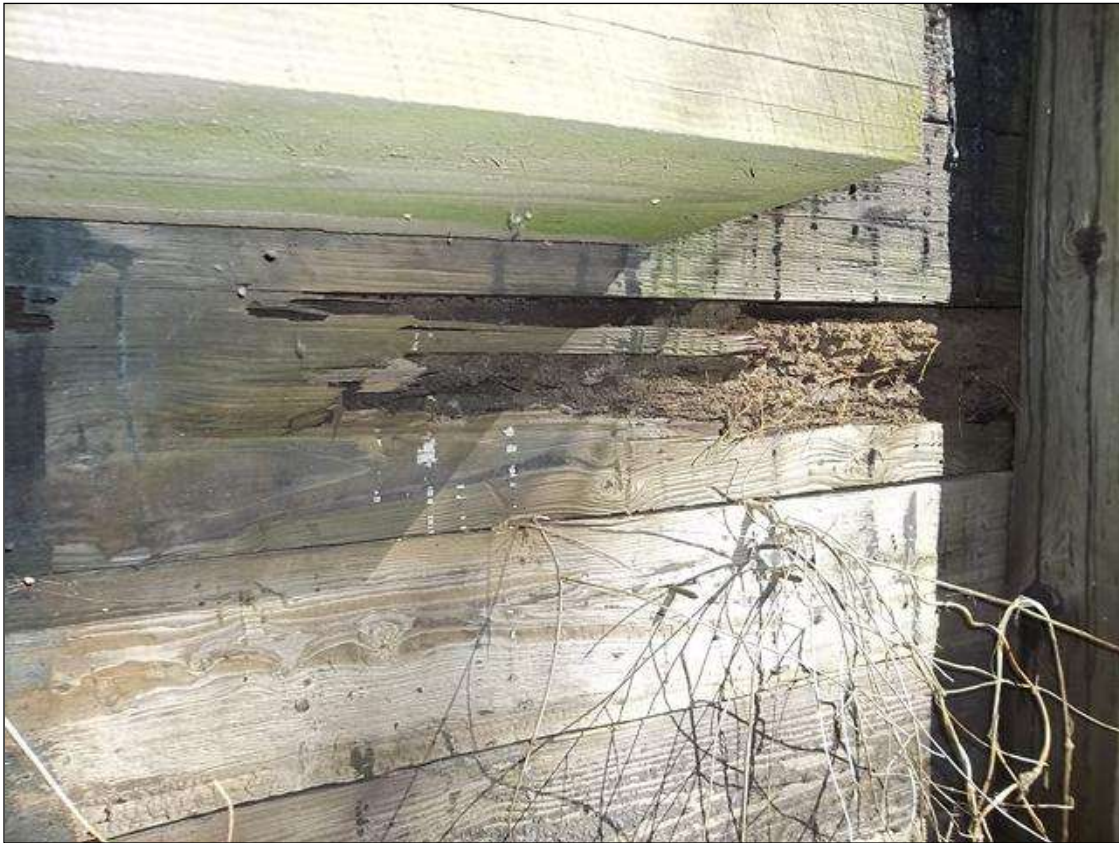
4' X 8" AREA OF DECAY IN END BENT 2 BULKHEAD OUTSIDE PILE 8, 5TH BOARD DOWN.

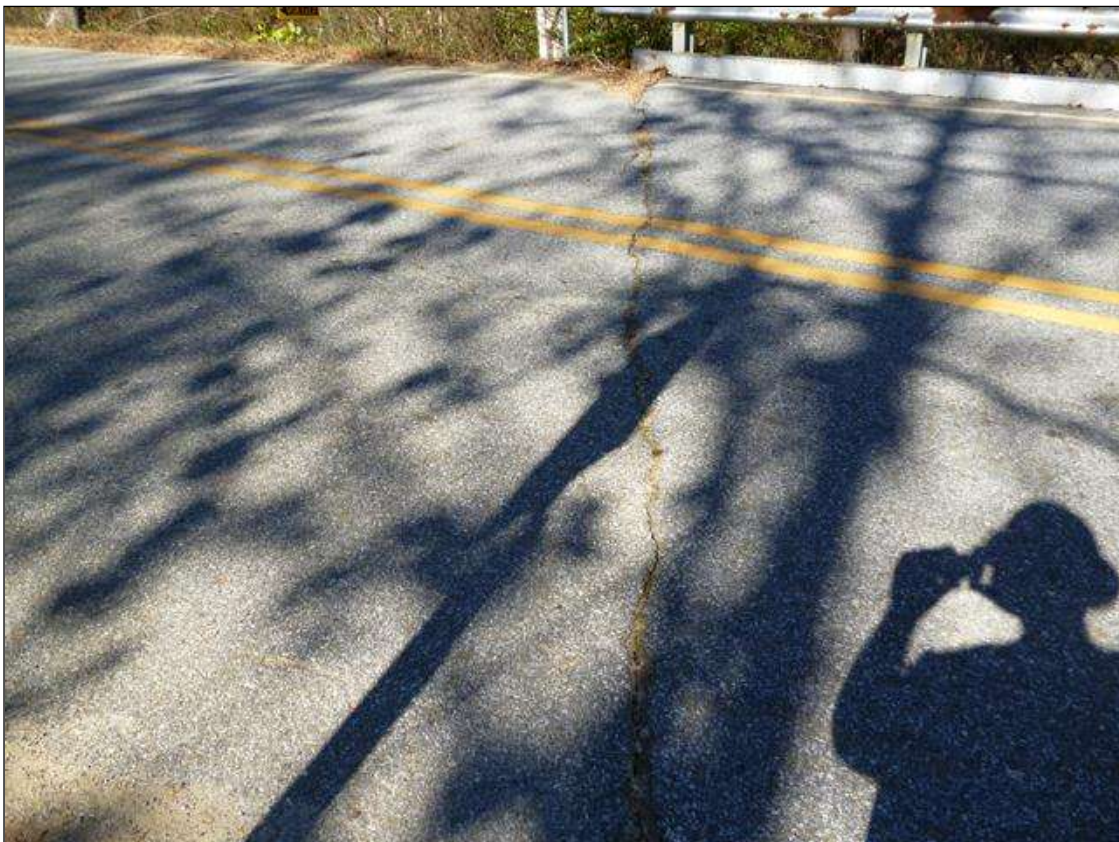
CRACK IN ASPHALT WEARING SURFACE OVER END BENT 1, LOOKING NORTH

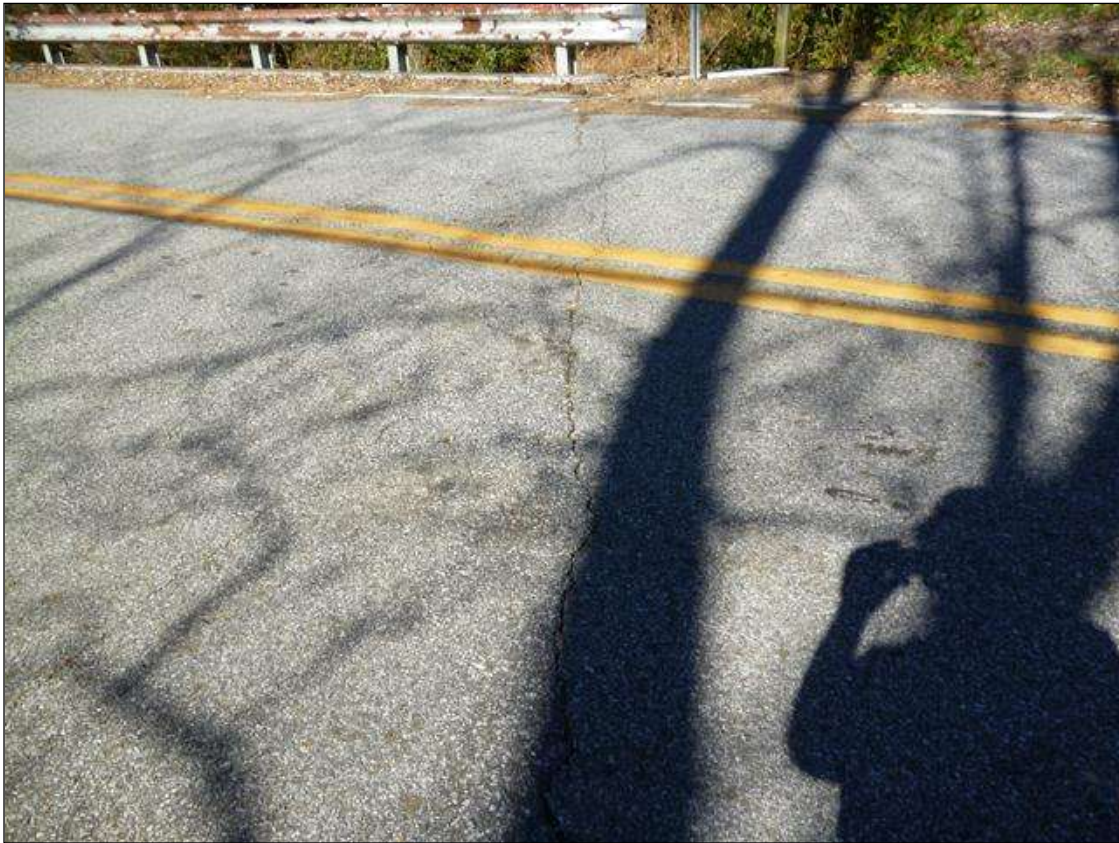
CRACK IN ASPHALT WEARING SURFACE OVER END BENT 2, LOOKING NORTH

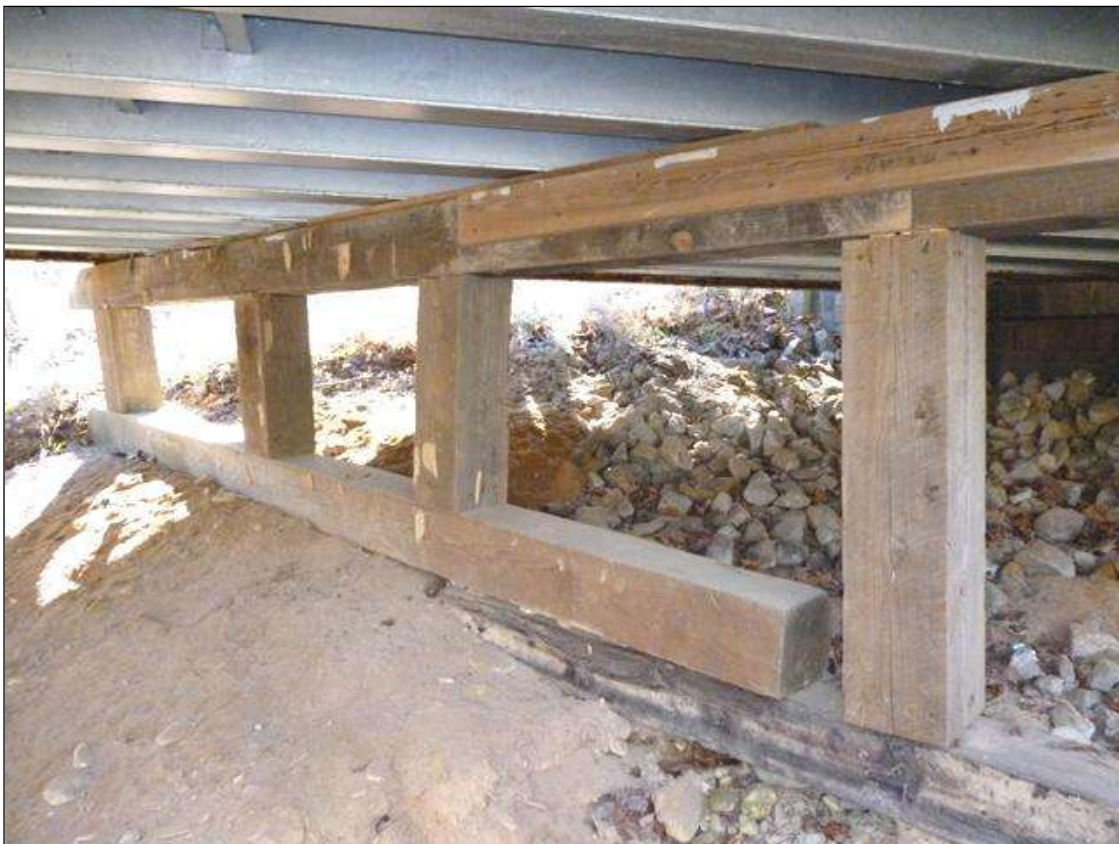
TEMPORARY BENT, MID SPAN 1 (NOT IN CONTACT WITH BEAMS)

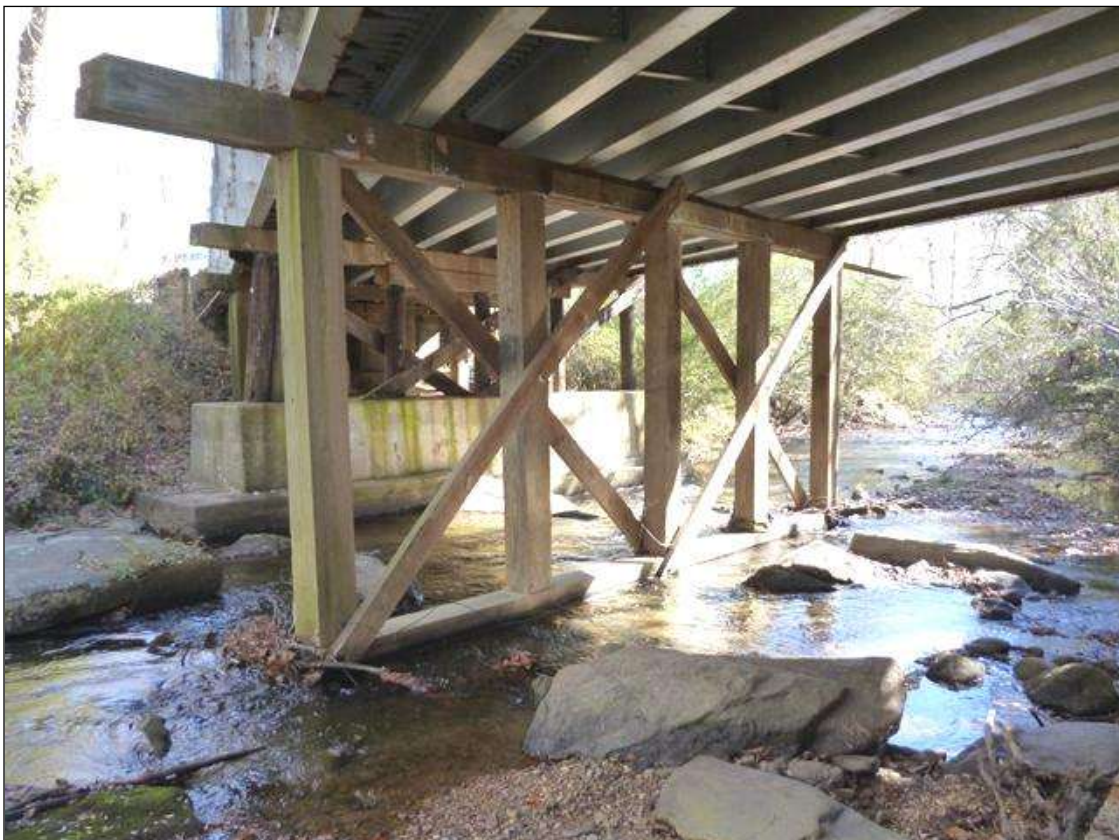
TEMPORARY BENT, MID SPAN 2 (NOT IN CONTACT WITH BEAMS)

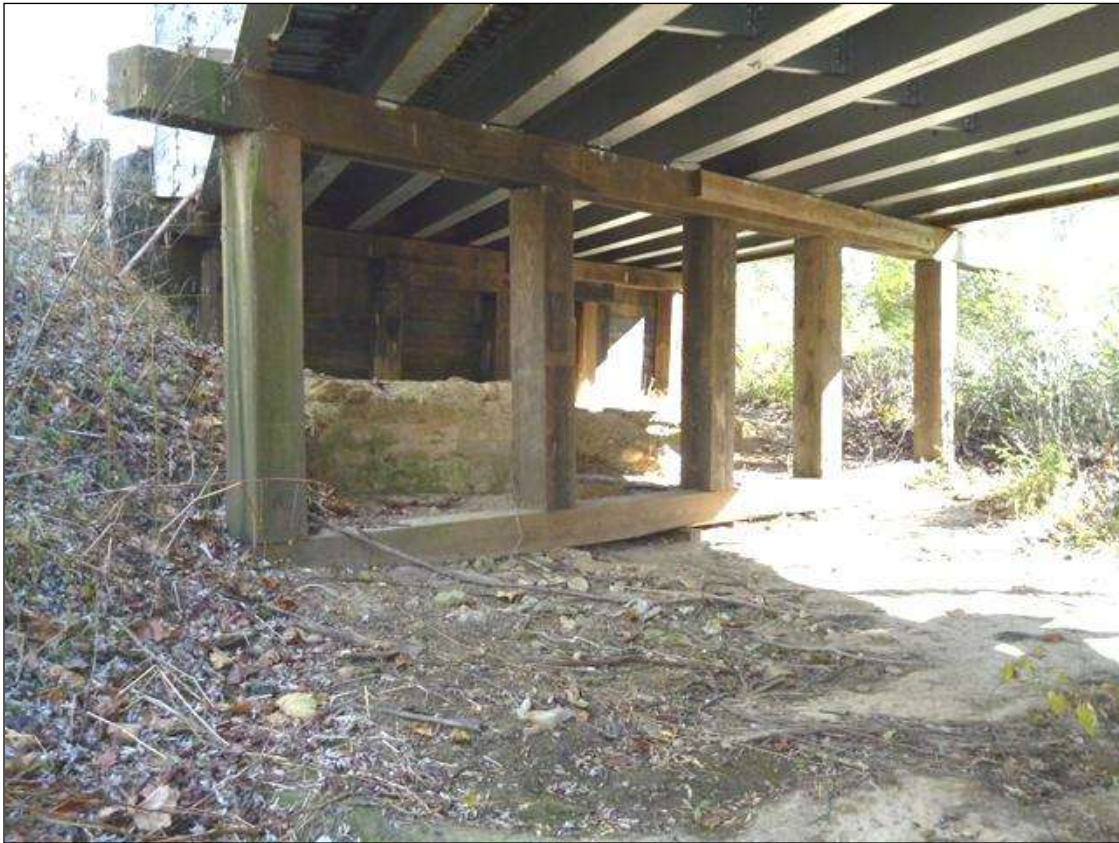
TEMPORARY BENT, MID SPAN 3 (NOT IN CONTACT WITH BEAMS)
