NC DEPARTMENT OF TRANSPORTATION  
DIVISION OF HIGHWAYS  
BRIDGE MANAGEMENT UNIT

# BRIDGE INSPECTION REPORT

COUNTY WILKES BRIDGE NUMBER 960144 INSPECTION CYCLE 0 YRS

ROUTE SR1737 ACROSS E.PRONG ROARING RIVER M.P. 0

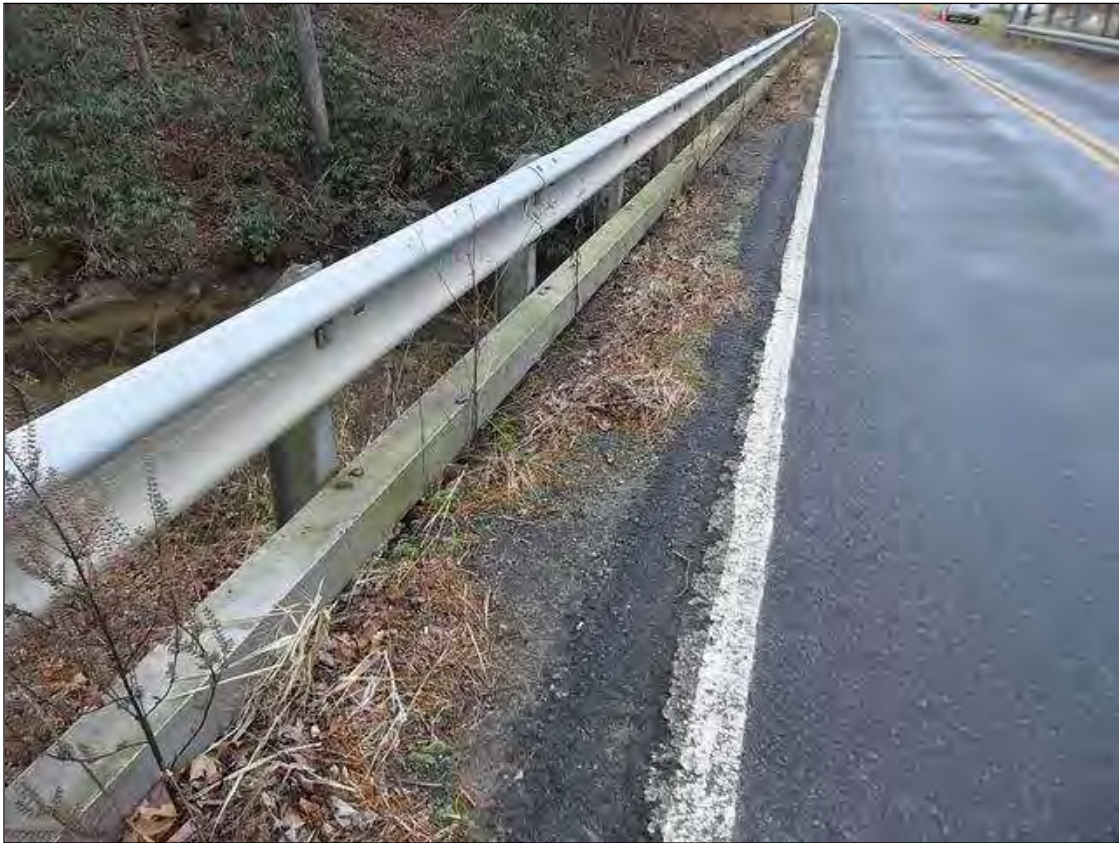
| Bridge I&A Form 1(82)H<br>State of North Carolina<br>Dept. of Transportation<br>Division of Highways | | <h1 style="text-align: center;">FIELD INSPECTION REPORT</h1> <p style="text-align: center;"><u>Bridge Inspection &amp; Analysis</u></p> | |
|---|---|---|--|
| 7 | F | DEBRIS AND VEGETATION GROWING ALONG BOTH CURBS UP TO 2' WIDE. | |

DEBRIS AND VEGETATION GROWING ALONG BOTH CURBS UP TO 2' WIDE.

| MMS Code | Description of Function | Unit | Quantity | Remarks | Est. Cost |
|---|---|---|---|---|---|
| 3376 | Clean/Wash Bridge Decks | SF | 540 | REMOVE VEGETATION AND DEBRIS ALONG BOTH CURBS. | |

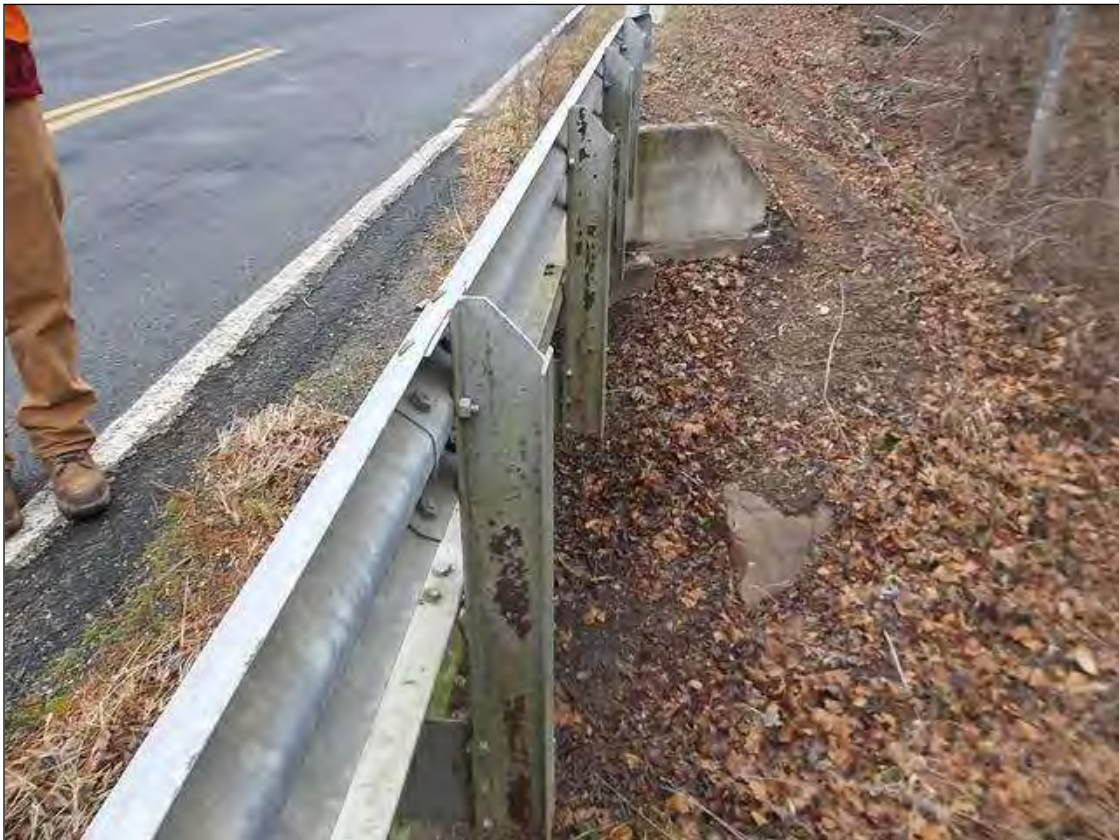
RANDOM PAINT PEELING AND FLAKING ON NORTH BRIDGE RAIL POSTS UP TO 20%. (SOUTH BRIDGE RAIL SIMILAR)

| MMS Code | Description of Function | Unit | Quantity | Remarks | Est. Cost |
|---|---|---|---|---|---|
| 3322 | Maint to Steel Handrail | LF | 270 | PAINT BOTH BRIDGE RAILS. | |

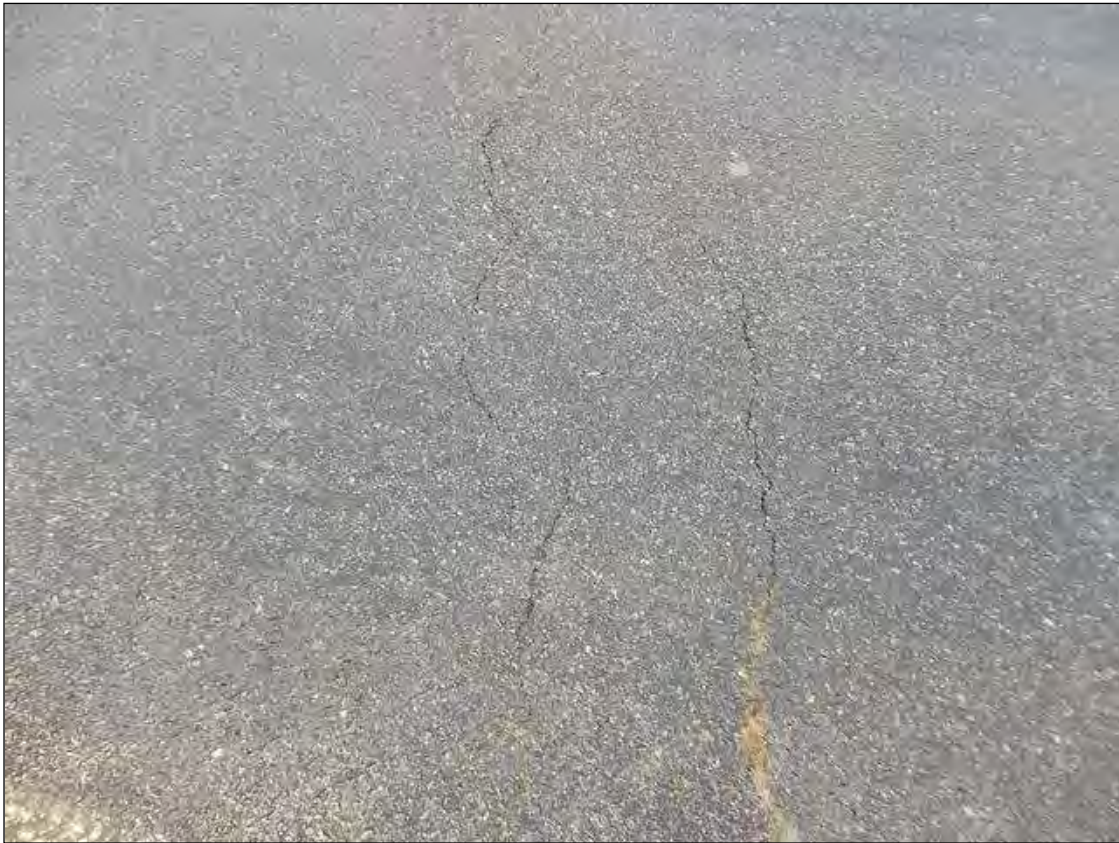
FULL WIDTH TRANSVERSE CRACKS IN ASPHALT WEARING SURFACE UP TO 1/8" OVER BENT 1. (SIMILAR OVER END BENT 1 AND END BENT 2)

| MMS Code | Description of Function | Unit | Quantity | Remarks | Est. Cost |
|---|---|---|---|---|---|
| 2816 | Asphalt Surface Repair or Replacement | SY | 100 | FULL WIDTH TRANSVERSE CRACK IN ASPHALT WEARING SURFACE UP TO 1/8" OVER BENT 1 (SIMILAR OVER END BENT 1 AND END BENT 2) | |

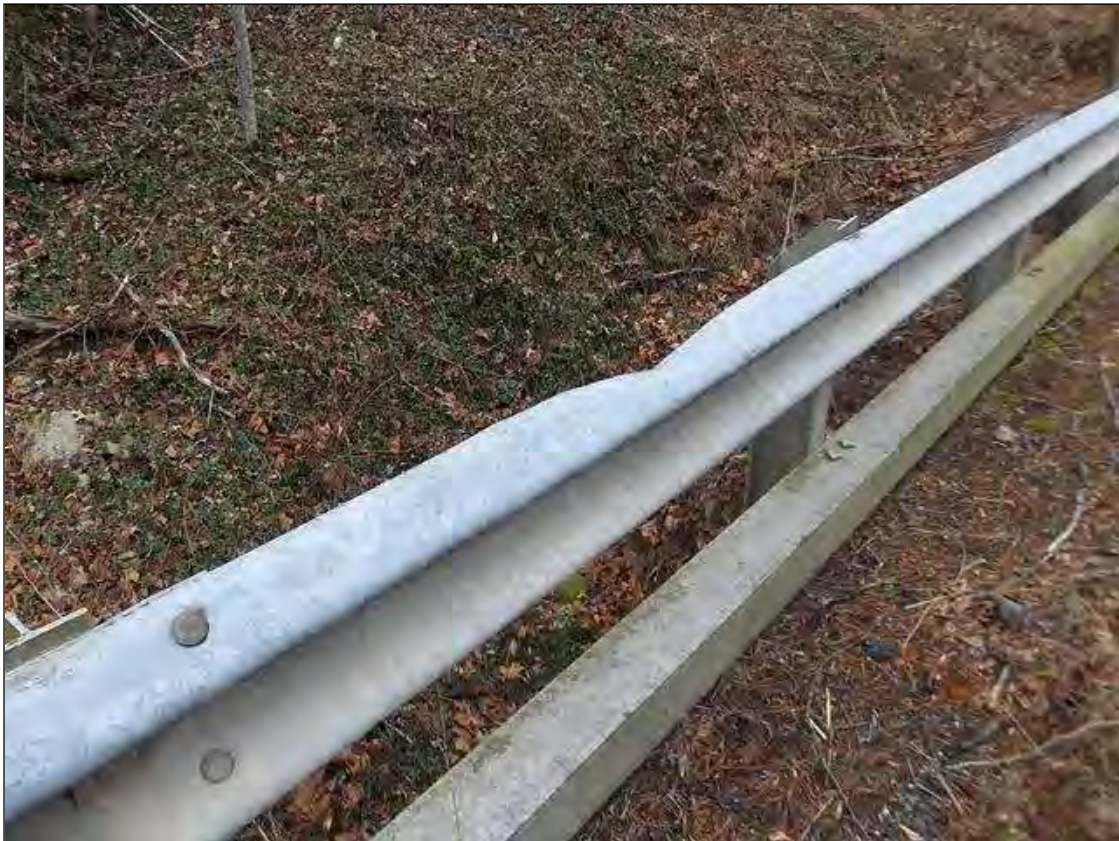
IMPACT DAMAGE ON TOP OF NORTH BRIDGE RAIL, MID-SPAN 3.

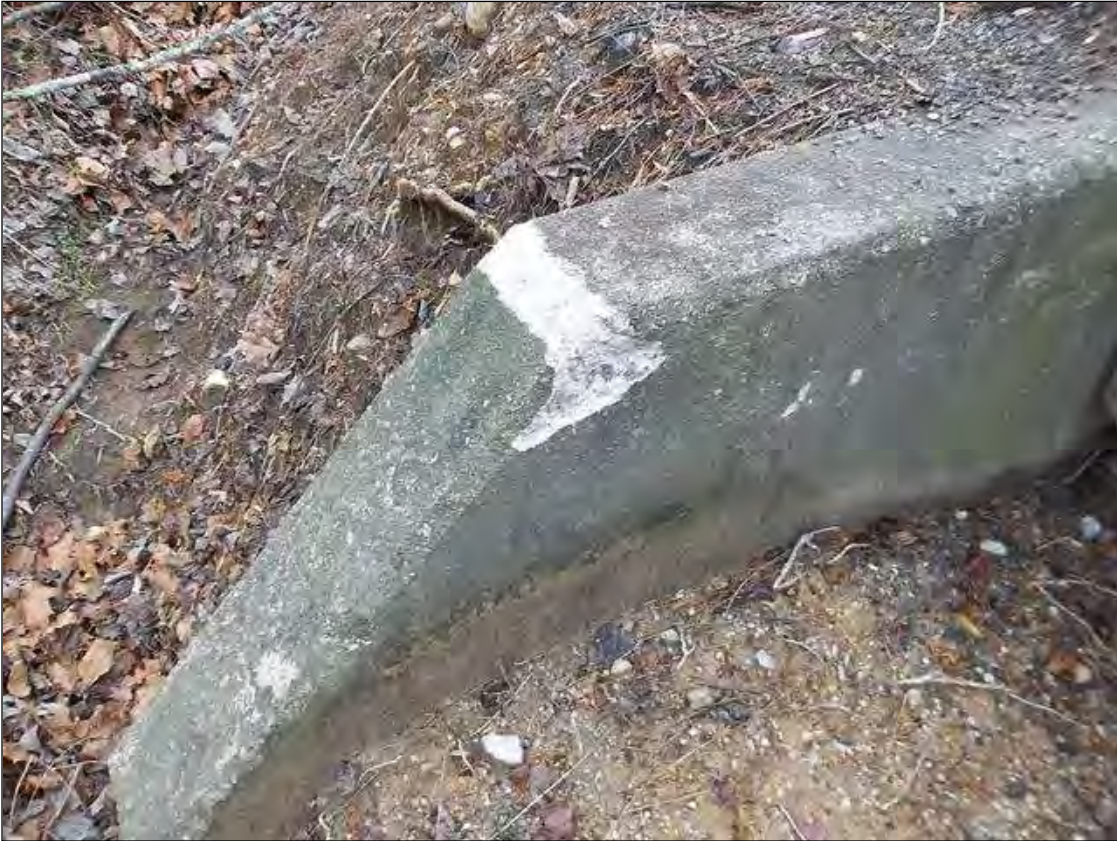
| Bridge I&A Form 1(82)H<br>State of North Carolina<br>Dept. of Transportation<br>Division of Highways | | <h1 style="text-align: center;">FIELD INSPECTION REPORT</h1> <p style="text-align: center;"><u>Bridge Inspection &amp; Analysis</u></p> | |
|---|---|---|--|
| 36d | G | 7" X 4" SPALL ON TOP OF NORTHEAST WINGWALL. | |

7" X 4" SPALL ON TOP OF NORTHEAST WINGWALL.

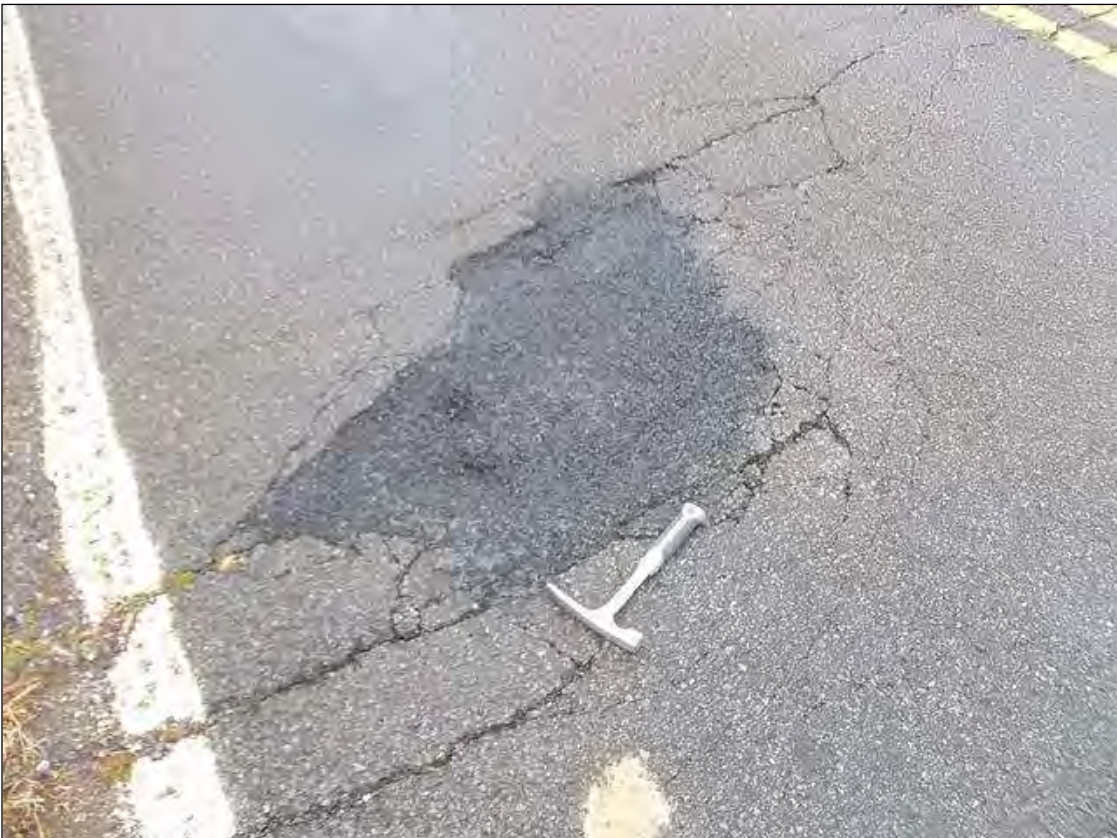
4' X 5' POT HOLE WITH PREVIOUS REPAIR AND SETTLEMENT UP TO 1-1/2" IN CENTER OF WEST BOUND LANE OVER BENT 2.

| MMS Code | Description of Function | Unit | Quantity | Remarks | Est. Cost |
|---|---|---|---|---|---|
| 2816 | Asphalt Surface Repair or Replacement | SY | 100 | 4' X 5' POT HOLE WITH PREVIOUS REPAIR AND SETTLEMENT UP TO 1-1/2" IN CENTER OF WEST BOUND LANE OVER BENT 2. | |

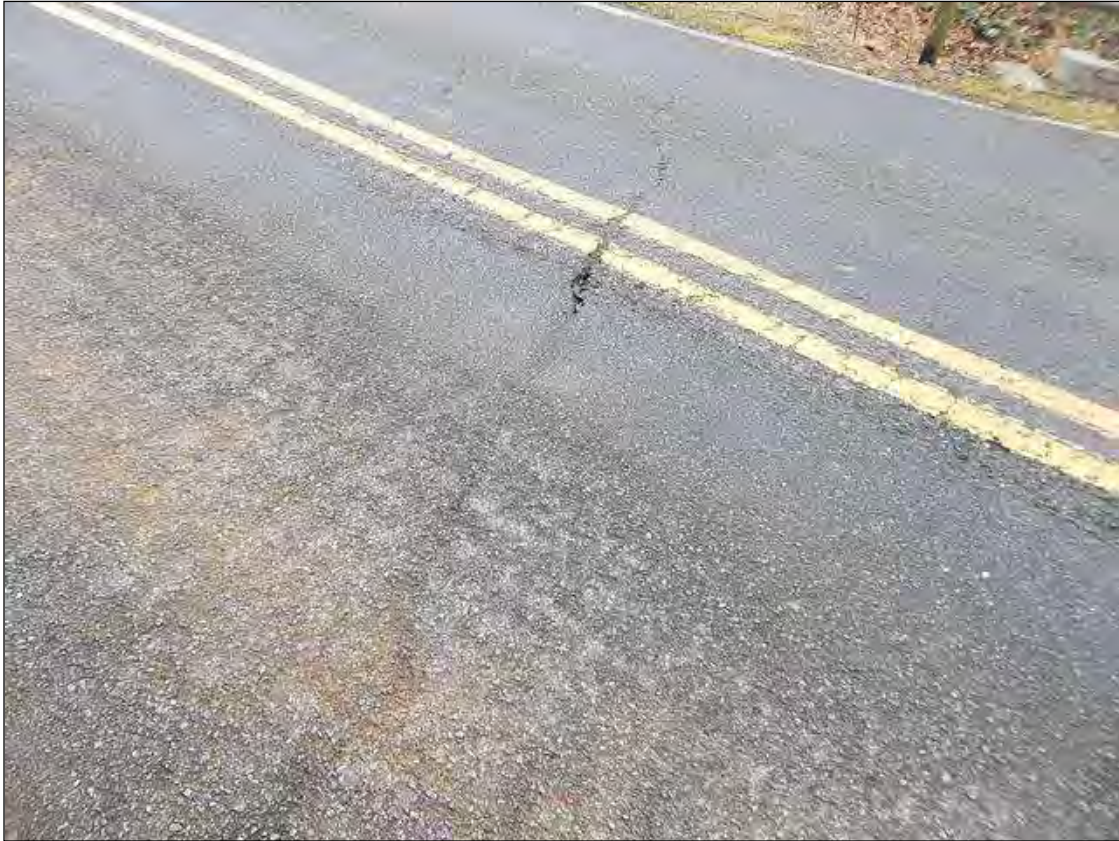
FULL WIDTH TRANSVERSE CRACK UP TO 1" IN ASPHALT WEARING SURFACE, EAST APPROACH APPROX. 7' FROM ABUTMENT 2.

| MMS Code | Description of Function | Unit | Quantity | Remarks | Est. Cost |
|---|---|---|---|---|---|
| 2816 | Asphalt Surface Repair or Replacement | SY | 100 | FULL WIDTH TRANSVERSE CRACK UP TO 1" IN ASPHALT WEARING SURFACE EAST APPROACH APPROXIMATLY 7' FROM ABUTMENT 2 | |

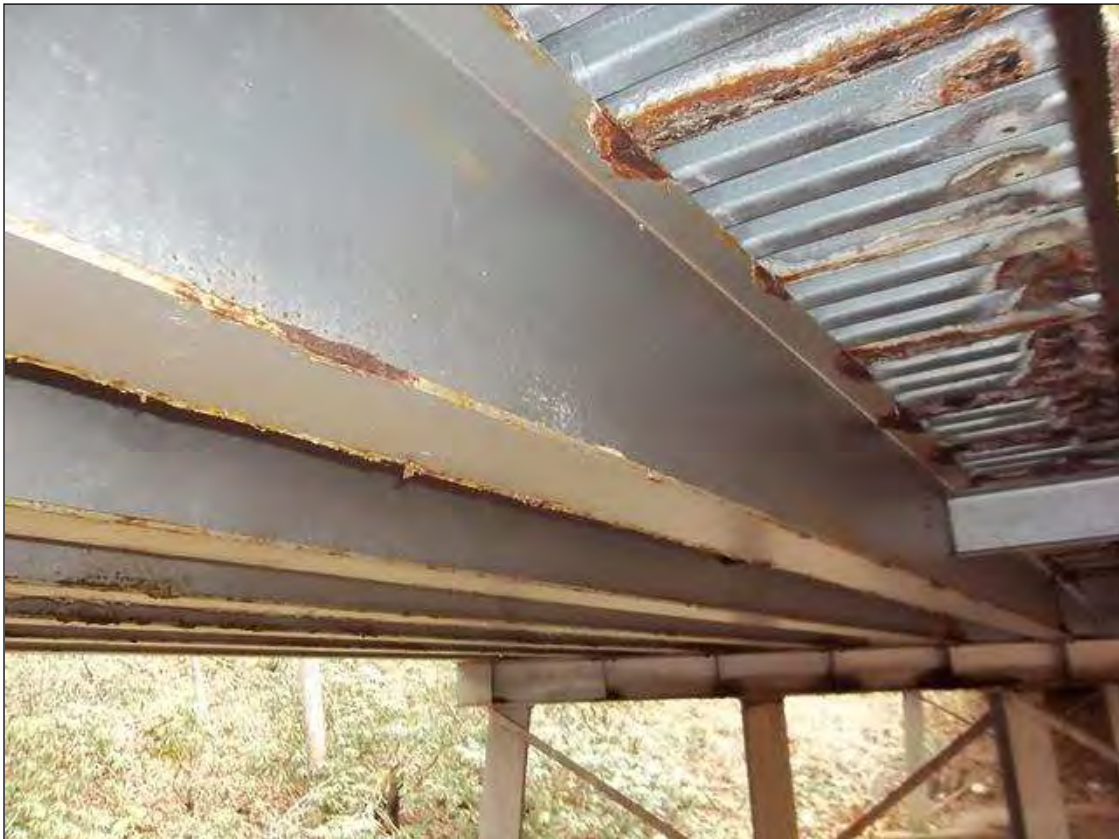
| Bridge I&A Form 1(82)H<br>State of North Carolina<br>Dept. of Transportation<br>Division of Highways | | <h1 style="text-align: center;">FIELD INSPECTION REPORT</h1> <p style="text-align: center;"><u>Bridge Inspection &amp; Analysis</u></p> | |
|---|---|---|--|
| 52 | F | PAINT PEELING AND FLAKING AT RANDOM ALONG TOP AND BOTTOM FLANGES UP TO 10%. | |

PAINT PEELING AND FLAKING AT RANDOM ALONG TOP AND BOTTOM FLANGES UP TO 10%.

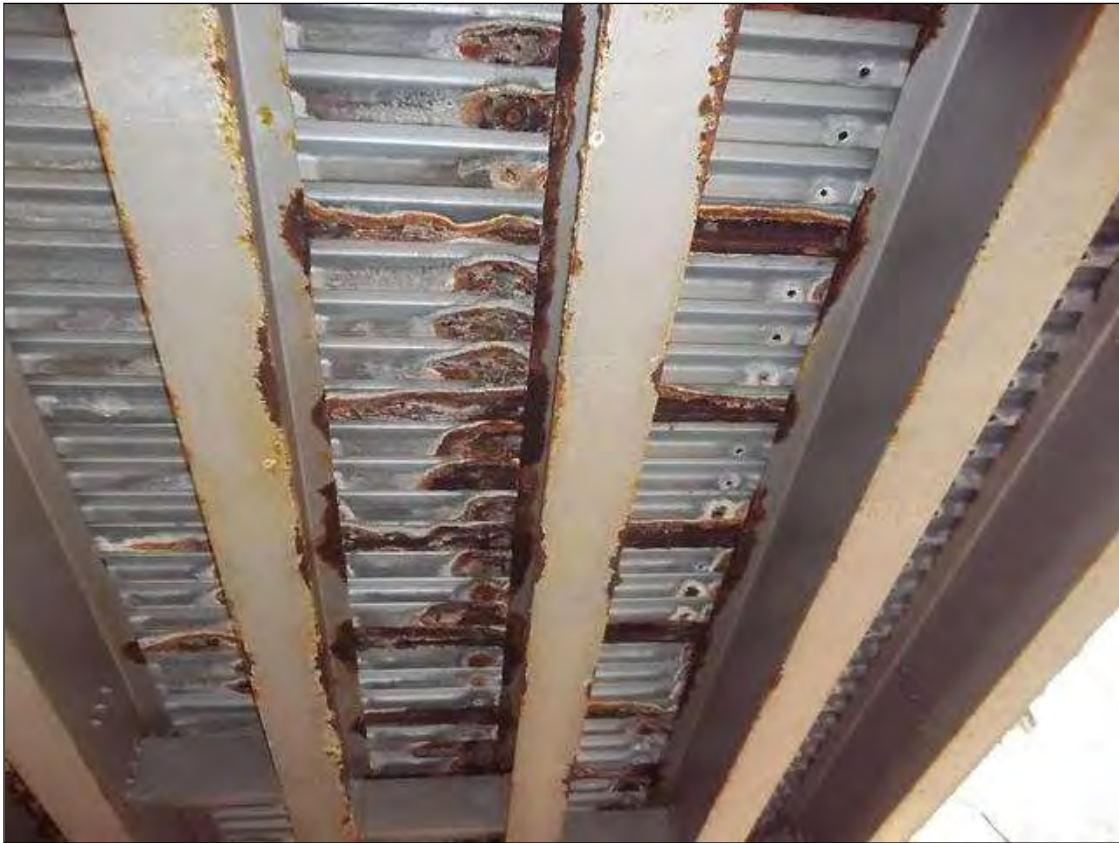
| Bridge I&A Form 1(82)H<br>State of North Carolina<br>Dept. of Transportation<br>Division of Highways | | <h1 style="text-align: center;">FIELD INSPECTION REPORT</h1> <p style="text-align: center;"><u>Bridge Inspection &amp; Analysis</u></p> | |
|---|---|---|--|
| 2c | P | HEAVY RUST SCALE ON UNDERSIDE OF STEEL PLANK WITH SOME SECTION LOSS, UP TO 40% OF DECK AREA. | |

HEAVY RUST SCALE ON UNDERSIDE OF STEEL PLANK WITH SOME SECTION LOSS UP TO 40% OF DECK.

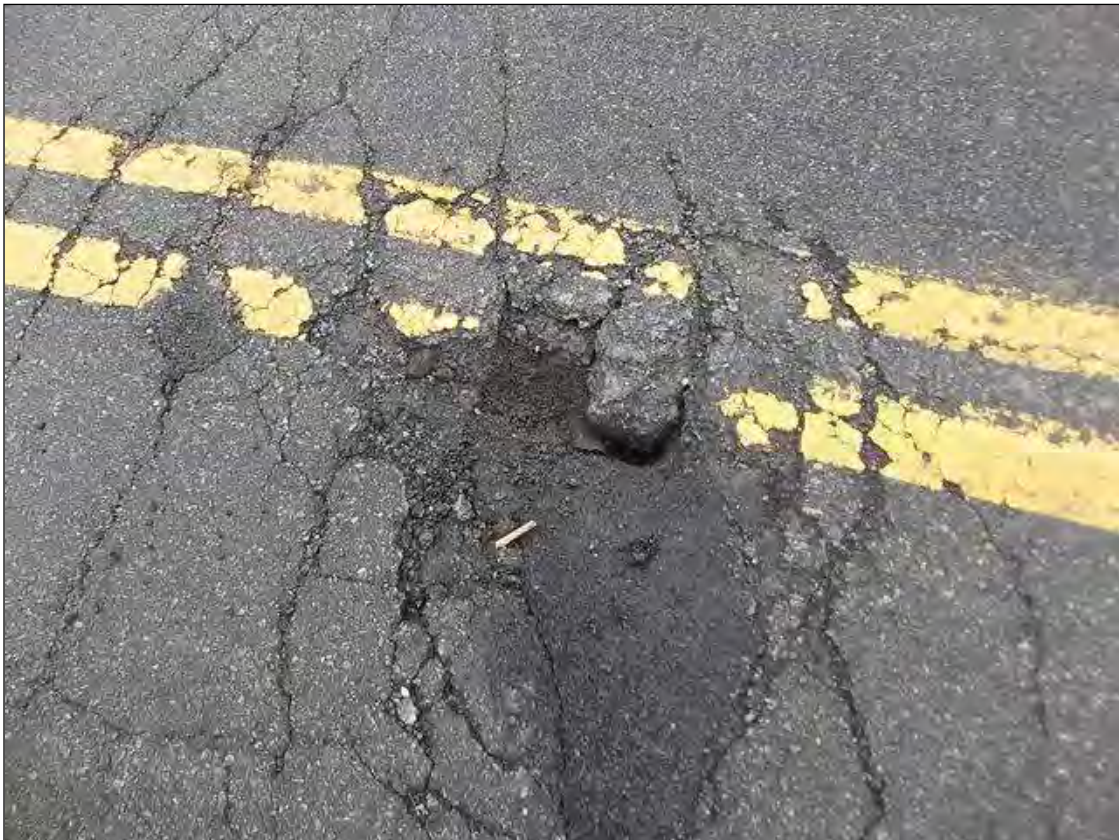
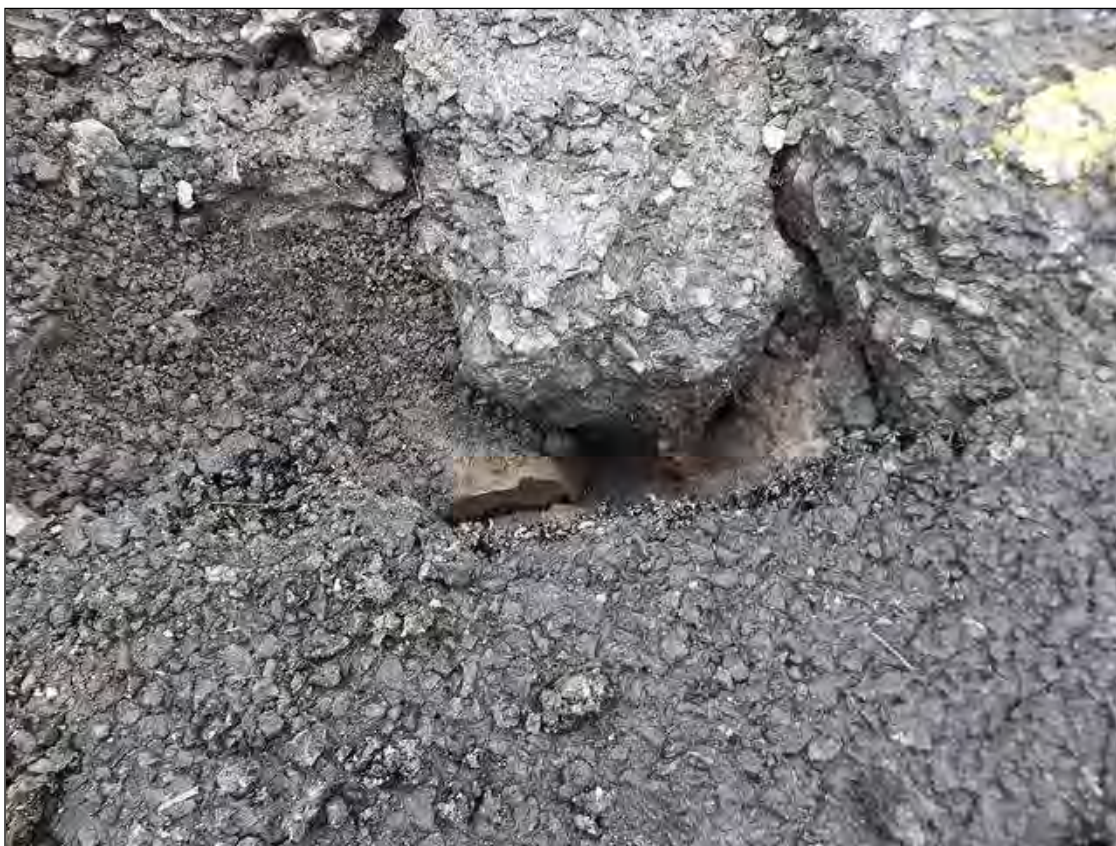
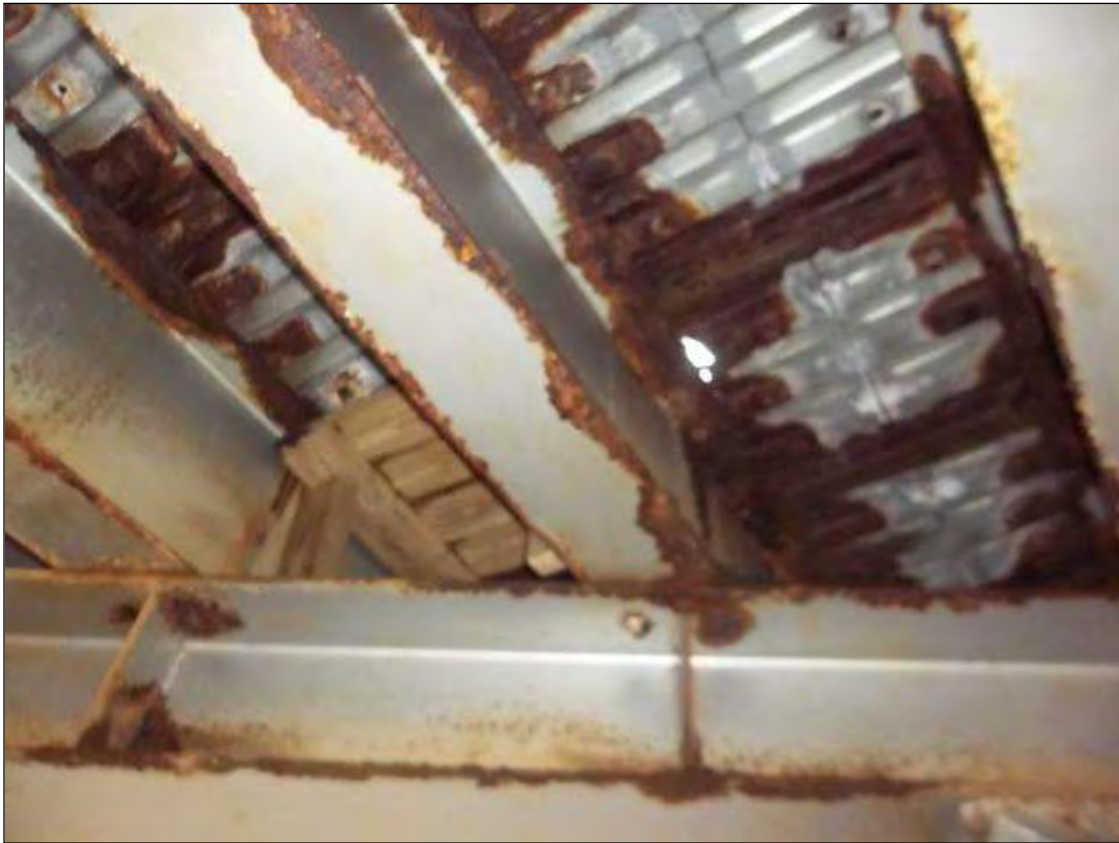
| Bridge I&A Form 1(82)H<br>State of North Carolina<br>Dept. of Transportation<br>Division of Highways | | <h1 style="text-align: center;">FIELD INSPECTION REPORT</h1> <p style="text-align: center;"><u>Bridge Inspection &amp; Analysis</u></p> | |
|---|---|---|--|
| 1 | P | 6' X 5' POT HOLE IN ASPHALT WEARING SURFACE OVER BENT 2 AT CENTER LINE WITH STEEL PLANK DECK RUSTED THROUGH DECK. (PRIORITY MAINTENANCE)<br>FULL WIDTH TRANSVERSE CRACKS IN ASPHALT WEARING SURFACE UP TO 1/8" OVER BENT 1. (SIMILAR OVER END BENT 1 AND END BENT 2)<br>4' X 5' POT HOLE WITH PREVIOUS REPAIR AND SETTLEMENT UP TO 1-1/2" IN CENTER OF WEST BOUND LANE OVER BENT 2.<br>FULL WIDTH TRANSVERSE CRACK IN ASPHALT WEARING SURFACE UP TO 1/2" OVER BENT 2. | |

6' X 5' POT HOLE IN ASPHALT WEARING SURFACE OVER BENT 2 AT CENTER LINE, STEEL PLANK DECK RUSTED THROUGH DECK. (PRIORITY MAINTENANCE)

| MMS Code | Description of Function | Unit | Quantity | Remarks | Est. Cost |
|---|---|---|---|---|---|
| 3328 | Maintenance/Repair/ Replace Steel Plank Bridge Floor | SF | 30 | 6' X 5' POT HOLE IN ASPHALT WEARING SURFACE OVER BENT 2 AT CENTER LINE WITH STEEL PLANK DECK RUSTED, POT HOLE PENETRATES THROUGH DECK. | |

| MMS Code | MMS Description | Quantity |
|---|---|---|
| 6' X 5' POT HOLE IN ASPHALT WEARING SURFACE OVER BENT 2 AT CENTER LINE, STEEL PLANK DECK RUSTED THROUGH DECK. | | |

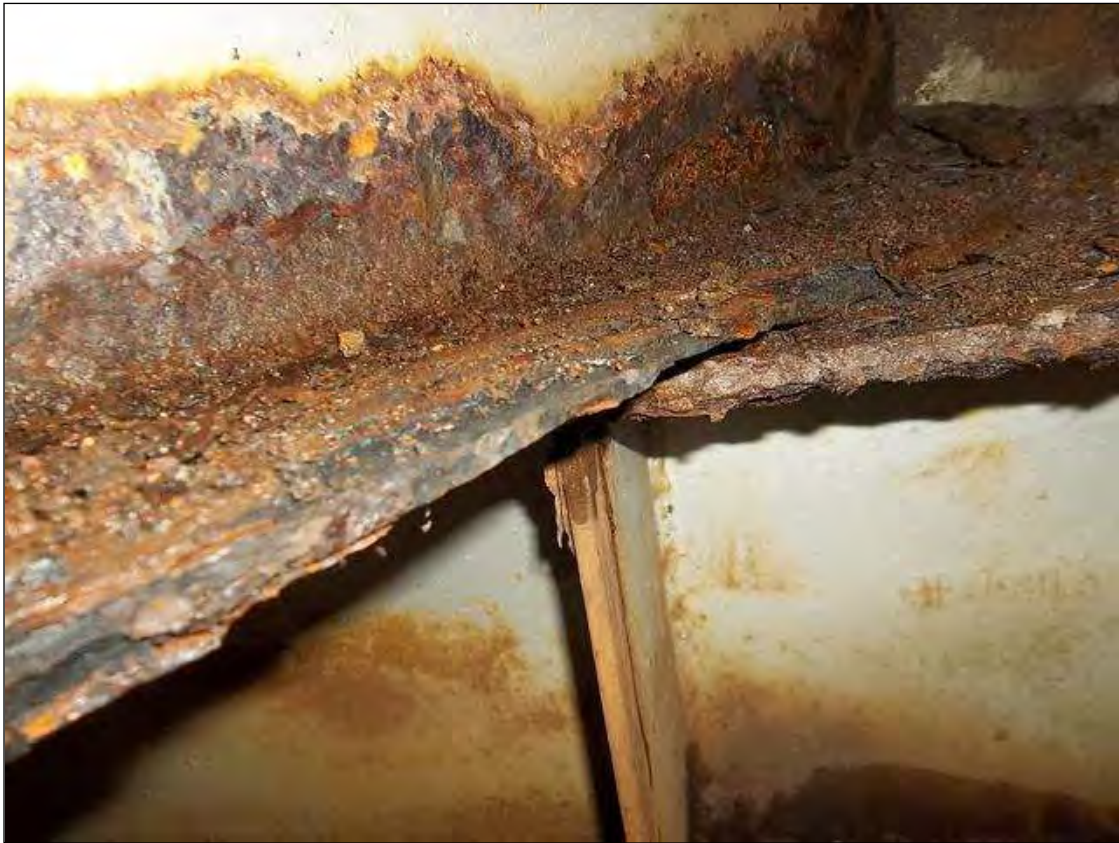
| Bridge I&A Form 1(82)H<br>State of North Carolina<br>Dept. of Transportation<br>Division of Highways | | <h1 style="text-align: center;">FIELD INSPECTION REPORT</h1> <p style="text-align: center;"><u>Bridge Inspection &amp; Analysis</u></p> | |
|---|---|---|--|
| 10 | F | 12" OF BOTTOM FLANGE HAS SECTION LOSS TO KNIFE EDGE, BEAM 7 AT ABUTMENT 1. (PRIORITY MAINTENANCE)<br>RANDOM SURFACE RUST ALONG TOP AND BOTTOM FLANGES THROUGH OUT ALL SPANS.<br>HEAVY RUST SCALE WITH SECTION LOSS AT GIRDER ENDS AT ABUTMENT 1 WITH 7/16" REMAINING, EXTENDS ON TO WEB. | |

12" OF BOTTOM FLANGE HAS SECTION LOSS TO KNIFE EDGE, BEAM 7 AT ABUTMENT 1. (PRIORITY MAINTENANCE)

| MMS Code | Description of Function | Unit | Quantity | Remarks | Est. Cost |
|---|---|---|---|---|---|
| 3314 | Maintain Steel Superstructure Components | LF | 1 | 12" AREA BOTTOM FLANGE HAS SECTION LOSS TO KNIFE EDGE BEAM 7 AT ABUTMENT 1. | |

| MMS Code | MMS Description | Quantity |
|---|---|---|
| 12" OF BOTTOM FLANGE HAS SECTION LOSS TO KNIFE EDGE, BEAM 7 AT ABUTMENT 1. | | |

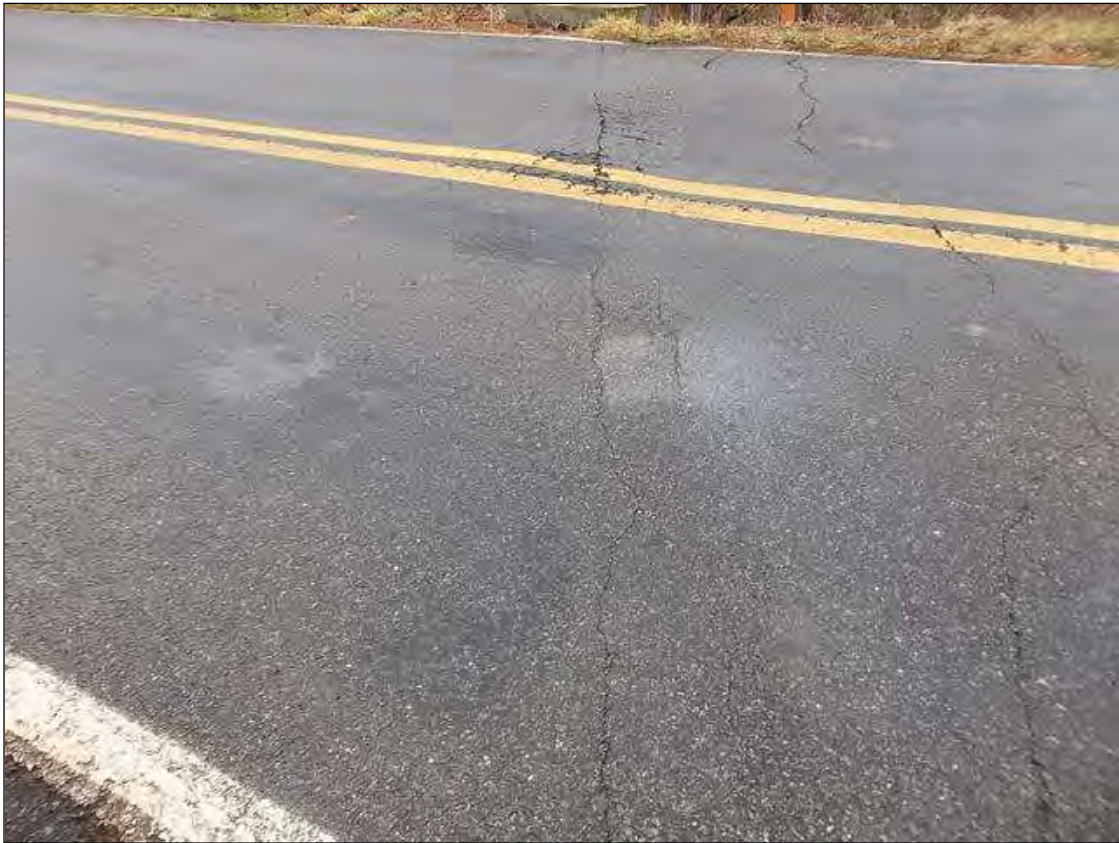
CRACK IN ASPHALT WEARING SURFACE OVER END BENT 1, LOOKING SOUTH

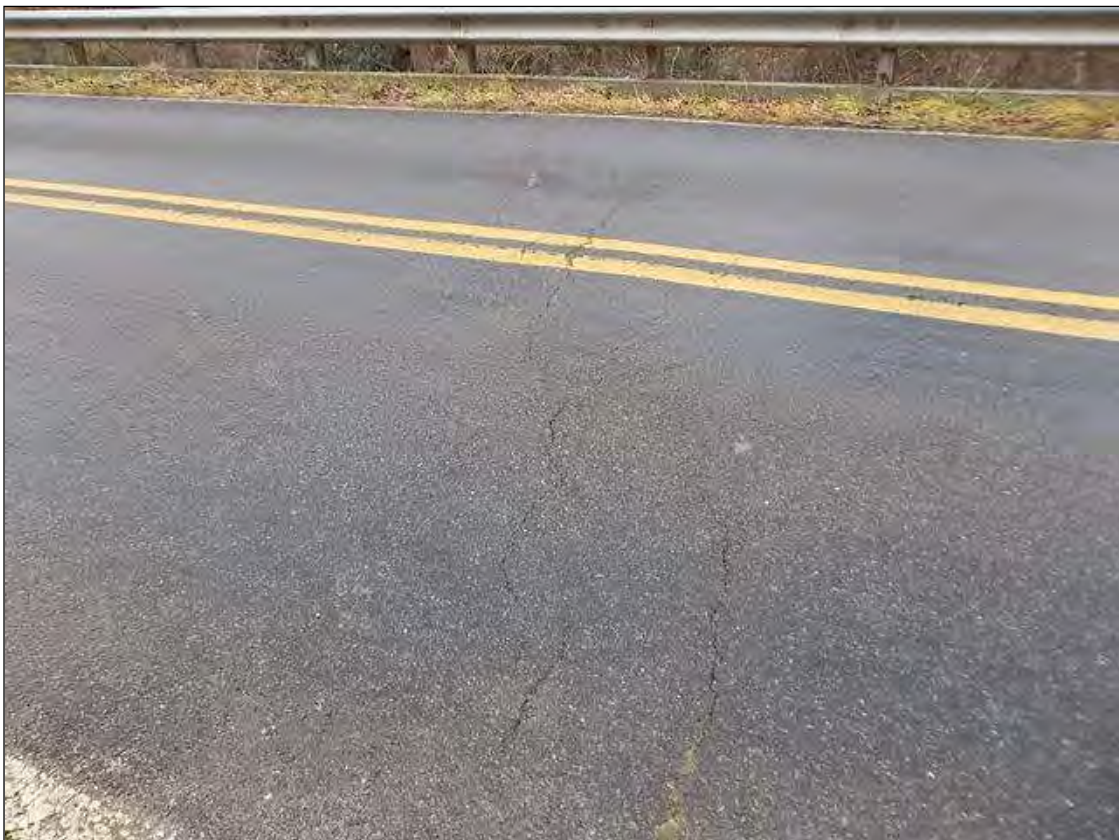
CRACK IN ASPHALT WEARING SURFACE OVER BENT 1, LOOKING SOUTH

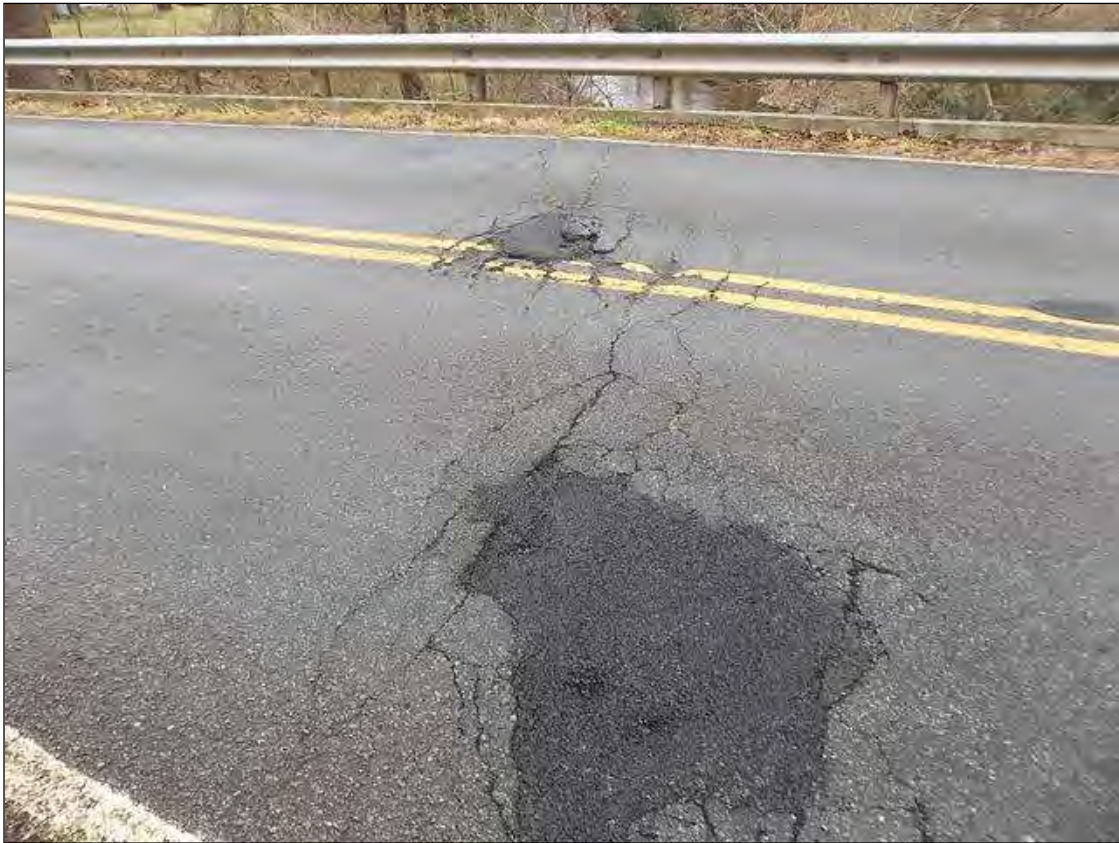
CRACK IN ASPHALT WEARING SURFACE OVER BENT 2, LOOKING SOUTH

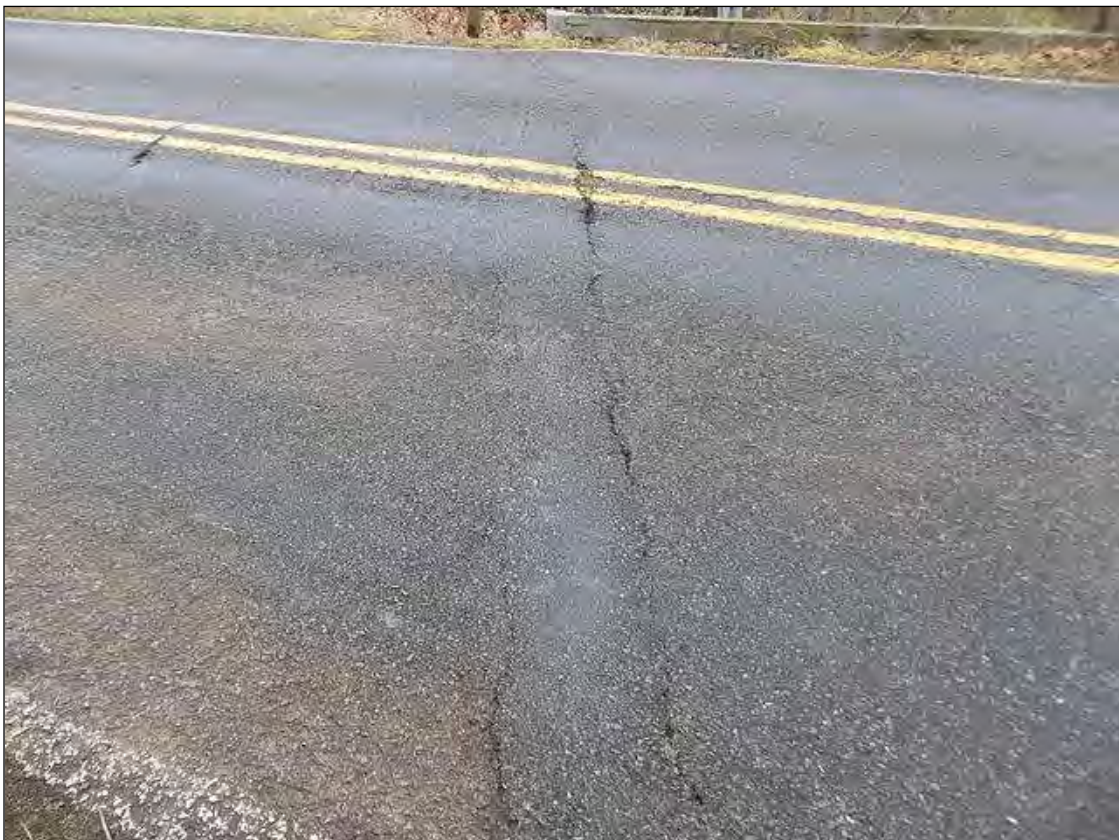
CRACK IN ASPHALT WEARING SURFACE OVER END BENT 2, LOOKING SOUTH
