NC DEPARTMENT OF TRANSPORTATION  
DIVISION OF HIGHWAYS  
BRIDGE MANAGEMENT UNIT

# BRIDGE INSPECTION REPORT

INSPECTION TYPE: Routine Inspection - Contract

COUNTY WILKES BRIDGE NUMBER 960187 INSPECTION CYCLE 0 YRS  
ROUTE SR2340 ACROSS FISHING CREEK M.P. 0

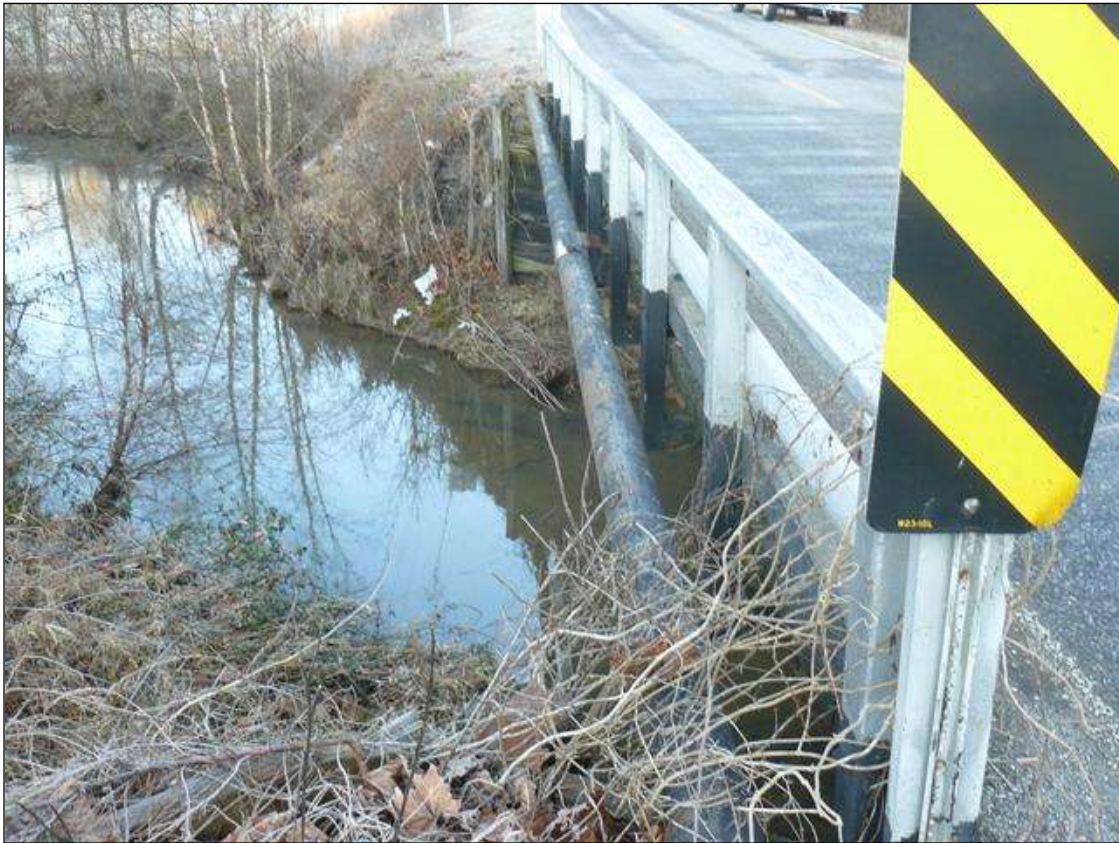
| Bridge I&A Form 1(82)H<br>State of North Carolina<br>Dept. of Transportation<br>Division of Highways | | <h1 style="text-align: center;">FIELD INSPECTION REPORT</h1> <h2 style="text-align: center;"><u>Bridge Inspeccion &amp; Analysis</u></h2> | |
|---|---|---|--|
| 53 | G | THERE IS A UTILITY LINE 6" CAST PIPE ALONG LT SIDE OF BRIDGE . | |

THERE IS A UTILITY LINE 6" CAST PIPE ALONG LT SIDE OF BRIDGE .

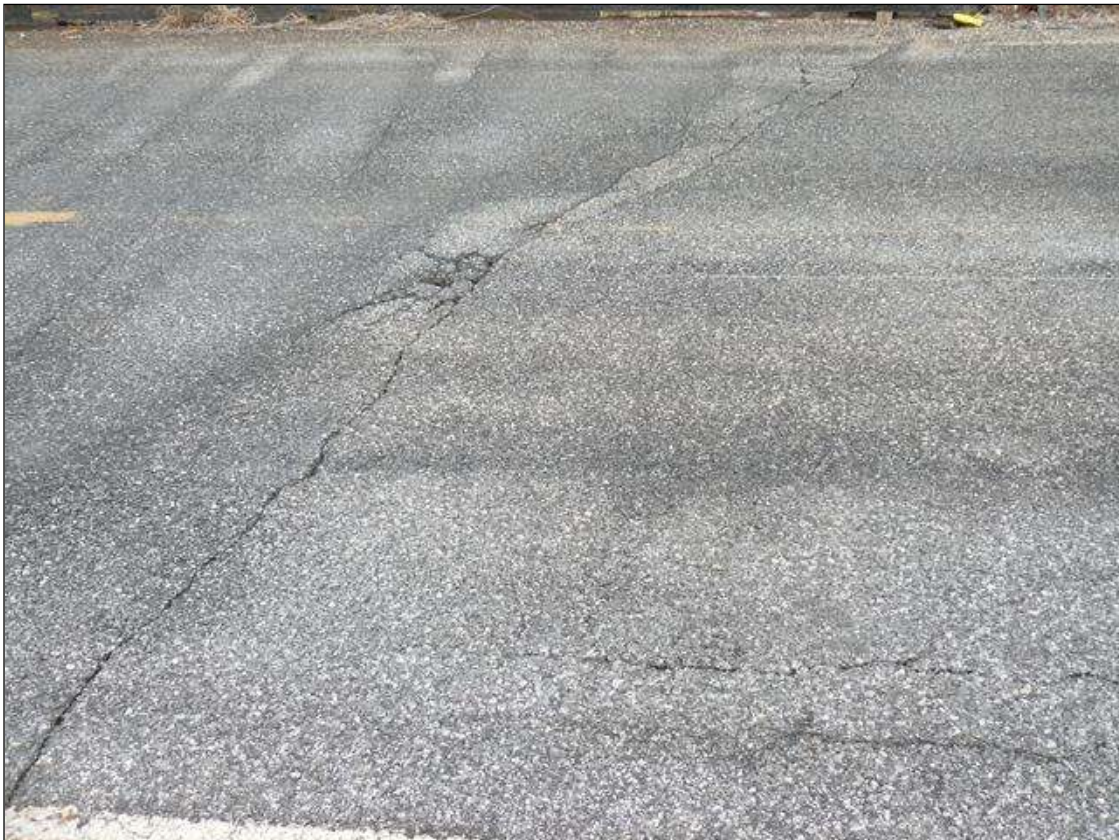
| Bridge I&A Form 1(82)H<br>State of North Carolina<br>Dept. of Transportation<br>Division of Highways | | <h1 style="text-align: center;">FIELD INSPECTION REPORT</h1> <h2 style="text-align: center;"><u>Bridge Inspeccion &amp; Analysis</u></h2> | |
|---|---|---|--|
| 50 | F | THE SOUTH APPROACH RDWY IS CRACKED AND BEGINING TO BREAK UP AT FILL FACE AND SETTLED 1". | |

THE SOUTH APPROACH RDWY IS CRACKED AND BEGINING TO BREAK UP AT FILL FACE AND SETTLED 1".

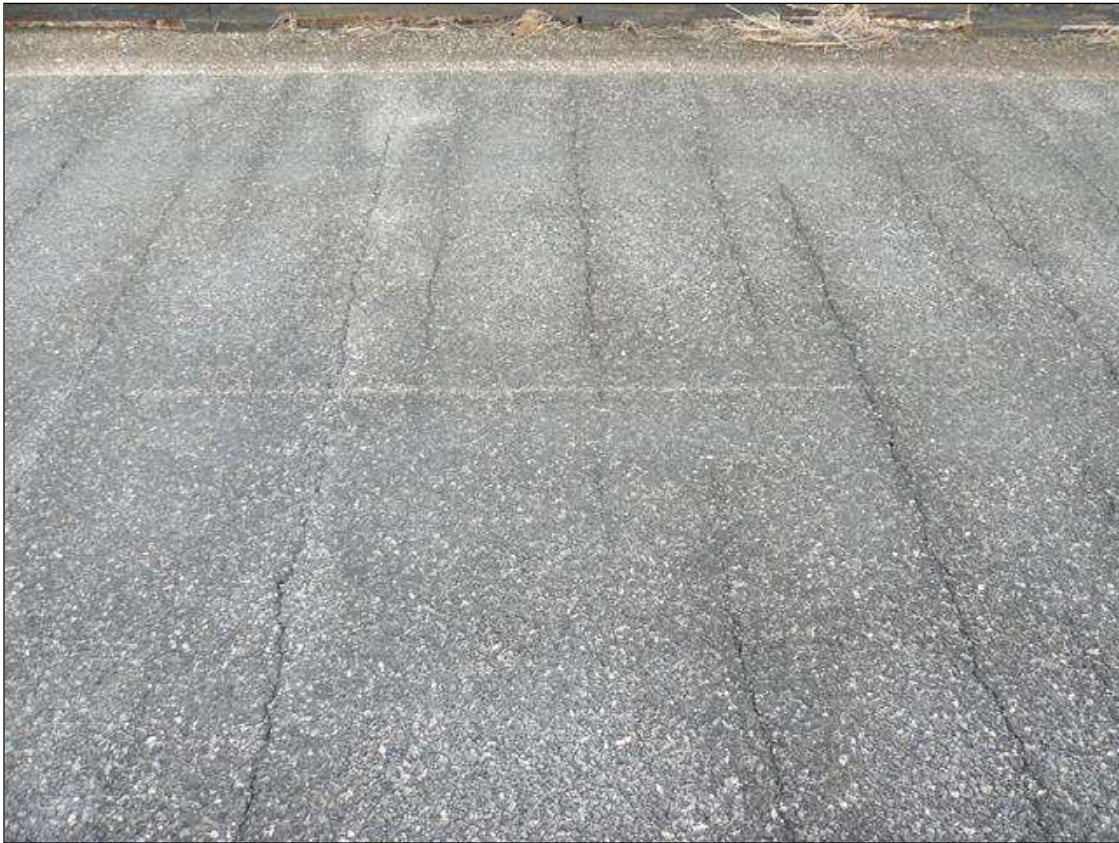
| Bridge I&A Form 1(82)H<br>State of North Carolina<br>Dept. of Transportation<br>Division of Highways | | <h1 style="text-align: center;">FIELD INSPECTION REPORT</h1> <h2 style="text-align: center;"><u>Bridge Inspeccion &amp; Analysis</u></h2> | |
|---|---|---|--|
| 1 | F | THE AWS IS CRACKED OVER THE FLOOR BOARDS ALL ACROSS BRIDGE. | |

THE AWS IS CRACKED OVER THE FLOOR BOARDS ALL ACROSS BRIDGE.

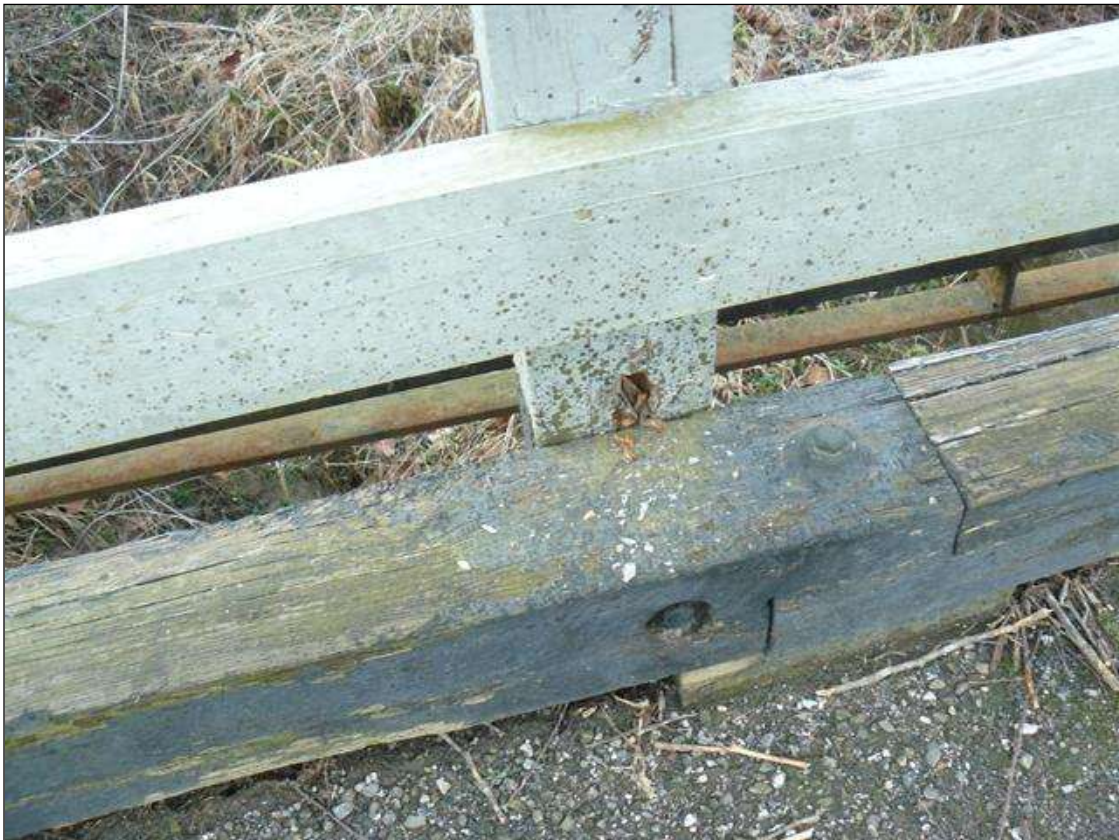
| Bridge I&A Form 1(82)H<br>State of North Carolina<br>Dept. of Transportation<br>Division of Highways | | <h1 style="text-align: center;">FIELD INSPECTION REPORT</h1> <h2 style="text-align: center;"><u>Bridge Inspeccion &amp; Analysis</u></h2> | |
|---|---|---|--|
| 3b | F | THE LT RAIL POST # 3 IS DECAYED IN FACE JUST ABOVE WHEEL GUARD. | |

THE LT RAIL POST # 3 IS DECAYED IN FACE JUST ABOVE WHEEL GUARD.

| MMS Code | Description of Function | Unit | Quantity | Remarks | Est. Cost |
|---|---|---|---|---|---|
| 3316 | Maint to Timber Handrail | LF | 4 | LT TIMBER RAIL POST # 3 IS DECAYED AT WHEEL GUARD | |

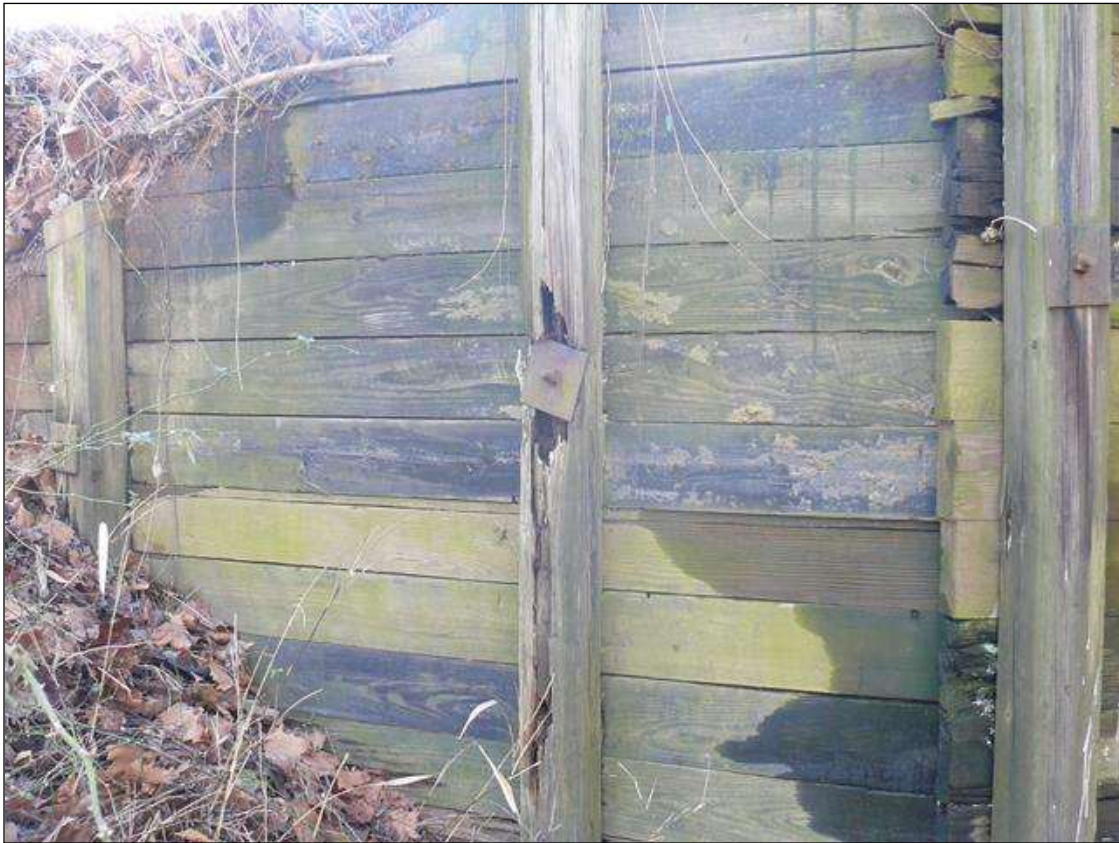
END BENT 1 THE RT WINGWALL IS DECAYED AND POST AND BOARDS ARE DECAYED.

| MMS Code | Description of Function | Unit | Quantity | Remarks | Est. Cost |
|---|---|---|---|---|---|
| 3346 | Repair / Maintain Timber Wings & Blkhs | SF | 200 | BULKHEAD BOARDS AT END BT 1 AND END BT 2 HAVE SCATTERED AREAS OF DECAY THROUGH OUT AND WING PILES DECAYED | |

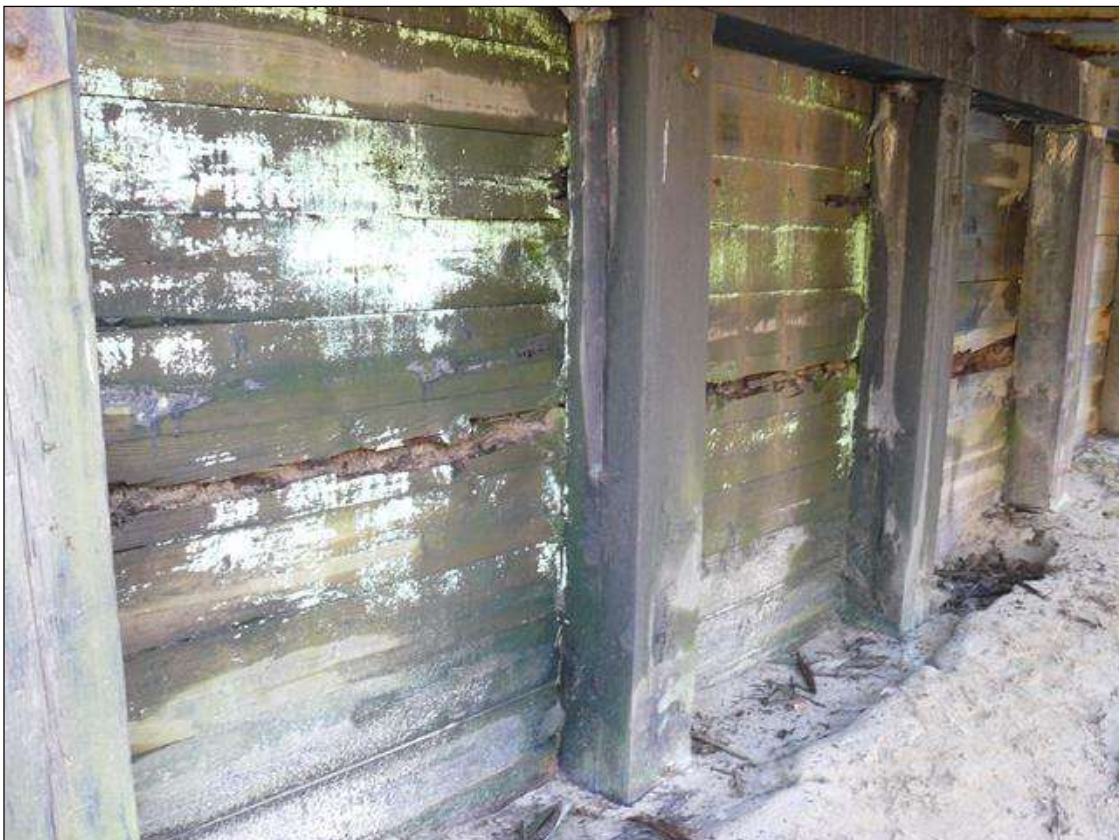
END BENT 1 BULKHEAD BOARDS ARE DECAYED BETWEEN MOST ALL PILES .

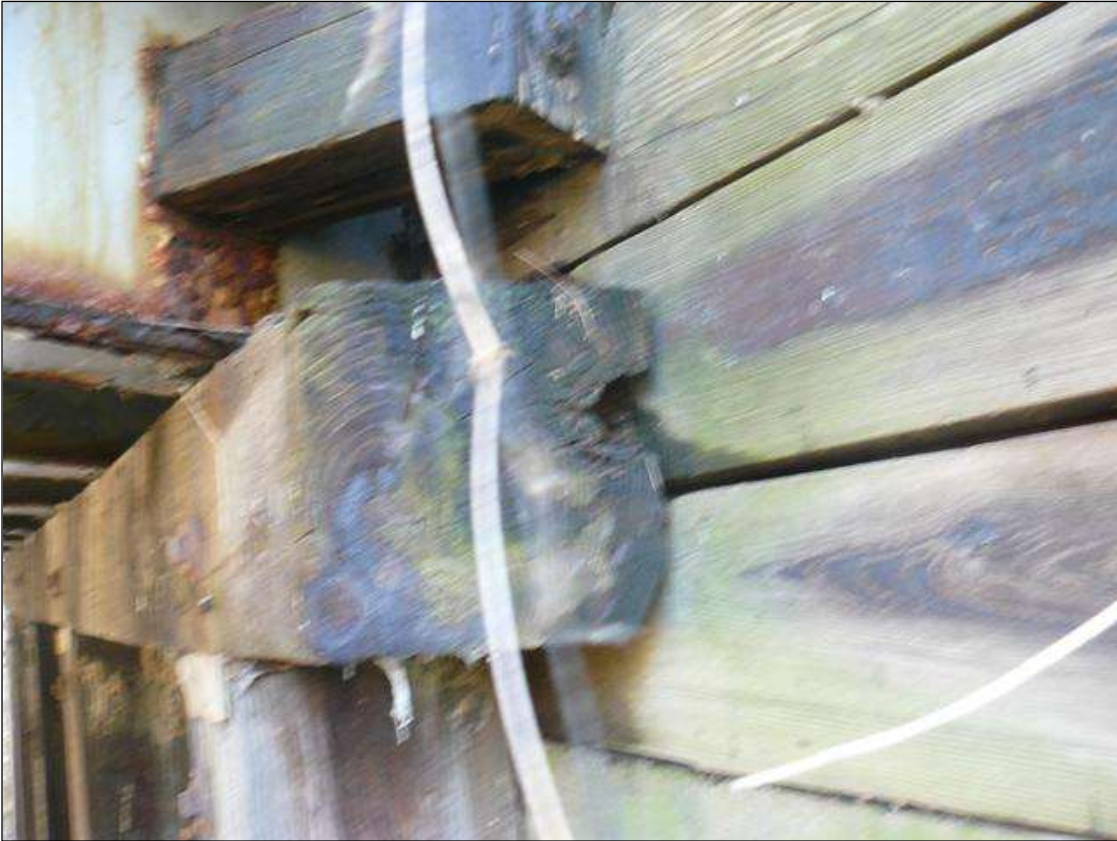
END BENT 1 CAP IS DECAYED ON THE LT END 3" X 3" X 20" DEEP ALONG BACK EDGE NEXT TO BULKHEAD.

| MMS Code | Description of Function | Unit | Quantity | Remarks | Est. Cost |
|---|---|---|---|---|---|
| 3344 | Repair / Replace Timber Substructure Components | LF | 4 | END BT 1 CAP DECAYED ALONG LT END IN AREA AT BULKHEAD, END BT 2 CAP RT END IS DECAYED ALONG BACK OF BULKHEAD. | |

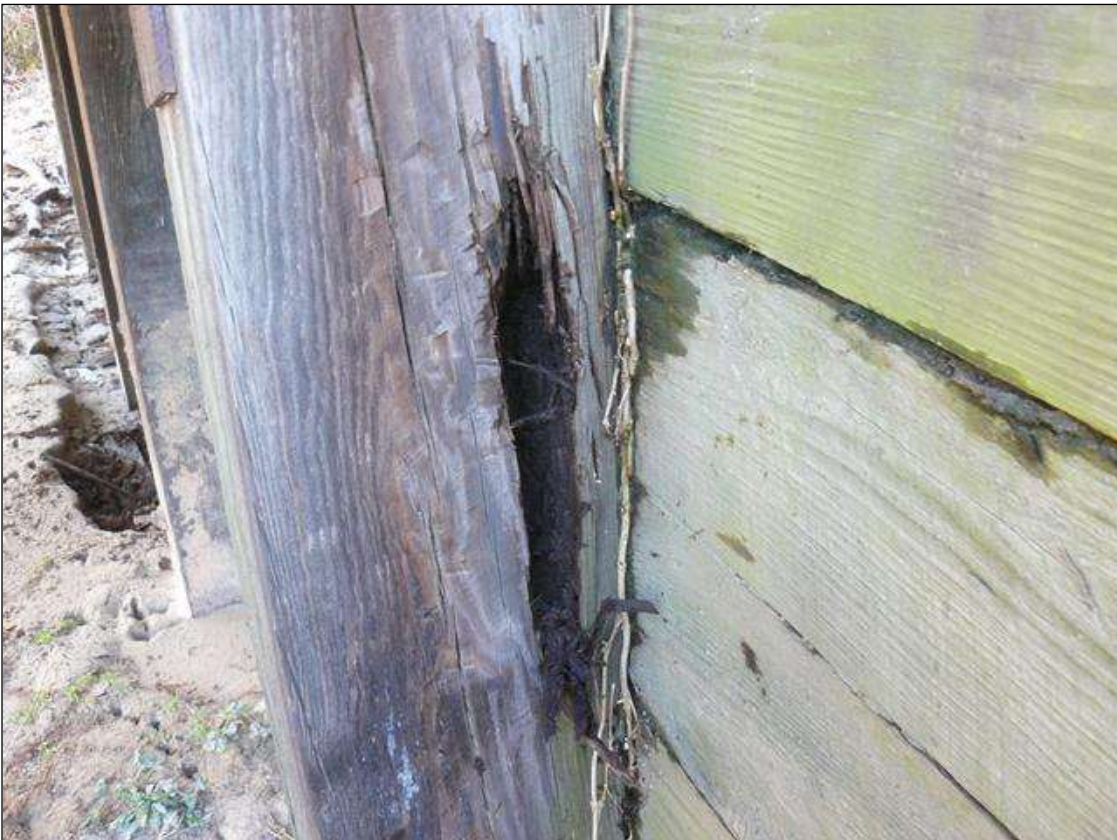
| MMS Code | MMS Description | Quantity |
|---|---|---|
| END BENT 1 PILE 1 IS DECAYED HAS A 1" INSIDE SHELL WITH AREA BEING 6" W X 6" D X 4' HIGH FROM TOP OF CAP DOWN. END BENT 1 PILE 1 IS DECAYED INSIDE A SHELL 6" WIDE X 6" DEEP X 4' HIGH FROM BOTTOM CAP DOWN. PM ISSUED | | |

END BENT 1 PILE 1 IS DECAYED INSIDE A SHELL 6" WIDE X 6" DEEP X 4' HIGH FROM BOTTOM CAP DOWN.  
PM ISSUED

| MMS Code | Description of Function | Unit | Quantity | Remarks | Est. Cost |
|---|---|---|---|---|---|
| 3344 | Repair / Replace Timber Substructure Components | LF | 5 | END BENT 1 PILE 1 IS DECAYED HAS A 1" INSIDE SHELL WITH AREA BEING 6" W X 6" D X 4' HIGH FROM TOP OF CAP DOWN. END BENT 1 PILE 1 IS DECAYED INSIDE A SHELL 6" WIDE X 6" DEEP X 4' HIGH FROM BOTTOM CAP DOWN. PM ISSUED | |

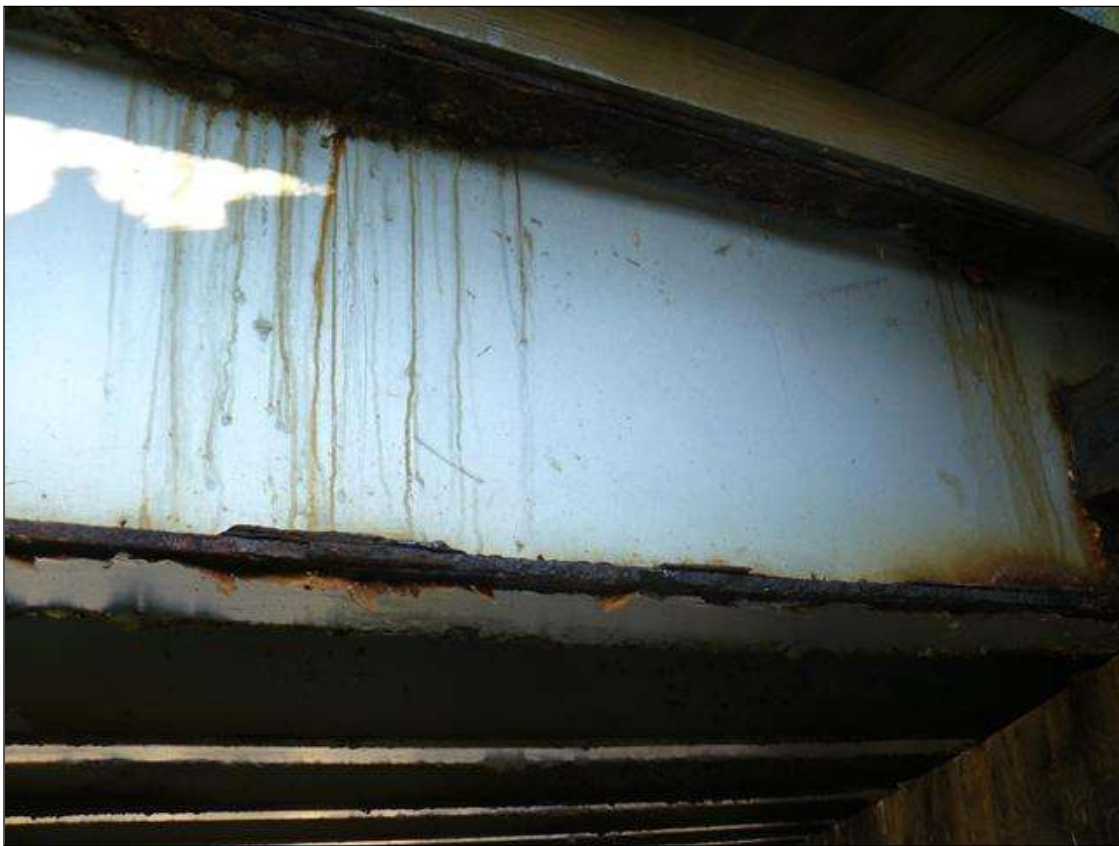
STEEL BEAMS ARE RUSTY AND SCALING ALONG THE TOP AND BOTTOM FLANGES WITH UP TO 1/8" SECTION LOSS.

| MMS Code | Description of Function | Unit | Quantity | Remarks | Est. Cost |
|---|---|---|---|---|---|
| 3342 | Clean and Paint Structural Steel | SF | 300 | BEAMS HAVE RUST AND FLAKING ALONG THE TOP AND BOTTOM FLANGES AND IN THE BEARING AREAS. | |

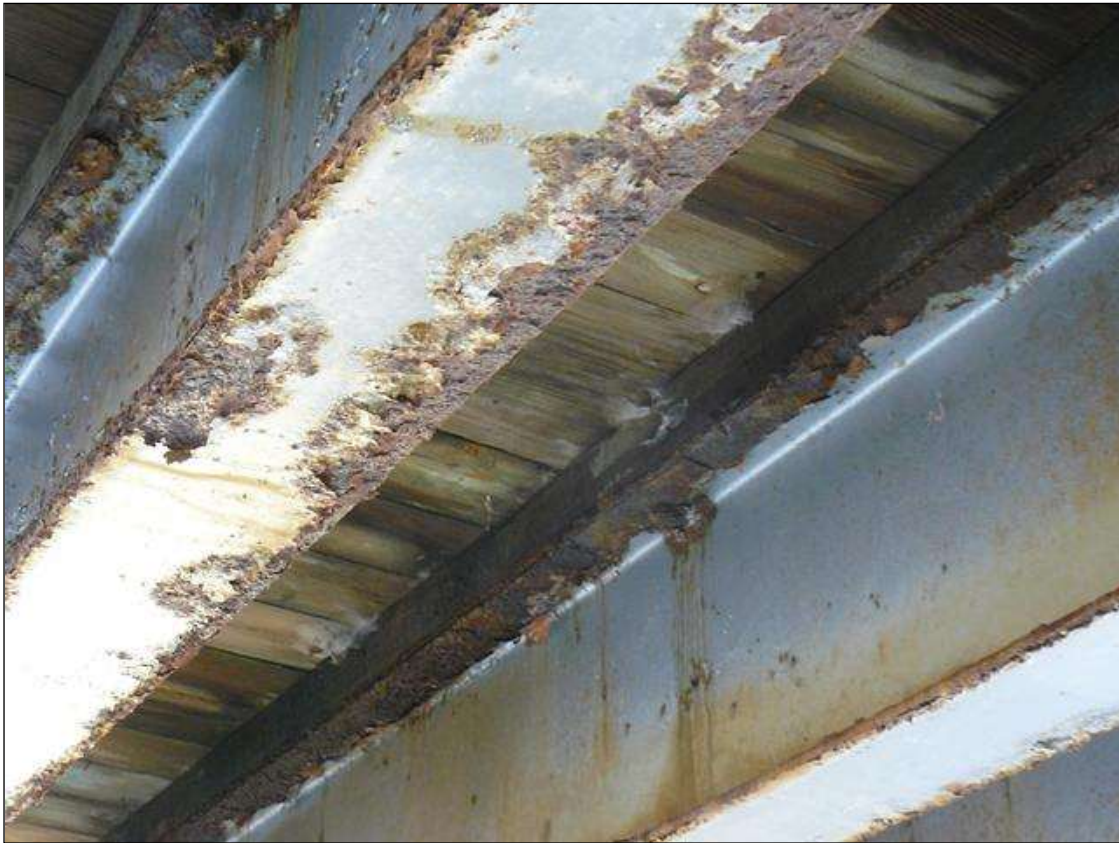
THE STEEL BEAMS HAVE RUST AND SCALING ALONG TOP FLANGES NEAR MIDSPAN ON MOST BEAMS WITH UP TO 3/16" LOSS IN SPOTS.

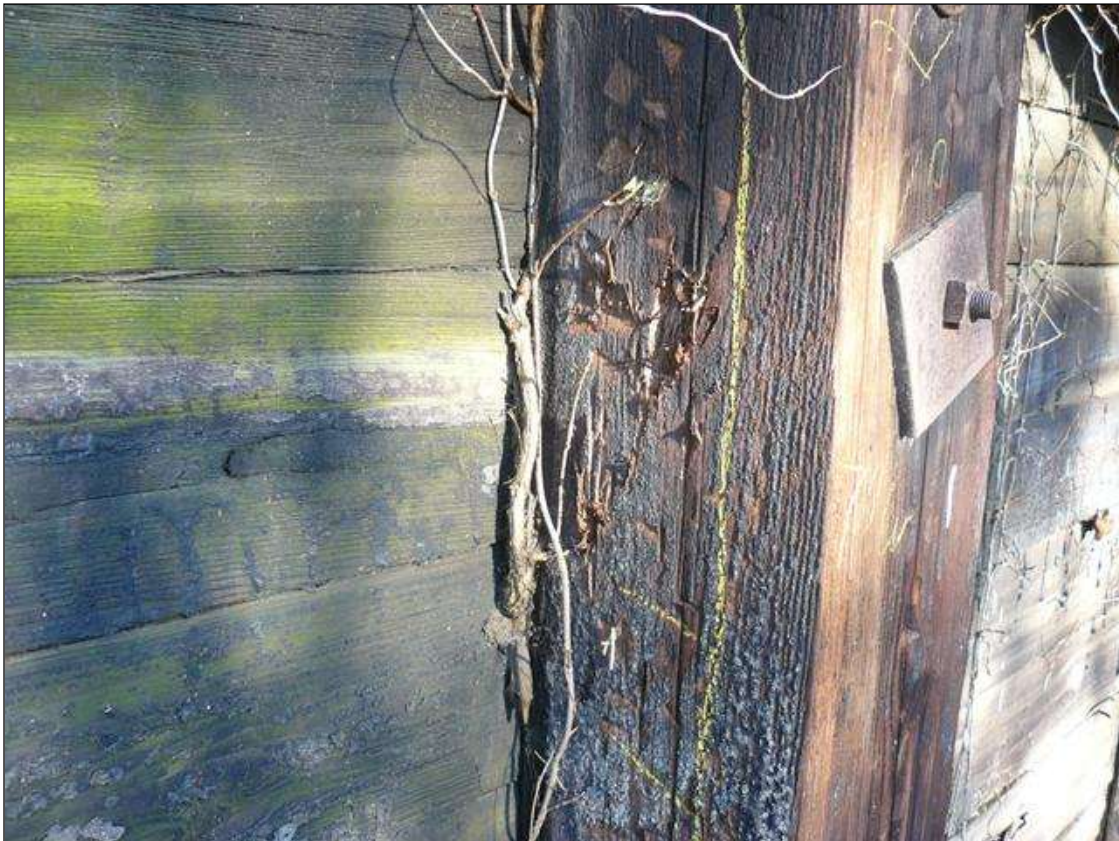
| MMS Code | MMS Description | Quantity |
|---|---|---|
| END BENT 2 PILE 1 IS DECAYED APPROX 6" DEEP X 7" WIDE AREA FROM BOTTOM OF CAP DOWN 4' END BENT 2 PILE 1 IS DECAYED 6" DEEP AREA X 7" WIDE X FROM TOP DOWN 4. PM ISSUED. | | |

END BENT 2 PILE 1 IS DECAYED 6" DEEP AREA X 7" WIDE X FROM TOP DOWN 4. PM ISSUED.

| MMS Code | Description of Function | Unit | Quantity | Remarks | Est. Cost |
|---|---|---|---|---|---|
| 3344 | Repair / Replace Timber Substructure Components | LF | 5 | END BENT 2 PILE 1 IS DECAYED APPROX 6" DEEP X 7" WIDE AREA FROM BOTTOM OF CAP DOWN 4' END BENT 2 PILE 1 IS DECAYED 6" DEEP AREA X 7" WIDE X FROM TOP DOWN 4. PM ISSUED. | |

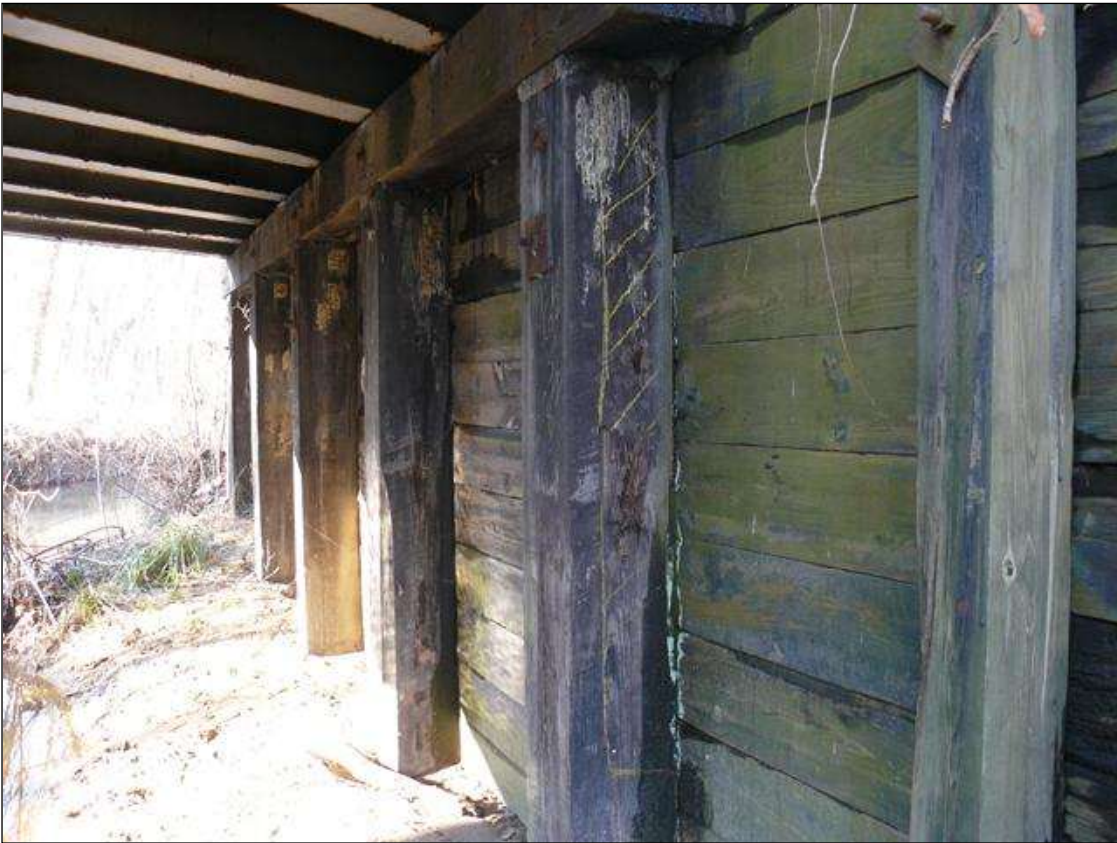
| MMS Code | MMS Description | Quantity |
|---|---|---|
| END BENT 2 PILE 5 IS DECAYED FROM THE TOP DOWN 5' X 6 1/2" WIDE AREA X 8" DEEP. END BENT 2 PILE 5 IS DECAYED FROM THE TOP DOWN 5' X 6 1/2" W X 8" DEEP. PM ISSUED | | |

END BENT 2 PILE 5 IS DECAYED FROM THE TOP DOWN 5' X 6 1/2" W X 8" DEEP. PM ISSUED

| MMS Code | Description of Function | Unit | Quantity | Remarks | Est. Cost |
|---|---|---|---|---|---|
| 3344 | Repair / Replace Timber Substructure Components | LF | 5 | END BENT 2 PILE 5 IS DECAYED FROM THE TOP DOWN 5' X 6 1/2" WIDE AREA X 8" DEEP. END BENT 2 PILE 5 IS DECAYED FROM THE TOP DOWN 5' X 6 1/2" W X 8" DEEP. PM ISSUED | |

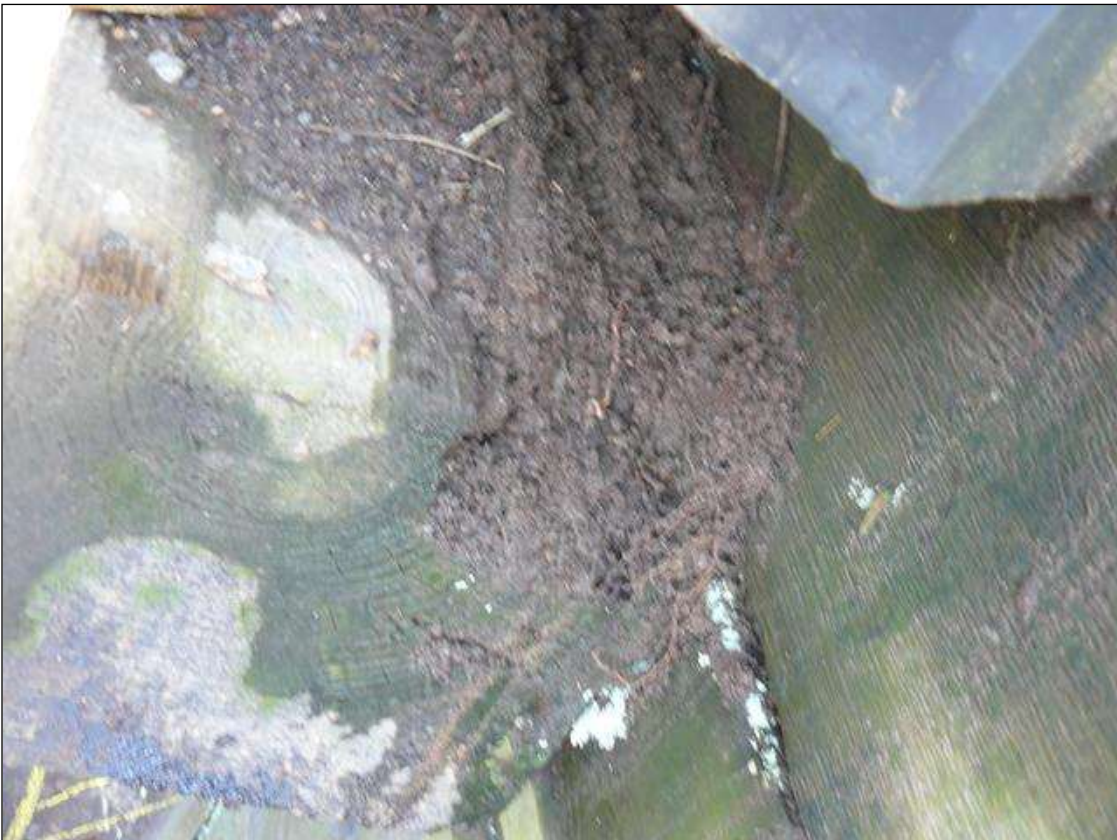
END BENT 2 RT END OF THE CAP IS DECAYED FROM BULKHEAD OUT 5 1/2" X 3 1/2" TOP DOWN AND 14" DEEP.

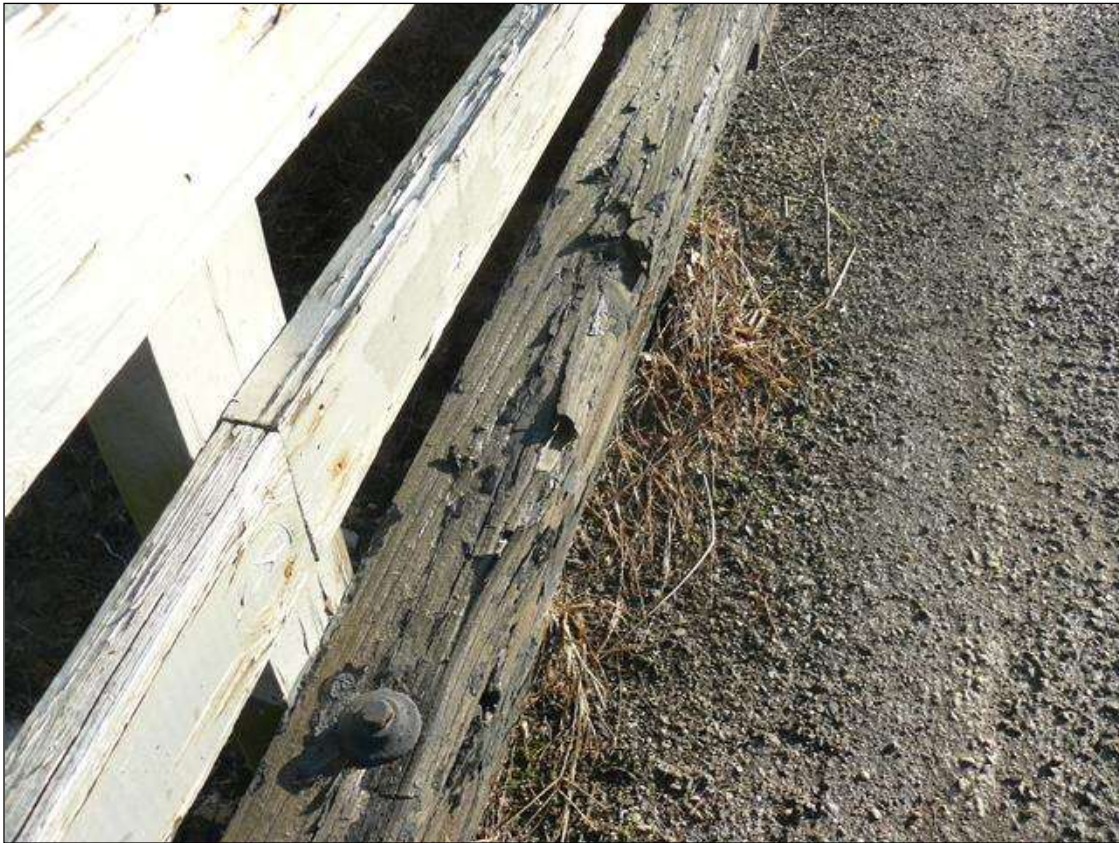
| Bridge I&A Form 1(82)H<br>State of North Carolina<br>Dept. of Transportation<br>Division of Highways | | <h1 style="text-align: center;">FIELD INSPECTION REPORT</h1> <h2 style="text-align: center;"><u>Bridge Inspeccion &amp; Analysis</u></h2> | |
|---|---|---|--|
| 4 | F | THE WHEEL GUARDS AND WEATHERED AND DRYING OUT AND SPLINTERING. | |

THE WHEEL GUARDS AND WEATHERED AND DRYING OUT AND SPLINTERING.
