NC DEPARTMENT OF TRANSPORTATION  
DIVISION OF HIGHWAYS  
BRIDGE MANAGEMENT UNIT

# BRIDGE INSPECTION REPORT

INSPECTION TYPE: Routine Inspection - Contract

BRIDGE NUMBER 040371

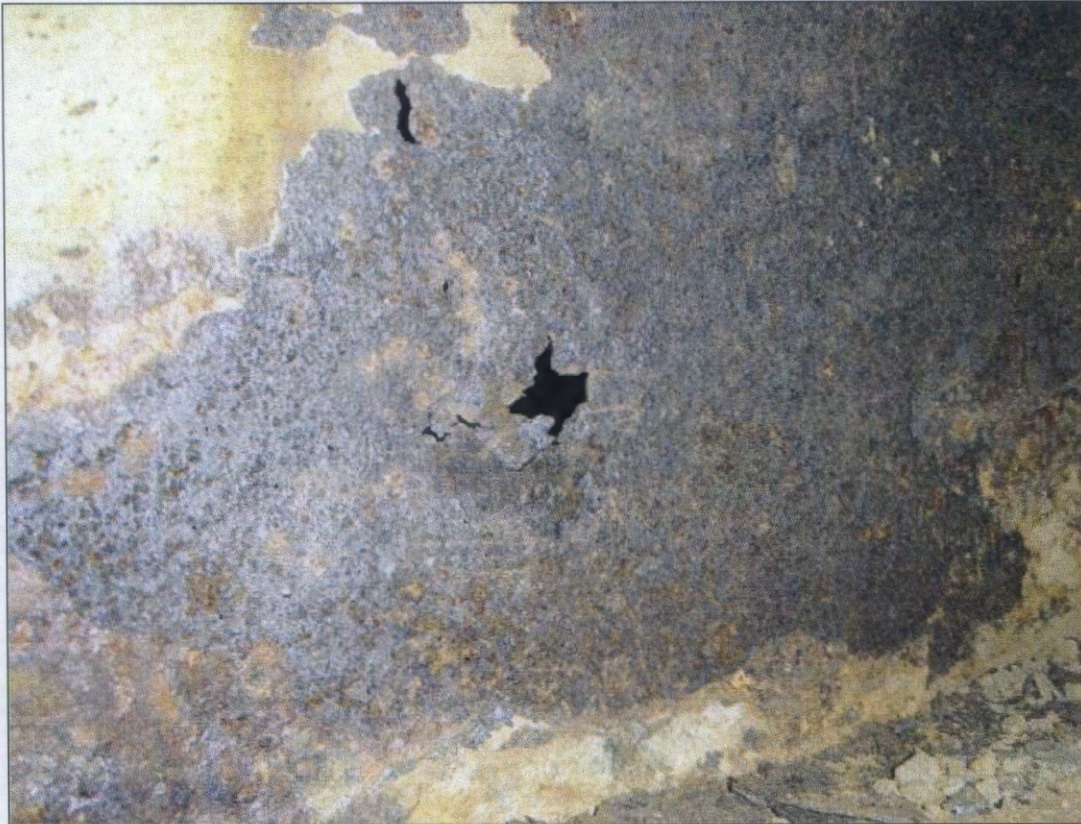
| 10 | F | THERE IS A 5/8" DIAMETER HOLE IN THE WEB OF BEAM 8, 3 1/2" ABOVE THE BOTTOM FLANGE AND 1'-9" FROM THE SOUTH END OF THE BEAM (PRIORITY MAINTENANCE) [SEE PHOTO]. THERE IS A 7" LONG X 1 1/2" WIDE AREA OF COMPLETE SECTION LOSS IN THE TOP FLANGE OF BEAM 8 AT 4" FROM THE NORTH END OF THE BEAM (PRIORITY MAINTENANCE) [SEE PHOTO]. THERE IS DELAMINATED STEEL WITH 0.194" THICKNESS REMAINING IN THE BOTTOM FLANGE OF BEAMS 7 - 10 AT THE ABUTMENT [SEE PHOTOS]. | |

5/8" DIAMETER HOLE IN THE WEB OF BEAM 8 AT 3 1/2" ABOVE THE BOTTOM FLANGE AND 1'-9" FROM THE SOUTH END OF THE BEAM [PRIORITY MAINTENANCE]

| MMS Code | Description of Function | Unit | Quantity | Remarks | Est. Cost |
|---|---|---|---|---|---|
| 3314 | Maintain Steel Superstructure Components | LF | <del>X TSC</del><br>11/13/12 | 5/8" DIAMETER HOLE IN THE WEB OF BEAM 8 AT 3 1/2" ABOVE THE BOTTOM FLANGE AND 1'-9" FROM THE SOUTH END OF THE BEAM [PRIORITY MAINTENANCE] | |

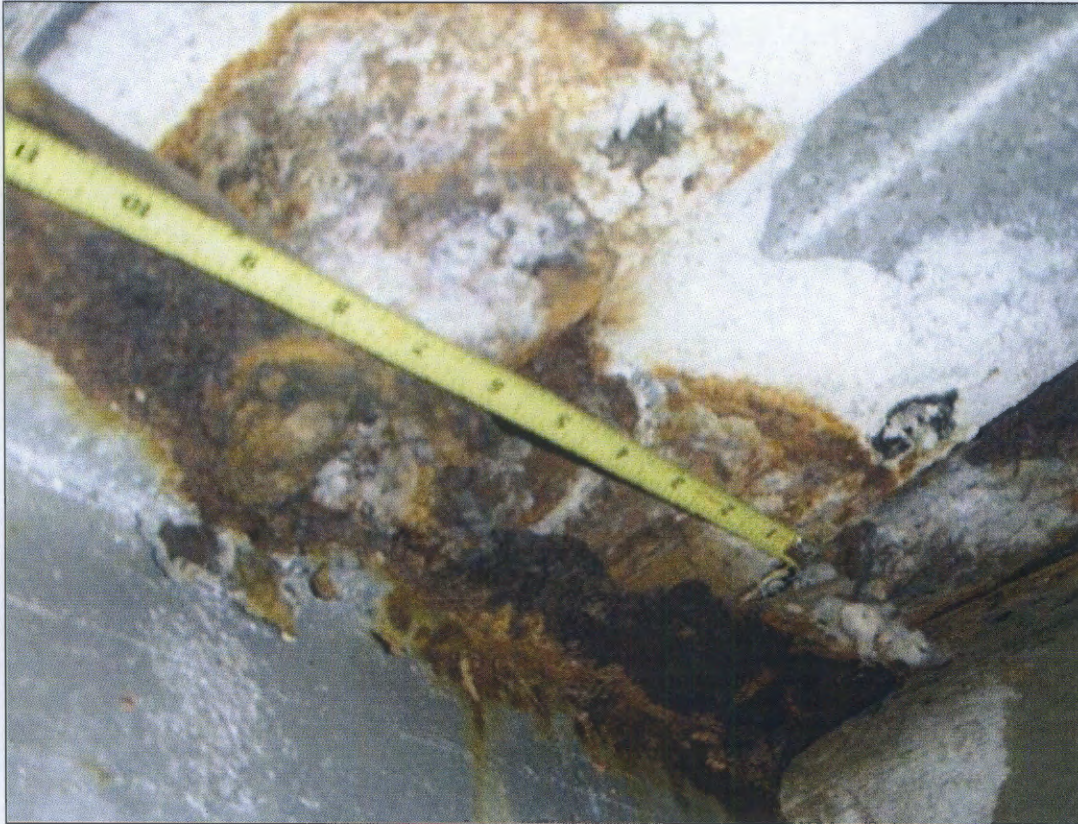
7" LONG X 1 1/2" WIDE SECTION LOSS IN THE TOP FLANGE OF BEAM 8 AT 4" FROM THE NORTH END OF THE BEAM [PRIORITY MAINTENANCE]

| MMS Code | Description of Function | Unit | Quantity | Remarks | Est. Cost |
|---|---|---|---|---|---|
| 3314 | Maintain Steel Superstructure Components | LF | <del>X TSC</del> | 7" LONG X 1 1/2" WIDE AREA OF 100% SECTION LOSS IN THE TOP FLANGE OF BEAM 8 AT 4" FROM THE NORTH END OF THE BEAM [PRIORITY MAINTENANCE] | |

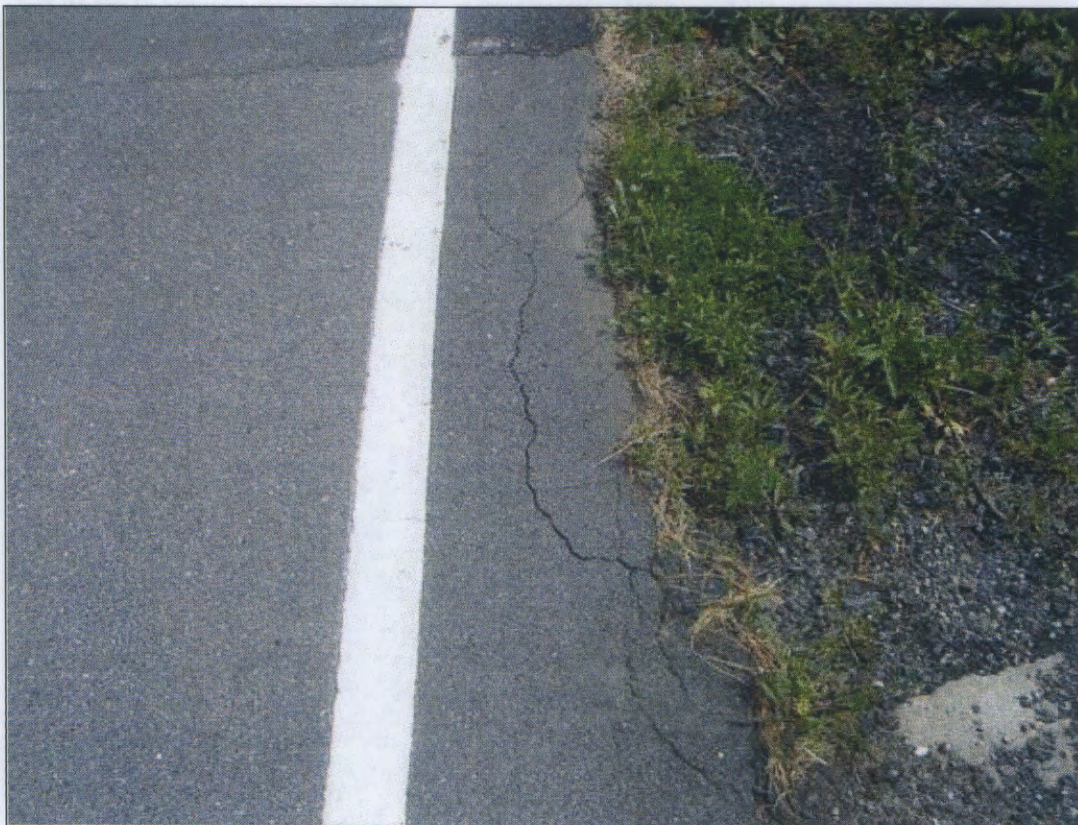
| <b>50</b> | <b>G</b> | THERE IS MAP CRACKING UP TO 1/8" WIDE IN THE WEST SHOULDER OF THE EAST APPROACH [SEE PHOTO]. | |

MAP CRACKING UP TO 1/8" WIDE IN THE WEST SHOULDER OF THE EAST APPROACH

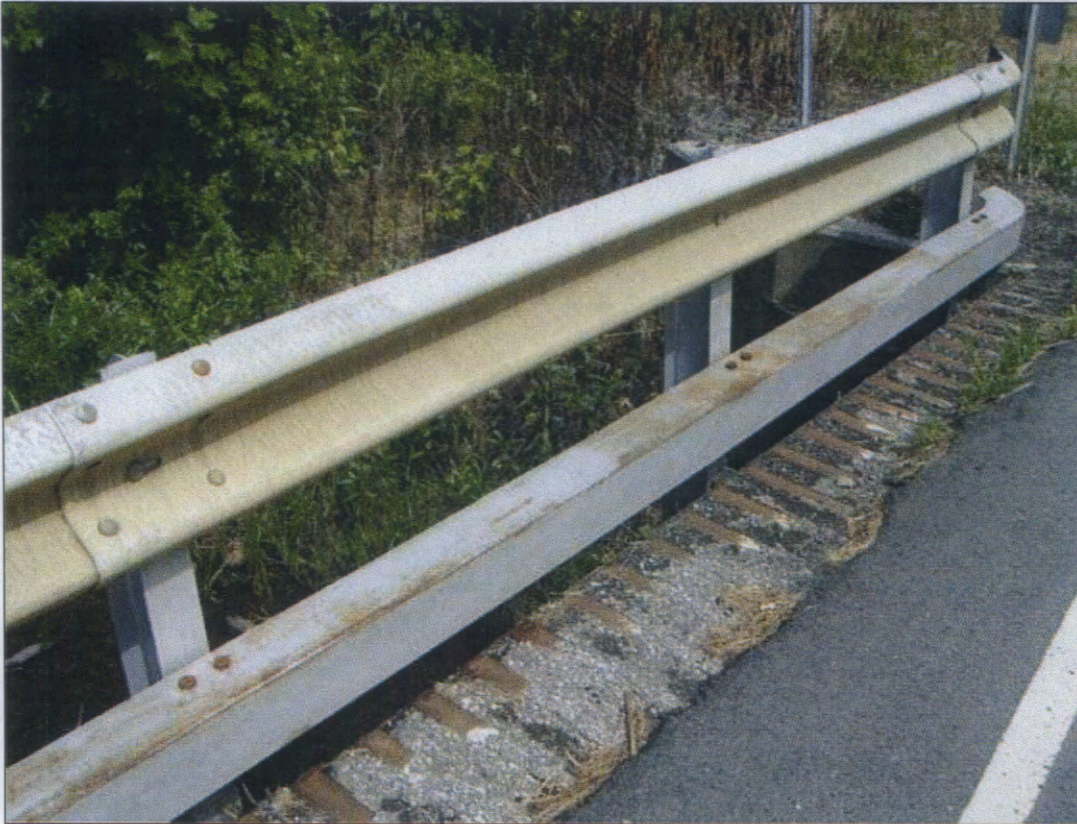
| 3d | G | THERE IS RUST STAINING ON THE BRIDGE RAILS [SEE PHOTO]. | |
| 4 | G | THERE IS SURFACE AND FRECKLE RUST ON BOTH CURBS [SEE PHOTO]. | |

RUST STAINING ON BRIDGE RAIL WITH SURFACE AND FRECKLE RUST ON CURBS

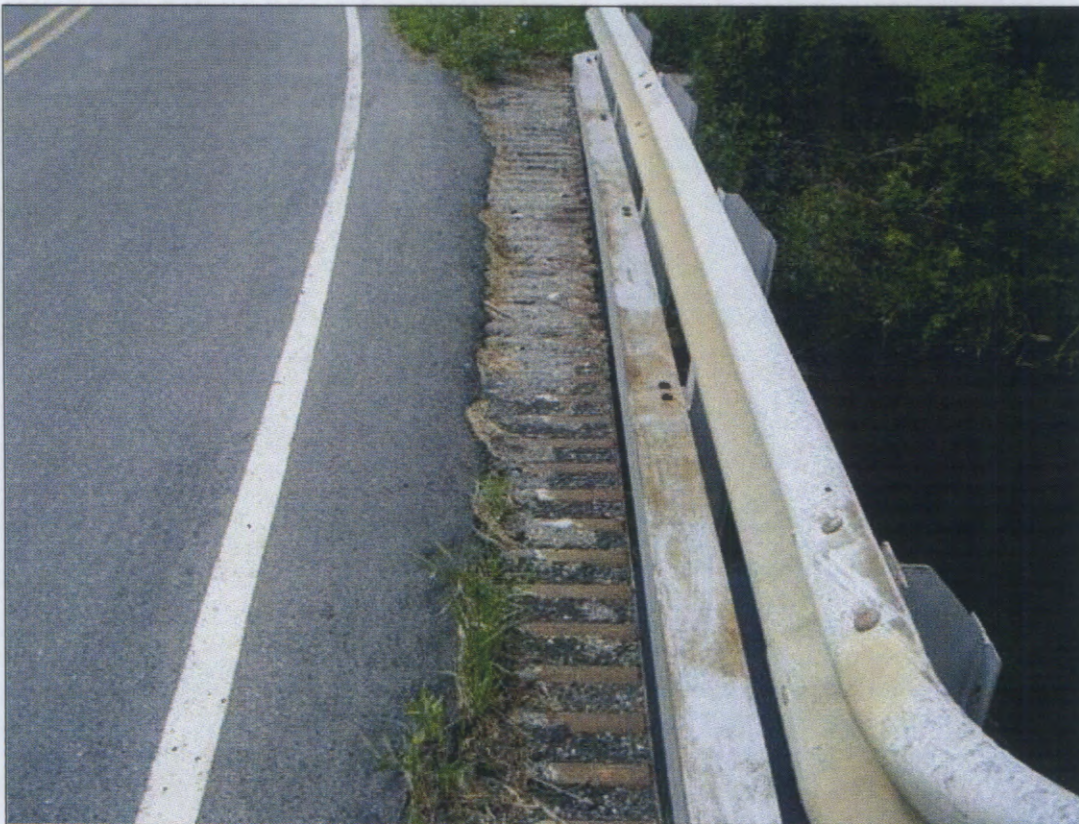
| 2c | F | THE PLANK DECKING IS EXPOSED UP TO 2-6" WIDE ALONG THE EDGE WITH SURFACE RUST THROUGHOUT [SEE PHOTO]. | |

PLANK DECKING ALONG EAST SIDE IS EXPOSED UP TO 2-6" WIDE WITH SURFACE RUST (WEST SIMILAR)

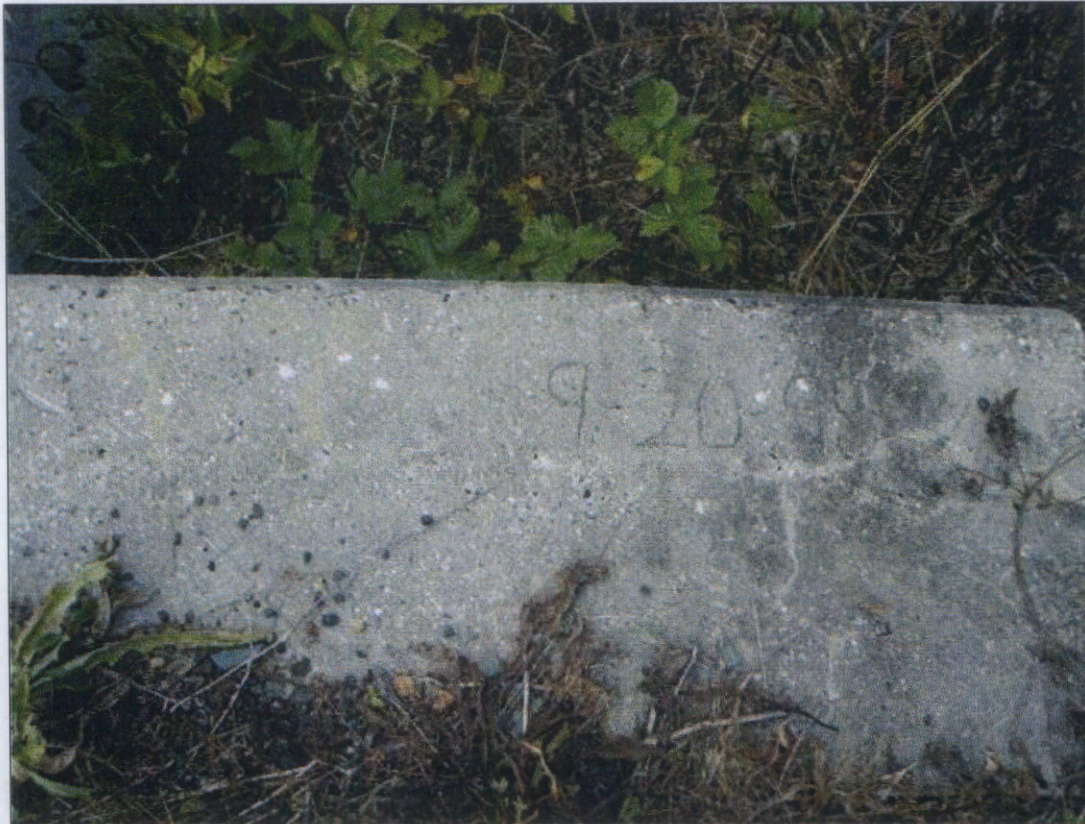
| 36d | F | HAIRLINE WRAP-AROUND CRACKS WITH EFFLORESCENCE ALONG THE SOUTHEAST, SOUTHWEST AND NORTHWEST WINGWALLS [SEE PHOTO]. FULL HEIGHT VERTICAL AND 4'-0" LONG HORIZONTAL CRACKS UP TO 1/16" WIDE WITH EFFLORESCENCE IN THE SOUTHWEST WINGWALL [SEE PHOTO]. | |

HAIRLINE WRAP-AROUND CRACKS WITH EFFLORESCENCE ALONG THE SOUTHEAST WINGWALL  
(NORTHWEST AND SOUTHWEST SIMILAR)

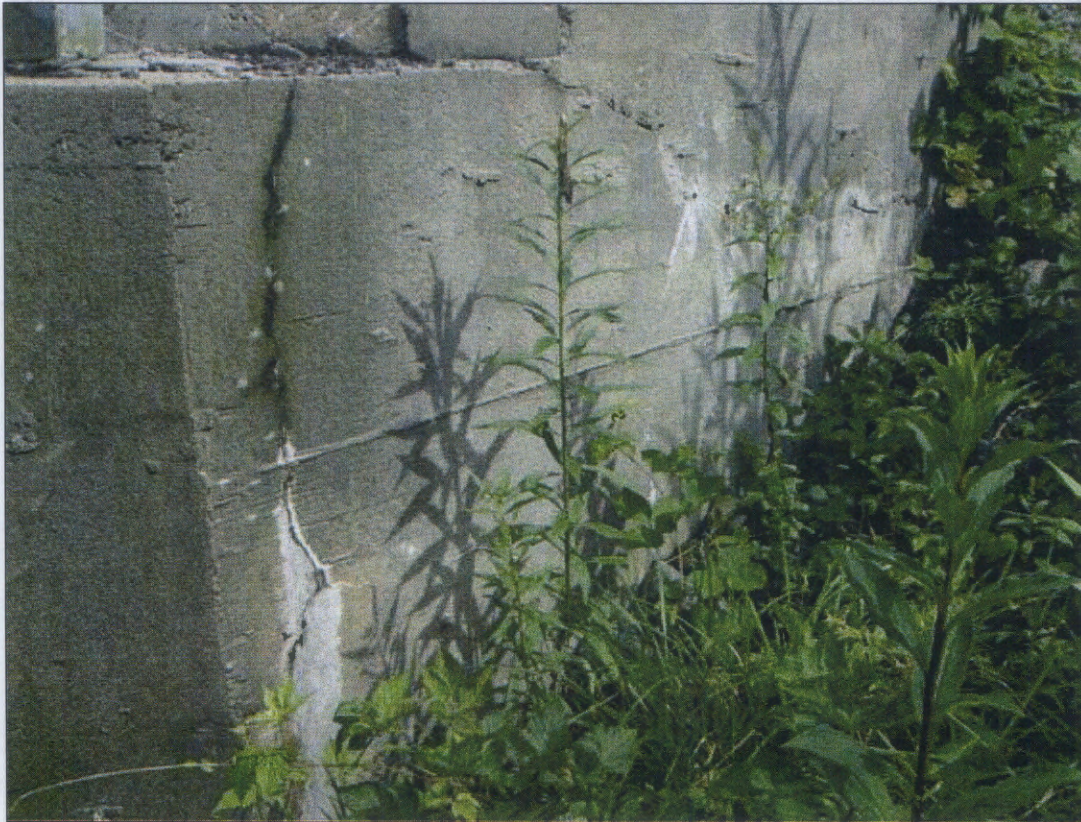
FULL HEIGHT VERTICAL AND 4'-0" LONG HORIZONTAL CRACKS UP TO 1/16" WIDE WITH EFFLORESCENCE IN THE SOUTHWEST WINGWALL

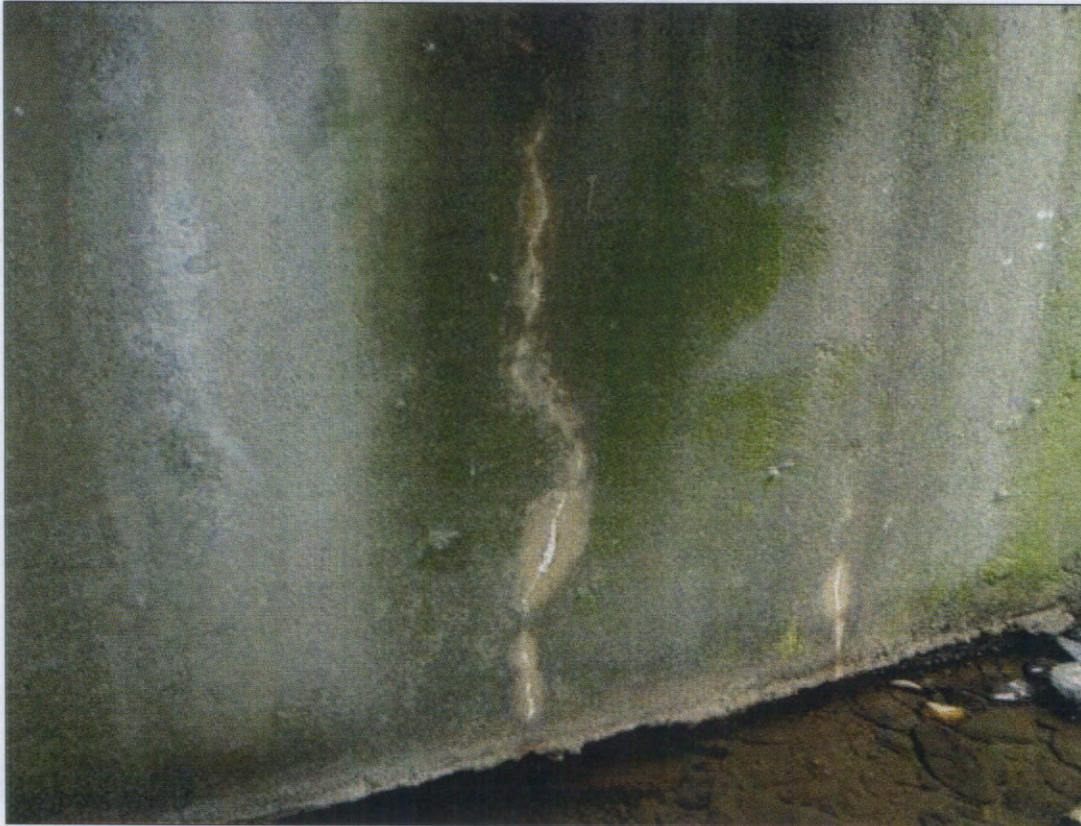
| 36a | F | THERE ARE RANDOM FULL HEIGHT VERTICAL CRACKS UP TO 1/16" WIDE WITH EFFLORESCENCE THROUGHOUT BOTH ABUTMENT CAPS [SEE PHOTO]. THERE IS A 4" LONG X 4 1/2" HIGH X 1" DEEP SPALL IN THE ABUTMENT 1 CAP BELOW BEAM 11 [SEE PHOTO]. | |

RANDOM FULL HEIGHT VERTICAL CRACKS UP TO 1/16" WIDE WITH EFFLORESCENCE THROUGHOUT BOTH ABUTMENT CAPS AND EXTENDING INTO THE BREASTWALLS

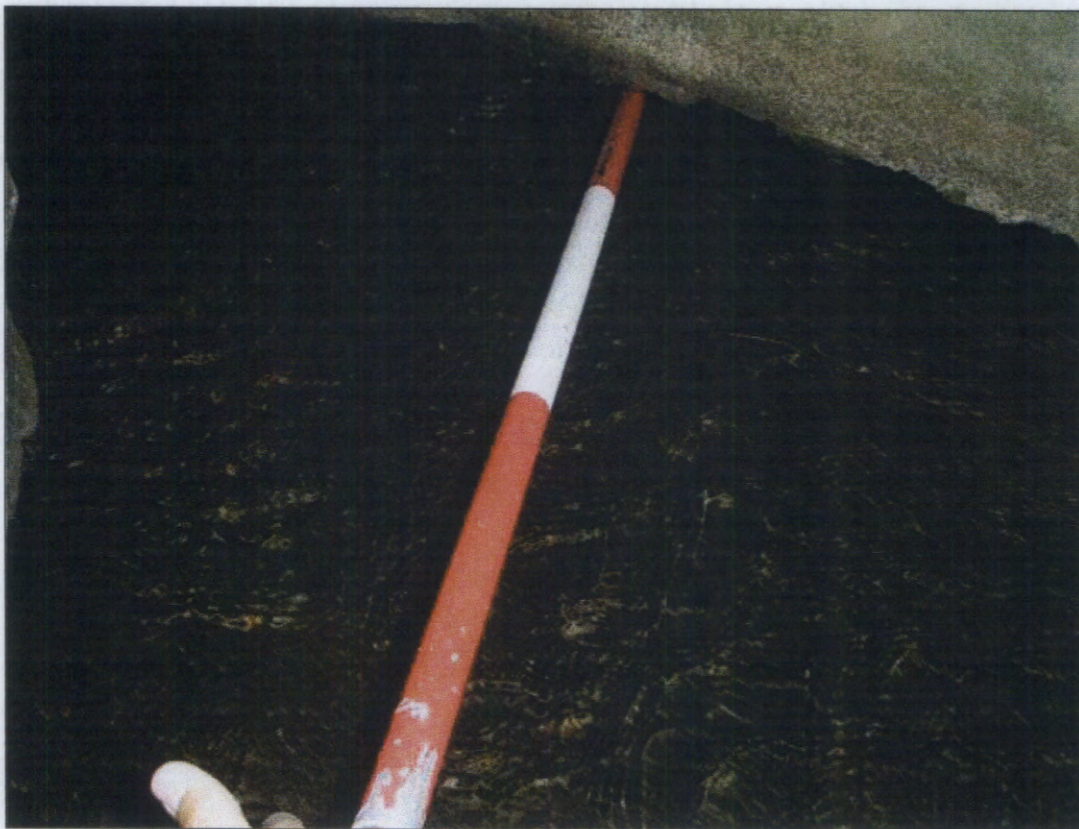
| <b>45c</b> | <b>F</b> | THERE ARE UNDERMINED AREAS UP TO 1'-2" DEEP ALONG ABUTMENT 1 FROM WEST OVERHANG TO BEAM 10 AND UP TO 2" ALONG ABUTMENT 2 [SEE PHOTO]. | |

UNDERMINED AREAS UP TO 1'-2" DEEP AT ABUTMENT 1 FROM WEST OVERHANG TO BEAM 10

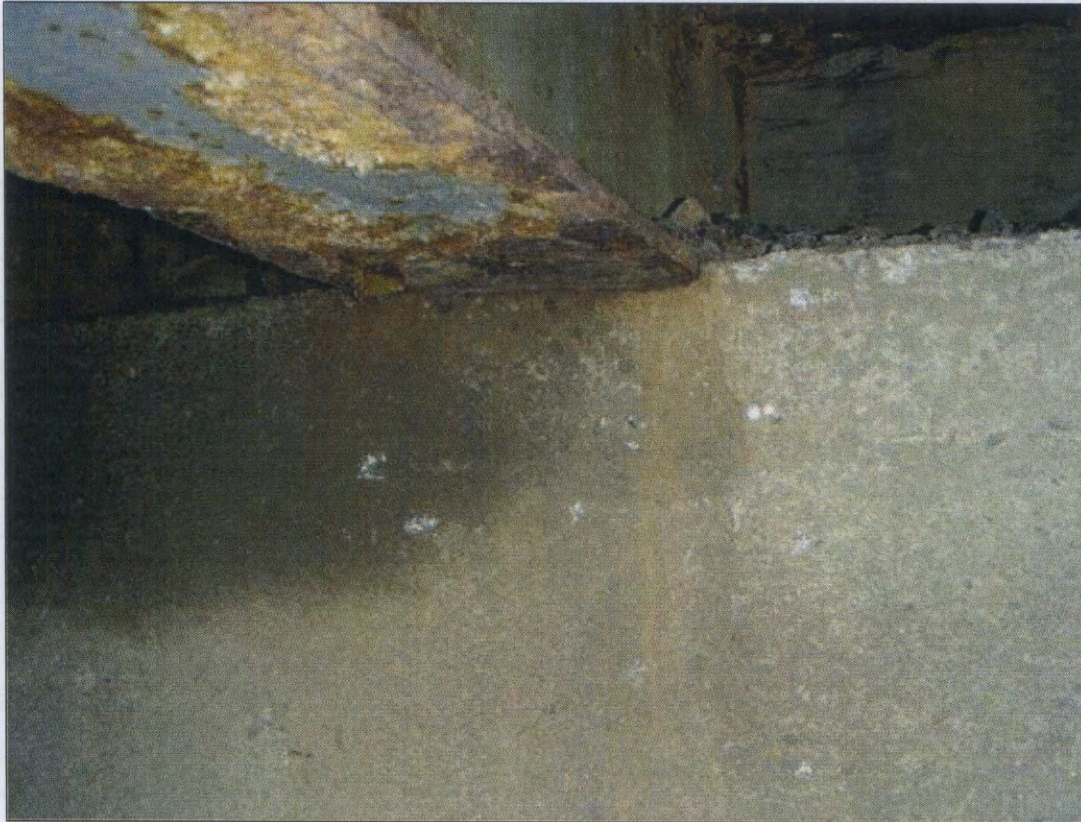
4" LONG X 4 1/2" HIGH X 1" DEEP SPALL IN THE ABUTMENT 1 CAP BELOW BEAM 11

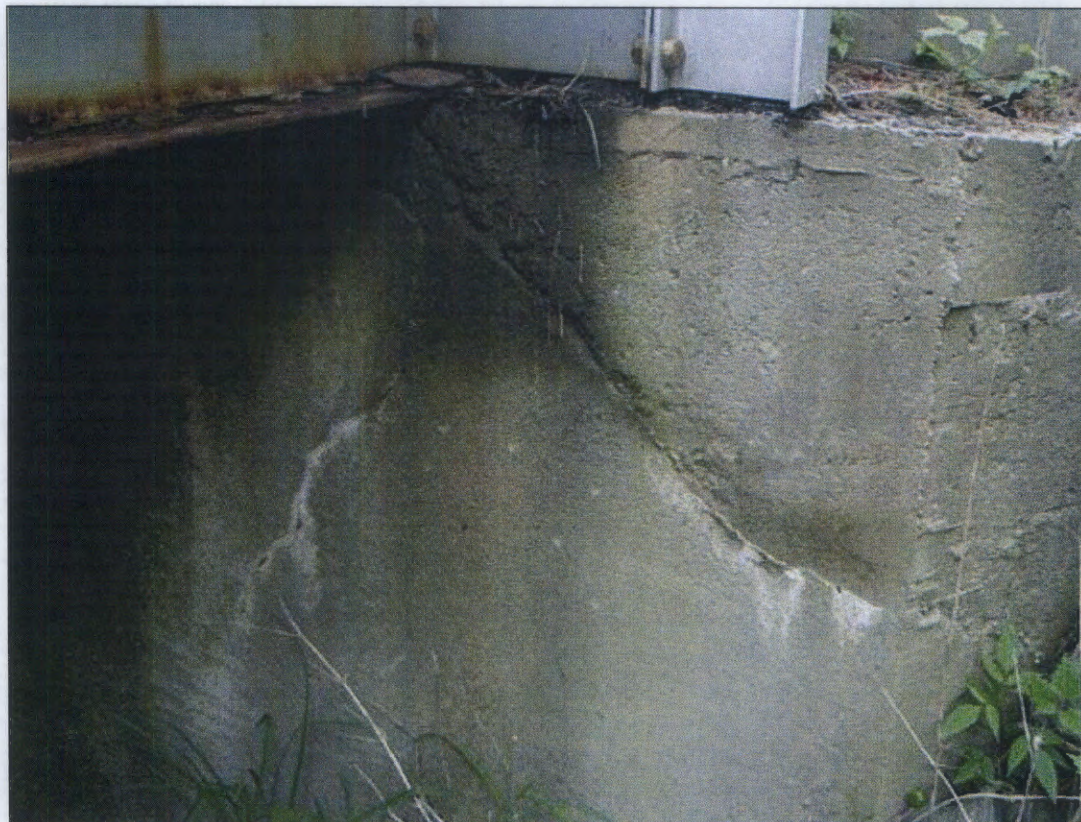
| 36b | F | THERE ARE RANDOM FULL HEIGHT VERTICAL CRACKS UP TO 1/16" WIDE WITH EFFLORESCENCE THROUGHOUT BOTH ABUTMENT BREASTWALLS [SEE PHOTO]. THERE IS AN UP TO 1" WIDE DIAGONAL CRACK UNDER BEAM 13 IN THE ABUTMENT 2 BREASTWALL [SEE PHOTO]. HORIZONTAL CRACKING UP TO 1/16" WIDE WITH EFFLORESCENCE IN ABUTMENT 2 BREASTWALL UNDER BEAMS 1 TO 10 [SEE PHOTO]. | |

UP TO 1" WIDE DIAGONAL CRACK UNDER BEAM 13 OF ABUTMENT 2 BREASTWALL

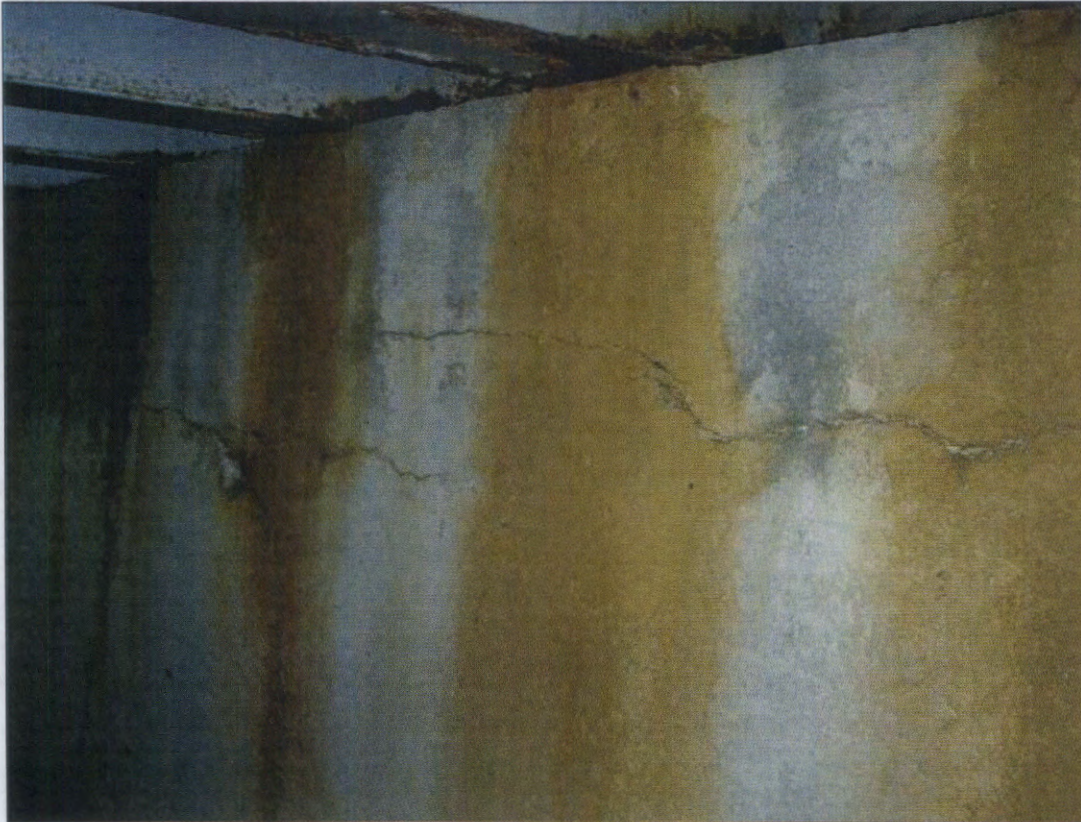
HORIZONTAL CRACKING WITH EFFLORESCENCE IN ABUTMENT 2 BREASTWALL UNDER BEAMS 1 TO 10

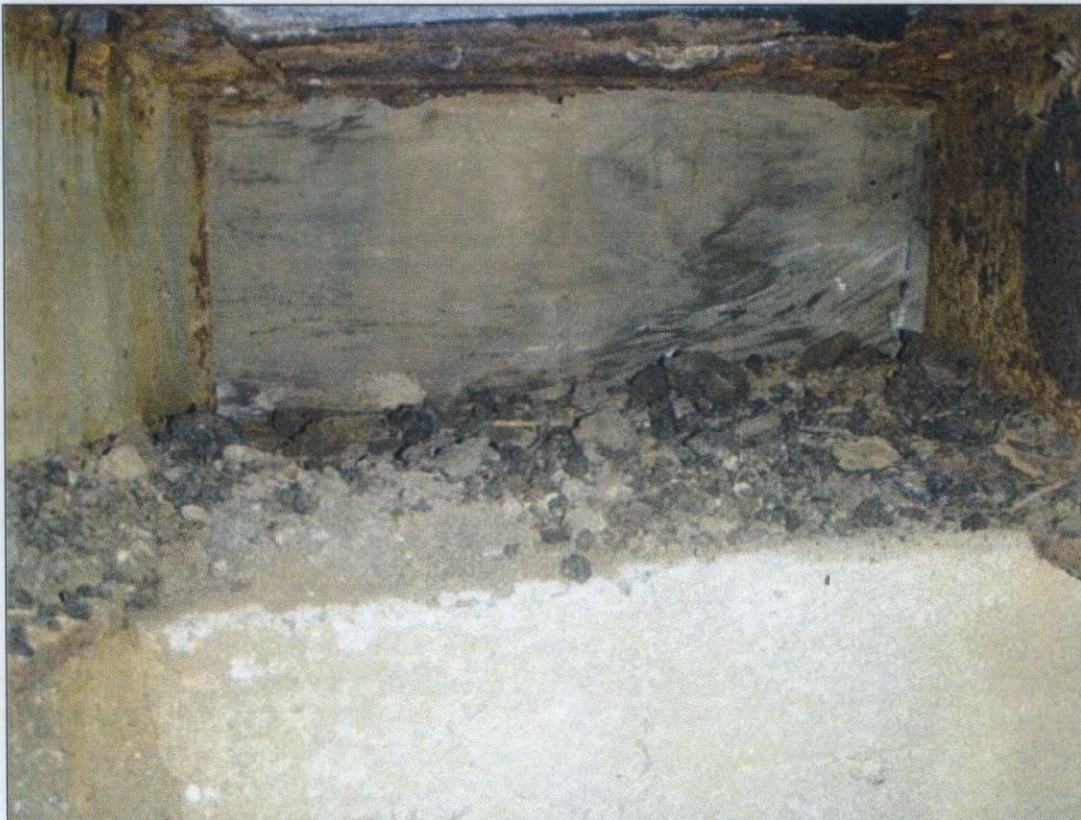
| 41 | G | THERE IS DRIFT ALONG THE ABUTMENT 1 CAP [SEE PHOTO]. | |

DRIFT ALONG THE ABUTMENT 1 CAP (BAY 10 SHOWN)

| MMS Code | Description of Function | Unit | Quantity | Remarks | Est. Cost |
|---|---|---|---|---|---|
| 3366 | Drift and Debris Removal | HR | 16 | REMOVE DRIFT FROM THE CAP OF ABUTMENT 1 | |

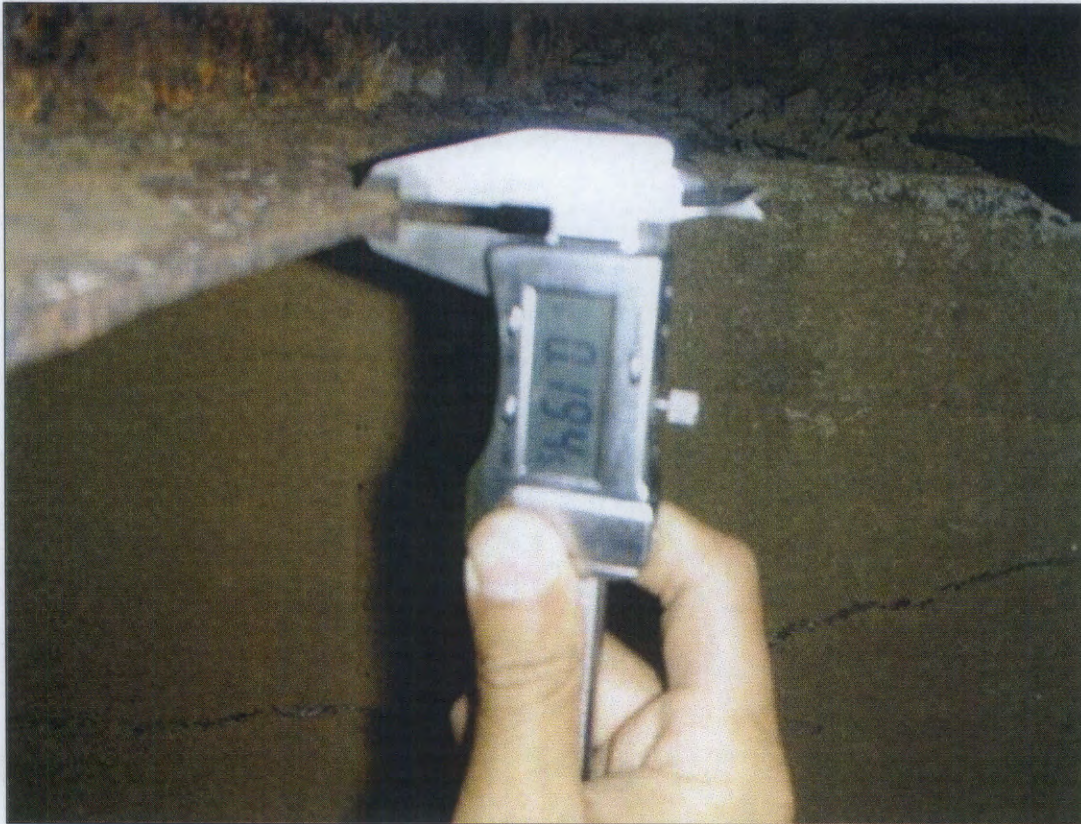
SECTION LOSS WITH 0.194" THICKNESS REMAINING IN THE BOTTOM FLANGE OF BEAM 8 (BEAMS 7, 9, AND 10 SIMILAR)

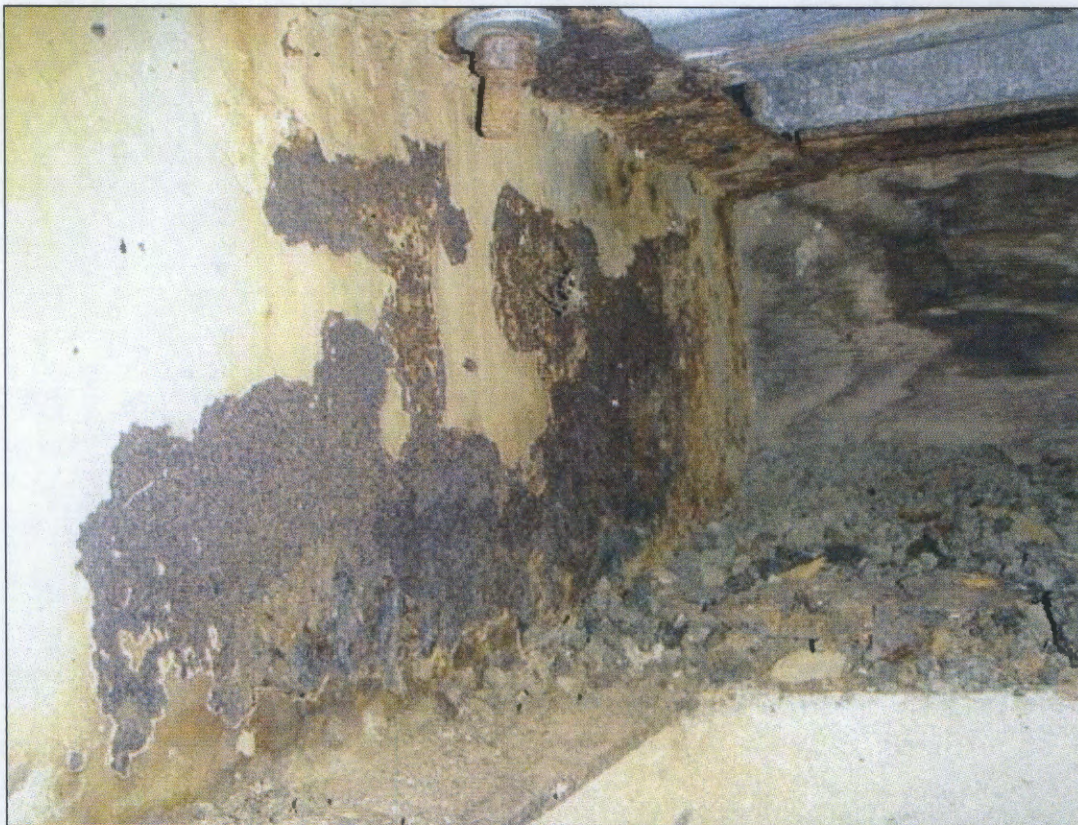
DELAMINATED STEEL IN THE BOTTOM FLANGE OF BEAM 10 AT ABUTMENT 1

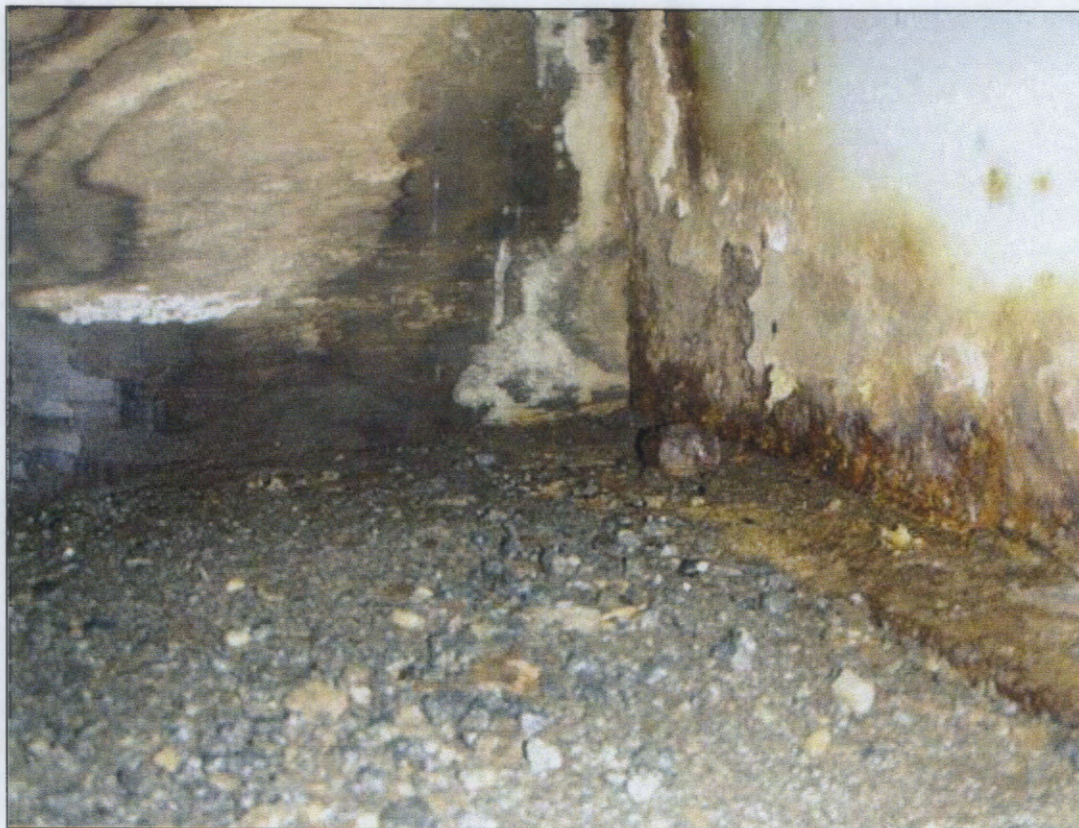
| 15 | F | THERE IS SURFACE RUST THROUGHOUT THE BEARINGS WITH NO SECTION LOSS NOTED. | |

BEAM 12 BEARING AT ABUTMENT 1 (OTHERS SIMILAR)
