NC DEPARTMENT OF TRANSPORTATION  
DIVISION OF HIGHWAYS  
BRIDGE MANAGEMENT UNIT

# BRIDGE INSPECTION REPORT

COUNTY IREDELL BRIDGE NUMBER 480282 INSPECTION CYCLE 2 YRS  
ROUTE SR1828 ACROSS NORTH HUNTING CREEK M.P. 0

SUPERSTRUCTURE STEEL PLANK DECK ON I-BEAMS

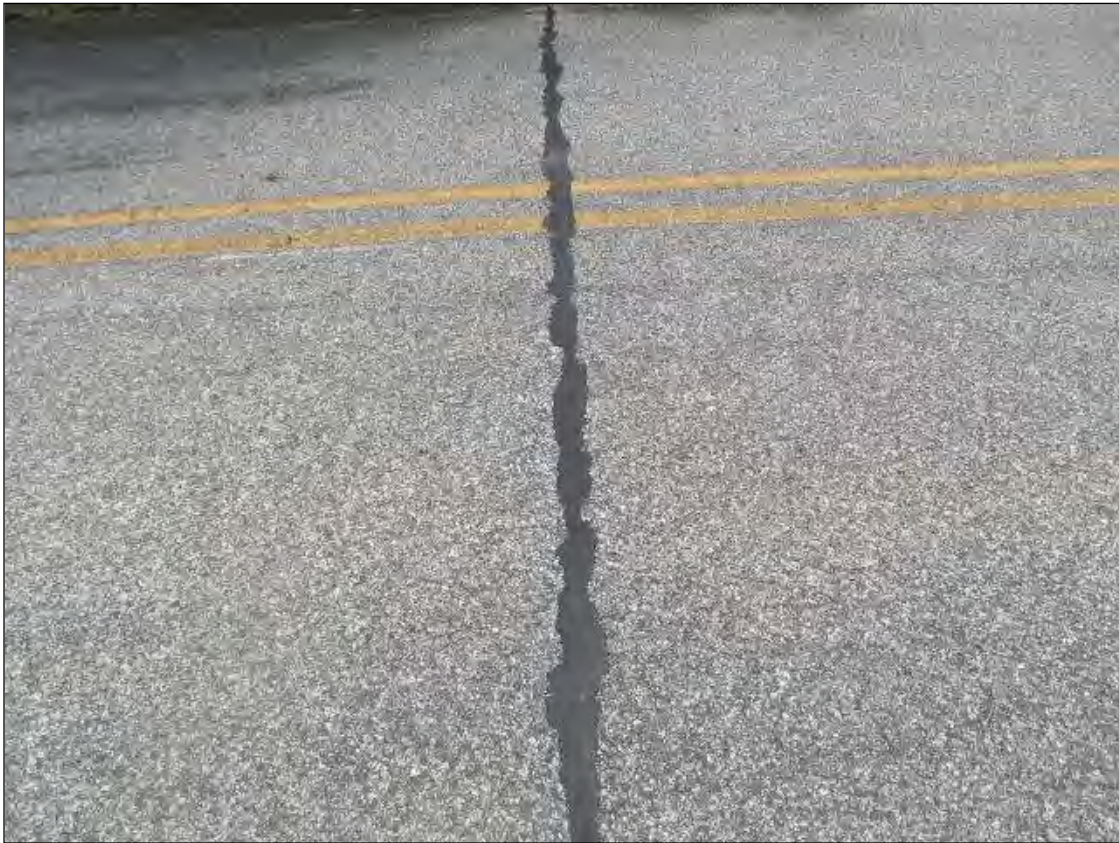
(5) STD. JOINTS ARE SEALED AND IN GOOD CONDITION AT THIS TIME...

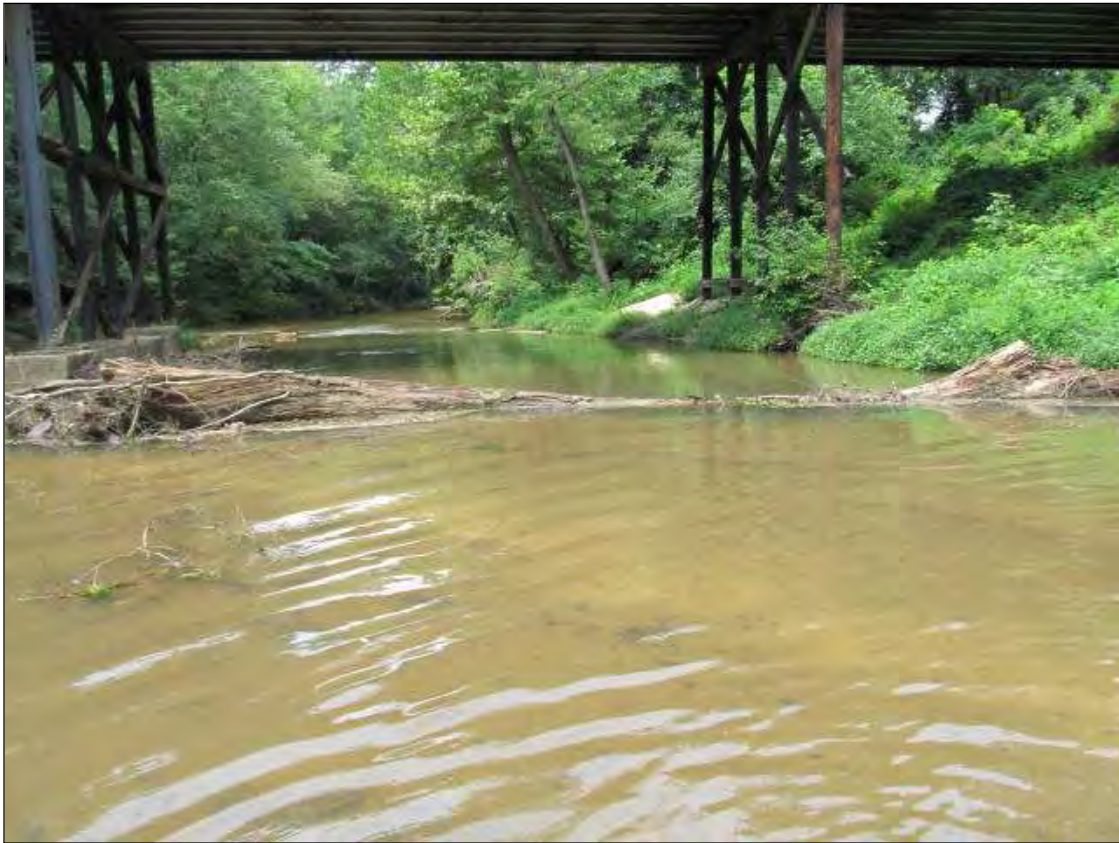
DRIFT, LARGE TREE (+/- 2 FT. DIAM.) X (+/- 30 FT. LONG) UPSTREAM IN SPAN (B)...

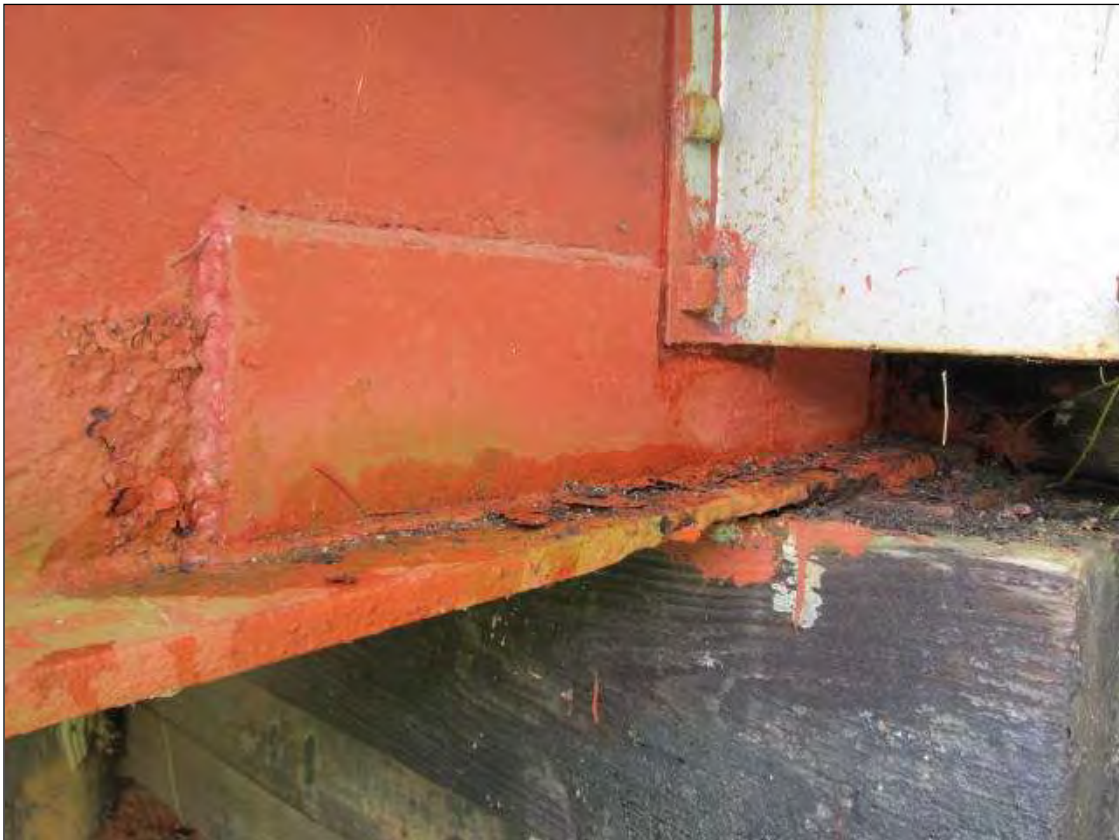
TEMP. REPAIR, END OF BEAM (1) AT ABUT. (A)...

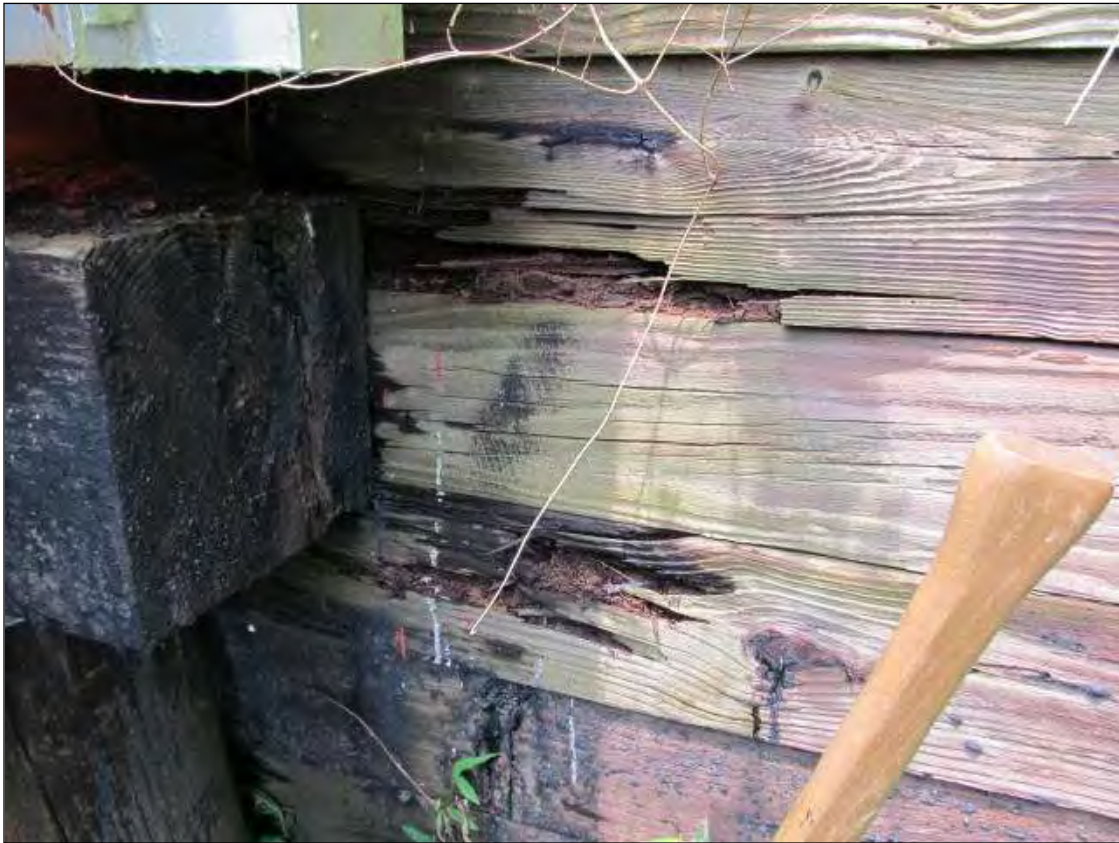
(2) BULKHEAD BOARDS ARE DECAYED ADJACENT TO LT. END OF ABUT. (A) CAP... (+/- 6 SF)

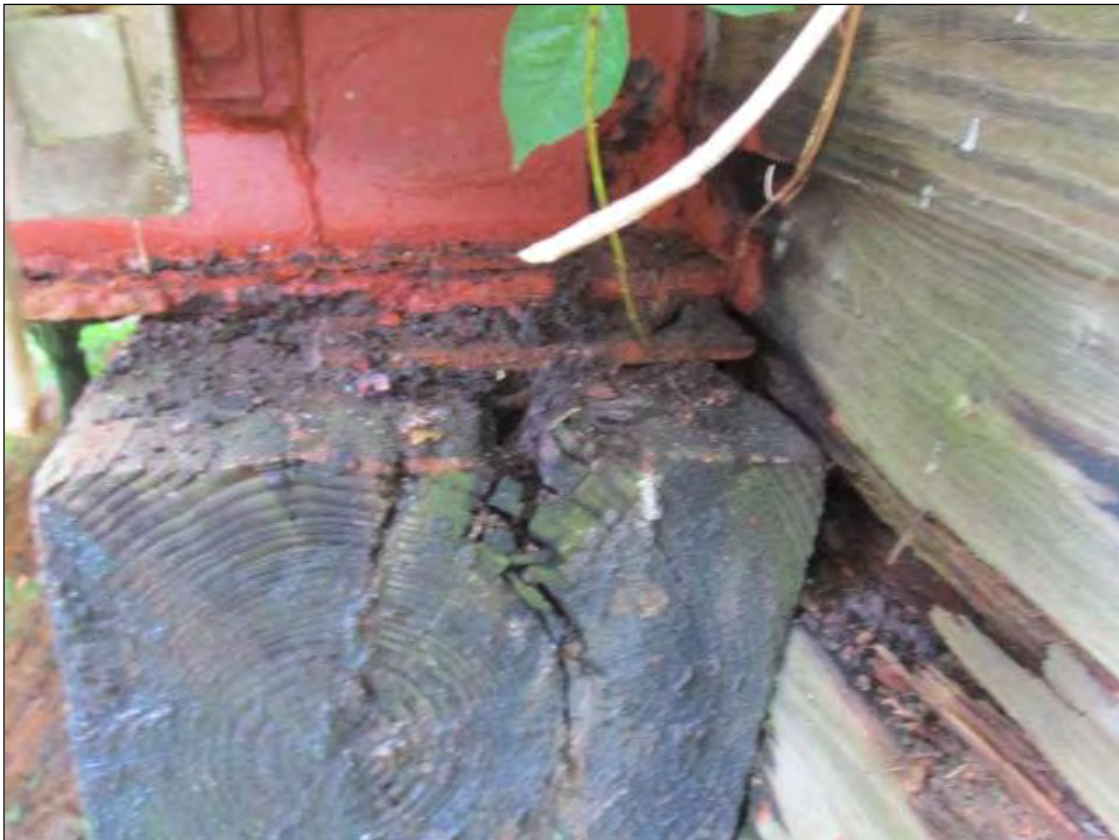
ABUT. (A) CAP IS DECAYED , AND SPLIT ALONG THE TOP, LT. END. DECAY EXTENDS BENEATH BRG. PLATE, AND PLATE IS CRUSHING INTO TOP OF CAP...

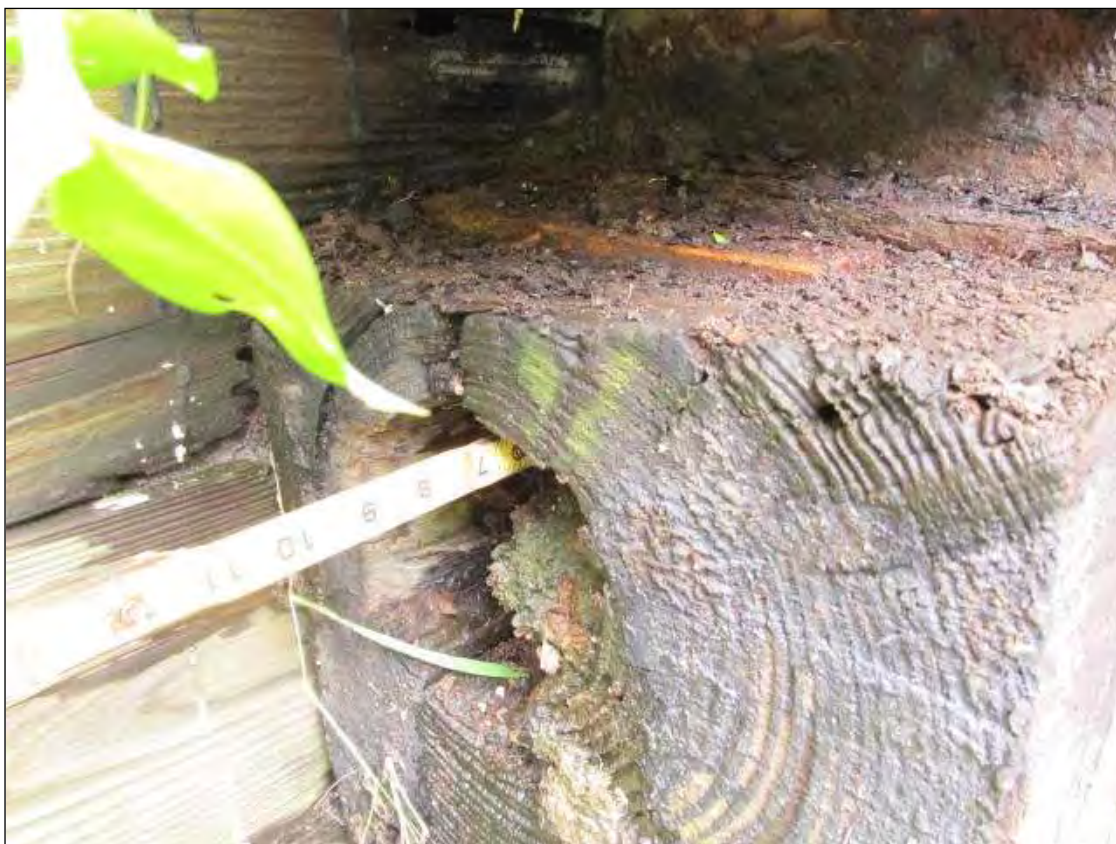
RT. END OF ABUT. (A) CAP IS DECAYED (+/- 6" DIAM.) AND EXTENDS BENEATH BEARING PLATE, WHICH IS CRUSHING INTO TOP OF CAP. CAP IS SPLIT FULL LENGTH...

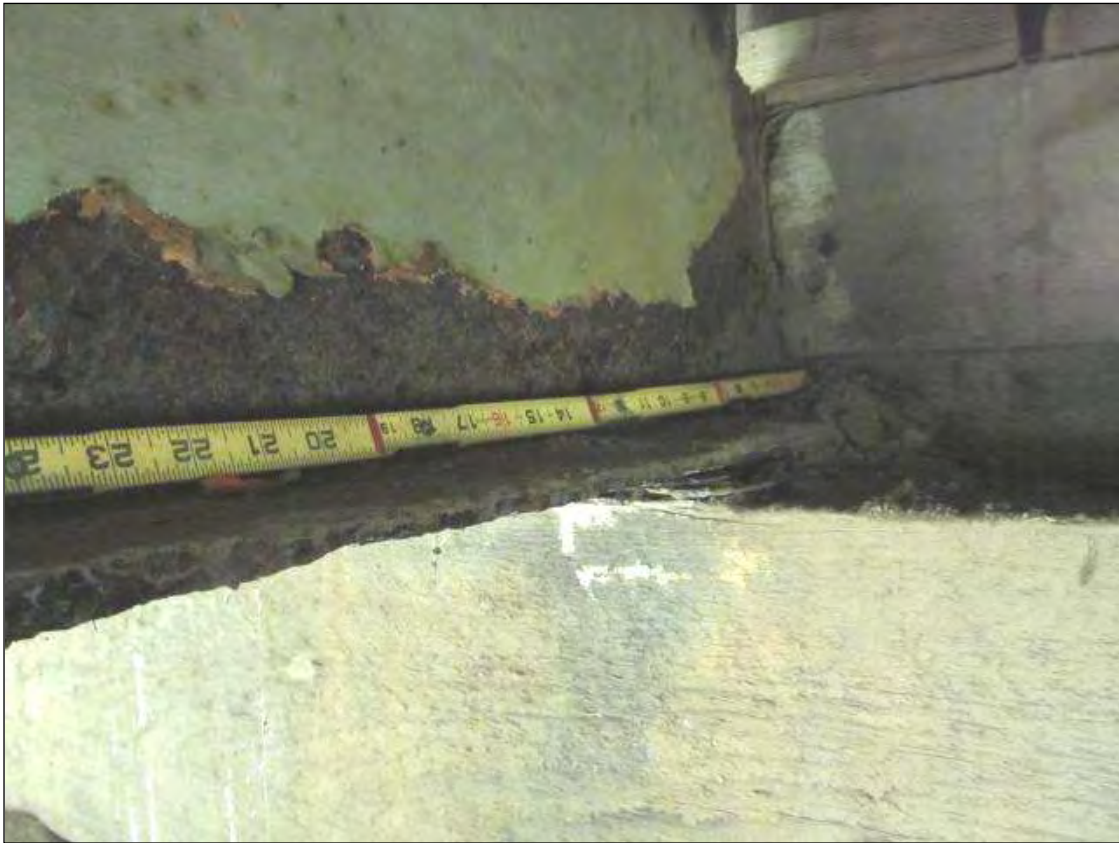
ALL BEAMS AT ABUT. (A) DETERIORATED (+/- 5 LF) ON ENDS... BOTT. FLANGES ARE REDUCED TO (+/- 1/4")...  
(THIS PHOTO IS BEAM (7)... SEE SKETCH

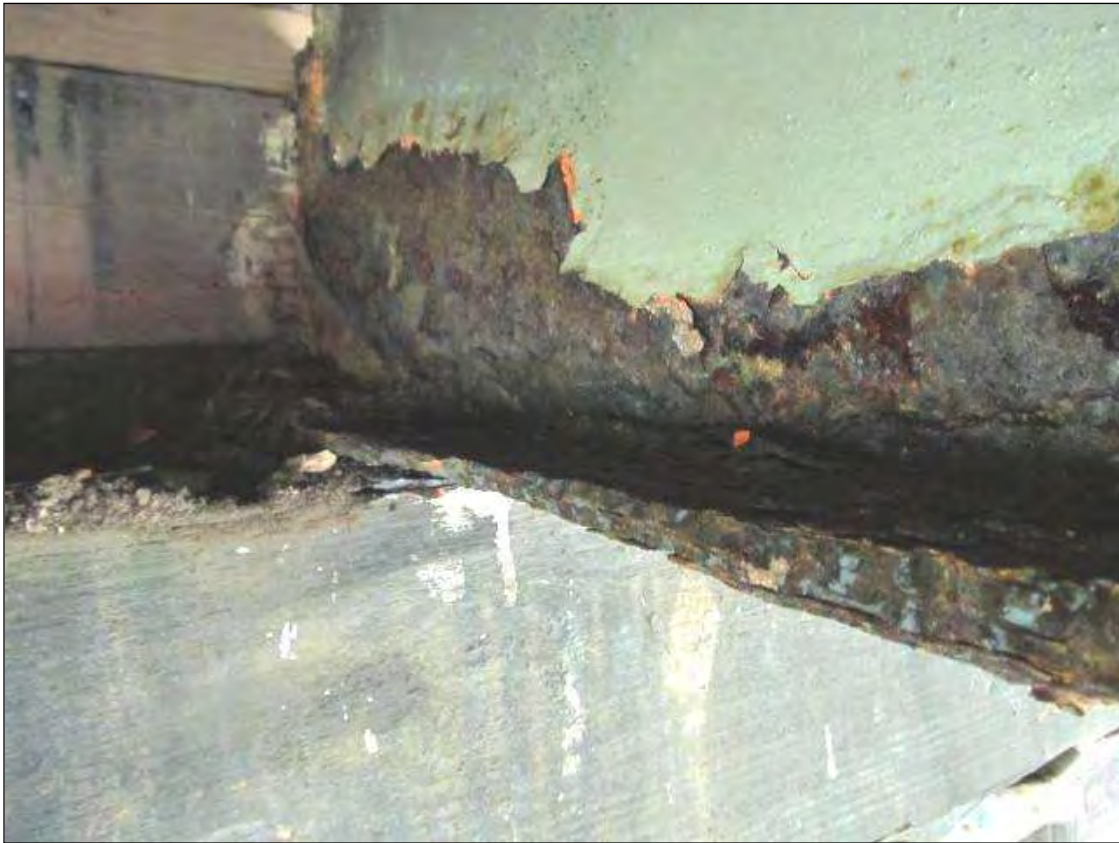
RUST SCALE AND LOSS OF SECTION ALONG BEAM BOTT. FLANGES AT ABUT. (A). (BEAM, 4 SHOWN)... SEE SKETCH

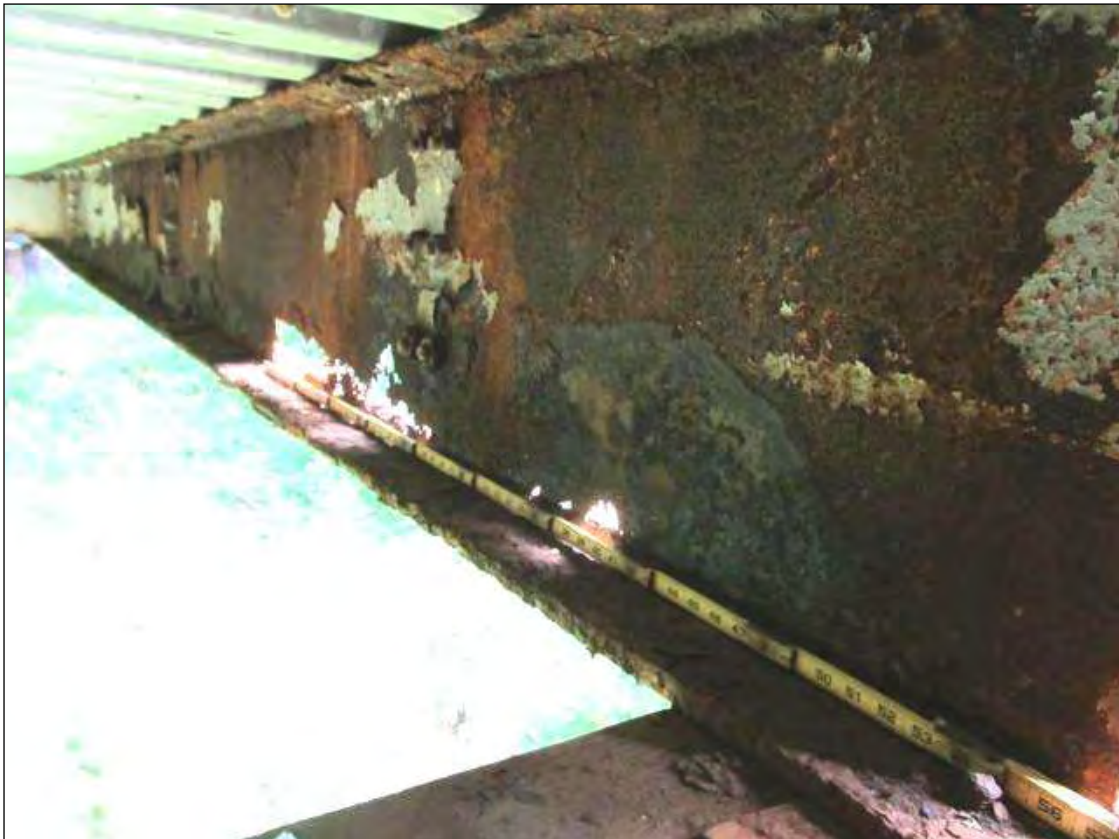
BEAM (1), SPAN (A) (RT. SIDE) AT PIER (1); HOLES IN BOTT. OF WEB (+/- 3' L X 6" H)... SEE SKETCH

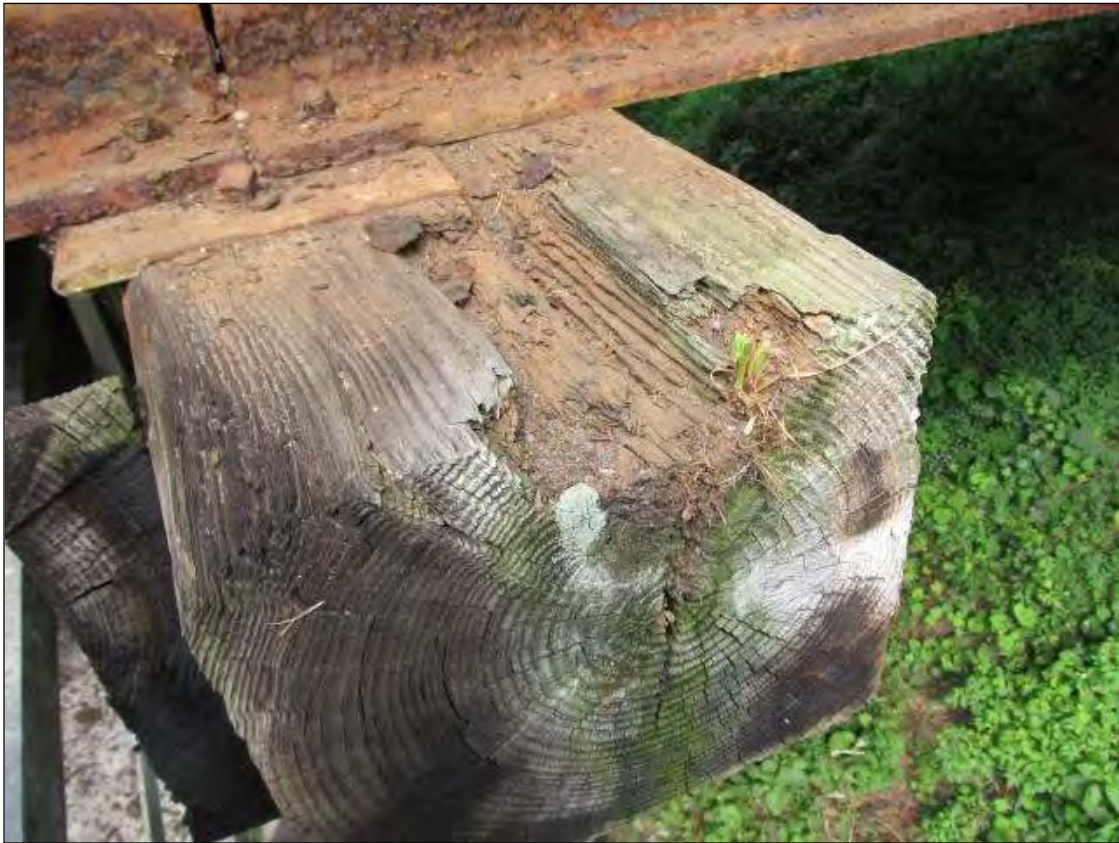
LT. END OF PIER (1) CAP IS SPLIT AND DECAYED ON END, DECAY EXTENDS BENEATH BRG. PLATE, AND THROUGH CAP FULL LENGTH... CAP IS HOLLOW.

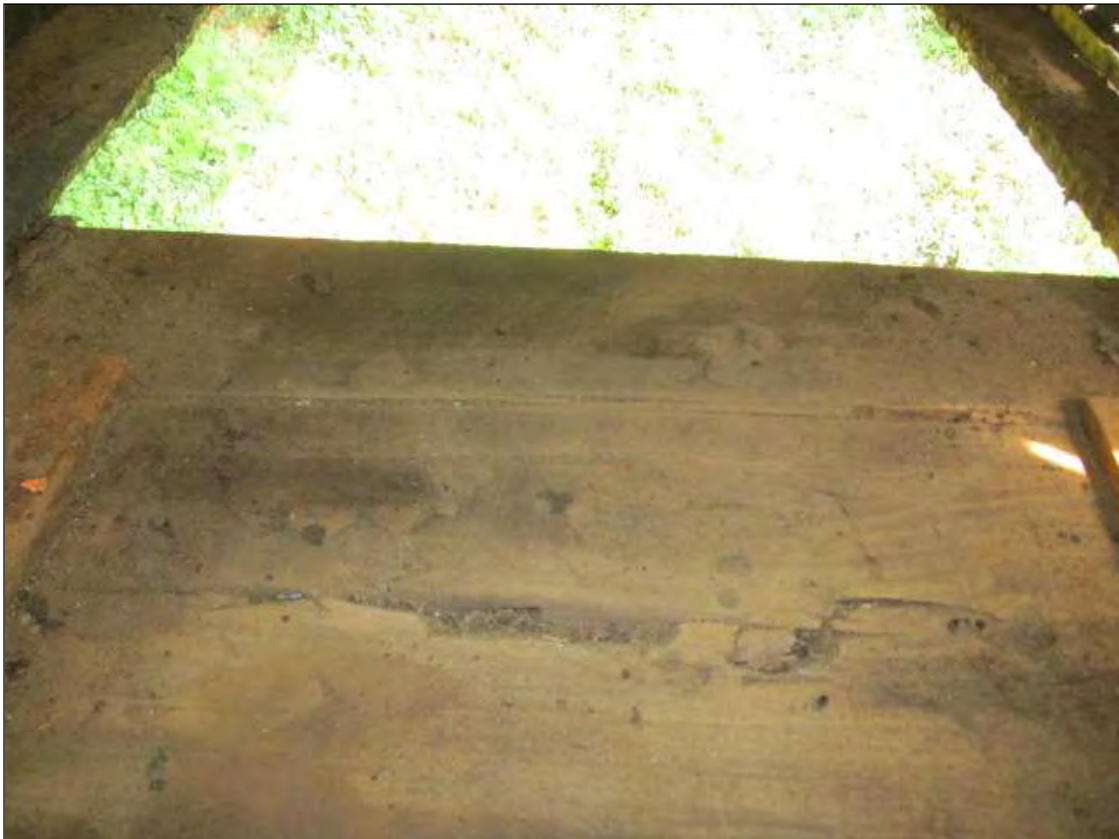
SPLIT ALONG TOP CENTER OF PIER (1) CAP... SHOWN BTWN. SEATS (1) AND (2)...

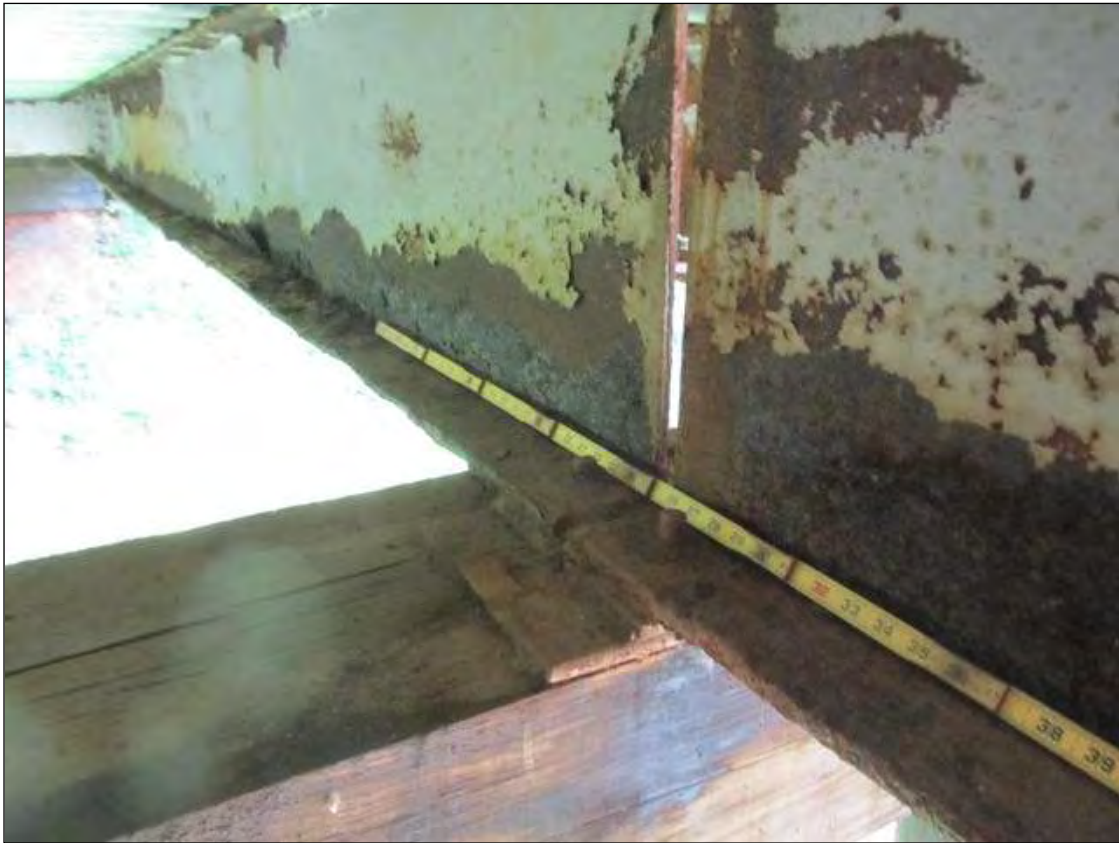
SEVERE RUST, SCALE AND LOSS OF SECTION AT ALL BEAM END WEBS AND BOTTOM FLANGES... SEE GENERAL CONDITION SKETCH FOR AREAS NOT MENTIONED IN PMN'S...

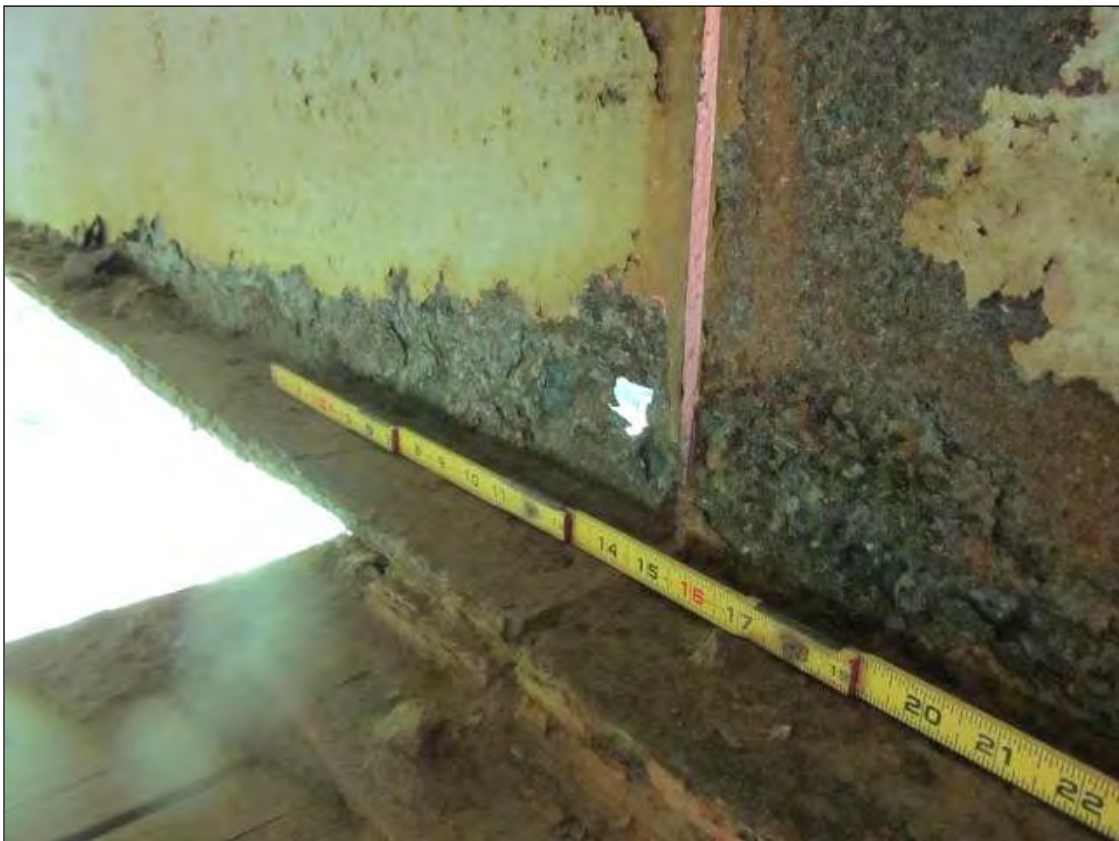
RT. SIDE BEAM (3), SPAN (A) AT PIER (1)... (+/- 2" DIAM.) HOLE IN WEB... SEE SKETCH

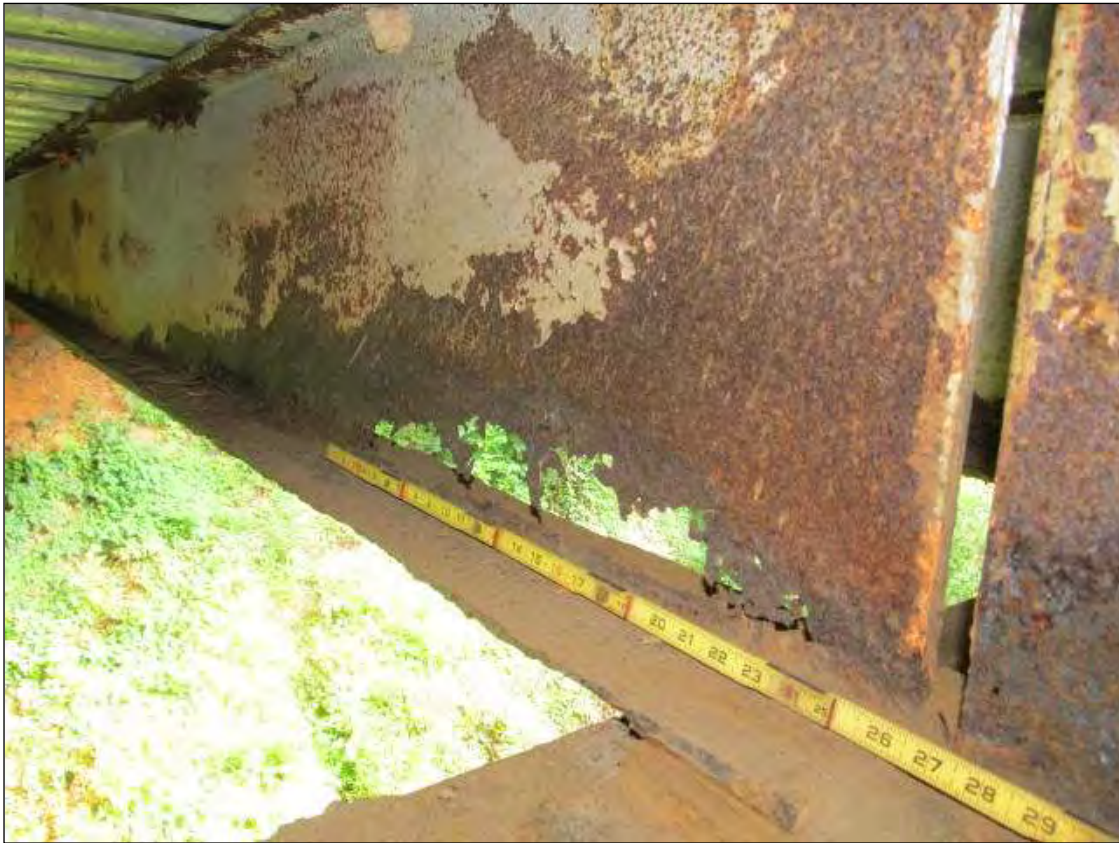
RT. SIDE BEAM (4), SPAN (A) AT PIER (1)... HOLE IN WEB (+/- 30" L X 6" H)... SEE SKETCH

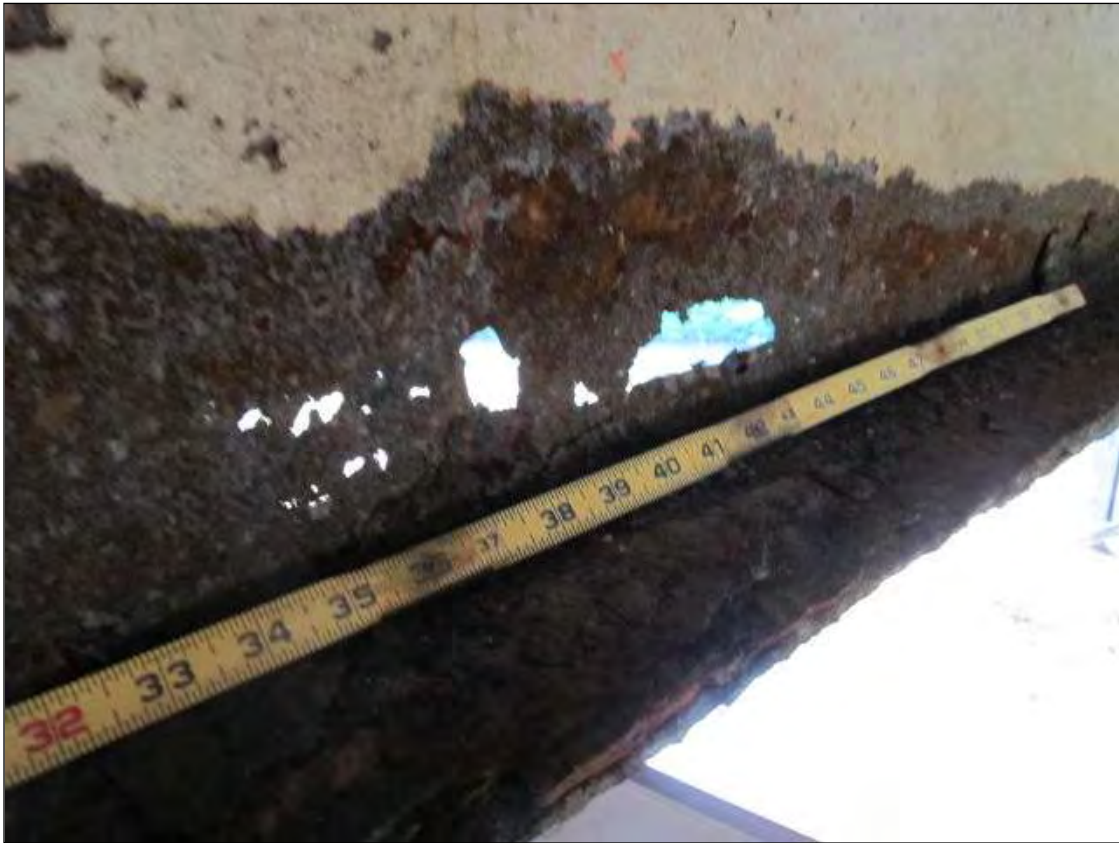
RT. SIDE BEAM (5), SPAN (B) (+/- 3' FROM PIER (1) CAP... HOLE IN WEB (+/- 12" L X 6" H)... SEE SKETCH

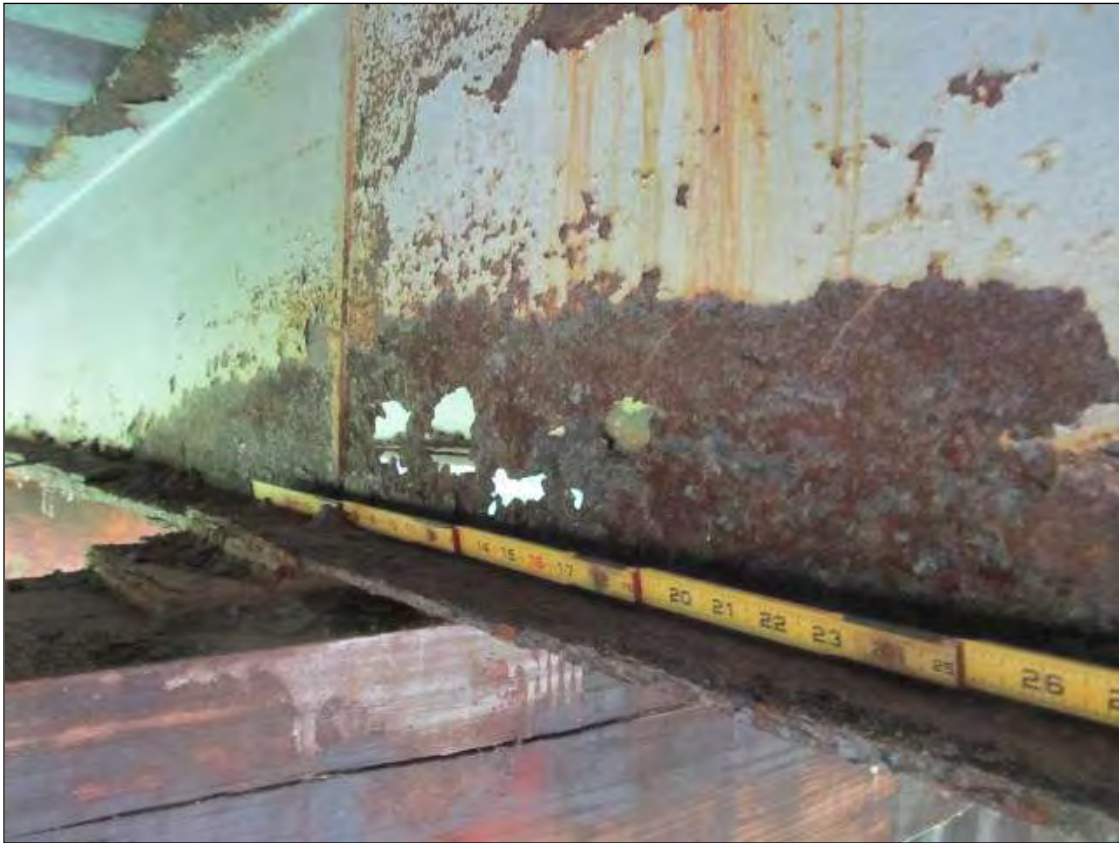
RT. SIDE OF BEAM (9), SPANS (A) AND (B) AT PIER (1)... HOLES IN WEB (+/- 18" L X 6" H)... SEE SKETCH

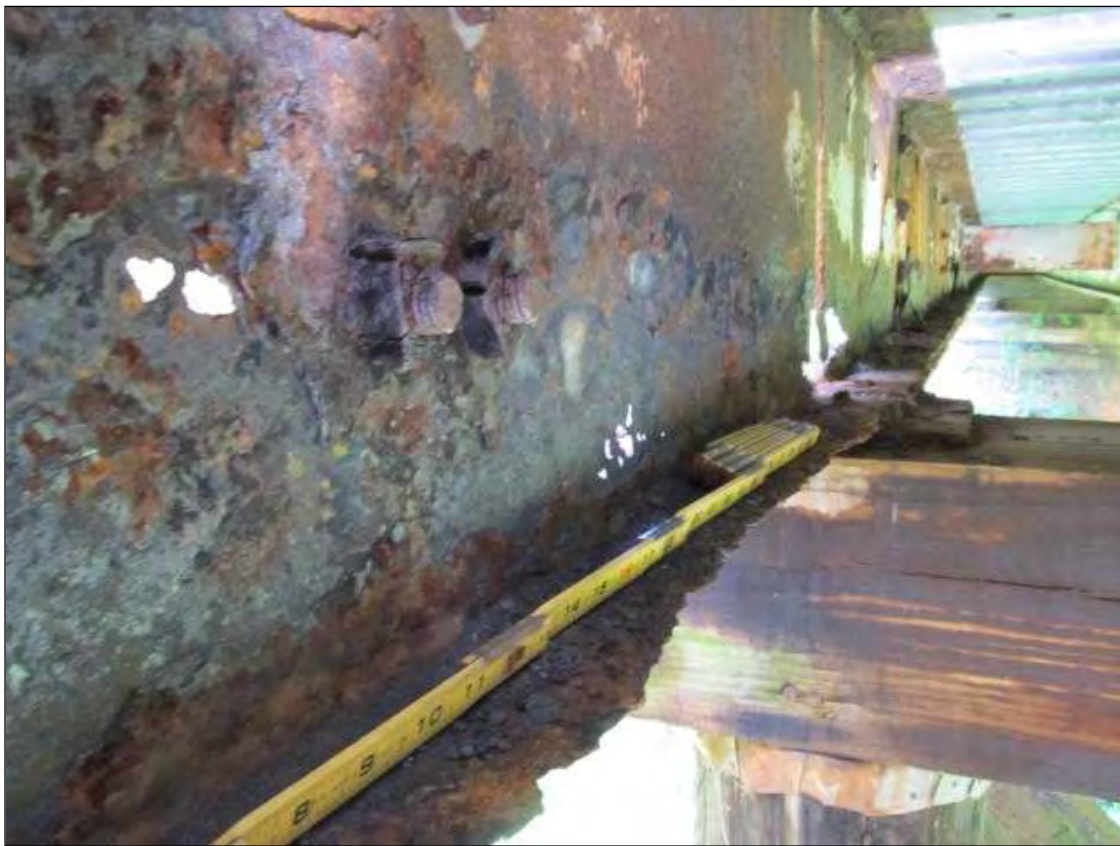
BEAM (10) WEB AT FIRST RAIL CONNECTION IN SPAN (B)... HOLES IN WEB (+/- 4' L W/ 2, +/- 4" DIAM. HOLES)...  
NOTE CONDITION OF BOTT. FLANGE... SEE SKETCH

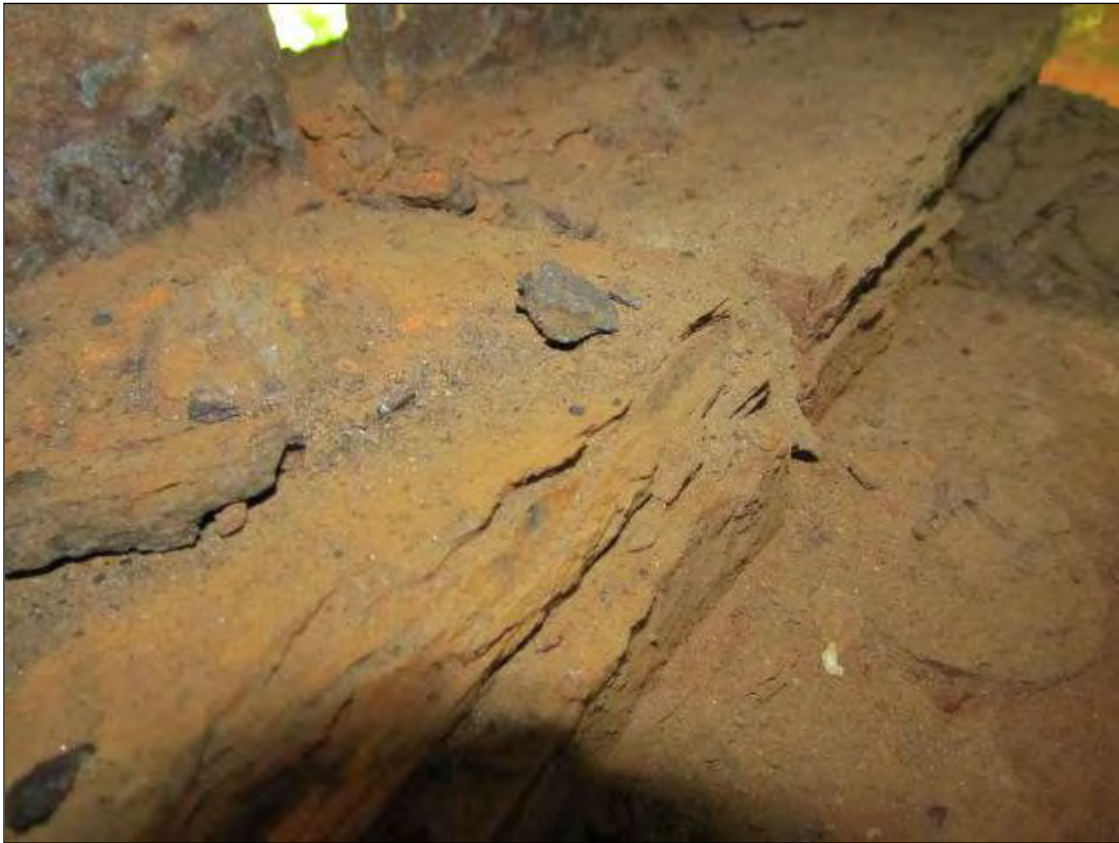
BEARING ARE SIMILAR THROUGHOUT, SEVERE RUST, SCALE AND LOSS OF SECTION. HARDWARE REDUCED 100 PERCENT.

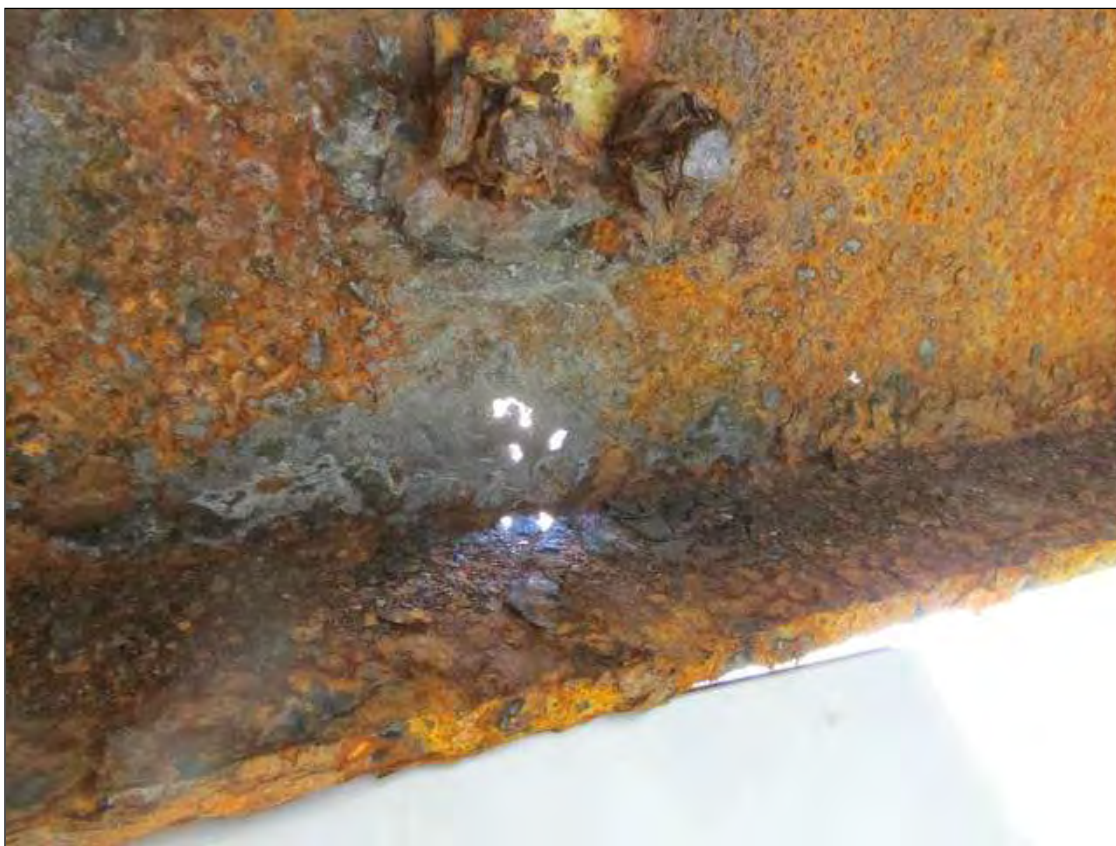
RT. SIDE BEAM (1), SPAN (B) ~ 11 FT. F/ FACE OF PIER (1) CAP... HOLES IN WEB (+/- 3" DIAM.) BELOW RAIL  
POST CONN... NOTE COND. OF CONN... SEE SKETCH

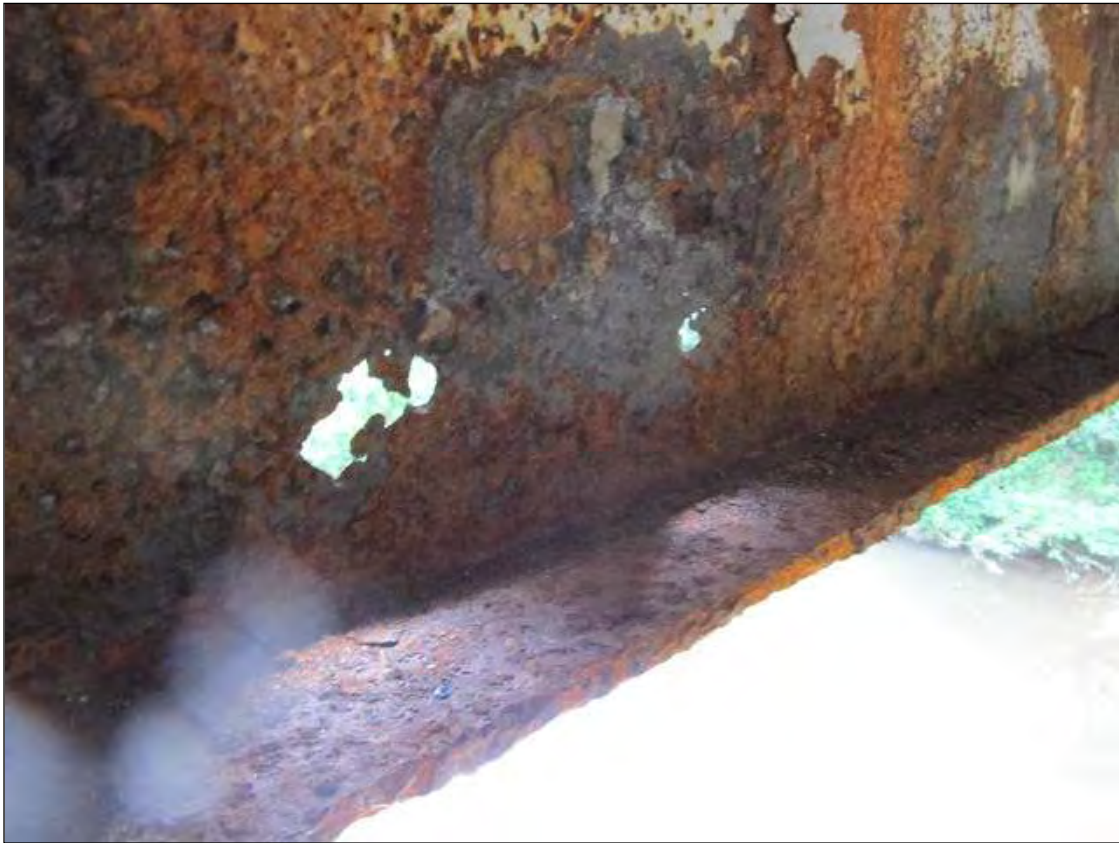
RT. SIDE BEAM (1), SPAN (B)... (+/- 22' FROM PIER (1) CAP NEAR MID SPAN. HOLES IN WEB (+/- 6" AND 3" DIAM.)... SEE SKETCH

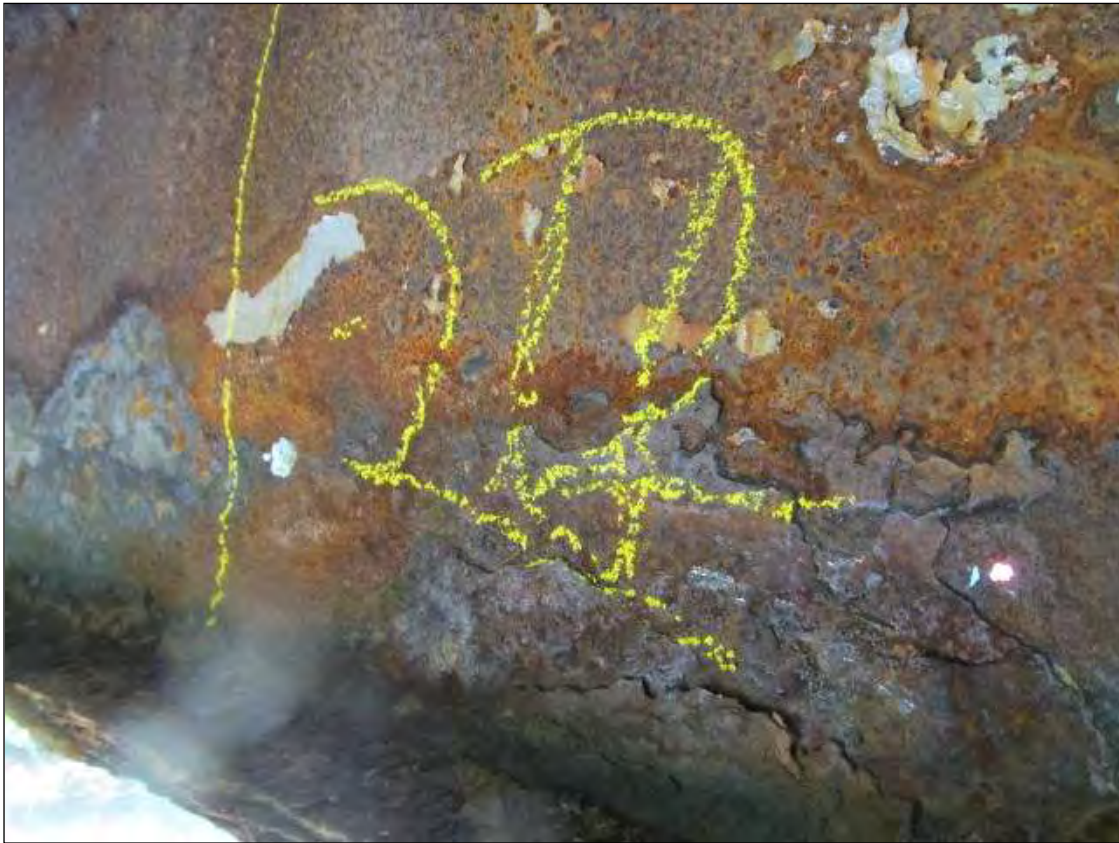
LT. SIDE BEAM (10), (+/- 24' F/ EAST FACE OF PIER (1) CAP) AT ~ MID SPAN (BOTT. FLNG. DET.) HOLES IN WEB (2) AT (+/- 2" DIAM.) ~ 1' BTWN. HOLES.

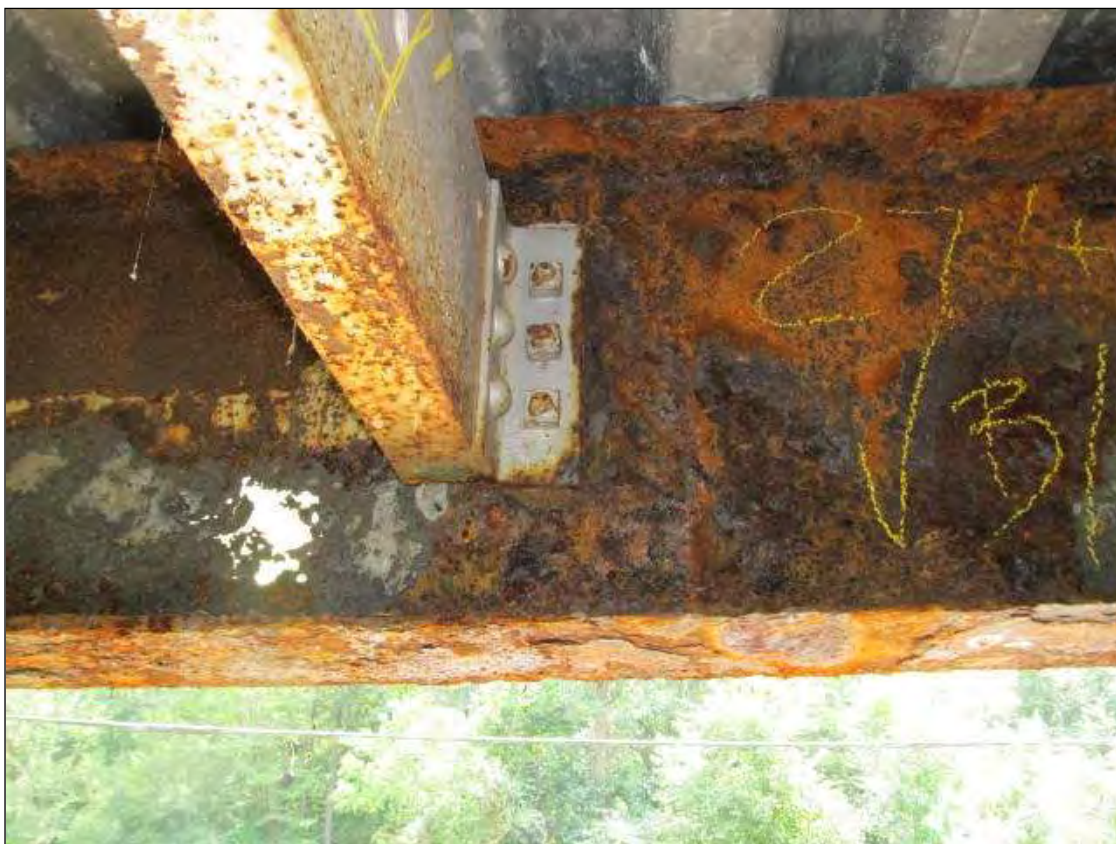
RT. SIDE OF BEAM (10), HOLES IN WEB (APPROX. MID SPAN) AT DIAP. AND RAIL POST CONNS... NOTE REDUCTION OF BOTT. FLANGE. SEE SKETCH & PHOTO 2636...

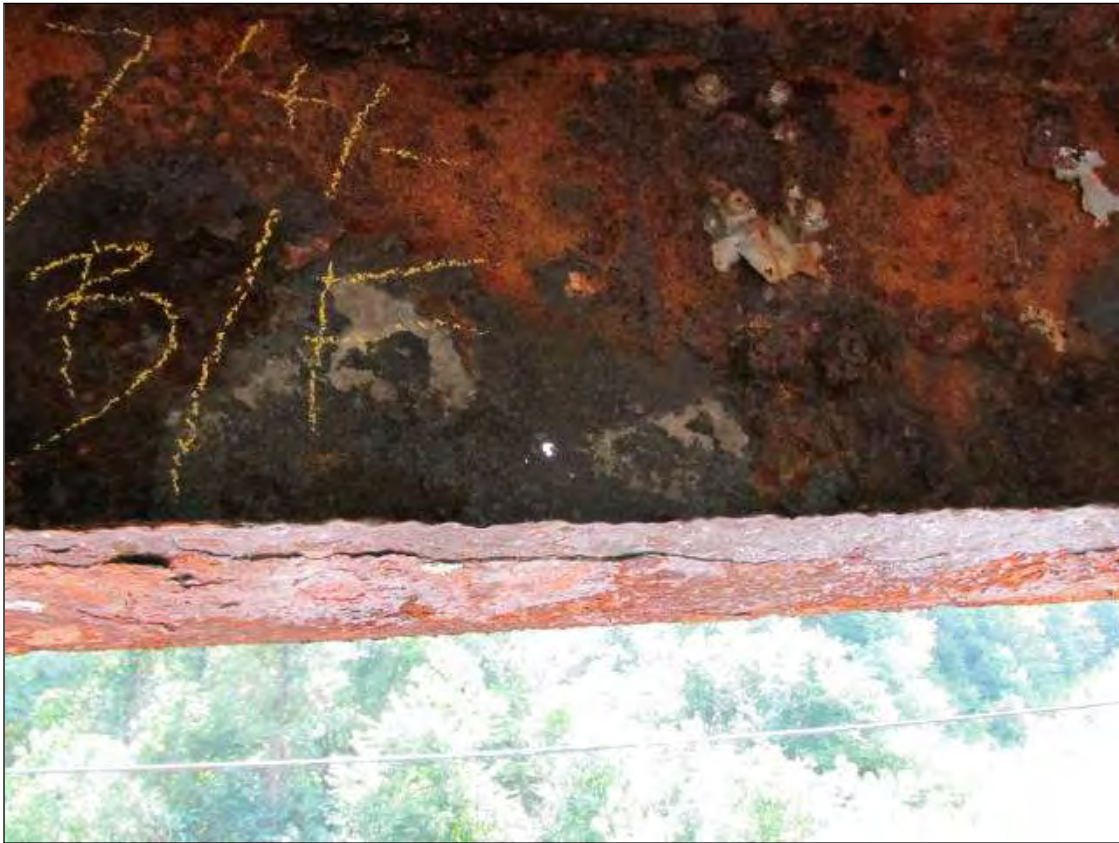
RT. SIDE BEAM (10) AT APPROX. MID SPAN (B), EITHER SIDE OF AN AREA APPROX. 27 FT. FROM PIER (1)  
CAP... SEE SKETCH
