NC DEPARTMENT OF TRANSPORTATION  
DIVISION OF HIGHWAYS  
BRIDGE MANAGEMENT UNIT

# BRIDGE INSPECTION REPORT

COUNTY IREDELL BRIDGE NUMBER 480282 INSPECTION CYCLE 2 YRS  
ROUTE SR1828 ACROSS NORTH HUNTING CREEK M.P. 0

SUPERSTRUCTURE STEEL PLANK DECK ON I-BEAMS

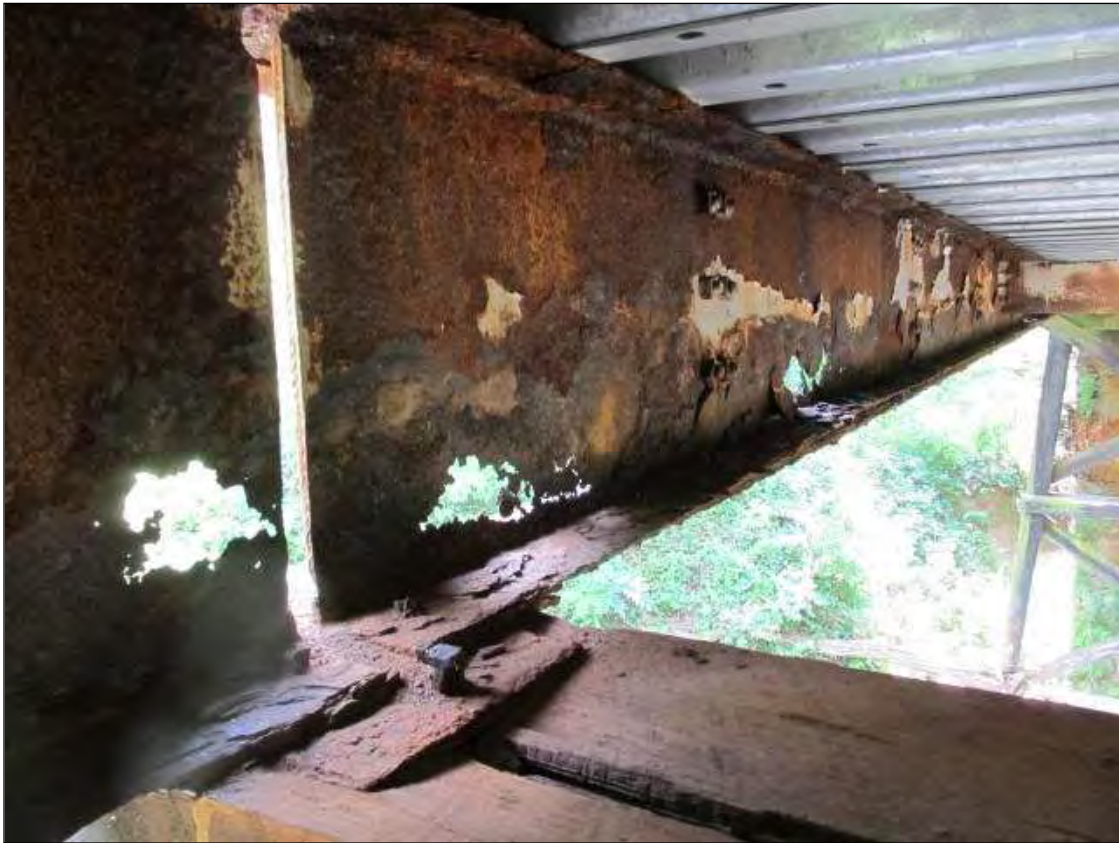
BEAM (1), SPANS (B) AND (C) AT PIER (2)... HOLES IN WEB AT BRGS... (SPAN (B) +/- 6" DIAM., SPAN (C) +/- 12" L X 6" H)... NOTE BOTT. FLNG.. SEE SKETCH

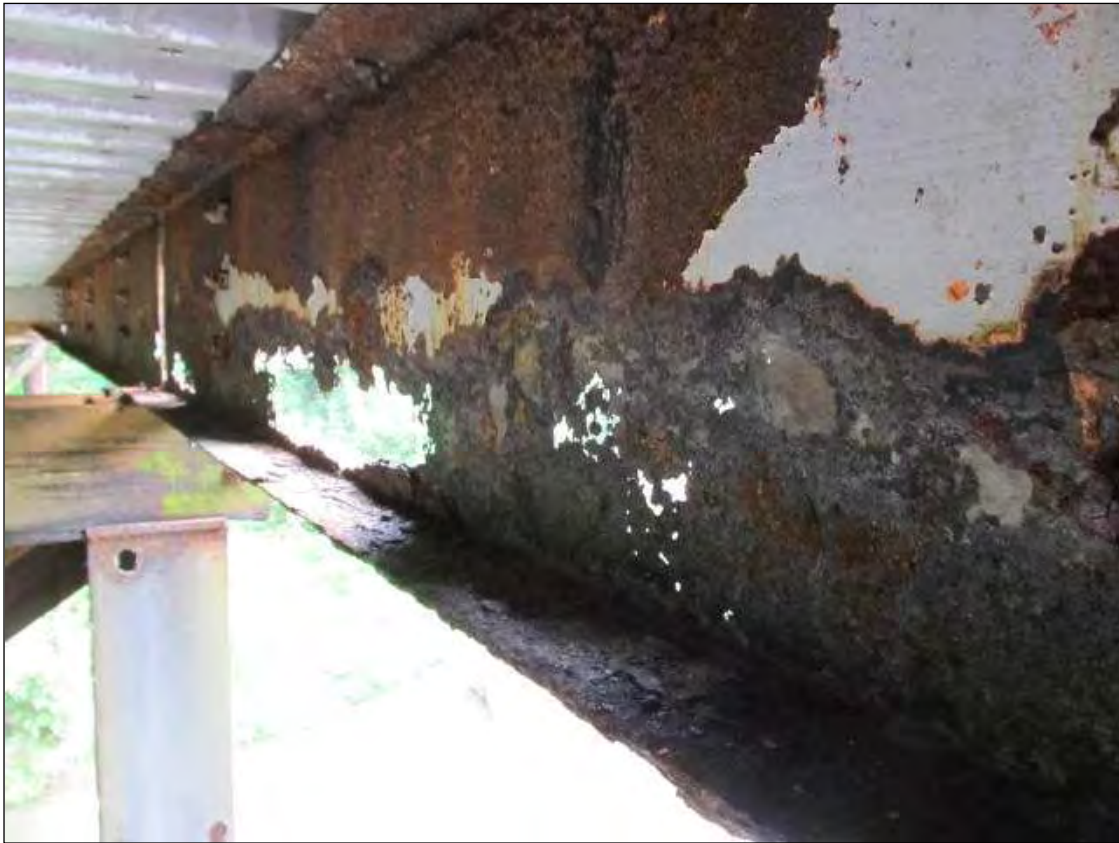
BEAM (1), SPAN (C), RT. SIDE NEAR OIER (2)... SEE SKETCH FOR DIMENSIONS AND LOCATION OF HOLES IN WEB AND DETERIORATION OF BOTT. FLANGE...

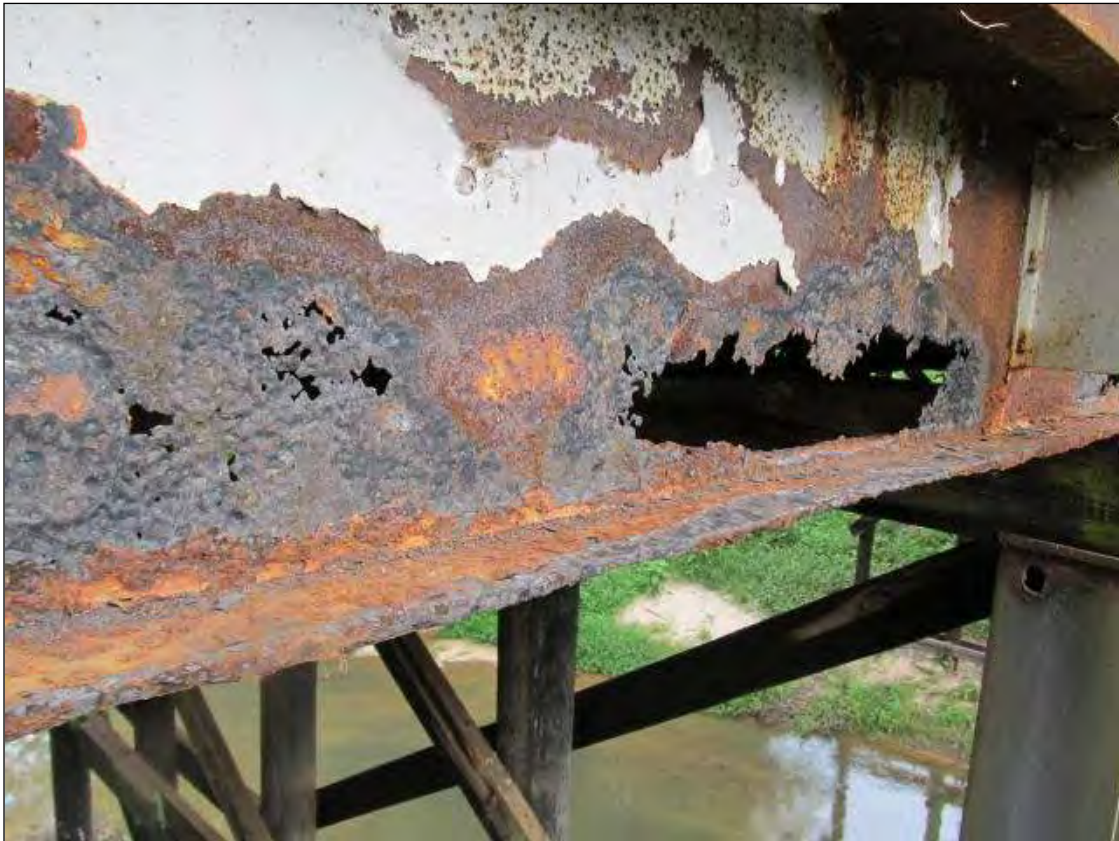
BEAM (1), SPAN (C), (LT. OUTSIDE SHOWN)... HOLES IN WEB AND DETERIORATION OF FLANGES... SEE SKETCH

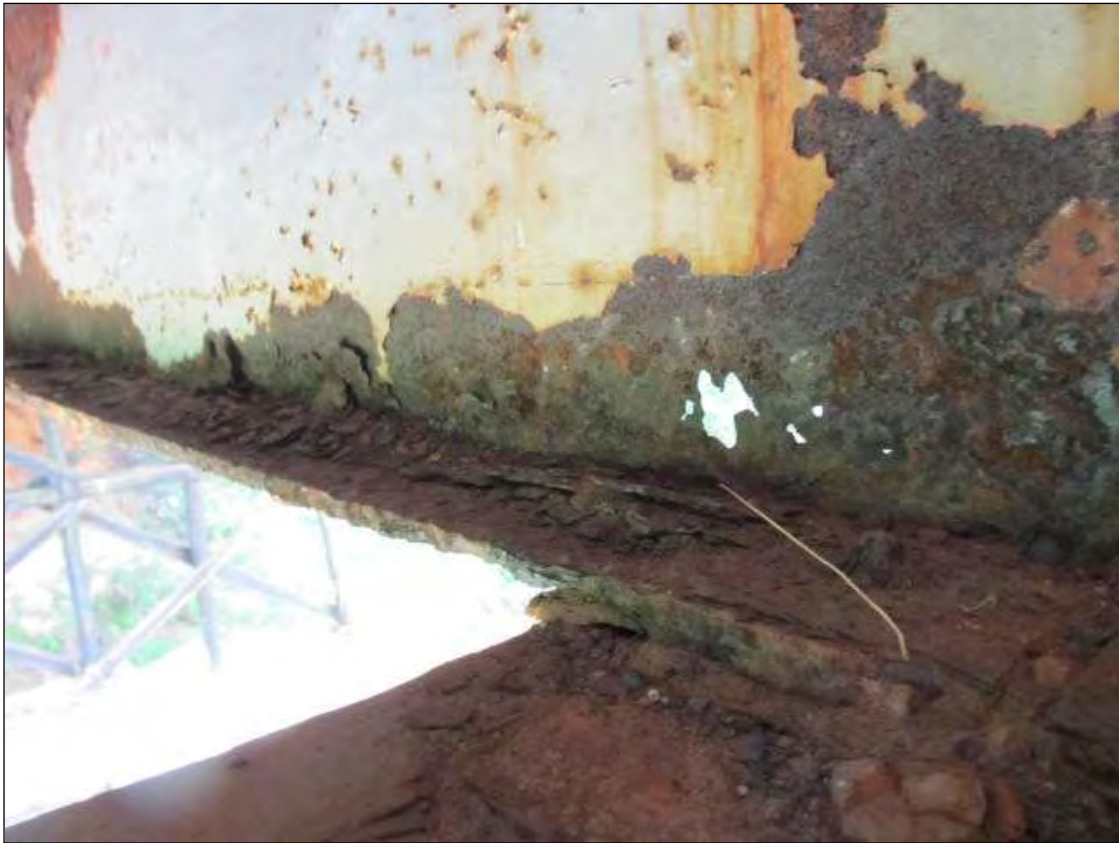
BEAM (2), SPAN (C) AT PIER (2)... HOLE IN WEB (+/- 6" L X 3" H), AND DETERIORATION OF BOTT. FLANGE...  
SEE SKETCH

| MMS Code | Description of Function | Unit | Quantity | Remarks | Est. Cost |
|---|---|---|---|---|---|
| 3314 | Maintain Steel Superstructure Components | LF | 1 | BEAM (2), SPAN (C) AT PIER (2)... HOLE IN WEB (+/- 6" L X 3" H), AND DETERIORATION OF BOTT. FLANGE... SEE SKETCH | |

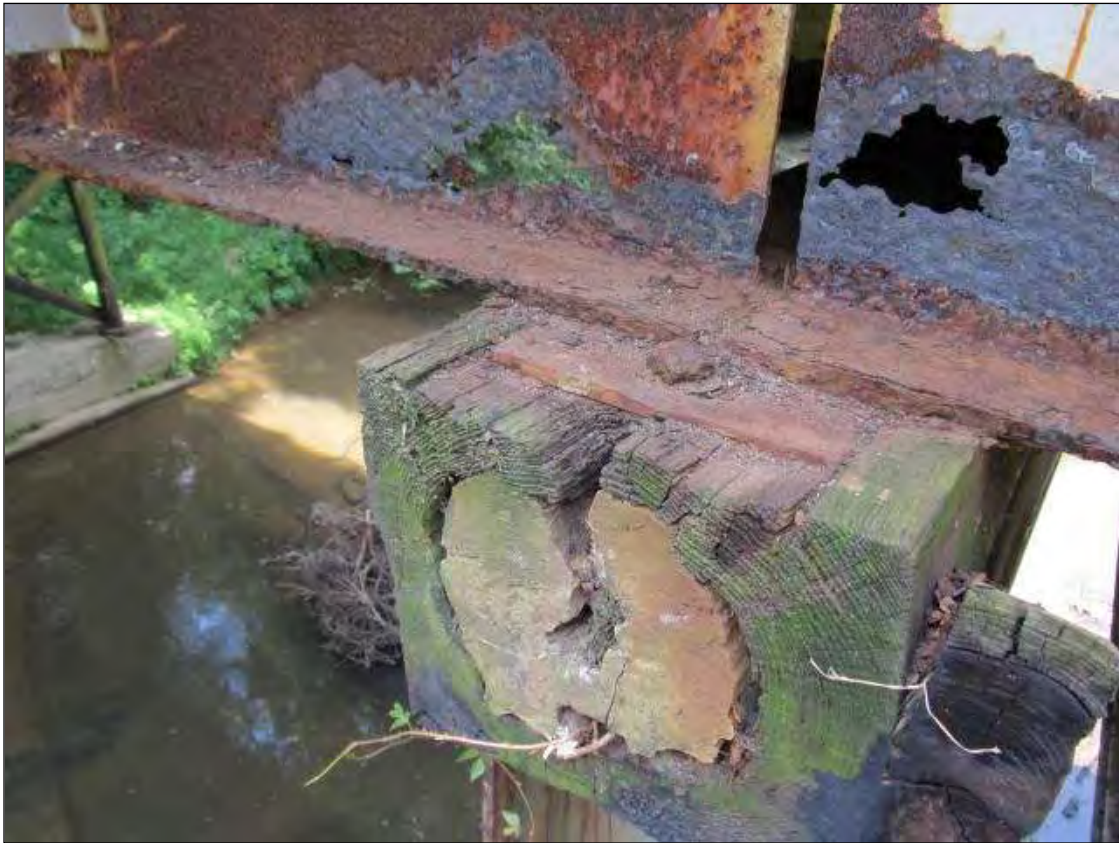
LT. END OF PIER (2) CAP; (CONCRETE REPAIR ATTEMPT HAS FAILED)... CAP SPLIT, AND DETERIORATED, BRG. PLATE CRUSHING, BEAMS ARE RESTING ON CAP... (25 LF)

| MMS Code | Description of Function | Unit | Quantity | Remarks | Est. Cost |
|---|---|---|---|---|---|
| 3344 | Repair / Replace Timber Substructure Components | LF | 25 | <p>PHOTO (1), LT. END OF PIER (2) CAP; (CONCRETE REPAIR ATTEMPT HAS FAILED)... CAP SPLIT, AND DETERIORATED, BRG. PLATE CRUSHING, BEAMS ARE RESTING ON CAP...</p> <p>PHOTO (2), PIER (2) CAP SPLIT ALONG TOP CENTER, HOLLOW INSIDE, SPLIT ALONG FACES AND CRUSHING, THIS PHOTO BTWN. SEATS (1) AND (2)...</p> <p>PHOTO (3), WEST FACE OF PIER (2) CAP, SPLIT AND BUCKLING... CAP IS SUBJECT TO FAILURE...</p> <p>PHOTO (4), PIER (2) CAP BTWN. SEATS (3) AND (4)... SPLIT ALONG TOP CENTER IS SIMILAR FULL LENGTH...</p> <p>PHOTO (5), BEARING PLATES ARE CRUSHING INTO TOP OF PIER (2) CAP...</p> | |

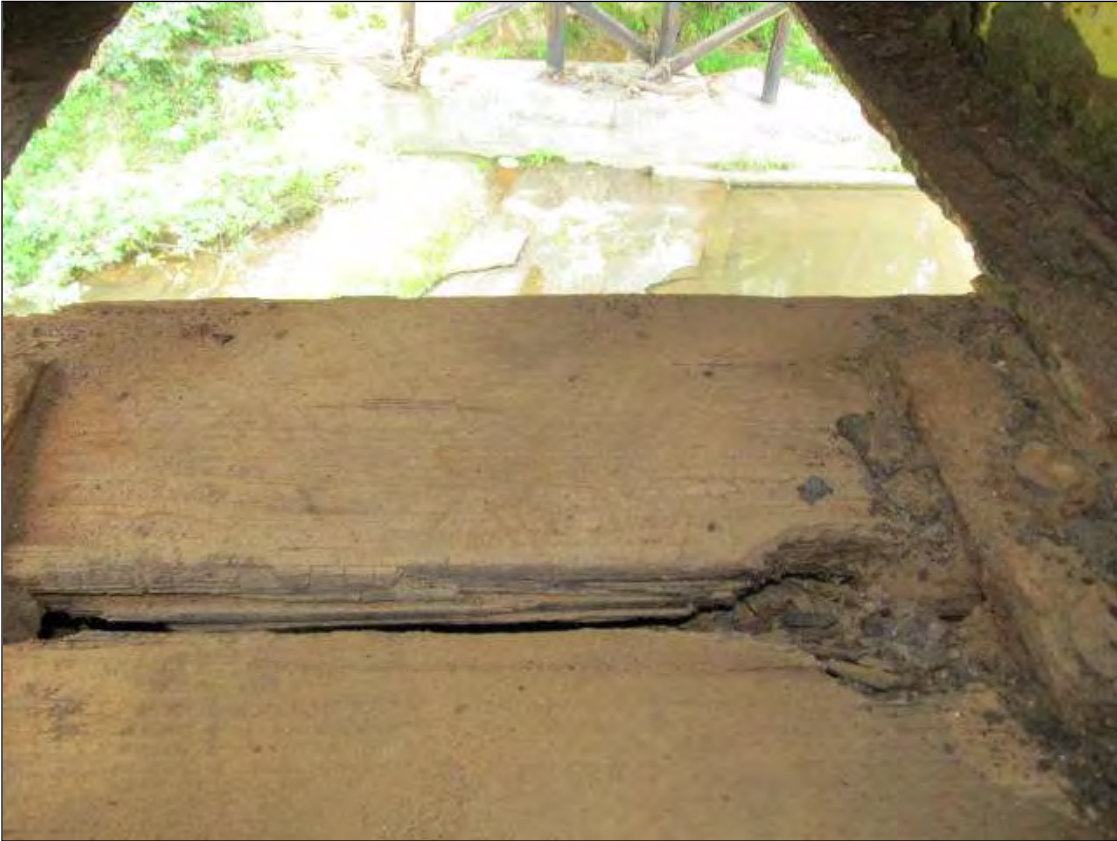
PIER (2) CAP SPLIT ALONG TOP CENTER, HOLLOW INSIDE, SPLIT ALONG FACES AND CRUSHING, THIS PHOTO BTWN. SEATS (1) AND (2)...

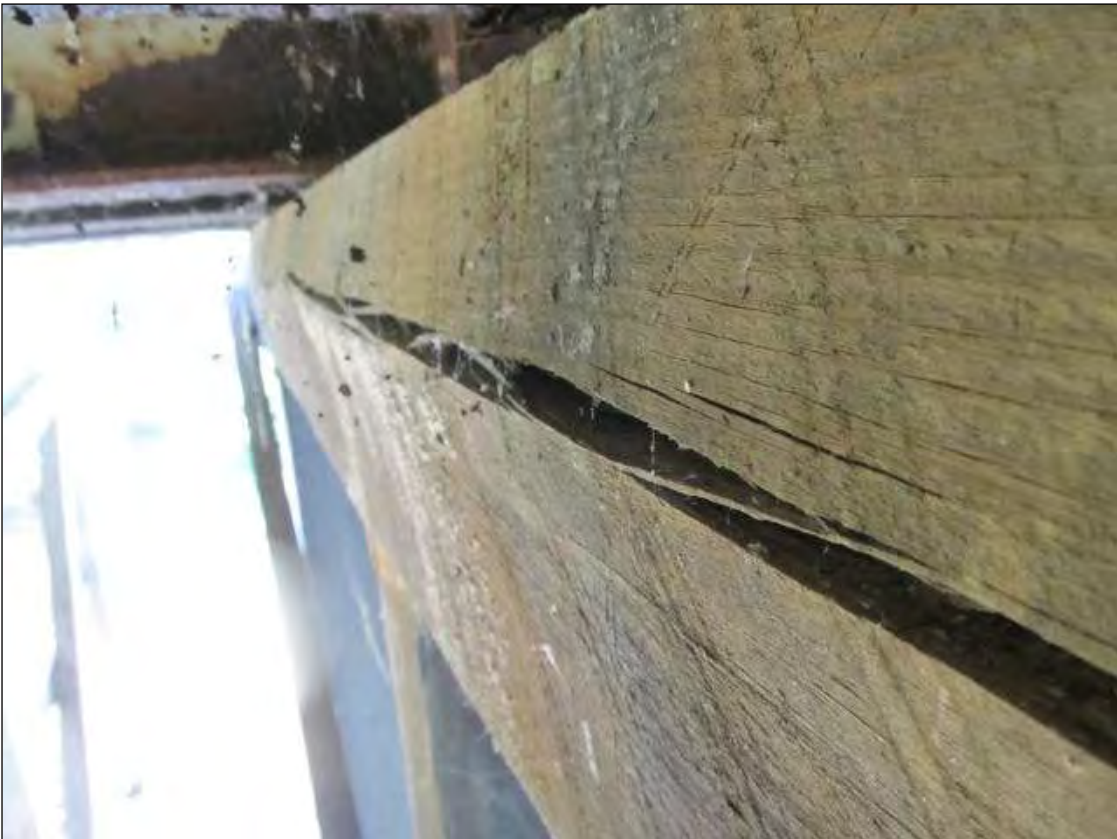
WEST FACE OF PIER (2) CAP, SPLIT AND BUCKLING... CAP IS SUBJECT TO FAILURE...

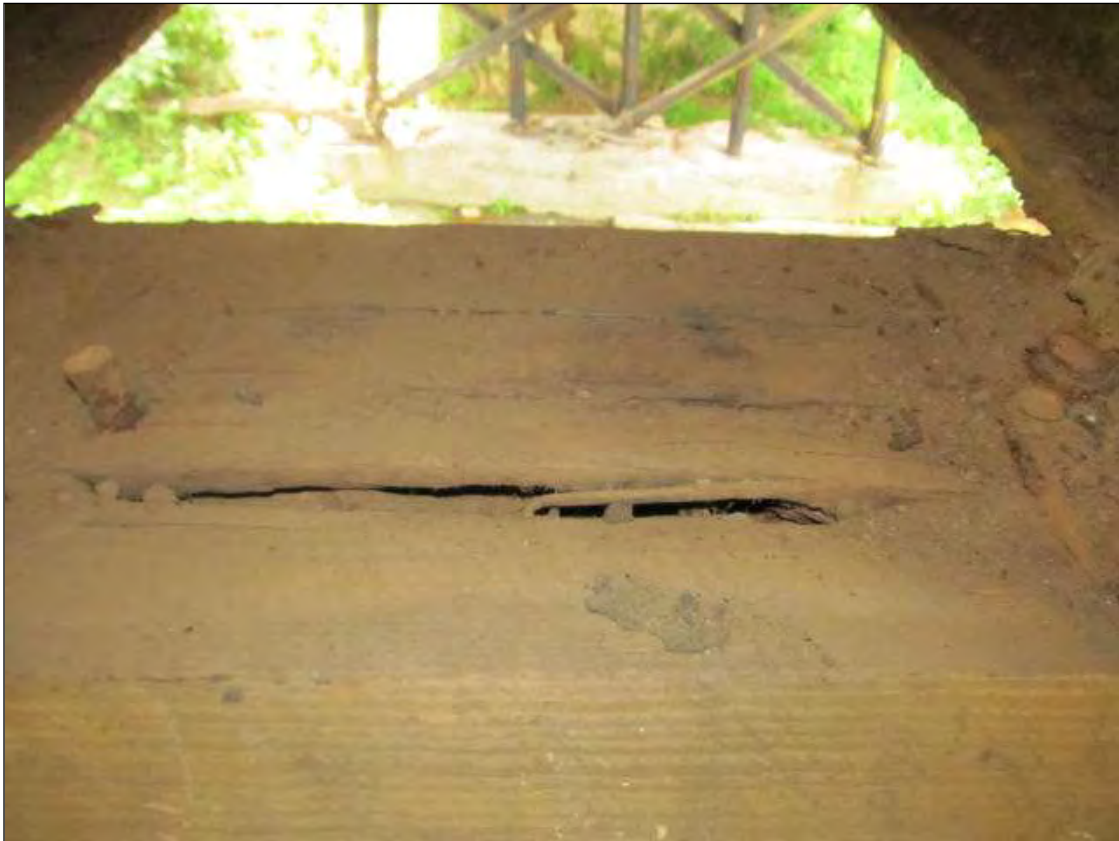
PIER (2) CAP BTWN. SEATS (3) AND (4)... SPLIT ALONG TOP CENTER IS SIMILAR FULL LENGTH...

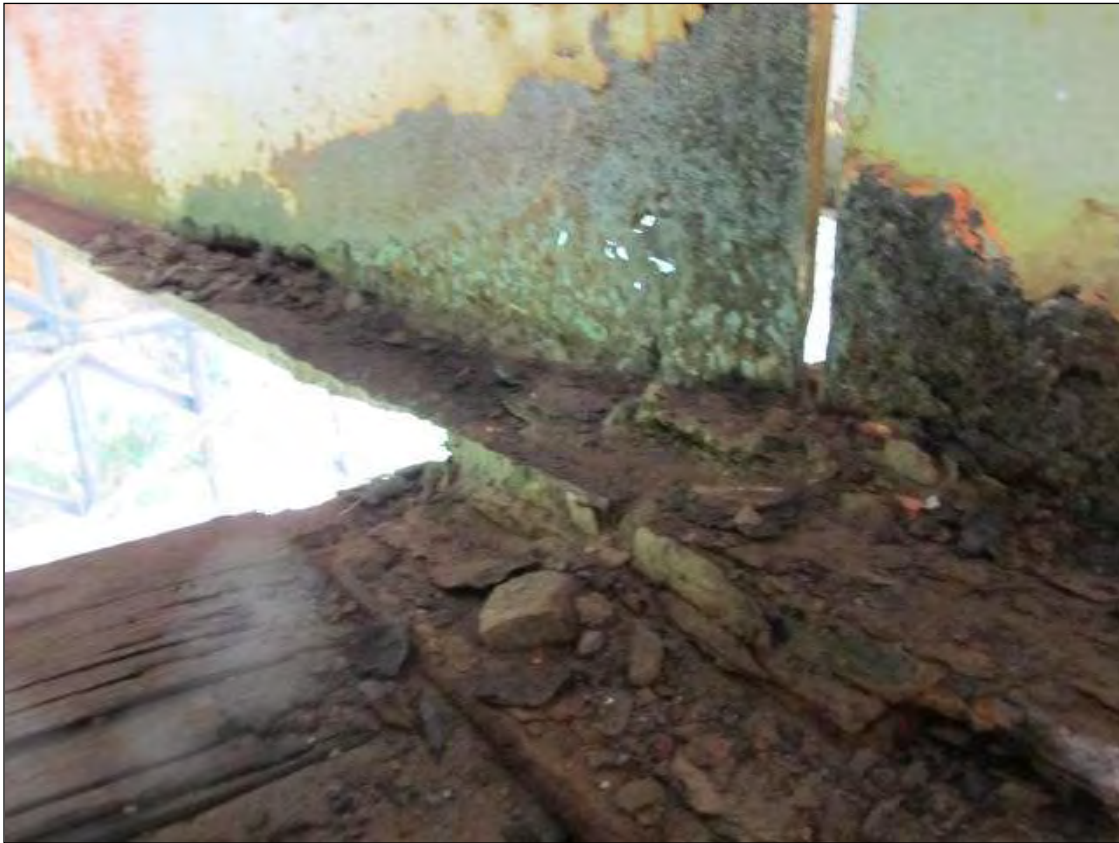
BEAM (3), SPAN (C) AT PIER (2); HOLES IN WEB (+/- 6" L X 3" H)... NOTE DETERIORATION OF BOTT. FLANGE...  
SEE SKETCH

| MMS Code | Description of Function | Unit | Quantity | Remarks | Est. Cost |
|---|---|---|---|---|---|
| 3314 | Maintain Steel Superstructure Components | LF | 1 | BEAM (3), SPAN (C) AT PIER (2); HOLES IN WEB (+/- 6" L X 3" H)... NOTE DETERIORATION OF BOTT. FLANGE... SEE SKETCH | |

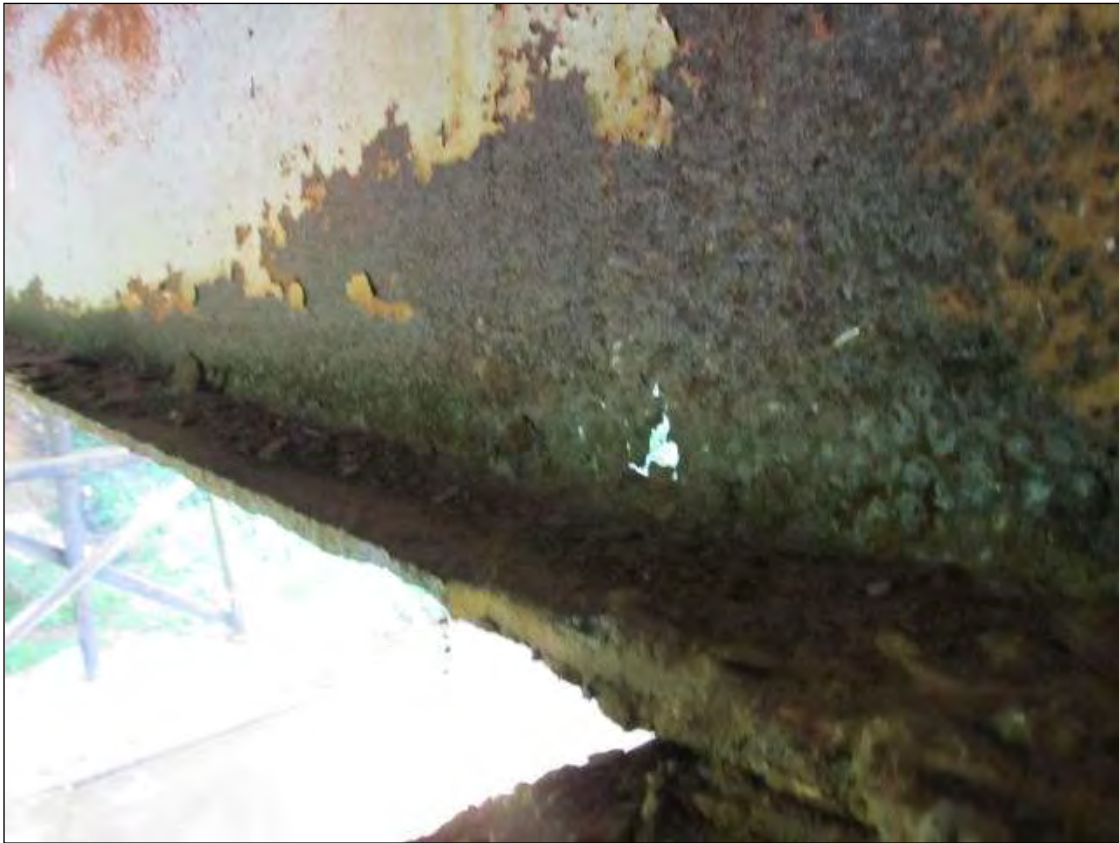
BEAM (4), SPAN (C) AT PIER (2); HOLES IN WEB (+/- 6" L X 2" H)... NOTE DETERIORATION OF BOTT. FLANGE...  
SEE SKETCH

| MMS Code | Description of Function | Unit | Quantity | Remarks | Est. Cost |
|---|---|---|---|---|---|
| 3314 | Maintain Steel Superstructure Components | LF | 1 | BEAM (4), SPAN (C) AT PIER (2); HOLES IN WEB (+/- 6" L X 2" H)... NOTE DETERIORATION OF BOTT. FLANGE... SEE SKETCH | |

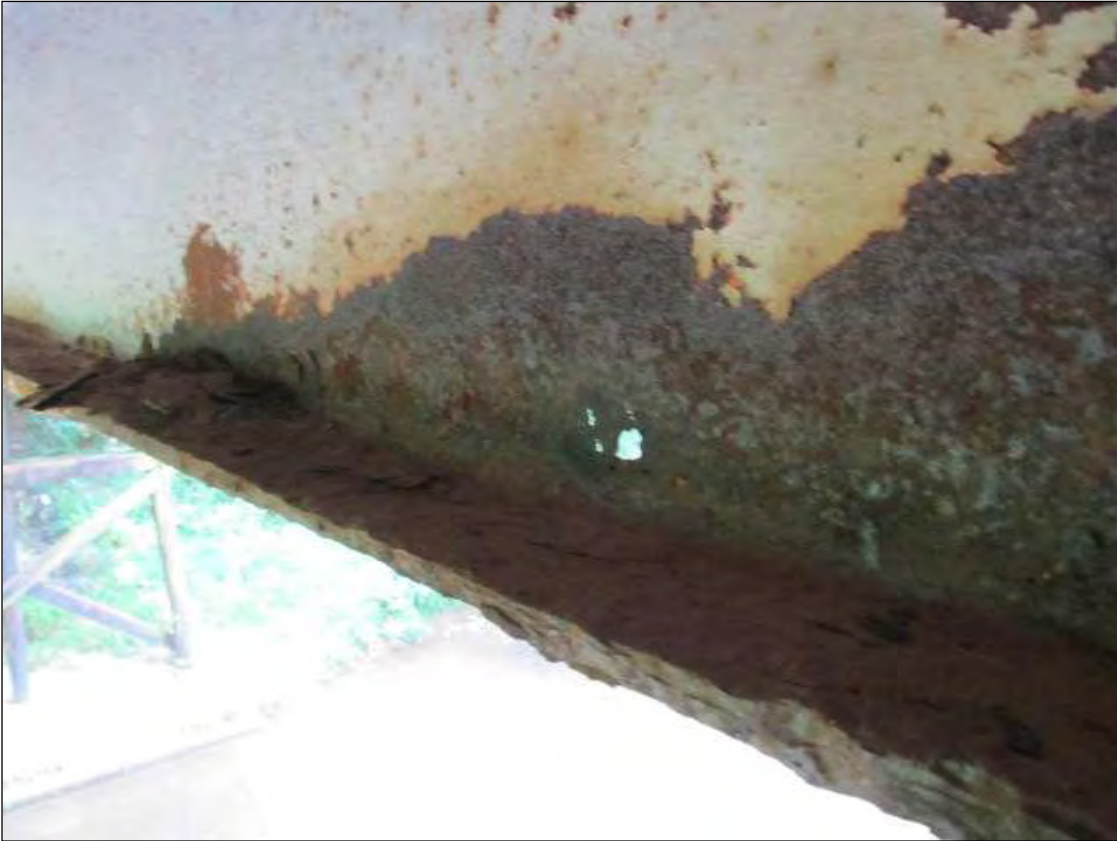
BEAM (5), SPAN (C) AT PIER (2); HOLES IN WEB (+/- 6" L X 2"H), NOTE DETERIORATION OF BOTT. FLANGE...  
SEE SKETCH

| MMS Code | Description of Function | Unit | Quantity | Remarks | Est. Cost |
|---|---|---|---|---|---|
| 3314 | Maintain Steel Superstructure Components | LF | 1 | BEAM (5), SPAN (C) AT PIER (2); HOLES IN WEB (+/- 6" L X 2" H), NOTE DETERIORATION OF BOTT. FLANGE... SEE SKETCH | |

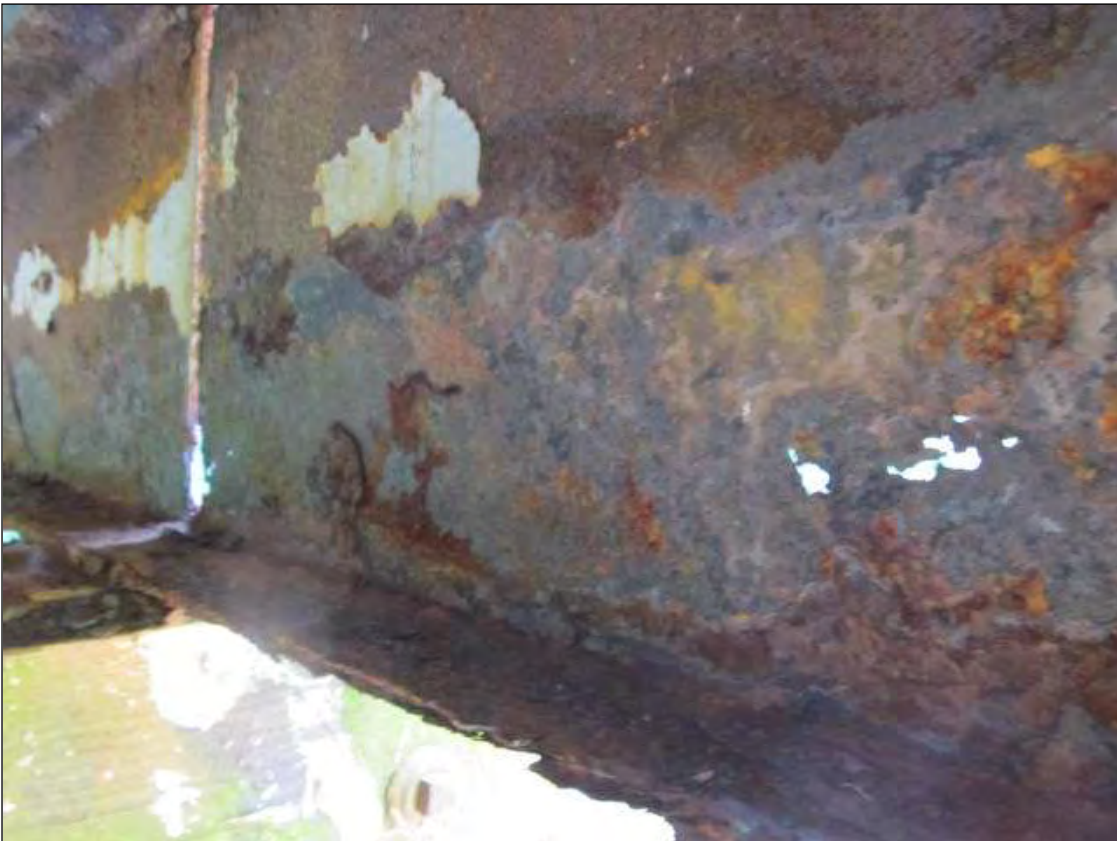
BEAM (10), SPAN (B) AT PIER (2), (+/- 2' FROM END OF BEAM); HOLES IN WEB (+/- 6" L X 3" H)... SEE SKETCH

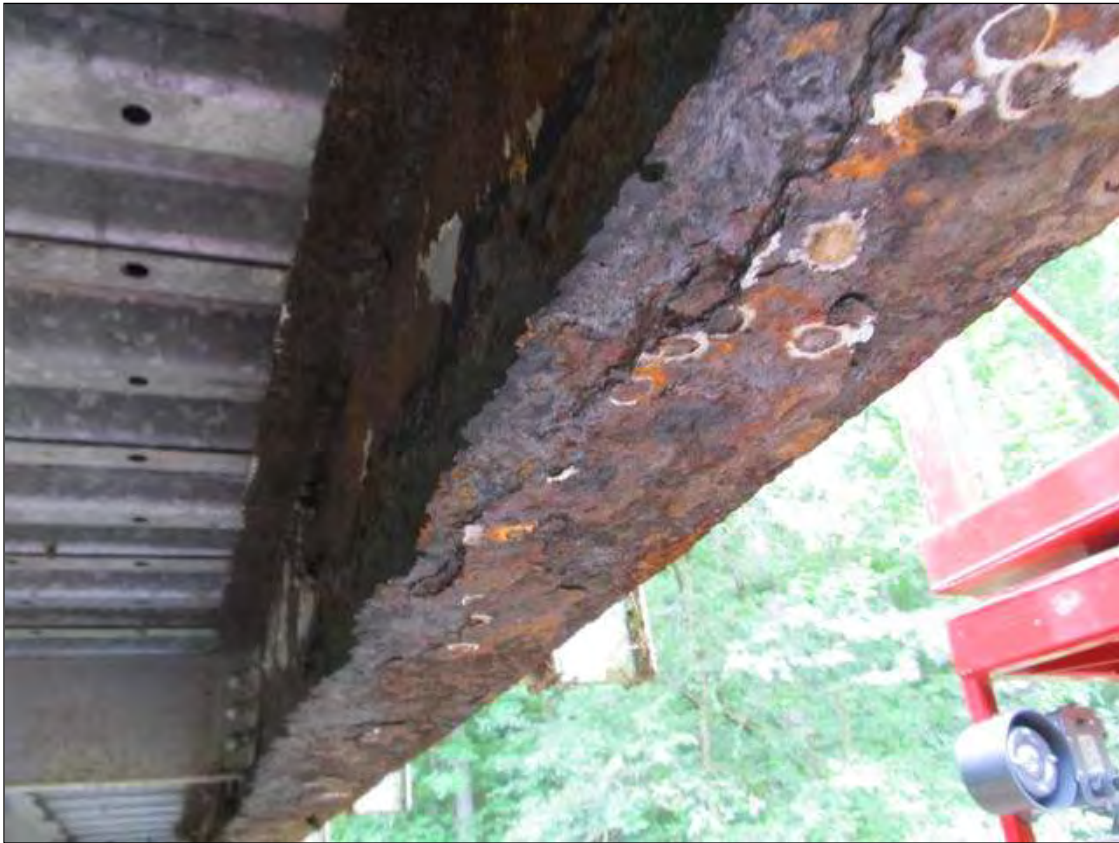
BEAM (10), SPAN (C) (+/- 10' FROM EAST FACE OF PIER (2) CAP), BOTT. FLANGE DETERIORATED... SEE SKETCH

| MMS Code | Description of Function | Unit | Quantity | Remarks | Est. Cost |
|---|---|---|---|---|---|
| 3314 | Maintain Steel Superstructure Components | LF | 12 | PHOTO (1), BEAM (10), SPAN (C) (+/- 10' FROM EAST FACE OF PIER (2) CAP), BOTT. FLANGE DETERIORATED... SEE SKETCH PHOTO (2),<br><br>BEAM (10), SPAN (C), (+/- 10' FROM EAST FACE OF PIER (2) CAP)... ALTERNATE VIEW... SEE SKETCH | |

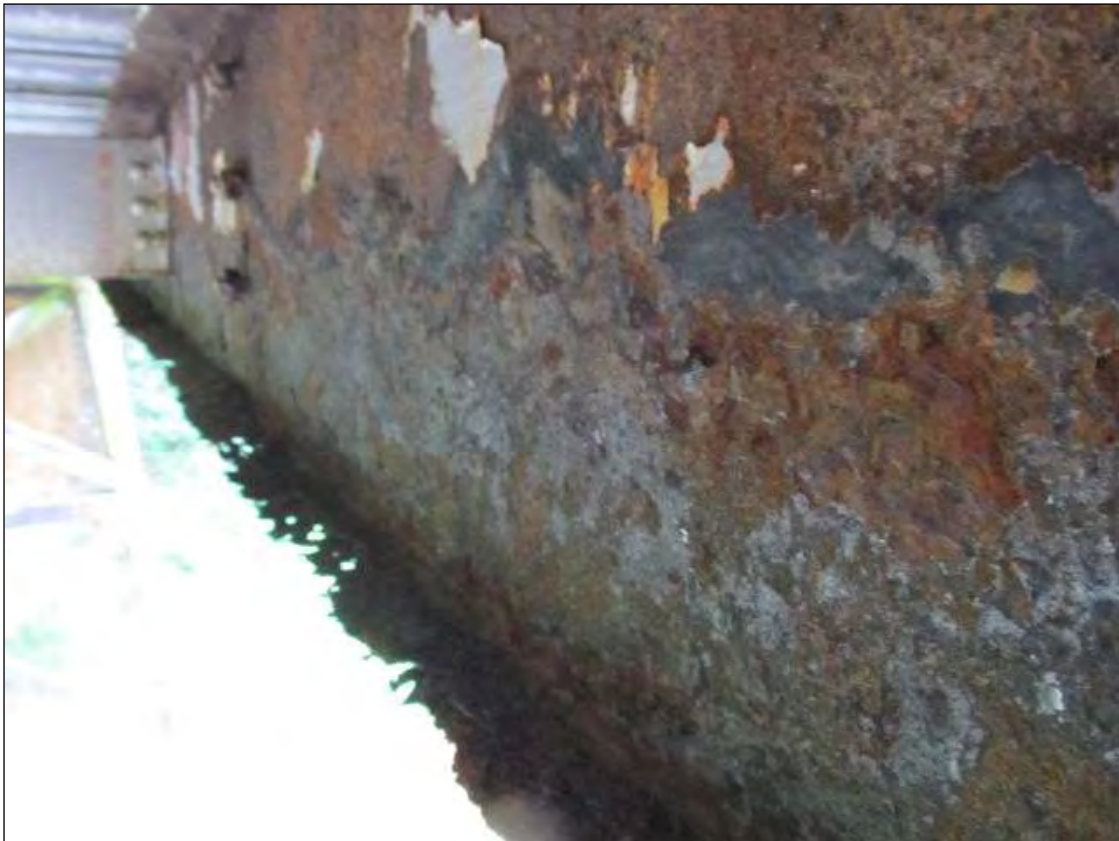
BEAM (10), SPAN (C), (+/- 10' FROM EAST FACE OF PIER (2) CAP)... ALTERNATE VIEW... SEE SKETCH

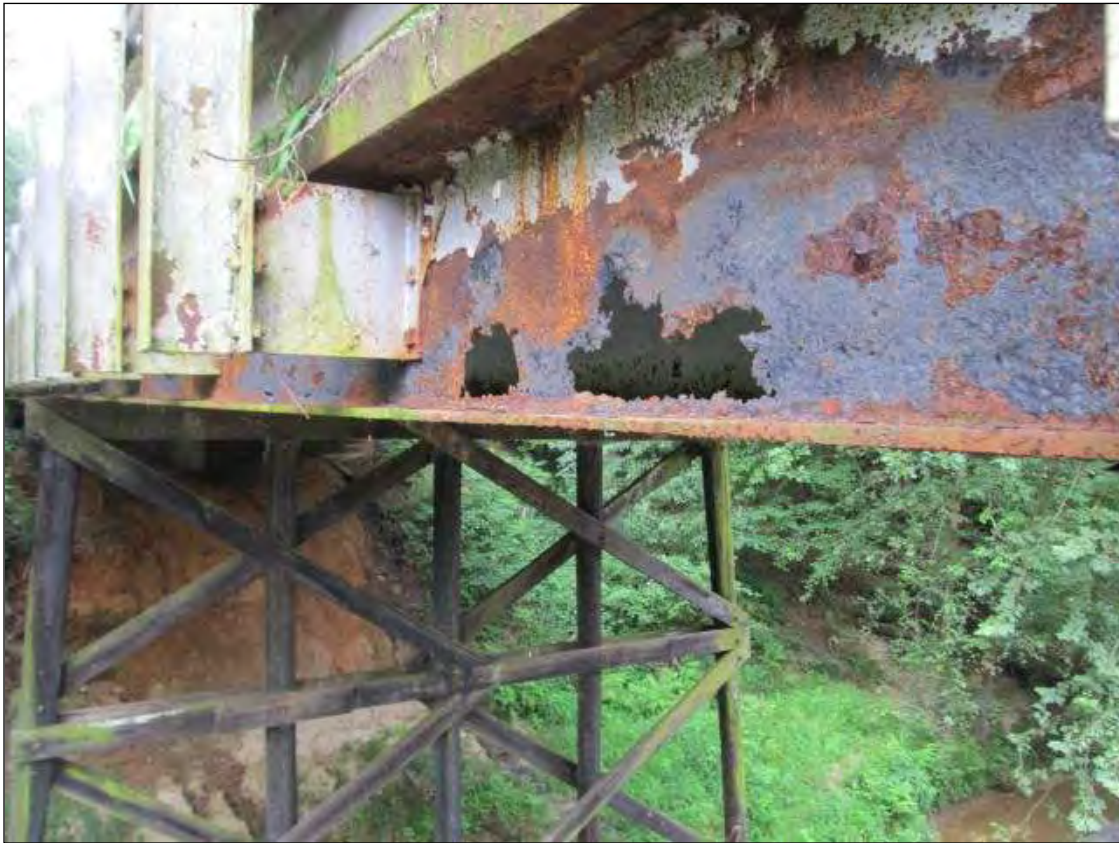
BEAM (1), SPAN (C) AT ~ MID SPAN; HOLES IN WEB, (+/- 12' L X 2" TO 10" H)... (INSIDE VIEW)... SEE SKETCH

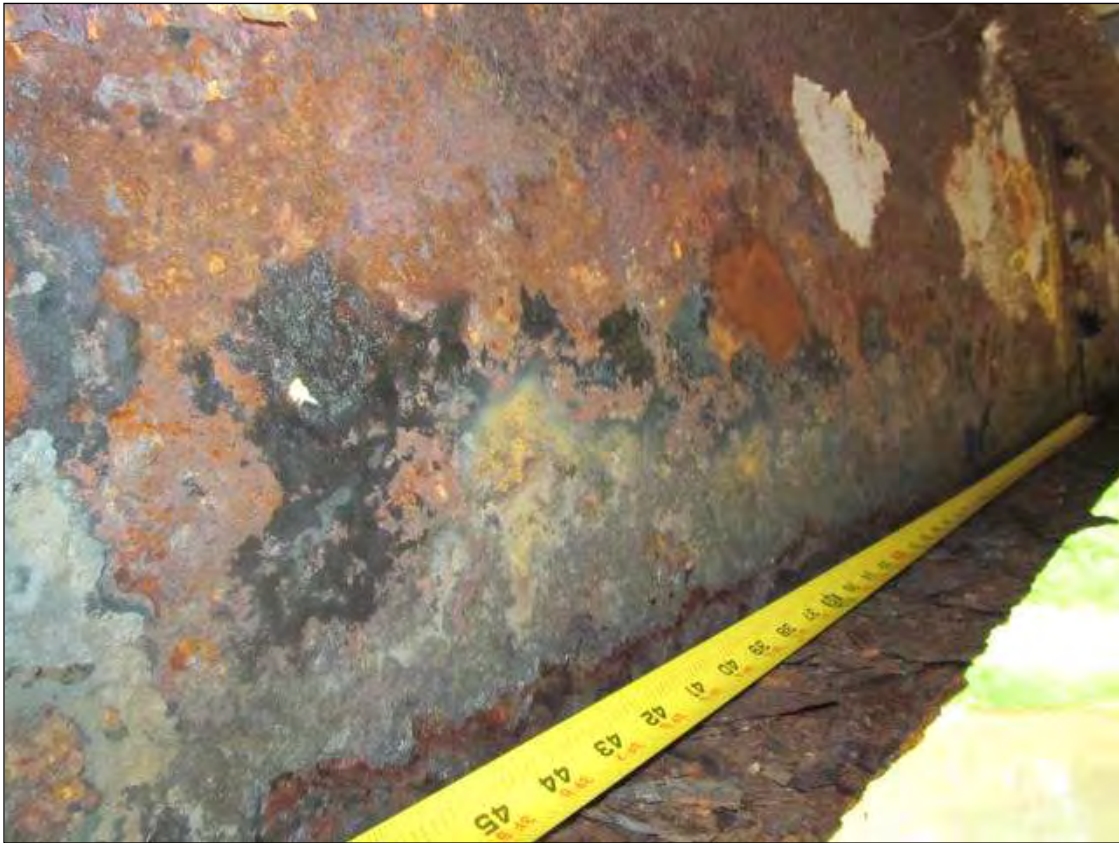
BEAM (10), SPAN (C); HOLES IN WEB, (+/- 3" DIAM.) AT ~ (26', 30' AND 34' FROM EAST FACE OF PIER (2) CAP)...  
WEB SECTION SEVERELY REDUCED. SEE SKETCH

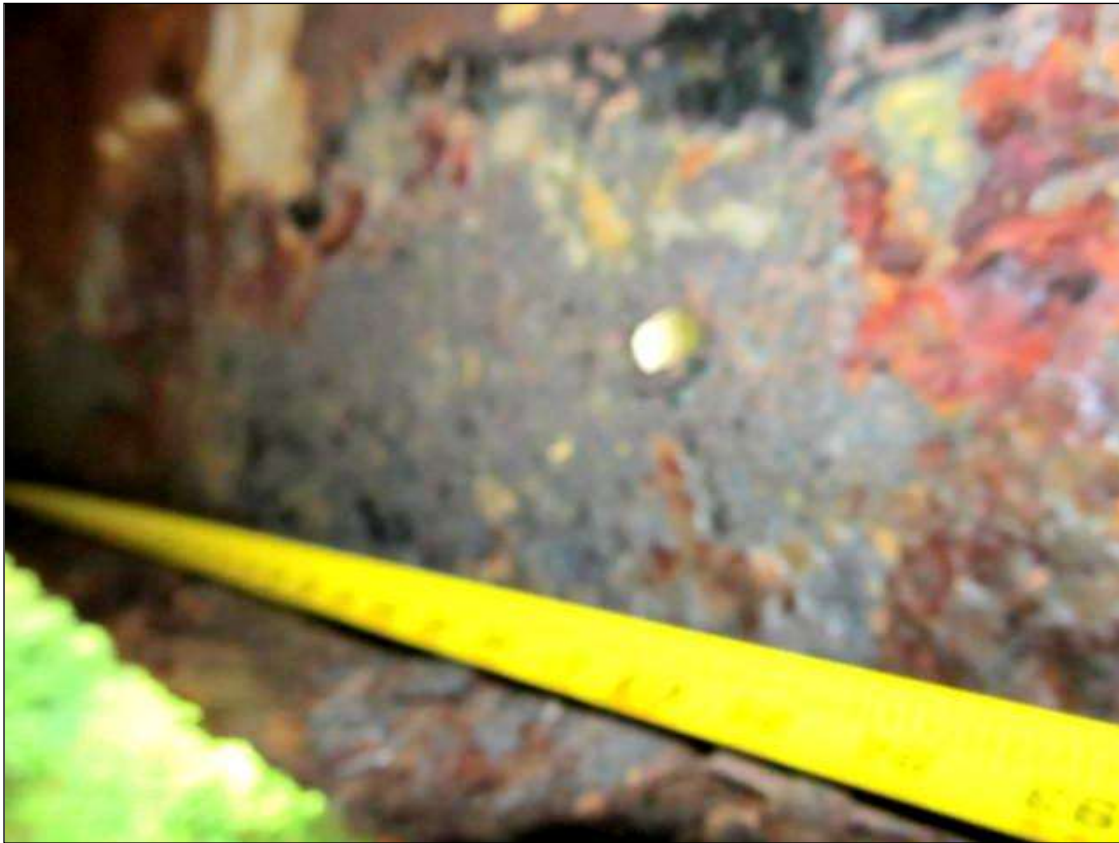
BEAM (10) AT ~ MID SPAN (C) HOLES IN WEB, (WEB SECTION SEVERLY REDUCED FULL LENGTH... SEE SKETCH AND PHOTOS 2654 AND 2656...

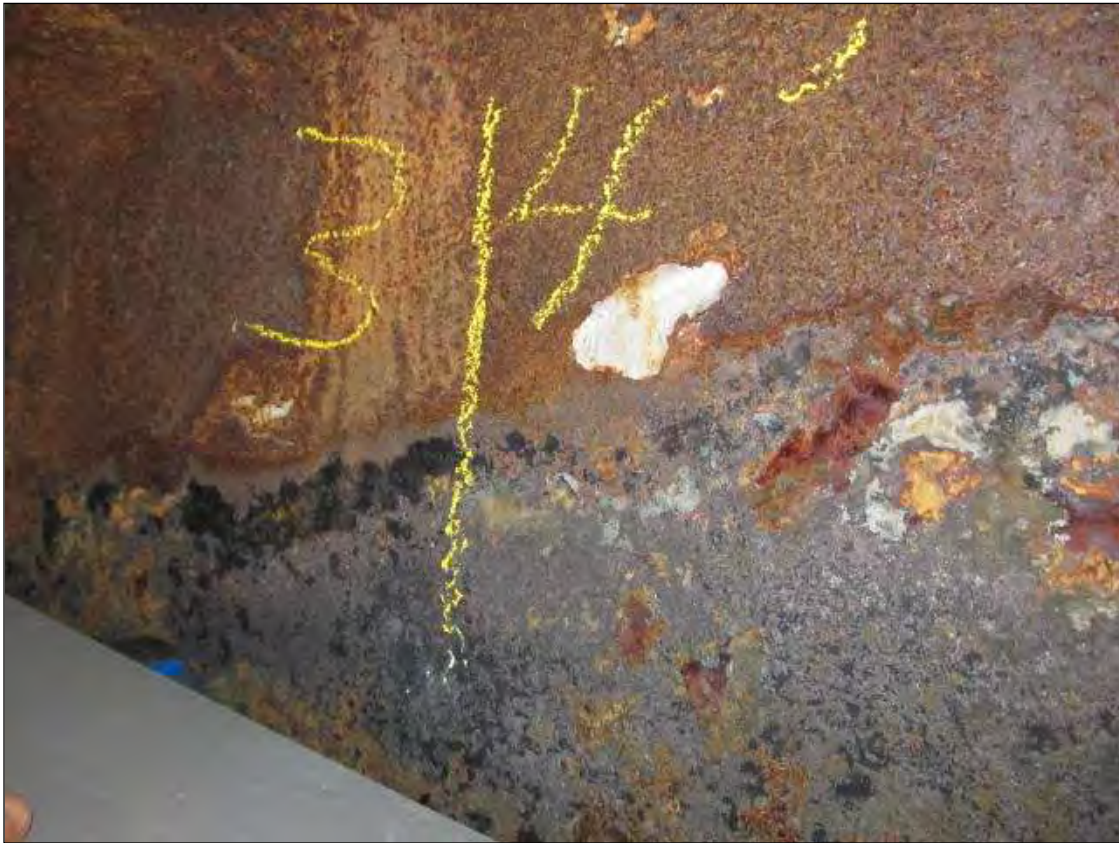
BEAM (10) AT ~ MID SPAN (C)... HOLES IN WEB, WEB SECTION SEVERELY REDUCED FULL LENGTH OF BEAM  
(+/- 45 LF)... SEE SKETCH

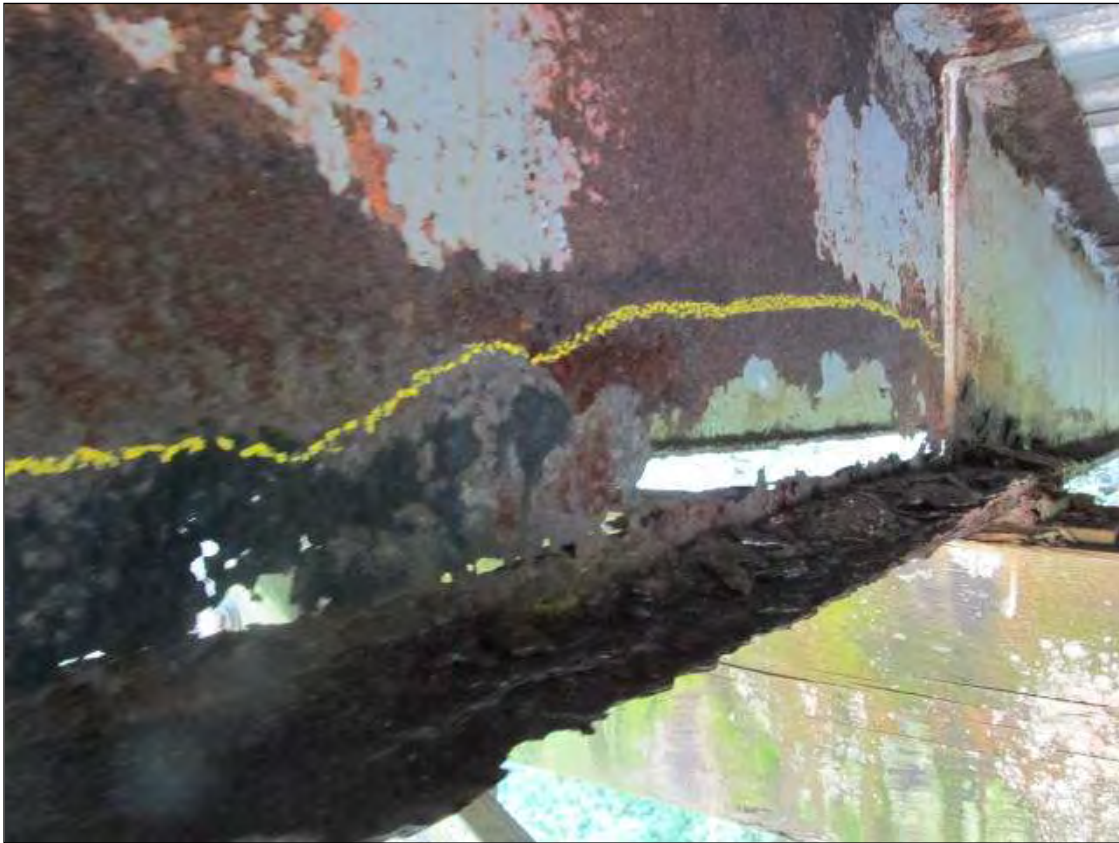
BEAM (1), SPAN (C) AT PIER (3); HOLES IN WEB, (+/- 7' L X 8" H)... NOTE CONDITION OF BOTT. FLANGE... SEE SKETCH

| MMS Code | Description of Function | Unit | Quantity | Remarks | Est. Cost |
|---|---|---|---|---|---|
| 3314 | Maintain Steel Superstructure Components | LF | 7 | BEAM (1), SPAN (C) AT PIER (3); HOLES IN WEB, (+/- 7' L X 8" H)... NOTE CONDITION OF BOTT. FLANGE... SEE SKETCH | |

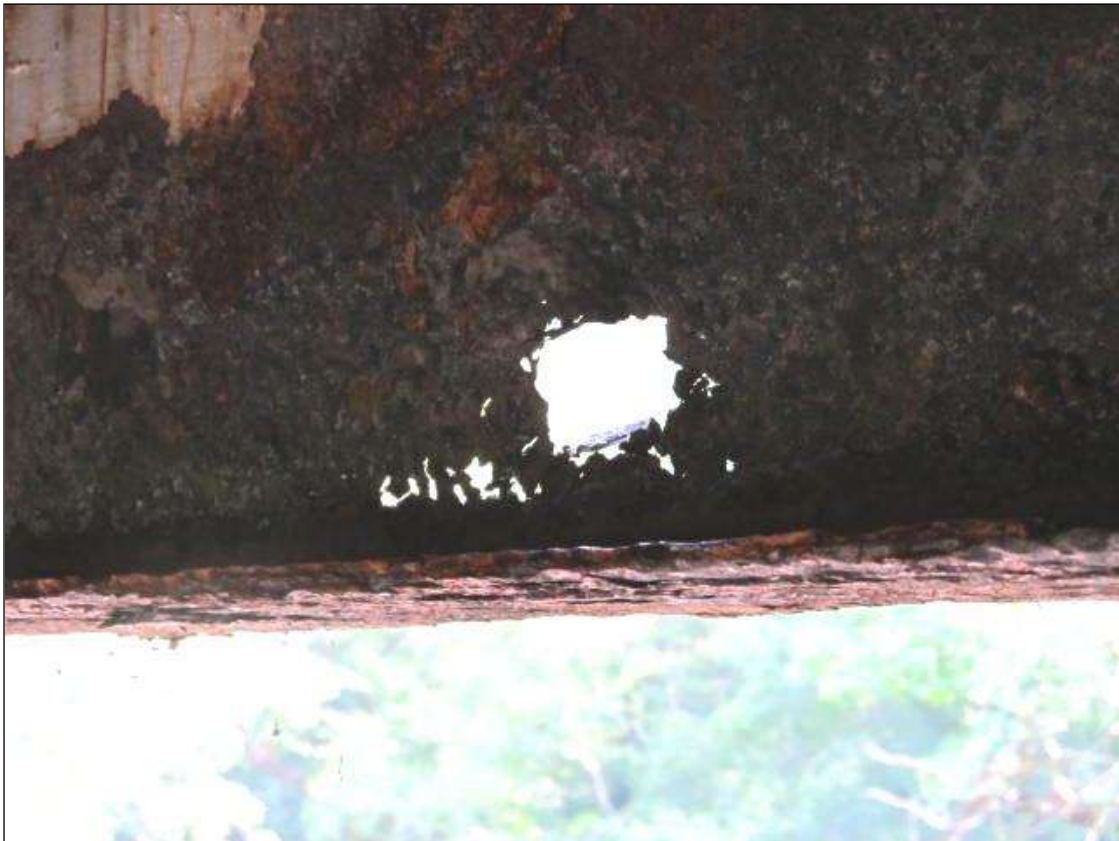
BEAM (1), SPAN (C) (+/- 40'-11" FROM WEST END OF BEAM)... HOLES IN WEB (+/- 12" L X 6" H)... SEE SKETCH

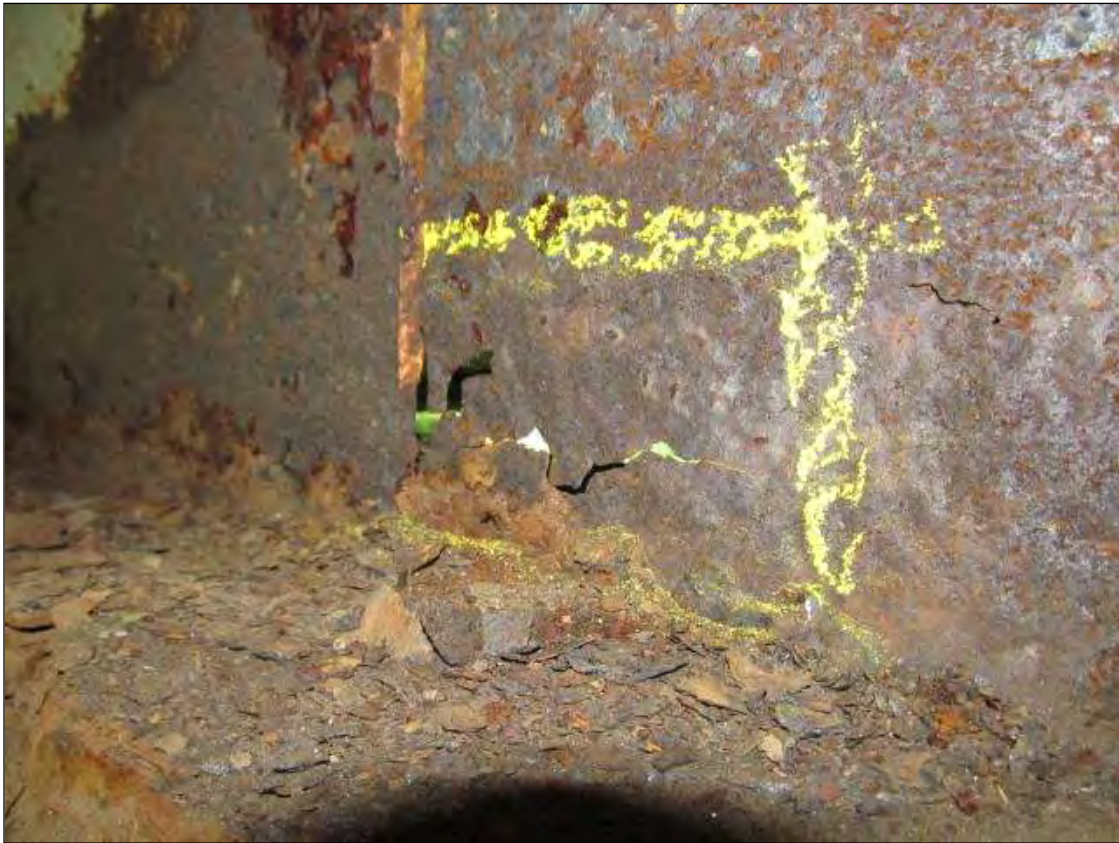
BEAM (4), SPAN (C) AT PIER (3); HOLES IN WEB AT END OF BEAM, (+/- 4" X 4")... SEE SKETCH

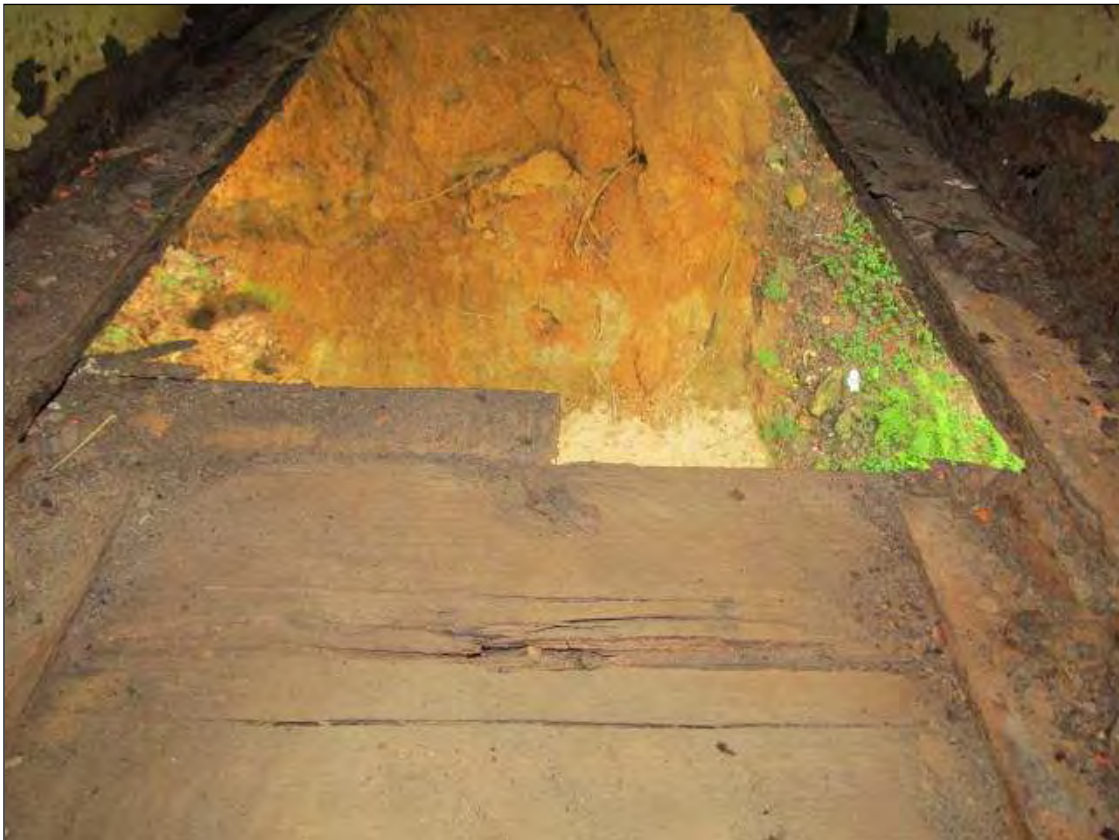
PIER (3) CAP; SPLIT FULL LENGTH ALONG TOP CENTER... CAP IS DECAYED IN CENTER, SPLIT WITH DEFORMATION ALONG WEST FACE... (+/- 25 LF)

| MMS Code | Description of Function | Unit | Quantity | Remarks | Est. Cost |
|---|---|---|---|---|---|
| 3344 | Repair / Replace Timber Substructure Components | LF | 25 | <p>PIER (3) CAP; SPLIT FULL LENGTH ALONG TOP CENTER...</p> <p>CAP IS DECAYED IN CENTER, SPLIT WITH DEFORMATION ALONG WEST FACE... (+/- 25 LF)</p> | |

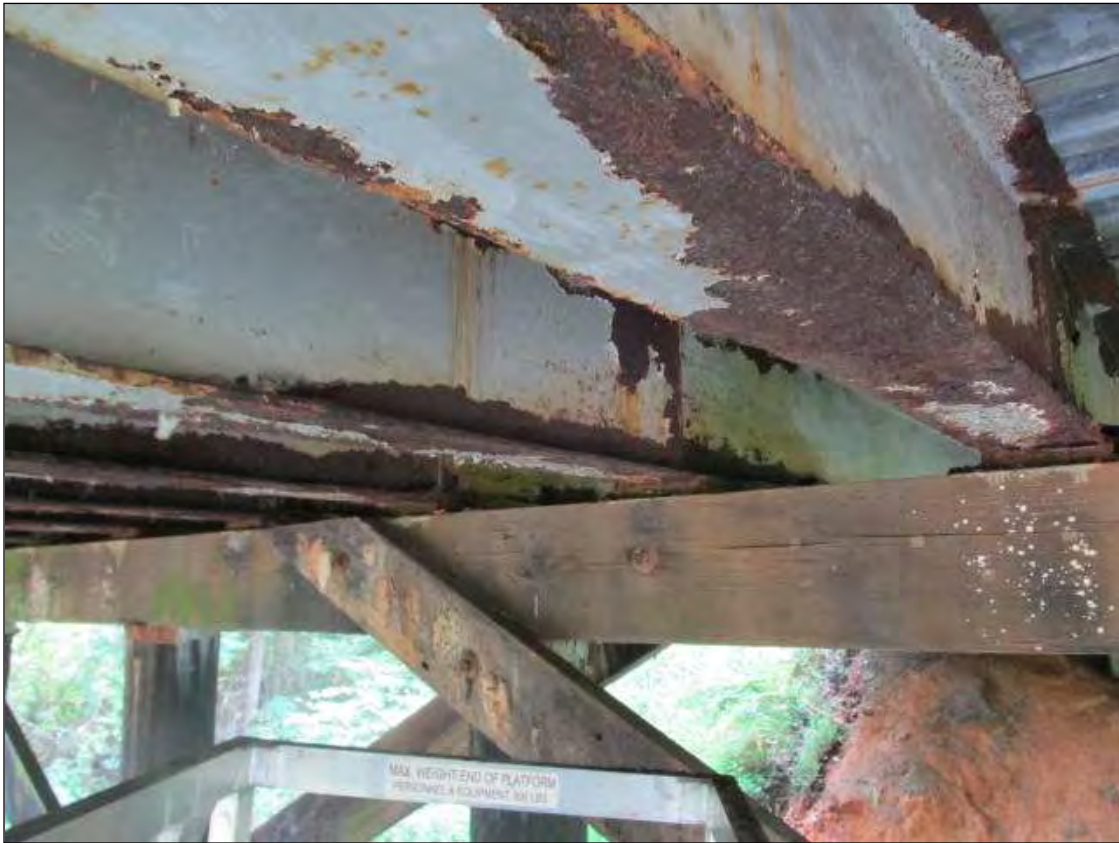
RUST, SCALE AND LOSS OF SECTION AT ALL BEAM ENDS THAT DO NOT HAVE HOLES... SEE SKETCH FOR DETAILS.
