NC DEPARTMENT OF TRANSPORTATION  
DIVISION OF HIGHWAYS  
BRIDGE MANAGEMENT UNIT

# BRIDGE INSPECTION REPORT

COUNTY IREDELL BRIDGE NUMBER 480282 INSPECTION CYCLE 2 YRS  
ROUTE SR1828 ACROSS NORTH HUNTING CREEK M.P. 0

SUPERSTRUCTURE STEEL PLANK DECK ON I-BEAMS

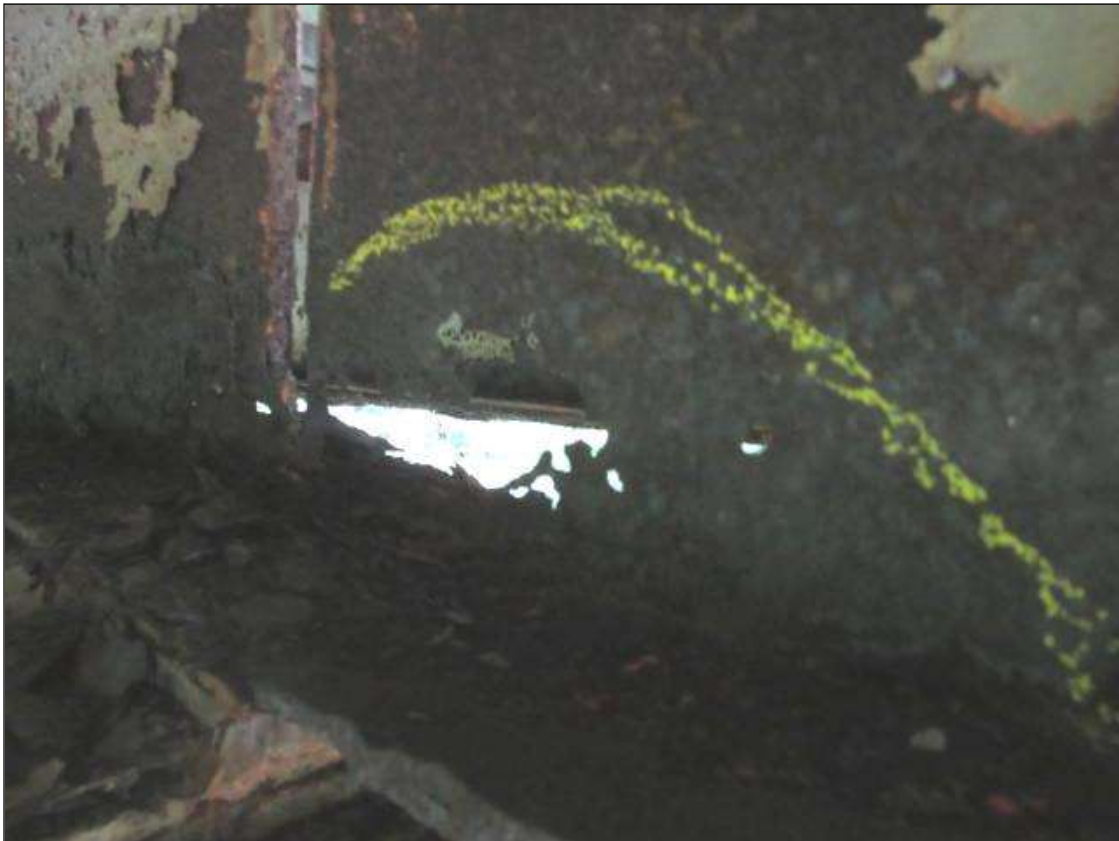
BEAM (8), SPAN (C) AT PIER (3); HOLE IN WEB AT BEAM END... (+/- 12" L X 6" H)... SEE SKETCH

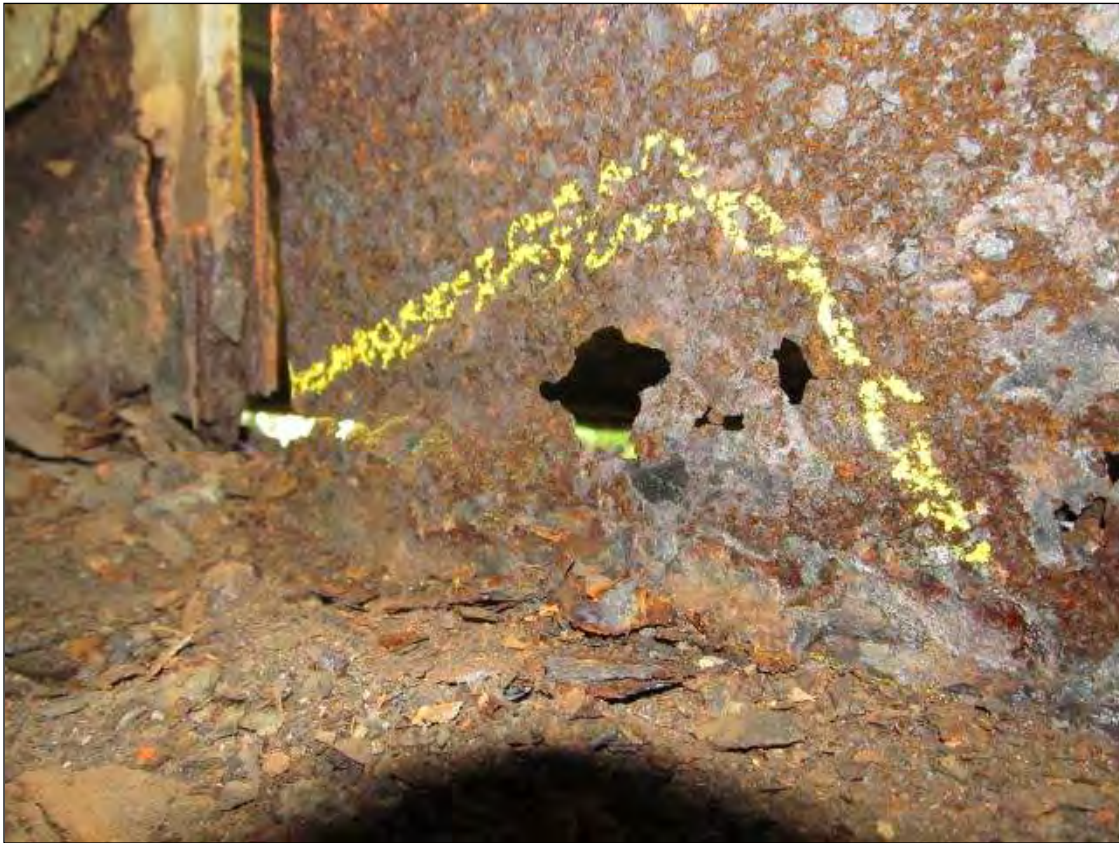
BEAM (9), SPAN (C) AT PIER (3); HOLES IN WEB, (+/- 12" L X 6" H)... SEE SKETCH

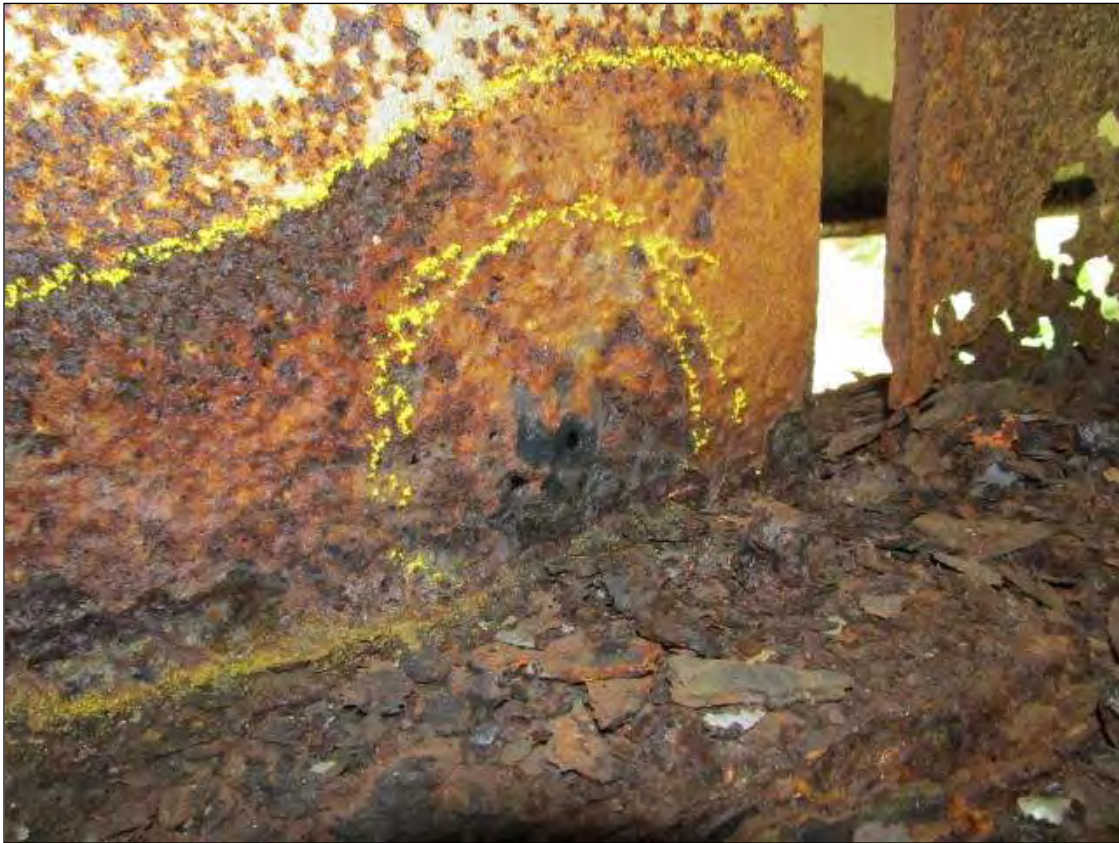
BEAM (2), SPAN (D) AT PIER (3); NUMEROUS PIN HOLES IN WEB AT END OF BEAM... NOTE SEVERE PITTING OF SURROUNDING AREA... SEE SKETCH

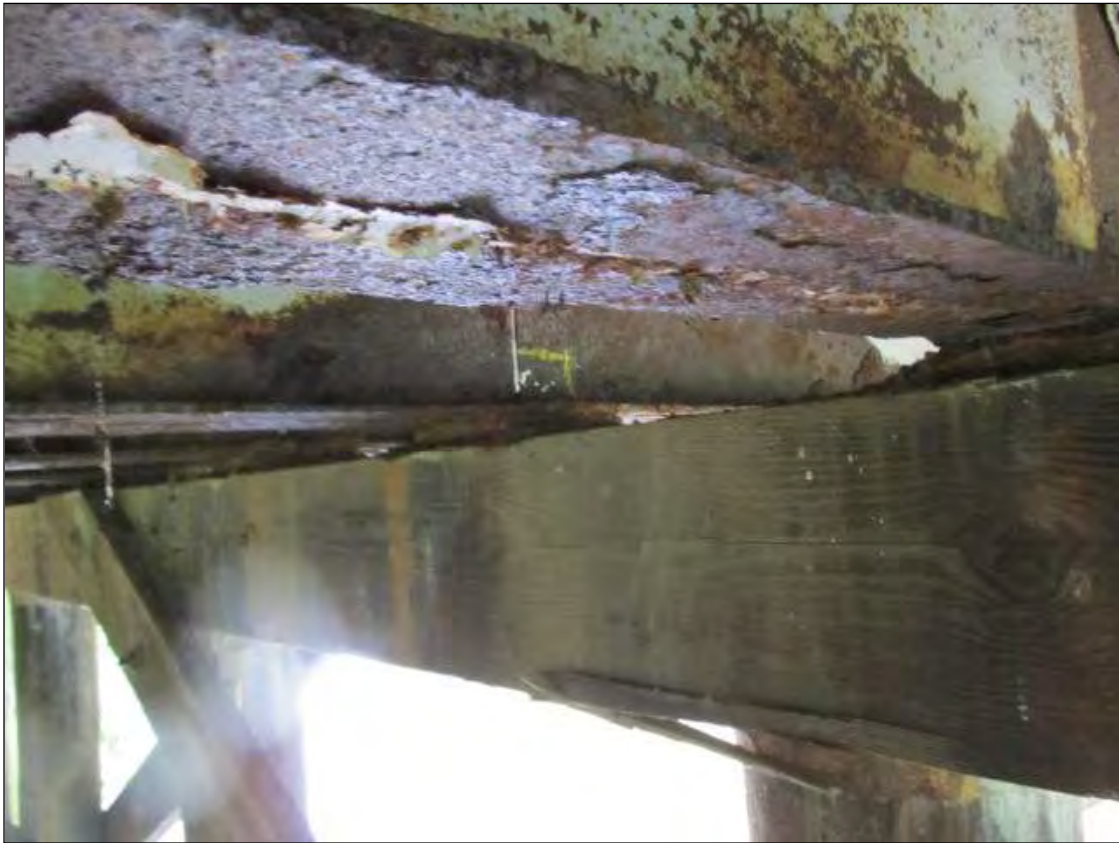
BEAMS (3) THROUGH (6), SPAN (D)... NOT HOLED THROUGH AT THIS TIME... RUST, SCALE AND LOSS OF SECTION AT BEAM ENDS (+/- 20 LF). SEE CONDITION SKETCH

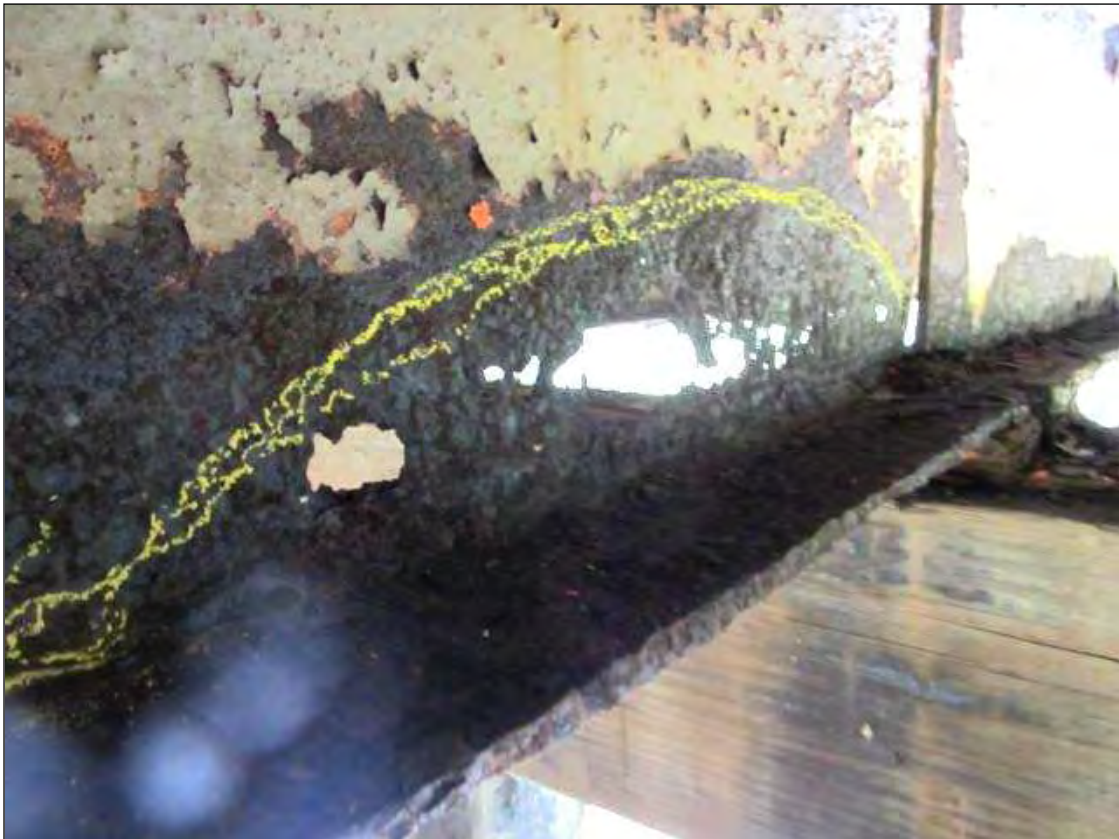
BEAM (7), SPAN (D) AT PIER (3); HOLES IN WEB AT BEAM END, (3' L X 6 TO 8" H))... SEE SKETCH

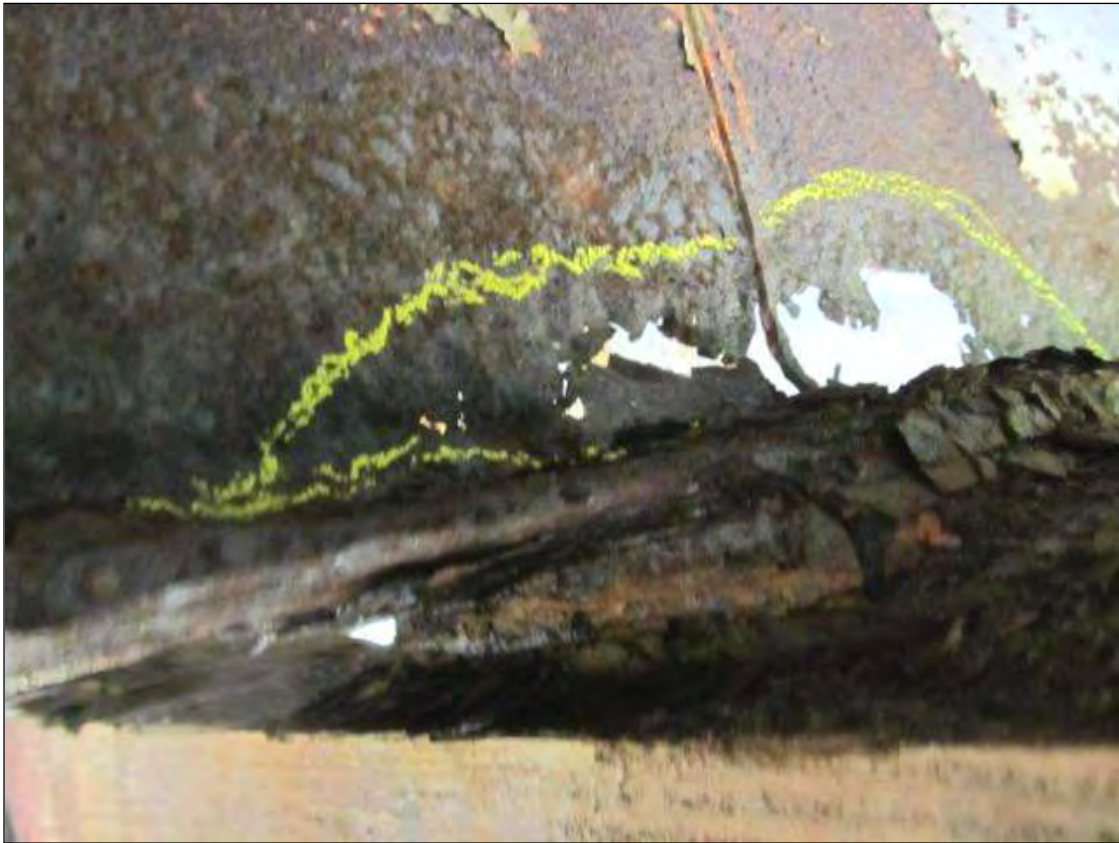
BEAM (8), SPANS (C) AND (D) AT PIER (3); HOLES IN WEB, (+/- 8" L X 4" H)... SEE SKETCH

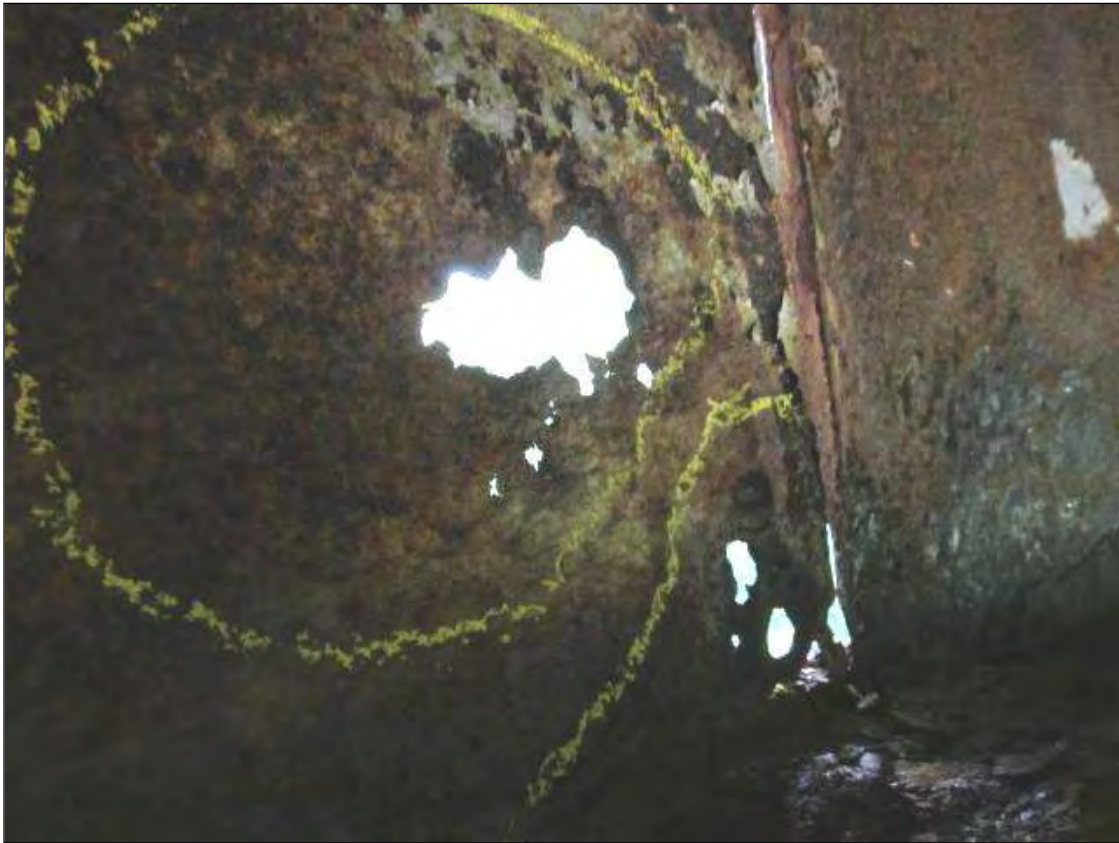
BEAM (10), SPAN (D) AT PIER (3); HOLES IN WEB... TOP IS (+/- 8" L X 6" H) AND BOTTOM IS (+/- 4" L X 2" H)...  
SEE SKETCH

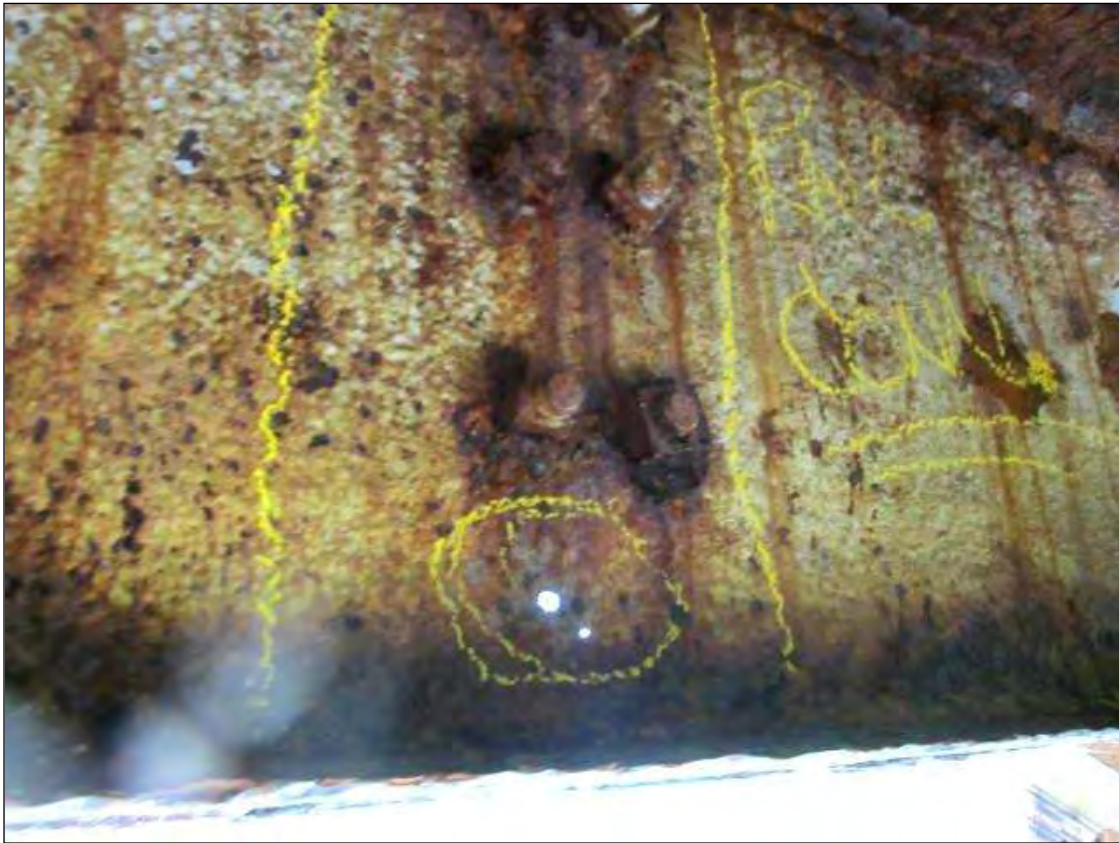
BEAM (10), SPAN (D) (+/- 3' FROM WEST END OF BEAM) BELOW RAIL POST CONNECTION... (2) SMALL (LESS THAN 1" DIAM.) HOLES... SEE SKETCH

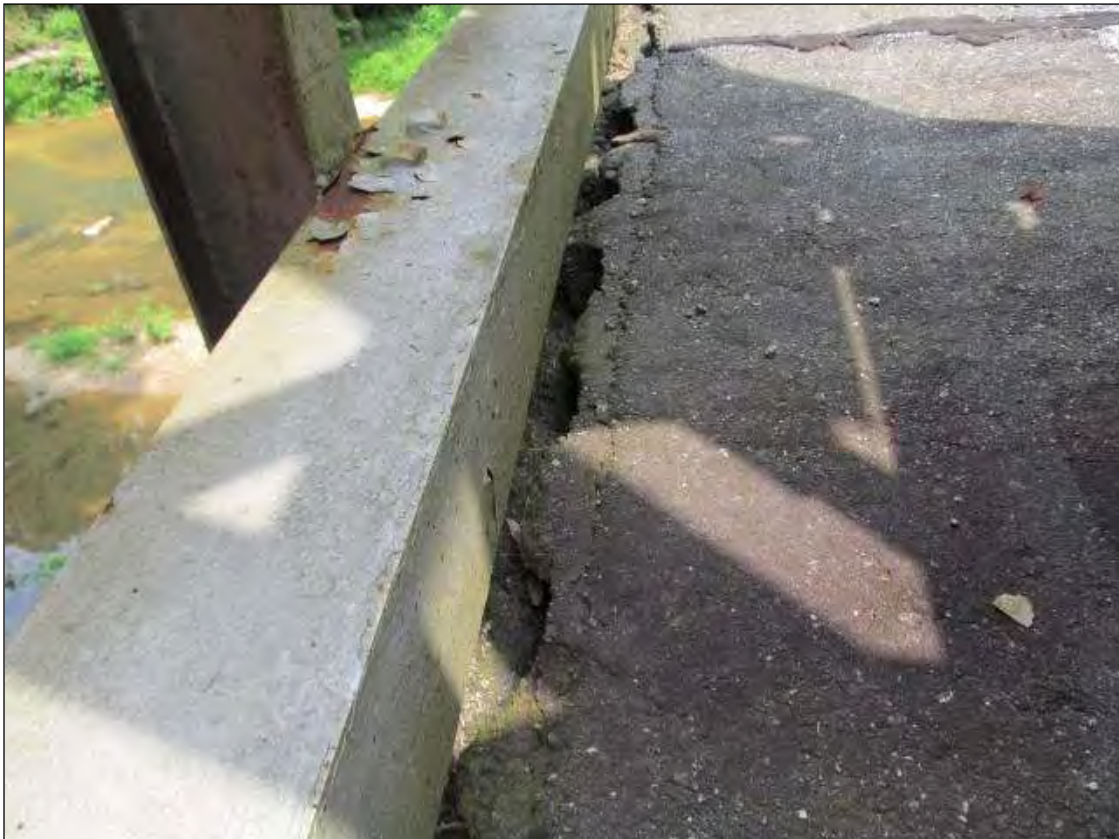
RT. SIDE DECK CHANNEL AT PIER (3) IS LOOSE FROM DECK... (+/- 15 LF)

| MMS Code | Description of Function | Unit | Quantity | Remarks | Est. Cost |
|---|---|---|---|---|---|
| 3328 | Maintenance/Repair/ Replace Steel Plank Bridge Floor | SF | 45 | RT. SIDE DECK CHANNEL AT PIER (3) IS LOOSE FROM DECK... (+/- 15 LF) | |

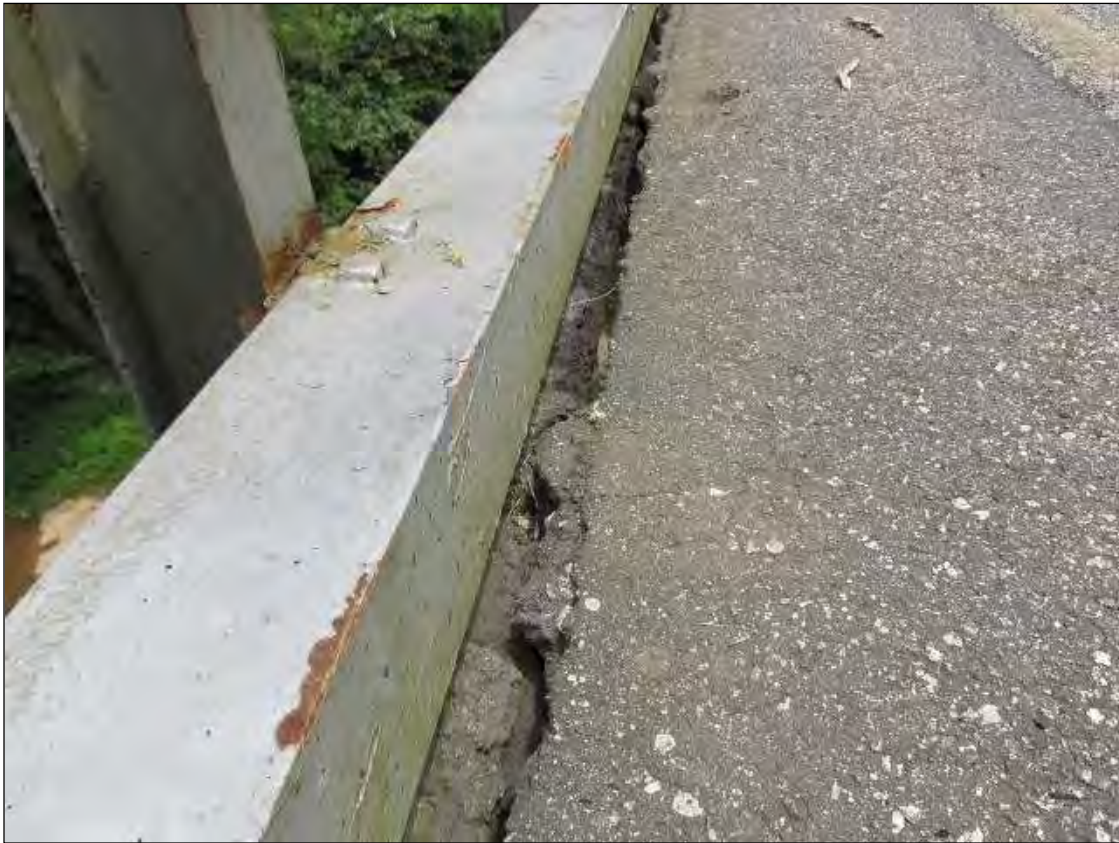
RT. SIDE CHANNEL, SPAN (B) AT PIER (2) IS LOOSE FROM DECK, (+/- 30 LF)

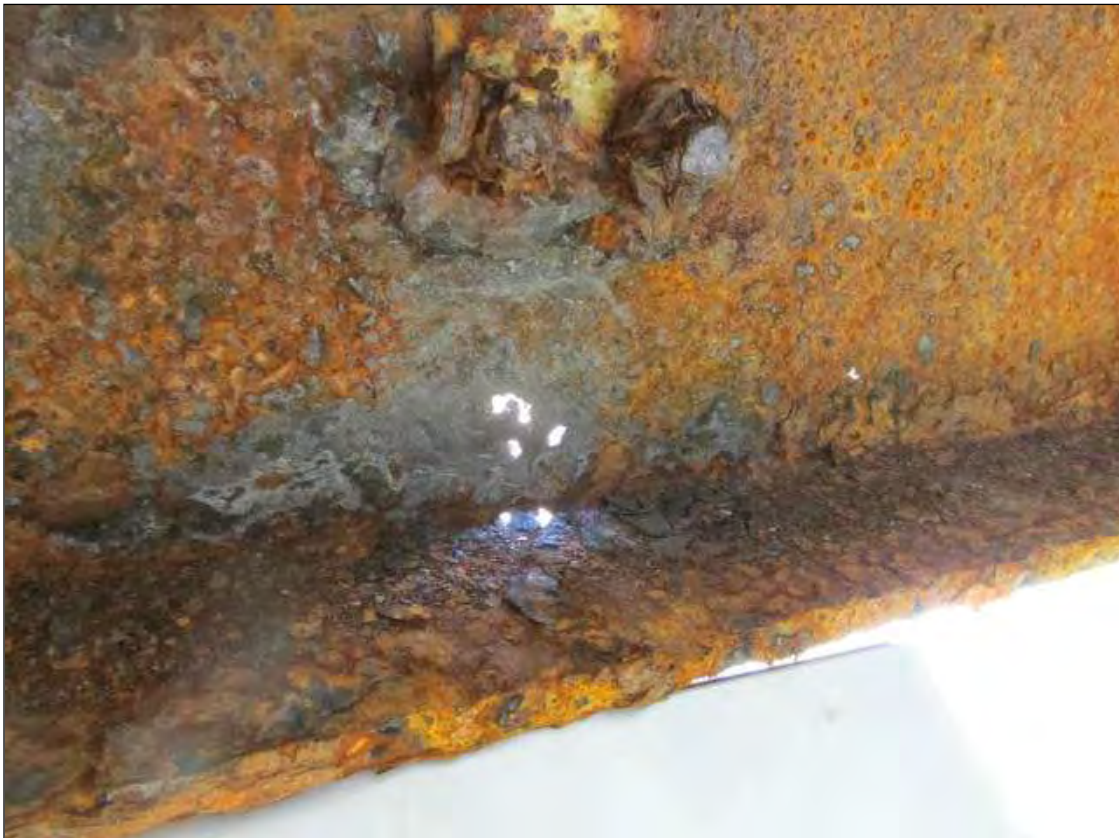
RAIL POST CONNECTIONS ARE POOR DUE TO THE DETERIORATION OF EXTERIOR BEAM WEBS... WEBS ARE REDUCED IN SEVERAL AREAS TO (+/- 1/32" SECTION REMAINING...

| MMS Code | Description of Function | Unit | Quantity | Remarks | Est. Cost |
|---|---|---|---|---|---|
| 3322 | Maint to Steel Handrail | LF | 364 | RAIL POST CONNECTIONS ARE POOR DUE TO THE DETERIORATION AND WEAKENING OF EXTERIOR BEAM WEBS, AND CONNECTION HARDWARE... | |

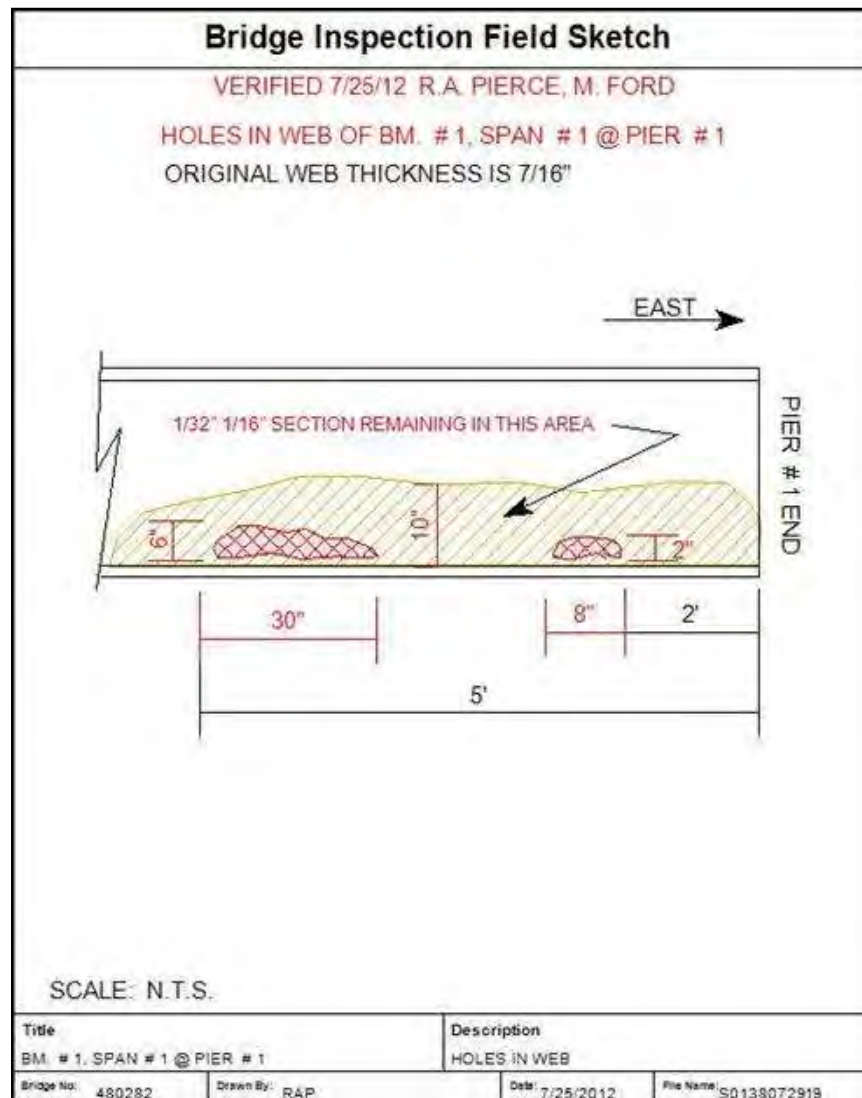
SKETCH, BEAM (1), SPAN (A) AT PIER (1)... (+/- 3 LF)

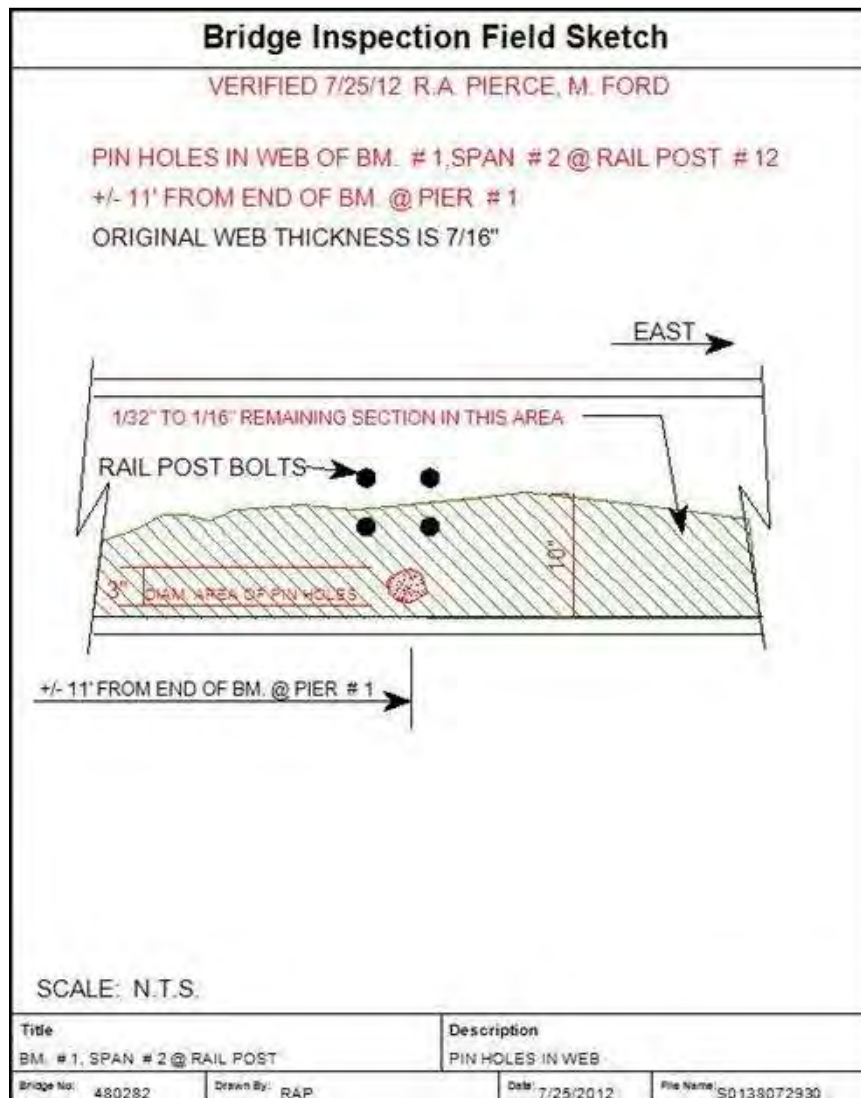
SKETCH, BEAM (1), SPAN (B) (+/- 11' FROM FACE OF PIER (1) CAP...

| MMS Code | Description of Function | Unit | Quantity | Remarks | Est. Cost |
|---|---|---|---|---|---|
| 3314 | Maintain Steel Superstructure Components | LF | 1 | SKETCH, BEAM (1), SPAN (B) (+/- 11' FROM FACE OF PIER (1) CAP... RUST SCALE AND LOSS OF SECTION ALONG BEAM BOTT. FLANGES AT ABUT. (A). (BEAM, 4 SHOWN)... SEE SKETCH | |

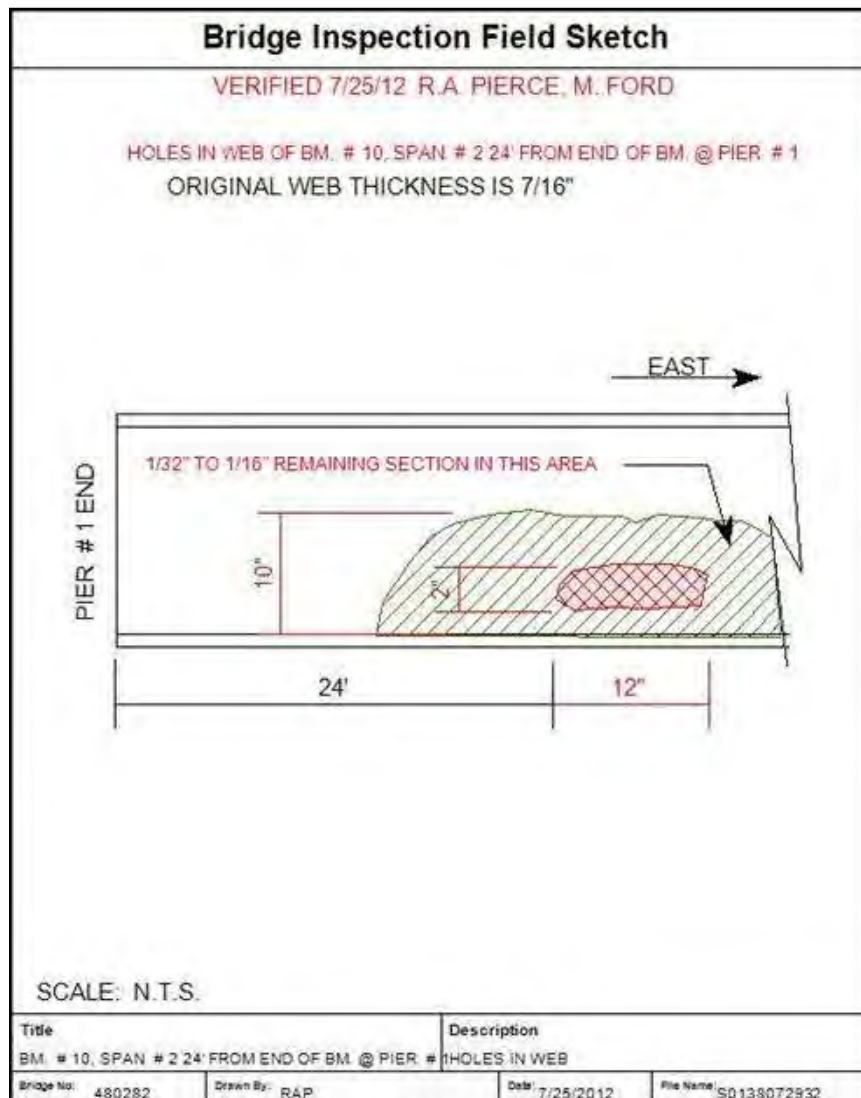
SKETCH, BEAM (10), SPAN (B) (+/- 24' FROM EAST FACE OF PIER (1) CAP... NOTE REDUCTION OF SURROUNDING MATERIAL...

| MMS Code | Description of Function | Unit | Quantity | Remarks | Est. Cost |
|---|---|---|---|---|---|
| 3314 | Maintain Steel Superstructure Components | LF | 4 | SKETCH, BEAM (10), SPAN (B) (+/- 24' FROM EAST FACE OF PIER (1) CAP... NOTE REDUCTION OF SURROUNDING MATERIAL...<br>BEAM (10) WEB AT FIRST RAIL CONNECTION IN SPAN (B)... HOLES IN WEB (+/- 4' L W/ 2, +/- 4" DIAM. HOLES)... NOTE CONDITION OF BOTT. FLANGE... SEE SKETCH | |

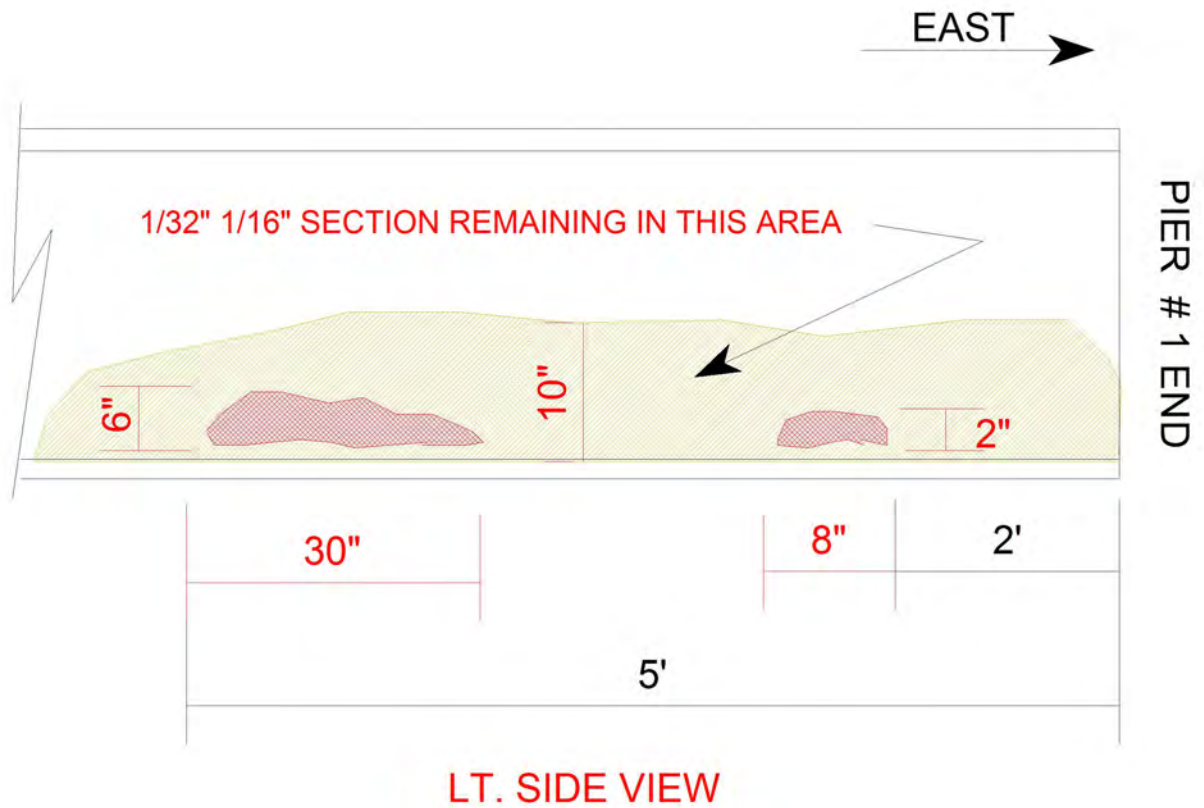
HOLES IN WEB OF BM. # 1, SPAN # 1 @ PIER # 1

ORIGINAL WEB THICKNESS IS 7/16"

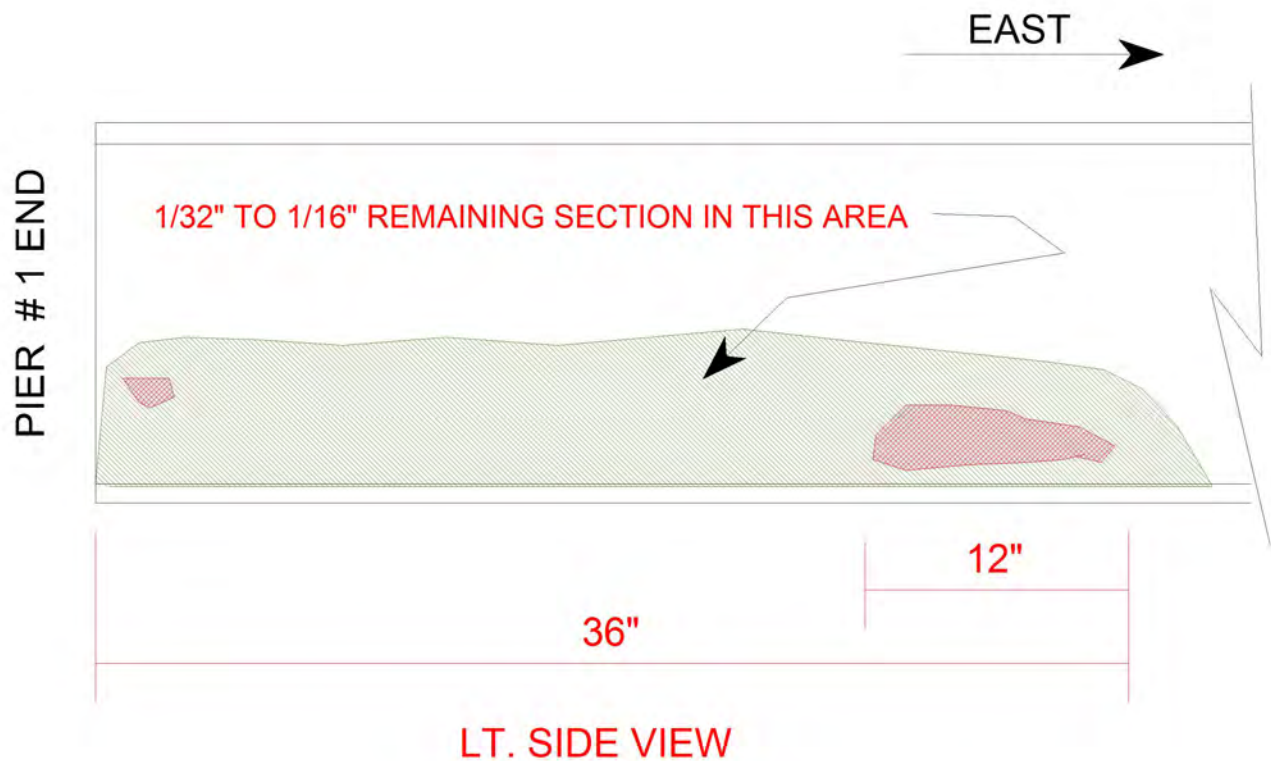
HOLE IN WEB OF BM. # 5, SPAN # 2 @ PIER # 1

ORIGINAL WEB THICKNESS IS 7/16"

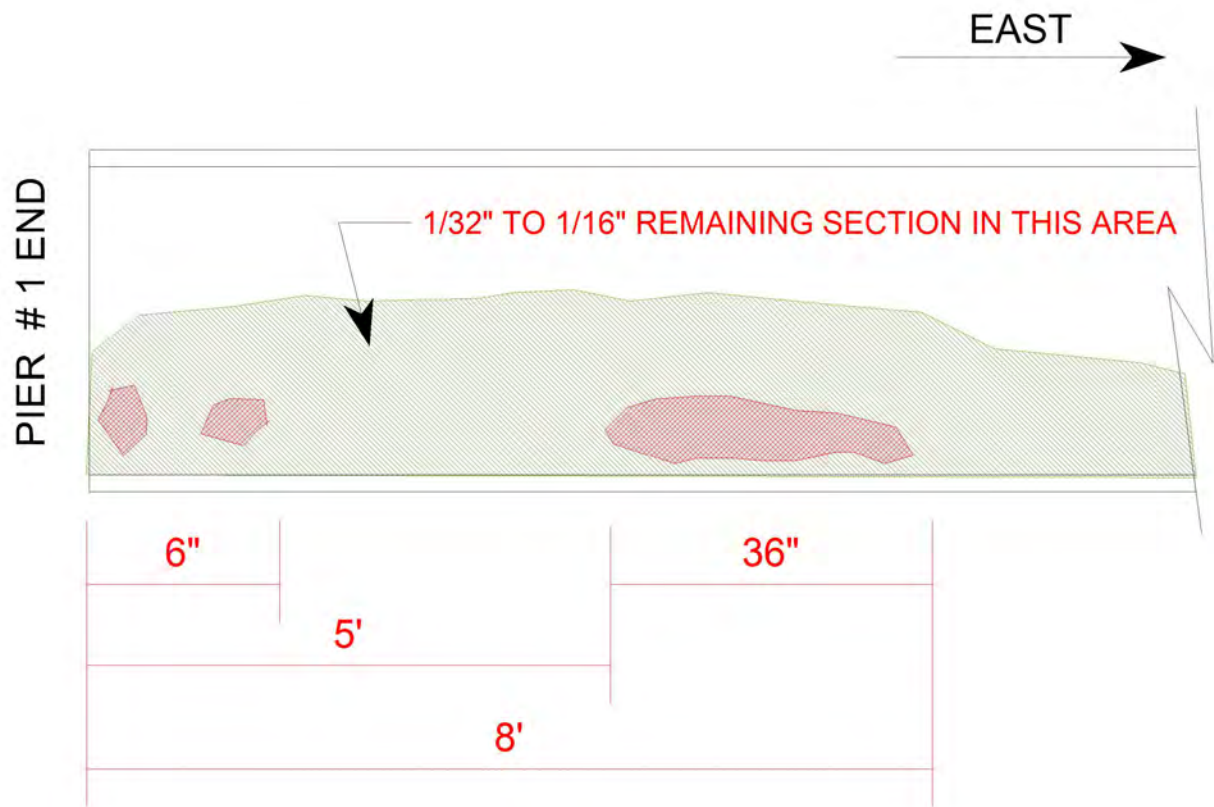
HOLES IN WEB OF BM. # 6, SPAN # 2 @ PIER # 1

ORIGINAL WEB THICKNESS IS 7/16"

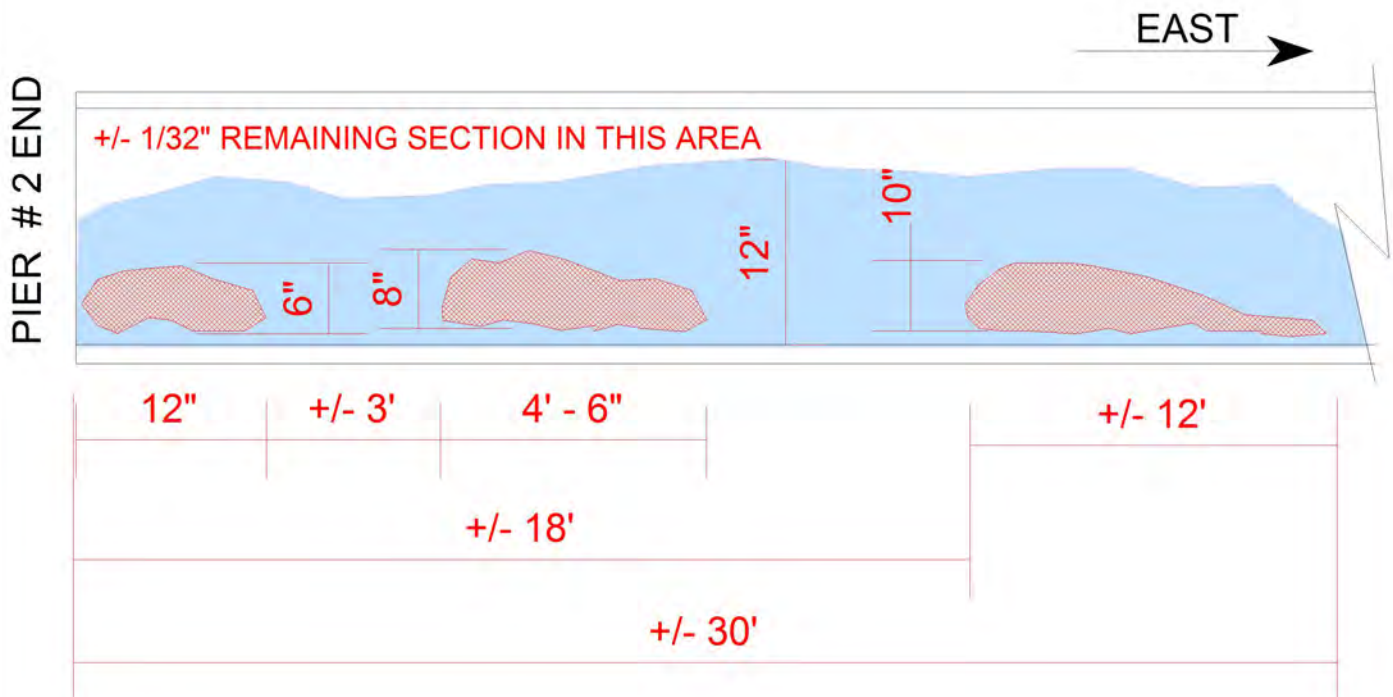
HOLES IN WEB OF BM. # 3, SPAN # 3 FROM END OF BM. @ PIER # 2 TO +/- MID SPAN  
ORIGINAL WEB THICKNESS = 7/16"
