NC DEPARTMENT OF TRANSPORTATION  
DIVISION OF HIGHWAYS  
BRIDGE MANAGEMENT UNIT

# BRIDGE INSPECTION REPORT

COUNTY HAYWOOD BRIDGE NUMBER 430020 INSPECTION CYCLE 2 YRS  
ROUTE SR1809 ACROSS RACoon CREEK M.P. 0

INSPECTION DATE 04/23/2013

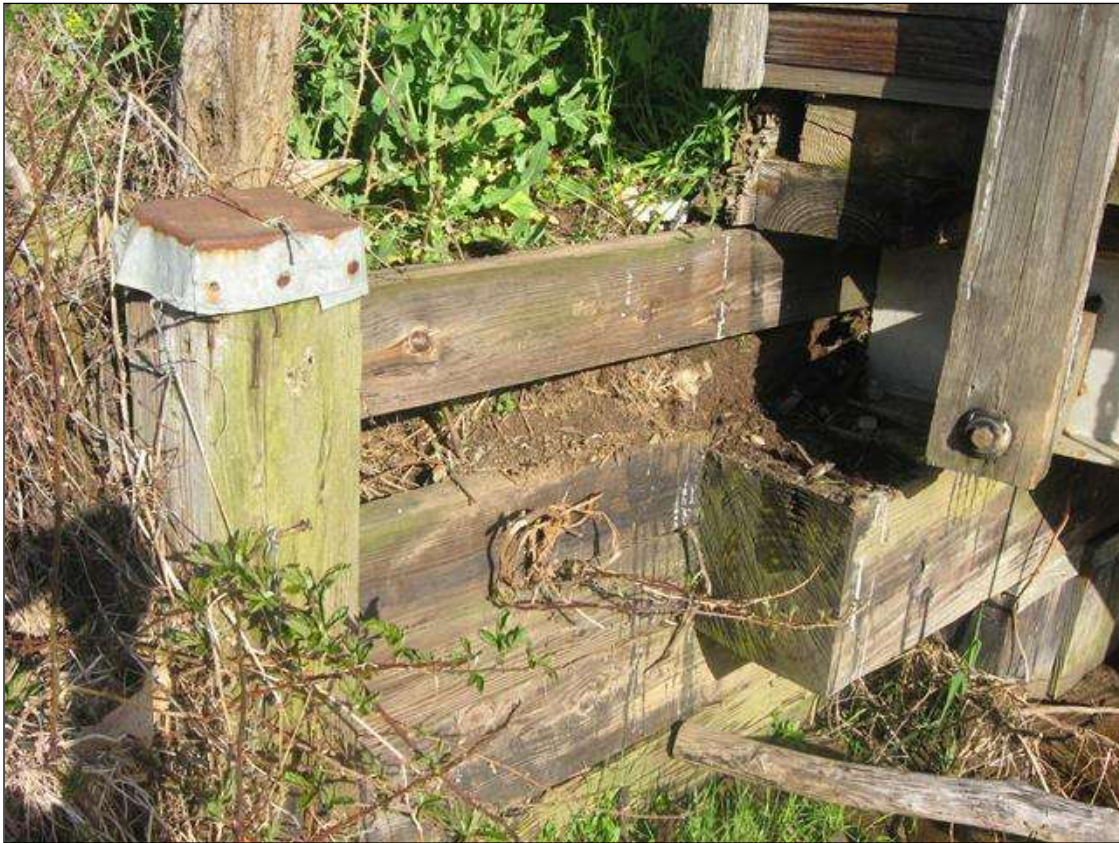
| Bridge I&A Form 1(82)H<br>State of North Carolina<br>Dept. of Transportation<br>Division of Highways | | <h1 style="text-align: center;">FIELD INSPECTION REPORT</h1> <p style="text-align: center;"><u>Bridge Inspection &amp; Analysis</u></p> | |
|---|---|---|--|
| 35c | F | TIMBER BULKHEAD AND WINGWALLS; 1ST AND 3RD BULKHEAD TIMBERS DOWN FROM TOP ON UPSTREAM MOST 5' AT ABUTMENT 1 HAVE COMPLETE DECAY.<br>[SEE PHOTO].<br>FILL IS VISIBLE BUT HAS NOT SPILLED THROUGH AS YET.<br>PRI. MAINT. ISSUED DUE TO THIS CONDITION.<br>ALL OTHER ORIGINAL TIMBERS ARE WEATHERED WITH SCATTERED AREAS OF 1" DEEP DECAY.<br>NO PROBLEMS DUE TO CONDITION AS YET. | |
| 61 | YES | PROMPT ACTION ISSUED; PRI. MAINT. ISSUED DUE TO COMPLETE DECAY TO UPSTREAM MOST 5' OF 1ST AND 3RD BULKHEAD TIMBERS DOWN FROM TOP AT ABUTMENT 1. | |

1ST AND 3RD BULKHEAD TIMBERS DOWN FROM TOP AT ABUTMENT 1 HAVE COMPLETE DECAY TO THEIR UPSTREAM MOST 5'.

| MMS Code | Description of Function | Unit | Quantity | Remarks | Est. Cost |
|---|---|---|---|---|---|
| 3346 | Repair / Maintain Timber Wings & Blkhds | SF | 10 | 1ST AND 3RD BULKHEAD TIMBERS DOWN FROM TOP AT ABUTMENT 1 HAVE COMPLETE DECAY TO THEIR UPSTREAM MOST 5' WITH FILL VISIBLE BUT NOT SPILLING AS YET. | |

| MMS Code | MMS Description | Quantity |
|---|---|---|
| 3346 | Repair / Maintain Timber Wings & Blkhds | 10              SF |

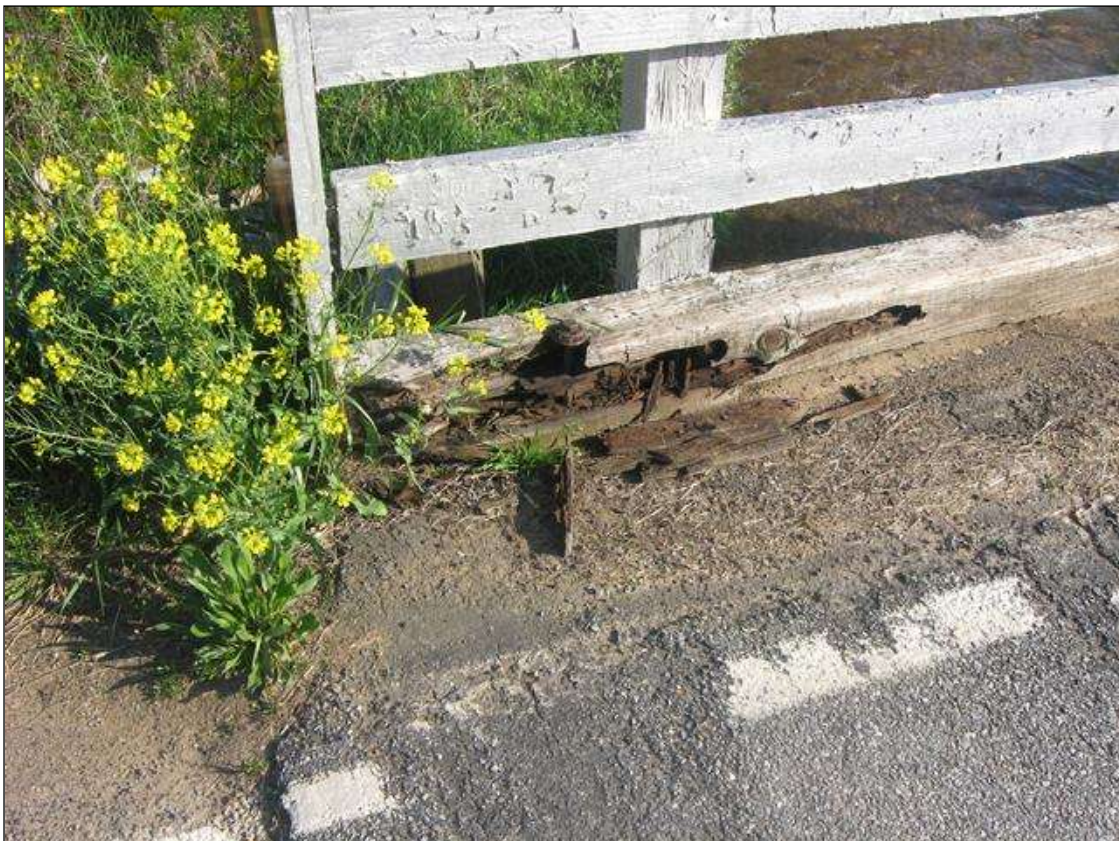
| Bridge I&A Form 1(82)H<br>State of North Carolina<br>Dept. of Transportation<br>Division of Highways | | <h1 style="text-align: center;">FIELD INSPECTION REPORT</h1> <p style="text-align: center;"><u>Bridge Inspection &amp; Analysis</u></p> | |
|---|---|---|--|
| 4 | P | TIMBER WHEELGUARDS; SCATTERED AREAS OF UP TO 3" DEEP DECAY ALONG BOTH SIDES OF BRIDGE.<br>[SEE REP. PHOTO]. | |

REP. OF DECAY TO WHEELGUARD. PHOTO WAS TAKEN OF DOWNSTREAM SIDE.

| MMS Code | Description of Function | Unit | Quantity | Remarks | Est. Cost |
|---|---|---|---|---|---|
| 3316 | Maint to Timber Handrail | LF | 41 | SCATTERED AREAS OF UP TO 3" DEEP DECAY TO WHEELGUARD TIMBERS. | |

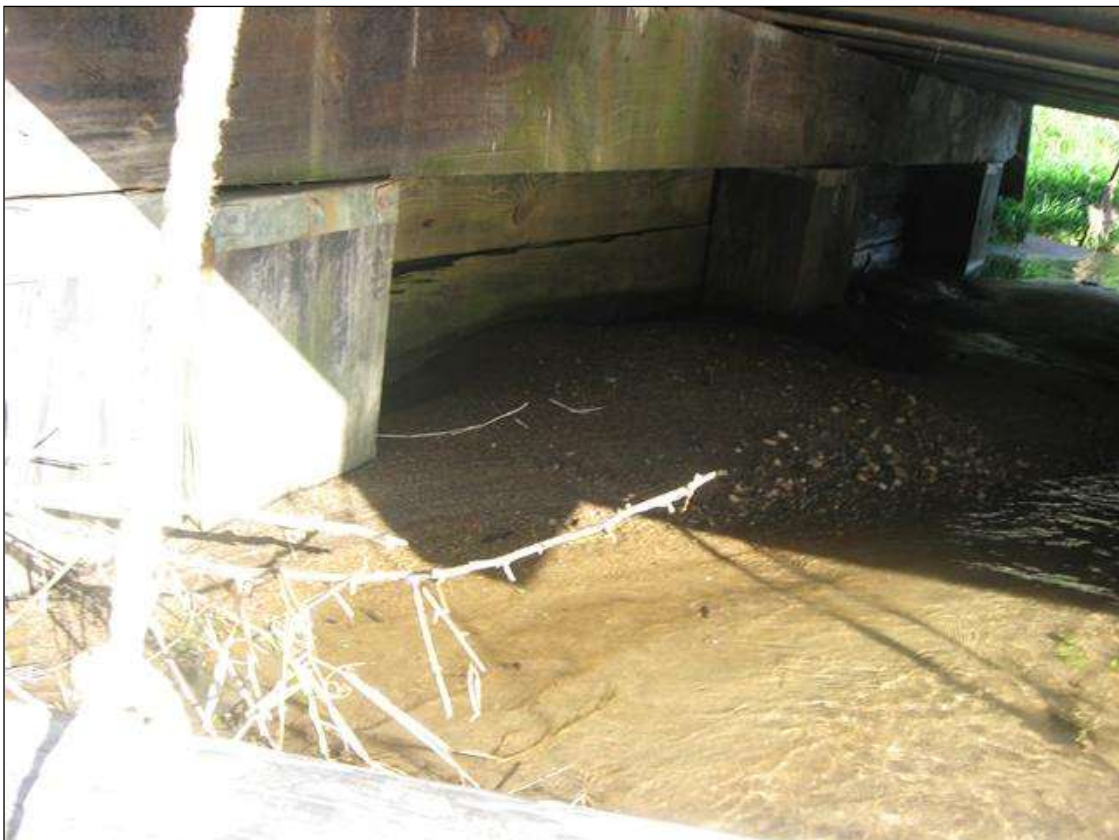
TEMPORARY REPAIRS- ALL POSTS ARE SUPPLIMENTED AT BOTH  
ABUTMENTS.

ABUTMENT 1 - TEMP. REPAIR TO POSTS 1, 2, AND 3.

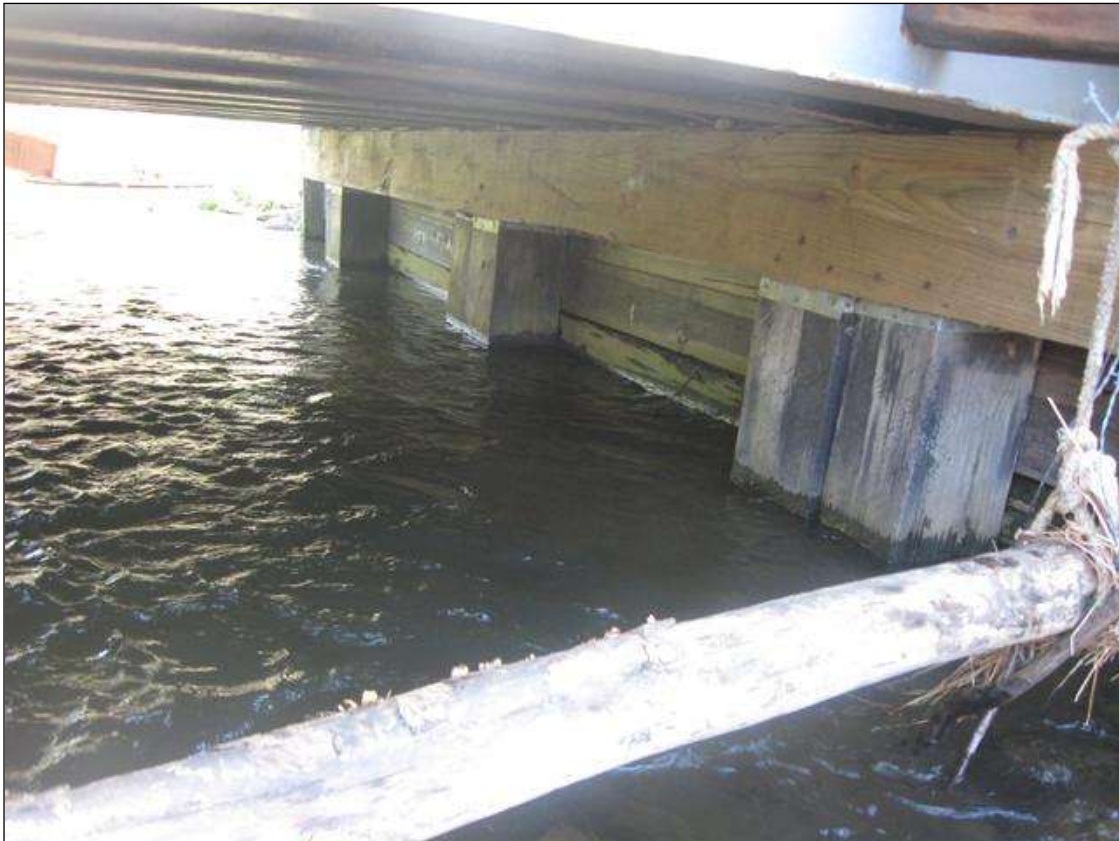
| Bridge I&A Form 1(82)H<br>State of North Carolina<br>Dept. of Transportation<br>Division of Highways | | <h1 style="text-align: center;">FIELD INSPECTION REPORT</h1> <p style="text-align: center;"><u>Bridge Inspection &amp; Analysis</u></p> | |
|---|---|---|--|
| 35b | F | TIMBER ABUTMENT POST; DOWNSTREAM POST OF DOUBLED POST 2 AT ABUTMENT 2 HAS AN AREA OF 2 1/2" WIDE X 2 1/2" DEEP DECAY IN ITS TOP 10" TO ITS DOWNSTREAM FACE.<br>THIS CONDITION HAS NOT CHANGED SINCE PREVIOUS INSP. AND SHOWS NO SIGNS OF CAUSING ANY PROBLEMS AS YET.<br>ALL OTHER POST ARE WEATHERED BUT SOUND.<br>"DOUBLED" POST ARE CONSIDERED A TEMP. REPAIR. | |

ABUTMENT 2- TEMP. REPAIR TO POSTS 1, 2, AND 3.
