# BRIDGE INSPECTION REPORT

INSPECTION TYPE: Routine Inspection

COUNTY HAYWOOD BRIDGE NUMBER 430102 INSPECTION CYCLE 2 YRS  
ROUTE SR1173 ACROSS PLOTT CREEK M.P. 0

INSPECTION DATE 02/11/2013

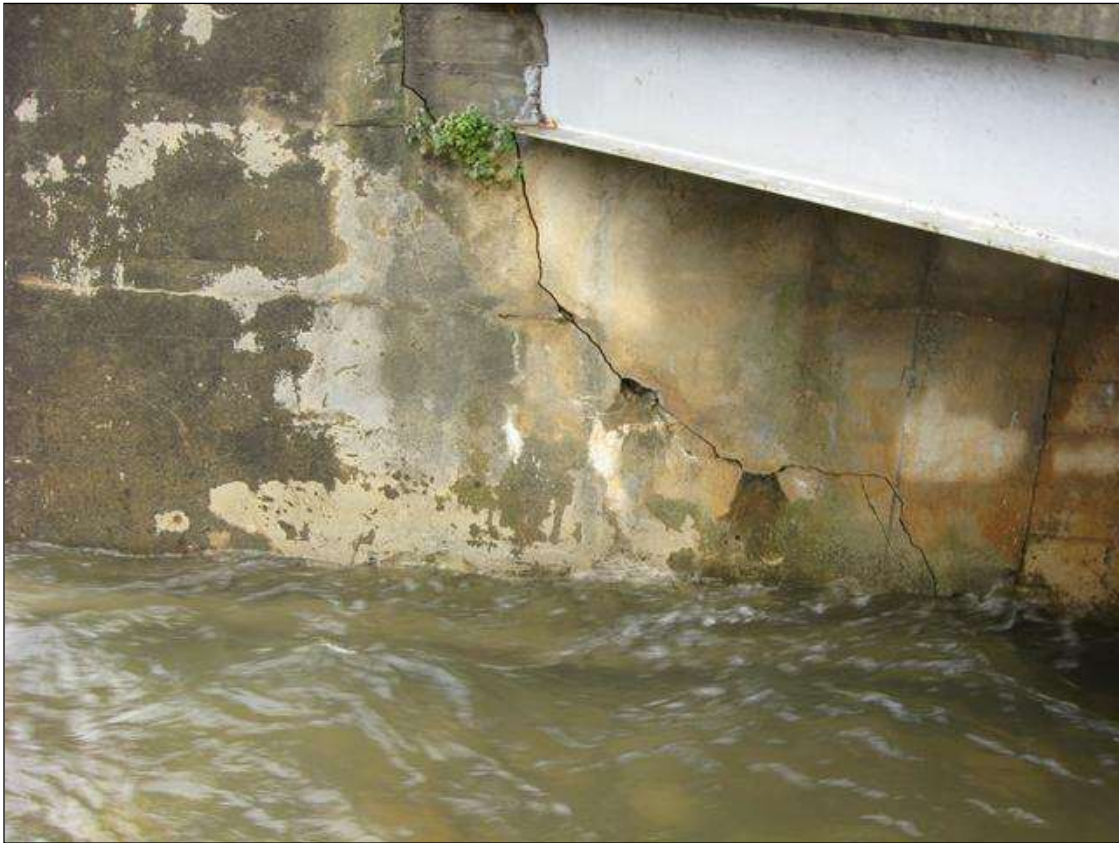
| Bridge I&A Form 1(82)H<br>State of North Carolina<br>Dept. of Transportation<br>Division of Highways | | <h1>FIELD INSPECTION REPORT</h1> <h2><u>Bridge Inspection &amp; Analysis</u></h2> | |
|---|---|---|--|
| 36a | F | CAPS,BREASTWALLS AND FOOTINGS; 1/8" TO 1/4" DIAG. TYPE CRACKS BEGINS IN VISIBLE PORTION OF FOOTING AND EXTENDS ENTIRE HT. OF ABUTMENT 2. [SEE PHOTO].<br>CRACK IS JUST DOWNSTREAM OF BEAM 1 AT CAP.<br>FOOTINGS ARE LIGHT TO MOD. DETER. UP TO 1" DEEP WHERE VISIBLE.<br>NO CHANGE IN PAST SEVERAL INSPS. | |

CRACK IN BREASTWALL ABUTMENT 1 ON DOWNSTREAM SIDE.

| MMS Code | Description of Function | Unit | Quantity | Remarks | Est. Cost |
|---|---|---|---|---|---|
| 3350 | Maint R C Wings and Walls | SF | 60 | ROCK AND DIRT SIT ATOP CAP AT BOTH ABUTMENTS IN SEVERAL LOCATIONS THESE AREAS SHOULD BE REPLACED WITH A MORE STABLE BACKWALL. LARGE CRACK IN WALL AT ABUTMENT 2. | |

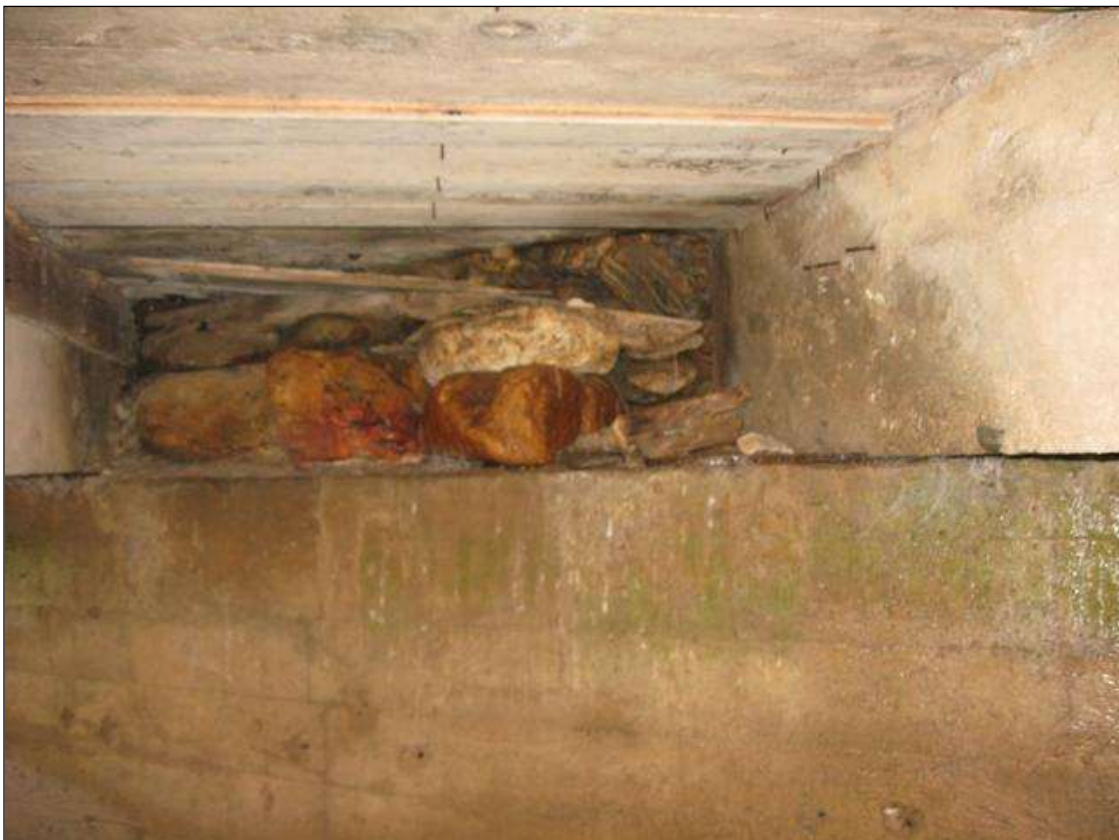
| Bridge I&A Form 1(82)H<br>State of North Carolina<br>Dept. of Transportation<br>Division of Highways | | <h1>FIELD INSPECTION REPORT</h1> <h2><u>Bridge Inspection &amp; Analysis</u></h2> | |
|---|---|---|--|
| 36d | F | CURTAIN WALLS; CURTAIN WALLS BETWEEN BEAMS - GOOD CONDITION. AREAS BETWEEN GIRDERS AT BOTH ABUTMENTS HAVE NO CURTAIN WALLS WITH AREAS CONSISTING OF LARGE ROCK AND LOOSE DIRT ATOP CAPS. [SEE REP. PHOTO]. | |

REP. OF LOOSE ROCK ATOP OF ABUTMENTS. PHOTO WAS TAKEN OF ABUTMENT 1.
