NC DEPARTMENT OF TRANSPORTATION  
DIVISION OF HIGHWAYS  
BRIDGE MANAGEMENT UNIT

# BRIDGE INSPECTION REPORT

COUNTY HAYWOOD BRIDGE NUMBER 430314 INSPECTION CYCLE 2 YRS  
ROUTE SR1355 ACROSS CREEK M.P. 0

INSPECTION DATE 05/15/2013 PRESENT CONDITION POOR

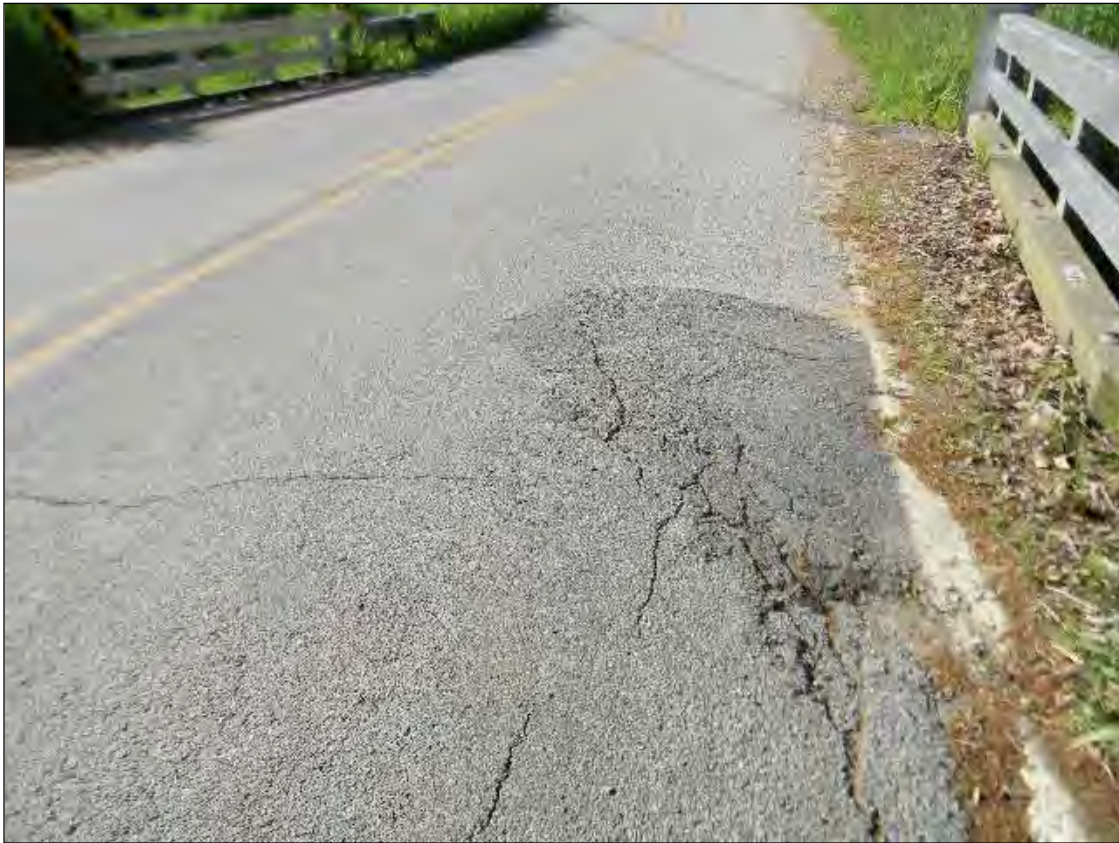
| 50 | F | 4' LONG X 3' WIDE PATCH AT THE NW CORNER HAS MAP CRACKING WITH ADDITIONAL CRACKING AND 1/2" SETTLEMENT ALONG THE FILLFACE. SE DELINEATOR IS MOSTLY HIDDEN BY HIGH GRASS. | |

4' LONG X 3' WIDE PATCH AT THE NW CORNER HAS MAP CRACKING WITH ADDITIONAL CRACKING AND 1/2" SETTLEMENT ALONG THE FILLFACE.

| MMS Code | Description of Function | Unit | Quantity | Remarks | Est. Cost |
|---|---|---|---|---|---|
| 2816 | Asphalt Surface Repair or Replacement | SY | 10 | 4' LONG X 3' WIDE PATCH AT THE NW CORNER HAS MAP CRACKING WITH ADDITIONAL CRACKING AND 1/2" SETTLEMENT ALONG THE FILLFACE. | |

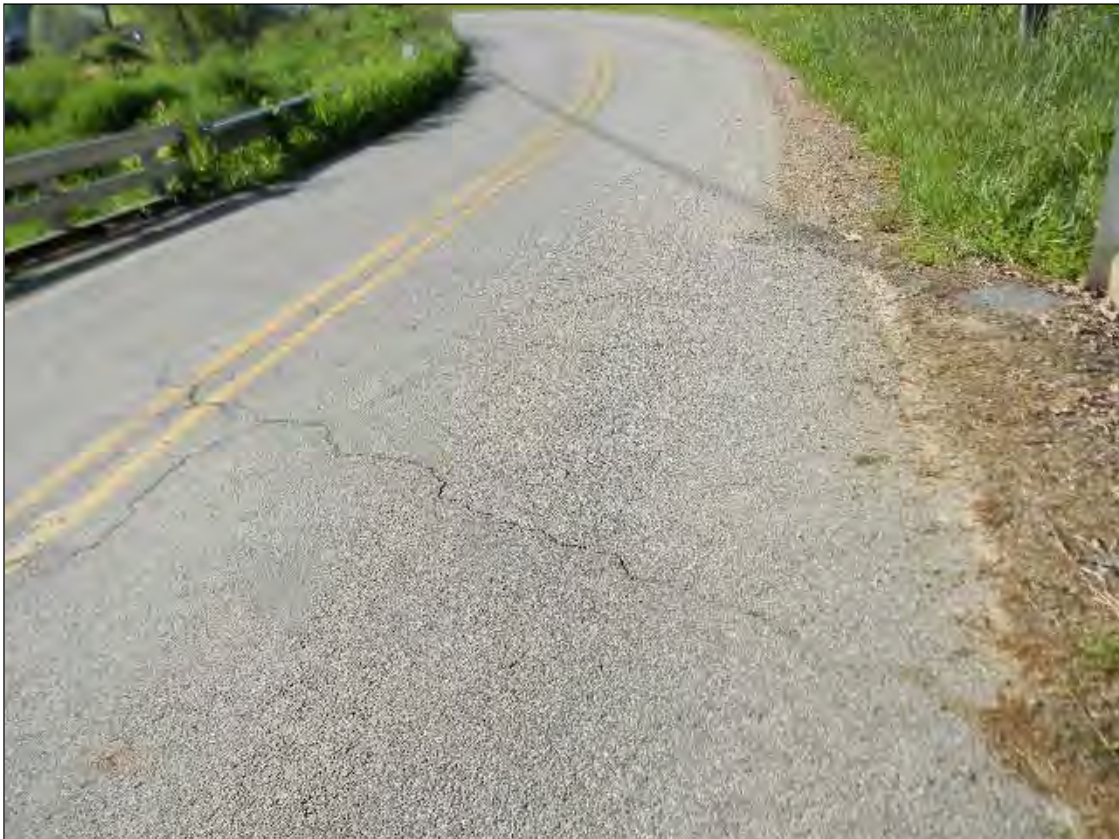
| 1 | G | WEARING SURFACE HAS A FEW MOST TRANSVERSE CRACKS. | |

WEARING SURFACE HAS A FEW MOST TRANSVERSE CRACKS.

| MMS Code | Description of Function | Unit | Quantity | Remarks | Est. Cost |
|---|---|---|---|---|---|
| 2816 | Asphalt Surface Repair or Replacement | SY | 10 | WEARING SURFACE HAS A FEW MOST TRANSVERSE CRACKS. | |

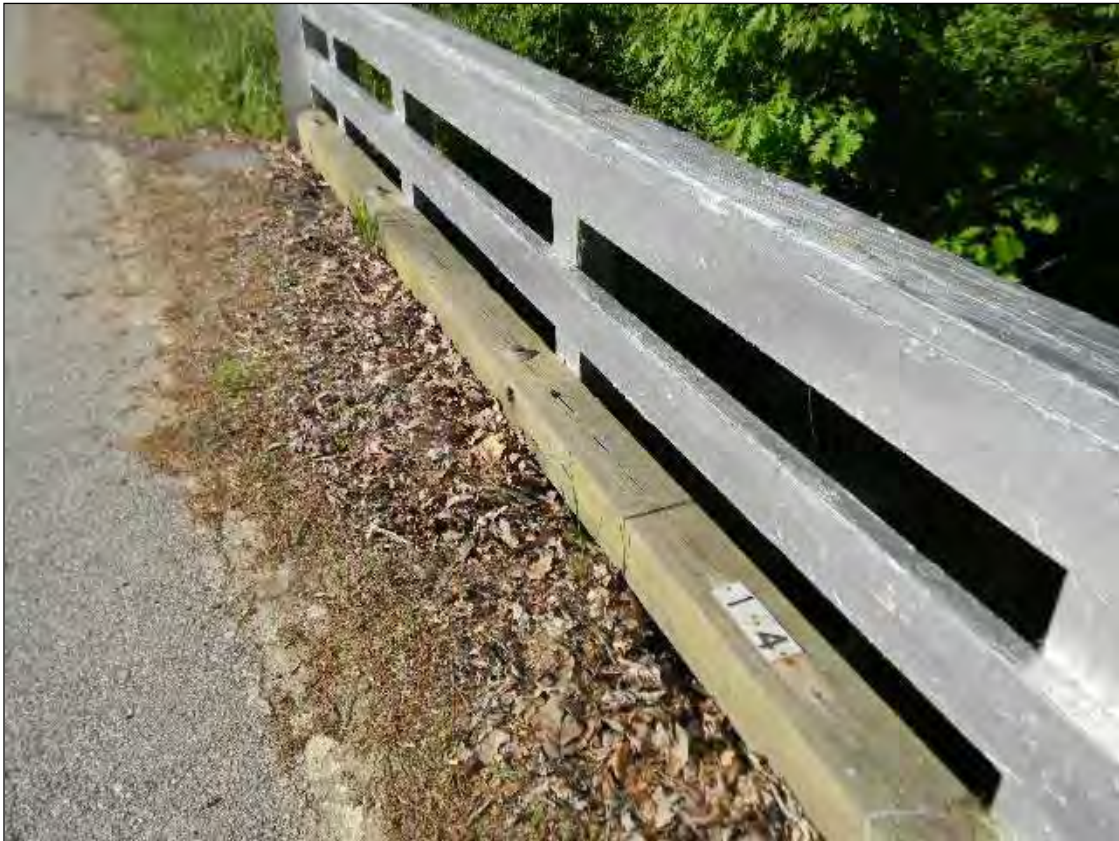
| 7 | F | 2" DEEP DIRT BUILDUP ALONG THE WHEELGUARDS HINDERING DRAINAGE. | |

2" DEEP DIRT BUILDUP ALONG THE WHEELGUARDS HINDERING DRAINAGE.

| MMS Code | Description of Function | Unit | Quantity | Remarks | Est. Cost |
|---|---|---|---|---|---|
| 3376 | Clean/Wash Bridge Decks | SF | 33 | | |

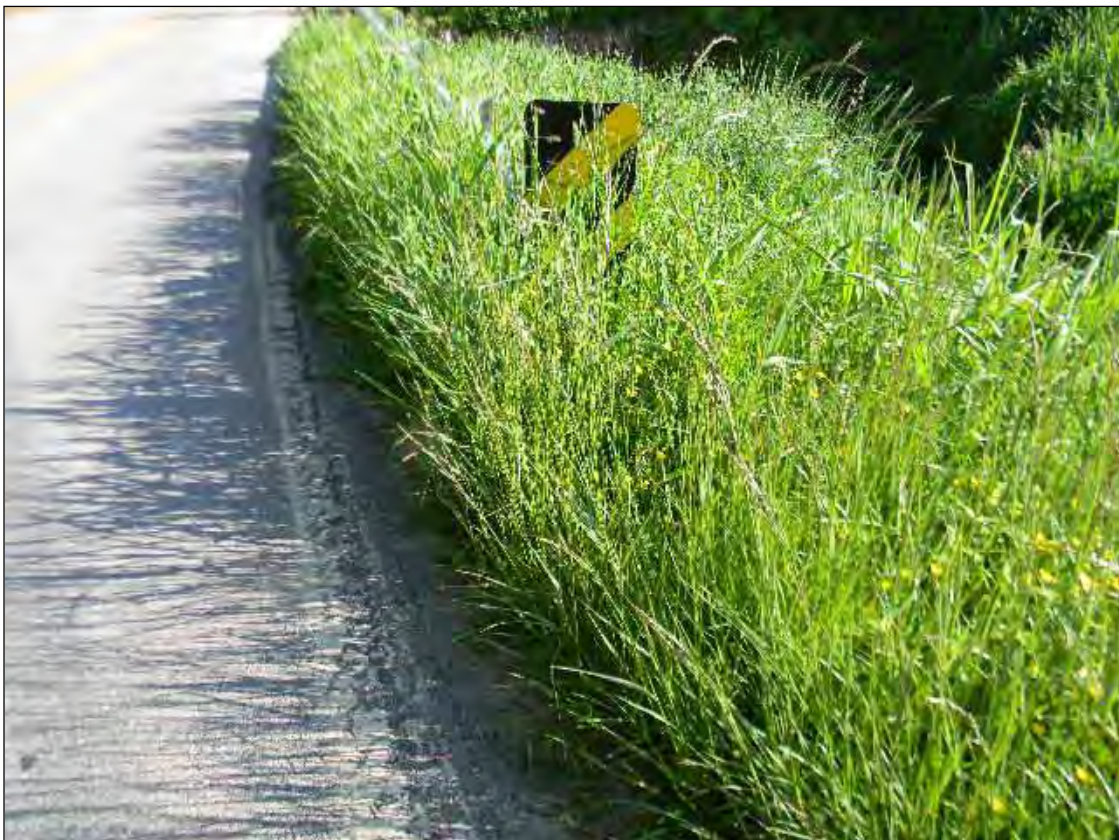
SE DELINEATOR IS MOSTLY HIDDEN BY HIGH GRASS.

| MMS Code | Description of Function | Unit | Quantity | Remarks | Est. Cost |
|---|---|---|---|---|---|
| 2910 | Manual Brush and Tree Control | LF | 20 | SE DELINEATOR IS MOSTLY HIDDEN BY HIGH GRASS. | |

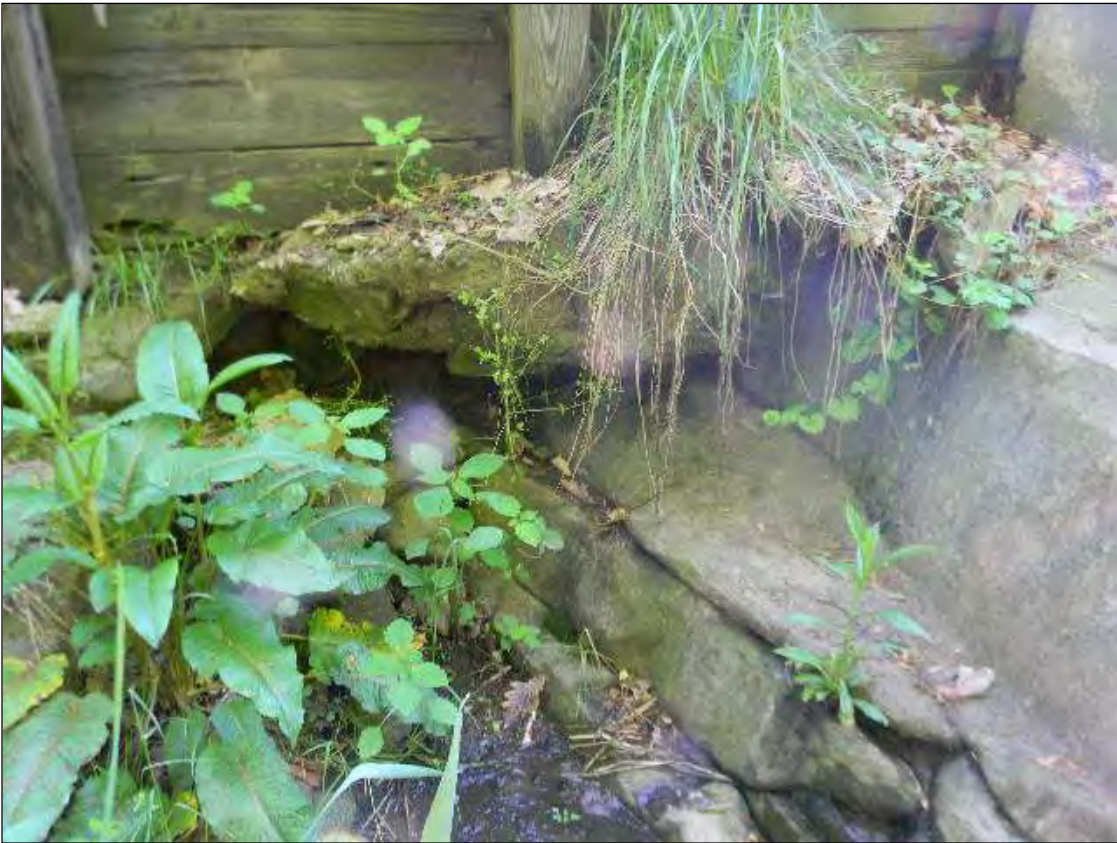
NW WING HAS CONCRETE SCOUR PROTECTION ALONG THE MID-AREA BUT PROTECTION IS UNDERMINED.

| MMS Code | Description of Function | Unit | Quantity | Remarks | Est. Cost |
|---|---|---|---|---|---|
| 3352 | Maint Slope Protection | SF | 5 | NW WING HAS CONCRETE SCOUR PROTECTION ALONG THE MID-AREA BUT PROTECTION IS UNDERMINED. 2" DEEP DIRT BUILDUP ALONG THE WHEELGUARDS HINDERING DRAINAGE. | |

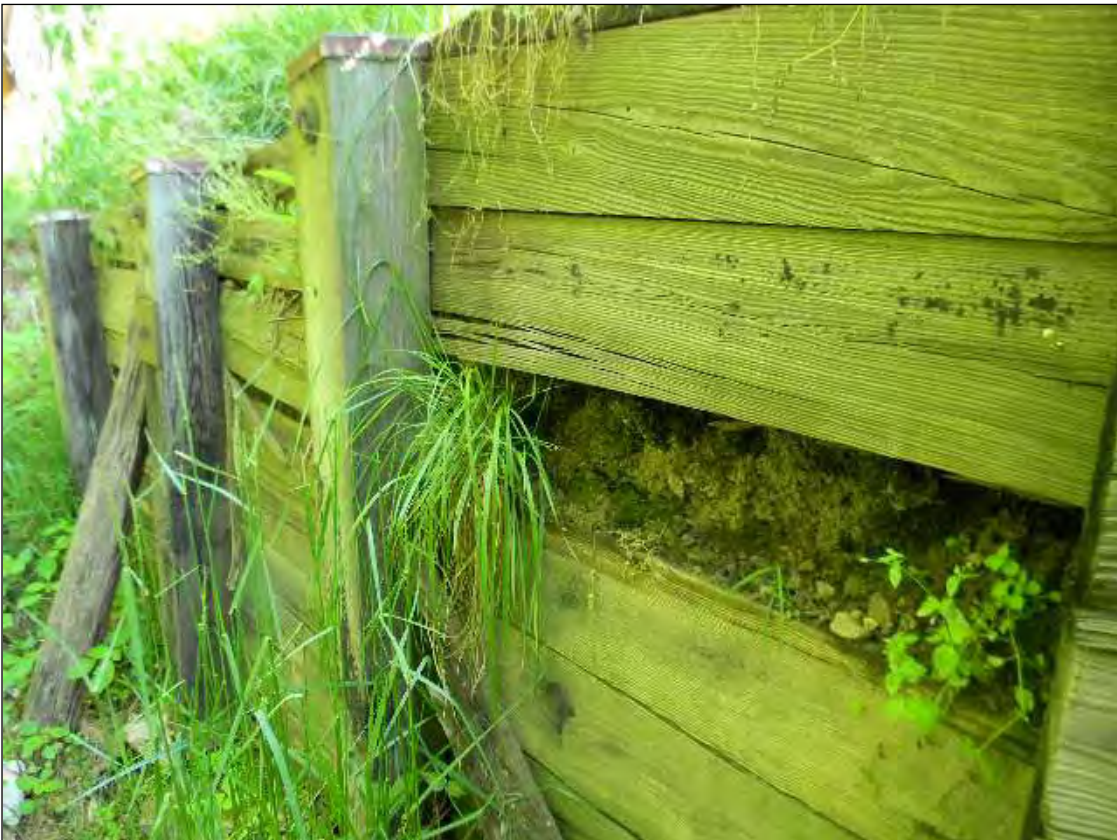
NW WING 3RD BOARD FROM THE TOP HAS COMPLETE DECAY EXPOSING THE FILL. THERE IS SCATTERED DECAY THROUGHOUT THE WING. THIS WING IS INCLUDED IN THE PRIORIT

| MMS Code | Description of Function | Unit | Quantity | Remarks | Est. Cost |
|---|---|---|---|---|---|
| 3346 | Repair / Maintain Timber Wings & Blkhds | SF | 40 | NW WING 3RD BOARD FROM THE TOP HAS COMPLETE DECAY EXPOSING THE FILL. THERE IS SCATTERED DECAY THROUGHOUT THE WING. THIS WING IS INCLUDED IN THE PRIORITY MAINTENANCE FOR THE BULKHEADS. | |

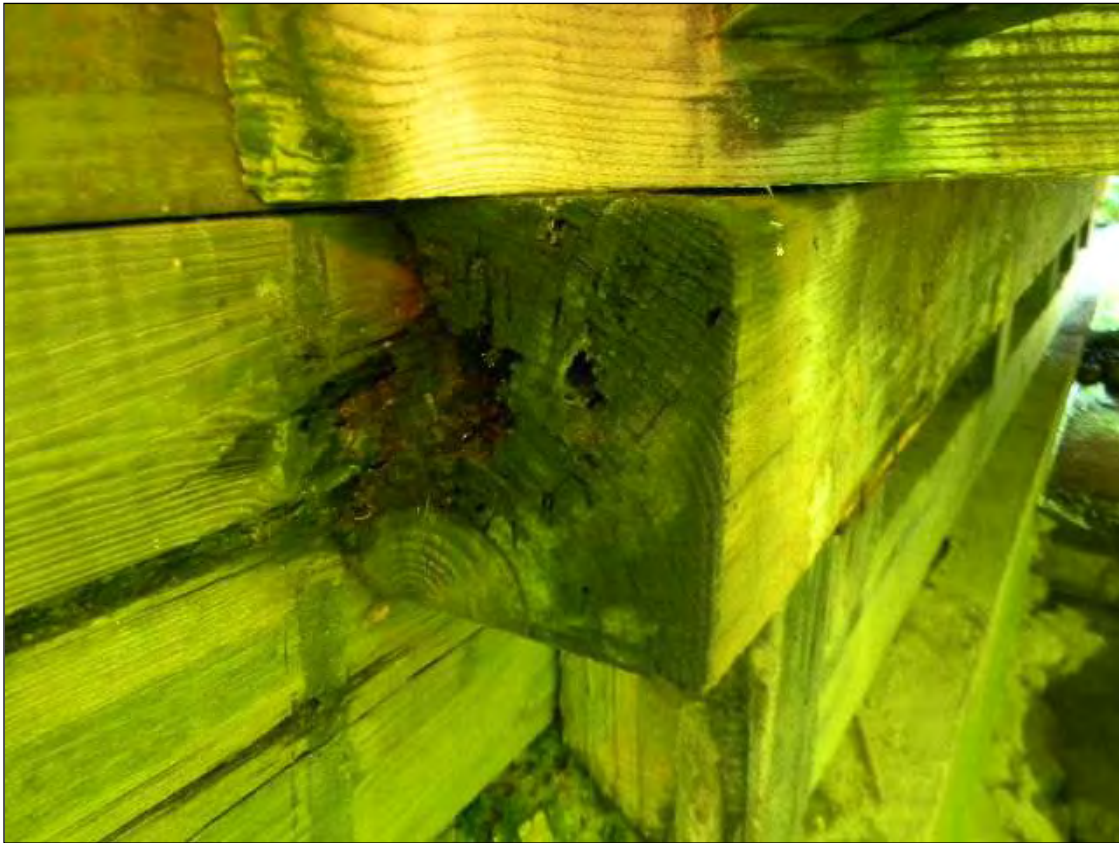
| MMS Code | MMS Description | Quantity |
|---|---|---|
| 6" WIDE X 11" HIGH X 10" DEEP DECAY IN THE LEFT END OF ABUTMENT 2 CAP EXTENDS UNDER THE 2 EXTERIOR JOISTS. A PRIORITY MAINTENANCE IS BEING RE-ISSUED FOR THIS CAP. | | |

6" WIDE X 11" HIGH X 10" DEEP DECAY IN THE LEFT END OF ABUTMENT 2 CAP EXTENDS UNDER THE 2 EXTERIOR JOISTS. A PRIORITY MAINTENANCE IS BEING RE-ISSUED F

| MMS Code | Description of Function | Unit | Quantity | Remarks | Est. Cost |
|---|---|---|---|---|---|
| 3344 | Repair / Replace Timber Substructure Components | LF | 2 | 6" WIDE X 11" HIGH X 10" DEEP DECAY IN THE LEFT END OF ABUTMENT 2 CAP EXTENDS UNDER THE 2 EXTERIOR JOISTS. A PRIORITY MAINTENANCE IS BEING RE-ISSUED FOR THIS CAP. | |

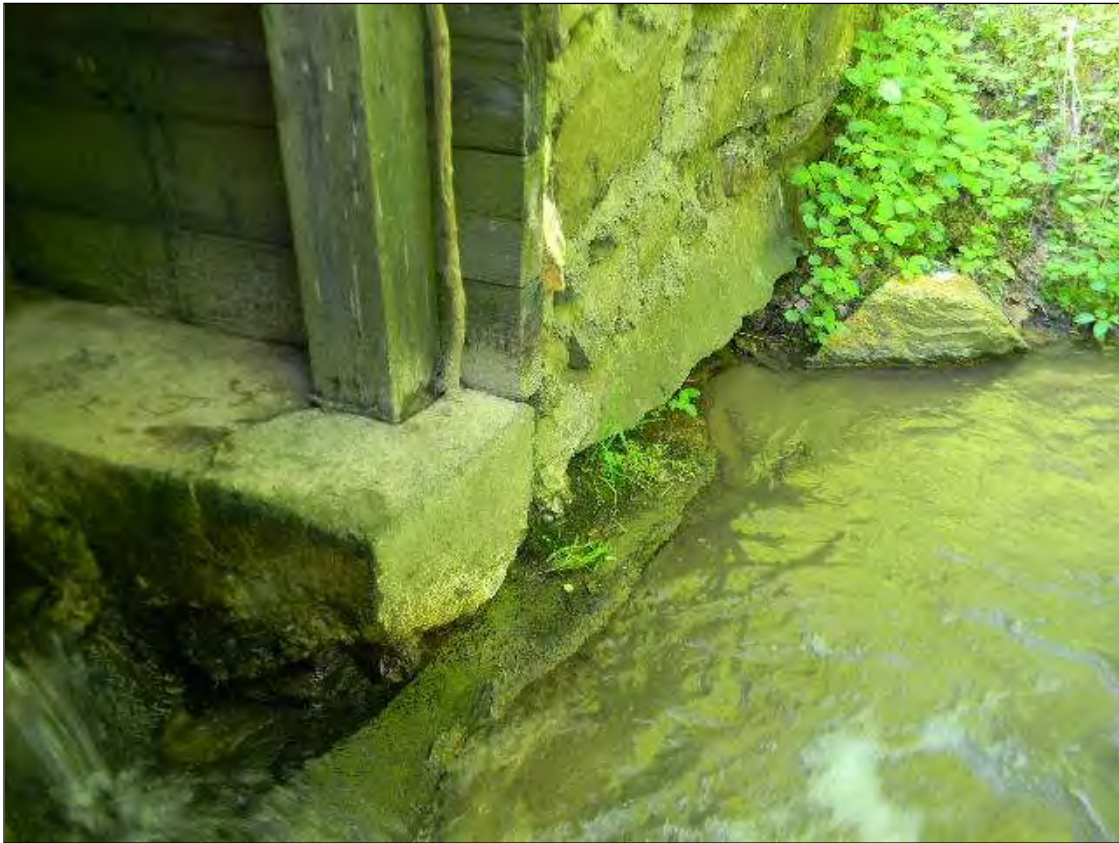
SW WING HAS CONCRETE SCOUR PROTECTION POURED ALONG THE BASE WHICH IS UNDERMINED 4" HIGH X 3' LONG X 6" DEEP.

| MMS Code | Description of Function | Unit | Quantity | Remarks | Est. Cost |
|---|---|---|---|---|---|
| 3352 | Maint Slope Protection | SF | 3 | SW WING HAS CONCRETE SCOUR PROTECTION POURED ALONG THE BASE WHICH IS UNDERMINED 4" HIGH X 3' LONG X 6" DEEP. | |

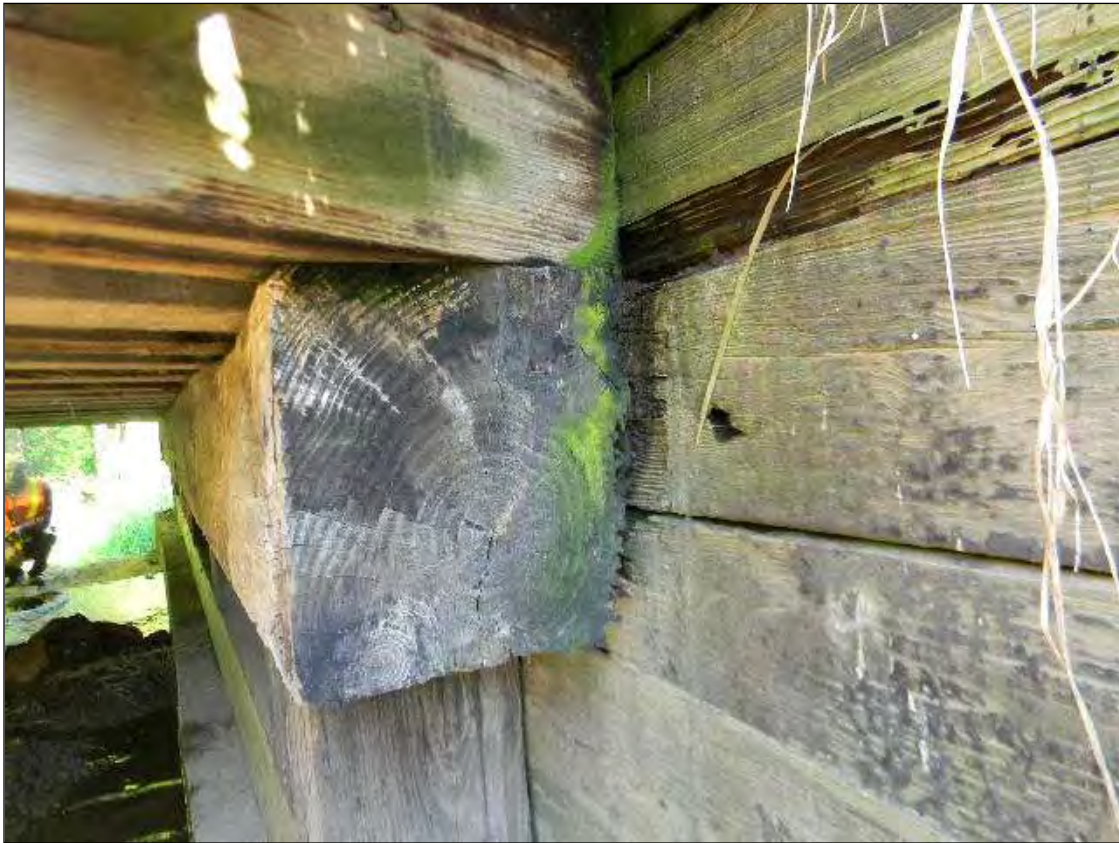
RIGHT END OF ABUTMENT 2 CAP HAS 2" WIDE X FULL HEIGHT X 2" DEEP DECAY ON THE CORNER AGAINST THE BULKHEAD.

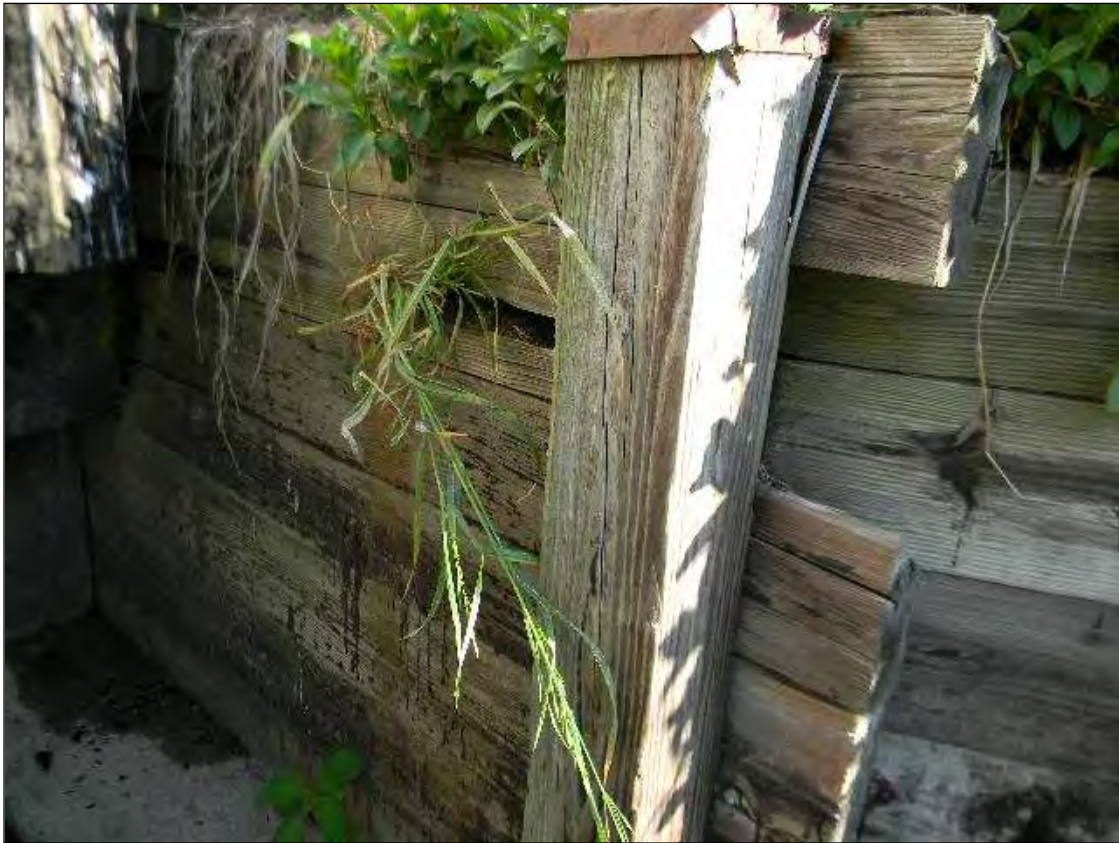
| MMS Code | MMS Description | Quantity |
|---|---|---|
| ABUTMENT 2 BULKHEAD BOARDS AT THE NE CORNER HAVE COMPLETE DECAY EXPOSING THE BACKFILL. THE STREAM FLOWS TOWARD THIS AREA. A PRIORITY MAINTENANCE IS BEING ISSUED FOR BOTH BULKHEADS AND ALL TIMBER WINGS. | | |

ABUTMENT 2 BULKHEAD BOARDS AT THE NE CORNER HAVE COMPLETE DECAY EXPOSING THE BACKFILL. THE STREAM FLOWS TOWARD THIS AREA. A PRIORITY MAINTENANCE IS BE

| MMS Code | Description of Function | Unit | Quantity | Remarks | Est. Cost |
|---|---|---|---|---|---|
| 3346 | Repair / Maintain Timber Wings & Blkhds | SF | 300 | ABUTMENT 2 BULKHEAD BOARDS AT THE NE CORNER HAVE COMPLETE DECAY EXPOSING THE BACKFILL. THE STREAM FLOWS TOWARD THIS AREA. A PRIORITY MAINTENANCE IS BEING ISSUED FOR BOTH BULKHEADS AND ALL TIMBER WINGS. | |

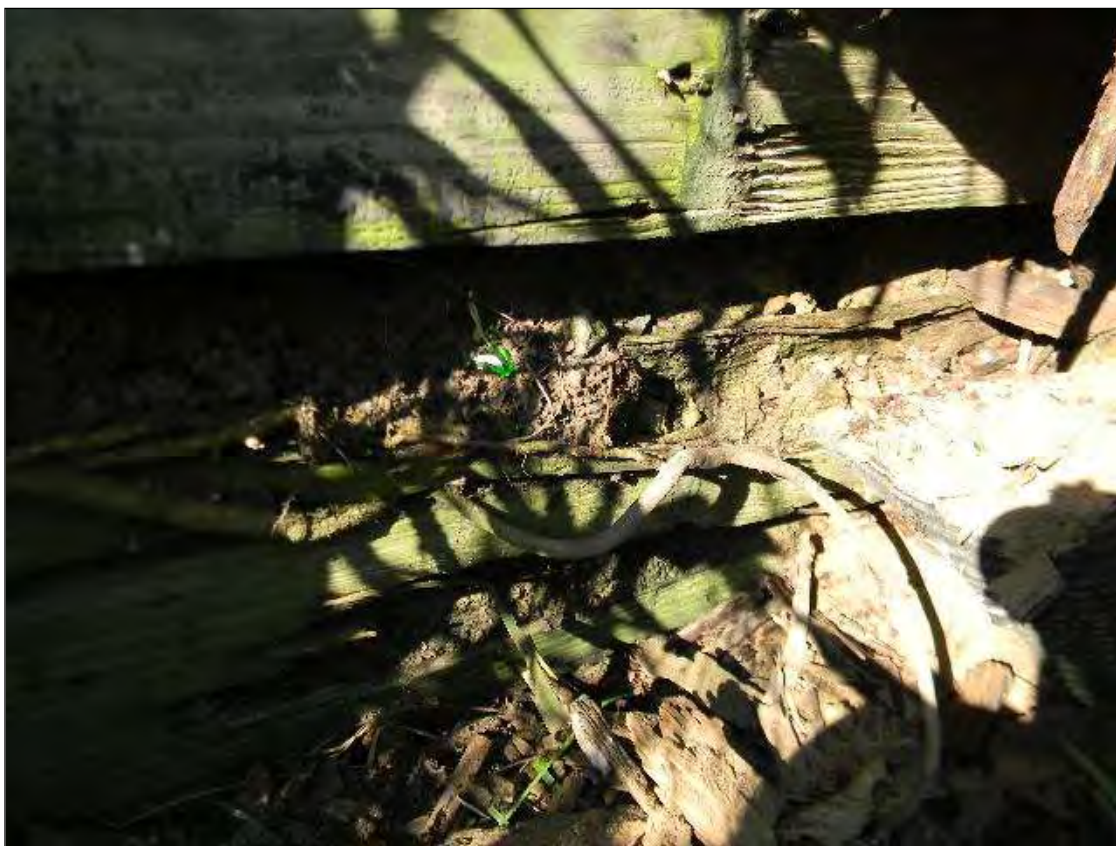
ABUTMENT 1 BULKHEAD AT THE SE CORNER HAS COMPLETE DECAY EXPOSING THE FILL. THIS AREA IS INCLUDED IN THE PRIORITY MAINTENANCE ISSUED FOR THE BULKHEADS.

| MMS Code | Description of Function | Unit | Quantity | Remarks | Est. Cost |
|---|---|---|---|---|---|
| 3346 | Repair / Maintain Timber Wings & Blkhds | SF | 40 | ABUTMENT 1 BULKHEAD AT THE SE CORNER HAS COMPLETE DECAY EXPOSING THE FILL. THIS AREA IS INCLUDED IN THE PRIORITY MAINTENANCE ISSUED FOR THE BULKHEADS. | |

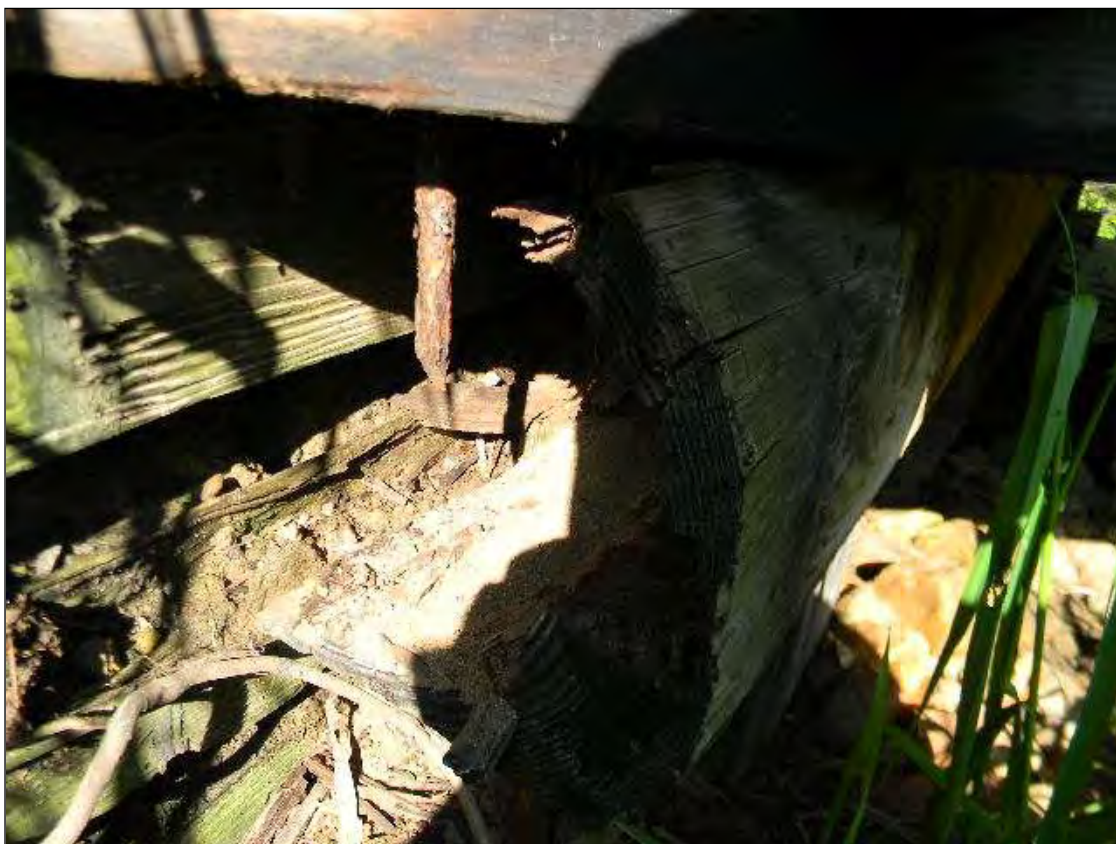
| MMS Code | MMS Description | Quantity |
|---|---|---|
| RIGHT END OF ABUTMENT 1 CAP HAS 95% LOSS UNDER THE 2 EXTERIOR JOISTS. DECAY EXTENDS 5' INTO THE CAP UNDER THE 5 EXTERIOR JOISTS. A PRIORITY MAINTENANCE IS BEING ISSUED FOR THIS CAP. | | |

RIGHT END OF ABUTMENT 1 CAP HAS 95% LOSS UNDER THE 2 EXTERIOR JOISTS. DECAY EXTENDS 5' INTO THE CAP UNDER THE 5 EXTERIOR JOISTS. A PRIORITY MAINTENANC

| MMS Code | Description of Function | Unit | Quantity | Remarks | Est. Cost |
|---|---|---|---|---|---|
| 3344 | Repair / Replace Timber Substructure Components | LF | 8 | RIGHT END OF ABUTMENT 1 CAP HAS 95% LOSS UNDER THE 2 EXTERIOR JOISTS. DECAY EXTENDS 5' INTO THE CAP UNDER THE 5 EXTERIOR JOISTS. A PRIORITY MAINTENANCE IS BEING ISSUED FOR THIS CAP. | |

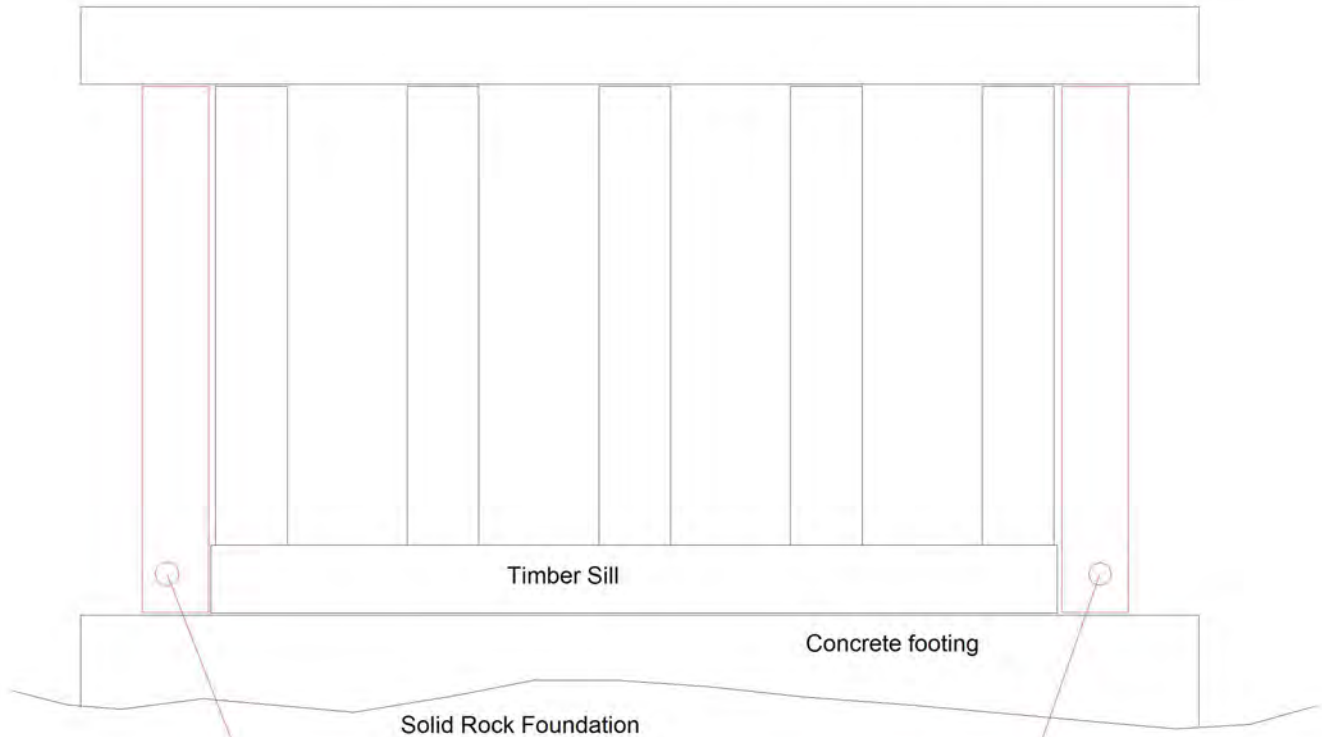
Note: Supplement post flush against outside of end posts of both abutments  
(9 3/4" x 9 3/4" @ abut. 1; 11 5/8" x 11 5/8" @ abut. 2)

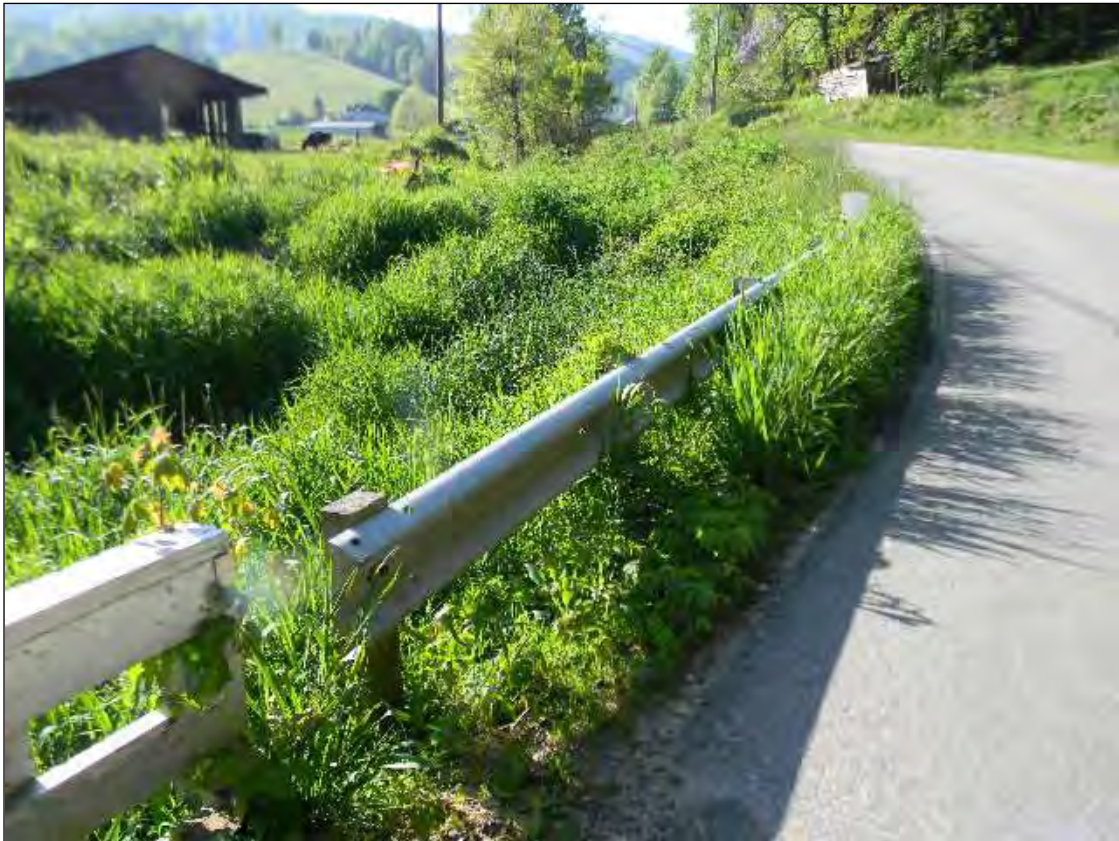
GUARDRAIL AT THE SE CORNER NW GUARDRAIL IS SIMILAR. NOTE GUARDRAIL NOT ATTACHED TO BRIDGERAIL.
