NC DEPARTMENT OF TRANSPORTATION  
DIVISION OF HIGHWAYS  
BRIDGE MANAGEMENT UNIT

# BRIDGE INSPECTION REPORT

COUNTY HAYWOOD BRIDGE NUMBER 430315 INSPECTION CYCLE 2 YRS  
ROUTE SR1346 ACROSS STEPHENS CREEK M.P. 0

INSPECTION DATE 03/05/2013

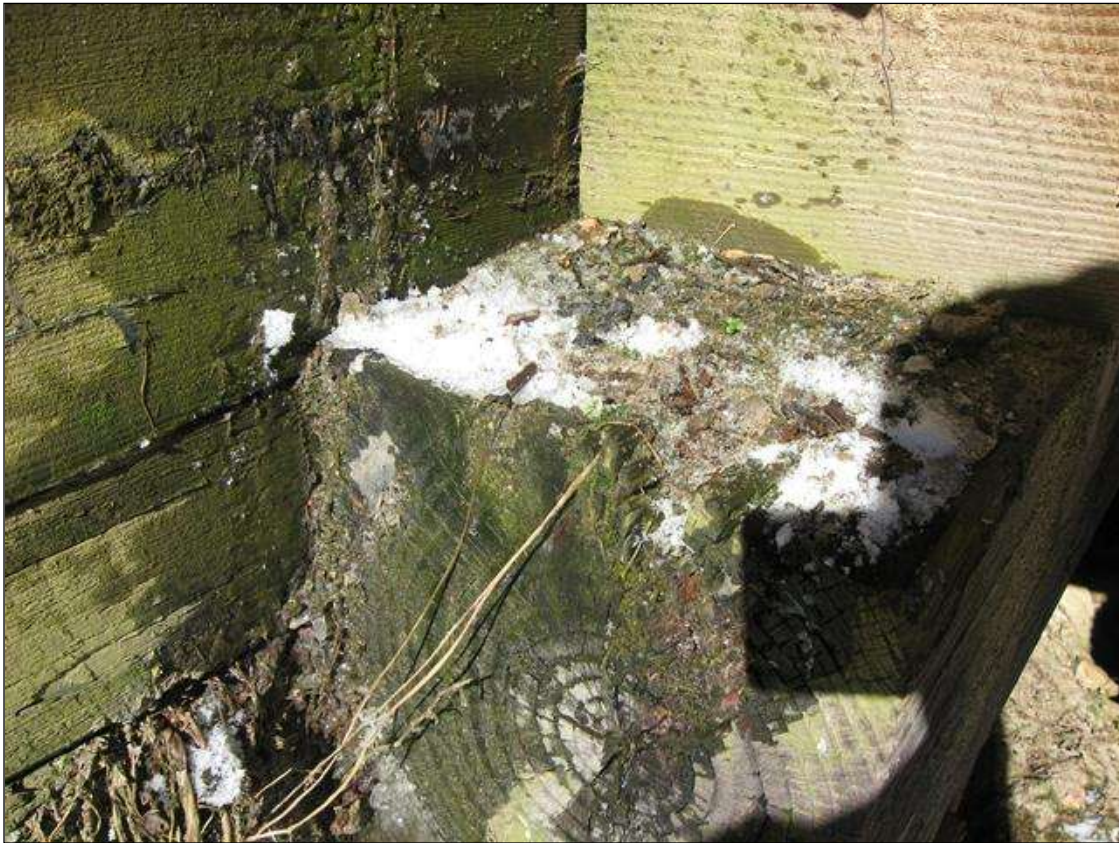
| <b>35a</b> | <b>F</b> | TIMBER ABUTMENT CAPS; ALL TIMBERS ARE WEATHERED.<br>CAP AT ABUTMENT 1 HAS AN AREA OF DECAY UP TO 3/4" DEEP X 3/4" WIDE TO ITS<br>UPSTREAM END WITH AREA EXTENDING TO EXT. JOIST AT THIS TIME.<br>[SEE REP. PHOTO].<br>NO PROBLEMS AS YET DUE TO CONDITION.<br>CAP AT ABUTMENT 2 IS WEATHERED WITH SCATTERED AREAS OF UP TO 1/2" DEEP<br>DECAY.<br>CONDITION IS CAUSING NO PROBLEMS AS YET. | |

AREA OF DECAY TO CAP ABUTMENT 1 ON UPSTREAM SIDE.

| MMS Code | Description of Function | Unit | Quantity | Remarks | Est. Cost |
|---|---|---|---|---|---|
| 3344 | Repair / Replace Timber Substructure Components | LF | 30 | AREA OF DECAY TO THE UPSTREAM END OF TIMBER CAP AT ABUTMENT 1.<br>AREA OF DECAY TO POST 3 AT ABUTMENT 2. | |

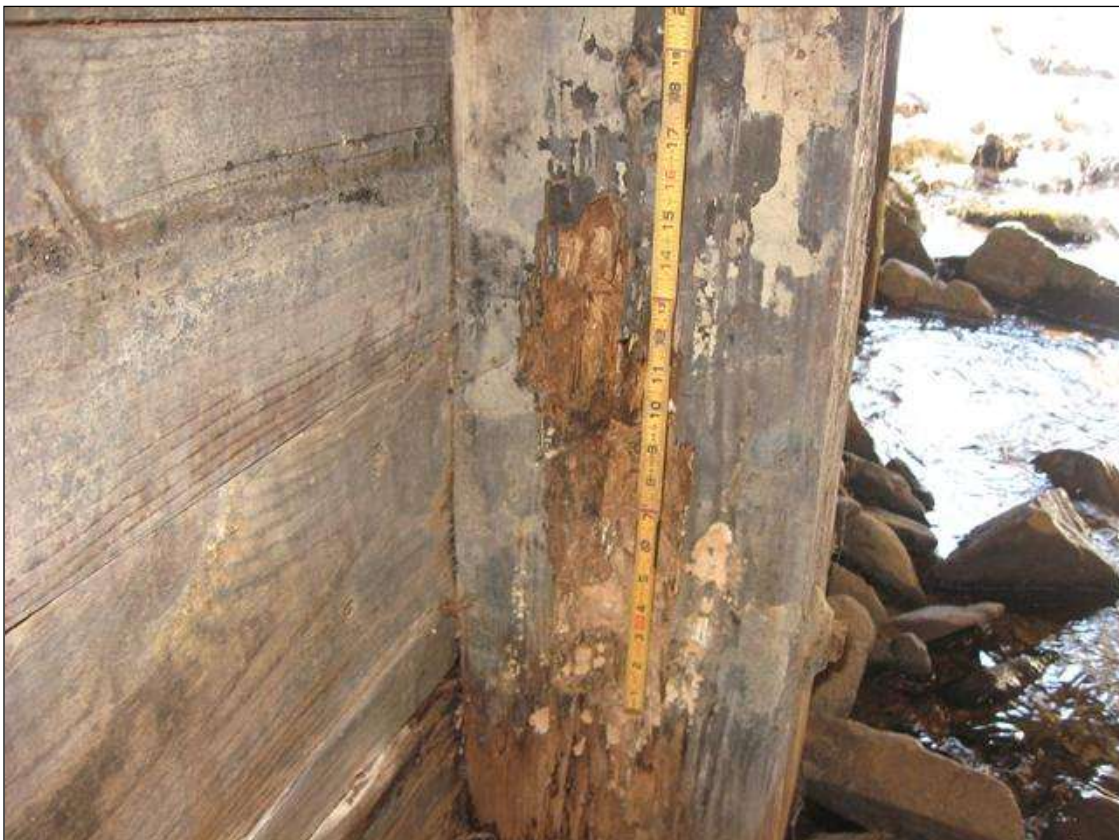
| <b>35b</b> | <b>F</b> | TIMBER ABUTMENT POST; POST 3 AT ABUTMENT 2 HAS AN AREA OF 4" WIDE X 3"<br>DEEP X 1'-3" HIGH DECAY TO ITS DOWNSTREAM FACE.<br>[SEE PHOTO].<br>ALL OTHER ORIGINAL TIMBERS ARE WEATHERED WITH A COUPLE HAVING LIGHT<br>DECAY UP TO 1/2" DEEP - VERY SCATTERED.<br>POST 1 AT ABUTMENT 1 HAS BEEN SUPPLEMENTED SOMETIME IN THE PAST.<br>THIS IS CONSIDERED A TEMP. REPAIR. | |

DECAY TO POST 3 ABUTMENT 2

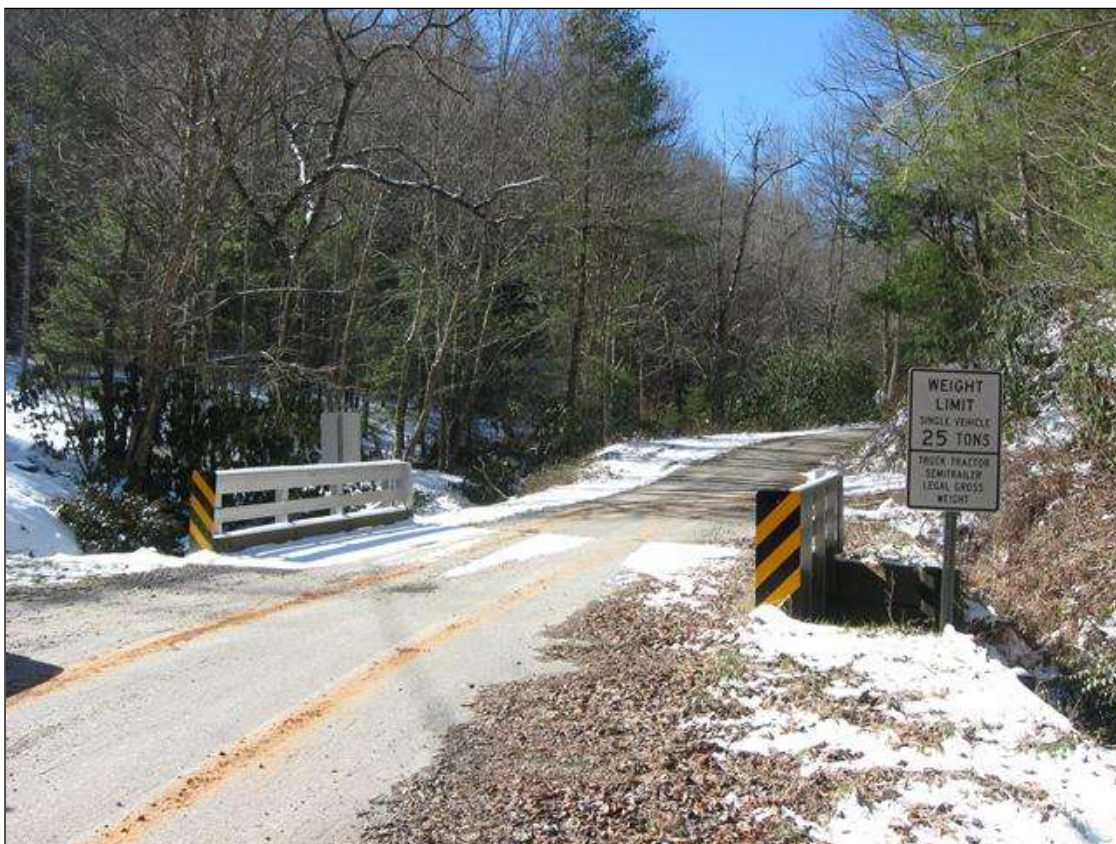
LOOKING SOUTH - BRIDGE IS POSTED SV 25 / LGW.

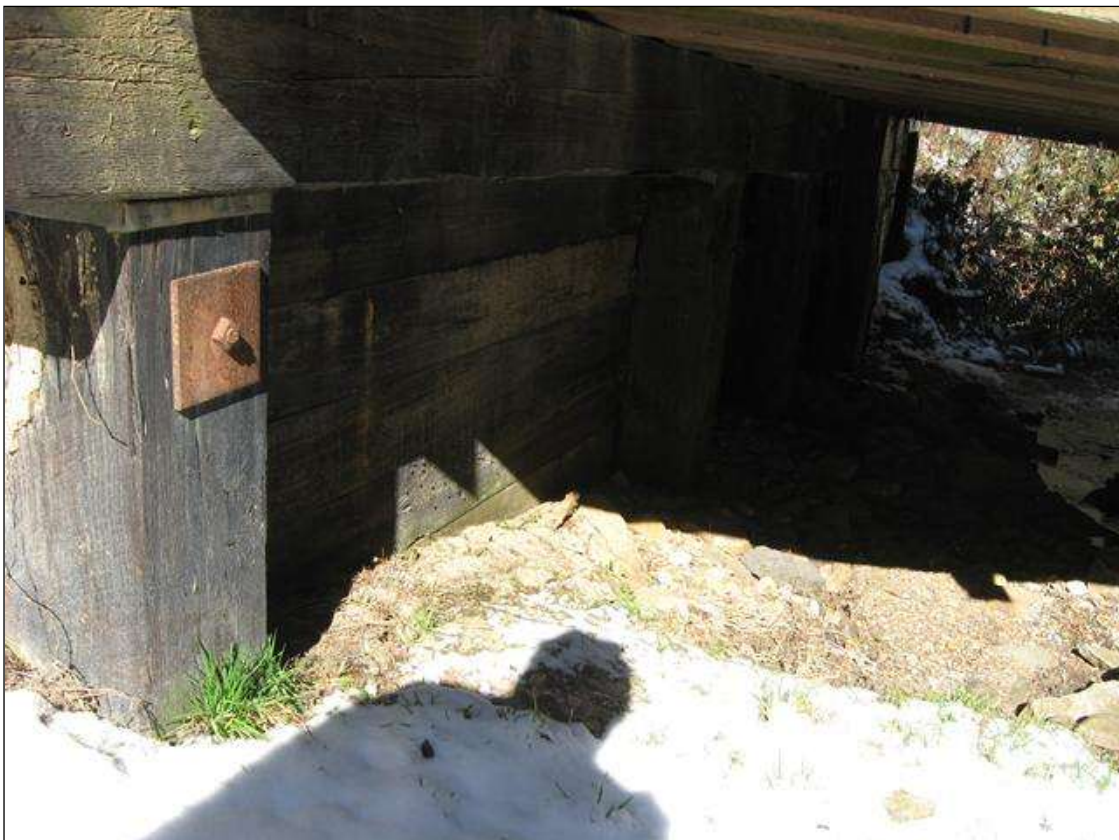
TEMP. REPAIR - POST 1 AT ABUTMENT 1 HAS BEEN  
SUPPLEMENTED SOMETIME IN THE PAST.

ABUTMENT 1 - TEMP. REPAIR TO POST 1.
