NC DEPARTMENT OF TRANSPORTATION  
DIVISION OF HIGHWAYS  
BRIDGE MANAGEMENT UNIT

# BRIDGE INSPECTION REPORT

COUNTY HAYWOOD BRIDGE NUMBER 430317 INSPECTION CYCLE 2 YRS  
ROUTE SR1346 ACROSS STEPHENS CREEK M.P. 0

INSPECTION DATE 12/12/2011

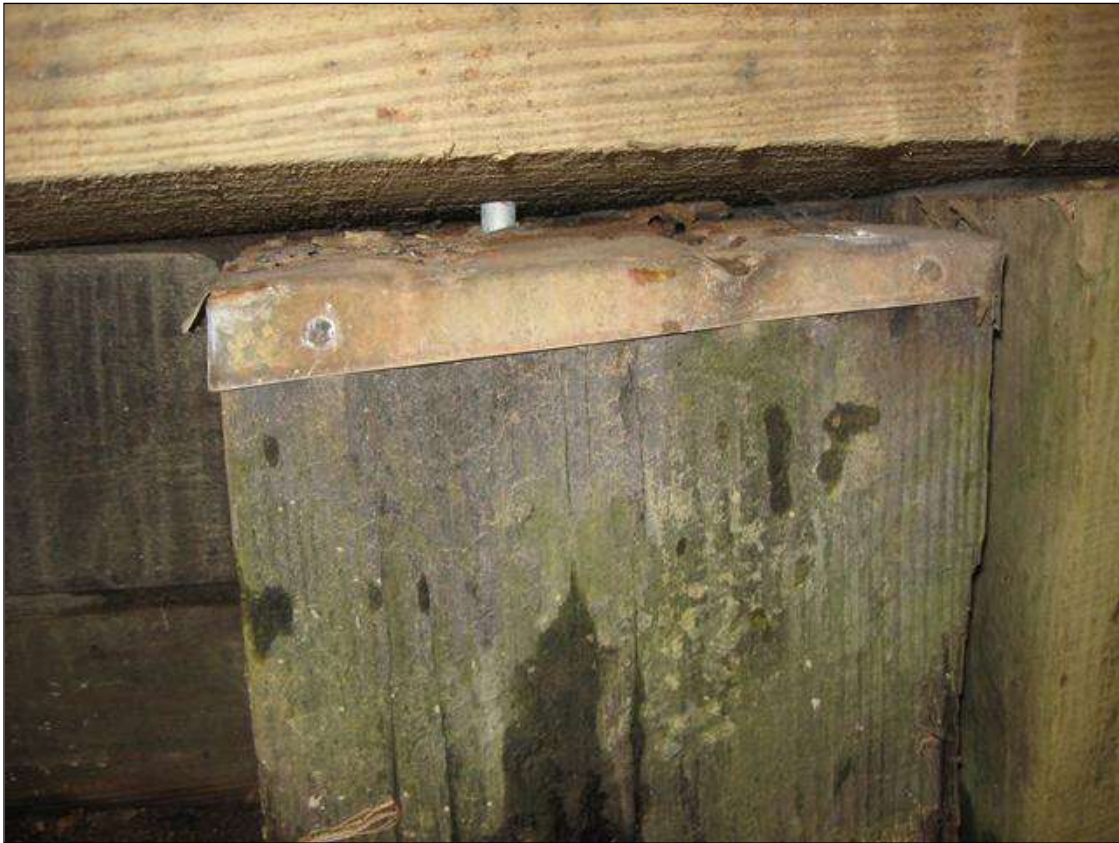
| Bridge I&A Form 1(82)H<br><b>State of North Carolina</b><br><b>Dept. of Transportation</b><br><b>Division of Highways</b> | | <h1 style="text-align: center;">FIELD INSPECTION REPORT</h1> <p style="text-align: center;"><u>Bridge Inspection &amp; Analysis</u></p> | |
|---|---|---|--|
| 35b | G | TIMBER POST; SEVERAL NEW TIMBER POST HAVE BEEN PLACED SINCE PREVIOUS INSP. AND ARE IN GOOD CONDITION AT THIS TIME.<br>1 1/2" HIGH GAP BETWEEN TOP OF POST 2 AND 3 AND BOTTOM OF CAP AT ABUTMENT 2.<br>[SEE PHOTOS].<br>1/2" HIGH GAP BETWEEN TOP OF POST 9 AND BOTTOM OF CAP AT ABUTMENT 2.<br>[SEE PHOTO].<br>NO PROBLEMS DUE TO CONDITION AS YET HOWEVER IT NOW CREATES VERY LONG CENTERS BETWEEN POST THAT HAVE SOUND BEARINGS.<br>PRI. MAINT. ISSUED DUE TO THESE CONDITIONS. | |
| 61 | YES | PROMPT ACTION ISSUED; PRI. MAINT. ISSUED DUE TO GAPS BETWEEN TOP OF POST 2,3 AND 9 AND BOTTOM OF CAP AT ABUTMENT 2. | |

| MMS Code | MMS Description | Quantity |
|---|---|---|
| 1 1/2" HIGH GAP BETWEEN TOP OF POST 2 AND BOTTOM OF CAP AT ABUTMENT 2. | | |

GAP BETWEEN TOP OF POST 2 AND BOTTOM OF CAP AT ABUTMENT 2.

| MMS Code | Description of Function | Unit | Quantity | Remarks | Est. Cost |
|---|---|---|---|---|---|
| 3344 | Repair / Replace Timber Substructure Components | LF | <i>1 TSC</i> | 1 1/2" HIGH GAP BETWEEN TOP OF POST 2 AND BOTTOM OF CAP AT ABUTMENT 2. | |

| MMS Code | MMS Description | Quantity |
|---|---|---|
| Abutment Substructure | Bent/Span No. 1 | BEARING AREA FOR CAP AT POST 2<br>OF ABUTMENT 2. |

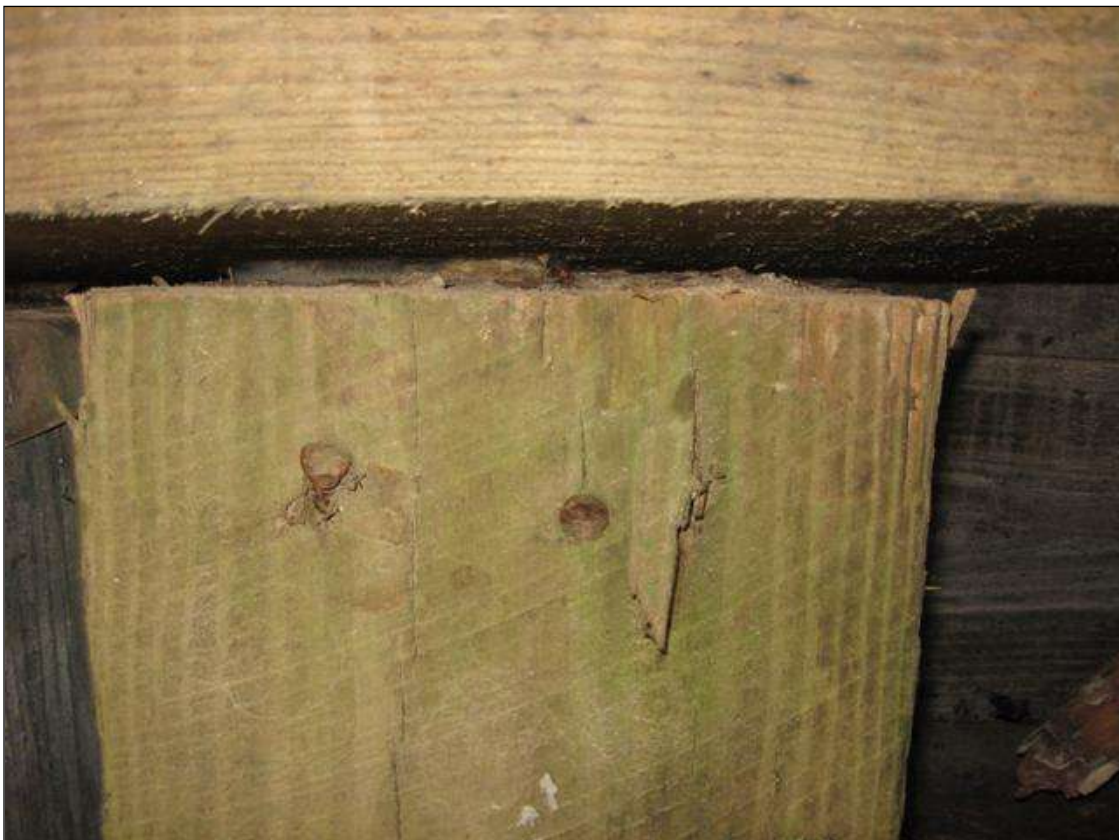
| MMS Code | MMS Description | Quantity |
|---|---|---|
| 1 1/2" HIGH GAP BETWEEN TOP OF POST 3 AND BOTTOM OF CAP AT ABUTMENT 2. | | |

GAP BETWEEN TOP OF POST 3 AND BOTTOM OF CAP AT ABUTMENT 2.

| MMS Code | Description of Function | Unit | Quantity | Remarks | Est. Cost |
|---|---|---|---|---|---|
| 3344 | Repair / Replace Timber Substructure Components | LF | <i>1 3/15/12</i> | 1 1/2" HIGH GAP BETWEEN TOP OF POST 3 AND BOTTOM OF CAP AT ABUTMENT 2. | |

| MMS Code | MMS Description | Quantity |
|---|---|---|
| Abutment Substructure | Bent/Span No. 1 | BEARING AREA FOR CAP AT POST 3<br>OF ABUTMENT 2. |

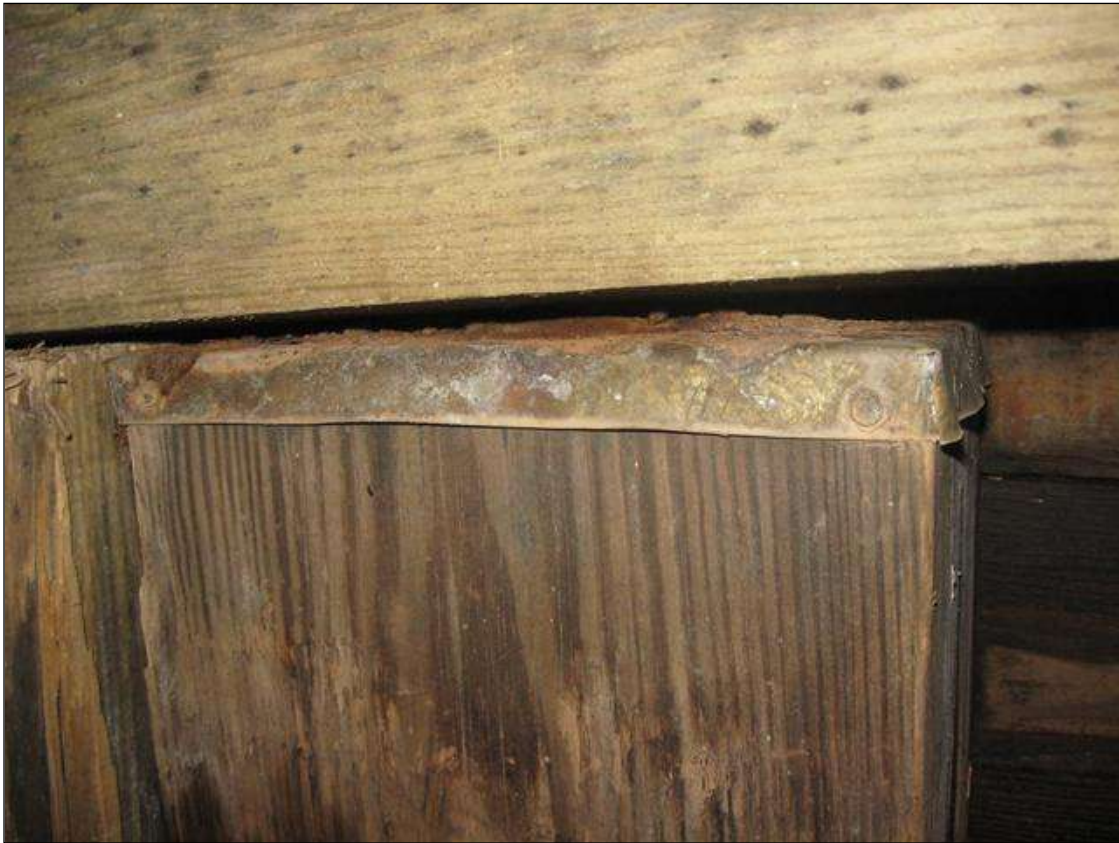
| MMS Code | MMS Description | Quantity |
|---|---|---|
| 1/2" HIGH GAP BETWEEN TOP OF POST 9 AND BOTTOM OF CAP AT ABUTMENT 2. | | |

GAP BETWEEN TOP OF POST 9 AND BOTTOM OF CAP AT ABUTMENT 2.

| MMS Code | Description of Function | Unit | Quantity | Remarks | Est. Cost |
|---|---|---|---|---|---|
| 3344 | Repair / Replace Timber Substructure Components | LF | <i>1 TSC</i> | 1/2" HIGH GAP BETWEEN TOP OF POST 9 AND BOTTOM OF CAP AT ABUTMENT 2. | |

| MMS Code | MMS Description | Quantity |
|---|---|---|
| Abutment Substructure | Bent/Span No. 1 | BEARING AREA FOR CAP ON POST 9<br>AT ABUTMENT 2. |
