NC DEPARTMENT OF TRANSPORTATION  
DIVISION OF HIGHWAYS  
BRIDGE MANAGEMENT UNIT

# BRIDGE INSPECTION REPORT

COUNTY HAYWOOD BRIDGE NUMBER 430372 INSPECTION CYCLE 2 YRS  
ROUTE SR1346 ACROSS STEPHENS CREEK M.P. 0

INSPECTION DATE 03/05/2013

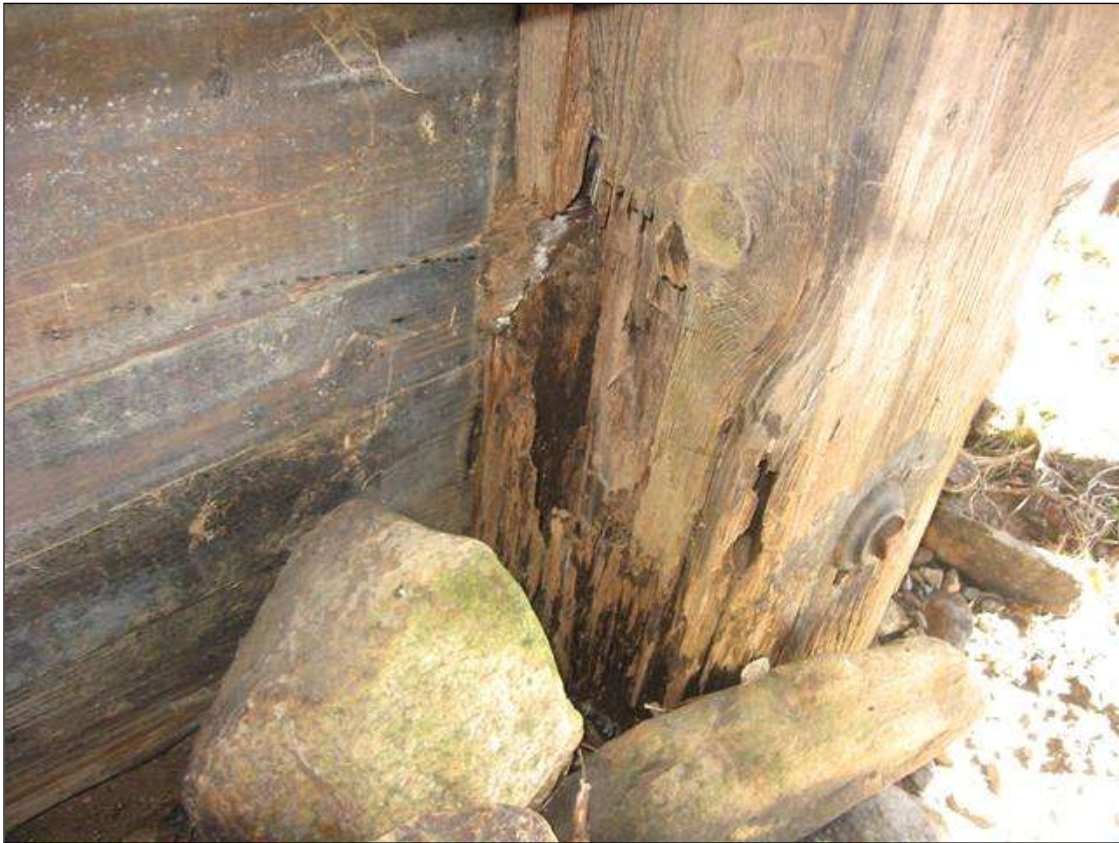
| <b>61</b> | <b>YES</b> | PROMPT ACTION ISSUED; PRI. MAINT. ISSUED DUE A 3" DEEP X 7" WIDE X 1'-6" HIGH AREA OF DECAY TO POST 3 AT ABUTMENT 2. | |

| MMS Code | MMS Description | Quantity |
|---|---|---|
| POST 3 AT ABUTMENT 2 HAS AN AREA OF 3" DEEP X 7" WIDE X 1'-6" HIGH DECAY TO ITS UPSTREAM FACE.<br>[SEE PHOTO].<br>NO SIGN OF ANY PROBLEMS DUE TO CONDITION AS YET. | | |

AREA OF 3" DEEP X 7" WIDE X 1'-6" HIGH DECAY TO UPSTREAM FACE OF POST 3 AT ABUTMENT 2.

| MMS Code | Description of Function | Unit | Quantity | Remarks | Est. Cost |
|---|---|---|---|---|---|
| 3344 | Repair / Replace Timber Substructure Components | LF | 4 | POST 3 AT ABUTMENT 2 HAS AN AREA OF 3" DEEP X 7" WIDE X 1'-6" HIGH DECAY TO ITS UPSTREAM FACE. [SEE PHOTO]. NO SIGN OF ANY PROBLEMS DUE TO CONDITION AS YET. | |

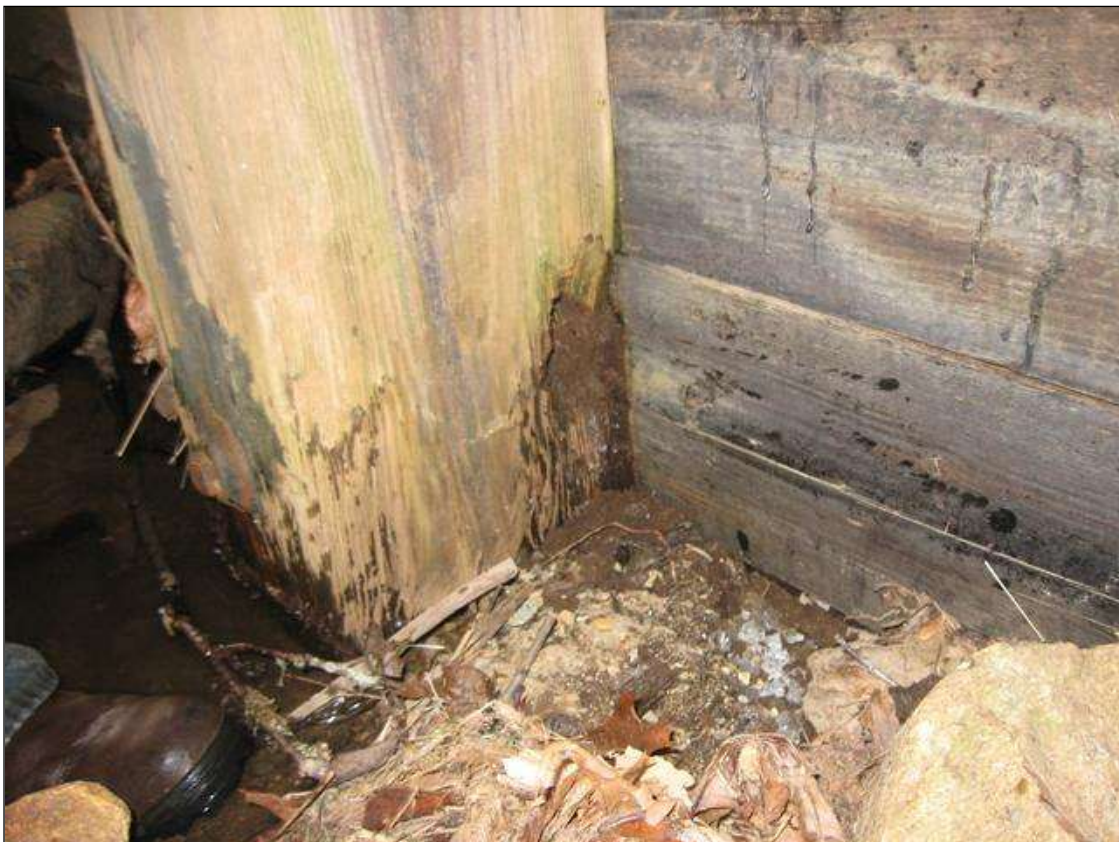
| <b>35b</b> | <b>F</b> | TIMBER ABUTMENT POST; SUPPLEMENT POST HAVE BEEN PLACED ALONGSIDE POST 1 AT BOTH ABUTMENTS SOMETIME IN THE PAST.<br>THIS REPAIR IS CONSIDERED TEMP.<br>SUPPLEMENT POST ARE IN GOOD CONDITION.<br>POST 2 AT ABUTMENT 2 HAS AN AREA OF 3" DEEP X 3" WIDE X 5" HIGH DECAY TO ITS DOWNSTREAM FACE.<br>[SEE PHOTO].<br>POST 3 AT ABUTMENT 2 HAS AN AREA OF 3" DEEP X 7" WIDE X 1'-6" HIGH DECAY TO ITS UPSTREAM FACE.<br>[SEE PHOTO].<br>PRI. MAINT. ISSUED DUE TO THIS CONDITION.<br>ALL OTHER ORIGINAL POST HAVE AREAS OF UP TO 3/4" DEEP DECAY TO THEIR LOWERMOST 1' +/-.<br>NO PROBLEMS AS YET. | |

DECAY TO POST 2 ABUTMENT 2.

| MMS Code | Description of Function | Unit | Quantity | Remarks | Est. Cost |
|---|---|---|---|---|---|
| 3344 | Repair / Replace Timber Substructure Components | LF | 4 | AREA OF 3" DEEP DECAY TO POST 2 AT ABUTMENT 2. | |

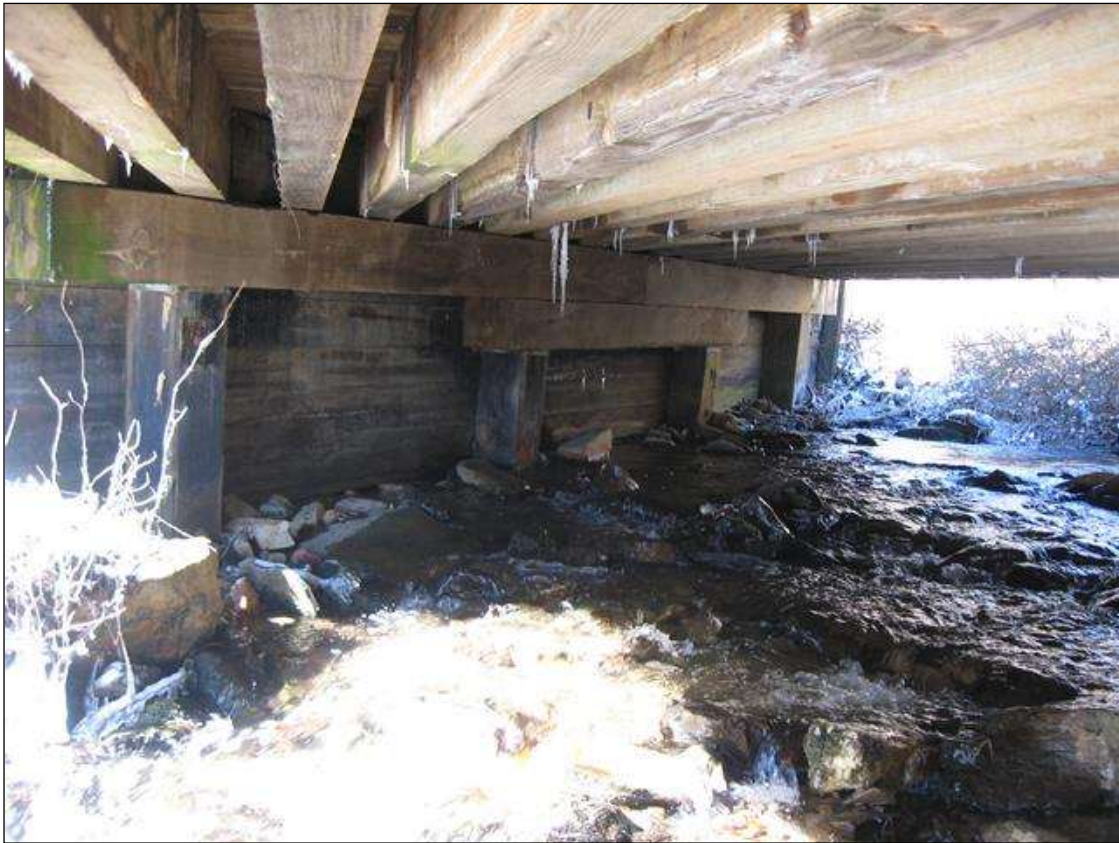
PRI. MAINT. ISSUED.  
TEMP. REPAIR - POST 1 AT BOTH ABUTMENTS HAVE  
BEEN SUPPLEMENTED SOMETIME IN THE PAST.

POST 1 HAS BEEN SUPPLEMENTED ON DOWNSTREAM SIDE AT BOTH ABUTS.  
 TIMBER AT ABUT.1 IS .97916 X .979166 WITH A 1' CTR. FROM ORIG. POST  
 TIMBER AT ABUT.2 IS .875 X 1' WITH A .9166 CTR. FROM ORIG. POST

ABUTMENT 1 - TEMP. REPAIR TO POST 1.

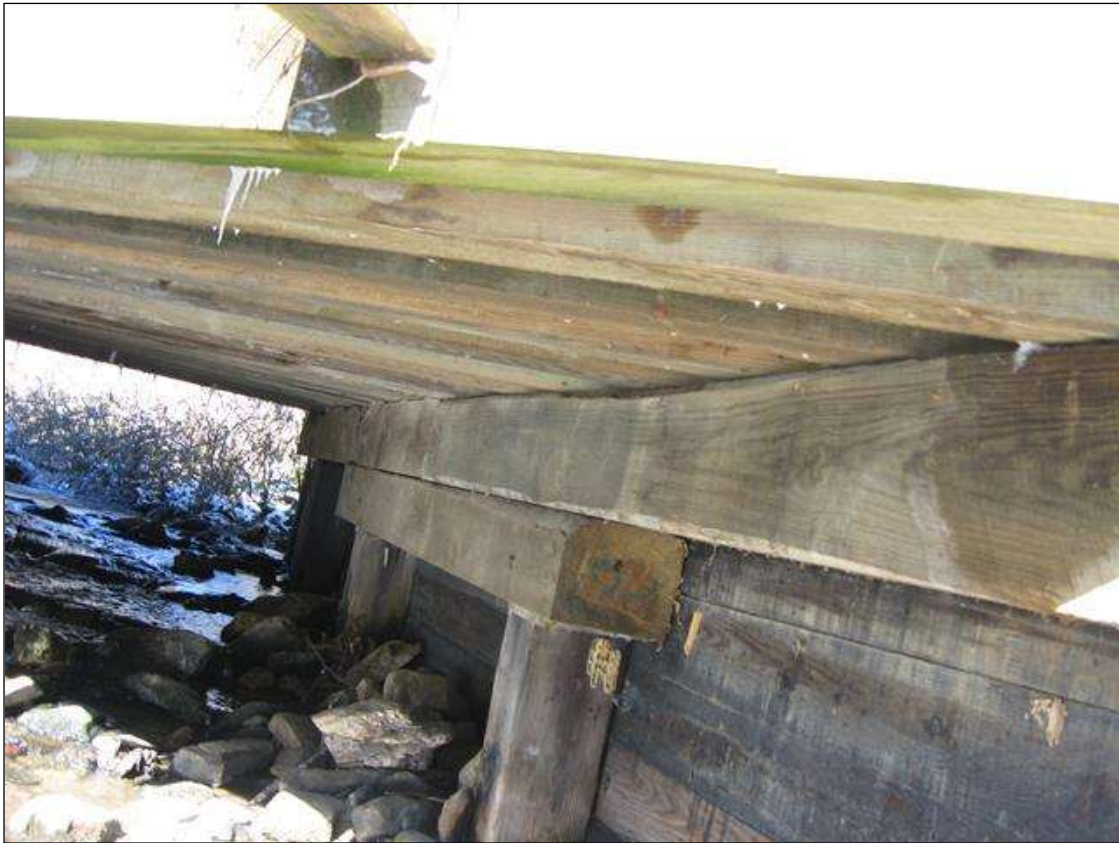
ABUTMENT 2 - TEMP. REPAIR TO POST 1.
