NC DEPARTMENT OF TRANSPORTATION  
DIVISION OF HIGHWAYS  
BRIDGE MANAGEMENT UNIT

# BRIDGE INSPECTION REPORT

COUNTY HAYWOOD BRIDGE NUMBER 430326 INSPECTION CYCLE 2 YRS  
ROUTE SR1318 ACROSS HEMPHILL CREEK M.P. 0

INSPECTION DATE 04/01/2013

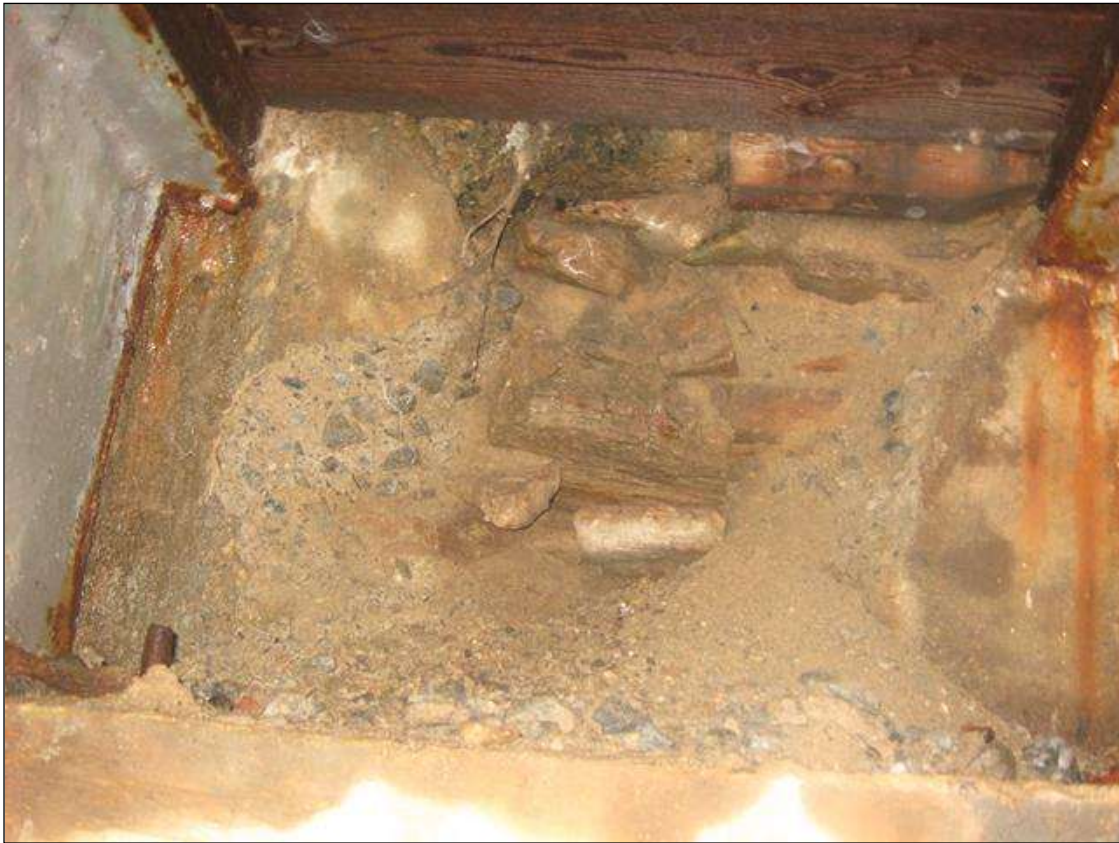
| <b>36d</b> | <b>F</b> | BACKWALLS; 1/8" TO 1/4" WIDE RANDOM TYPE CRACKS UP TO 2' LONG FOUND AT SCATTERED LOCATIONS TO BOTH ABUTMENTS. AREAS OF UP TO 1' ROUND X 3" DEEP DETER. TO BACKWALLS AT SCATTERED LOCATIONS TO BOTH ABUTMENTS. [SEE REP. PHOTO]. | |

AREA OF SPALLING TO BREASTWALL BETWEEN BEAMS 1 AND 2 AT ABUTMENT 2.

| MMS Code | Description of Function | Unit | Quantity | Remarks | Est. Cost |
|---|---|---|---|---|---|
| 3348 | Maintain Concrete Substructure Components | LF | 10 | AREAS OF CRACKING AND DETER. TO BACKWALLS AT BOTH ABUTMENTS. | |

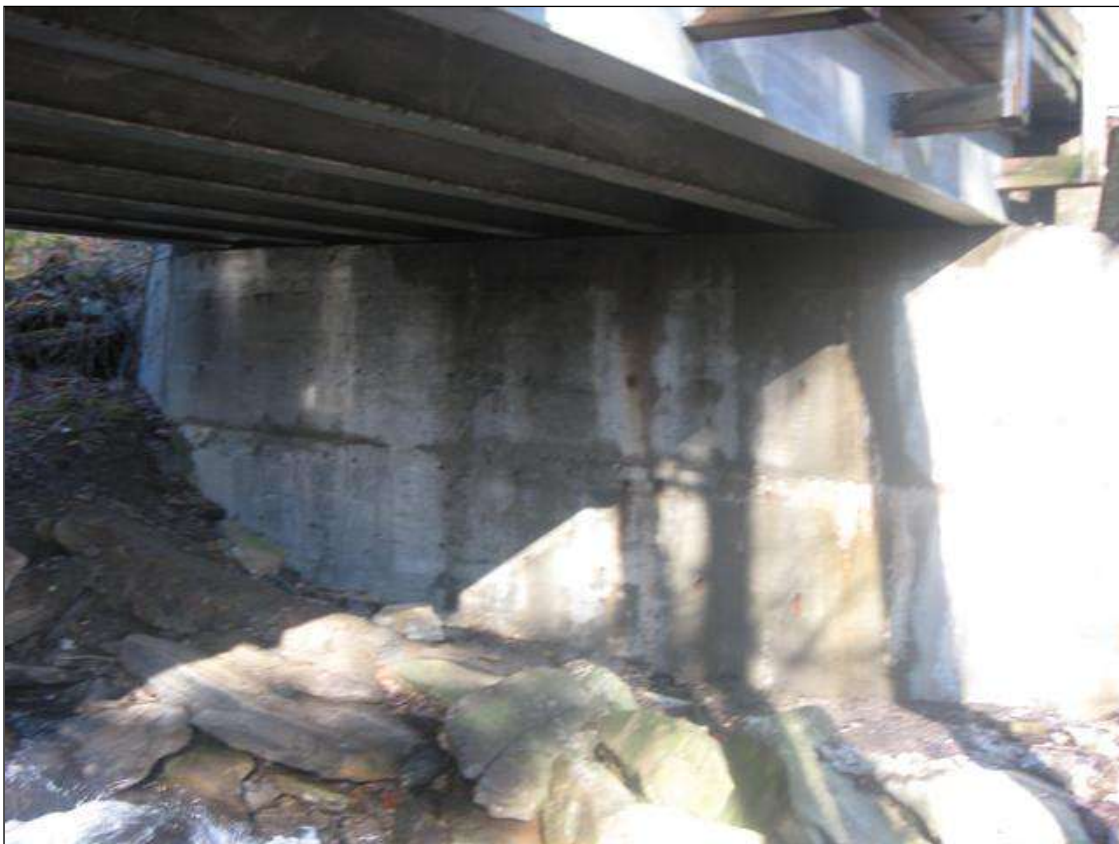
| <b>36a</b> | <b>G</b> | CONCRETE ABUTMENTS; 6" [ +/- ] WIDE FACE OF CONCRETE HAS BEEN PLACED ON STREAM FACE OF BOTH ABUTMENTS SOMETIME IN THE PAST. THIS REPAIR IS CONSIDERED TEMP. | |

ABUTMENT 1 - TEMP. REPAIR TO BREASTWALL.

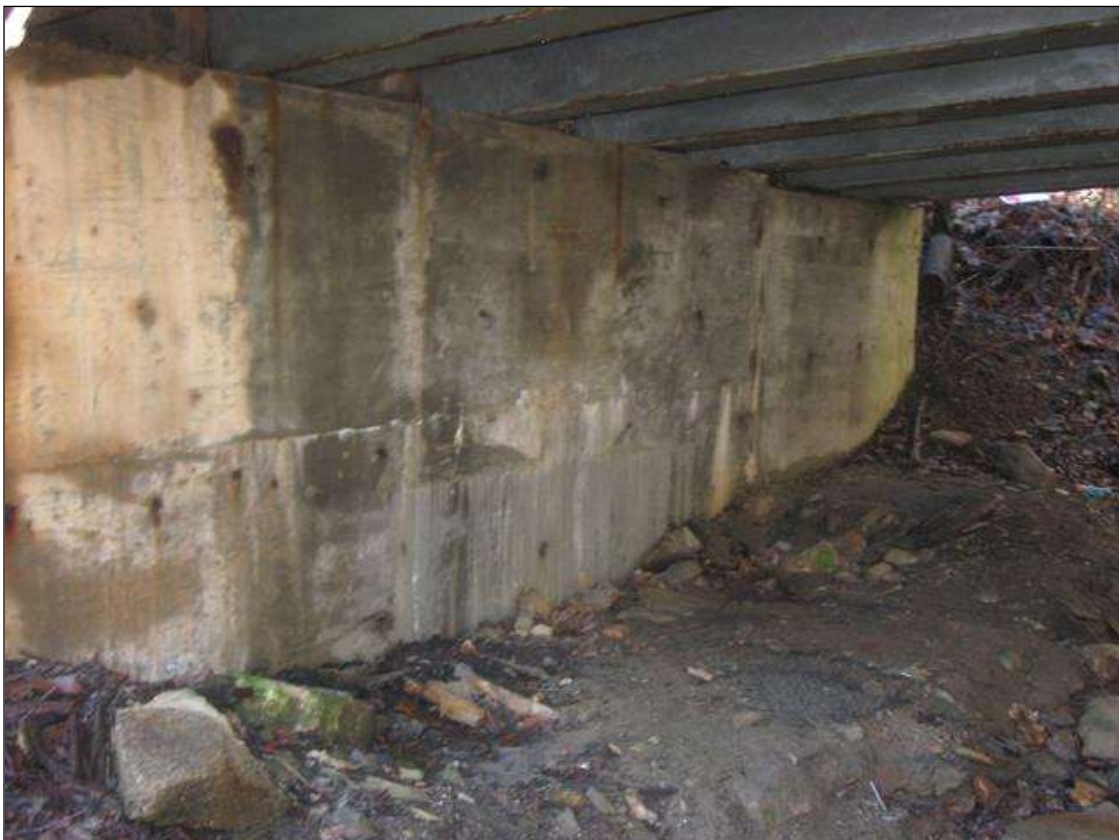
ABUTMENT 2 - TEMP. REPAIR TO BREASTWALL.
