NC DEPARTMENT OF TRANSPORTATION  
DIVISION OF HIGHWAYS  
BRIDGE MANAGEMENT UNIT

# BRIDGE INSPECTION REPORT

INSPECTION TYPE: Routine Inspection

COUNTY HAYWOOD BRIDGE NUMBER 430334 INSPECTION CYCLE 2 YRS  
ROUTE SR1212 ACROSS CREEK M.P. 0

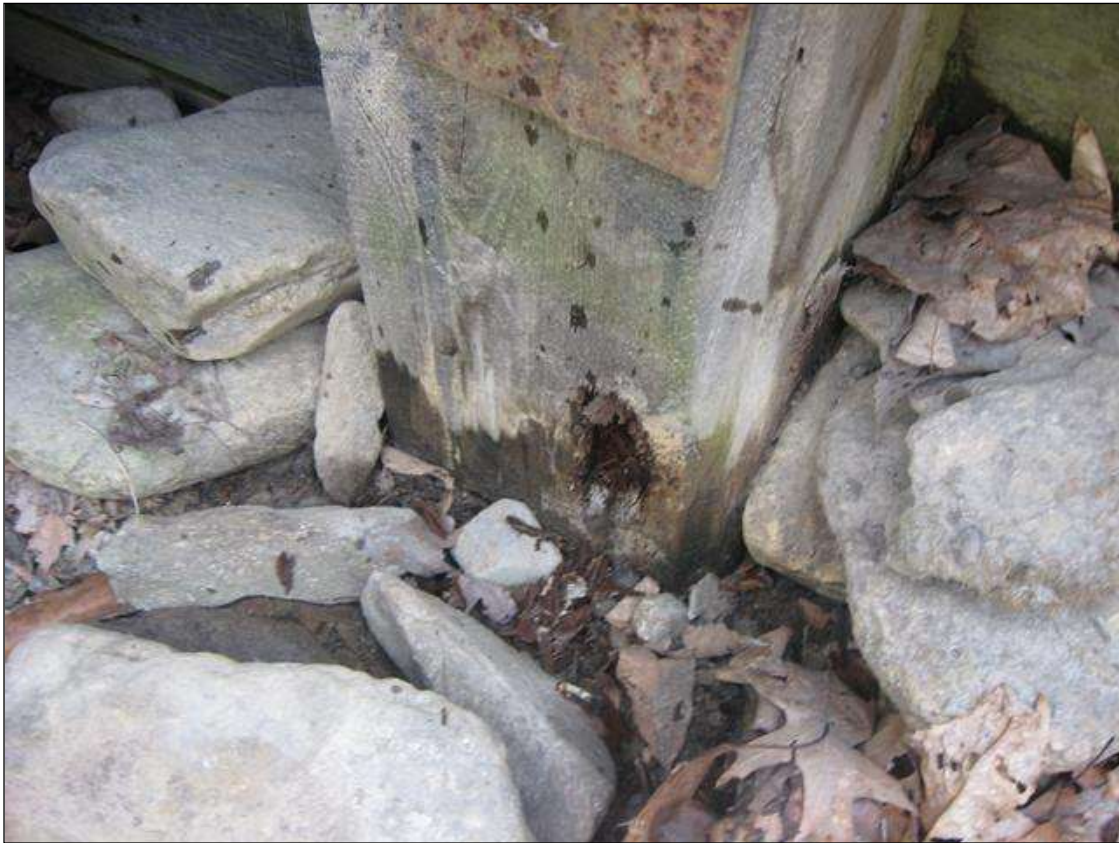
| <b>35b</b> | <b>F</b> | TIMBER POST; ALL ORIGINAL TIMBERS ARE WEATHERED WITH SCATTERED AREAS OF DECAY UP TO 1" DEEP DECAY.<br>2 1/2" DEEP X 2" ROUND AREA OF DECAY TO POST 5 AT ABUTMENT 2.<br>[SEE PHOTO].<br>NO PROBLEMS DUE TO CONDITION AS YET.<br>POST 1 AND POST 5 AT ABUTMENT 1 AND POST 1 AT ABUTMENT 2 HAVE BEEN SUPPLEMENTED SOMETIME IN THE PAST.<br>[SEE DATA WORKSHEET].<br>THESE ARE CONSIDERED TEMP. REPAIRS. | |

DECAY TO POST 5 ABUTMENT 2.

| MMS Code | Description of Function | Unit | Quantity | Remarks | Est. Cost |
|---|---|---|---|---|---|
| 3344 | Repair / Replace Timber Substructure Components | LF | 4 | AREA OF 2 1/2" DEEP DECAY TO POST 5 AT ABUTMENT 2. | |

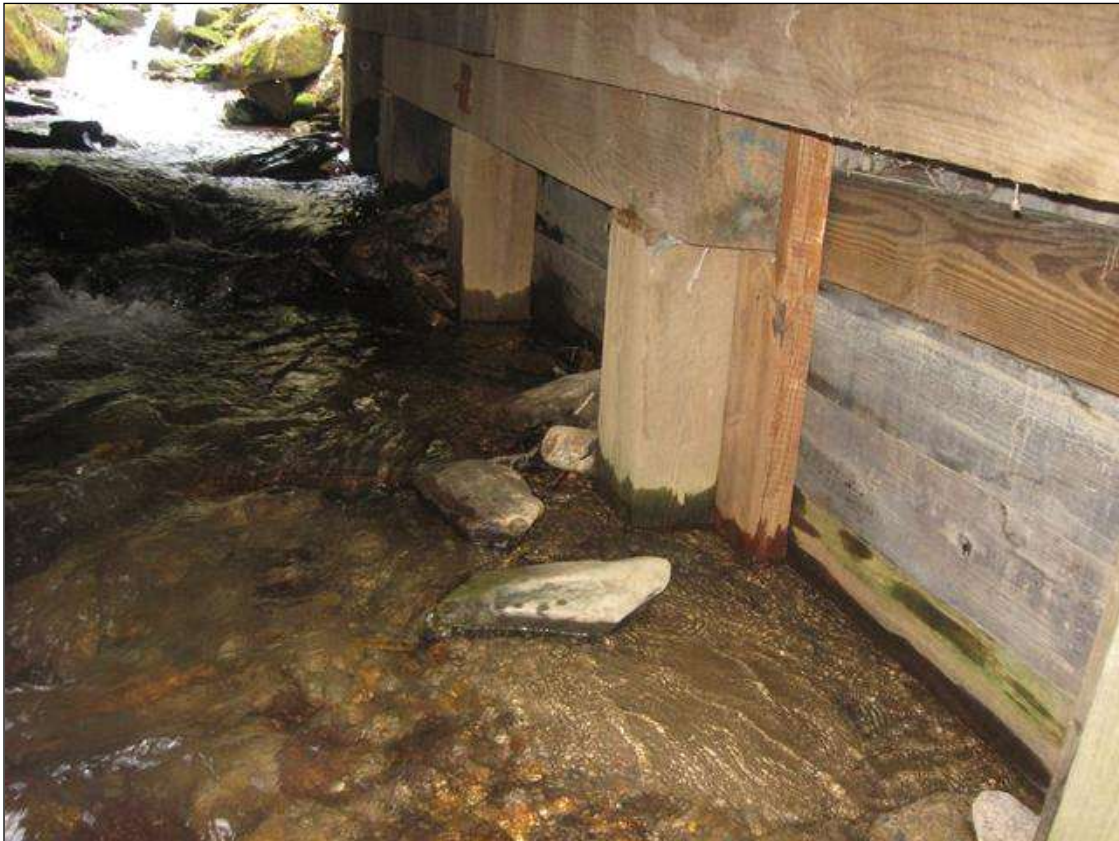
ABUTMENT 1 - TEMP. REPAIR TO POST 1 AND 5.

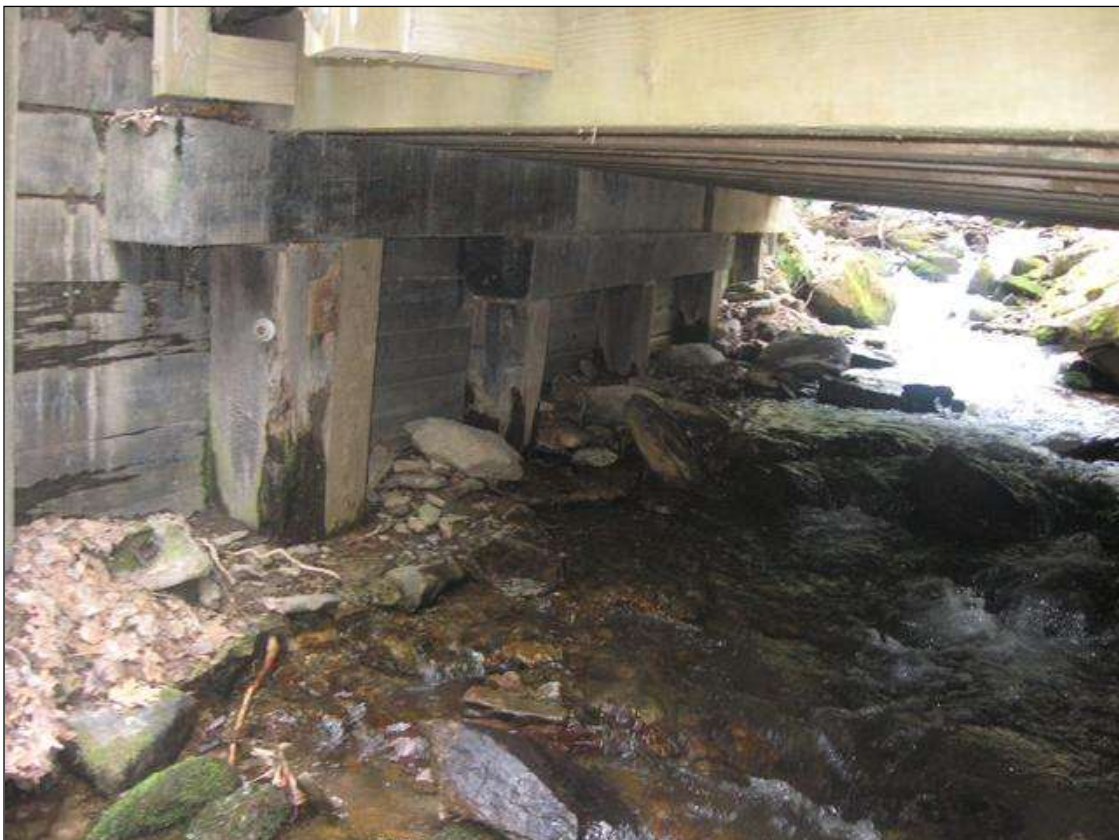
ABUTMENT 2- TEMP. REPAIR TO POST 1.
